# Assessment of Dam Safety Coal Combustion Surface Impoundments (Task 3) Draft Report

Big Rivers Electric  
Cooperative

Coleman Generating  
Station

Hawesville, Kentucky

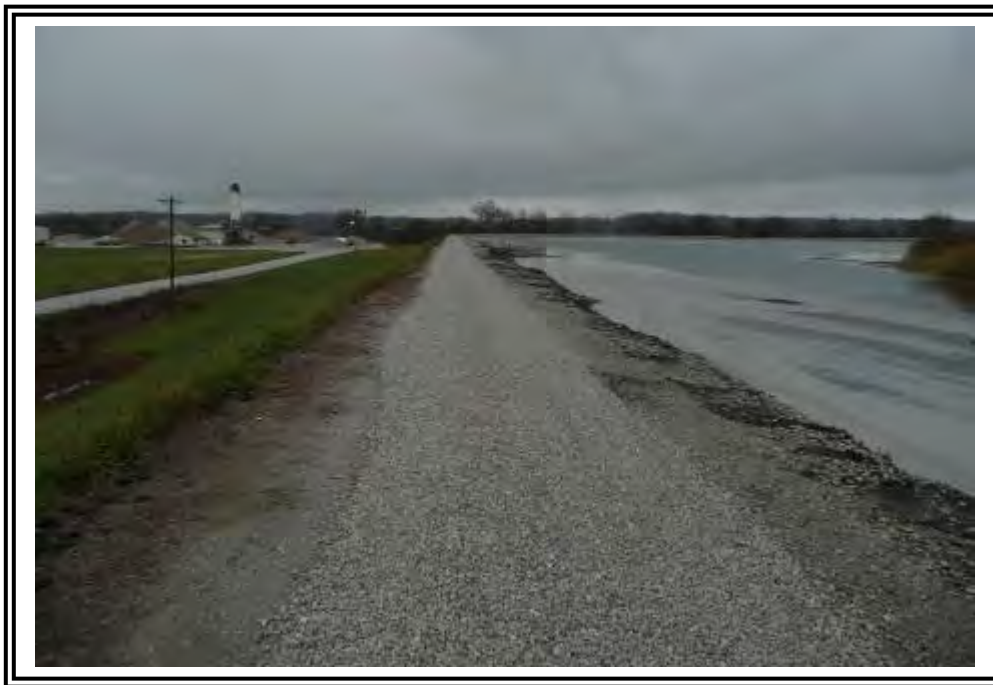
8

North dike crest looking east. Note wet area at toe of dike to left of photo.

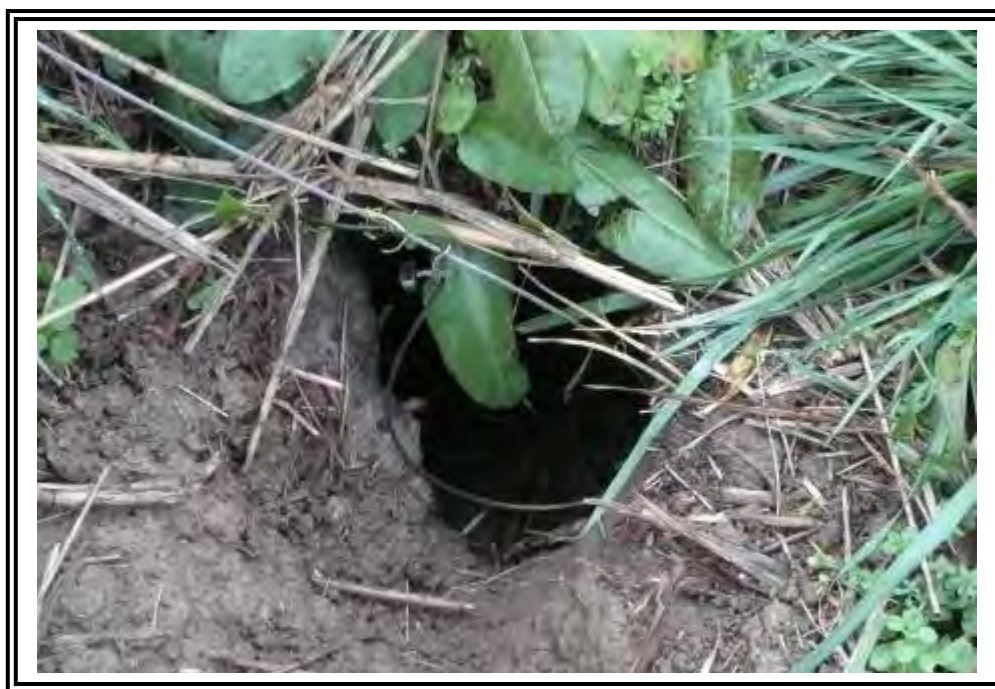
21

Rodent burrow with trap.

Isolated rodent burrows were observed along the outboard slopes of Ash Pond A. At one location a trap was observed indicating that BREC is actively moving to control these animals. This rodent control measure and others should continue to be utilized as needed.

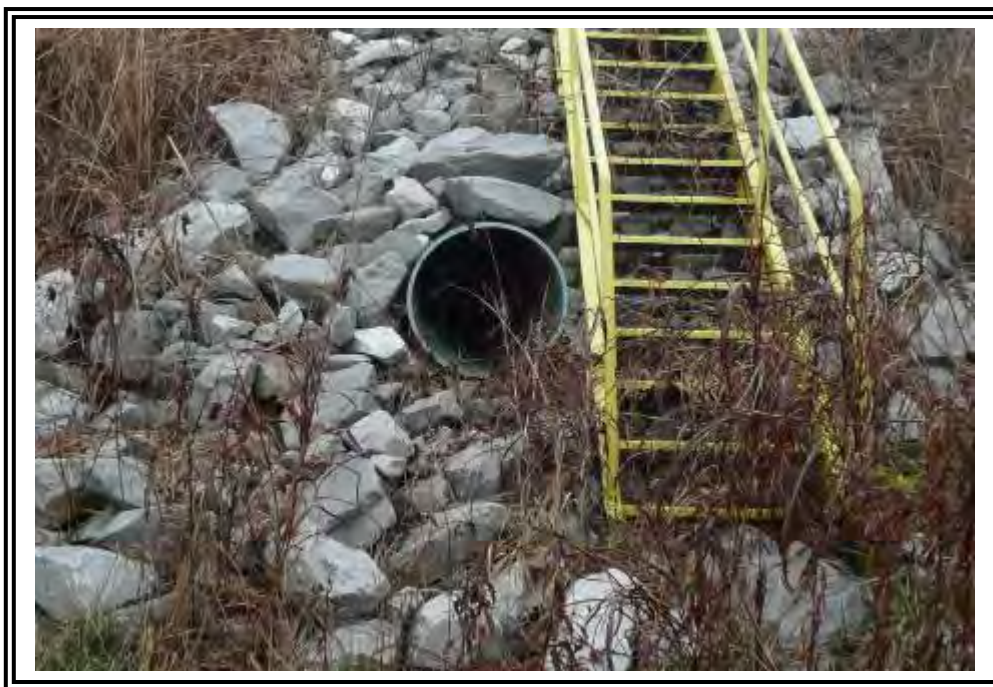
29

The primary outlet structure is a 24-inch diameter PVC riser connected to a 24-inch diameter PVC pipe located along the south dike (Photo 28). This pipe conveys water beyond the dike toe to the upper portions of the drainage feature running parallel to the south dike, eventually emptying into the Ohio River. At the time of the site assessment, the pond was dry and the outlet was inactive. It appeared to be open and unobstructed, with rip rap outlet protection. Sporadic dead or dying vegetation was observed in the outlet protection (Photo 29).

Outlet pipe on south dike.
