# Assessment of Dam Safety Coal Combustion Surface Impoundments (Task 3) Final Report

Big Rivers Electric  
Corporation

Coleman Generating  
Station

Hawesville, Kentucky

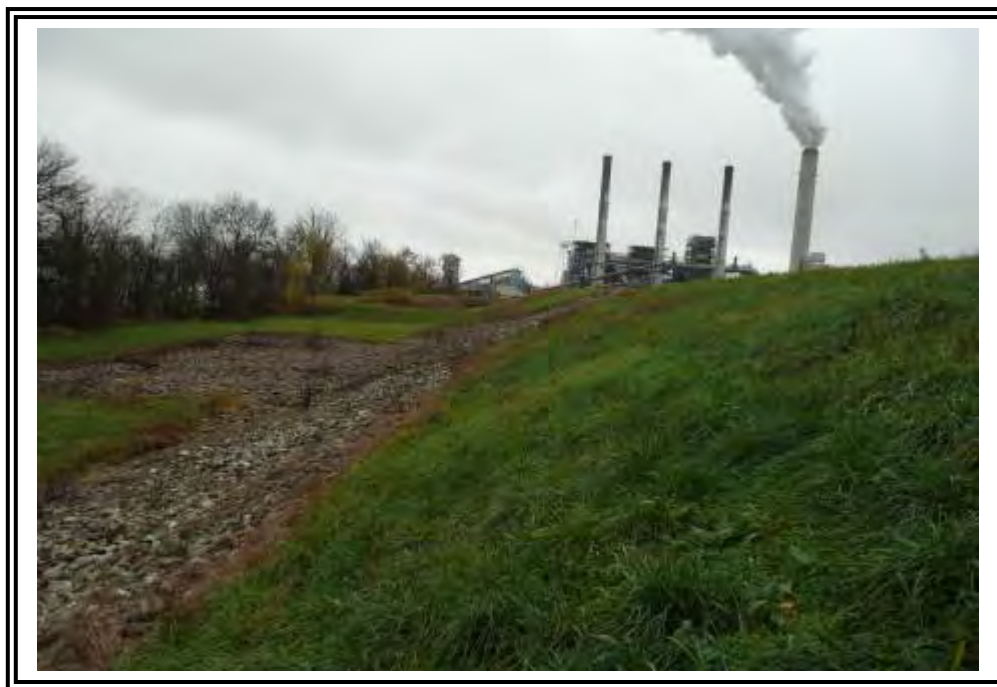
1

East dike outboard slope, looking south. Note rock toe drain.

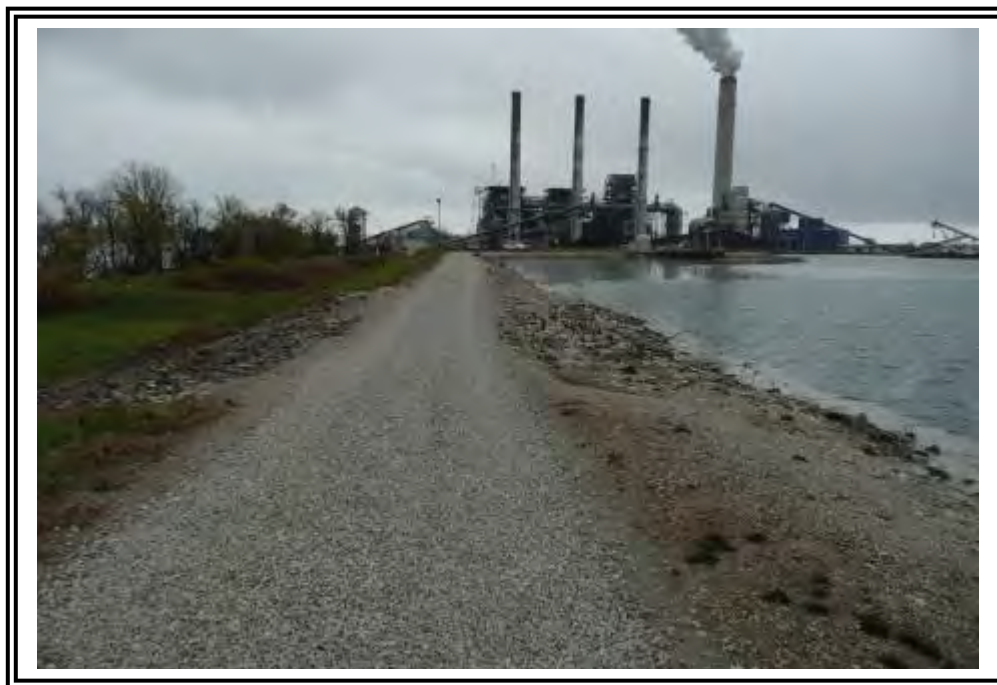
2

In general, the Ash Pond A dikes do not show signs of changes in horizontal alignment from the designed alignment (Photos 2, 8, 13, 14). The crest areas supported a granular surfaced access drive to service the impoundment. These appeared stable and free from any abrupt gross vertical deformation or cracking. In some areas the embankment crest areas were overbuilt due to ash handling processes, and a build-up of ash could be observed, making the crest area wider than initially designed (Photo 14). This was particularly evident along the western and central portions of the south dike, and to a somewhat lesser extent along the west dike and the western portion of the north dike. Isolated areas of softened surface gravel and bird baths were also observed on the south dike crest as well (Photo 16).

East dike crest, looking south. Note gravel crest surface.

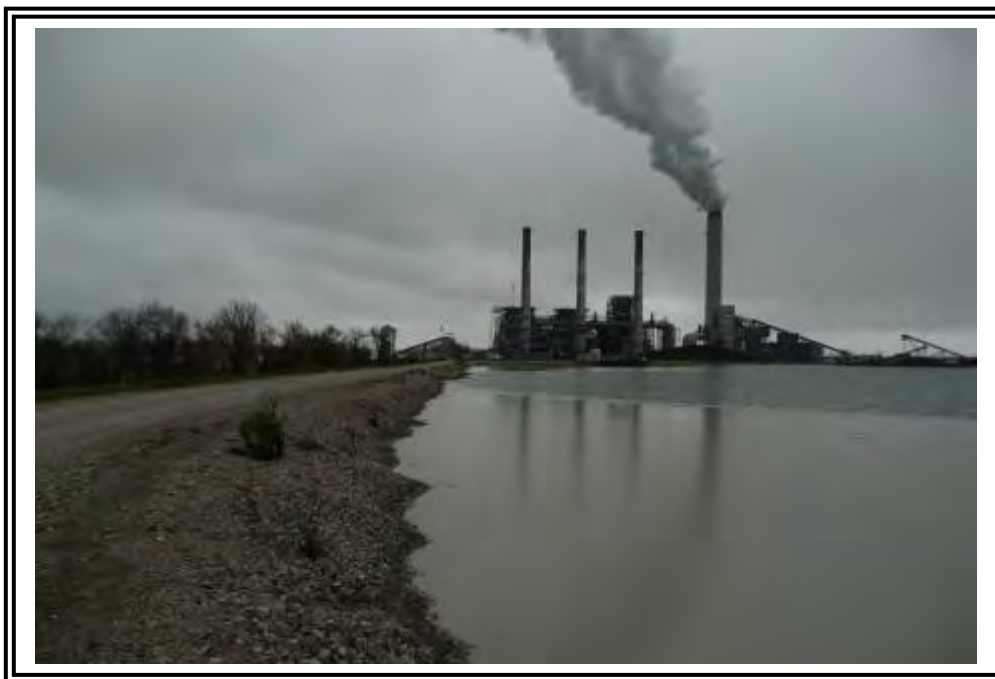
4

Inboard slope areas of the impoundment were generally rock or ash covered (Photos 4, 9, 13, 14, and 17). As a result of grading activities, looser materials had been pushed out on these slopes, making them susceptible to erosion rills in locations where surface runoff has become concentrated (Photos 10 and 18). These areas were also susceptible to beaching erosion, particularly in the western portion of pond. Available freeboard appears to be on the order 1.5 to

East dike inboard slope with rock surface, looking south. Note isolated woody vegetation.

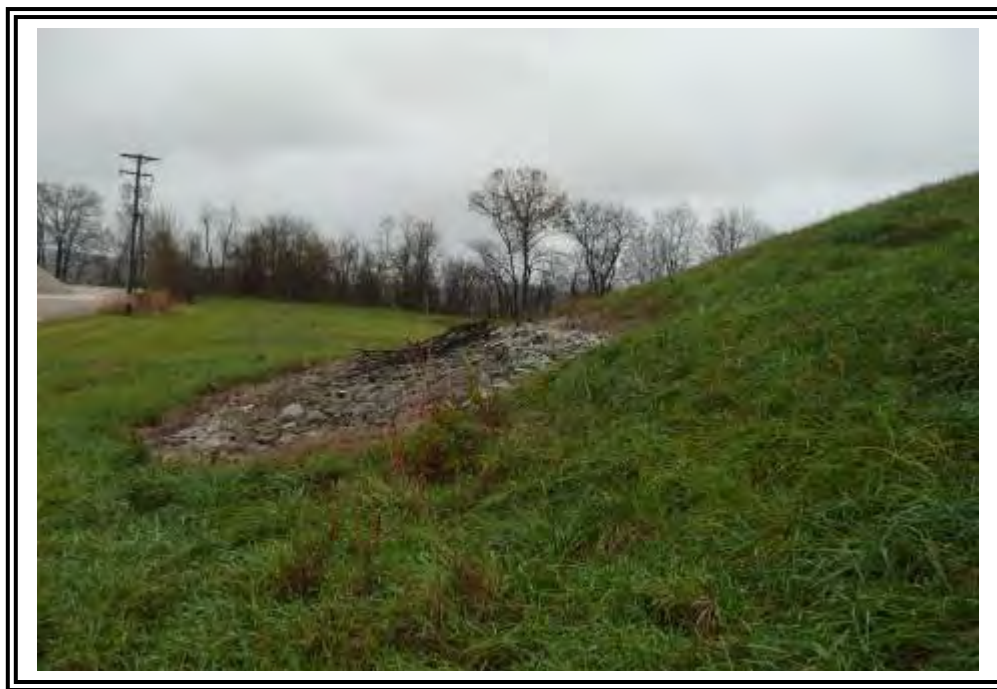
5

Rock toe drain at northeast corner of Ash Pond A, outboard slope.

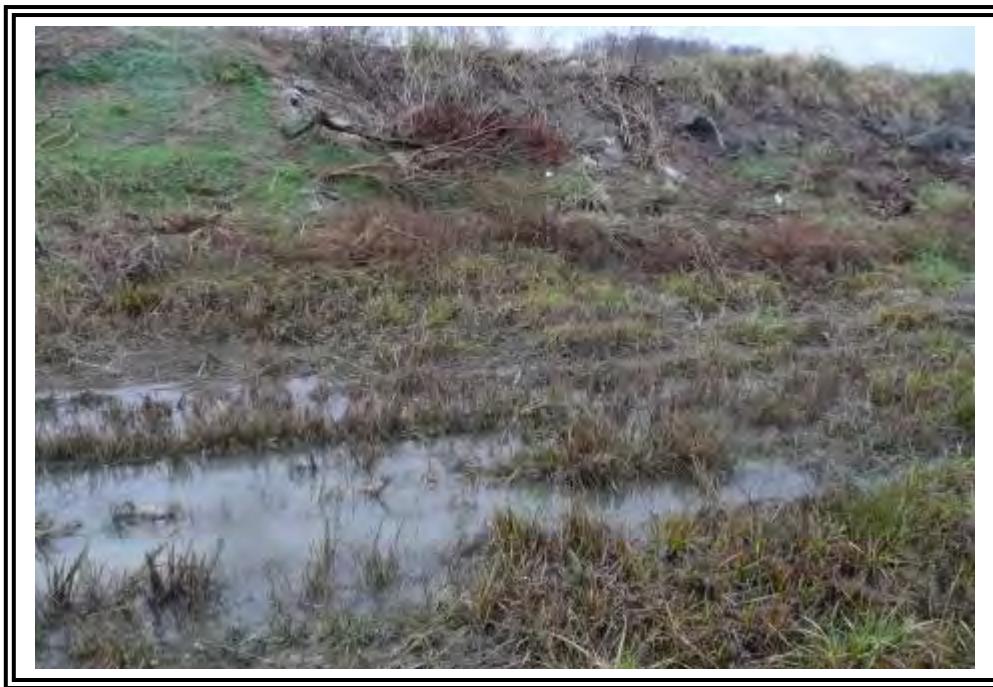
7

Standing water was also observed at the toe area of the north dike. In this area however, in addition to the recent precipitation, the standing water was the consequence of a drainage culvert beneath an access drive being crushed and completely covered (Photo 7). This has blocked the culvert and apparently allowed standing water to build up in this area for a period of time. In this area the soil at the base of the drainage swale had begun to soften, allowing a probe to penetrate approximately 1 foot.

Poor drainage at toe of north dike where culvert under road has been blocked.

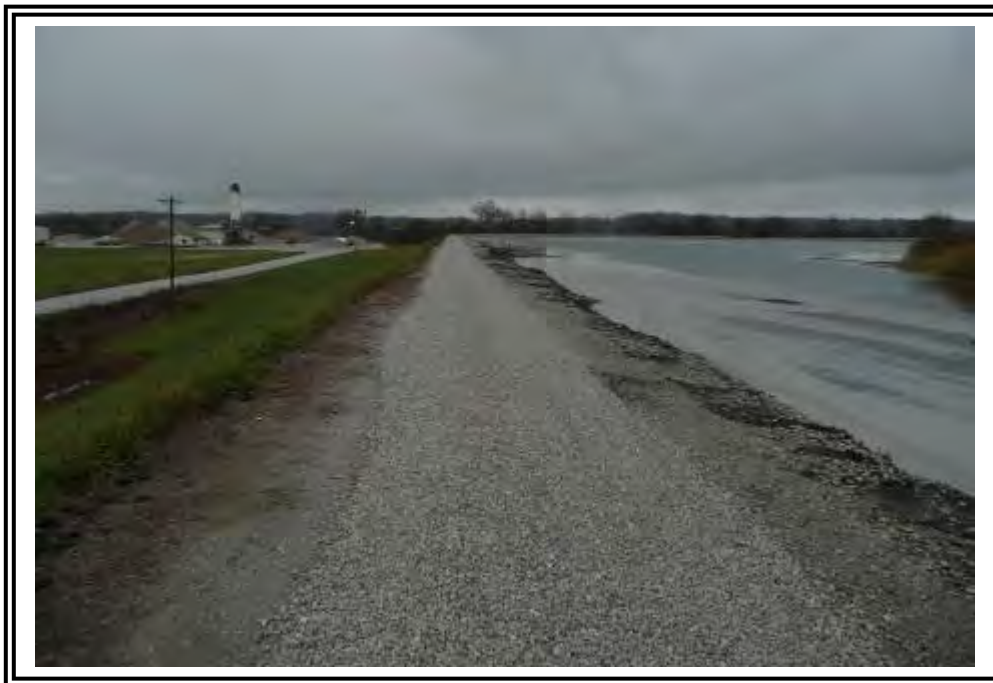
8

North dike crest looking east. Note wet area at toe of dike to left of photo.

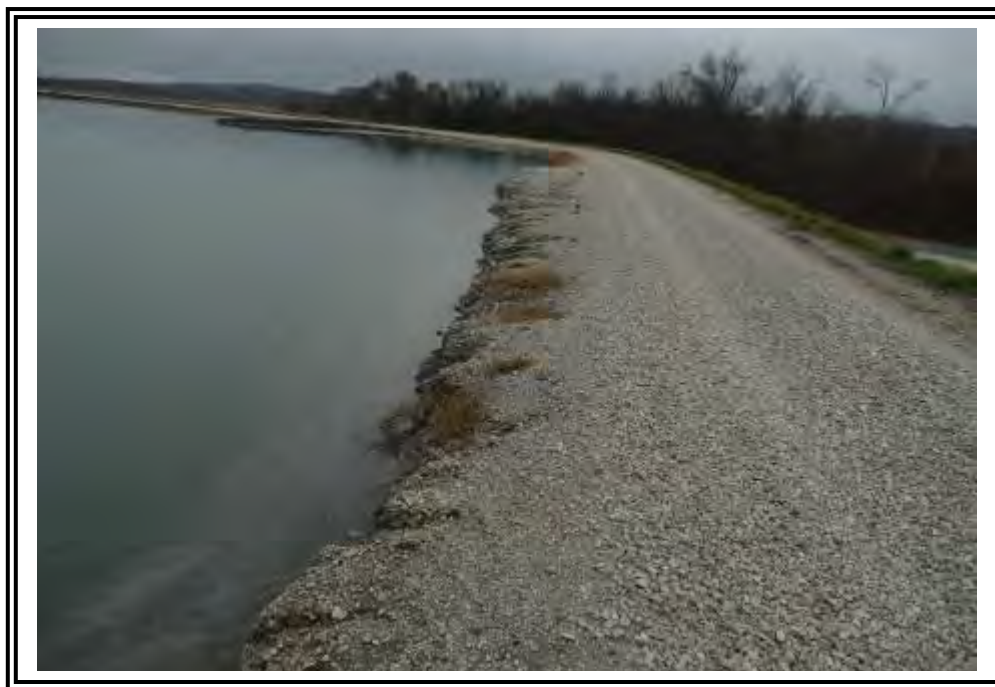
9

North dike inboard slope. Note beaching erosion and erosion rills.

Intermittent erosion rills and beaching erosion was observed on the dikes adjacent to the open water pond areas. This should not cause an immediate safety concern as long as a sufficient freeboard and dike crest width is maintained. Based upon the conditions encountered, this

erosion is most likely due to poorly compacted material pushed to the edge of the dike on the inboard side. At present the most probable concern is incremental loss of capacity over time as the erosion rills transport material into the pond area. CHA recommends that the crest and slope areas be dressed to remove loose materials and appropriately compacted to increase their erosion resistance. An alternative may be to place heavier crushed rock and stone on the crest and inboard slope. These steps can also be taken to repair softened areas and depressions or ruts holding water in the crest access road, such as those noted along the south dike.

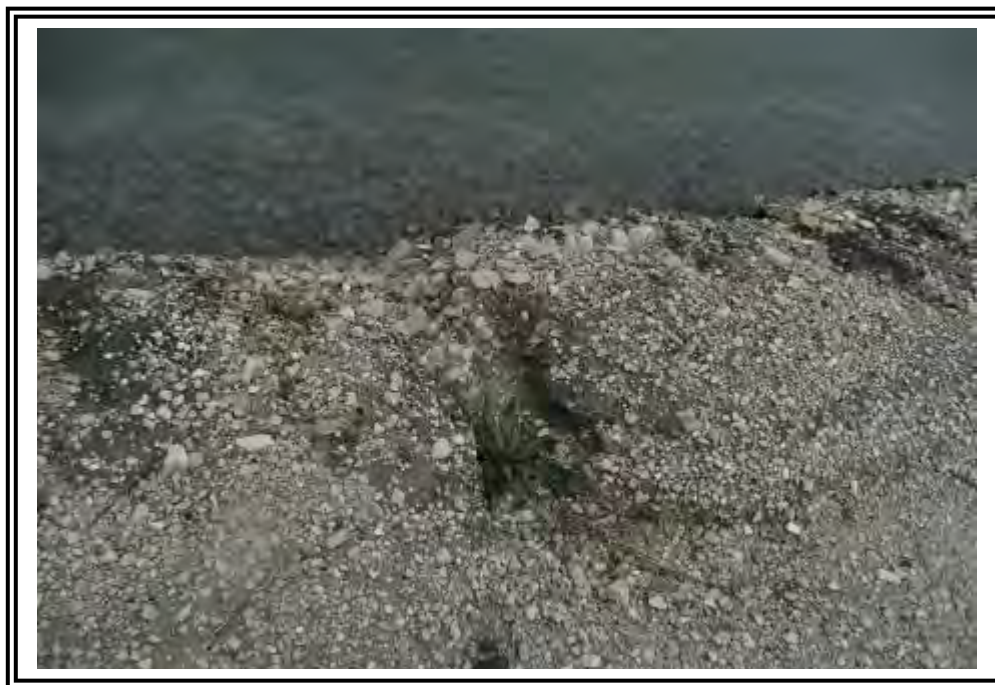
10

Close up of slight beaching on inboard slope of north dike.

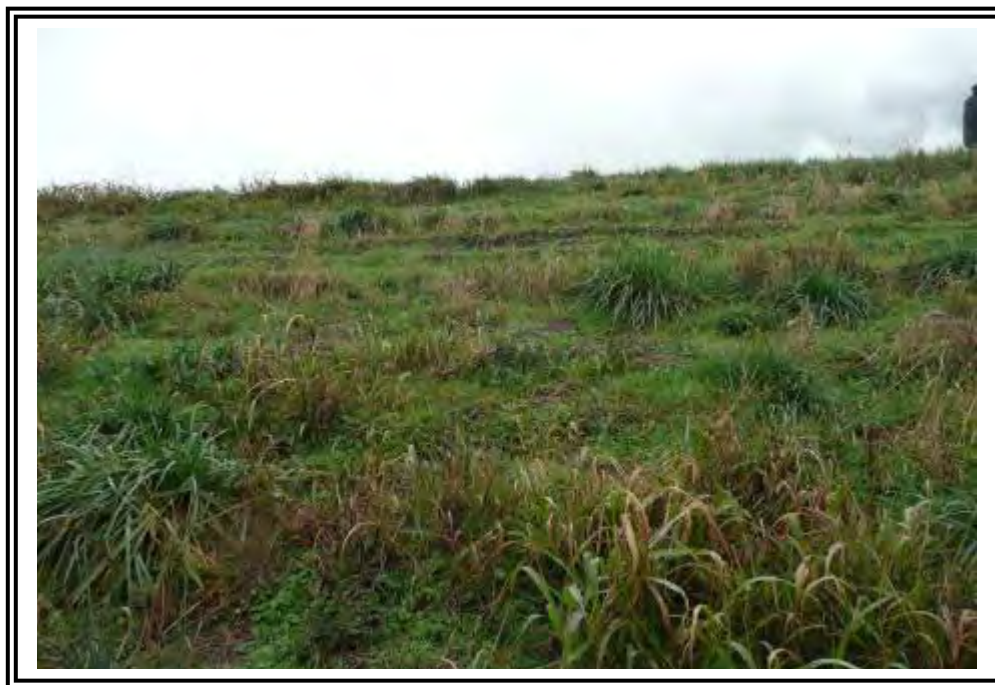
12

Mowing ruts on west dike outboard slope.

In general, a good, stable grass cover was observed on the outboard slope areas. Routine mowing and reseeding should continue as needed. In some areas, surficial slope deformation (rutting) due to these mowing activities were observed. It is likely that this rutting is the result of repeated passes of large riding equipment in these areas or attempting to mow too soon after a rain event. CHA recommends that mowing activities not commence on the slopes until the areas are fairly dry and the surface soils have stiffened.

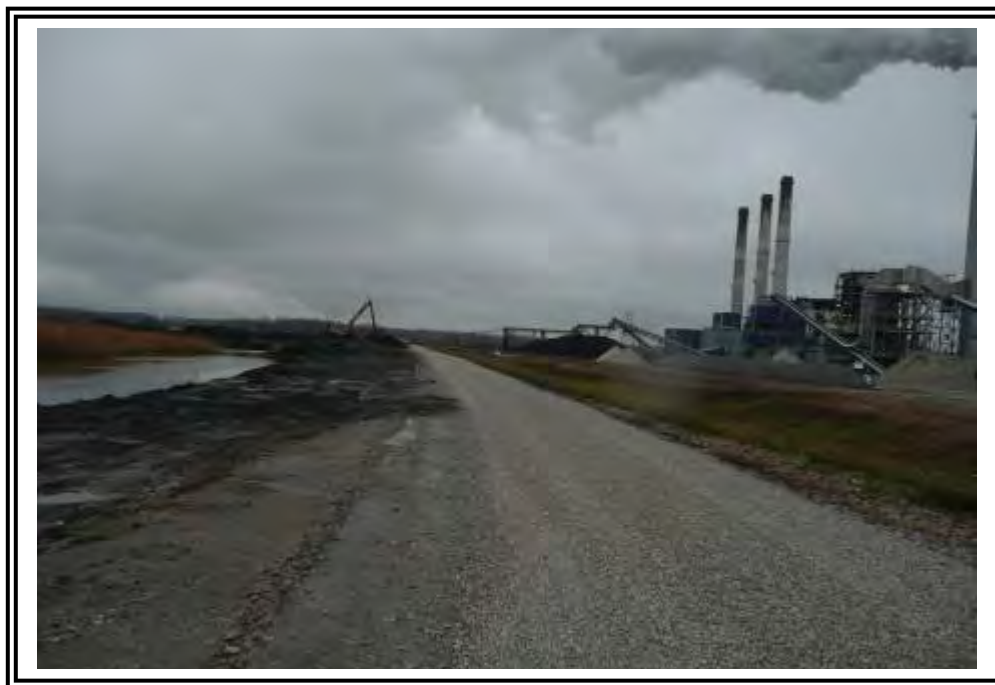
14

South dike inboard slope and crest at ash processing area, looking east.  
Note buildup of ash on inboard slope that widens crest area.

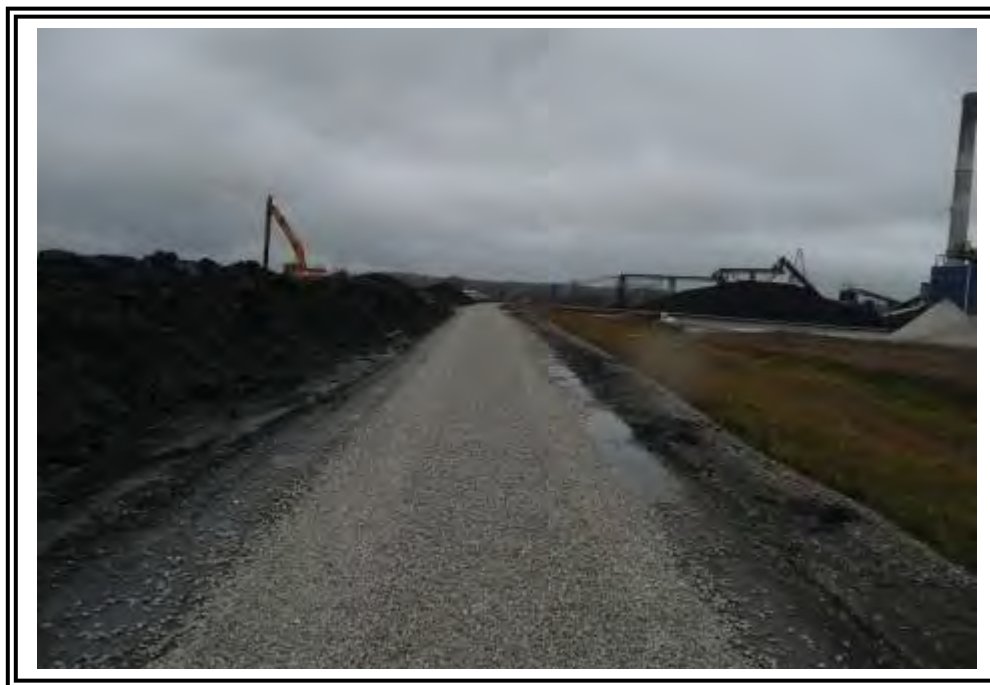
16

South dike crest looking east. Note standing water in puddles.

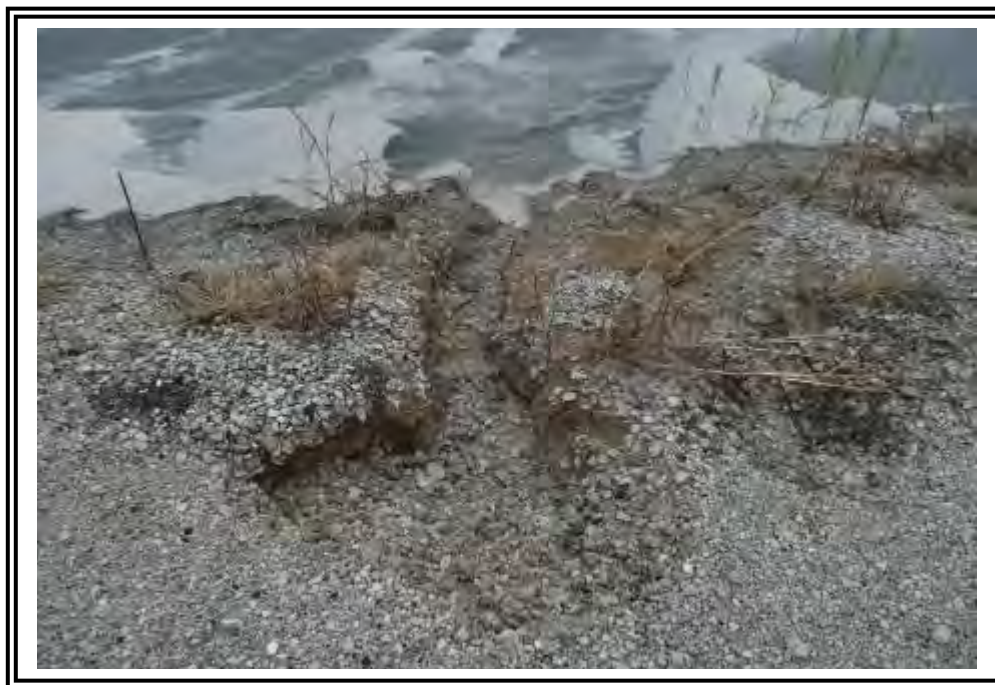
18

Erosion rills on inboard slope of south dike.

A related grass slope maintenance item is erosion. Erosion rills, most of them grass and weed covered, occurring along the embankment slopes should be filled with compacted soil and seeded to stabilize the repaired area. This should also help with reducing the slope softening and subsequent mower rutting that can occur in these areas.

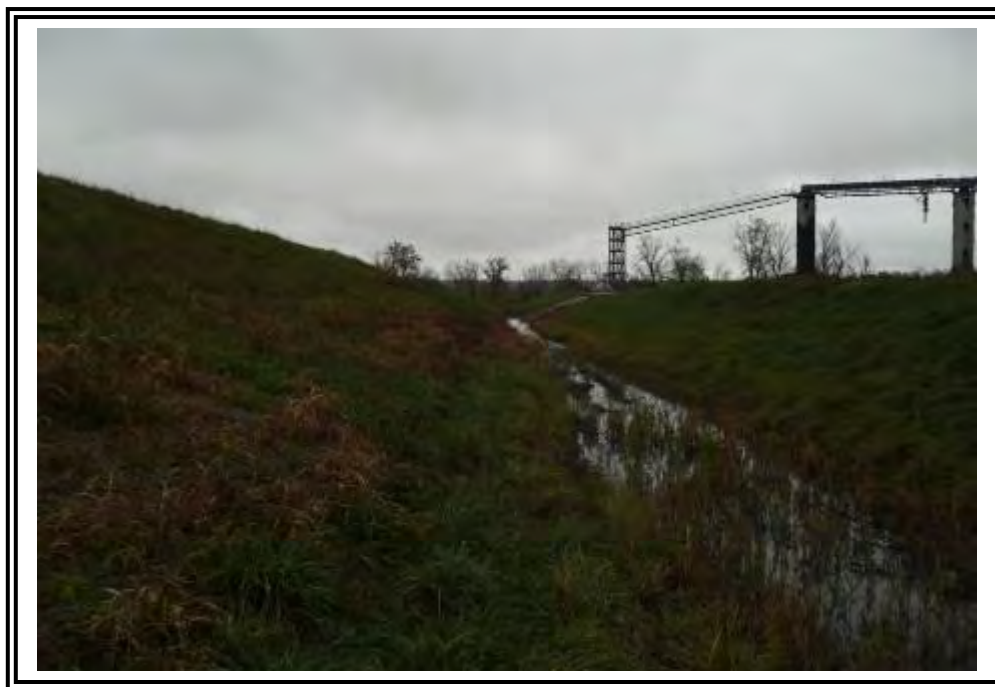
19

An access ramp for ash processing equipment and pond maintenance was observed on the south dike outboard slope. Ash sluicing lines and other waste water pipelines emptying into the pond were also noted on this ramp. In the portion of the dike north of this access ramp, standing water was observed at the dike toe in a drainage swale. This appeared to be due to precipitation before and during the site visit in addition to possible poor drainage (Photo 19).

Standing water in drainage swale at toe of south dike.

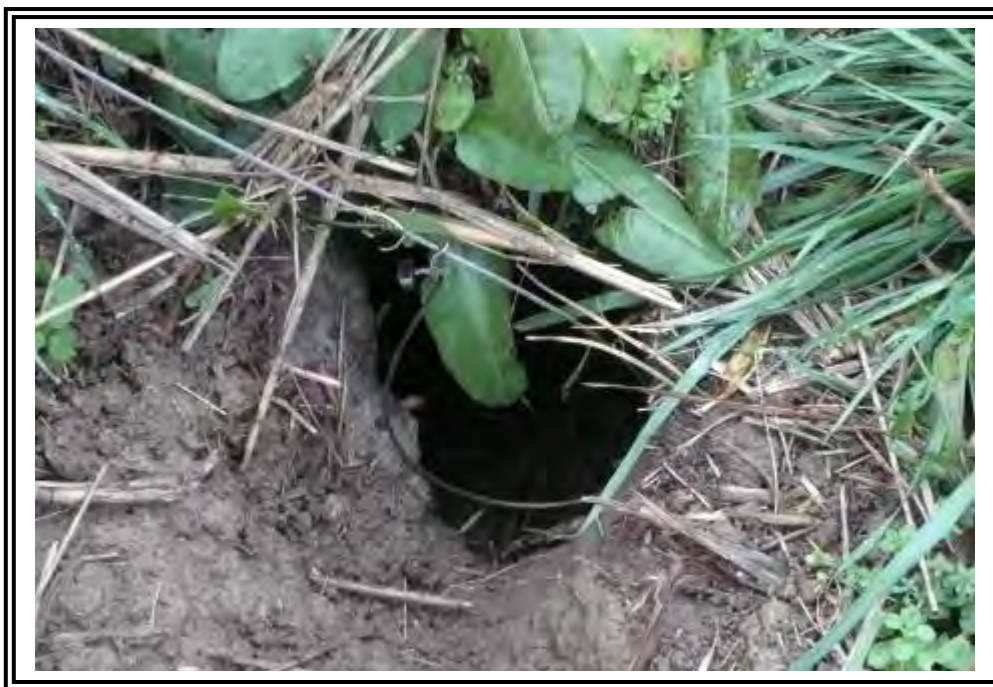
21

Rodent burrow with trap.

Isolated rodent burrows were observed along the outboard slopes of Ash Pond A. At one location a trap was observed indicating that BREC is actively moving to control these animals. This rodent control measure and others should continue to be utilized as needed.

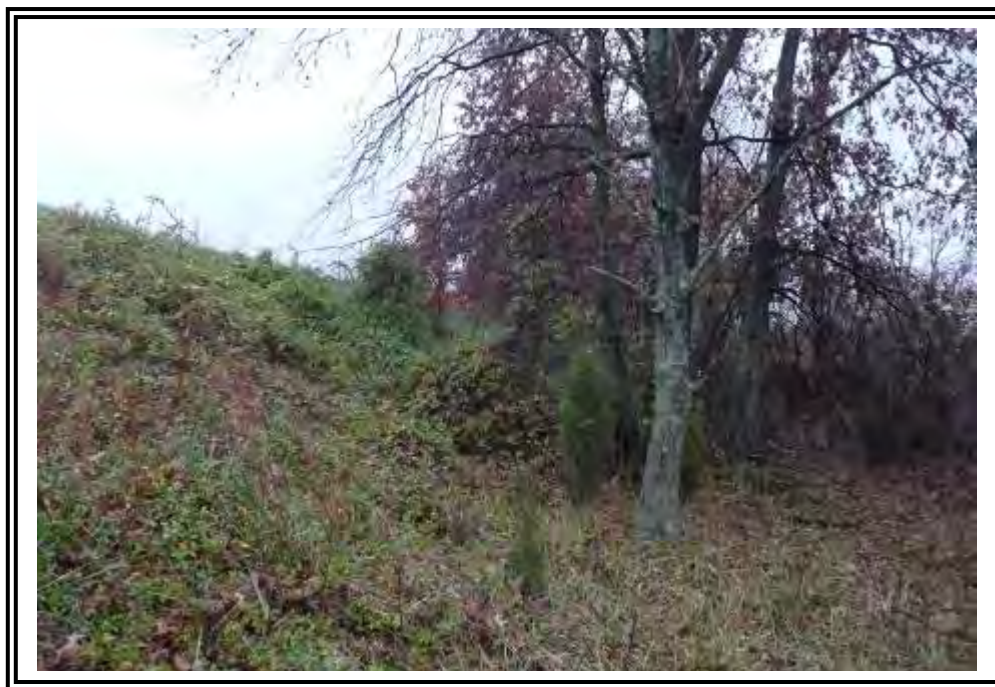
27

South dike outboard slope, looking east.  
Note trees and brush vegetation on slope and at slope toe.

The heavy vegetation and trees established along the south dike adjacent to the drainage feature need to be removed. This should be done at least to the toe of the constructed dike and to the eastern extent of the dike where it ties in to the natural grade at the incised portion of the pond. According to an excerpt from the meeting minutes of a meeting held November 9, 2009, this tree removal activity was on an action item list, so it appears if this was recommended previously. To aid in determining the extent of tree removal, it is also suggested that a detailed survey be obtained in the area so that vegetation along the natural swale can be retained.

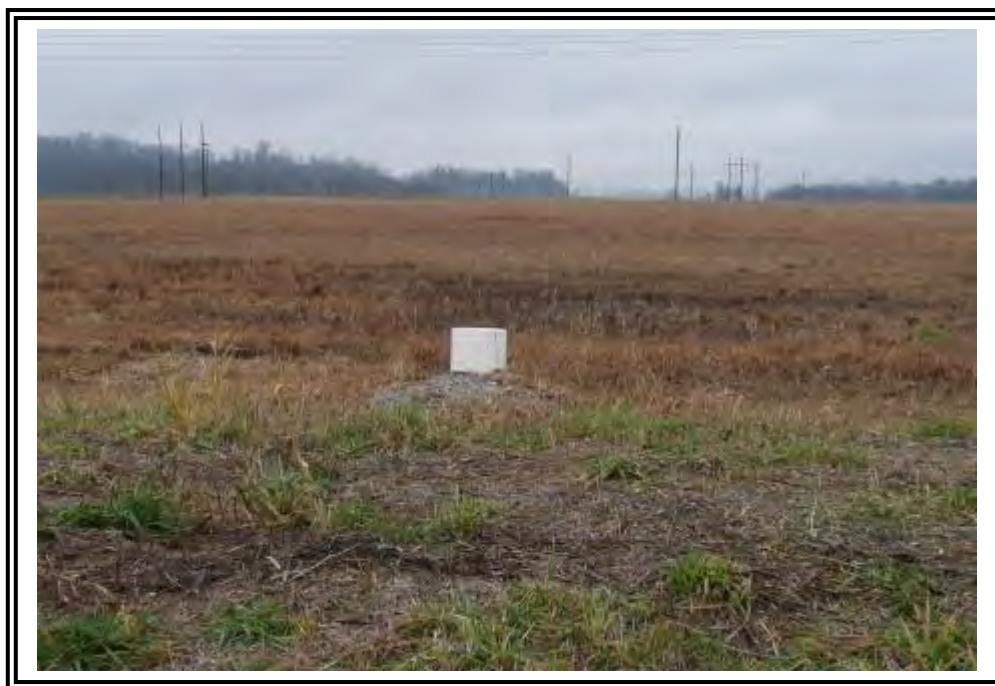
28

The primary outlet structure is a 24-inch diameter PVC riser connected to a 24-inch diameter PVC pipe located along the south dike (Photo 28). This pipe conveys water beyond the dike toe to the upper portions of the drainage feature running parallel to the south dike, eventually emptying into the Ohio River. At the time of the site assessment, the pond was dry and the outlet was inactive. It appeared to be open and unobstructed, with rip rap outlet protection. Sporadic dead or dying vegetation was observed in the outlet protection (Photo 29).

Outlet riser in pond area.

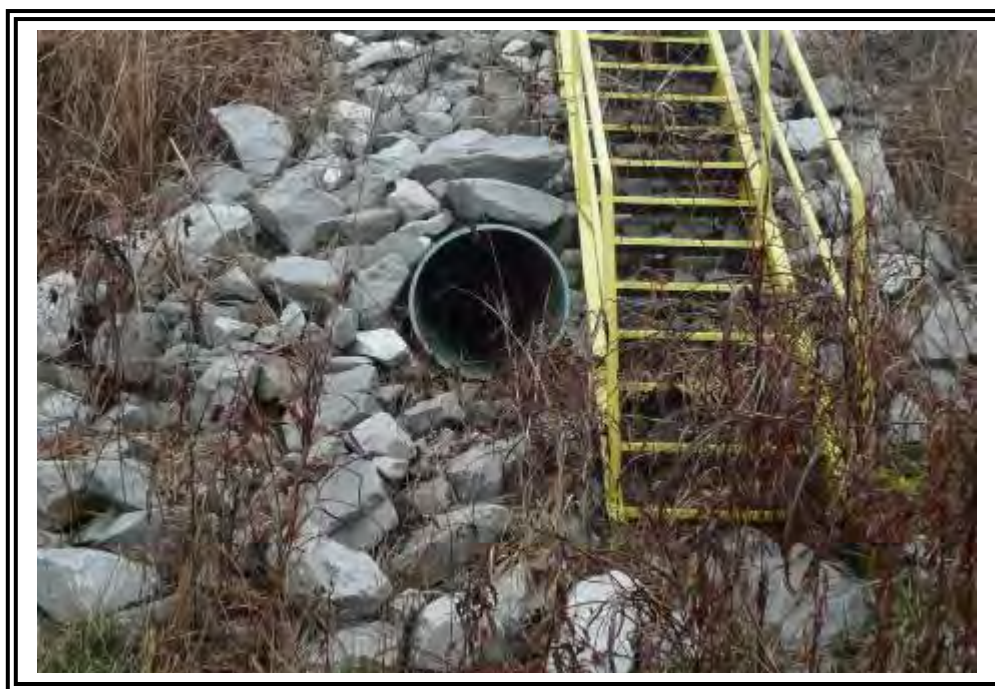
29

Outlet pipe on south dike.

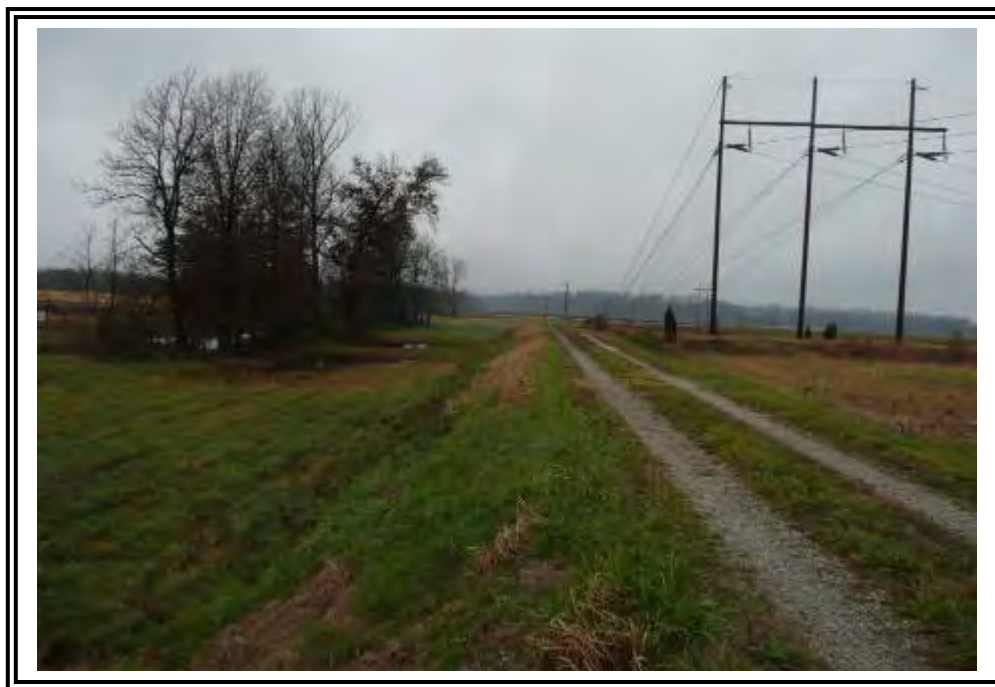
31

South dike crest area, looking west. Note standing water near toe area.

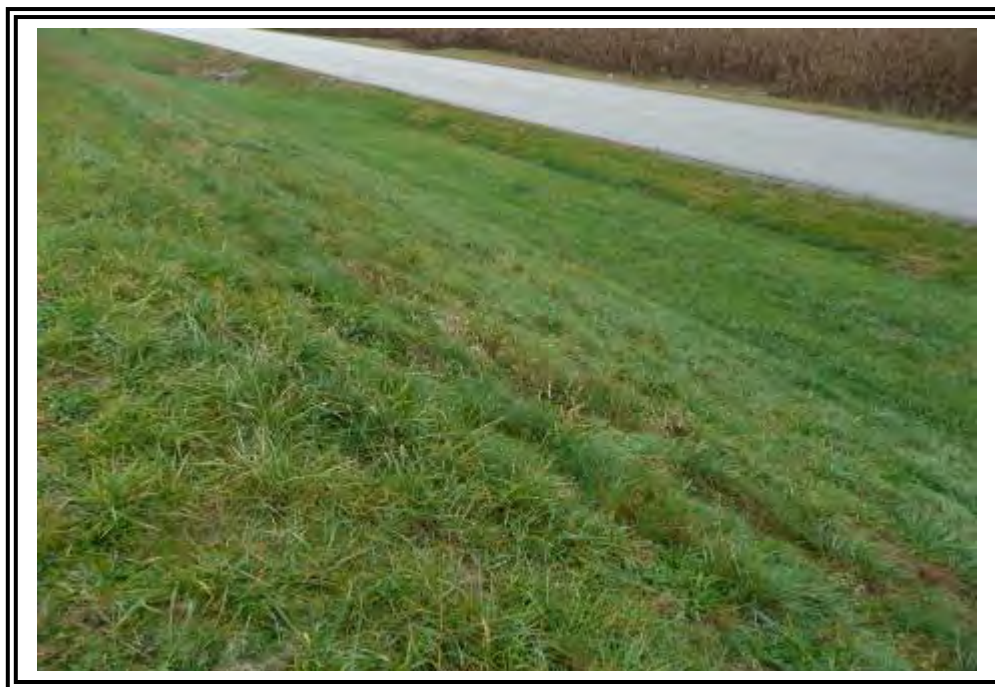
39

Mowing ruts in surface on west dike outboard slope.

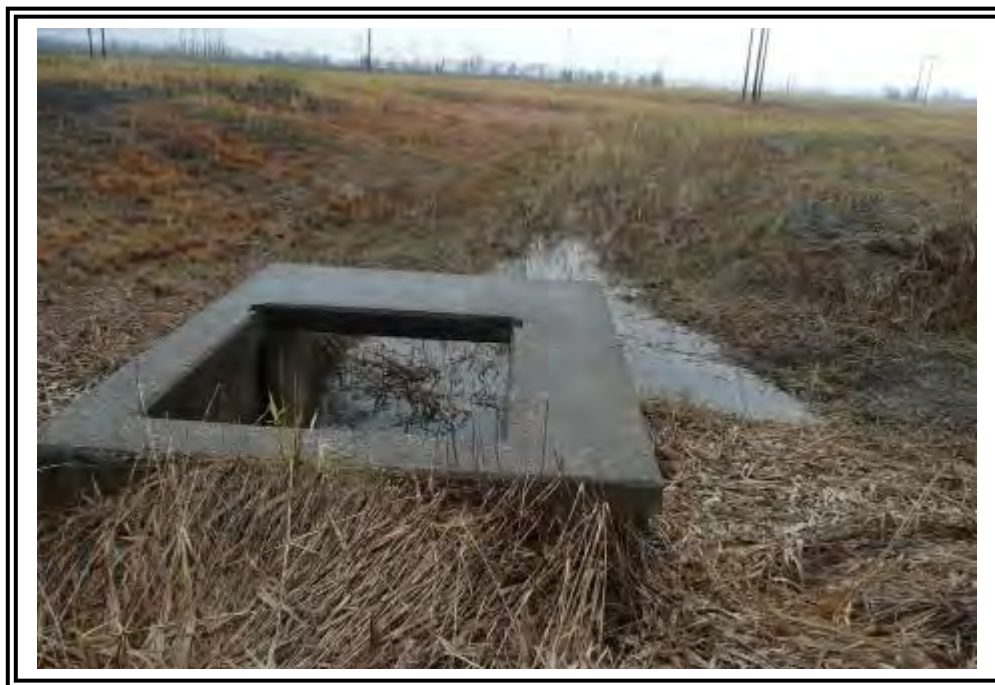
42

A secondary outlet is a roughly 9-foot by 12-foot reinforced concrete spillway riser located on the north dike (Photo 42). This structure is connected to a 48-inch diameter reinforced pipe and conveys water to a sump pit in the area where the old North Ash Pond was reclaimed (Photo 43). Effluent collected in this sump is pumped to Ash Pond A. This structure is configured to accept stop logs to control the pond level; however this structure is no longer actively controlling a water level. During the site visit, the ash level and dried ground surface was generally observed to be above this structure. Furthermore, this area had been graded so that drainage swales from the pond area could convey water to this location when dredged ash was being dewatered and promote positive drainage for stormwater runoff. Water was noted pooling against this structure and dead or dying weedy vegetation was encountered at the structure opening. This vegetation did not appear to be impeding the structure in its present function.

Old outlet structure to closed and reclaimed North Pond.
