Assessment of Dam Safety Coal Combustion Surface Impoundments (Task 3) Draft Report

Big Rivers Electric
Cooperative

Coleman Generating
Station

December 23, 2009

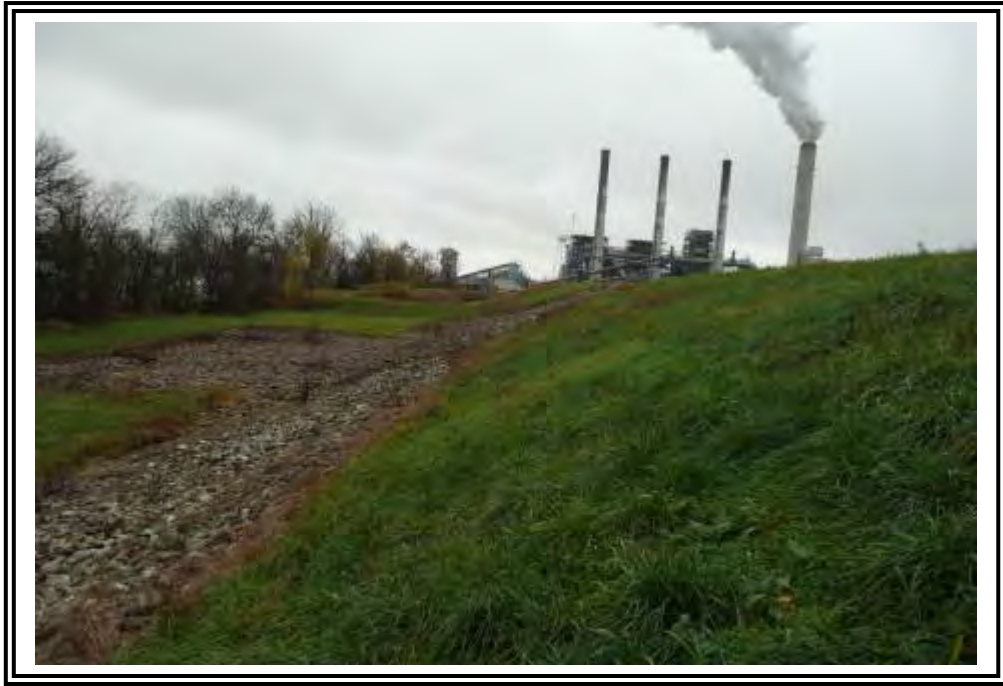
1

East dike outboard slope, looking south. Note rock toe drain.

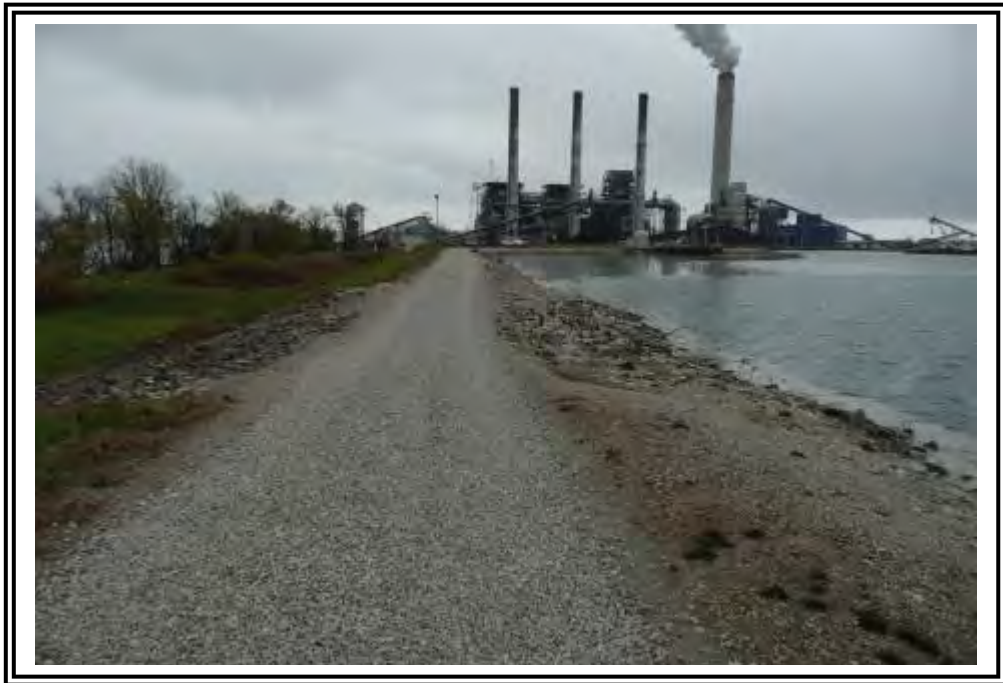
2

East dike crest, looking south. Note gravel crest surface.

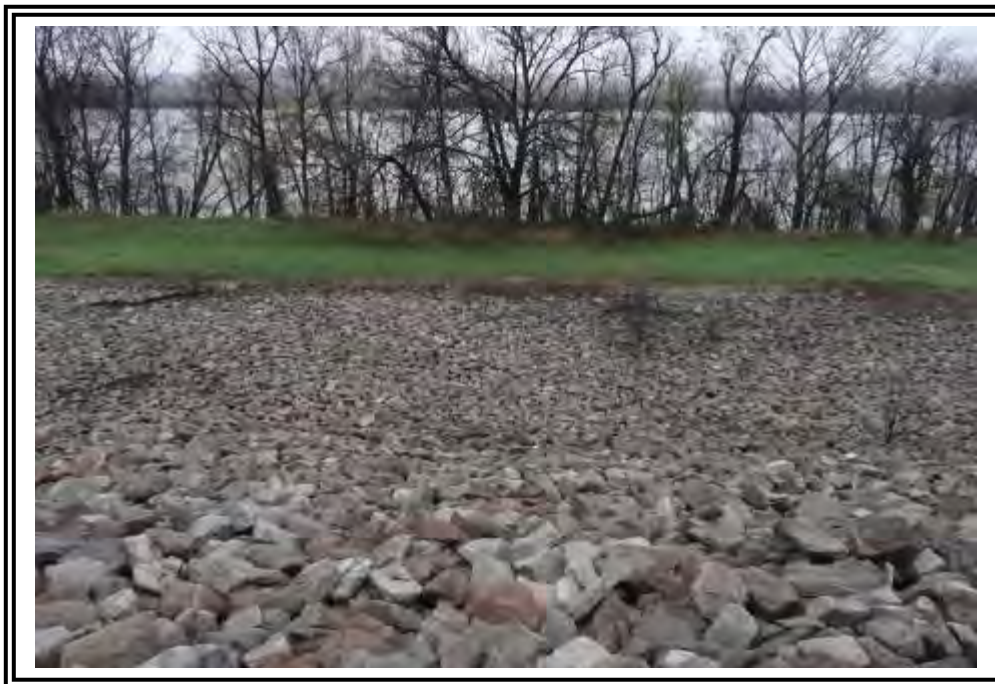
3

armoring was observed from the crest to the toe. This is the area of the emergency spillway (Photo 3).

East dike emergency spillway, looking east toward the Ohio River. Note isolated dying woody vegetation.

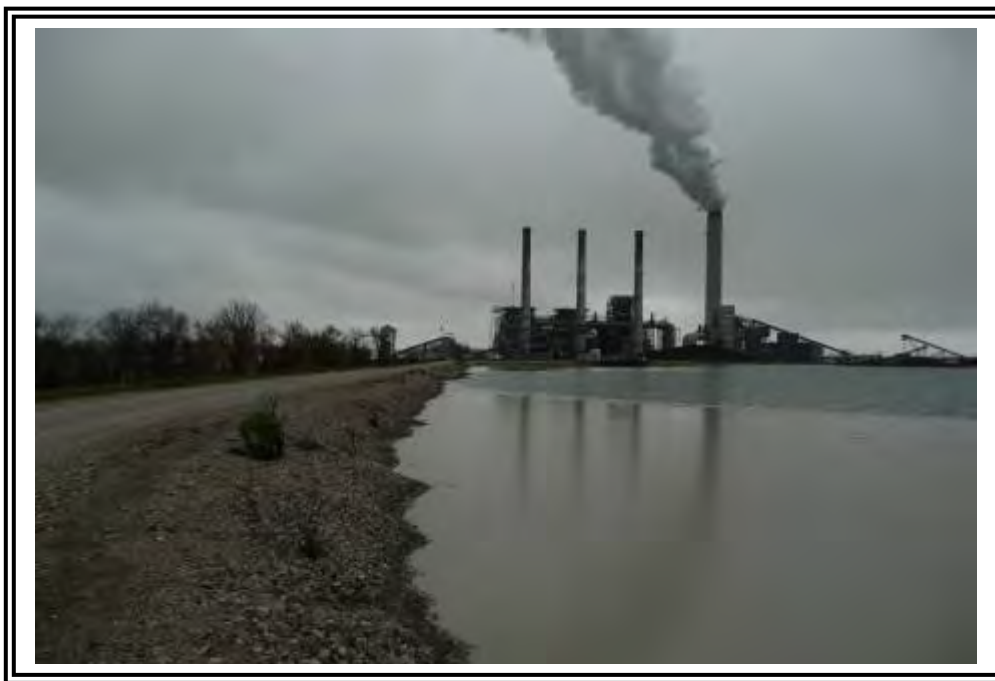
4

East dike inboard slope with rock surface, looking south. Note isolated woody vegetation.

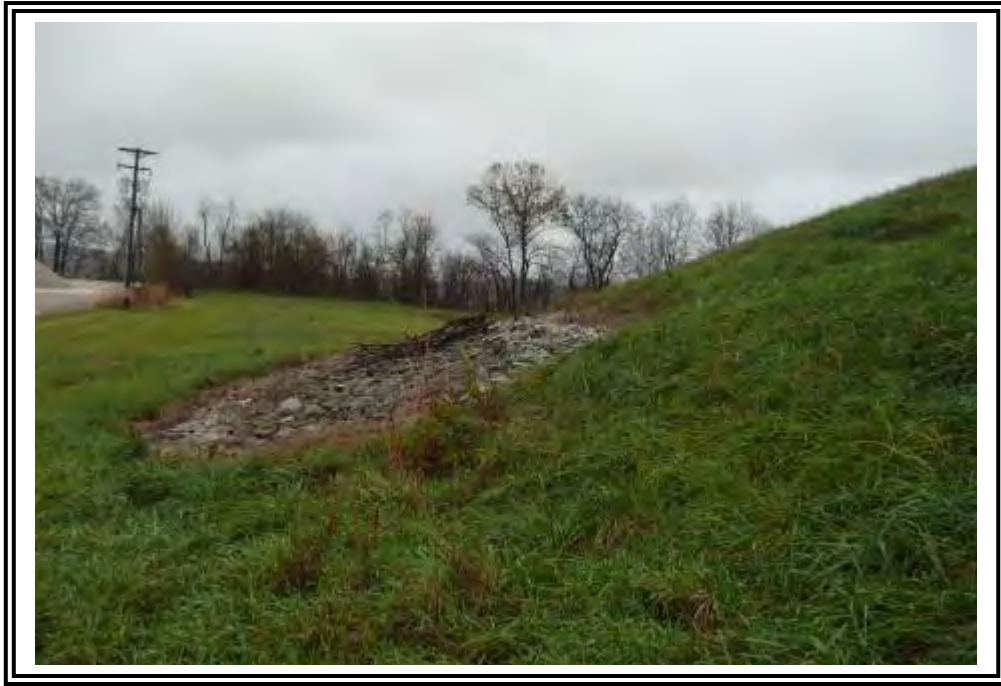
5

Rock toe drain at northeast corner of Ash Pond A, outboard slope.

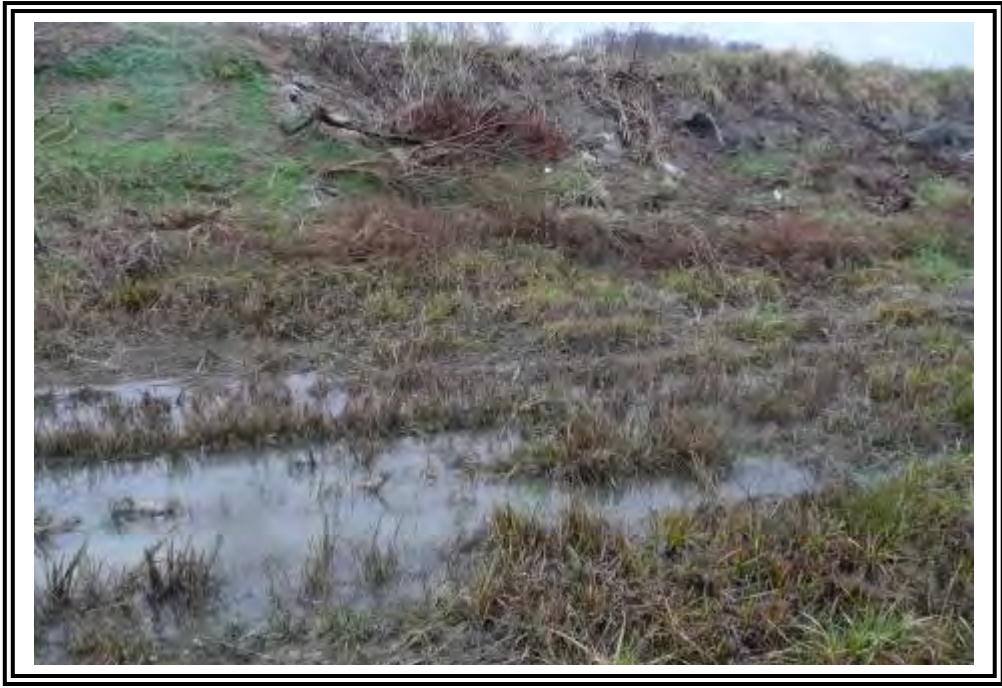
7

Standing water was also observed at the toe area of the north dike. In this area however, in addition to the recent precipitation, the standing water was the consequence of a drainage culvert beneath an access drive being crushed and completely covered (Photo 7). This has blocked the culvert and apparently allowed standing water to build up in this area for a period of time. In this area the soil at the base of the drainage swale had begun to soften, allowing a probe to penetrate approximately 1 foot.

Poor drainage at toe of north dike where culvert under road has been blocked.

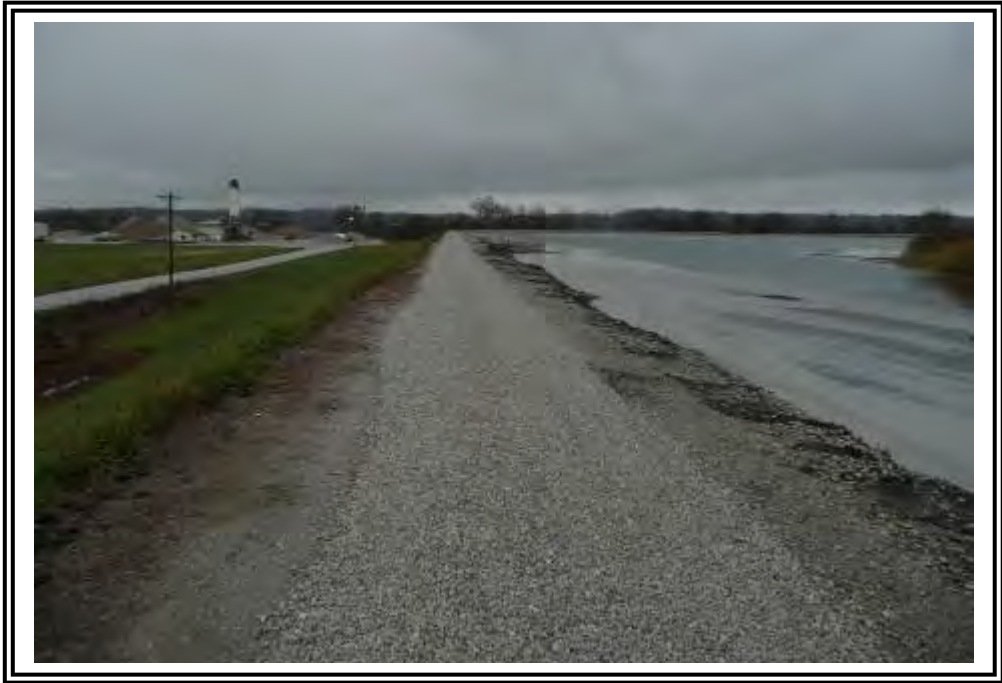
8

North dike crest looking east. Note wet area at toe of dike to left of photo.

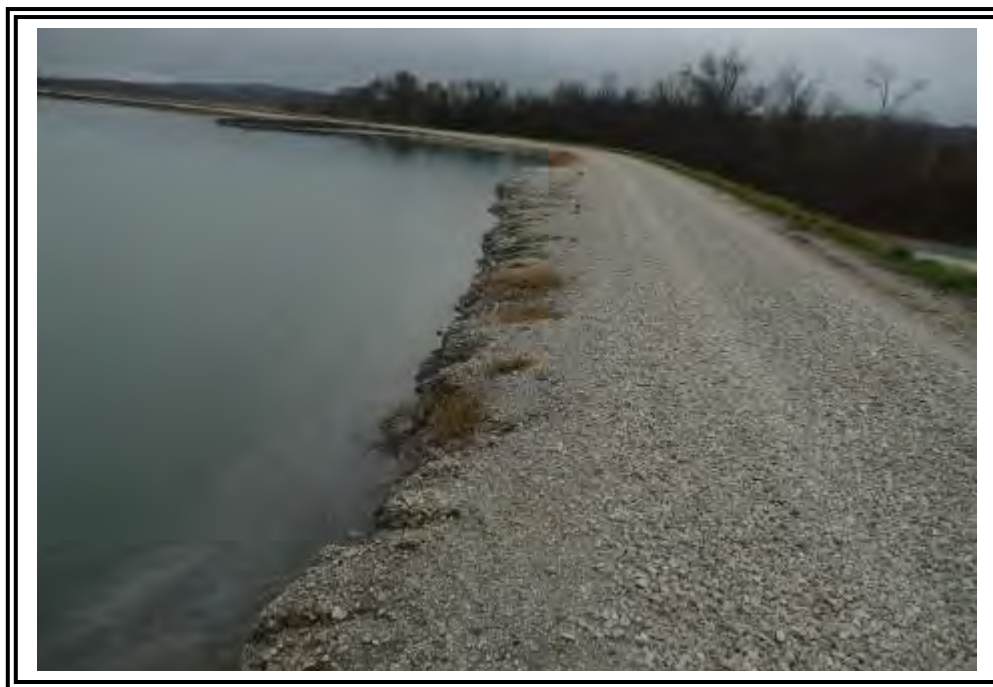
9

North dike inboard slope. Note beaching erosion and erosion rills.

Intermittent erosion rills and beaching erosion was observed on the dikes adjacent to the open water pond areas. This should not cause an immediate safety concern as long as a sufficient freeboard and dike crest width is maintained. Based upon the conditions encountered, this

erosion is most likely due to poorly compacted material pushed to the edge of the dike on the inboard side. At present the most probable concern is incremental loss of capacity over time as the erosion rills transport material into the pond area. CHA recommends that the crest and slope areas be dressed to remove loose materials and appropriately compacted to increase their erosion resistance. An alternative may be to place heavier crushed rock and stone on the crest and inboard slope. These steps can also be taken to repair softened areas and depressions or ruts holding water in the crest access road, such as those noted along the south dike.

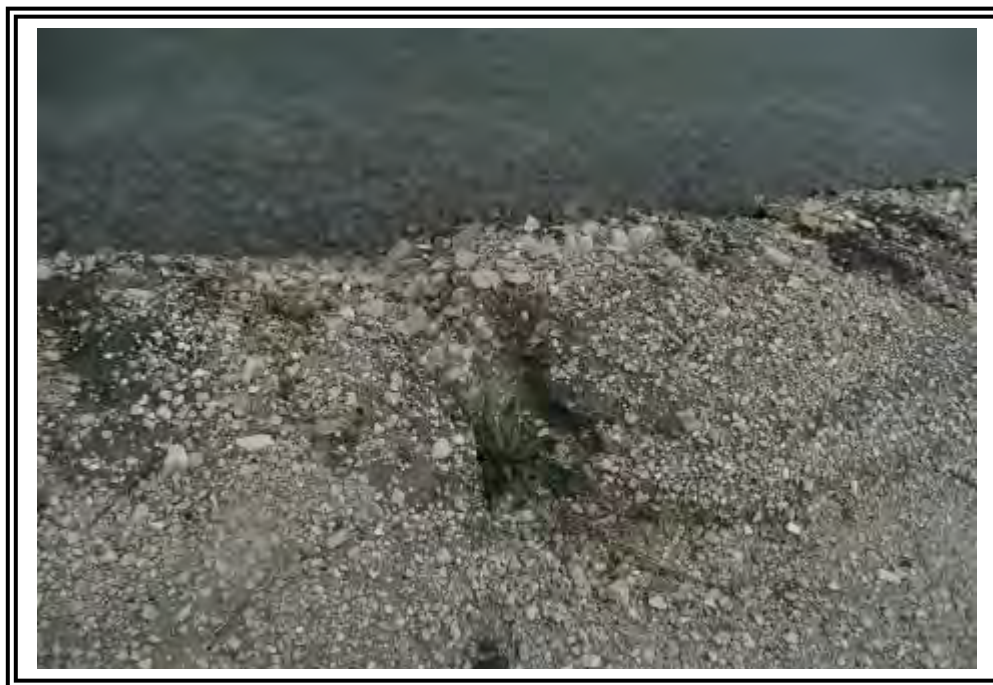
10

Close up of slight beaching on inboard slope of north dike.

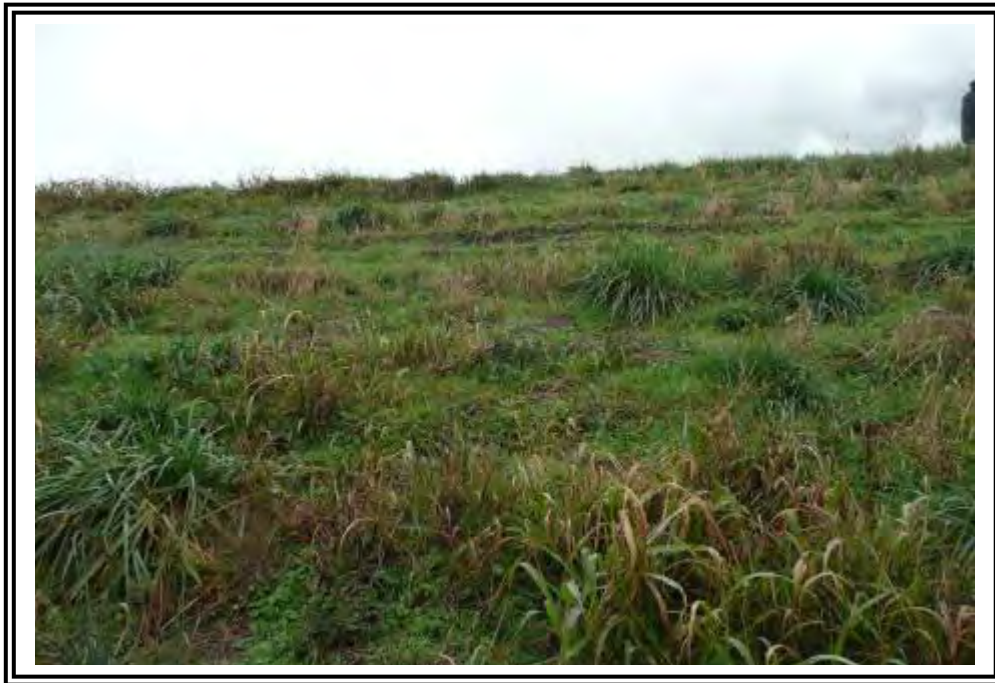
12

Mowing ruts on west dike outboard slope.

In general, a good, stable grass cover was observed on the outboard slope areas. Routine mowing and reseeded should continue as needed. In some areas, surficial slope deformation (rutting) due to these mowing activities were observed. It is likely that this rutting is the result of repeated passes of large riding equipment in these areas or attempting to mow too soon after a rain event. CHA recommends that mowing activities not commence on the slopes until the areas are fairly dry and the surface soils have stiffened.

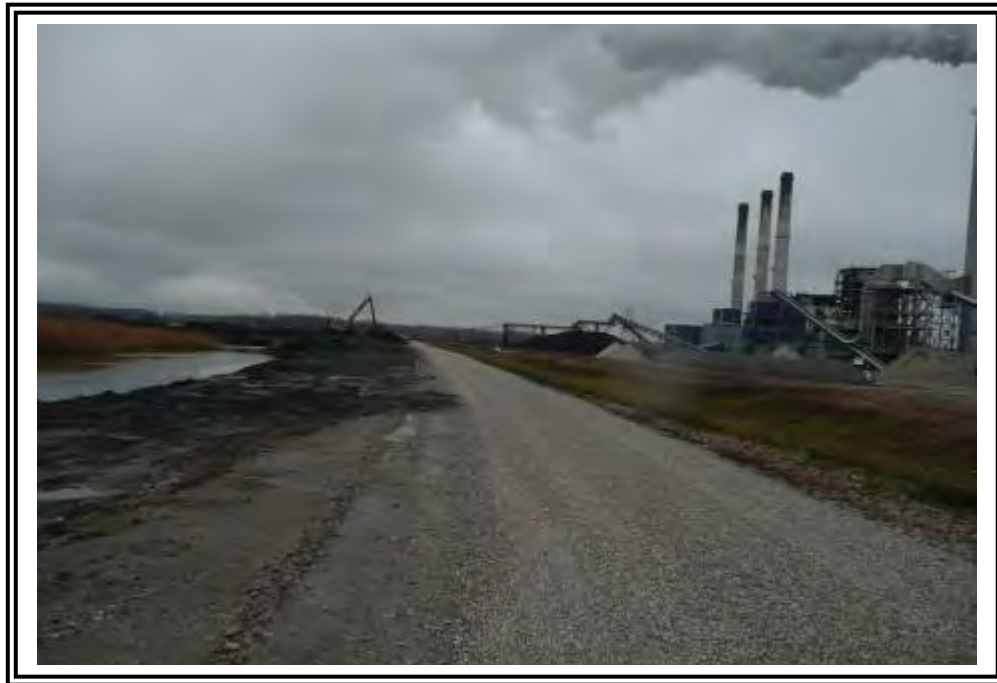
14

South dike inboard slope and crest at ash processing area, looking east.
Note buildup of ash on inboard slope that widens crest area.

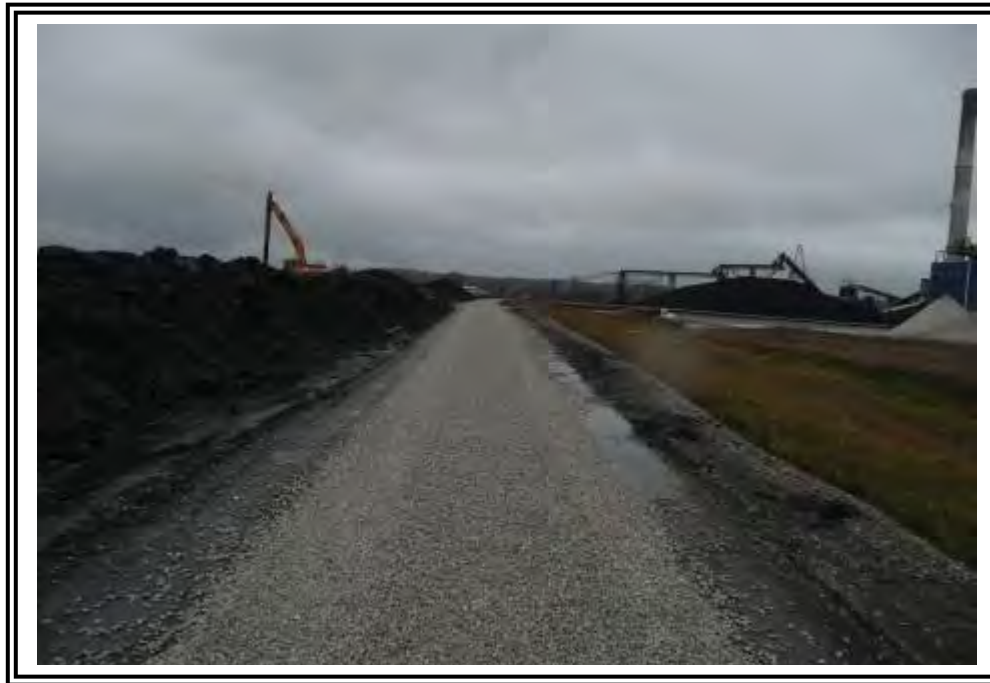
16

In general, the Ash Pond A dikes do not show signs of changes in horizontal alignment from the designed alignment (Photos 2, 8, 13, 14) The crest areas supported a granular surfaced access drive to service the impoundment. These appeared stable and free from any abrupt gross vertical deformation or cracking. In some areas the embankment crest areas were overbuilt due to ash handling processes, and a build-up of ash could be observed, making the crest area wider than initially designed (Photo 14). This was particularly evident along the western and central portions of the south dike, and to a somewhat lesser extent along the west dike and the western portion of the north dike. Isolated areas of softened surface gravel and bird baths were also observed on the south dike crest as well.(Photo 16).

South dike crest looking east. Note standing water in puddles.

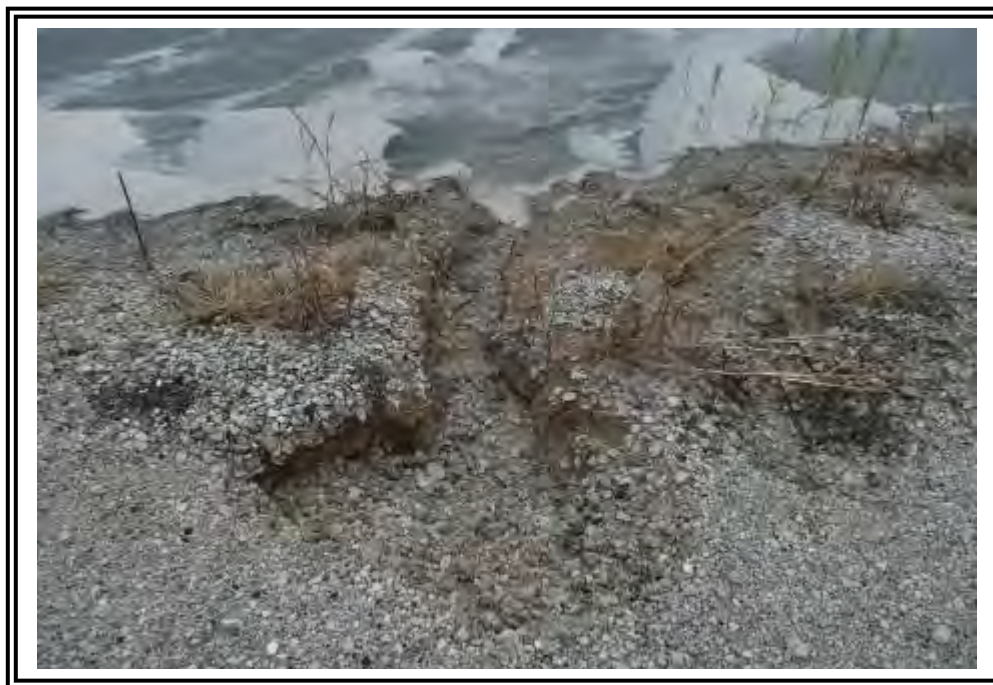
18

Erosion rills on inboard slope of south dike.

A related grass slope maintenance item is erosion. Erosion rills, most of them grass and weed covered, occurring along the embankment slopes should be filled with compacted soil and seeded to stabilize the repaired area. This should also help with reducing the slope softening and subsequent mower rutting that can occur in these areas.

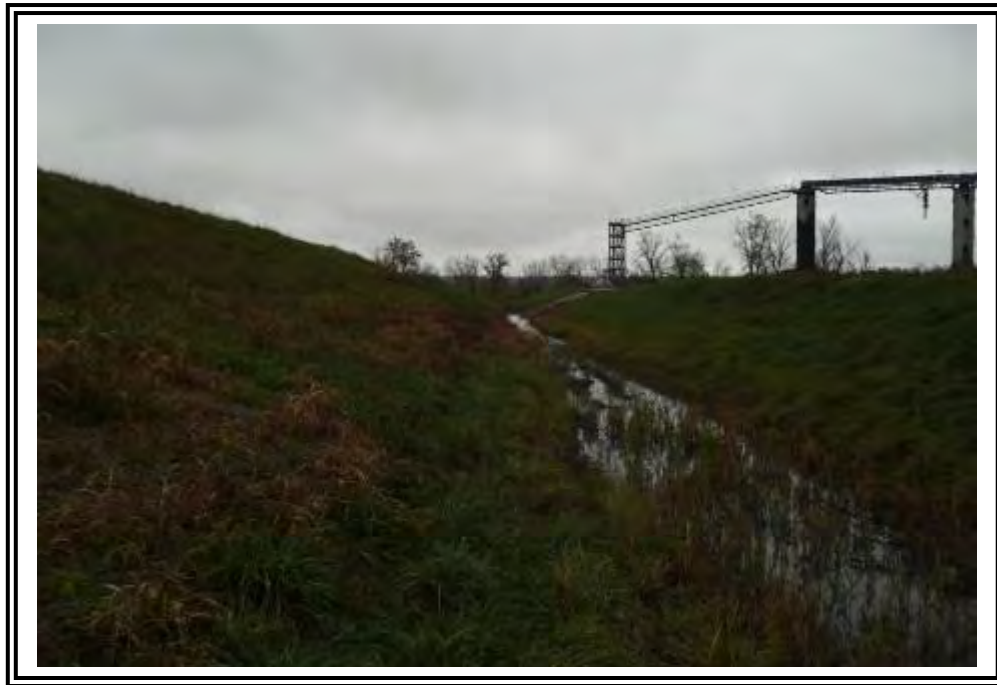
19

An access ramp for ash processing equipment and pond maintenance was observed on the south dike outboard slope. Ash sluicing lines and other waste water pipelines emptying into the pond were also noted on this ramp. In the portion of the dike north of this access ramp, standing water was observed at the dike toe in a drainage swale. This appeared to be due to precipitation before and during the site visit in addition to possible poor drainage (Photo 19).

Standing water in drainage swale at toe of south dike.

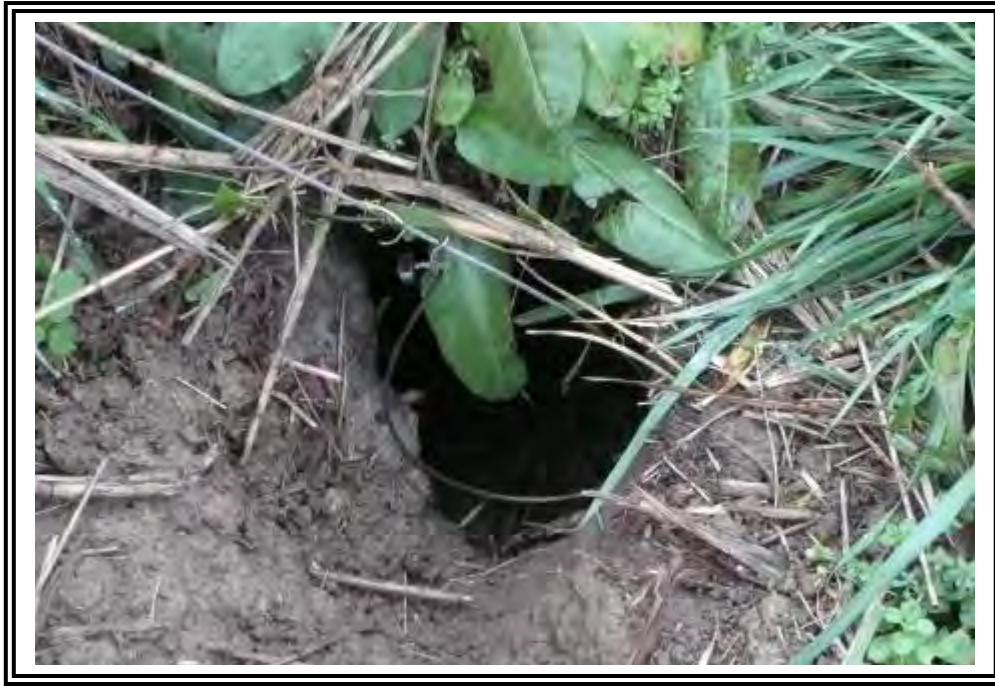
21

Rodent burrow with trap.

Isolated rodent burrows were observed along the outboard slopes of Ash Pond A. At one location a trap was observed indicating that BREC is actively moving to control these animals. This rodent control measure and others should continue to be utilized as needed.

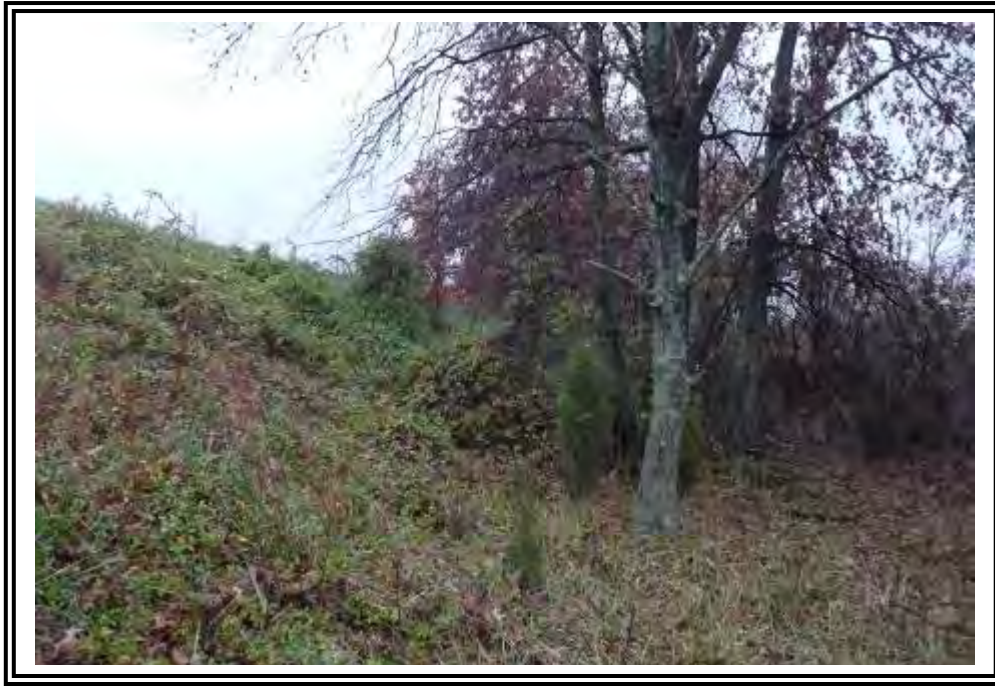
27

South dike outboard slope, looking east.
Note trees and brush vegetation on slope and at slope toe.

The heavy vegetation and trees established along the south dike adjacent to the drainage feature need to be removed. This should be done at least to the toe of the constructed dike and to the eastern extent of the dike where it ties in to the natural grade at the incised portion of the pond. According to an excerpt from the meeting minutes of a meeting held November 9, 2009, this tree removal activity was on an action item list, so it appears if this was recommended previously. To aid in determining the extent of tree removal, it is also suggested that a detailed survey be obtained in the area so that vegetation along the natural swale can be retained.

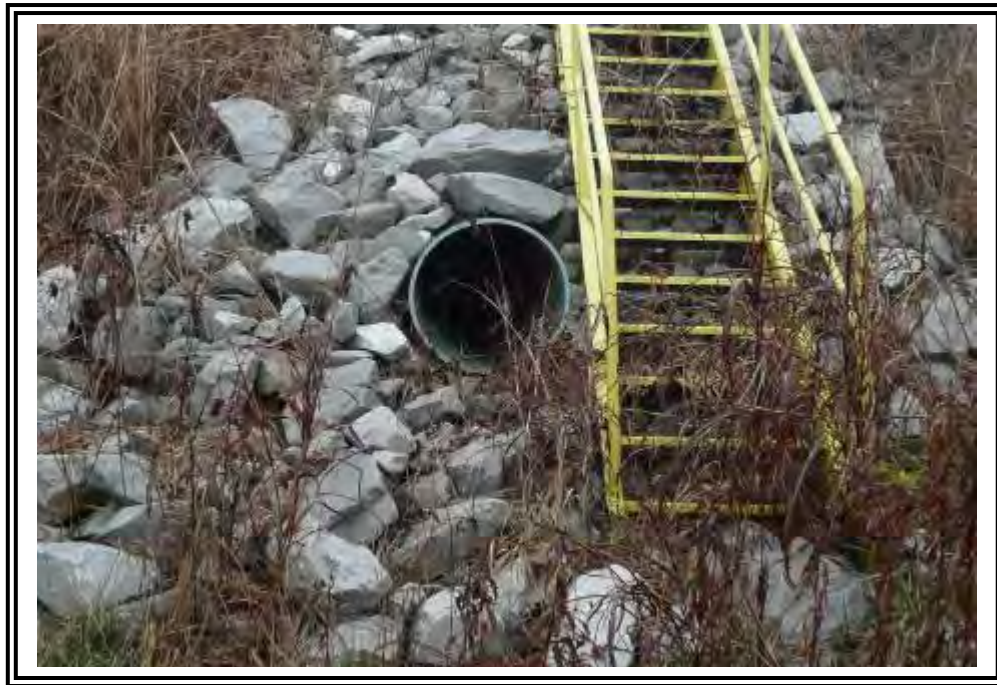
29

The primary outlet structure is a 24-inch diameter PVC riser connected to a 24-inch diameter PVC pipe located along the south dike (Photo 28). This pipe conveys water beyond the dike toe to the upper portions of the drainage feature running parallel to the south dike, eventually emptying into the Ohio River. At the time of the site assessment, the pond was dry and the outlet was inactive. It appeared to be open and unobstructed, with rip rap outlet protection. Sporadic dead or dying vegetation was observed in the outlet protection (Photo 29).

Outlet pipe on south dike.

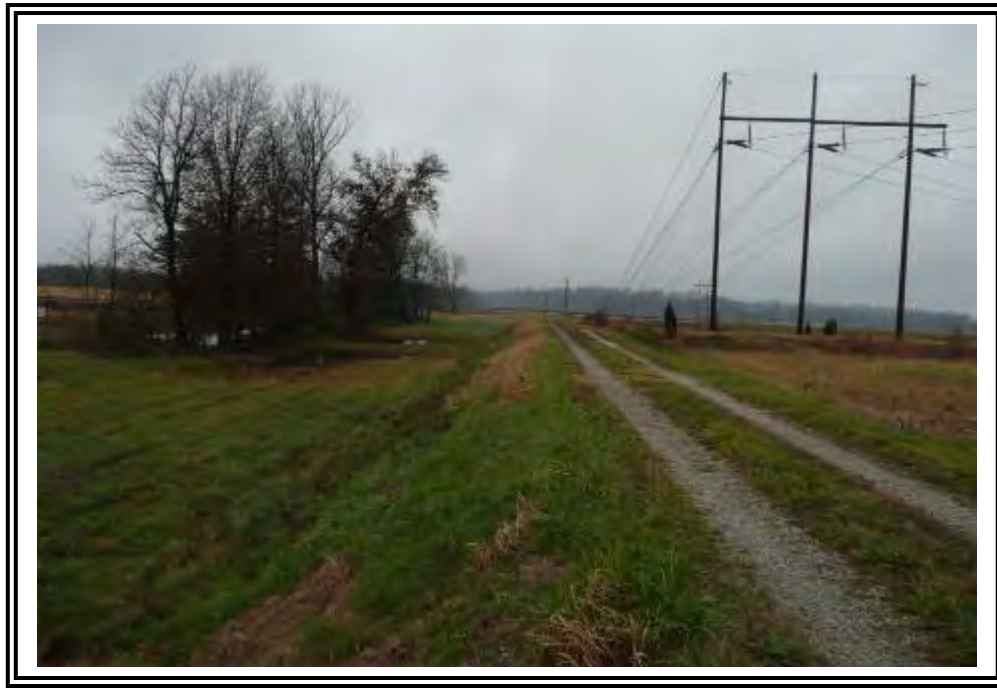
31

South dike crest area, looking west. Note standing water near toe area.

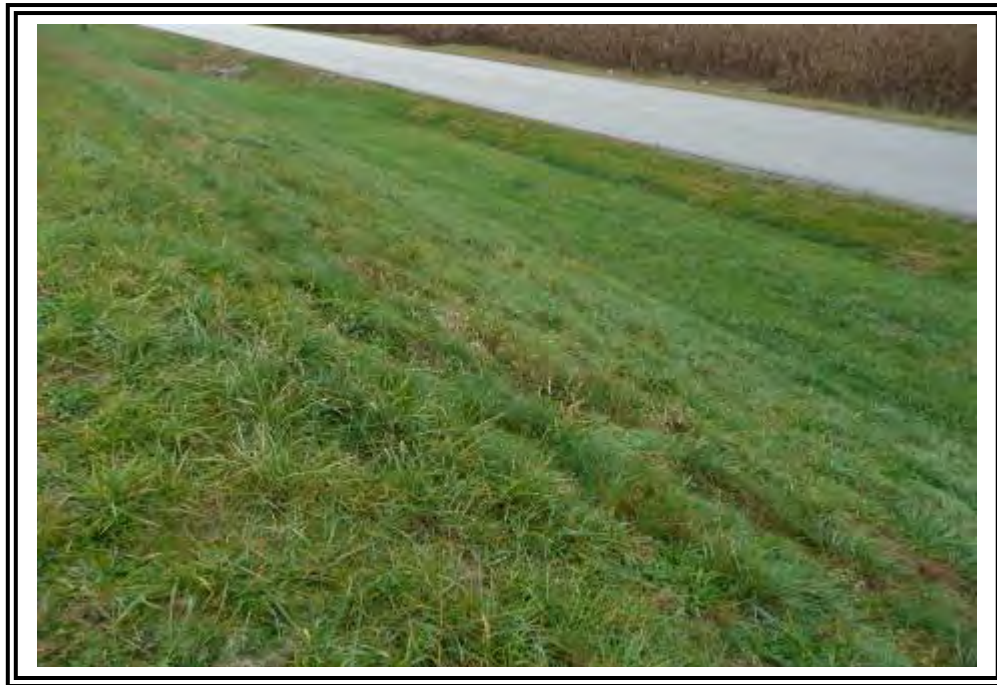
39

Mowing ruts in surface on west dike outboard slope.

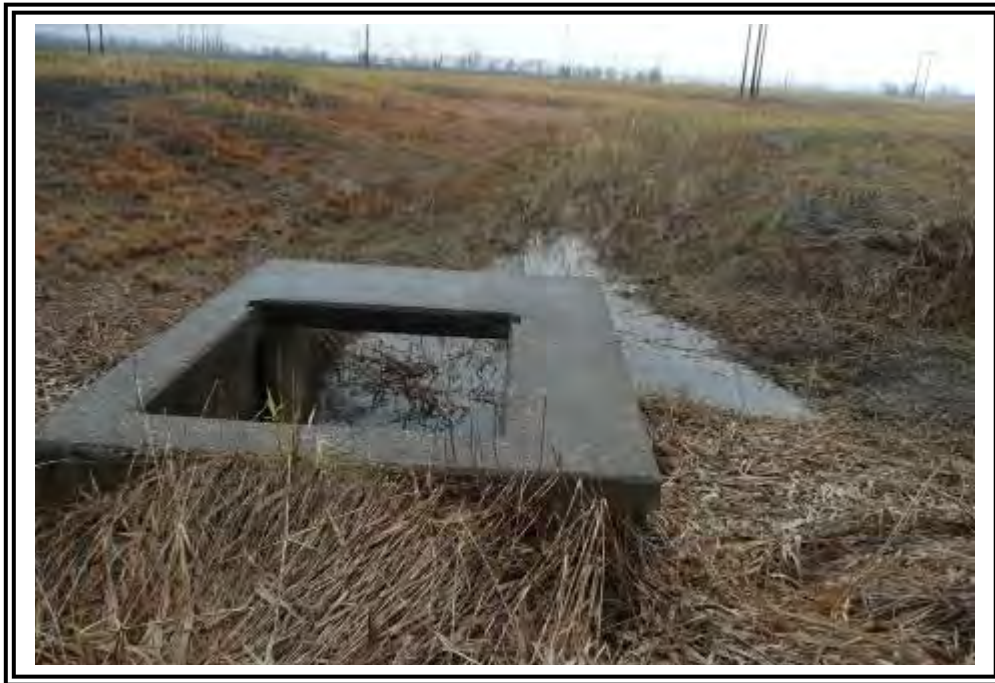
42

A secondary outlet is a roughly 9-foot by 12-foot reinforced concrete spillway riser located on the north dike (Photo 42). This structure is connected to a 48-inch diameter reinforced pipe and conveys water to a sump pit in the area where the old North Ash Pond was reclaimed (Photo 43). Effluent collected in this sump is pumped to Ash Pond A. This structure is configured to accept stop logs to control the pond level; however this structure is longer actively controlling a water level. During the site visit, the ash level and dried ground surface was generally observed to be above this structure. Furthermore, this area had been graded so that drainage swales from the pond area could convey water to this location when dredged ash was being dewatered and promote positive drainage for stormwater runoff. Water was noted pooling against this structure and dead or dying weedy vegetation was encountered at the structure opening. This vegetation did not appear to be impeding the structure in its present function.

Old outlet structure to closed and reclaimed North Pond.
