# Assessment of Dam Safety Coal Combustion Surface Impoundments (Task 3) Final Report

Big Rivers Electric  
Corporation

Coleman Generating  
Station

Hawesville, Kentucky

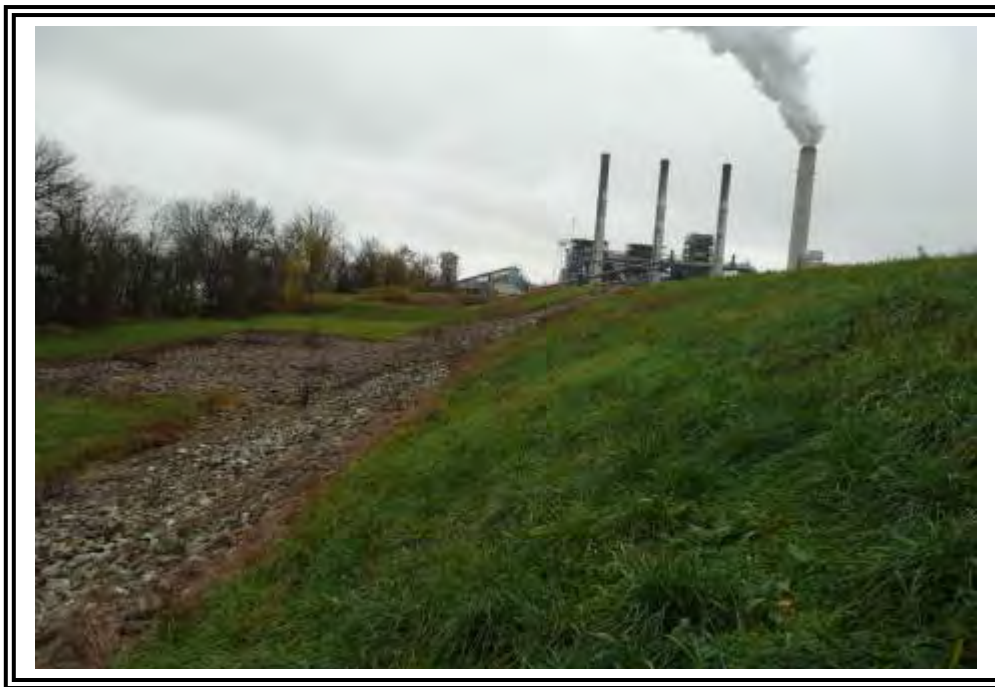
1

East dike outboard slope, looking south. Note rock toe drain.

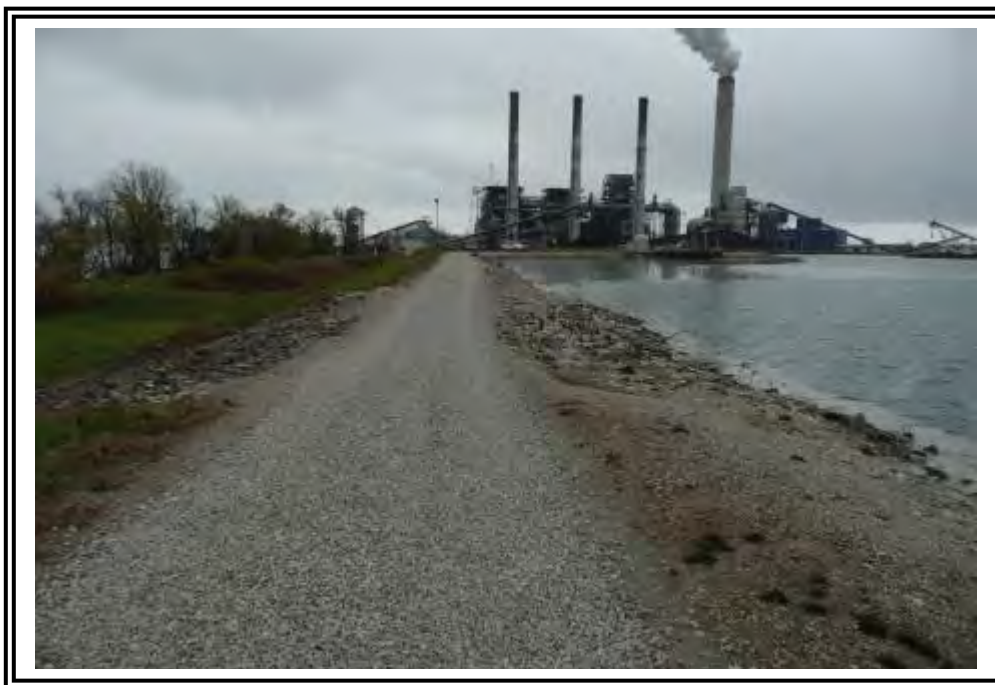
2

East dike crest, looking south. Note gravel crest surface.

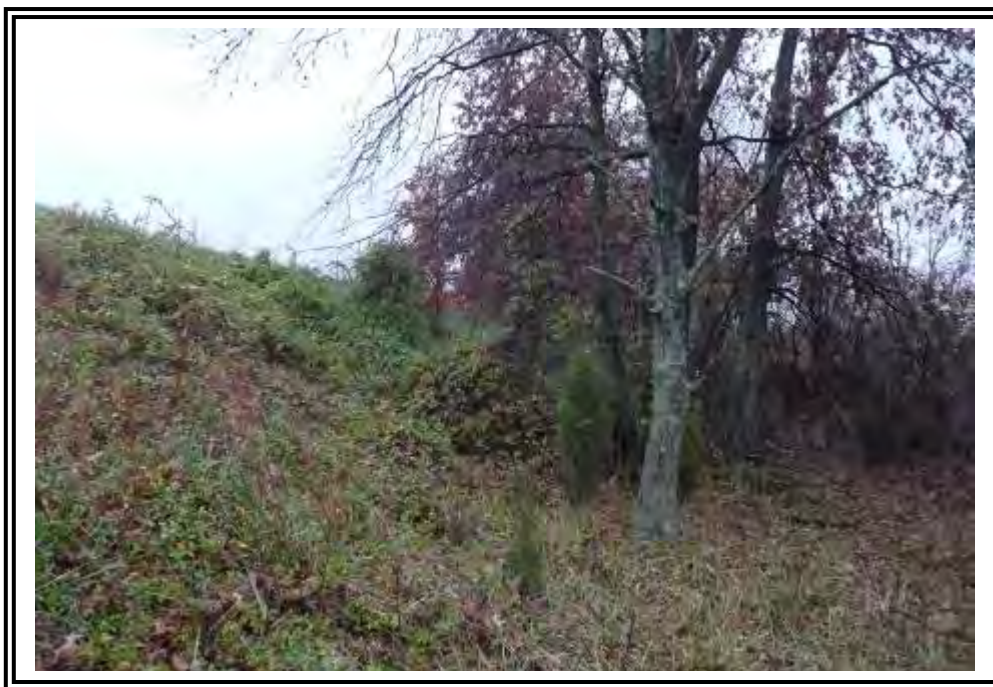
27

South dike outboard slope, looking east.  
Note trees and brush vegetation on slope and at slope toe.

The heavy vegetation and trees established along the south dike adjacent to the drainage feature need to be removed. This should be done at least to the toe of the constructed dike and to the eastern extent of the dike where it ties in to the natural grade at the incised portion of the pond. According to an excerpt from the meeting minutes of a meeting held November 9, 2009, this tree removal activity was on an action item list, so it appears if this was recommended previously. To aid in determining the extent of tree removal, it is also suggested that a detailed survey be obtained in the area so that vegetation along the natural swale can be retained.

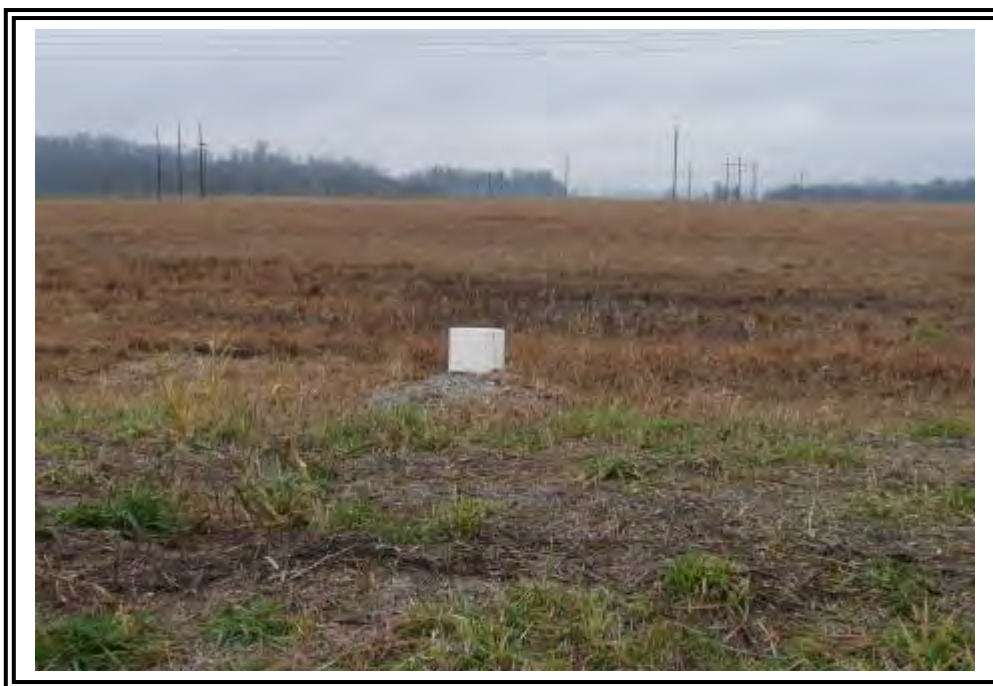
28

The primary outlet structure is a 24-inch diameter PVC riser connected to a 24-inch diameter PVC pipe located along the south dike (Photo 28). This pipe conveys water beyond the dike toe to the upper portions of the drainage feature running parallel to the south dike, eventually emptying into the Ohio River. At the time of the site assessment, the pond was dry and the outlet was inactive. It appeared to be open and unobstructed, with rip rap outlet protection. Sporadic dead or dying vegetation was observed in the outlet protection (Photo 29).

Outlet riser in pond area.

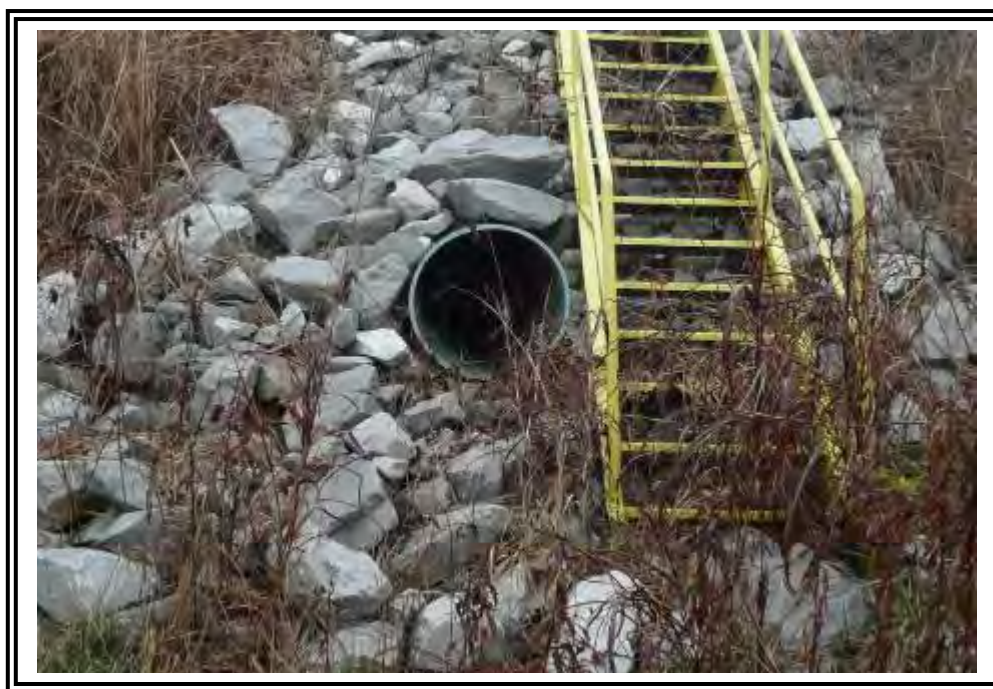
29

Outlet pipe on south dike.
