**Dam Safety Assessment of CCW
Impoundments**

**Reid/Green/HMP&L Station II
Report**

**Lockheed Martin
Contractor for the USEPA**

October 2009

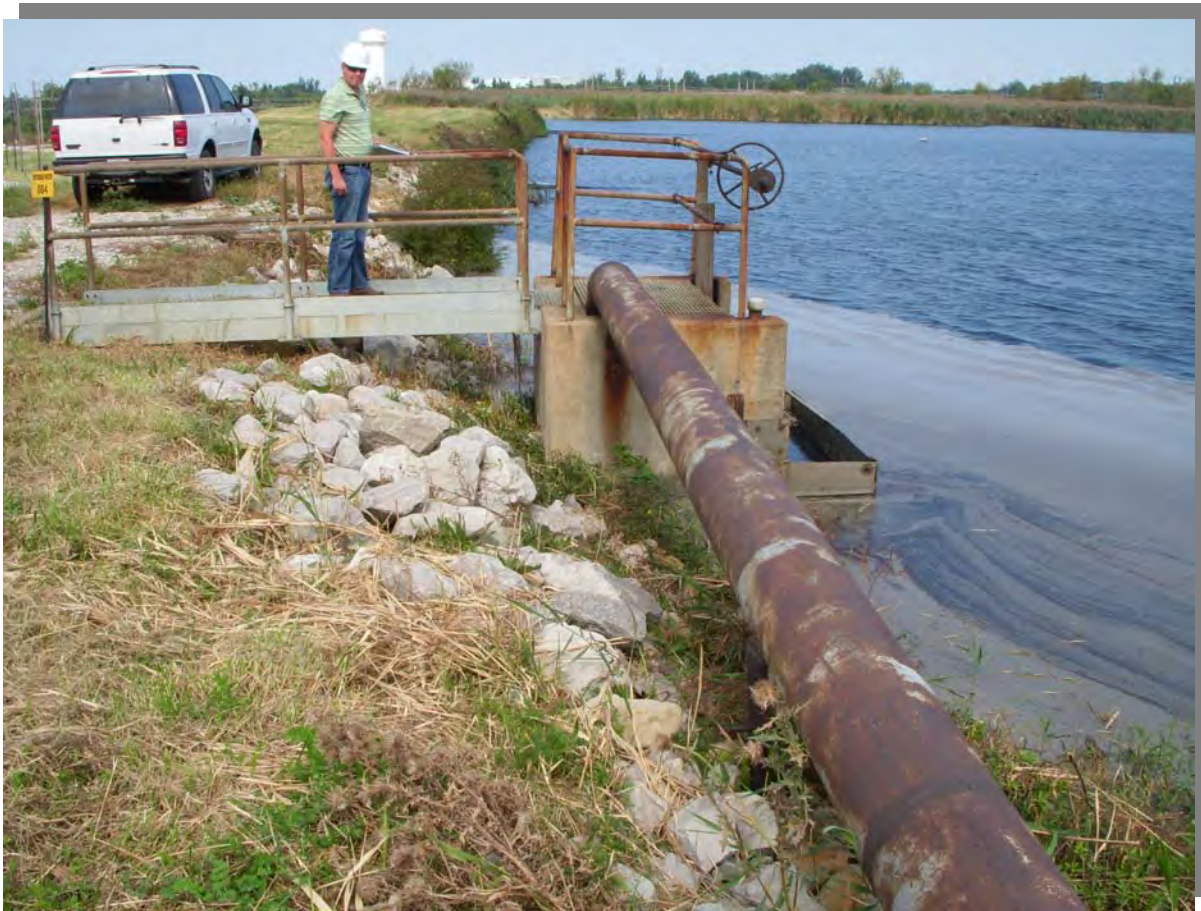
- A mature willow tree is growing on the eastern crest and inboard slope.
- The outlet structure appeared to be in good condition and functioning normally (Appendix B – Photo 1) .

Photo 1 – View of pond outlet structure

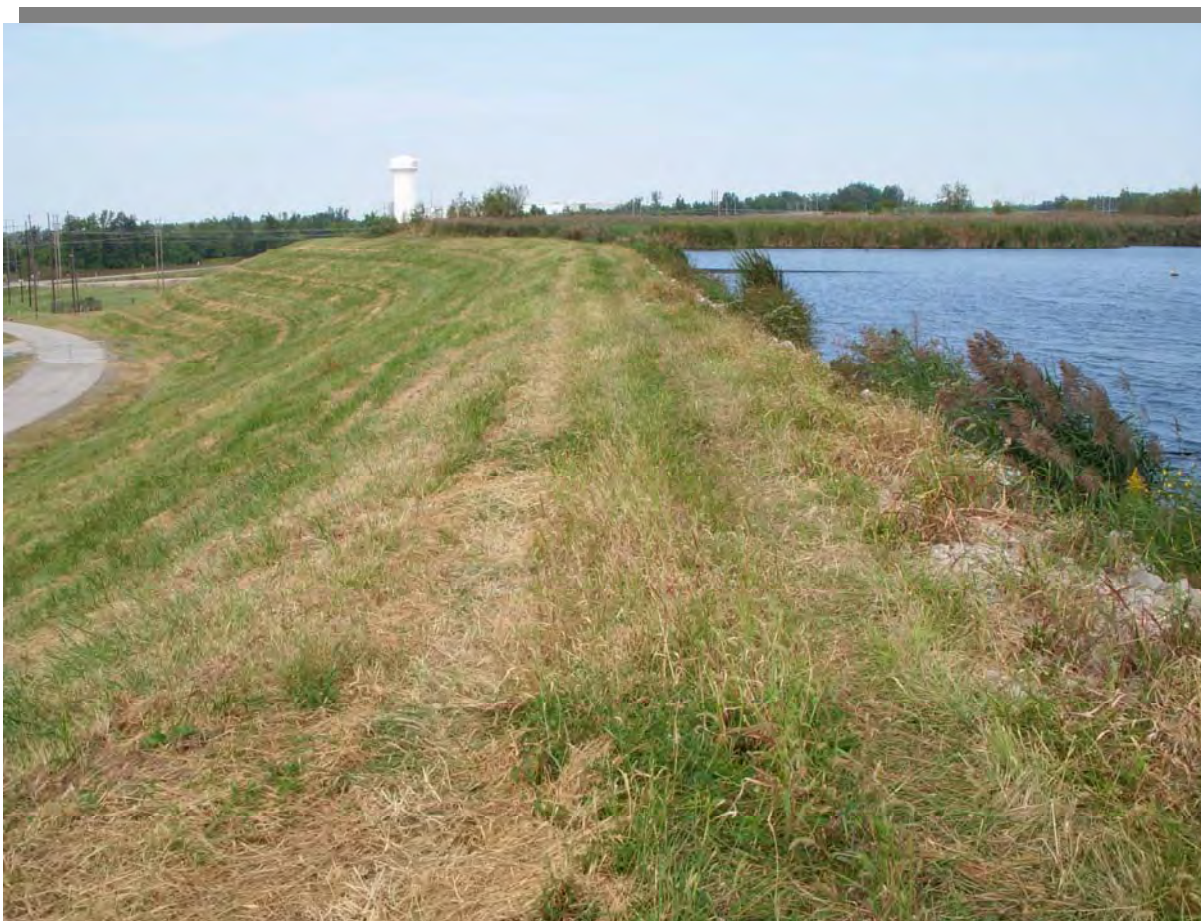
Photo 2 – View of south dike crest looking west.

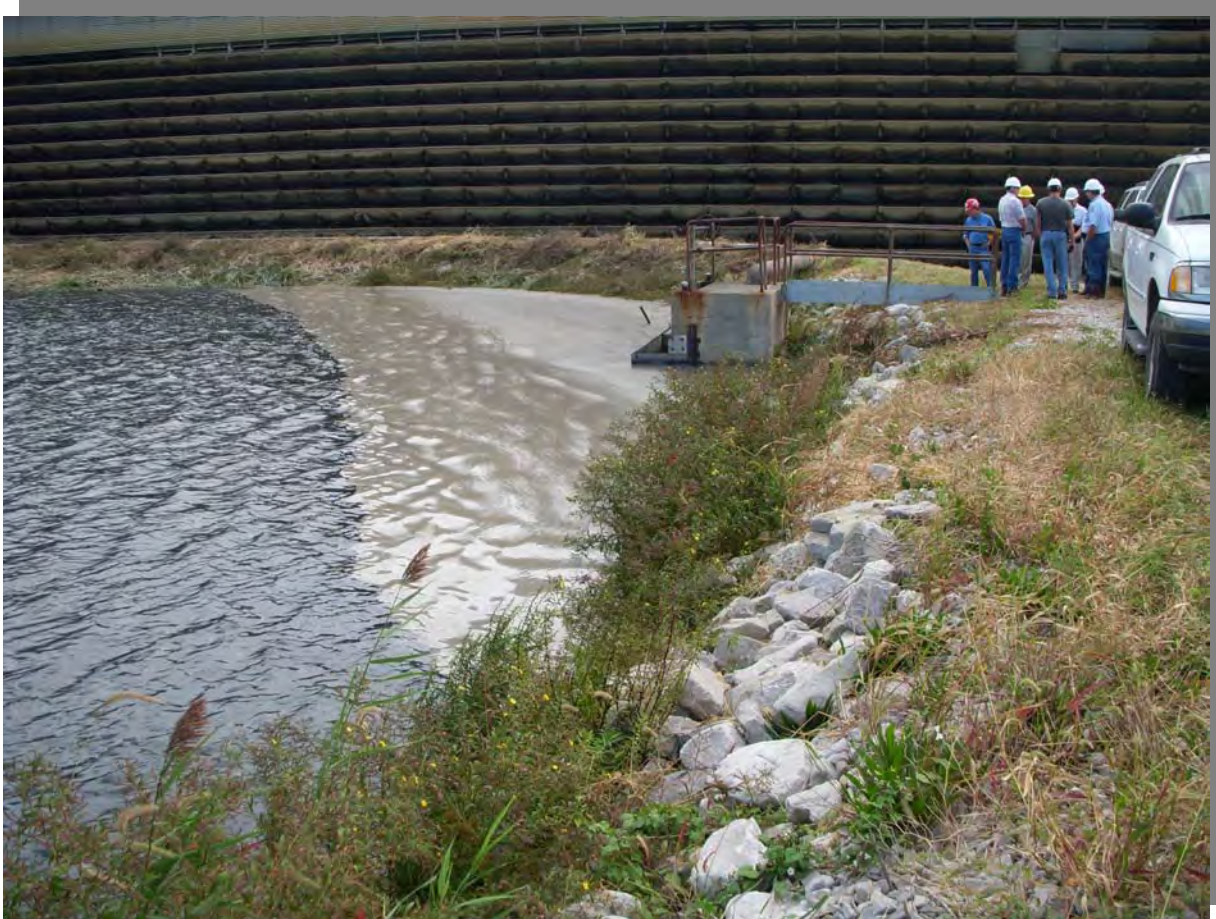
Photo 3 – View along inboard slope of south dike looking east. Note riprap armoring.

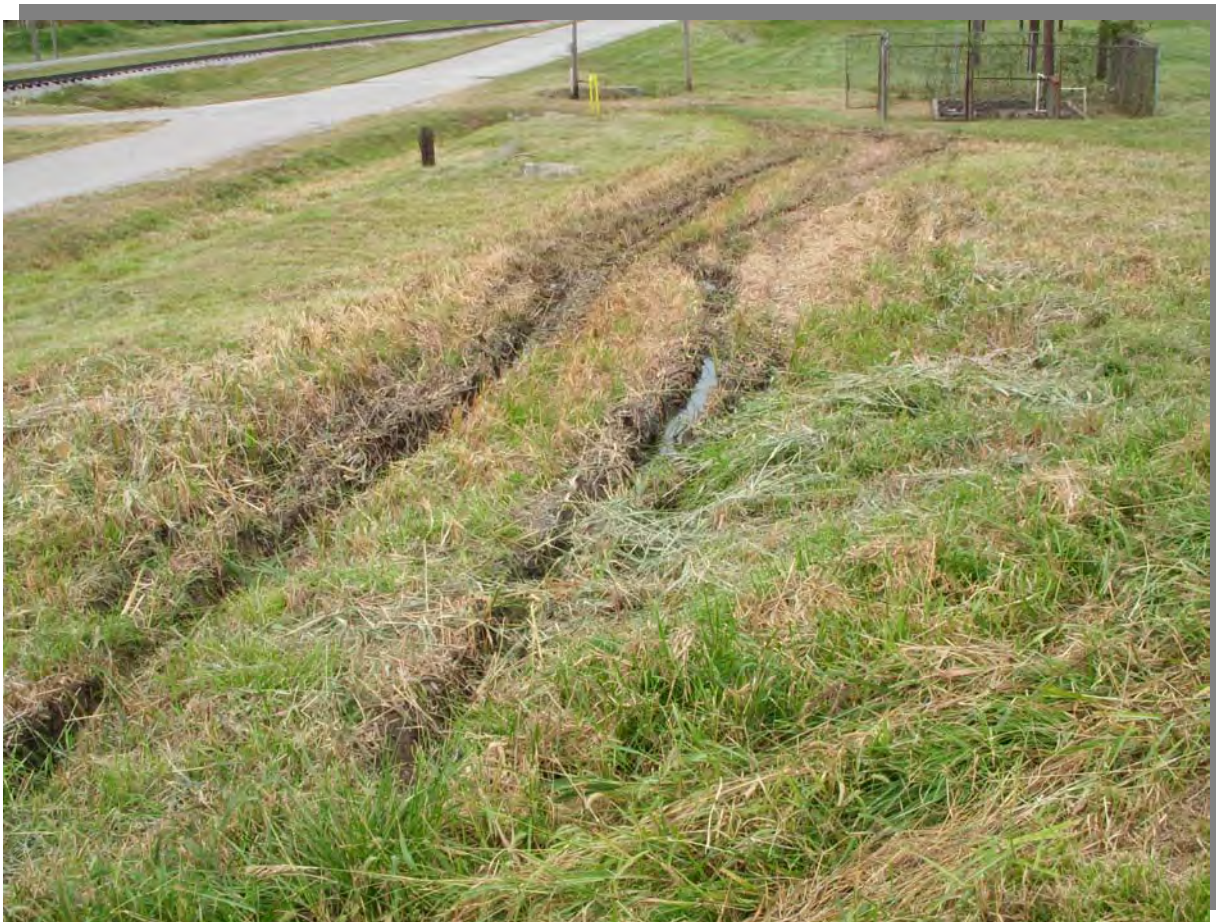
- The outboard slope and crest were covered with well maintained grass. The crest has been rutted by the mowing tractor in a few isolated locations.
- Minor seepage was evident along the toe of the outboard southern and western slopes. The seepage rate was very low with no discernible flow. Seepage was observed to accumulate in rutted areas at the toe of slope created by the mowing tractor. The seepage is believed to be controlled discharge from the sand toe drain.

Photo 4 – Seepage and rutting along south outboard toe.

- Outboard toe – regrade the swale along the toe to improve drainage. The swale may need to be lined with alternate materials, such as crushed stone or concrete to alleviate the soft soil condition. Consider installing a V-notch weir to monitor seepage flow rate. Remove wooden poles and fill with compacted material consistent with the dike design.

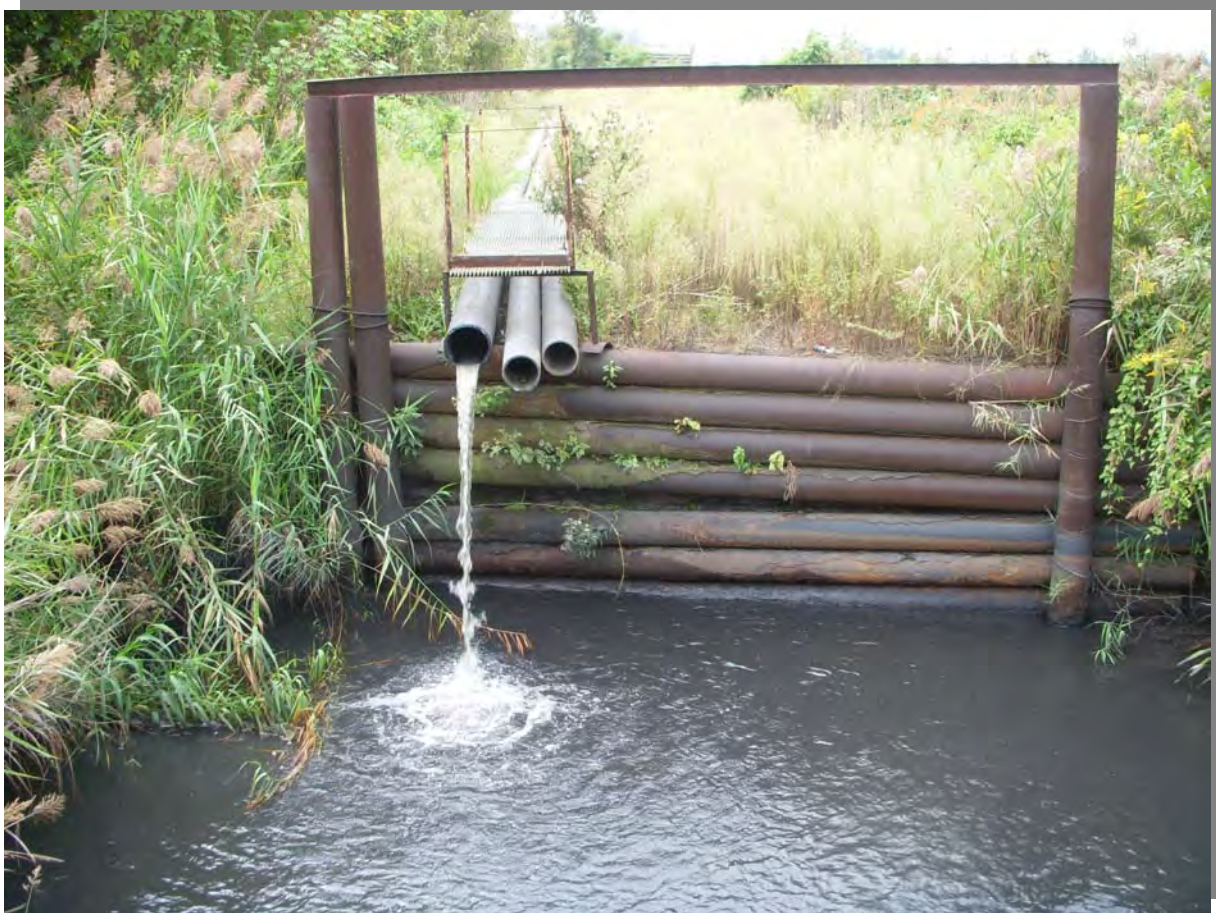
Photo 5 – Influent pipe discharging into northern ditch that parallels a portion of the northern inboard slope.

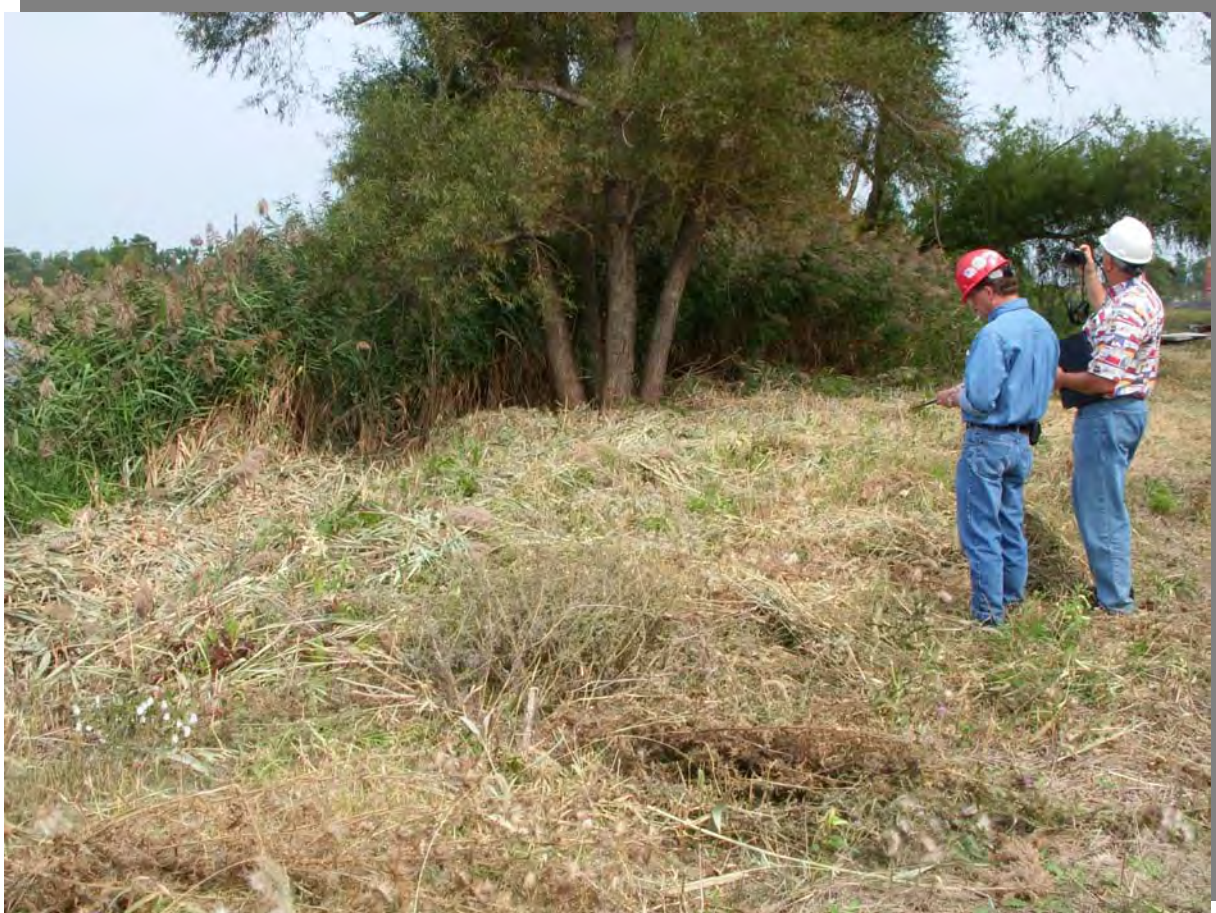
Photo 6 – East dike crest with willow tree.

- Crest – fill ruts on crest and re-establish vegetative cover. Remove willow tree from crest of eastern dike.
- Inboard slopes – repair eroded inboard slopes. Repairs should be completed in accordance with an engineered design. Inspect and maintain erosion that may develop on freeboard section of all inboard slopes on a regular basis. Keep vegetation under control to allow for visual inspection of the exposed portion of the slope above the waterline.

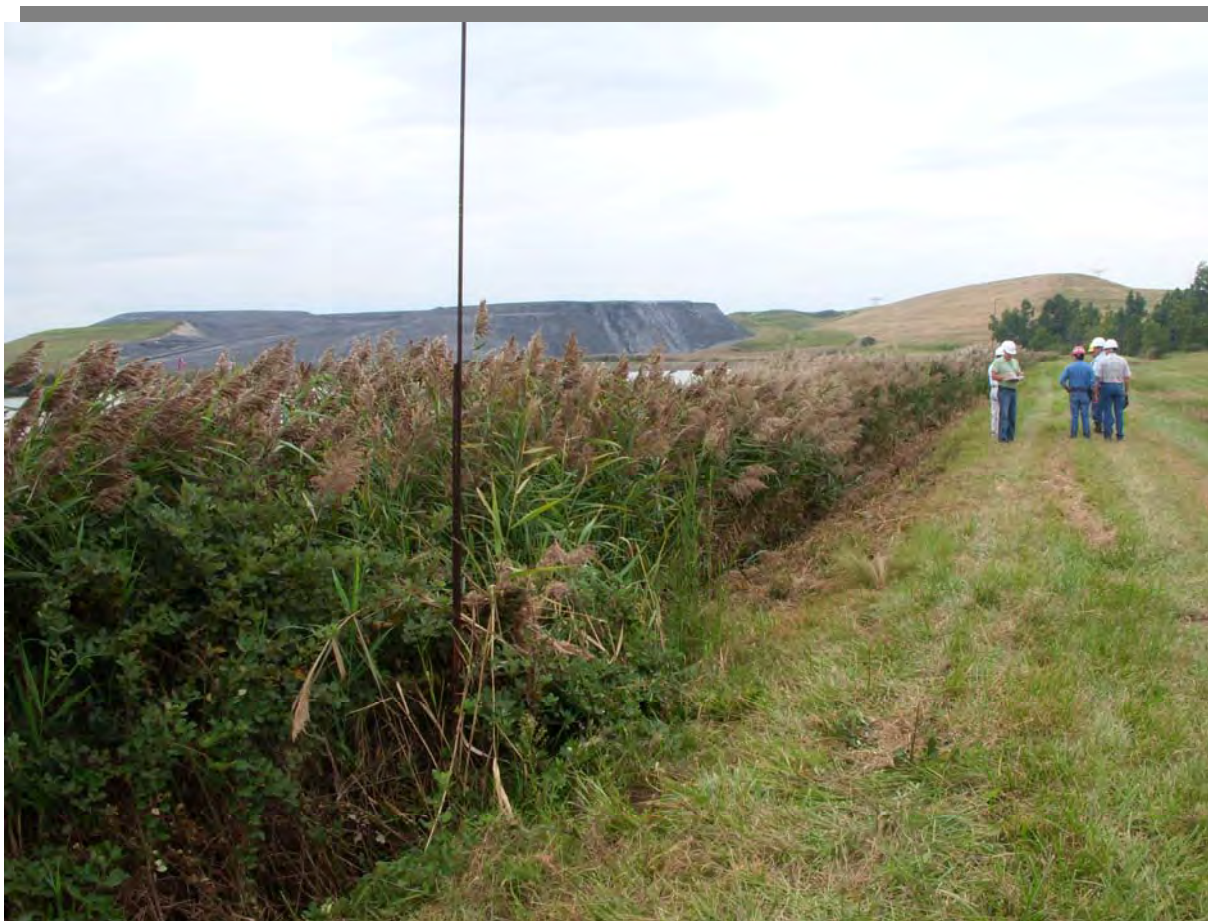
- The inboard slopes along portions of the pond were overgrown with reedy grasses such as fragmites (Appendix C – Photo 2).
- Some erosion of the exposed inboard slopes was observed along the west side of the pond.

Photo 2 – Crest of low west dike looking south. Note heavy vegetation on inboard slope.

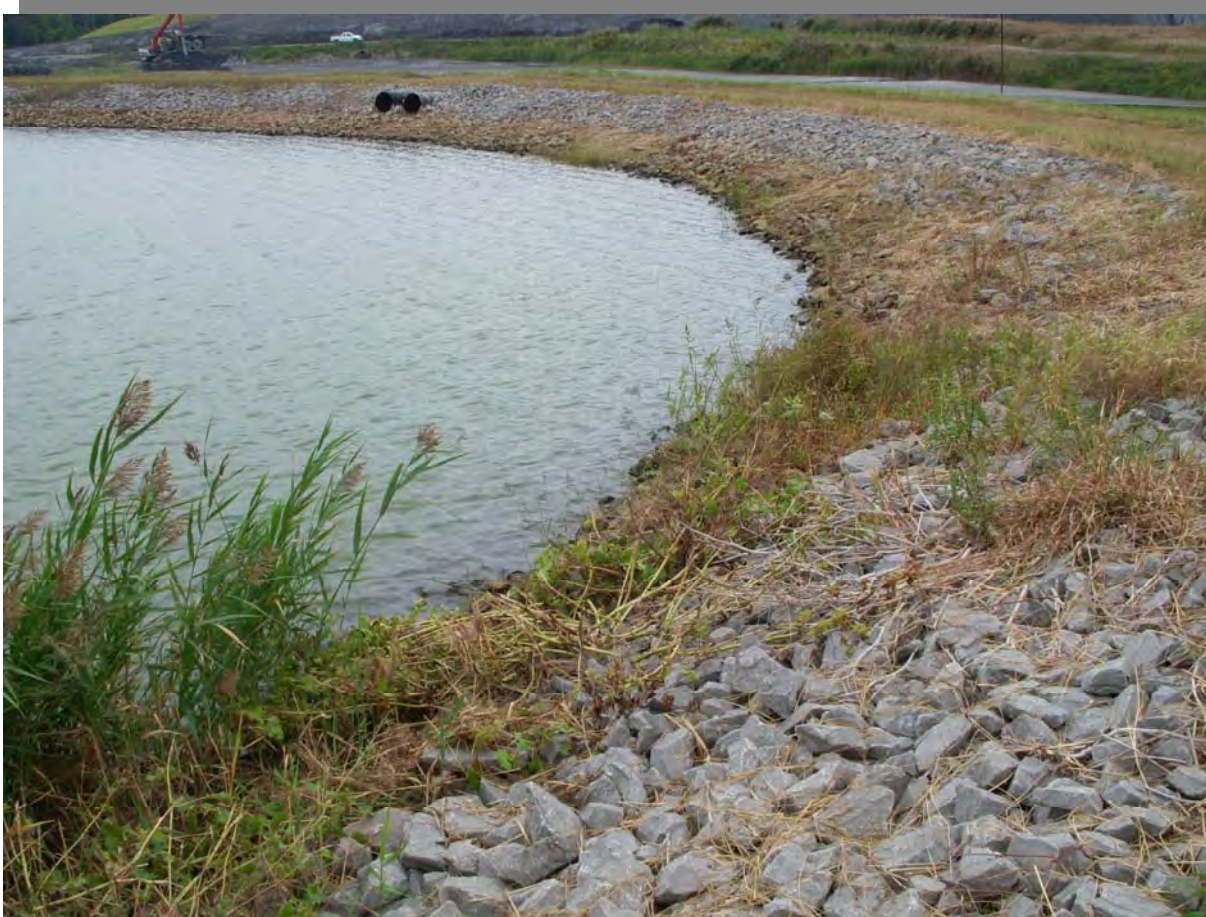
- The inboard slopes along the south end of the pond are armored with riprap to protect against wave action (Appendix C – Photo 3).
- Standing water (less than 6-inches deep) was observed within poorly drained swales along the western and southern embankment toe. The source of this water appears to be storm water and not seepage from the impoundment.

Photo 3 – Riprap-armored inboard slope of south dike. Note emergency overflow pipes in background.

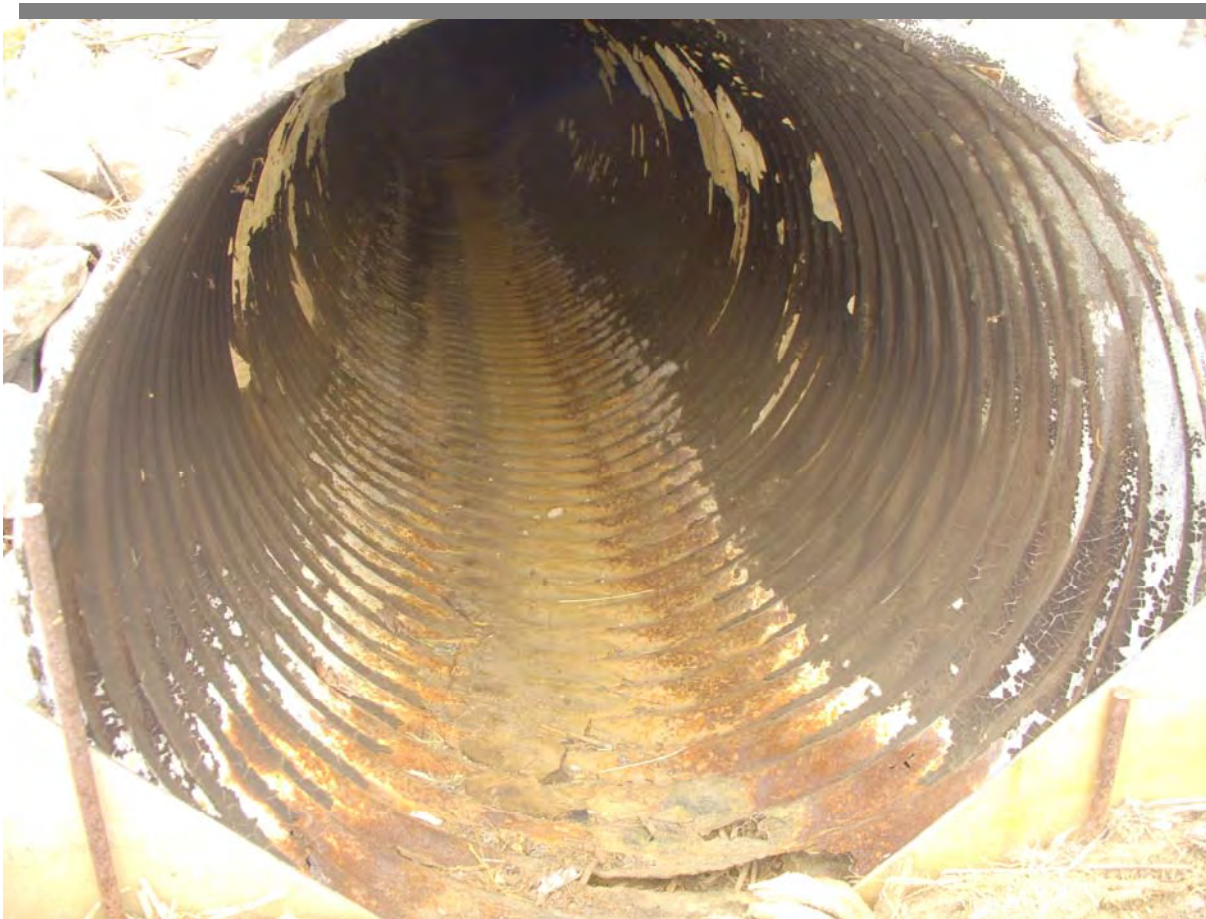
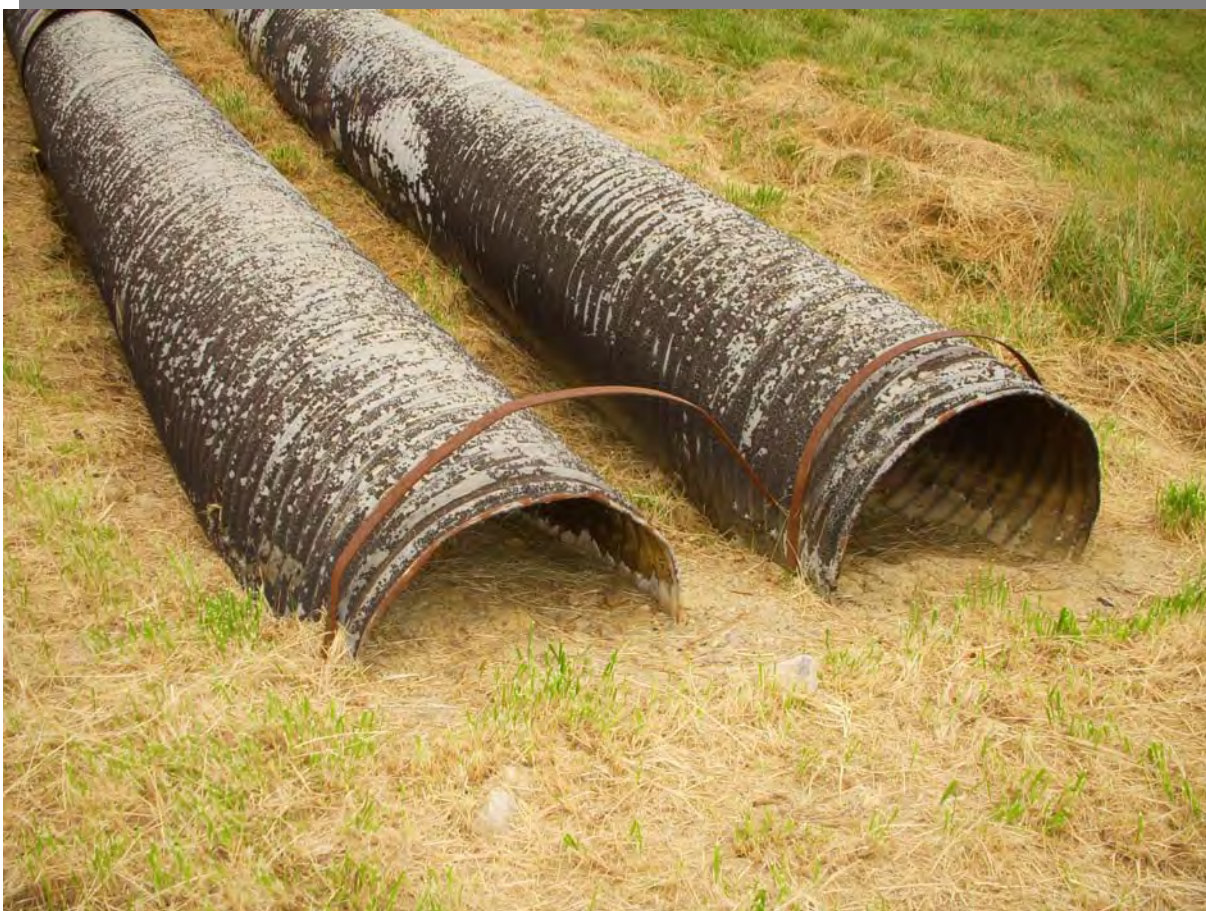
- The dual 30-inch emergency overflow pipes (CMP) located at the southwestern corner of the ash pond were observed to be deteriorated and damaged. These pipes were partially obstructed with silt at the discharge end. Our observations of the pipes indicated that they are rarely used (Appendix C – Photos 4 and 5).

- The west inboard slope is experiencing erosion due to wave action.
- The emergency outlet pipes are deteriorated and obstructed at the downstream end.

Photo 4 – View of deteriorated 30-inch CMP emergency overflow pipe at upstream end.

Photo 5 – Downstream end of emergency overflow pipes. Note siltation of outlet.

Based on our conversations with Mr. David Lamb, PE of Associated Engineers, Inc., plans are underway to repair the erosion problems on the western inboard slope and to repair the emergency overflow pipes.

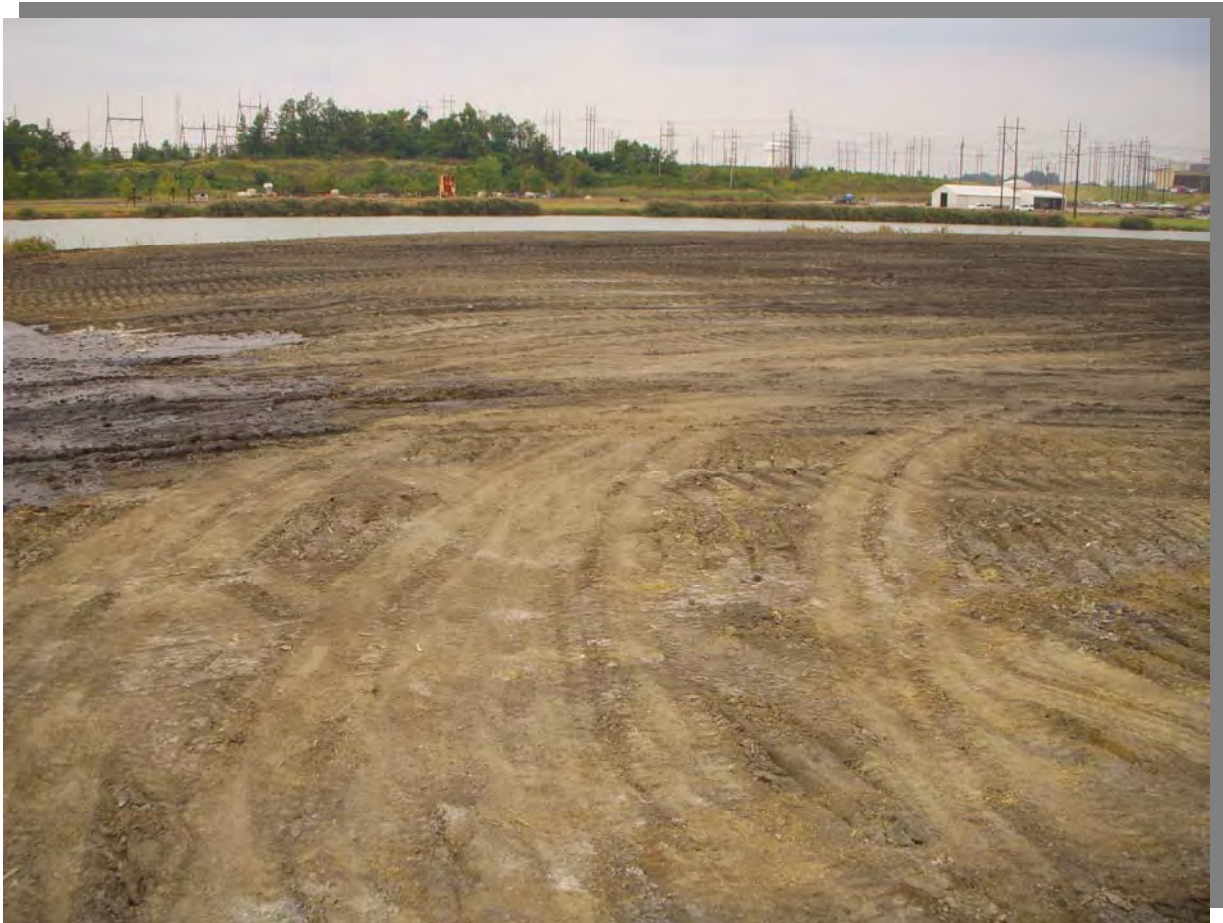
- The crest and outboard slopes appeared to be covered with well-maintained grass and in good condition (Appendix C – Photo 6).
- Bottom ash has accumulated above the normal pool elevation in much of the eastern portion of the pond. This area is used to stockpile excavated bottom ash which is allowed to drain, then loaded on trucks and hauled to the landfill located south of the ash pond. (Appendix C – Photo 7).

Photo 7 – View across the pond toward the west from the east side. Land in the foreground is former pond area that has been reclaimed with bottom ash.

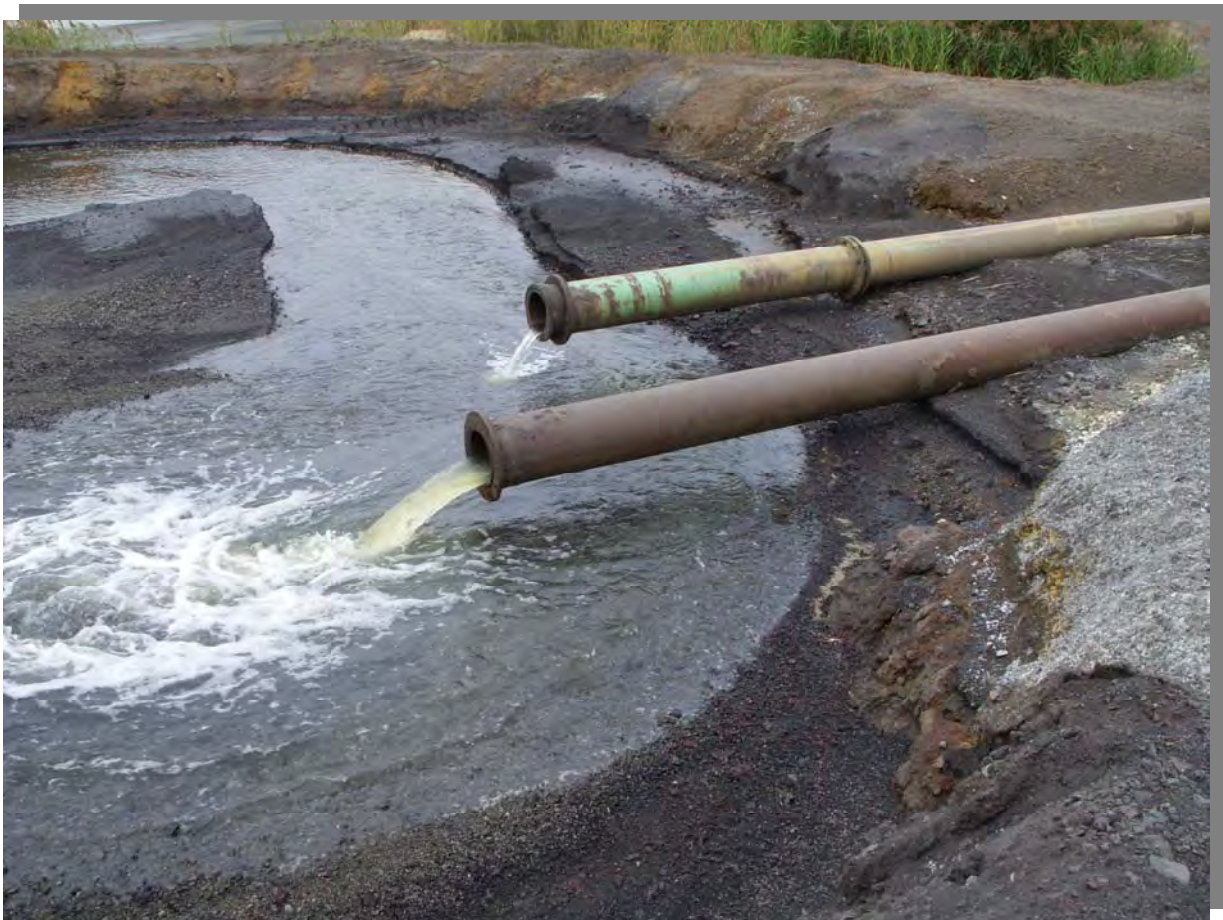
Photo 8 – Influent pipes discharging sludged bottom ash into pond.

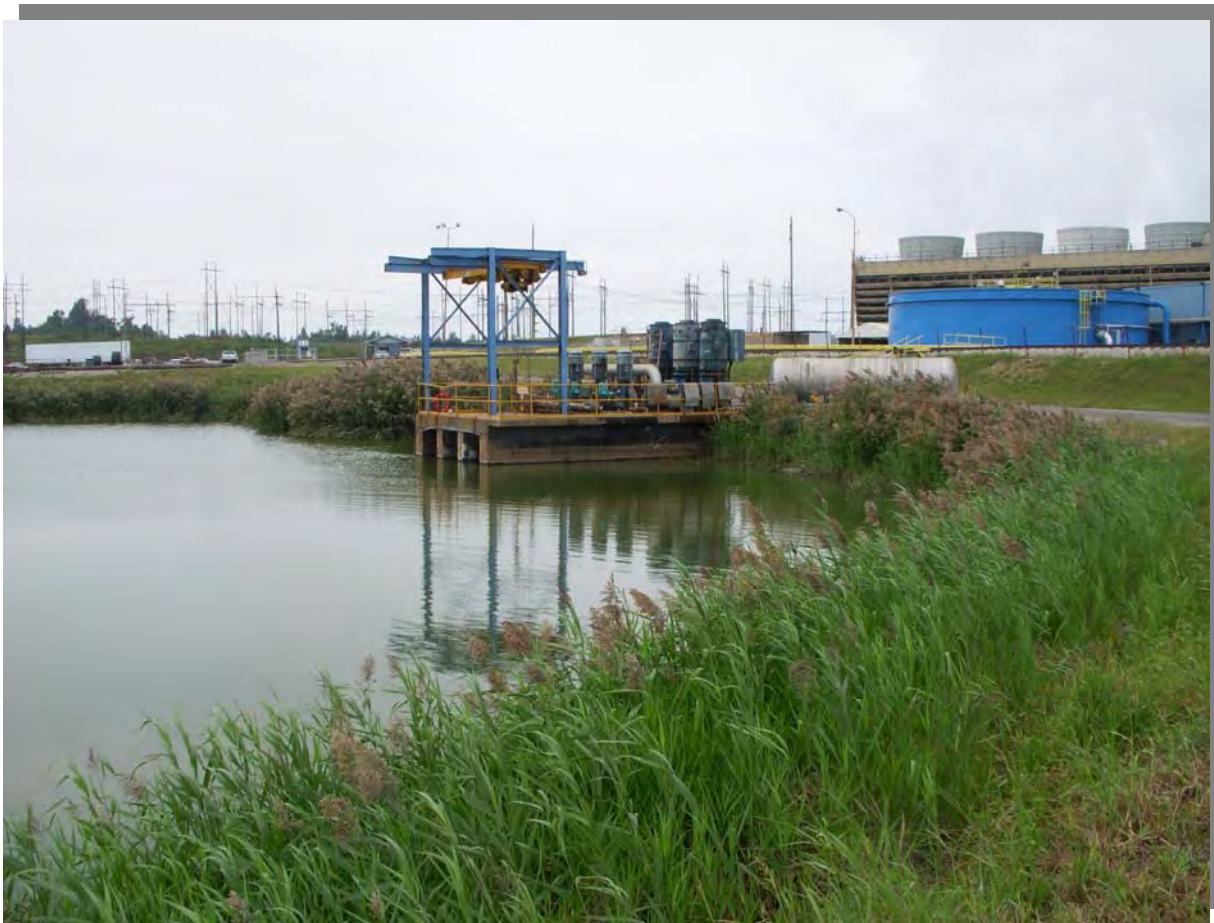
Photo 9 – View of pump station on incised inboard slope at the north end of the pond.
