**FINAL**  
**Coal Ash Impoundment -**  
**Specific Site Assessment Report**  
**PacifiCorp Energy**  
Jim Bridger Power Station

Submitted to:  
**Lockheed-Martin Corporation**  
2890 Wood Bridge Avenue  
Building 209 BAYF  
Edison, NJ 08837

Submitted by:  
**GEI Consultants, Inc.**  
6950 South Potomac Street, Suite 300  
Centennial, CO 80112

September 2009  
Project 091330

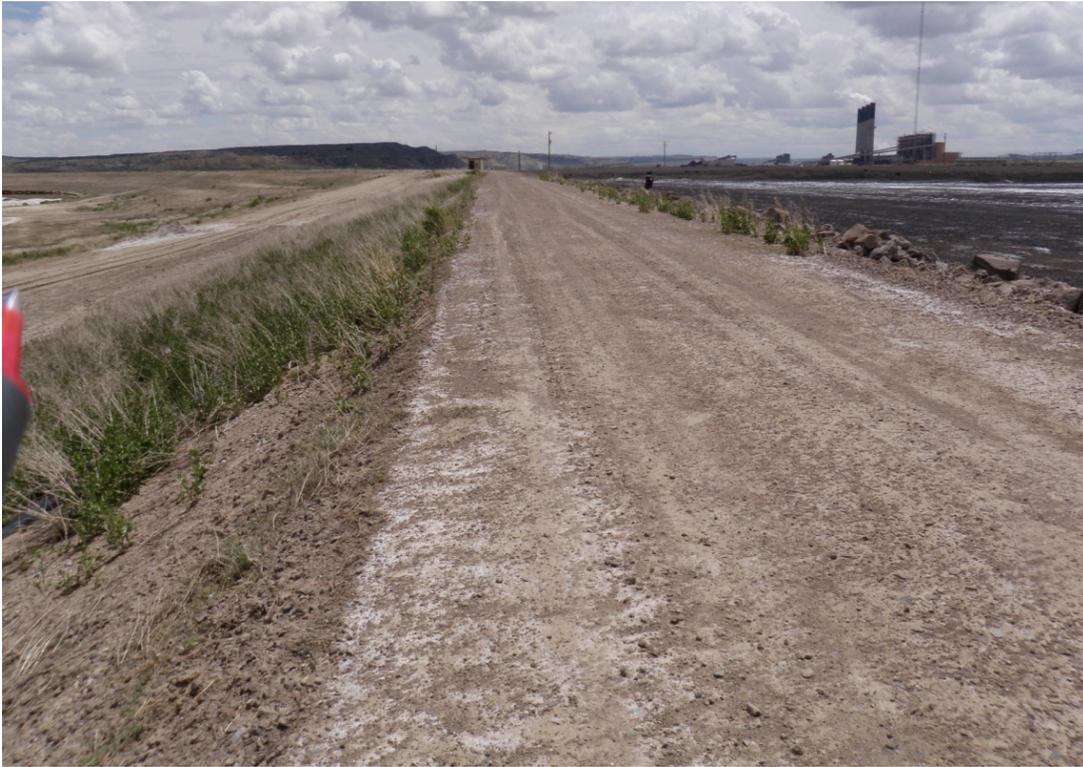
The dam crest appears to be in good condition. We saw no obvious signs of settlement or displacement, see photos 1 and 5.

The upstream slope of the dam was not observed because it is covered with settled FGD solids and a temporary bottom ash cover. See photo 1, 2, 5, and 6.

**Photo 1: Crest and downstream toe of Saddle Dike (Dike B); Looking to the right (east)**

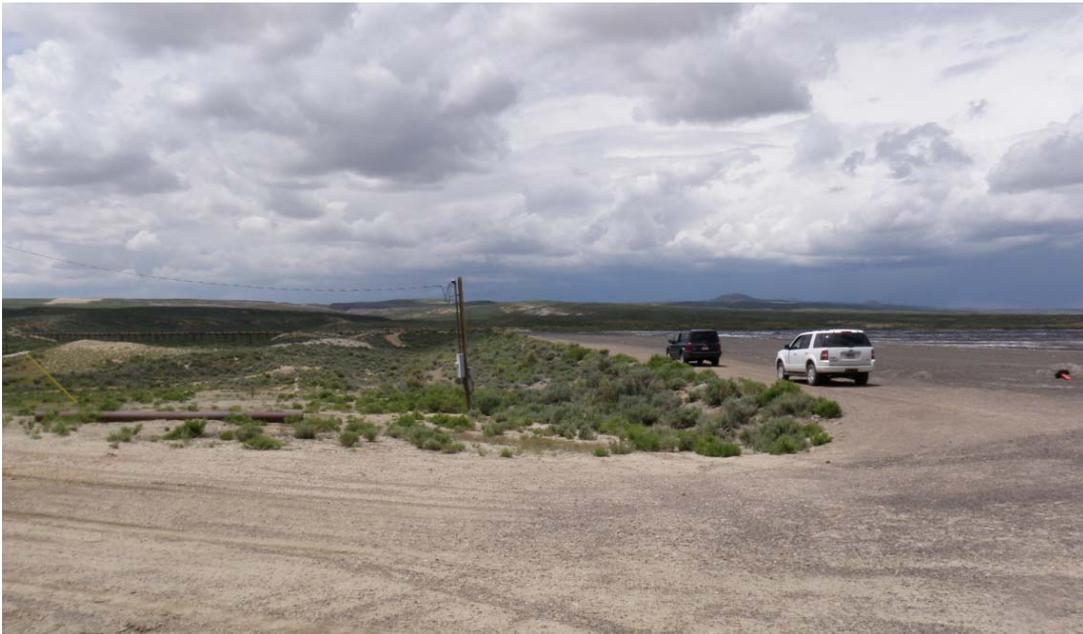
**Photo 2: FGD Pond 1, Crest and downstream face of the main dam (Dike A); looking from Left abutment toward the west**

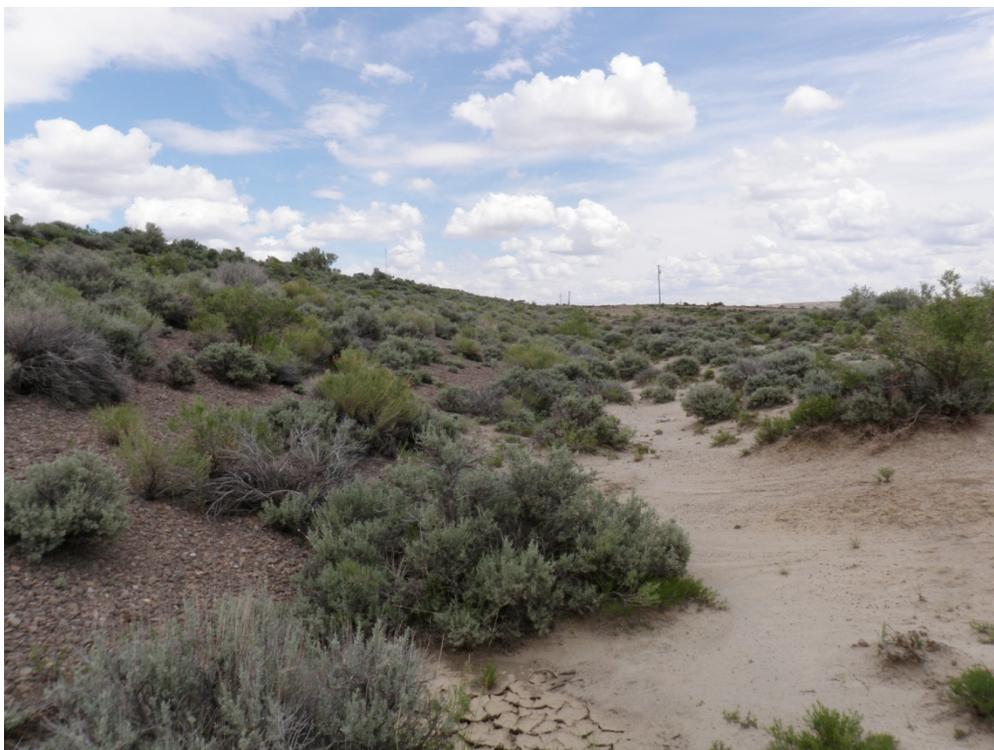
The downstream slope and toe berm of FGD Pond 1 are covered with thick mature sagebrush, grasses, and bushes. This vegetation should be removed to enable visual inspection of the dam and prevent roots from penetrating the dam. See photos 3 and 4. Except for the excessive vegetation, the downstream slope was observed to be in generally good condition. We recognize that FGD Pond 1 is not in service, has been dewatered, and is in the process of formal closure. According to PacifiCorp, the closure plan includes establishment of native vegetation including grasses, forbs, and sagebrush, on the final soil cover. While such vegetation with intrusive root systems is not acceptable on dam embankments, PacifiCorp may choose to incorporate the existing, or similar, vegetation into the final soil cover assuming FGD Pond 1 remains dewatered and closure cover construction occurs in the near future.

Photo 3: FGD Pond 1, Downstream toe of the main dam; Looking to the left (east)

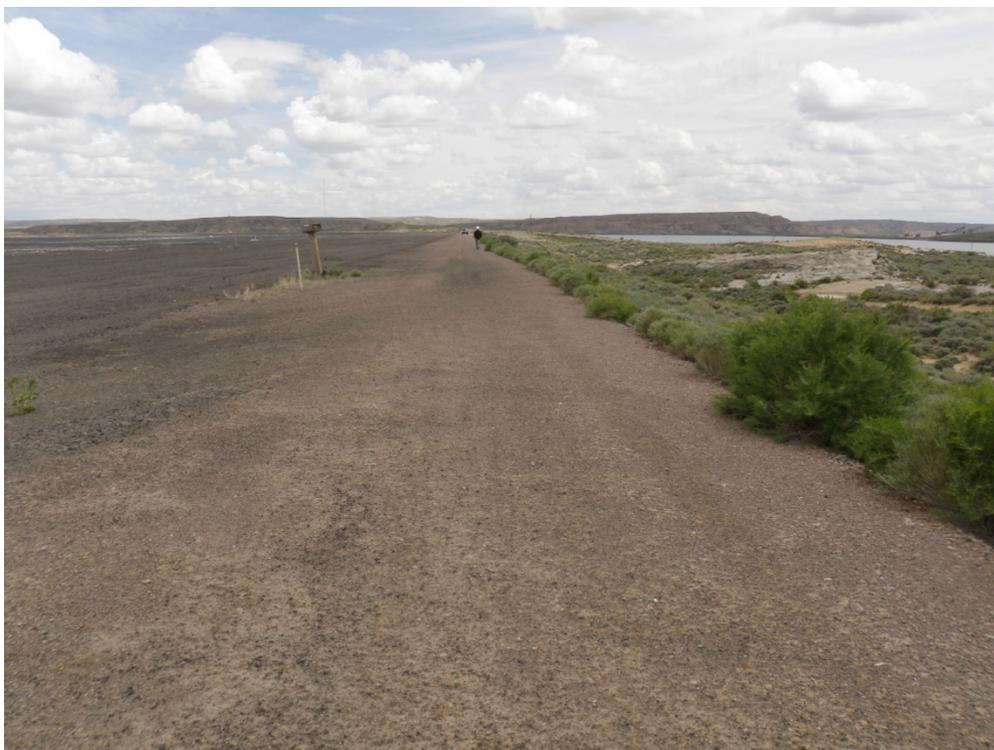
Photo 5: FGD Pond 1, Crest of the main dam; Standing near right abutment and looking to the left (east)

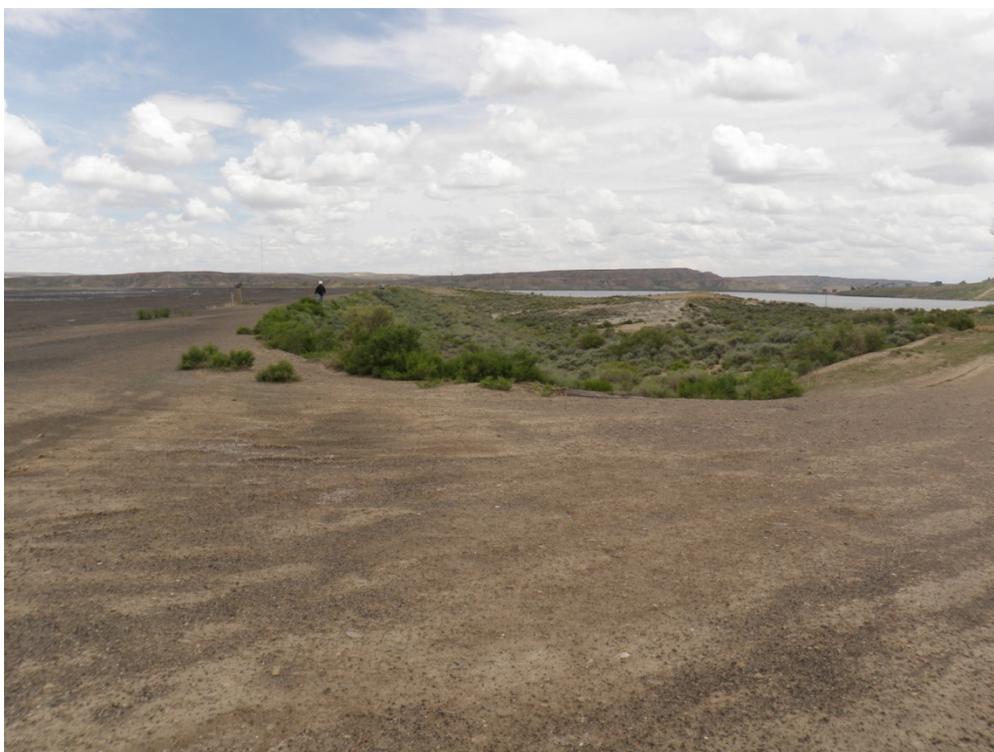
Photo 6: FGD Pond 1, Crest – View of right abutment and downstream groin of main dam; Looking to the left (east)

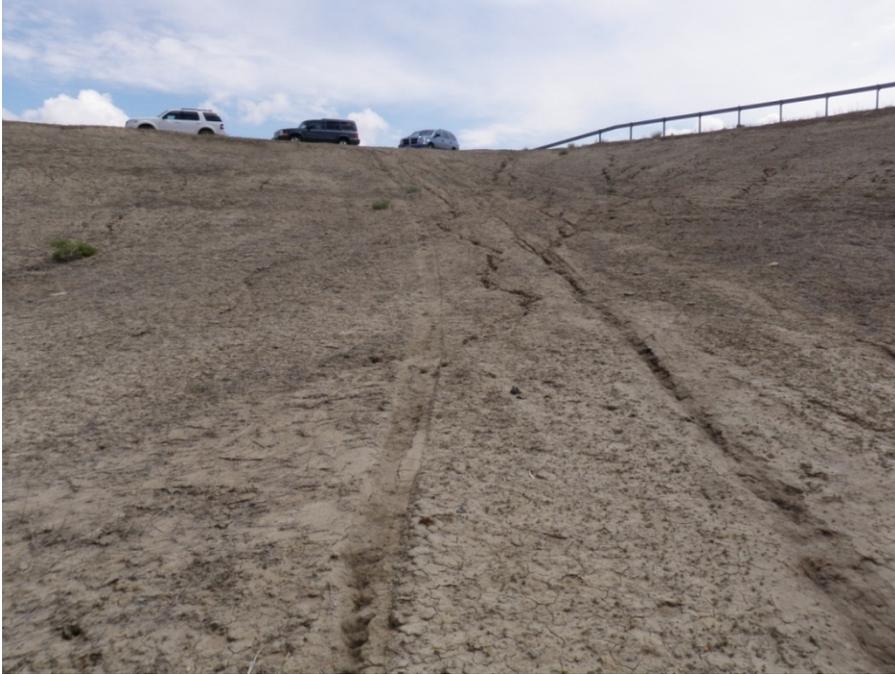
Photo 7: FGD Pond 2, Upstream face at turn in embankment near Station 45+00, note erosion rills; Looking North upslope to crest

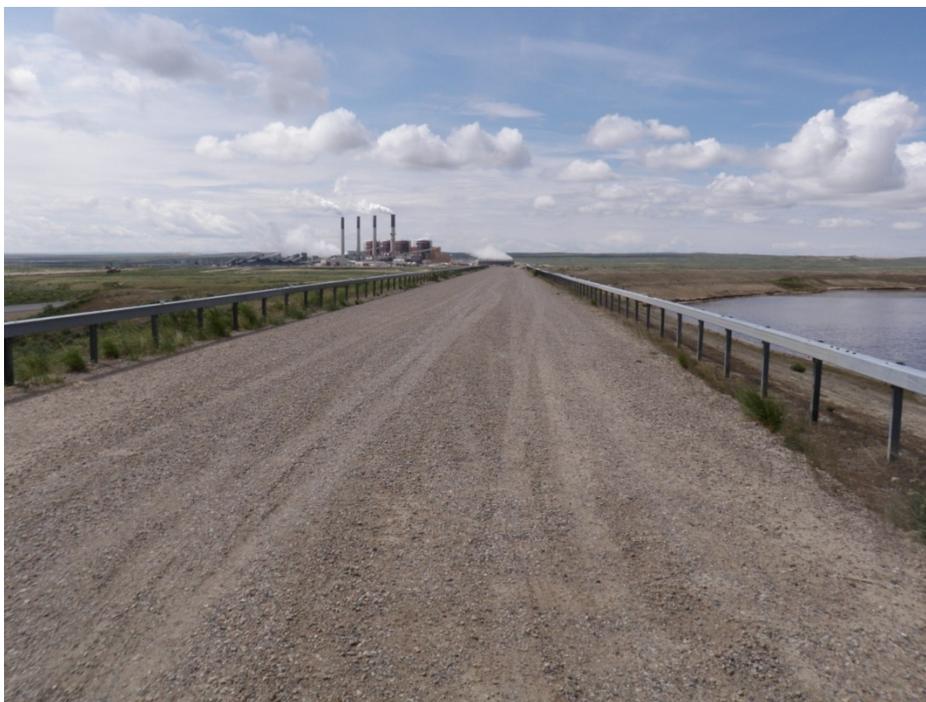
The dam crest was generally level and in good condition with exception of a rutted area along the crest between FGD Pond 1 and Pond 2 that is attributed to vehicle activity on a wet area caused by snow melt. We saw no obvious signs of settlement or displacement. See photos 9, 12, 22, 30, and 36.

Photo 9: FGD Pond 2, Crest near Station 45+00 Looking right (southwest)

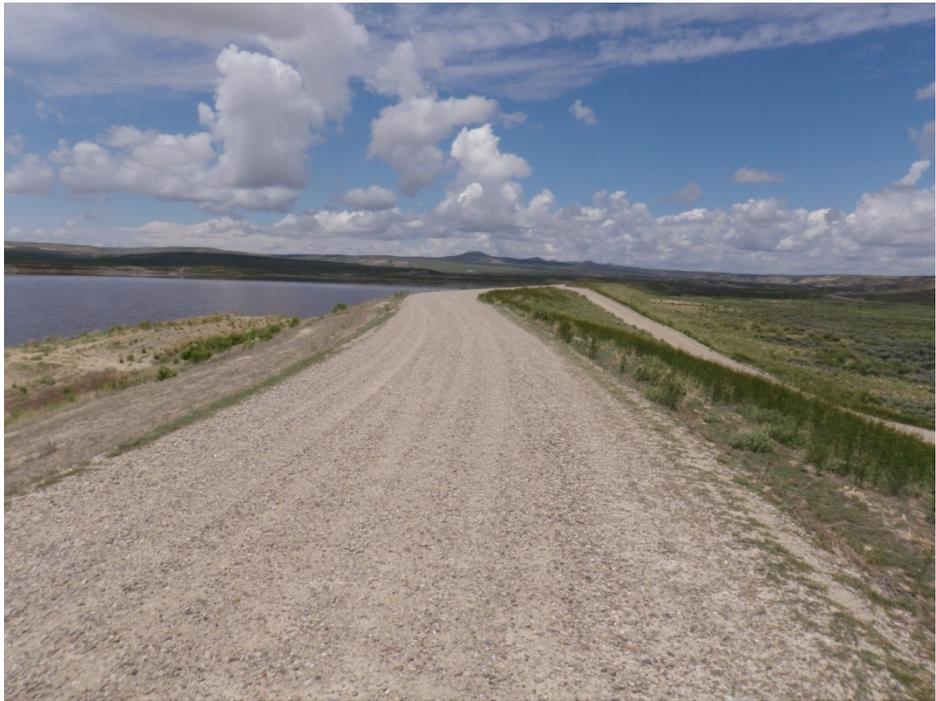
Photo 12: FGD Pond 2, Crest near Station 47+00 Looking left (west)

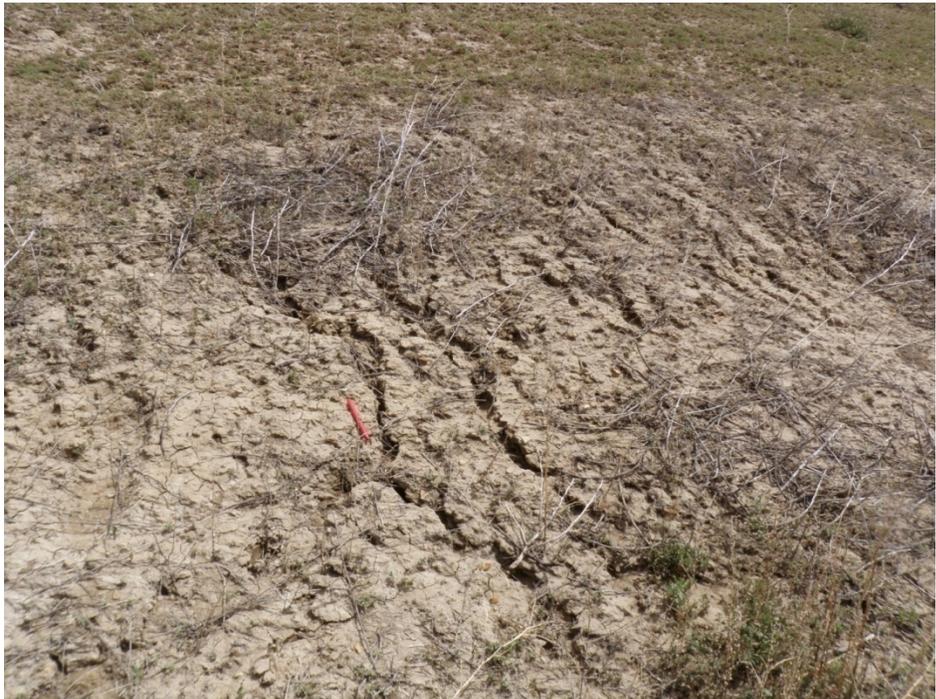
Photo 14: FGD Pond 2, Upstream Face Erosion rills approx. 3 inches deep (typical) Looking north upslope

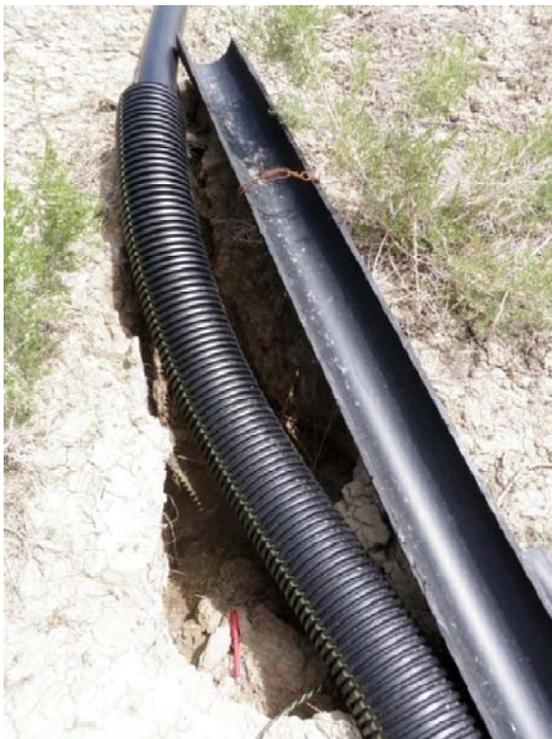
**Photo 16: FGD Pond 2, Upstream Erosion face Looking North upslope near Station 73+00**

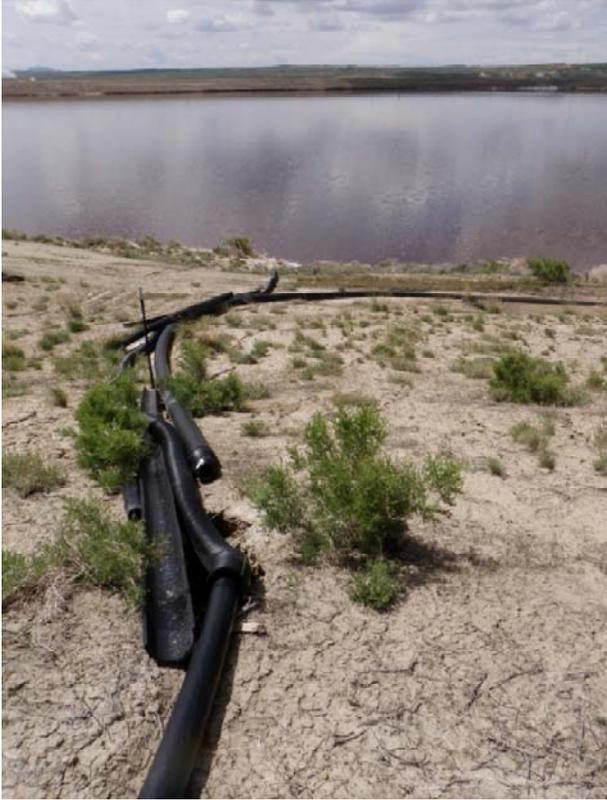
**Photo 17: FGD Pond 2, Upstream face showing pipe and erosion Looking South downslope near Station 73+00**

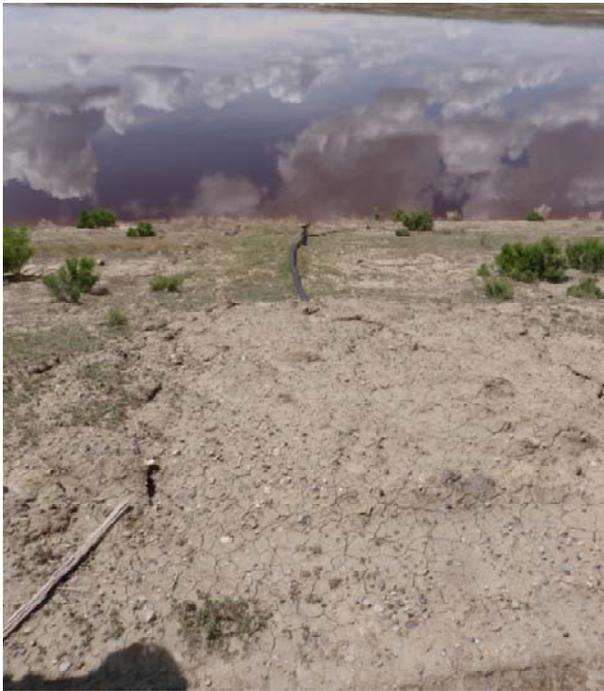
**Photo 18: FGD Pond 2, Upstream face Pipe causing erosion from Crest pipe from Sump Drain Pump Back Near Station 84+00**

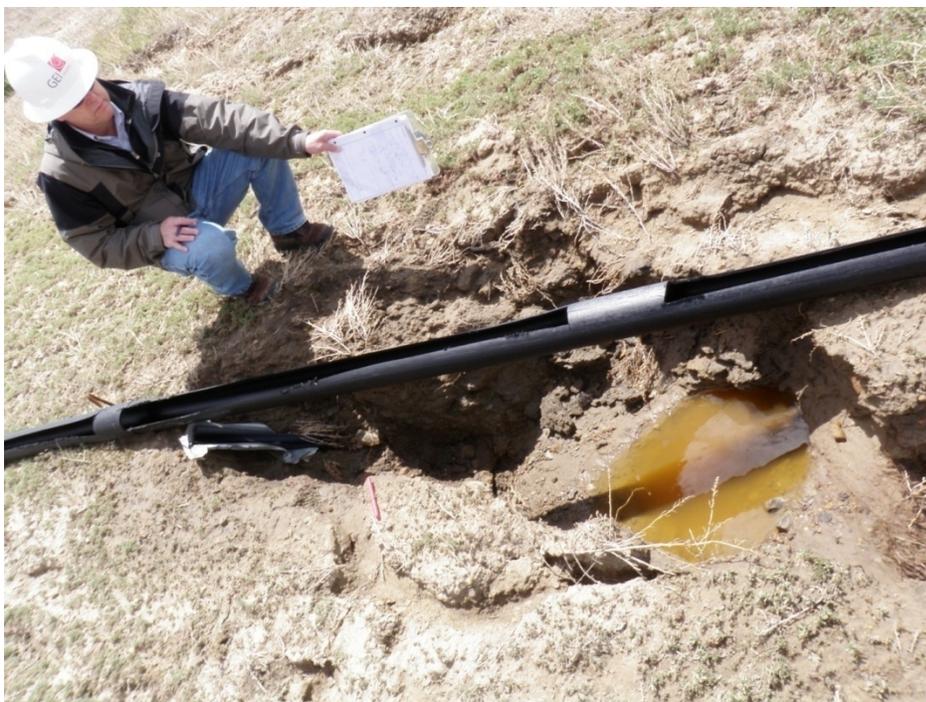
Photo 19: FGD Pond 2, Upstream Face Erosion and Pipe from Sump Drain Pump Back Near Station 84+00

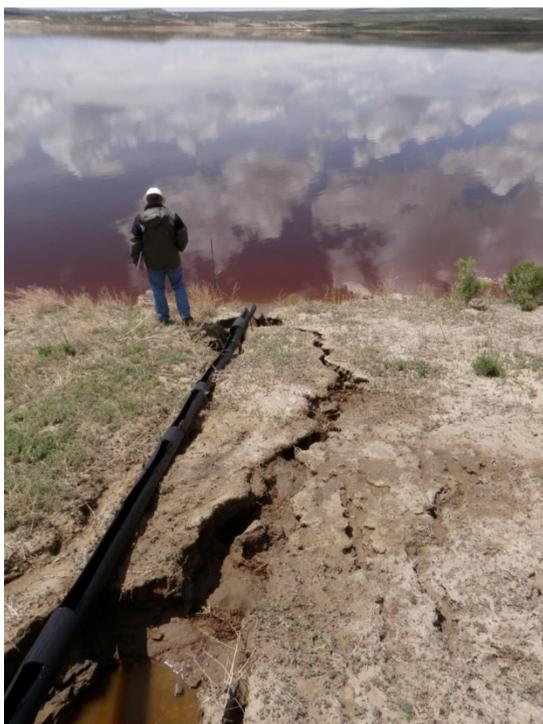
Photo 20: FGD Pond 2, Upstream Face Erosion and Pipe from Sump Drain Pump Back Near Station 84+00

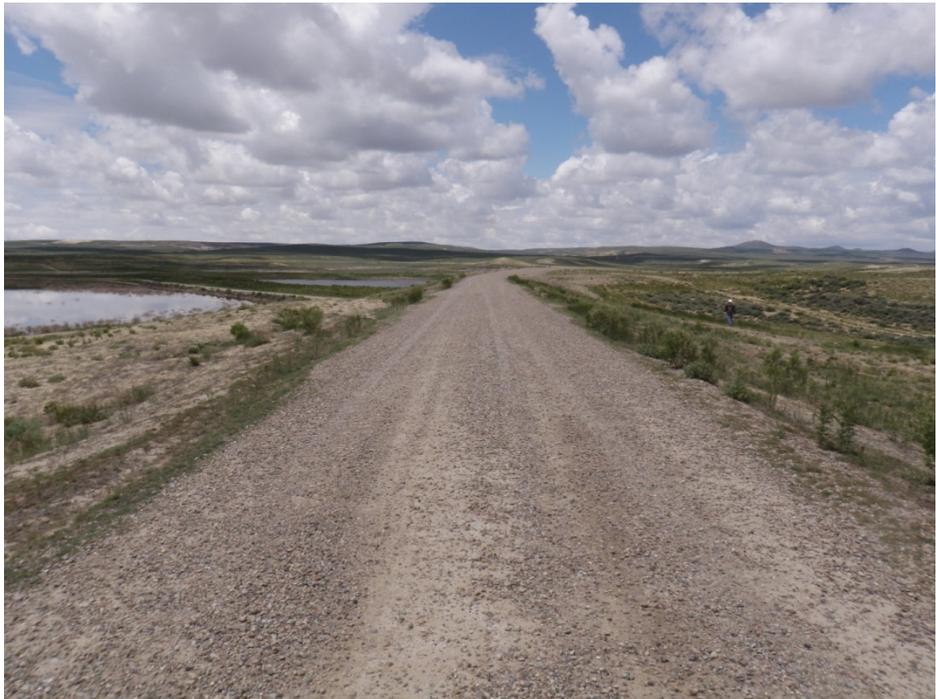
Photo 22: FGD Pond 2, Crest near Station 93+00 Left Abutment Looking West

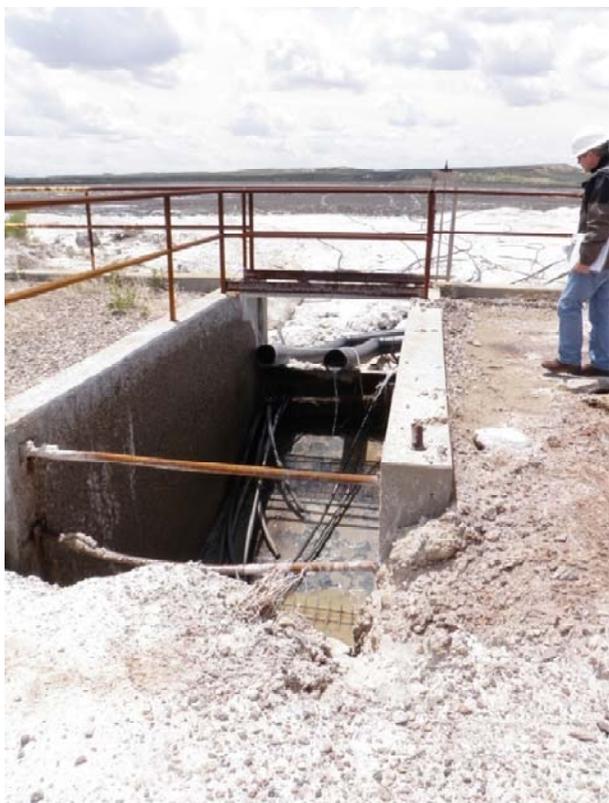
The structure is missing the west and north safety railing. Surface soil and rock appears to be sloughing into the structure from the north. A few cobble sized rocks are present atop a metal screening and dead tumbleweed is present in the structure. The concrete appears to be in good condition considering the age of the outlet (See Photo 25).

Photo 25: Looking South at outfall from FGD Pond 1. Large pipes are directly from plant, smaller pipes are from FGD Pond 1 dewatering wells

There is no spillway at FGD Pond 1 or FGD Pond 2. FGD Pond 1 outlet structure was observed to be in acceptable condition. The decant structure trashrack should be cleaned of debris and safety railings should be replaced, see photo 25. There is no outlet at FGD Pond 2 and water is only removed by evaporation.

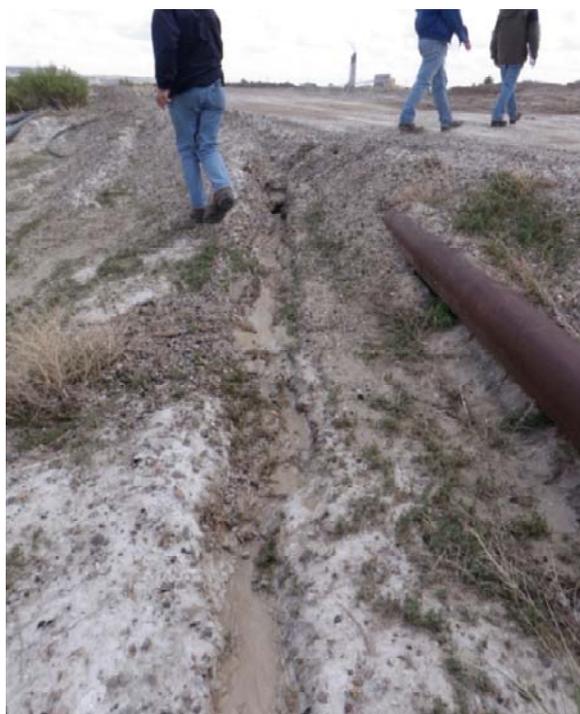
Photo 28: FGD Pond 2, Looking left (southeast) at Erosion rill off crest down the upstream face. Metal pipe is abandoned and runs parallel to crest.

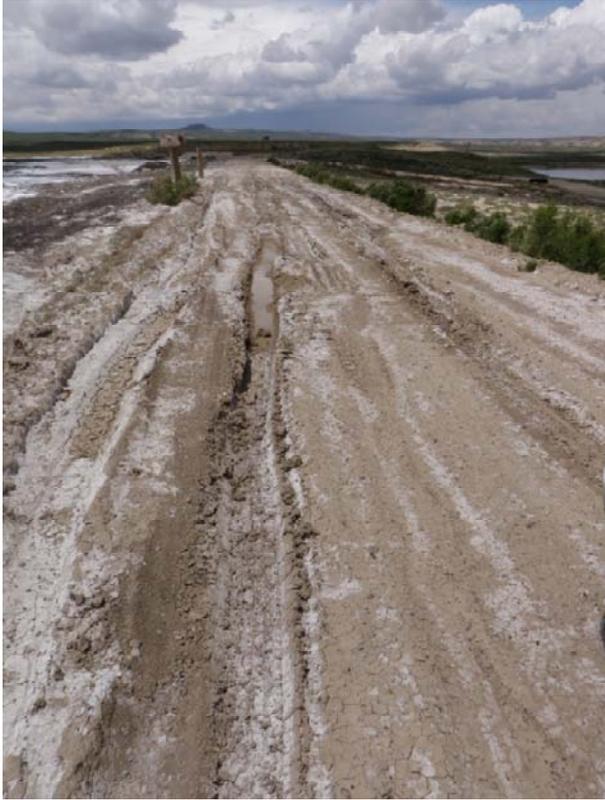
Photo 29: Looking right (west) Ruts in Crest of saddle dike between FGD Pond 1 (left) and FGD Pond 2 (right).

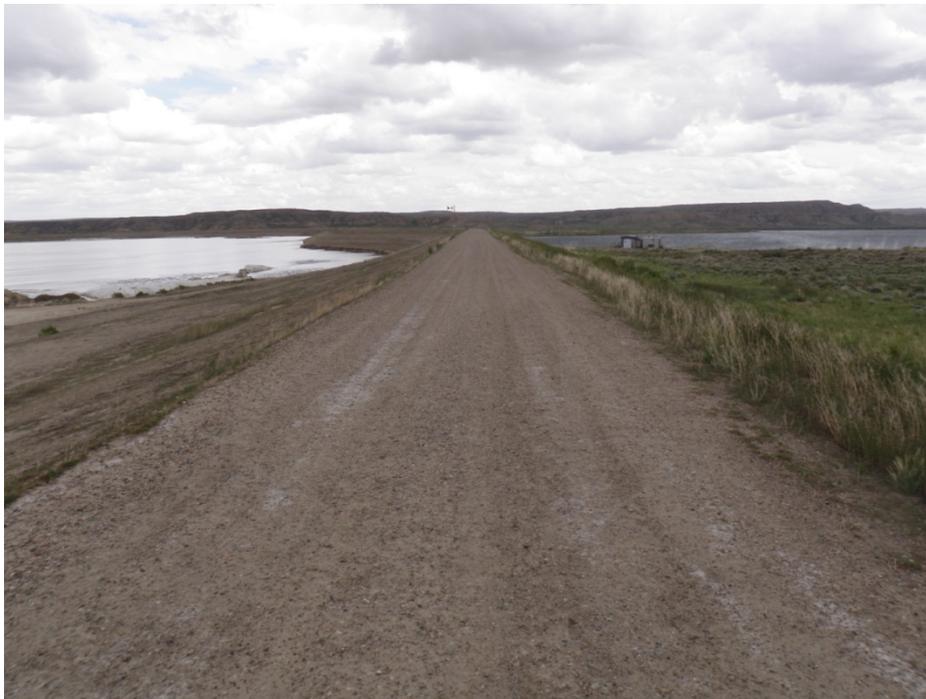
Photo 30: FGD Pond 2, Crest near Station 4+00 Evaporation Pond on right Looking left (east)

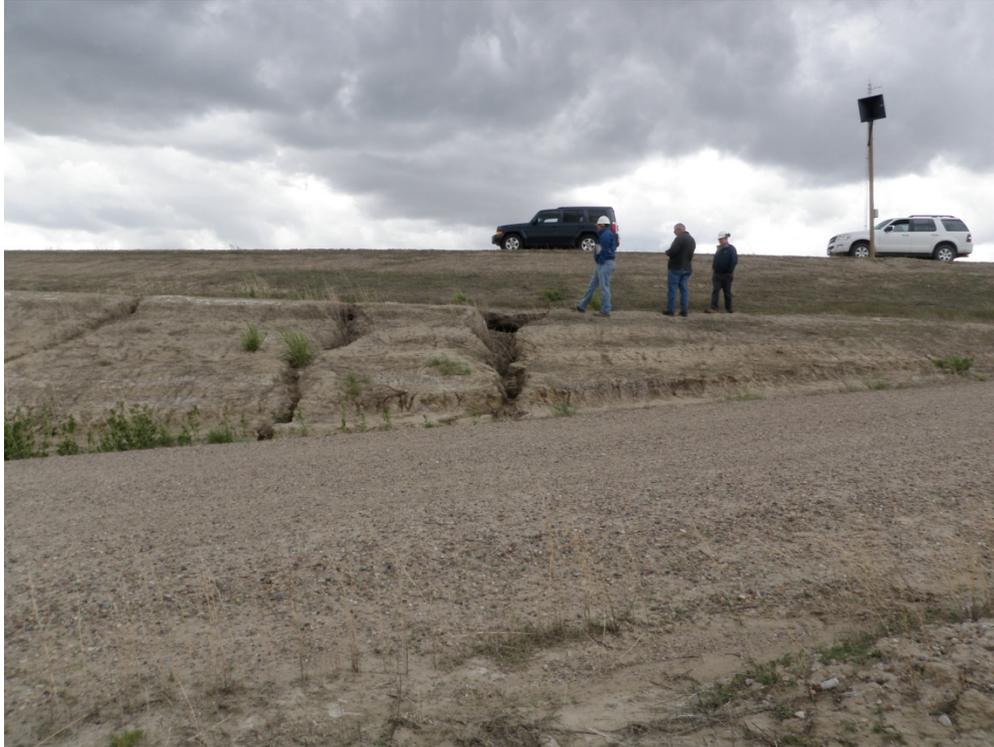
Photo 33: FGD Pond 2, Erosion of Upstream face Near Station 4+00

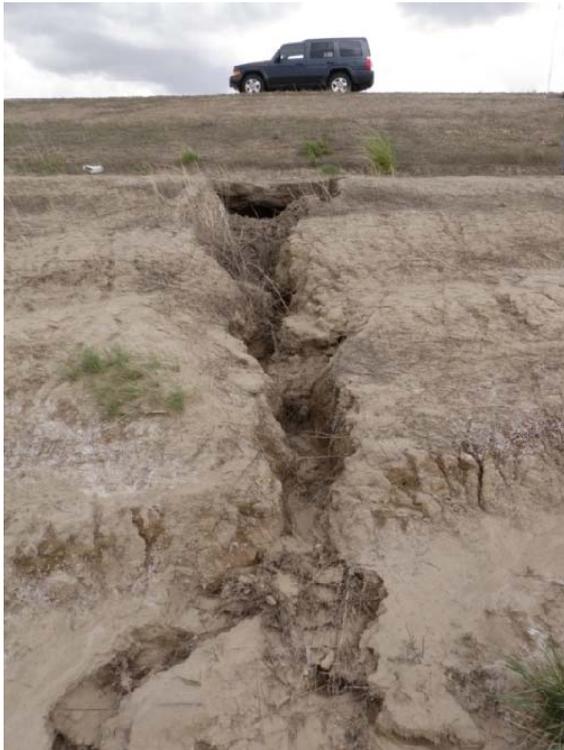
Erosion observed on FGD Pond 2 is generally minor, its source is apparent, and easily could be repaired. The more significant erosion feature discussed above should be repaired and the cause of the erosion addressed to prevent.

Photo 34: FGD Pond 2, Significant erosion of upstream face near station 4+00 Looking Southeast

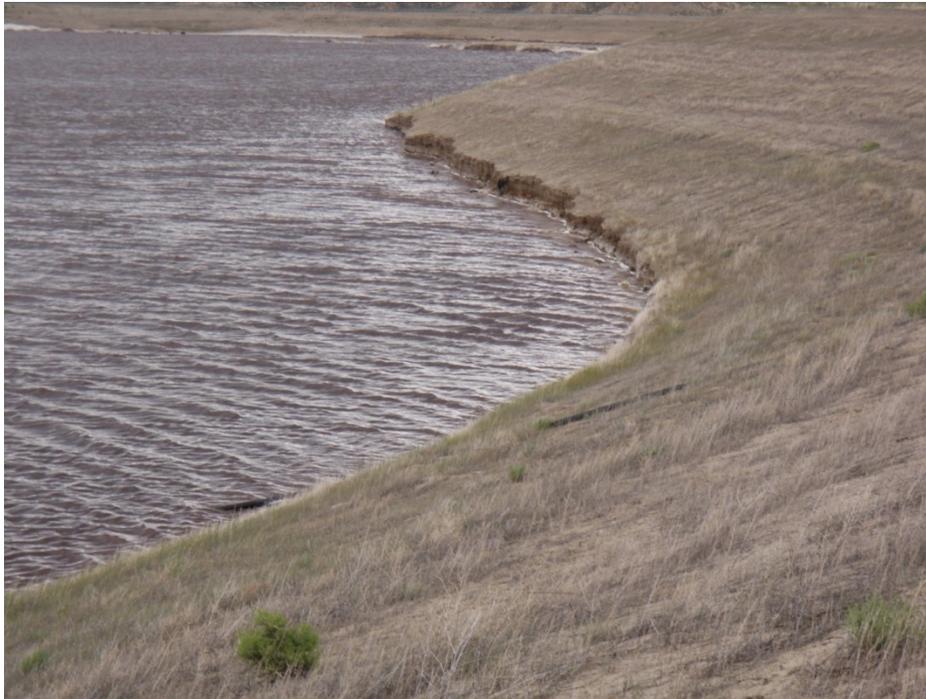
The upstream face of the dam does not have slope protection, see photo 35, and there is localized wave cutting erosion of the eastern embankment (Stations 10+00 to Station 40+00) that appears to extend about one foot above the reservoir water surface. This wave erosion could be alleviated with the addition of riprap armament or other slope protection, however, the 2001 Design Report considered the anticipated loss of embankment due to wave erosion to have negligible influence on the performance of the embankment because the eroded compacted fill of the embankment would be replaced by settled FGD solids. This assumption was justified in the 2001 Design Report because the planned 1.5-foot, or less, height of ponded water on top of the FGD solids would cause the wave heights to be small and the associated erosion to be small and the limited embankment erosion loss would be balanced by the planned annual infilling of about a foot of solids. Assuming the ponded water depth was 1.5 feet during the assessment, the observed erosion height of one foot above the water surface would result in a loss of about 7.5 foot horizontal distance of compacted fill from the embankment. Strength and permeability properties of the FGD solids were not developed in the 2001 design information. However, GEI expects that the FGD solids that replace the embankment fill would have lower strength properties compared to the original compacted embankment. The 2001 Design Report recommends addressing isolated areas of erosion by discharging effluent at multiple points to allow for immediate infilling of the affected areas. PacifiCorp has indicated that they do not plan to discharge at multiple points because it is not feasible. GEI considers the embankment that is lost to erosion and backfilled by FGD solids to be a sacrificial zone that does not contribute to the stability and seepage performance of the constructed dike. GEI considers the discharge of FGD solids at various locations to address localized areas of erosion to be feasible as one possible component of addressing erosion issues at FGD Pond 2.

Photo 35: FGD Pond 2, Upstream toe near Station 17+00 Wave cutting of toe Looking left (northeast)

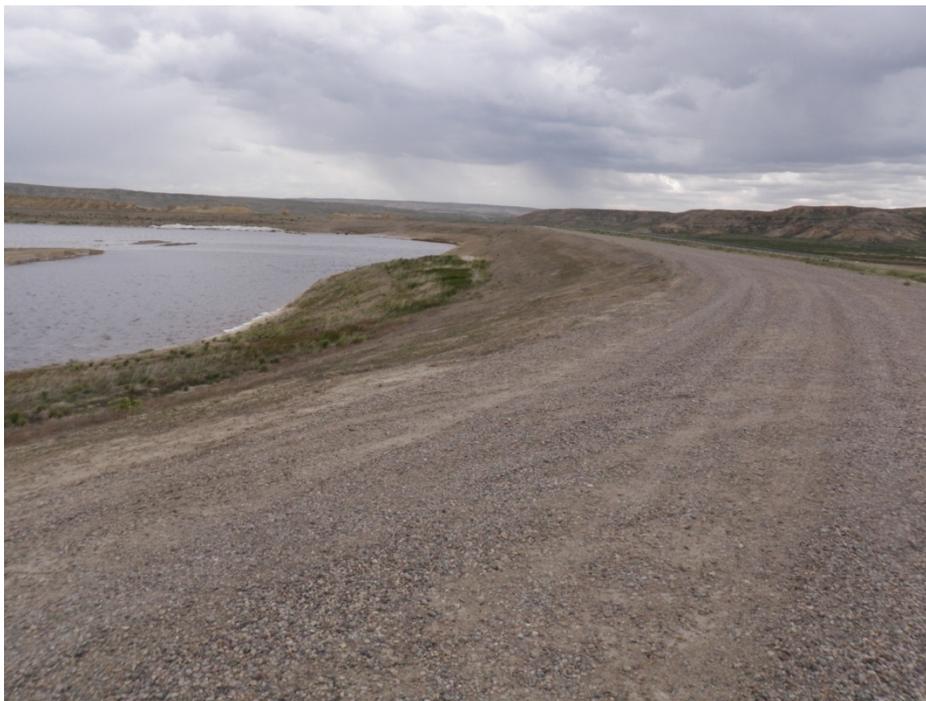
Photo 36: FGD Pond 2, Crest near Station 17+00 Looking left (north)

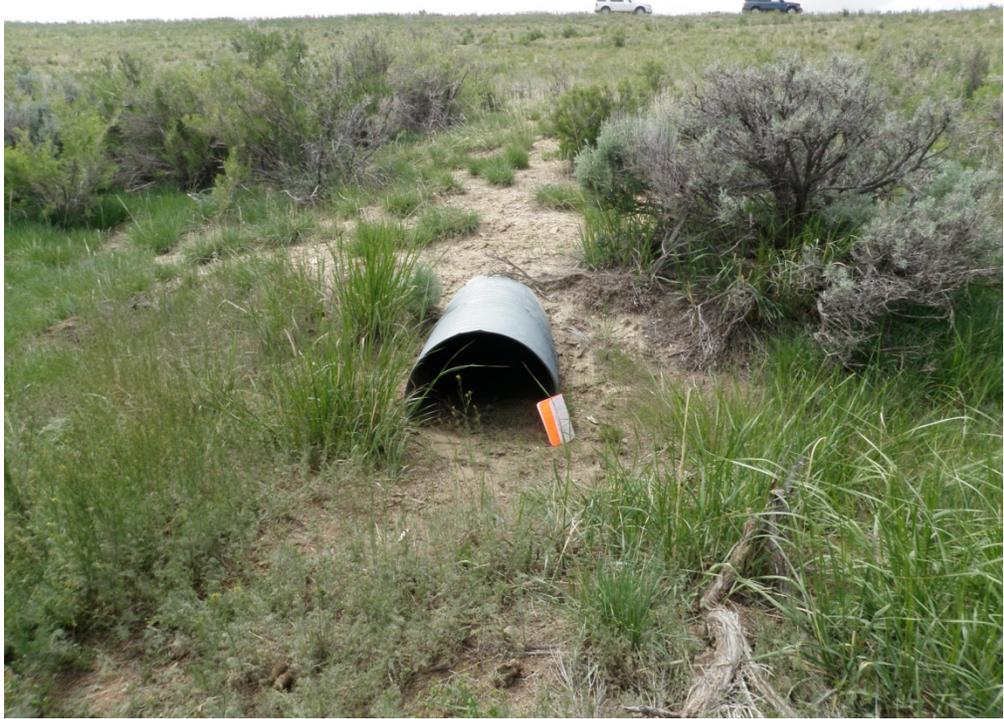
The downstream slope of the dam does not have additional erosion protection. It is currently grass covered. Near Station 59+00 a 24-inch-diameter CMP culvert was observed at the downstream toe that penetrates beneath the toe of the downstream slope, see photo 40. From the subsequent review of design documents, it appears that this culvert was associated with former saddle Dike III. Based on the drawings, the culvert extends from the downstream toe of Dike III a distance of approximately 225 feet to the north. The culvert should be removed or properly abandoned by grouting full and the affected embankment repaired as necessary. Prior to removing/abandoning the culvert the length and condition of the culvert should be confirmed.

Photo 40: FGD Pond 2, Dry pipe penetrating beyond downstream toe. Old culvert associated with Dike III.
