**Pennsylvania Department of Environmental Protection's Comments On:  
Draft Report – Little Blue Run Dam Inspection Report  
Bruce Mansfield Power Plant  
Beaver County, Pennsylvania**

The Draft Report has been prepared for the U.S. Environmental Protection Agency, Washington, D.C., by CHA.

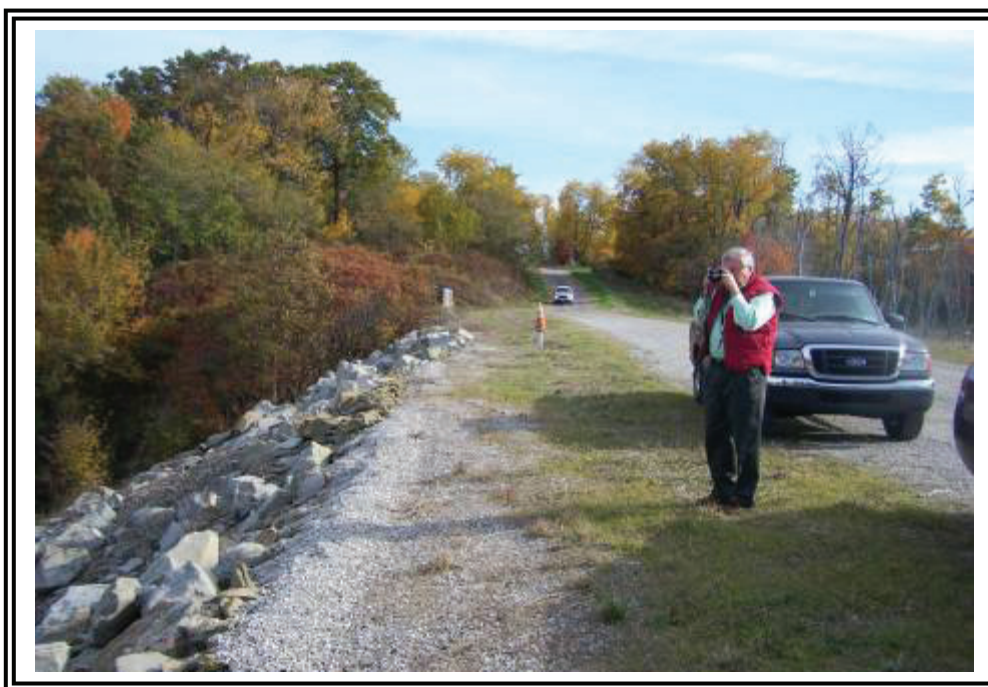
1

East abutment, looking east.

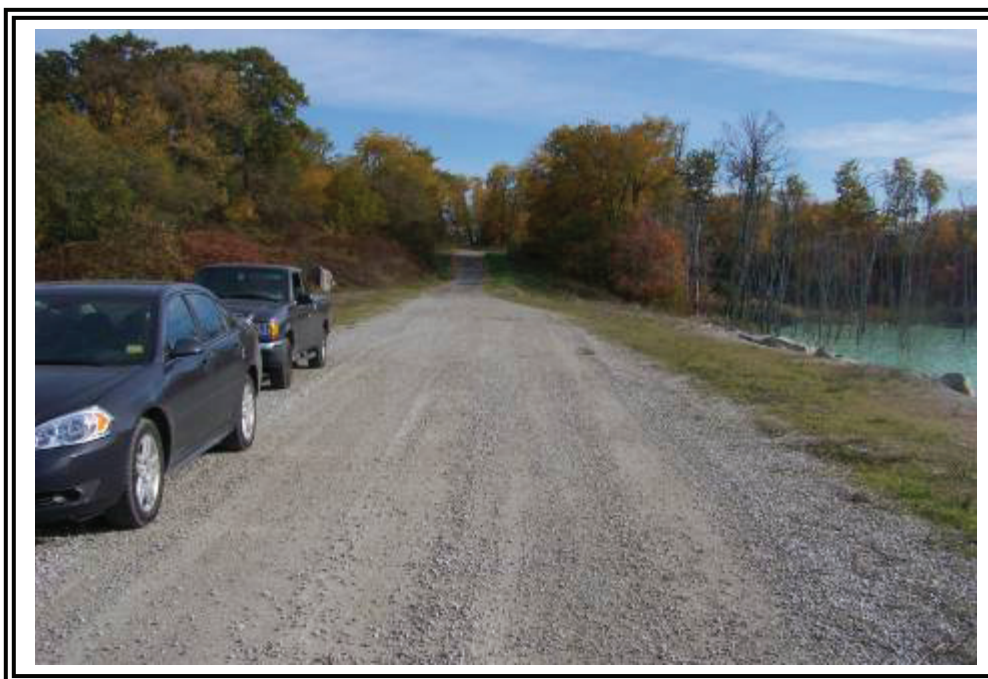
2

Crest and east abutment, looking east.

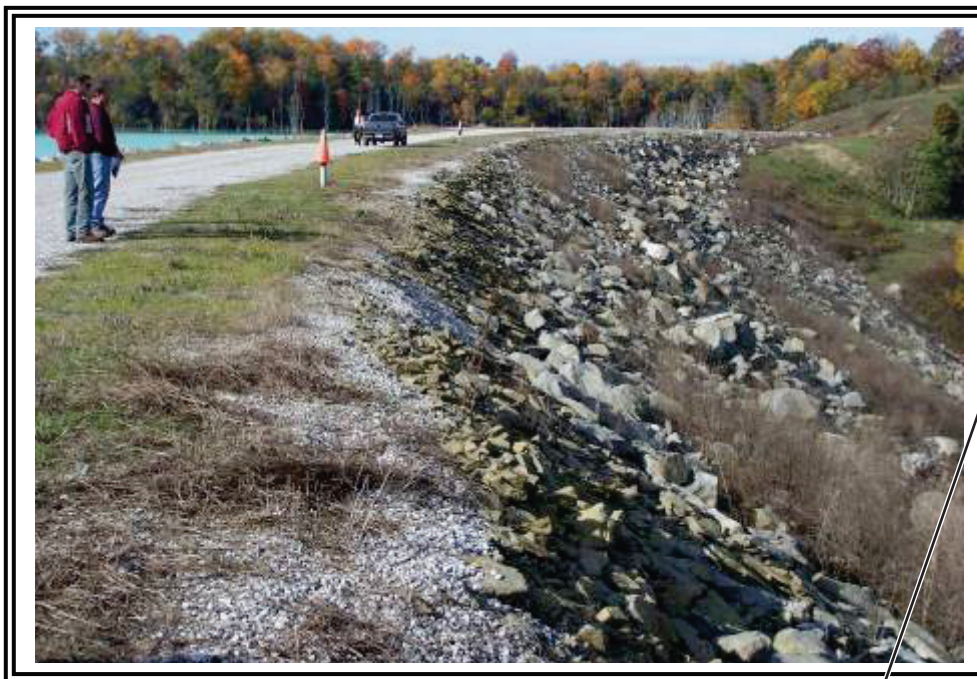
8

Crest elevation re-establishment made with darker stone and gravel.

The crest elevation and 2-foot camber was made by adding 0-3.5 feet of rock fill to the top of the dam and rip rap slope protection to the upstream and downstream slope.

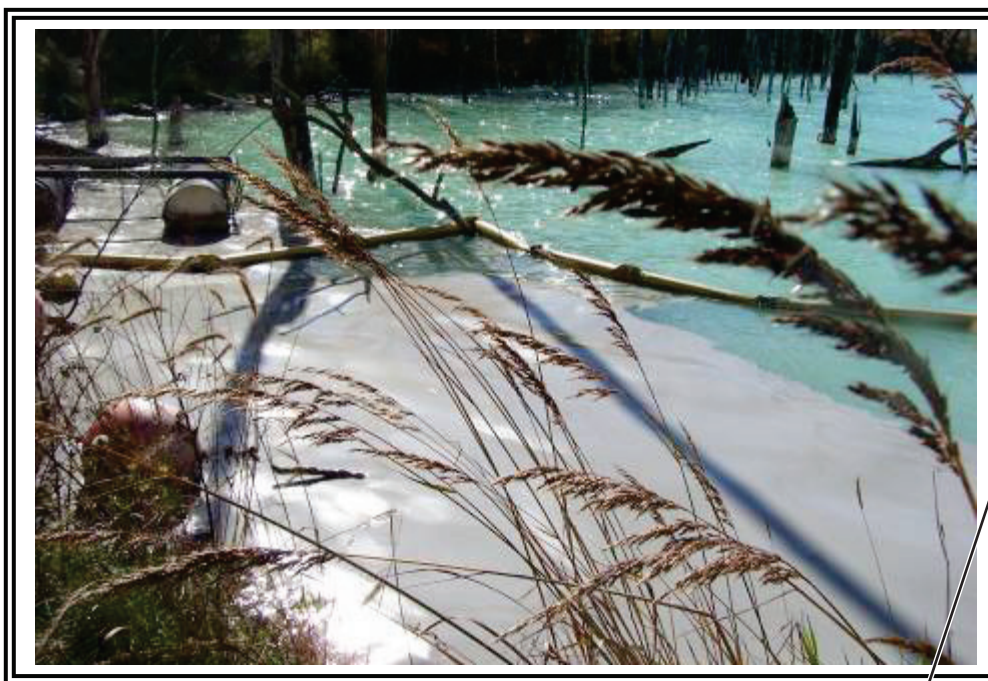
22

Area of secondary spillway intake. Pipe was submerged during our sit visit.

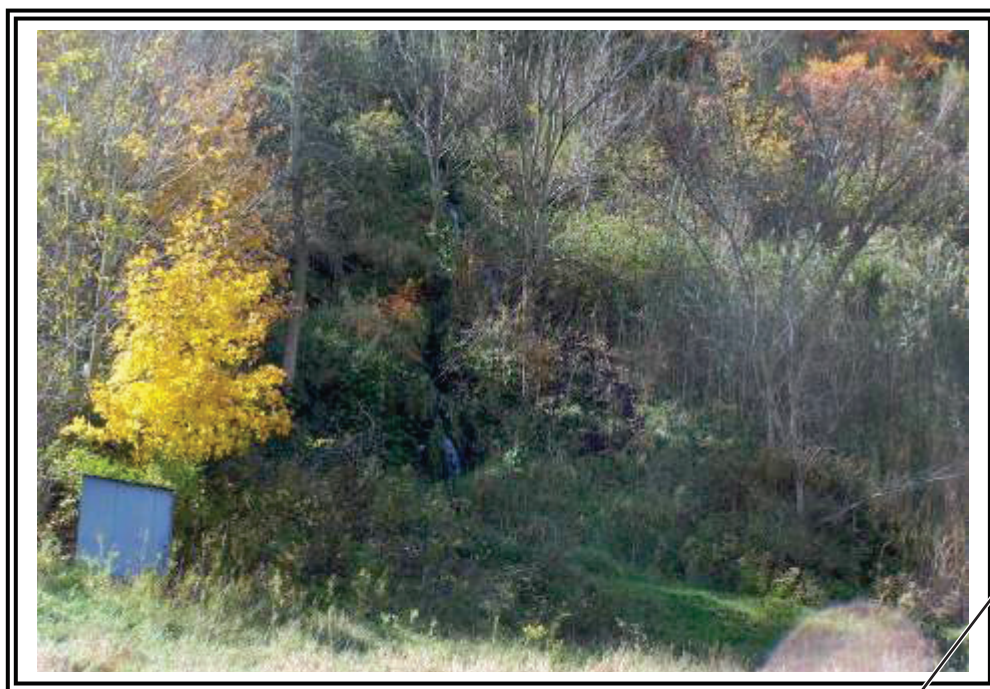
27

West abutment seepage.

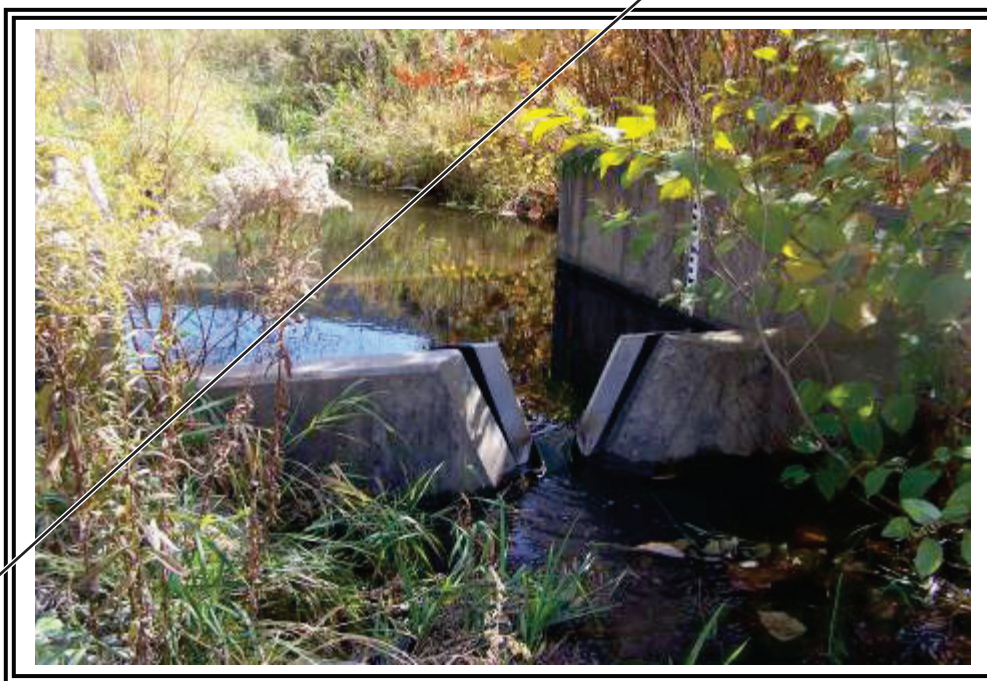
30

weir (ULA) was clogged causing back-flow in to the weir structure (Photo No. 30). The Parshall Flume toe drain (TD) which is a monitoring point for blanket drain seepage was also observed (Photo Nos. 28 and 29).

V-notch monitoring weir for west abutment seepage monitoring. Clogged culvert was causing back flow during our site visit.

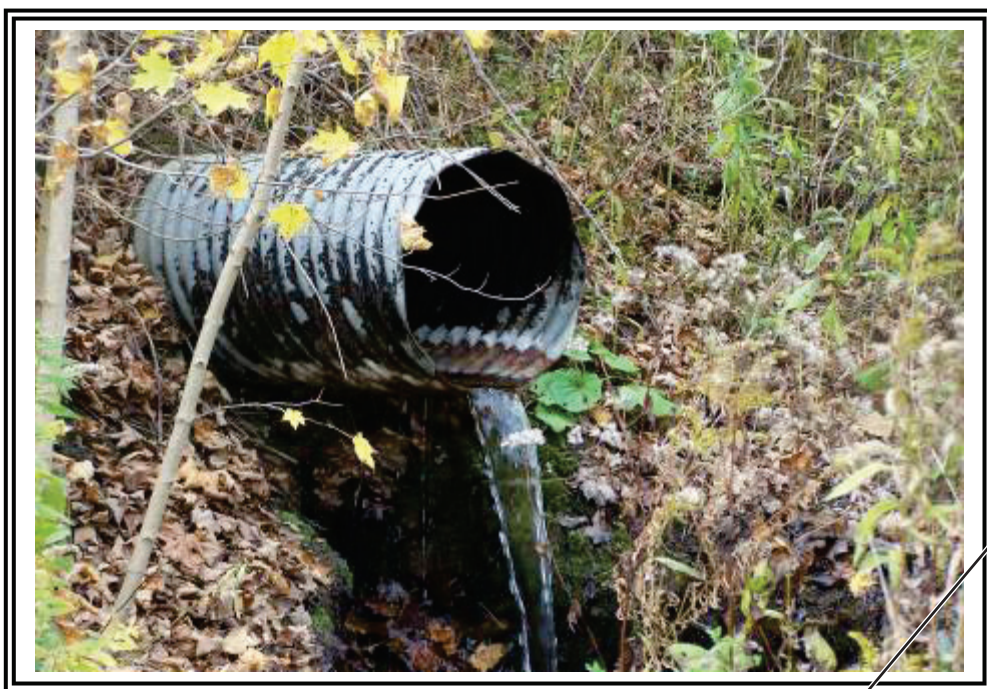
33

Lower left (west) abutment seepage. This natural seepage maintains flow in Little Blue Run per permit conditions.

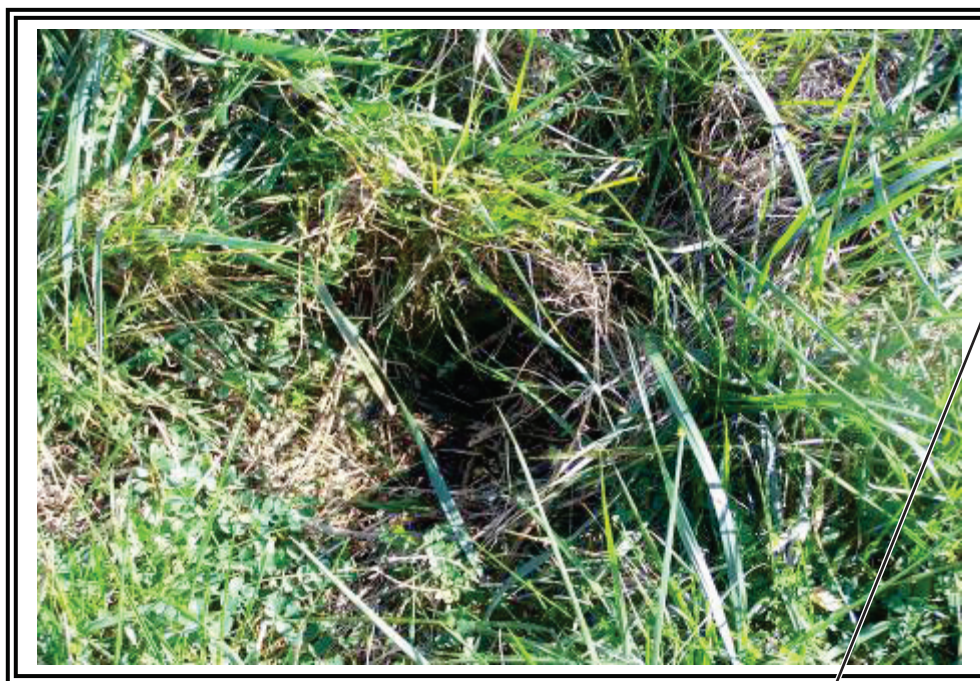
38

At the time of the site visit the Little Blue Run Dam was not impounding water. A gravel access road runs the length of the crest of the Little Blue Run Saddle Dam (Photo No. 36). The upstream and downstream embankment slopes are grass covered (Photo Nos. 37 and 39). A small rodent hole was observed on the upstream slope (Photo No. 38).

Small rodent hole on upstream slope of Little Blue Run Saddle Dam.

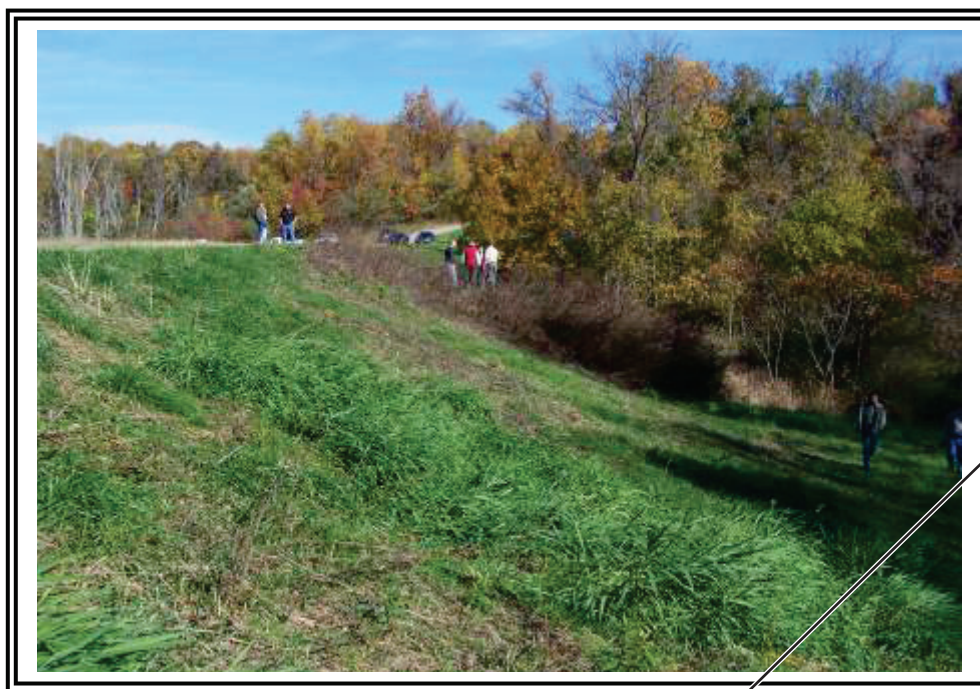
39

Downstream slope of Little Blue Run Saddle ~~Dike~~, looking north.  
Vegetation near group of people on slope consists of material that the mower cannot traverse.

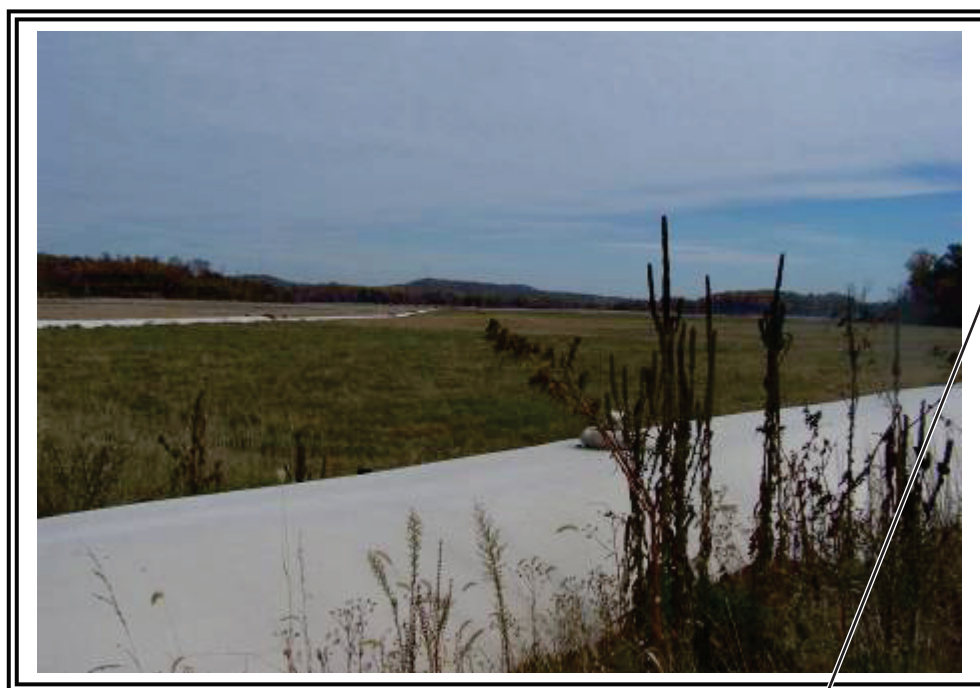
40

The Geotubes which were installed for vertical expansion of ~~the impoundment~~ without raising the elevation of the existing dam embankment were observed during the site visit (Photo No. 40).

| | Author: cargolr<br>Geotubes and CCW waste placement at the south end of the impoundment. | Subject: Replacement Text | Date: 1/26/2010 4:08:17 PM | 2 |
