**CCW IMPOUNDMENTS  
INSPECTION REPORT**

**BRUCE MANSFIELD POWER  
PLANT  
BEAVER COUNTY,  
PENNSYLVANIA**

**PROJECT NO. 09-4157  
OCTOBER 2009**

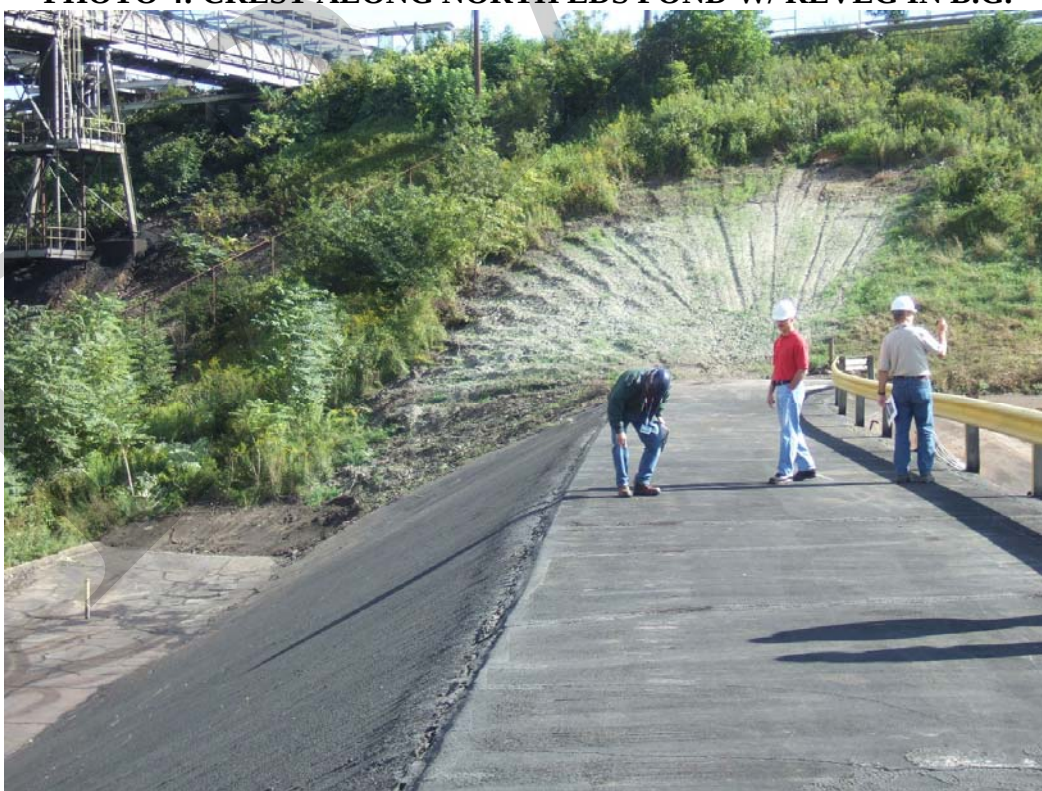
**PHOTO 4: CREST ALONG NORTH LDS POND W/ REVEG IN B.G.**

The rebuild and revegetation of the earthen embankment at the northeast corner of the impoundment due to a prior manhole overflow appeared to be in good condition. The rebuild was well-graded, and the vegetation was taking hold nicely (**Photograph 4**).

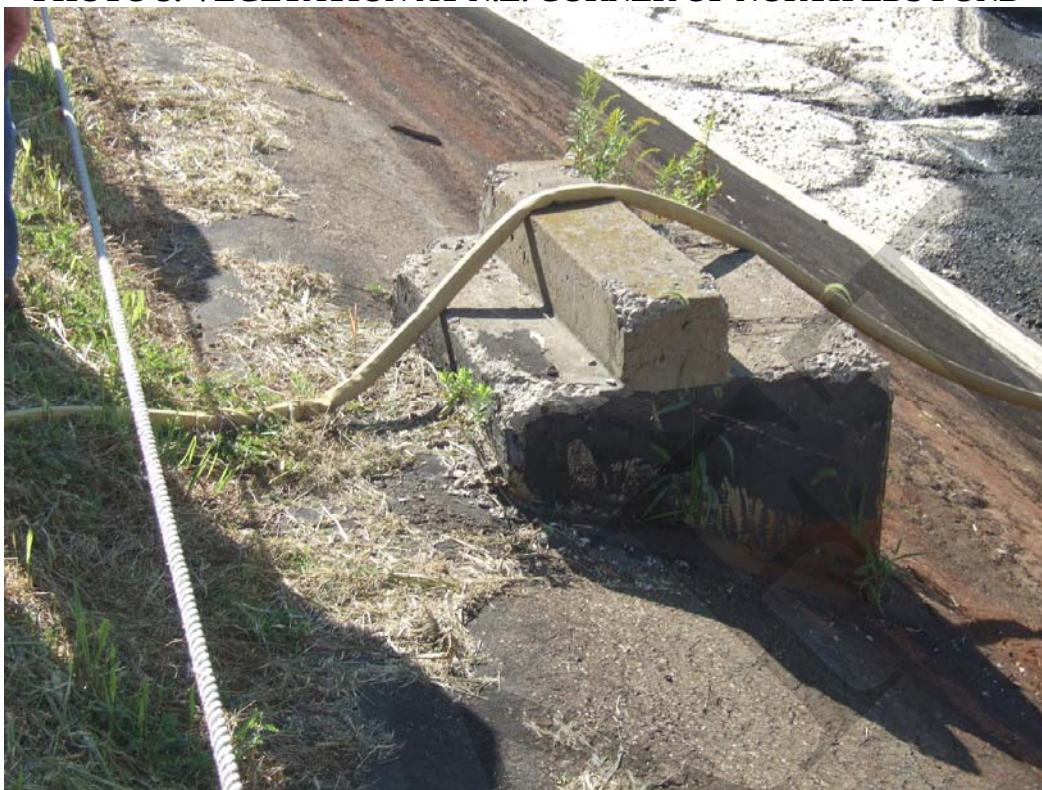
**PHOTO 5: VEGETATION AT N.E. CORNER OF NORTH LDS POND**

Along the eastern embankment, the vegetation is well-maintained and trimmed back approximately 10 feet from the edge of the asphalt liner. Some minor vegetation creep was observed along the end of the asphalt line along the slope of the eastern embankment (**Photograph 5**).

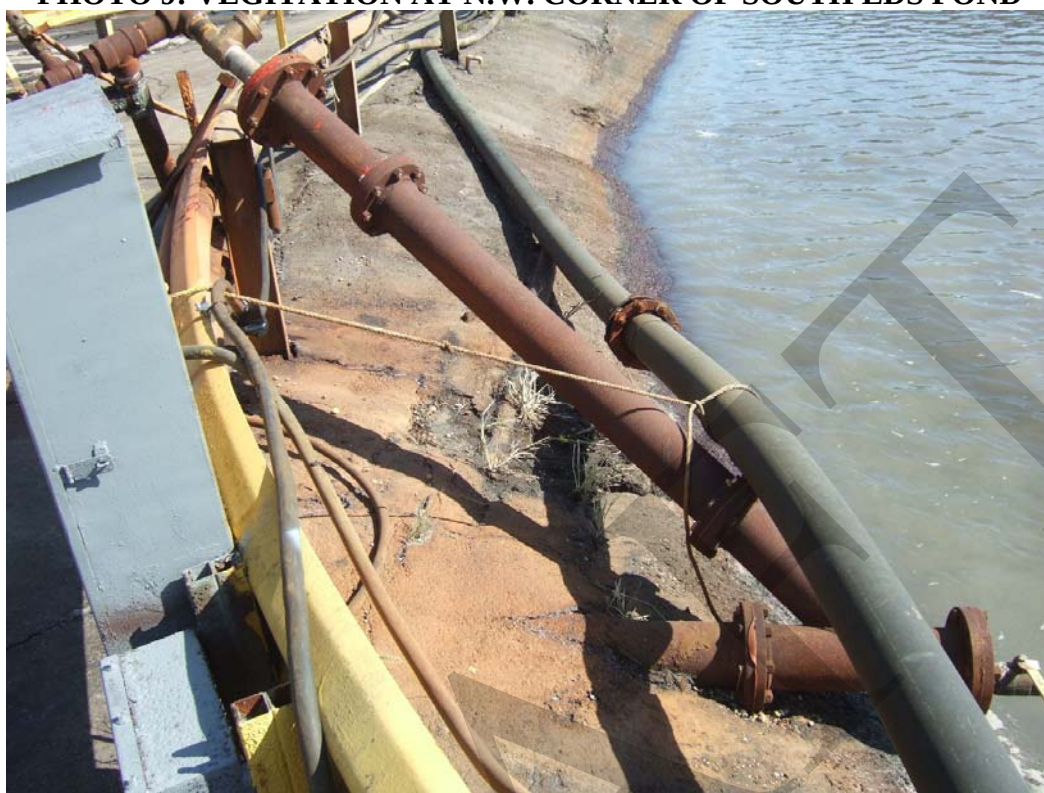
PHOTO 9: VEGETATION AT N.W. CORNER OF SOUTH LDS POND

There was about 2 feet of freeboard along the upstream slope of the South LDS Pond at the time of inspection. No major cracks were observed in the visible portion of the upstream liner, which is constructed of the more impervious asphalt material. Some minor damage and vegetation was observed at the northwest corner of the upstream slope, near the fire hose system and bubbler

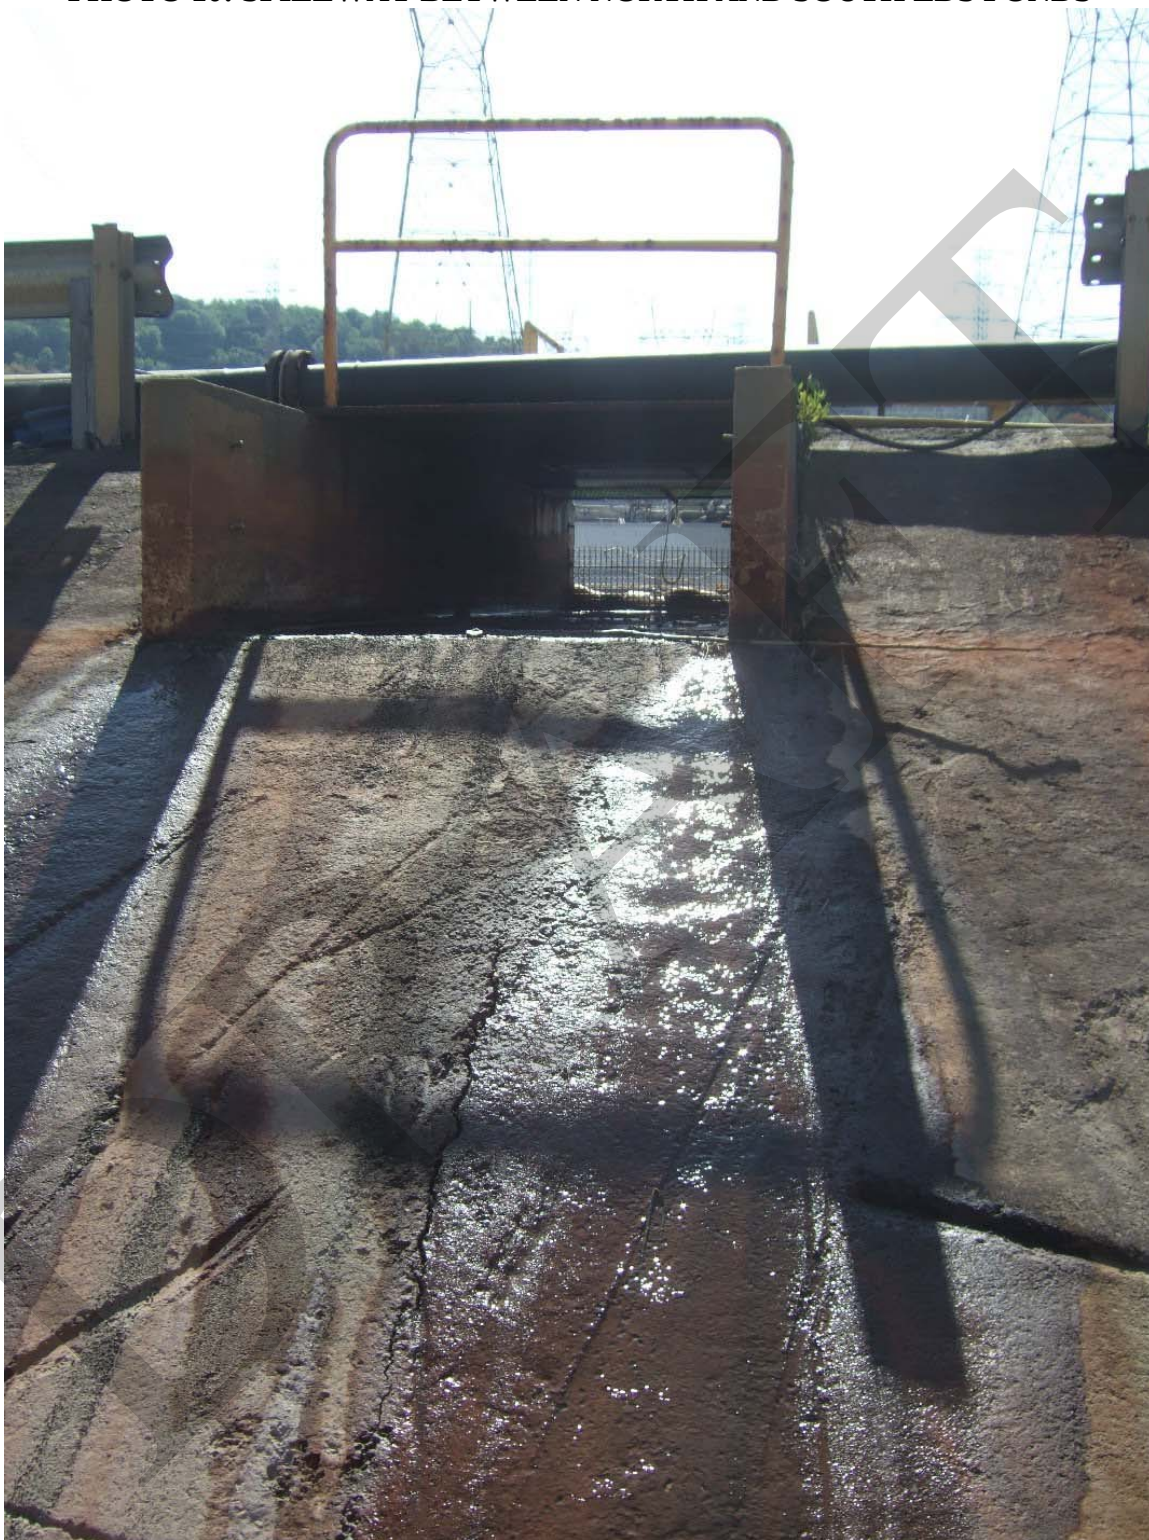
PHOTO 10: SPILLWAY BETWEEN NORTH AND SOUTH LDS PONDS

The small spillway between the North and South LDS Ponds was in good condition at the time of inspection (**Photograph 10**). The concrete was in good condition, while the weir and trashrack were observed to be free of obstructions or debris.

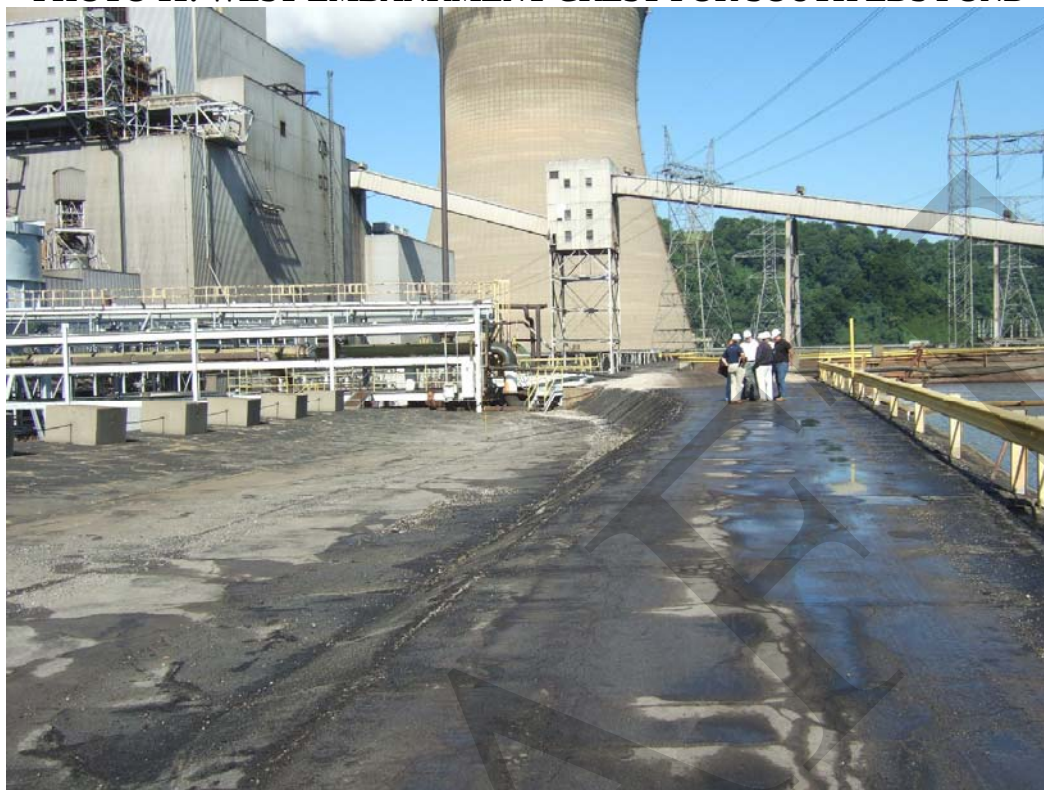
**PHOTO 11: WEST EMBANKMENT CREST FOR SOUTH LDS POND**

(**Photograph 9**). The crest of embankment and downstream slope showed cracks and spalling throughout the top layer (about 3 inches) asphalt, due to sun exposure and weathering (**Photograph 11**). These cracks are cosmetic, do not extend to the underlying soil, and do not pose any risk to the stability and integrity of the embankments. Nonetheless, they should be sealed periodically to reduce vegetation growth. Along the eastern embankment, the vegetation is well-maintained and trimmed back approximately 10 feet from the edge of the asphalt liner. The western downstream slope is vegetated and was well maintained and trimmed at the time of inspection. No seepage was observed by RIZZO along the downstream toe of the South LDS Pond. However, historical data shows past seepage observed at the toe of the western downstream embankment, and several minor wet spots were observed by the PADEP at the time of the inspection.

We recommend that the surface asphalt along the crest and downstream slopes of all embankments continue to be maintained as part of the plant facility's regular maintenance activities. Clearing of vegetation, sealing of cracks, and repair of larger defects should be performed on a regular basis. The hydrologic study for the site states that SDF will overtop the impoundments by approximately 0.3 foot. Passage of the SDF without erosion of the embankments is dependent on the asphalt layer, and it should not be allowed to degrade to a point where an overtopping could cause a failure.

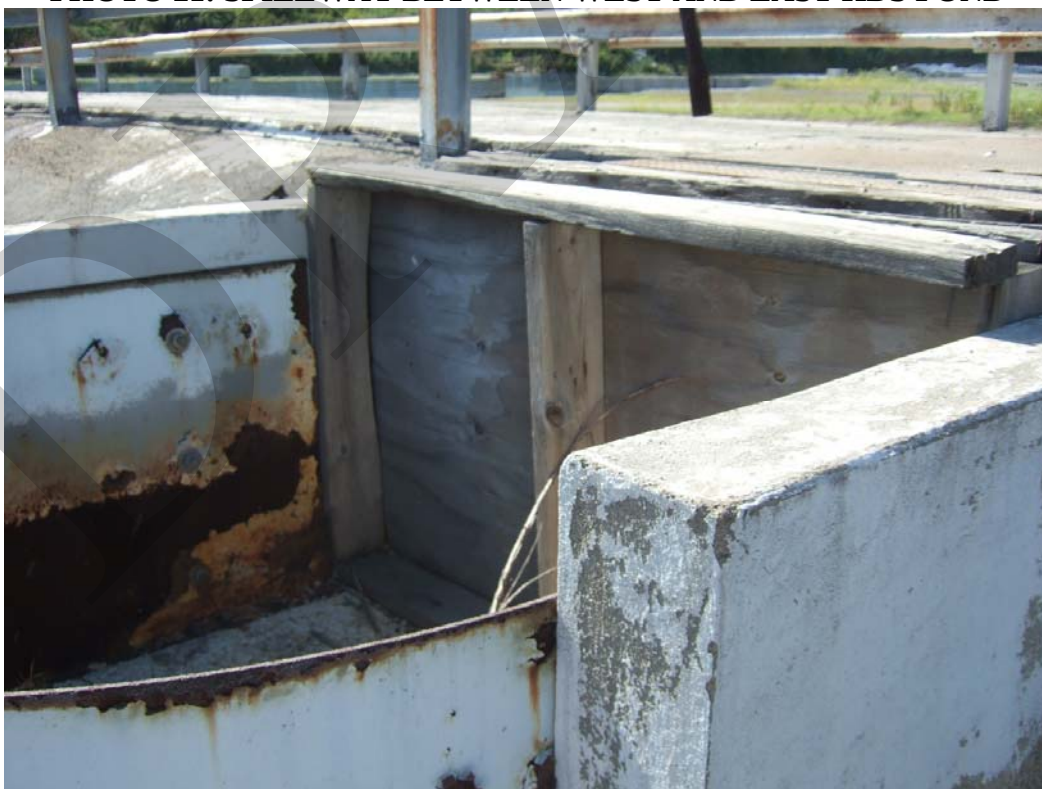
**PHOTO 21: SPILLWAY BETWEEN WEST AND EAST HDS POND**

The small spillway between the East and West HDS Ponds has been decommissioned, but the concrete still appeared in good condition at the time of inspection (**Photograph 21**).
