### **CCW IMPOUNDMENTS INSPECTION REPORT**

**BRUCE MANSFIELD POWER  
PLANT  
BEAVER COUNTY,  
PENNSYLVANIA**

**PROJECT NO. 09-4157  
DECEMBER 2009**

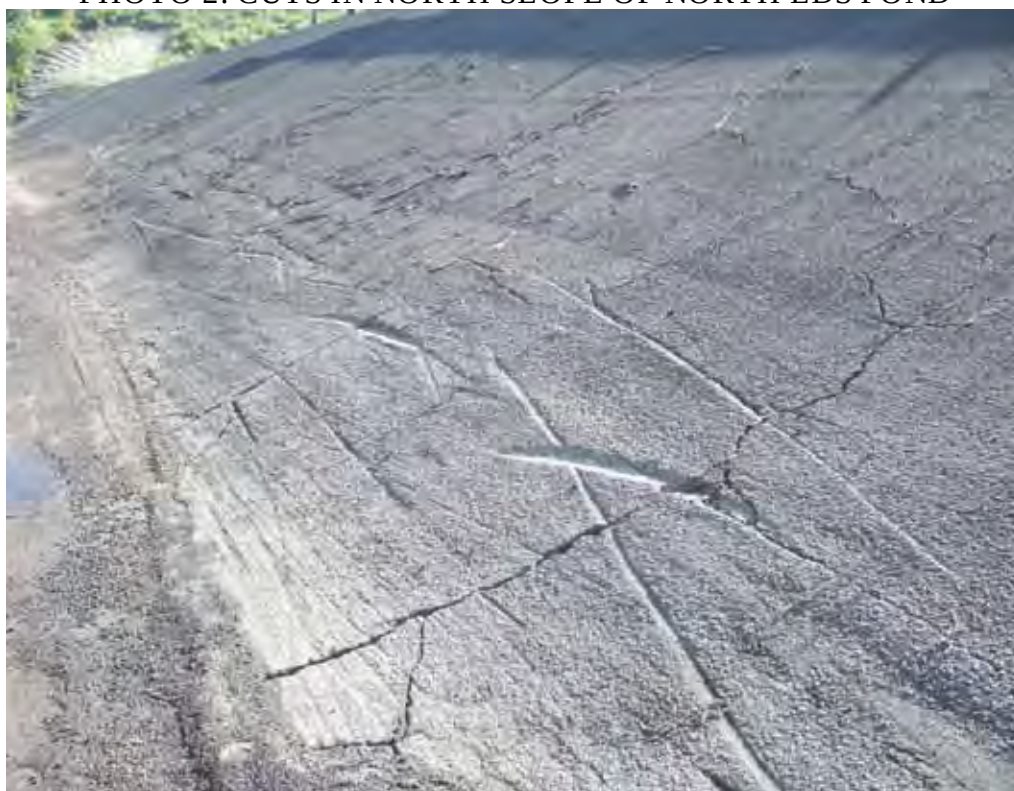
PHOTO 2: CUTS IN NORTH SLOPE OF NORTH LDS POND

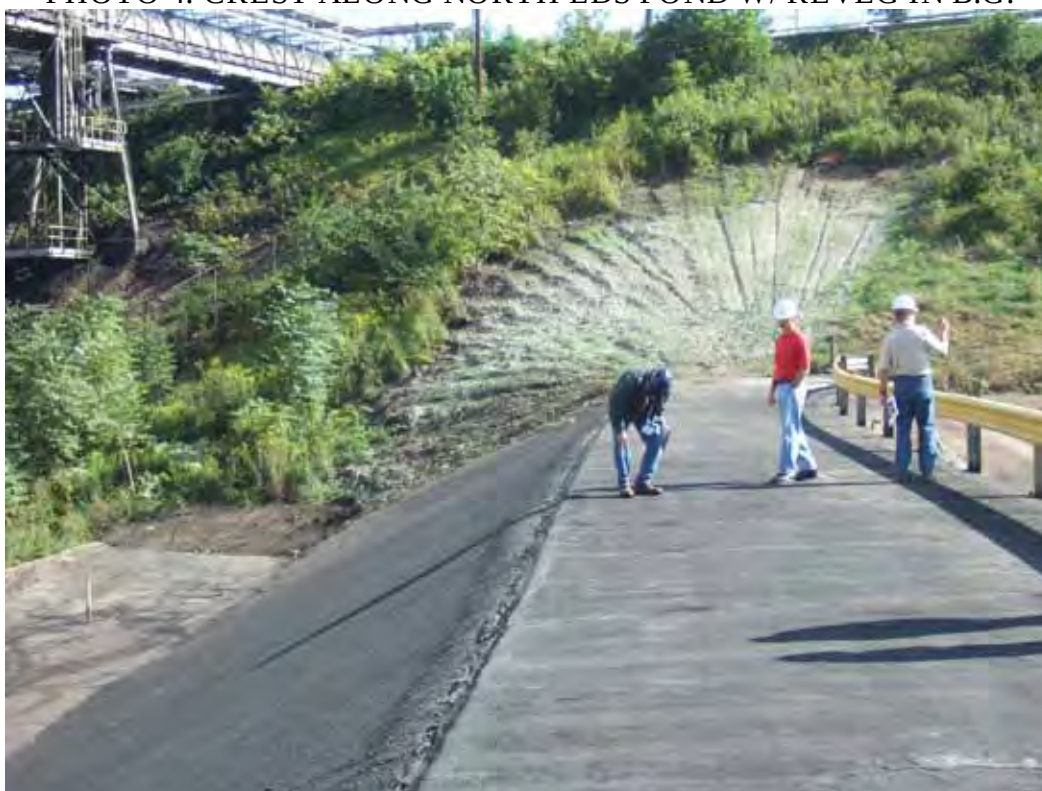
PHOTO 4: CREST ALONG NORTH LDS POND W/ REVEG IN B.G.

The rebuild and revegetation of the earthen embankment at the northeast corner of the impoundment due to a prior manhole overflow appeared to be in good condition. The rebuild was well-graded, and the vegetation was taking hold nicely (**Photograph 4**).

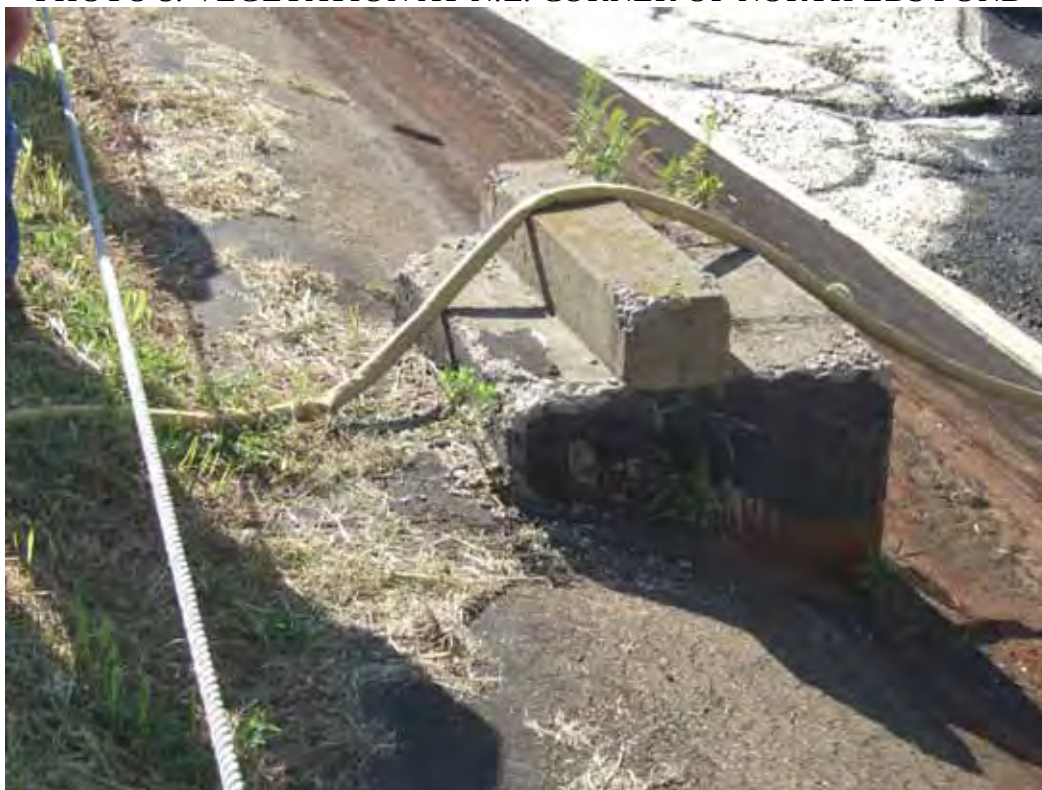
PHOTO 5: VEGETATION AT N.E. CORNER OF NORTH LDS POND

Along the eastern embankment, the vegetation is well-maintained and trimmed back approximately 10 feet from the edge of the asphalt liner. Some minor vegetation creep was observed along the end of the asphalt line along the slope of the eastern embankment (**Photograph 5**).

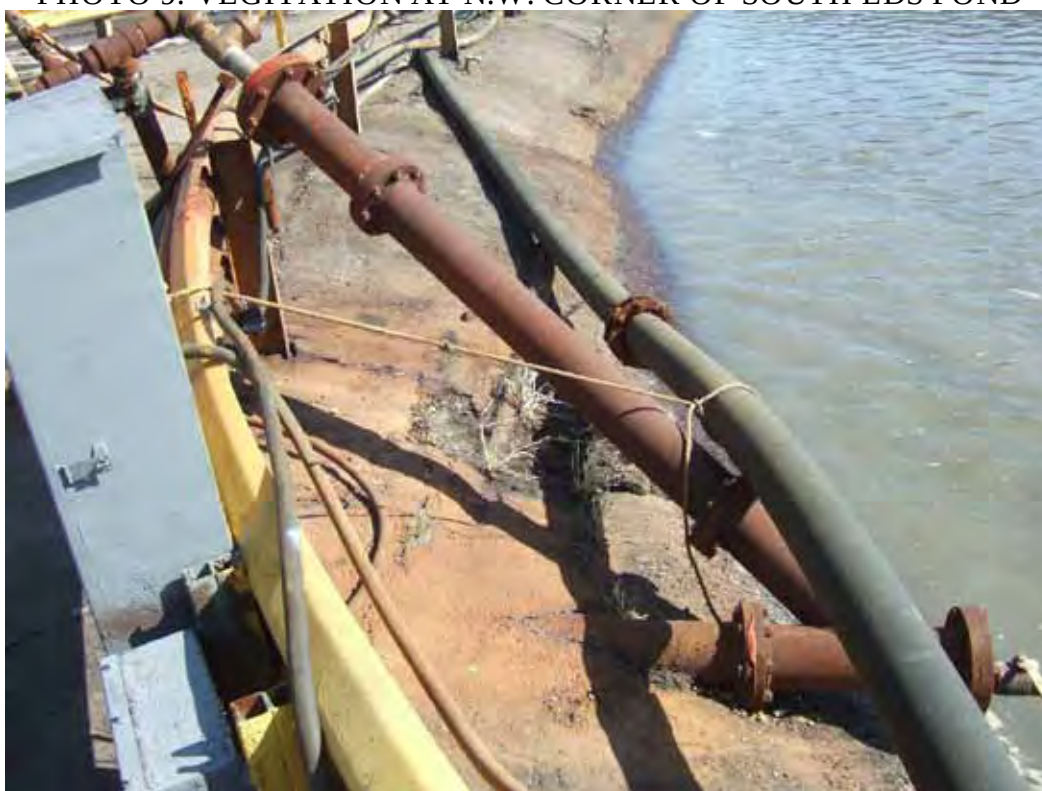
PHOTO 9: VEGITATION AT N.W. CORNER OF SOUTH LDS POND

There was about 2 feet of freeboard along the upstream slope of the South LDS Pond at the time of inspection. No major cracks were observed in the visible portion of the upstream liner, which is constructed of the more impervious asphalt material. Some minor damage and vegetation was observed at the northwest corner of the upstream slope, near the fire hose system and bubbler

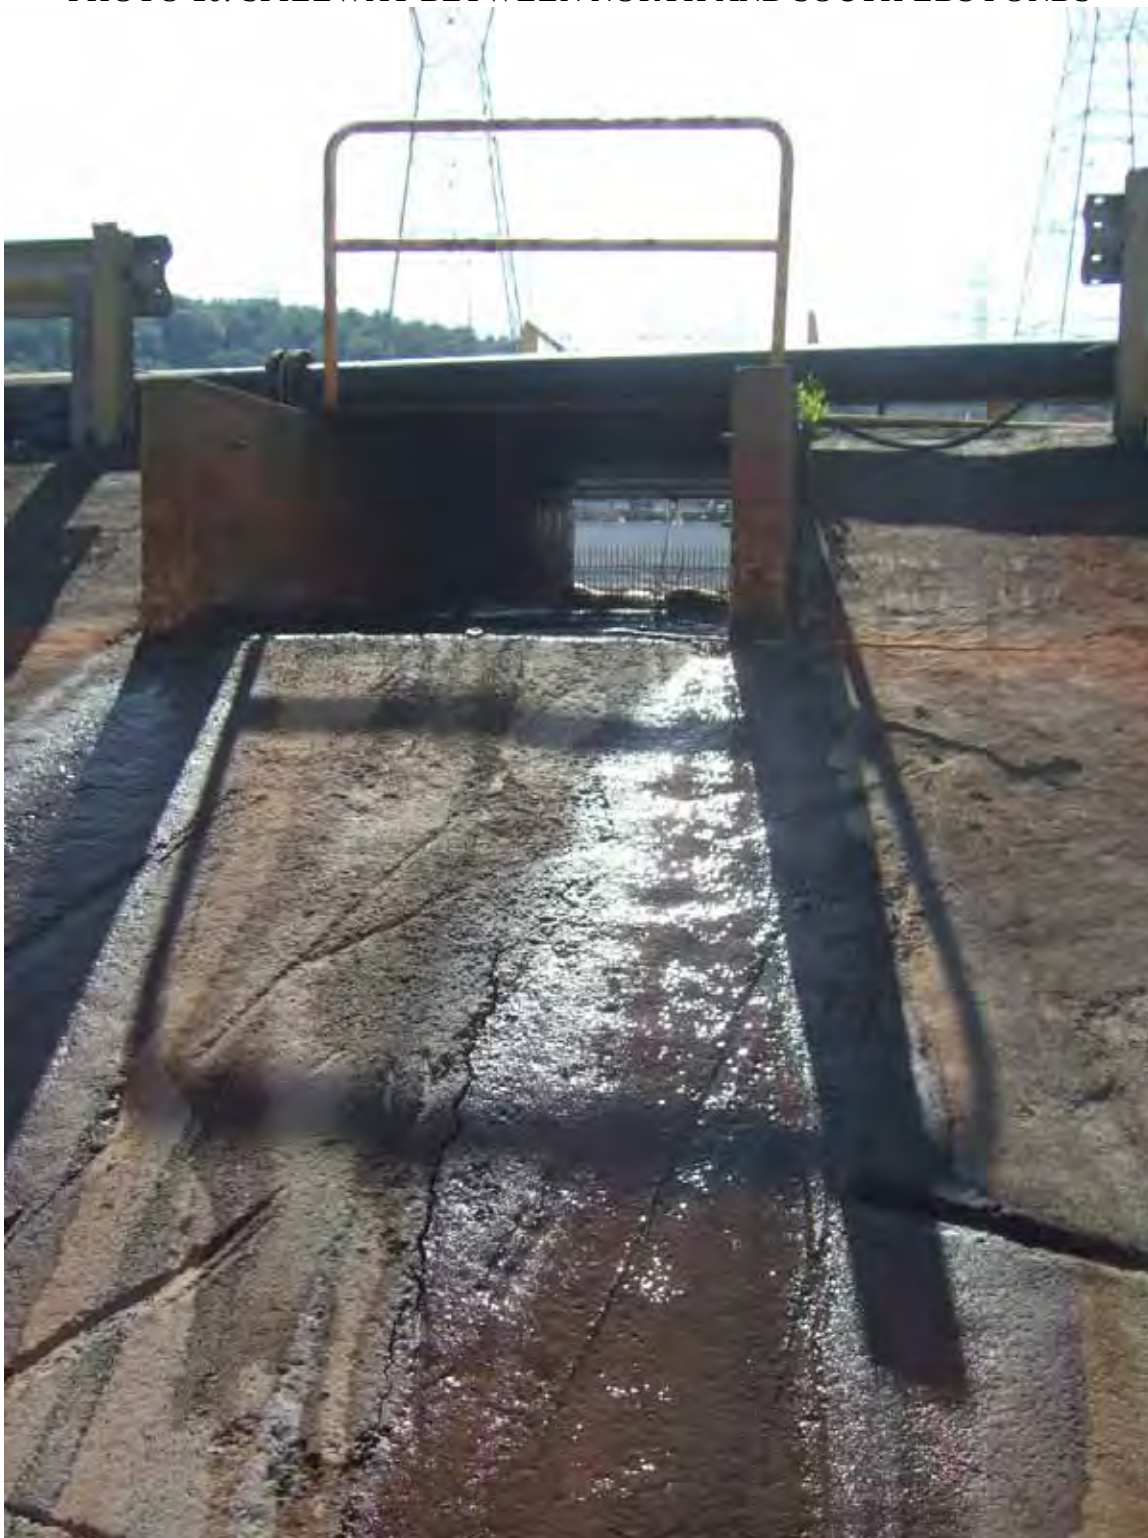
PHOTO 10: SPILLWAY BETWEEN NORTH AND SOUTH LDS PONDS

The small spillway between the North and South LDS Ponds was in good condition at the time of inspection (**Photograph 10**). The concrete was in good condition, while the weir and trashrack were observed to be free of obstructions or debris.

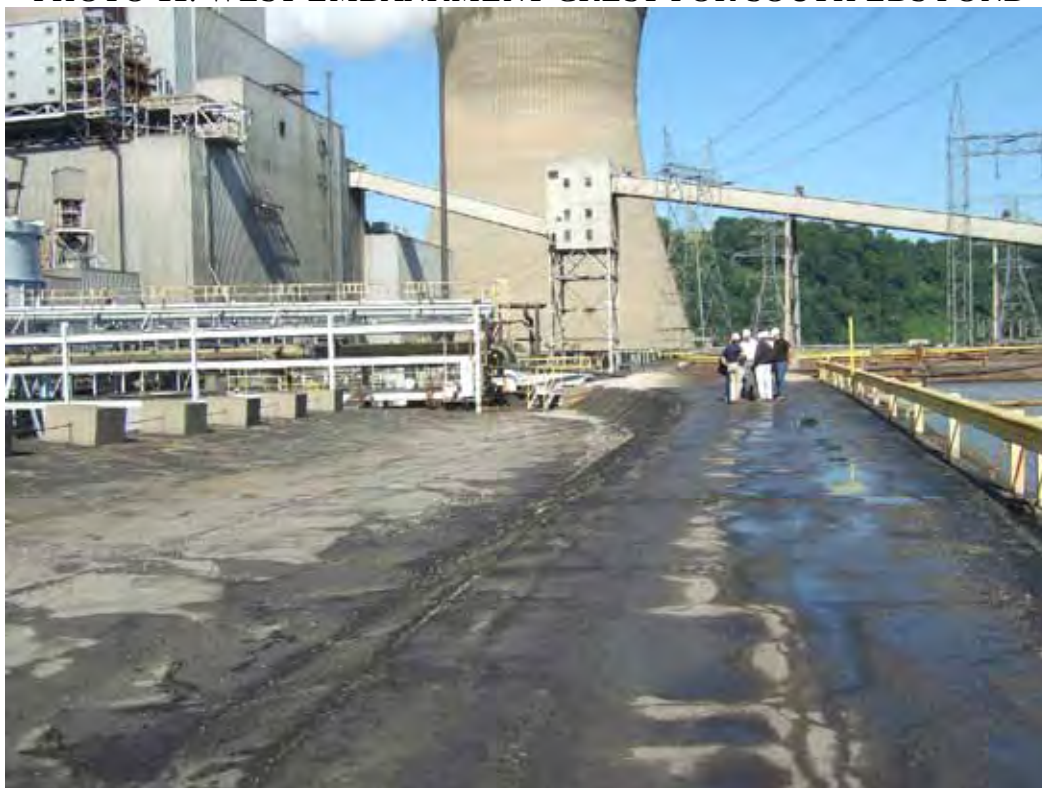
PHOTO 11: WEST EMBANKMENT CREST FOR SOUTH LDS POND

(**Photograph 9**). The crest of embankment and downstream slope showed cracks and spalling throughout the top layer (about 3 inches) asphalt, due to sun exposure and weathering (**Photograph 11**). These cracks are cosmetic, do not extend to the underlying soil, and do not pose any risk to the stability and integrity of the embankments. Nonetheless, they should be sealed periodically to reduce vegetation growth. Along the eastern embankment, the vegetation is well-maintained and trimmed back approximately 10 feet from the edge of the asphalt liner. The western downstream slope is vegetated and was well maintained and trimmed at the time of inspection. No seepage was observed by RIZZO along the downstream toe of the South LDS Pond. Several minor wet spots were observed at the toe of the western downstream embankment by the PADEP and RIZZO at the time of the inspection. According to the owner, this area is subject to rain, periodic dust control watering, and is periodically hosed down for general cleaning.

We recommend that the surface asphalt along the crest and downstream slopes of all embankments continue to be maintained as part of the plant facility's regular maintenance activities. Clearing of vegetation, sealing of cracks, and repair of larger defects should be performed on a regular basis. The hydrologic study for the site states that SDF will overtop the impoundments by approximately 0.3 foot. Passage of the SDF without erosion of the embankments is dependent on the asphalt layer, and it should not be allowed to degrade to a point where an overtopping could cause a failure.

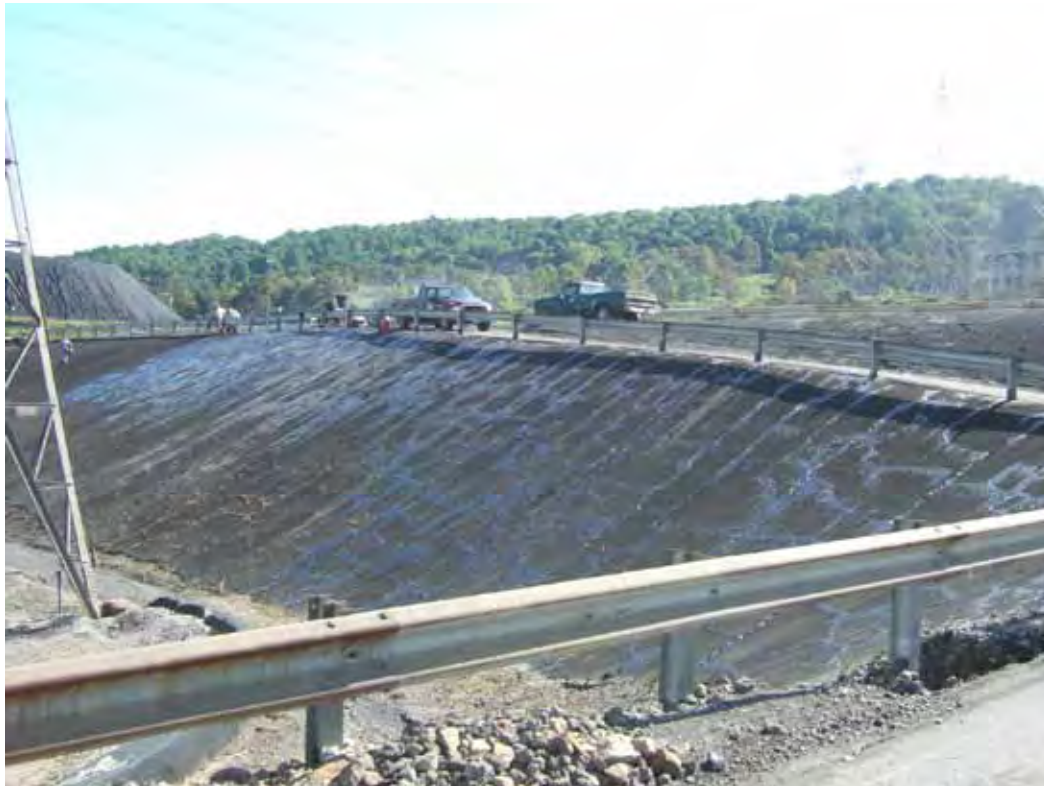
PHOTO 13: REPAIR OF ASPHALT ON WEST HDS POND NORTH SLOPE

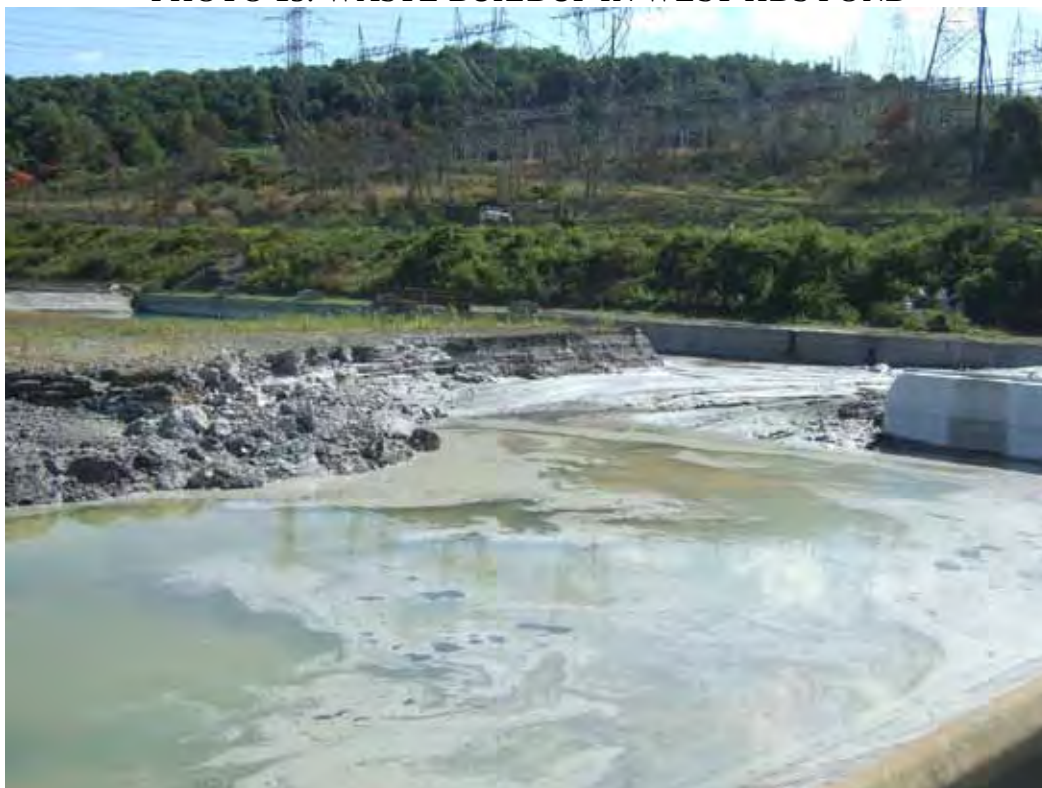
PHOTO 15: WASTE BUILDUP IN WEST HDS POND

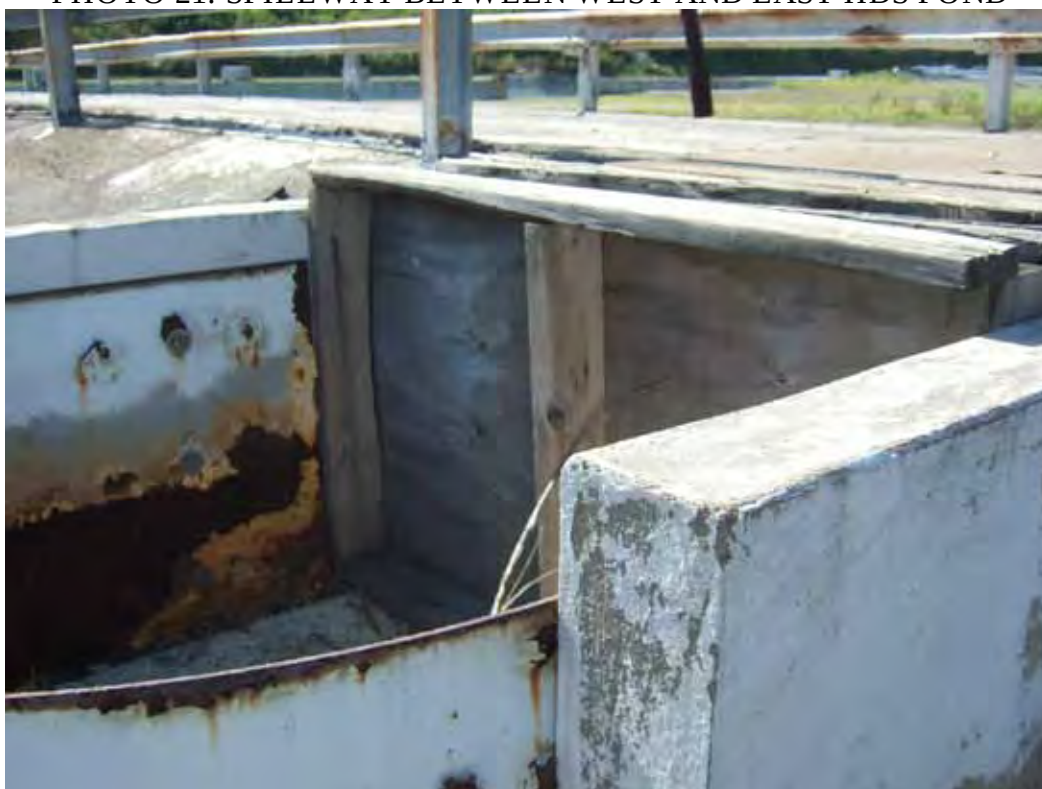
PHOTO 21: SPILLWAY BETWEEN WEST AND EAST HDS POND

The small spillway between the East and West HDS Ponds has been decommissioned, but the concrete still appeared in good condition at the time of inspection (*Photograph 21*).
