# Assessment of Dam Safety

## Coal Combustion Surface Impoundments (Task 3)

Bruce Mansfield  
Power Plant  
Little Blue Run Dam  
Shippingport, Pennsylvania

February 23, 2010

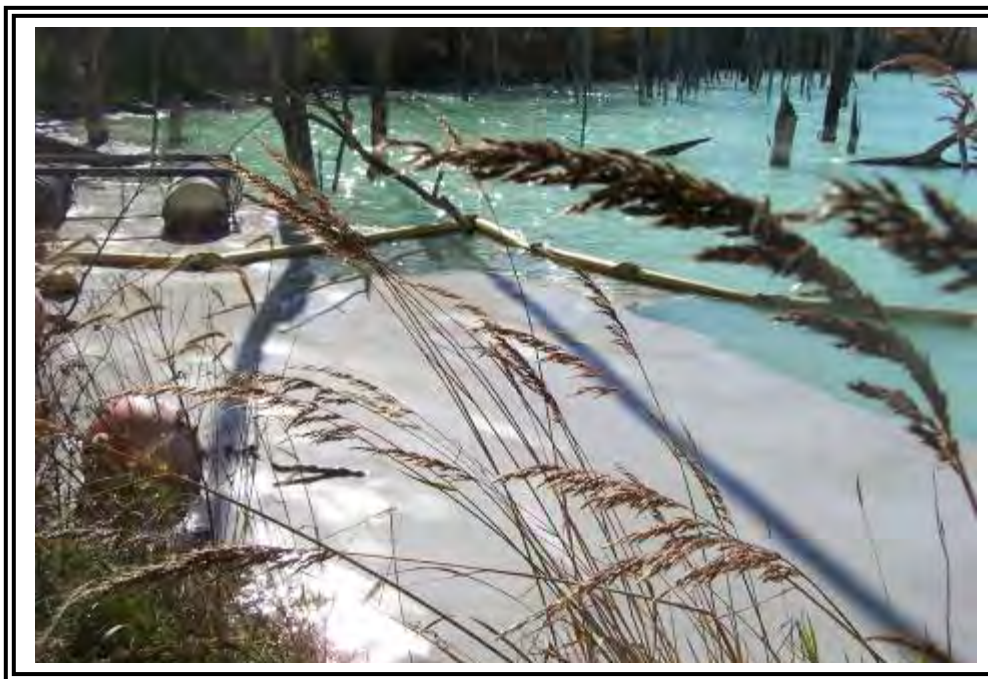
22

Impoundment side of Secondary Spillway approach channel. Pipe was submerged during our site visit.

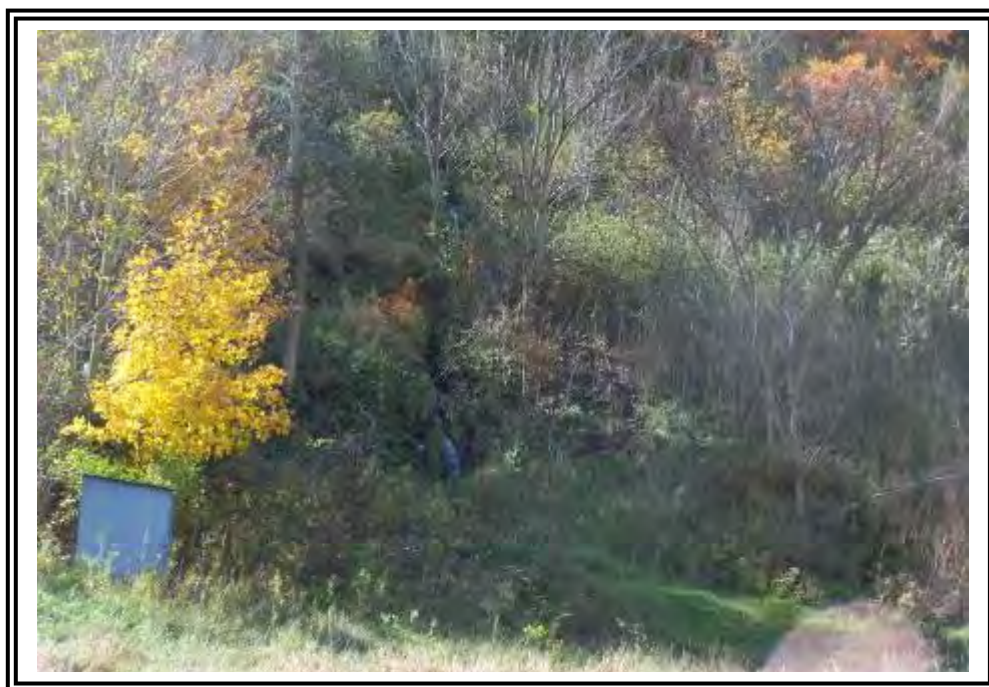
During the site visit, FirstEnergy and GAI representatives pointed out areas previously repaired on the west abutment where surface sloughing and sliding of surficial soils had occurred in the location of a temporary construction access road some years ago (Photos 12 and 13). Seepage that is directed to weirs for monitoring was observed on the west abutment (Photos No. 27 and 33). The east abutment was also observed (Photo Nos. 1, 10, and 11).

West abutment seepage.

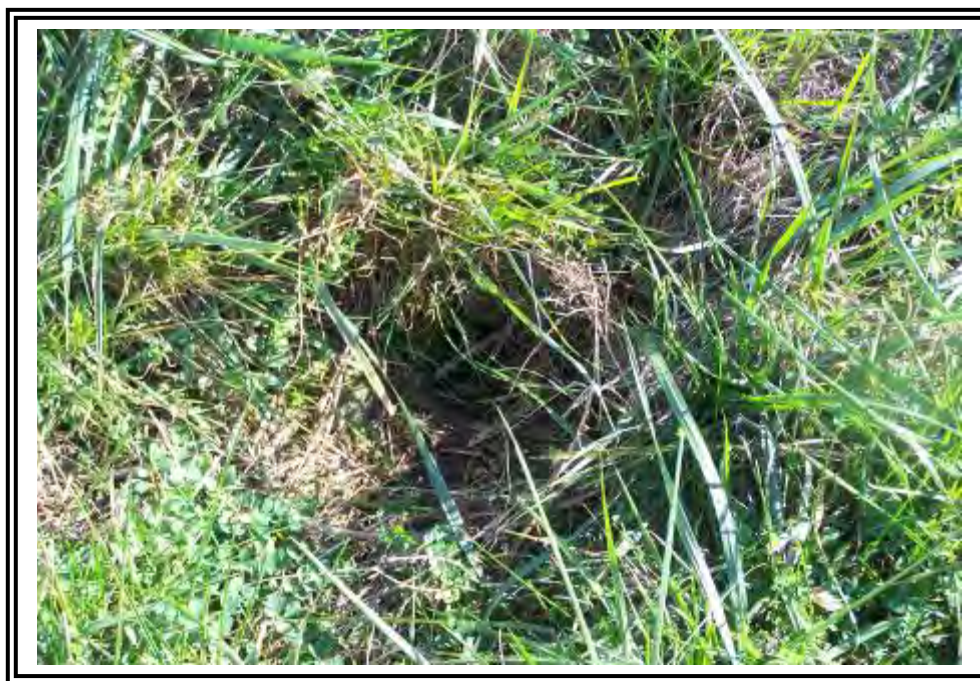
38

At the time of the site visit the Little Blue Run Saddle Dam was not impounding water. A gravel access road runs the length of the crest of the Little Blue Run Saddle Dam (Photo No. 36). The upstream and downstream embankment slopes are grass covered (Photo Nos. 37 and 39). A small rodent hole was observed on the upstream slope (Photo No. 38).

Small rodent hole on upstream slope of Little Blue Run Saddle Dam.

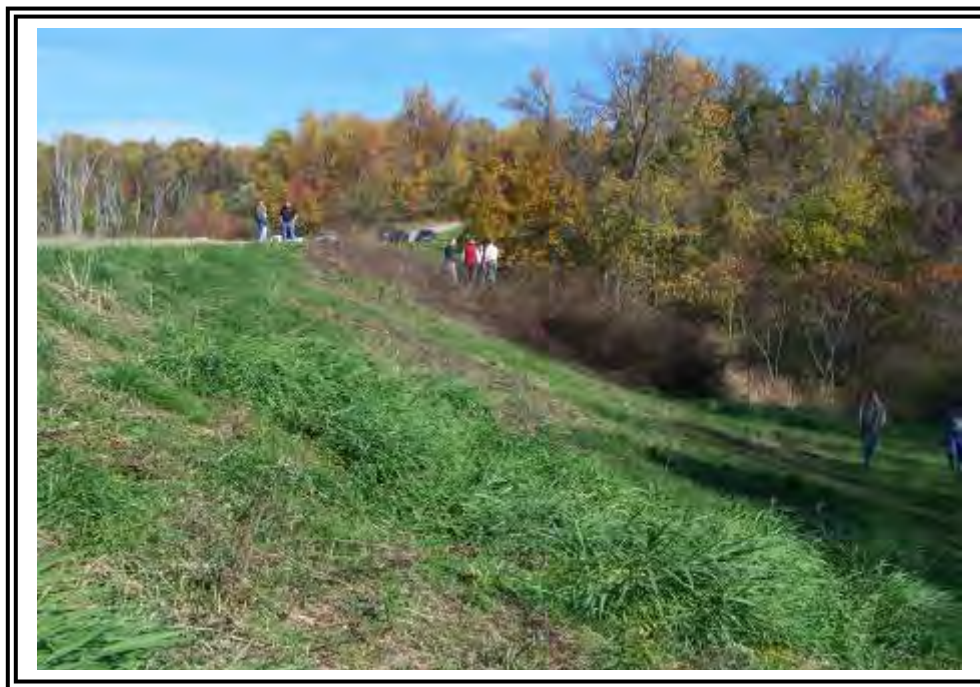
39

Downstream slope of Little Blue Run Saddle Dam, looking north.  
Vegetation near group of people on slope consists of material that the mower cannot traverse.
