DRAFT REPORT

Dam Safety Assessment of CCW Impoundments

J.R. Whiting Plant

November 30, 2010

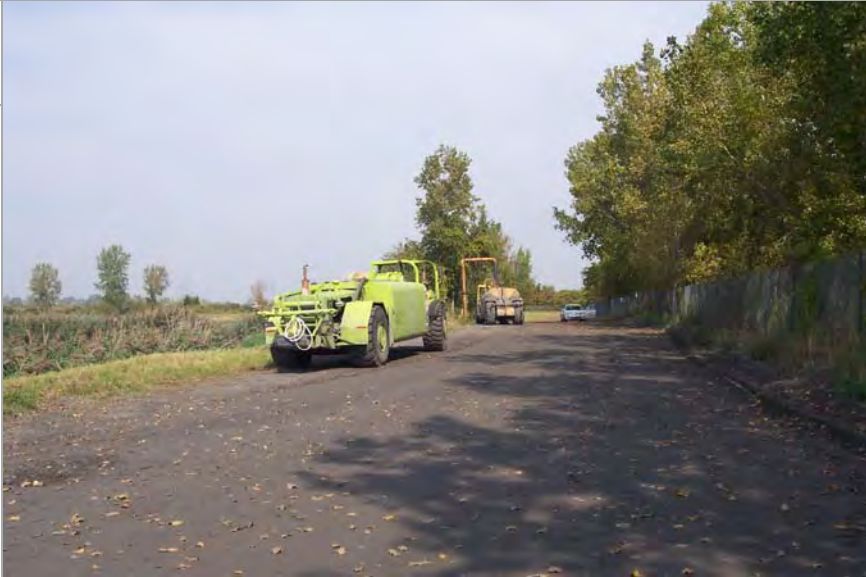
CLIENT NAME: US EPA		SITE LOCATION: CONSUMER'S ENERGY – J.R. WHITING	PROJECT NO. 13498 46122
PHOTO NO. C	DATE: 9/23/10

DESCRIPTION View looking north View along crest of east embankment Note mature tree line at right

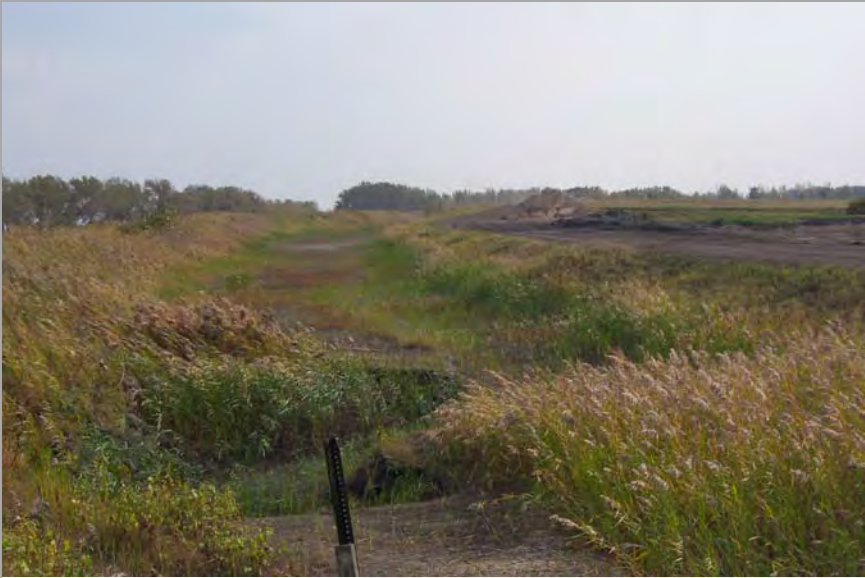
CLIENT NAME: US EPA		SITE LOCATION: CONSUMER'S ENERGY – J.R. WHITING		PROJECT NO. 13498 46122
PHOTO NO. D	DATE: 9/23/10

DESCRIPTION View looking south from north end of landfill/former impoundments Photo is directed along center of former impoundments. Note haul road for placement of final ash in landfill Depressed area in center of photo is last area where ash was wet sluiced to former impoundments

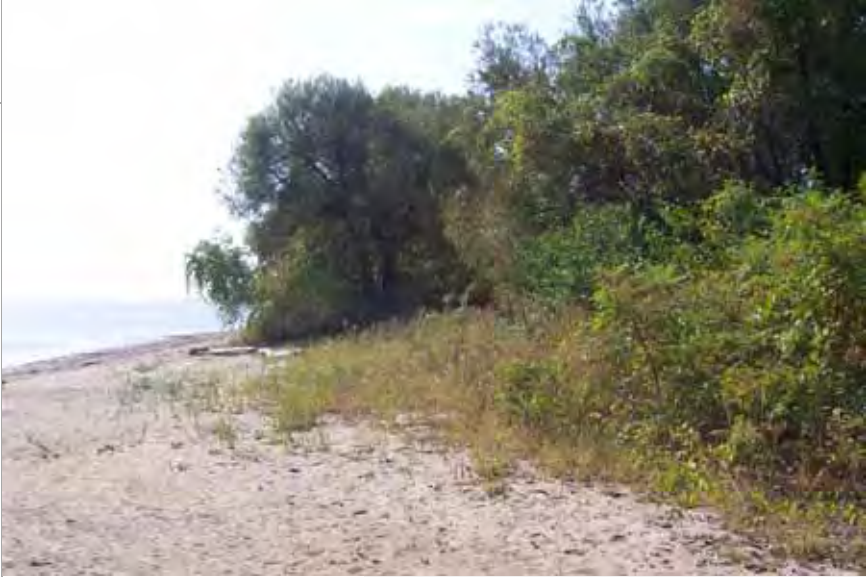
CLIENT NAME: US EPA		SITE LOCATION: CONSUMER'S ENERGY – J.R. WHITING		PROJECT NO. 13498 46122
PHOTO NO. 2	DATE: 9/23/10

DESCRIPTION View looking south Outboard side of north portion of east embankment Note heavy vegetative growth on slope at right, lake Erie at left

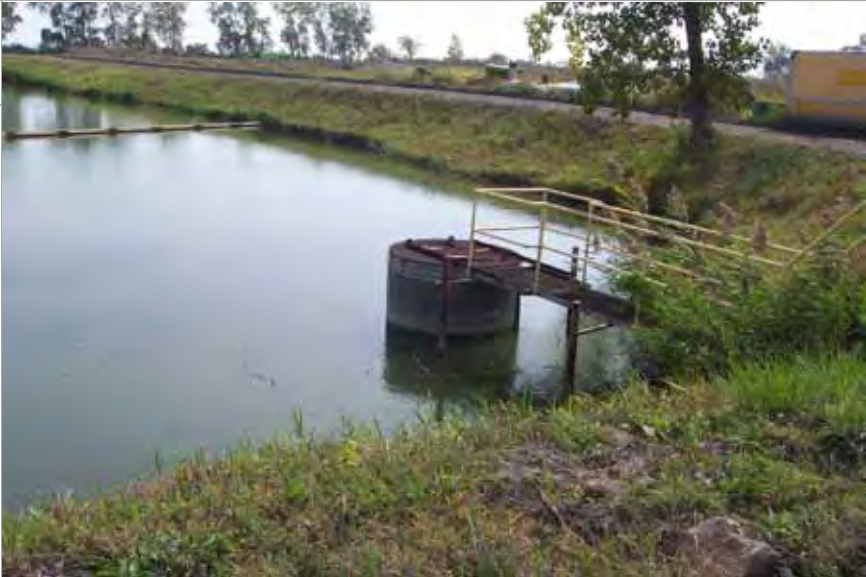
CLIENT NAME: US EPA		SITE LOCATION: CONSUMER'S ENERGY – J.R. WHITING		PROJECT NO. 13498 46122
PHOTO NO. 10	DATE: 9/23/10

DESCRIPTION View looking east View of outlet intake structure in southwest corner of Pond 1 Note mature tree growing on divider road between Ponds 1 & 2

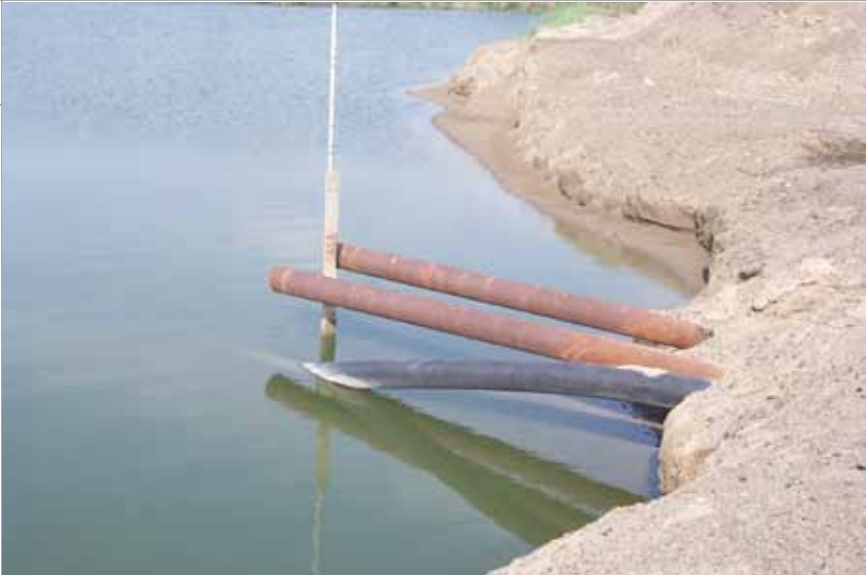
CLIENT NAME: US EPA		SITE LOCATION: CONSUMER'S ENERGY – J.R. WHITING		PROJECT NO. 13498 46122
PHOTO NO. 12	DATE: 9/23/10

DESCRIPTION View looking east Inlet piping for bottom ash into Pond 2

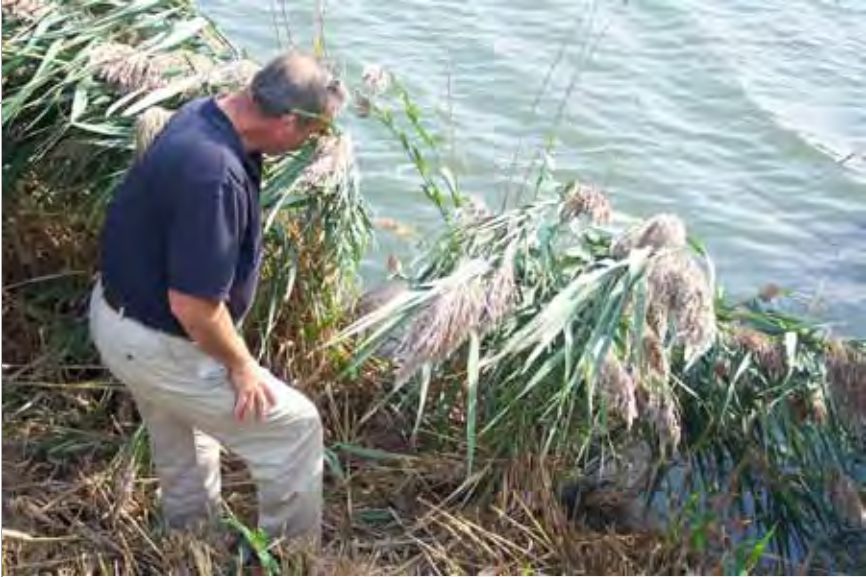
CLIENT NAME: US EPA		SITE LOCATION: CONSUMER'S ENERGY – J.R. WHITING		PROJECT NO. 13498 46122
PHOTO NO. 14	DATE: 9/23/10

- A minor eroded area was observed adjacent to and just west of the inlet side of the transfer pipe between Ponds 1 & 2.

DESCRIPTION View looking south View of inlet end (in Pond 2) of transfer pipe between Ponds 1 & 2 An eroded area was observed adjacent to this pipe (right of pipe in picture) but is hidden from view by vegetation

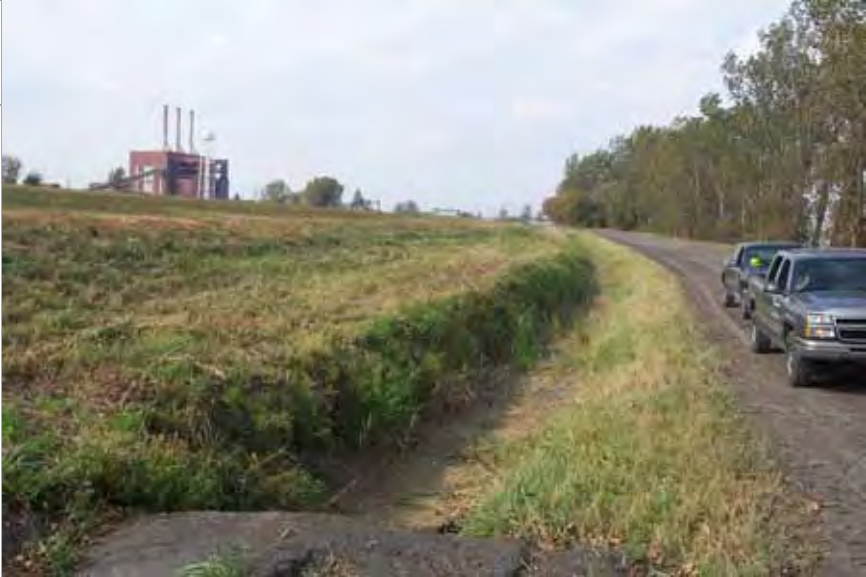
CLIENT NAME: US EPA		SITE LOCATION: CONSUMER'S ENERGY – J.R. WHITING	PROJECT NO. 13498 46122
PHOTO NO. 9	DATE: 9/23/10

DESCRIPTION View looking north. View along crest of former embankment Slope to the left is stored ash in footprint of former impoundment, final cover yet to be placed over subject area of photo

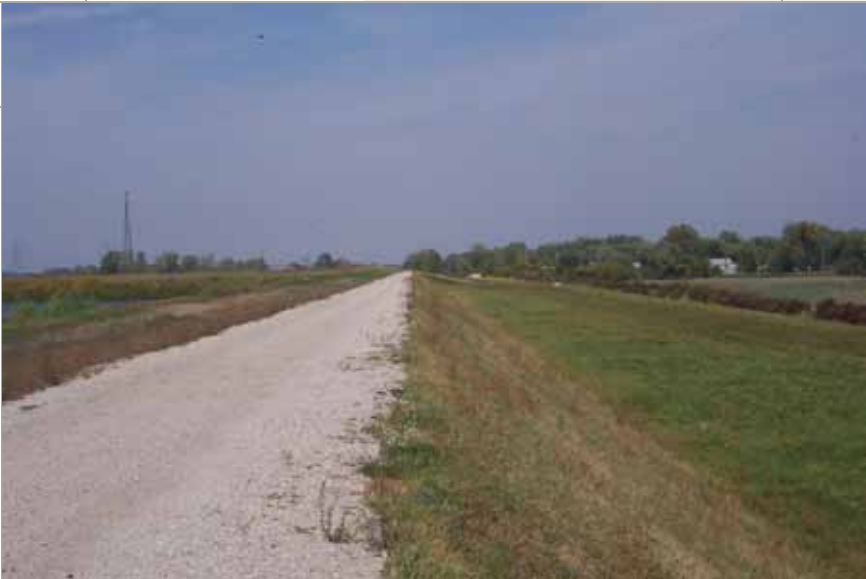
CLIENT NAME: US EPA		SITE LOCATION: CONSUMER'S ENERGY – J.R. WHITING		PROJECT NO. 13498 46122
PHOTO NO. 1	DATE: 9/23/10

DESCRIPTION View looking north View along crest and upper outboard slope of south portion of east embankment

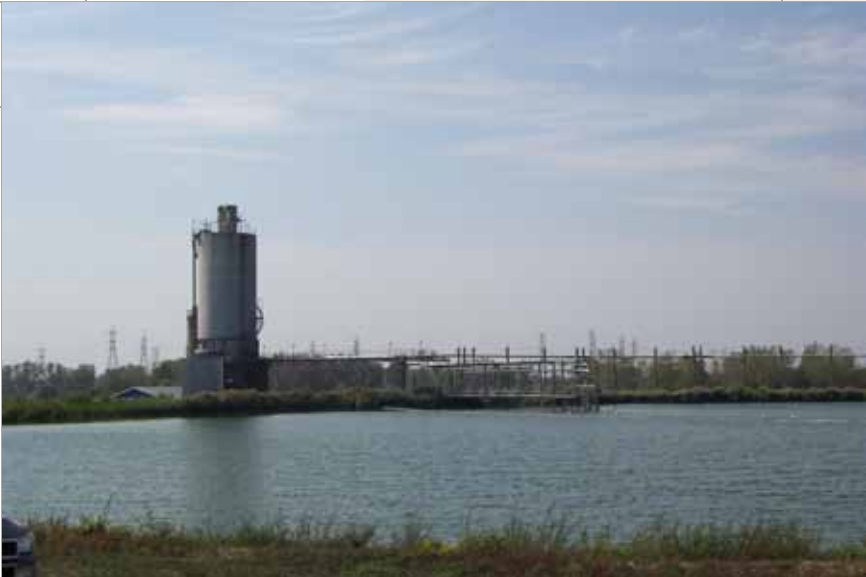
CLIENT NAME: US EPA		SITE LOCATION: CONSUMER'S ENERGY – J.R. WHITING		PROJECT NO. 13498 46122
PHOTO NO. 17	DATE: 9/23/10

DESCRIPTION View looking southwest View of recycle water/blend water intake platform and fly ash storage silo from across impoundment

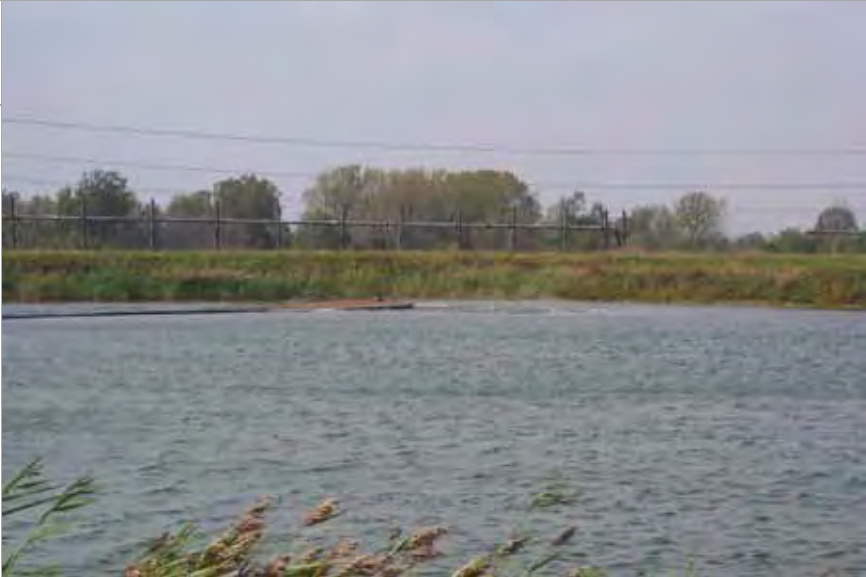
CLIENT NAME: US EPA		SITE LOCATION: CONSUMER'S ENERGY – J.R. WHITING		PROJECT NO. 13498 46122
PHOTO NO. 18	DATE: 9/23/10

DESCRIPTION View looking northwest View of recycle water being circulated in pond from across impoundment
