Dam Safety Assessment of CCW Impoundments

J.R. Whiting Plant

United States Environmental Protection Agency
Washington, DC

June 27, 2011

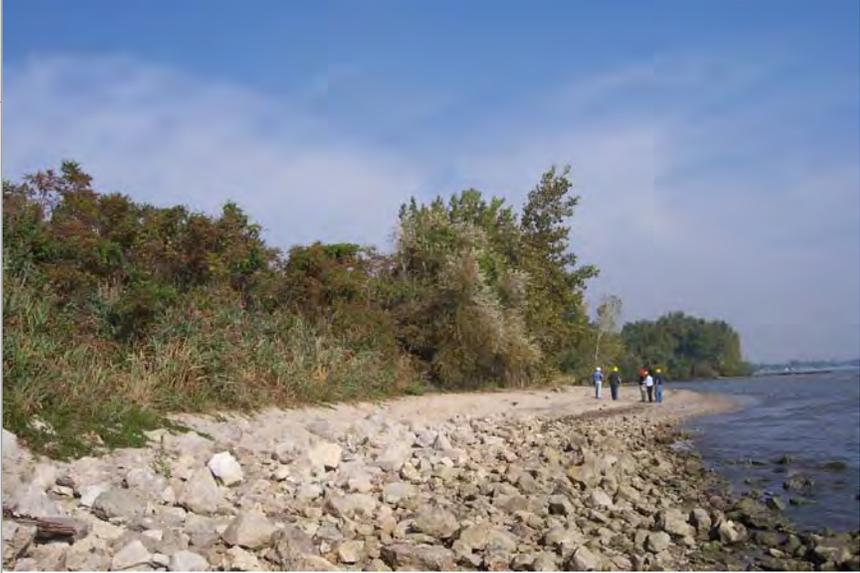
CLIENT NAME: US EPA		SITE LOCATION: CONSUMER'S ENERGY – J.R. WHITING		PROJECT NO. 13498 46122
PHOTO NO. A	DATE: 9/23/10

DESCRIPTION View looking north Outboard side of south portion of east embankment of Ponds 1 & 2 Note heavy vegetative growth on slope at left

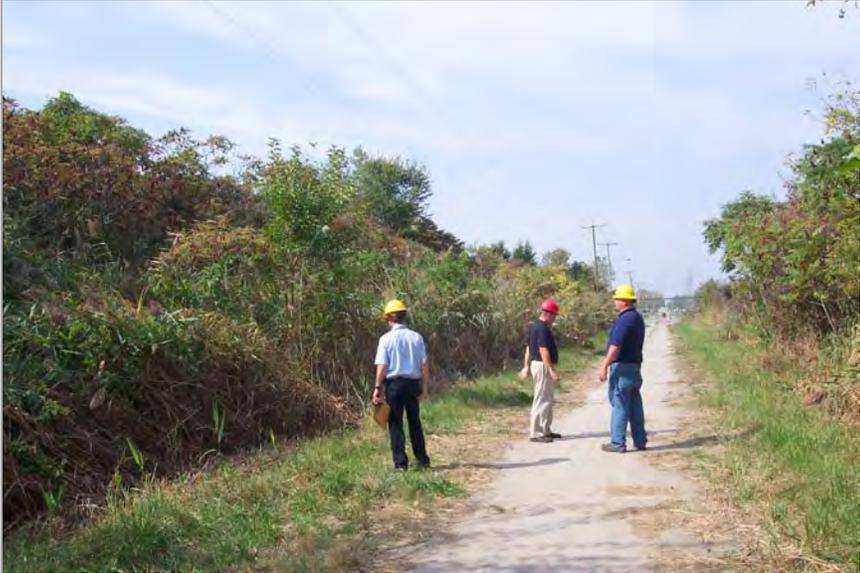
CLIENT NAME: US EPA		SITE LOCATION: CONSUMER'S ENERGY – J.R. WHITING		PROJECT NO. 13498 46122
PHOTO NO. B	DATE: 9/23/10

DESCRIPTION View looking west. Outboard side of north embankment of Ponds 1 & 2 Note heavy vegetative growth on slope at left

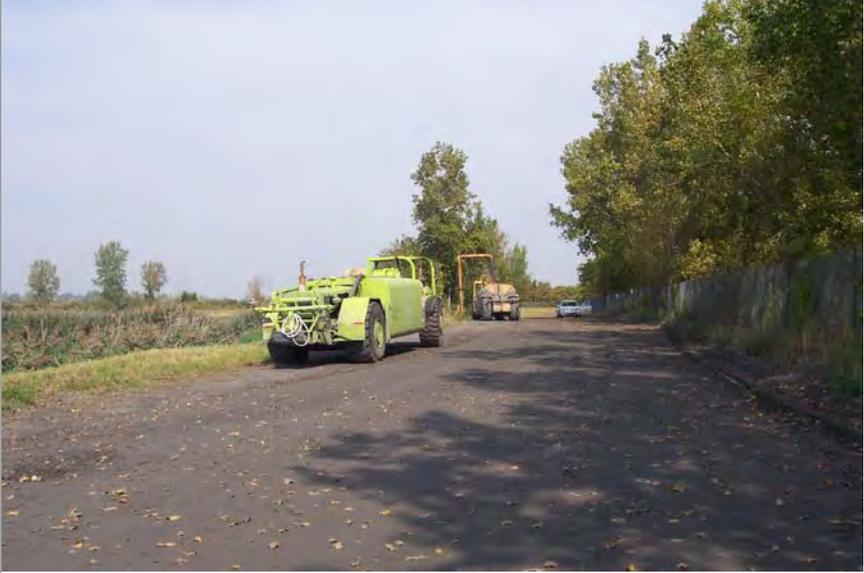
CLIENT NAME: US EPA		SITE LOCATION: CONSUMER'S ENERGY – J.R. WHITING		PROJECT NO. 13498 46122
PHOTO NO. C	DATE: 9/23/10

DESCRIPTION View looking north View along crest of east embankment Note mature tree line at right

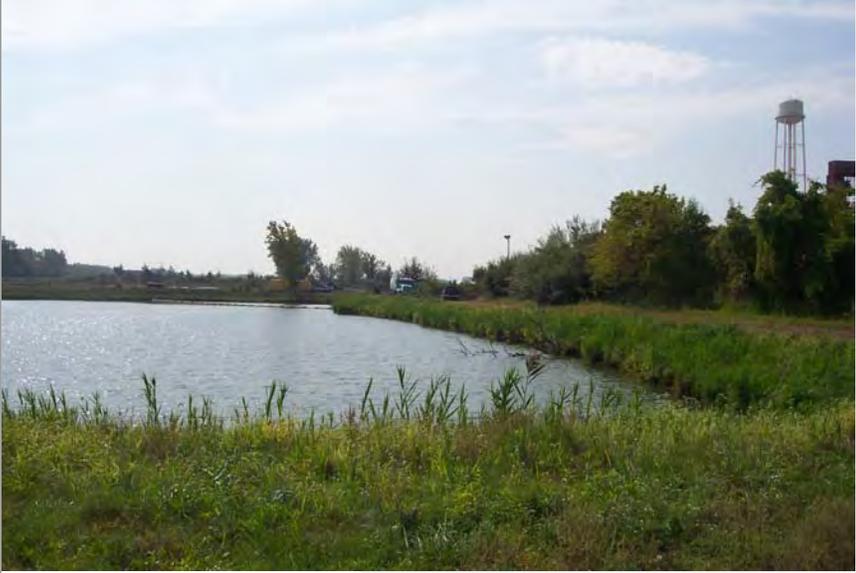
CLIENT NAME: US EPA		SITE LOCATION: CONSUMER'S ENERGY – J.R. WHITING		PROJECT NO. 13498 46122
PHOTO NO. D	DATE: 9/23/10

DESCRIPTION View looking south Inboard side of west embankment of Ponds 1 & 2 Note heavy vegetative growth at right

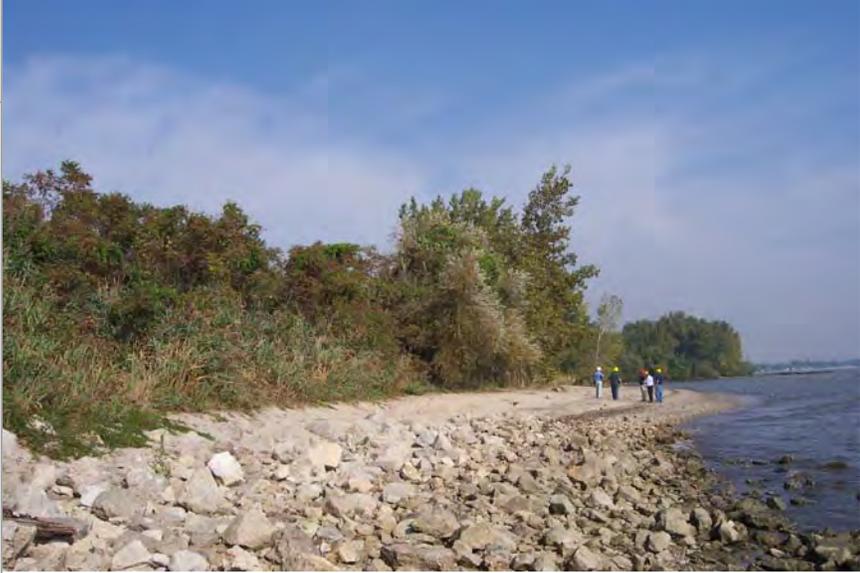
CLIENT NAME: US EPA		SITE LOCATION: CONSUMER'S ENERGY – J.R. WHITING	PROJECT NO. 13498 46122
PHOTO NO. 1	DATE: 9/23/10

DESCRIPTION View looking north Outboard side of south portion of east embankment Note heavy vegetative growth on slope at left, Lake Erie at right

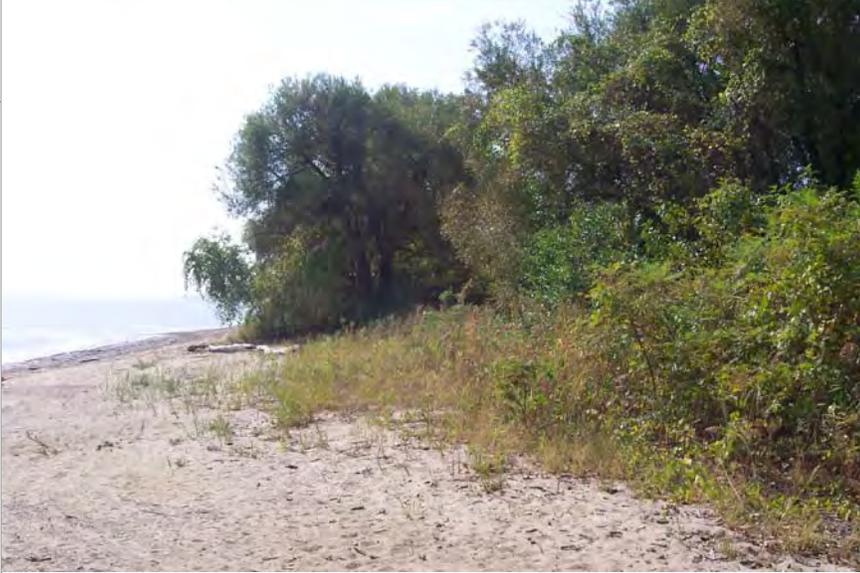
CLIENT NAME: US EPA		SITE LOCATION: CONSUMER'S ENERGY – J.R. WHITING	PROJECT NO. 13498 46122
PHOTO NO. 2	DATE: 9/23/10

DESCRIPTION View looking south Outboard side of north portion of east embankment Note heavy vegetative growth on slope at right, lake Erie at left

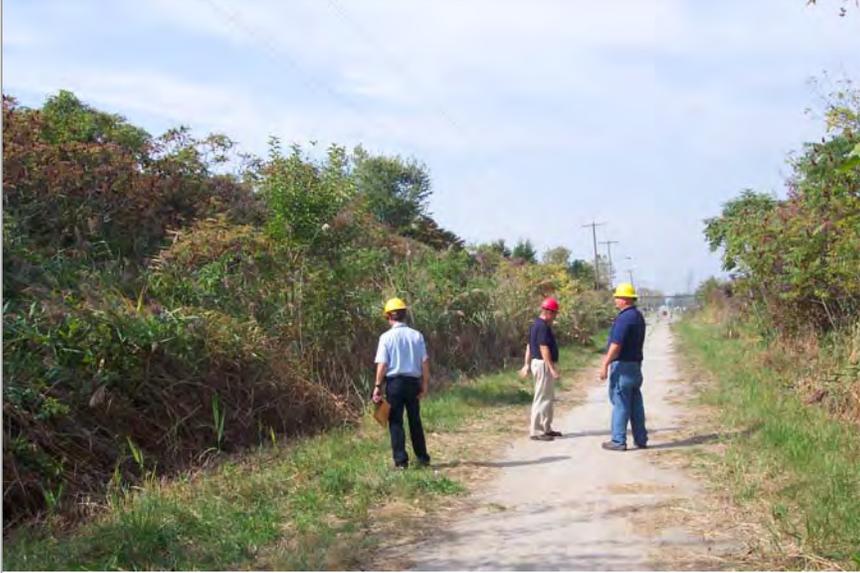
CLIENT NAME: US EPA		SITE LOCATION: CONSUMER'S ENERGY – J.R. WHITING	PROJECT NO. 13498 46122
PHOTO NO. 3	DATE: 9/23/10

DESCRIPTION View looking west Outboard side of north embankment Note heavy vegetative growth on slope at left

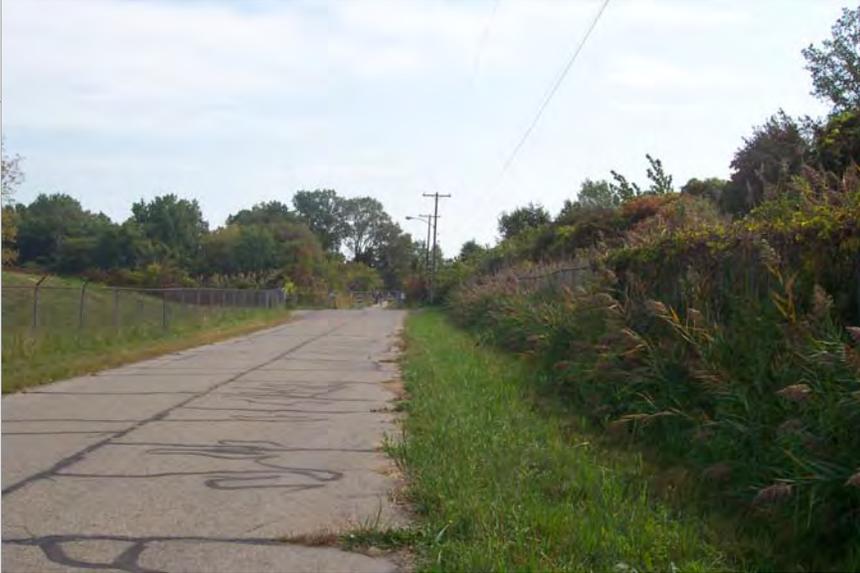
CLIENT NAME: US EPA		SITE LOCATION: CONSUMER'S ENERGY – J.R. WHITING	PROJECT NO. 13498 46122
PHOTO NO. 4	DATE: 9/23/10

DESCRIPTION View looking east Outboard side of north embankment Note heavy vegetative growth at right

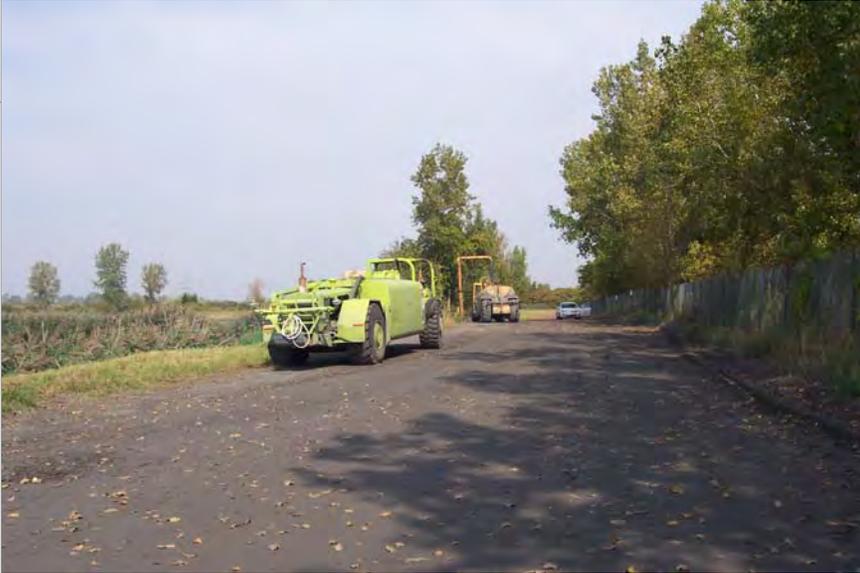
CLIENT NAME: US EPA		SITE LOCATION: CONSUMER'S ENERGY – J.R. WHITING	PROJECT NO. 13498 46122
PHOTO NO. 5	DATE: 9/23/10

DESCRIPTION View looking north View along crest of east embankment Note mature tree line at right

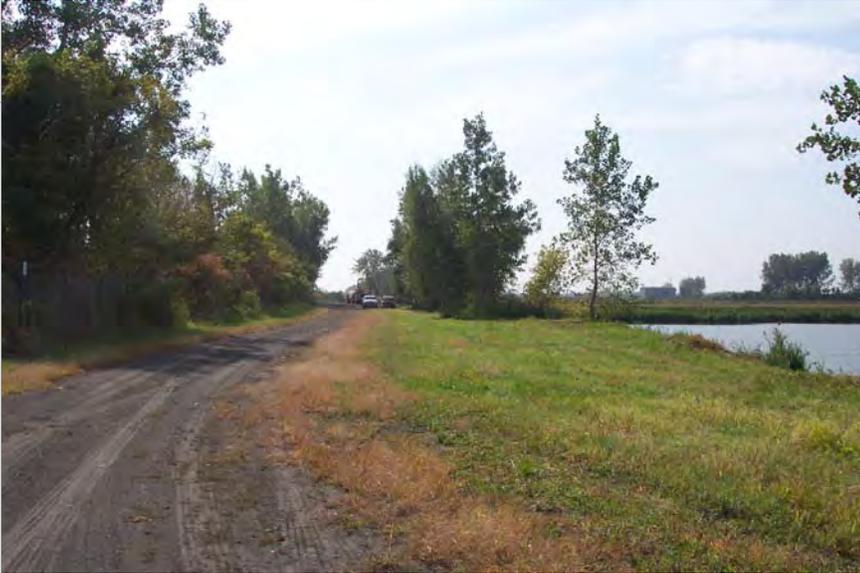
CLIENT NAME: US EPA		SITE LOCATION: CONSUMER'S ENERGY – J.R. WHITING	PROJECT NO. 13498 46122
PHOTO NO. 7	DATE: 9/23/10

DESCRIPTION View looking south View along crest of east embankment Note mature tree line at left and mature trees near impoundment water surface at right

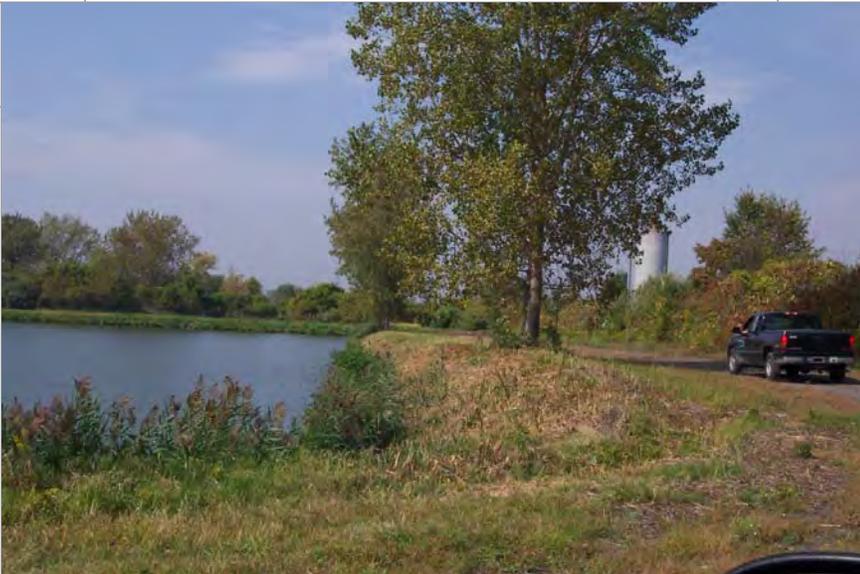
CLIENT NAME: US EPA		SITE LOCATION: CONSUMER'S ENERGY – J.R. WHITING	PROJECT NO. 13498 46122
PHOTO NO. 8	DATE: 9/23/10

DESCRIPTION View looking west View along inboard slope and crest of north embankment Note heavy vegetative growth at right and mature trees near impoundment water surface

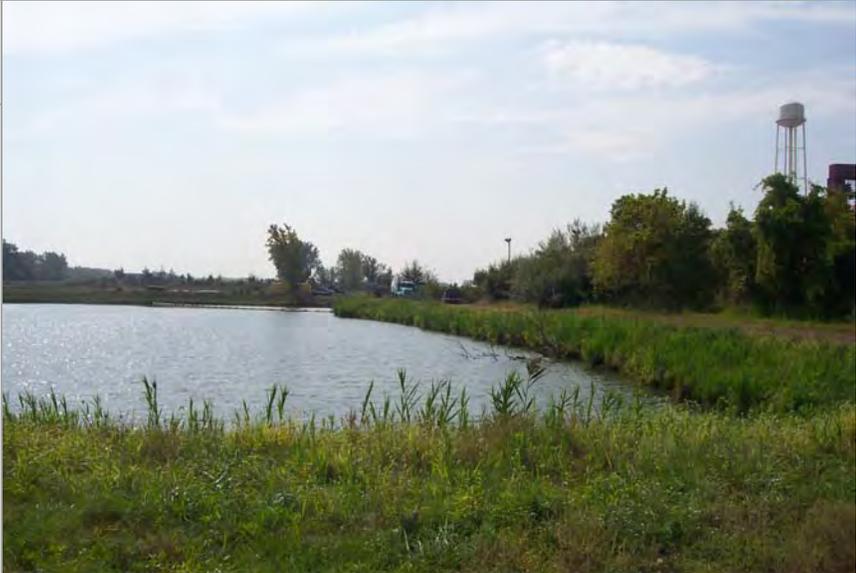
CLIENT NAME: US EPA		SITE LOCATION: CONSUMER'S ENERGY – J.R. WHITING	PROJECT NO. 13498 46122
PHOTO NO. 9	DATE: 9/23/10

DESCRIPTION View looking south Inboard side of west embankment Note heavy vegetative growth at right

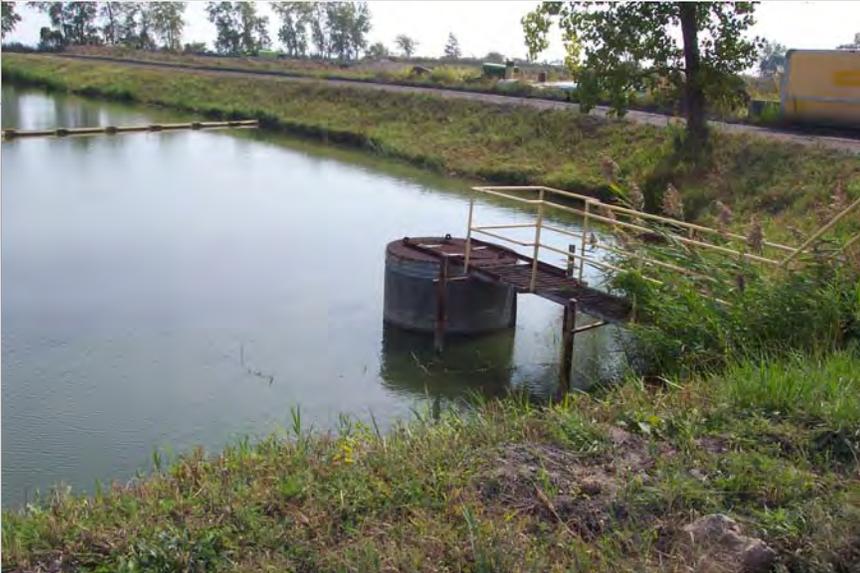
CLIENT NAME: US EPA		SITE LOCATION: CONSUMER'S ENERGY – J.R. WHITING	PROJECT NO. 13498 46122
PHOTO NO. 10	DATE: 9/23/10

DESCRIPTION View looking east View of outlet intake structure in southwest corner of Pond 1 Note mature tree growing on divider road between Ponds 1 & 2

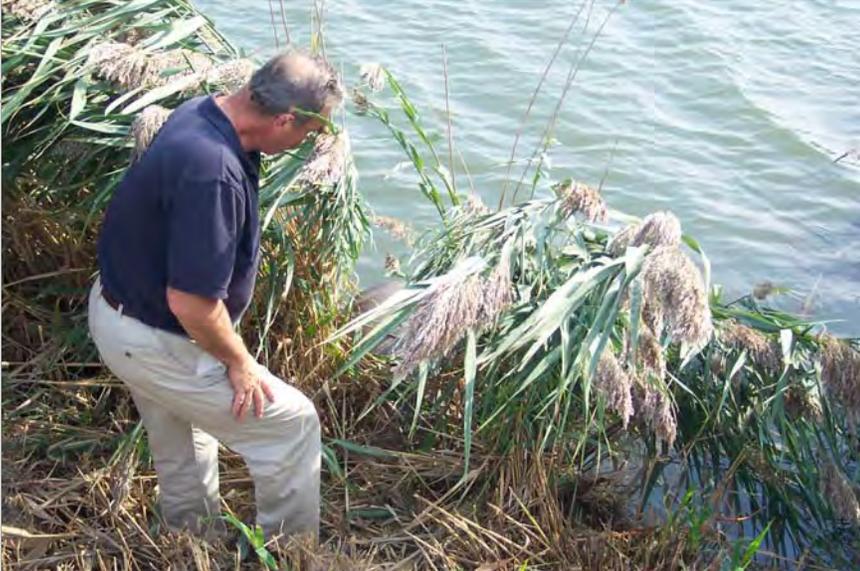
CLIENT NAME: US EPA		SITE LOCATION: CONSUMER'S ENERGY – J.R. WHITING	PROJECT NO. 13498 46122
PHOTO NO. 14	DATE: 9/23/10

DESCRIPTION View looking south View of inlet end (in Pond 2) of transfer pipe between Ponds 1 & 2 An eroded area was observed adjacent to this pipe (right of pipe in picture) but is hidden from view by vegetation

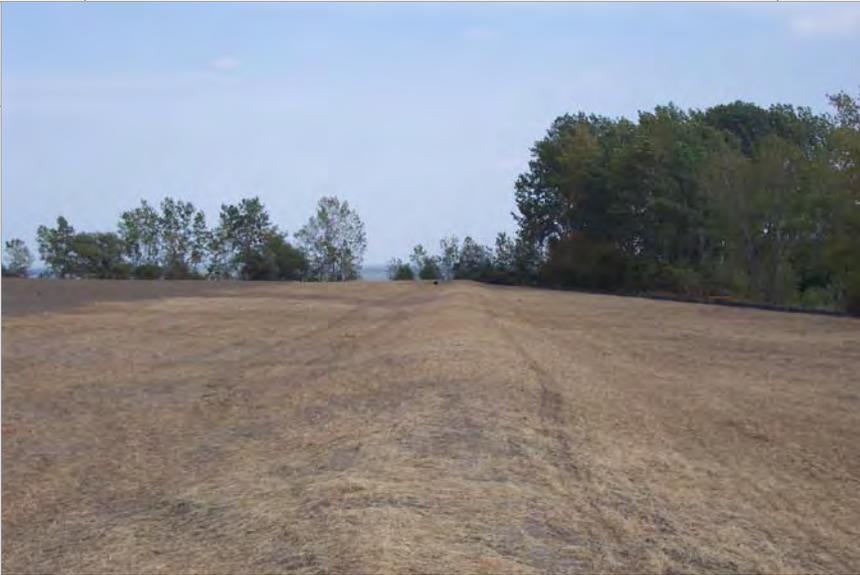
DESCRIPTION View looking east View along newly constructed final cover and runoff berm on southern portion of former impoundments Note stairway down to former outfall, former outfall pipes were observed to be sealed

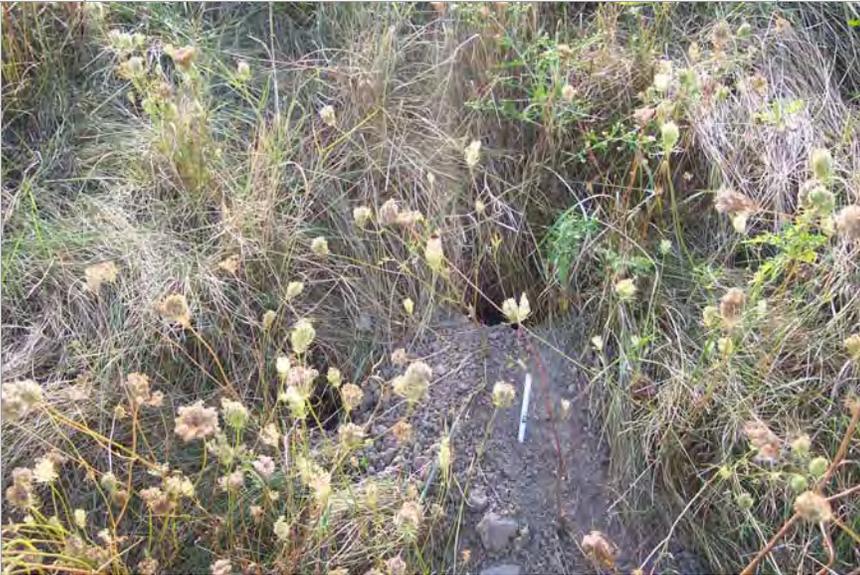
DESCRIPTION View looking south Rodent burrow observed on north embankment Typical of rodent burrows observed around this impoundment

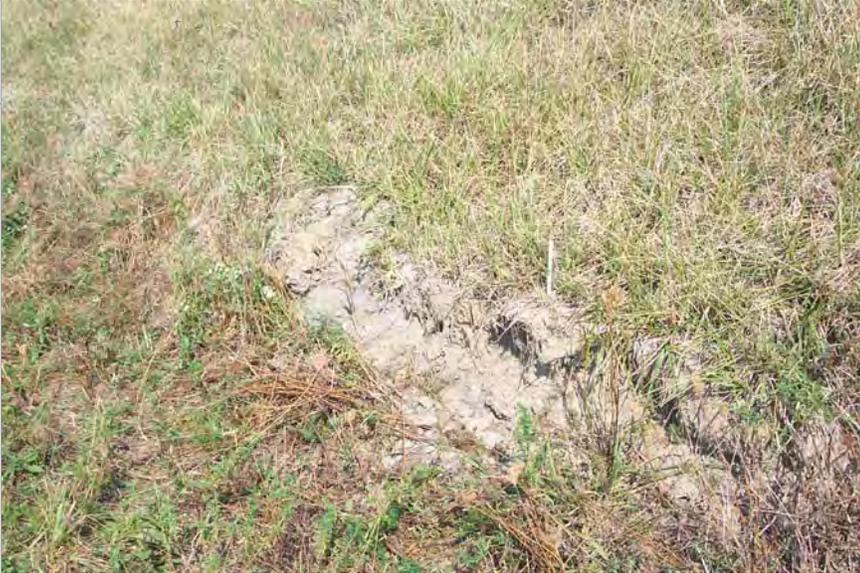
DESCRIPTION View looking northwest View of minor scarp at base of upper outboard slope on west embankment

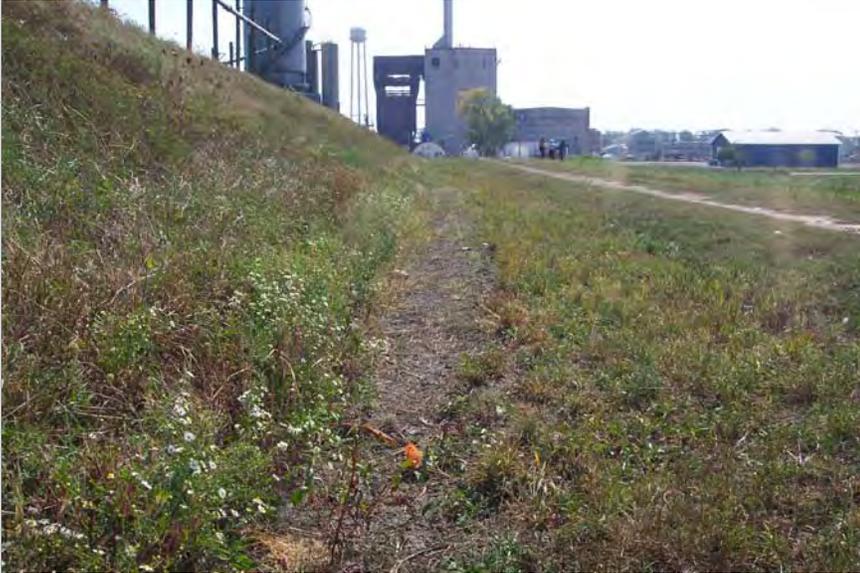
DESCRIPTION View looking south View of seasonal wet area (currently dry) at base of upper outboard slope at south portion of west embankment

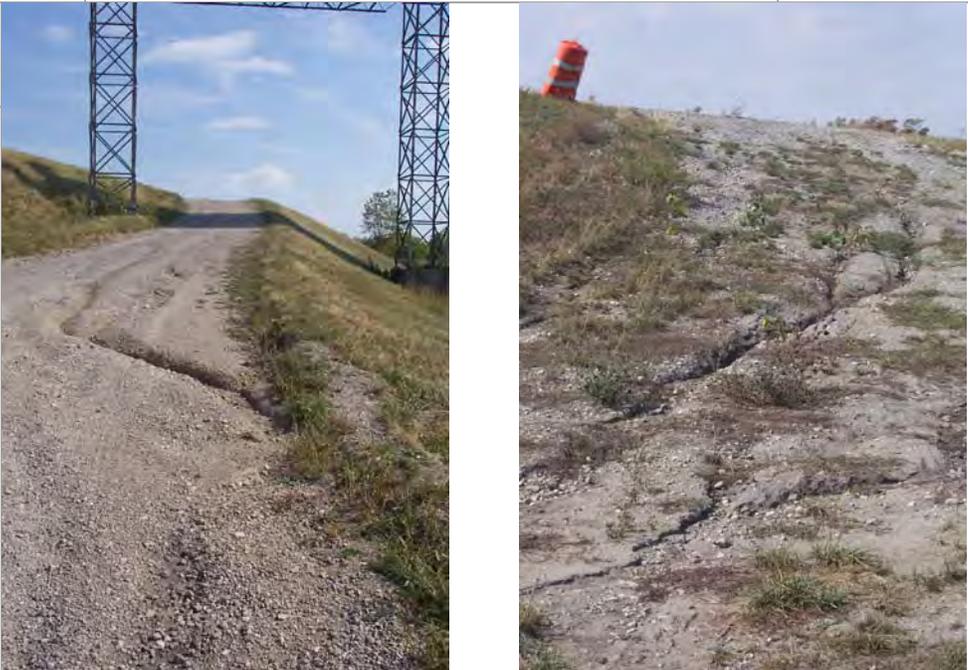
DESCRIPTION <u>Left photo</u> View looking east Minor erosion observed on access roadway at southwest corner of embankment <u>Right photo</u> View looking west Minor erosion observed on access roadway at southeast corner of embankment

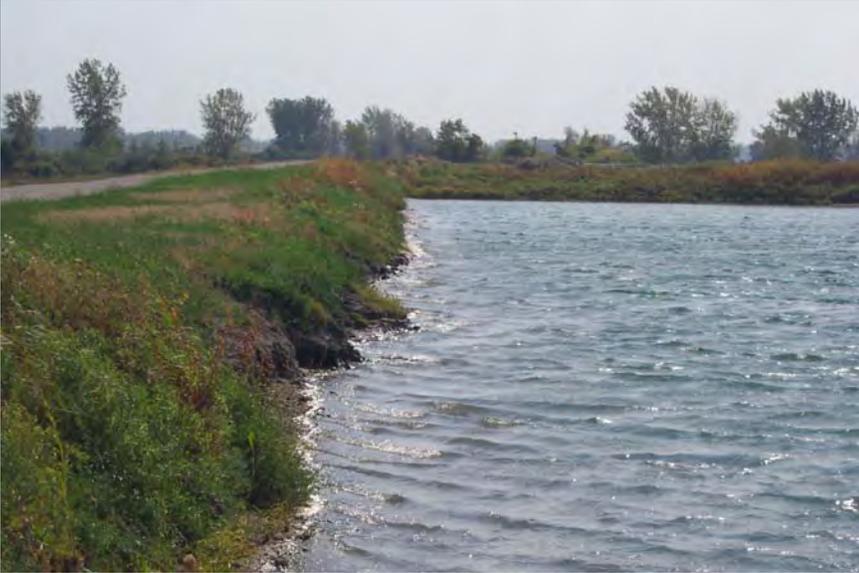
DESCRIPTION View looking south View long inboard side of east embankment Note minor scarping/wave eroded areas along water's edge
