**DRAFT REPORT
ROUND 7 DAM ASSESSMENT
CONSUMERS ENERGY COMPANY - D.E. KARN PLANT
1 & 2 SOLID WASTE DISPOSAL AREA
ESSEXVILLE, MICHIGAN**

January 12, 2011

**GZA GeoEnvironmental, Inc.
19500 Victor Parkway, Suite 300
Livonia, MI 48152
GZA File No. 01.0170142.20**

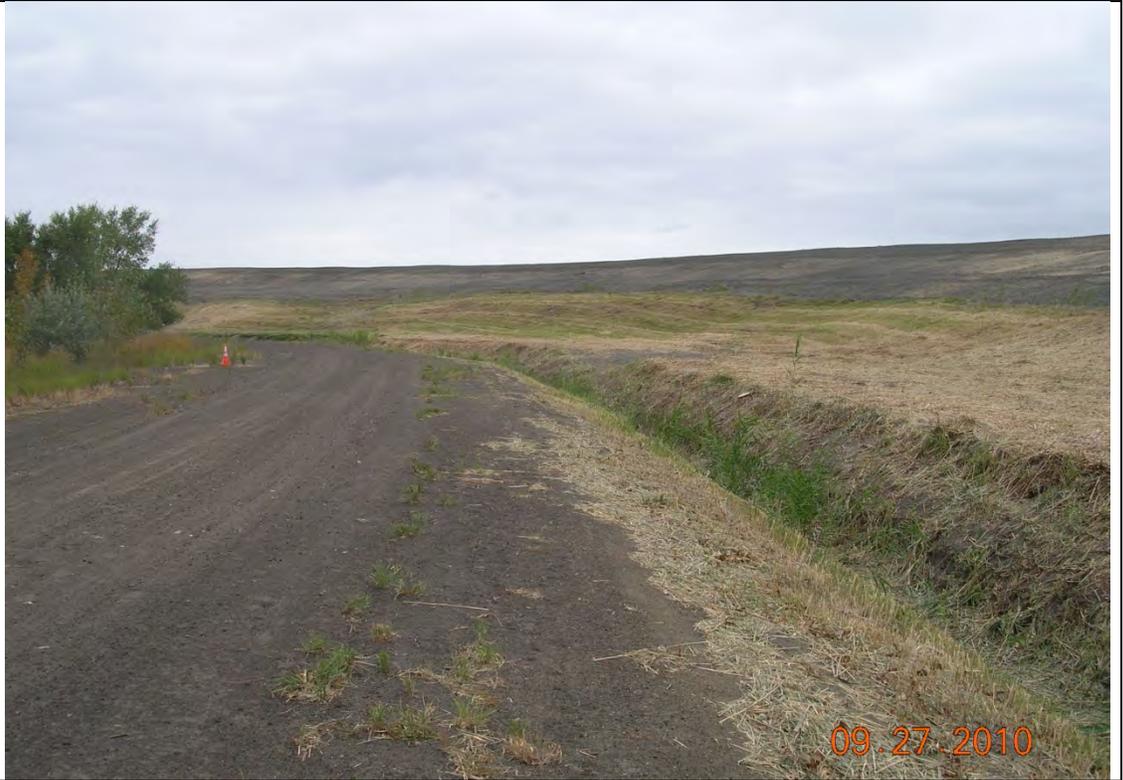
Description:
Toe of the inner slope of the dike, the stormwater collection ditch, and dry storage of compacted coal ash.

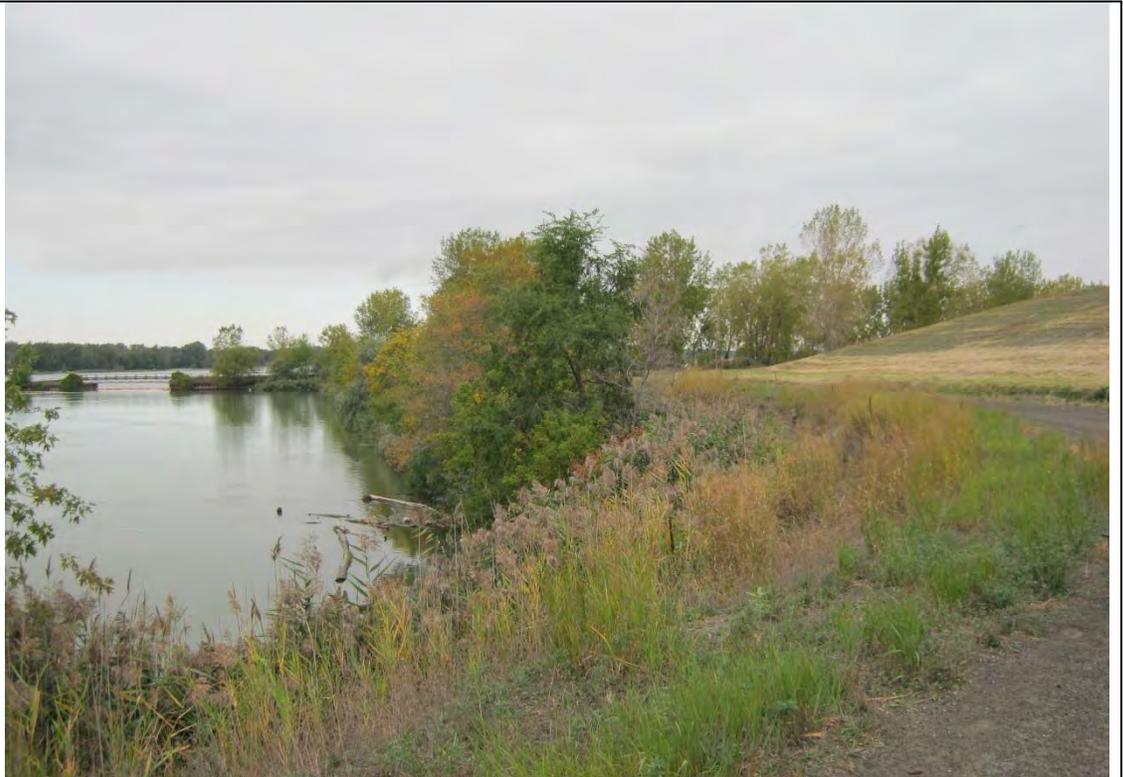
Photo No.
2

Description:
The dike abuts the D.E. Karn Plant's Intake Channel.

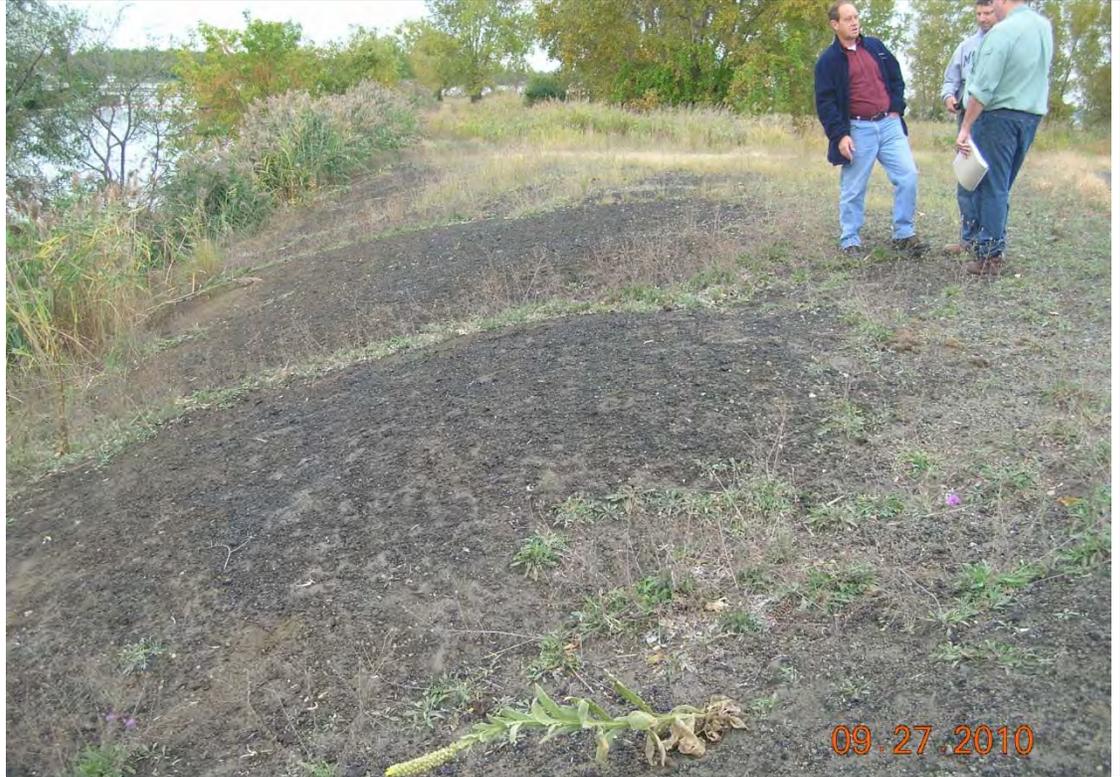
Description: Erosion channels in the dike near the Intake Channel.

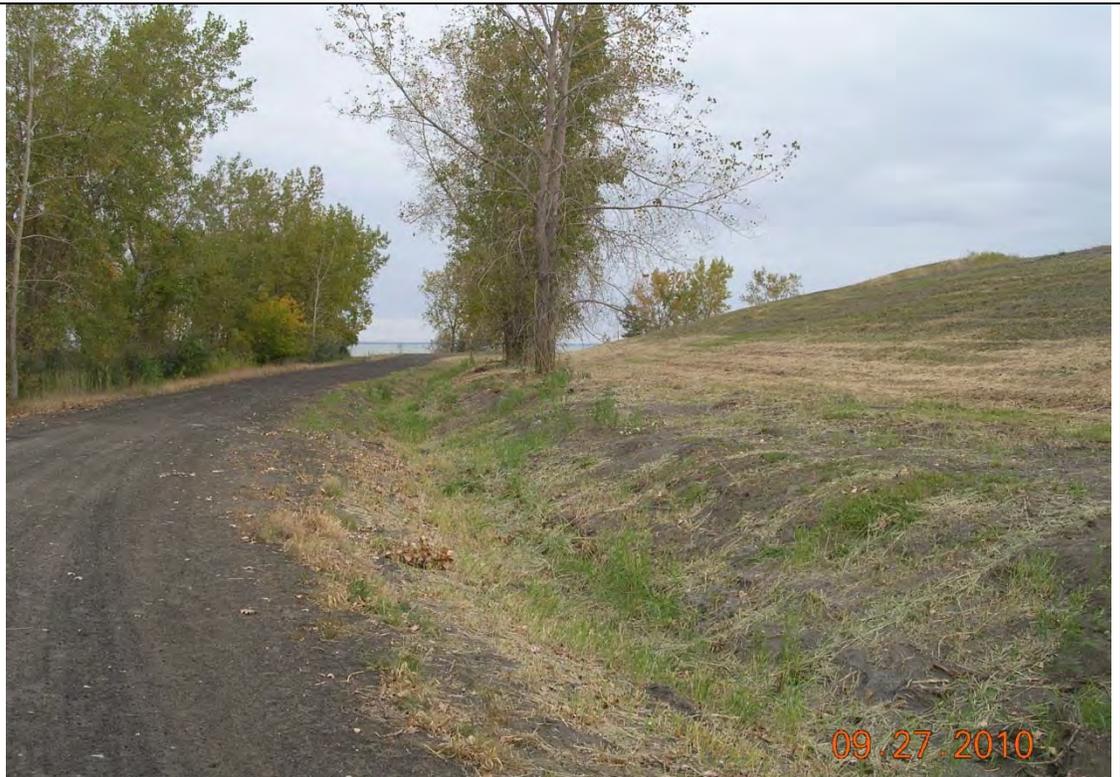
Photo No. 4

Description: The crest and inner slope of the dike near the northwestern portion of the impoundment. Note the trees growing on the exterior and interior slopes.

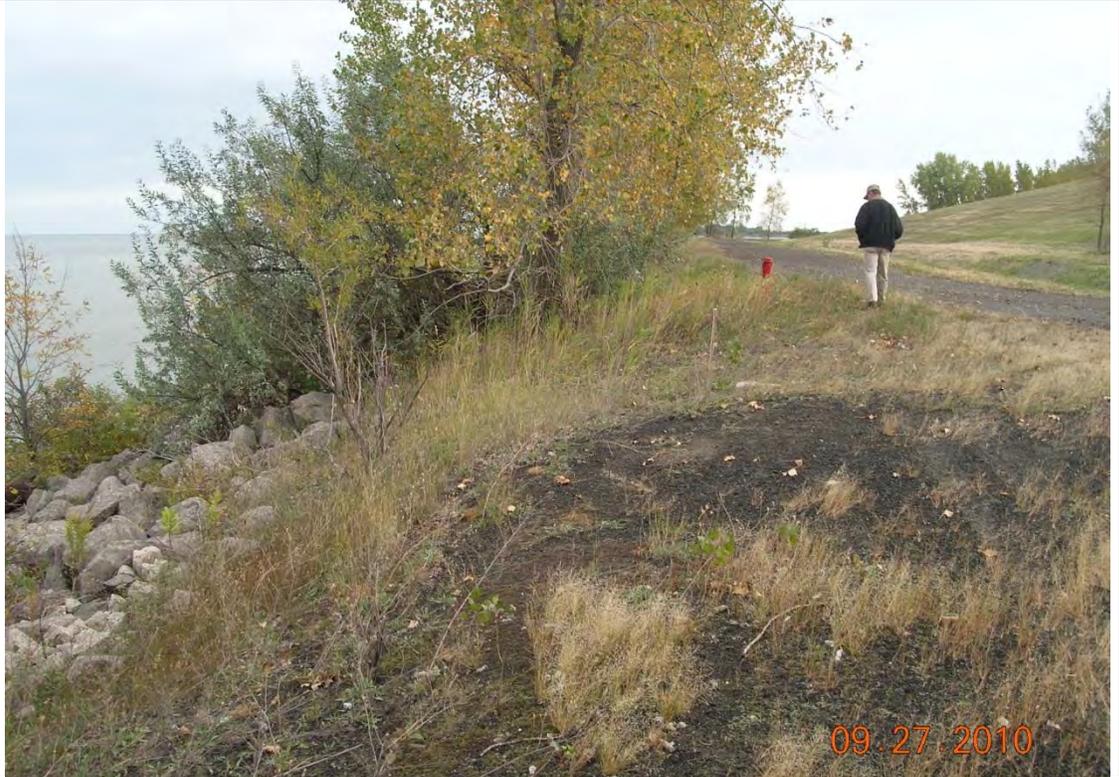
Description: Vegetation growing on the outer slope of the dike near the northwestern corner of the impoundment. Rip rap is also present at this location.

1. Clear vegetation, including small brush and grass, from the heavily vegetated areas to increase visibility of the slopes for monitoring purposes;
2. Develop a maintenance plan for monitoring of the large trees along the downstream slope. Trees that are damaged or uprooted by storm events should be removed and the dike area repaired;
3. Install riprap or other stabilizing material on the outer slope near the Intake Channel to reduce surface erosion. Similarly, CEC should consider flattening the dike slope along the Discharge Canal as recommended by AECOM; and,
4. Complete and/or analyze other embankment stability and seepage improvements recommended by AECOM.

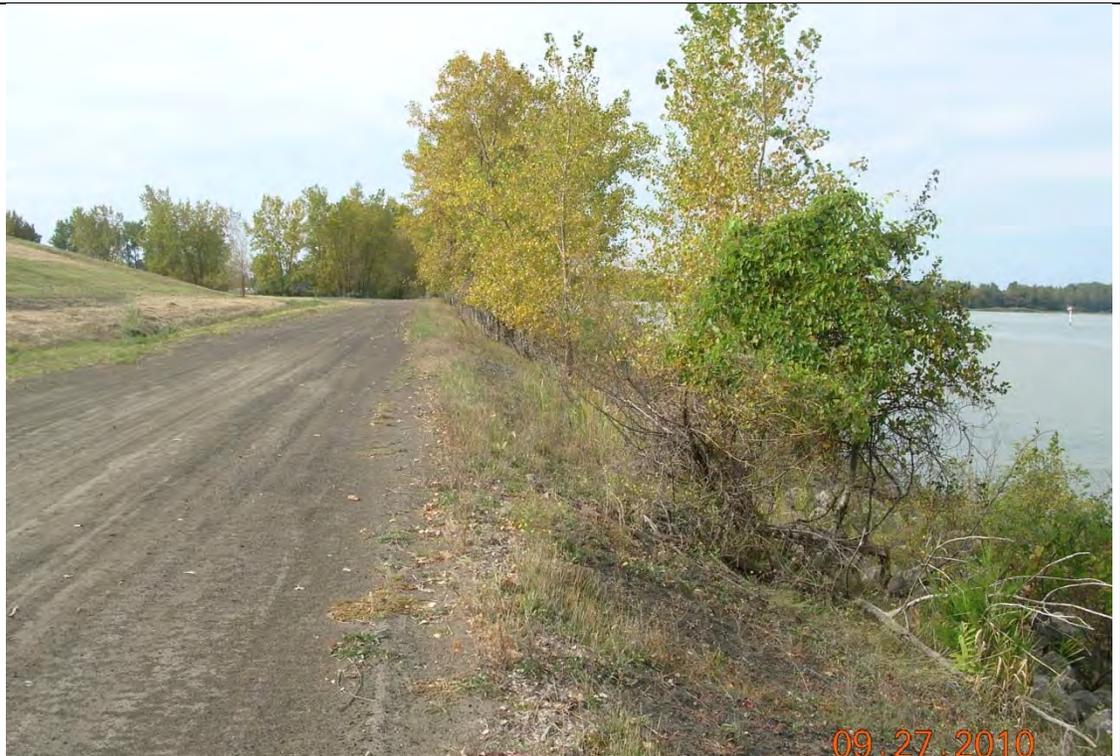
Description:
Crest and outer dike slope near the northwestern corner of the Karn Disposal Area.

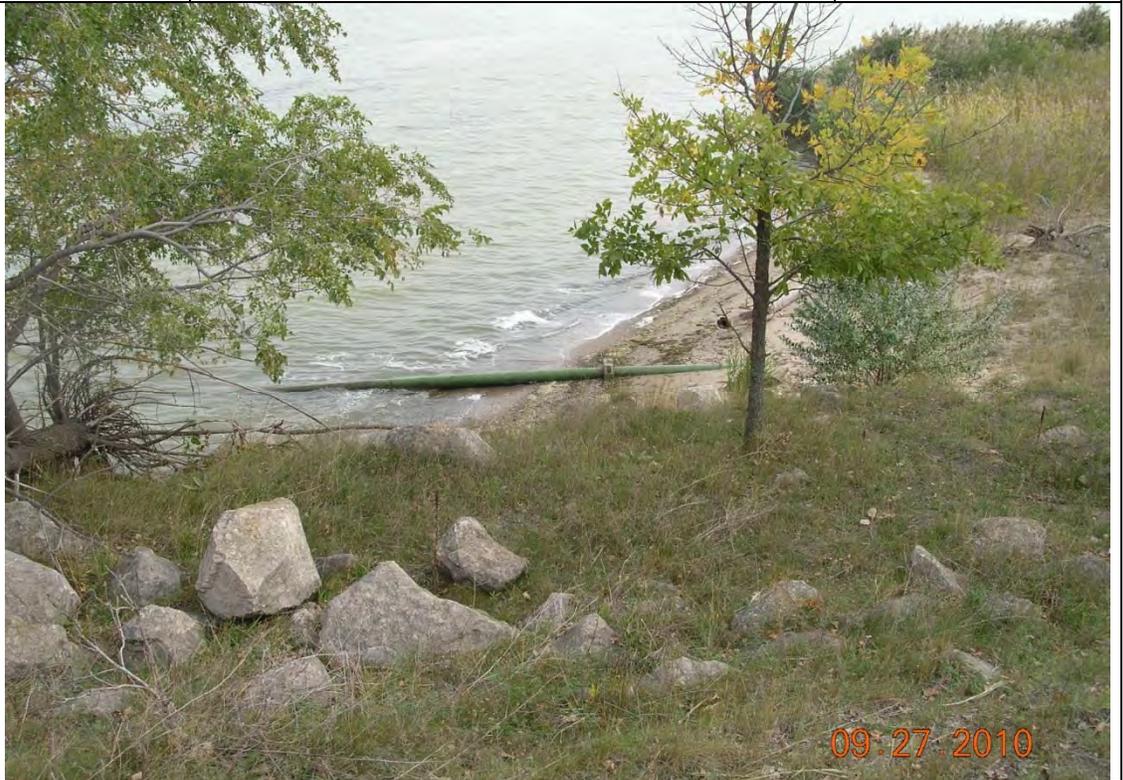
Description: Pipe of unknown origin or purpose that does not appear to penetrate the dike.

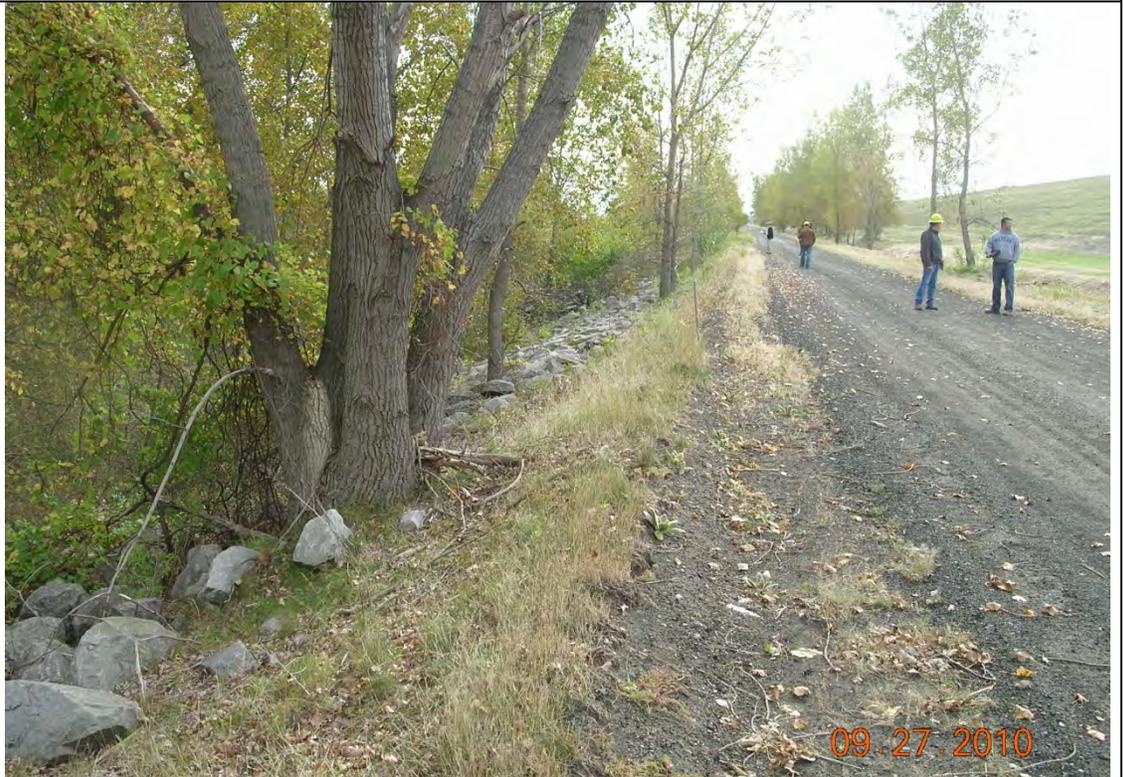
Photo No. 10

Description: Vegetation and rip rap along the outer slope of the dike.

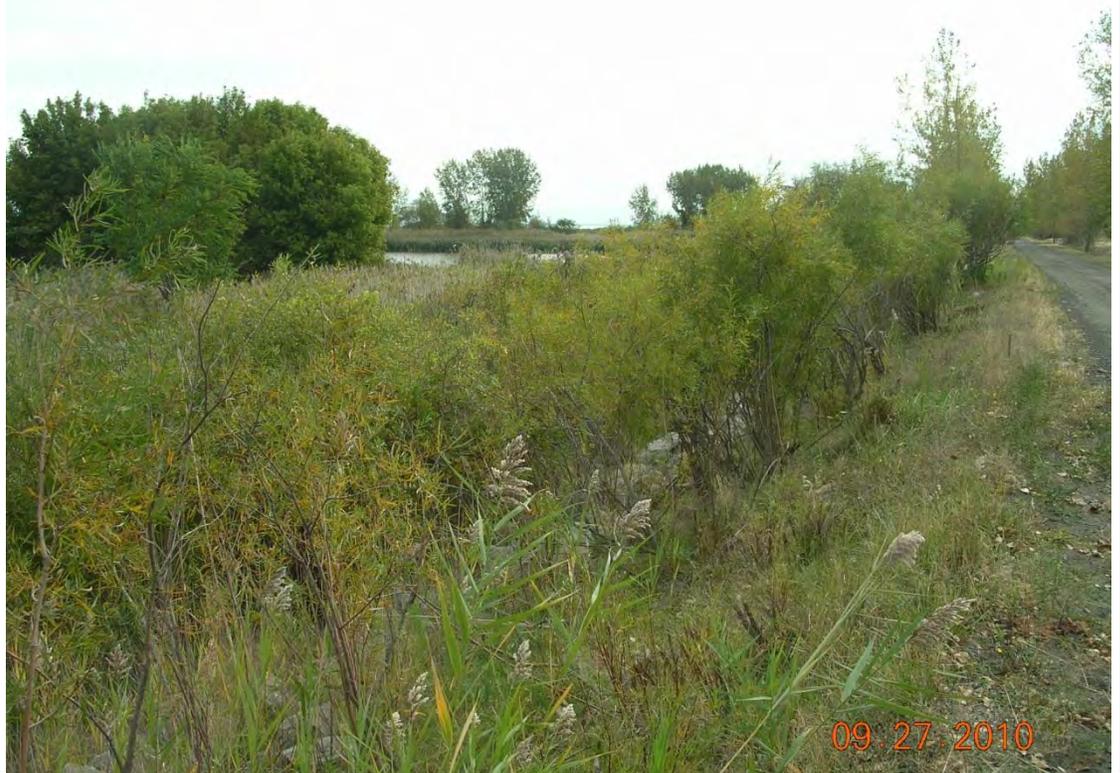
Description:
Vegetation on the outer slope of the dike.

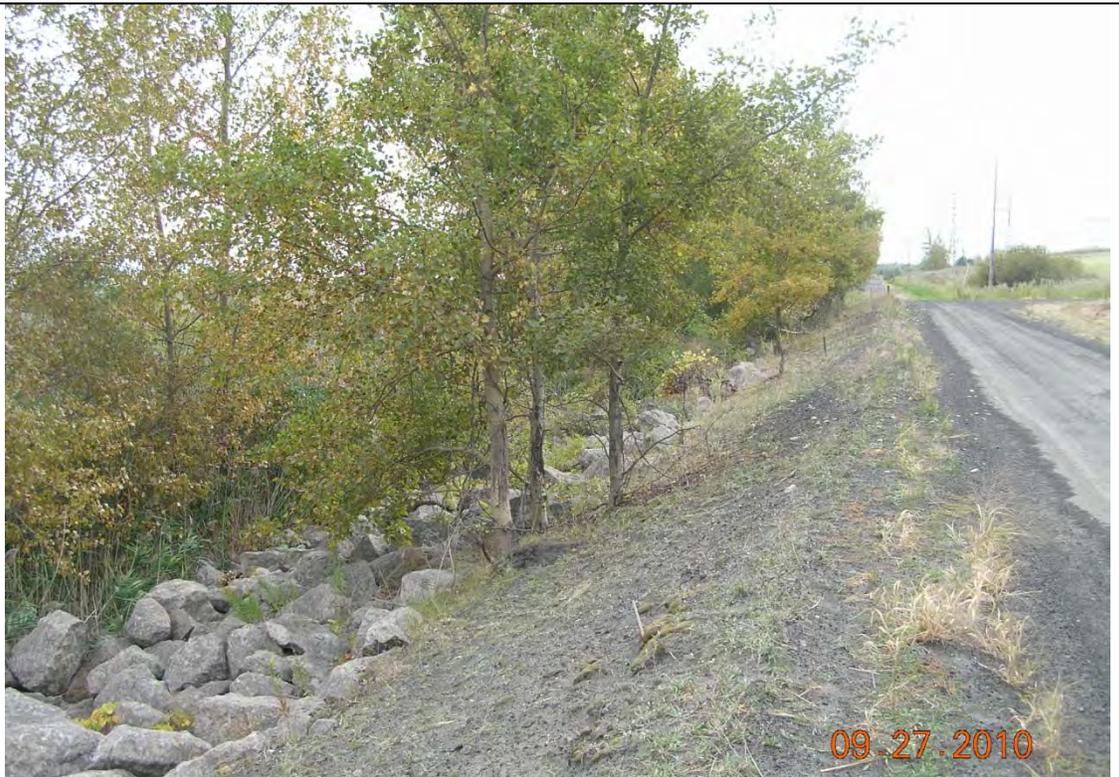
Photo No. 16

Vegetation and rip rap on the outer slope of the dike. Note the bottom ash that was used to build up the crest.

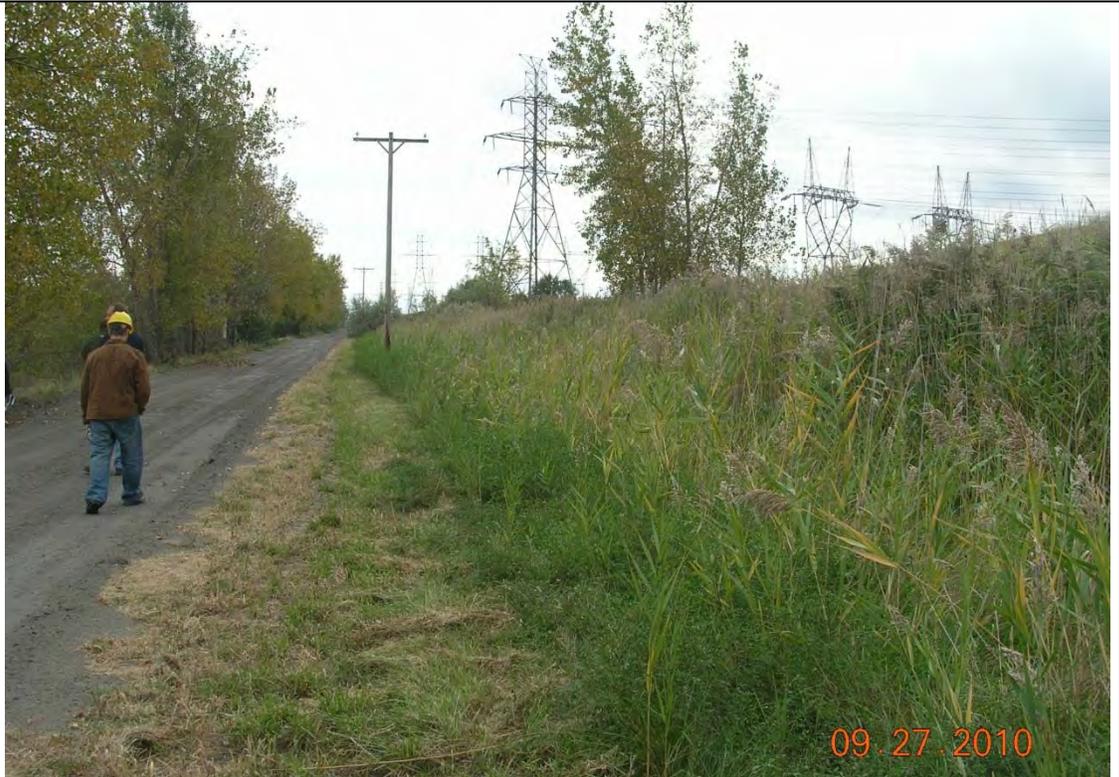
Photo No. 18

Description: Vegetation on the inner dike slope in the storm water drainage ditch.

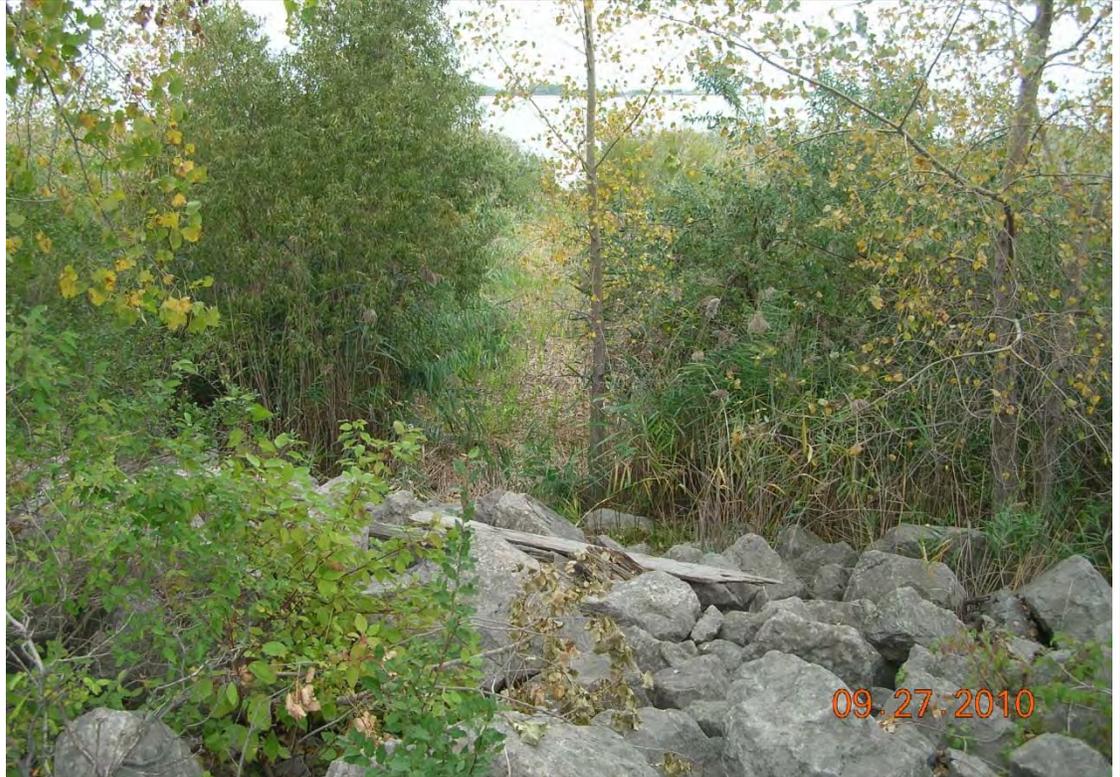
Description: Drift wood on top of the outer dike slope, indicating that the water level in Lake Huron has been as high as the rip rap.

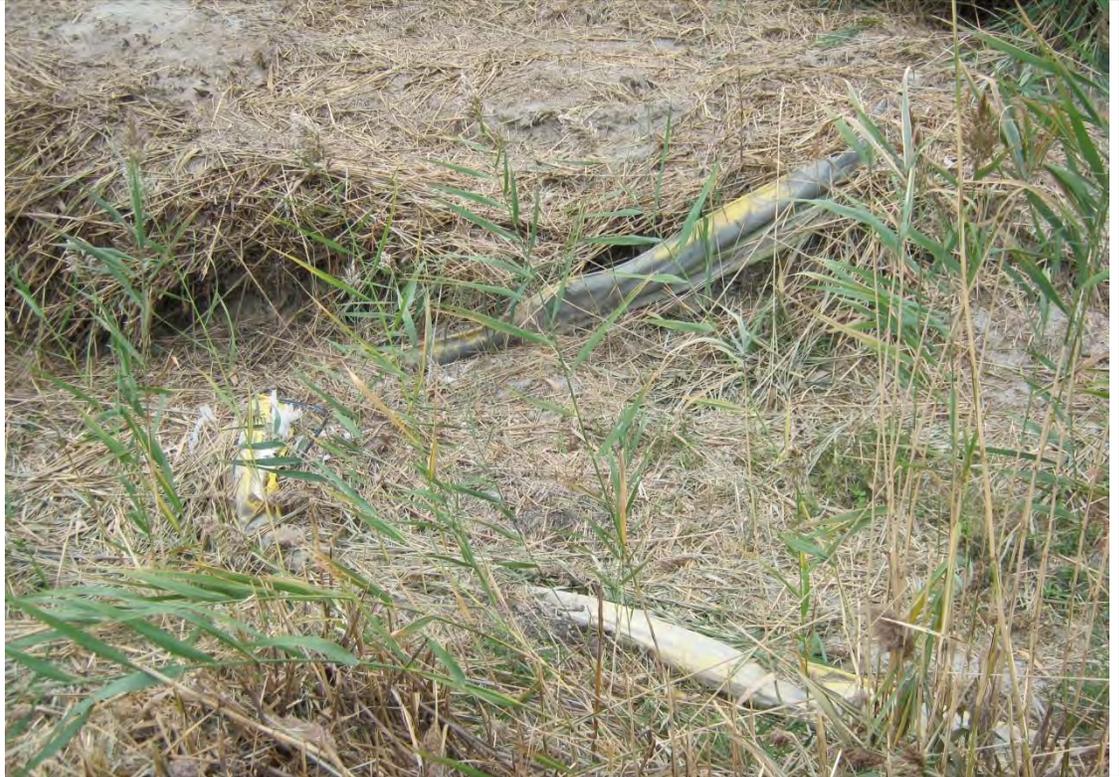
Description: Trash in the stormwater drainage ditch.

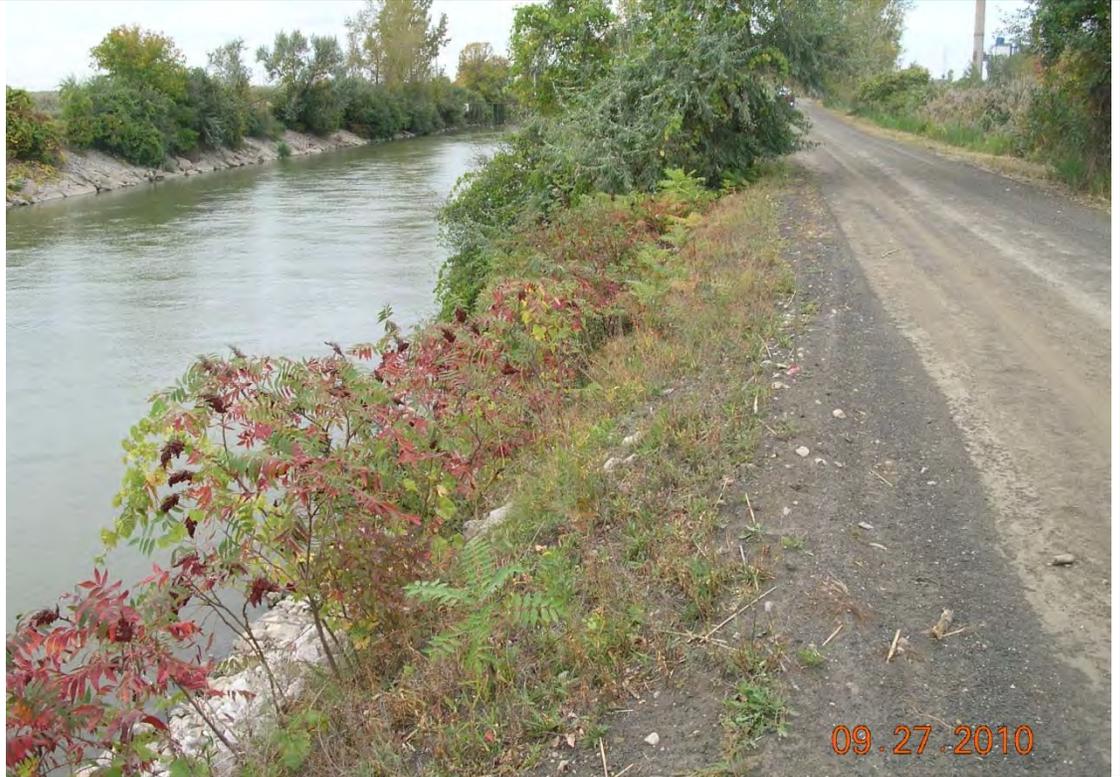
Description: Vegetation and rip rap on the outer dike slope at the Discharge Canal.

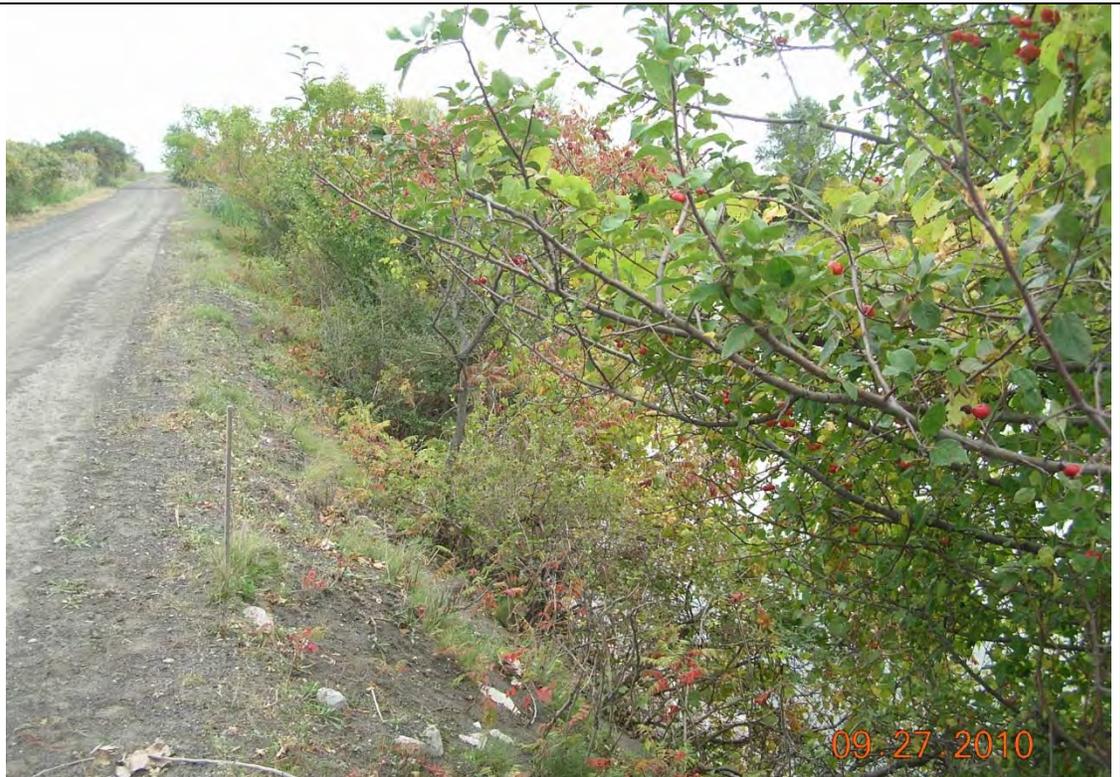
Photo No. 28

Description: Vegetation on the outer dike slope at the Discharge Canal.

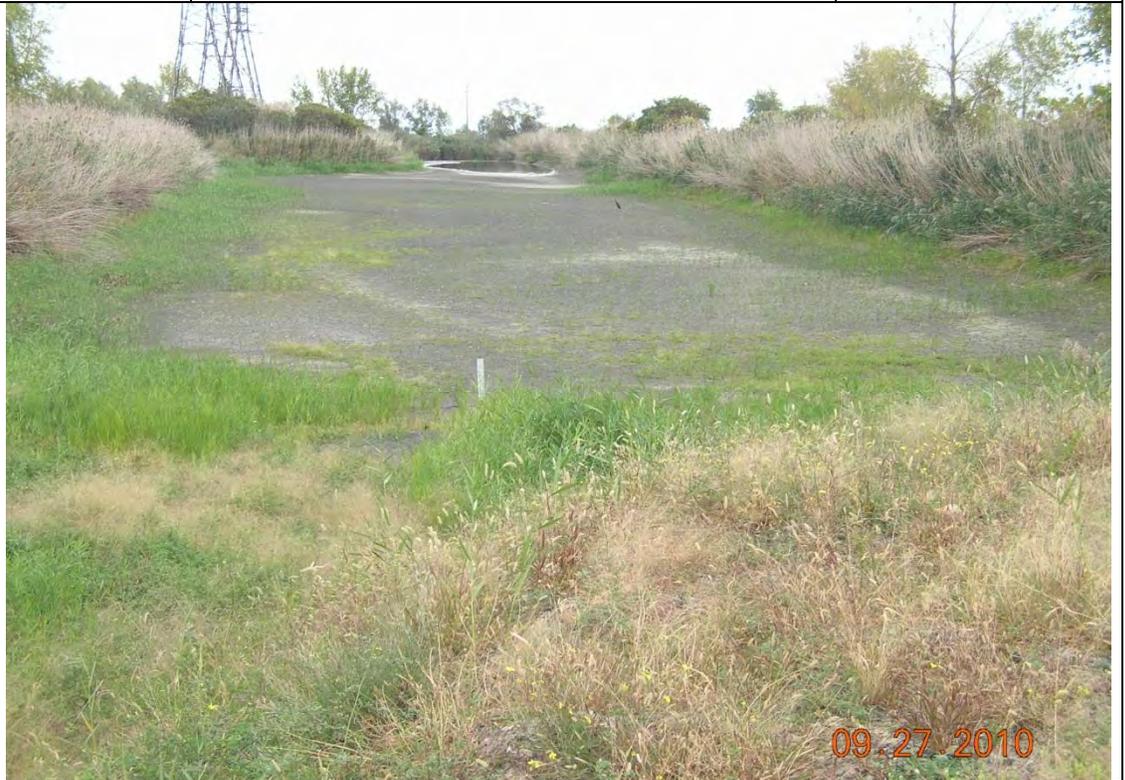
Description: Pond E has been significantly drained within the last year.

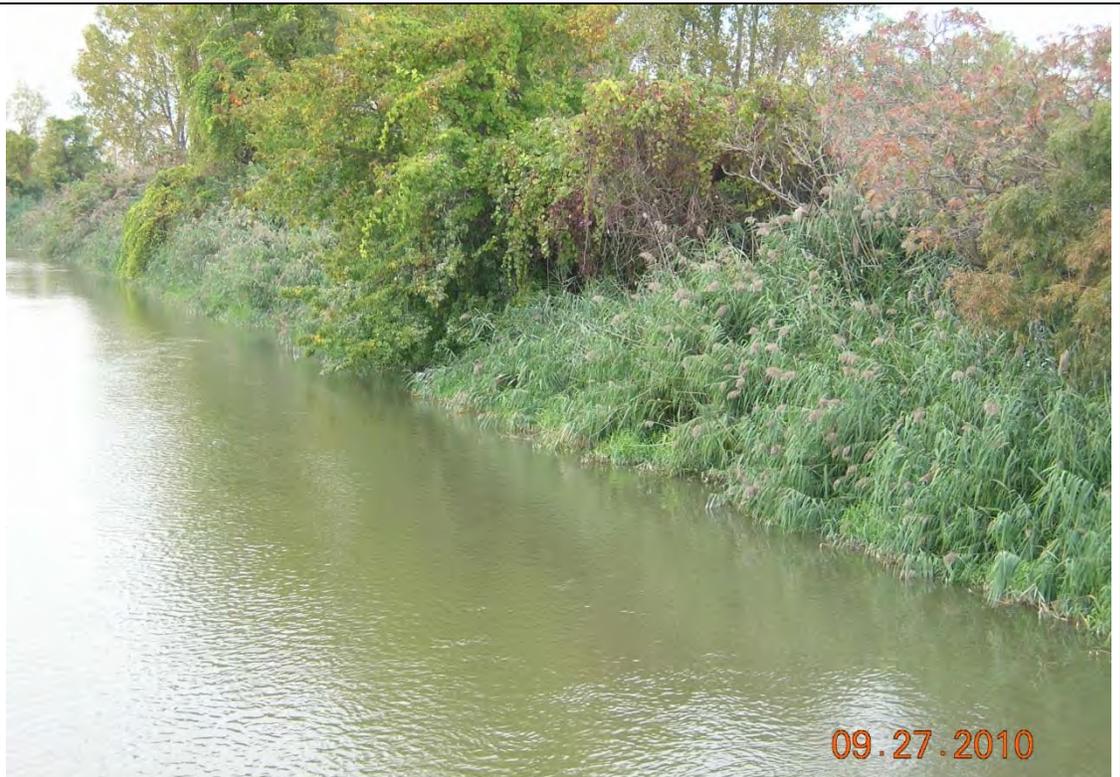
Description:
Vegetation growing on the outer dike slope at the Discharge Canal.
