**FINAL REPORT
ROUND 7 DAM ASSESSMENT
CONSUMERS ENERGY COMPANY - D.E. KARN PLANT
1 & 2 SOLID WASTE DISPOSAL AREA
ESSEXVILLE, MICHIGAN**

June 30, 2011

**GZA GeoEnvironmental, Inc.
19500 Victor Parkway, Suite 300
Livonia, MI 48152
GZA File No. 01.0170142.20**

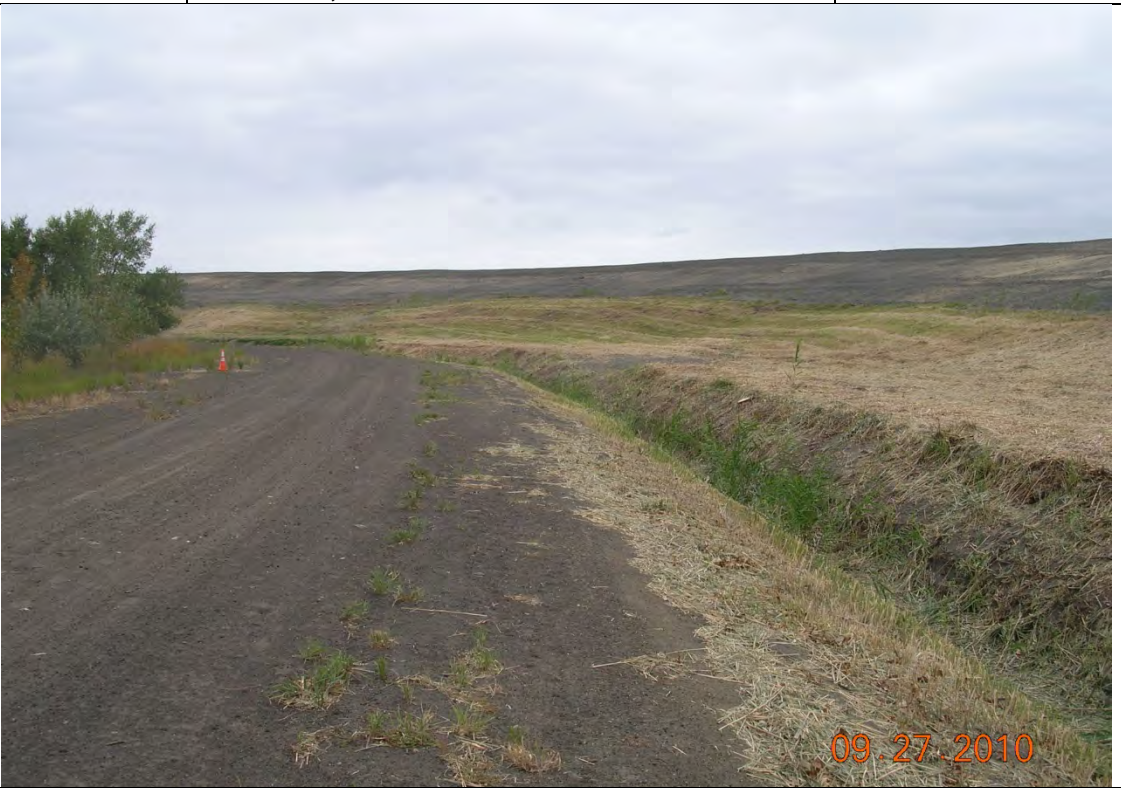
Description:
Toe of the inner slope of the dike, the stormwater collection ditch, and dry storage of compacted coal ash.

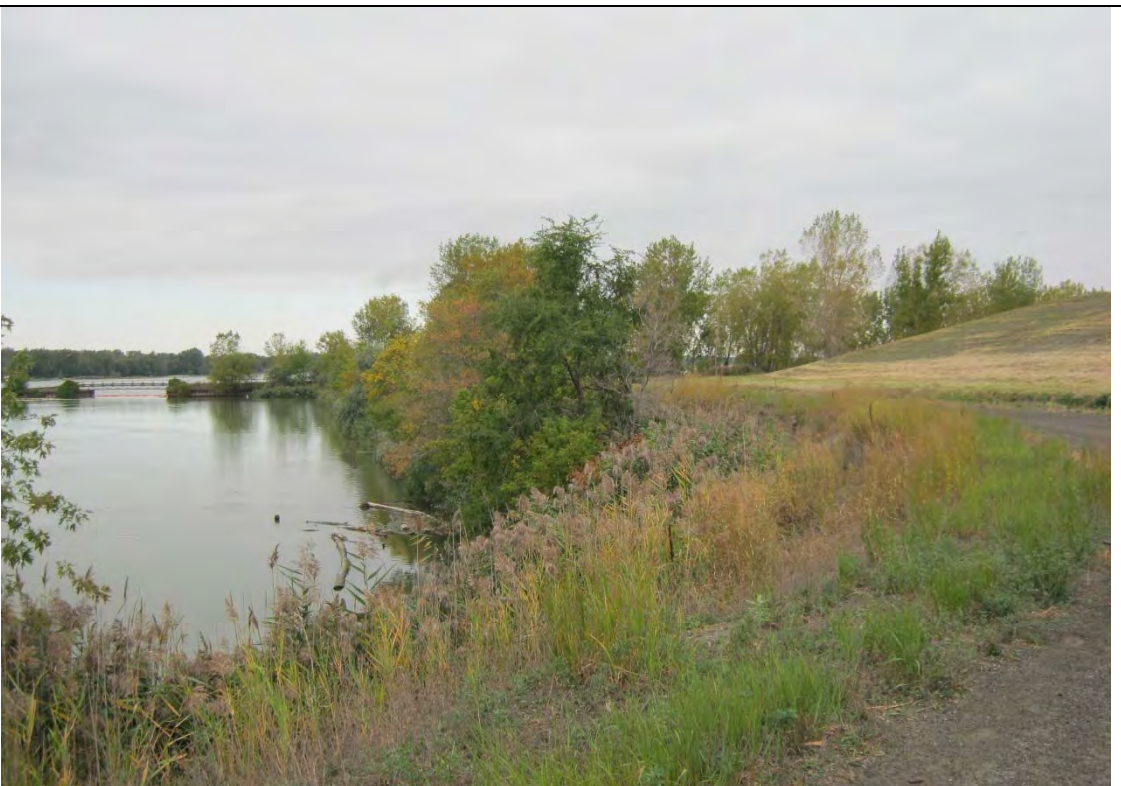
Description:
The dike abuts the D.E. Karn Plant's Intake Channel.

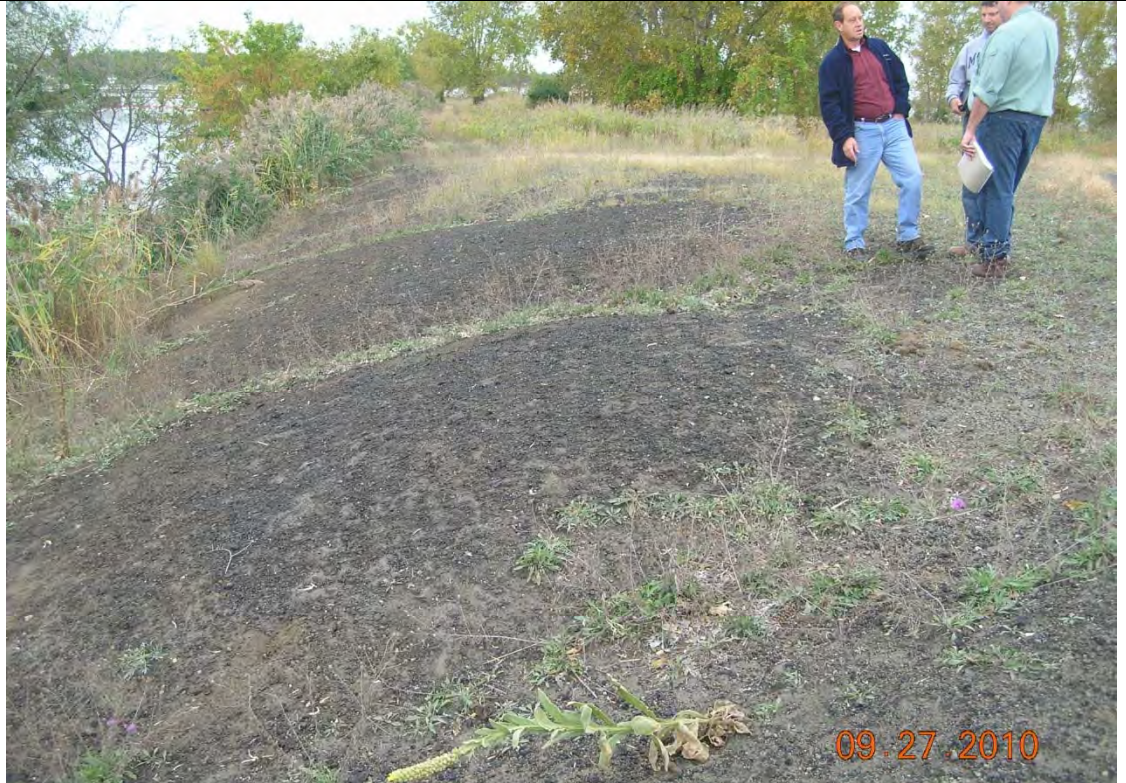
Description: Erosion channels in the dike near the Intake Channel.

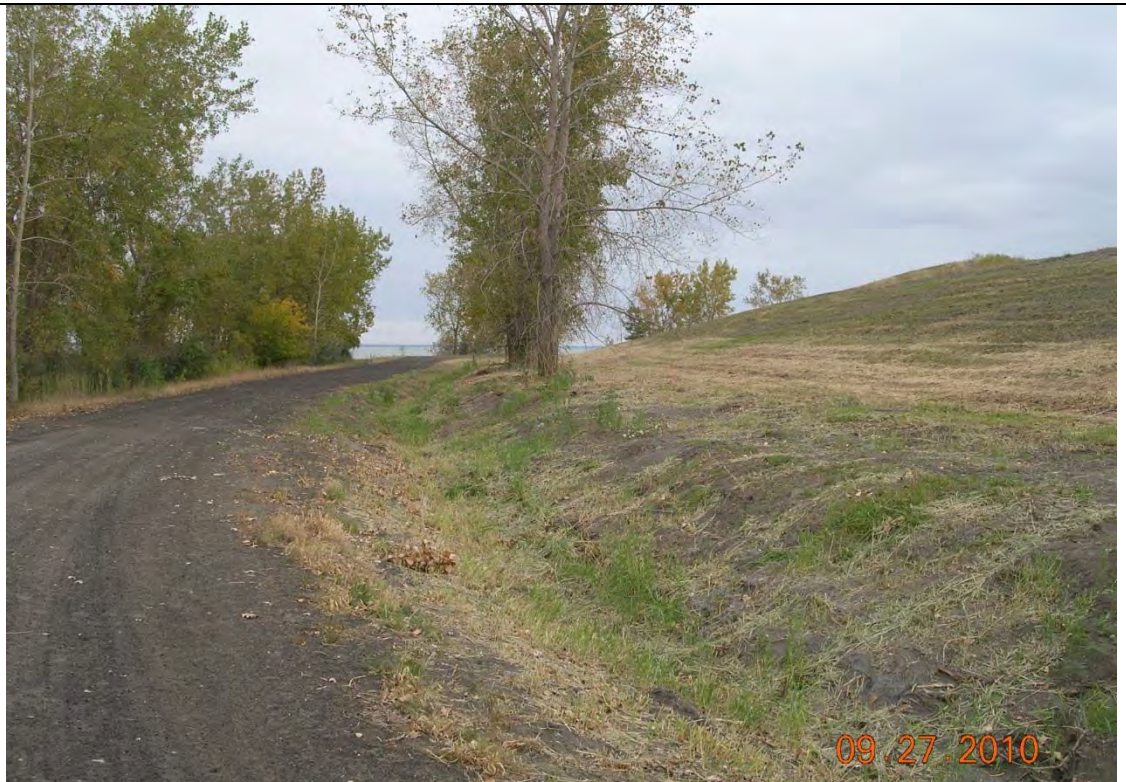
Photo No. 4

Description: The crest and inner slope of the dike near the northwestern portion of the impoundment. Note the trees growing on the exterior and interior slopes.

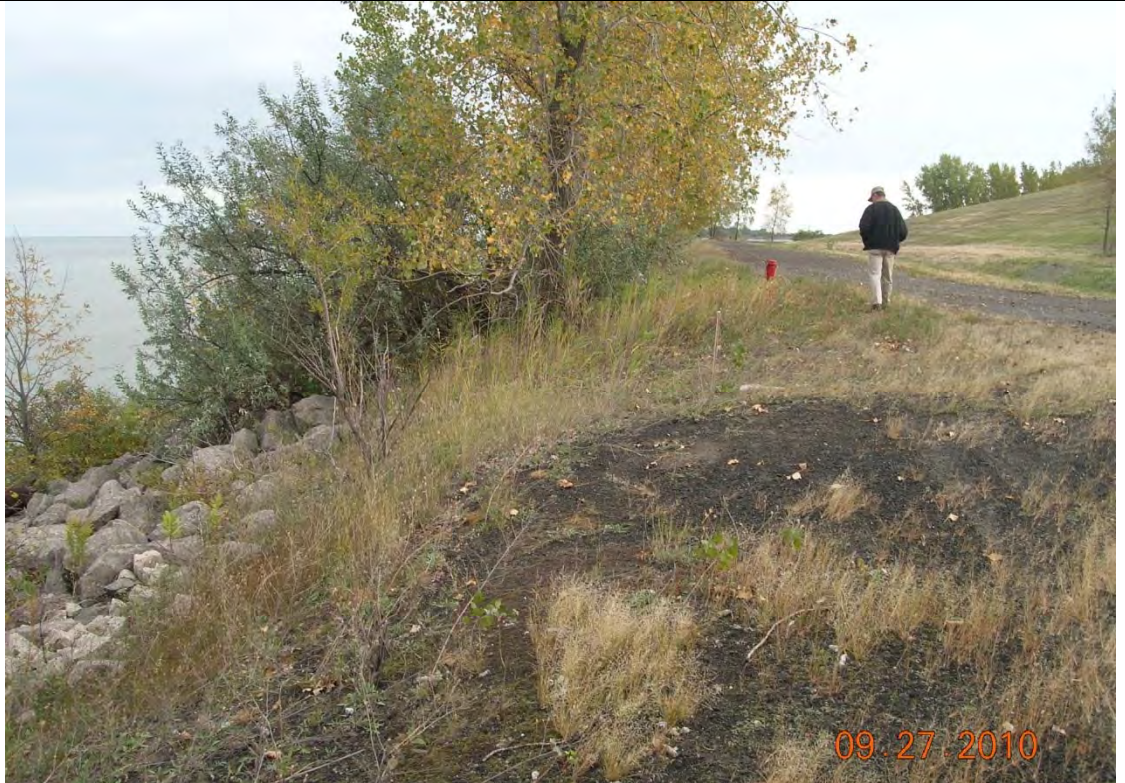
Description: Vegetation growing on the outer slope of the dike near the northwestern corner of the impoundment. Rip rap is also present at this location.

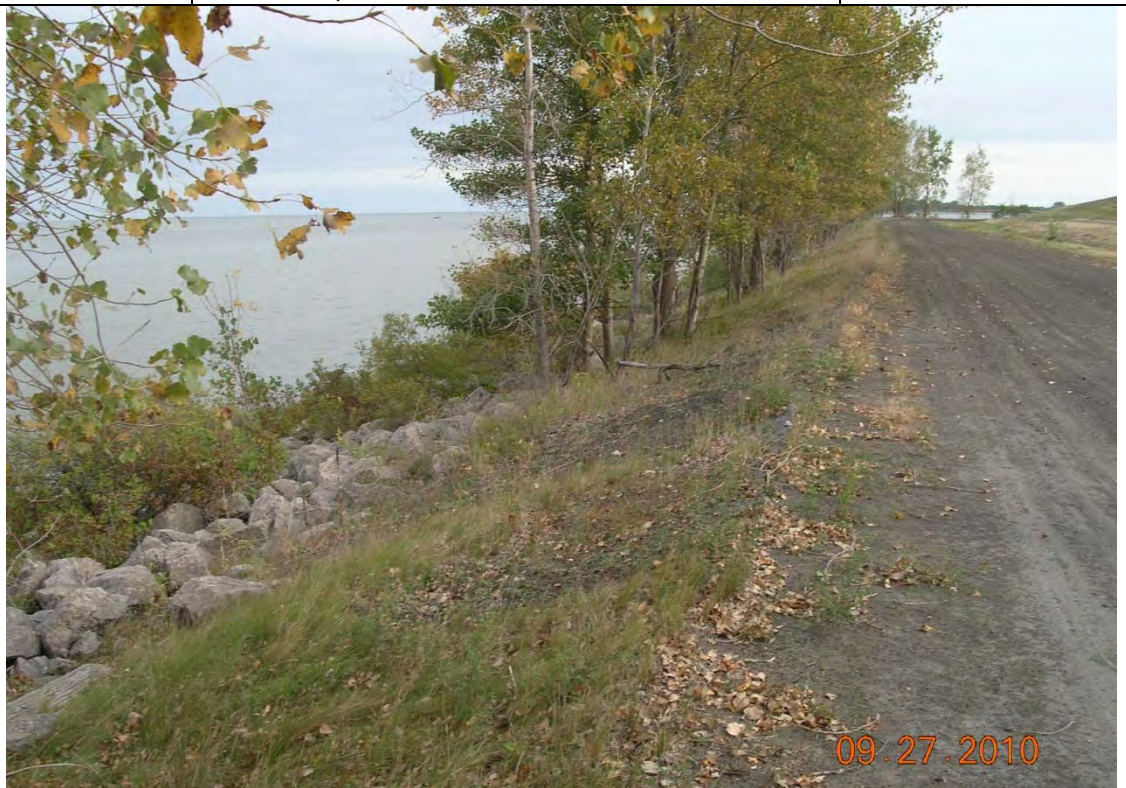
Description:
Rip rap and trees on the outer dike slope. Saginaw Bay abuts the dike at this location.

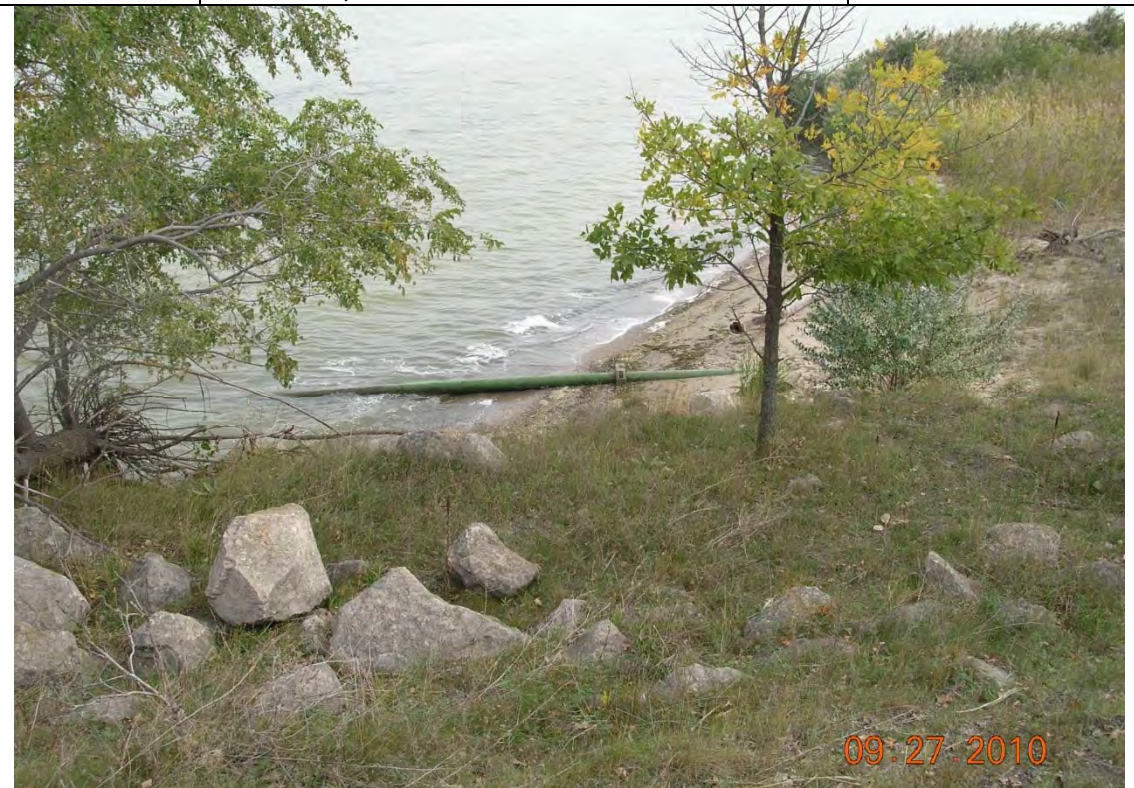
Description:
 Pipe of unknown origin or purpose that does not appear to penetrate the dike.

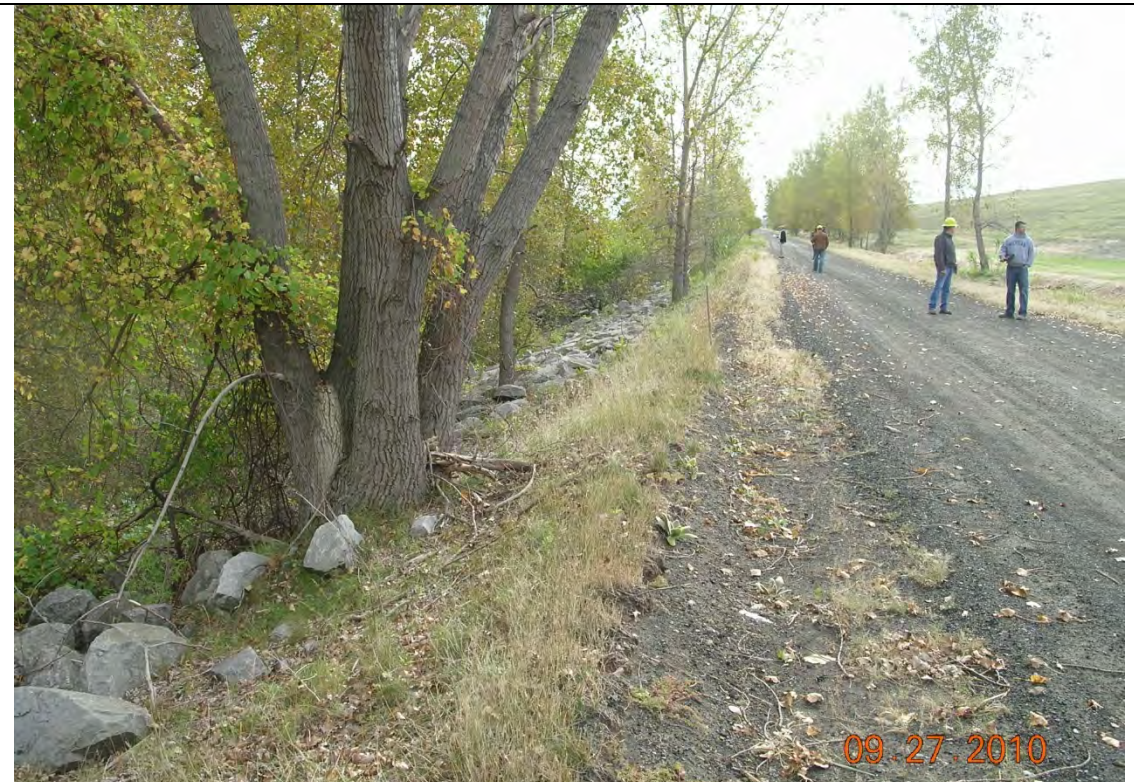
Description:
 Vegetation and rip rap along the outer slope of the dike.

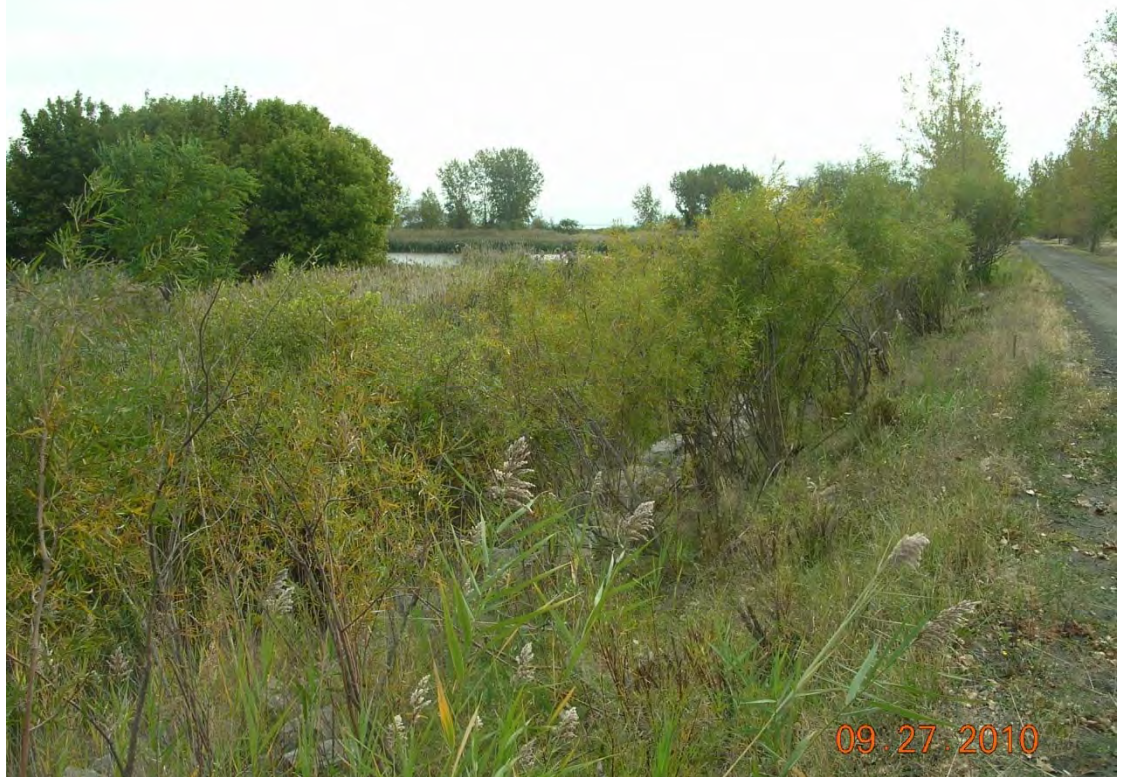
Description: Vegetation on the outer slope of the dike.

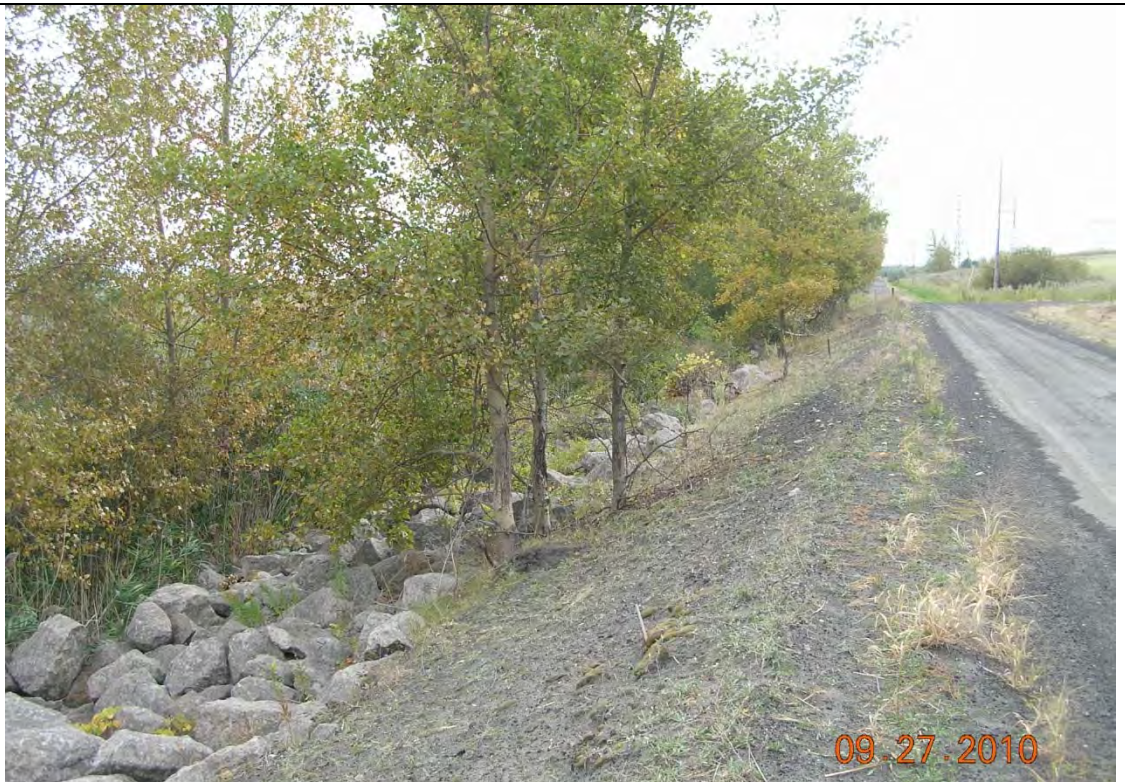
Photo No.
16

Description:
Vegetation and rip rap on the outer slope of the dike. Note the bottom ash that was used to build up the crest.

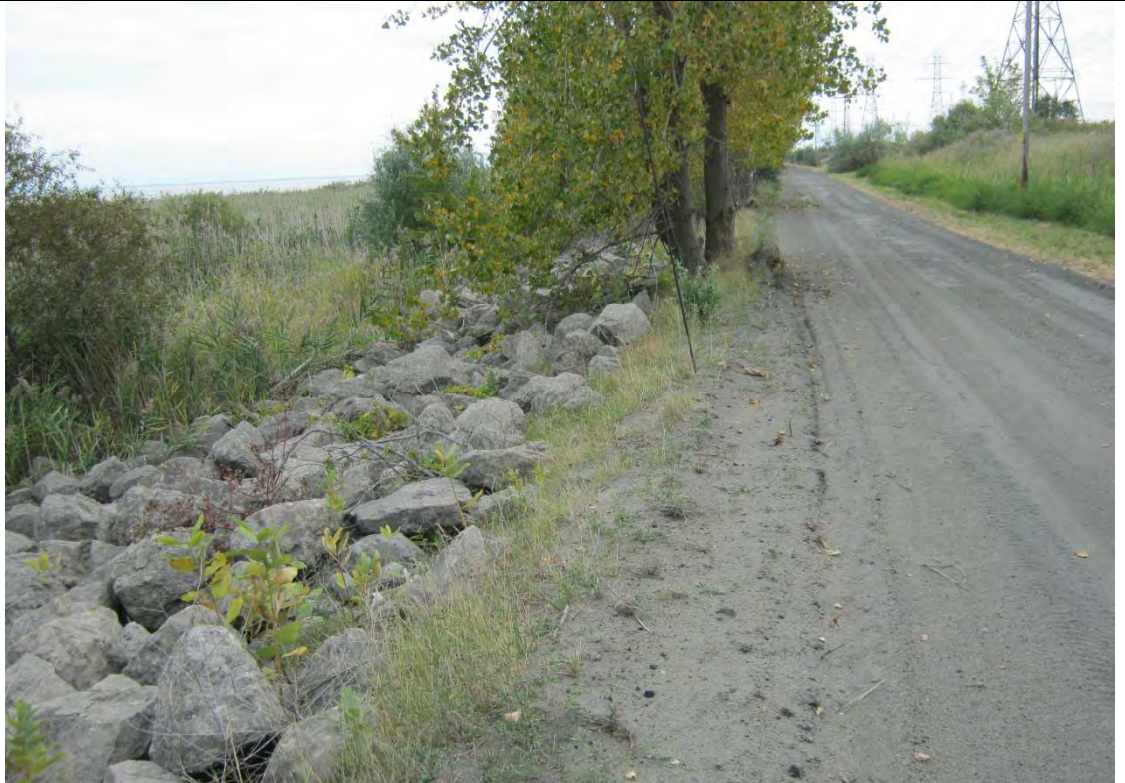
Description: Rip rap and vegetation on the outer dike slope.

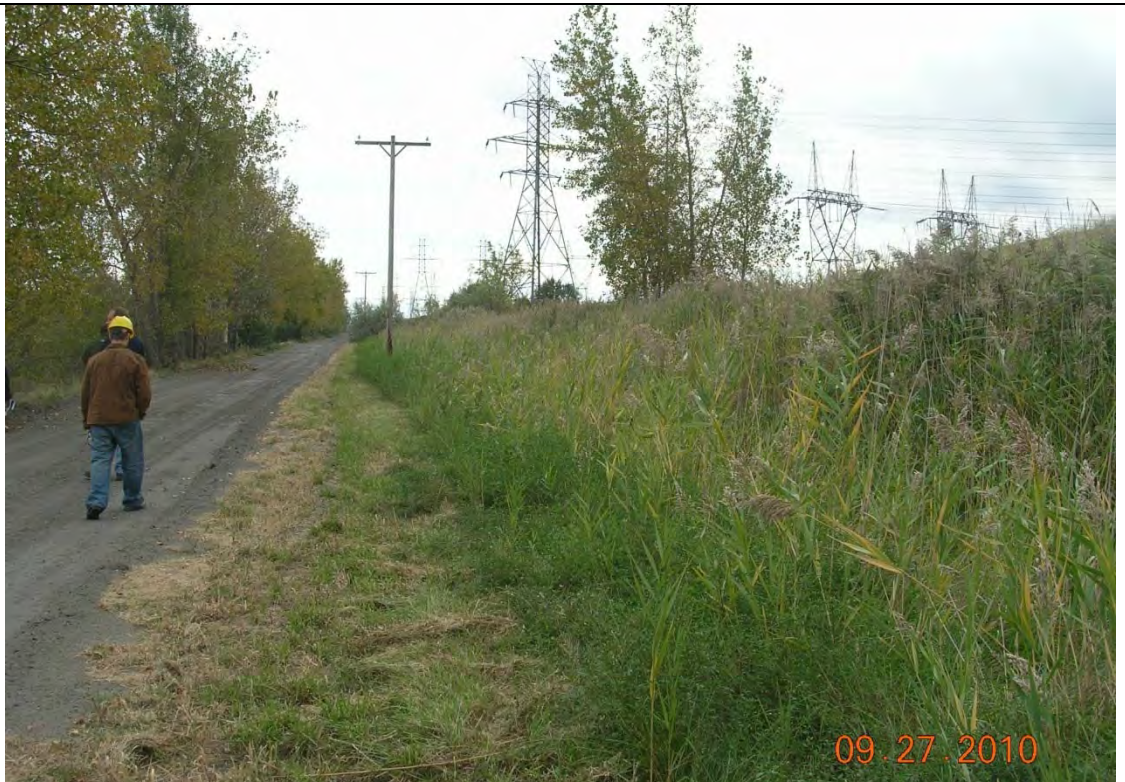
Photo No. 18

Description: Vegetation on the inner dike slope in the storm water drainage ditch.

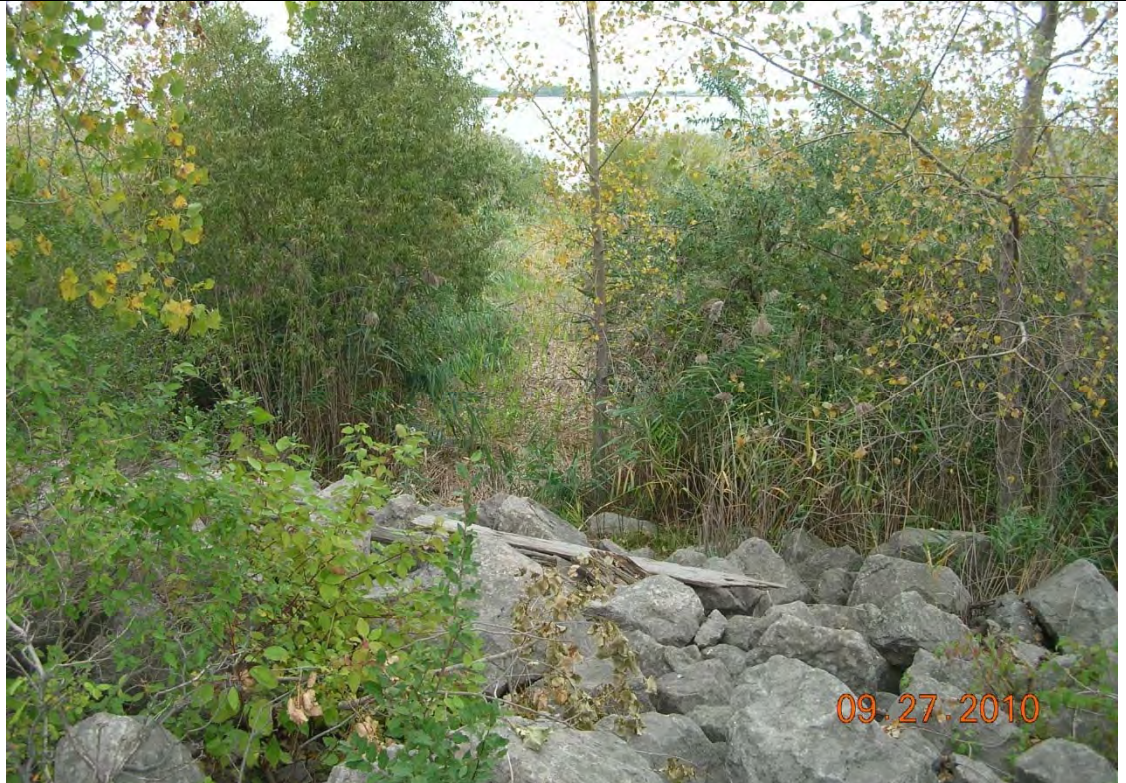
Description: Drift wood on top of the outer dike slope, indicating that the water level in Lake Huron has been as high as the rip rap.

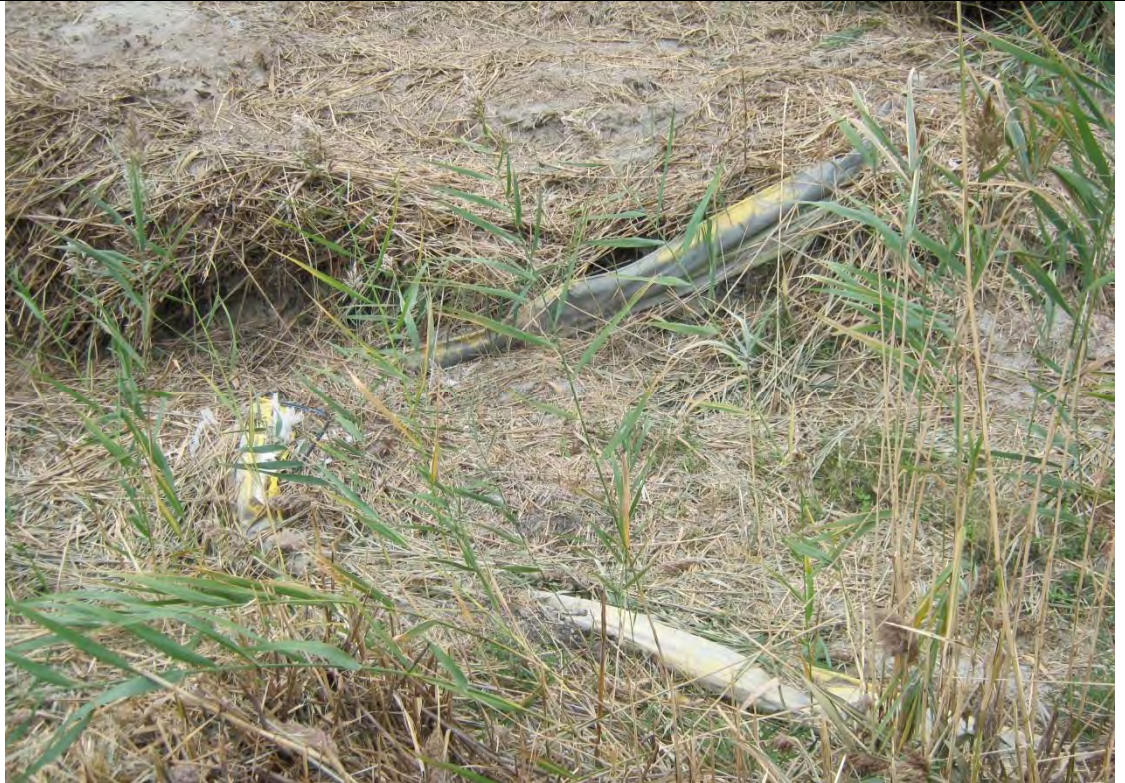
Description: Trash in the stormwater drainage ditch.

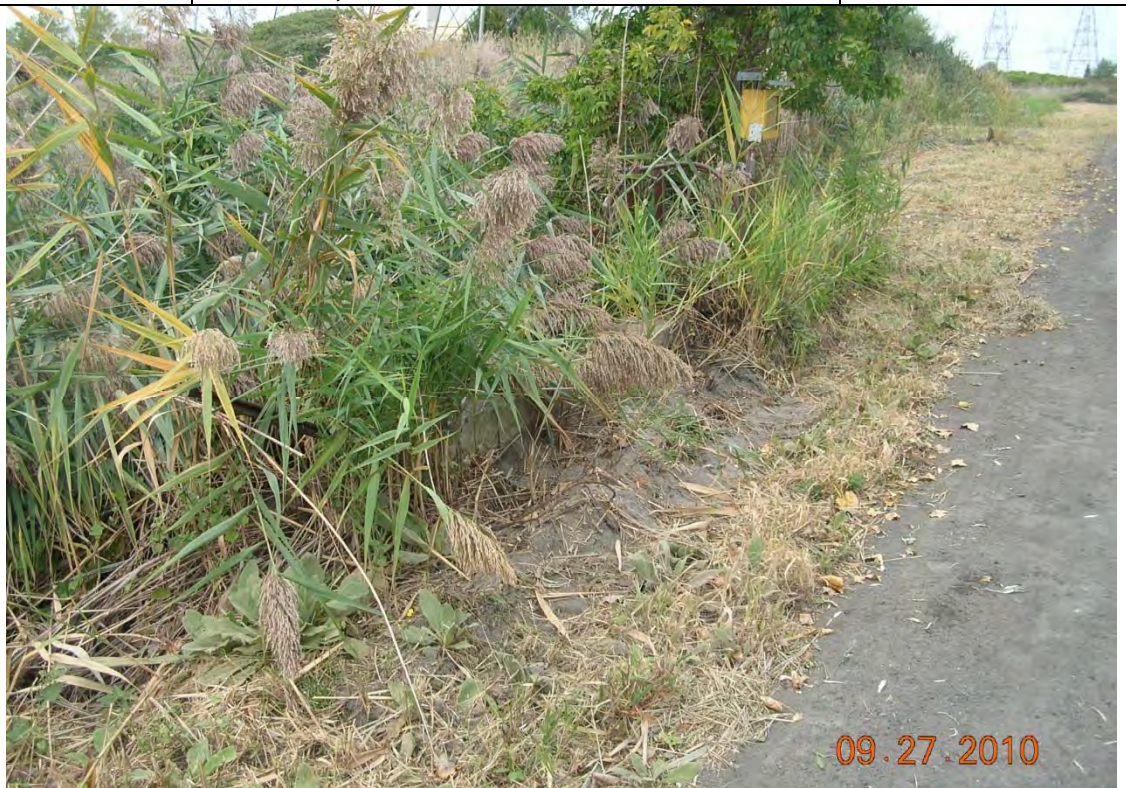
Description:
The former NPDES discharge outlet equipment is still in place.

1. Remove the former NPDES discharge structure, including excavating and removing the former pipes, and replace with compacted fill.

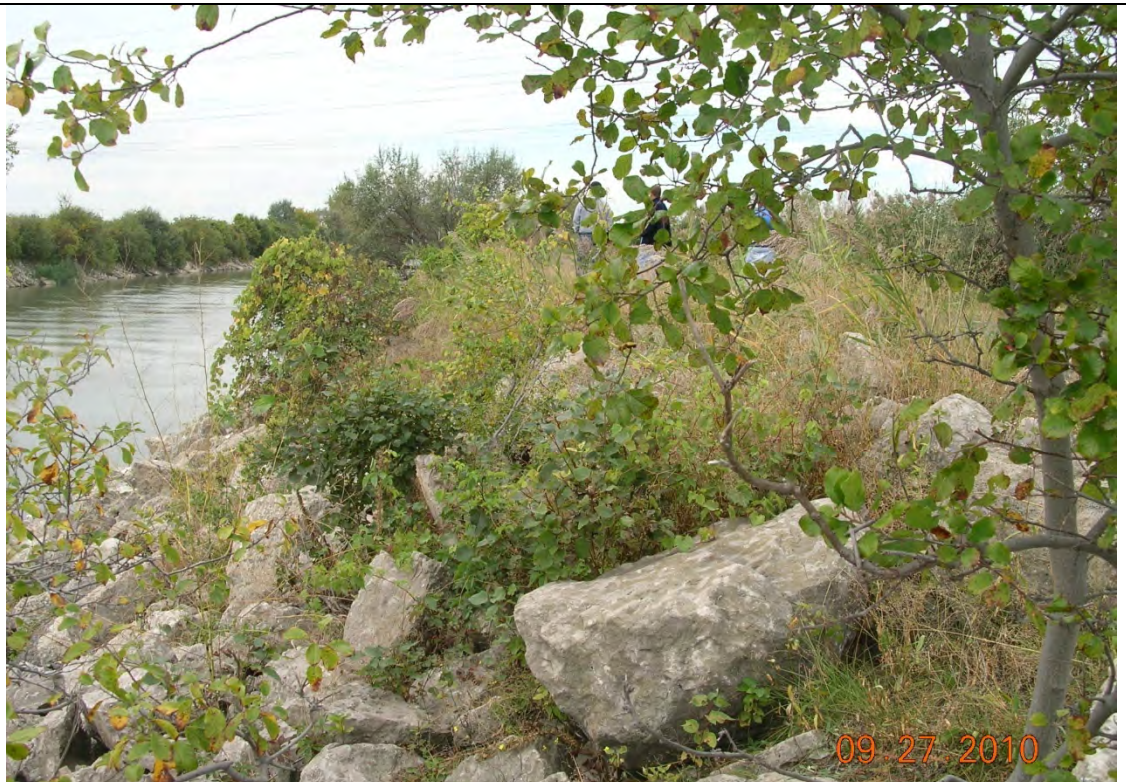
Description:
Vegetation and rip rap on the outer dike slope at the Discharge Canal.

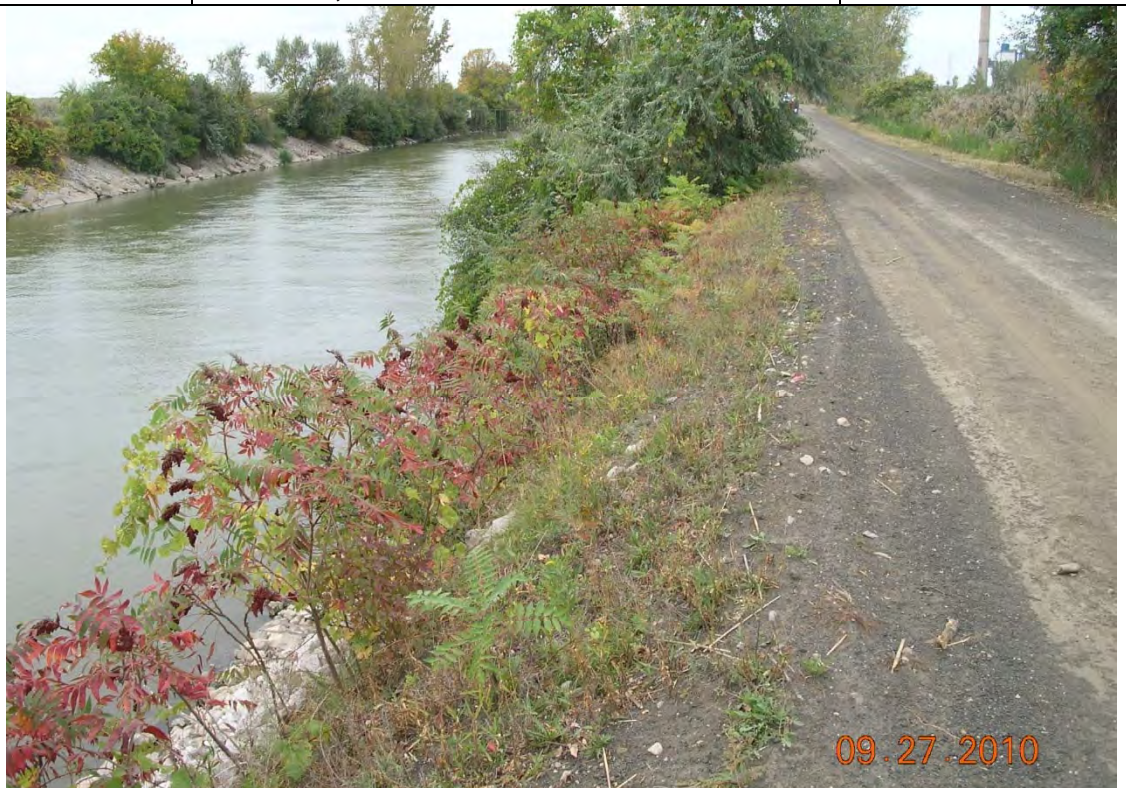
Description:
Vegetation and rip rap on the outer dike slope at the Discharge Canal.

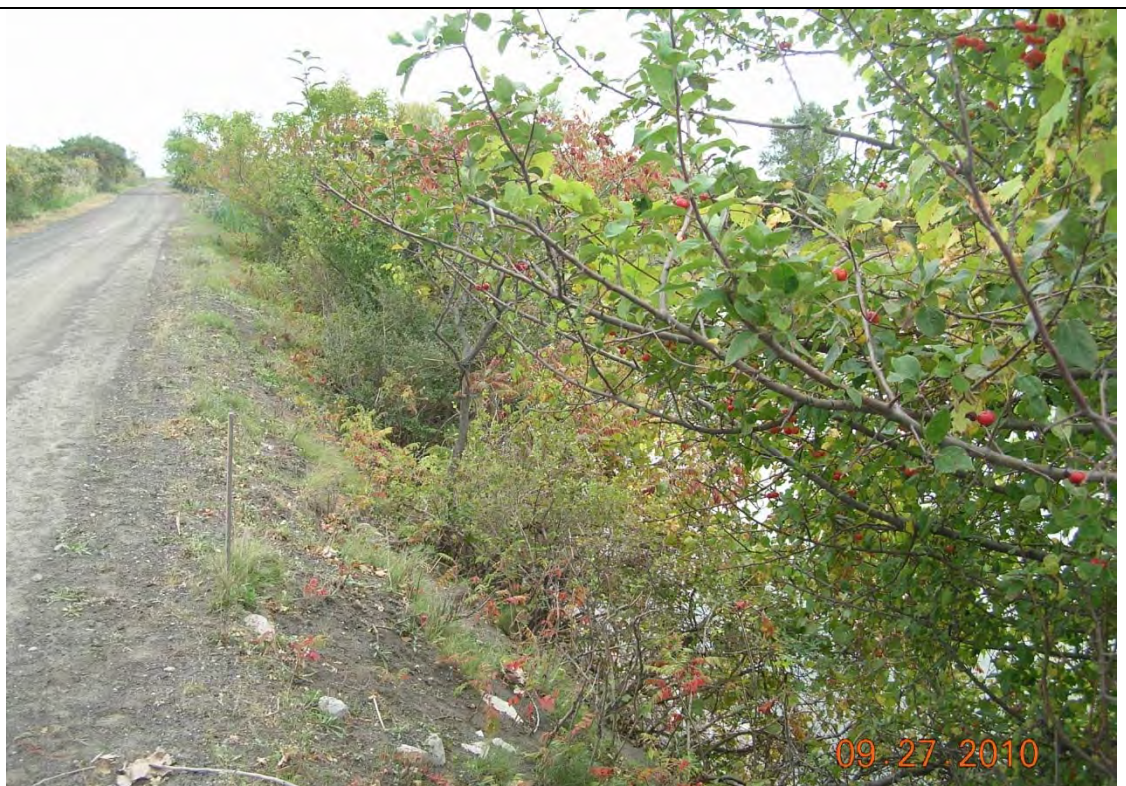
Description:
Vegetation on the outer dike slope at the Discharge Canal.

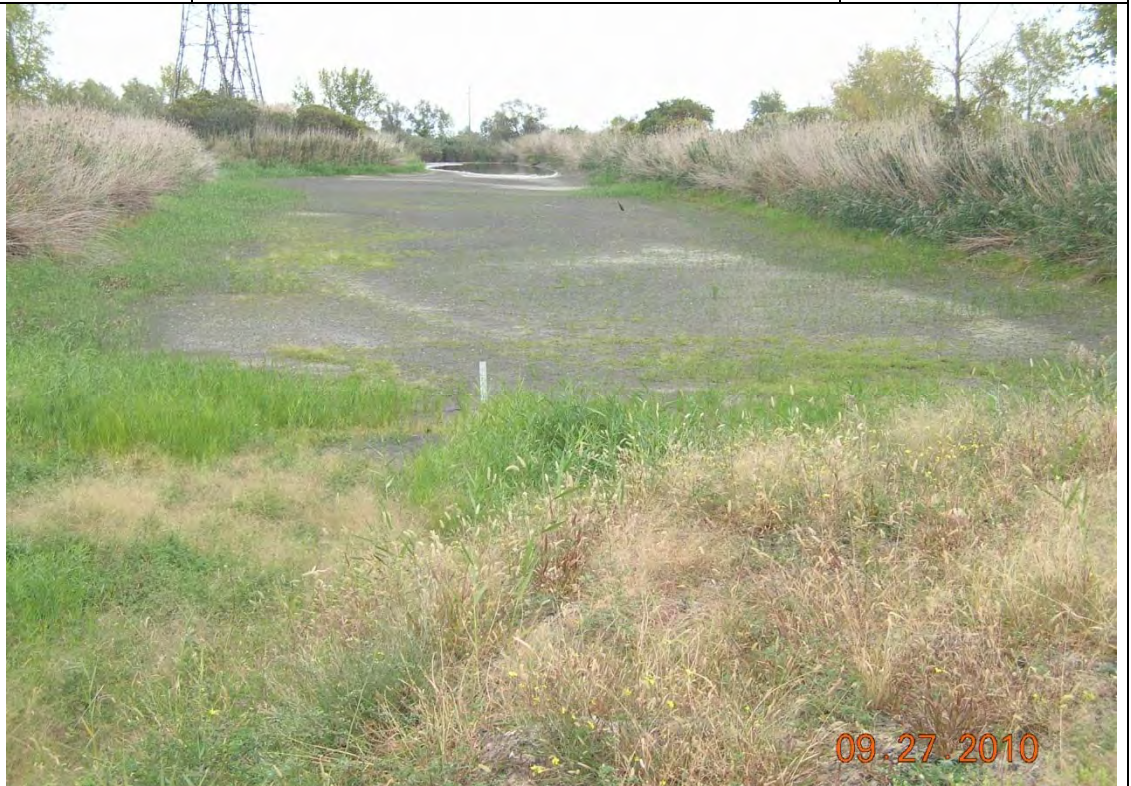
Description: Pond E has been significantly drained within the last year.

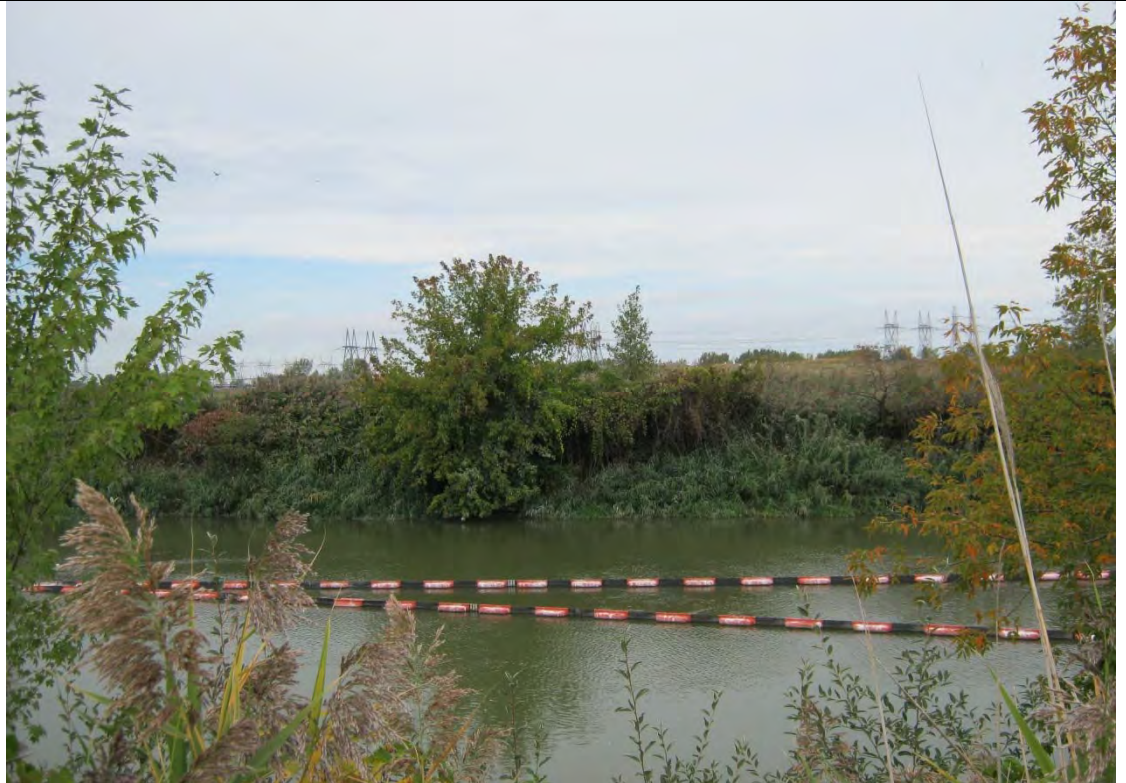
Description: View of the NPDES outlet into the Discharge Canal from the opposite side of the Karn Disposal Area. Note the heavy vegetation.

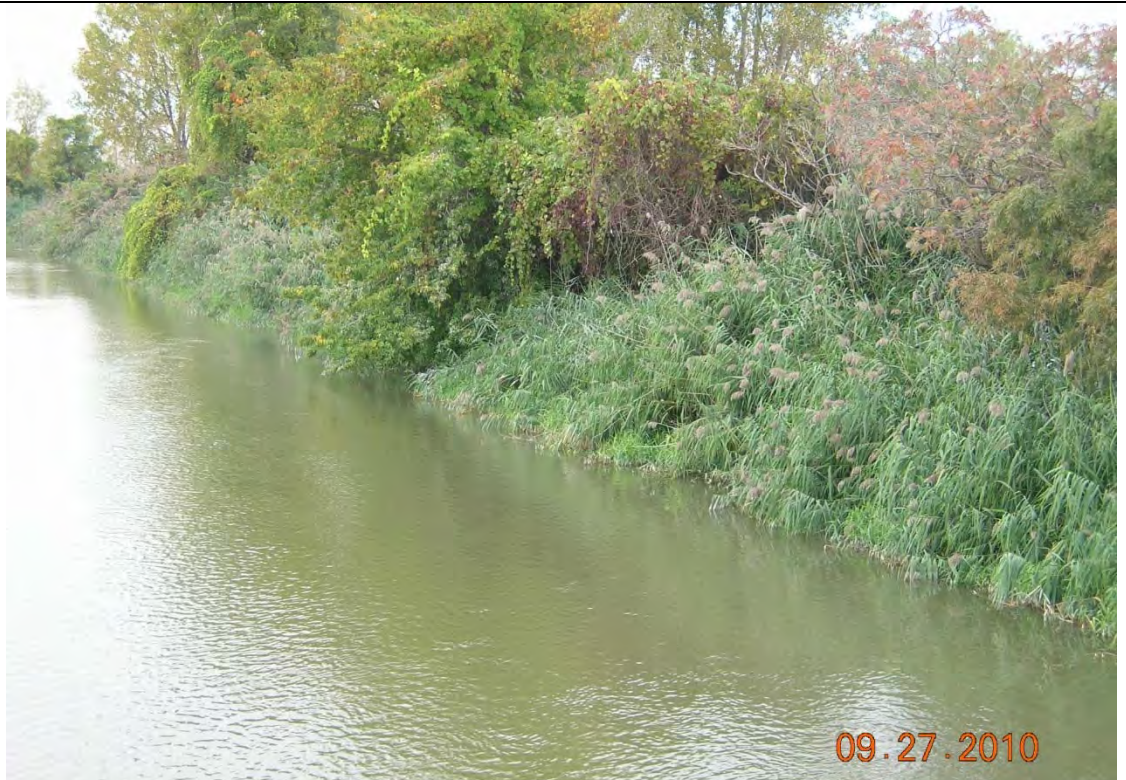
Photo No. 34

Description: Vegetation growing on the outer dike slope at the Discharge Canal.
