Report of Dam Safety Assessment of Coal  
Combustion Surface Impoundments  
Central Louisiana Electric Company (Cleco)  
American Electric Power (AEP)  
Southwest Electric Power Company (SWEPCO)  
Dolet Hills Power Station, Mansfield, LA

AMEC Project No. 3-2106-0183.0004

November 2010

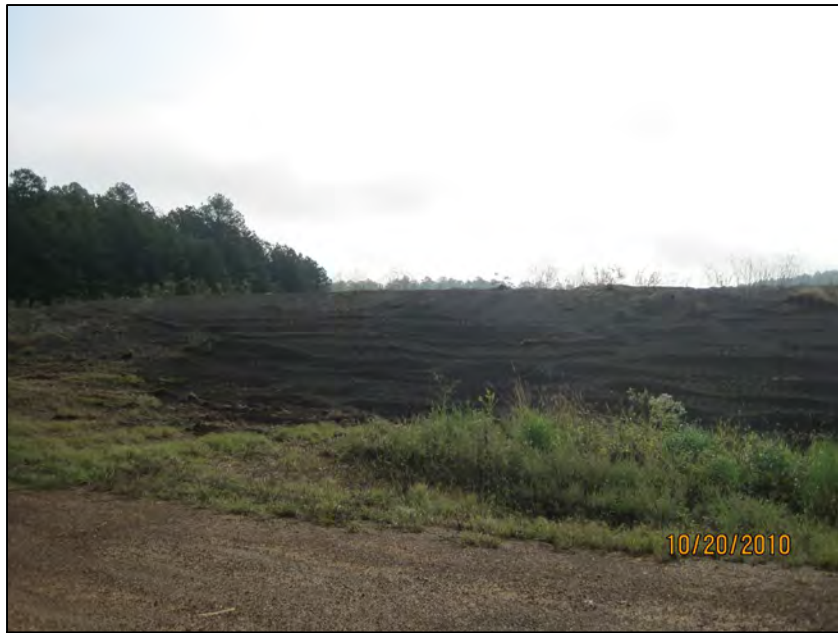
The main embankment wraps around the north end of Ash Pond 2 (Photo 24). Ash was noted stacked just inside the embankment on much of the upper portions of Ash Pond 2 (Photos 25 and 26). The ground along the downstream embankment toe adjacent to Ash Pond 2 is sloped quite heavily from the north to the west of the ash pond as well as from the southwestern toe to the west (Photos 28, 29, 32, and 35). Much of the area had been recently repaired and seeded.

**25**  
**ASH POND 2-LOOKING EAST AT STACKED ASH**

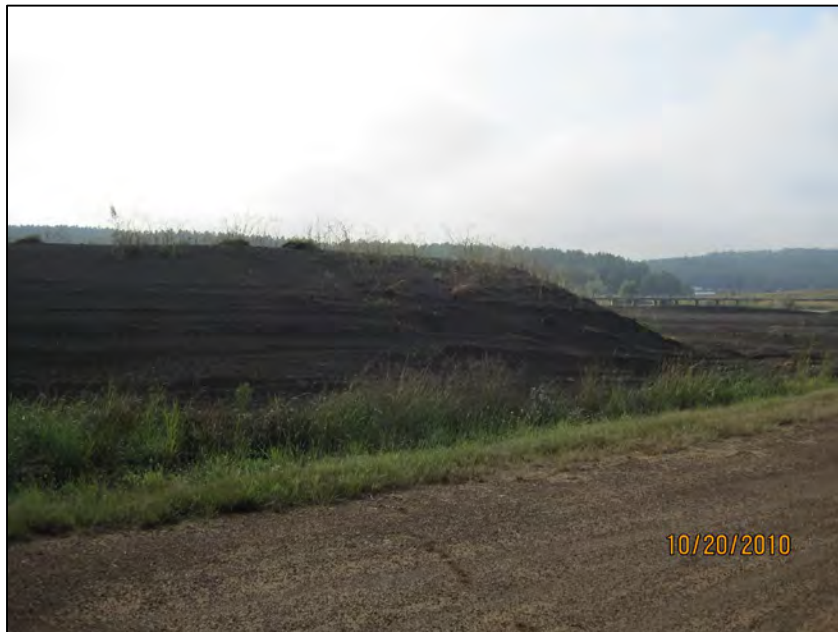
**26**  
**ASH POND 2-LOOKING SOUTH AT STACKED ASH**

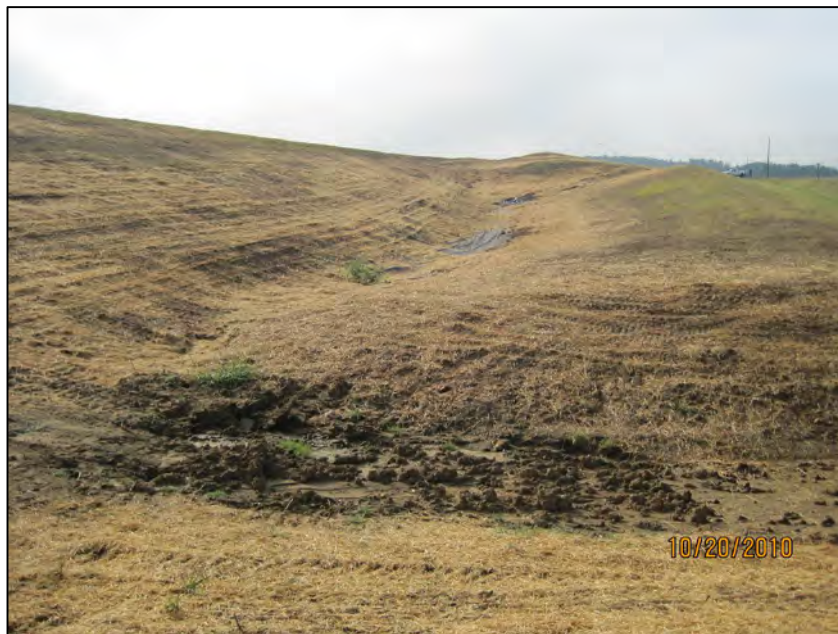
**32**  
**ASH POND 2-LOOKING SOUTH ALONG RESEED**  
**EMBANKMENT FACE**
