Report of Dam Safety Assessment of Coal Combustion  
Surface Impoundments  
Central Louisiana Electric Company (Cleco)  
American Electric Power (AEP)  
Southwest Electric Power Company (SWEPCO)  
Dolet Hills Power Station, Mansfield, LA

AMEC Project No. 3-2106-0183.0004

May 2011

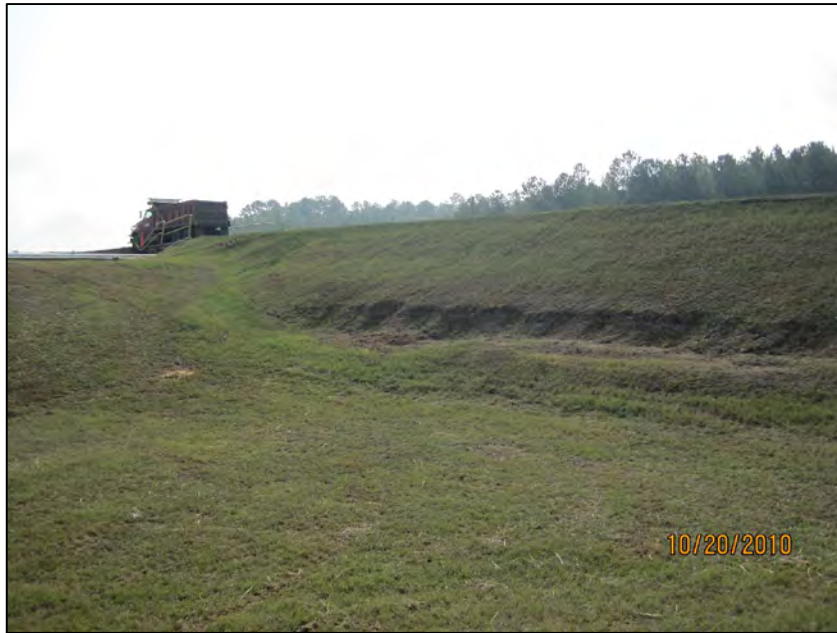
19

**ASH POND 1-LOOKING SOUTHEAST AT EROSION ON SIDE OF ROADWAY LEADING TO ASH POND 1 EMBANKMENT CREST**

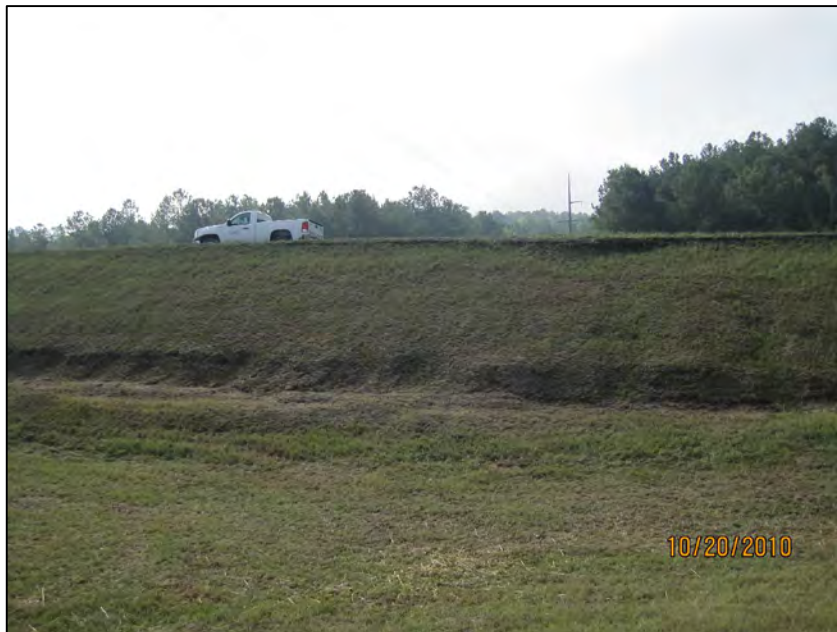
20

**ASH POND 1-LOOKING SOUTH AT EROSION ON SIDE OF ROADWAY LEADING TO ASH POND 1 EMBANKMENT CREST**

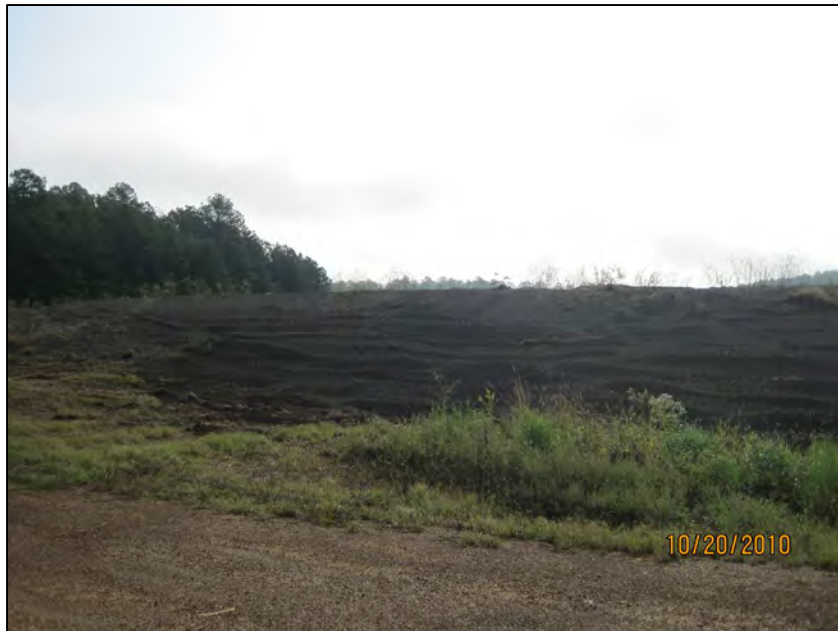
The main embankment wraps around the north end of Ash Pond 2 (Photo 24). Ash was noted stacked just inside the embankment on much of the upper portions of Ash Pond 2 (Photos 25 and 26). The ground along the downstream embankment toe adjacent to Ash Pond 2 is sloped quite heavily from the north to the west of the ash pond as well as from the southwestern toe to the west (Photos 28, 29, 32, and 35). Much of the area had been recently repaired and seeded.

ASH POND 2-LOOKING EAST AT STACKED ASH

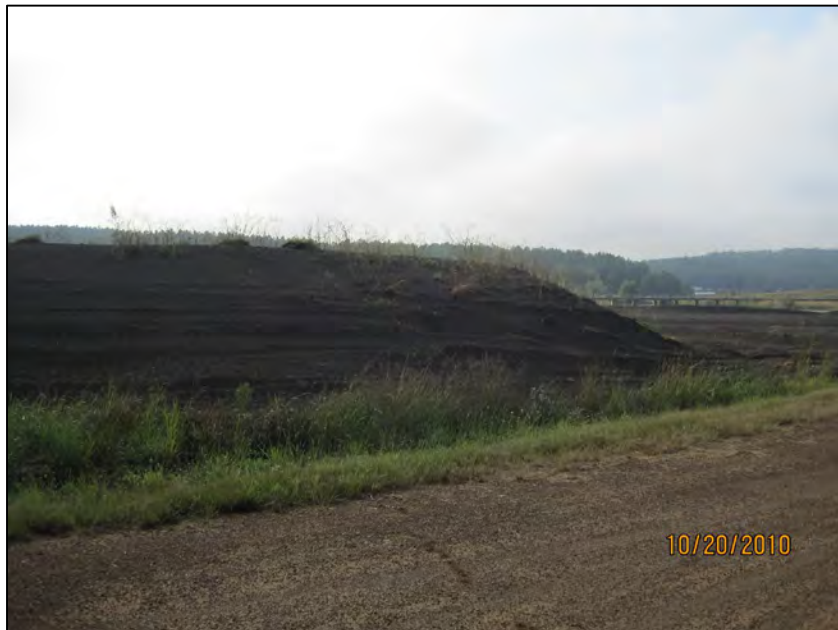
26

ASH POND 2-LOOKING SOUTH AT STACKED ASH

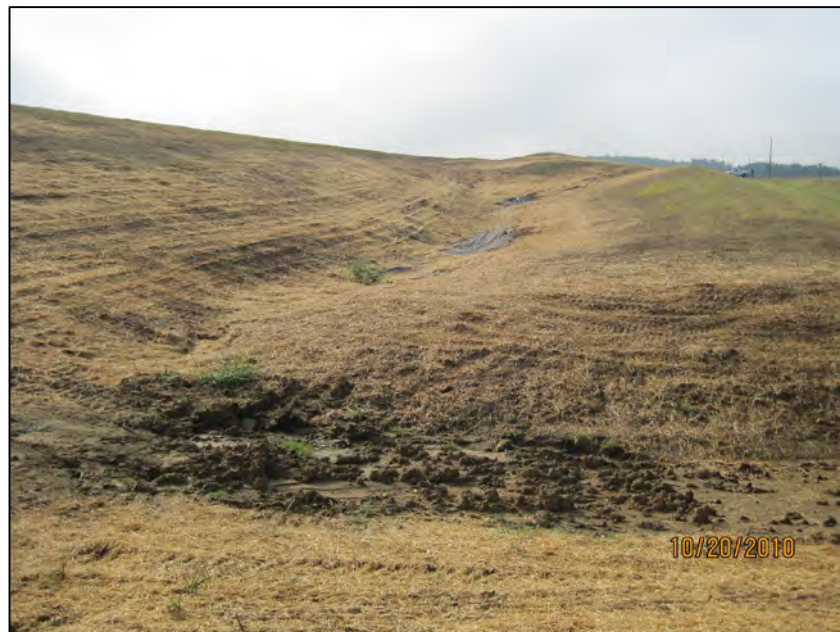
32

### ASH POND 2-LOOKING SOUTH ALONG RESEEDED EMBANKMENT FACE

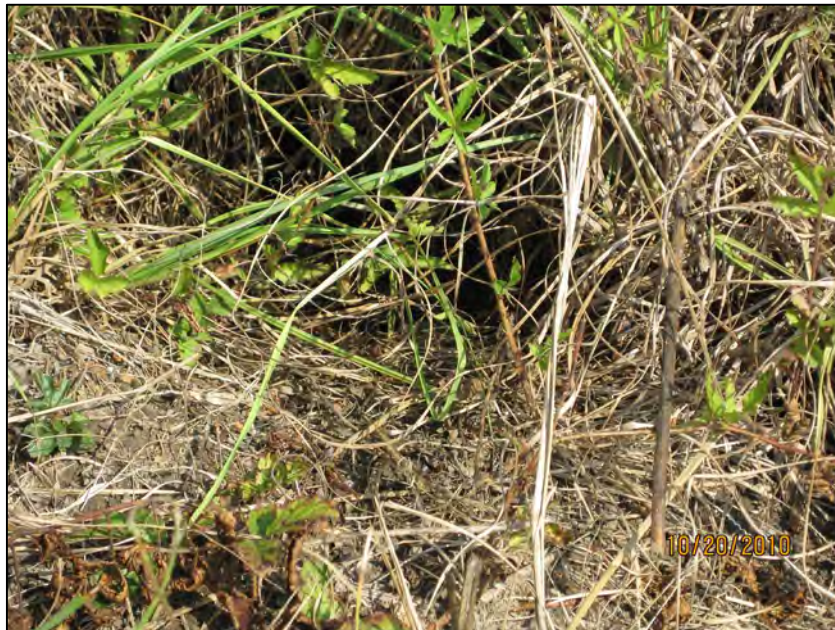
50

Like the Auxiliary Surge Pond, Surge Pond 1 is primarily incised (Photos 53 and 54). A moderate embankment exists on the southern boundary of Surge Pond 1 as shown in Photos 49, 51, and 52. Those photos also show railroad tracks that are located below the Surge Pond 1 embankment. An animal burrow was noted on the central portion of the embankment (Photo 50).

**SURGE POND 1-ANIMAL BURROW LOCATED  
ON SOUTH FACE OF EMBANKMENT**

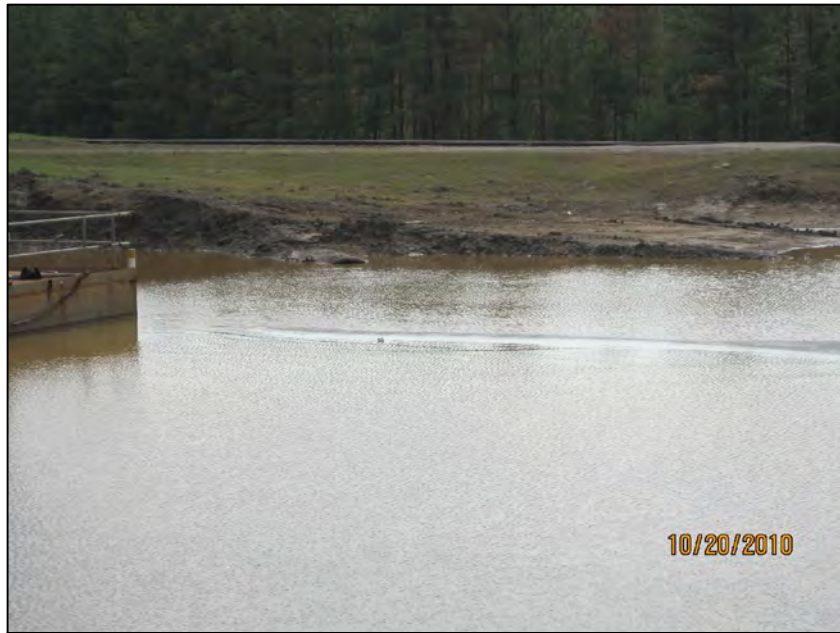
55

**SURGE POND 1-MOSTLY SUBMERGED INFLUENT CULVERT**

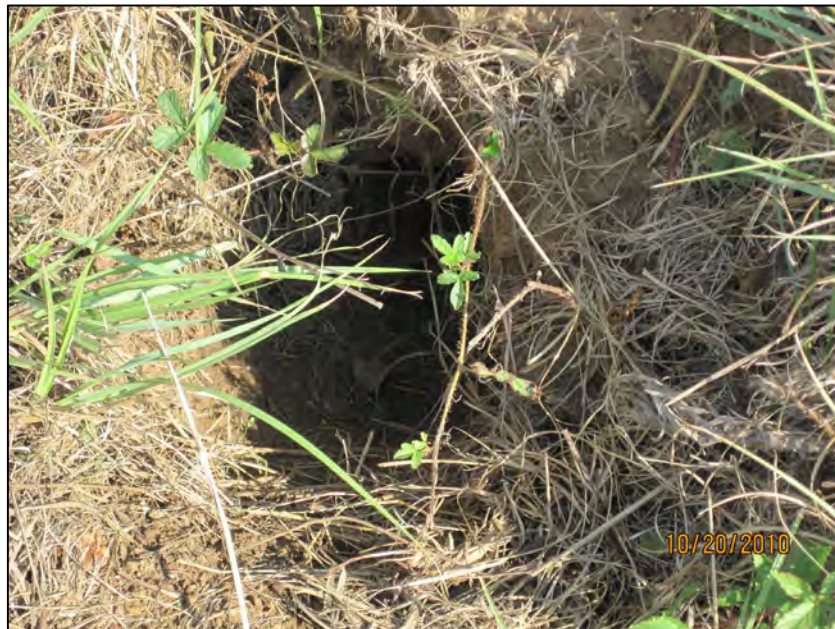
57

Surge Pond 2, the largest of the surge ponds, is completely diked. The grass covered embankment, shown in Photos 58 and 59 had been subject to recent reseeding efforts. An animal burrow was noted in the embankment behind a short wall built adjacent to monitoring well OW-24 (Photos 56 and 57).

**SURGE POND 2-ANIMAL BURROW LOCATED BEHIND WALL SHOWN ADJACENT TO MONITORING WELL 24**

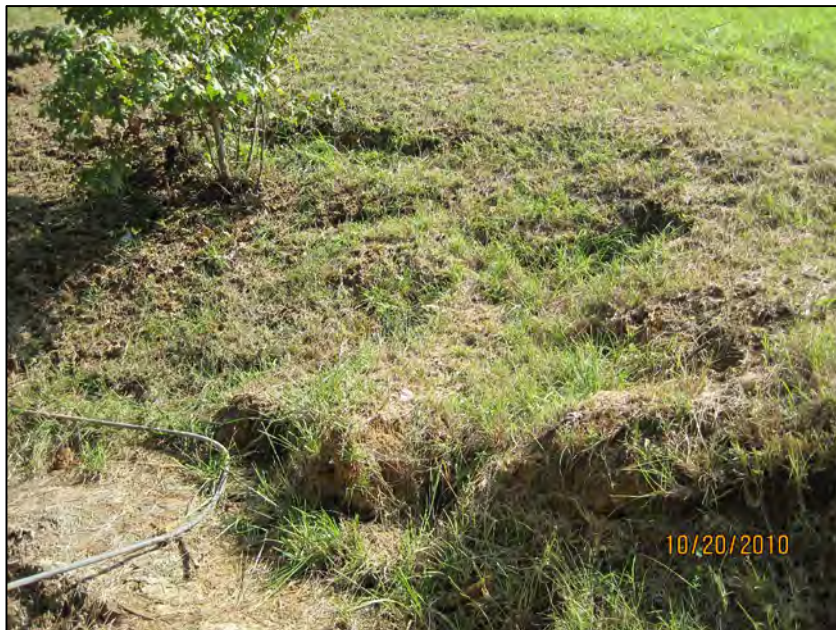
64

This pond was created with a cross valley configuration. The embankment was constructed on the western side of the pond and runs from the northeast to the southwest. The embankment crest is approximately 28 feet wide and contains a roadway (Photos 61 and 62). The upstream and downstream embankment slopes are covered by grass. Photos 62, 65, and 68 illustrate trees that are present on the downstream embankment slope. Additionally, a slump was noted in the downstream embankment face adjacent to the pond's downstream discharge valve (Photo 64).

LANDFILL RUNOFF POND-SLUMP  
ADJACENT TO POND DISCHARGE VALVE

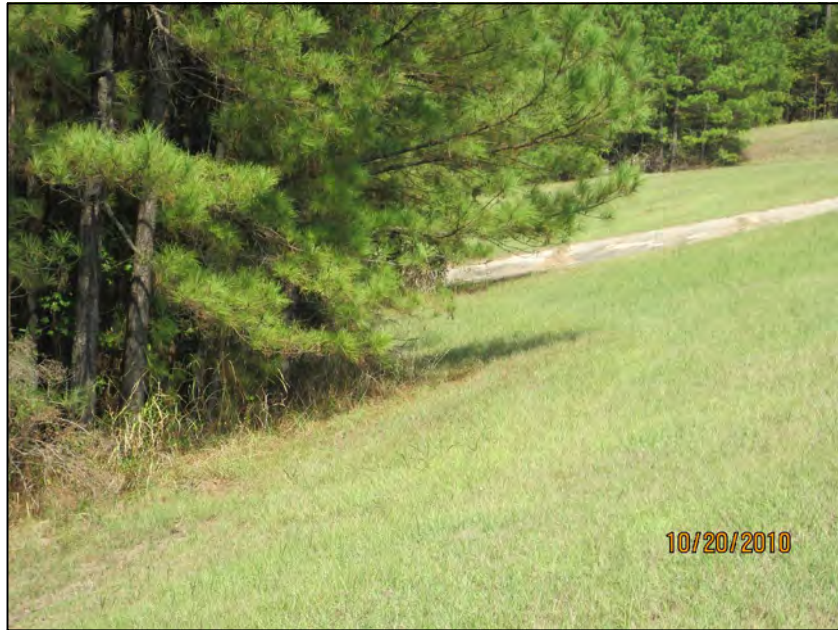
**65**  
**LANDFILL RUNOFF POND-TREES ON**  
**DOWNSTREAM TOE OF EMBANKMENT**
