GZA  
GeoEnvironmental, Inc.

Re: Task 3 Dam Assessment Report  
Project #0-381  
Clifty Creek Station  
West Bottom Ash Pond  
Madison, Indiana

## EXECUTIVE SUMMARY

This Phase I Inspection/Evaluation Report details the results of a visual dam inspection of the Clifty Creek West Bottom Ash Pond Dam, located in Madison, Jefferson County, Indiana. The entrance to the plant is at Clifty Hollow Road, Route 56. The inspection was performed on June 10, 2009 by GZA GeoEnvironmental, Inc (GZA).

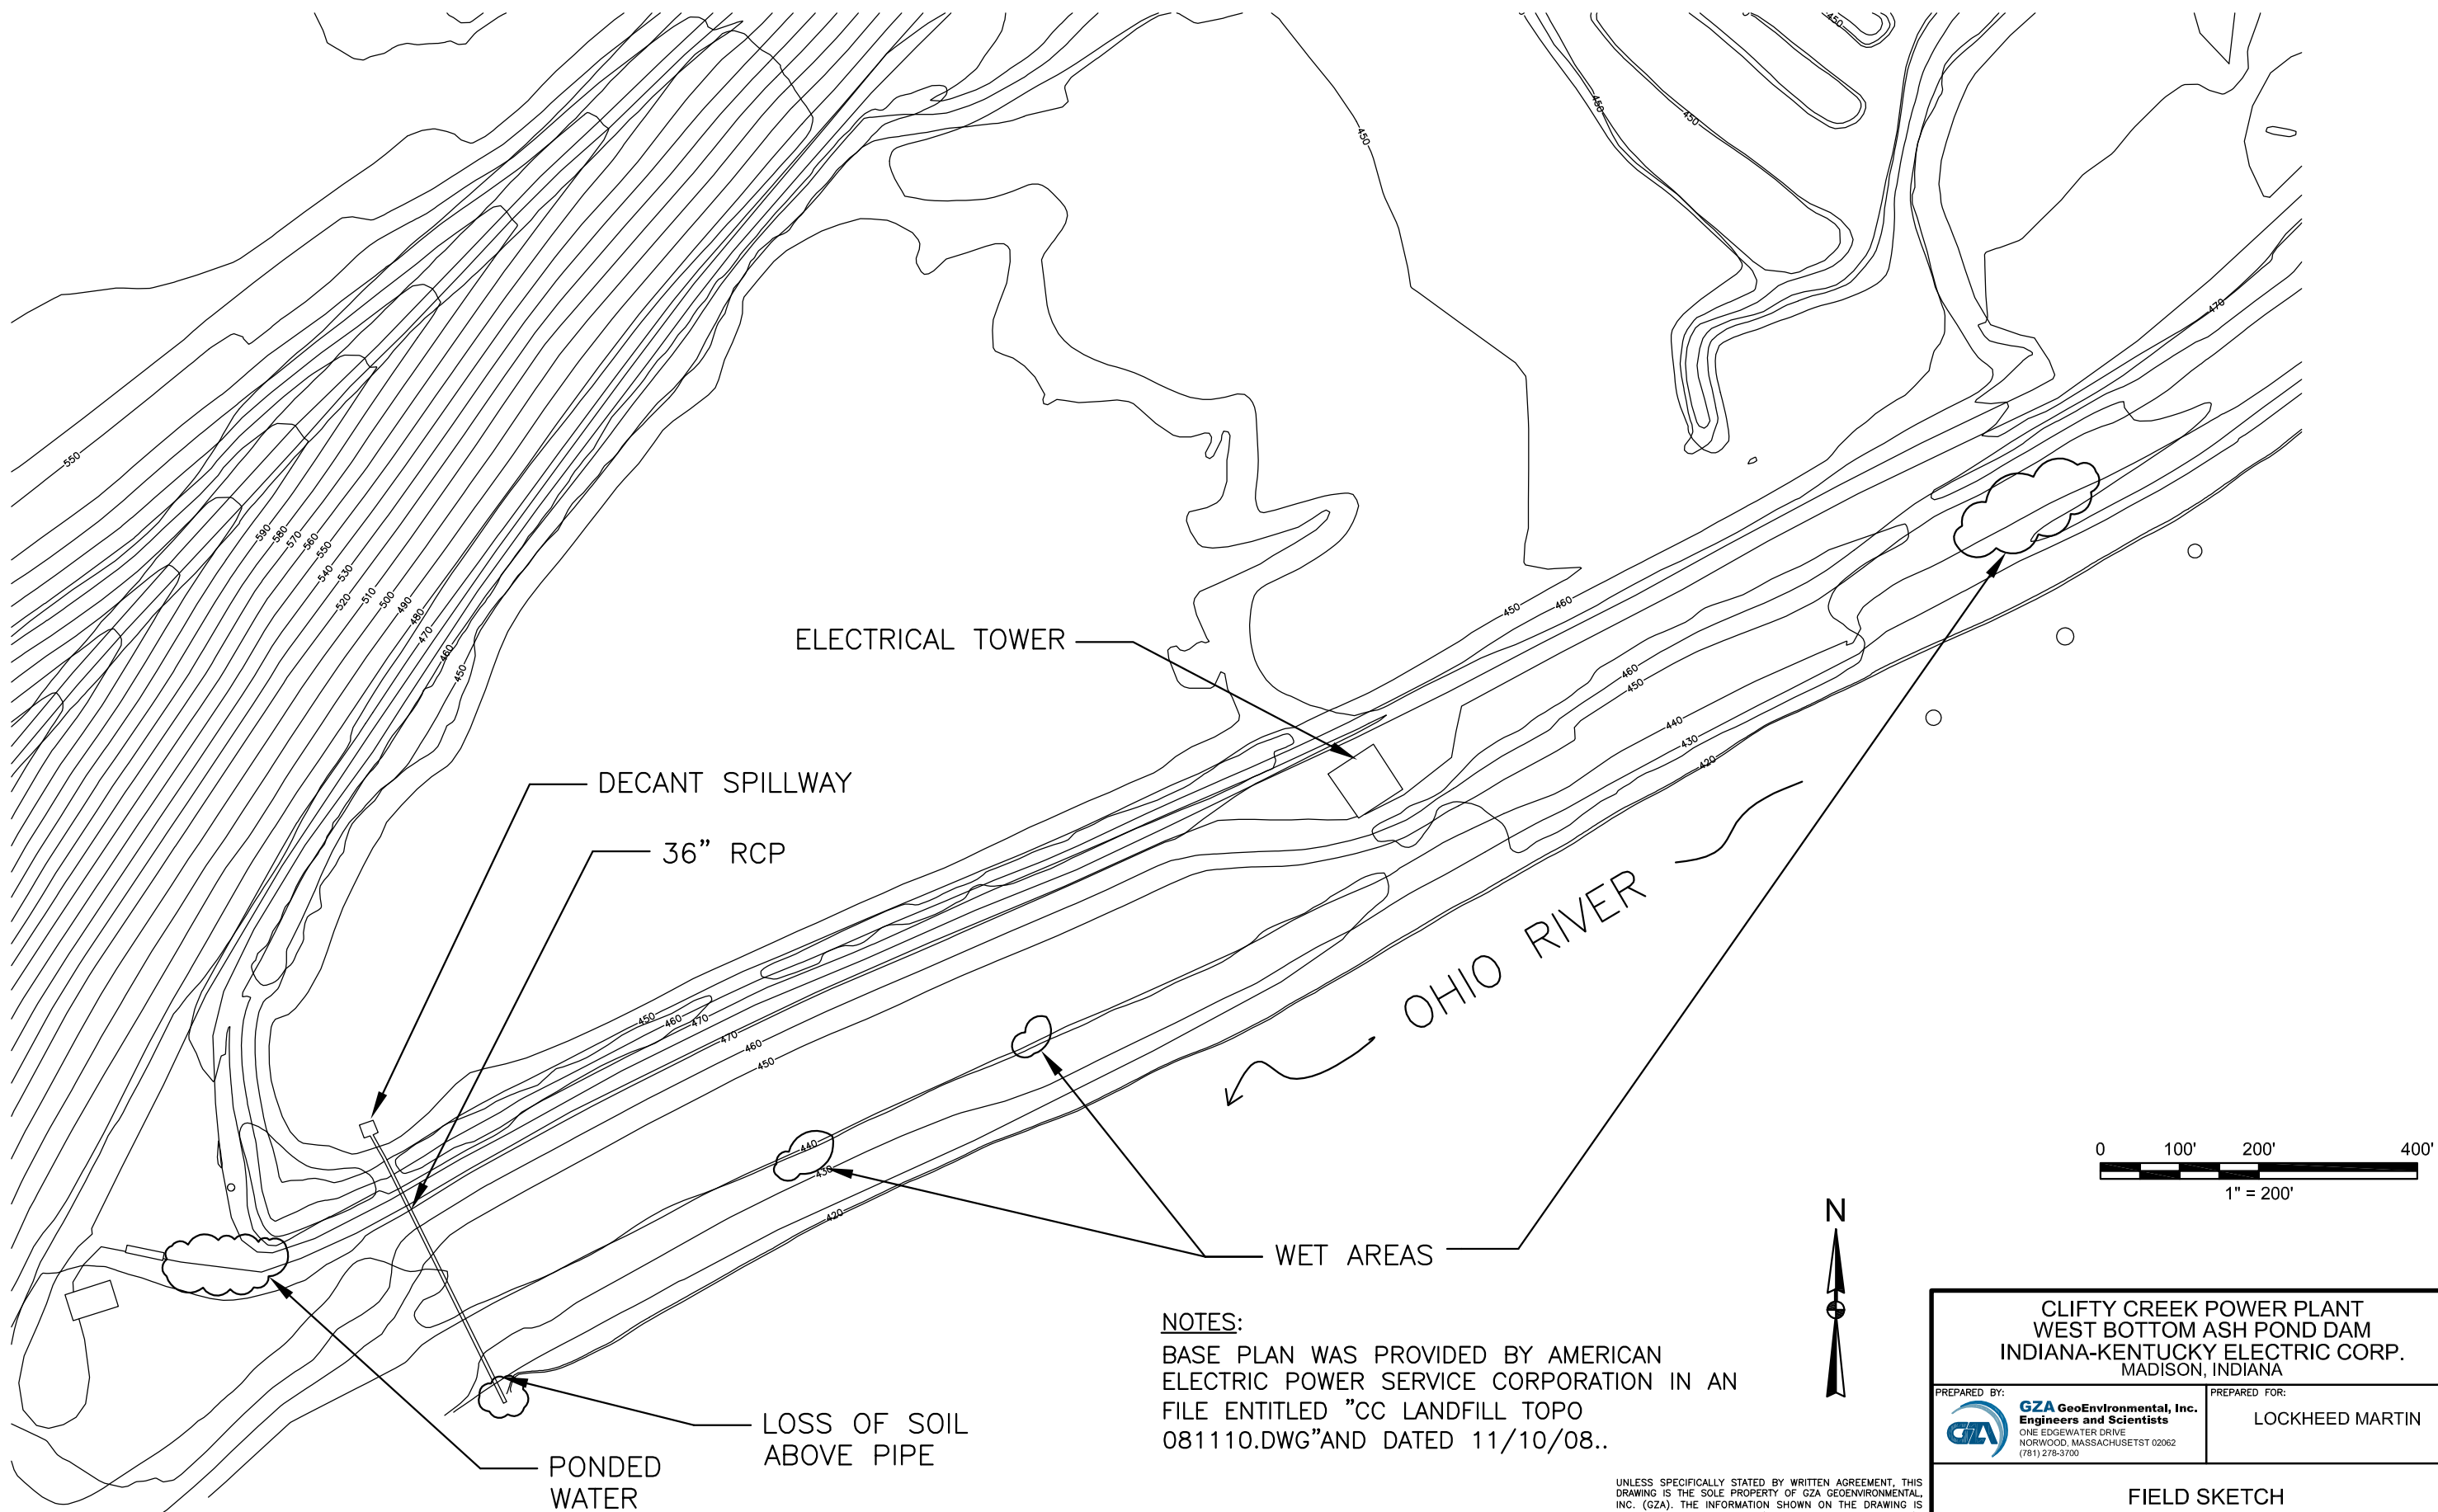
In general, the West Bottom Ash Pond Dam was found to be in **SATISFACTORY** condition. The specific concerns are identified in more detail in the sections below. A sketch showing the dam in plan and noting areas of observed deficiencies as well as location and orientation of photographs is contained in **Figure 5**.

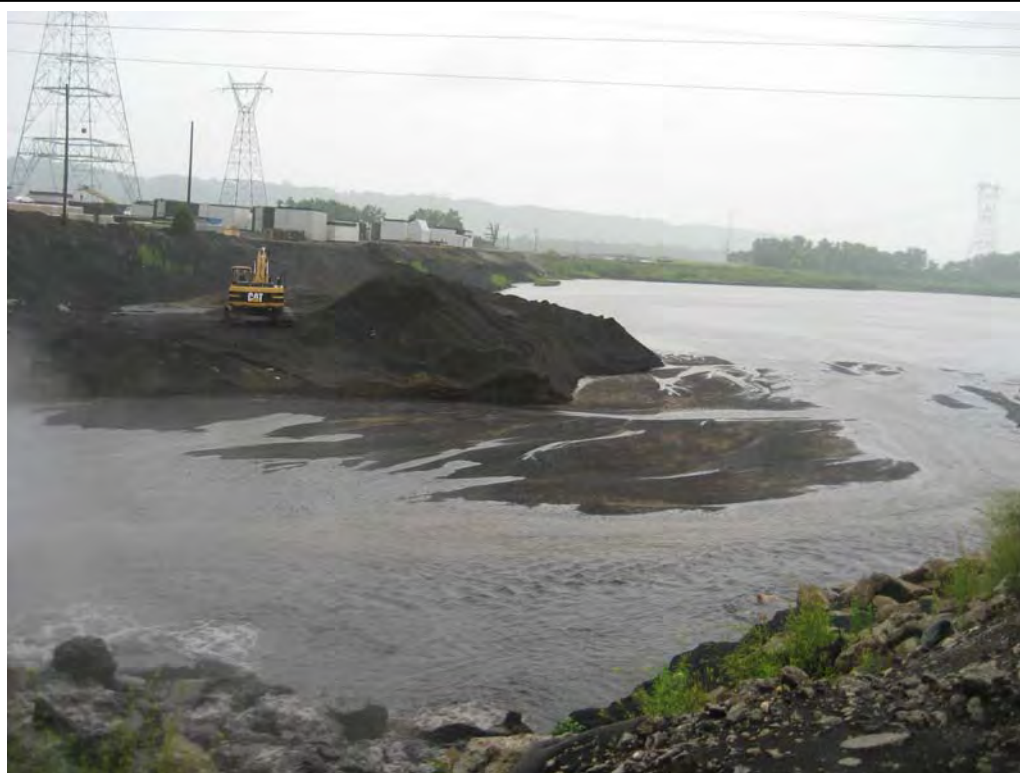
#1 - Overview of Bottom Ash Pond taken from head water area looking southwest

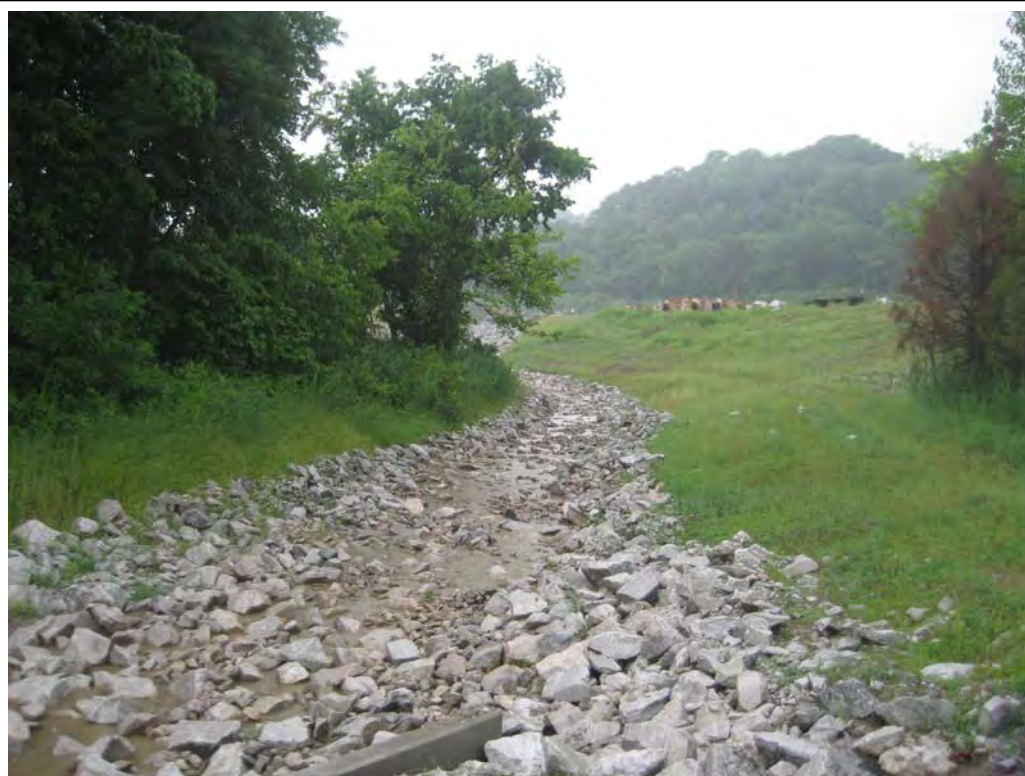
#2 - Relocated Runoff Drain Entering Pond

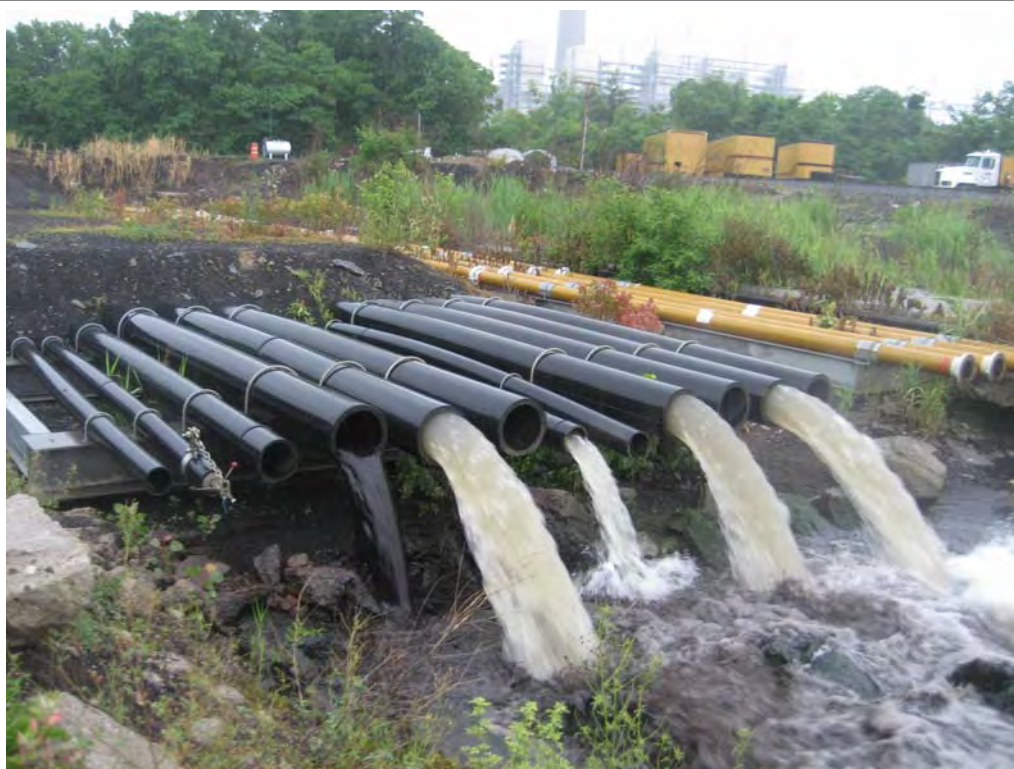
#3 - Boiler Room Sumps and Sluice Discharge Lines Into Pond

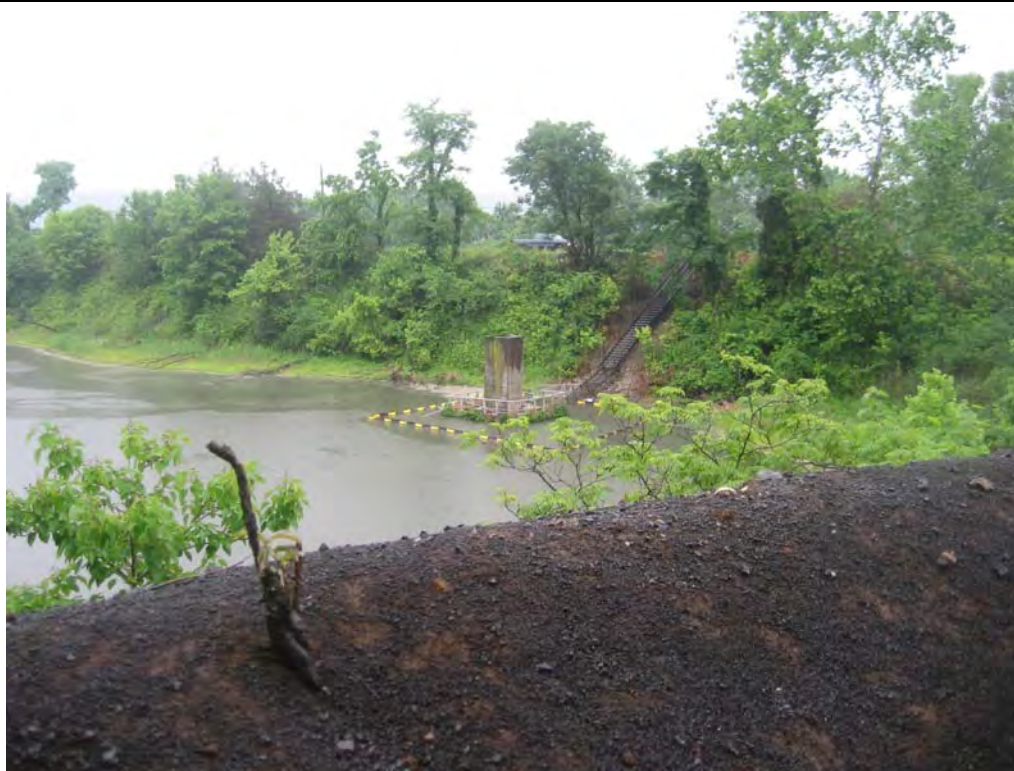
# 4 - Decant Spillway and Portion of Upstream Face of Dam Embankment; (note dense tree growth)

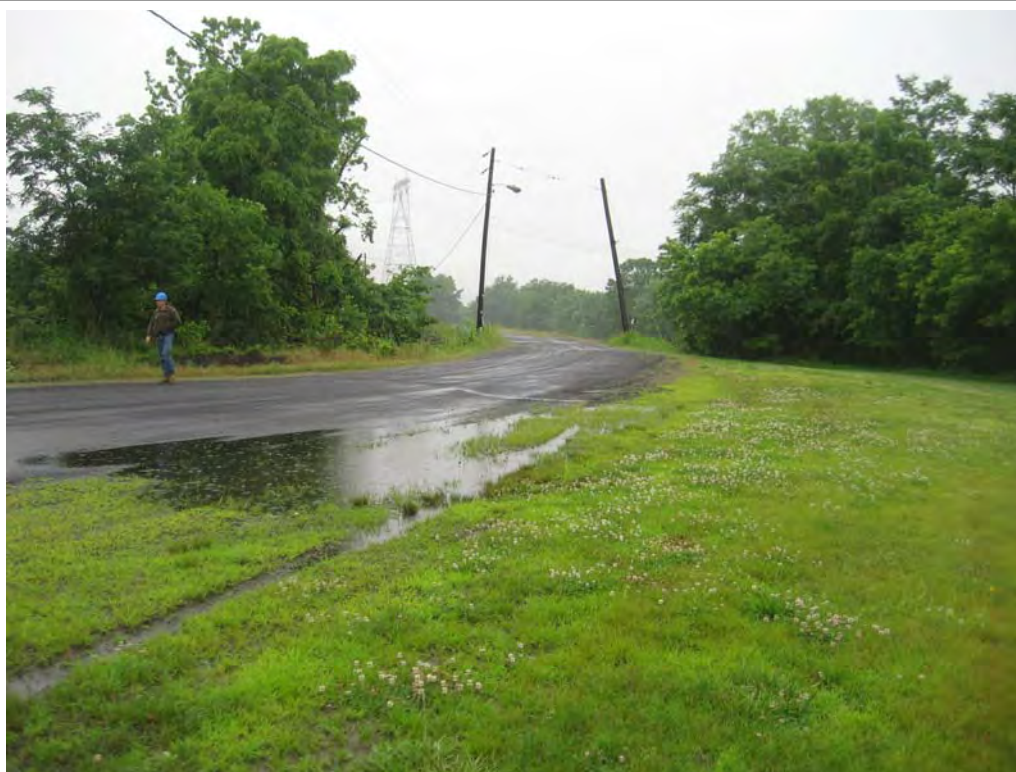
The top of the dam runs in a generally straight line parallel to the Ohio River. An approximately 20 foot wide access road in contiguous with the top of the dam and continues as a ring road beyond the left and right abutment. The roadway consists of cinders and boiler slag and is in fair condition. Some minor rutting with shallow ponding of surface runoff was observed primarily at the right abutment area and the right half portion of the embankment. The area of the top of the dam beyond the roadway edge was surfaced with grasses and other herbaceous vegetation, which was noticeably higher on the upstream side. Based on the visual inspection, the vertical alignment of the top of dam appeared to be fairly level. However, as previously discussed, the recent topographic survey and AutoCAD drawing indicates that spot elevations on the crest progress from elevation 472.5 near the right abutment, 471.6 between the abutment and transmission tower, 469.2 at the base of the tower, to 468.8 near the left abutment. These top of dam elevation are significantly lower than the design elevation of 475.

#5 - Standing Water on Crest Near Right Abutment

1. Repair of grading including minor depressions found on the crest to insure a consistent top of dam at about elevation 470 MSL.
2. Investigate seeps at the downstream slope in dry weather, with repairs designed by a professional engineer and construction by a contractor experienced in dam repair.

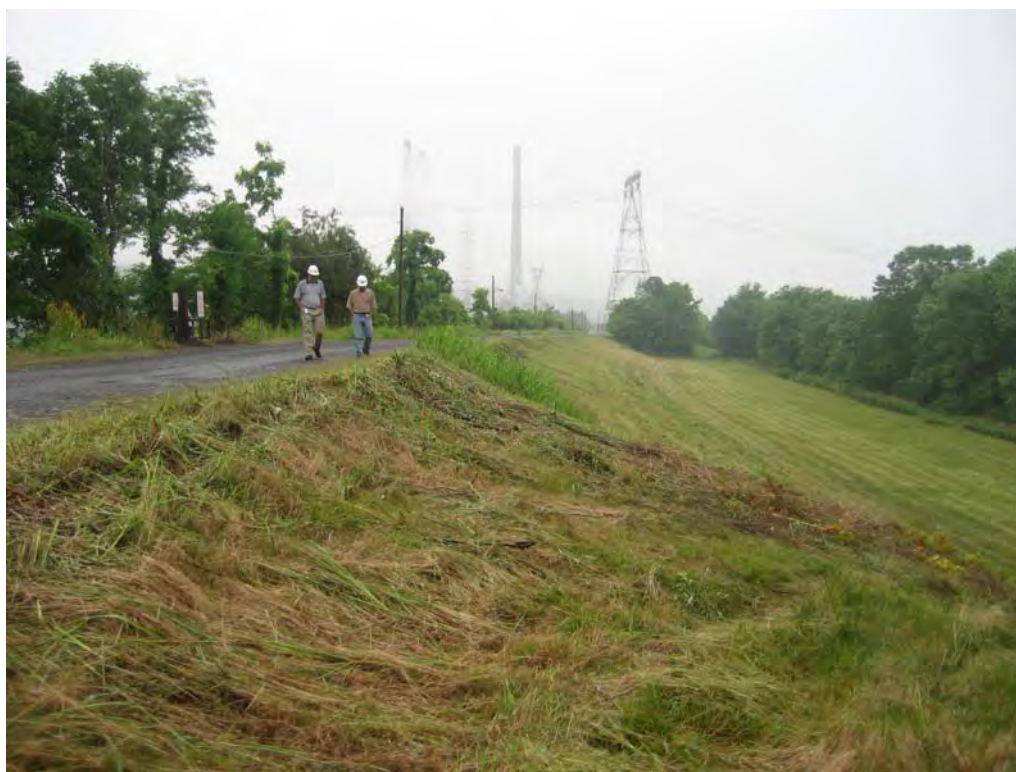
#6 - Upper Slope and Berm of Downstream Face Taken Near Right Abutment

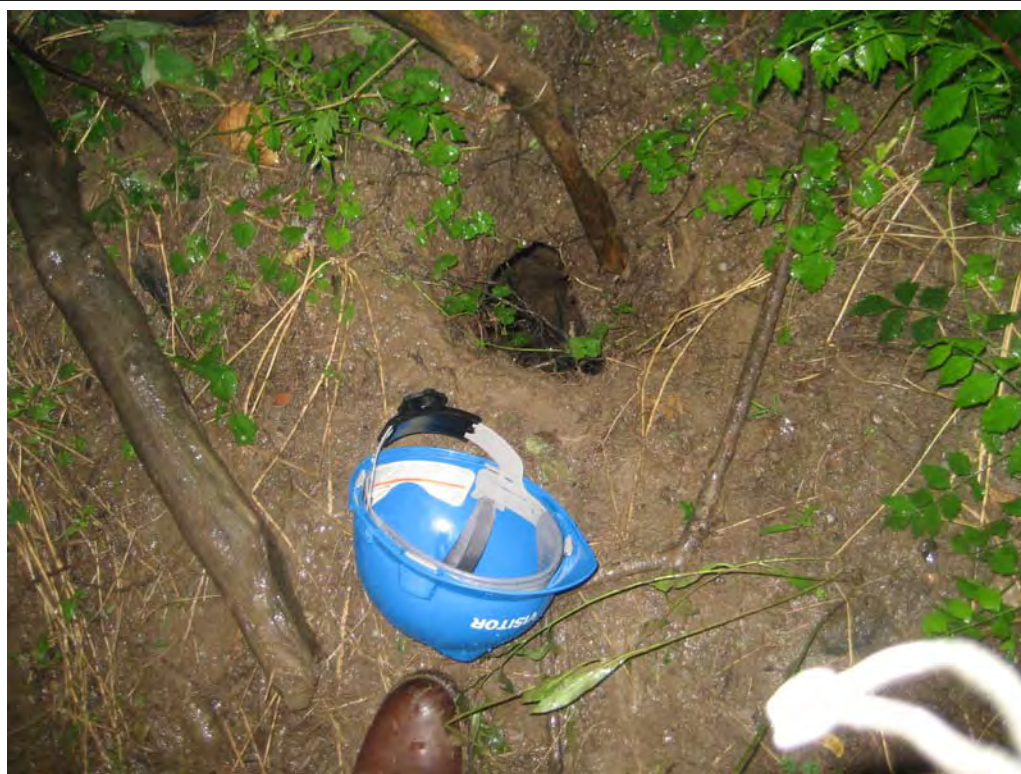
A small sinkhole was discovered on the ground surface in an area approximate over the crown of the pipe and about 10 to 15 feet upgradient from the end of the pipe. The depression was about 8-inches in diameter and about 3 feet deep. The hole was dry and not seepage in the area was observed. IKEC maintenance staff subsequently backfilled the hold with quick-setting concrete (Photo 8), and will continue to monitor the repair for future loss of material and subsidence.

While internal inspection of the spillway outlet pipe was beyond our scope of services, we were able to review a video of a 2007 inspection of the pipe. Based on the video, the majority of the pipe appeared to be in good conditions. A few concrete stop planks were in the pipe but, according to IKEC, were subsequently removed. No other obstructions were noted. The pipe slope did not appear to be consistent based on viewing the water line on the interior surfaces of the pipe. A discontinuity in the water stain was noted at the first joint, about 15 feet up from the end of the pipe. The water line was noticeable at a lower level downgradient from this first joint and may be indicative of exfiltration at this location. Given that the sinkhole was discovered at about this point above the crown of the pipe, a possible mechanism for loss of soil and sinkhole creation is postulated.

#7 - Sinkhole Above Downstream End of 36" Outlet Pipe

1. Develop a formal, written Emergency Action Plan;
2. Enact the proposed inspection program which is to include routine drive by inspections, quarterly checklist completion by IKEC engineering staff.
3. Install a staff gage at the intake (or other convenient location) in order to easily and regularly record pond level.
4. Monitor repaired sinkhole near the end of the outlet pipe on a monthly basis, at a minimum.

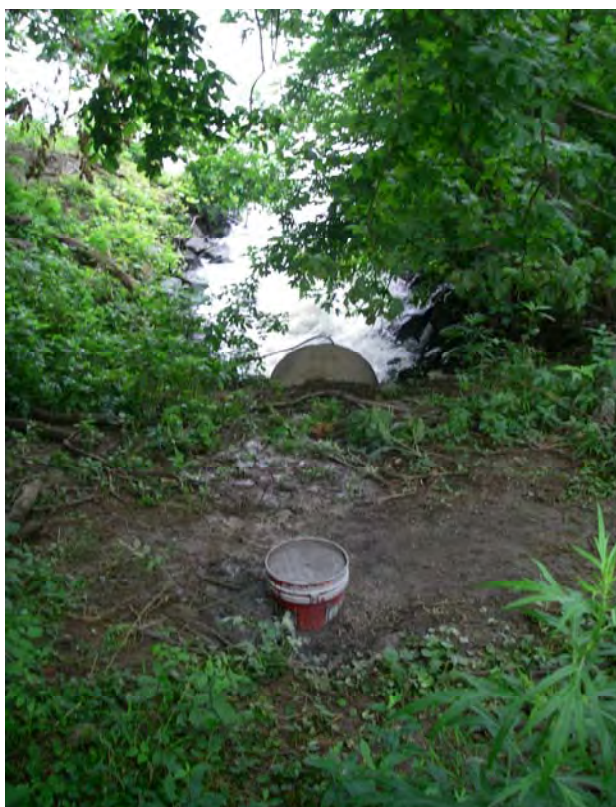
#8 - Repaired Sinkhole & RCP Outlet to Ohio River

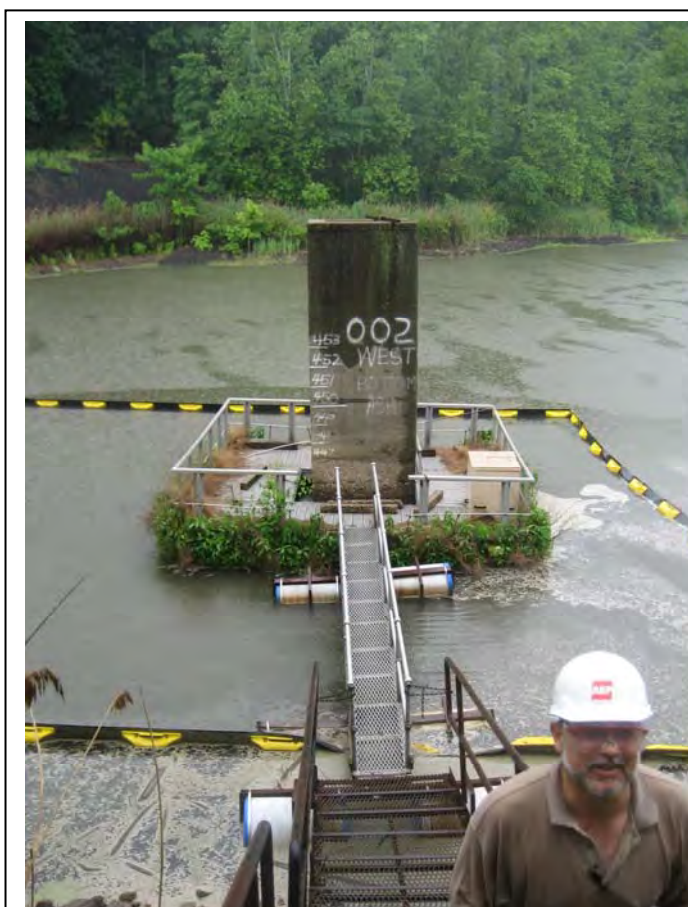
#9 - Decant Spillway in Floating Catwalk/Spillway and debris boom

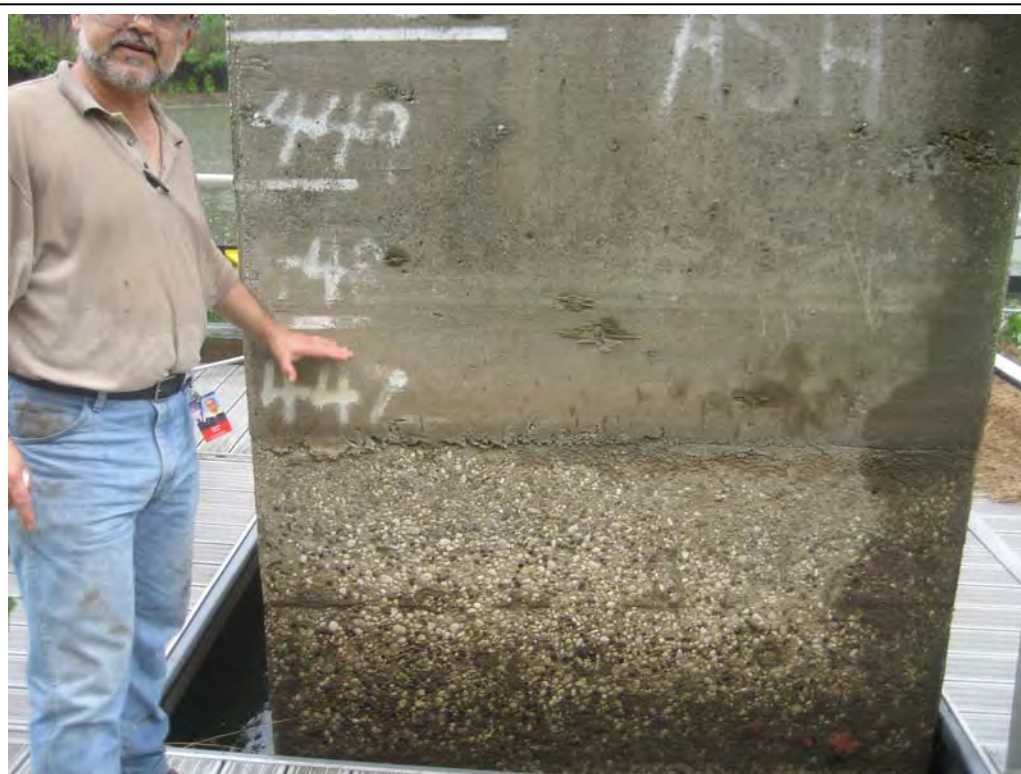
#10 - Surface Wear of Concrete Spillway Riser. EL 447 was Former Normal Pool Level.

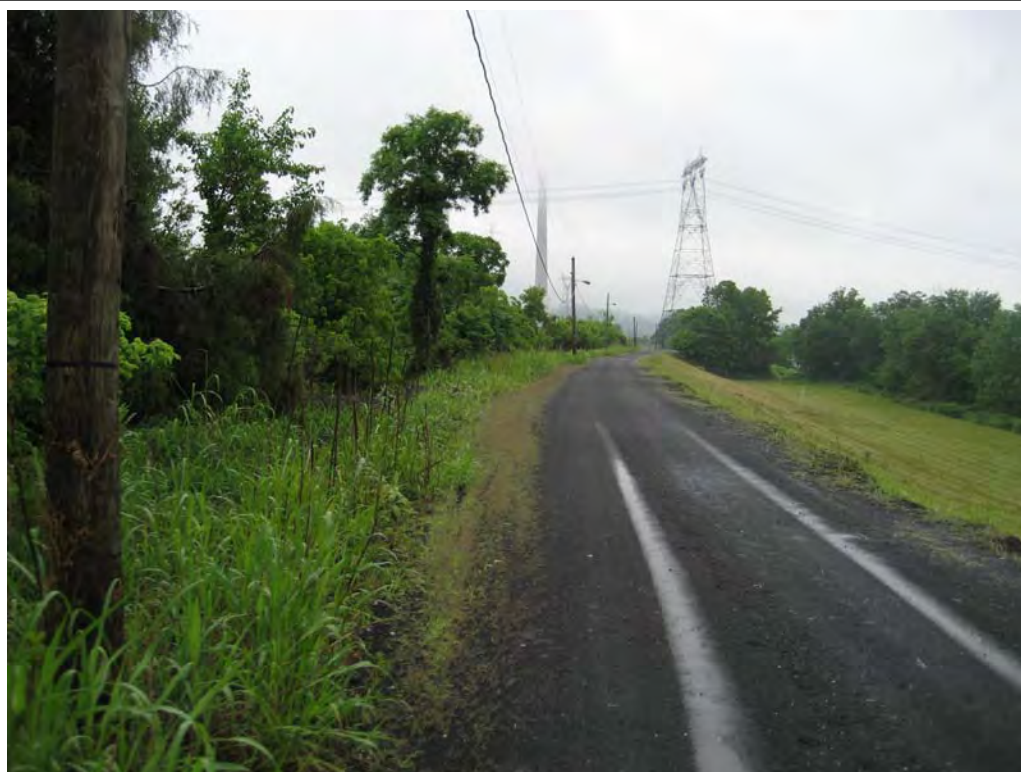
#11 - Access Road on Crest with Shallow Ponding in Tire Ruts looking eastward toward left abutment

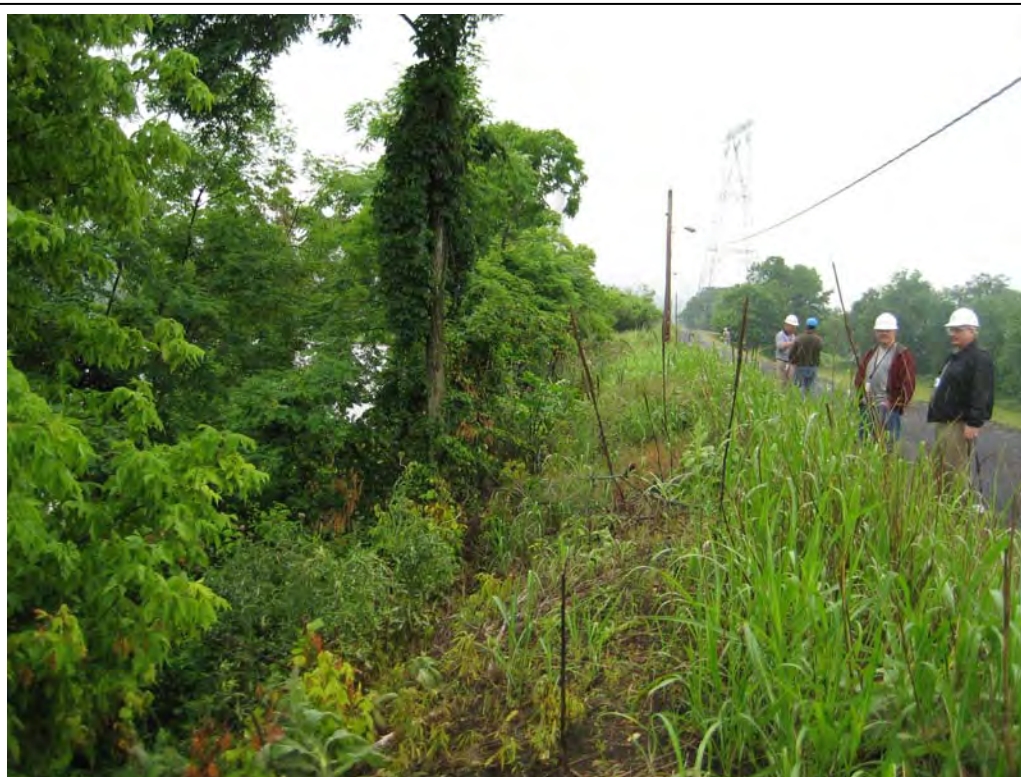
#12 - Typical Vegetative Growth on Upstream Face of Embankment

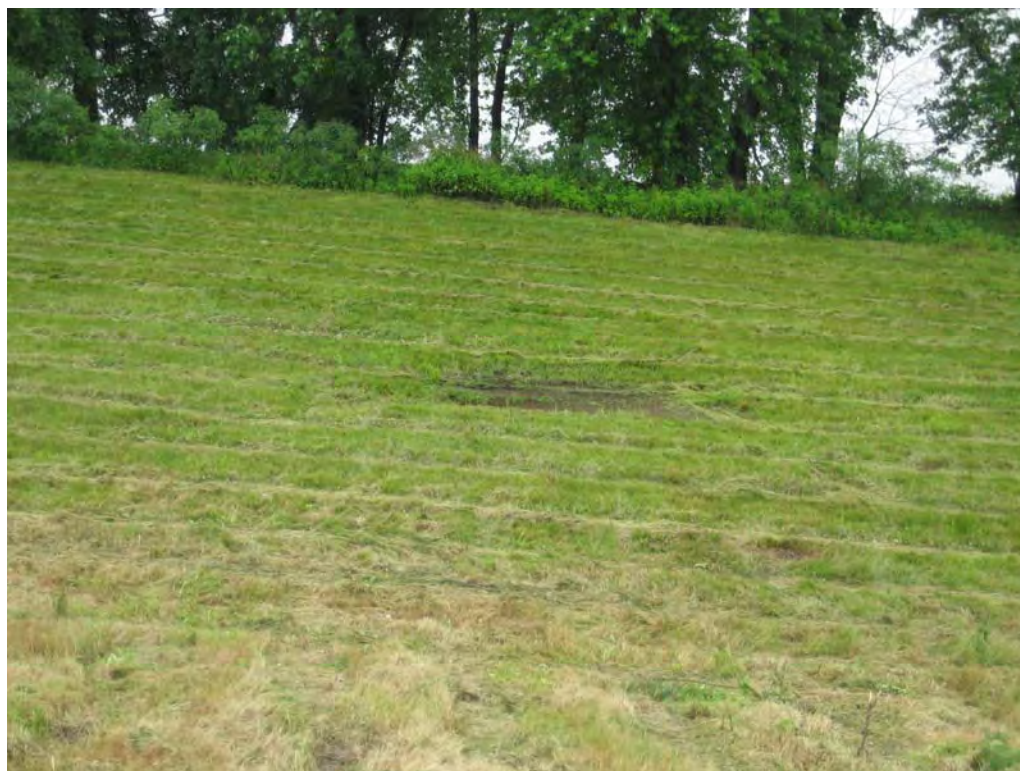
1. Wet areas were observed in several locations near the horizontal berm area between the right abutment and transmission tower. In addition, a seep area continues to exist on the downstream embankment near the left abutment about 150 feet downgradient from the top of the dam.
2. Dense scrub vegetation and mature trees cover the majority of the upstream embankment slope; in addition the upstream slope does not appear to have any riprap protection at and above the normal pool level.
3. A small sinkhole was identified above the outlet pipe about 15 feet upgradient from the end of the pipe. IKEC operations staff subsequently backfilled the hole and will monitor the effectiveness of the repair.

**#13 - Downstream Face Along Horizontal Berm; Note Wet Area in Middle of Frame**

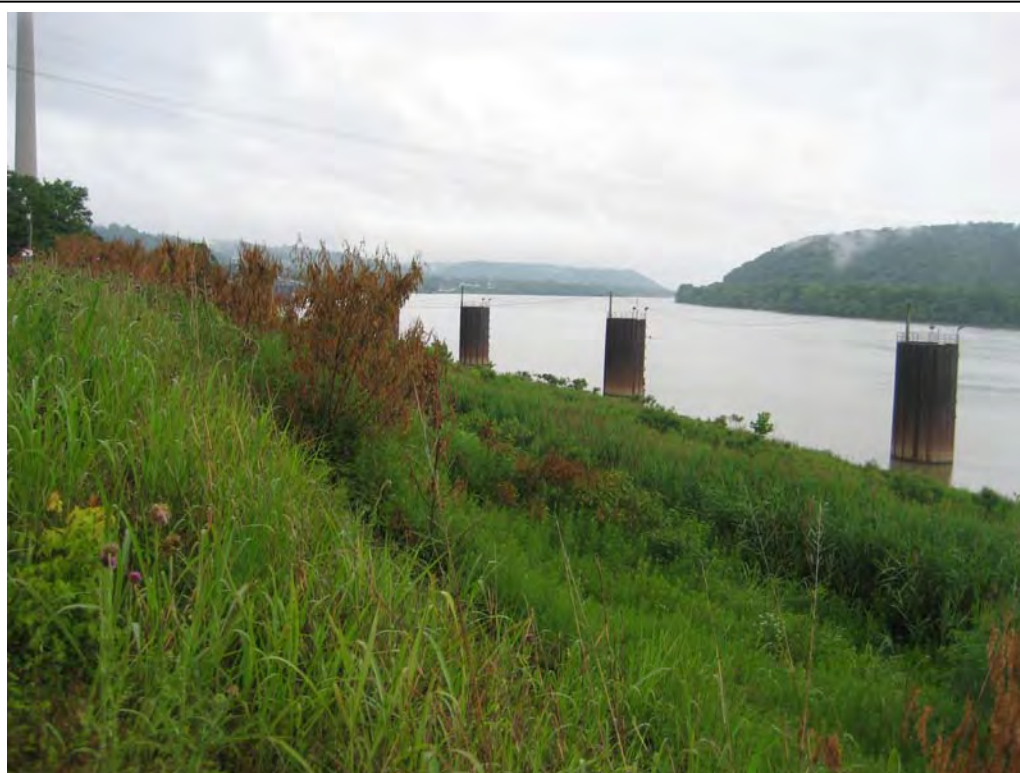
**#14 - Lower Slope of Downstream Face at Location of Wet Areas**

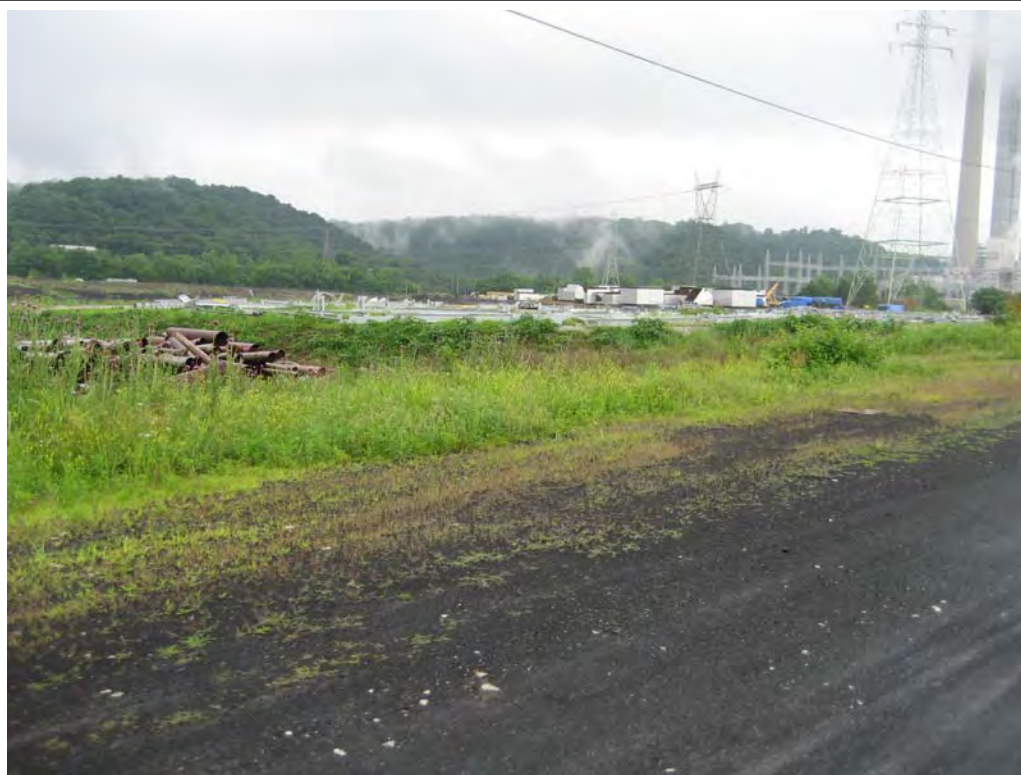
#15 - Crest and Upstream Face at Left Abutment
