Re: Task 3 Dam Assessment Report  
Project #0-381  
Clifty Creek Station  
South Fly Ash Pond  
Madison, Indiana

## EXECUTIVE SUMMARY

This Phase I Inspection/Evaluation Report details the results of a visual dam inspection of the Clifty Creek South Fly Ash Pond Dam (SFAP), located in Madison, Jefferson County, Indiana. The entrance to the plant is at Clifty Hollow Road, Route 56. The inspection was performed on June 11, 2009 by GZA GeoEnvironmental, Inc (GZA).

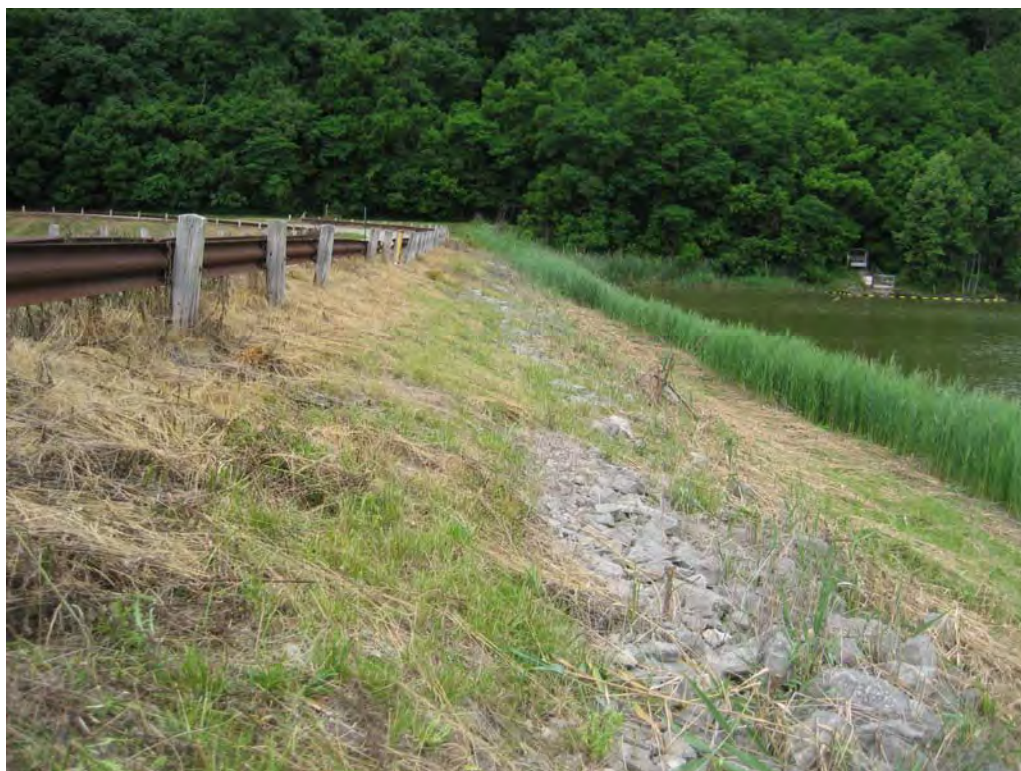
#5 – Upstream Slope; Note Riprap Protection

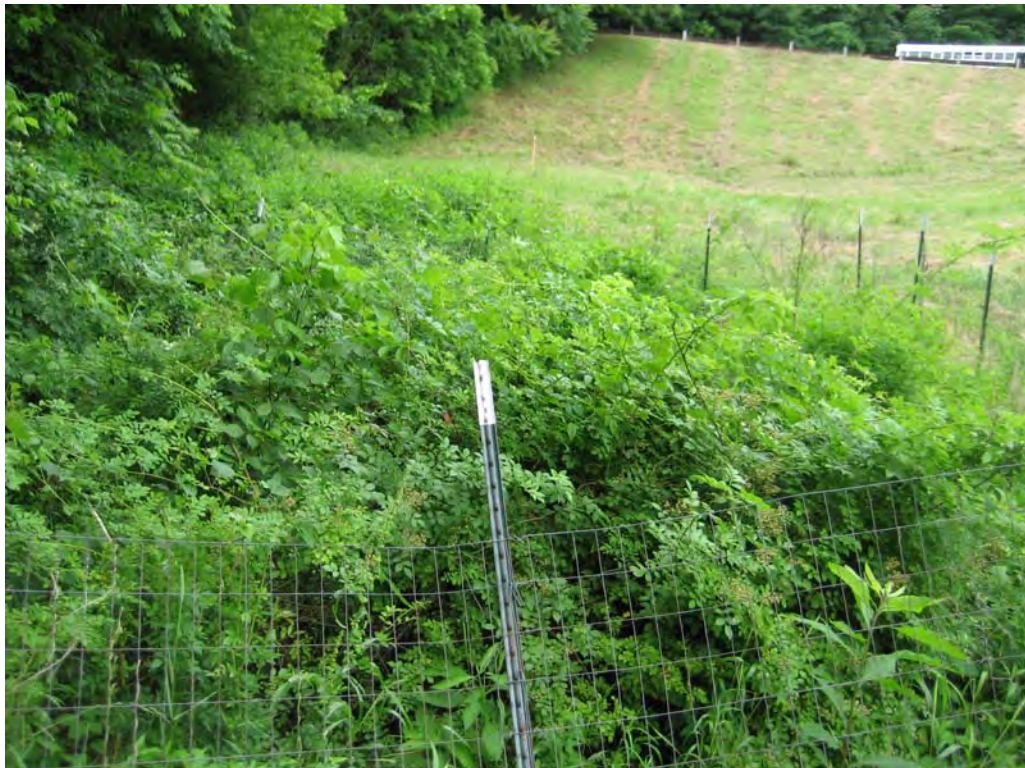
The end of the 72-inch RCP and associated head wall appeared to be in good conditions. Access to the structure was made difficult due to the dense overgrowth of the herbaceous vegetation on top of and the sides of the structure (see Photo 22). The tailwater extended about to the springline of the pipe. Flow was adequately dissipated prior to discharge to Panther Creek, with no erosion or other unusual movement observed.

**#10 – Downstream Slope Looking Up Toward Crest Near Right Groin. Overgrowth of Vegetation Near Outfall in Foreground of Picture.**

1. Dense scrub vegetation covers the outfall to the 72-inch pipe at the toe of the dam. This vegetation should be removed and replaced with short grass cover to increase visual inspection in the future.
2. Numerous minor scarps existing on the downstream face of the saddle dike embankment. These should continue to be monitored for movement.
3. The floating debris boom at the spillway intake is in poor operating condition and should be repaired or replaced to better prevent debris from penetrating the intakes.

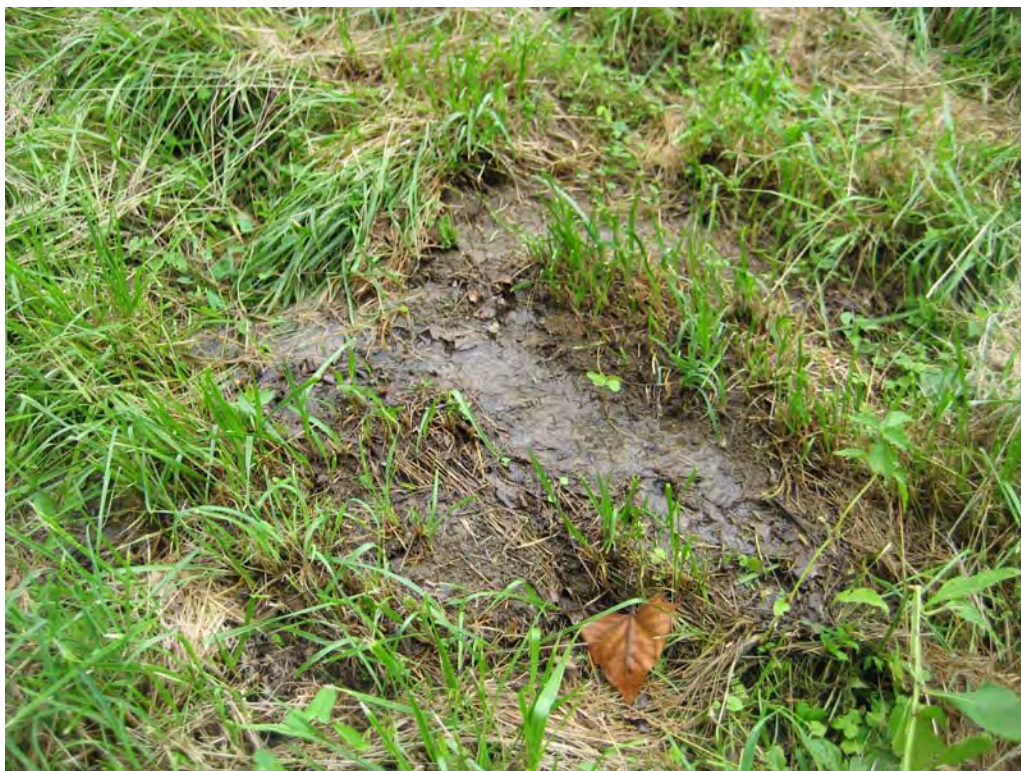
#11 – Soil Erosion Due to Surface Runoff at Toe Near Outlet Pipe Headwall

1. Repair minor eroded areas on downstream slope near outfall headwall.

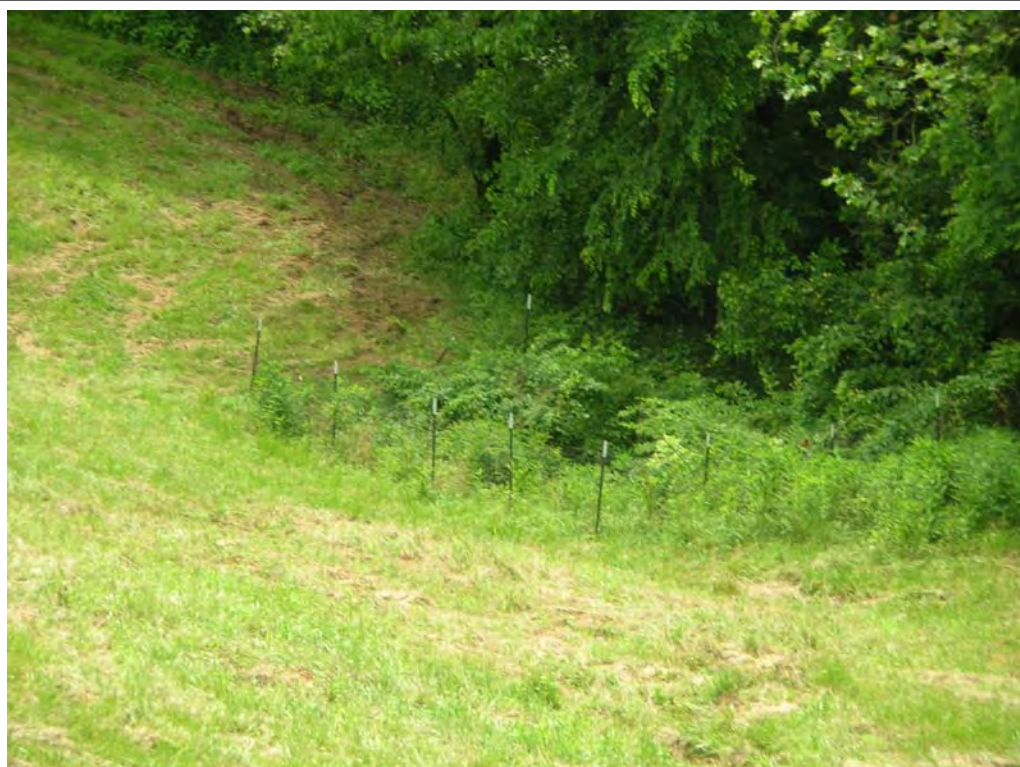
#14 – Looking Downgradient at Toe at 72" Pipe Outfall Location; Note Heavy Growth

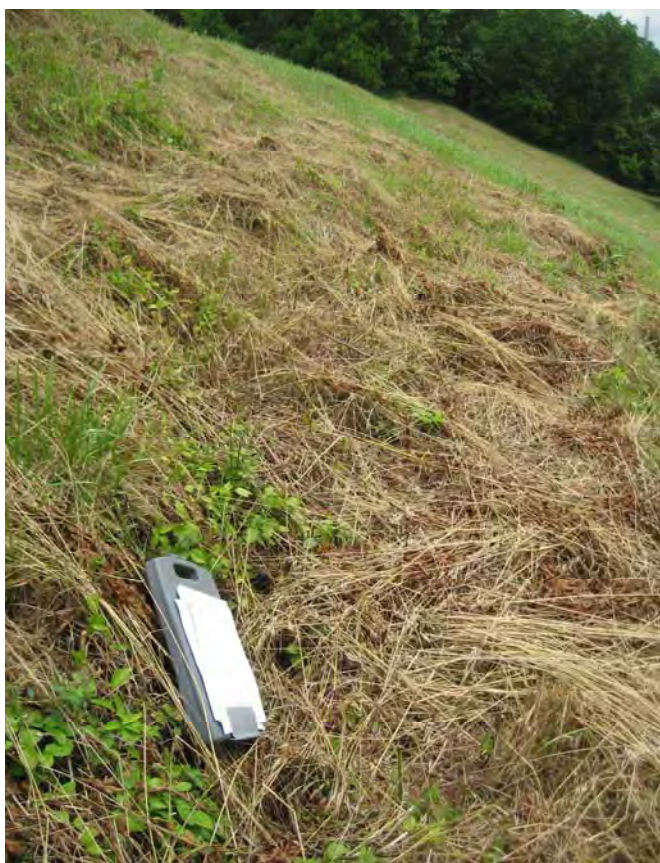
#17 – Typical Slope Scarp on Downstream Face on Saddle Dike

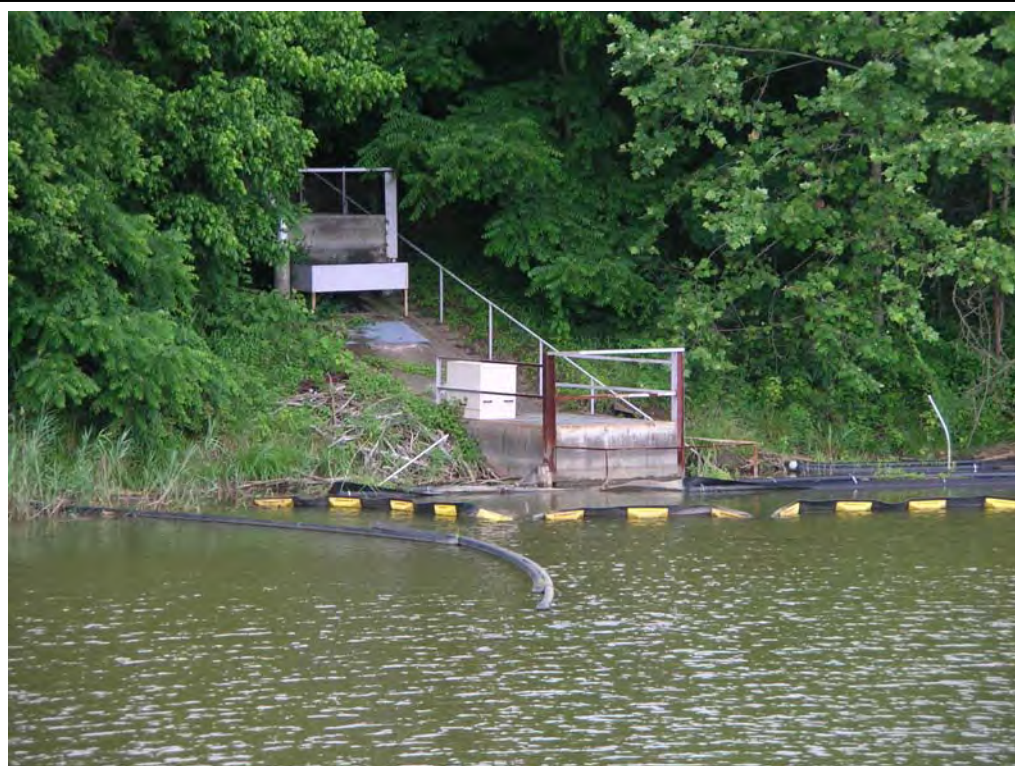
The water level in the pond is controlled by defined openings in the top of the reinforced concrete chute portion of the decant spillway. Access to the spillway was via the right abutment down a stairway which parallels the chute. The structure was in fair to good condition. Walkway grating, above the second intake, was in good condition. Some woody debris had accumulated on the grated inlets and newly cored opening (see Photo 19). More well established vegetation could be seen growing and partially blocking the third intake (see Photo 21). This debris and vegetation was subsequently removed by IKEC staff while we were on the site. IKEC staff demonstrated how the solid cover hatches over the intakes are removed. The ease to which one could open these hatches during a large storm event is questionable. The floating debris boom, located at the spillway intake, appeared to be in poor condition and partially submerged, allowing floatable objects to reach the intakes.

#18 – Sloped Decant Spillway Structure and Debris Boom

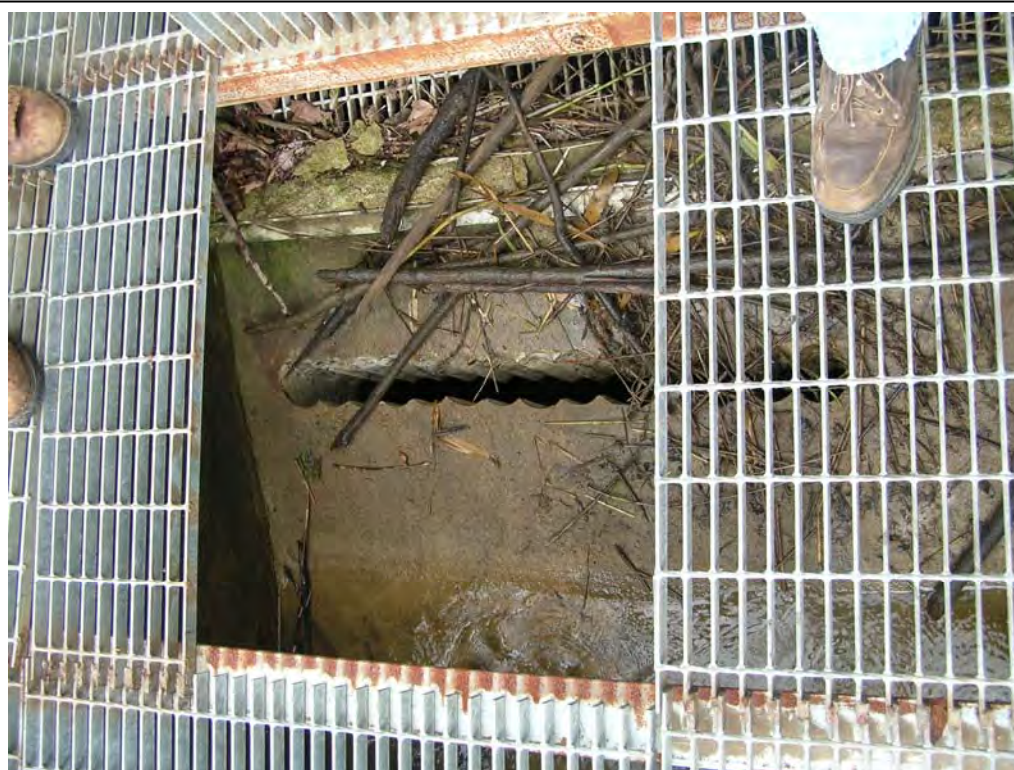
#19 – Mid-level Intake with Minor Woody Debris; Note Concrete Cores Creating Modified Intakes

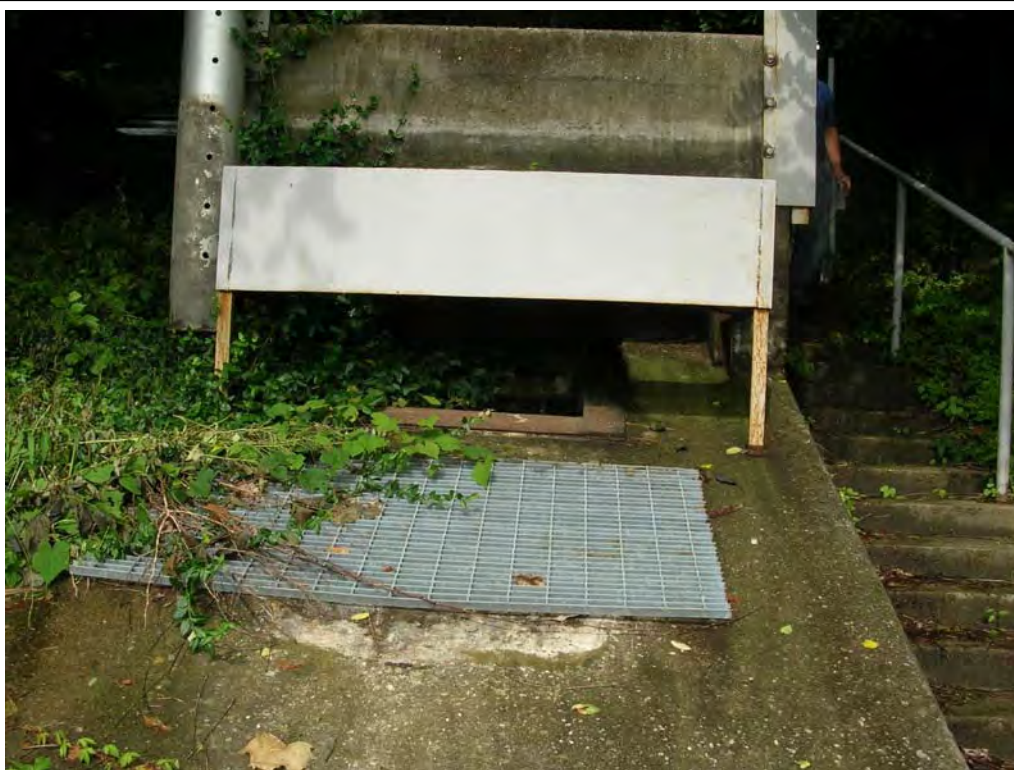
#21 – Minor Vegetative Growth Blocking Portion of Upper Intake (Vegetation Subsequently Removed)

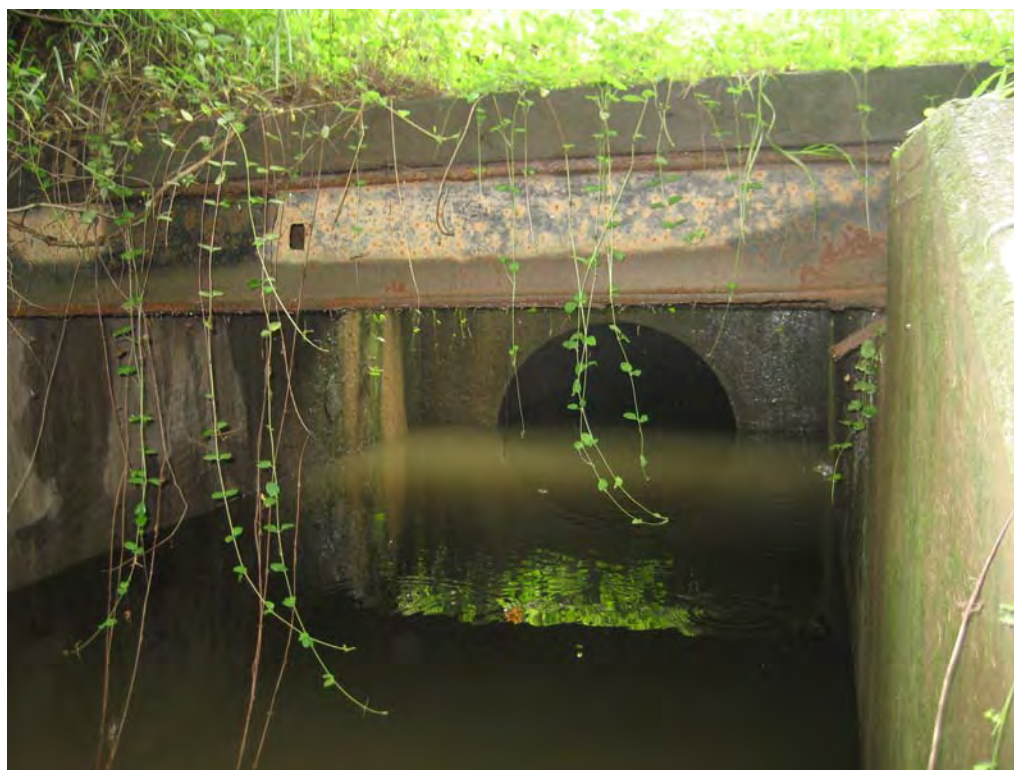
#22 – Outlet Headwall and Training Walls for 72-inch Discharge Pipe
