Re: Task 3 Dam Assessment Report
Project #0-381
Clifty Creek Station
South Fly Ash Pond
Madison, Indiana

EXECUTIVE SUMMARY

This Phase I Inspection/Evaluation Report details the results of a visual dam inspection of the Clifty Creek South Fly Ash Pond Dam (SFAP), located in Madison, Jefferson County, Indiana. The entrance to the plant is at Clifty Hollow Road, Route 56. The inspection was performed on June 11, 2009 by GZA GeoEnvironmental, Inc (GZA).

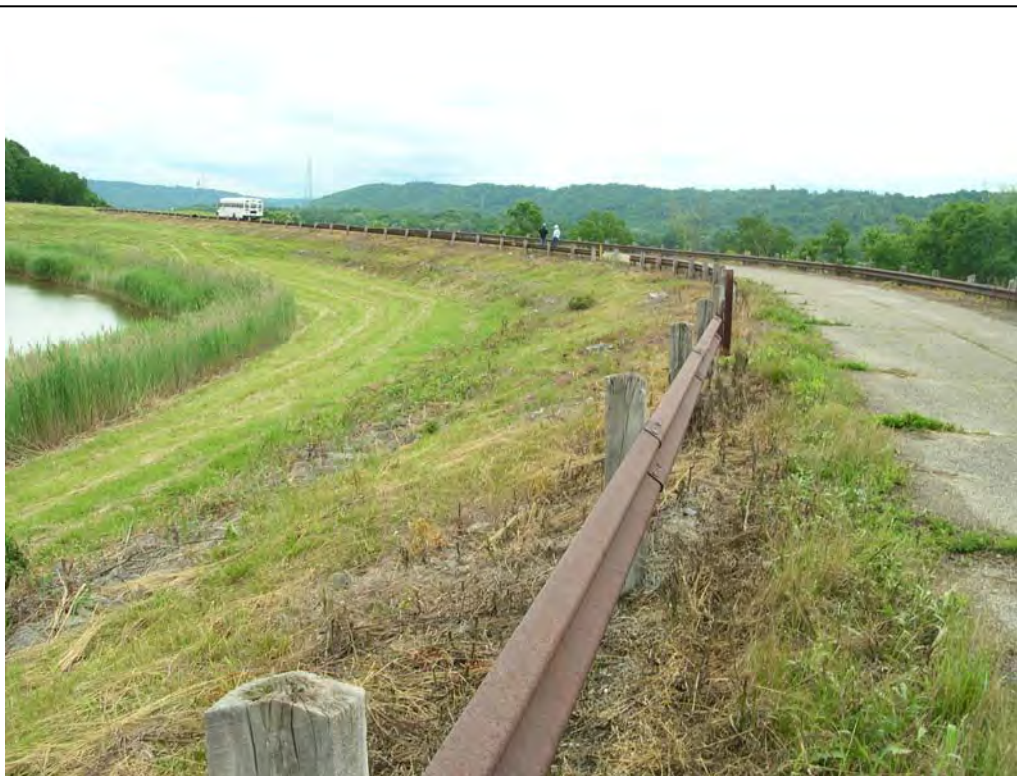
#2 – Upstream Face and Roadway at Crest with Wetland Growth at Pond Level

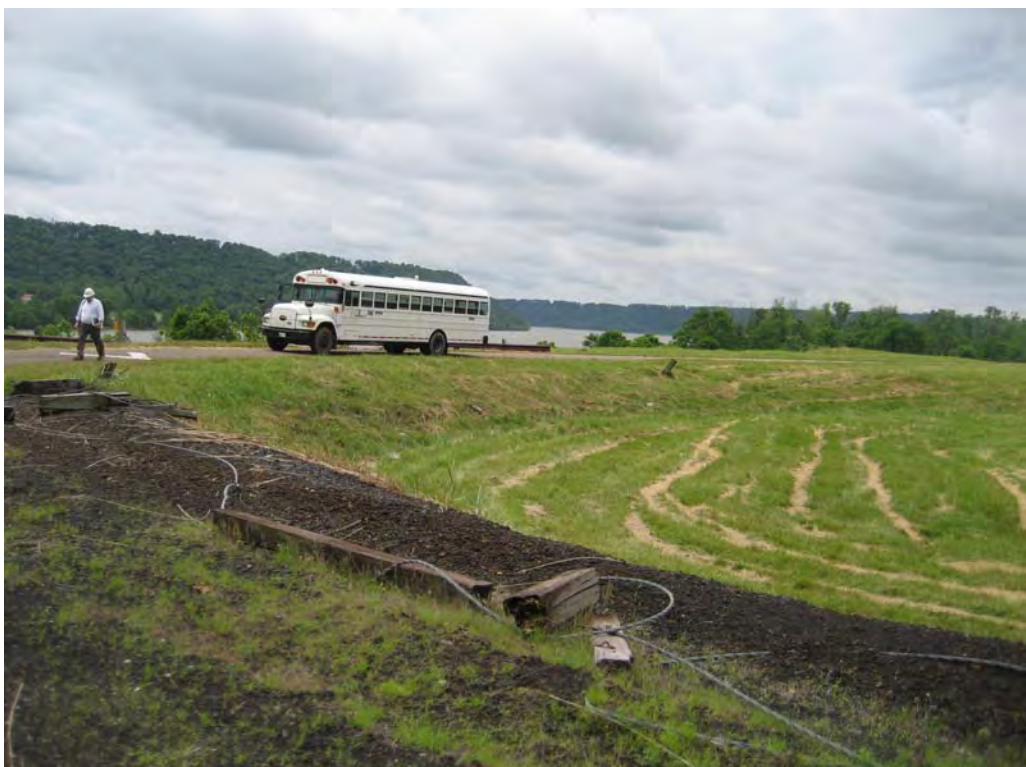
#4 – Stability Berm on Upstream Face Near Left Abutment

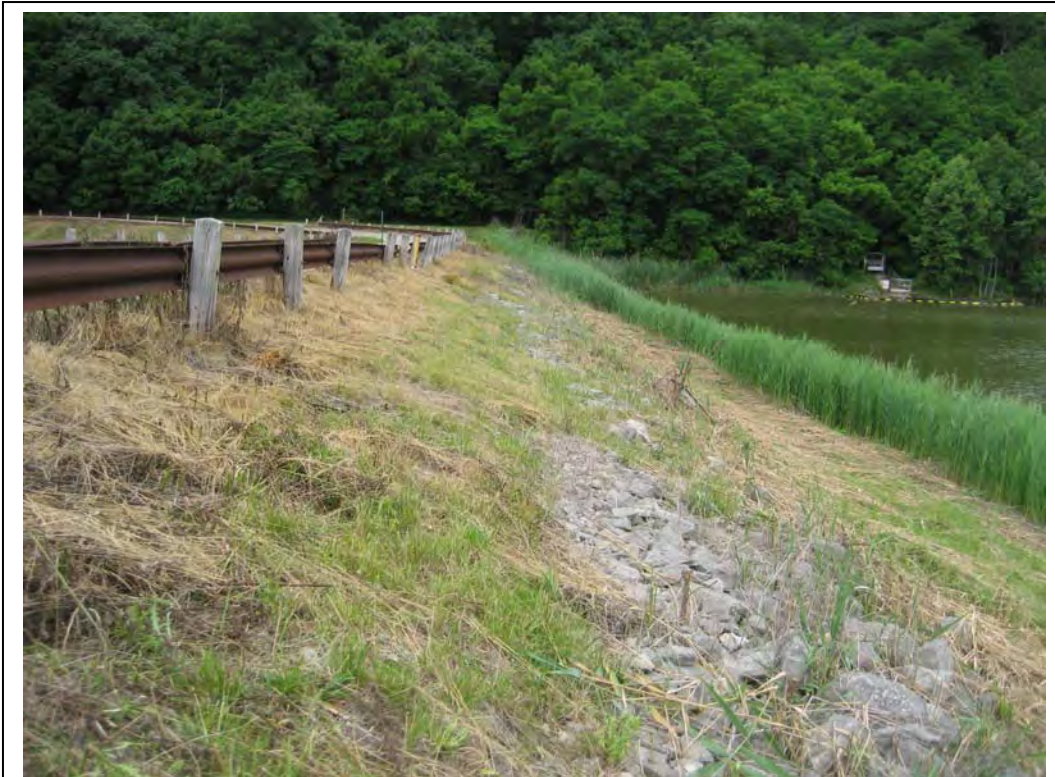
The upstream slope was built at slope of about 4.4H:1V. In general, the slope is in good condition and consists of cover of maintained short grass. Intermittently, the slope above the normal pool and top of dam was protected with small riprap. At the base of the slope, at the water line, the area contains 8 to 12-inch tall wetland grasses. No unusual movement or sloughing was observed. The slope at the saddle dike was much shallower sloped and irregular due to past filling. This area too was grassed, well maintained, and recently mowed.

#5 – Upstream Slope; Note Riprap Protection

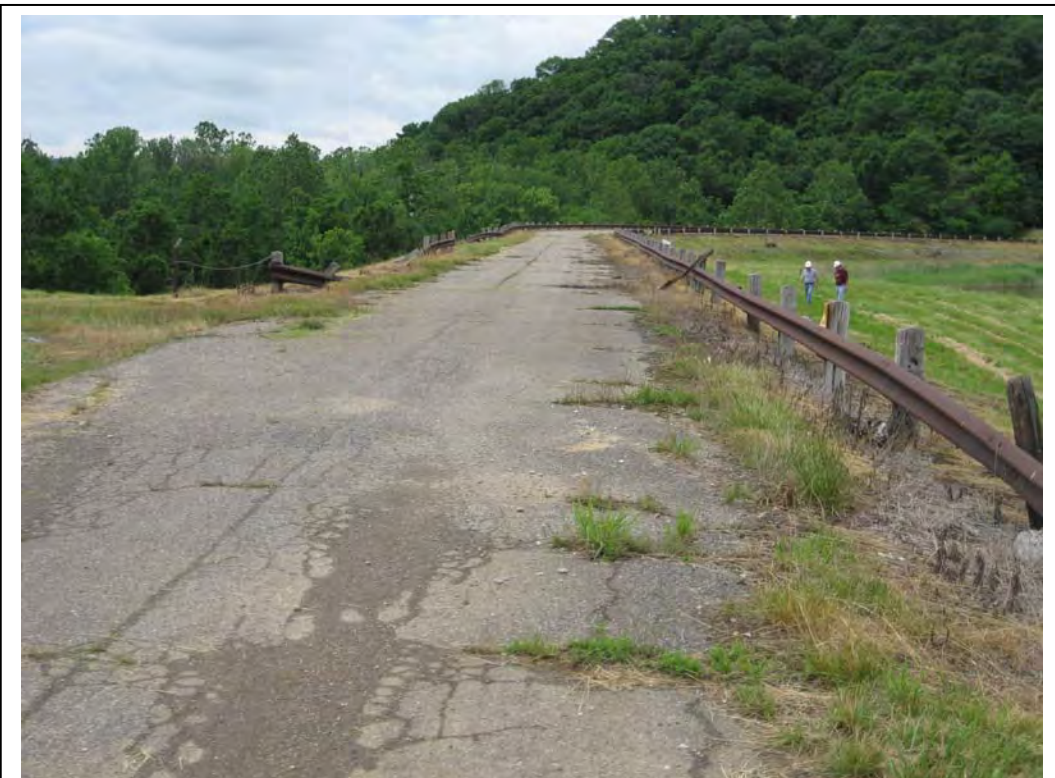
The top of the dam runs in a curvilinear shape following the natural high ground. It primarily consists of an asphalt paved surface serving as an access road for facility staff. The road was originally a public way. As reported earlier in this report, the crest's vertical alignment is fairly level, ranging from a low point elevation of 502.9 MSL about 300 feet east of the right abutment to elevation 504.7 and 505.92 MSL at the right and left abutments, respectively. The condition of the paved surface is fair to poor, with numerous lateral and longitudinal cracking. Encroachment of weeds and grass through many of the cracks, especially at the edges of the pavement is occurring. The guard rail on the majority of the crest is in poor condition.

#6 – Paved Crest Looking Toward Right Abutment

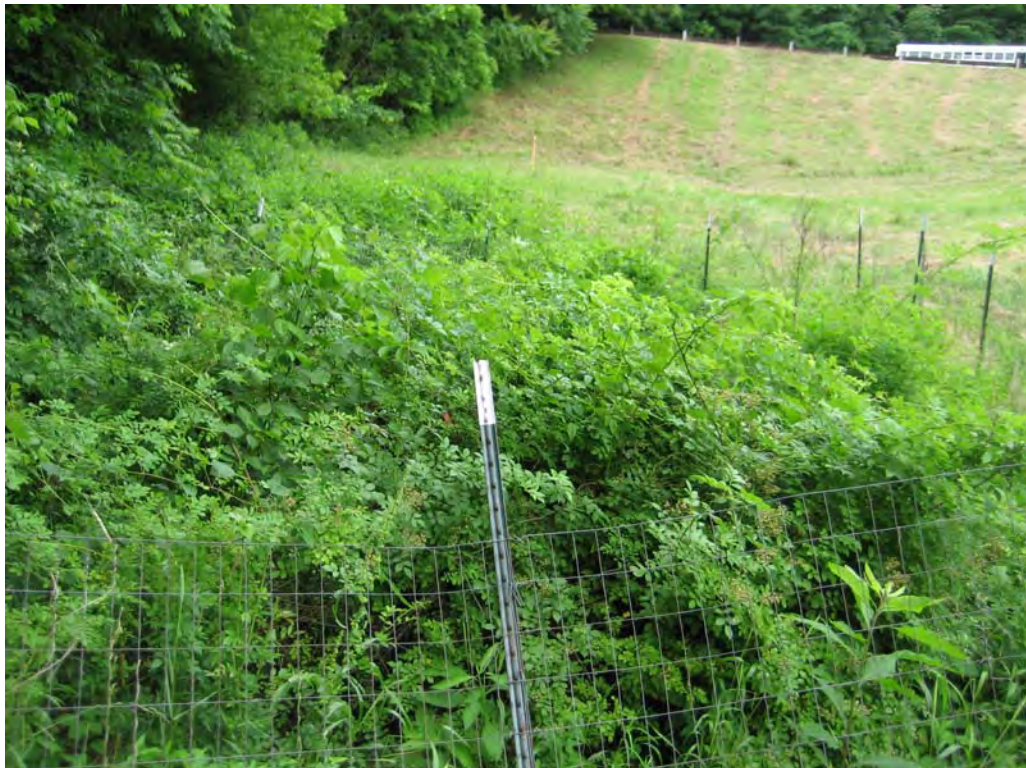
#10 – Downstream Slope Looking Up Toward Crest Near Right Groin. Overgrowth of Vegetation Near Outfall in Foreground of Picture.

1. Dense scrub vegetation covers the outfall to the 72-inch pipe at the toe of the dam. This vegetation should be removed and replaced with short grass cover to increase visual inspection in the future.
2. Numerous minor scarps existing on the downstream face of the saddle dike embankment. These should continue to be monitored for movement.
3. The floating debris boom at the spillway intake is in poor operating condition and should be repaired or replaced to better prevent debris from penetrating the intakes.

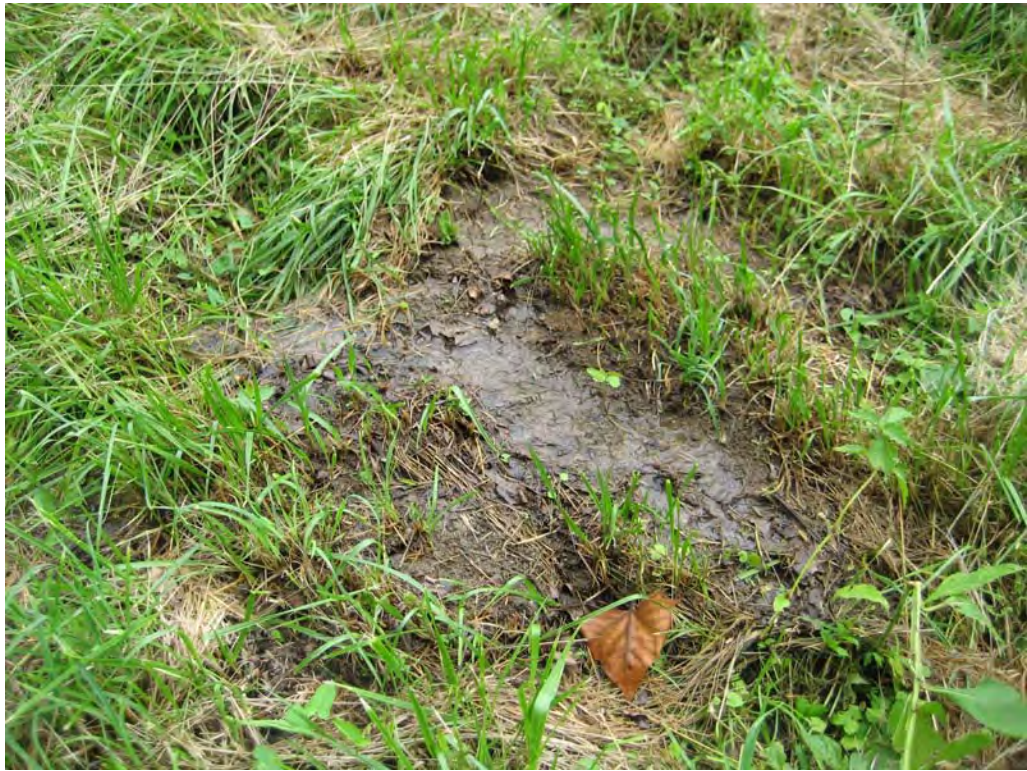
The downstream slope of the dam is generally in good condition. The face is consistently covered with grass, which was recently mowed. The main dam is set at a slope of about 2.7H:1V above elevation 474 and about 3.3H:1V below elevation 474, and appears to be stable. No unusual movement was observed. Surficial soils were somewhat saturated, but this was attributed to the heavy rainfall experienced in the days leading up to the field inspection. Surface runoff could be seen moving down the slope in several areas of the slope in the vicinity of the maximum section. Some shallow surficial erosion was noted near the base of the slope

(see Photo 11). The condition of the downstream slope at the saddle dike was found to be in similar condition. However, the surface did exhibit many shallow scarps owing to its 2:1 slope. Most scarps were healed and were fully vegetated. Based on discussions with AEP and IKEC personnel, this shallow movement in the saddle dike slope is a long-time condition. Previous filling at the toe had been done in an attempt to buttress the slope and mitigate the further sloughing of the slope. This was an issue noted in previous inspection reports and should continued to be monitored for further movement.

#11 – Soil Erosion Due to Surface Runoff at Toe Near Outlet Pipe Headwall

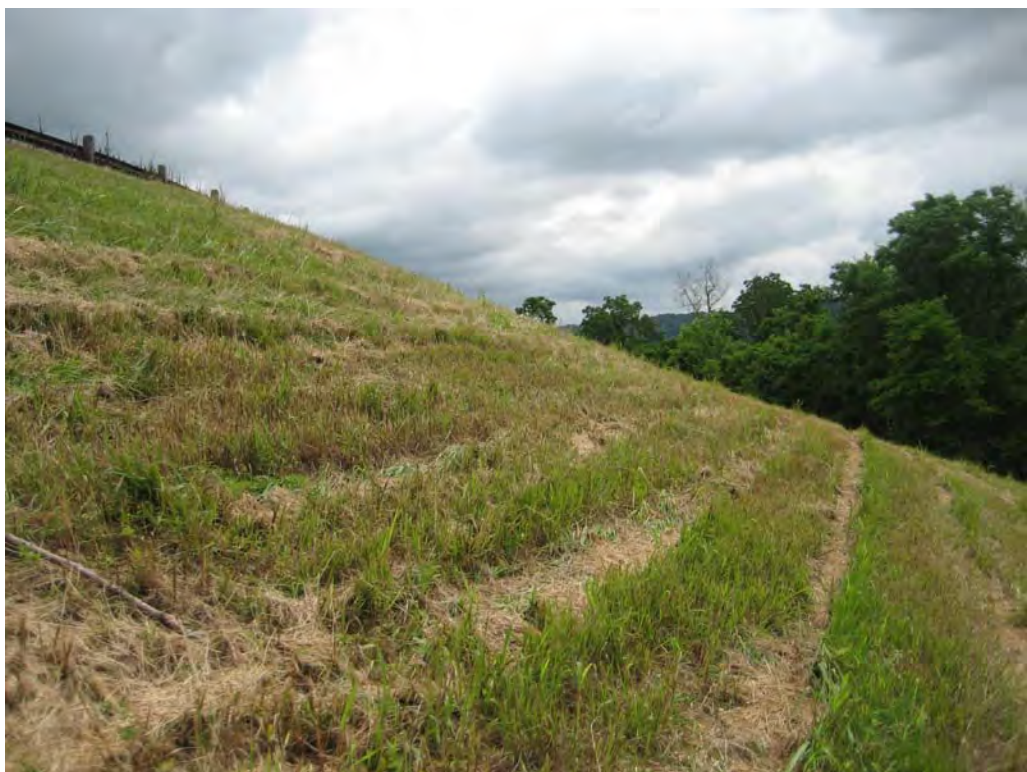
#12 – Typical Condition of Downstream Slope

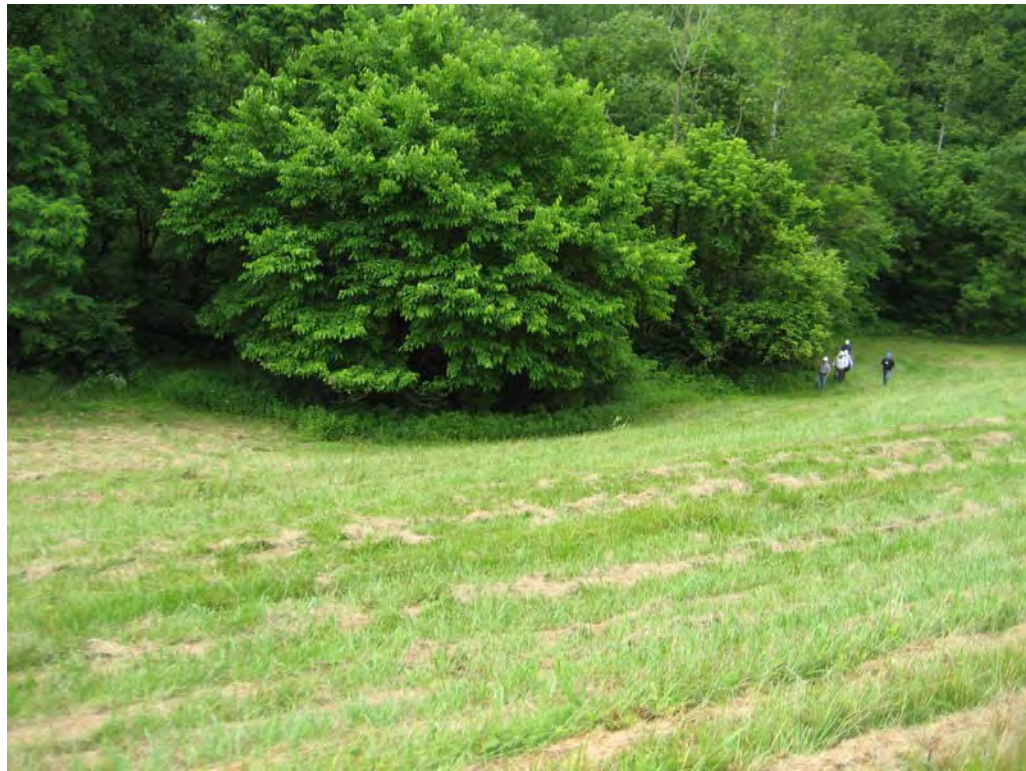
#13 – Downstream Face and Tree Growth Just Beyond Toe

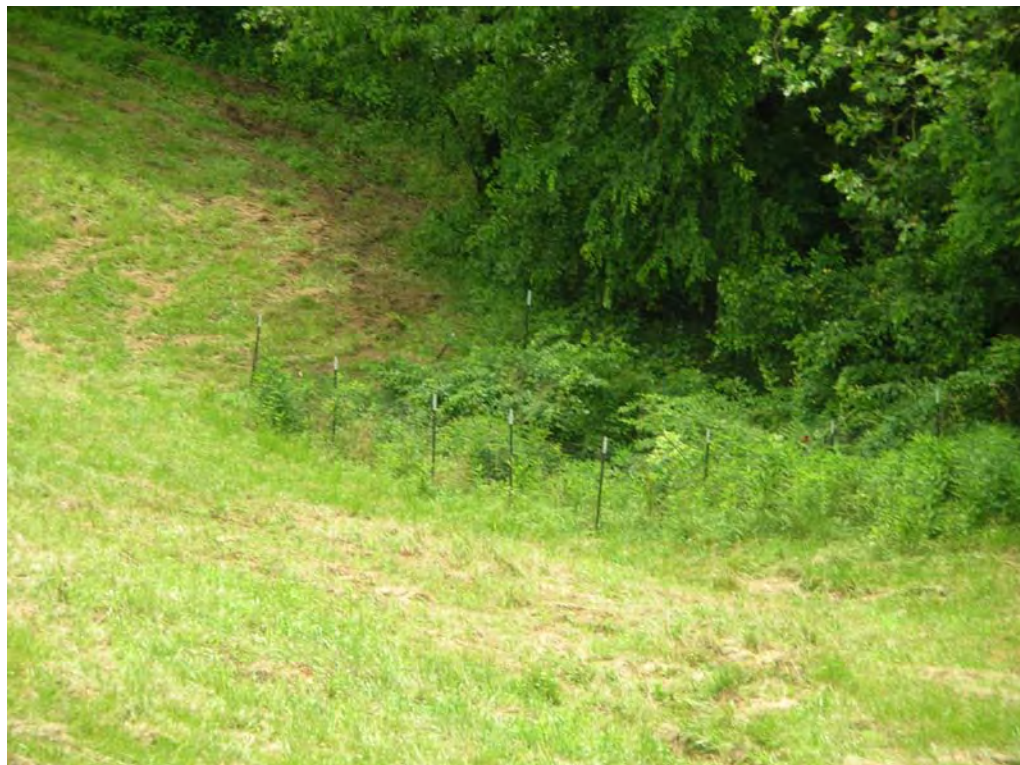
The end of the 72-inch RCP and associated head wall appeared to be in good conditions. Access to the structure was made difficult due to the dense overgrowth of the herbaceous vegetation on top of and the sides of the structure (see Photo 22). The tailwater extended about to the springline of the pipe. Flow was adequately dissipated prior to discharge to Panther Creek, with no erosion or other unusual movement observed.

#14 – Looking Downgradient at Toe at 72" Pipe Outfall Location; Note Heavy Growth

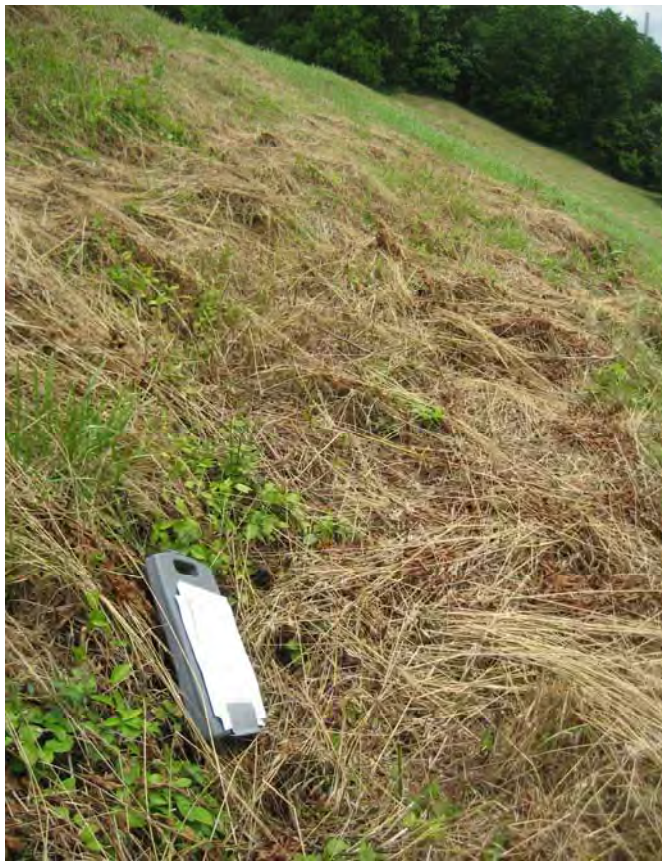
#17 – Typical Slope Scarp on Downstream Face on Saddle Dike

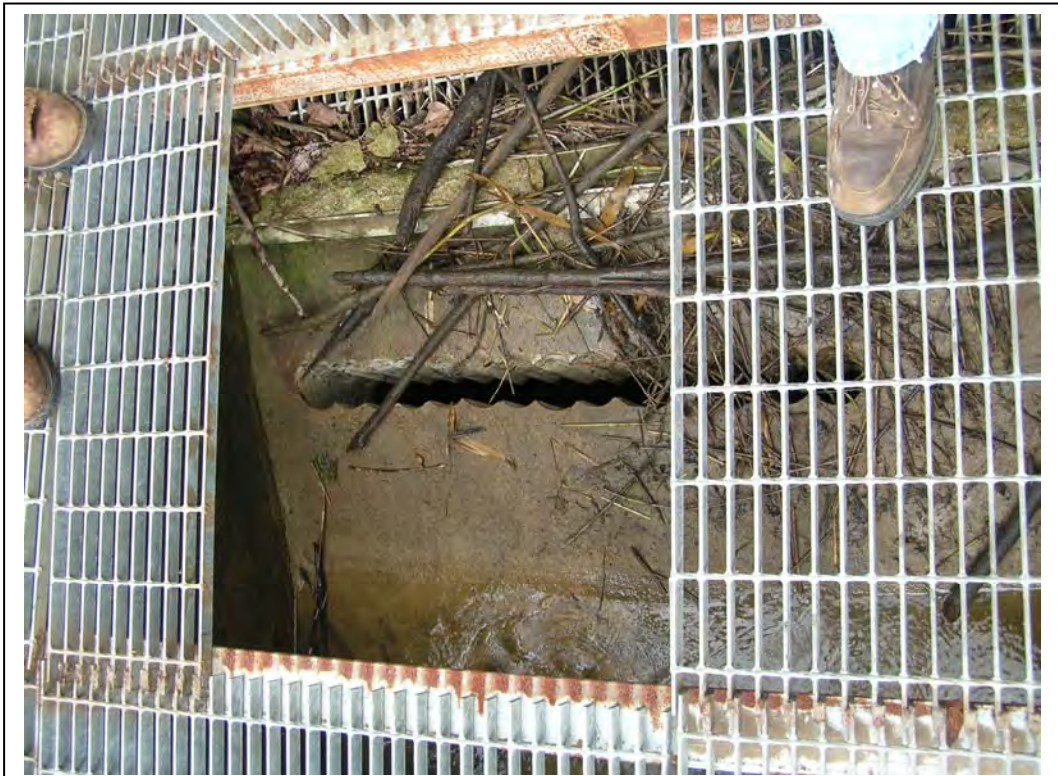
The water level in the pond is controlled by defined openings in the top of the reinforced concrete chute portion of the decant spillway. Access to the spillway was via the right abutment down a stairway which parallels the chute. The structure was in fair to good condition. Walkway grating, above the second intake, was in good condition. Some woody debris had accumulated on the grated inlets and newly cored opening (see Photo 19). More well established vegetation could be seen growing and partially blocking the third intake (see Photo 21). This debris and vegetation was subsequently removed by IKEC staff while we were on the site. IKEC staff demonstrated how the solid cover hatches over the intakes are removed. The ease to which one could open these hatches during a large storm event is questionable. The floating debris boom, located at the spillway intake, appeared to be in poor condition and partially submerged, allowing floatable objects to reach the intakes.

#19 – Mid-level Intake with Minor Woody Debris; Note Concrete Cores Creating Modified Intakes

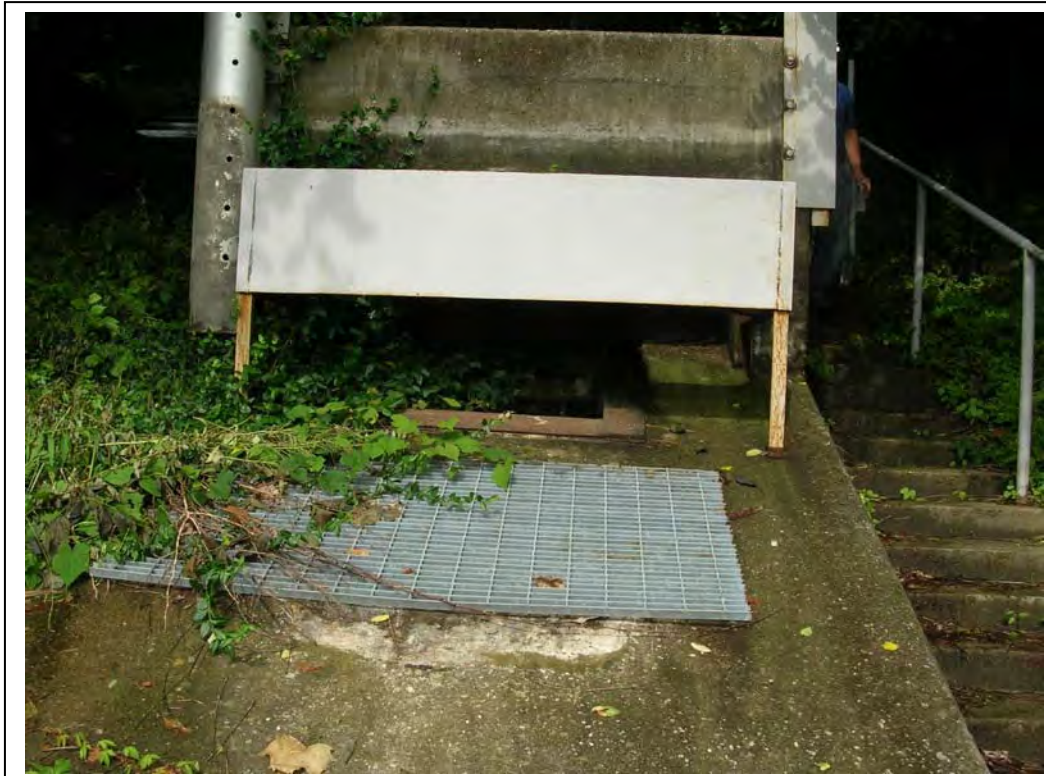
#21 – Minor Vegetative Growth Blocking Portion of Upper Intake (Vegetation Subsequently Removed)

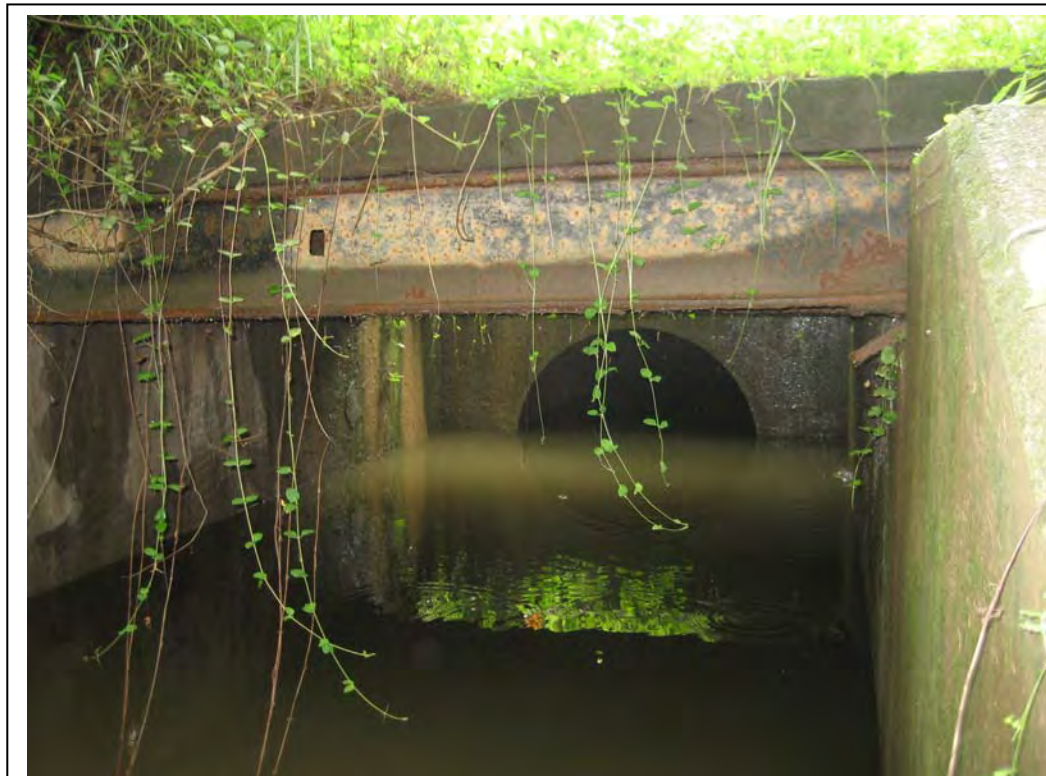
#22 – Outlet Headwall and Training Walls for 72-inch Discharge Pipe
