# Assessment of Dam Safety of Coal Combustion Surface Impoundments

**Coletto LP, LLC**

**Coletto Creek Power, LP**

**August 4, 2010**

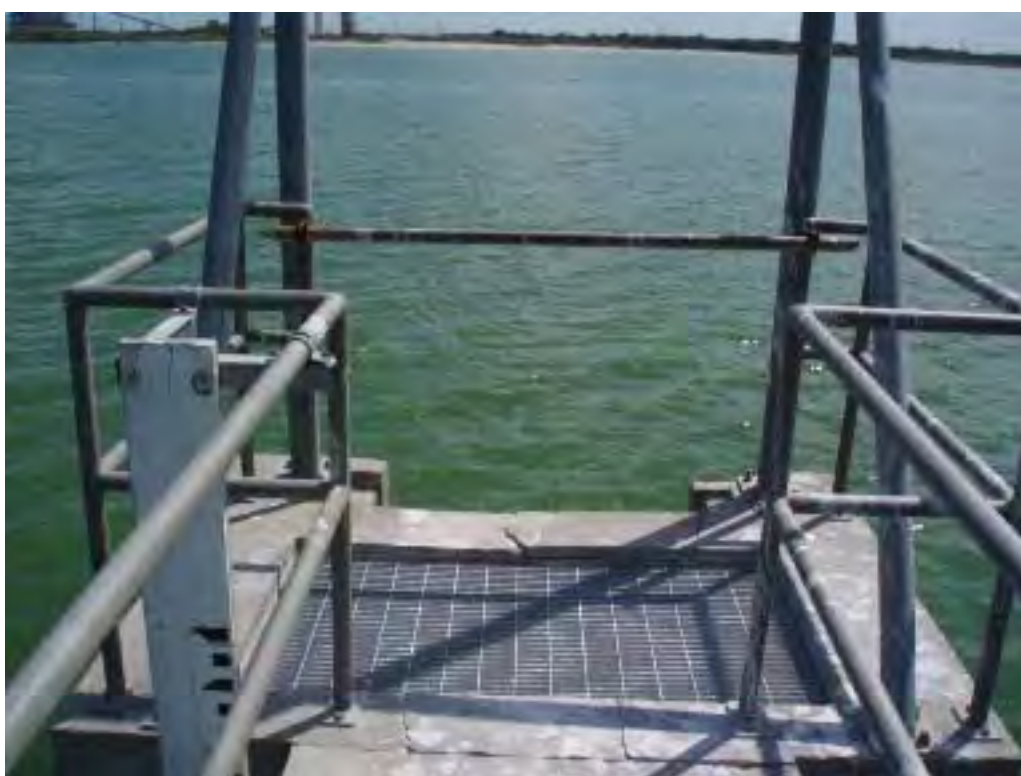
The inlet structure in the Primary Ash Pond appeared to be in fair condition (Photo 6, 7, and 8). The inlet structure was clear of debris. Some cracking in the concrete around the top of the intake structure was observed (Photo 7). The remainder of the structure above the water level and the catwalk appeared to be good condition.

Photo No. 8: Close-up of inlet structure, looking southwest.

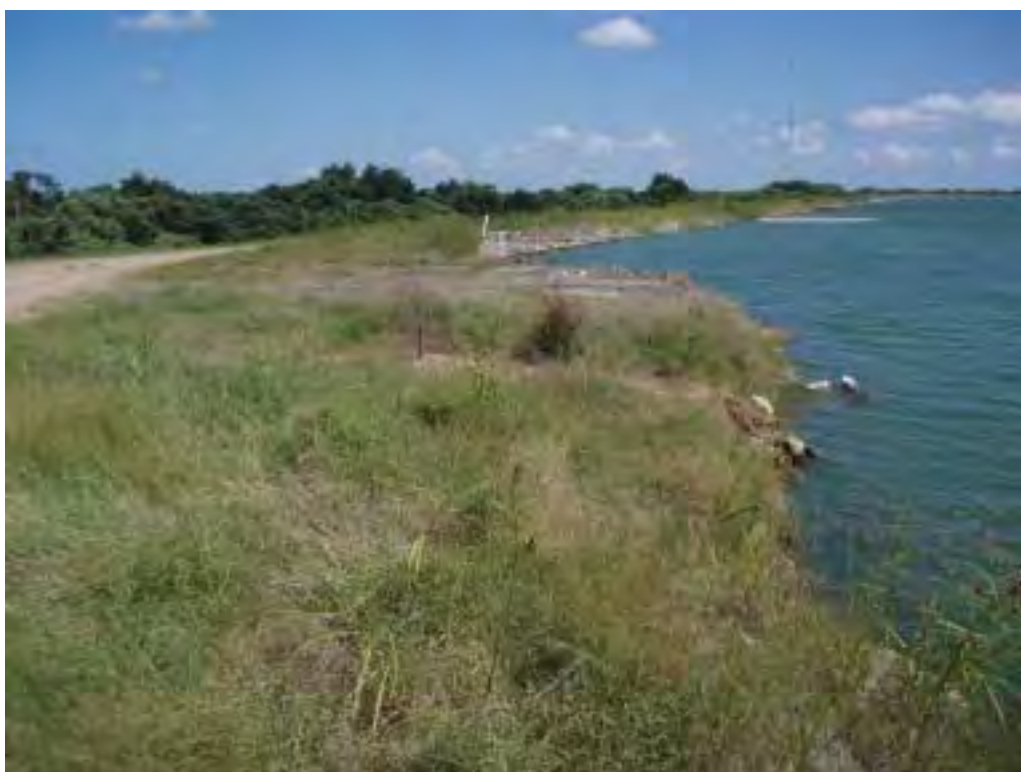
Two areas on the east embankment were observed where BMT has dumped excess flyash and bottom ash and pushed the material into the Primary Ash Pond (Photo 12). No riprap erosion protection was present in these areas.

Photo No. 12: Primary Ash Pond - East interior slope, looking southeast. Note areas where Boral trucks have dumped excess material on the interior slope.

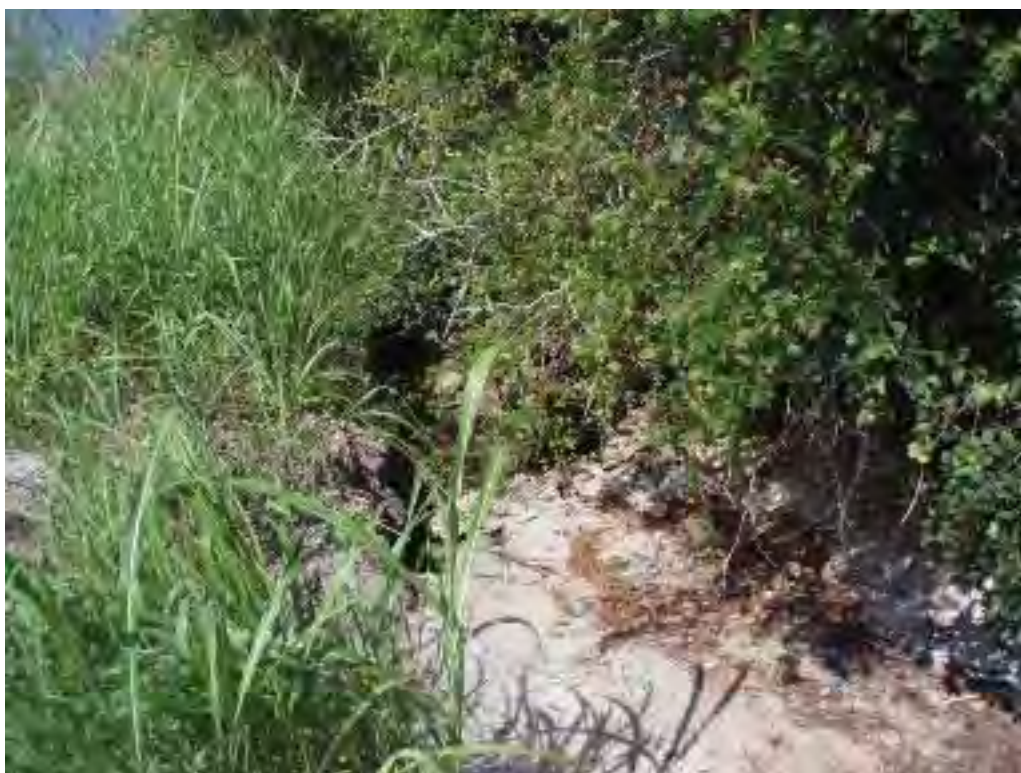
The outlet pipes and recirculating pump station appeared to be in fair condition (Photos 19, 20, 21, and 24). The outfall in the discharge canal appeared to be in poor condition (Photo 22). The discharge channel has deteriorated. The concrete is overgrown with vegetation, cracked and spalled, and sections of the channel are missing exposing the underlying soil.

Photo No. 22: Overview of outfall channel. Note channel is deteriorated. Concrete is cracked, spalled, and missing and there is exposed soil.

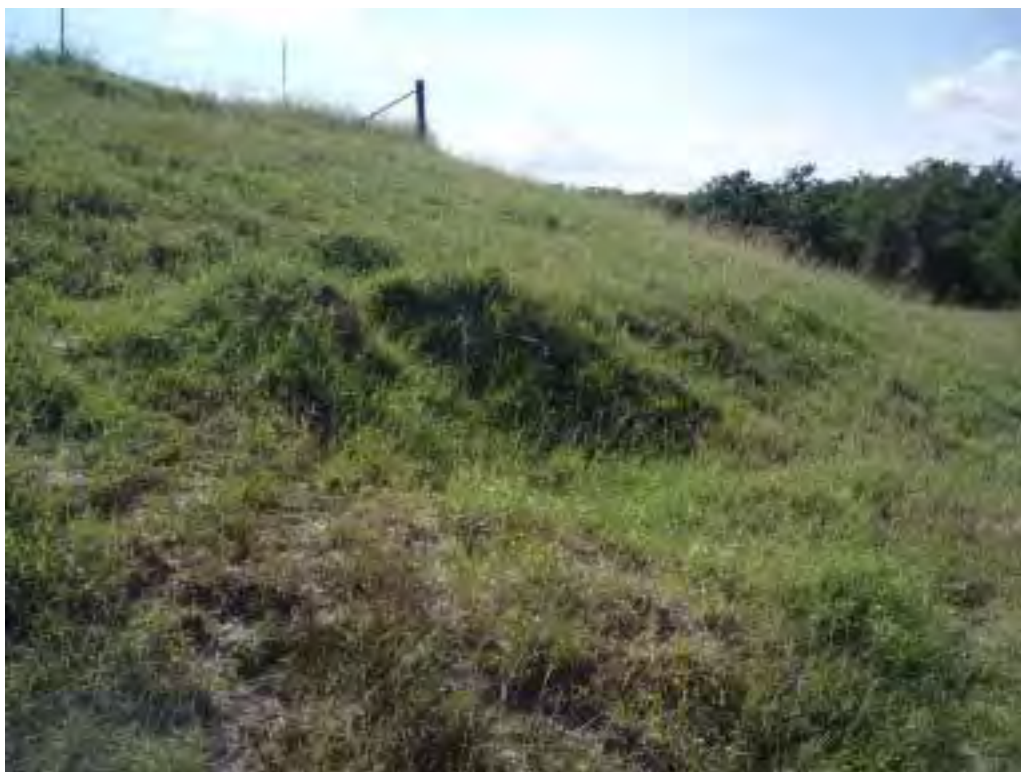
Multiple depressions were observed on the north and east embankment exterior slopes (Photos 28, 30, 31, 32, and 36). The depressions ranged in size from 4 to 8 feet long and up to 3 feet deep. The depressions appear to be grown in erosion rills because no displaced material was observed below the depressions. Multiple erosion rills were observed at the toe of the north embankment exterior slope (Photo 33, 34, and 36). The erosion rills ranged in size from 6 to 10 feet long and up to 3 feet deep.

Photo No. 32: Secondary Pond - North embankment exterior slope, looking at 8'Lx8'Wx3'D depression.

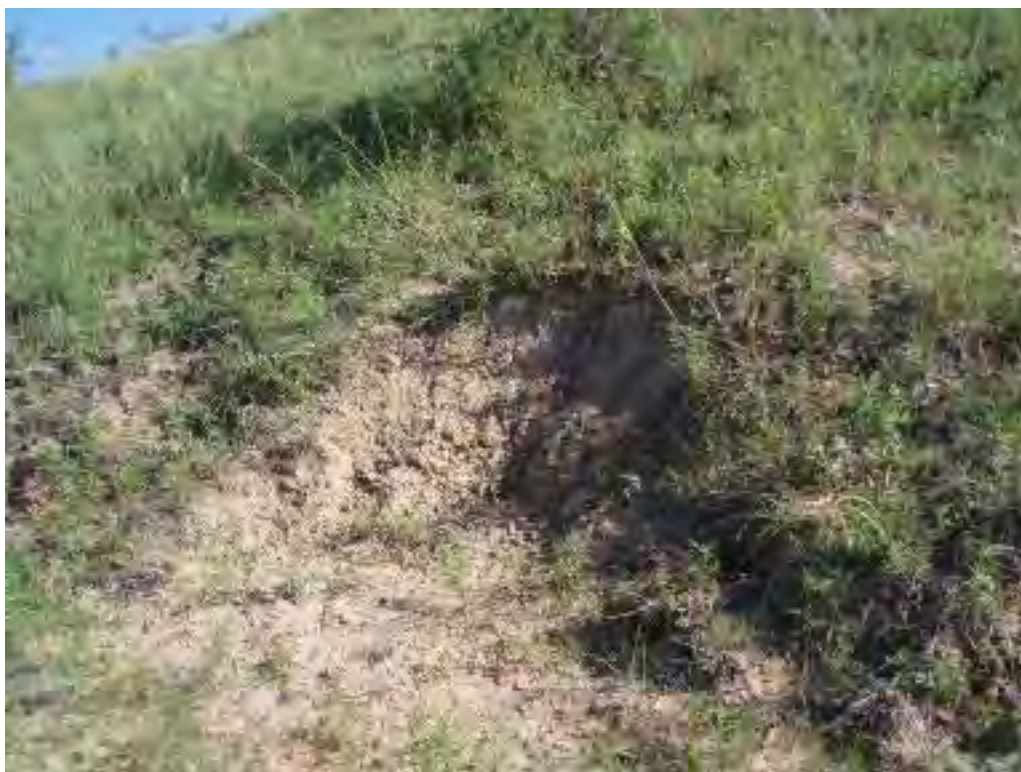
Photo No. 34: Secondary Pond - North embankment exterior slope, looking at 8'Lx4'Wx2'D erosion rill.

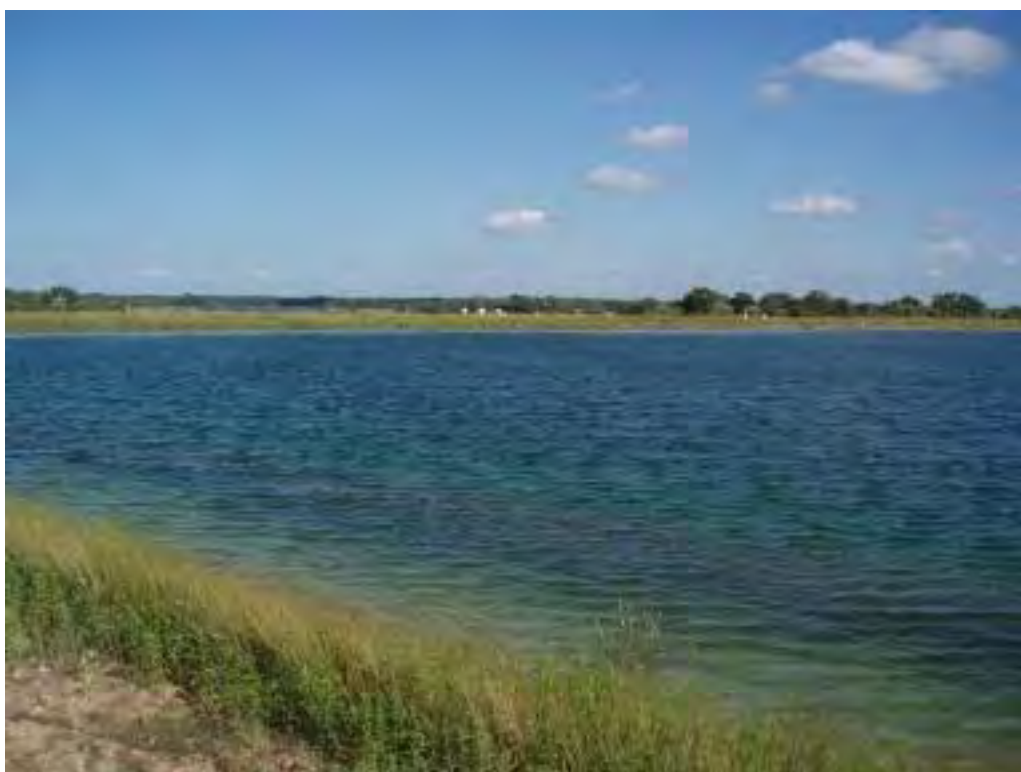
Photo No. 44: Secondary Pond - Looking southeast at east embankment interior slope from north embankment.

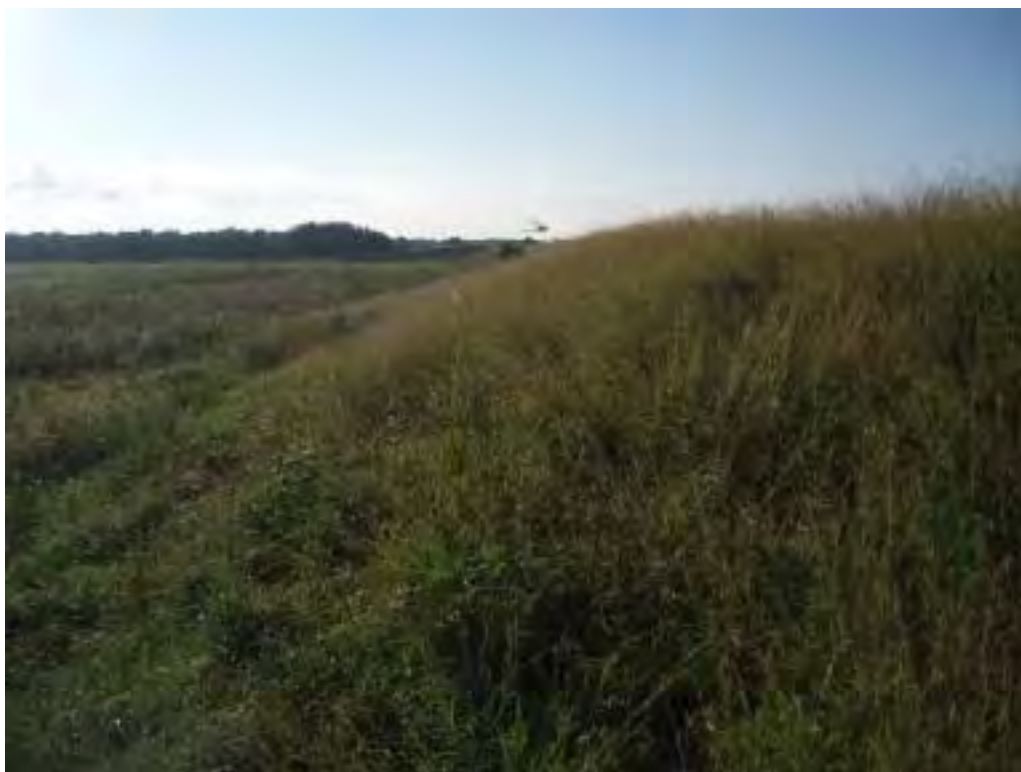
Photo No. 56: Primary Ash Pond – North embankment exterior slope, looking east.

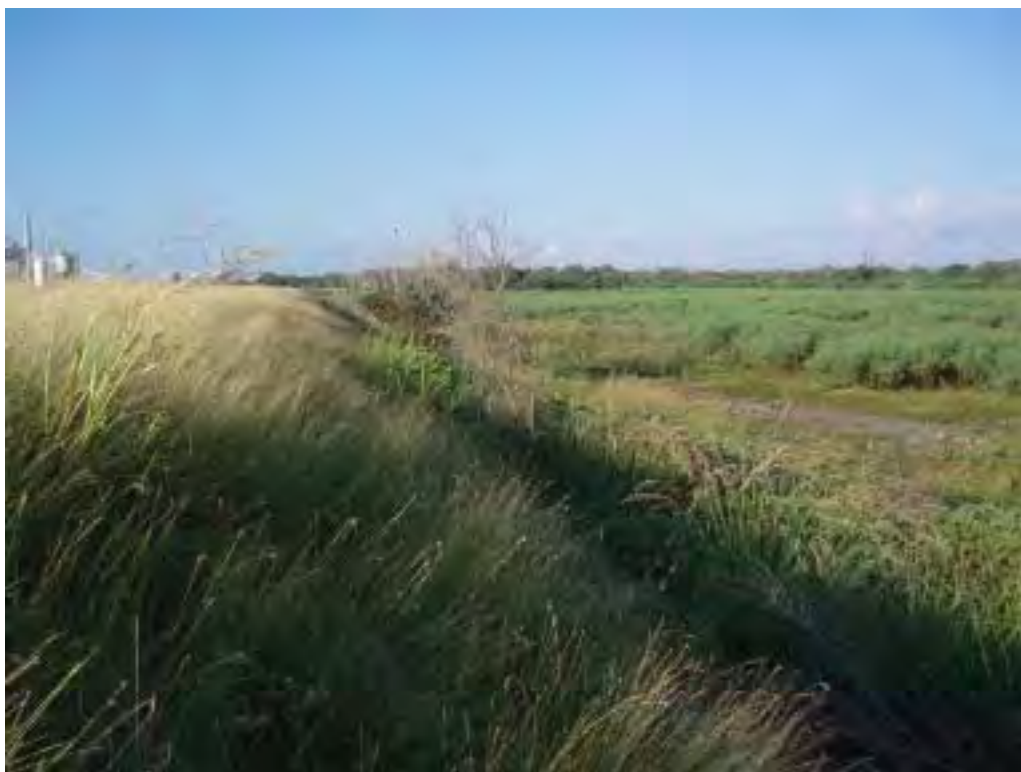
Photo No. 66: Primary Ash Pond - West embankment exterior slope, looking south at thick vegetation and mesquite trees.

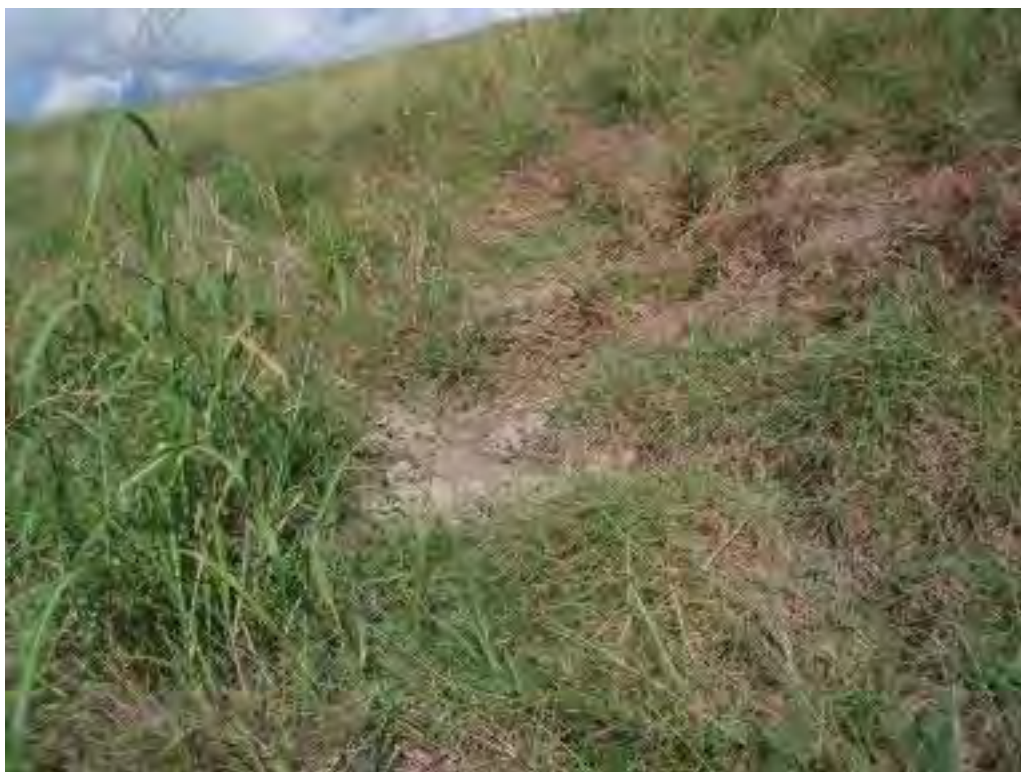
On the southeast embankment two seeps were observed. One of the seeps appeared to have developed at the location of an 8-inch-diameter animal burrow (Photo 97). The other seep observed on the southeast embankment was near the toe of the slope and was approximately 8-feet-long by 2-feet-wide (Photo 98). Flow from the seeps was estimated to be less than 10 gallons per day (gpd).

Photo No. 98: Primary Ash Pond – Southeast embankment exterior slope, looking at 8'Lx2'W seep near toe.

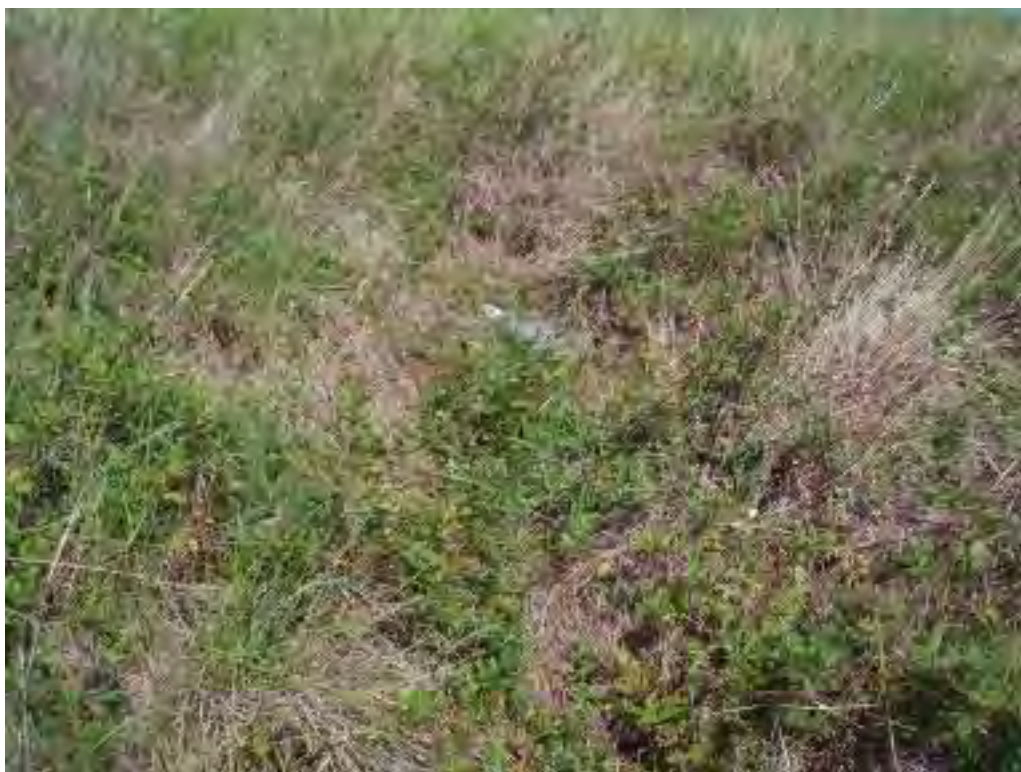
Photo No. 106: Primary Ash Pond - East embankment exterior slope, looking at 4'Wx4'Lx2'D depression. Note apparent dried seepage areas in the vicinity.

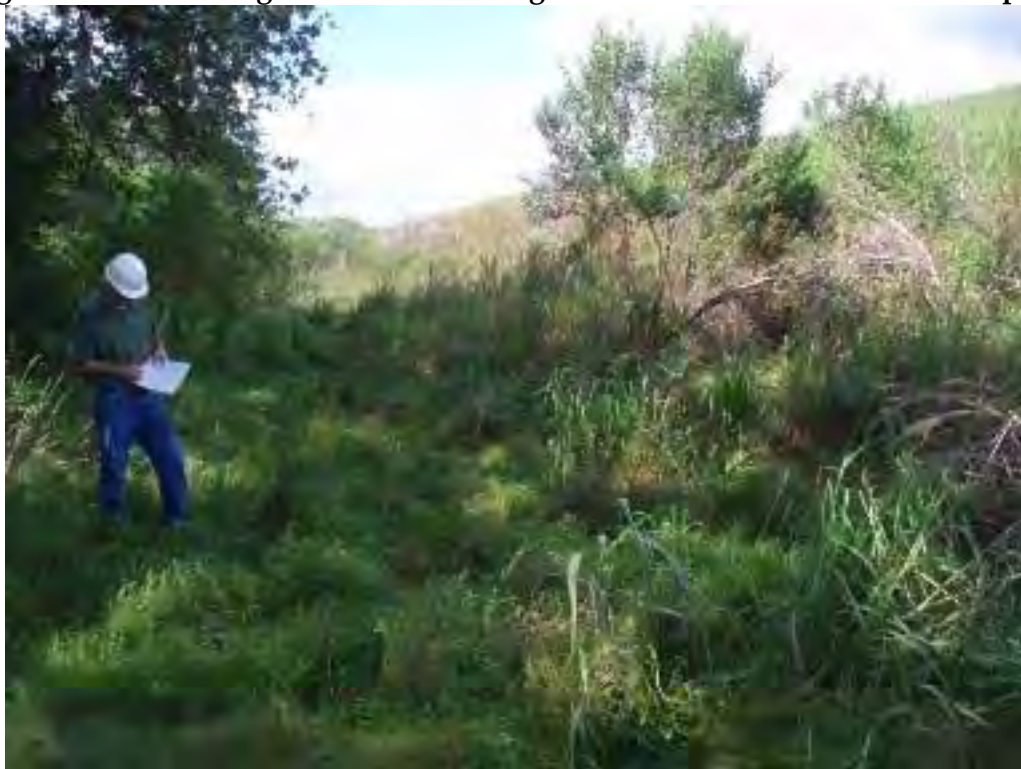
There were multiple seeps observed on the east embankment exterior face and in the toe area. An approximately 40-foot-long by 10-foot-wide seep was observed on the lower third of the slope (Photo 105). To the north of that seep there were more minor seeps that were less than 2-feet-wide and observed near the toe of the slope. These seeps appeared dry and crusted at the time of the site visit. A surface depression approximately 4 feet long by 4 feet wide by 2 feet deep was also observed in the area (Photo 106) of these seeps. A large seepage area approximately 400 feet long by 20 feet wide was observed at the embankment toe area (Photos 107 and 108). The seepage area was saturated, soft, and boggy with standing water up to 12 inches in depth. Well established vegetation, mesquite trees, and hog wallows were also observed in this seepage area. Seepage rates could not be estimated in the area of this large seep due to its extent.

Photo No. 108: Primary Ash Pond - East embankment exterior slope, looking south at end of approximately 400-foot-long seepage area.
