# ASSESSMENT OF DAM SAFETY OF COAL COMBUSTION SURFACE IMPOUNDMENTS – DRAFT REPORT

**Columbia Power & Light  
Department**

**Columbia Municipal  
Power Plant  
Columbia, Missouri**

October, 2012  
Revision 1, July 2013

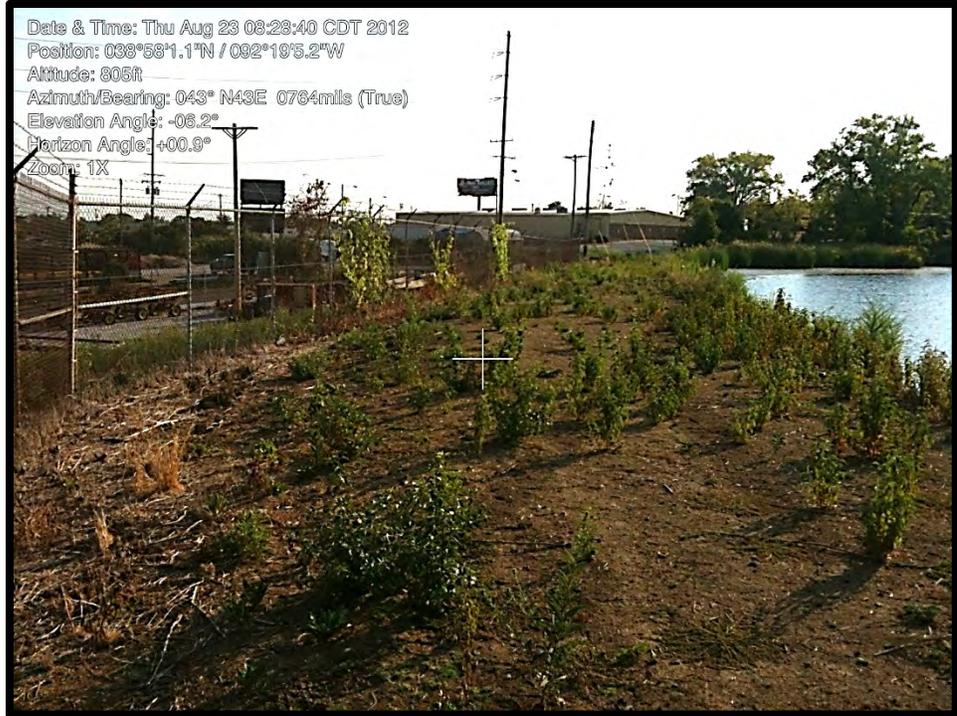
Photograph 5.1. Crest of Dam Looking Northeast

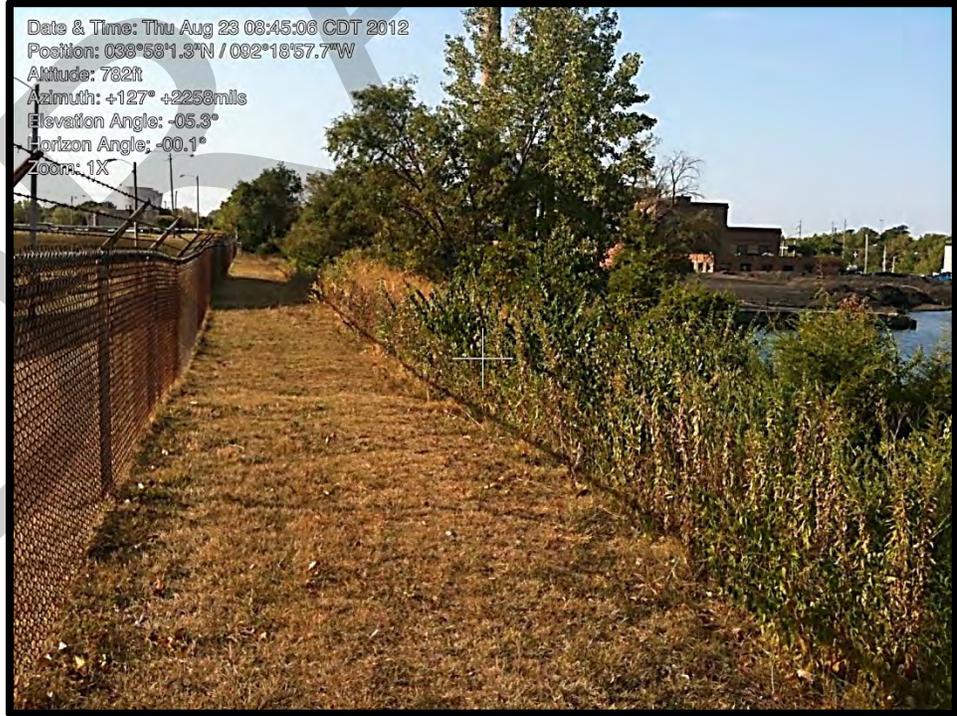
Photograph 5.2. Crest of East Embankment with Overgrown Vegetation and Tree on Inside Slope Looking South

- e. The removal of trees, shrubs and bushes on or near the embankment is recommended. The greatest density of this vegetation was observed along the east and north-east portions of the embankment. Vegetation removal should include the majority of roots within the footprint of the embankment. Compacted structural fill should be used to backfill excavations and holes made in the embankment areas before restoring final grades with compacted native materials free of debris and organic materials.

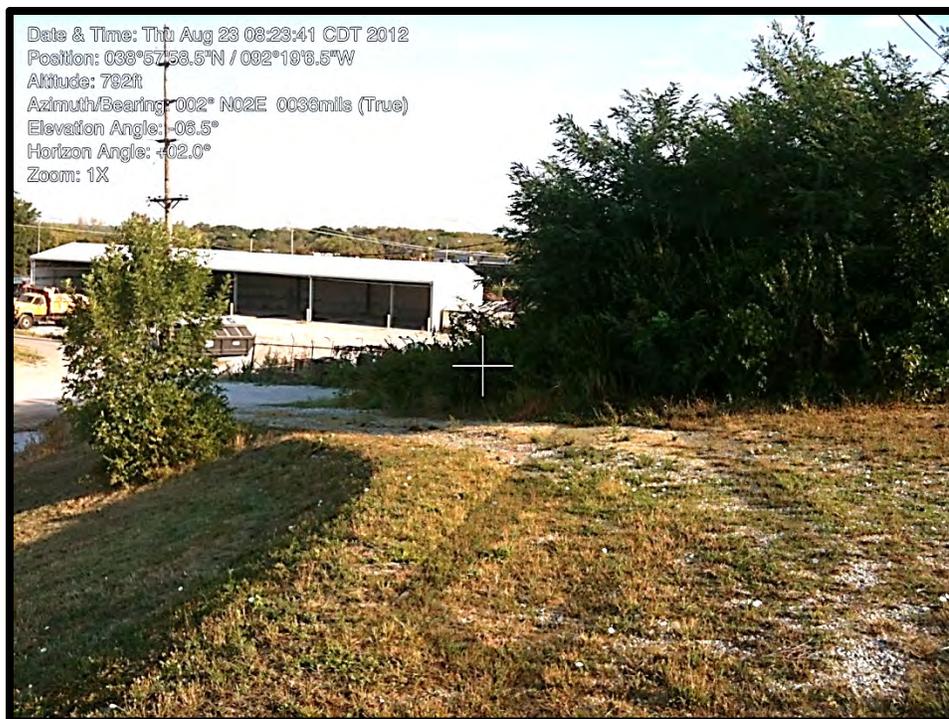
Photograph 5.3. Gravel Road on Downstream Slope of Dam

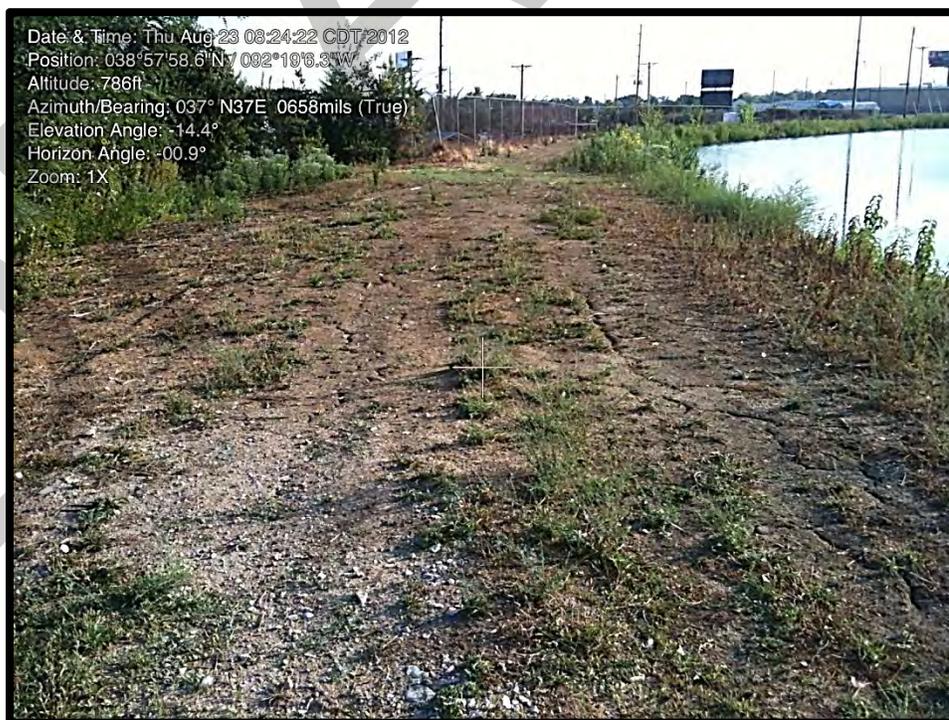
Shrinkage cracks were observed on the crest of the west embankment, and also erosion features on the inside slopes of the west and south embankments. The collection basin for the outfall drain of the impoundment appeared to be in good condition, with water flowing freely through the top of the basin at the time our visit.

Photograph 5.4. Crest of Dam Showing Shrinkage Cracks Looking North

- b. Shrinkage cracks on the crest of the west embankment (dam) should be documented; backfilled and grass cover should be established to protect the surface from shallow erosion and slope failures. Irrigation and periodic inspections should be conducted to maintain these grass covered slopes.

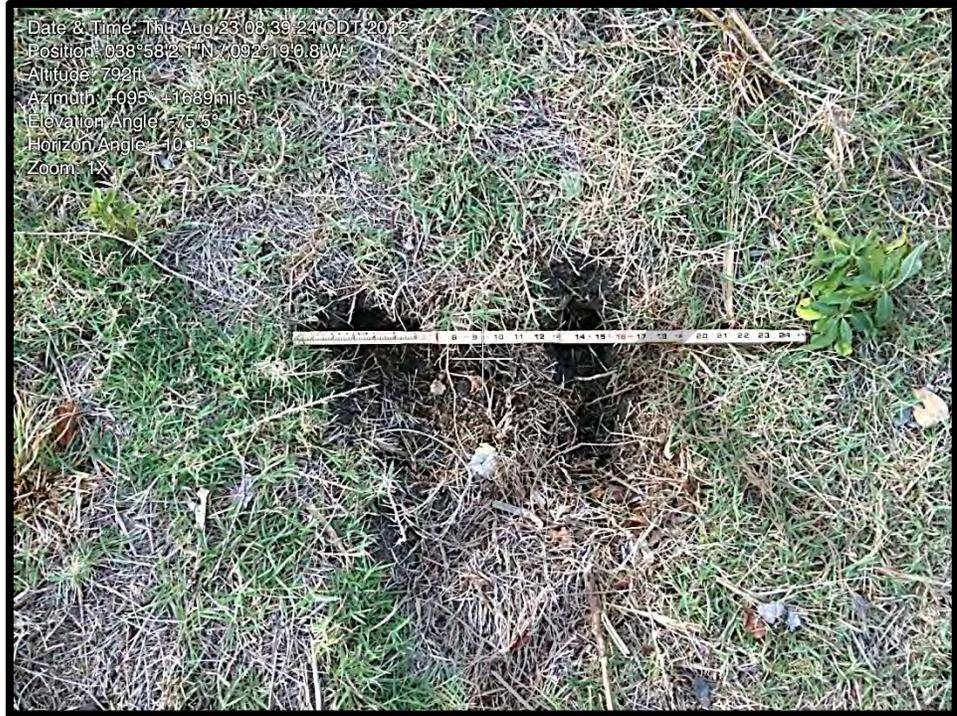
Photograph 5.5. Animal Burrow on North Embankment

- d. Animal burrows were observed and have reportedly been an ongoing problem. Areas disturbed by animal activity should be documented, the animals removed, and the burrows backfilled with compacted structural fill to protect the integrity of the embankments.

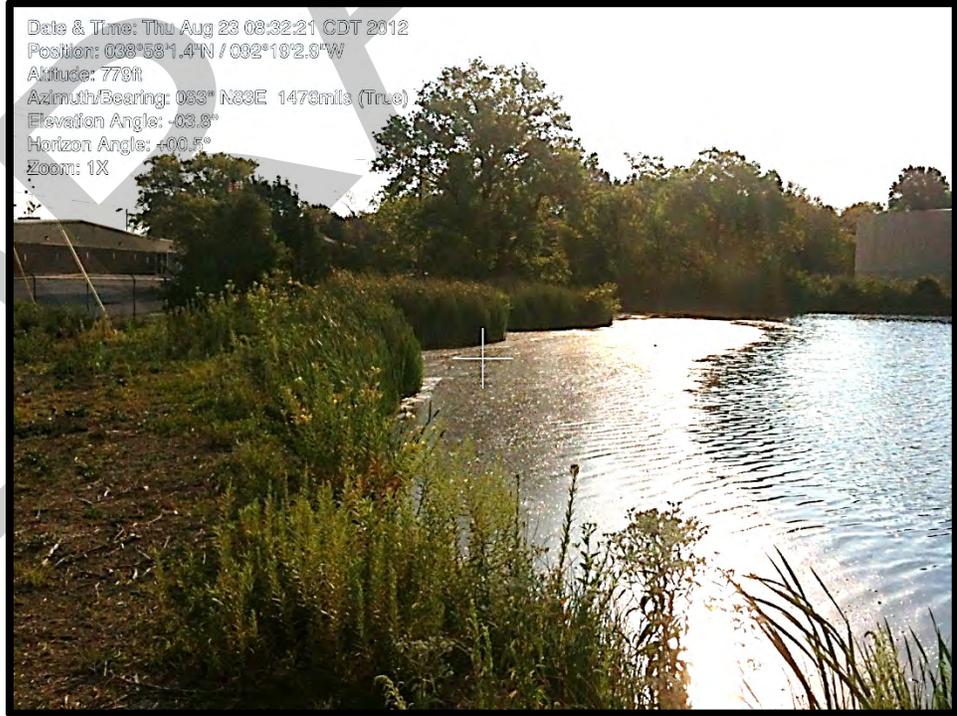
Photograph 5.6. North Embankment with Trees in Background Looking East

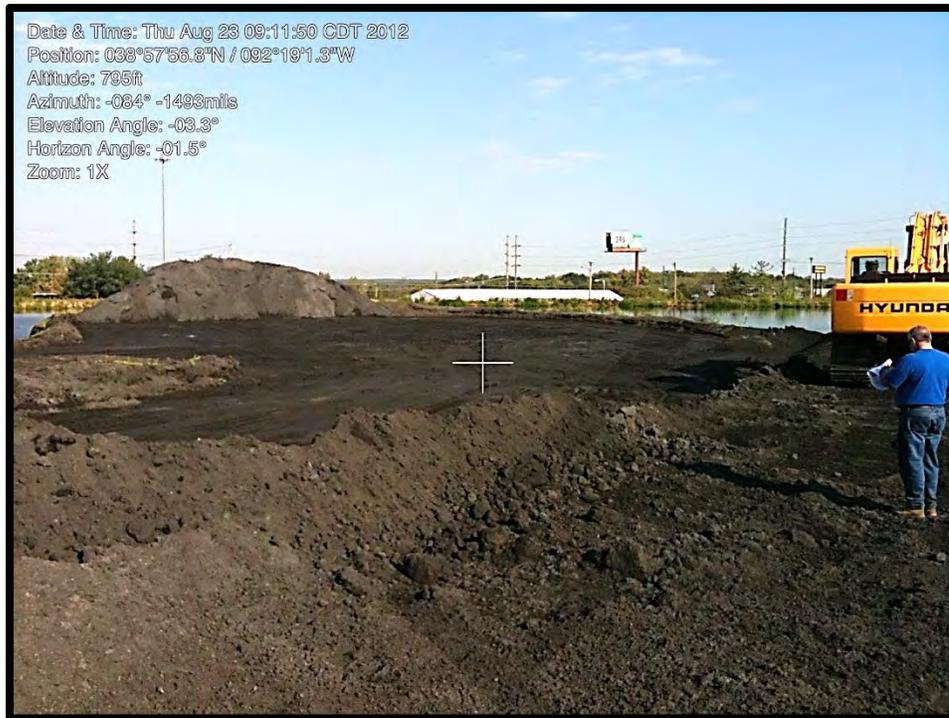
**Photograph 5.7. Drying Coal Ash on South Embankment Looking Northwest**

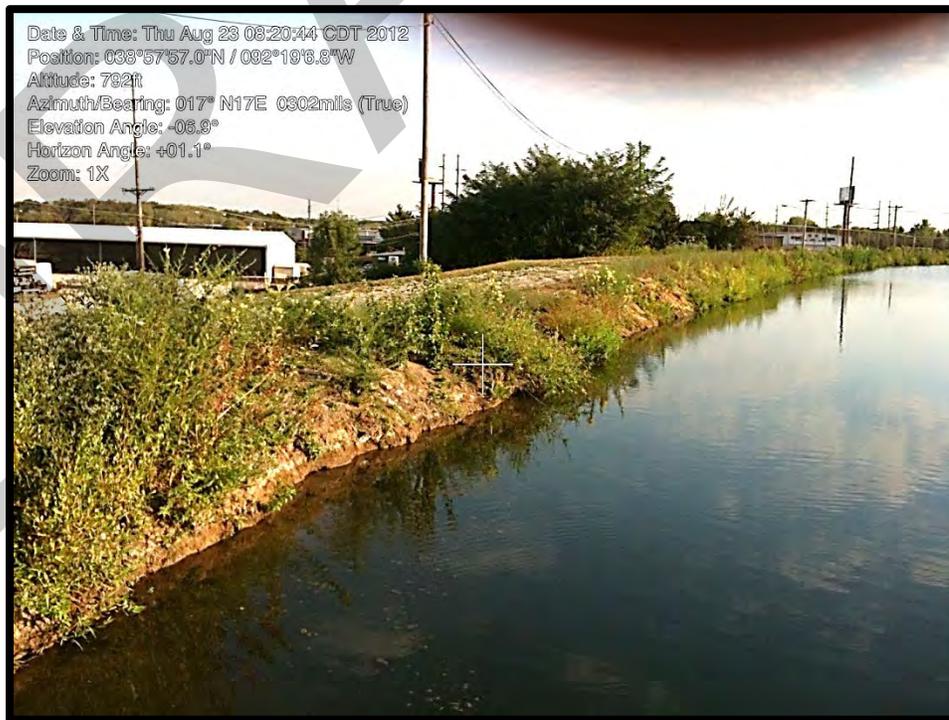
**Photograph 5.8. Erosion Features on Inside Slope of West Embankment Looking North**

- c. Erosion was observed on the inside slopes of the west and south embankments. To restore areas of erosion, it is recommended to place and compact structural fill or riprap in eroded areas and grade to adjacent contours.

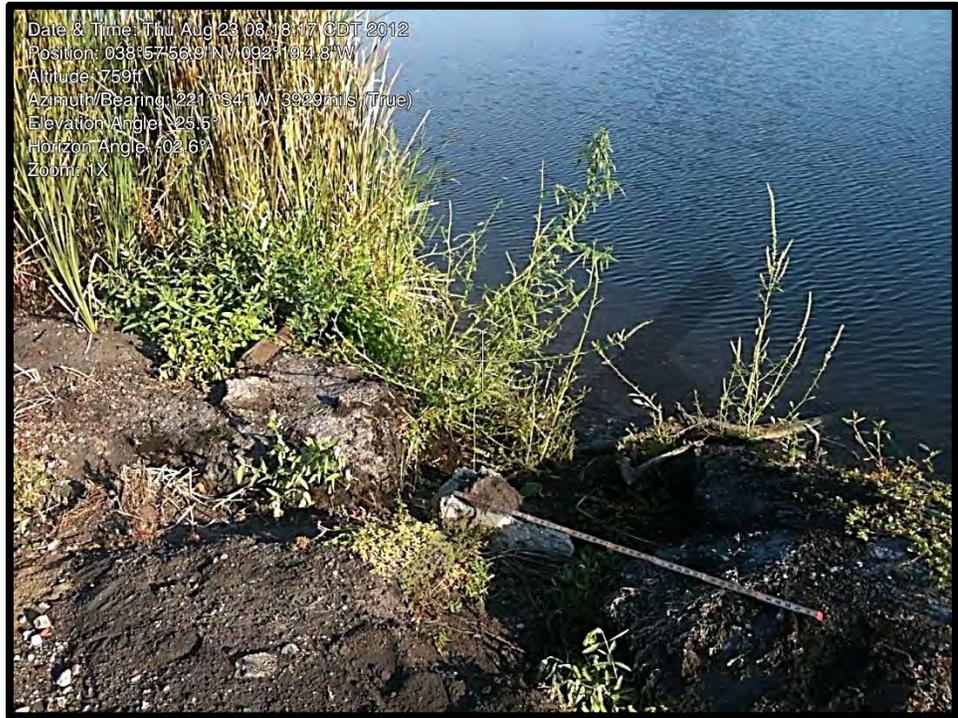
Photograph 5.9. Erosion Feature on Inside Slope of South Embankment

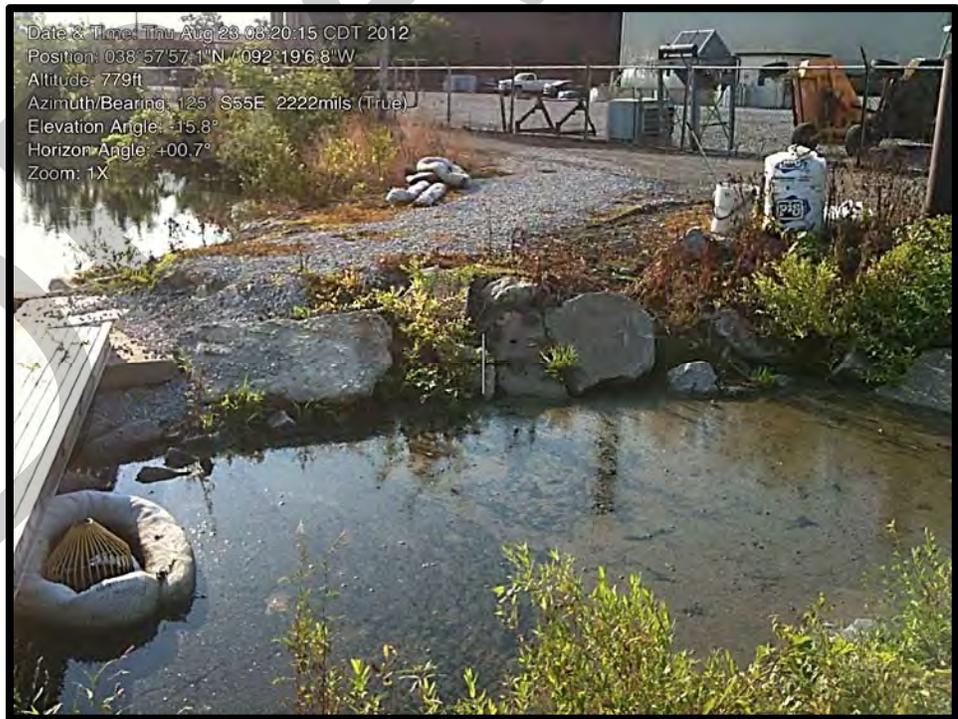
Photograph 5.10. Riprap near Outfall Drain at Southwest Inside Slope

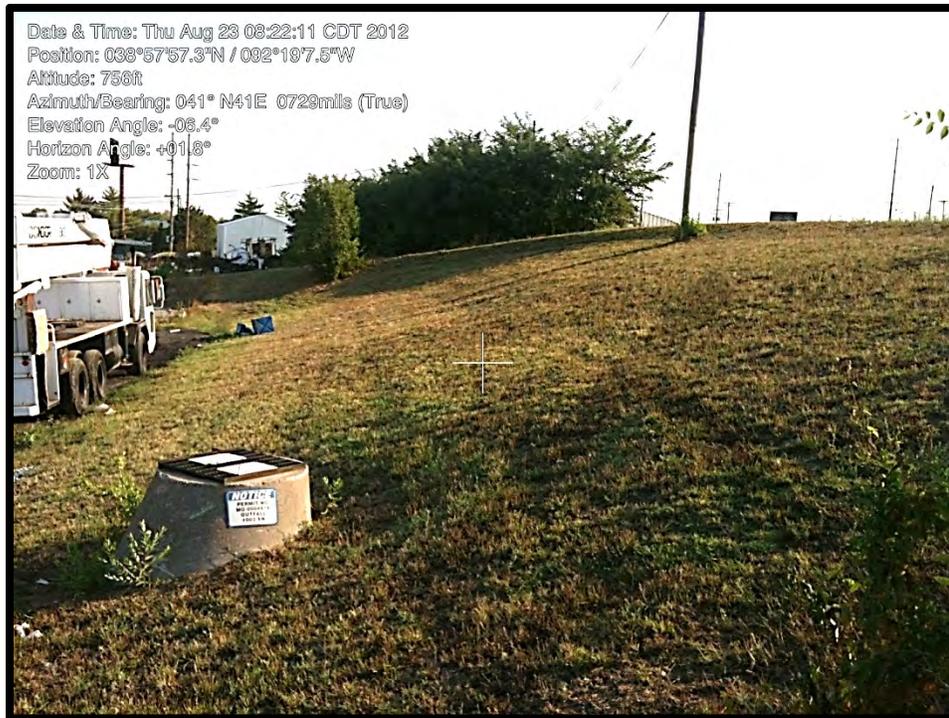
Photograph 5.11. Outside Slope of Dam (West Embankment) Looking North

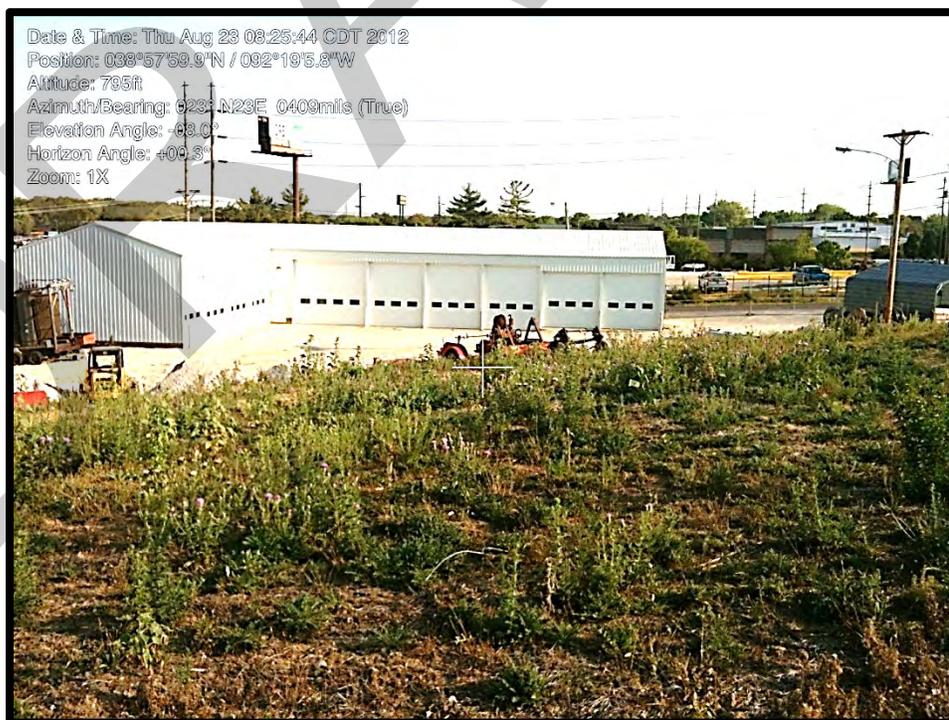
Photograph 5.12. Outside Slope of Dam towards Equipment Storage Yard Looking Northwest

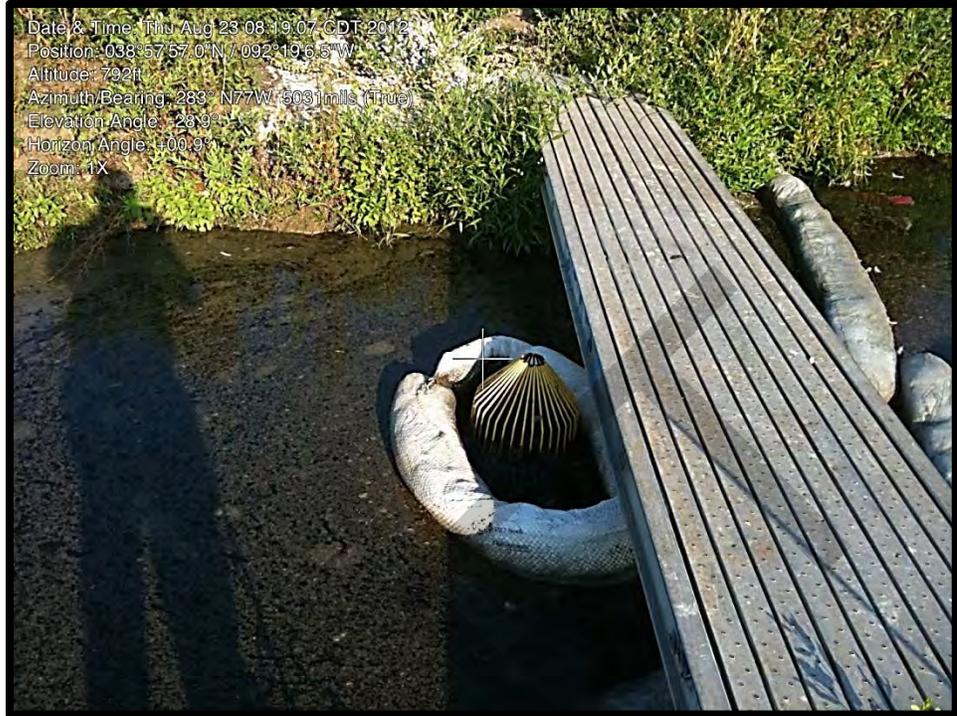
Photograph 5.13. Overflow Structure Southwest of CCW Impoundment

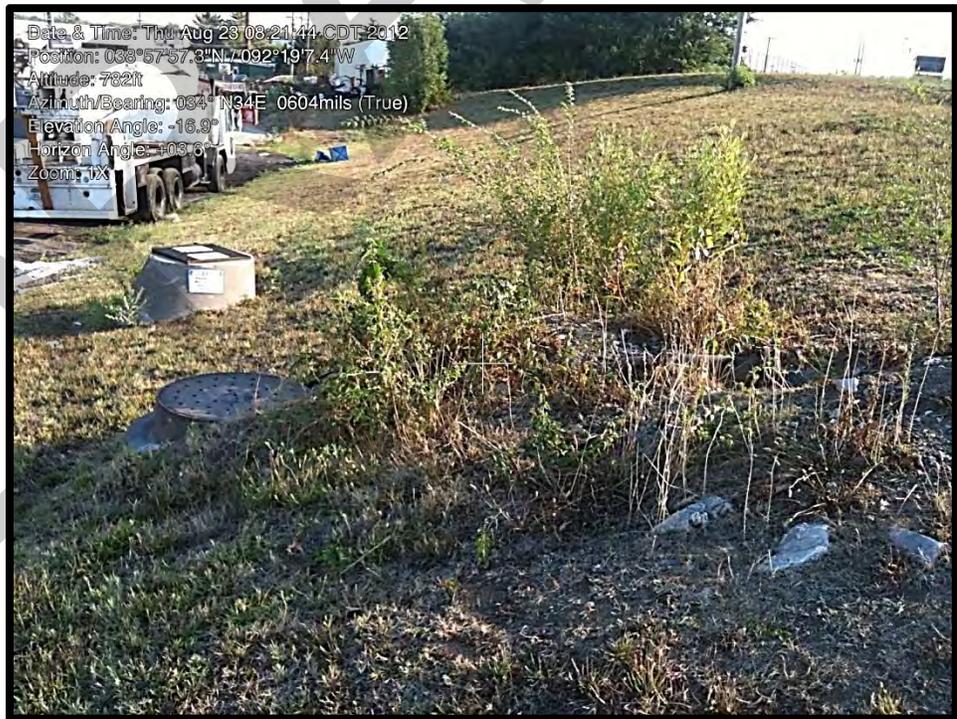
Photograph 5.14. Manholes for Overflow Structure on Exterior Slope of West Embankment Looking North
