# ASSESSMENT OF DAM SAFETY OF COAL COMBUSTION SURFACE IMPOUNDMENTS – FINAL REPORT

**City of Columbia, Water  
& Light Department**

**Columbia Municipal  
Power Plant  
Columbia, Missouri**

Prepared for  
*United States Environmental  
Protection Agency  
Washington, D.C.*

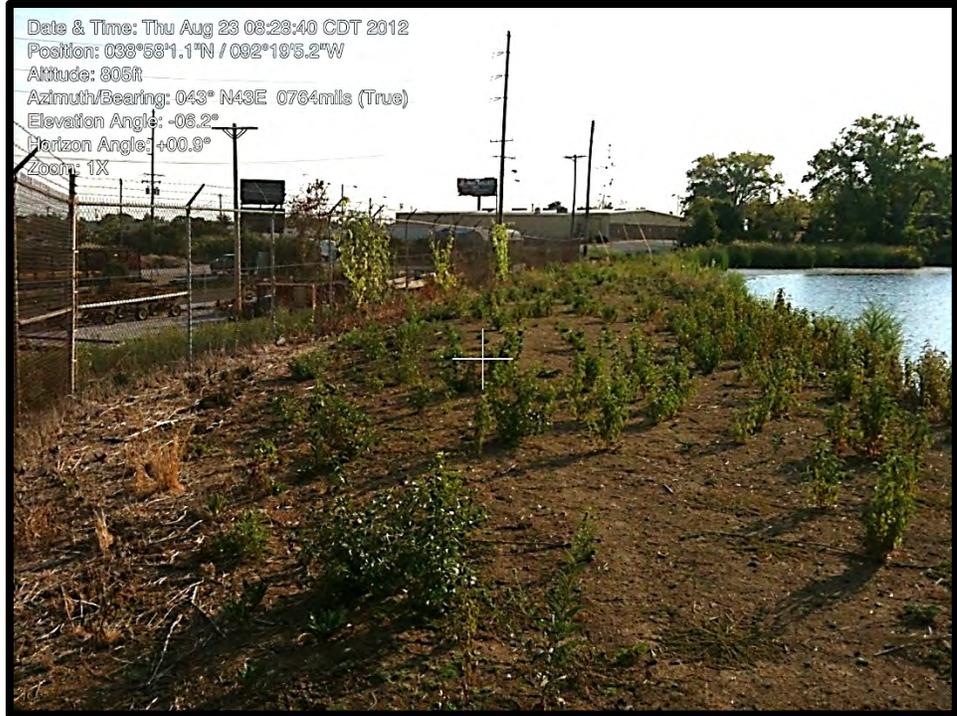
Photograph 5.1. Crest of Dam Looking Northeast

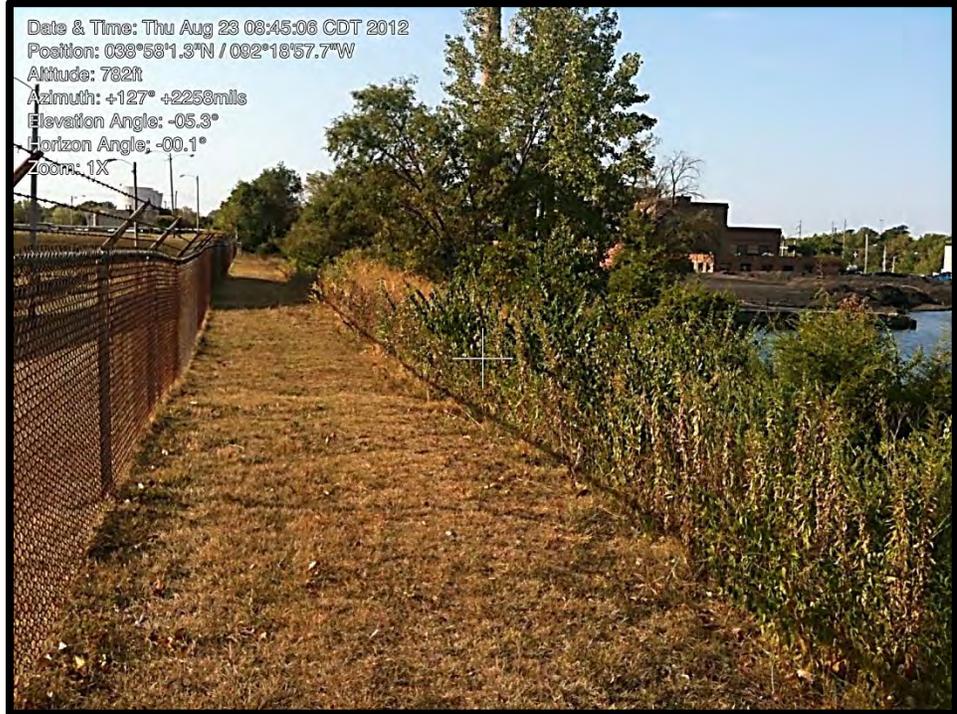
Photograph 5.2. Crest of East Embankment with Overgrown Vegetation and Tree on Inside Slope Looking South

- e. The removal of trees, shrubs and bushes on or near the embankment is recommended. The greatest density of this vegetation was observed along the east and north-east portions of the embankment. Vegetation removal should include the majority of roots within the footprint of the embankment. Compacted structural fill should be used to backfill excavations and holes made in the embankment areas before restoring final grades with compacted native materials free of debris and organic materials.

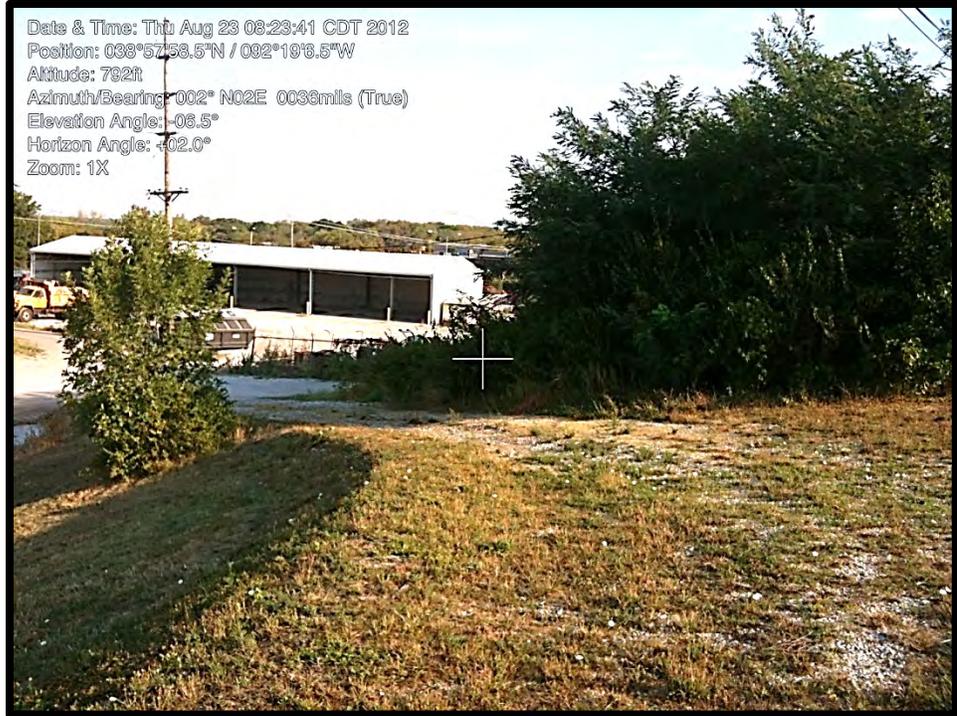
Photograph 5.3. Gravel Road on Downstream Slope of Dam

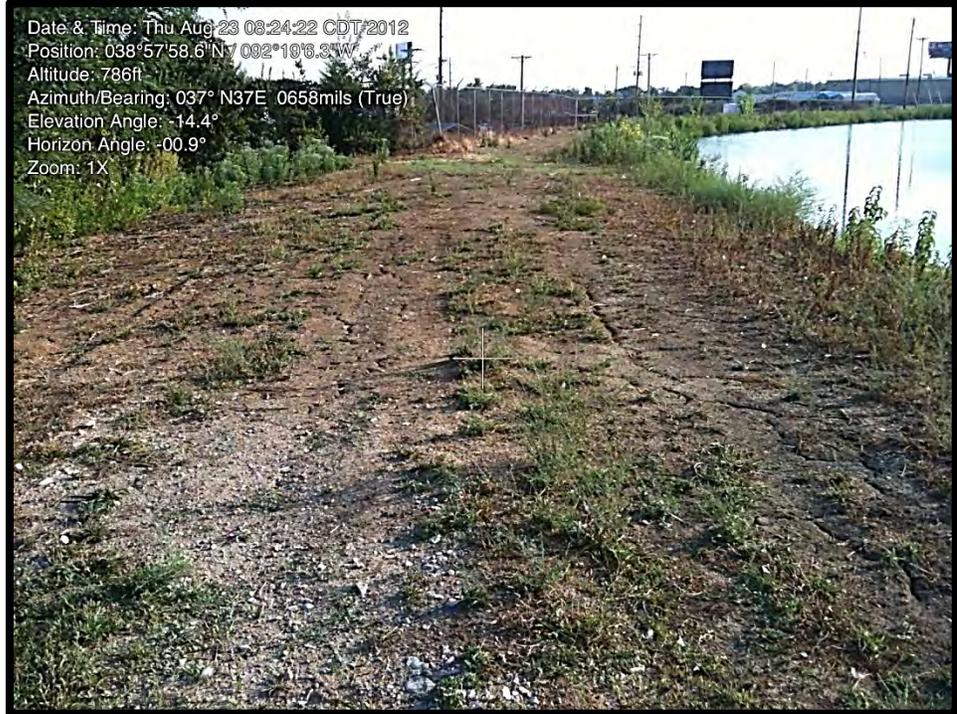
Shrinkage cracks were observed on the crest of the west embankment, and also erosion features on the inside slopes of the west and south embankments. The collection basin for the outfall drain of the

Photograph 5.4. Crest of Dam Showing Shrinkage Cracks Looking North

- b. Shrinkage cracks on the crest of the west embankment (dam) should be documented; backfilled and grass cover should be established to protect the surface from shallow erosion and slope failures. Irrigation and periodic inspections should be conducted to maintain these grass covered slopes.

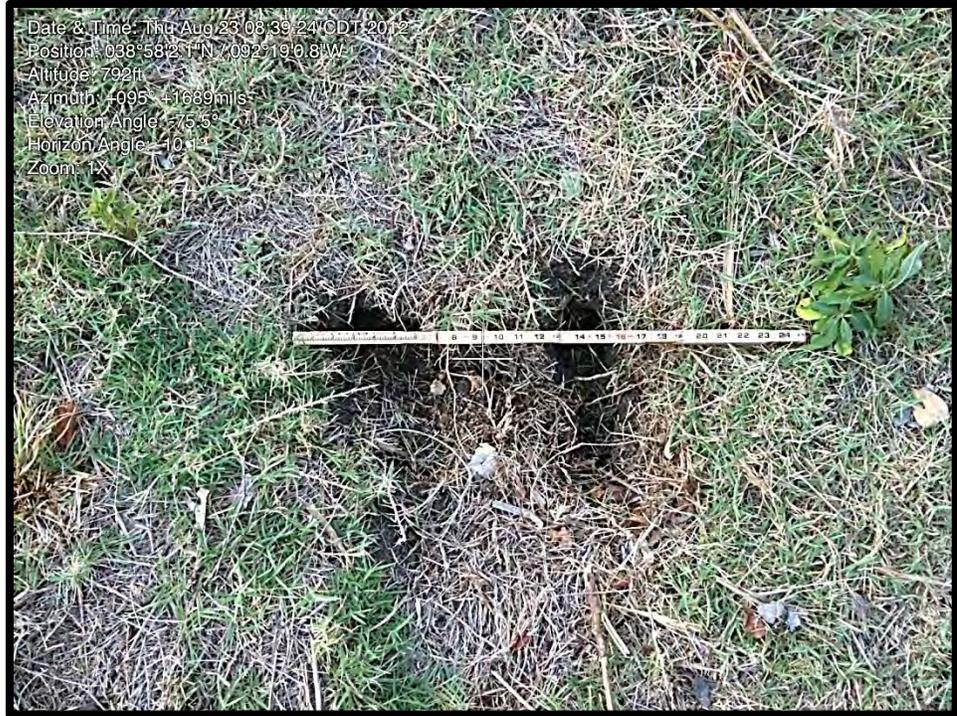
Photograph 5.5. Animal Burrow on North Embankment

- d. Animal burrows were observed and have reportedly been an ongoing problem. Areas disturbed by animal activity should be documented, the animals removed, and the burrows backfilled with compacted structural fill to protect the integrity of the embankments.

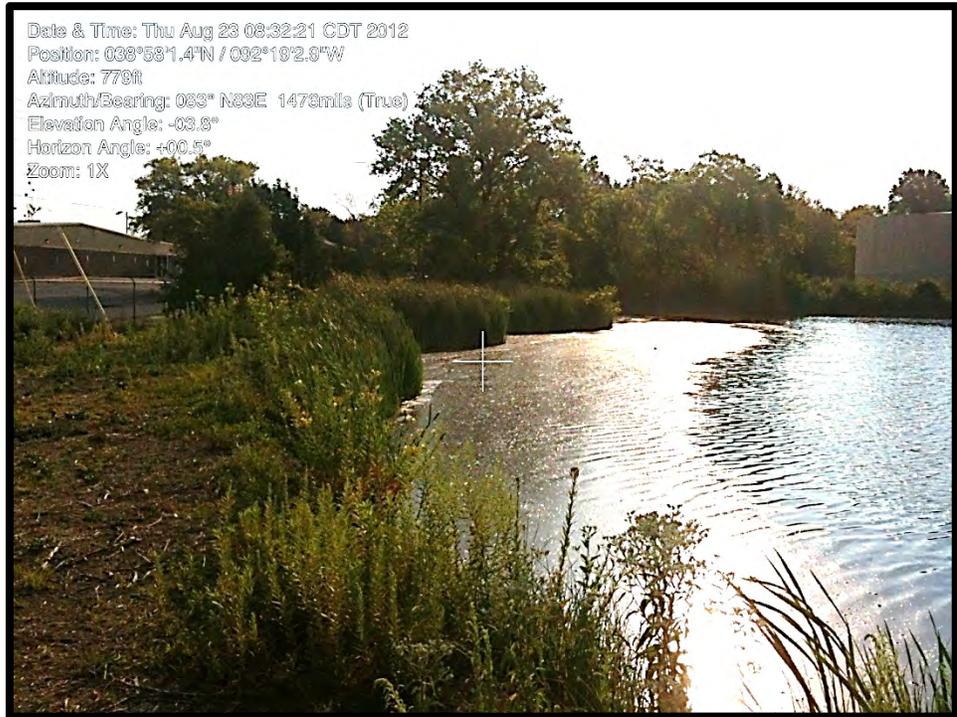
Photograph 5.6. North Embankment with Trees in Background Looking East

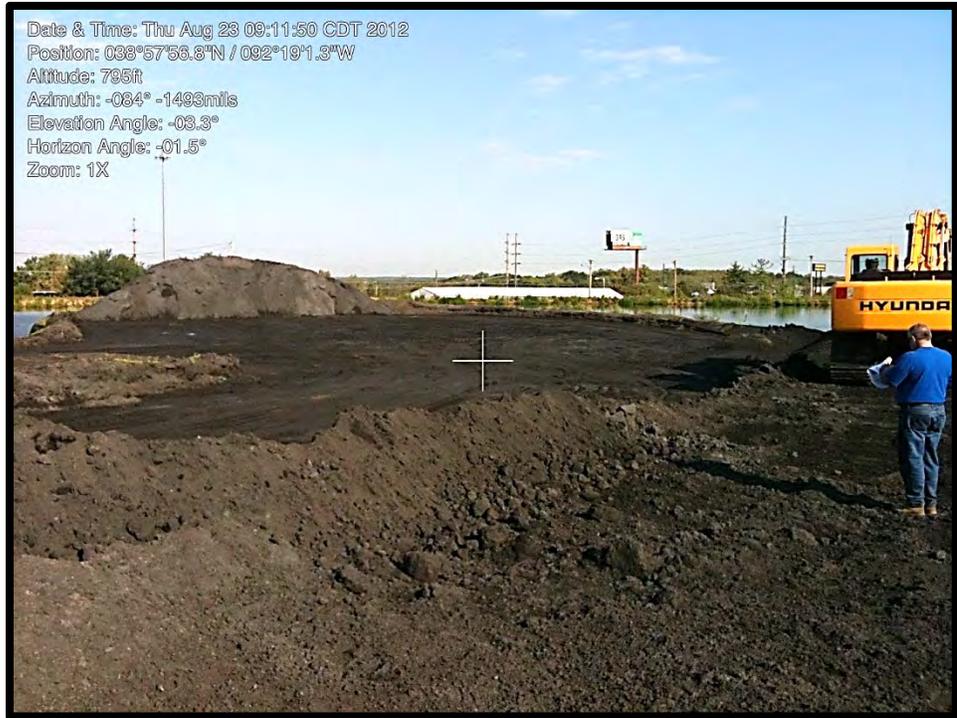
**Photograph 5.7. Drying Coal Ash on South Embankment Looking Northwest**

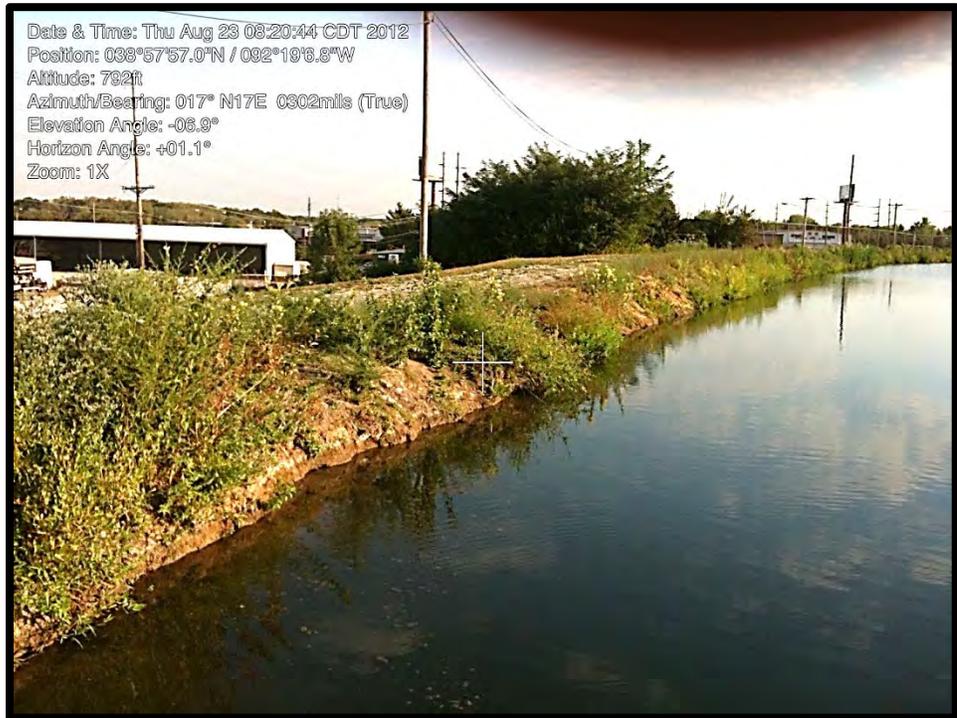
**Photograph 5.8. Erosion Features on Inside Slope of West Embankment Looking North**

- c. Erosion was observed on the inside slopes of the west and south embankments. To restore areas of erosion, it is recommended to place and compact structural fill or riprap in eroded areas and grade to adjacent contours.

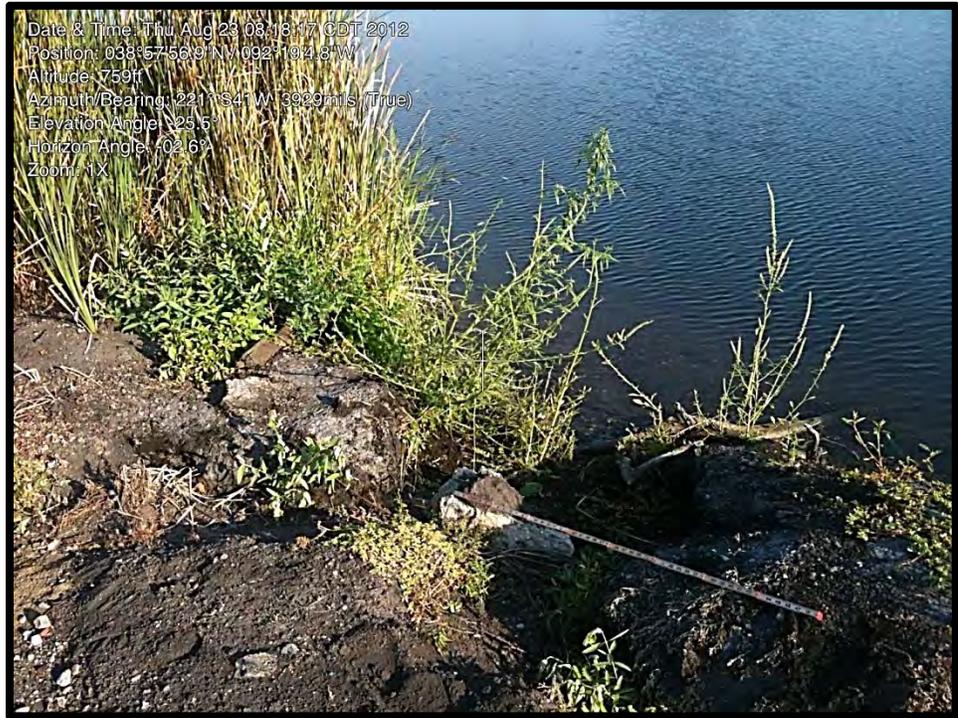
**Photograph 5.9. Erosion Feature on Inside Slope of South Embankment**

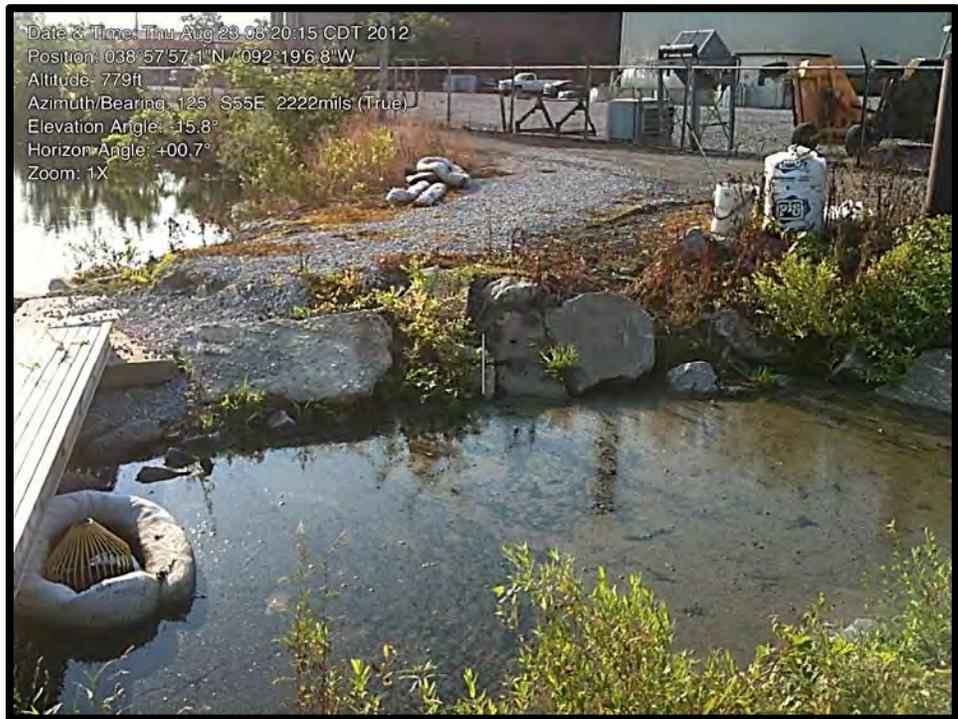
**Photograph 5.10. Riprap near Outfall Drain at Southwest Inside Slope**

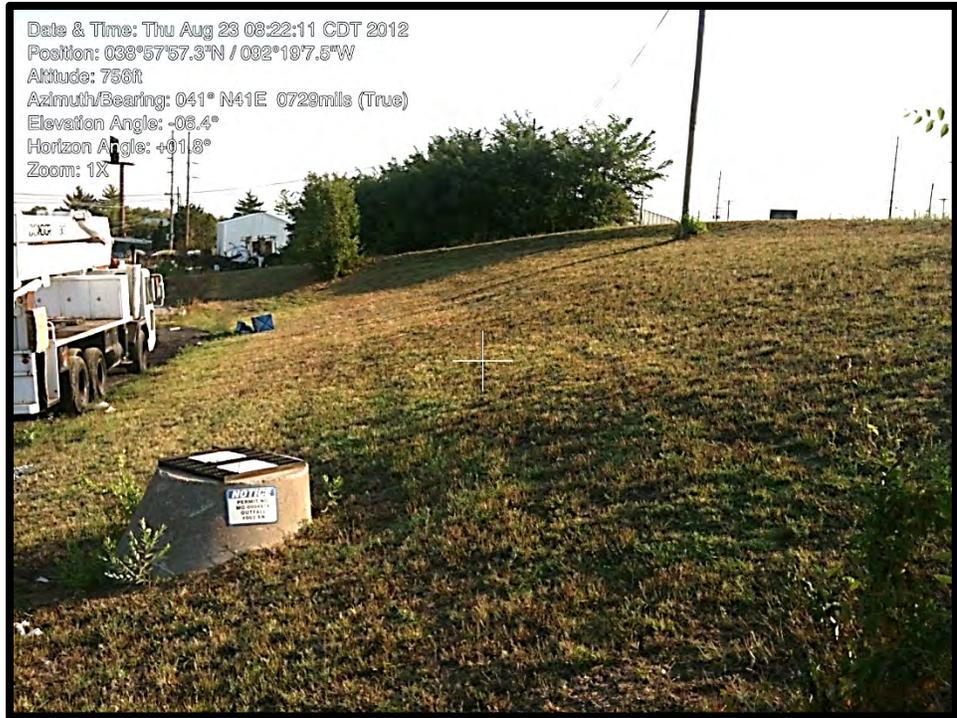
Photograph 5.11. Outside Slope of Dam (West Embankment) Looking North

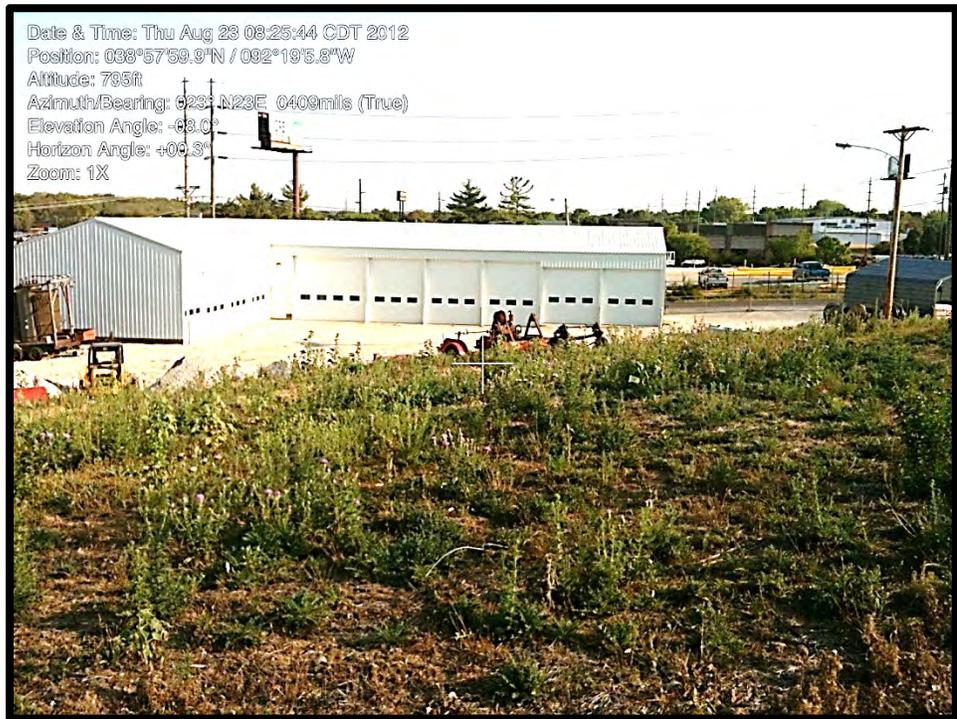
Photograph 5.12. Outside Slope of Dam towards Equipment Storage Yard Looking Northwest

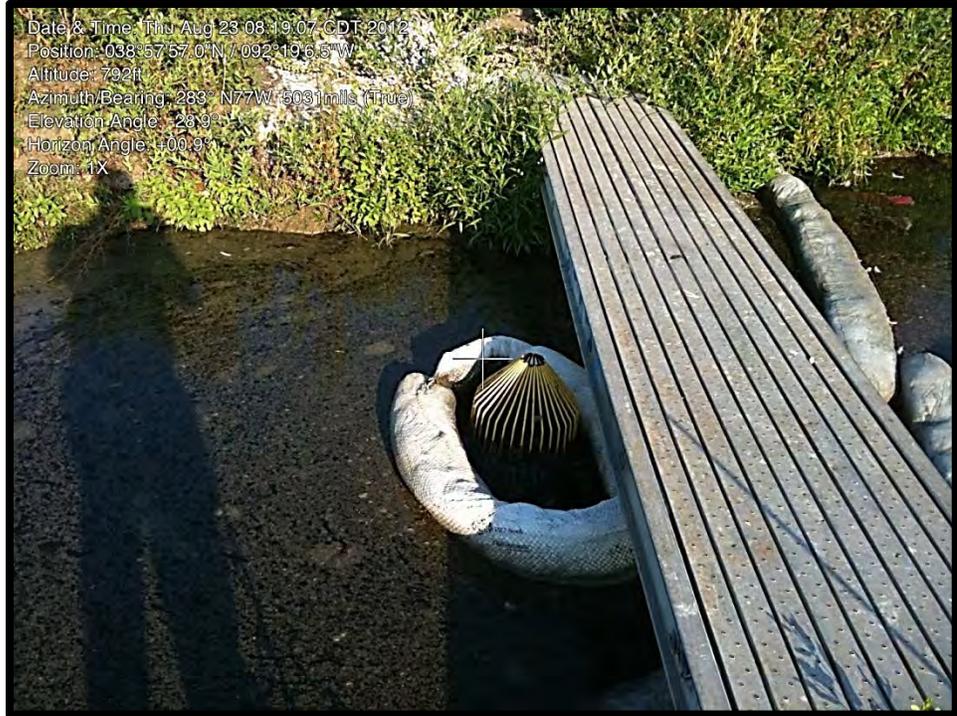
impoundment appeared to be in good condition, with water flowing freely through the top of the basin at the time our visit.

**Photograph 5.13. Overflow Structure Southwest of CCW Impoundment**

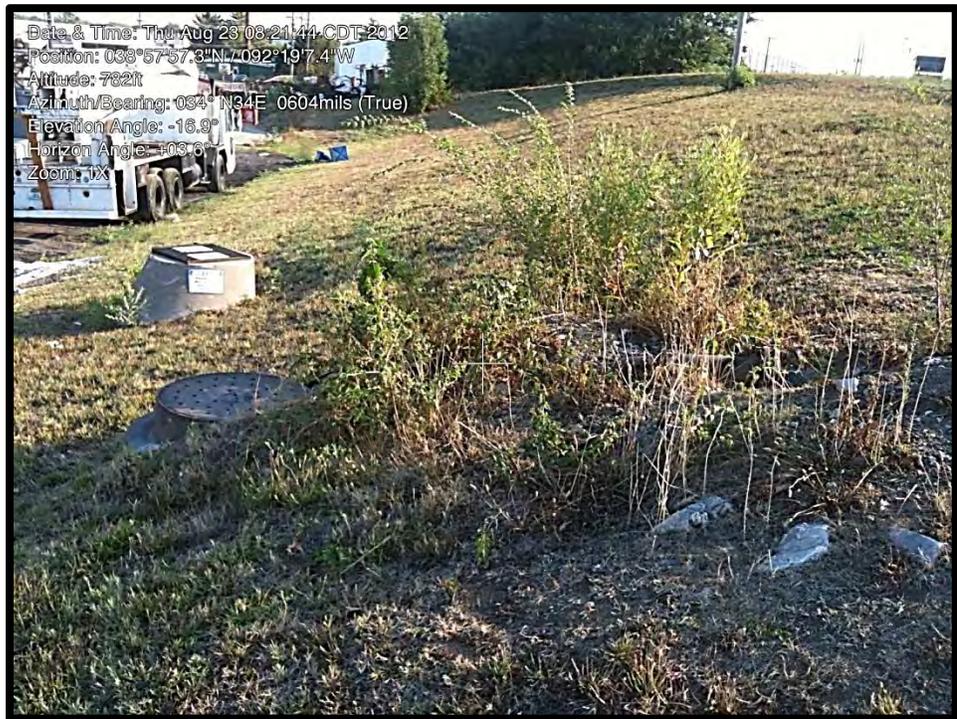
**Photograph 5.14. Manholes for Overflow Structure on Exterior Slope of West Embankment Looking North**
