GZA  
GeoEnvironmental, Inc.

Re: Task 3 Dam Assessment Report - Draft  
Project #0-381  
SRP Coronado Generating Station Evaporation Pond Dam  
Apache County, Arizona

This Phase I Inspection/Evaluation Report presents the results of a visual dam inspection of the Salt River Project – Coronado Generating Station (SRP/CGS) Evaporation Pond Dam located off U.S. Highway 191 in Apache County, Arizona. The inspection was performed on September 9 and 10, 2009 by representatives of GZA GeoEnvironmental, Inc (GZA), accompanied by representatives of SRP/CGS the U.S. Environmental Protection Agency (EPA).

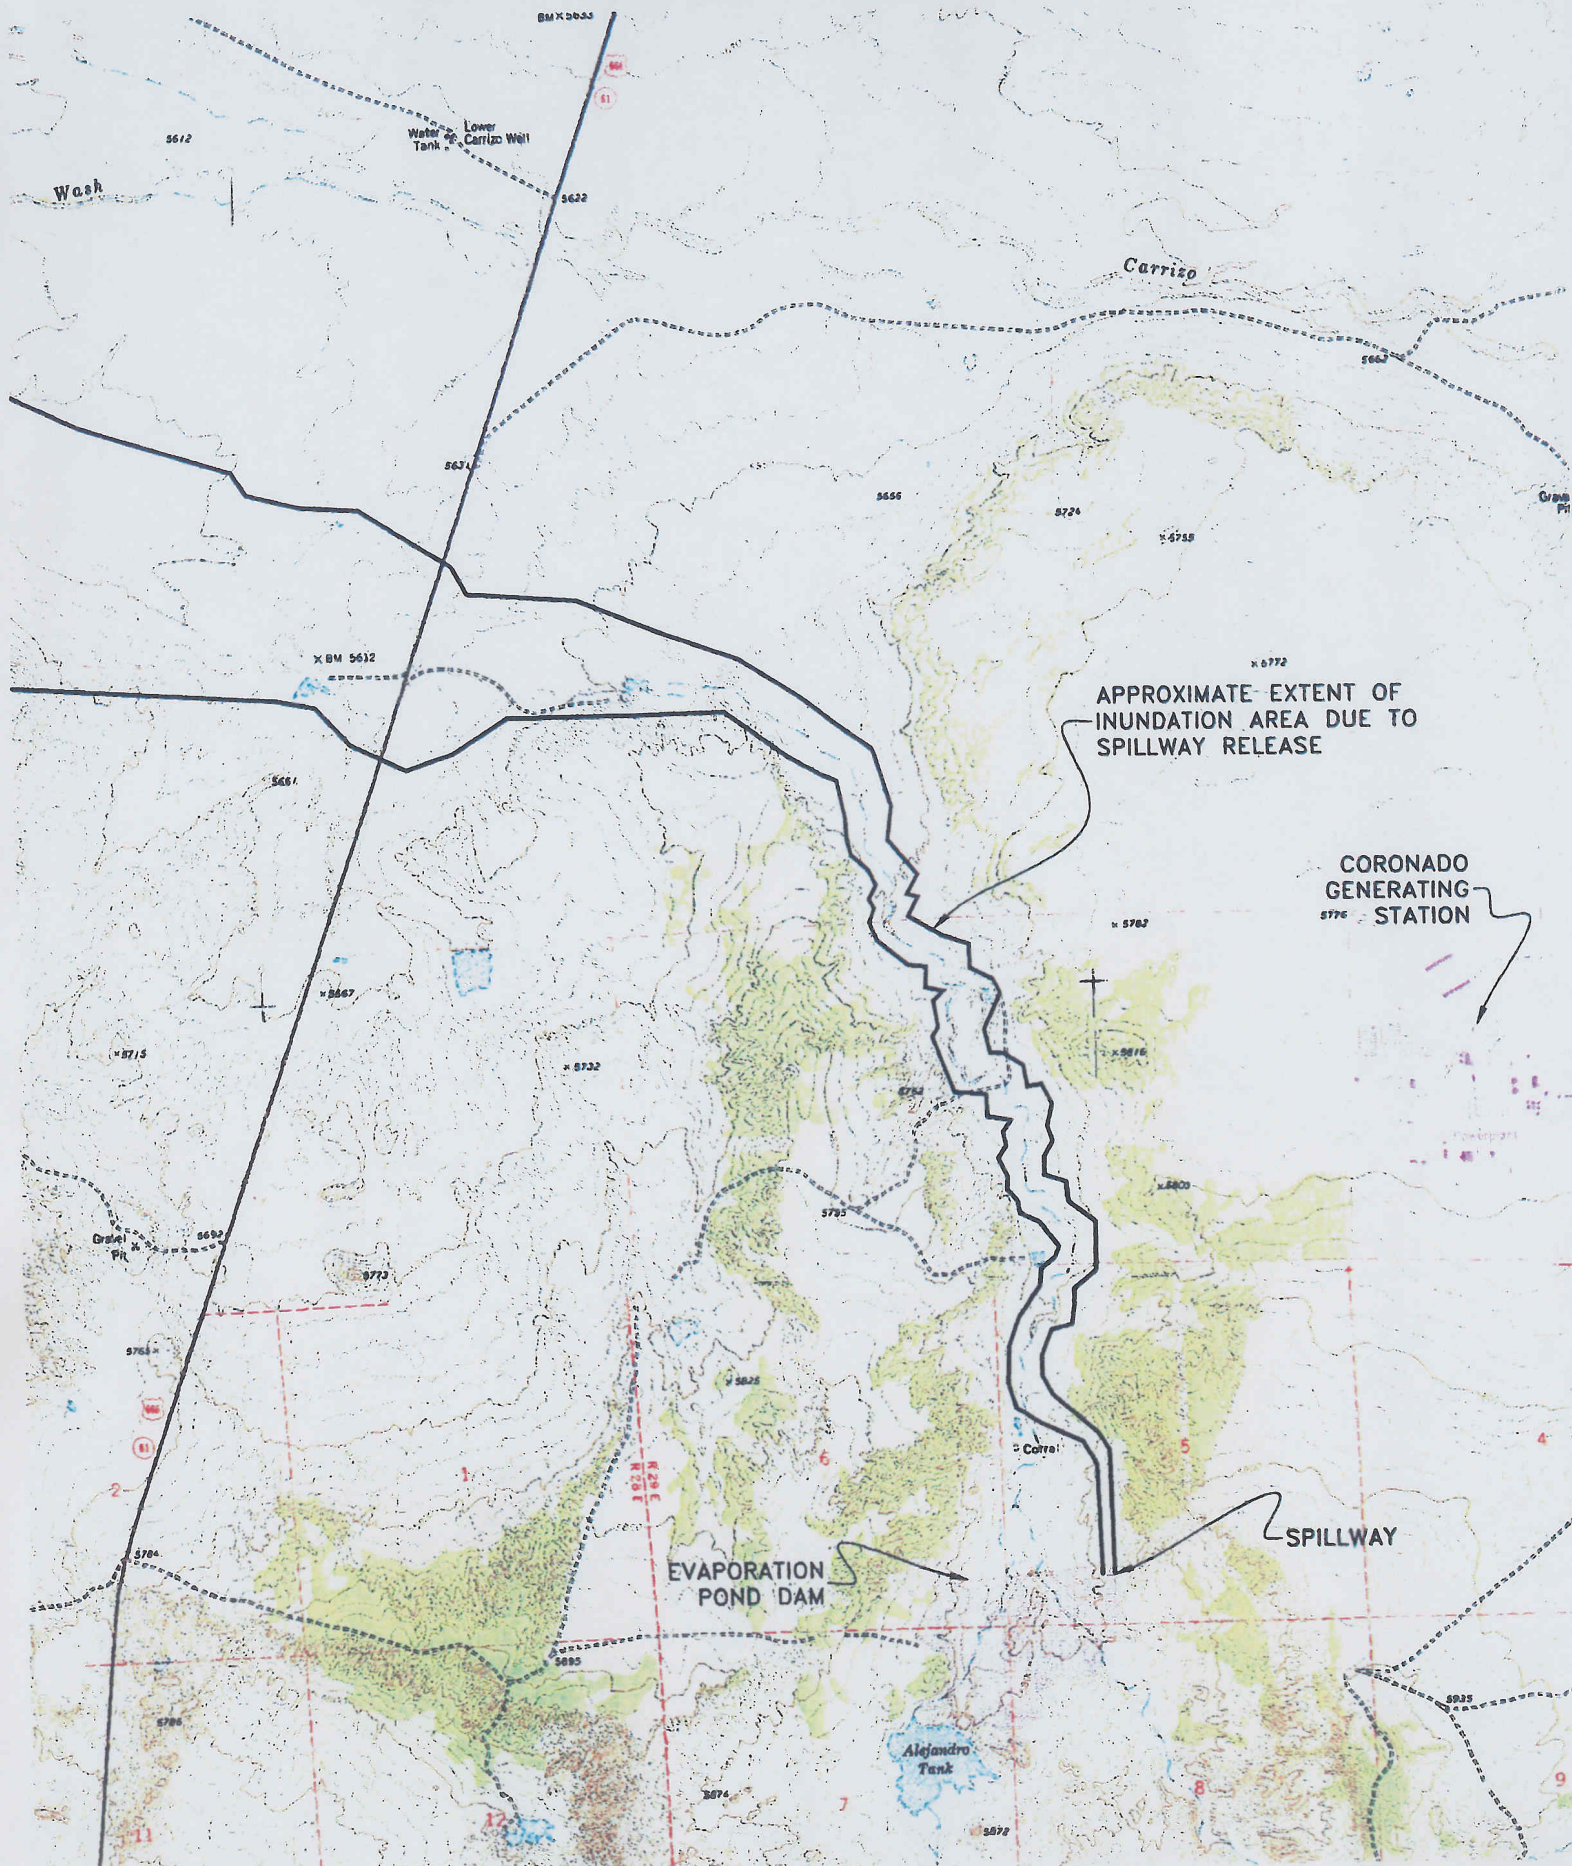
**FIGURE 9**

and the potential environmental impacts and interruption of power generation due to a failure of the dam and subsequent loss of impoundment capacity. The area downstream of the dam is shown in **Figure 3**, and the dam break inundation area from the Evaporation Pond Dam Emergency Action Plan is shown in **Figure 9**.

**DAM BREAK - RELEASE INUNDATION MAP**

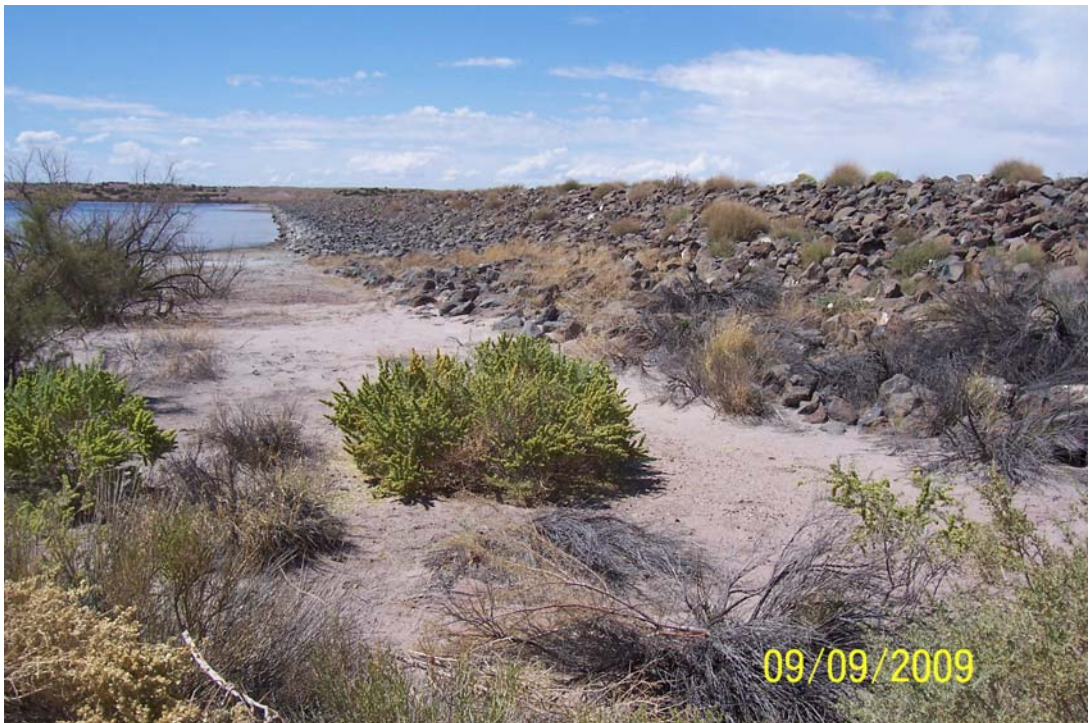
**Photo 2: Overview of upstream slope of dam from right abutment contact. Note moderate brush growth on riprap slope.**

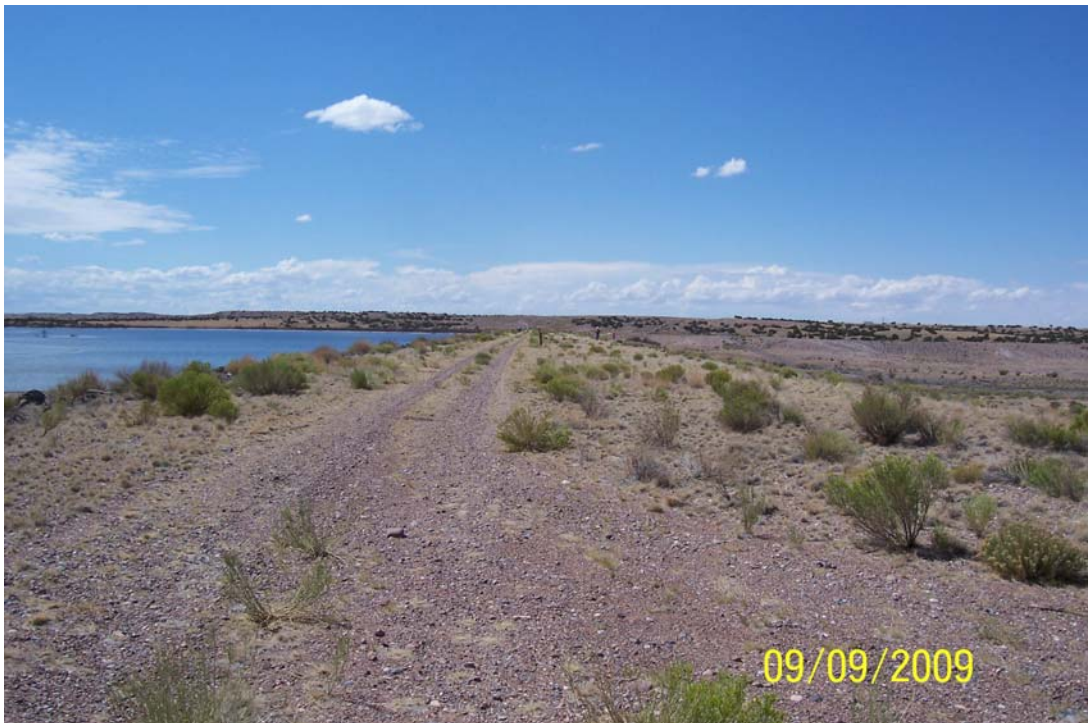
**Photo 4: View along top of dam from right abutment area. Note grass and brush vegetative cover and minor rutting from vehicular traffic.**

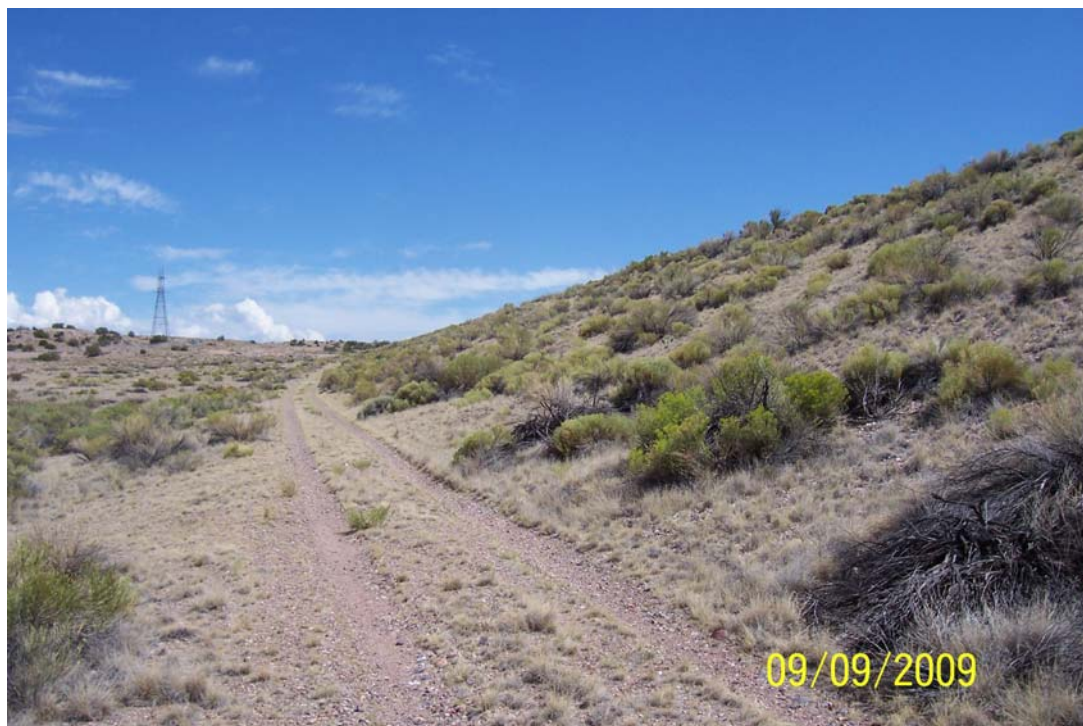
**Photo 7: View along downstream slope of dam looking towards right abutment, taken from access road along downstream toe. Note minor rutting of access road.**

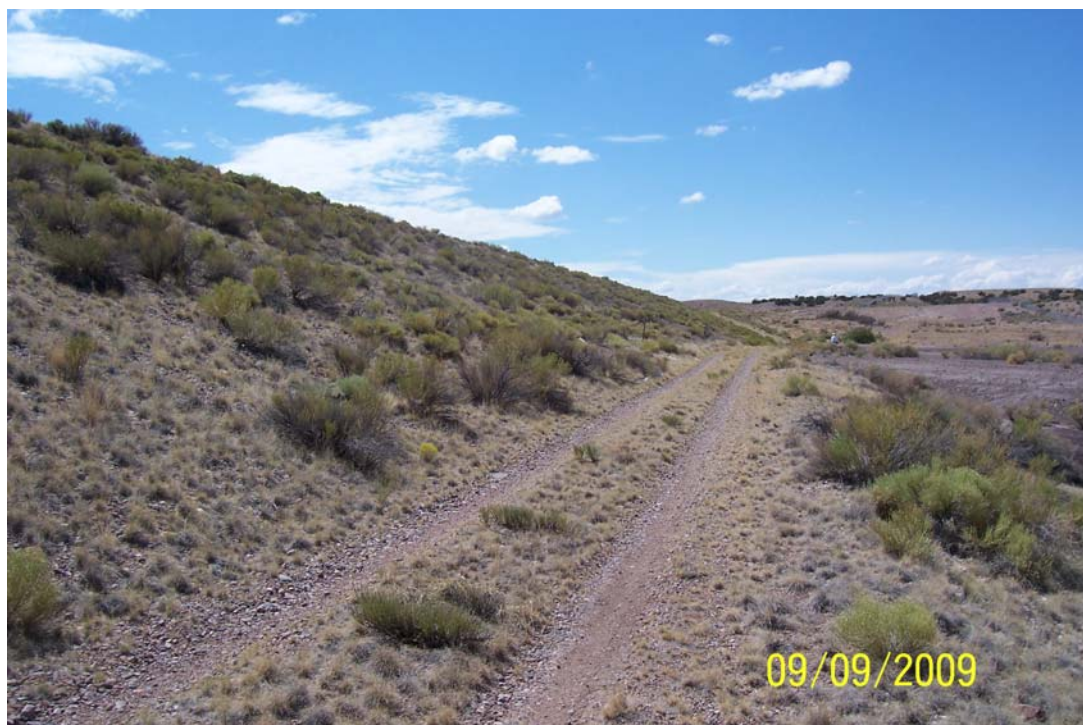
**Photo 8: View along downstream slope of dam looking towards left abutment, taken from access road along downstream toe. Note minor rutting of access road**

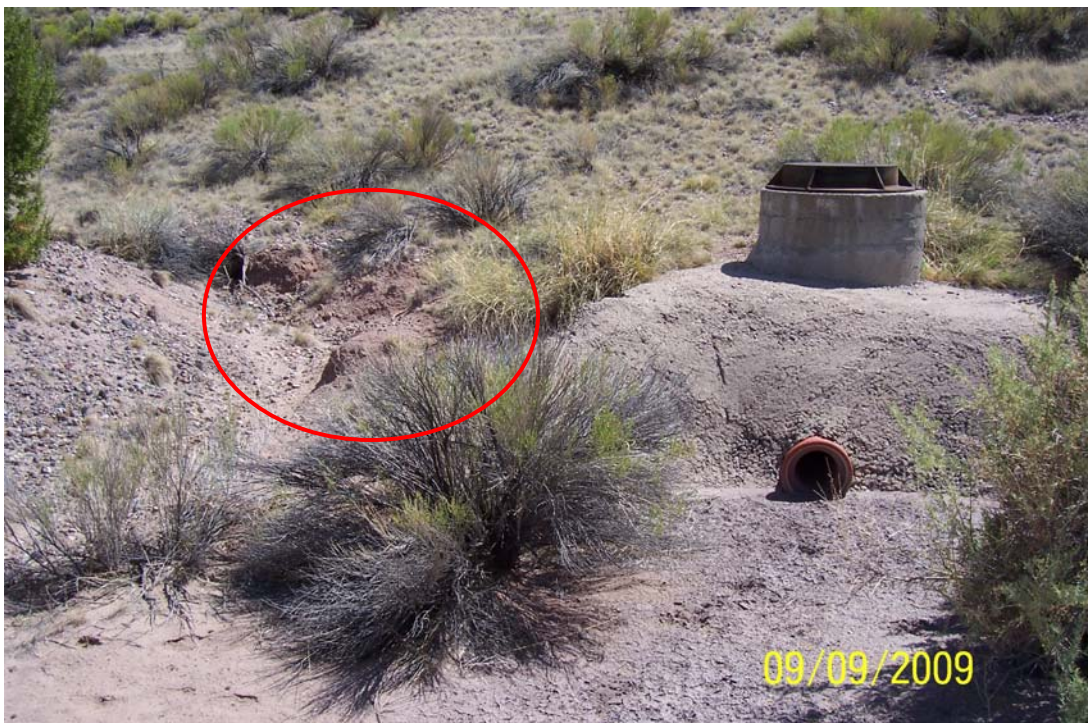
**Photo 10: View of right toe drain manhole from downstream dry channel. Note minor erosion adjacent to concrete cover (circled).**

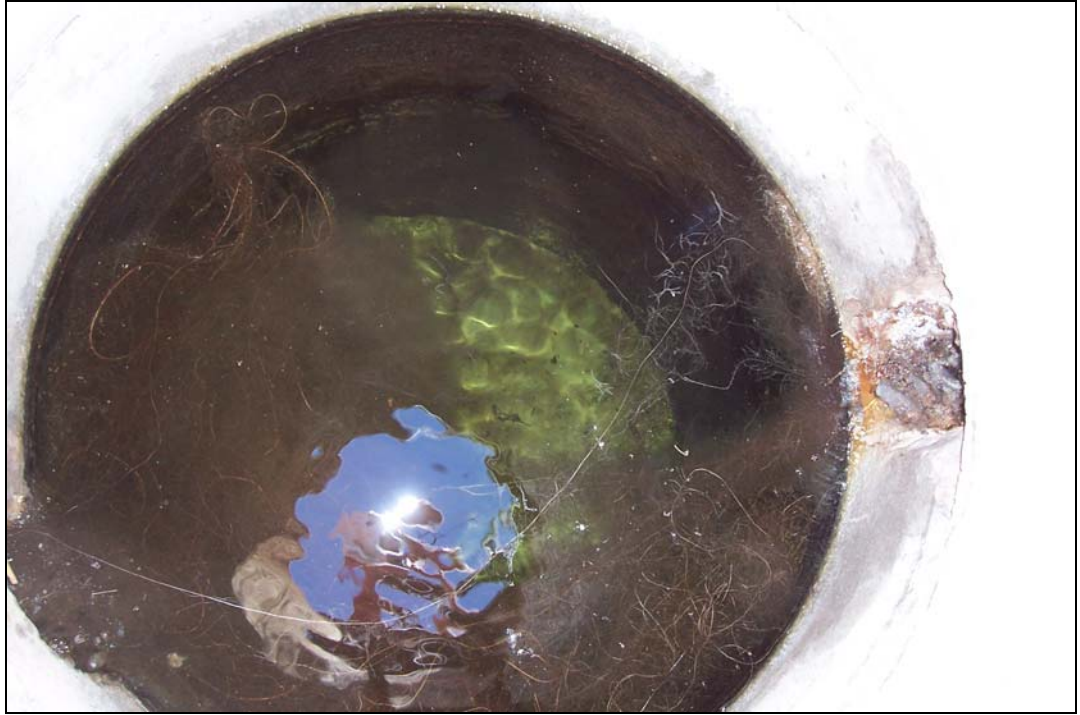
**Photo 15: View inside left toe drain manhole. Note standing water and roots within manhole. Toe drain collection pipe flowing at right.**

3. Conduct a camera survey of the interior of the left and right toe drain seepage collection pipes to evaluate the condition of the pipe section alignment, joints, and any potential blockage.

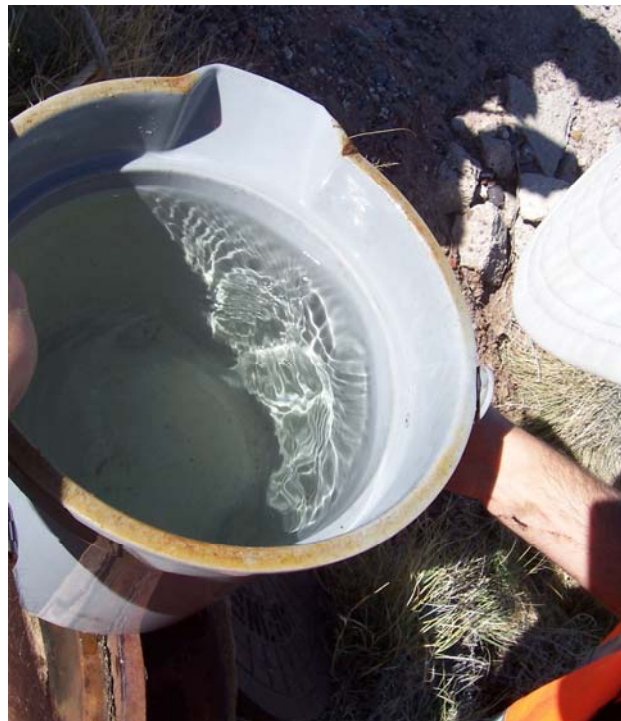
**Photo 16: View of seepage water taken from left toe drain manhole.**

5. Monitor toe drain seepage clarity at the toe drain manhole (rather than sump), including visual observations of water clarity and monthly measurements of turbidity. A contingency plan should also be prepared if high flow rates or increased turbidity are observed in the seepage water.

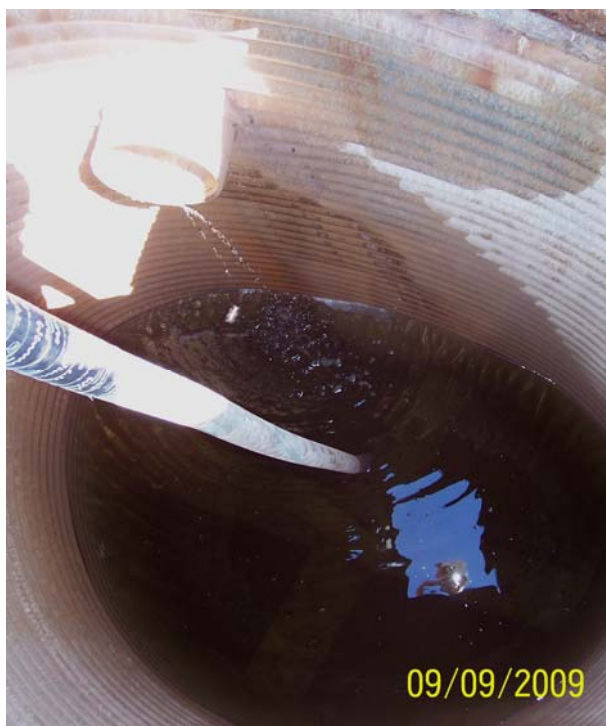
**Photo 18: View inside left toe drain sump. Note seepage discharge from inlet pipe, and hanging pipe for pumping collected seepage back to Pond.**

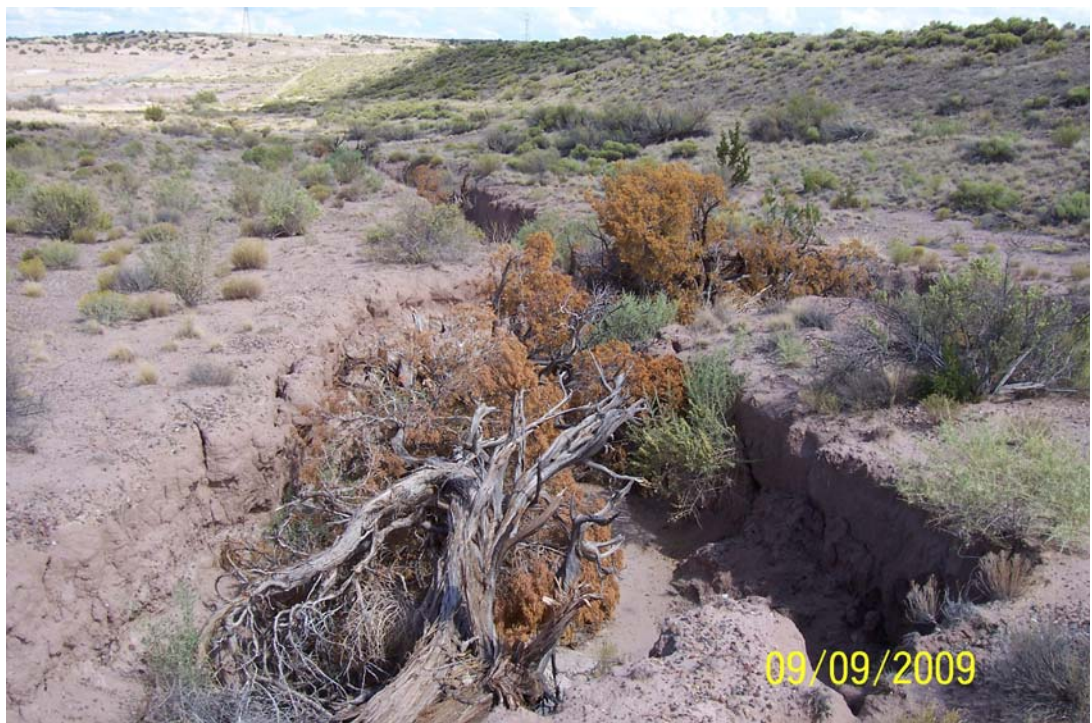
**Photo 20: View of erosion gulley near left downstream toe of dam. Note woody debris placed in channel by SRP/CGS to control erosion.**

1. Repair erosion gullies along the left and right downstream abutment groins, the left upstream abutment groin, and near the downstream toe of the dam at the secondary containment structure. Repair eroded upstream slope at the left abutment and reset any displaced riprap stones. Implement erosion control measures (riprap lining, check dams, vegetative barriers, etc.) to prevent further channel erosion and headcutting.
2. Remove roots from left toe drain manhole and repair any damage from shrub growth and/or root penetration.
3. Repair/replace leaking PVC piping connecting left toe drain manhole to sump. Minimizing leakage from this pipe will help eliminate a potential source of saturated soil in downstream secondary containment area.

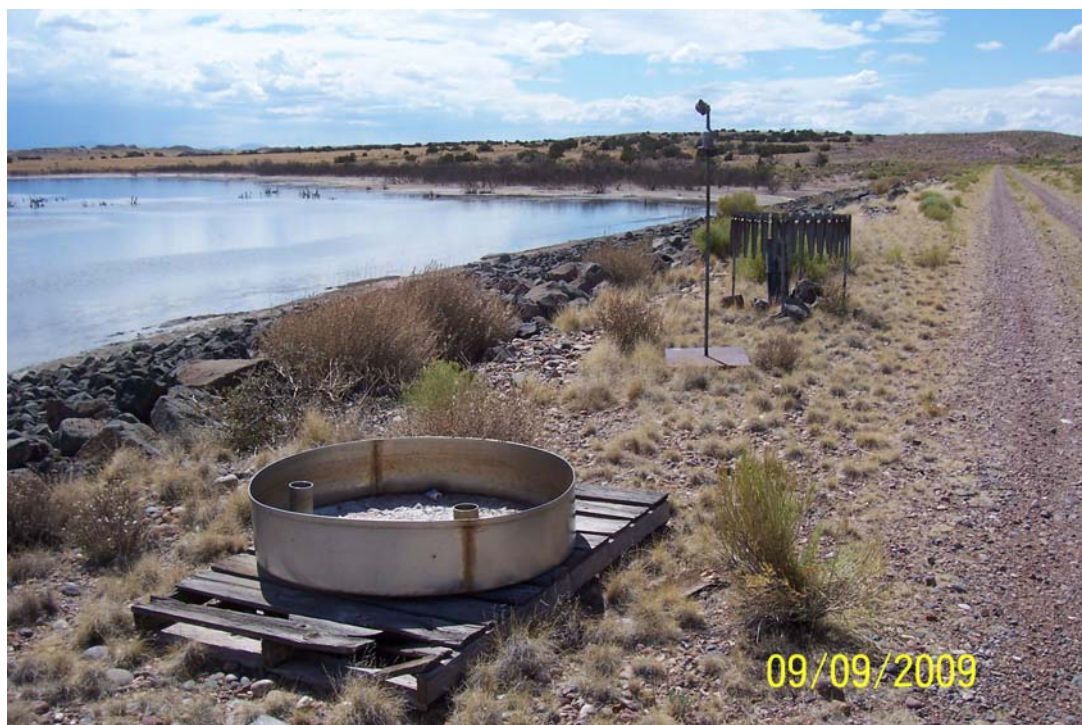
**Photo 21: View of meteorological instruments on top of dam, left side.**

4. Monitor left toe drain discharge channel and downstream secondary containment area for presence of wet, soggy soil or unusual vegetative growth.
5. Clear vegetation from emergency spillway approach channel area, and remove sediment as it accumulates.
6. Repair/replace staff gage markers so that Pond water surface elevation can be easily read from the upstream slope of the dam. A distinct marking should be provided at the maximum operating level.
7. Investigate operability of the meteorological instruments on top of the dam. Remove instruments if inoperable.

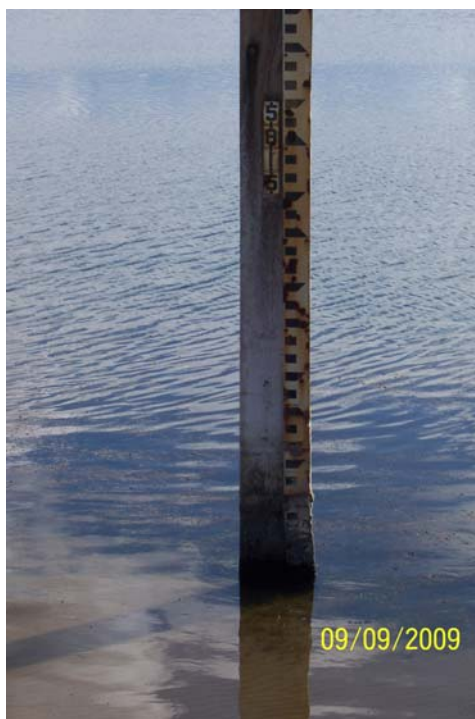
**Photo 22: View of staff gage on upstream berm. Note lower markings difficult to read. Pond level at time of inspection was approximately 5810 feet.**

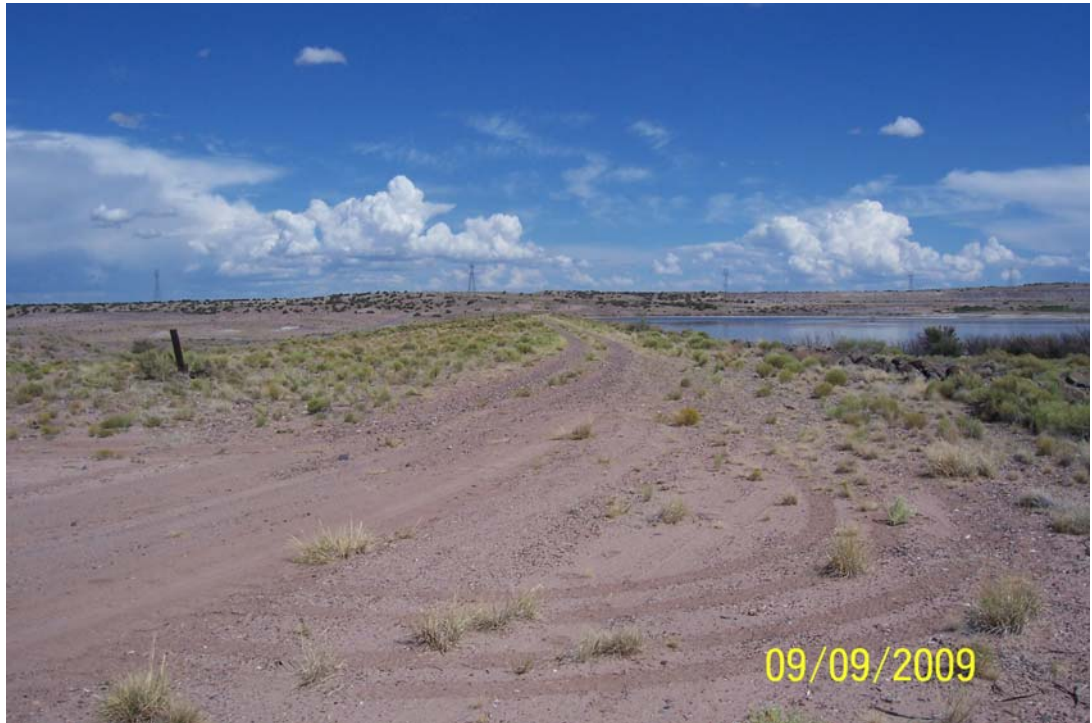
**Photo 25: View along top of dam from left abutment. Note minor rutting from vehicle traffic.**

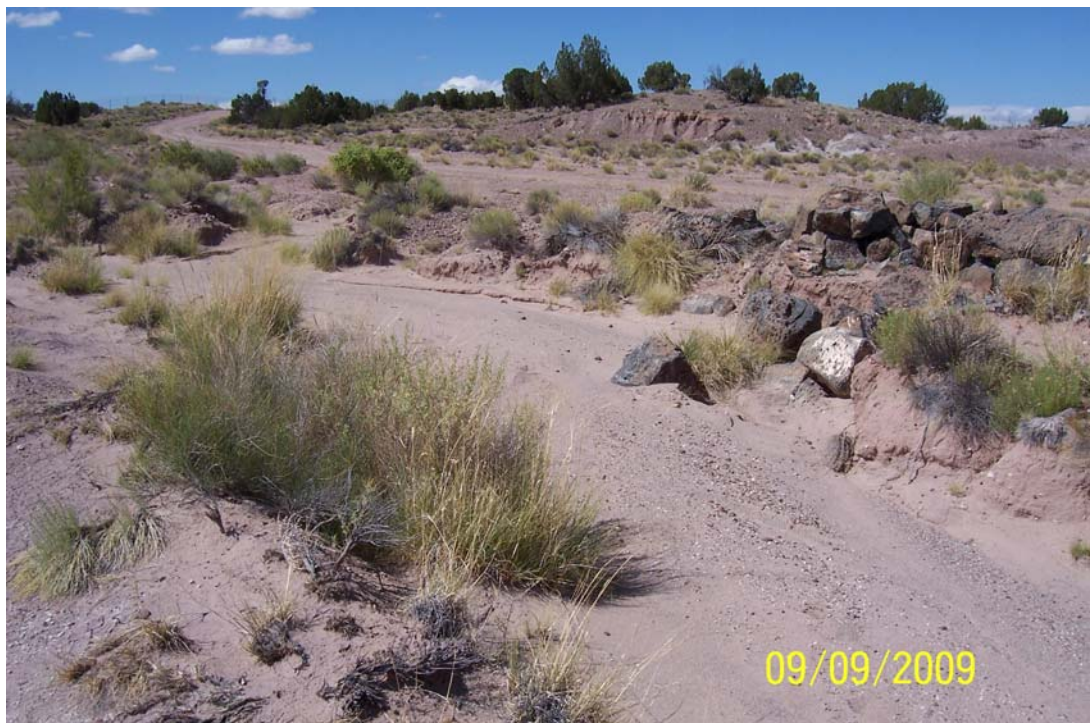
**Photo 26: View of erosion channel along left upstream abutment groin. Note undercutting and displacement of riprap slope at right.**

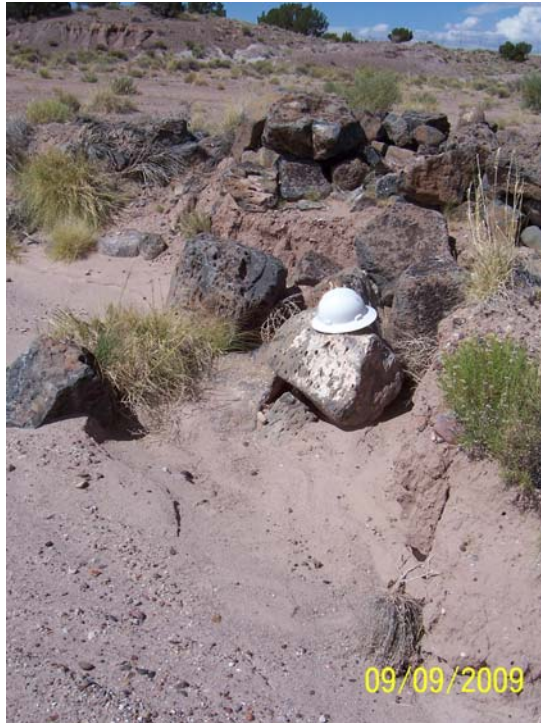
**Photo 27: View of undercutting and displacement of riprap at left abutment contact. Hard hat shown for scale.**

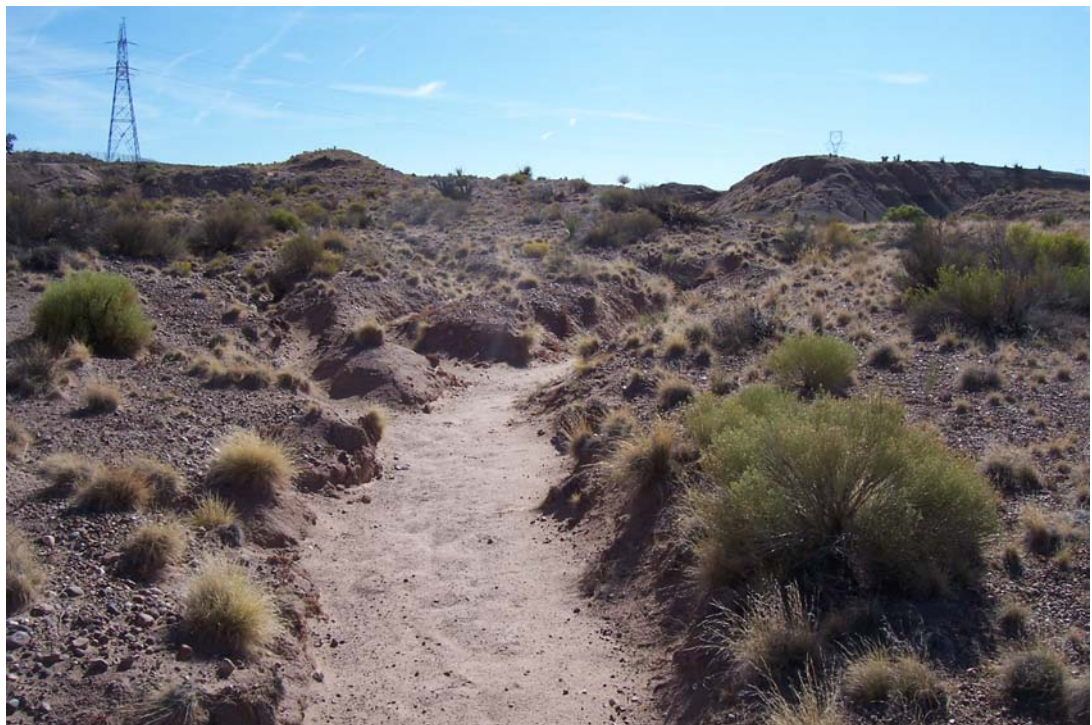
**Photo 28: View of erosion channel along right downstream abutment contact.**

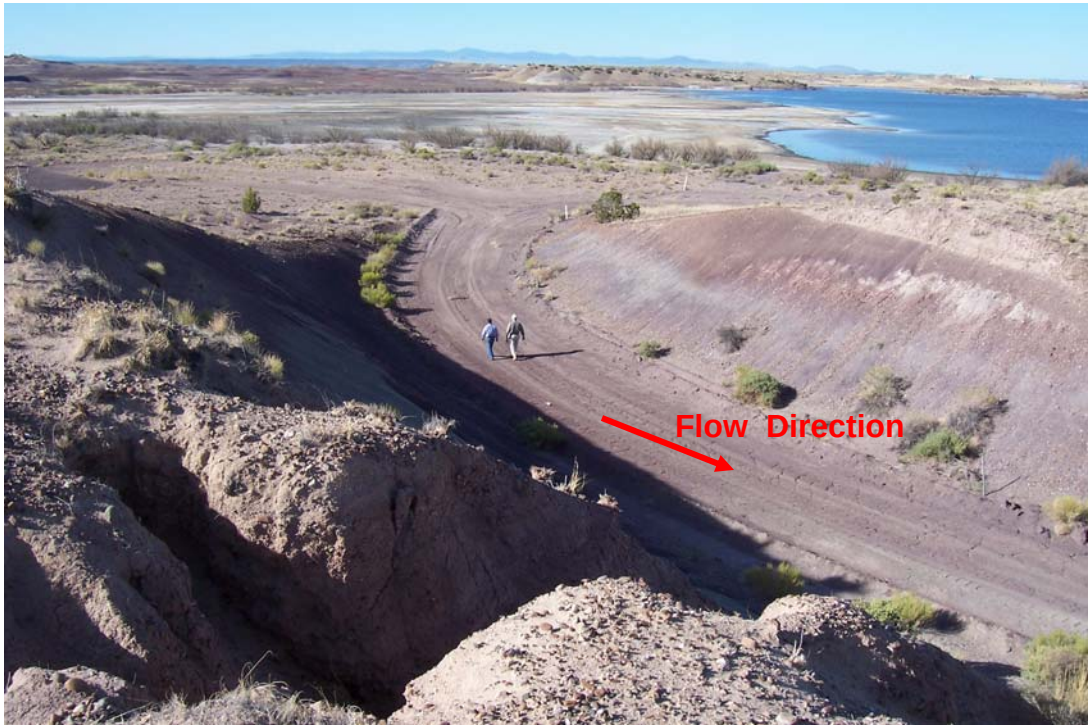
**Photo 29: View of emergency spillway approach channel and pond from top of right channel slope. Note slope erosion in foreground.**

1. In conjunction with the results of the updated hydrologic and hydraulic analyses, repair the emergency spillway side slopes along the length of the channel. Provide grading and/or other means to direct surface runoff away from the channel slopes, especially along the axis of the dam. Repairs must address the area along the dam axis where a longitudinal crack at the top of the left spillway side slope was observed. Consider improvements, as needed, to stabilize the spillway side slopes and invert control elevation.

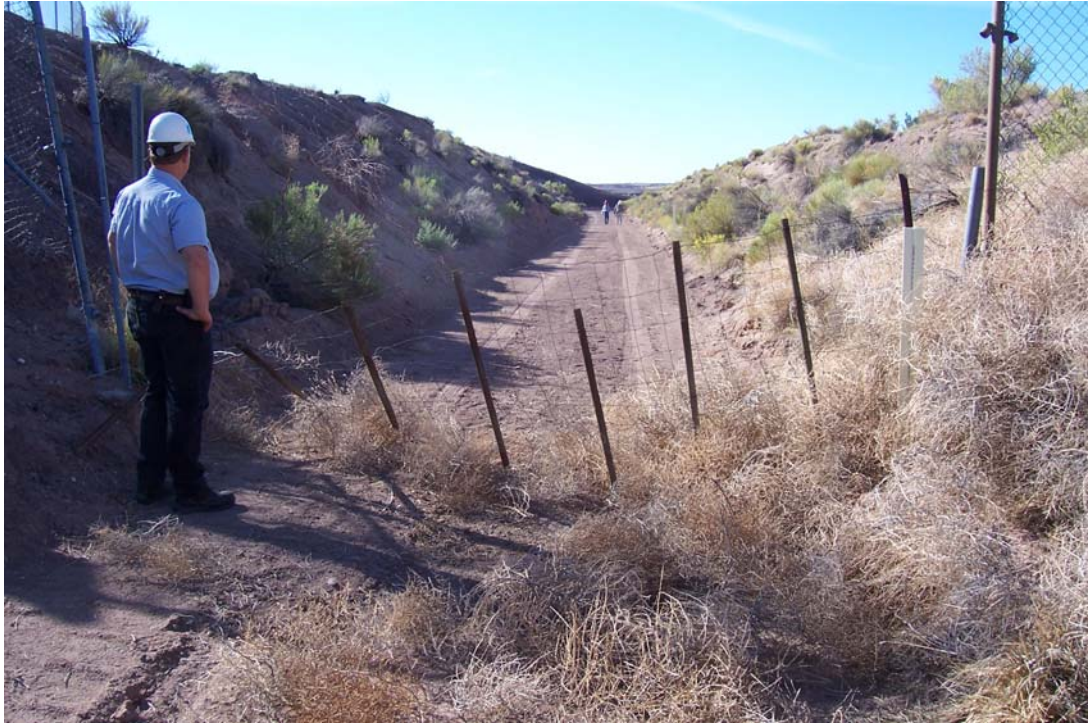
**Photo 31: View within emergency spillway channel looking upstream from break-away cattle gate. Note accumulation of tumbleweeds.**

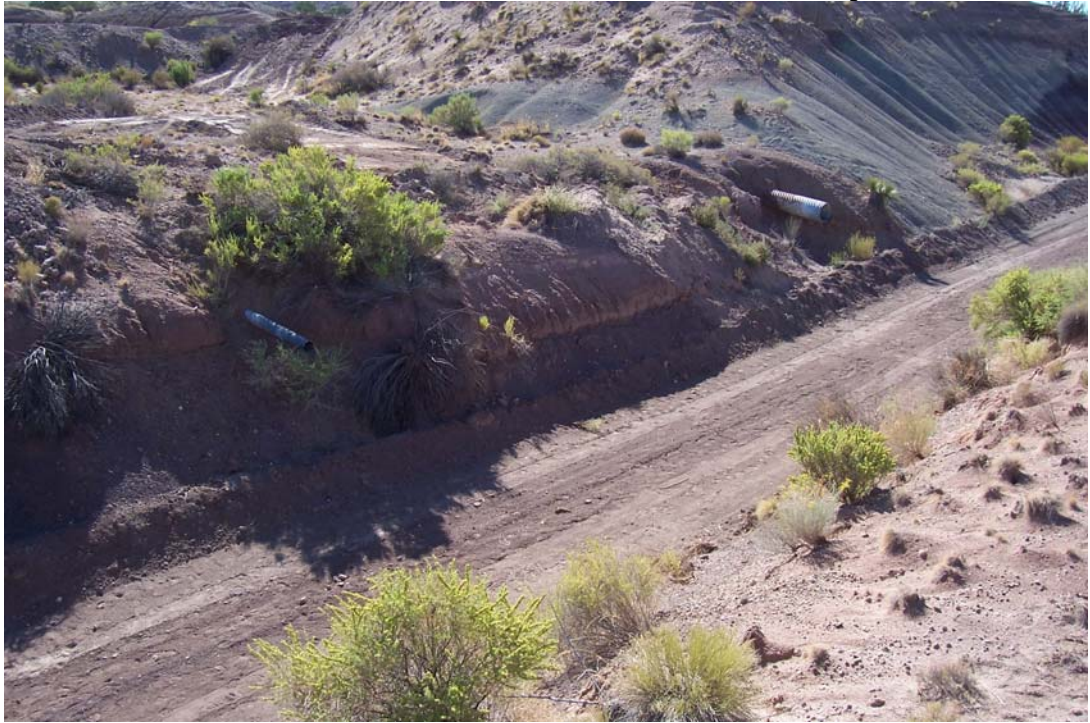
**Photo 35: View of emergency spillway near channel control section. Note eroded channel slope. Surface crack observed at top of left slope (see following photos).**

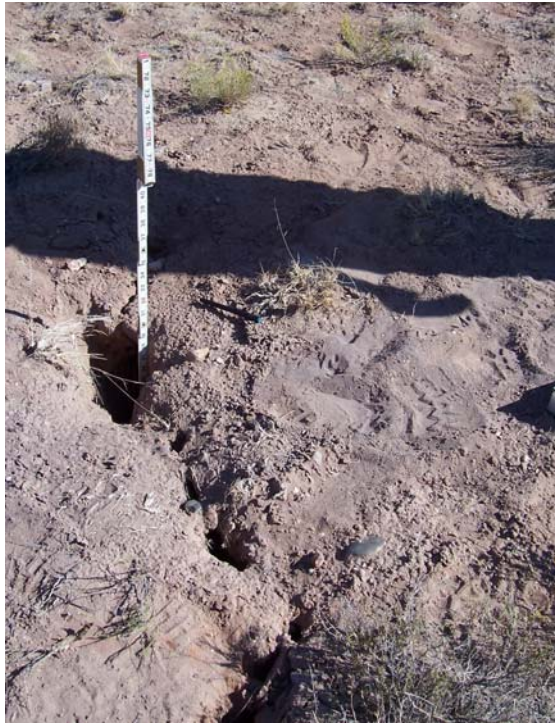
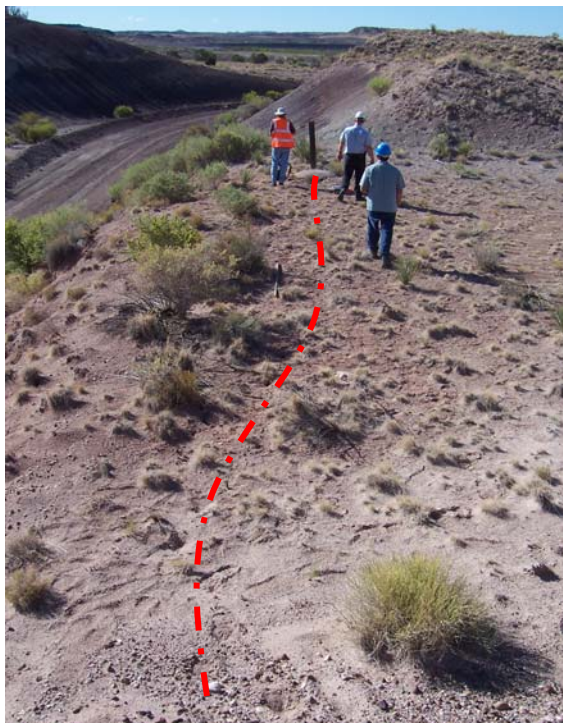
**Photo 36: View of surface crack near top of left slope of emergency spillway channel, near control section of channel and axis of dam.**

**Photo 37: Detail view of surface crack near top of left slope of emergency spillway channel. Note ruler inserted approximately 30 inches into crack.**

**Photo 38: Overview of top of slope area where surface crack was observed. Approximate alignment of surface crack shown with dashed line.**

2. Evaluate the surface crack on top of the left slope of the emergency spillway channel (along the dam axis by surface settlement monument #10). Monitor the surface crack for signs of additional movement or enlargement.

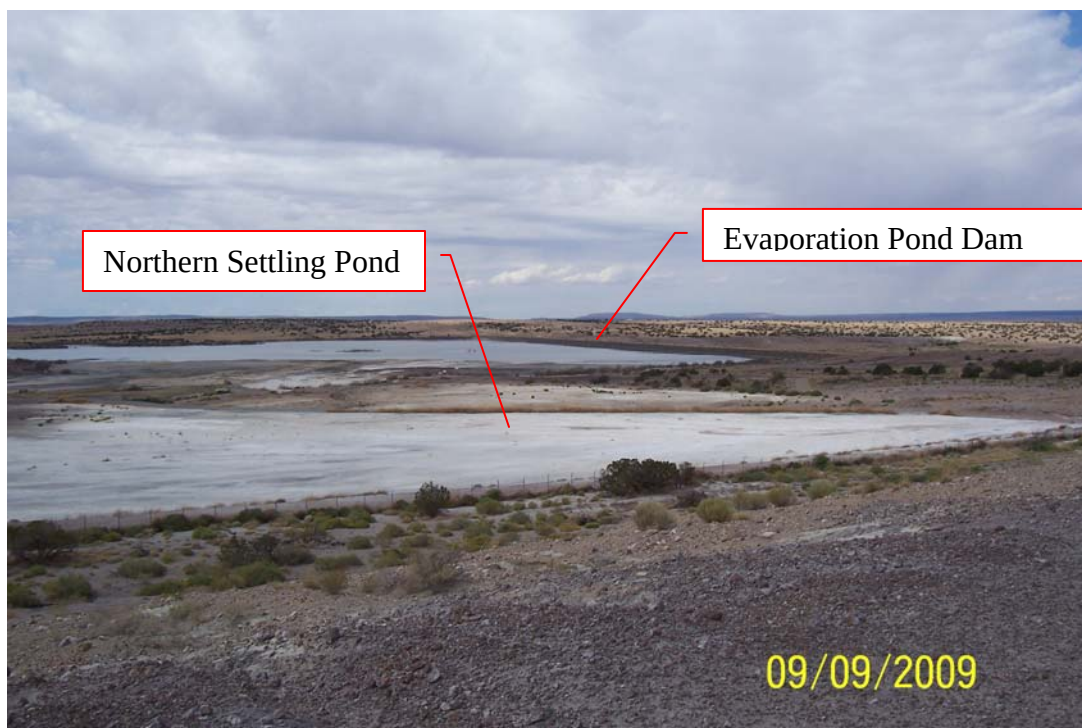
GZA also observed that secondary settling ponds have been and are being constructed upstream of the dam, within the drainage area of the dam. The settling ponds are formed by earthfill embankment structures, and are located immediately east of the Evaporation Pond adjacent to a dry landfill that is used for disposal of dry CCW.

**Photo 39: View from Ash Landfill area towards settling pond and Evaporation Pond Dam. Note small earthen berm around northern settling pond.**

7. Collect/develop documentation of the “As-Built” configuration of the two settling pond embankments and appurtenant structures.
8. Investigate the potential impacts of an embankment failure of the two settling pond embankments, including an evaluation of the resulting flood wave impact to the Evaporation Pond Dam.
