ASSESSMENT OF DAM SAFETY OF COAL COMBUSTION SURFACE IMPOUNDMENTS – DRAFT REPORT

**CPS Energy
J.T. Deely Power Plant
San Antonio, Texas**

Prepared for
*U.S. Environmental
Protection Agency
Washington, D.C.*

December 2012
Revision 1, December 2013

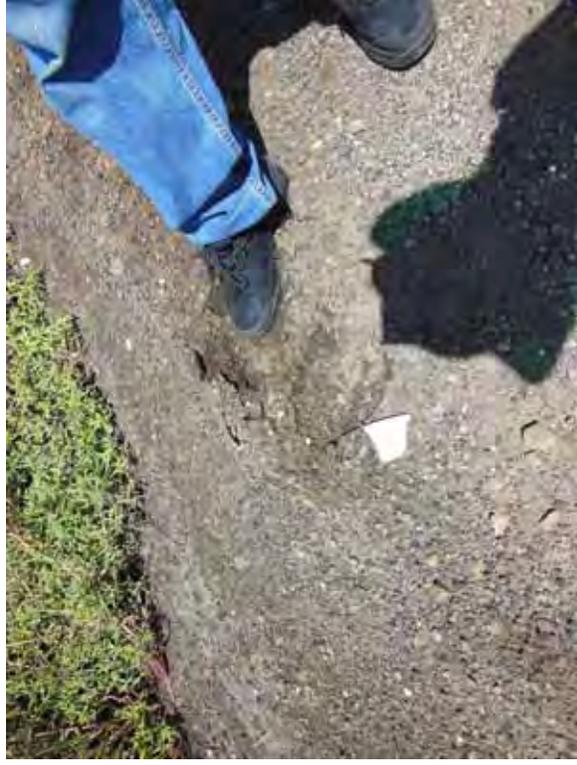
Photo 14: NP - Loose ash material at east embankment interior slope.

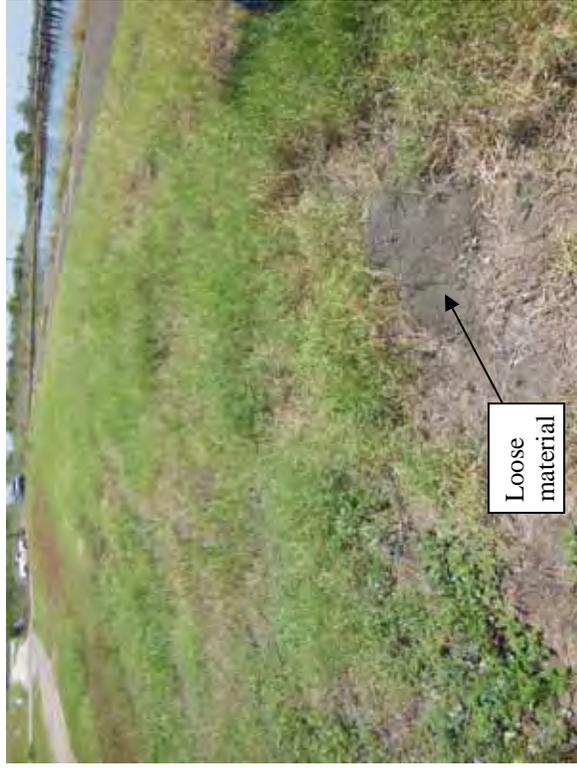
Photo 41: NP - West embankment exterior slope, looking north. Note area of loose soil/ash material.

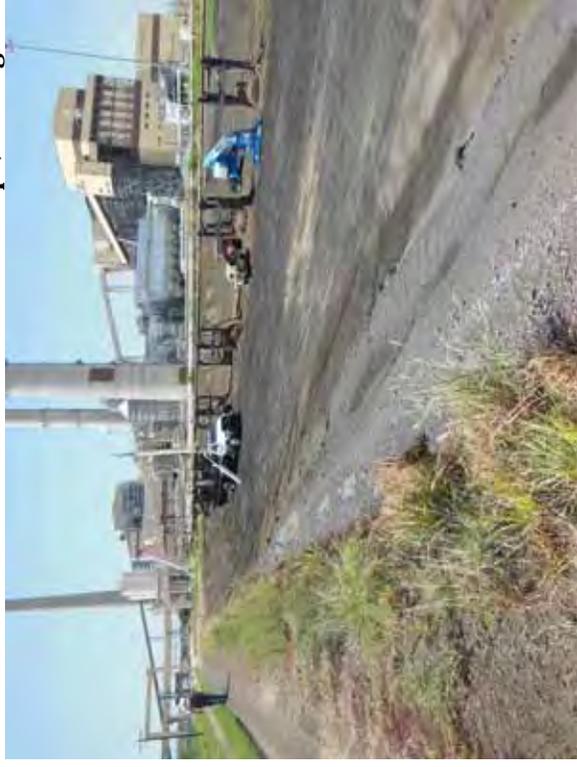
Photo 68: SP - South embankment exterior slope, looking west. Note equipment working in pond to replace inlet piping.

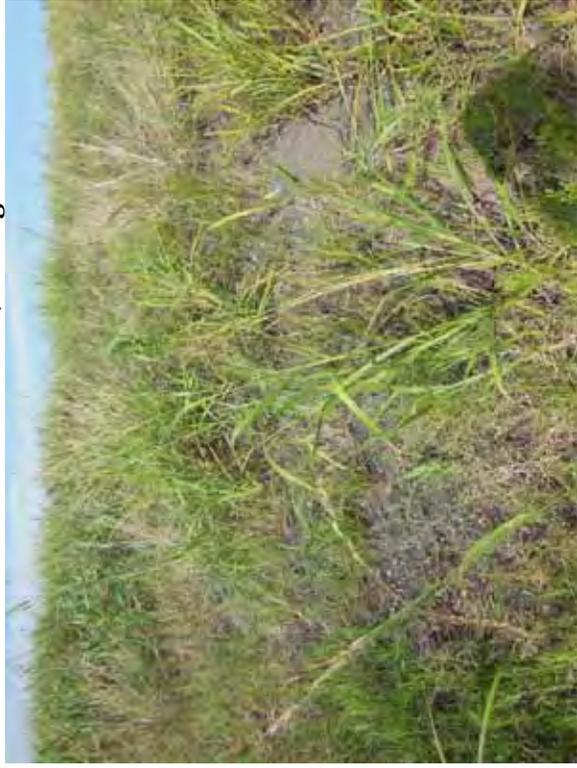
Photo 92: Loose soils on east embankment exterior slope.

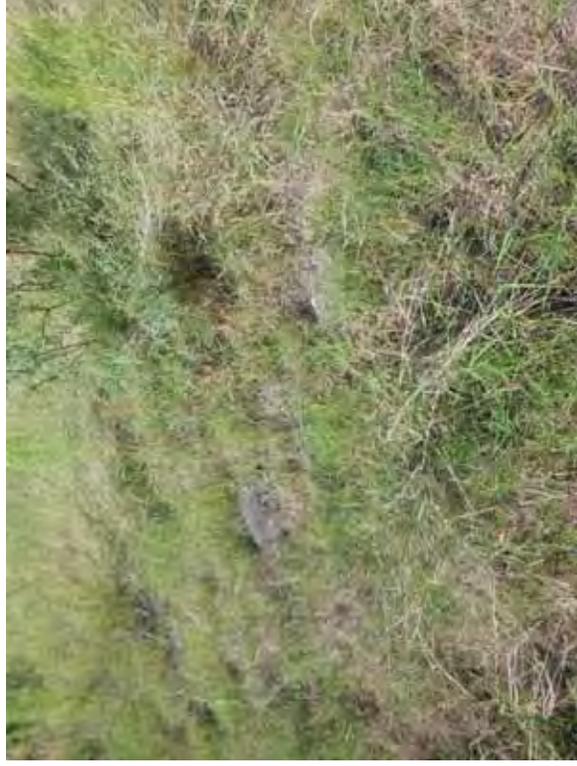
Photo 94: Loose soils on east embankment exterior slope.

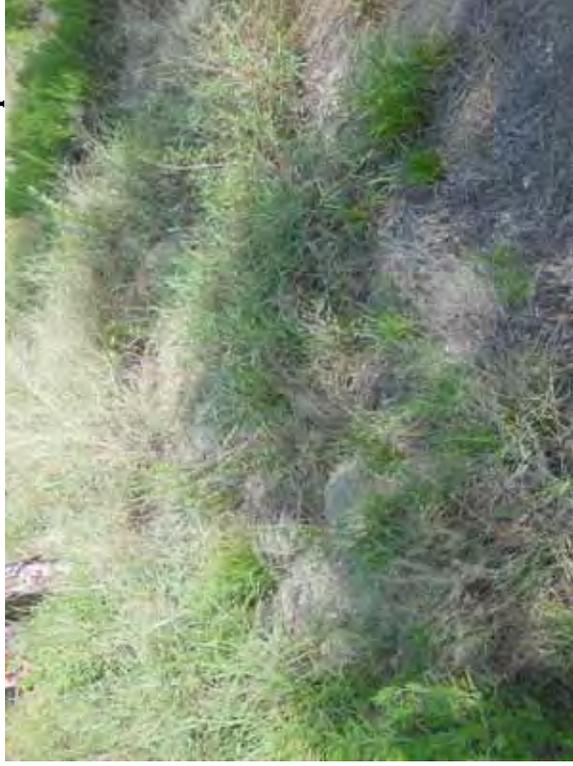
Photo 96: Loose soils near east embankment exterior toe.

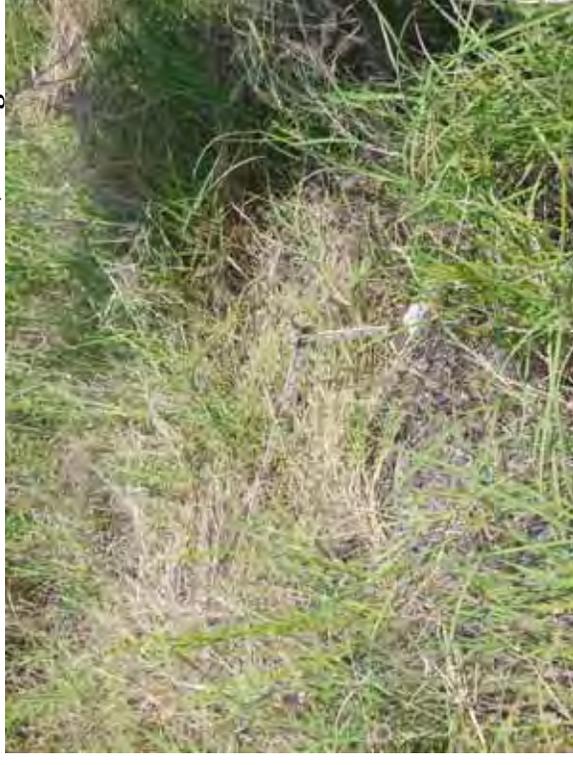
Photo 97: East embankment exterior slope measured approximately 4H:1V.
