# ASSESSMENT OF DAM SAFETY OF COAL COMBUSTION SURFACE IMPOUNDMENTS FINAL REPORT

**CPS Energy  
J.T. Deely Power Plant  
San Antonio, Texas**

Prepared for  
*U.S. Environmental  
Protection Agency  
Washington, D.C.*

February 2014  
Revised May 2014  
Revised June 2014

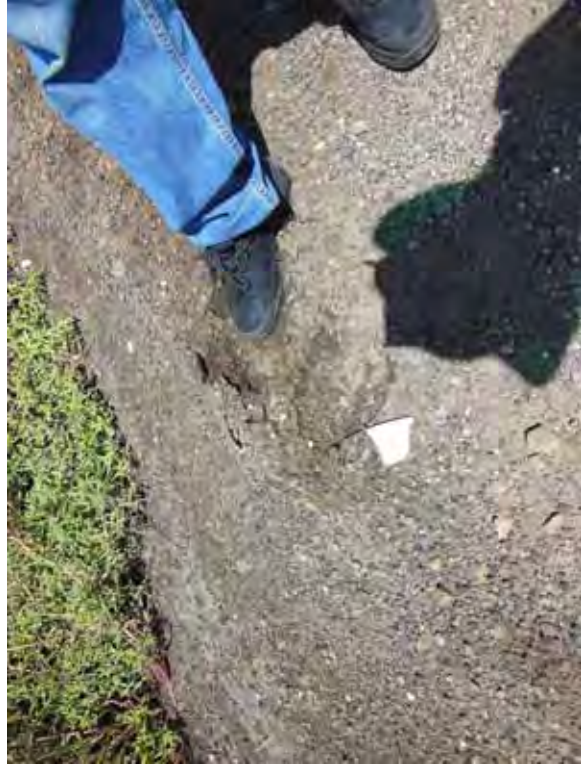
**Photo 14: NP - Loose ash material at east embankment interior slope.**

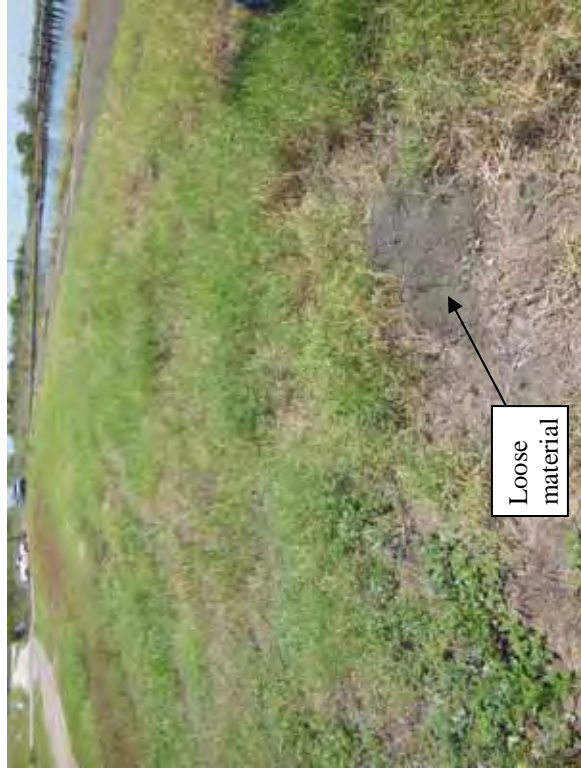
**Photo 41: NP - West embankment exterior slope, looking north. Note area of loose soil/ash material.**

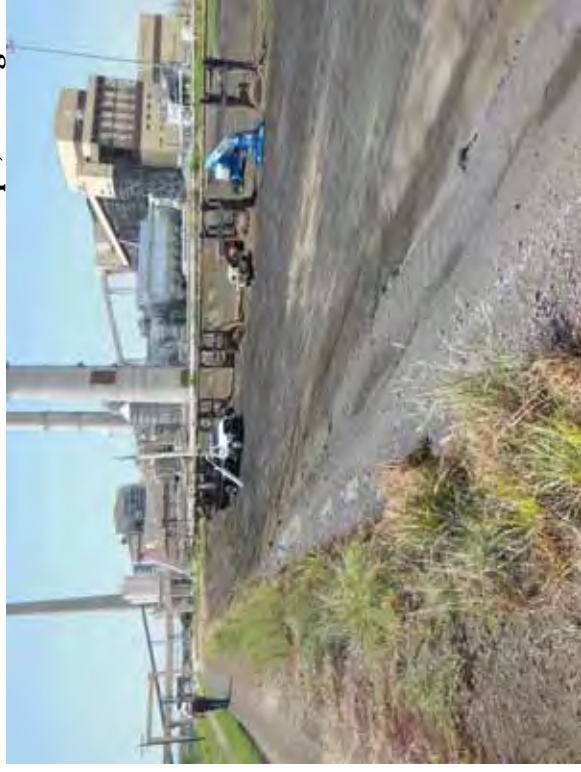
**Photo 68: SP - South embankment exterior slope, looking west. Note equipment working in pond to replace inlet piping.**

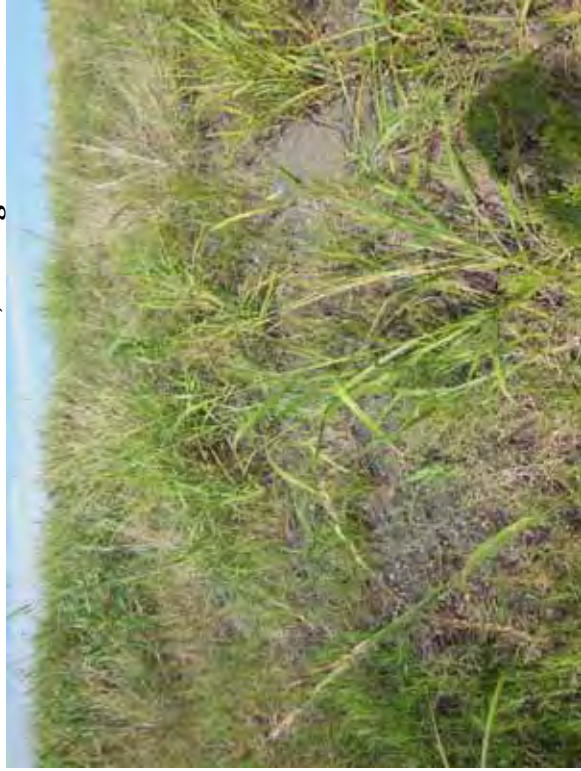
**Photo 92: Loose soils on east embankment exterior slope.**

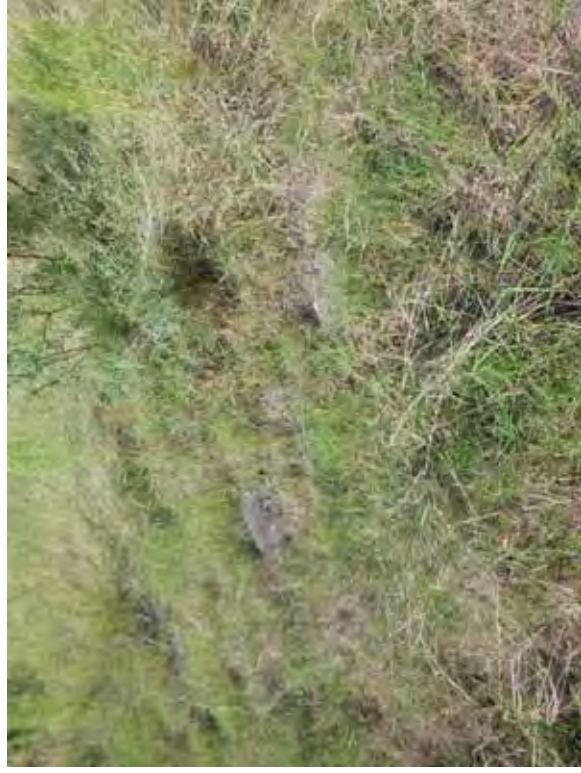
**Photo 94: Loose soils on east embankment exterior slope.**

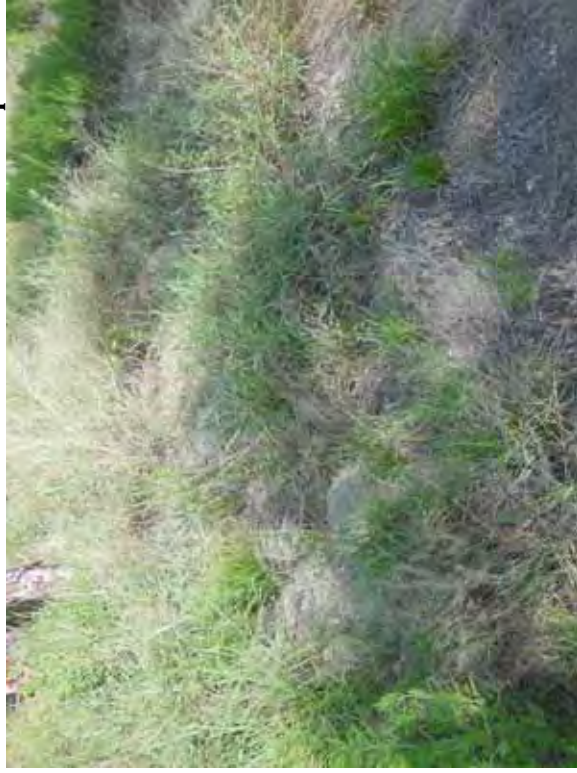
**Photo 96: Loose soils near east embankment exterior toe.**

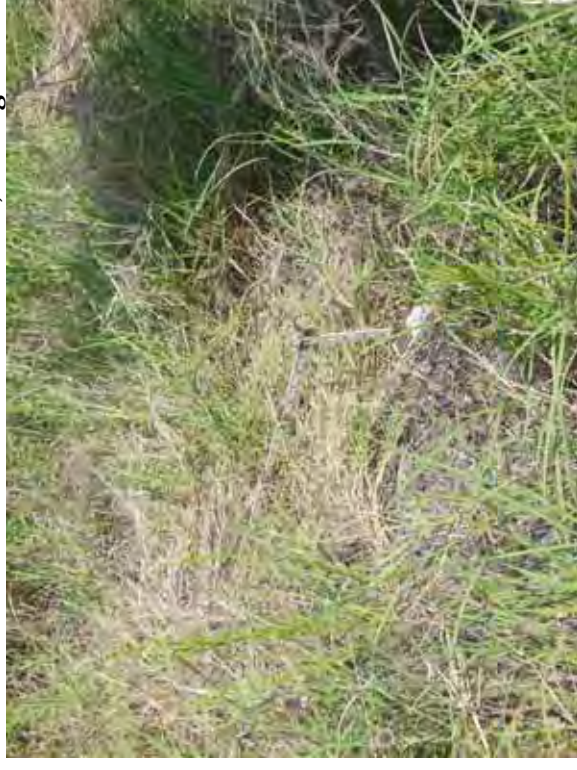
**Photo 97: East embankment exterior slope measured approximately 4H:1V.**
