ASSESSMENT OF DAM SAFETY OF COAL COMBUSTION SURFACE IMPOUNDMENTS – FINAL REPORT

**Crisp County Power
Commission
Plant Crisp
Warwick, Georgia**

Prepared for
*U.S. Environmental
Protection Agency
Washington, D.C.*

December 2013
Revision 1, February 2014

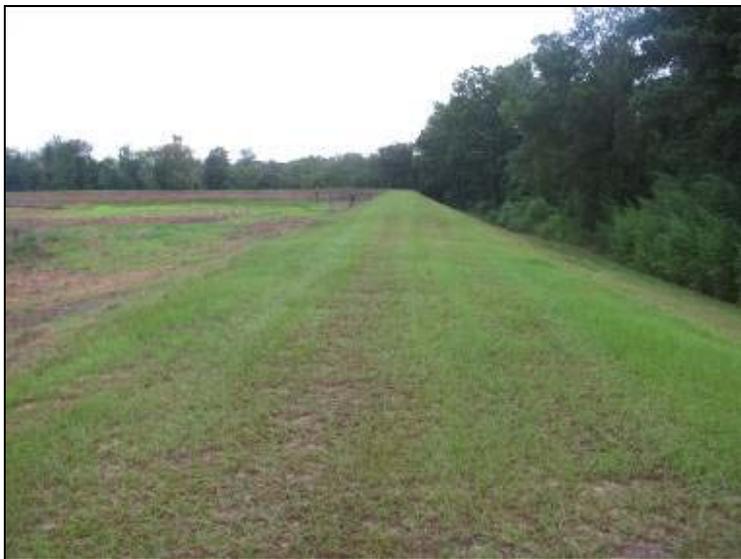
The crest of the perimeter embankment appeared to be in **SATISFACTORY** condition (Photographs 1, 34, 37, 40, 41, 46, 48 and 58). The crest width varies from about 15 and 20 feet. The crest of the embankments has a grass cover that was about 4 to 6 inches high. Reportedly, the crest is exposed to very limited vehicle traffic, only during maintenance operations. No signs of cracks, erosion, scarps, depressions, or settlement were observed on the crest of any of the embankments.

Photo 1: Ash Pond – Crest of north embankment, looking west.

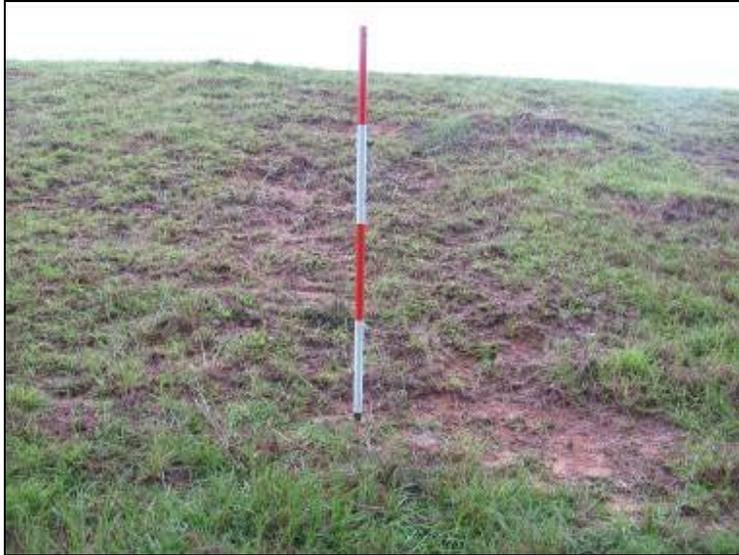
Photo 5: Ash Pond – North embankment exterior slope, minor surficial erosion looking south.

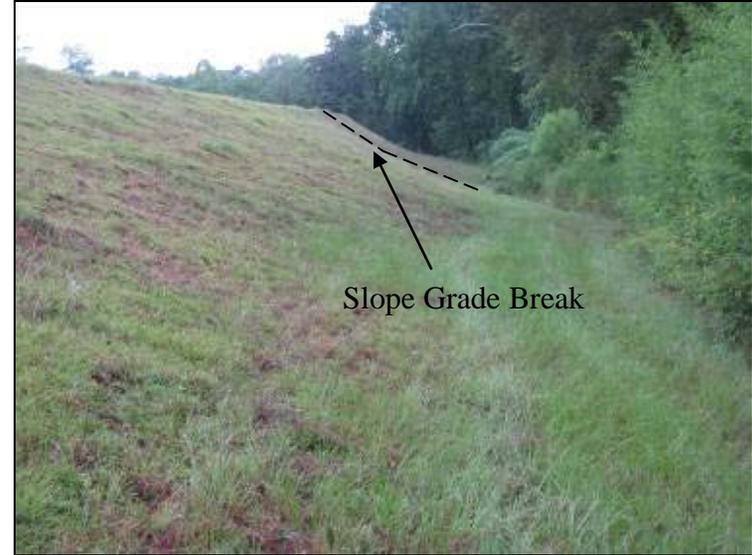
Photo 6: Ash Pond – North embankment exterior slope, change in slope grade from approximately 2.8 H:1V to 2H:1V, looking west.

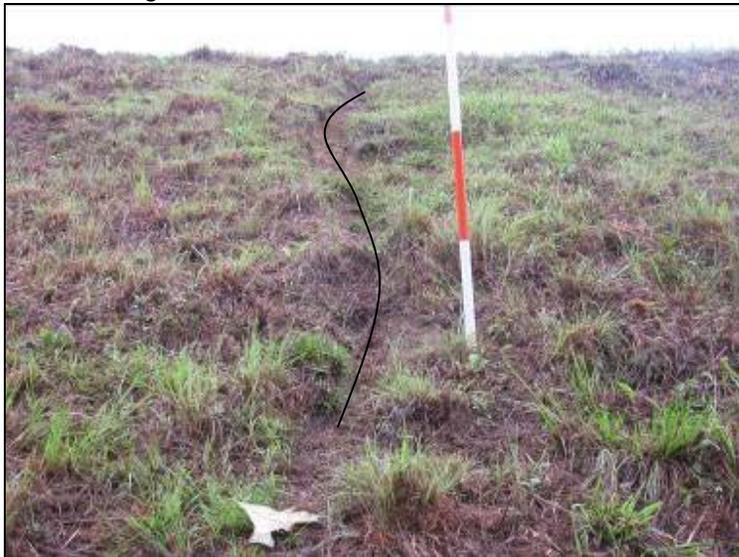
Photo 7: Ash Pond – North embankment exterior slope, surficial erosion rill running from crest to toe of slope looking south.

Erosion rills and scarps – Erosion rills and scarps were observed on the exterior and interior slopes of the west embankment. Structural fill should be placed and compacted in the rills and scarps and the repaired areas graded to meet the adjacent existing contours. After slope restoration, it is recommended that the exposed surface of the embankment be stabilized with sod or hydroseeded to restore vegetation cover on the slopes.

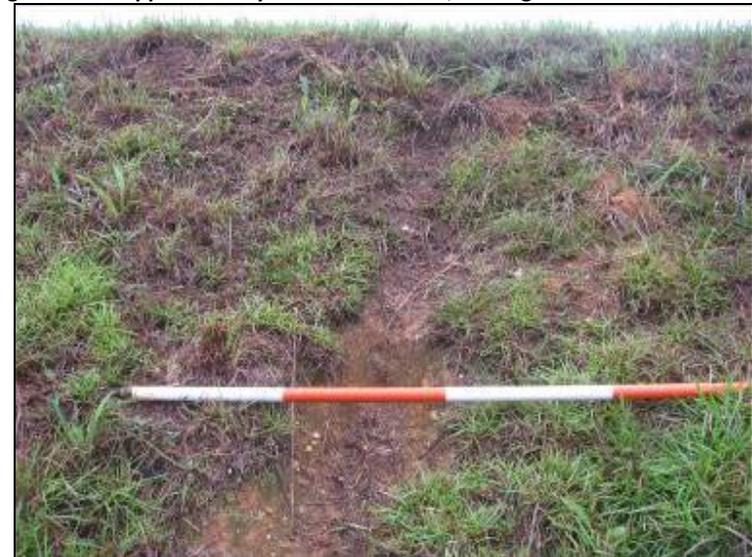
Photo 8: Ash Pond – North embankment exterior slope, erosion rill near crest, looking south.

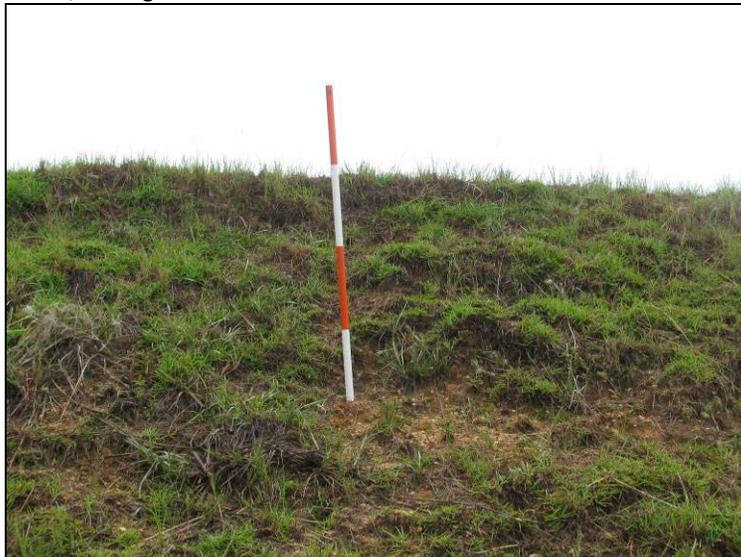
The exterior slopes appear to be in **FAIR** condition. The exterior slopes of the embankments are about 2H:1V at the north and west embankments, 5H:1V at the south embankment, and 4H:1V at the southeast embankment. The east portion of the north embankment has an approximate slope of 3H:1V with a slope break near the outlet structure to 2H:1V (Photograph 6). Slopes shown on the drawings provided are 3H:1V. The exterior slopes are covered with grass that was approximately 4 to 6 inches high at the time of the visual assessment (Photographs 14 to 17, 31, 32, 38, 39, 44 and 45). Surficial erosion rills and scarps were observed at the north embankment (Photographs 5, 7 and 8). An apparent 16-foot-long semicircular surficial slough (Photographs 21 to 23) and several minor sloughs and scarps near the crest (Photograph 18, 19, 20, and 24 to 27) were observed on the west embankment.

Photo 19: Ash Pond – West embankment exterior slope sloughing, looking east.

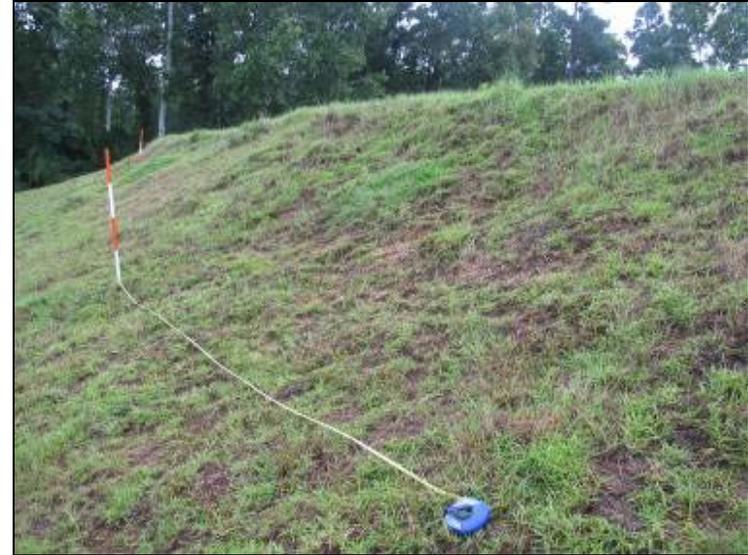
Photo 22: Ash Pond – West embankment exterior slope, apparent 16-foot long semi-circular sloughing, looking north.

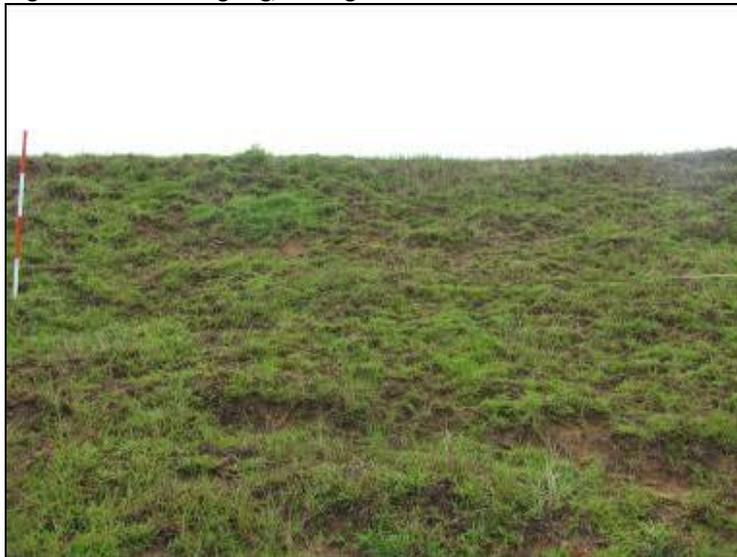
Photo 23: Ash Pond – West embankment exterior slope, apparent 16-foot long semi-circular sloughing, looking east.

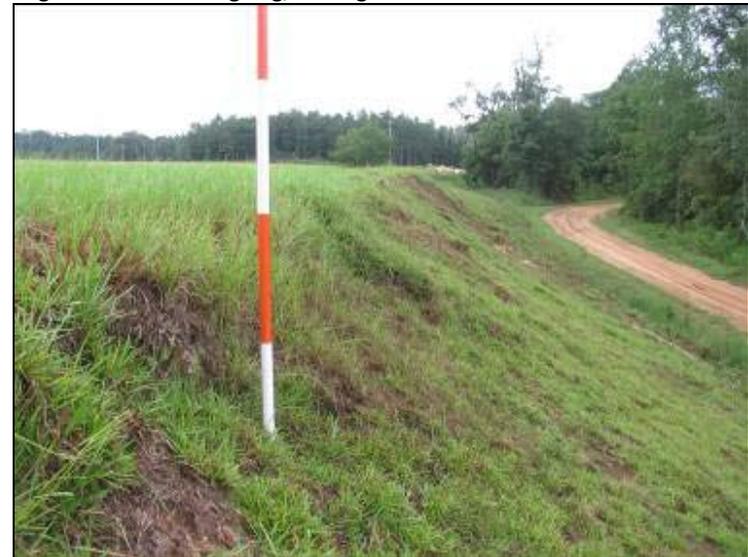
Photo 24: Ash Pond – West embankment exterior slope, scarp near crest of embankment, looking southeast.

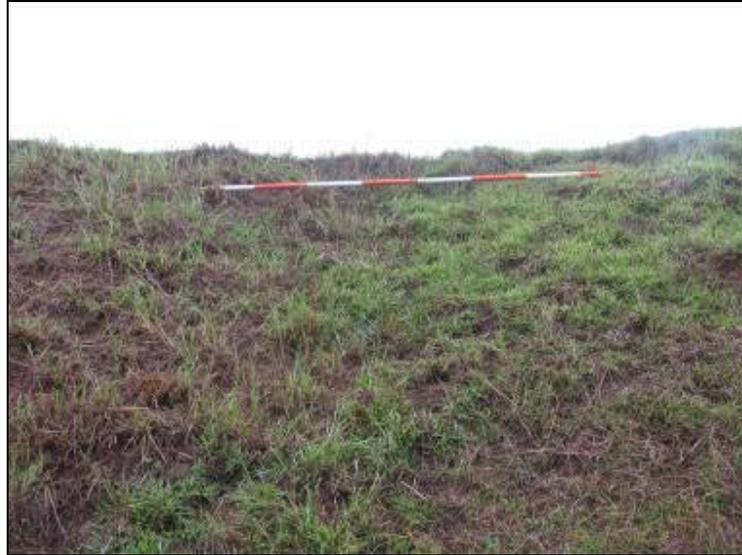
Photo 25: Ash Pond – West embankment exterior slope, sloughing near crest of embankment, looking east.

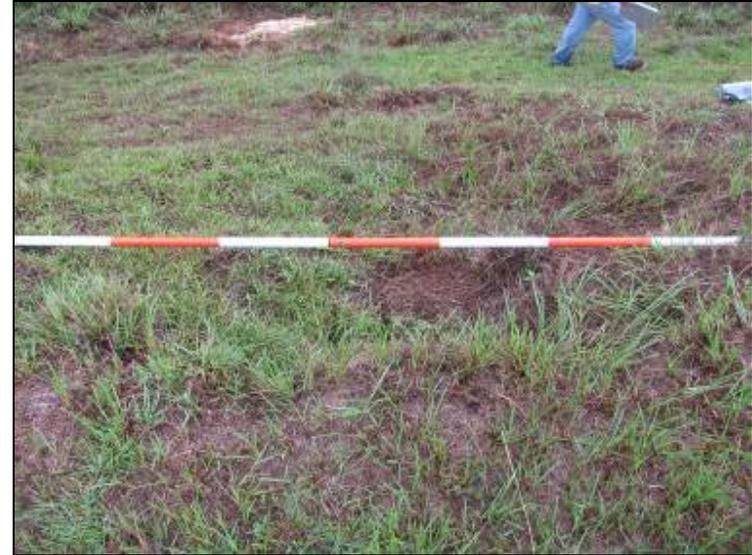
Photo 26: Ash Pond – West embankment exterior slope, sloughing near crest, looking west.

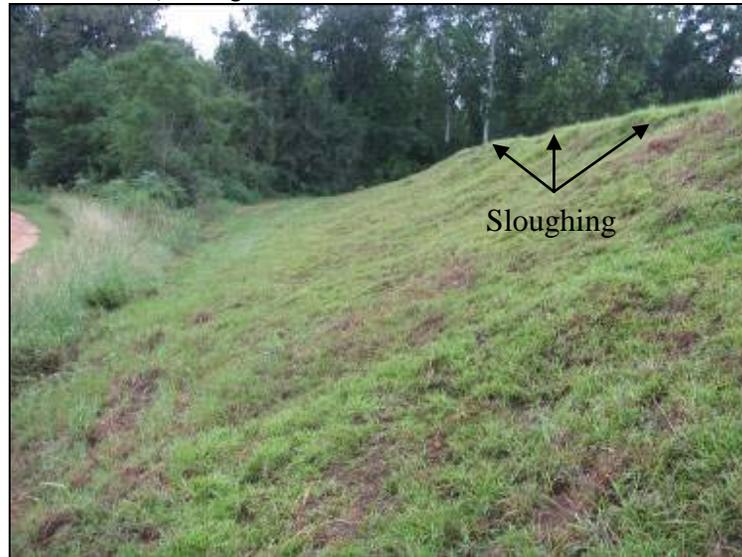
Photo 27: Ash Pond – West embankment exterior slope, looking north.

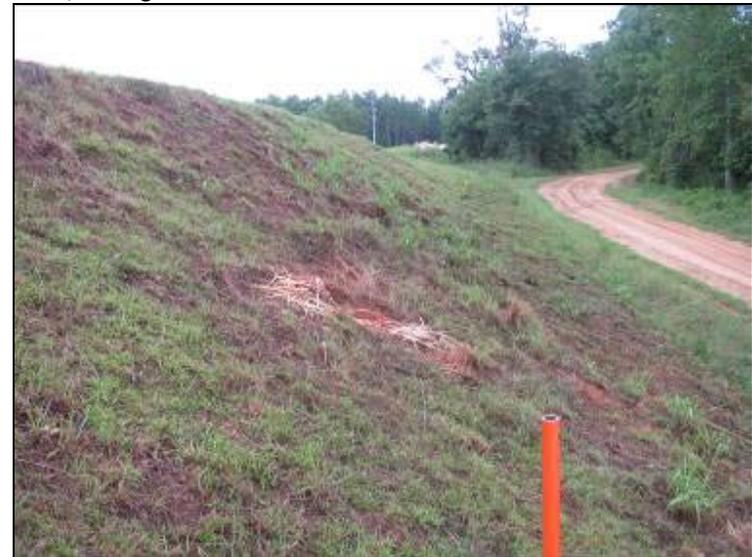
Photo 28: Ash Pond – West embankment exterior slope, looking south.
Note: steepness of slope (2H:1V).

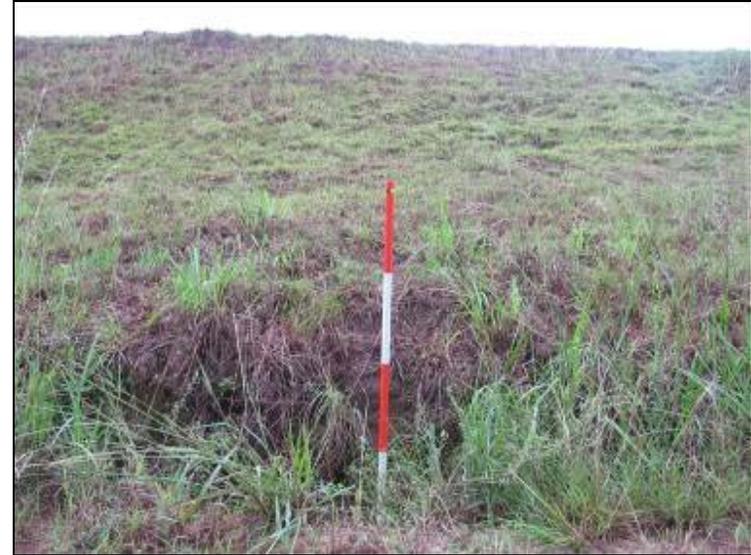
Photo 30: Ash Pond – West embankment exterior slope, swale cut at toe of slope, looking east.

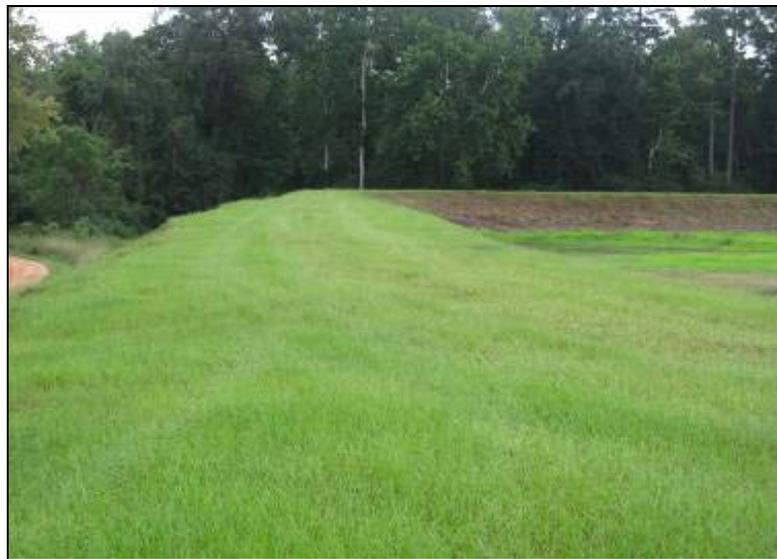
Photo 34: Ash Pond – Crest of west embankment looking north.

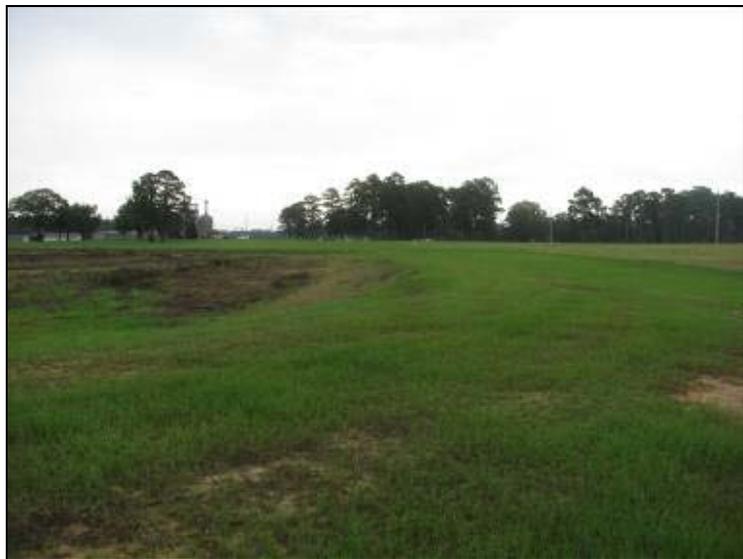
Photo 37: Ash Pond – Crest of South embankment looking east.

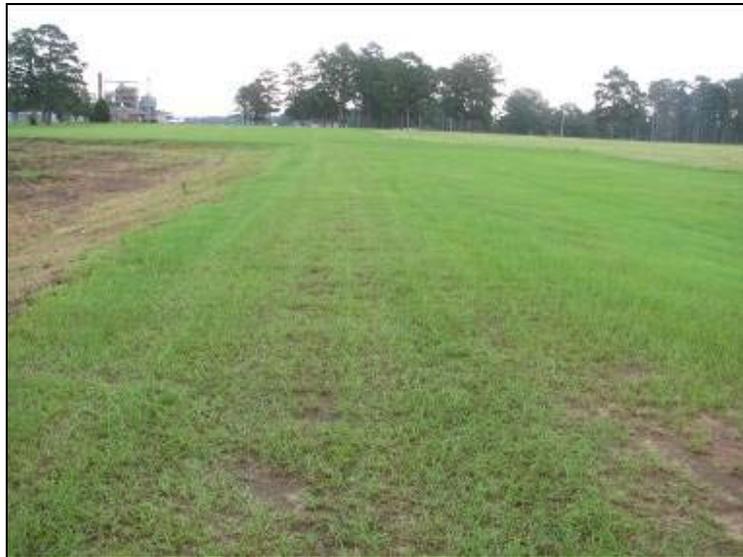
Photo 41: Ash Pond – Crest South Embankment looking east.

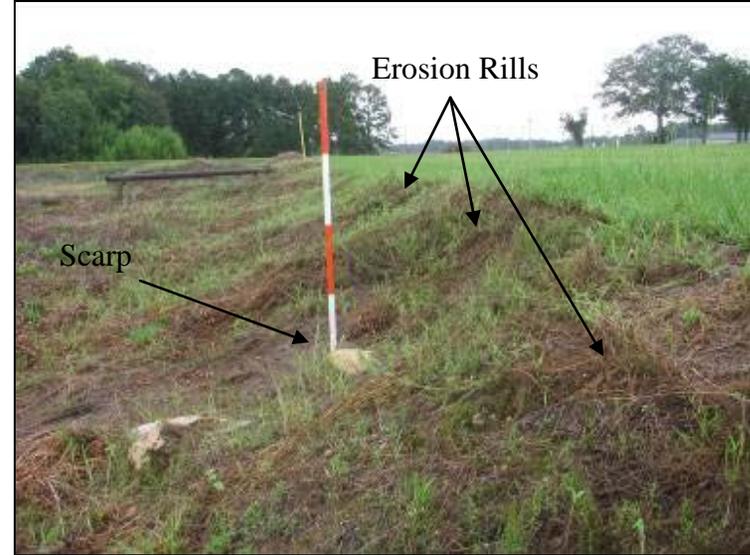
Photo 50: Ash Pond – Southeast embankment interior slope, looking northeast. Note: erosion rills and surficial scarps.

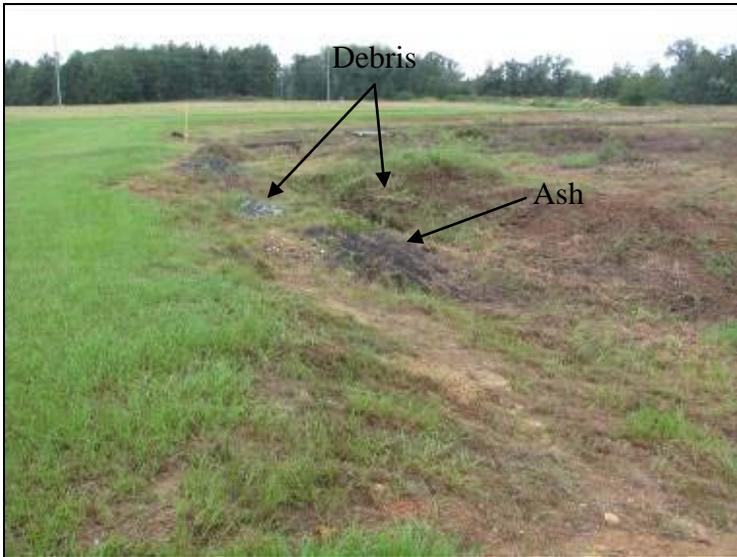
The interior slopes of the Ash Pond embankments appear to be in **FAIR** condition. The interior slopes are about 2H:1V at the north and west embankments, 3H:1V at the south embankment, and 5H:1V at the southeast embankment. Slopes shown on the drawings provided are 3H:1V. Interior slopes have a grass cover approximately 4 inches high (Photographs 4, 9, 10, 42, 43, 57, 60, 67, 71 and 72). Scarps and erosion rills (Photographs 50, 59, 61, 62, 66, 70 and 75) were observed along the interior slopes of the north, west, and south embankments. Several boulders (rocks with size greater than 12 inches) protruding from the face of the slope (Photographs 65 and 73) were observed on the north and south embankments. Near the southeast embankment, accumulated ash and debris were clearly visible (Photograph 53).

Photo 53: Ash Pond – Crest and interior slope southeast embankment, looking southwest. Note: Ash and debris at pond surface.

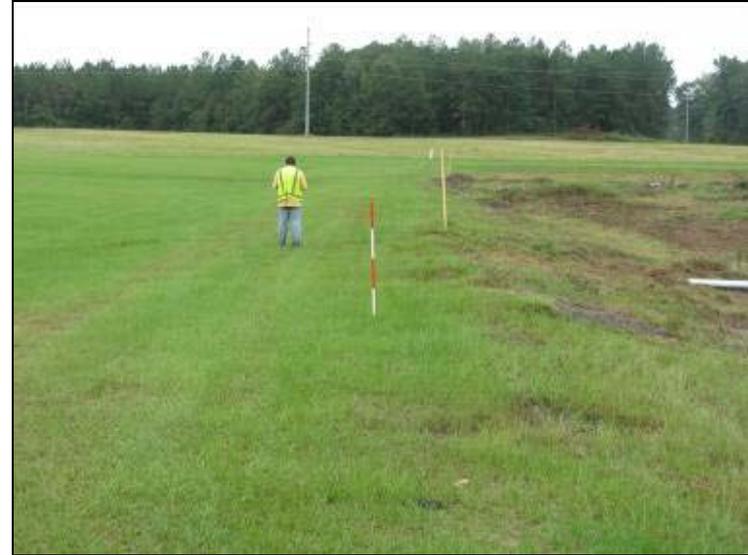
Photo 58: Ash Pond – Crest of southeast embankment near northeast corner, looking southwest.

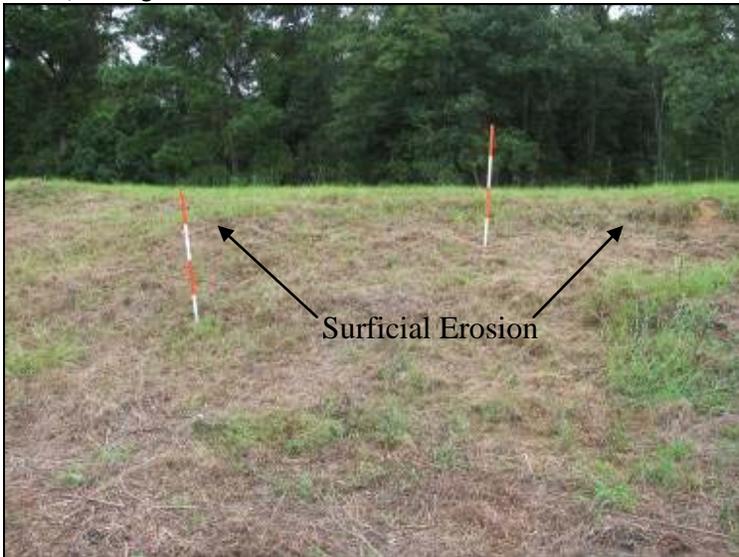
Photo 59: Ash Pond – North embankment interior slope, surficial erosion (30-foot long) looking northwest.

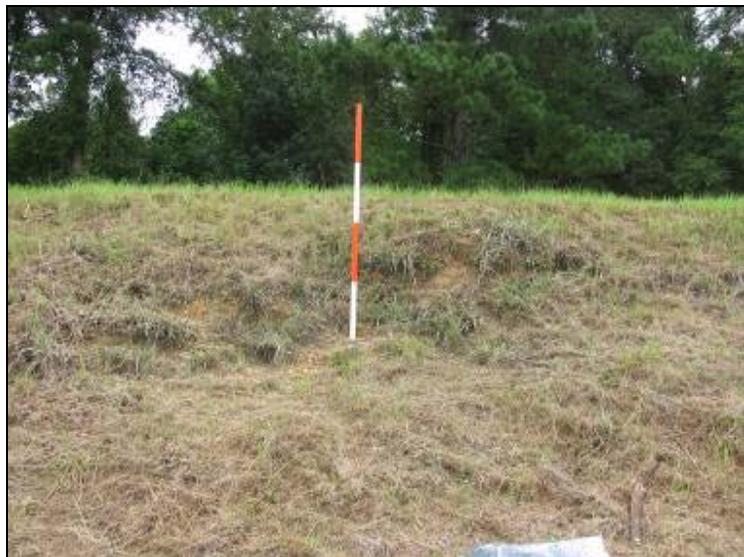
Photo 61: Ash Pond – North embankment interior slope surficial erosion, looking north.

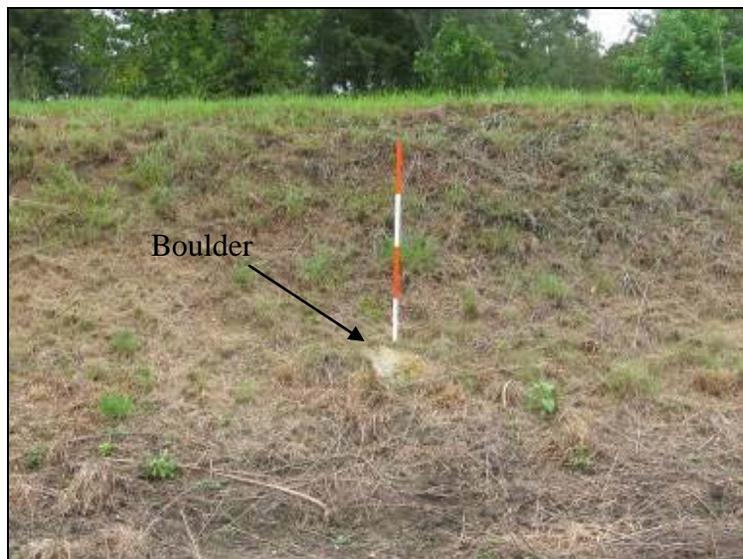
Photo 65: Ash Pond – North embankment interior slope, looking north.
 Note: boulder (12"-24") and steepness of slope (2H:1V).

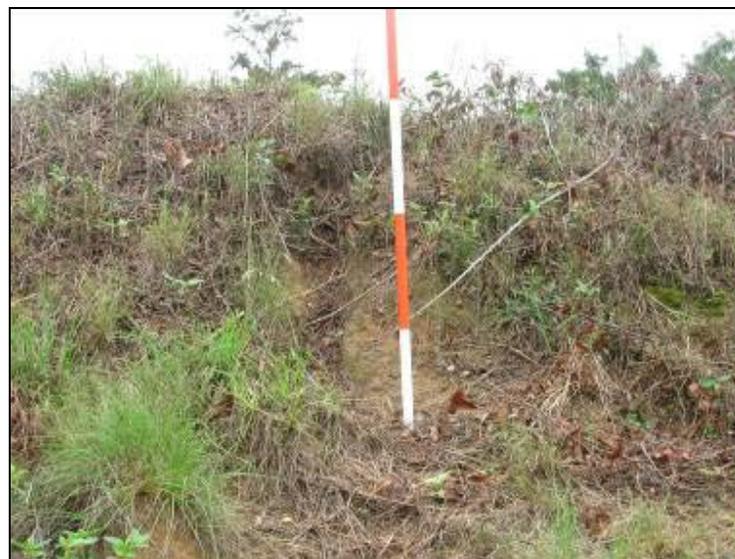
Photo 66: Ash Pond – North Embankment interior slope, erosion rills near outlet structure looking north.

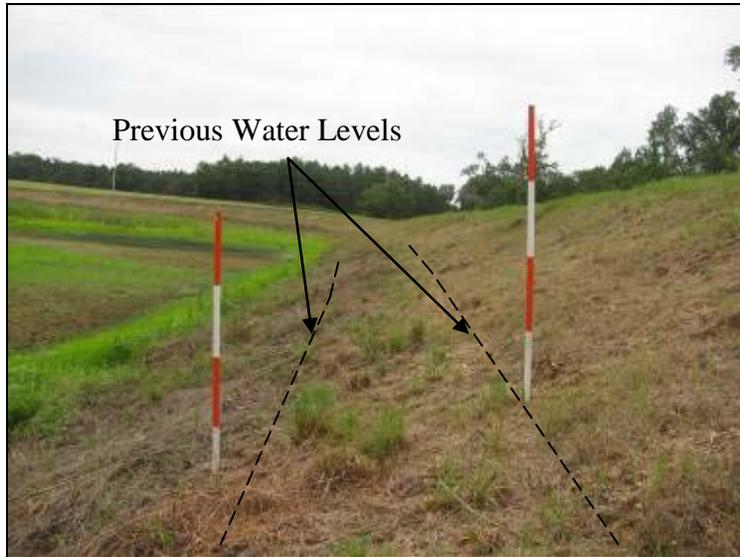
Photo 69: Ash Pond – West embankment interior slope, looking south. Note apparent previous water level marks.

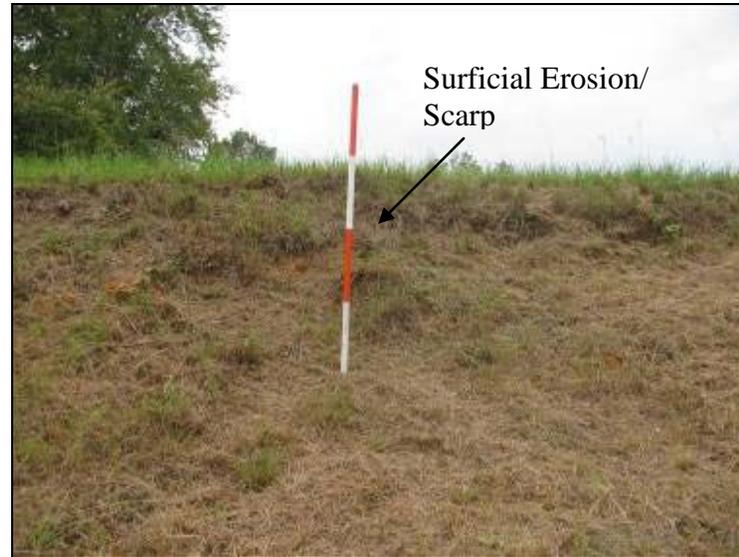
Photo 70: Ash Pond – West embankment interior slope surficial erosion/scarp, looking west.

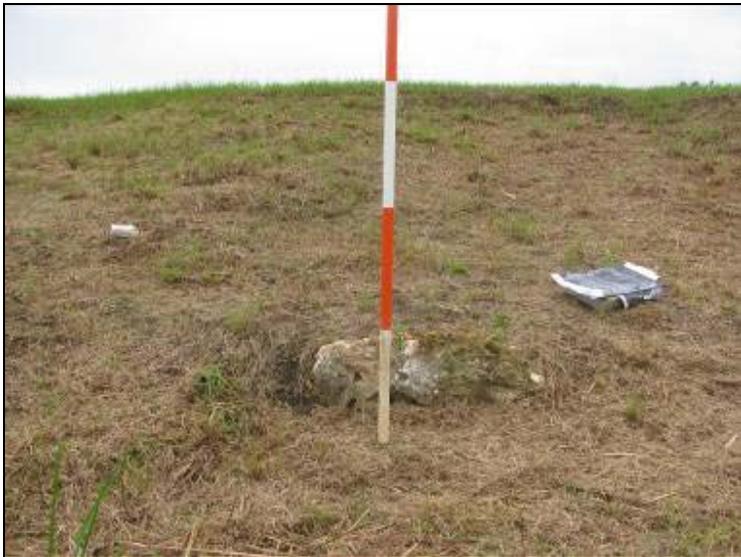
Photo 73: Ash Pond – South embankment interior slope, looking south. Note protruding rock at slope face.

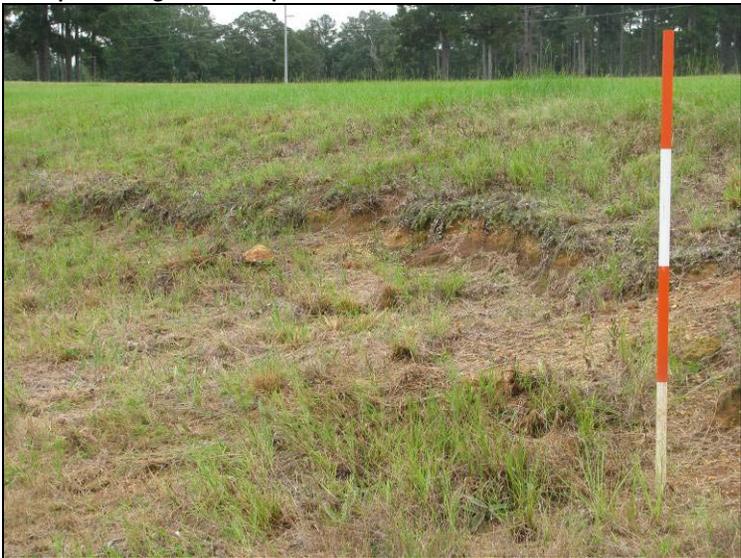
Photo 75: Ash Pond – South embankment interior slope, surficial erosion looking southeast.
