**COAL ASH IMPOUNDMENT  
SITE ASSESSMENT DRAFT REPORT**

**Dallman Power Station  
City of Springfield  
Springfield, Illinois**

**KLEINFELDER PROJECT NUMBER 112618-6**

**October 1, 2010**

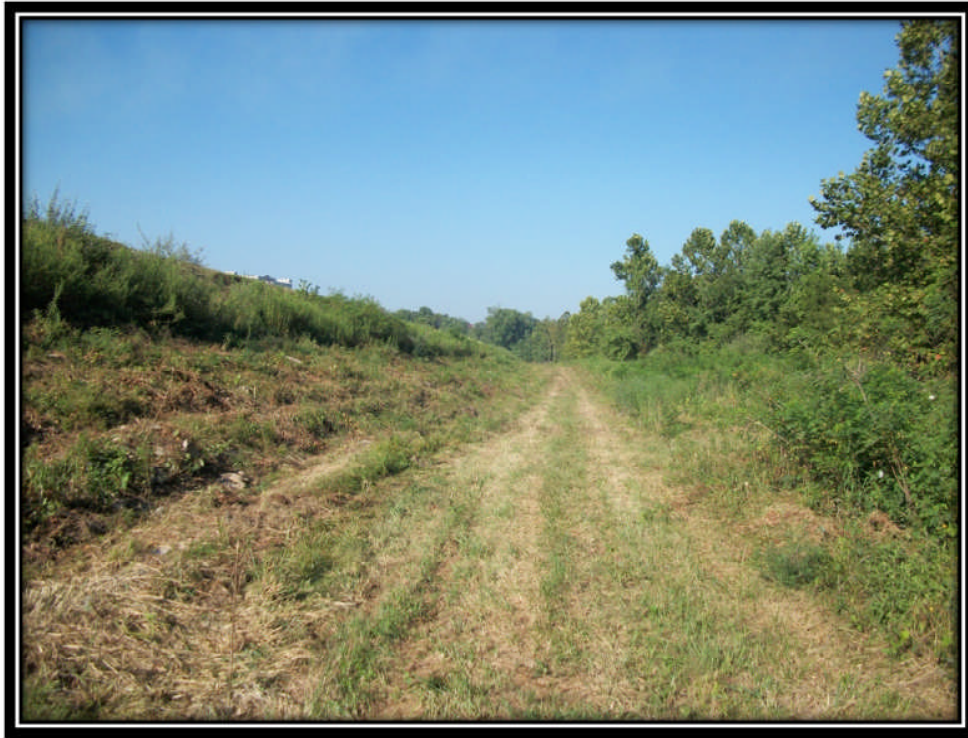
Photo 1 – Dallman Ash Pond Typical Northern Embankment Looking West (Note Uneven Slope Surface)

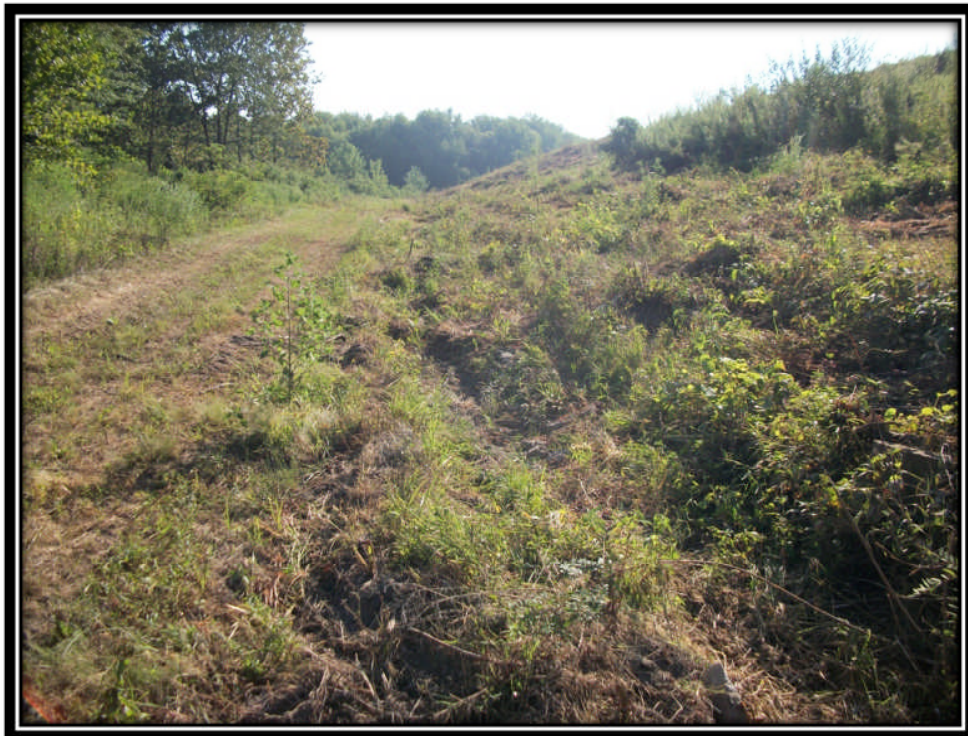
Photo 2 – Dallman Ash Pond Typical Northern Embankment Looking East (Note Vegetation on Slope)

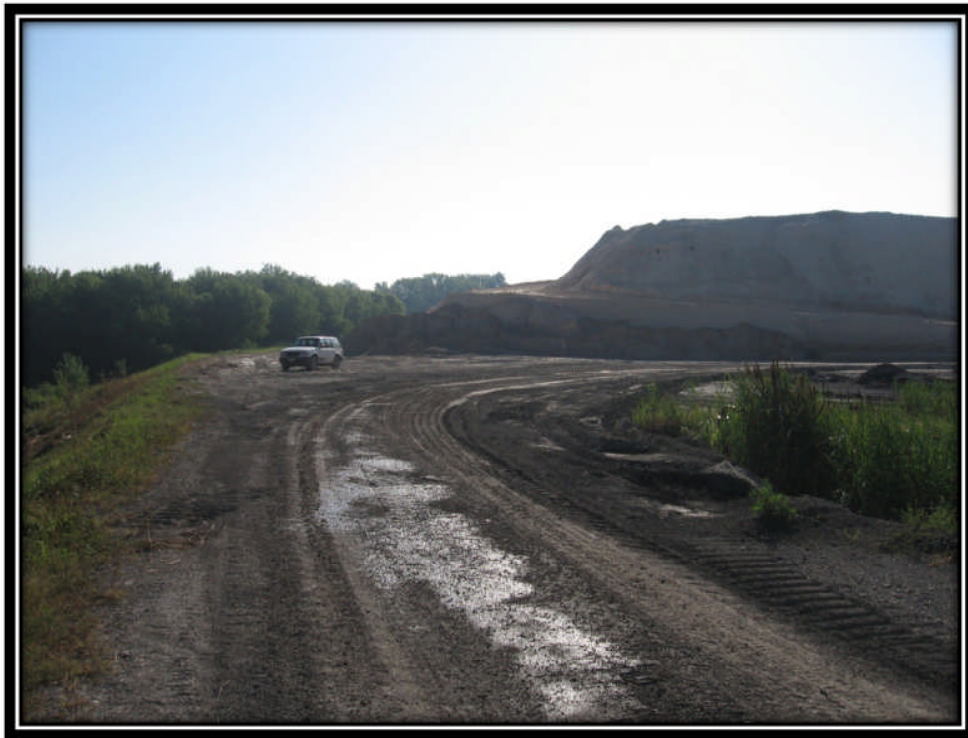
Overall, the crest of the impoundment was in good condition. Photograph 3 shows the condition of the crest. Specific observations include:

- The impoundment crest is a roadway.
- No major depressions or rutting were noted on the impoundment crest.
- Minor erosion was noted on crest in multiple locations. This erosion was typically less than six inches in depth and typically appeared on the edges of the crest, where grade breaks occurred when transitioning to embankment slopes.
- The crest is dissected at several locations by sluice piping that enters the pond from the west side (see Photograph 8 as an example).

Photo 3 – Dallman Ash Pond Typical Crest Condition Looking East

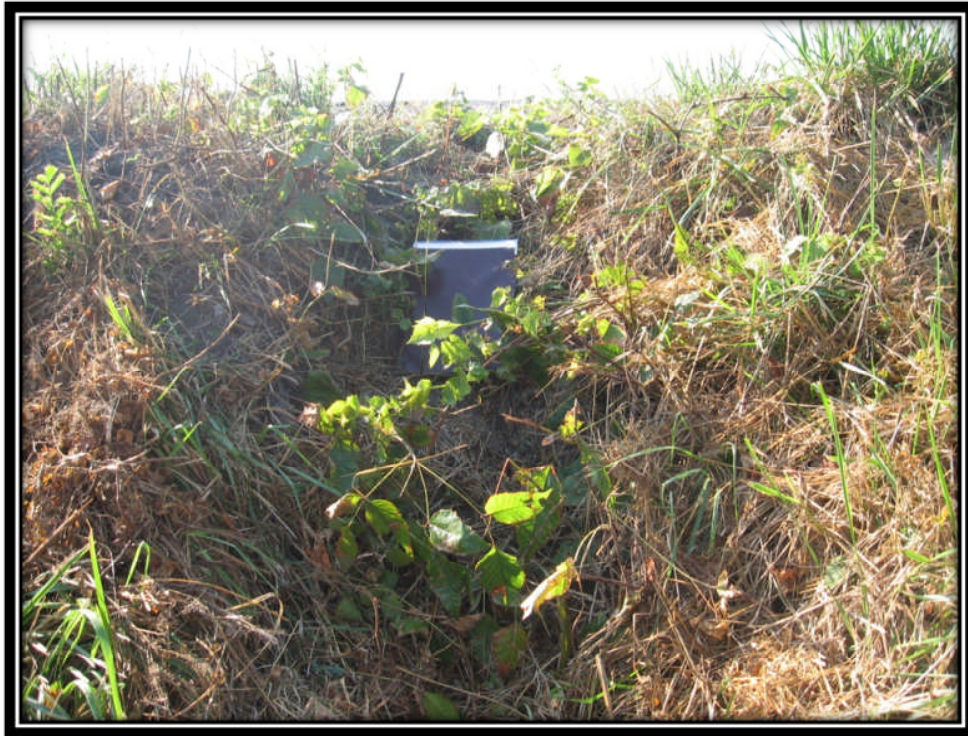
- Grasses and woody bushes were observed on the downstream slope and at the toe of the embankment for a large portion of the impoundment.
- Minor erosion was noted near the crest in multiple locations. This erosion was typically less than six inches in depth and typically appeared on the edges of the crest where grade breaks occurred when transitioning to embankment slopes. However, we noted some locations where the erosion was greater than 12 inches in depth as shown in Photograph 7.

Photo 7 – Surface Erosion Greater than 12” on Downstream Slope and Edge of Crest

1. **Repair erosion of embankment on an as-needed basis.** Minor surface erosion was noted at various locations across the site. Areas where erosion has occurred should be filled in and re-dressed with appropriate fill in order to prevent erosion from cutting further into the embankments.

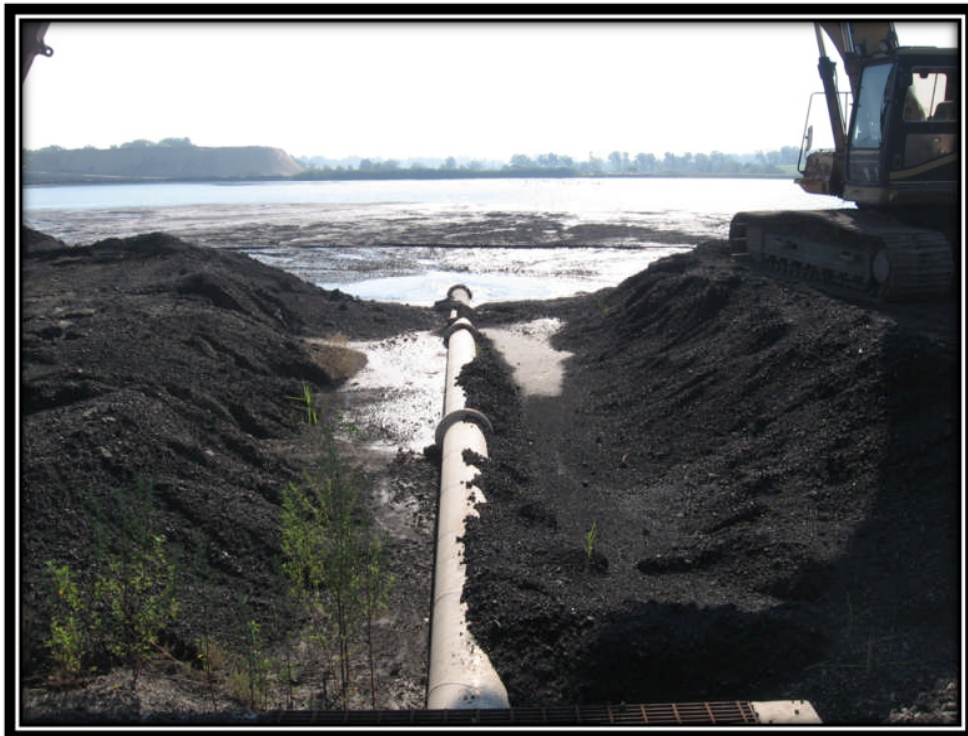
Photo 8 – Sluice Pipe Inlet into Dallman Ash Pond (Note Cut in Embankment)

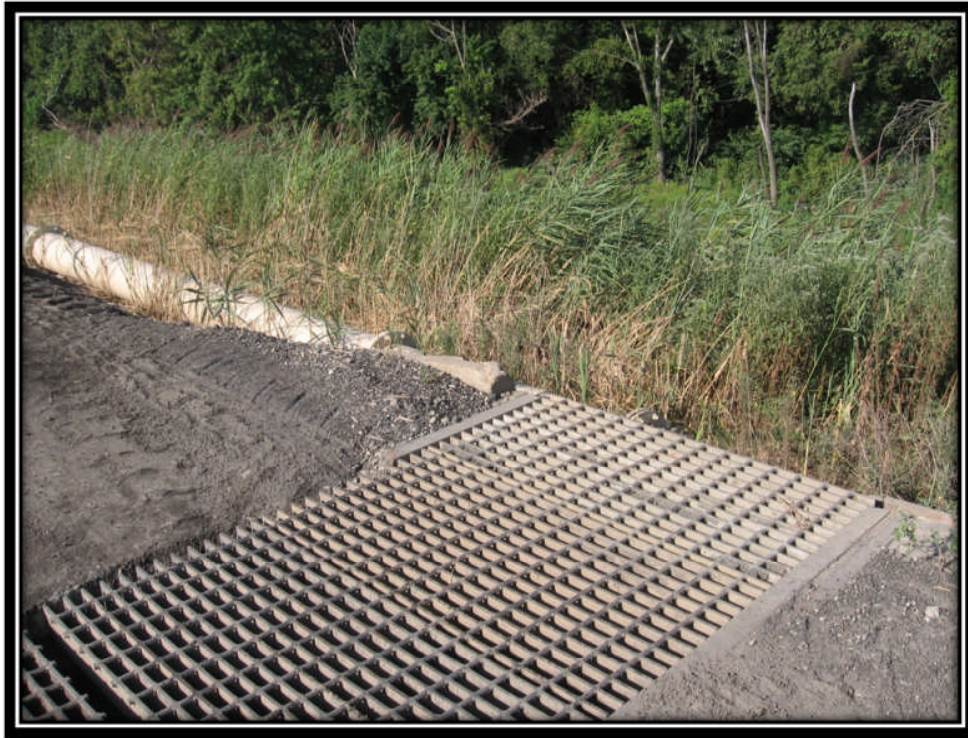
Overall, the downstream slope was in good condition. Photograph 9 shows the conditions of the downstream slope. Specific observations include:

Photo 9 – Grate on Crest Providing Roadway Access Over Sluice Pipe Inlet into Dallman Ash Pond

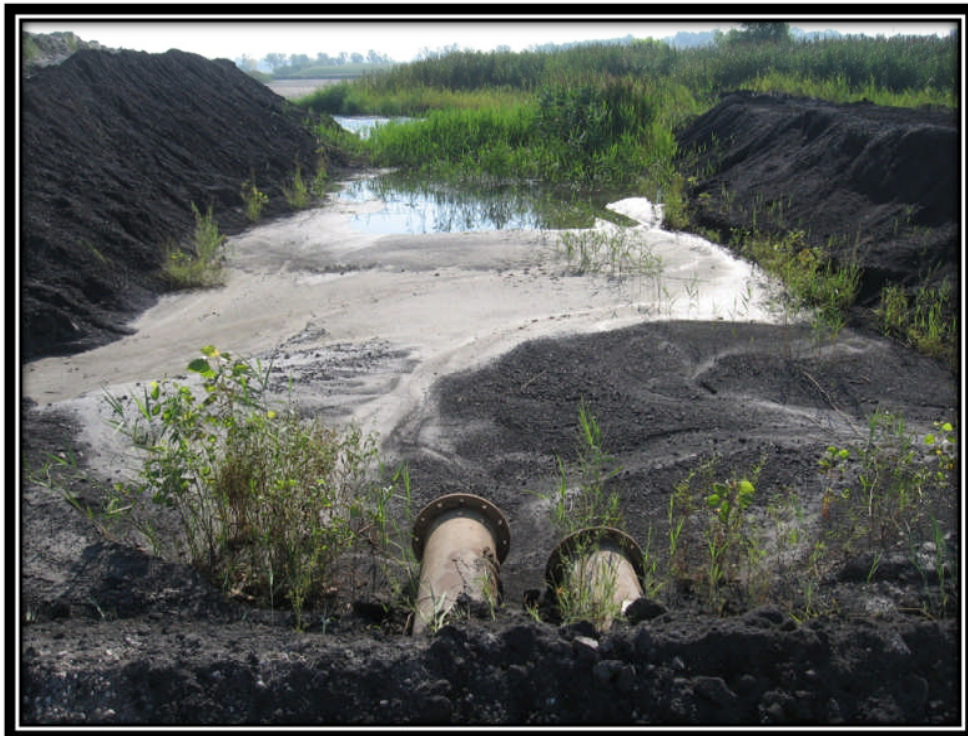
Photo 10 – Alternate Sluice Pipes (Not Active during Inspection, Note Cut in Embankment)

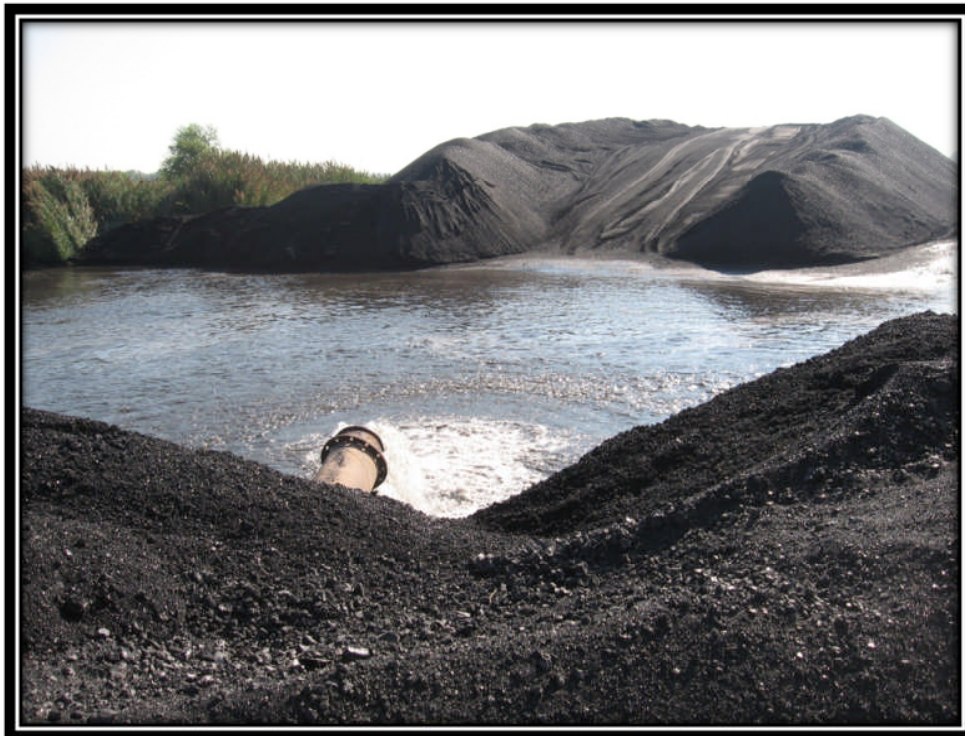
Photo 12 – Boiler Slag Sluice Pipe into Dallman Ash Pond (Note Backfilled Embankment)

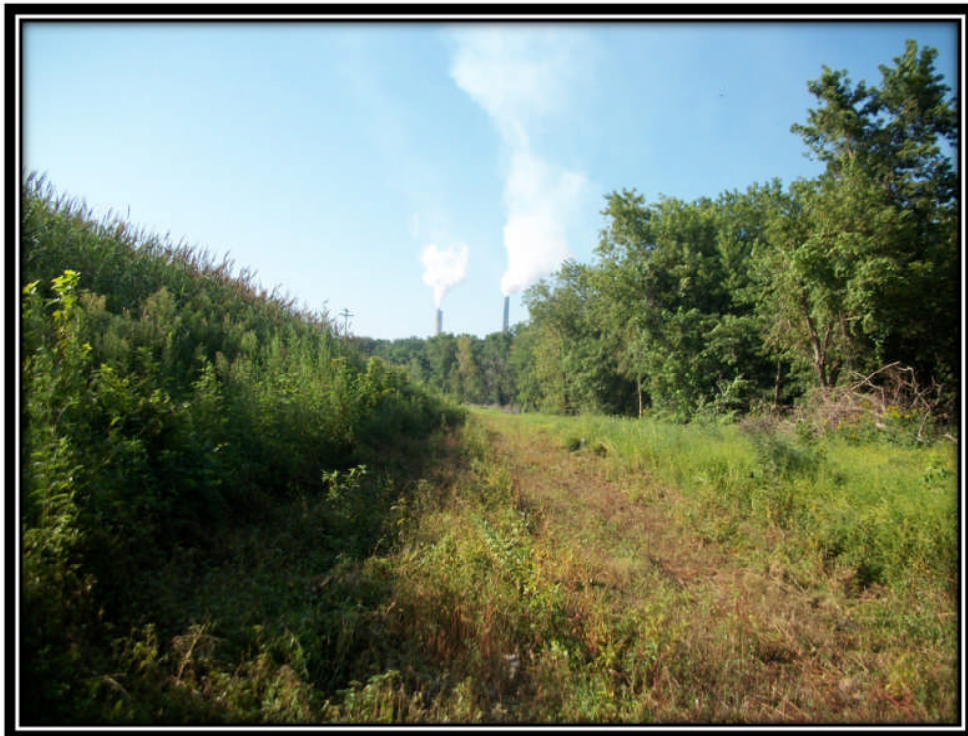
The toe areas of the embankment were in good condition. See Photographs 16 and 18 for the condition of these areas. Specific observations include:

Photo 16 – Dallman Ash Pond Typical Western Embankment Looking South

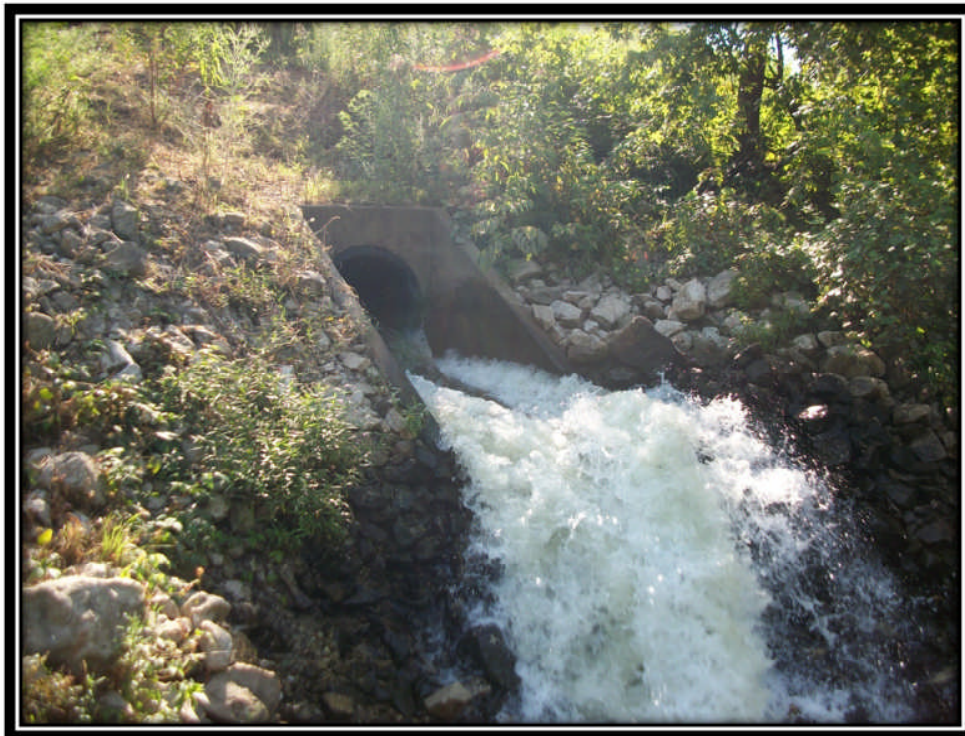
- A mature tree was noted at the toe of the embankment near the clarification pond outlet.

Photo 18 – Termination of Outlet Pipe for Clarification Pond (Note Mature Tree on Slope)

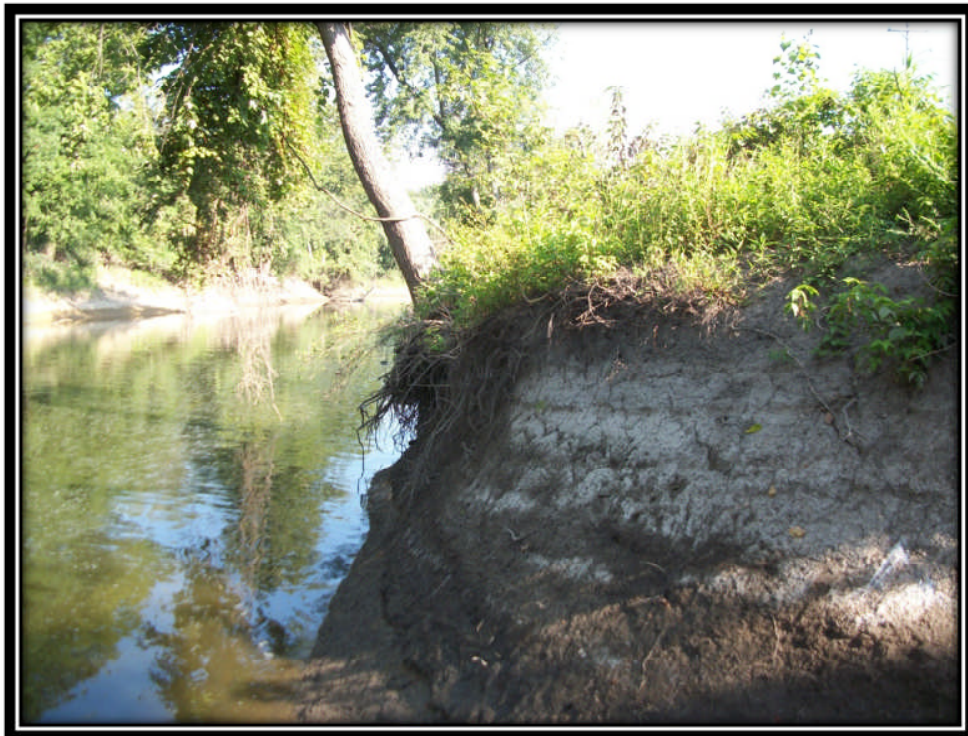
Photo 20 – Erosion of Creek Slopes Adjacent to Outlet Works Piping from Clarification Pond

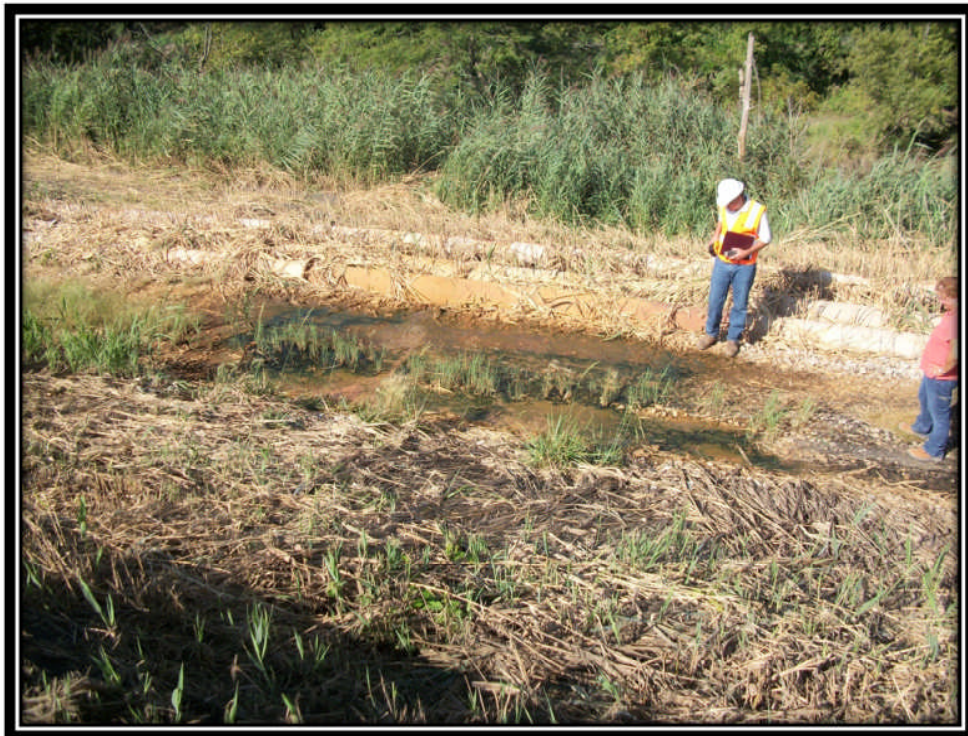
Regarding seepage, we understand that uncontrolled seepage has been observed at various locations on the downstream slope along the north and west sides of the Lakeside Ash Pond's vertical embankment extension by the City of Springfield and Hanson Professional Services at various times between 1992 and 2008. As a result, we understand that various modifications were made to limit uncontrolled seepage at the raised portion of the embankment, including installation of additional toe drains, inverted filters, and filter cake sludge seals. We noted visible uncontrolled seepage along the west side of the Lakeside Ash Pond during our recent visit as well. Based on the continued presence of uncontrolled seepage water, some type of monitoring system would be valuable to document changes in seepage rate or composition.

Photo 24 – Seepage Area Looking West from Crest

3. **Establish seepage and ground water monitoring program by 3/1/2011.** As discussed in Section, 3.5, uncontrolled seepage water was observed on the west downstream slope of the Lakeside Ash pond. The presence of uncontrolled seepage water at the downstream embankment raises questions regarding the integrity and the stability of the embankment. Therefore, a detailed monitoring program should be established to quantify various important factors, including seepage quantities through the embankment, the amount of sediments carried by the seepage water, and the fluctuation of ground water levels.

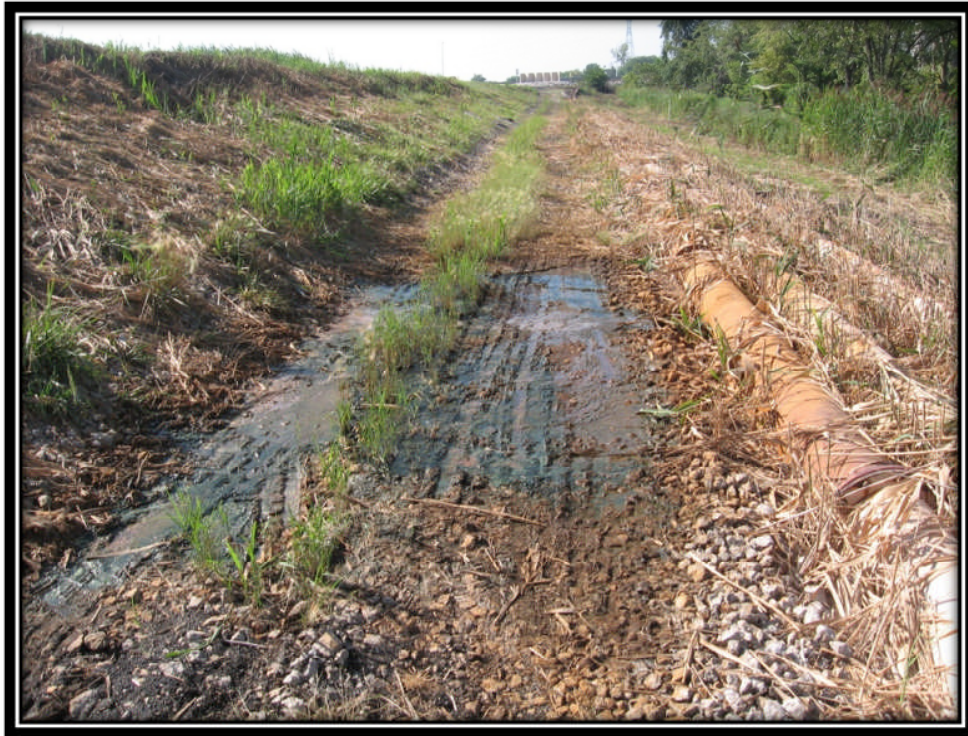
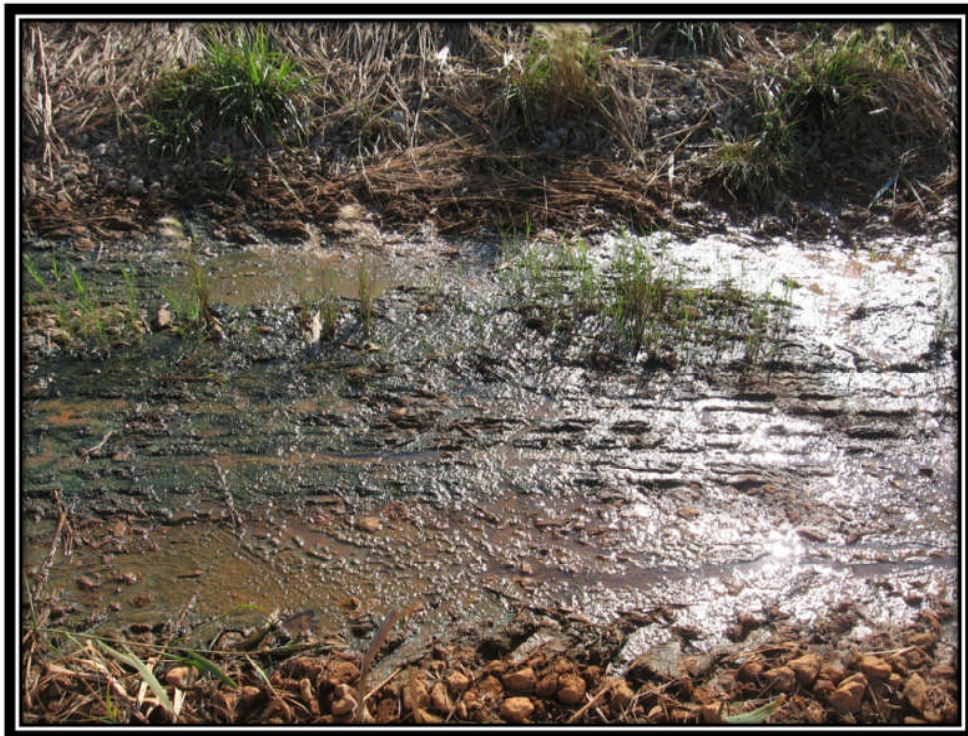
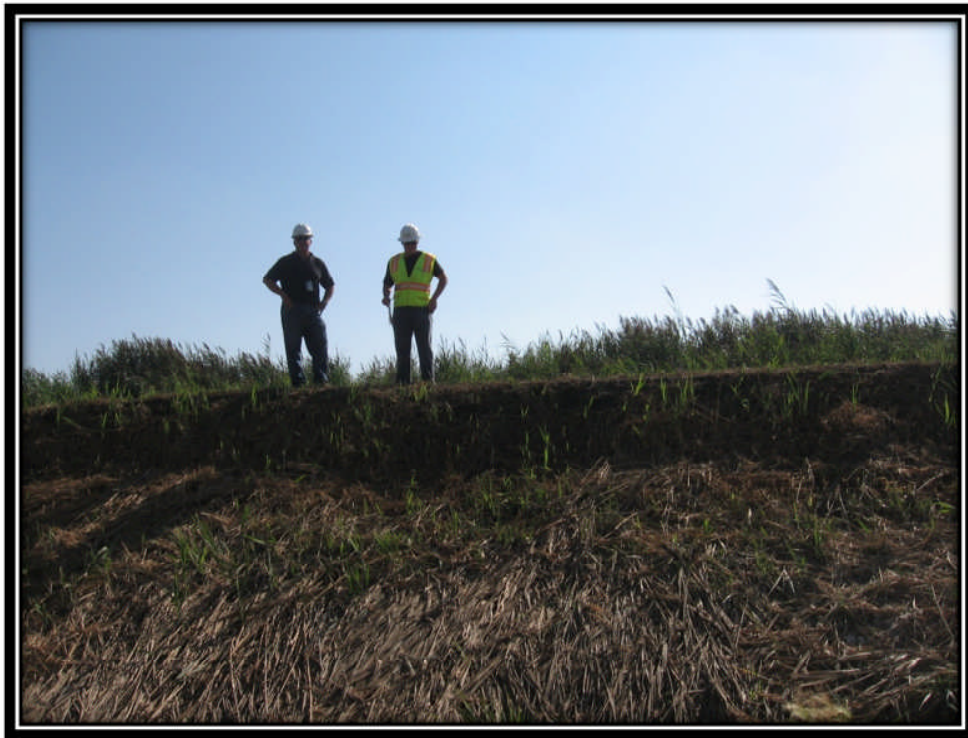
Overall, the downstream slope was in good condition. Photographs 25, 26, and 27 show the conditions of the downstream slope. Specific observations include:

- Uncontrolled seepage was noted on the west downstream slope near the juncture between the original top of embankment and the toe of the raised portion of the embankment. This area also serves as a vehicle access road.
- Portions of the downstream slopes were covered with thick vegetation.
- Sluice lines are located on the west downstream slope.

Photo 25 – Seepage Area Looking South

Photo 26 – Seepage Area at Base of Vertical Extension of Old Lakeside Ponds

Photo 27 – Seepage Area Looking East (Note Vertical Extension of Old Lakeside Ponds)

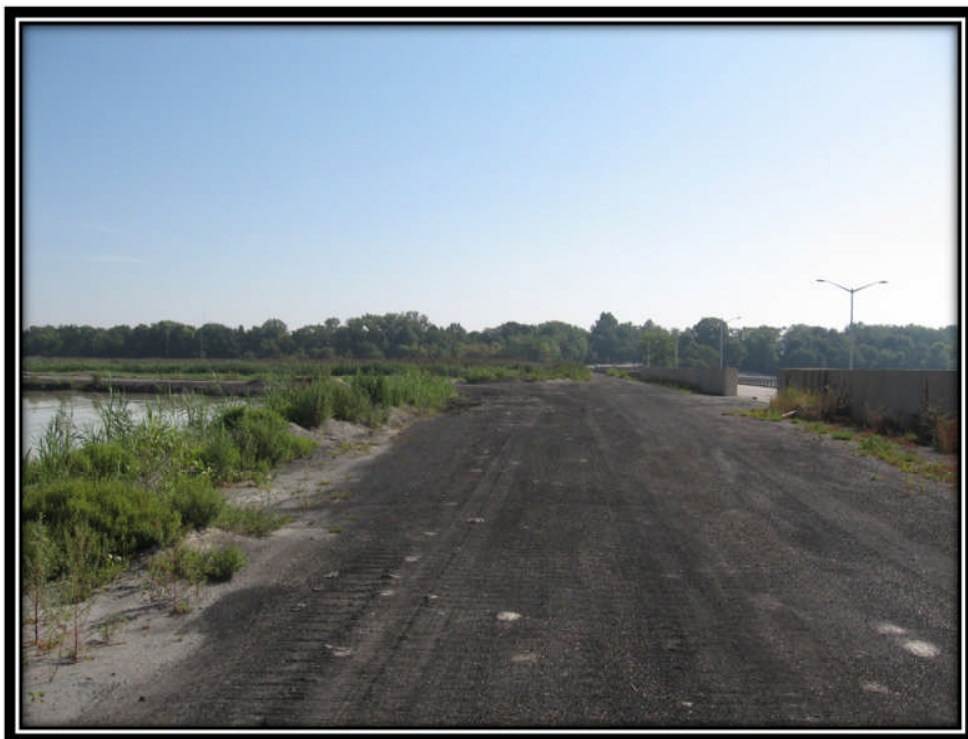
Overall, the crest of the impoundment was in good condition. Photograph 28 shows the condition of the crest where it abuts the crest of Spaulding Dam. Specific observations include:

- The impoundment crest is a roadway.
- No major depressions or rutting were noted on the impoundment crest.
- Minor erosion was noted on the crest in multiple locations. This erosion was typically less than six inches in depth and typically appeared on the edges of the crest, where grade breaks occurred when transitioning to embankment slopes.

Photo 28 – Southern Edge of the Old Lakeside Ponds Embankment Looking East

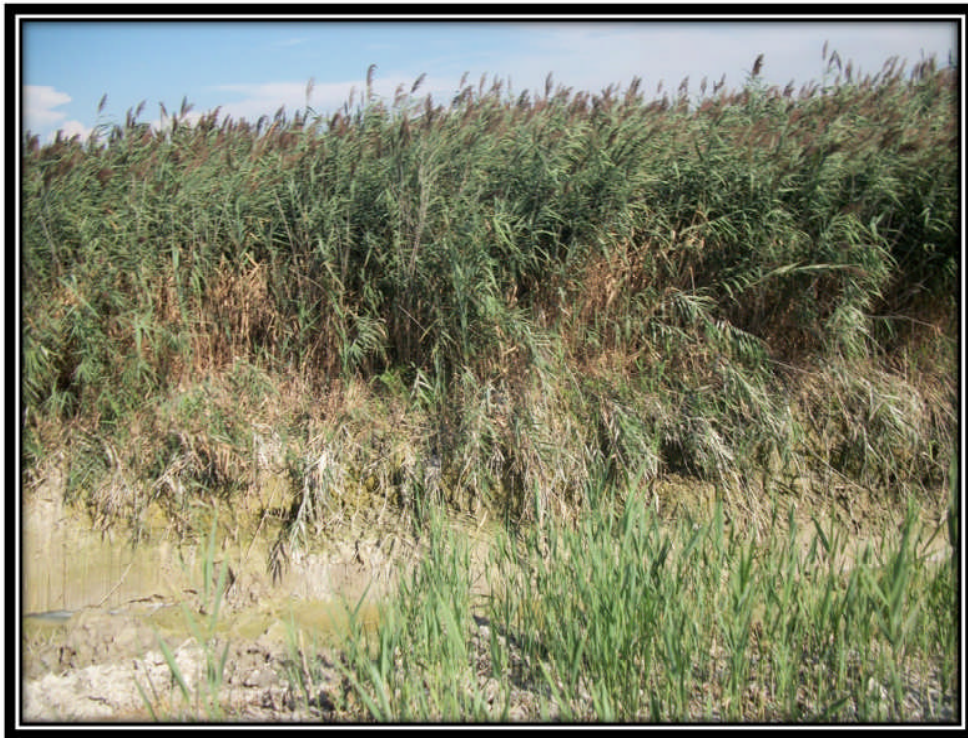
- Grasses and woody bushes were observed on the upstream slope for Cell Number 3.

Photo 31 – Old Lakeside Pond Cell Number 3 Overgrown and Currently Inactive

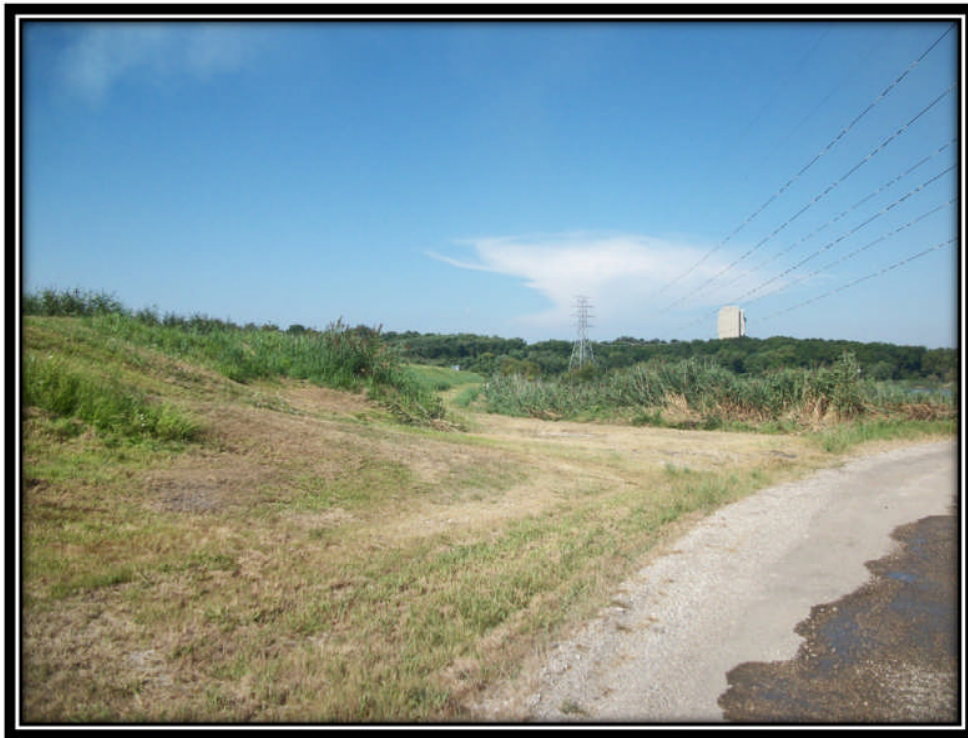
The toe areas of the embankment were in good condition. See Photograph 33 for the condition of these areas.

Photo 33 – Embankment Separating the Old Lakeside Ponds from the Clarification Pond
