**DRAFT REPORT
ROUND 10 DAM ASSESSMENT
DAYTON POWER AND LIGHT COMPANY
KILLEN ELECTRIC GENERATING STATION
BOTTOM ASH POND AND FLY ASH POND**

Re: Round 10 Dam Assessment - Draft Report
EPA Contract No. EP10W001313
Dayton Power and Light Company – Killen Electric Generating Station
Bottom Ash Pond and Fly Ash Pond
Manchester, Ohio

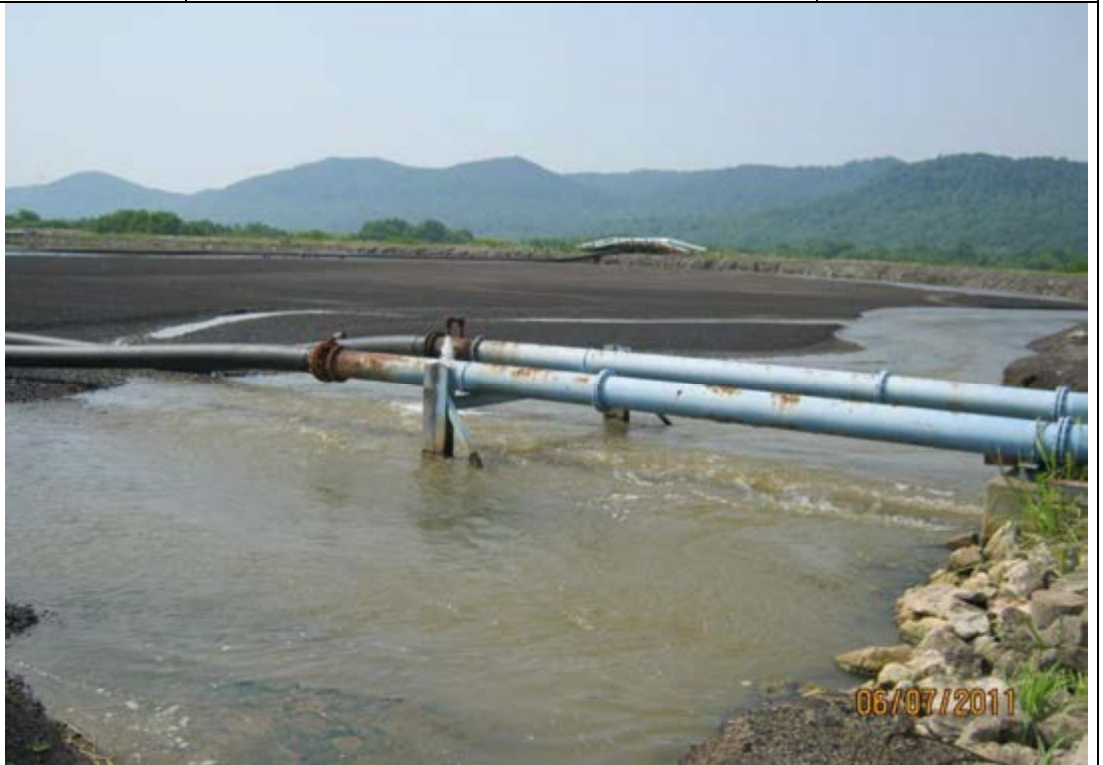
Photo No. 2

View of Bottom Ash Pond and pump station intake structure. Killen Generating Station shown in the background.

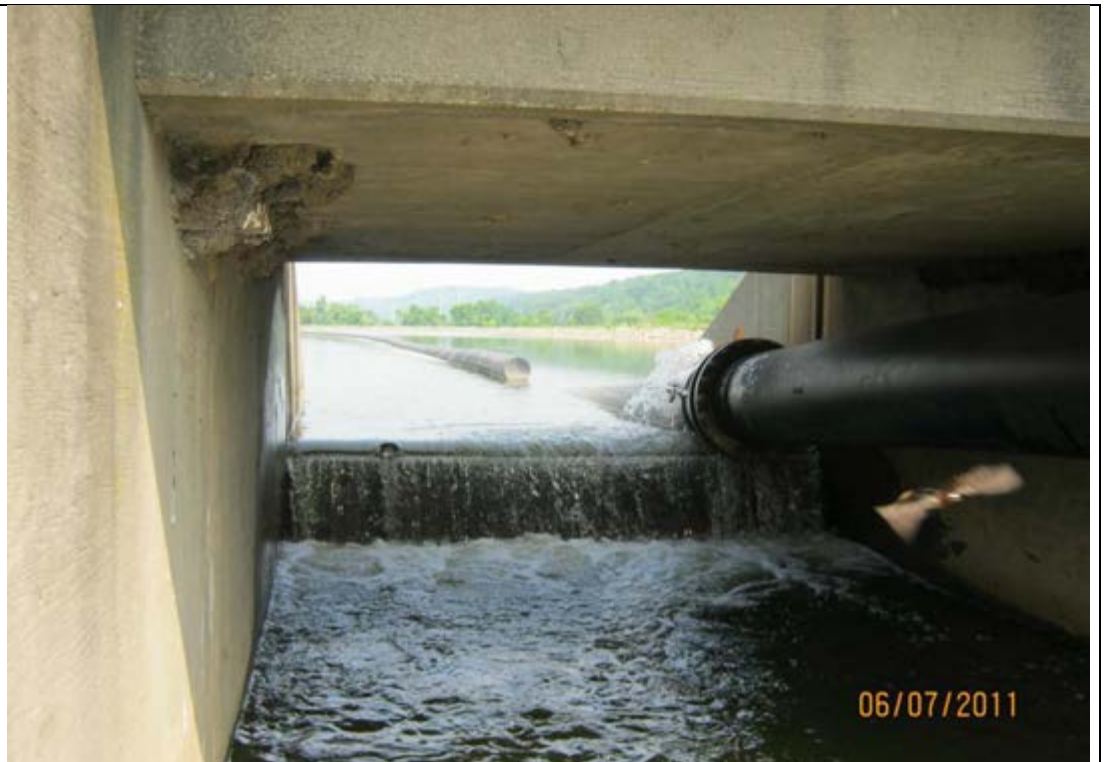
Photo No. 6 Date: 06/07/11

There are two discharge structures in the Bottom Ash Pond, the pump station inlet structure (Photo 2) and the overflow structure (Photos 5 and 6). Both of these structures were observed to be in good condition and clear of debris. The concrete visible above the water surface in both structures appeared intact. The interior of the pump station inlet structure could not be observed to evaluate sluice gates, piping or other features. The transfer pipes associated with the pump station inlet structure are sub-grade and could not be visually inspected during the assessment. However, DP&L reportedly has never had an issue with any of the discharge pipes since the Bottom Ash Pond was originally constructed. The stoplogs on the overflow structure appeared to be in good condition.

View looking at Bottom Ash Pond through (beneath) overflow structure between the Bottom Ash Pond and Fly Ash Pond. Structure contains stop logs to control Bottom Ash Pond water level. Pipe shown in picture carries liquids from the Plant Drain to the Fly Ash Pond.

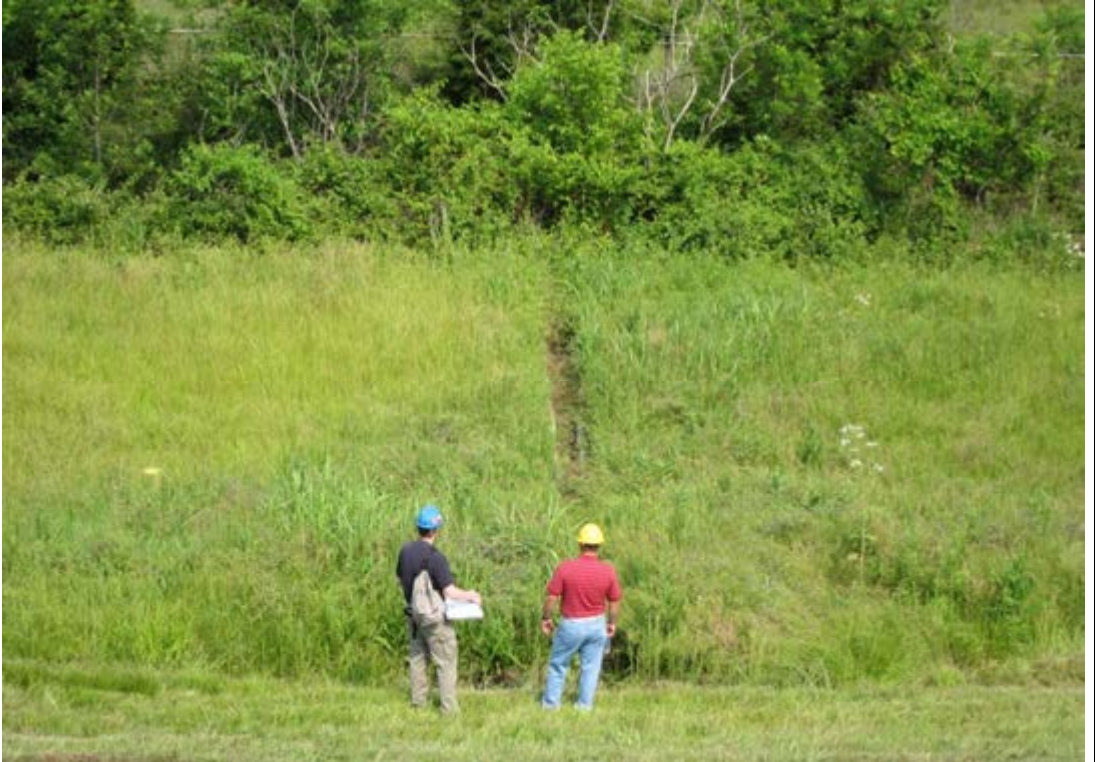
Client Name: U.S. Environmental Protection Agency		Site Location: Dayton Power & Light Company Killen Electric Generating Station Manchester, Ohio	Project No. 01.0170142.30
Photo No. 7	Date: 06/07/11

Direction Photo Taken: West-Northwest			
Description: Inspection of T-Drain at toe of exterior slope of Bottom Ash Pond in the vicinity of Station 4+50.

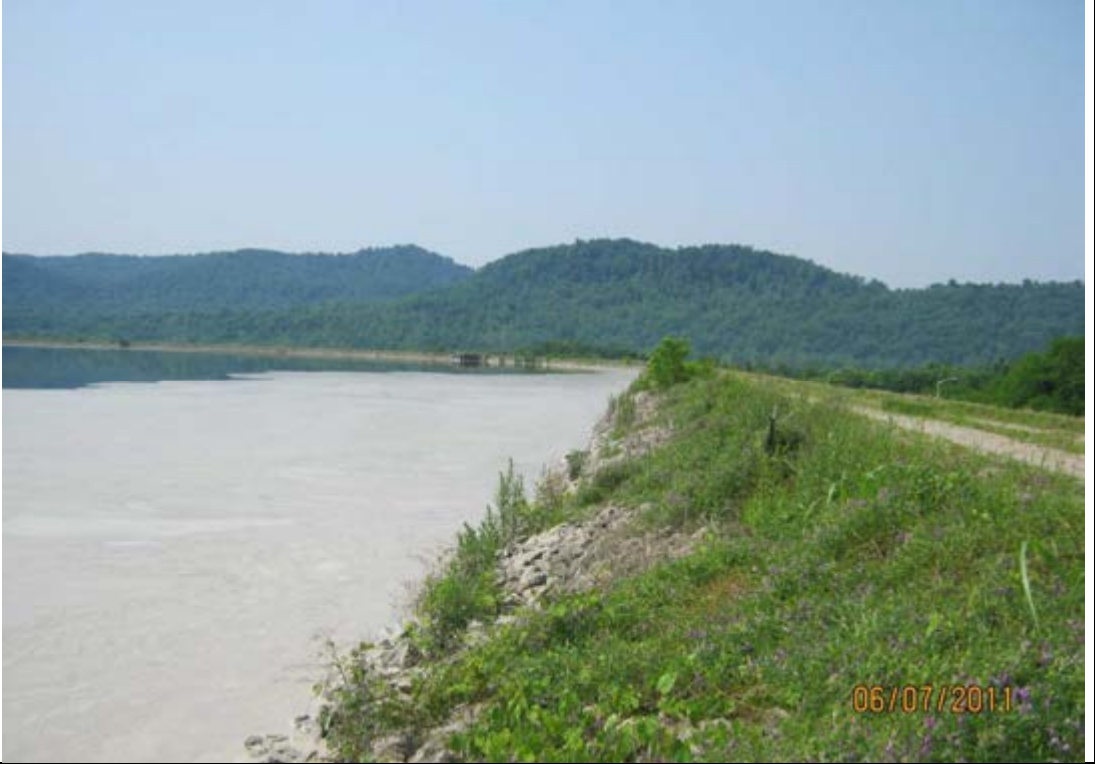
Client Name: U.S. Environmental Protection Agency		Site Location: Dayton Power & Light Company Killen Electric Generating Station Manchester, Ohio	Project No. 01.0170142.30
Photo No. 15	Date: 06/07/11

<p>06/07/2011</p>	
Direction Photo Taken: Southwest			
Description: View of interior slope of Fly Ash Pond in the vicinity of Station 119+00

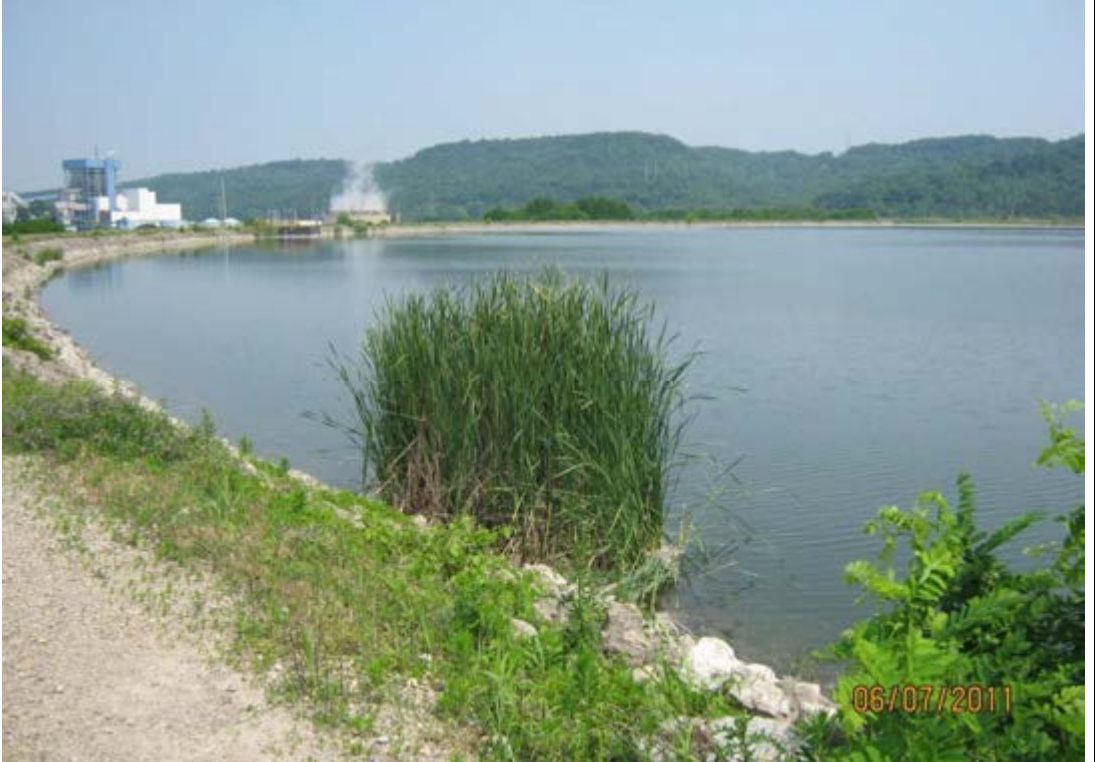
Client Name: U.S. Environmental Protection Agency		Site Location: Dayton Power & Light Company Killen Electric Generating Station Manchester, Ohio	Project No. 01.0170142.30
Photo No. 17	Date: 06/07/11

Direction Photo Taken: North-Northwest			
Description: Vegetation growth on interior slope of Fly Ash Pond in the vicinity of Station 105+00.

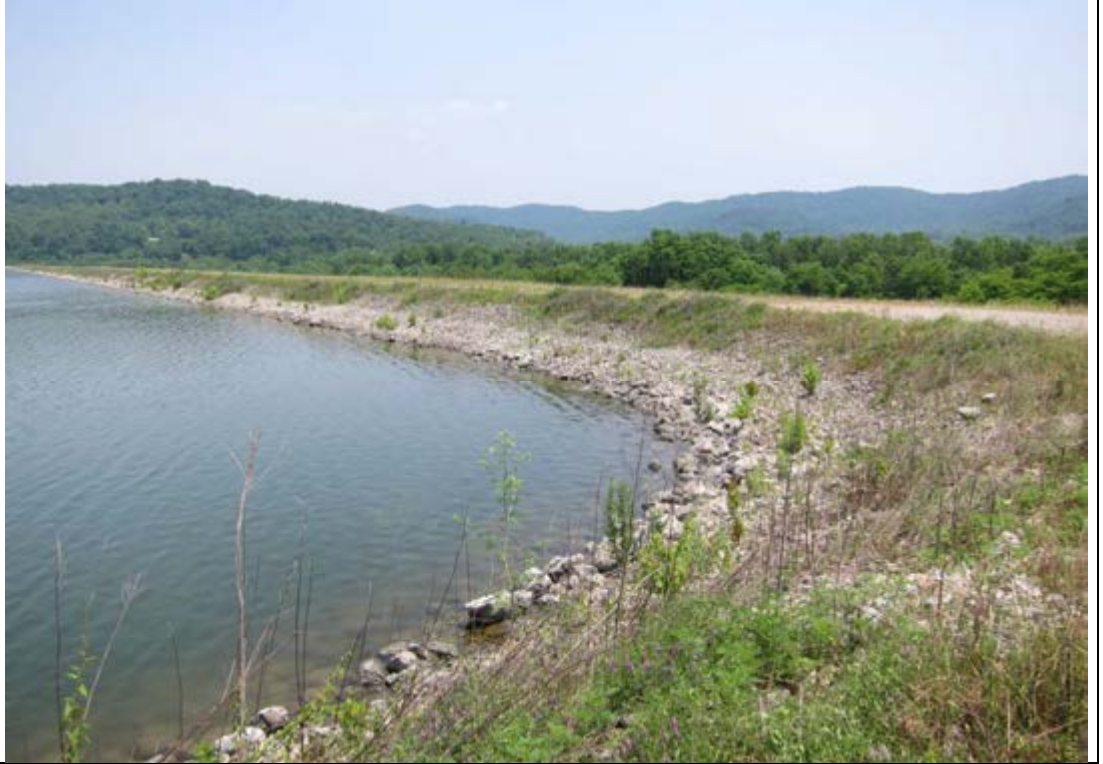
View of rip rap on the interior slope of the Fly Ash Pond in the vicinity of Station 81+00. Note the variable size of stone.

2. Replenish the displaced riprap and repair erosion along the west interior slope of the Bottom Ash Pond and the south interior slope of the Fly Ash Pond. It appears that the size of the riprap on these slopes should be increased. Monitor the interior slopes for erosion.

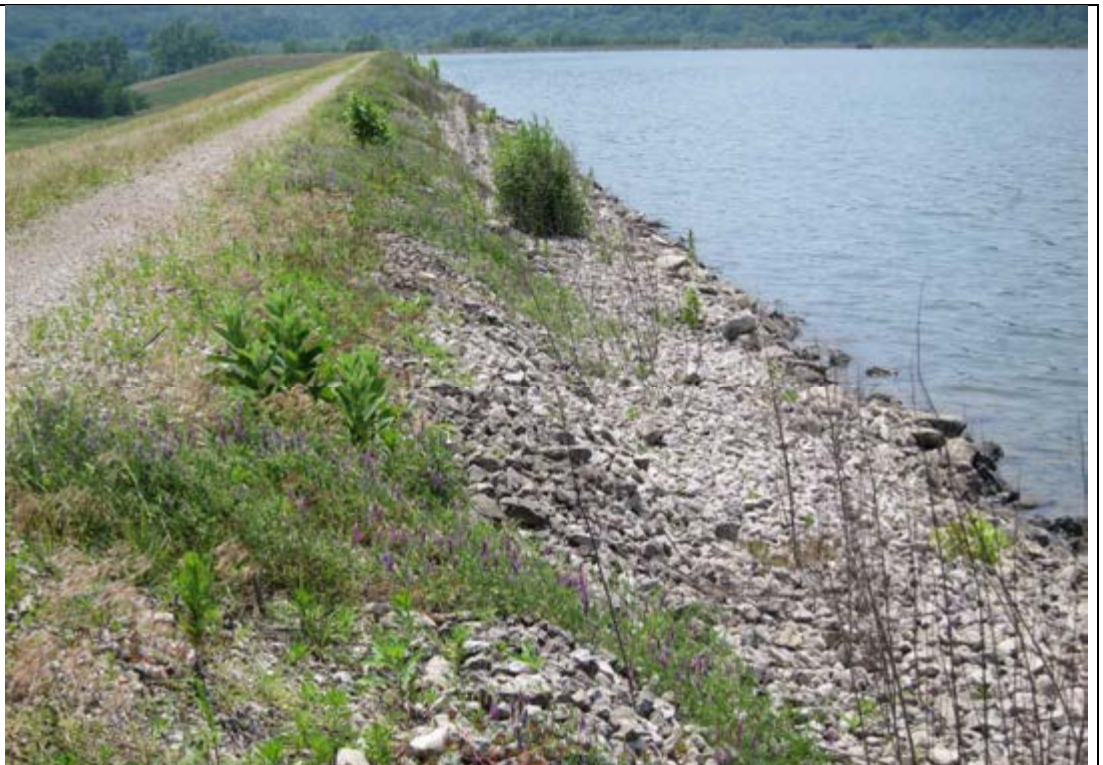
Photo No. 20

View of rip rap on the interior slope of the Fly Ash Pond in the vicinity of Station 60+00. Note the variable size of stone and apparent benching of the slope.

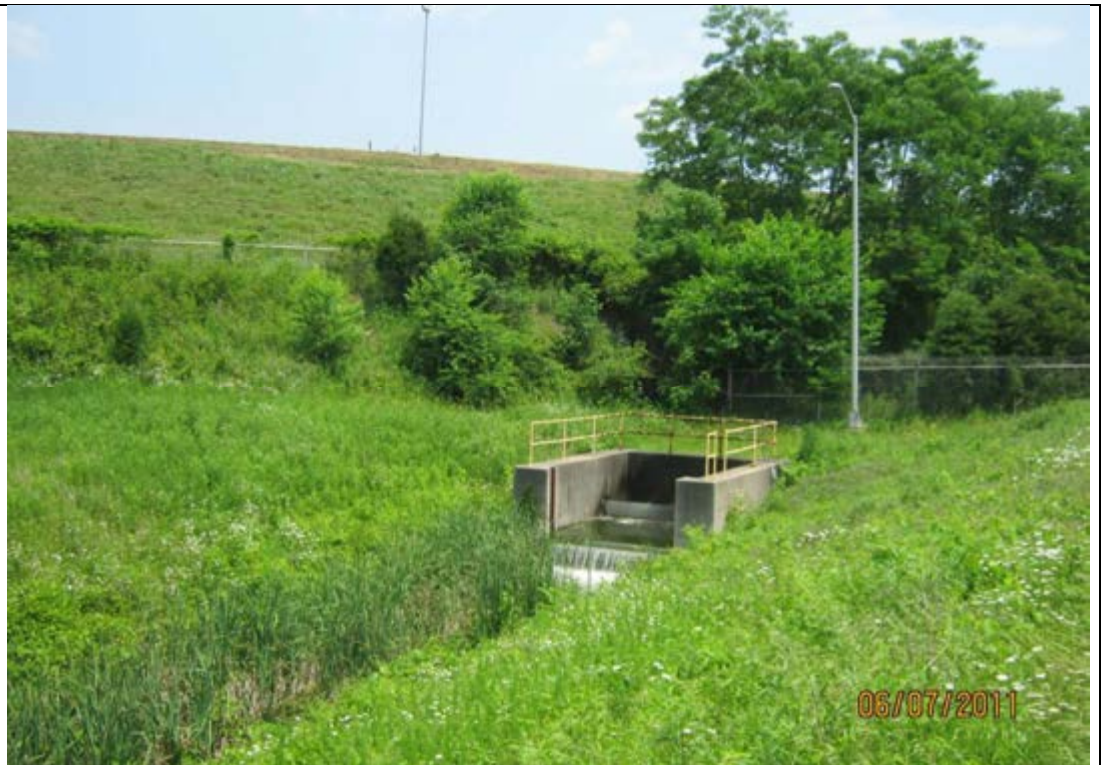
Photo No. 26

Some established vegetation in the form of trees and brush was observed on the lower portion and toe of the outer embankment slope near the outfall structure (Photo 26).

View of outfall from Fly Ash Pond through energy dissipater and Parshall flume. Note presence of tree and brush growth on lower portion and toe of exterior slope of Fly Ash Pond in the background.

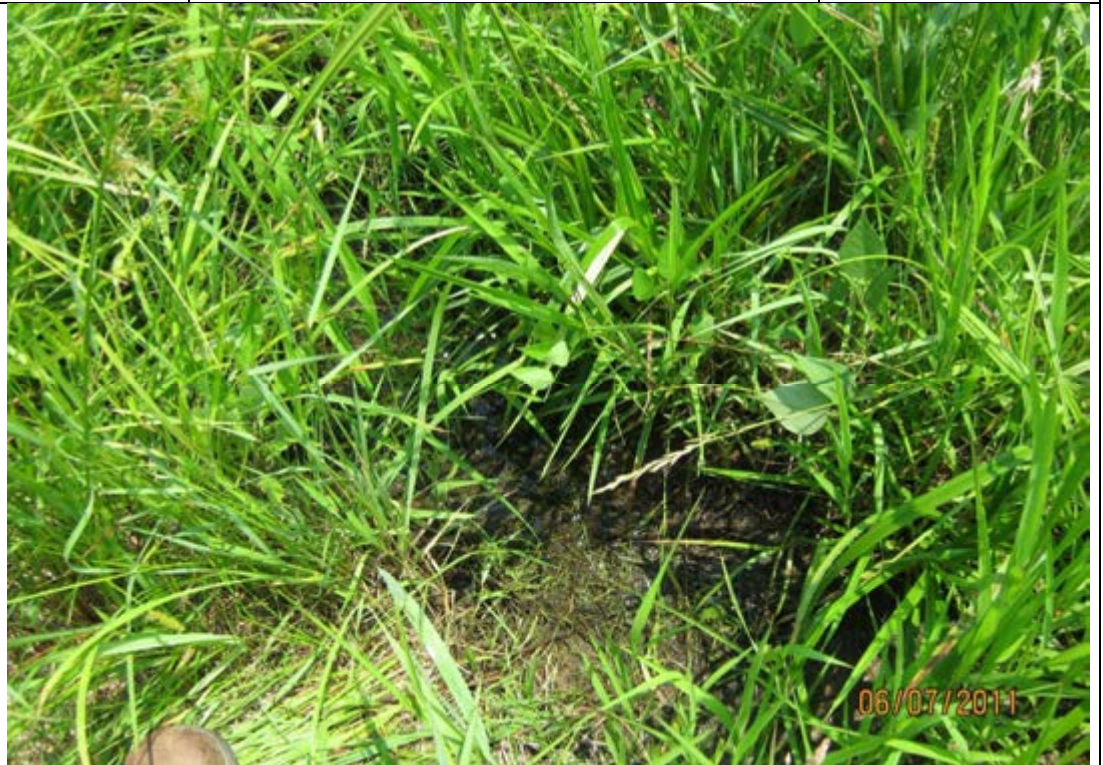
View of a portion of the wet area observed midway between the crest and toe of the exterior slope of the Fly Ash pond in the vicinity of Station 80+00. Wet area occurs at the junction of the southeastern berm and the southwestern berm.

2. Install piezometers/observation wells in the noted wet areas (between Stations 36+00 to 39+00 and in the vicinity of Stations 80+00 and 88+00) to evaluate water levels, and possibly water chemistry, in these areas. This activity may require consultation and/or design by a licensed Professional Engineer;

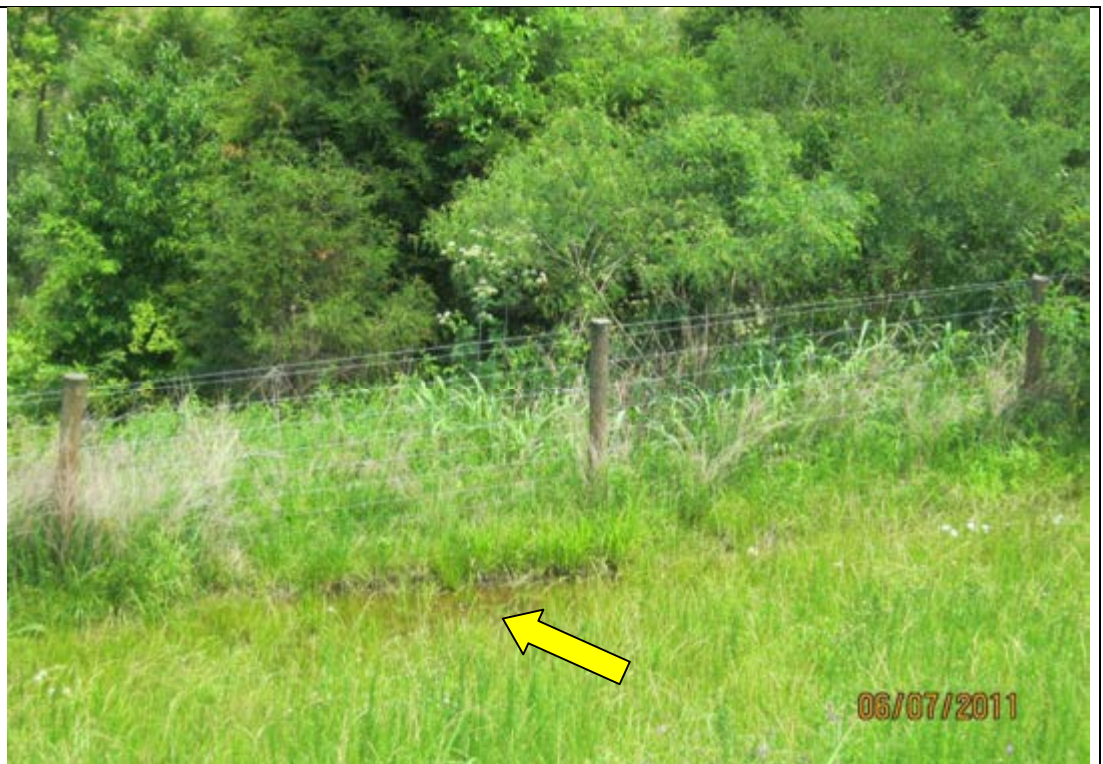
Photo No. 28

View of a wet spot, with standing water, at the toe of the exterior slope of the Fly Ash Pond in the vicinity of Station 38+00. Stormwater ditch with tree growth is visible in the background.
