**FINAL REPORT  
ROUND 10 DAM ASSESSMENT  
DAYTON POWER AND LIGHT COMPANY  
KILLEN ELECTRIC GENERATING STATION  
BOTTOM ASH POND AND FLY ASH POND**

**August 16, 2012**

Re: Round 10 Dam Assessment - Final Report  
EPA Contract No. EP10W001313  
Dayton Power and Light Company – Killen Electric Generating Station  
Bottom Ash Pond and Fly Ash Pond  
Manchester, Ohio

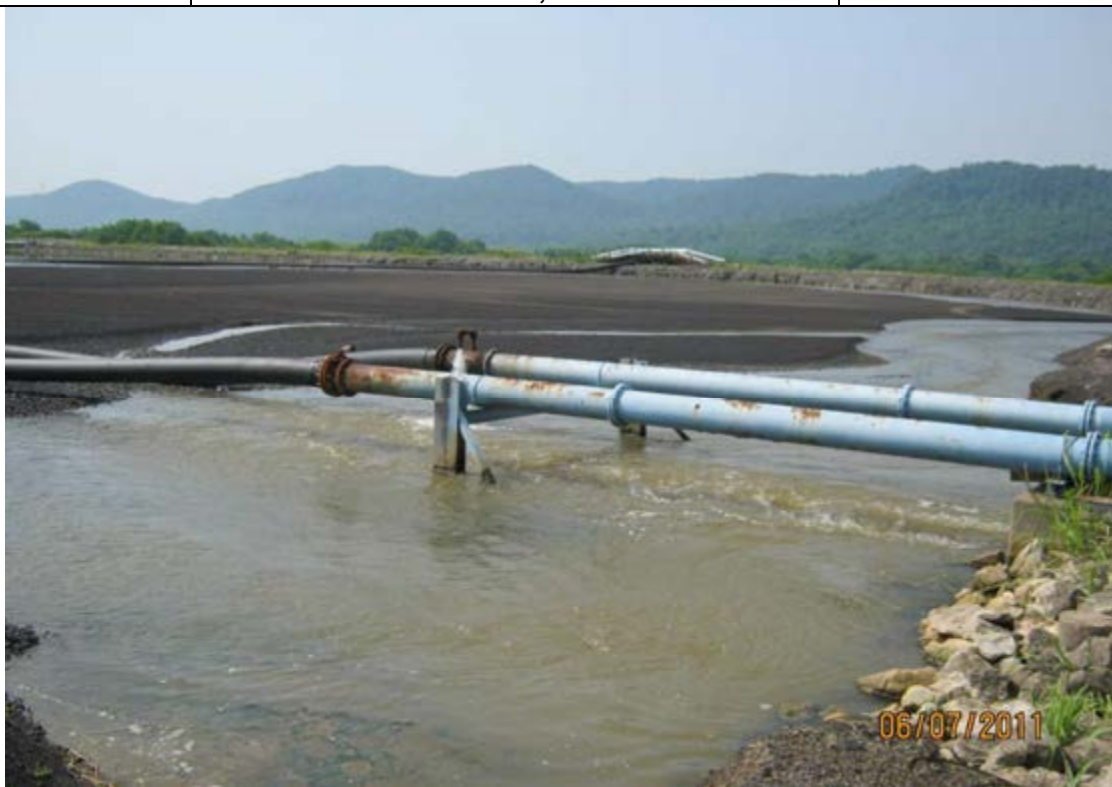
**Photo No.**  
2

There are two discharge structures in the Bottom Ash Pond, the pump station inlet structure (Photo 2) and the overflow structure (Photos 5 and 6). Both of these structures were observed to be in good condition and clear of debris. The concrete visible above the water surface in both structures appeared intact. The interior of the pump station inlet structure could not be observed to evaluate sluice gates, piping or other features. The transfer pipes associated with the pump station inlet structure are sub-grade and could not be visually inspected during the assessment. However, DP&L reportedly has never had an issue with any of the discharge pipes since the Bottom Ash Pond was originally constructed. The stoplogs on the overflow structure appeared to be in good condition.

View of Bottom Ash Pond and pump station intake structure. Killen Generating Station shown in the background.

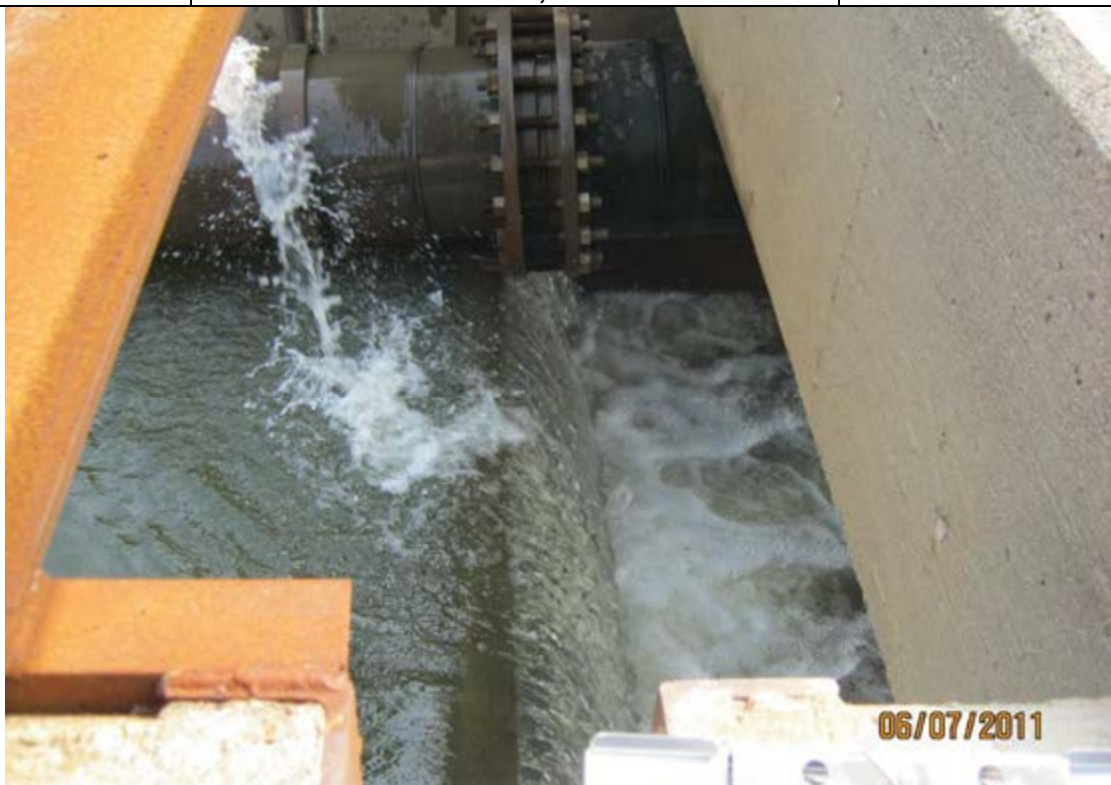
**Photo No.**  
6

View looking at Bottom Ash Pond through (beneath) overflow structure between the Bottom Ash Pond and Fly Ash Pond. Structure contains stop logs to control Bottom Ash Pond water level. Pipe shown in picture carries liquids from the Plant Drain to the Fly Ash Pond.

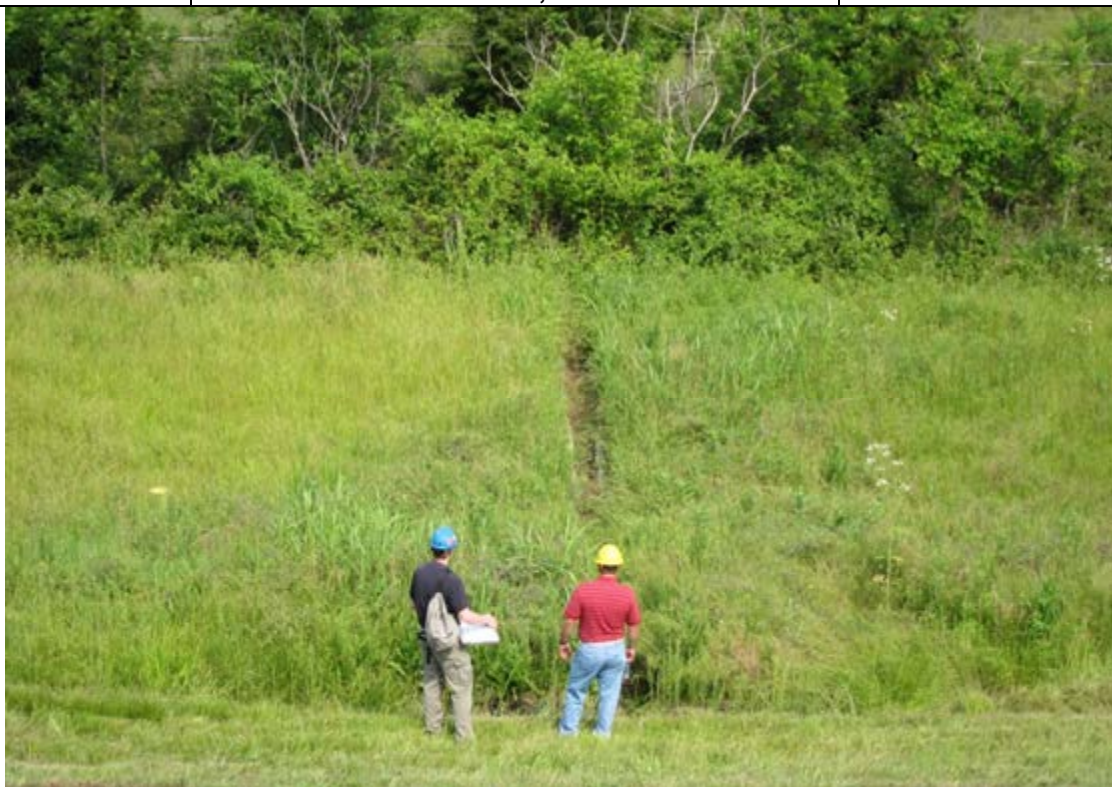
**Photo No.**  
8

**Description:**  
T-Drain at toe of exterior slope of Bottom Ash Pond in the vicinity of Station 4+50.

3. Repair the erosion gullies located along the toe areas of both east embankments, and repair the "T drain located on the benches of both ponds.
4. Repair the ruts in the west embankment crest of the Bottom Ash Pond.

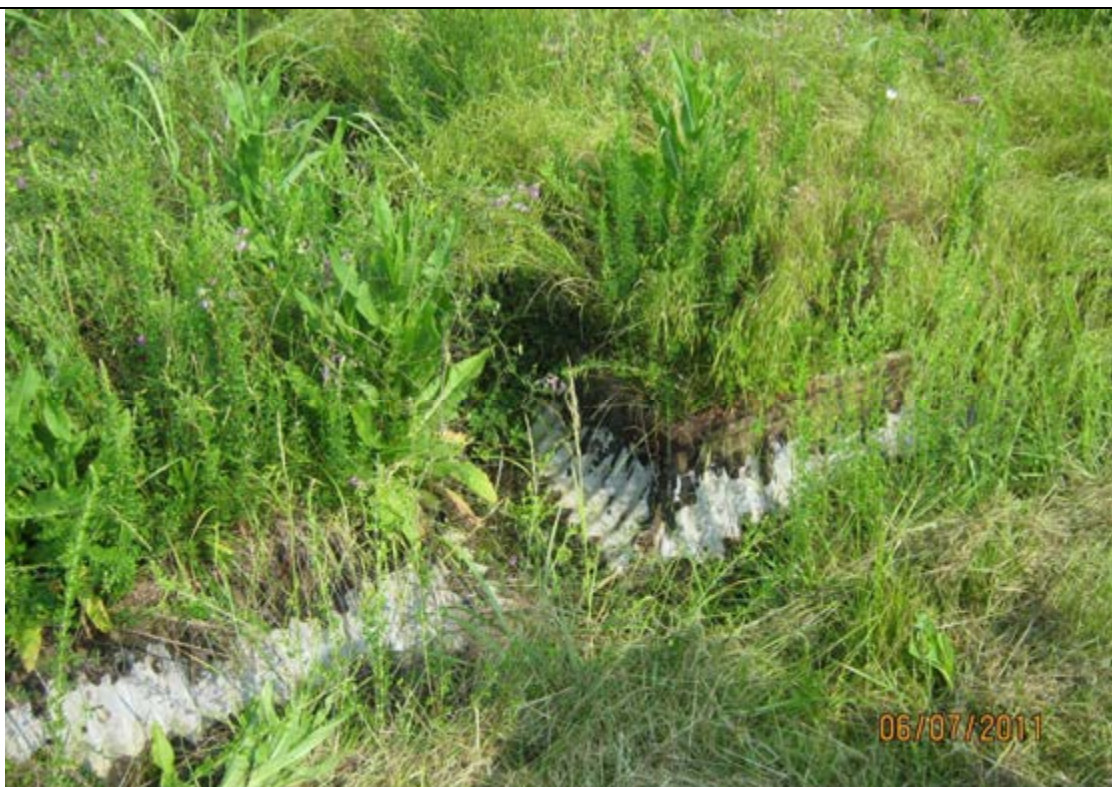
View of interior slope of the west-northwest dike of Bottom Ash Pond in the vicinity of Station 3+00.

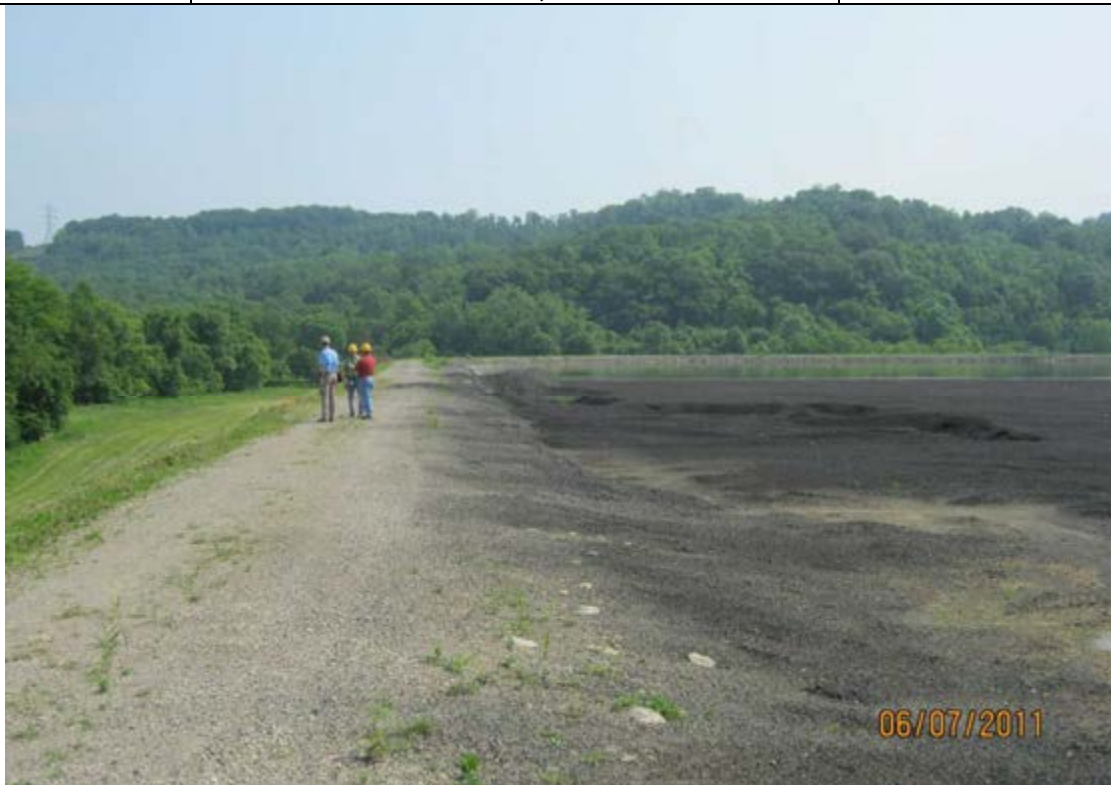
**Photo No.**  
10

View of interior slope of the west-northwest dike of Bottom Ash Pond in the vicinity of Station 11+00.

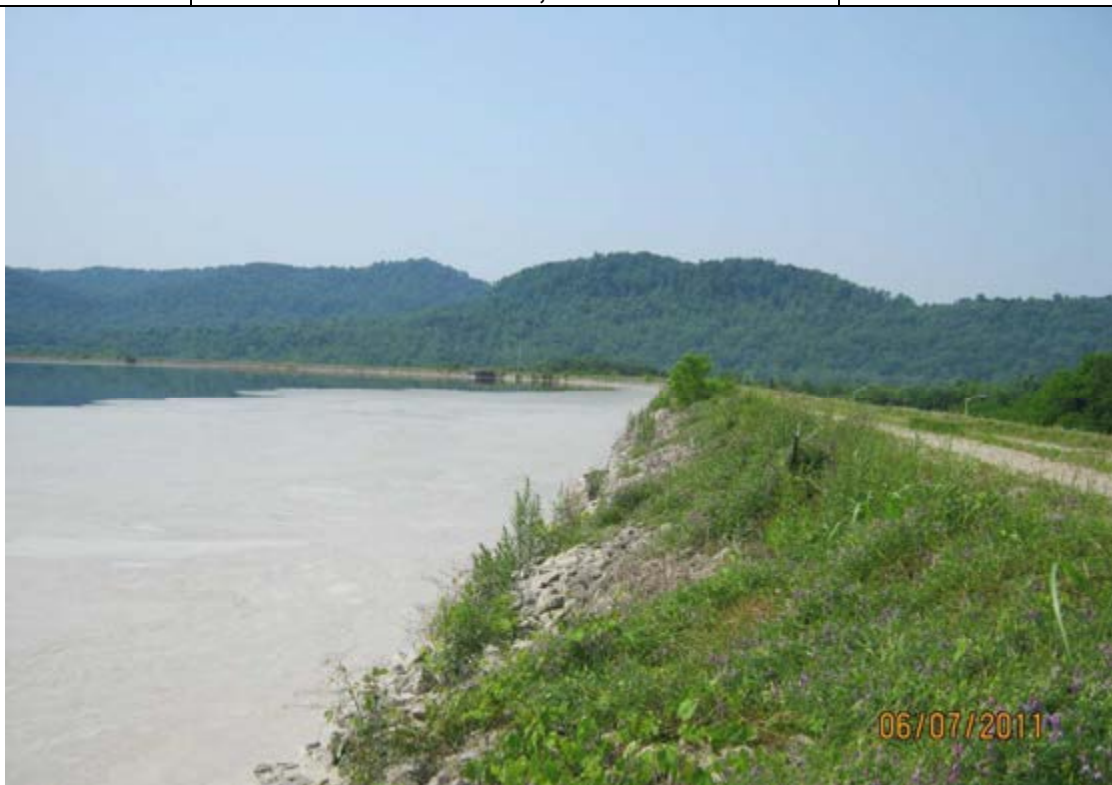
**Photo No.**  
16

The overall condition of the interior embankment slope generally appeared to be in good condition. However, multiple areas were observed to have vegetation of less than 1-inch in diameter (Photos 15, 16, 17, 19, 20 and 21). The rip rap present along portions of the interior slope appears to vary in size and is undersized in some locations as noted in the most recent ODNr report (Photos 19 and 20). Additionally, sloughing and apparent benching of the rip rap in the vicinity of Station 60+00 was observed (Photo 20). As of December 31, 2008 DP&L reported that approximately 4,144,298 tons of material was stored in the Fly Ash Pond, which has an estimated capacity of 21,566,007 tons.

View of vegetation growth on interior slope of Fly Ash Pond in the vicinity of Station 110+00

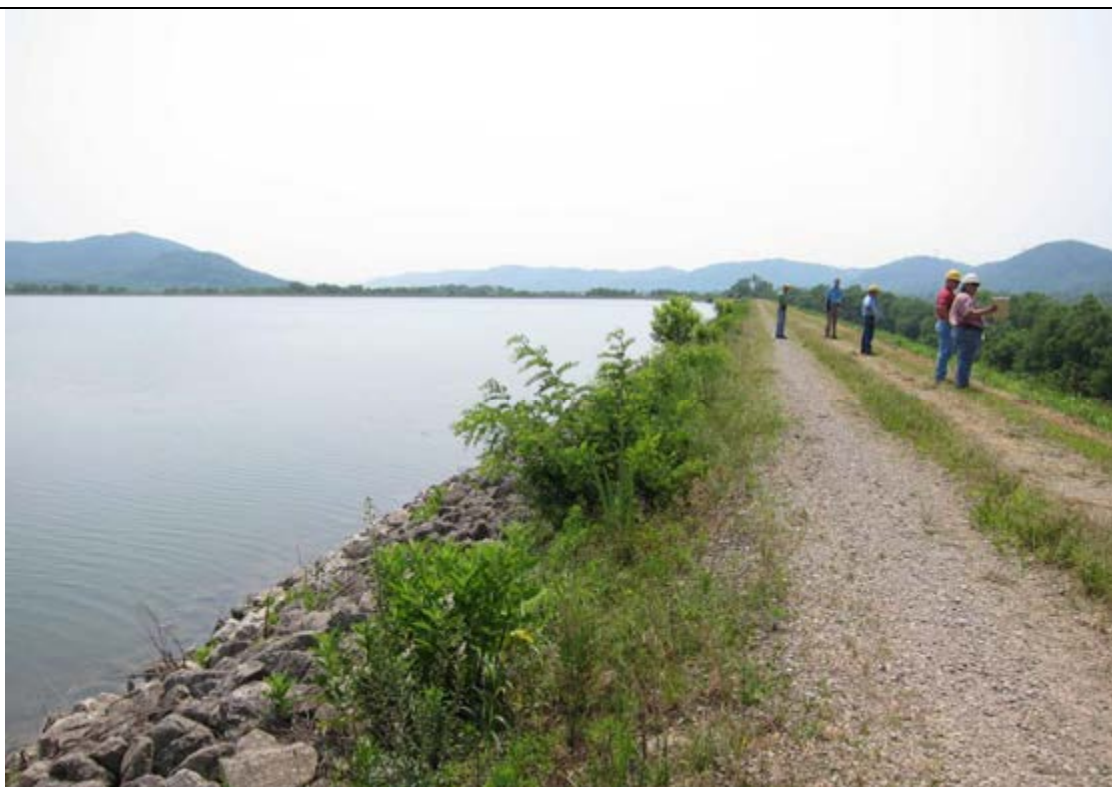
Vegetation growth on  
interior slope of Fly Ash  
Pond in the vicinity of  
Station 105+00.

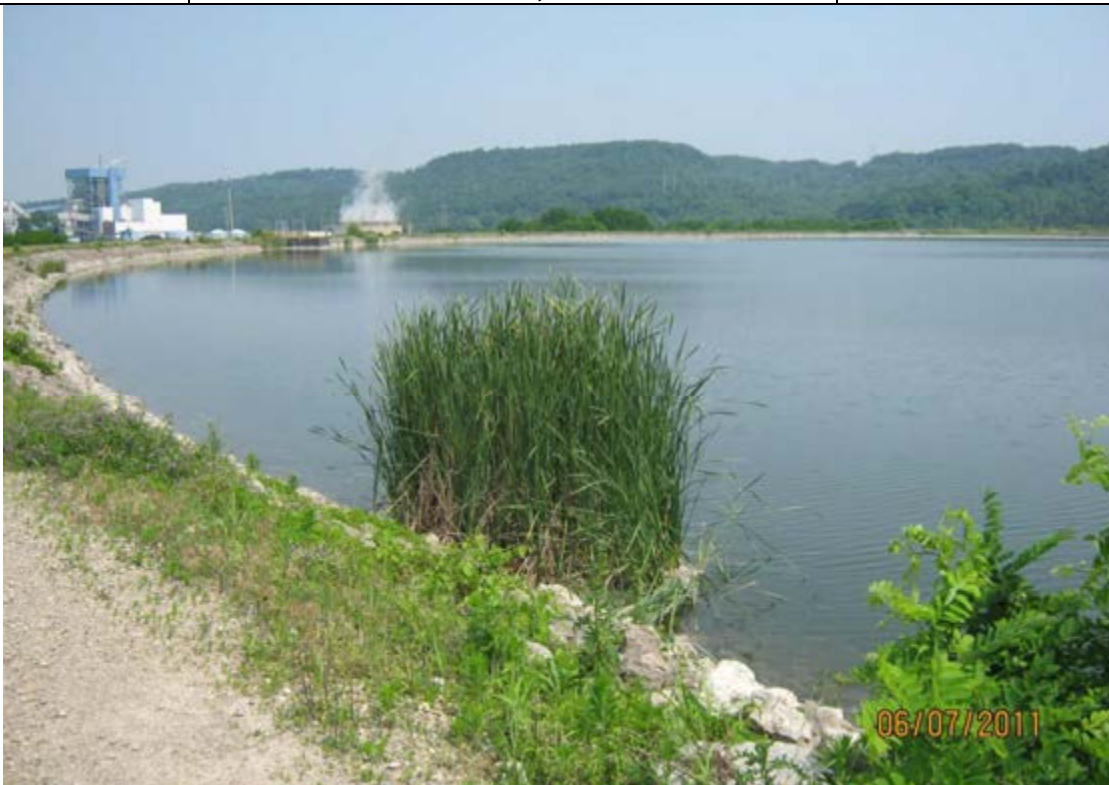
**Photo No.**  
18

View of wet area at toe of  
exterior slope of Fly Ash  
Pond in the vicinity of  
Station 88+00.

2. Install piezometers/observation wells in the noted wet areas (between Stations 36+00 to 39+00 and in the vicinity of Stations 80+00 and 88+00) to evaluate water levels, and possibly water chemistry, in these areas. This activity may require consultation and/or design by a licensed Professional Engineer;

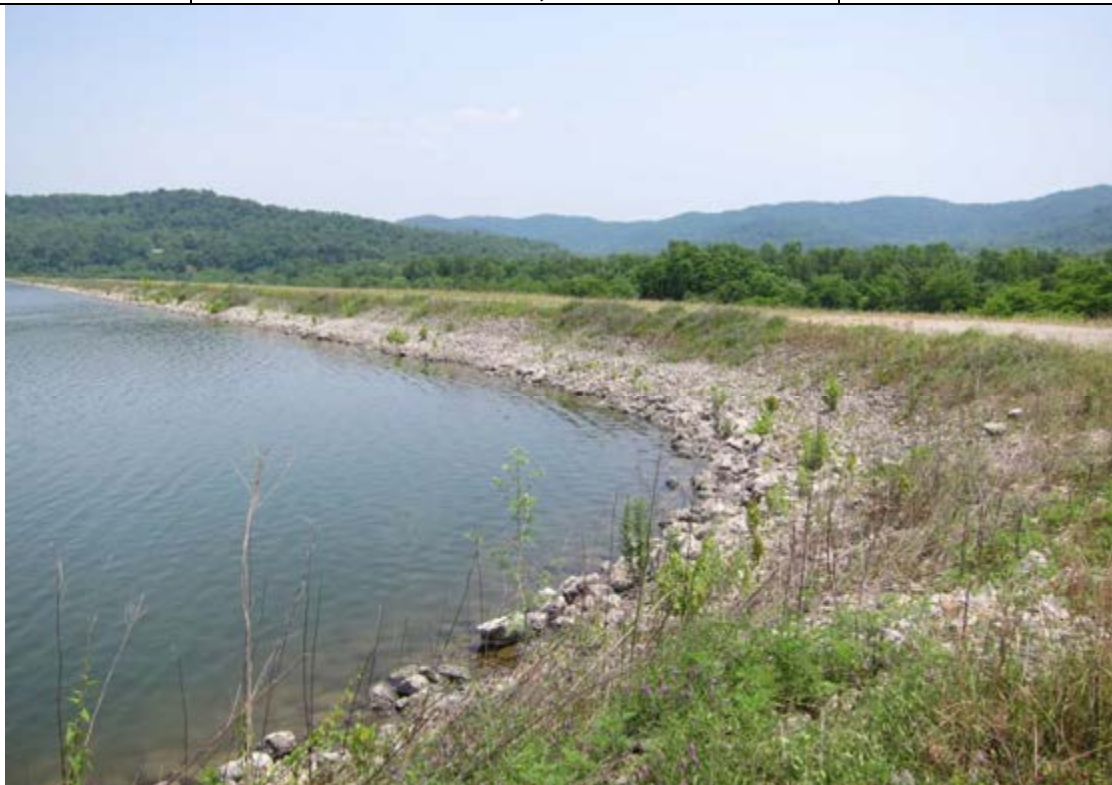
**Photo No.**  
20

View of rip rap on the  
interior slope of the Fly Ash  
Pond in the vicinity of  
Station 60+00. Note the  
variable size of stone and  
apparent benching of the  
slope.

6. Provide or perform a slope stability analysis for the embankments. Analysis should include assessment of upstream slope stability in light of observed movement of riprap. Analysis may require a subsurface exploration program to develop appropriate input data. Most recent inspection should be provided to the EPA for review.

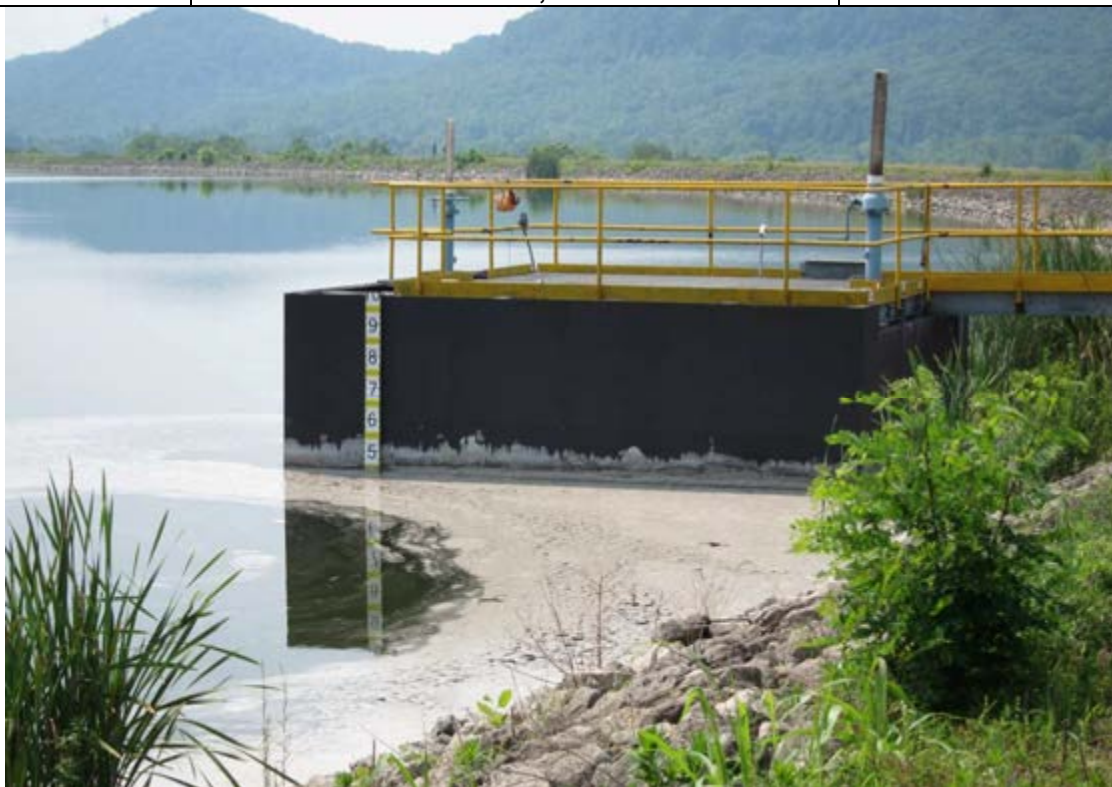
**Photo No.**  
24

The decant structure is the only discharge structure located within the Fly Ash Pond (Photos 23, 24, and 25). This structure was observed to be in good condition and clear of debris, and the concrete visible above the water surface appeared intact. A staff gauge (Photos 23 and 24) was present on the exterior portion of the decant structure and was observed to be clean and in good condition. The interior of the decant structure could not be observed to evaluate sluice gates, piping or other features. The transfer pipes associated with the decant structure are below grade and could not be visually inspected during the assessment. However, DP&L reportedly has never had an issue with any of the discharge pipes since the Fly Ash Pond was originally constructed. Water from the decant structure is ultimately discharged to an energy dissipater (Photo 26) and Parshall flume that ultimately discharges to the Ohio River in accordance with DP&L's existing NPDES permit. The energy dissipater and Parshall flume were observed to be in good condition.

**Description:**  
View of decant structure in the Fly Ash Pond.

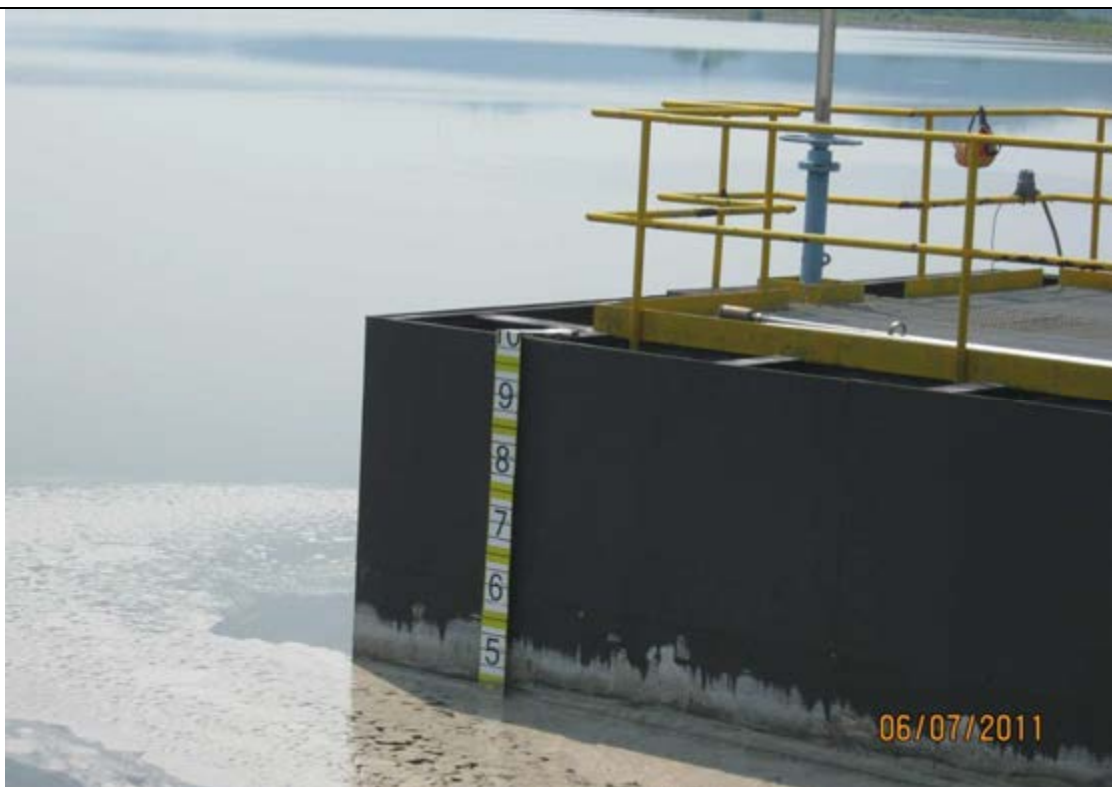
**Description:**  
View of water from Fly Ash Pond entering the decant structure.

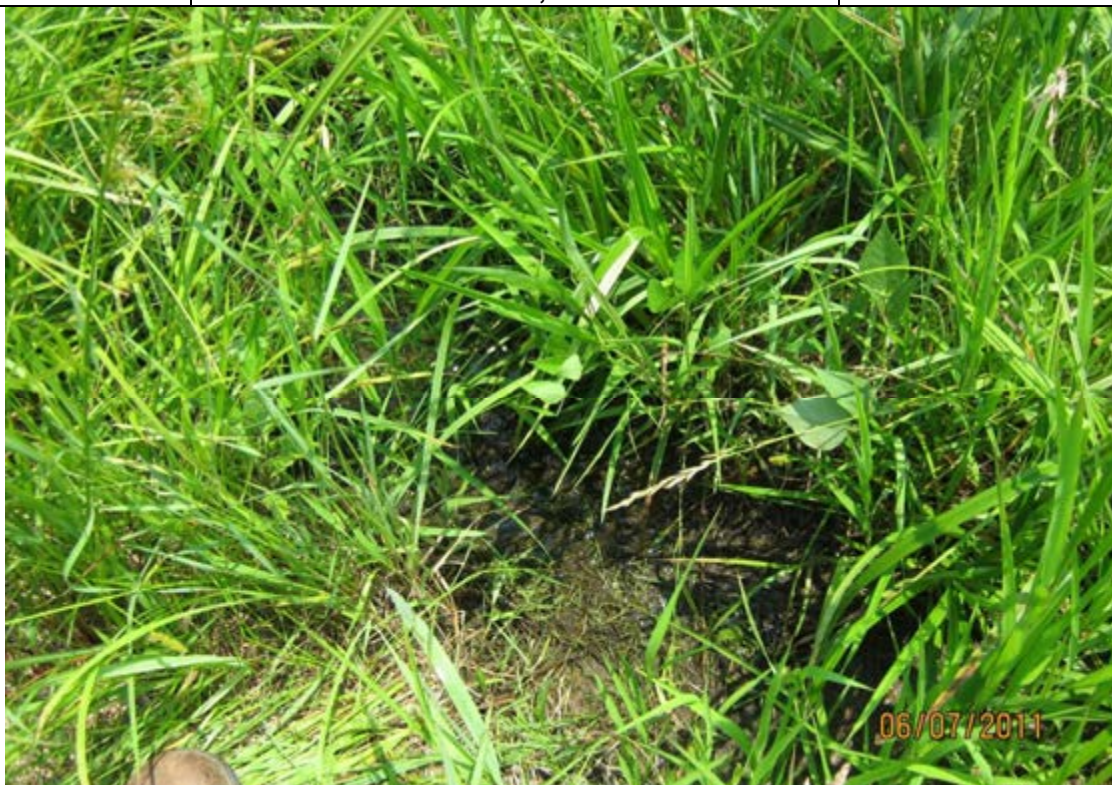
**Photo No.**  
28

View of a wet spot, with standing water, at the toe of the exterior slope of the Fly Ash Pond in the vicinity of Station 38+00. Stormwater ditch with tree growth is visible in the background.
