# ASSESSMENT OF DAM SAFETY OF COAL COMBUSTION SURFACE IMPOUNDMENTS

**Gainesville Regional  
Utilities  
Deerhaven Plant  
Gainesville, Florida**

Prepared for  
*U.S. Environmental  
Protection Agency  
Washington, D.C.*

October, 2012  
Revision 1, September 2013

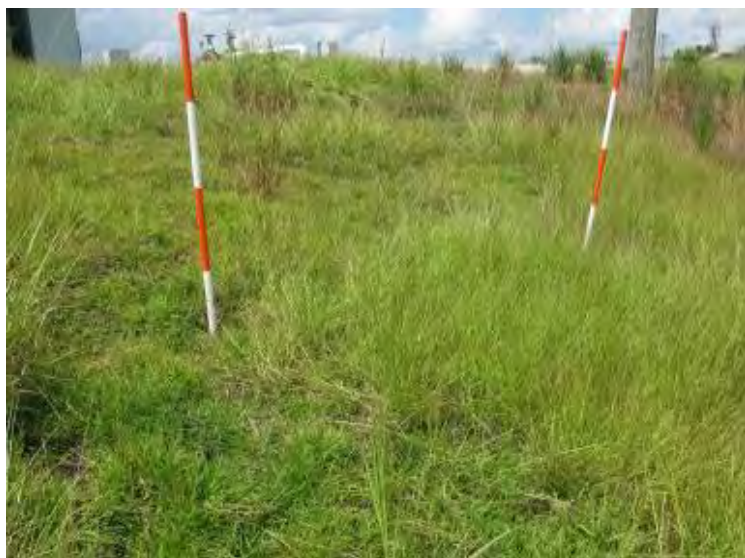
Photo 5: Pump Back Cell No. 1 – Southeast embankment exterior slope, minor surficial erosion rills looking northeast.

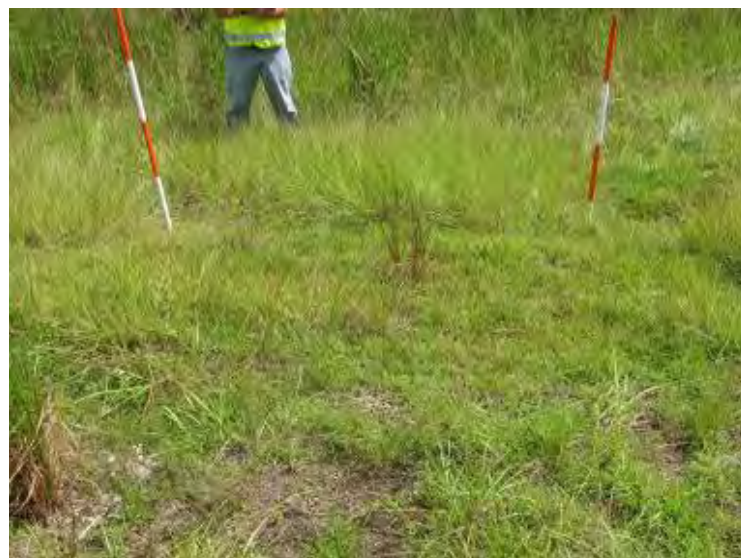
Photo 6: Pump Back Cell No. 1 – Southeast embankment exterior slope, minor erosion rills looking southeast.

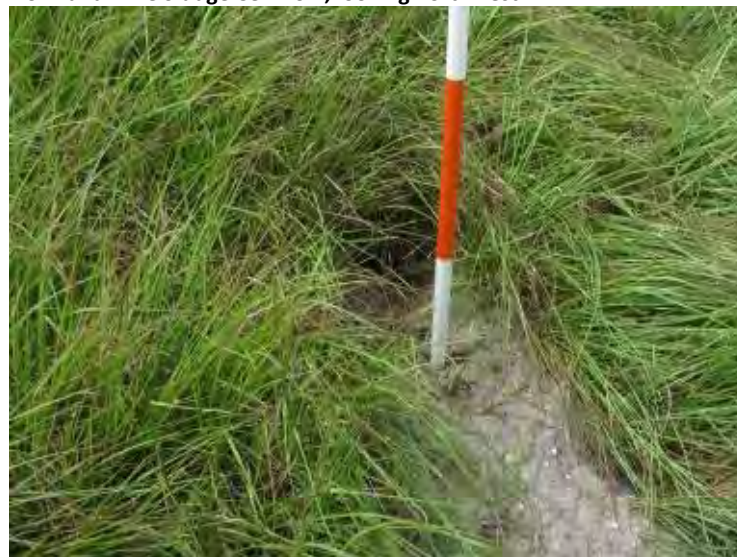
Animal burrows were observed on the southeast and northwest embankments exterior slopes. Although not seen in other areas, high vegetation cover on the embankments may have hidden other animal burrows. CDM Smith recommends documenting areas disturbed by animal activity, removing the animals and backfilling the burrows with compacted structural fill to protect the integrity of the embankments. Vegetation should be maintained at a height that potential animal burrows can be readily observed.

The crest of the Lime Sludge Ponds appears to be in fair condition. The typically crest width is approximately 25 feet (Photographs 14, 17, 19, 92 and 93). No evidence of settlement or major cracks was observed on the crests. The interior slopes appear to be in fair condition and they appear to be approximately 3H:1V. These slopes are riprap armored with sparse vegetation cover (Photograph 18 and 93). A concrete valve box for the inlet pipes was observed at the northwest embankment at each Sludge Cell (Photograph 20). Dry lime sludge piles near the east corner of Sludge Cell #1 (Photograph 94) were observed. The exterior slopes appear to be in satisfactory condition and they are approximately 4H:1V. They are covered with grass that was approximately 6 to 8 inches high at the time of the visual assessment (Photographs 87 to 91). Lime sludge pipes are located at the toe of slope of the northeast embankment exterior slope of Sludge Cell #2 (Photographs 96 and 97). An animal burrow was observed on the southeast embankment exterior slope of Sludge Cell #2 (Photograph 16).

Photo 16: Lime Sludge Cell No. 2 – Animal burrow, southeast embankment exterior slope, looking northwest.

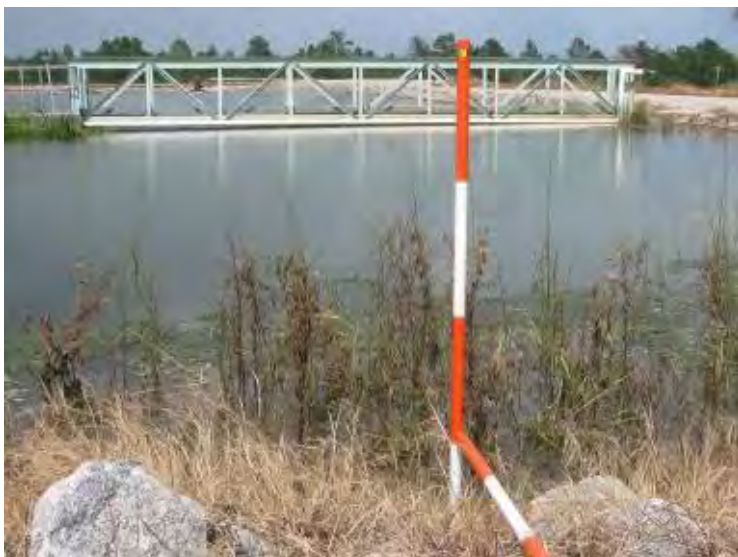
Photo 21: Ash Cell No. 1 – Southwest embankment interior slope, view of pond surface showing 1-foot of freeboard looking northeast.

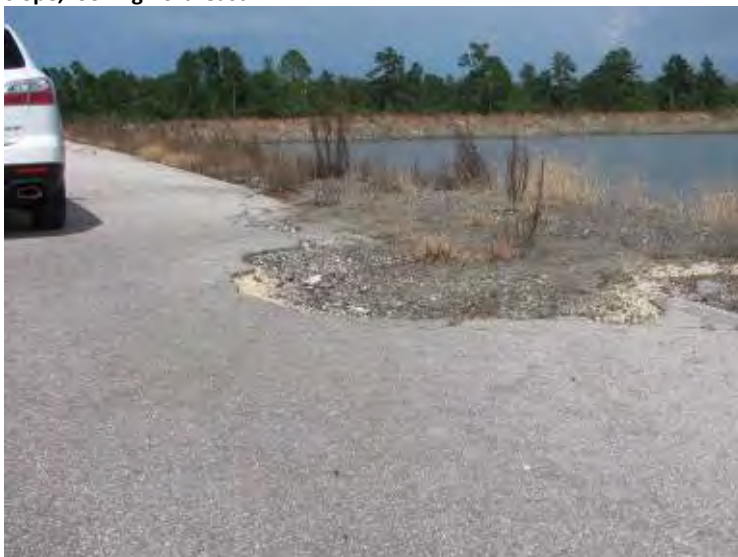
Erosion rills and scarps were observed on the interior slopes of the Ash Cell #1 and Ash Cell #2, primarily on the northwest embankment. These areas should be repaired with compacted structural fill and regraded to match adjacent existing contours. After slope restoration, it is recommended that the exposed surface of the embankment be stabilized with riprap consisting of a heterogeneous mixture of irregular-shaped rocks placed over the compacted fill and a geotextile fabric to match existing riprap stabilization.

Photo 27: Ash Cell No. 2 – Northwest embankment interior slope, erosion along top of slope looking southeast. Note pavement distress.

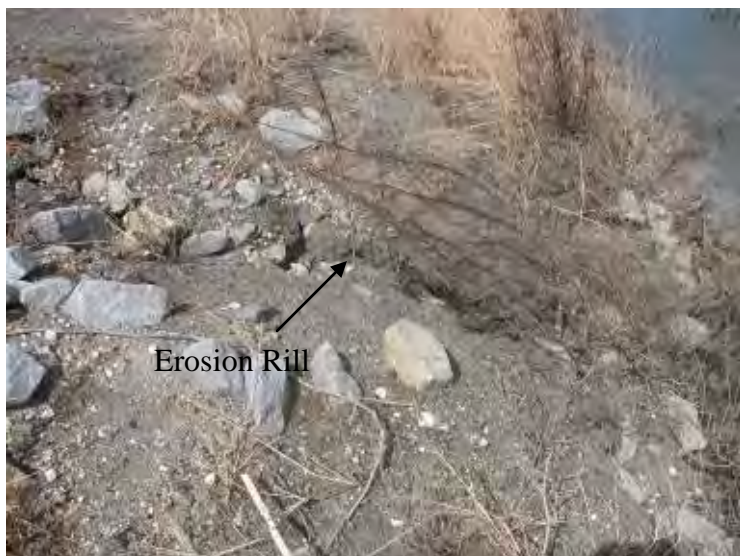
Photo 29: Ash Cell No. 2 – Northwest embankment interior slope, erosion rills looking southeast. (typical of several)

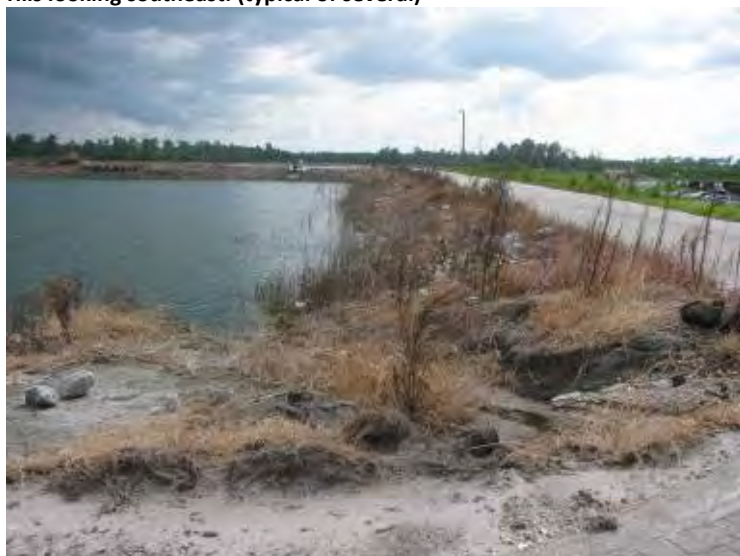
Photo 31: Ash Cell No. 2 – Northwest embankment interior slope, erosion along edge of crest looking south.

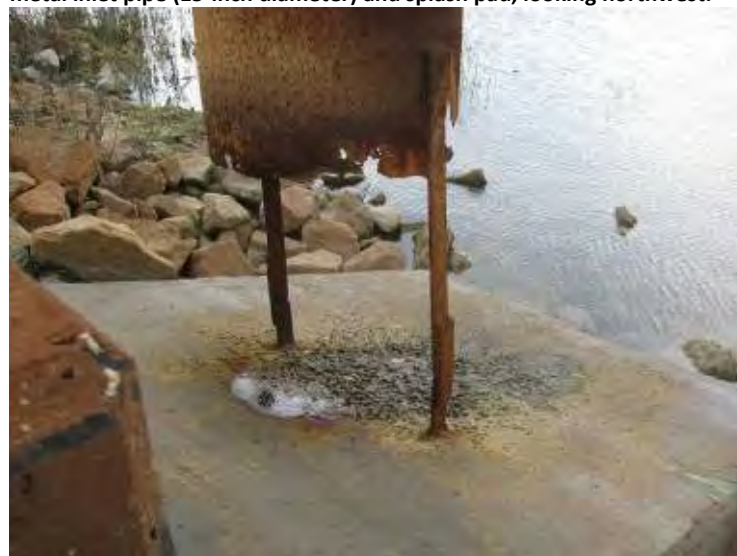
Photo 36: Ash Cell No. 2 – Close up of splash pad looking north. Note rusted end of inlet pipe and eroded concrete.

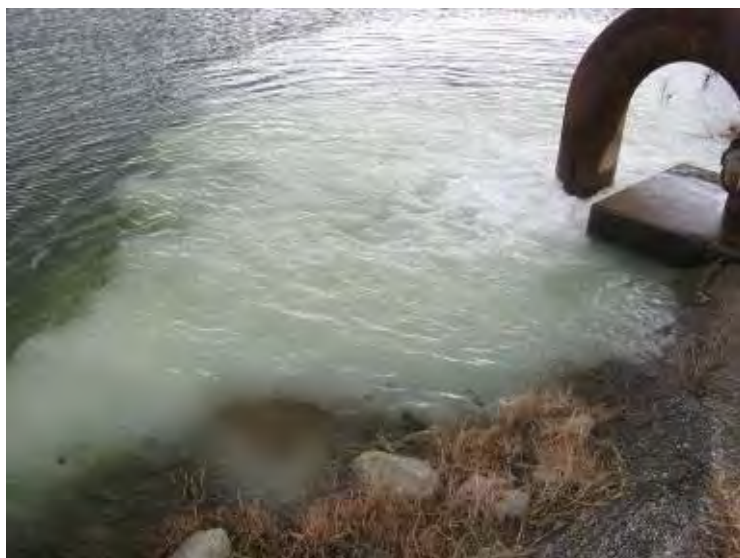
Photo 45: Ash Cell No. 1 – Inlet metal pipe (15-inch diameter), looking northwest. Note discharge water turbidity.

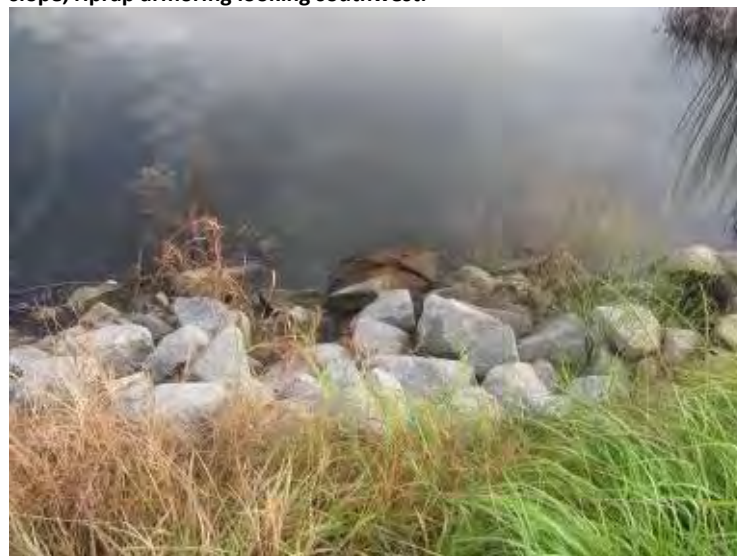
Photo 48: Coal Stockpile Runoff Collection Pond – south embankment interior slope, rusted corrugated inlet metal pipe looking north.

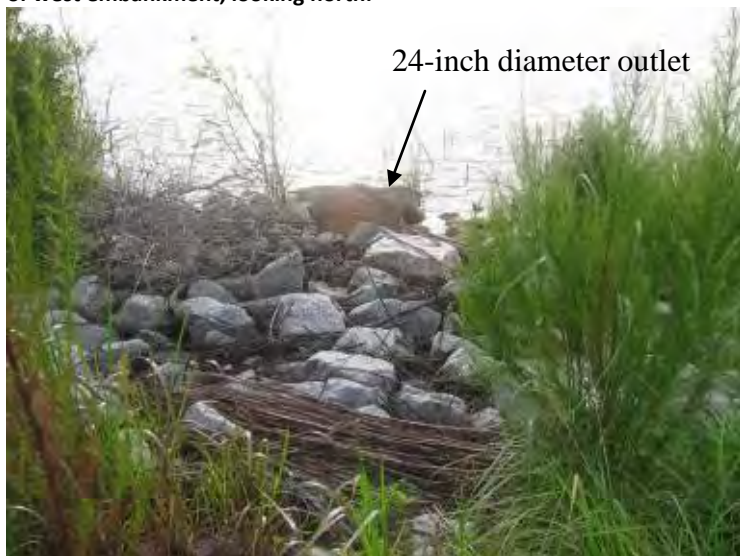
Photo 59: Coal Stockpile Collection Pond – West embankment interior slope upstream side of 24-inch diameter metal outlet pipe, looking east. Pipes are partially crushed and blocked. No flow was observed.

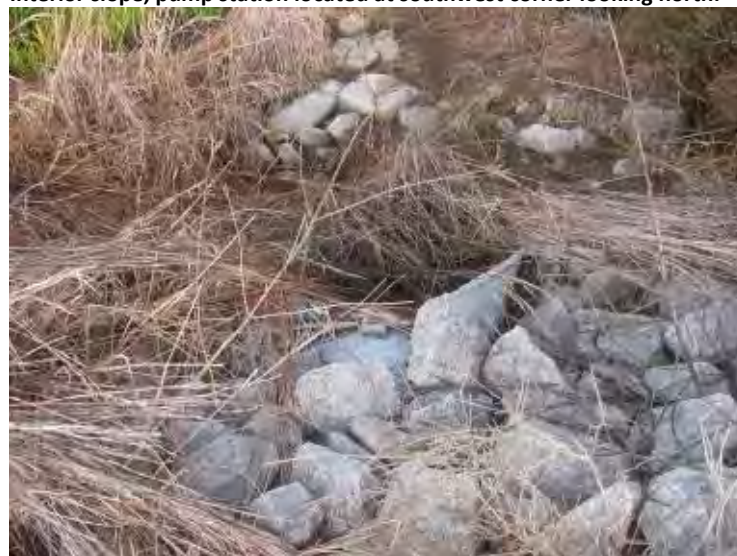
Photo 60: Coal Stockpile Collection Pond – West embankment exterior slope, downstream side of 24-inch diameter metal outlet pipes, looking west. Pipes are partially crushed and blocked. No flow was observed.

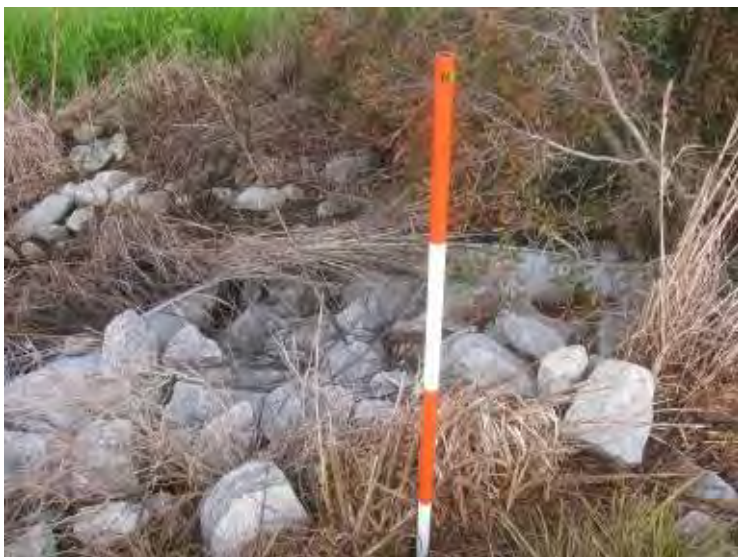
Photo 61: Coal Stockpile Runoff Collection Pond – West embankment exterior slope, downstream side of 24-inch diameter metal outlet pipes, looking west. Pipes are partially crushed and blocked. No flow was observed.

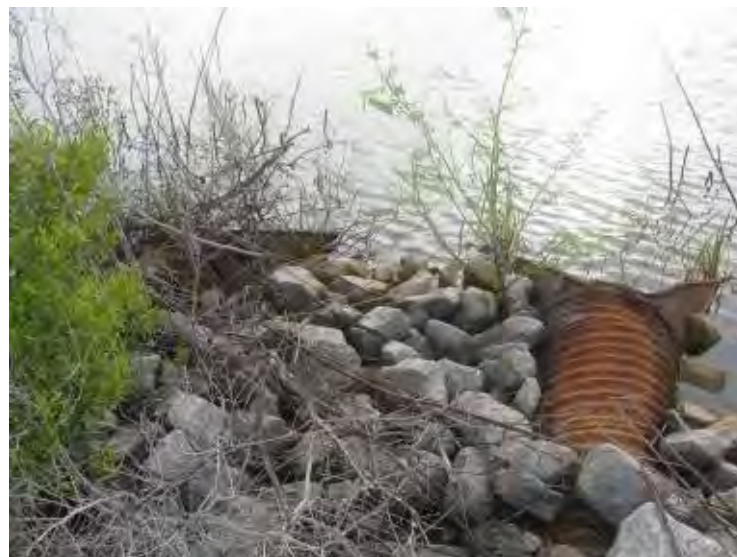
Photo 62: Coal Stockpile Runoff Collection Pond – West embankment interior slope, upstream side of 24-inch diameter metal outlet pipes, looking east. Pipes are partially crushed and blocked. No flow was observed.

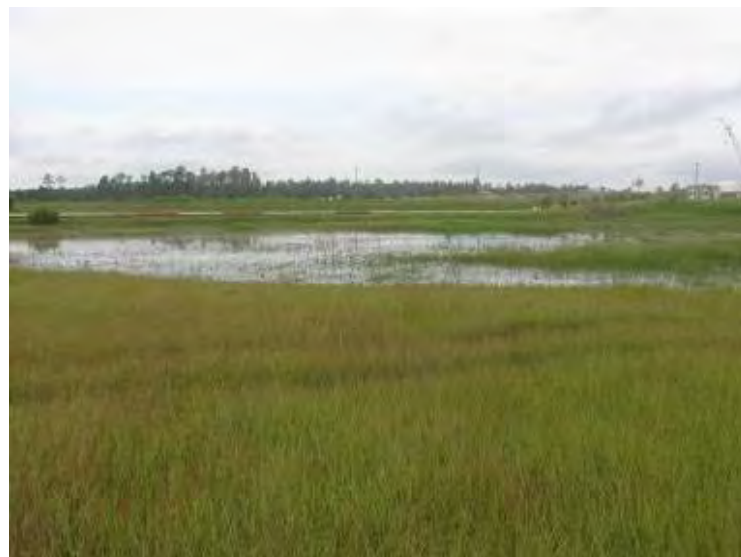
Photo 66: Coal Stockpile Runoff Collection Pond – General view of standing water in surrounding low areas to the west and southwest of pond, looking west.

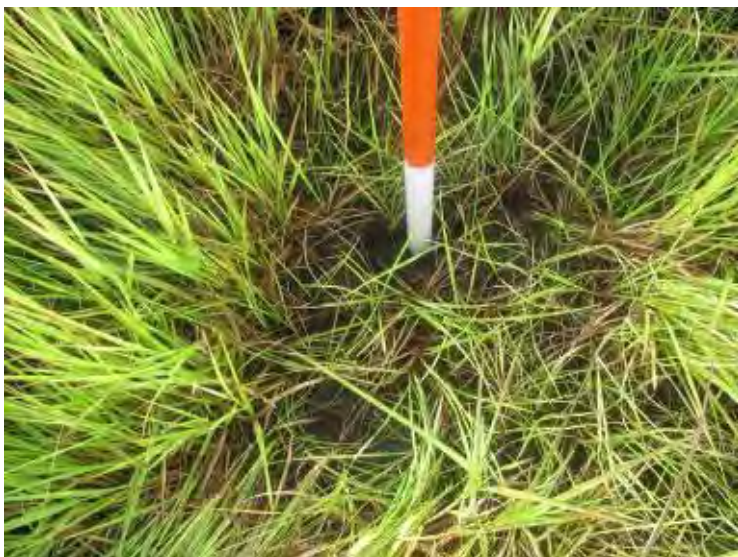
that requires a continuing surveillance and monitoring program. Saturated areas at the toe of slope of the embankments were observed, which indicates that potential seepage may be occurring. The GRU representative indicated several monitoring wells are installed around the site to monitor for water levels and water quality. One monitoring well was observed, southeast of the Pump Back Cell #1. Well data were not provided to CDM Smith.

Photo 85: Ash Cell No. 2 – Northwest embankment exterior slope, saturated area along toe of slope, looking southeast.

CDM Smith recommends an instrumentation monitoring program to monitor potential areas of seepage along the southeast, southwest and northwest embankments of Ash Cell #1 and Ash Cell #2 and Pump Back Cell #1.
