ASSESSMENT OF DAM SAFETY OF COAL COMBUSTION SURFACE IMPOUNDMENTS FINAL REPORT

Gainesville Regional Utilities Deerhaven Plant Gainesville, Florida

Prepared for
*U.S. Environmental
Protection Agency
Washington, D.C.*

May, 2014

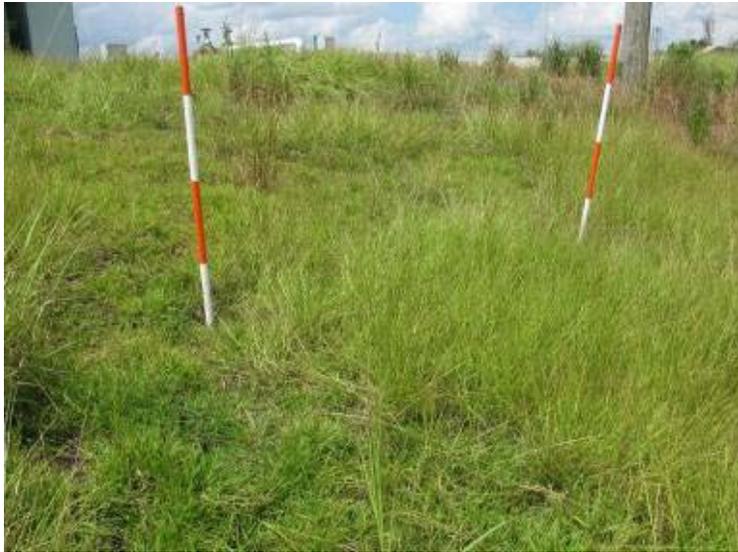
Minor erosion rills were observed on the exterior slope of the southeast embankment of Pump Back Cell #1 (Photographs 5 and 6). An animal burrow was observed on the northwest embankment of Ash Cell #1 (Photograph 80).

Photo 5: Pump Back Cell No. 1 – Southeast embankment exterior slope, minor surficial erosion rills looking northeast.

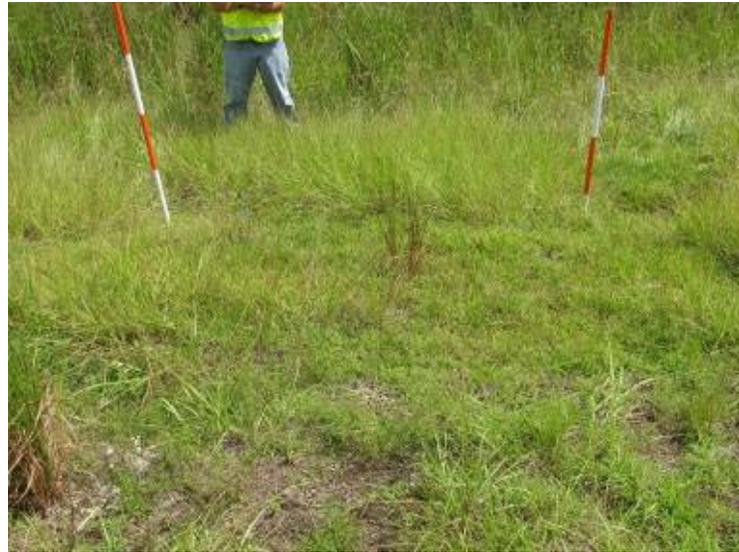
Photo 6: Pump Back Cell No. 1 – Southeast embankment exterior slope, minor erosion rills looking southeast.

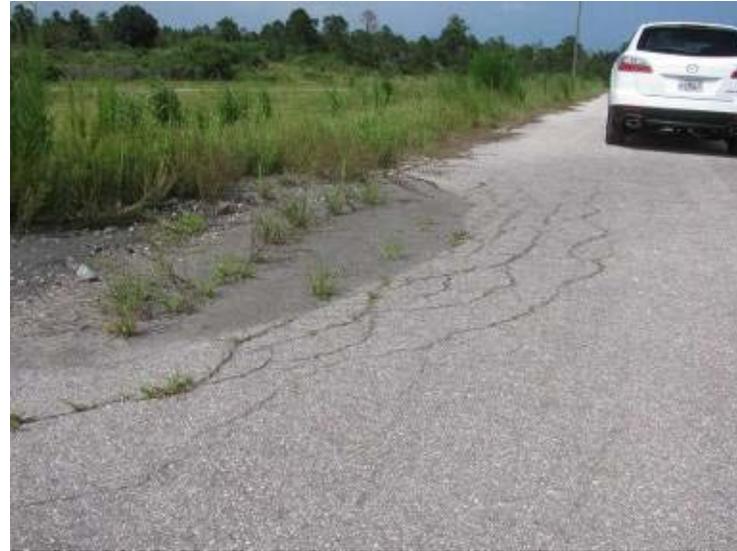
The crest of the perimeter embankments and divider embankments appeared to be in fair condition (Photographs 13-15, 22-25 and 38). Signs of previously repaired scarps and erosion areas were observed at the crest of the northwest embankment of the Ash Cell #2. The crests were typically 25 feet wide. The crest of the embankments has paved surfaces with exposure to limited vehicle traffic during normal operations. In general, no major cracks or evidence of settlement were observed on the crests of any of the embankments. Minor depressions and areas of erosion were observed near Ash Cell #2 on the northwest embankment (Photographs 26 and 27).

Photo 26: Ash Cell No. 2 – Northwest embankment exterior slope, erosion along top of slope, looking north. Note pavement distress.

Erosion rills and scarps were observed on the interior and exterior slopes of the Ash Cell #1 and Ash Cell #2 embankments, primarily on the northwest embankment. These areas should be repaired with

compacted structural fill and regraded to match adjacent existing contours. After slope restoration, it is recommended that the exposed surface of the interior embankment slopes be stabilized with riprap consisting of a heterogeneous mixture of irregular-shaped rocks placed over the compacted fill and a geotextile fabric to match existing riprap stabilization.

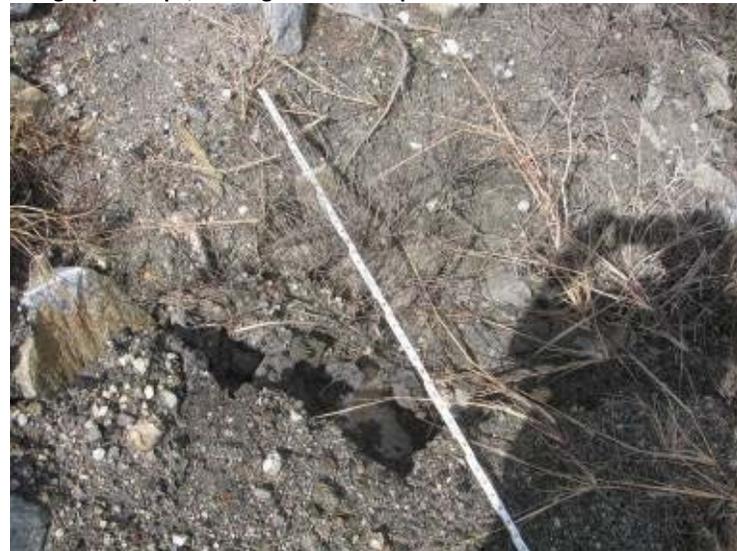
Photo 28: Ash Cell No. 2 – Northwest embankment interior slope, erosion rill looking southeast. (typical of several)

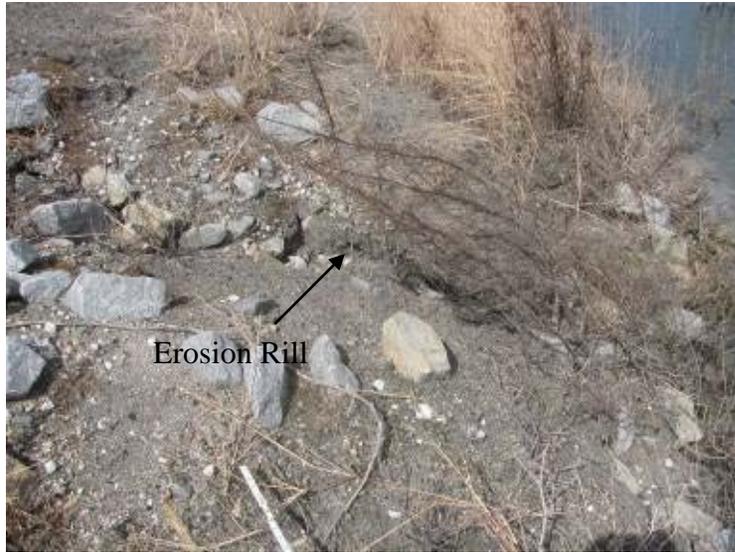
Photo 29: Ash Cell No. 2 – Northwest embankment interior slope, erosion rills looking southeast. (typical of several)

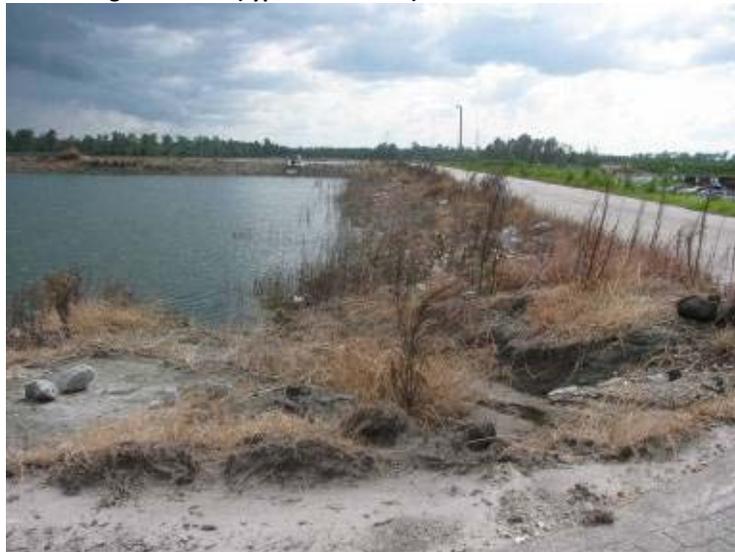
Photo 31: Ash Cell No. 2 – Northwest embankment interior slope, erosion along edge of crest looking south.

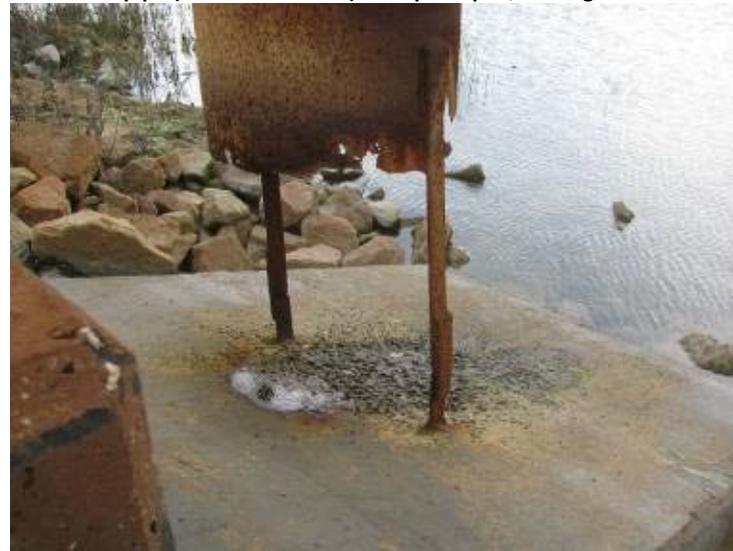
Photo 36: Ash Cell No. 2 – Close up of splash pad looking north. Note rusted end of inlet pipe and eroded concrete.

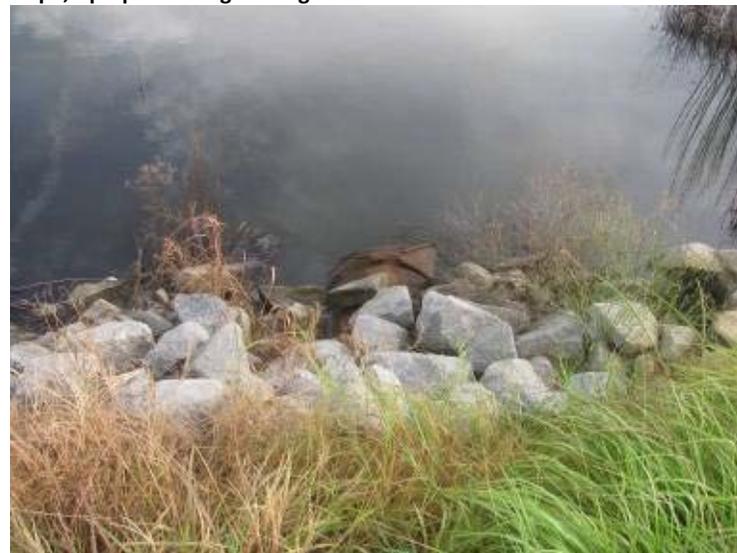
Photo 48: Coal Stockpile Runoff Collection Pond – south embankment interior slope, rusted corrugated inlet metal pipe looking north.

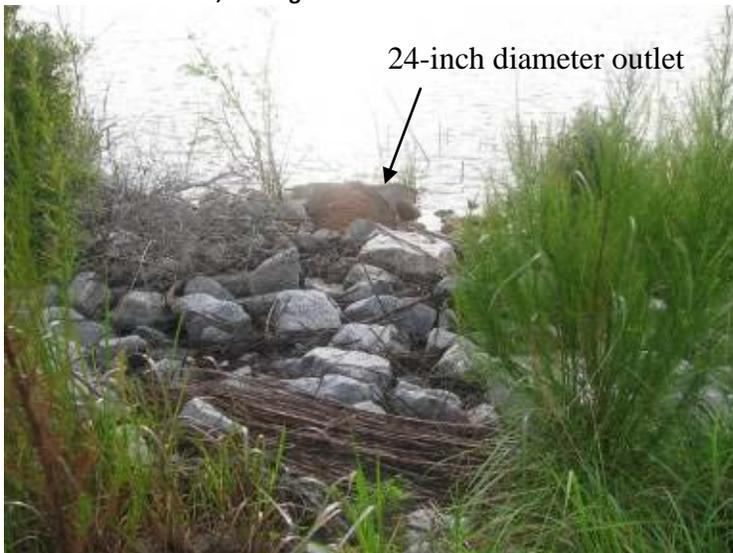
Photo 59: Coal Stockpile Collection Pond – West embankment interior slope upstream side of 24-inch diameter metal outlet pipe, looking east. Pipes are partially crushed and blocked. No flow was observed.

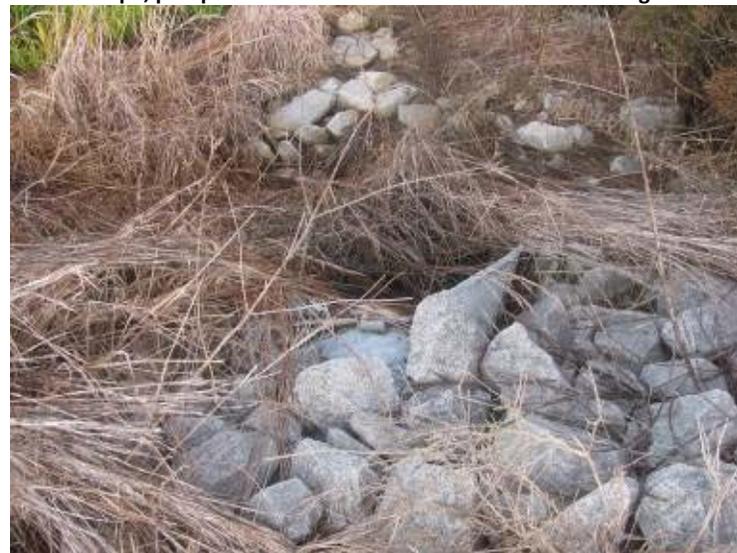
Photo 60: Coal Stockpile Collection Pond – West embankment exterior slope, downstream side of 24-inch diameter metal outlet pipes, looking west. Pipes are partially crushed and blocked. No flow was observed.

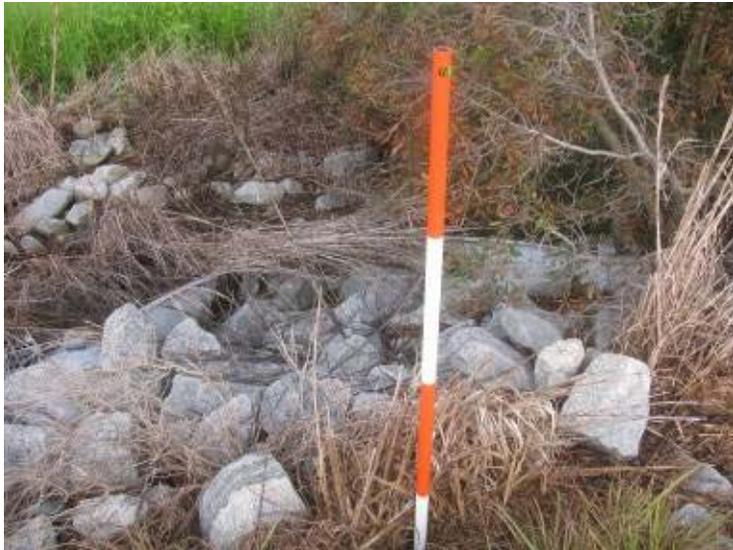
Photo 61: Coal Stockpile Runoff Collection Pond – West embankment exterior slope, downstream side of 24-inch diameter metal outlet pipes, looking west. Pipes are partially crushed and blocked. No flow was observed.

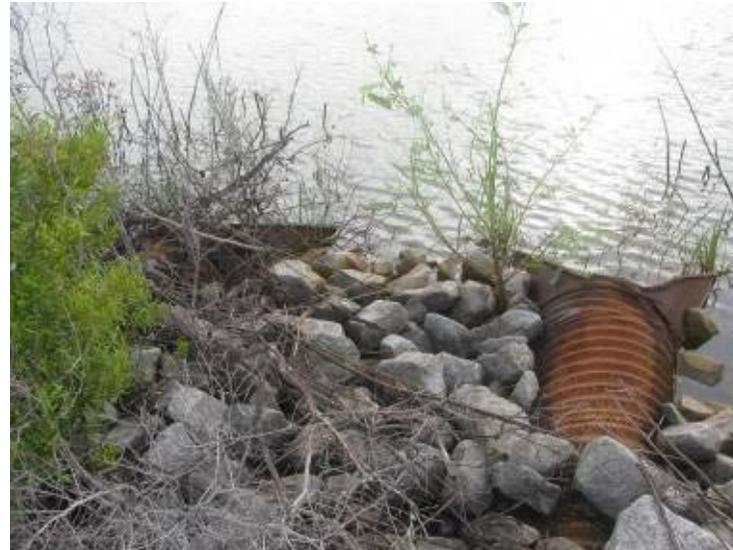
Photo 62: Coal Stockpile Runoff Collection Pond – West embankment interior slope, upstream side of 24-inch diameter metal outlet pipes, looking east. Pipes are partially crushed and blocked. No flow was observed.

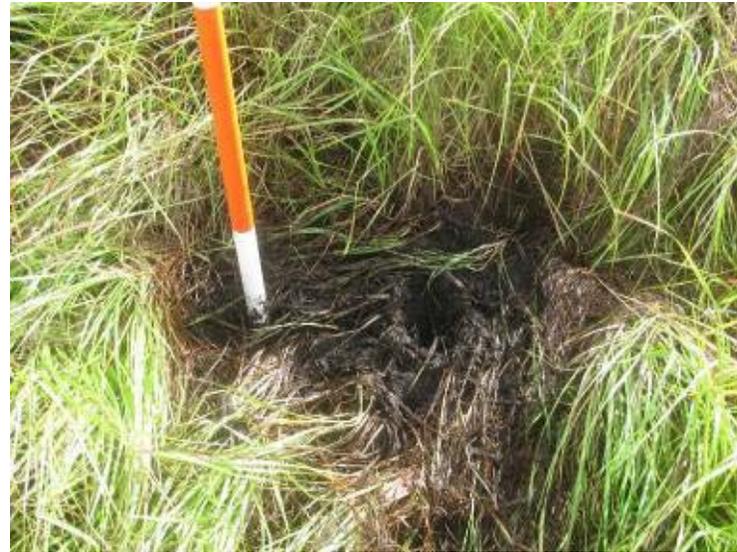
Photo 78: Ash Cell No. 1 – Southwest embankment exterior slope, saturated area along exterior toe of slope (typical), looking northeast.

CDM Smith recommends an instrumentation monitoring program to monitor potential areas of seepage along the southeast, southwest, and northwest embankments of Ash Cell #1 and Ash Cell #2 and Pump Back Cell #1.

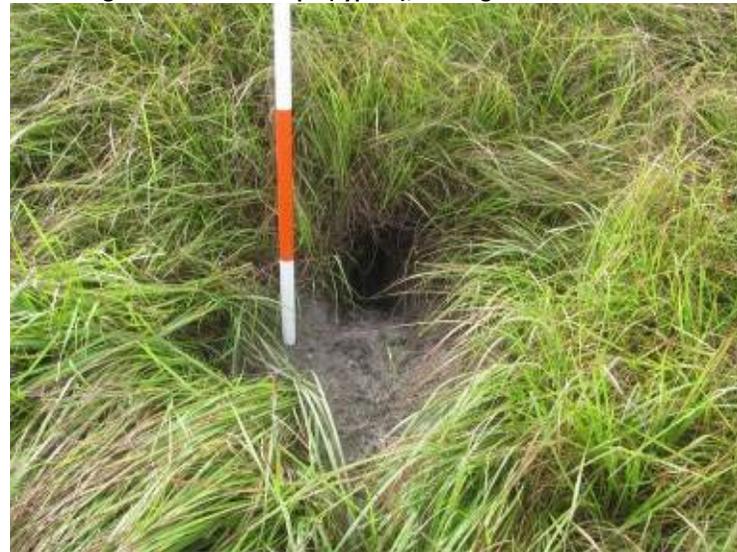
Photo 80: Ash Cell No. 1 – Animal burrow, northwest embankment exterior slope, looking southeast.

Animal burrows were observed on the southeast and northwest embankments exterior slopes. Although not seen in other areas, high vegetation cover on the embankments may have hidden other animal burrows. CDM Smith recommends documenting areas disturbed by animal activity, removing the animals and backfilling the burrows with compacted structural fill to protect the integrity of the embankments. Vegetation should be maintained at a height that potential animal burrows can be readily observed.
