**DRAFT REPORT**

# **Dam Safety Assessment of CCR Impoundments**

## **Bremo Power Station**

June 11, 2010

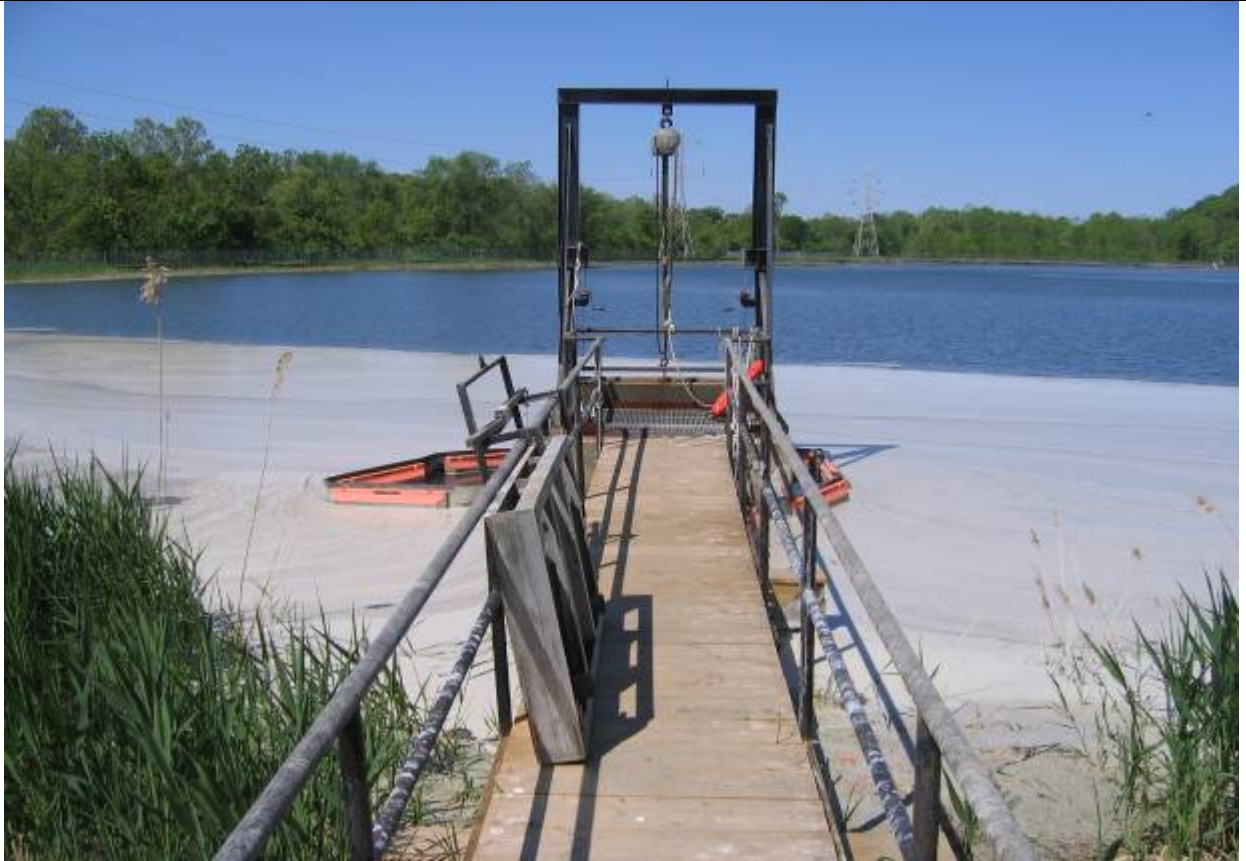
- The outlet structure appeared to be in good condition and functioning normally. The cenosphere boom/ baffle system was in place and functioning. Decant water appeared clear.

Outlet Structure

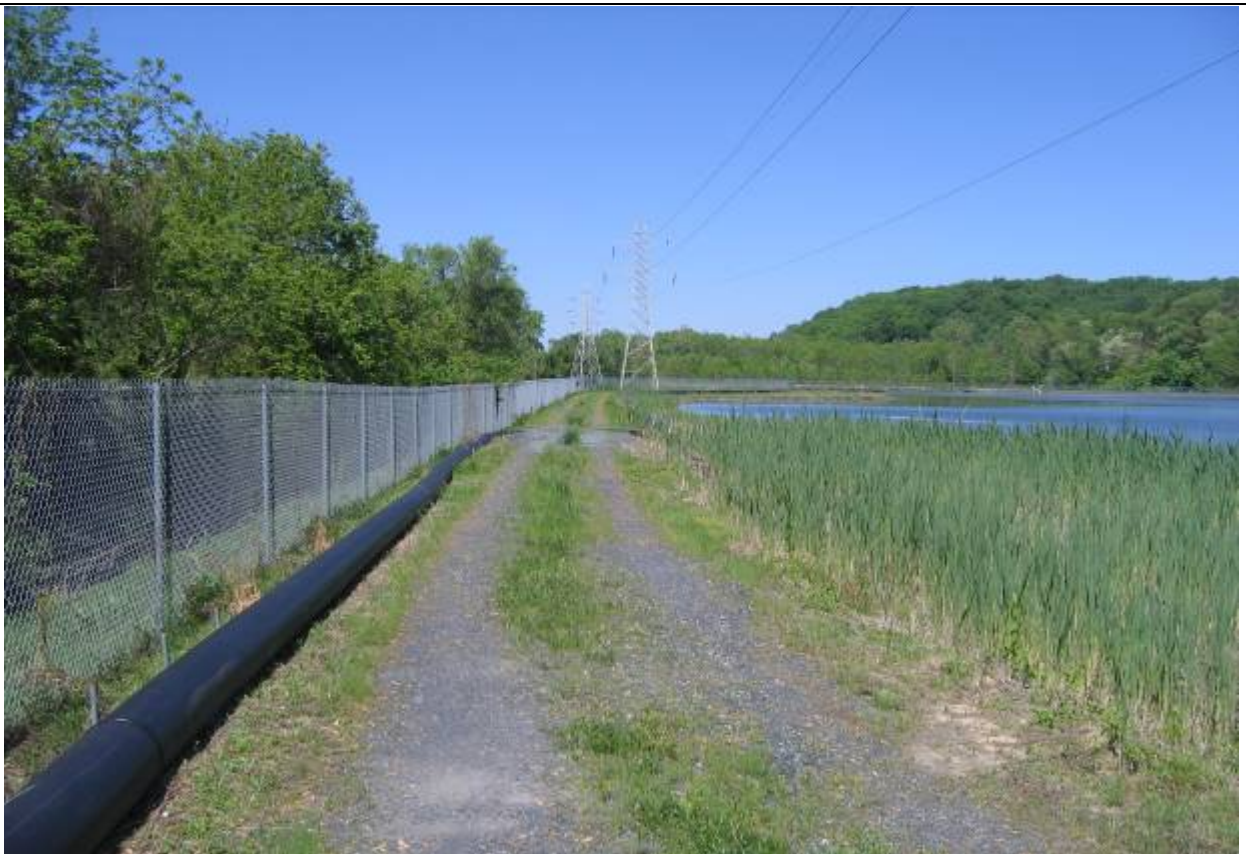
- Sluiced CCW by-product discharge is conveyed on aboveground piping that is routed up the downstream slope of the embankment in the southeast corner of the West Ash Pond and along the embankment crest to the dividing dike between the West Ash Pond and the Heavy Metals Pond (Photos B2, B3, B4, B5 and B12). The CCW discharge is discharged via multiple valved discharge points into the west side of the West Ash Pond (Photo B4). The CCW piping could be valved to discharge to the Heavy Metals Pond (Photo B3) although no CCW materials were observed in the Heavy Metals Pond (Photos B5, B6).

Southern  
Embankment

Note: CCW  
discharge pipe  
on crest

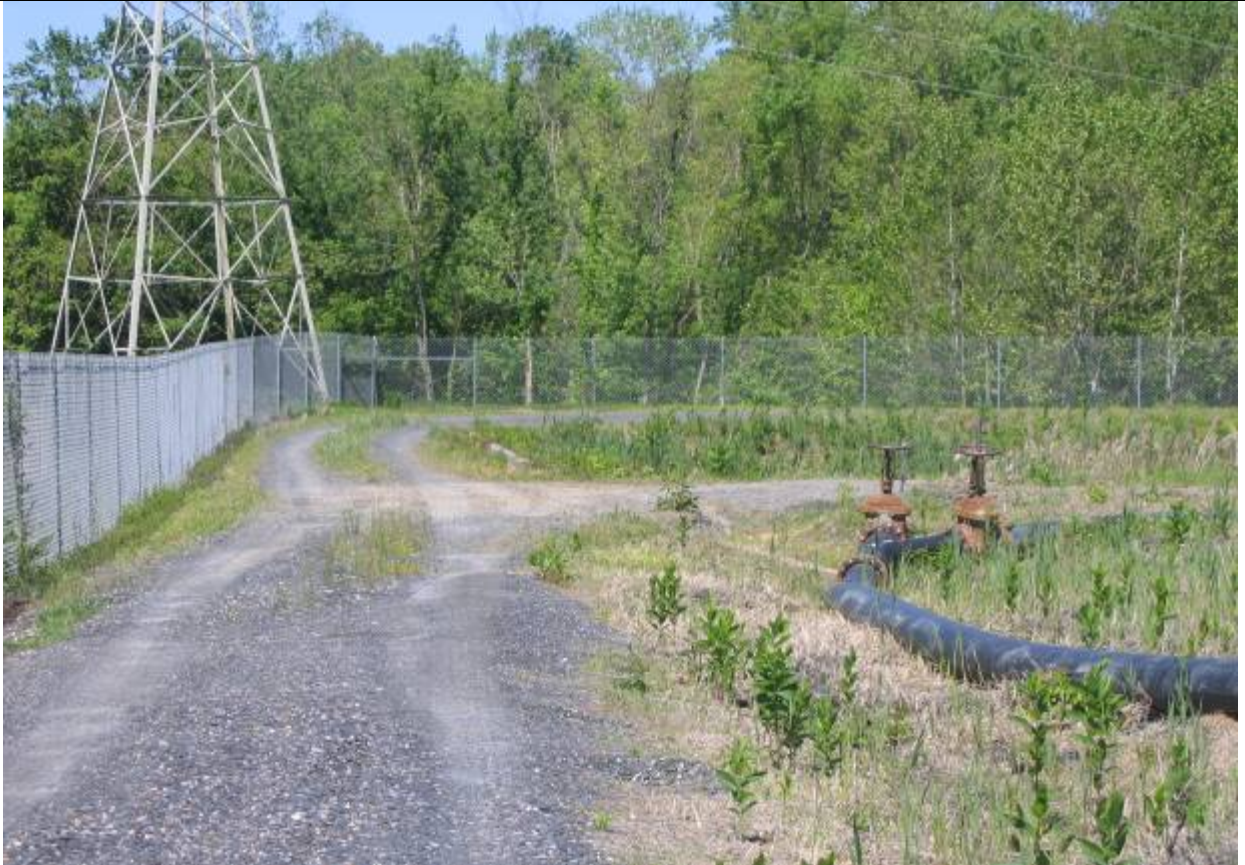
Photo Number:  
B3

Description:  
Southern  
Embankment

Note: CCW  
discharge split  
to Heavy Metals  
or West Ash  
Pond

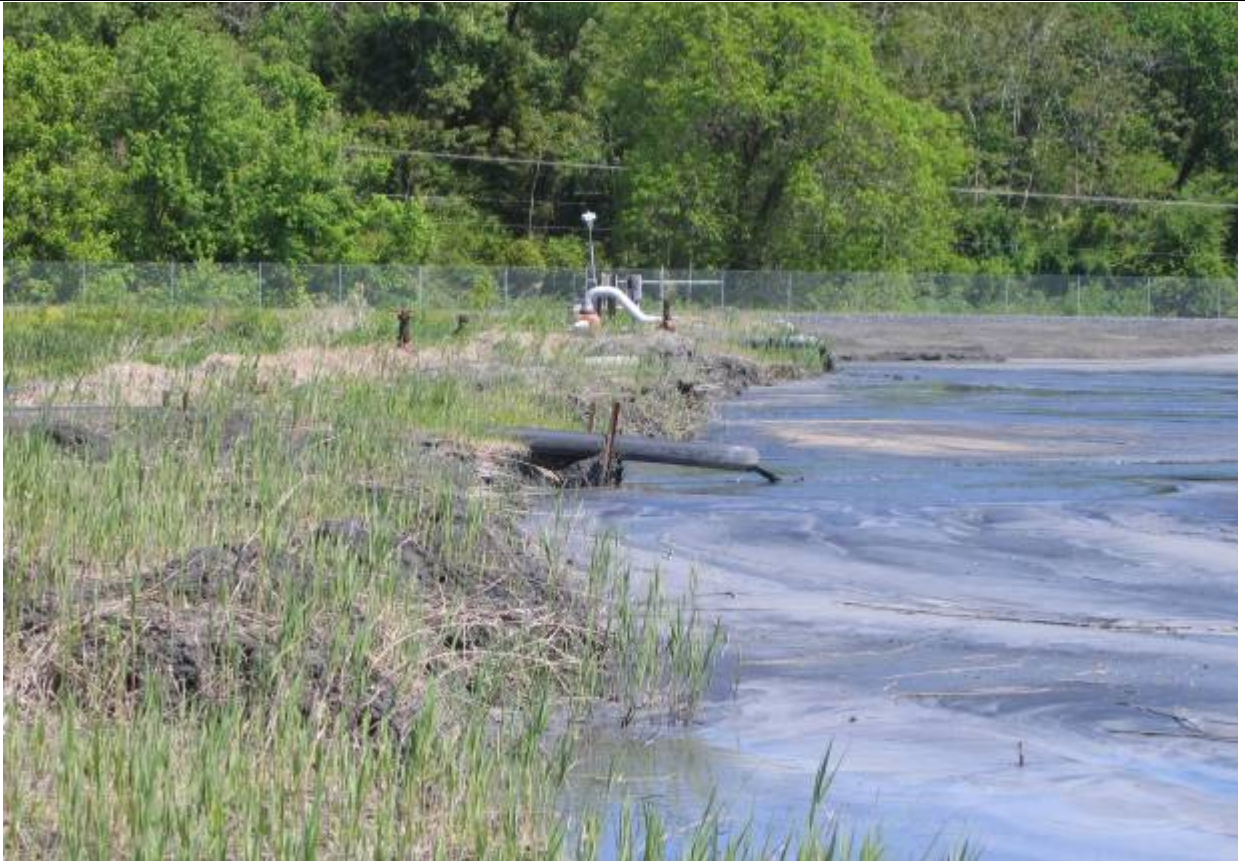
Photo Number:  
B4

Description:  
Dividing Dike  
Between West  
Ash Pond &  
Heavy Metals  
Pond

Note: CCW  
discharges

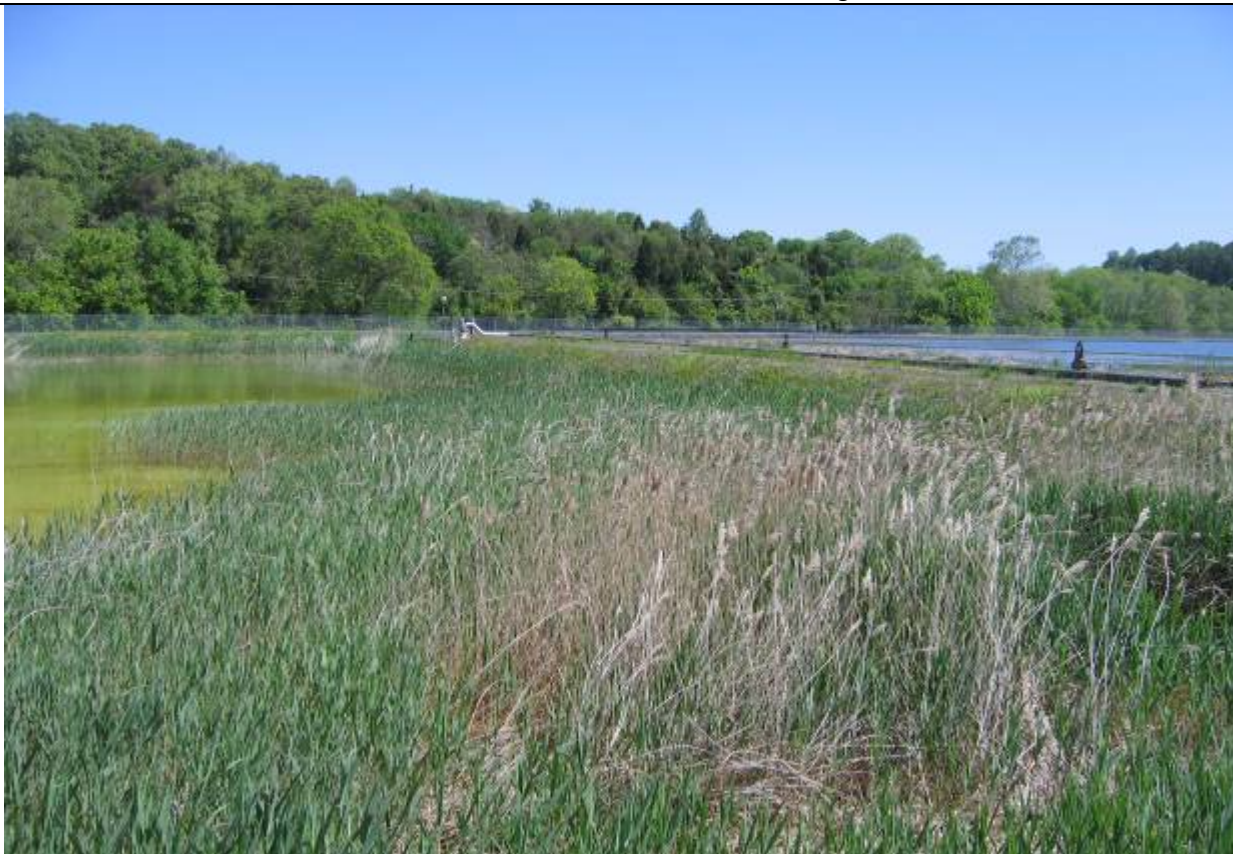
Photo Number:  
B5

Description:  
Dividing Dike  
Between West  
Ash & Heavy  
Metals Pond

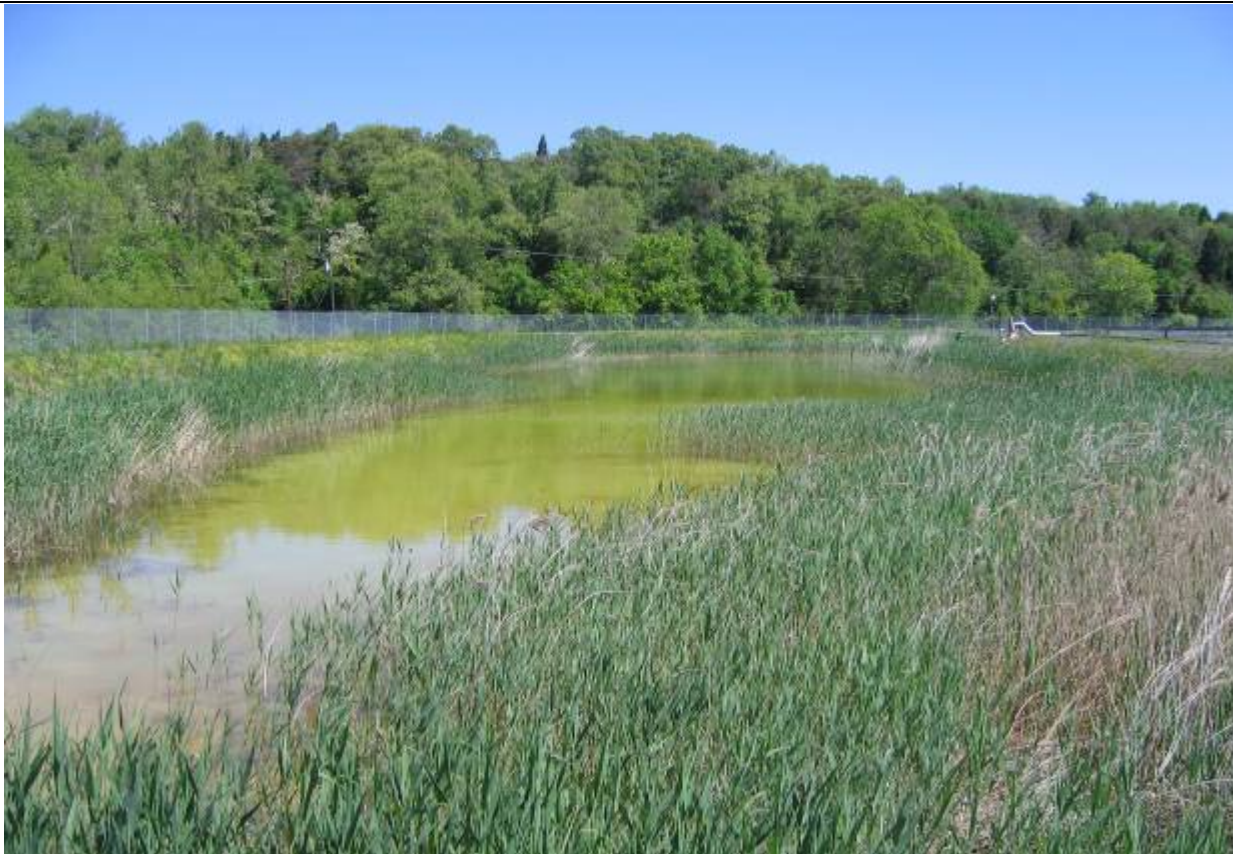
Photo Number:  
B6

Description:  
Heavy Metal  
Pond

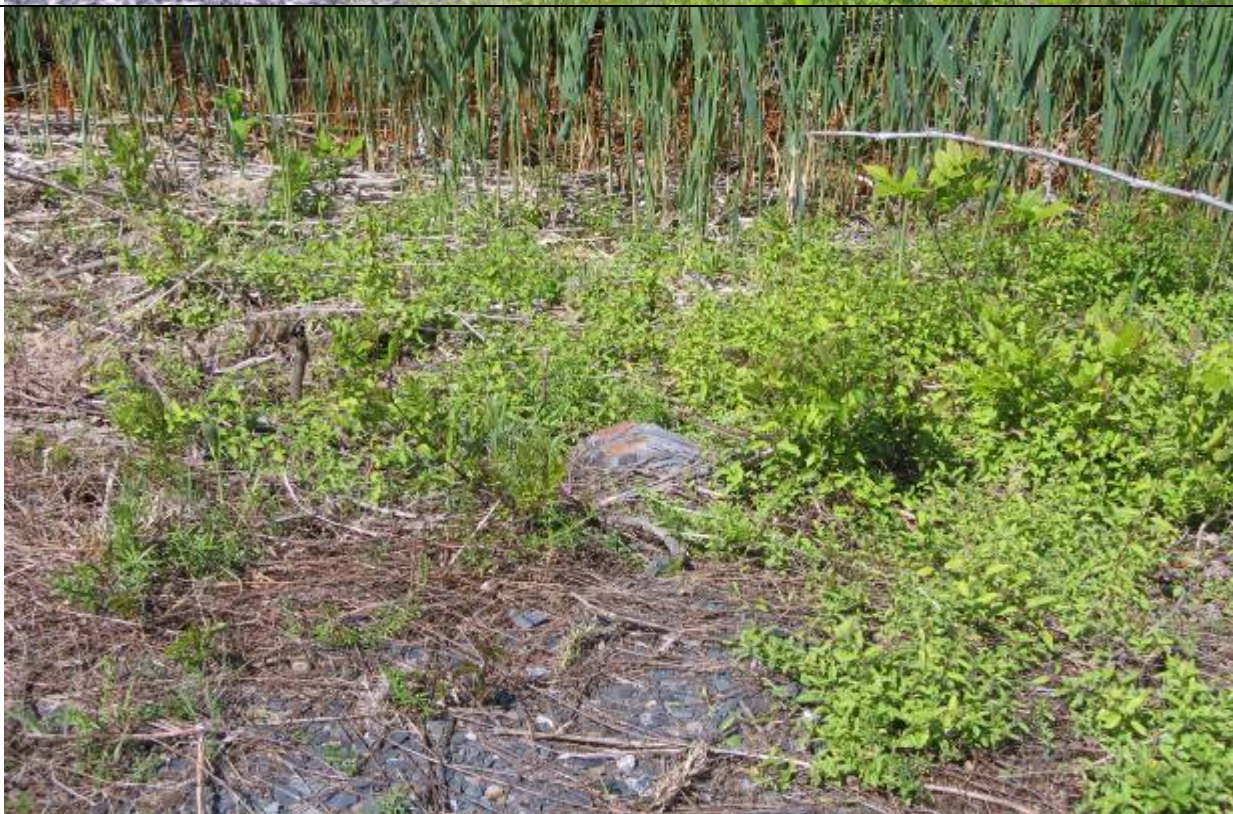
Photo Number:  
B8

- Two hydraulic interconnections exist between the West Ash Pond and the Heavy Metals Pond. The first is a corrugated metal pipe through the dividing dike (Photo B8). No water was observed flowing into the Heavy Metals Pond. The pipe on the West Ash Pond side of the dike could not be located. The second interconnection is the Heavy Metal Pond pump (acid waste pump) system,

Description:  
Overflow Pipe  
from West Ash  
Pond into  
Heavy Metals  
Pond

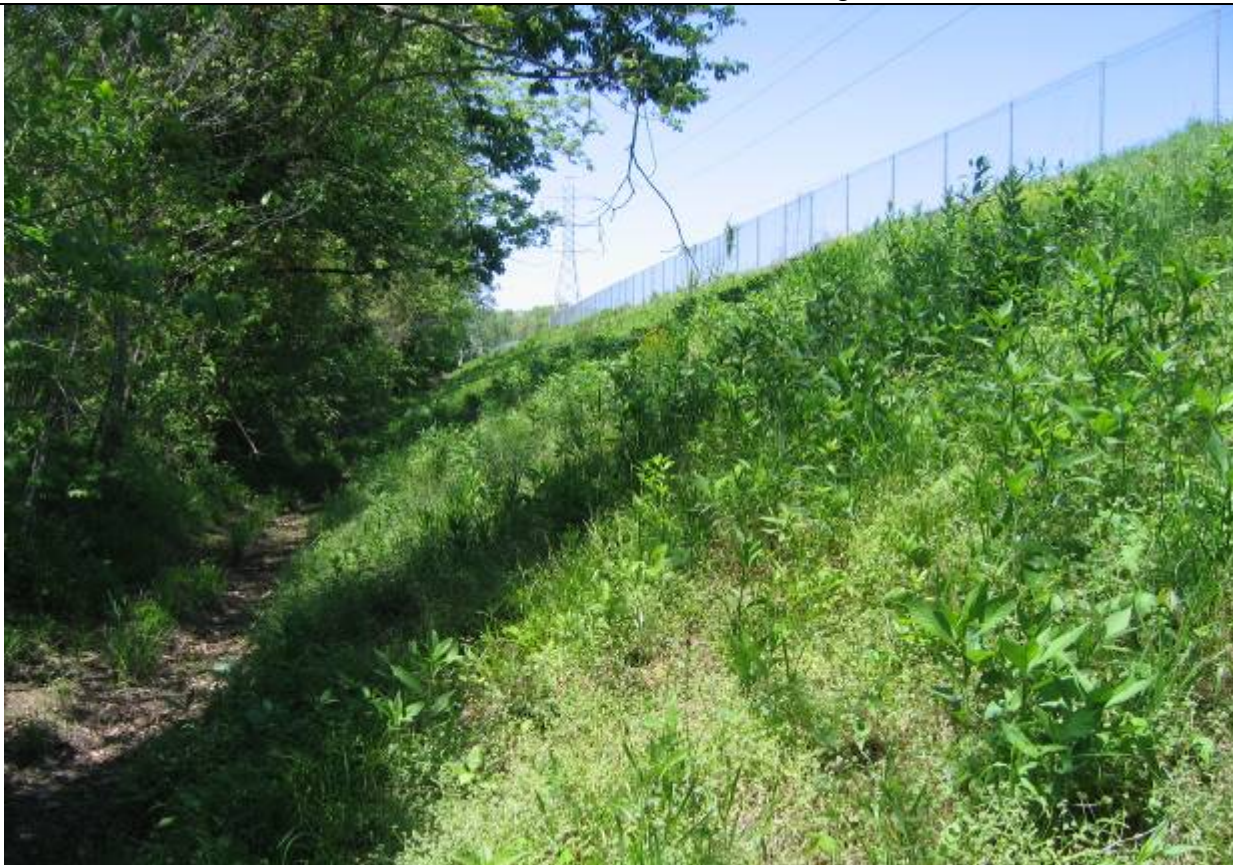
Photo Number:  
B13

Description:  
Southern  
Embankment

Note: Drainage  
swale at toe of  
slope

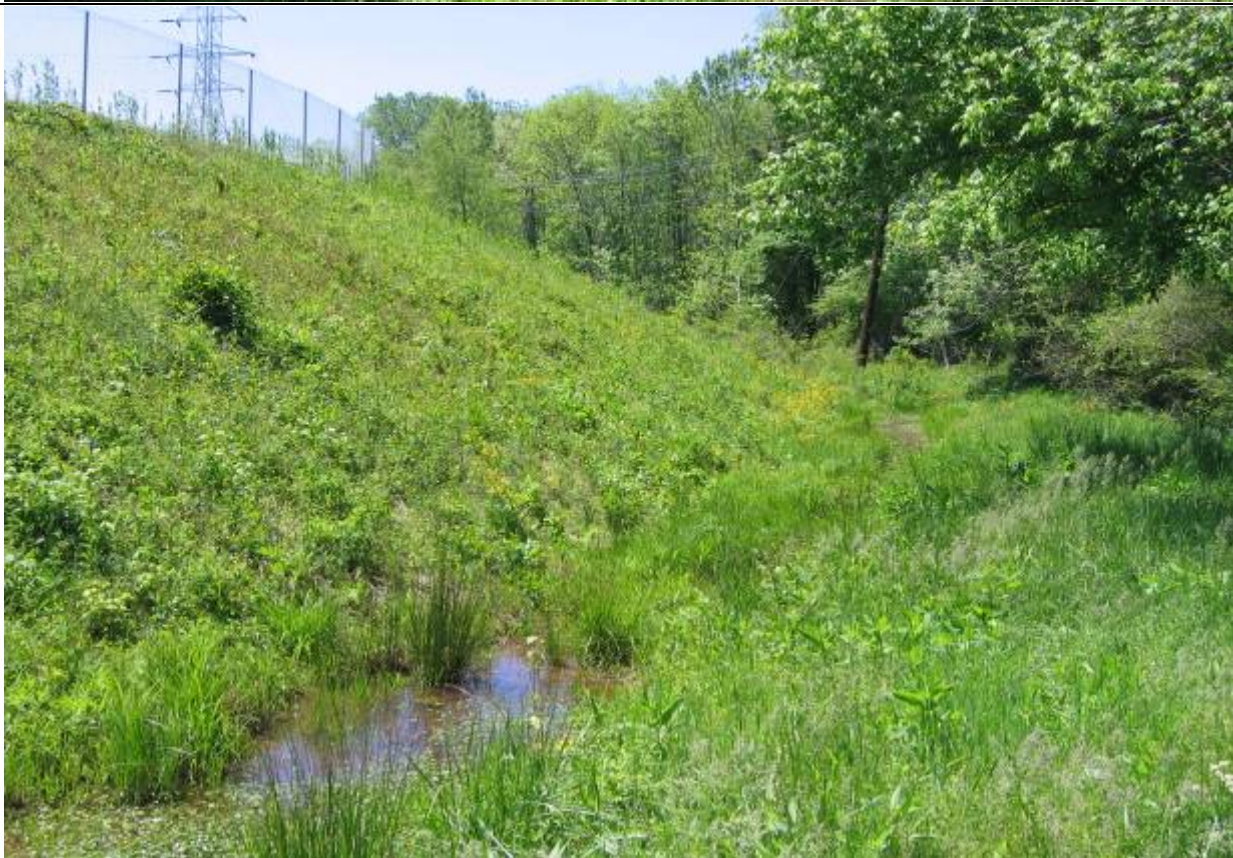
Photo Number:  
B14

- Standing water was observed in the perimeter drainage ditch on the west and north sides at the toe of the embankments. This water could be toe drain discharge or stormwater or both.

Description:  
Western  
Embankment of  
Heavy Metals  
Pond

Note: Standing  
water at toe of  
slope

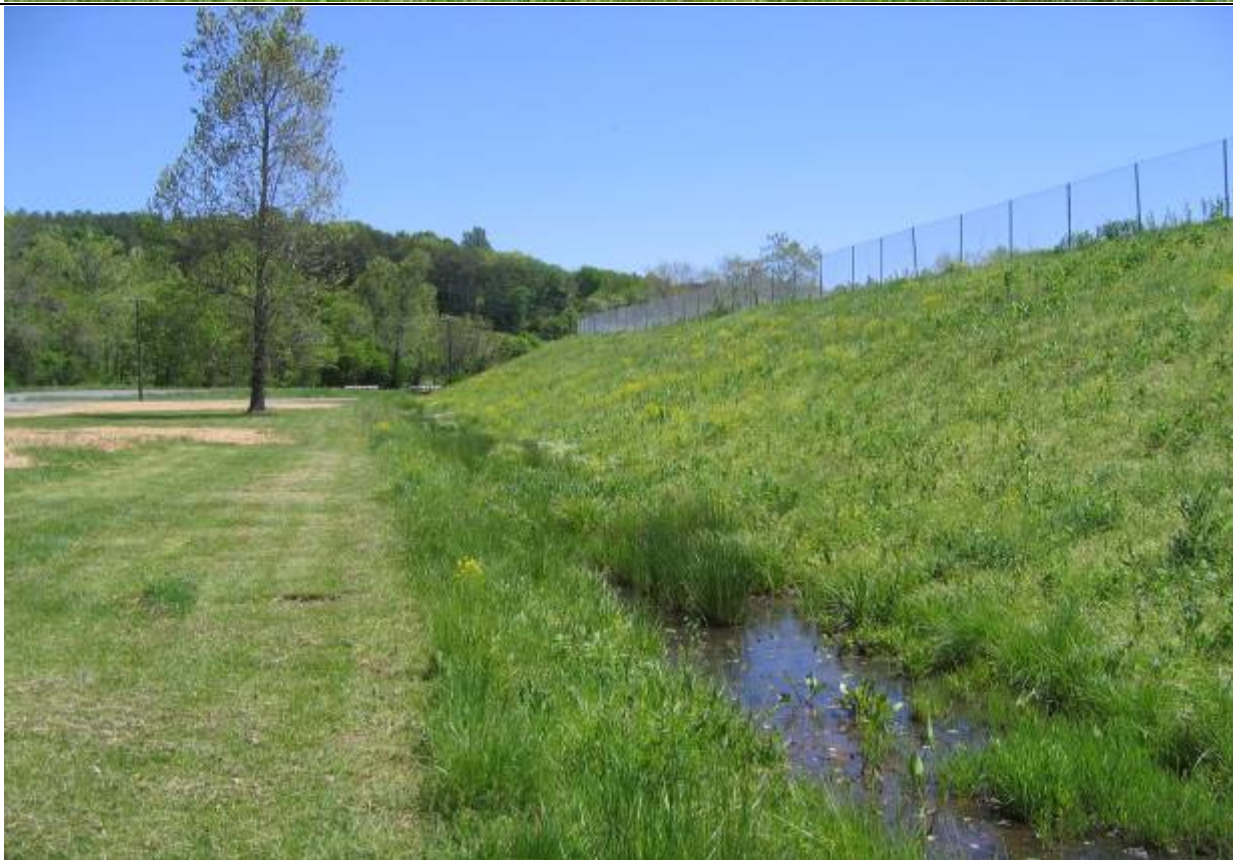
Photo Number:  
B16

Description:  
Northern  
Embankment of  
West Ash Pond

Note: Standing  
water at toe of  
slope

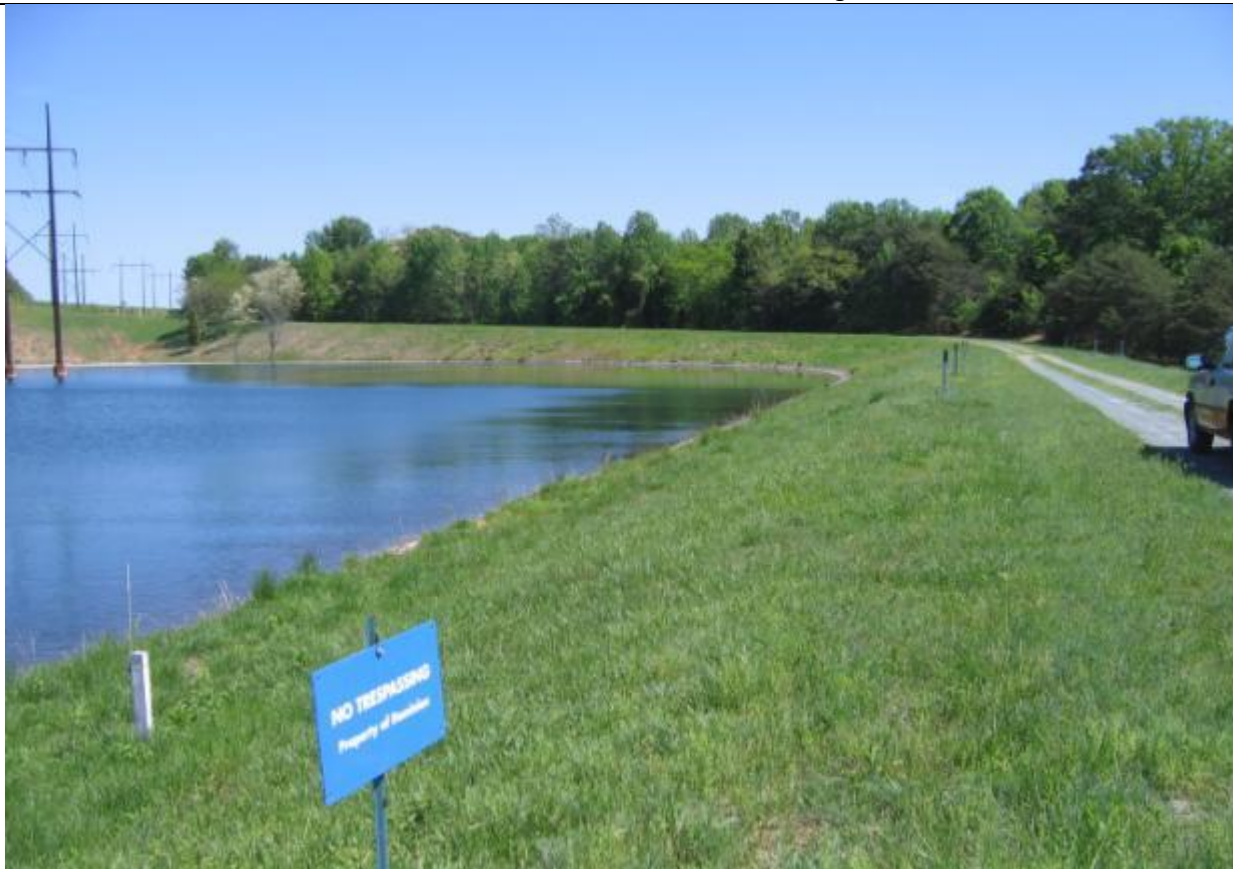
Photo Number:  
C1

Description:  
North Ash Pond  
Dam Crest

Note:  
Superficial  
Sloughing

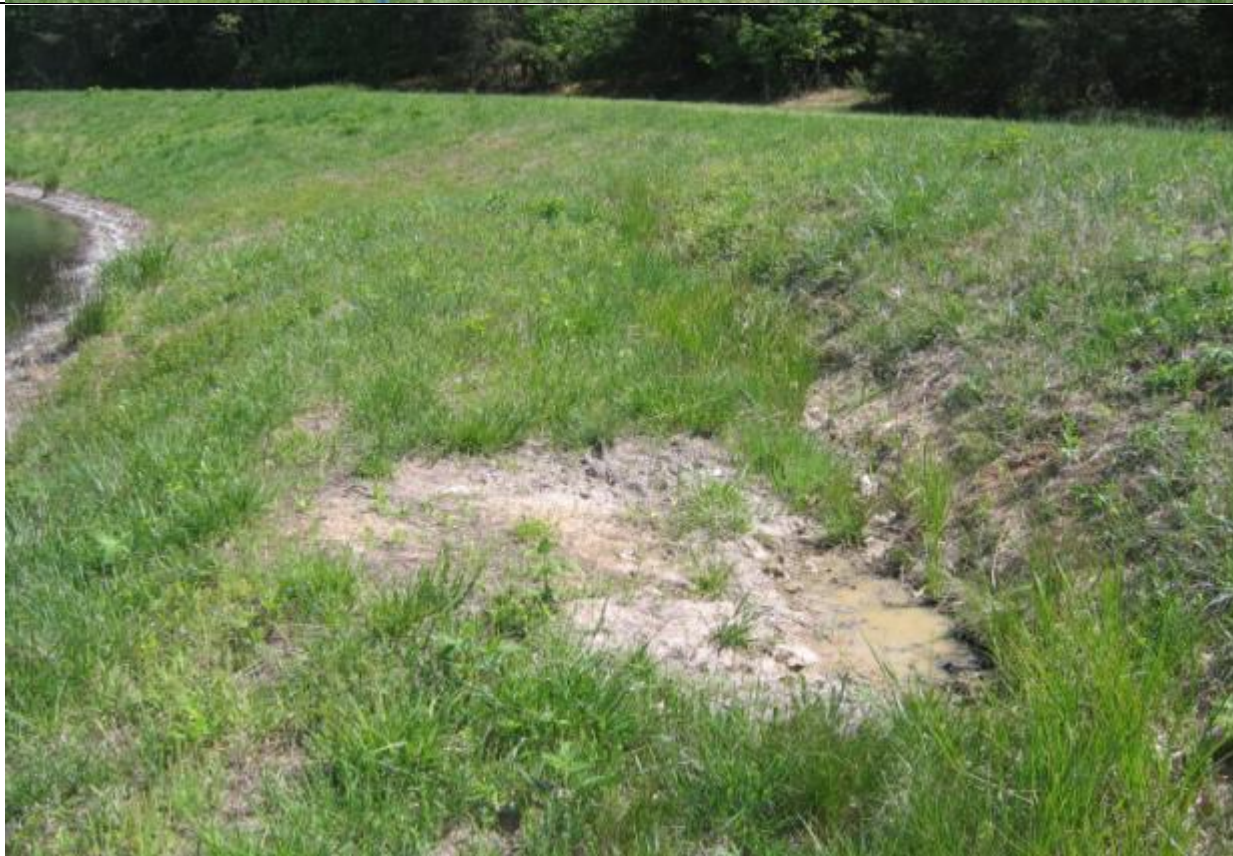
Photo Number:  
C2

- The crest and gravel crest road appeared to be in good condition with no cracks or settlement (Photos C4, C12, C13 and C14); the exposed portions of the inboard slope exhibit minor wave erosion on the wave berm at the water interface. Some minor erosion/superficial sloughing has occurred on the wave berm and the upstream slope to the crest along the dam (Photo C2).

Description:  
North Ash Pond  
Dam Crest

Note:  
Superficial  
Sloughing

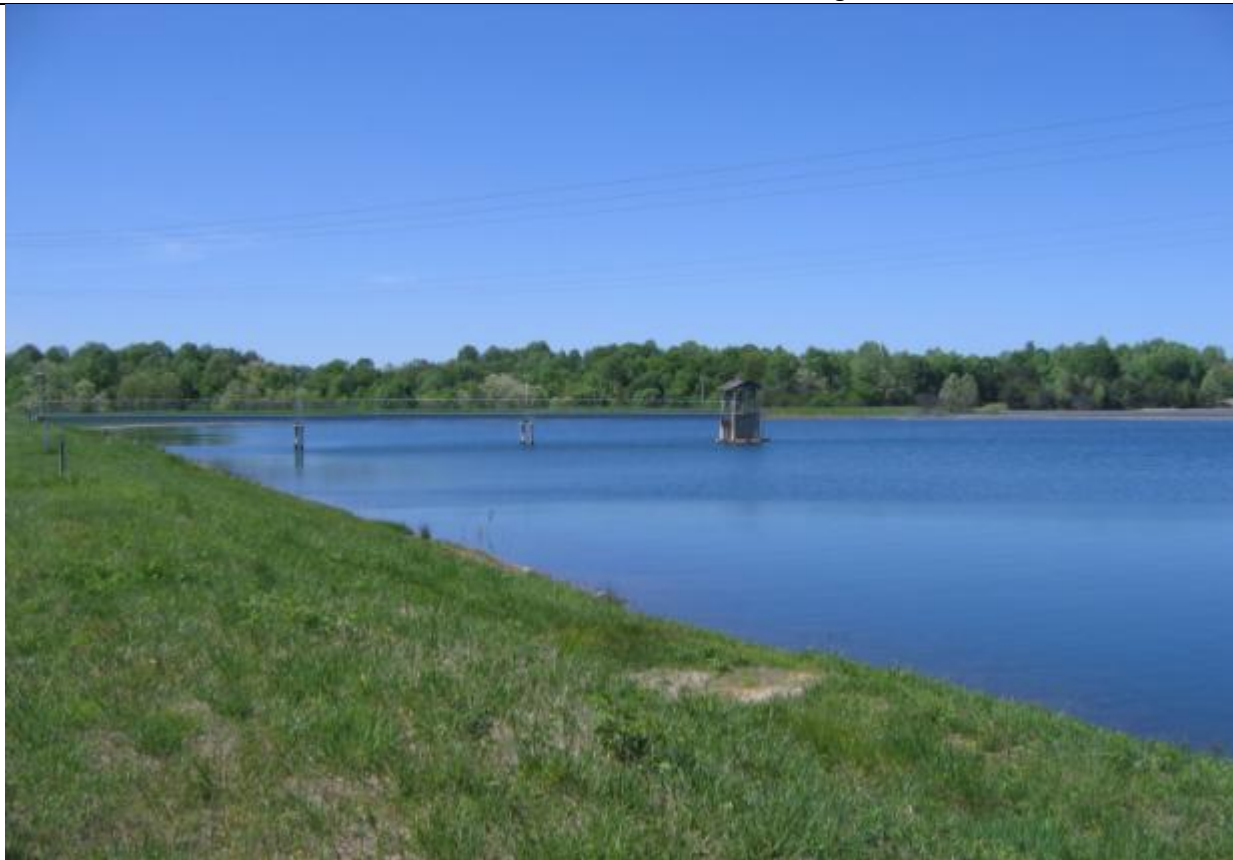
Photo Number:  
C3

- Significant vegetation and trees were observed downstream of the emergency spillway.
- The outlet structure appeared to be in good condition and functioning normally. The cenosphere boom/ baffle system was in place (Photo C3). Decant water appeared clear.

Description:  
Outlet Structure

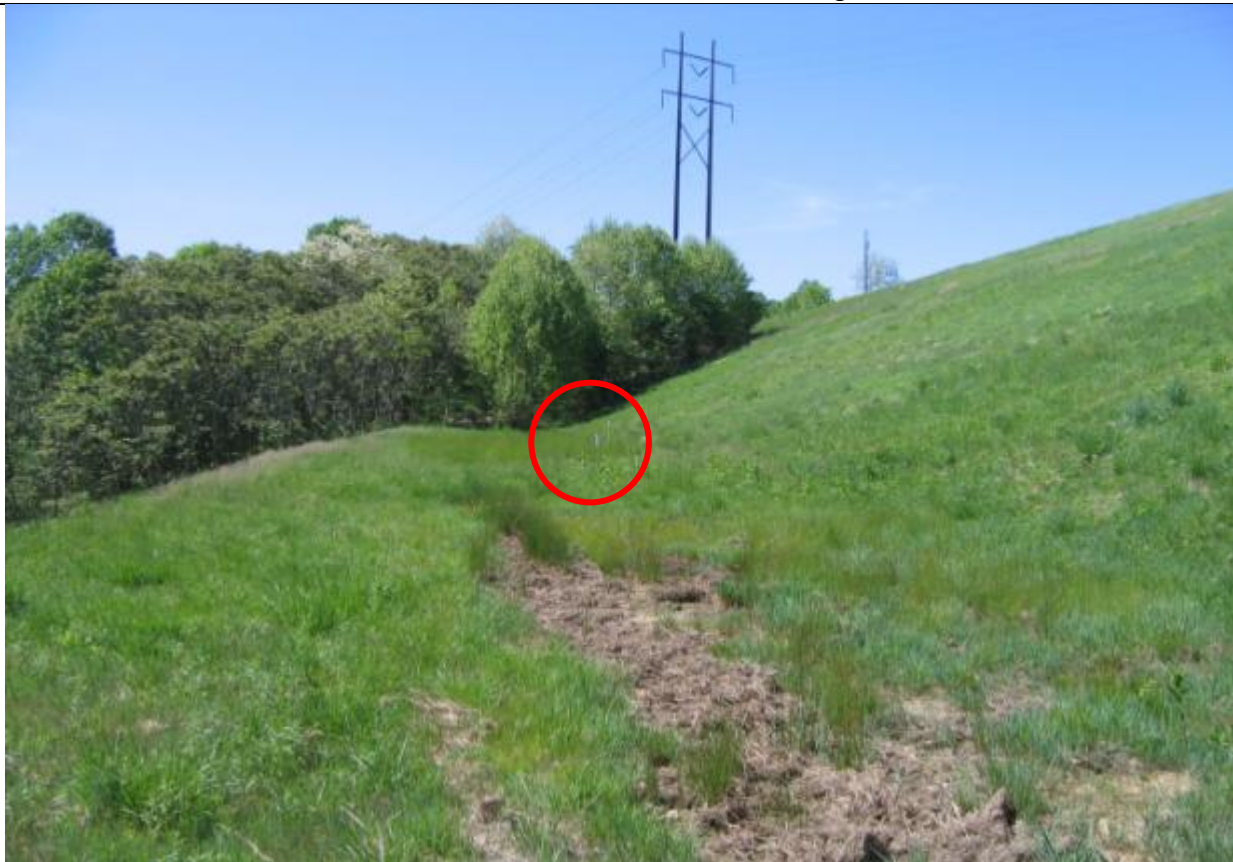
Photo Number:  
C7

- Standing water was not observed on the toe berm but the ground was soft ( Photo C7). The top of the toe berm was moist at the surface due slow drainage of stormwater.

Description:  
Downstream  
Toe of North  
Ash Pond Dam

Note:  
Piezometer on  
Toe Berm

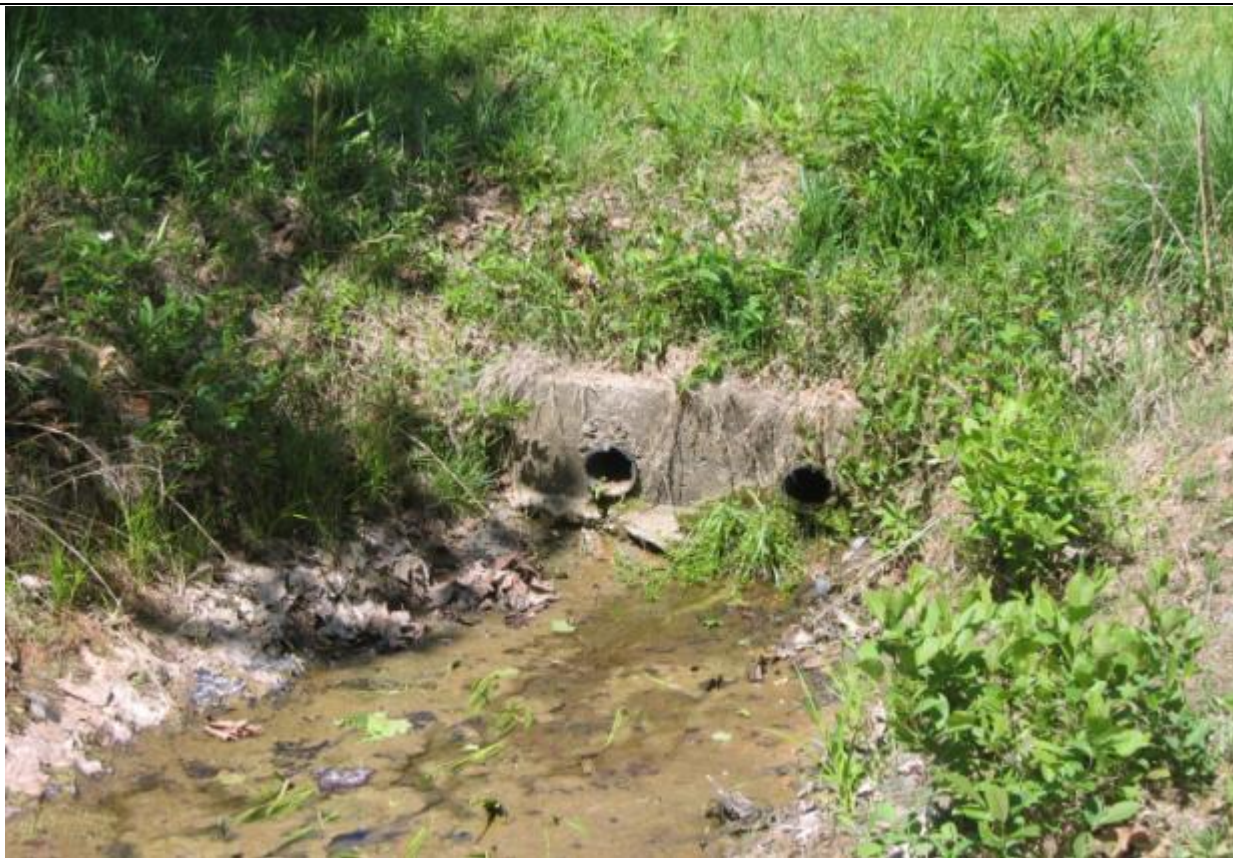
Photo Number:  
C8

- No seepage was observed on downstream slopes of the dam embankments.
- Flow from three of the four toe drain pipes was observed and was visually estimated to be less than 2 gallons per minute. Flow from the toe drains was observed to be clear (Photos C8, C10). Water was flowing freely to the diversion ditch.

Description:  
Toe Drain East  
Headwall

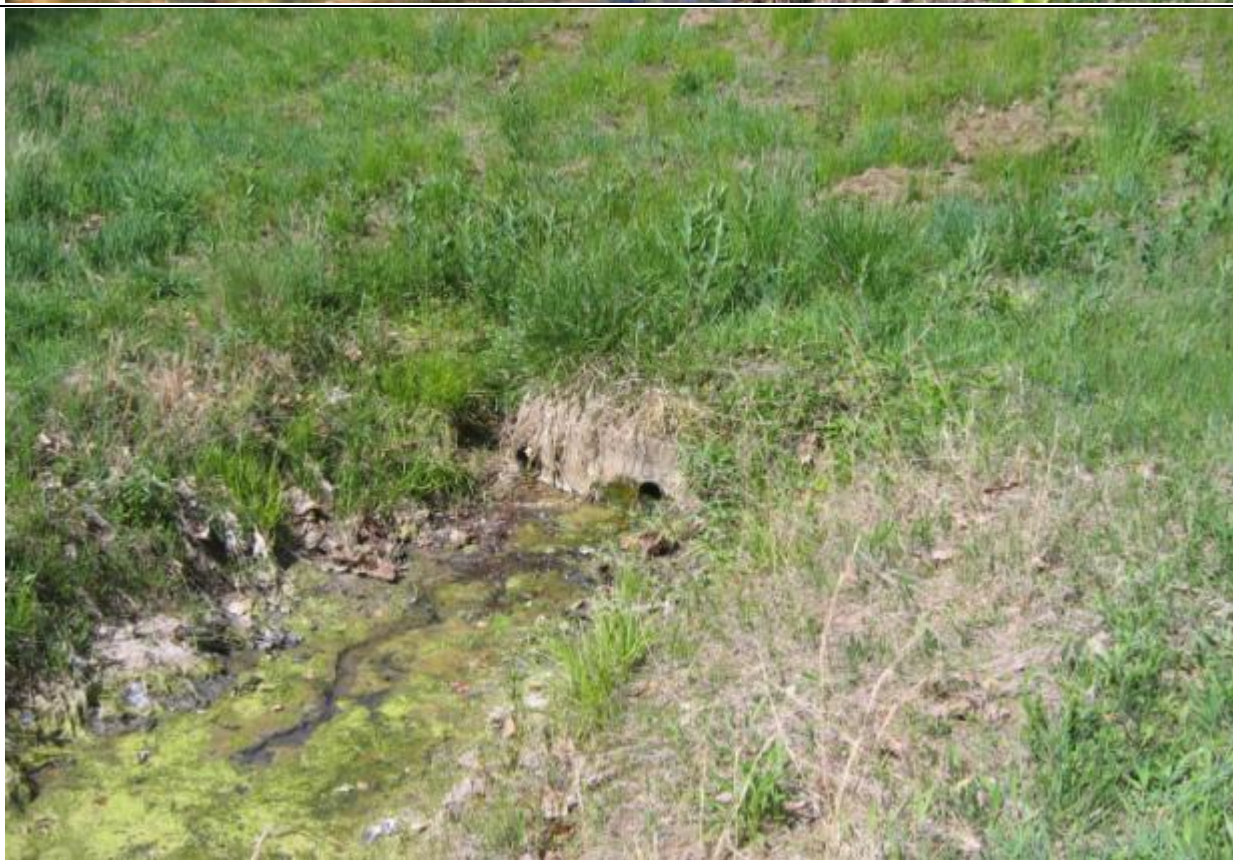
Photo Number:  
C10

Description:  
Toe Drain West  
Headwall
