Dam Safety Assessment of CCW Impoundments

Bremo Power Station

United States Environmental Protection Agency
Washington, DC

September 29, 2010

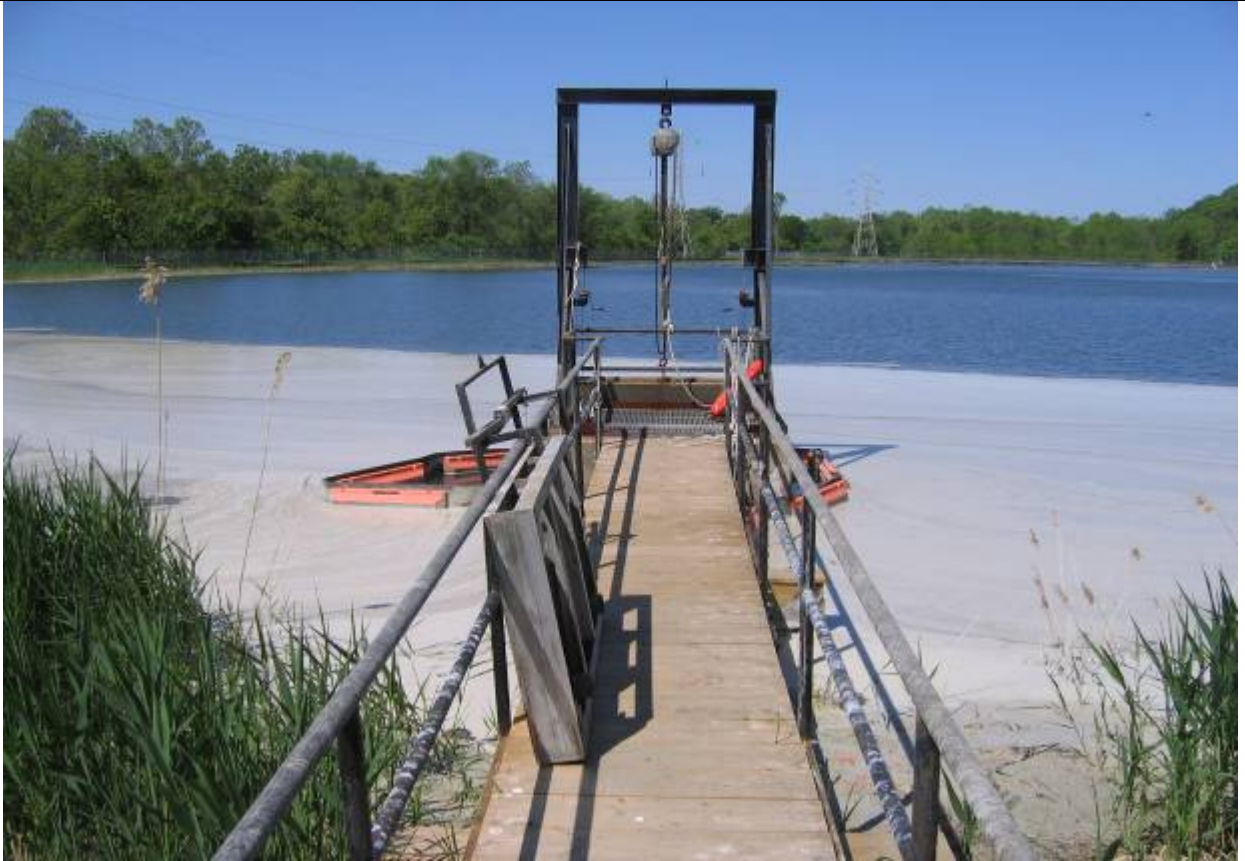
- The outlet structure appeared to be in good condition and functioning normally. The cenosphere boom/baffle system was in place and functioning. Decant water appeared clear.

Outlet Structure

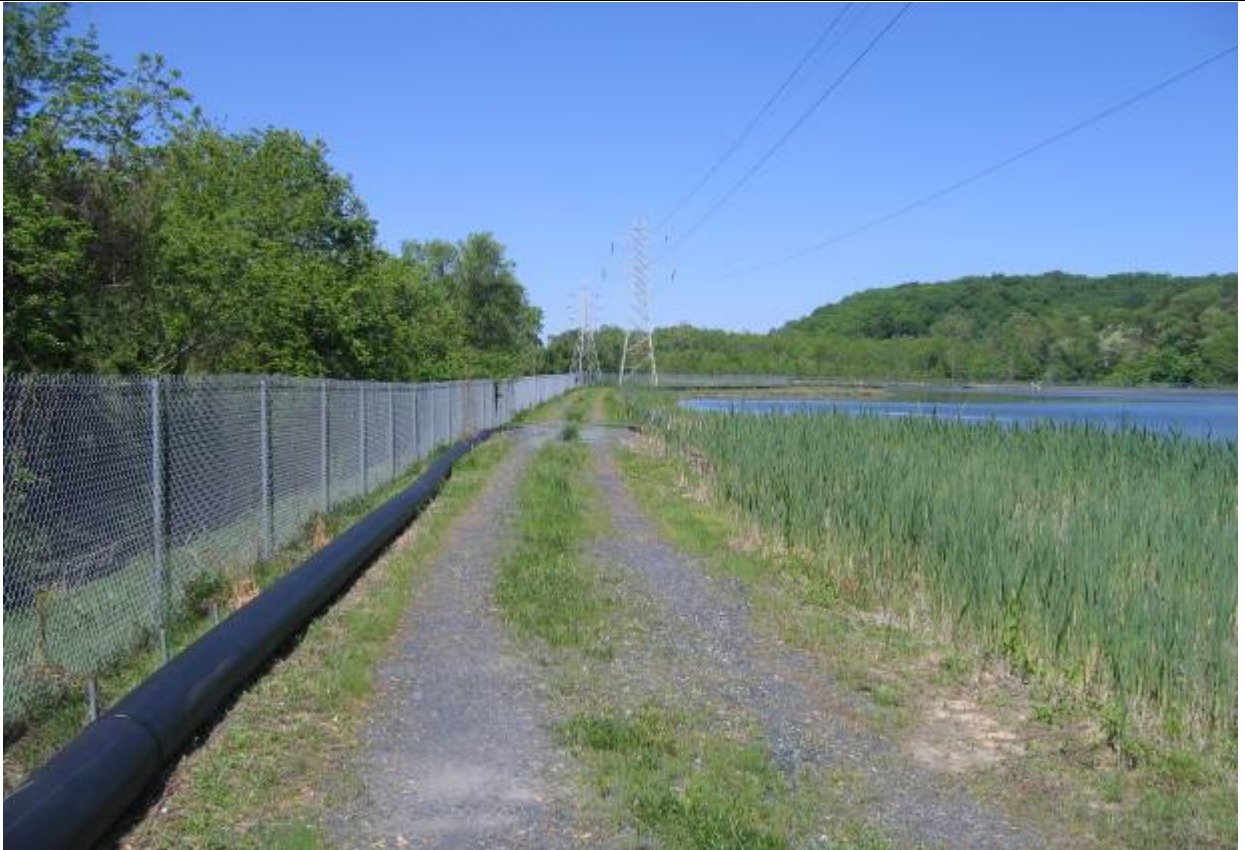
- Sluiced CCW by-product discharge is conveyed on aboveground piping that is routed up the downstream slope of the embankment in the southeast corner of the West Ash Pond and along the embankment crest to the dividing dike between the West Ash Pond and the Metals Pond (Photos B2, B3, B4, B5 and B12). The CCW discharge is discharged via multiple valved discharge points into the west side of the West Ash Pond (Photo B4). The CCW piping could be valved to discharge to the Metals Pond (Photo B3) although no CCW materials were observed in the Metals Pond (Photos B5, B6).

Southern
Embankment

Note: CCW
discharge pipe
on crest

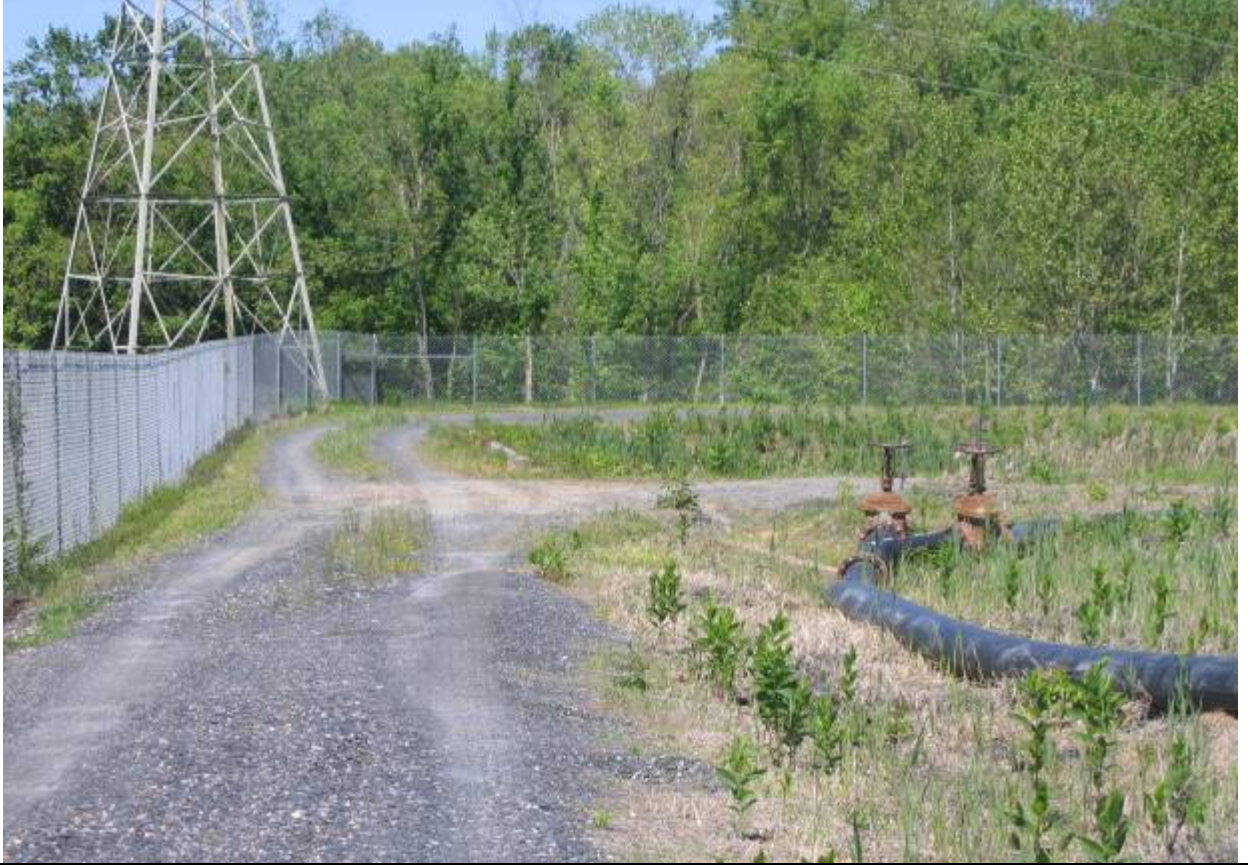
Photo Number:
B3

Description:
Southern
Embankment

Note: CCW
discharge split
to Metals or
West Ash Pond

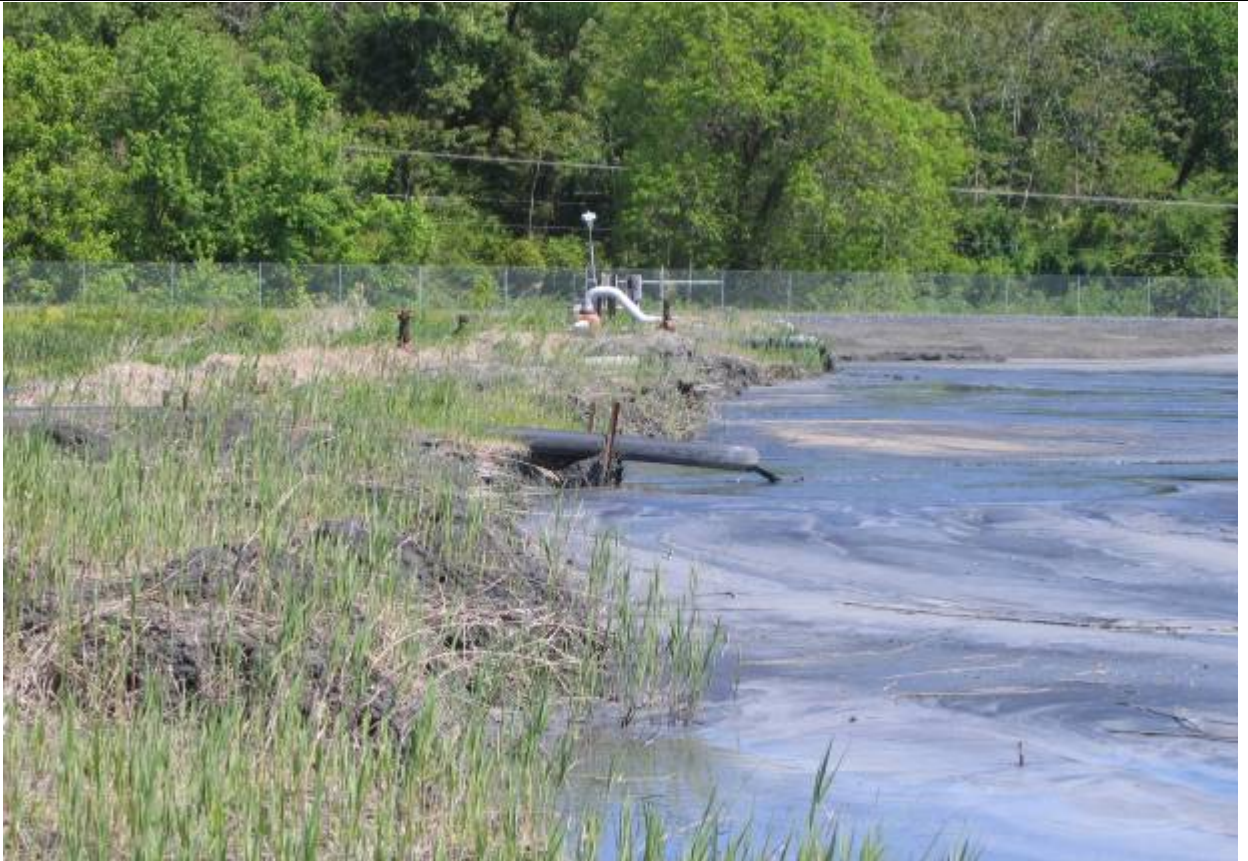
Photo Number:
B4

Description:
Dividing Dike
Between West
Ash Pond &
Metals Pond

Note: CCW
discharges

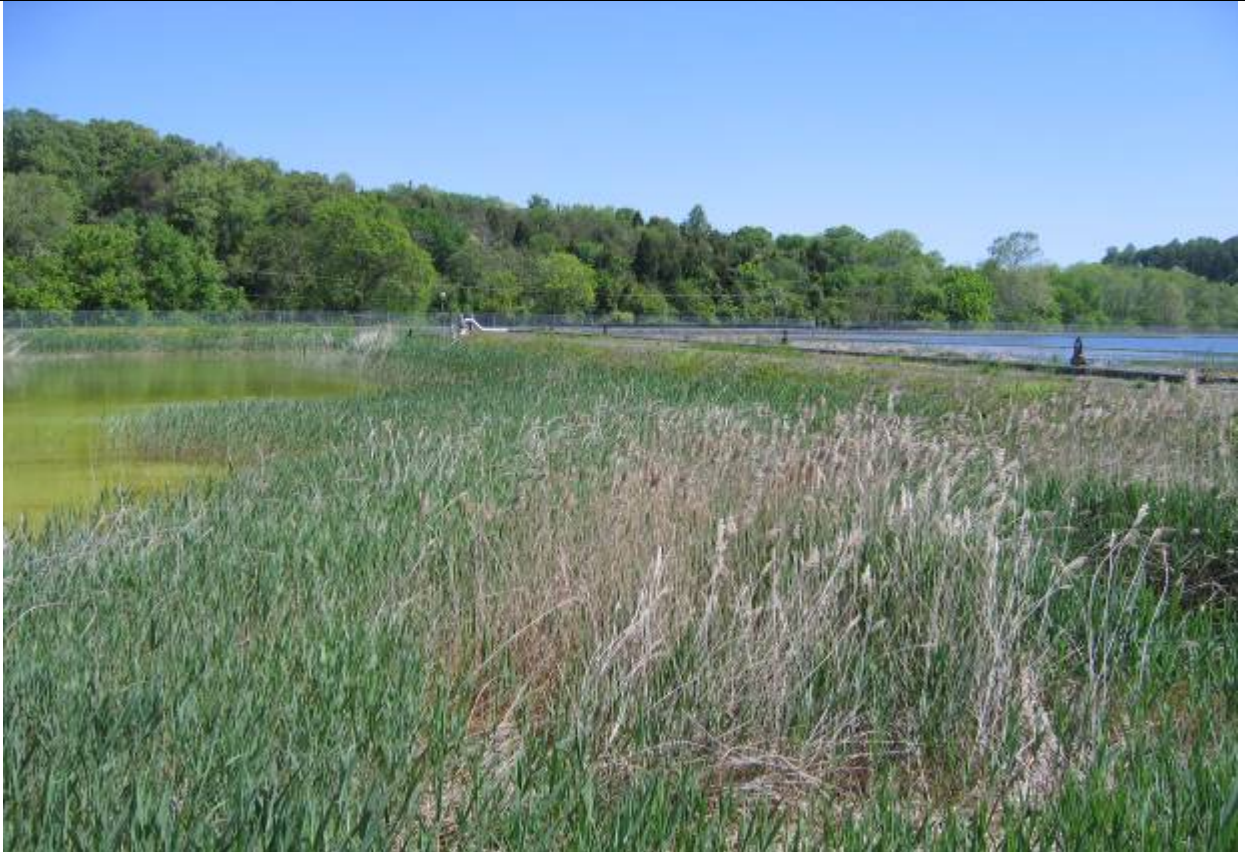
Photo Number:
B5

Description:
Dividing Dike
Between West
Ash & Metals
Pond

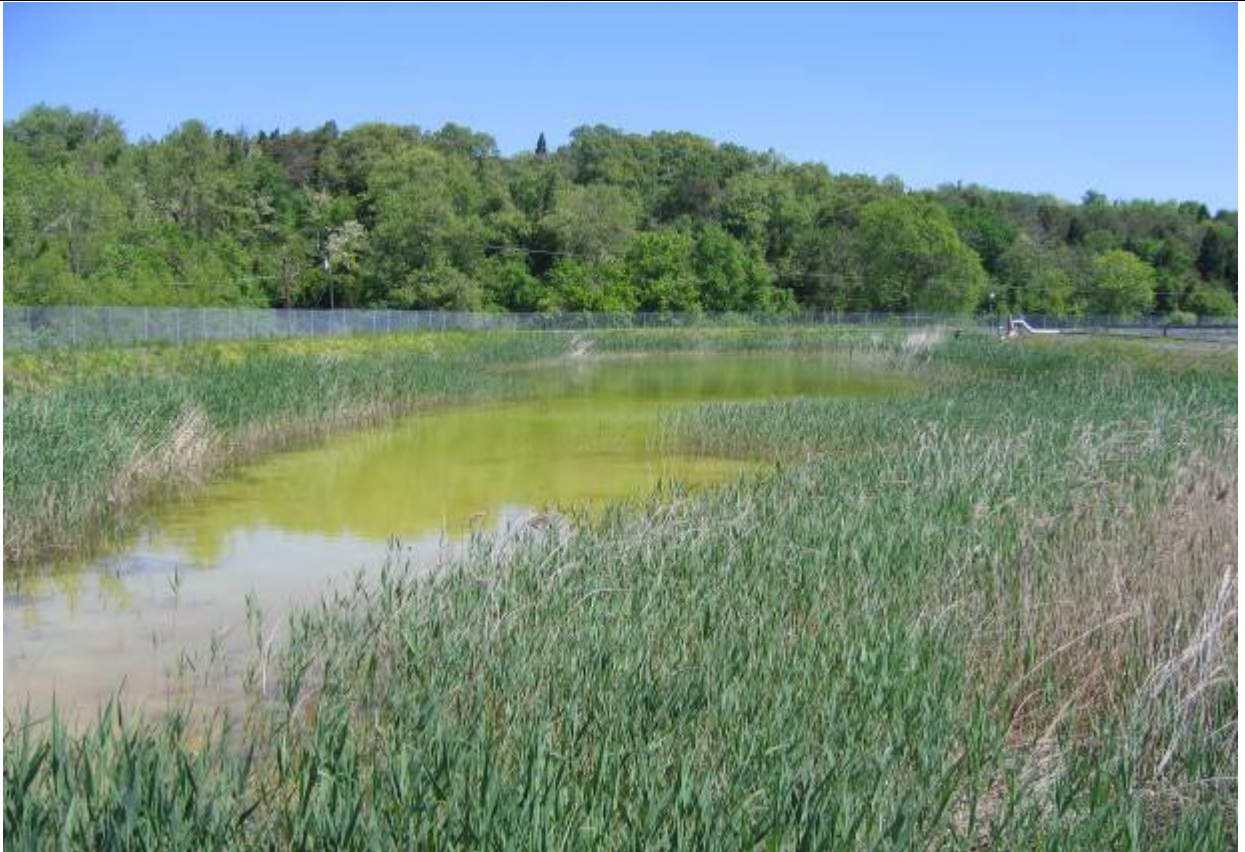
Photo Number:
B6

Description:
Metals Pond

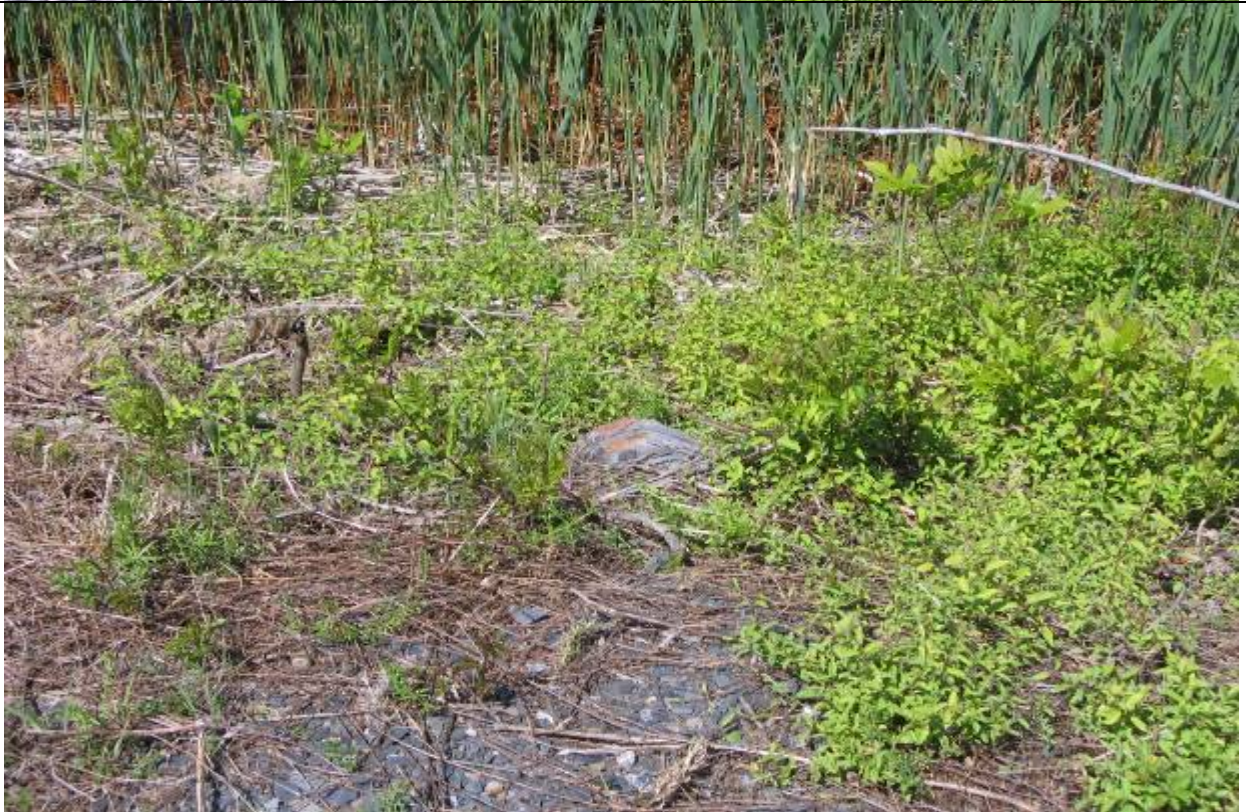
Photo Number:
B8

- Two hydraulic interconnections exist between the West Ash Pond and the Metals Pond. The first is a corrugated metal pipe through the dividing dike (Photo B8). No water was observed flowing into the Metals Pond. The pipe on the West Ash Pond side of the dike could not be located. The second interconnection is the Metal Pond pump (acid waste pump) system, which can pump from the Metal Pond into the West Ash Pond. This system was not operating during the inspection. It appears that operation is activated at the local control panel and used intermittently after receipt of wastewaters from chemical cleaning of station boilers and associated equipment.

Description:
Overflow Pipe
from West Ash
Pond into
Metals Pond

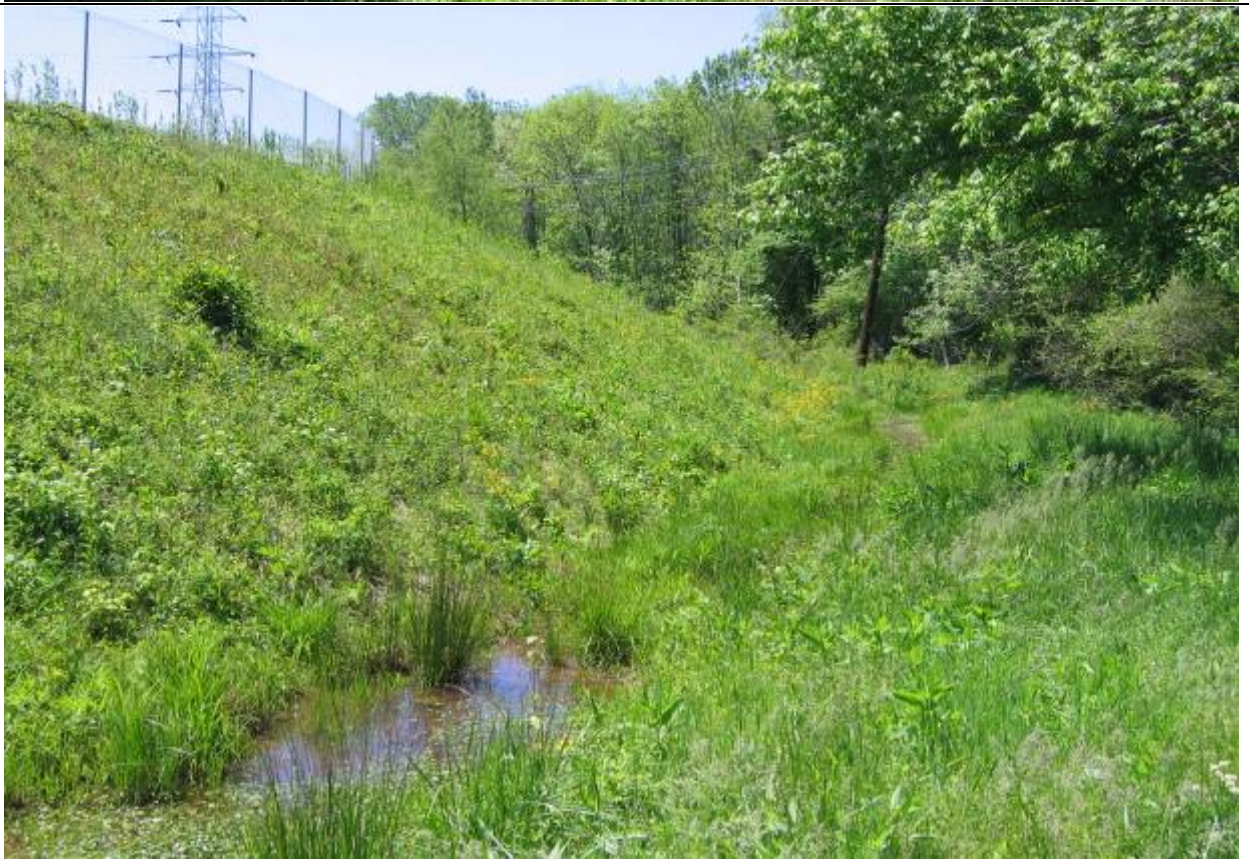
- Standing water was observed in the perimeter drainage ditch on the west and north sides at the toe of the embankments. This water could be toe drain discharge or stormwater or both.

Western
Embankment of
Metals Pond

Note: Standing
water at toe of
slope

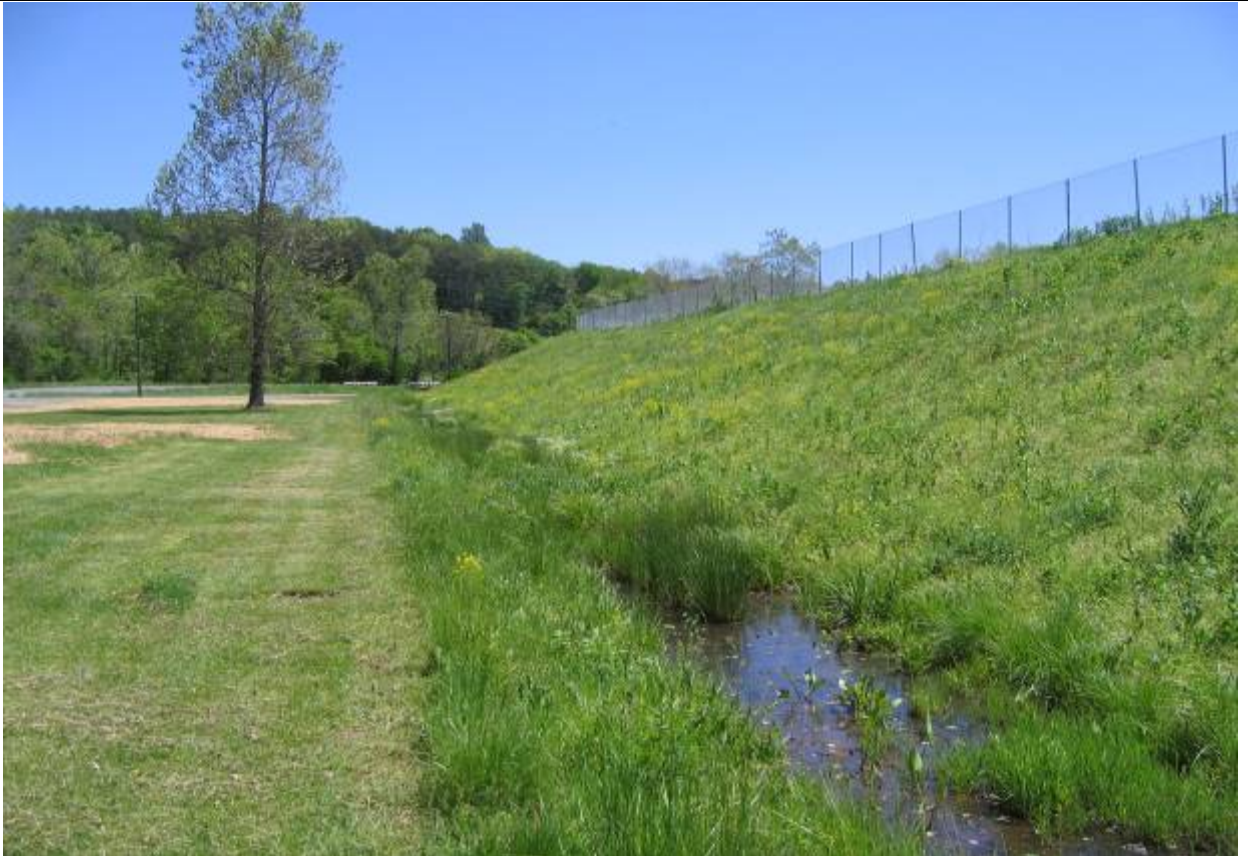
Photo Number:
B16

Description:
Northern
Embankment of
West Ash Pond

Note: Standing
water at toe of
slope

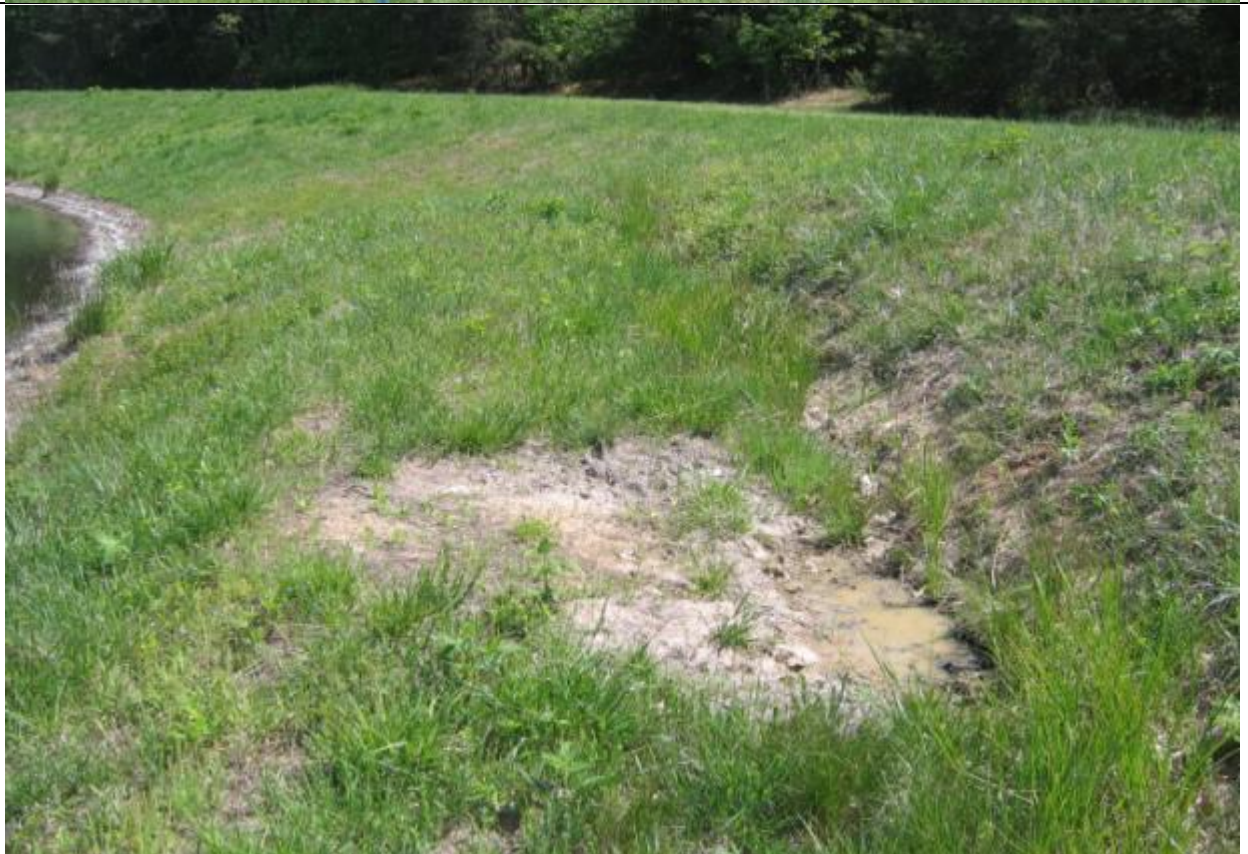
Photo Number:
C2

- The crest and gravel crest road appeared to be in good condition with no cracks or settlement (Photos C4, C12, C13 and C14); the exposed portions of the inboard slope exhibit minor wave erosion on the wave berm at the water interface. Some minor erosion/superficial sloughing has occurred on the wave berm and the upstream slope to the crest along the dam (Photo C2).

Description:
North Ash Pond
Dam Crest

Note: Minor
Erosion/Superficial
Sloughing

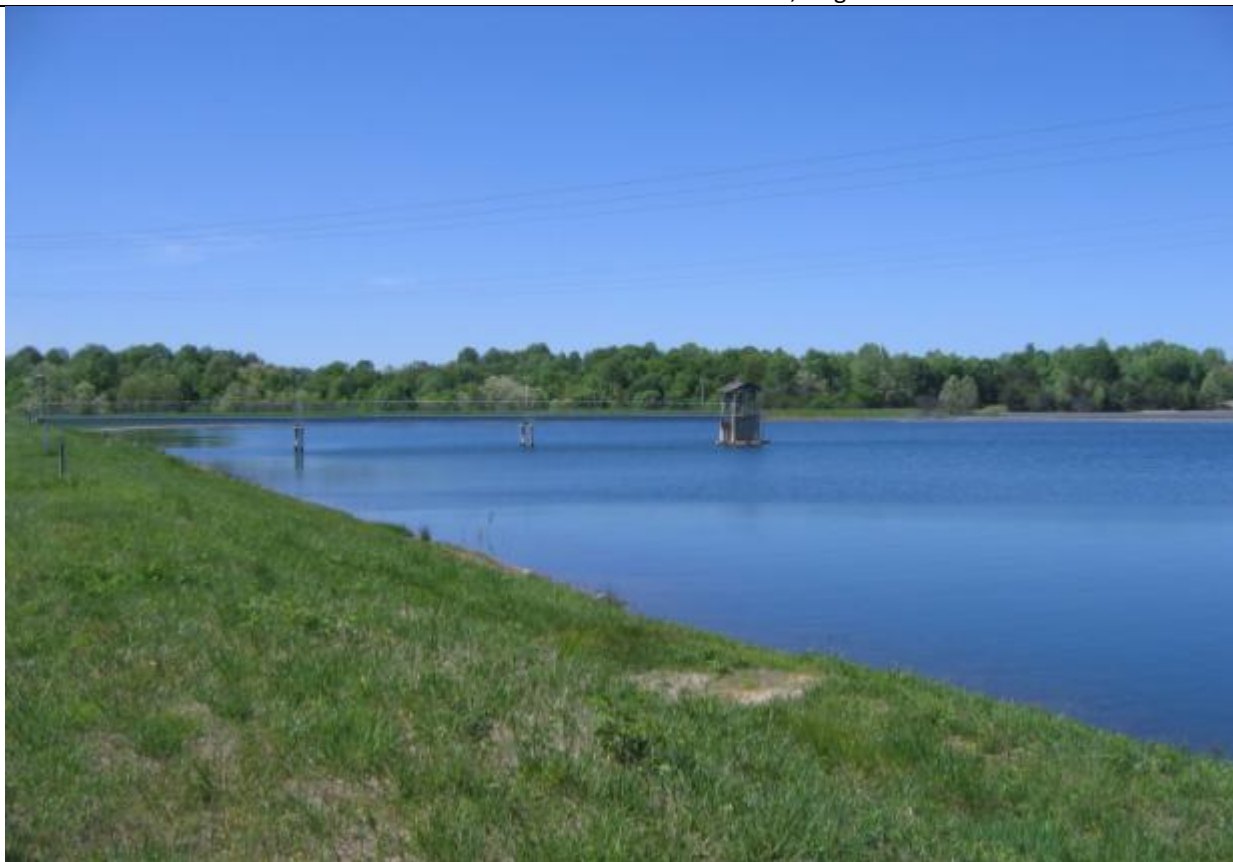
- Significant vegetation and trees were observed immediately downstream of the emergency spillway crest.
- The outlet structure appeared to be in good condition and functioning normally. The cenosphere boom/baffle system was in place (Photo C3). Decant water appeared clear.

Outlet Structure

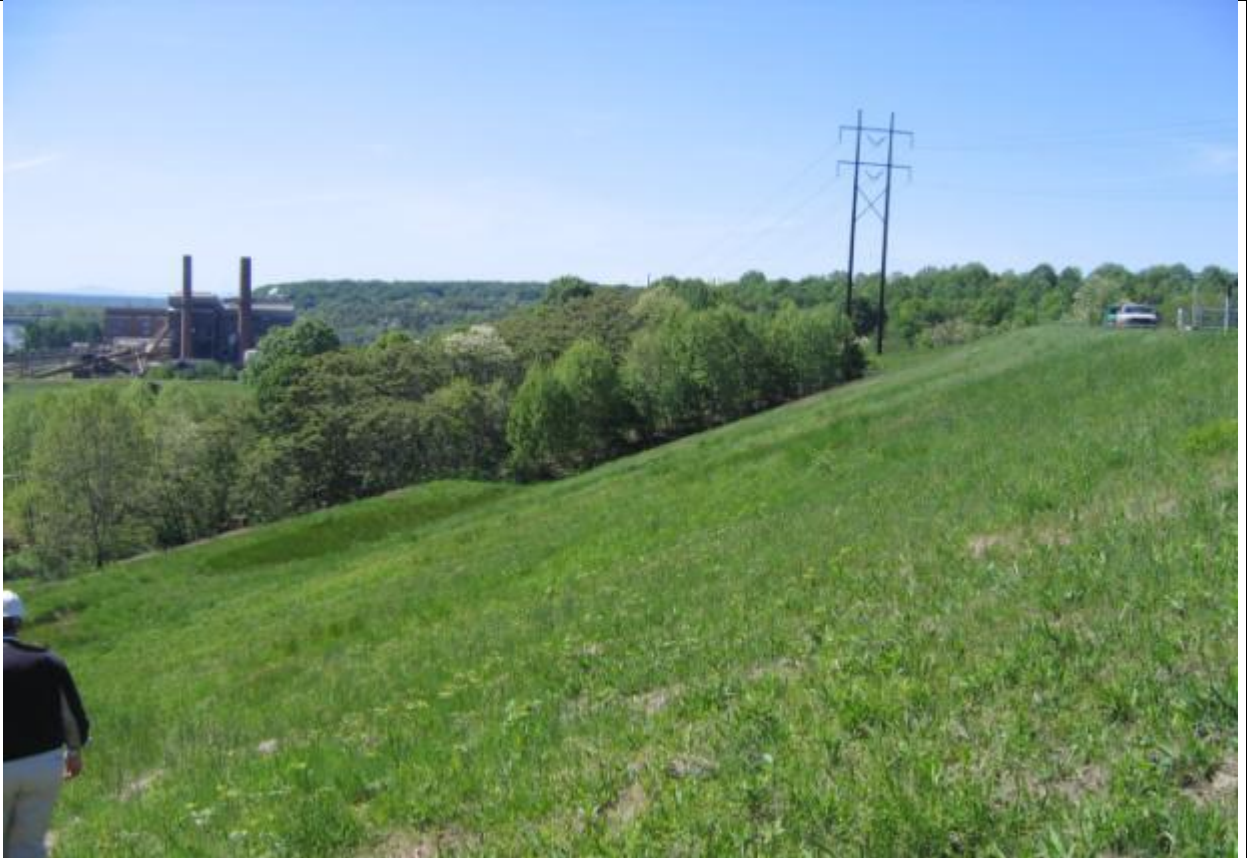
Photo Number:
C5

- The upstream and downstream slopes of the dam embankments have 6 to 12 inches of vegetation but could be inspected by walking the slopes. No cracks, sloughing, bulging or major erosion was observed on these slopes (Photos C5 to C7, C11).

Description:
Downstream
slope of North
Ash Pond Dam

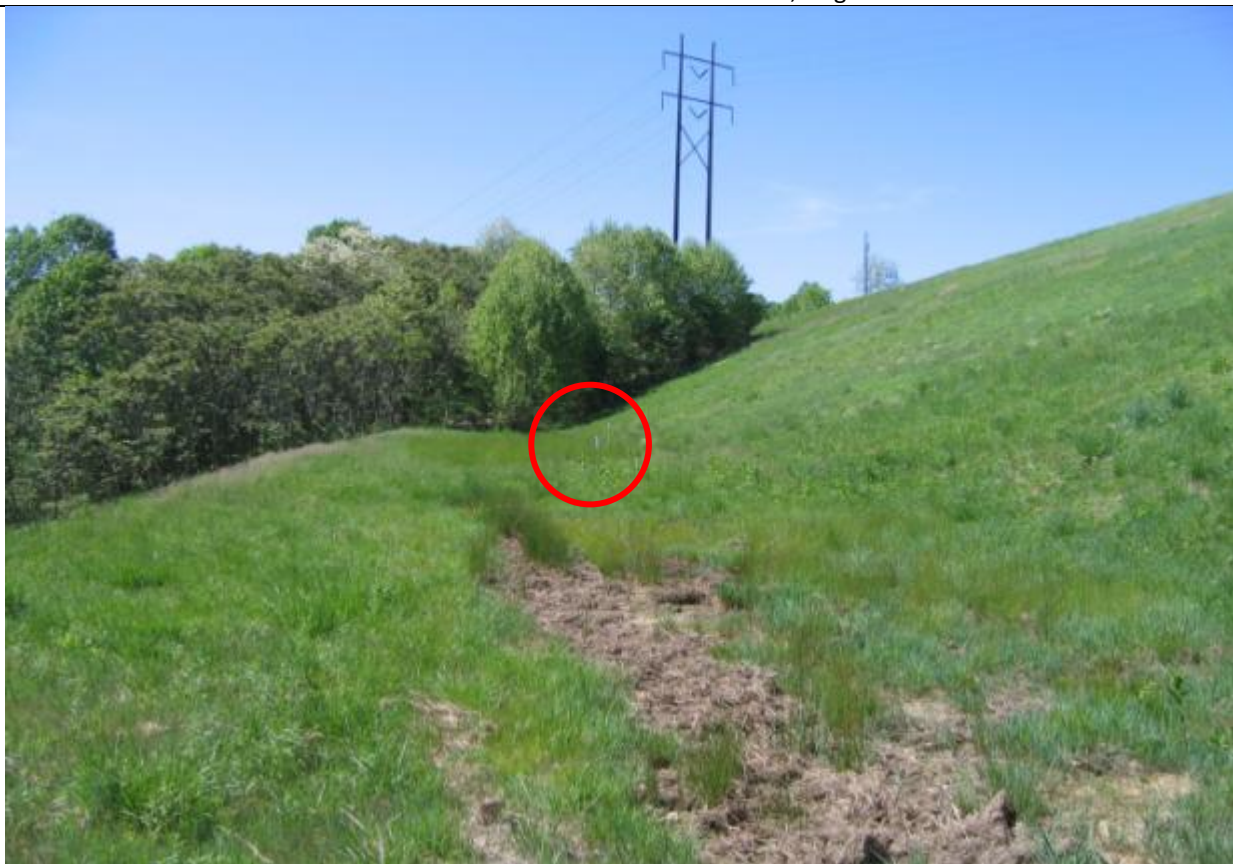
Photo Number:
C7

- Standing water was not observed on the toe berm but the ground was soft (Photo C7). The top of the toe berm was moist at the surface due slow drainage of stormwater.

Description:
Downstream
Toe of North
Ash Pond Dam

Note:
Piezometer on
Toe Berm

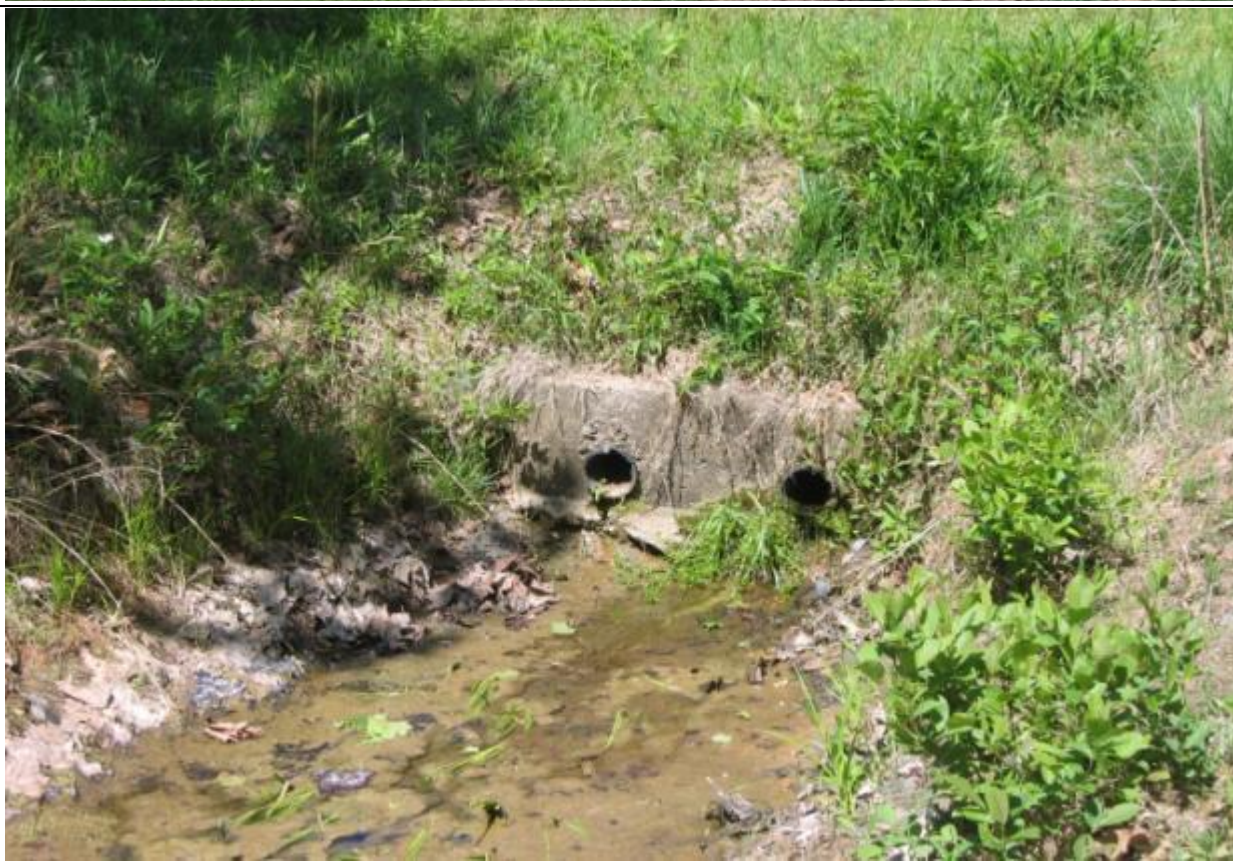
Photo Number:
C8

- No seepage was observed on downstream slopes of the dam embankments.
- Flow from three of the four toe drain pipes was observed and was visually estimated to be less than 2 gallons per minute. Flow from the toe drains was observed to be clear (Photos C8, C10). Water was flowing freely to the diversion ditch.

Description:
Toe Drain East
Headwall

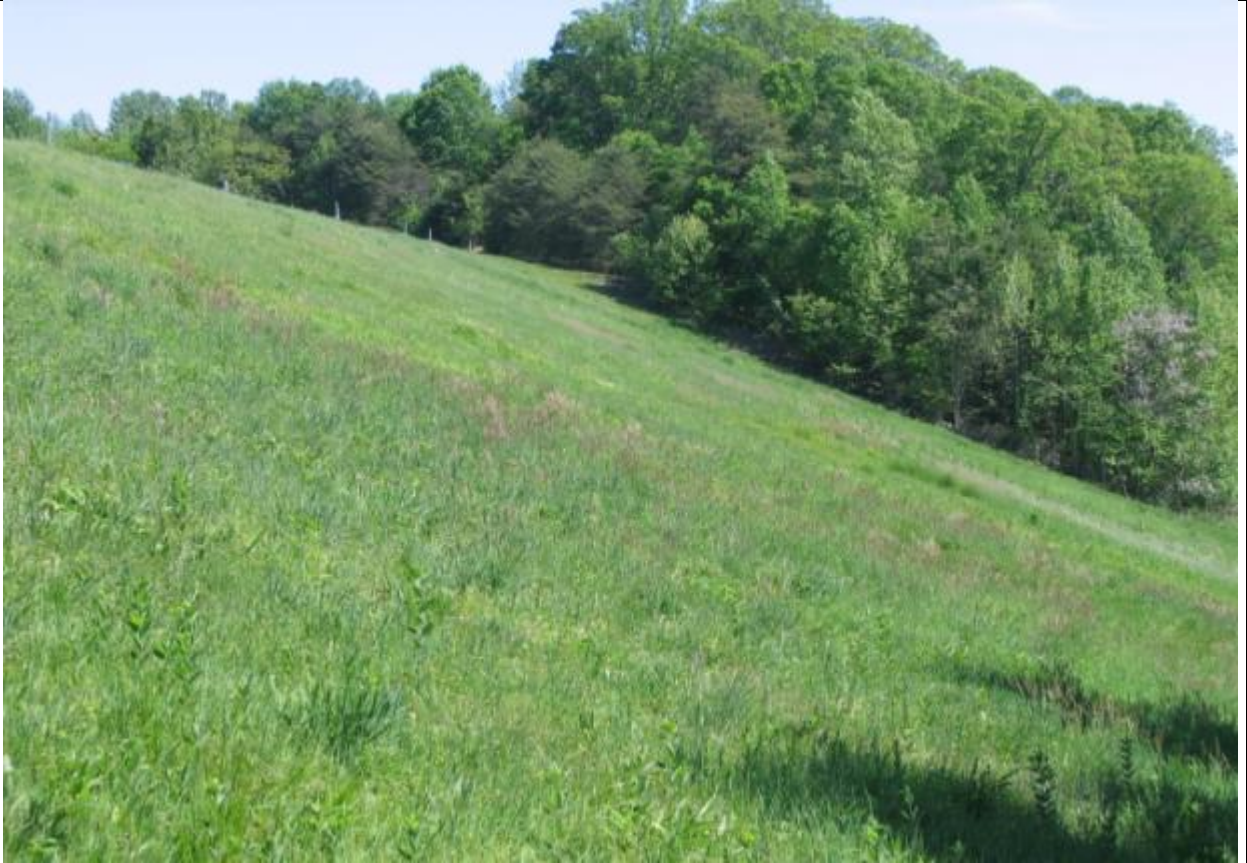
Photo Number:
C11

Description:
Downstream
Slope of Dam

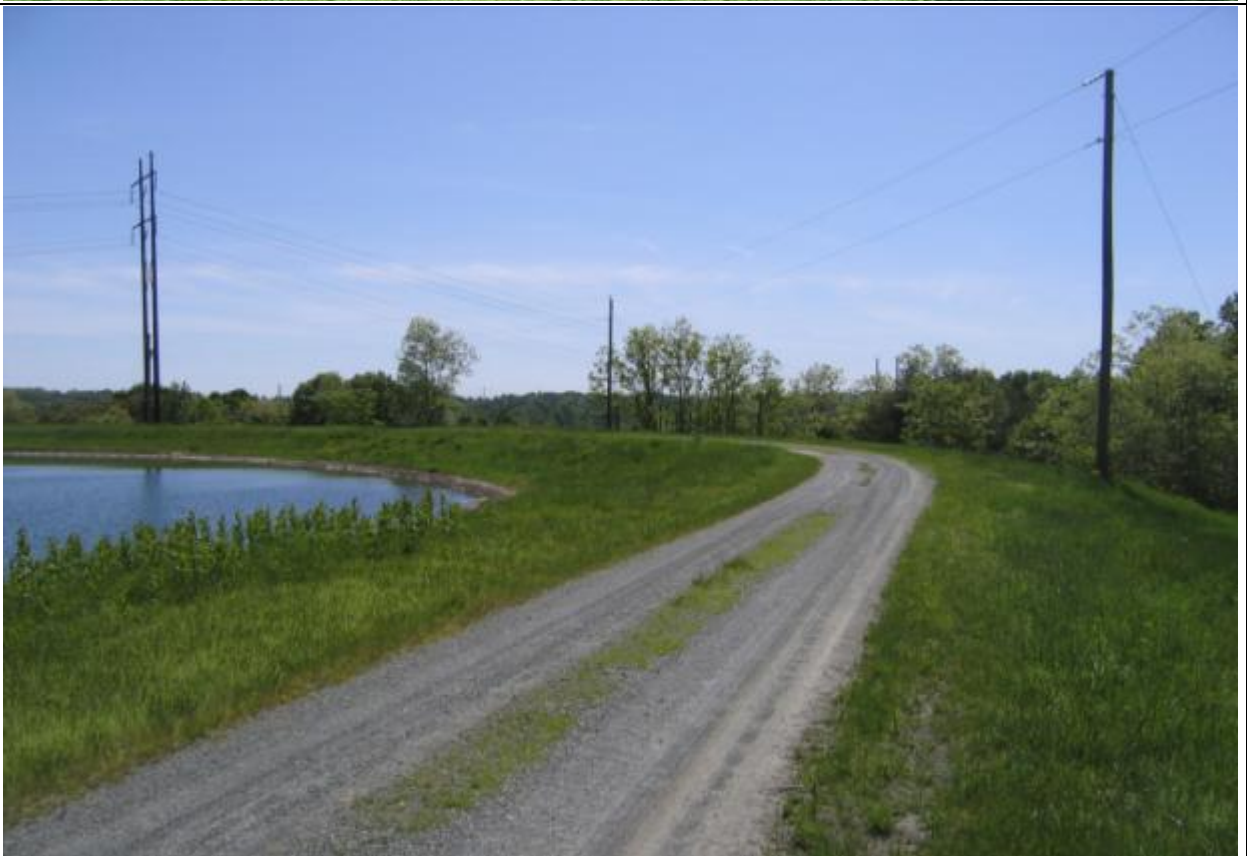
Photo Number:
C12

Description:
North Ash Pond
Dam / Side Hill
Embankment
Crest

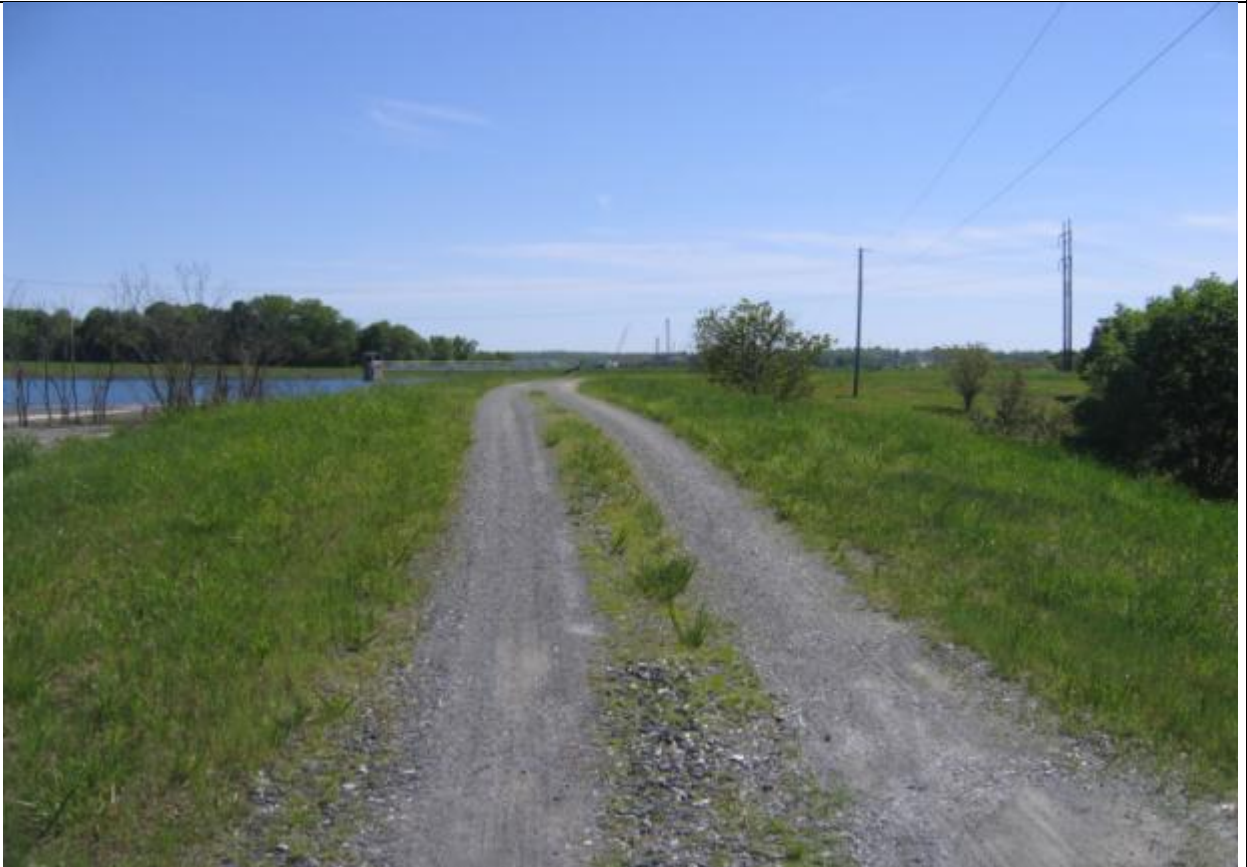
Photo Number:
C13

Description:
North Ash Pond
shallow
embankment
near emergency
spillway

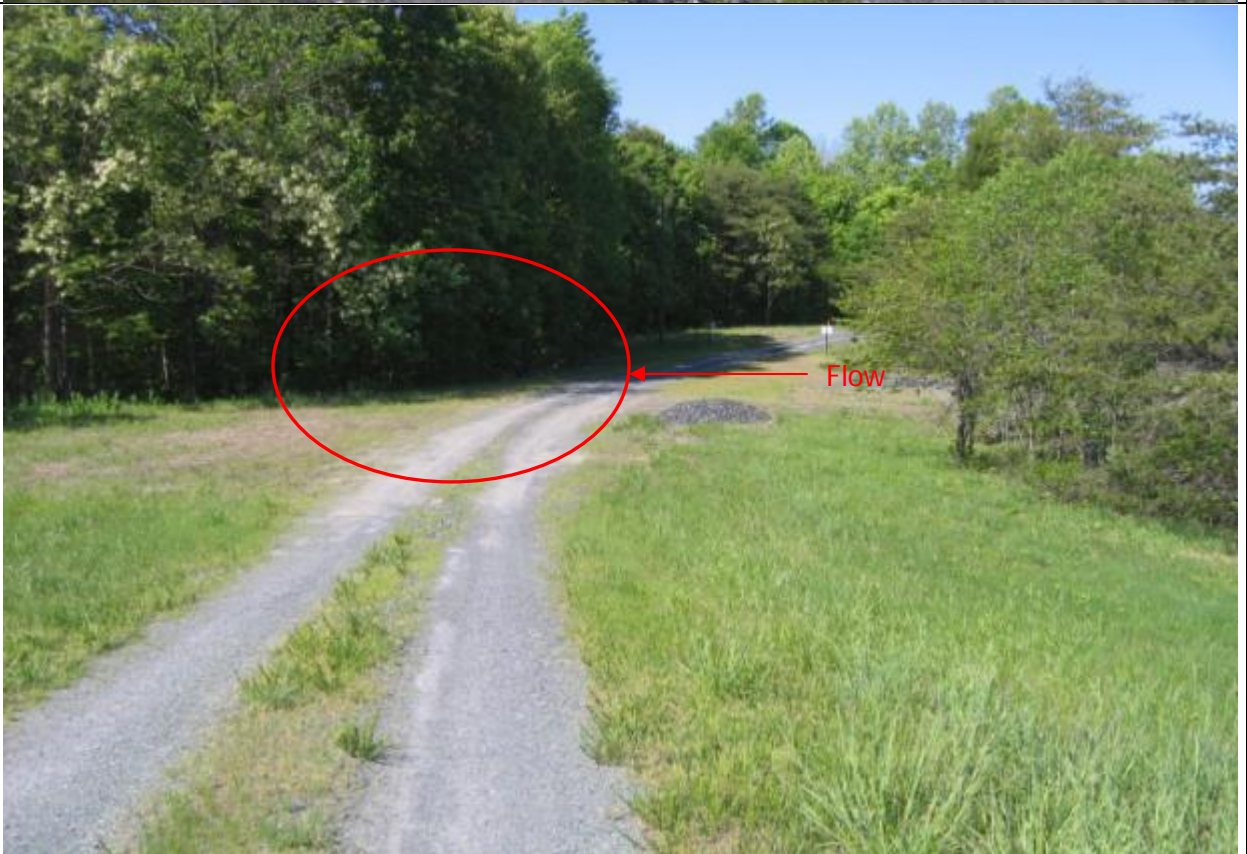
Photo Number:
C14

Based on the ratings defined in the RFP (Satisfactory, Fair, Poor and Unsatisfactory), the information reviewed and the visual inspection, the overall condition of the North Ash Pond dam is considered to be **FAIR**. Acceptable performance is expected under applicable static, seismic, and hydrologic conditions. The primary reason for this condition rating is that a minor deficiency exists in the form of trees, brush, and other obstructions downstream of the emergency spillway crest in the emergency spillway.

Description:
North Ash Pond
Dam Crest and
Emergency
Spillway

Note:
Significant trees
and brush
downstream of
crest
