Dam Safety Assessment of CCW Impoundments

Chesapeake Energy Center

September 30, 2010

O'BRIEN & GERE
www.obg.com

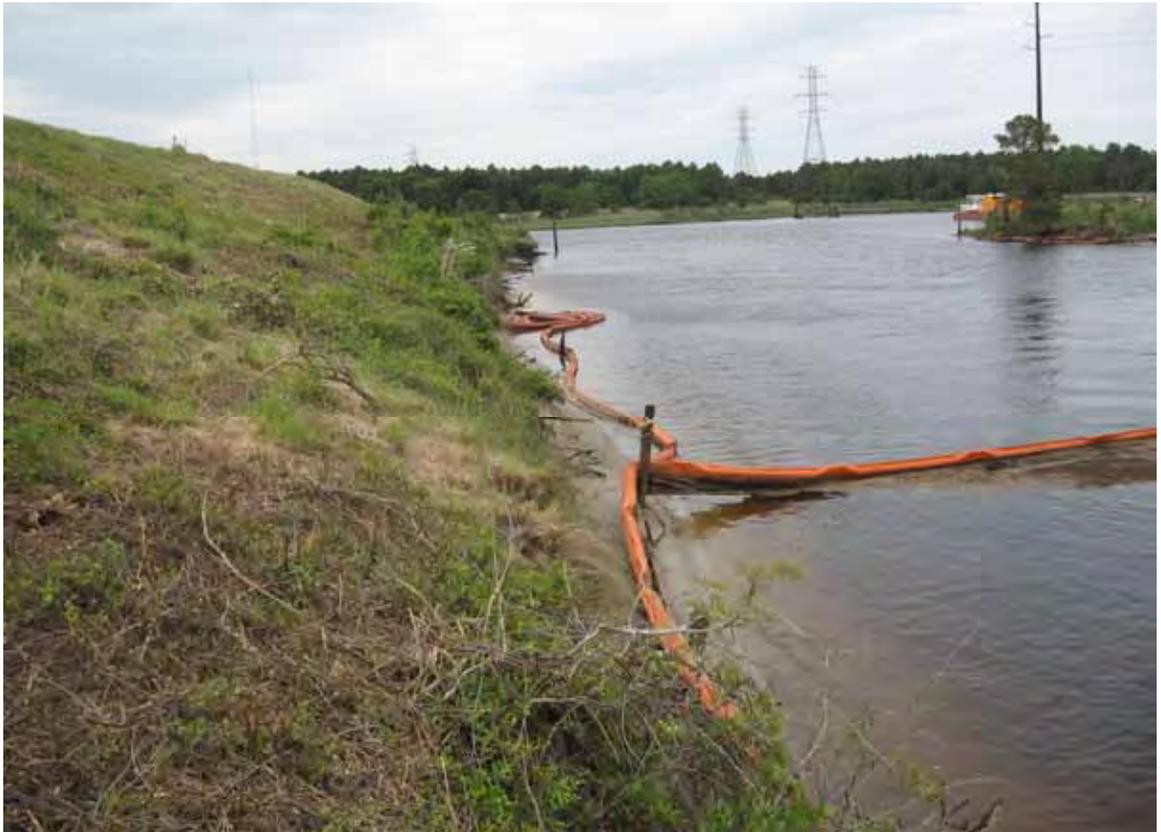
Photo Number:
1

Description:
Outboard slope
and toe of
Western
embankment

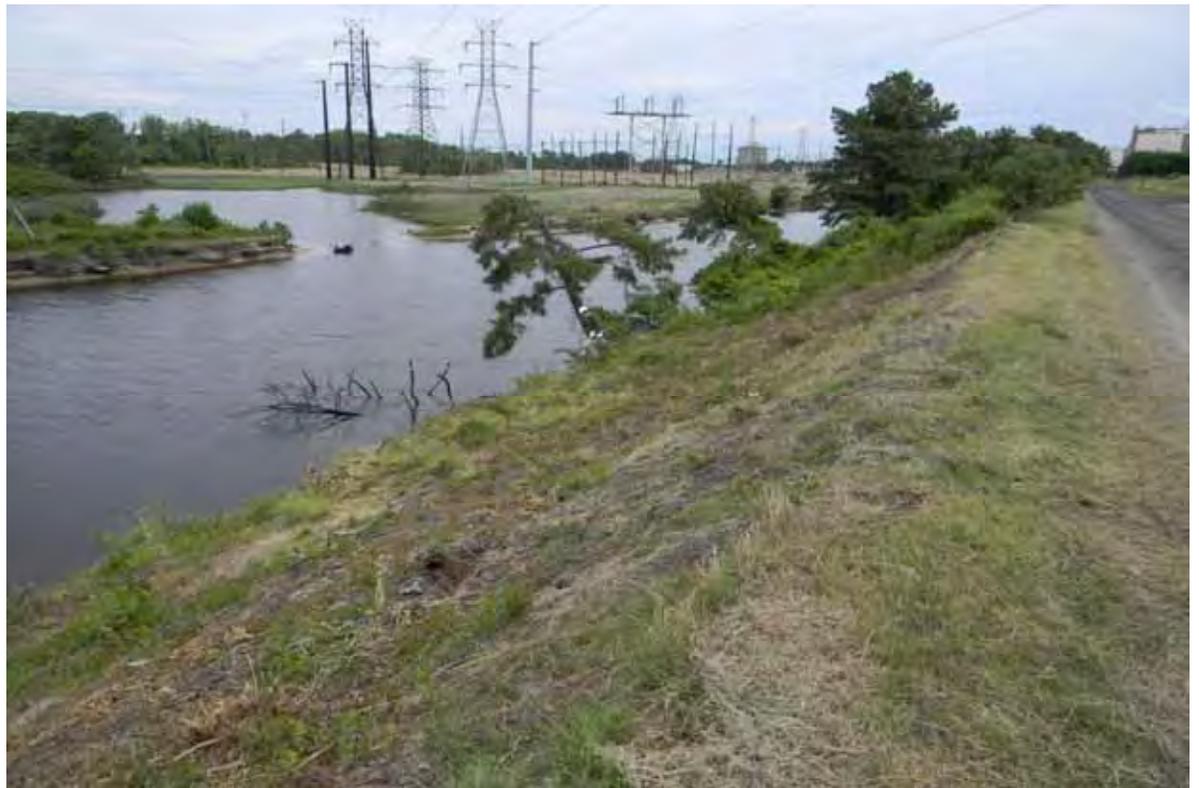
Photo Number:
2

Description:
Outboard slope
and crest of
Western
embankment

Note vegetation
remaining north
of
impoundment

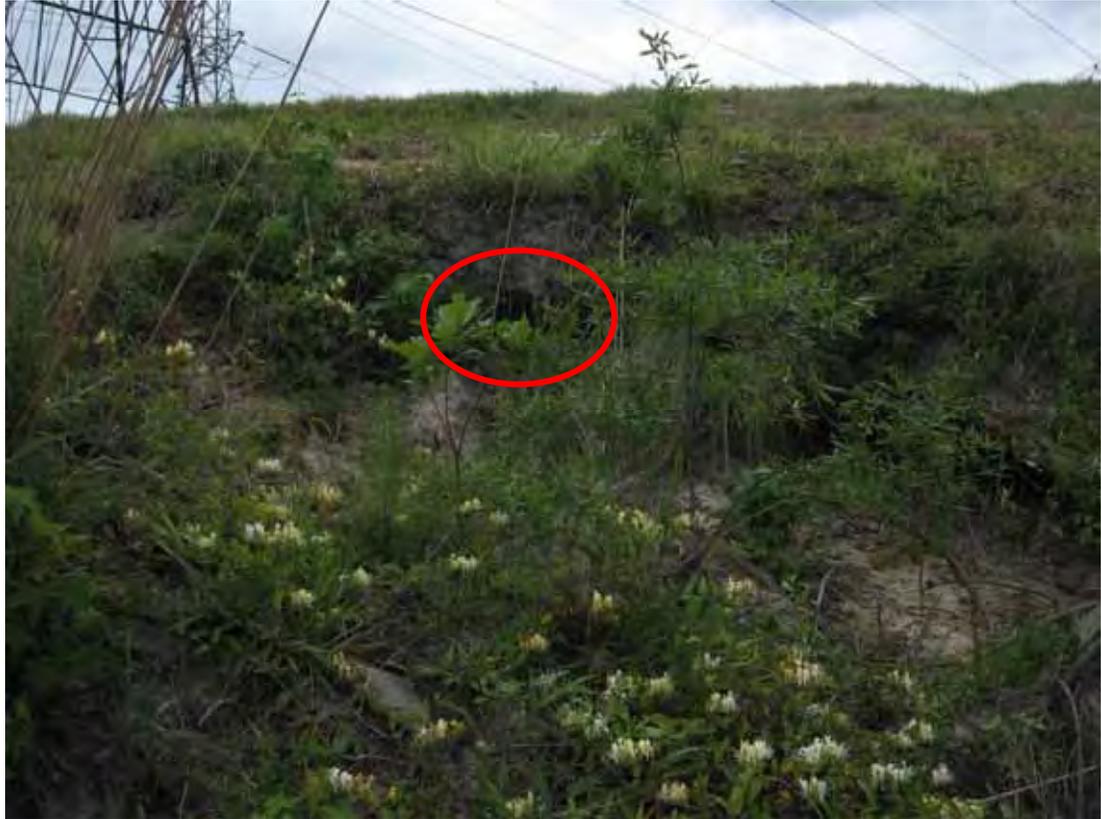
Photo Number:
3

- The western embankment has experienced localized erosion and/or shallow slope failures in the native soils that form the embankment foundation. Some animal burrows were also observed on the western embankment (Photo 3).

Description:
Erosion and/or
localized
shallow slope
failure of
western
embankment.

Note animal
burrow.

- Continue to observe and monitor the condition of the eastern and western embankment slopes as recommended by Schnabel until short and long term repairs are made. NOTE – DVP reports that daily observations of eastern and western embankments are being made.
- Conduct annual inspections and six year reporting per the VDCR requirements for regulated structures. NOTE – DVP reports that an annual inspection program has been implemented.

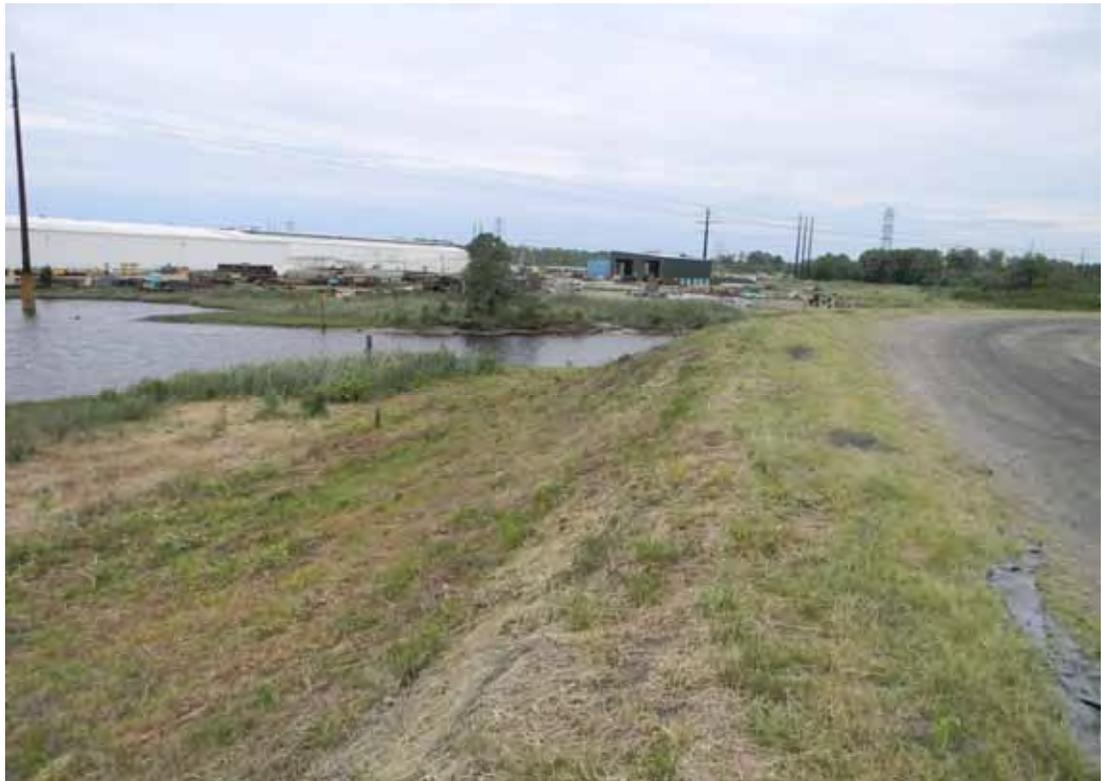
Photo Number:
4

Description:
Outboard slope
and crest of
southern
embankment

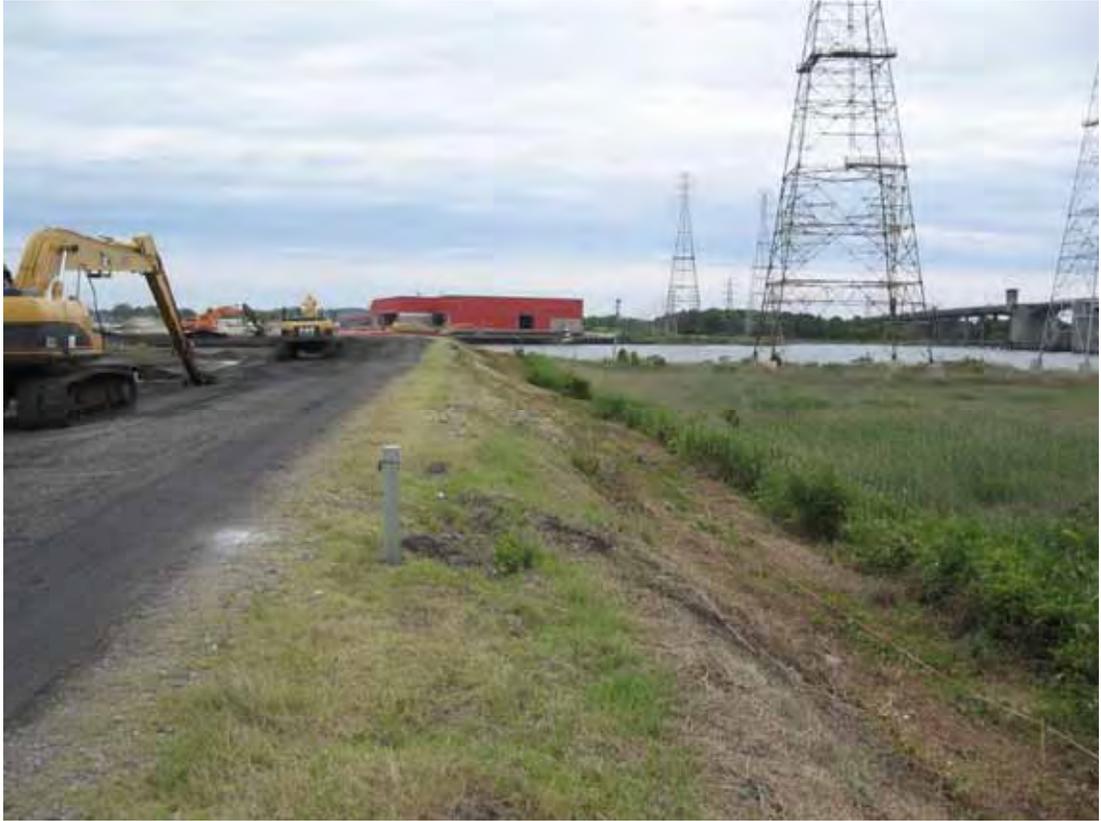
Photo Number:
5

Description:
Outboard slope
and crest of
southern
embankment

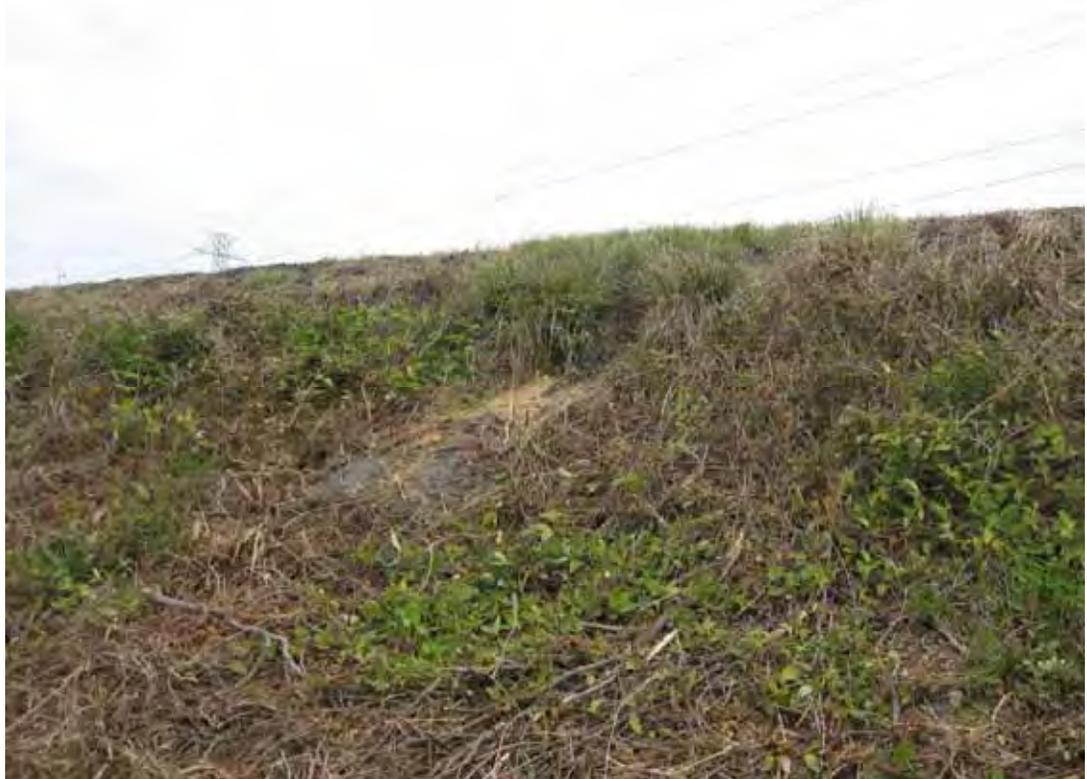
Photo Number:
6

Description:
Minor erosion
on outboard
slope of
southern
embankment

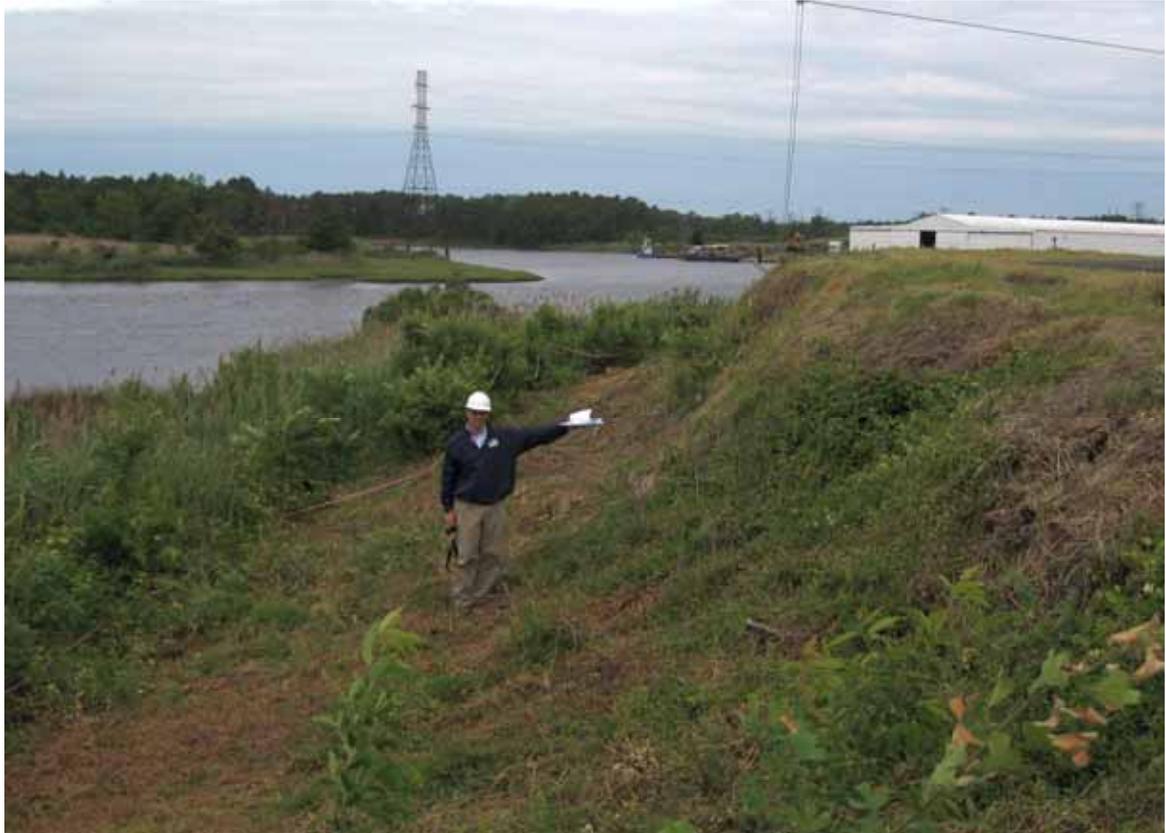
Photo Number:
7

Description:
Outboard slope
of southern
embankment

Note slope of
upper portion
of embankment

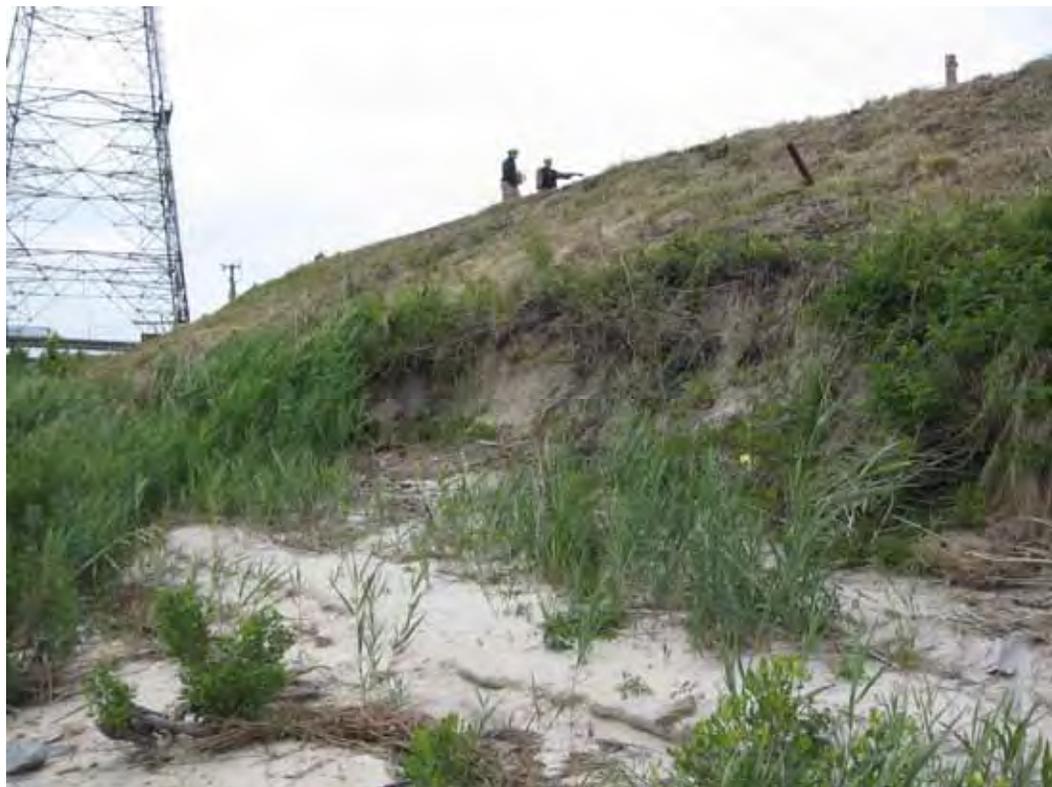
Photo Number:
8

- The eastern embankment has experienced localized erosion and/or shallow slope failures (Photo 8).
- The outboard slope of the embankment appears to have been constructed steeper than 2H:1V (Photo 7).

Description:
Outboard slope
and toe of
eastern
embankment

Note erosion or
localized slope
failure of toe

- Develop basic plan and details to repair the eastern embankment toe erosion/failure and hire civil contractor to make the recommended repairs (**develop plan concurrent with survey, timing of repairs subject to permitting requirements**).

- Perform conceptual study and develop conceptual plan, details and cost estimate for (a) improving the eastern embankment’s long-term stability using sheet pile wall at toe; and (b) placing riprap buttress along discharge canal to restore eroded areas below the western embankment. Bathymetric survey recommended by Schnabel was performed several years ago and may be able to be utilized in the conceptual study (**next three months**). NOTE – DVE reports that a study is currently underway to develop the conceptual design for repairs to the eastern and western embankments.

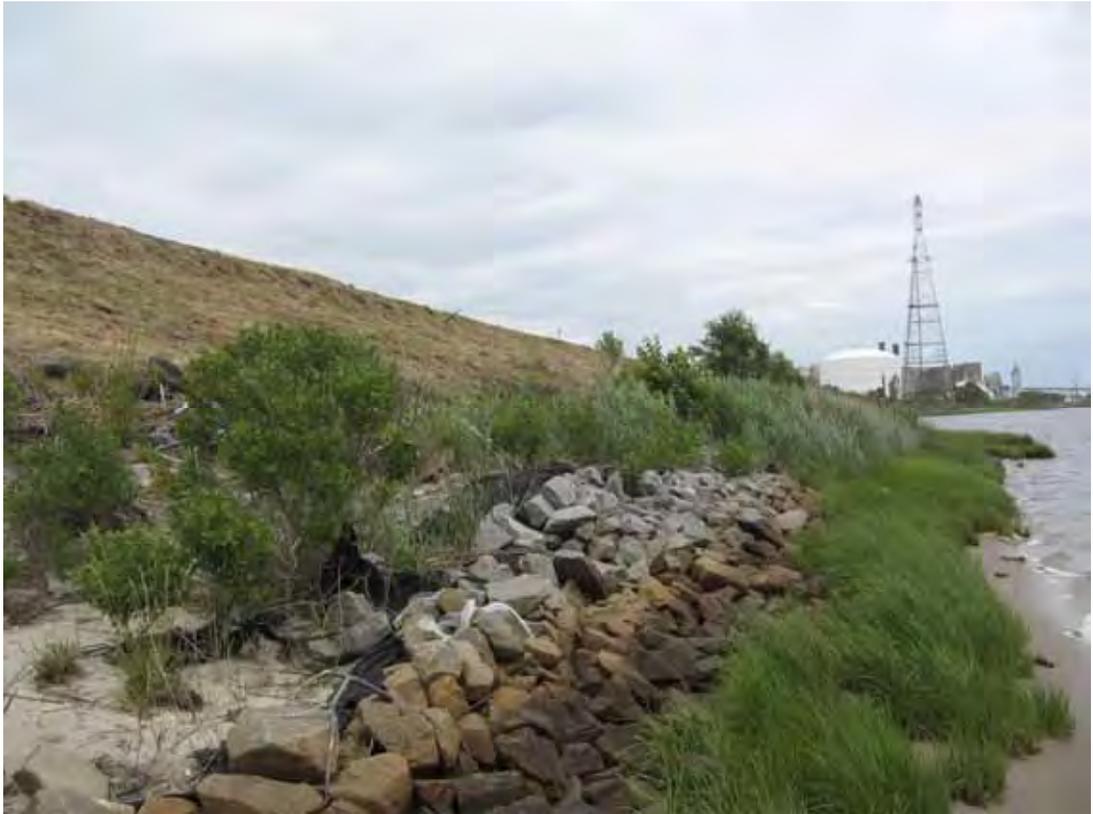
Photo Number:
9

Description:
Outboard slope
and toe of
eastern
embankment

Note riprap
erosion
protection of
toe

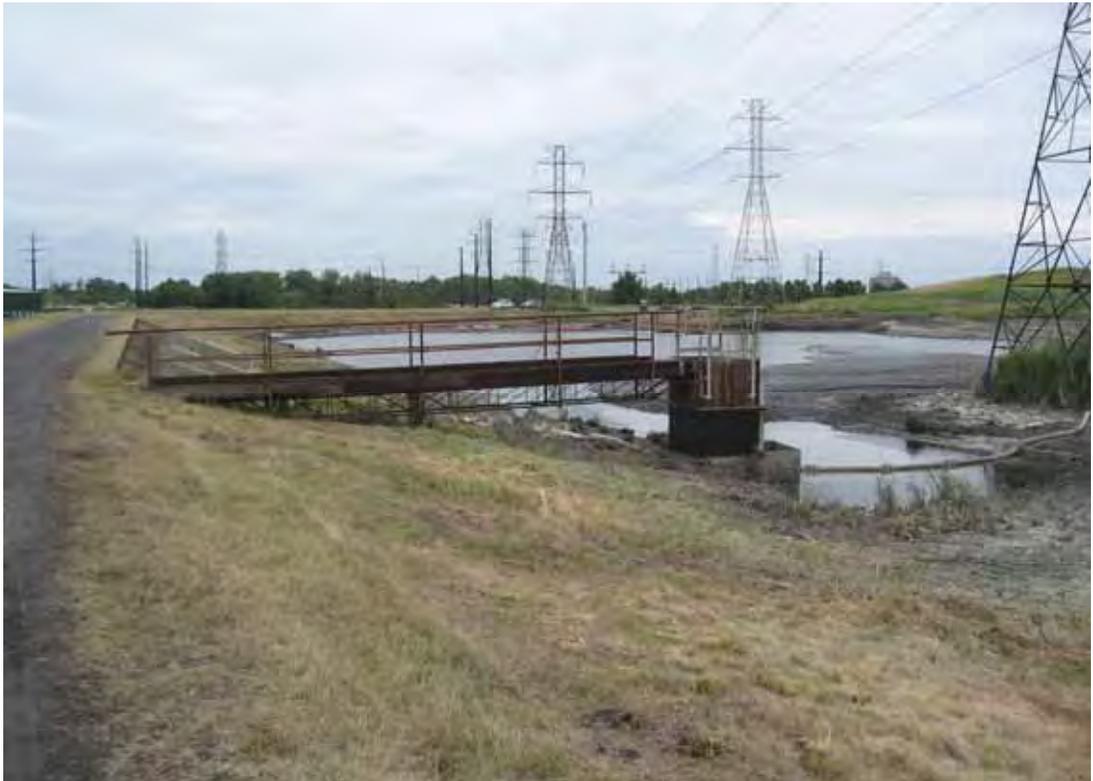
Photo Number:
10

Description:
Inboard slope of
southern
embankment
and outlet
structure

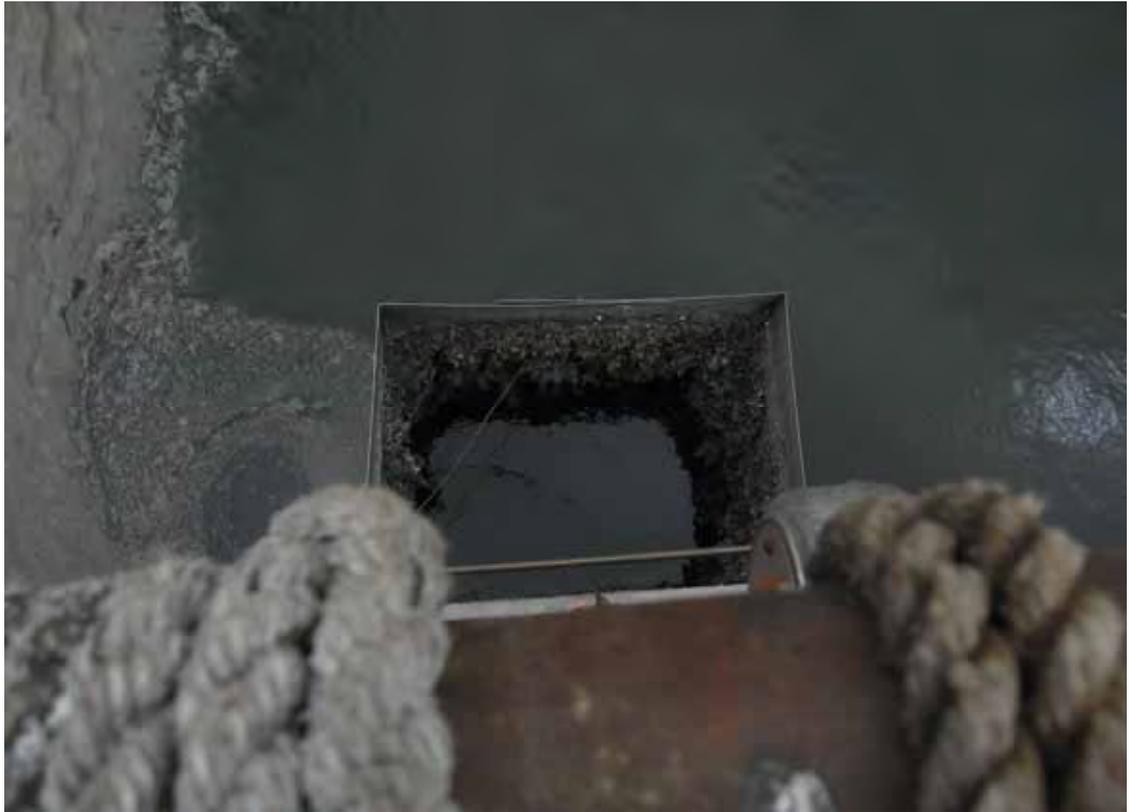
Photo Number:
11

Description:
Debris baffle for
outlet structure

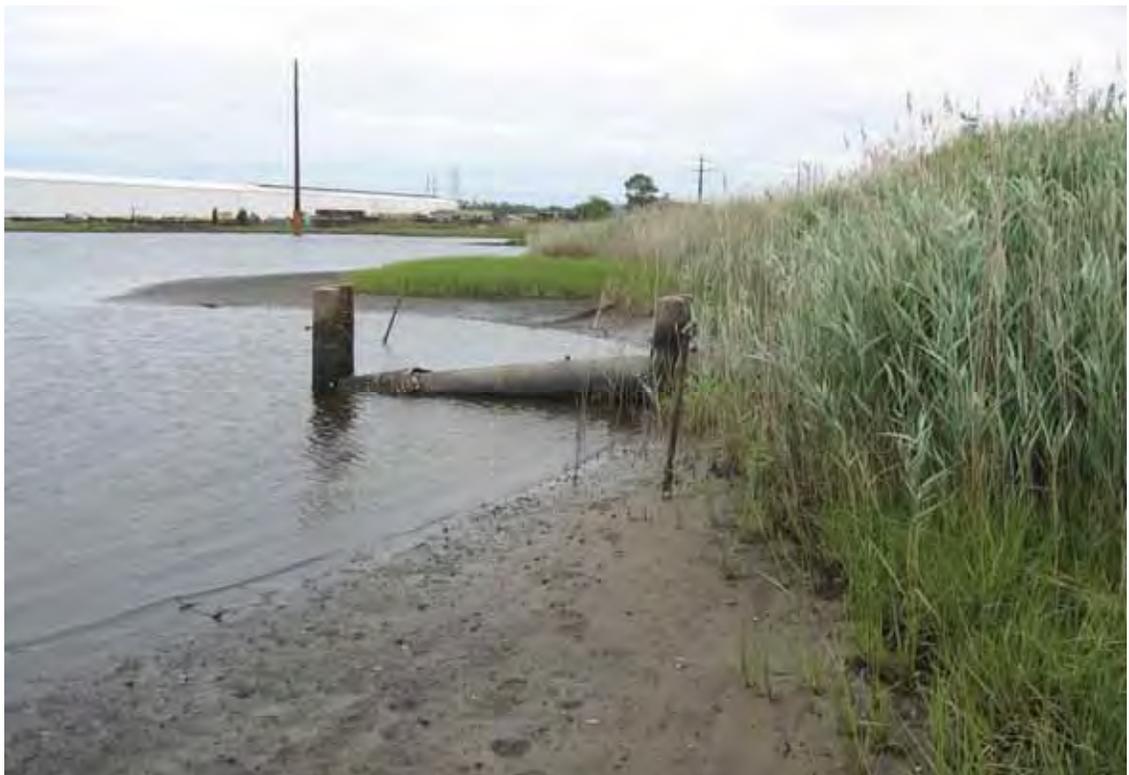
Photo Number:
12

- The outlet structure appeared to be in good condition, discharge from the structure could not be observed because the pipe ends below the water surface in the Deep Creek.

Description:
Discharge end
of 20-inch HDPE
outlet pipe
through
southern
embankment
into Deep Creek

Note
submerged
downstream
end of pipe

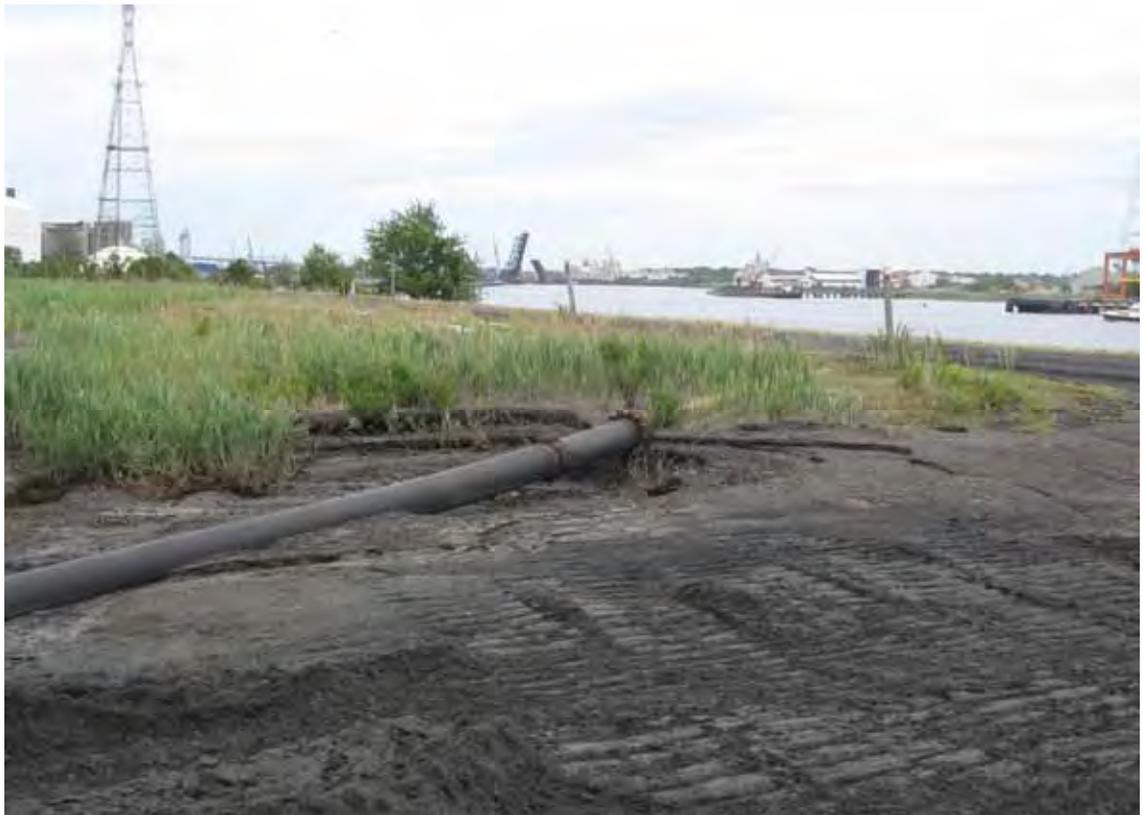
Orientation:
NortheastDescription:
Influent pipe

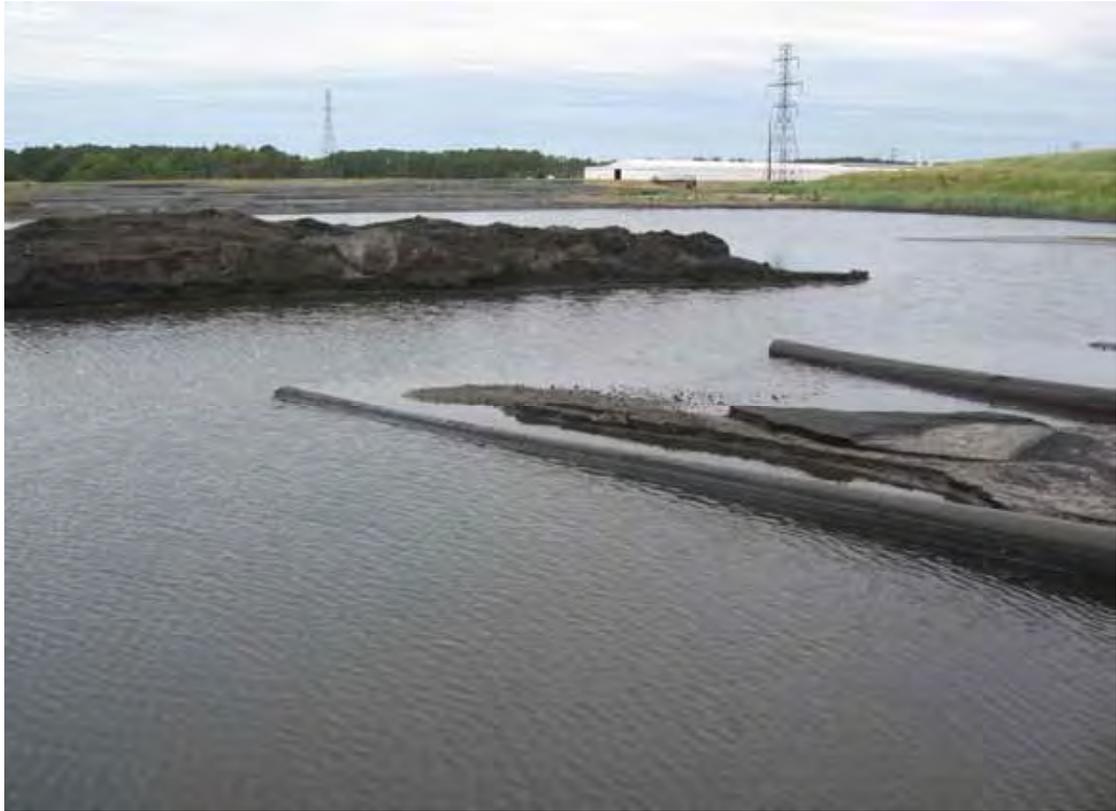
Photo Number:
15

Description:
Interior of Bottom Ash and Sedimentation Pond. Photo depicts CCW dividing dike that has been breached for reconstruction

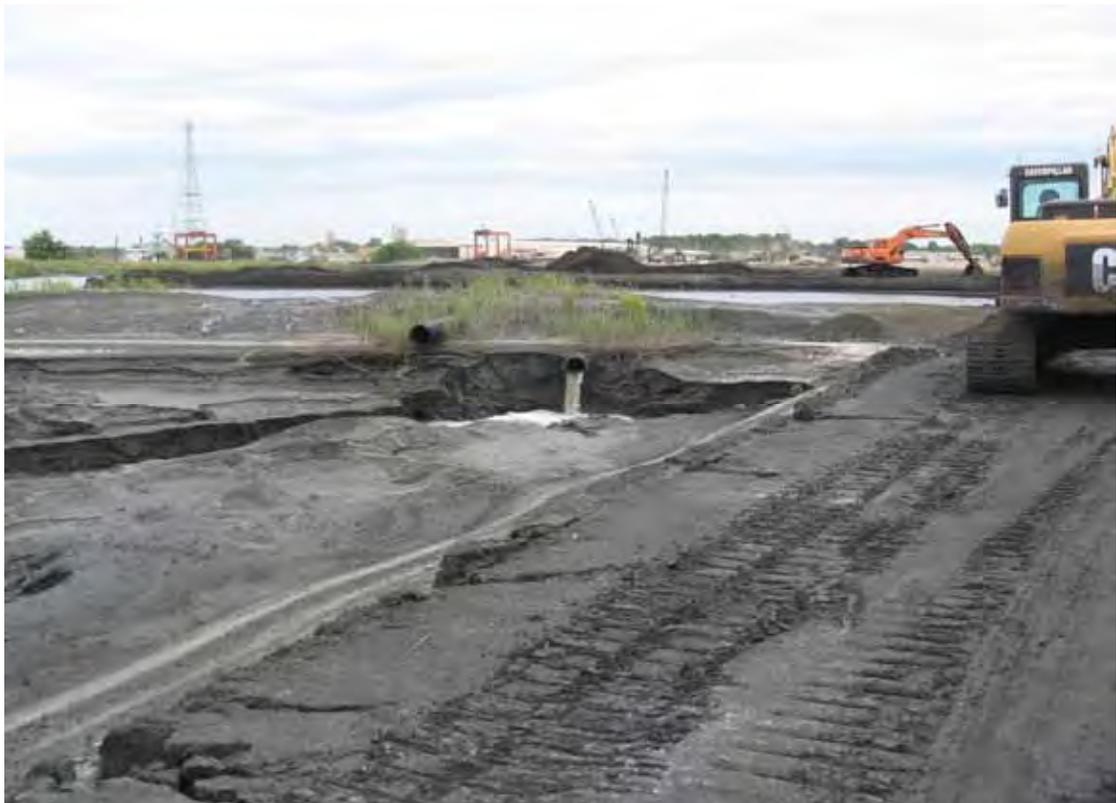
Photo Number:
16

Description:
Decant pipe from easternmost portion of the impoundment into western portion

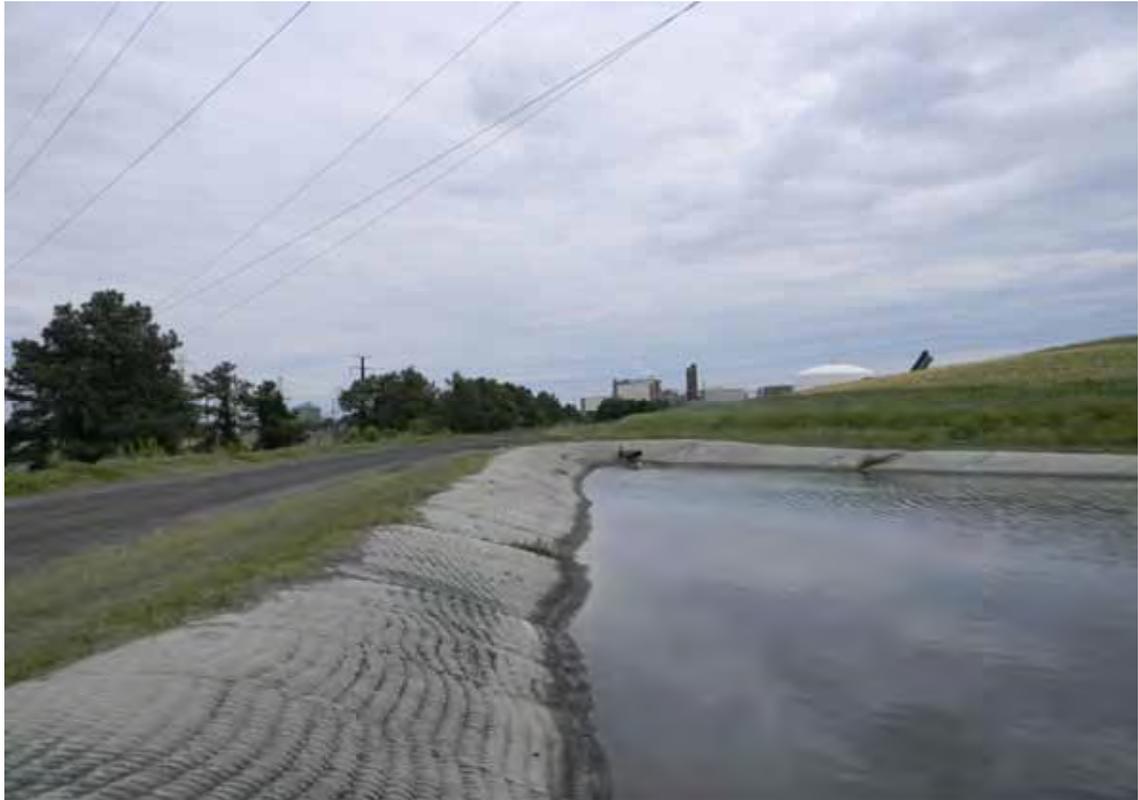
Interior of Spill Retention Pond.
