**DRAFT REPORT**

# **Dam Safety Assessment of CCW Impoundments**

## **Chesterfield Power Station**

June 10, 2010

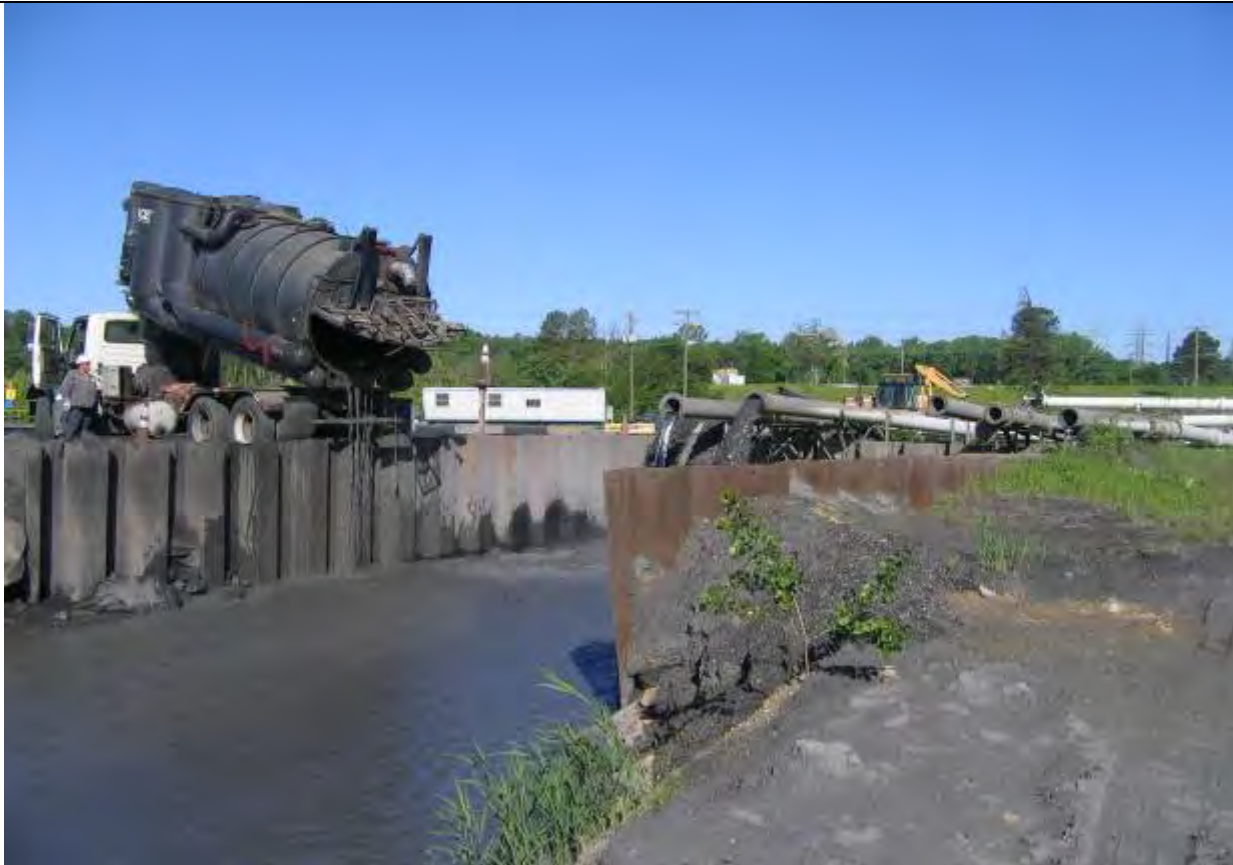
Photo Number:  
1

Description:  
View of sluiced  
CCW discharge  
to lower ash  
pond

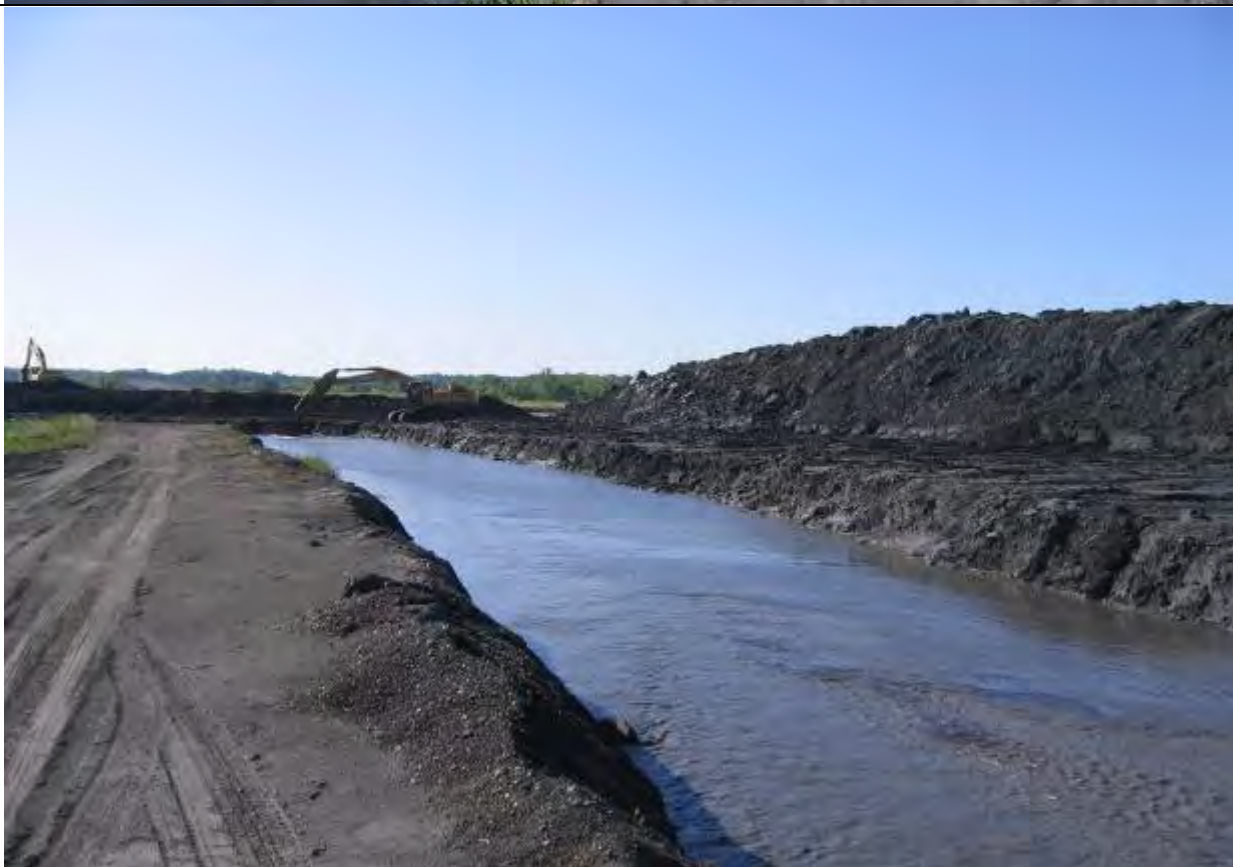
Photo Number:  
2

Description:  
Excavated  
channel in  
accumulated  
ash

Note: Stockpiles  
of ash to be  
transported to  
dry disposal  
area

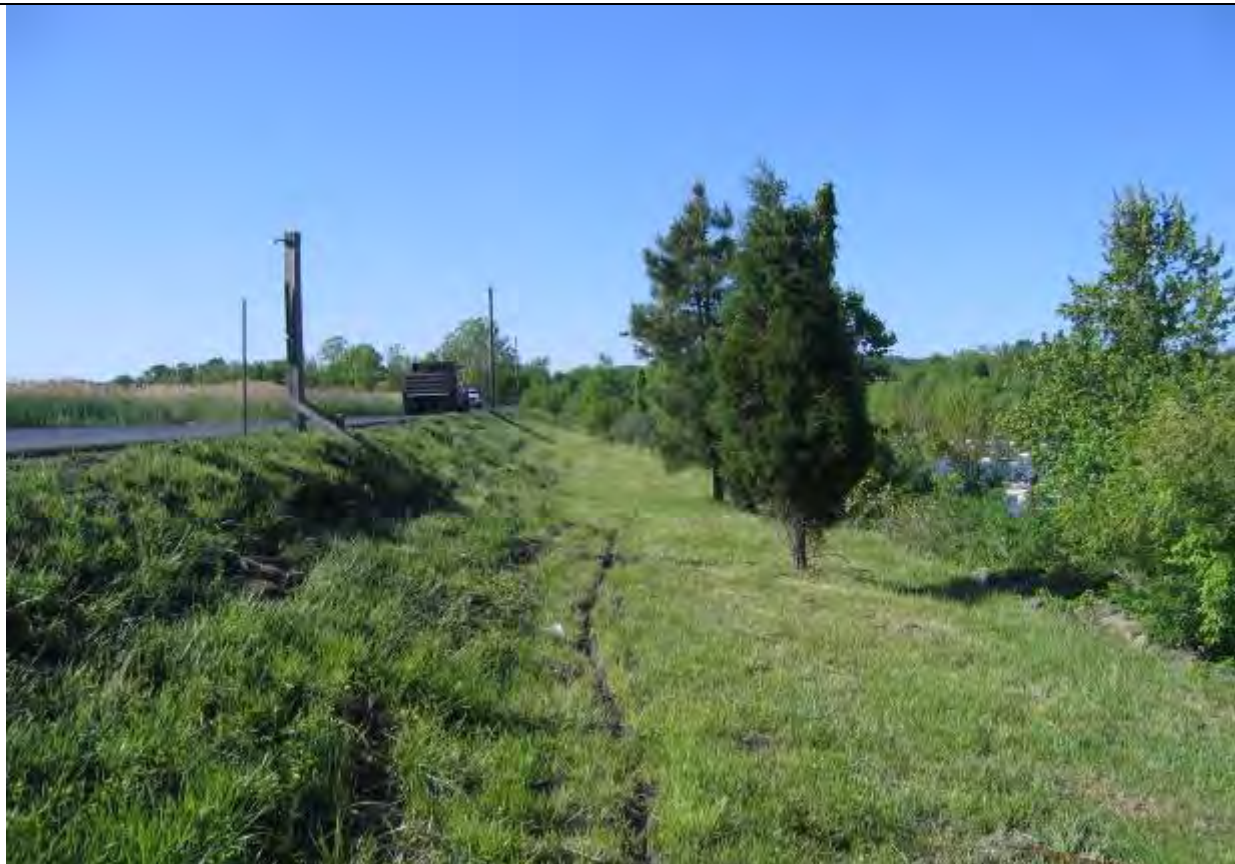
Photo Number:  
3

- The crest of the western dike is a paved roadway that carries ash truck traffic to and from the Upper Ash Pond. The crest appeared to be in good condition. (Photo 3)

Description:  
View along  
down slope toe  
of west dike

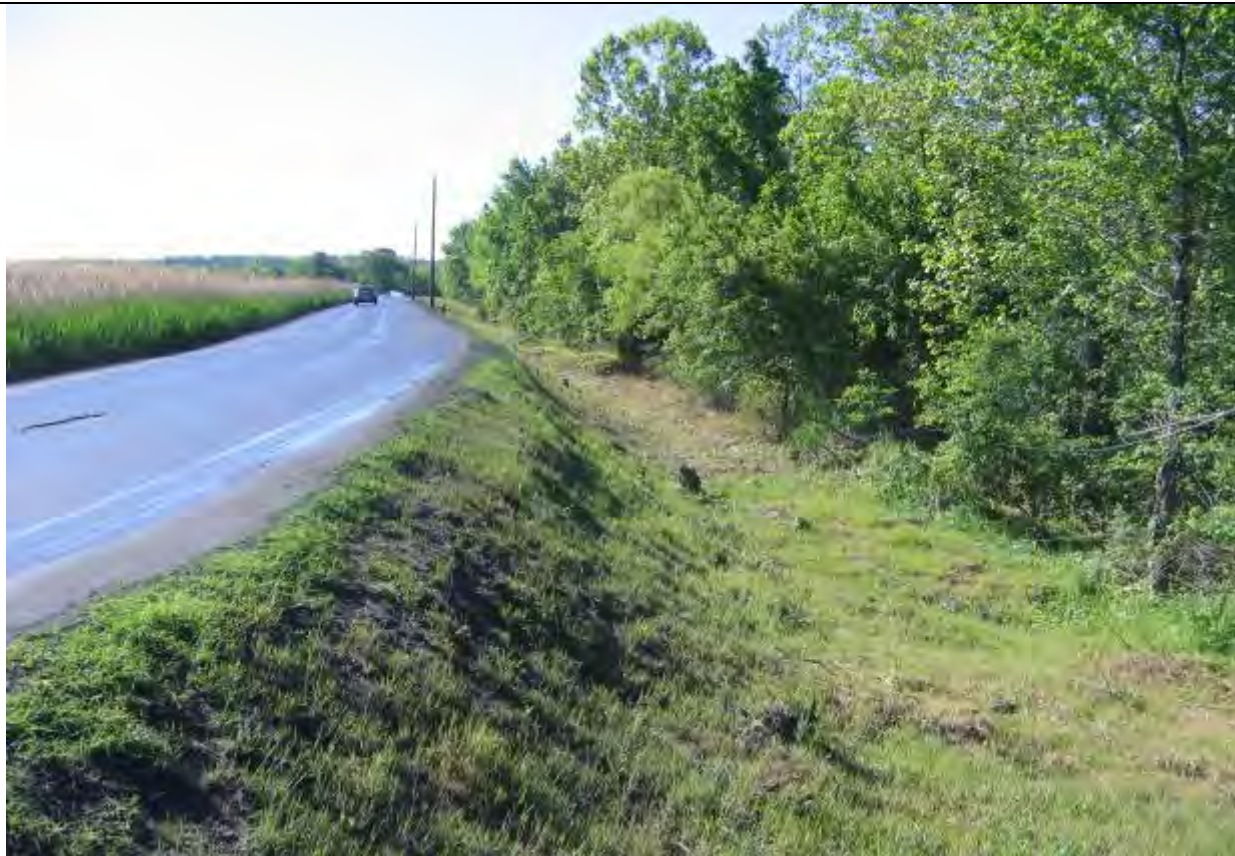
Photo Number:  
4

The Lower Ash Pond dam is considered to be in **FAIR** condition, due to calculated slope stability factors of safety of the west dike that are below typically accepted criteria for embankment dams. While acceptable performance is expected under all required loading conditions, recent stability analyses for a deep-seated slope failure of the downstream slopes indicate that two sections of the west dike have calculated factors of safety less than the typically accepted USACE factor of safety criteria of 1.5, under normal pool, steady state seepage loading conditions with truck surcharge load. Slope stability analyses for a shallow slope failure mode indicate calculated factors of safety of 1.0 or less for two sections of the west dike for all loading conditions. The report recommends several options for improving the stability of the west dike. We understand that Dominion Fossil & Hydro Engineering is assessing the various options and plans to implement the stabilizing measures in the near future.

Description:  
View along  
downstream  
slope toe of  
west dike

Note: Steepness  
of slope

Measures should be implemented to improve the stability of the downstream slope of the western dike and bring the stability factors of safety up to accepted criteria for all loading conditions and failure modes. The stability improvements implemented should include a means to improve drainage and monitor seepage along the toe of western dike.

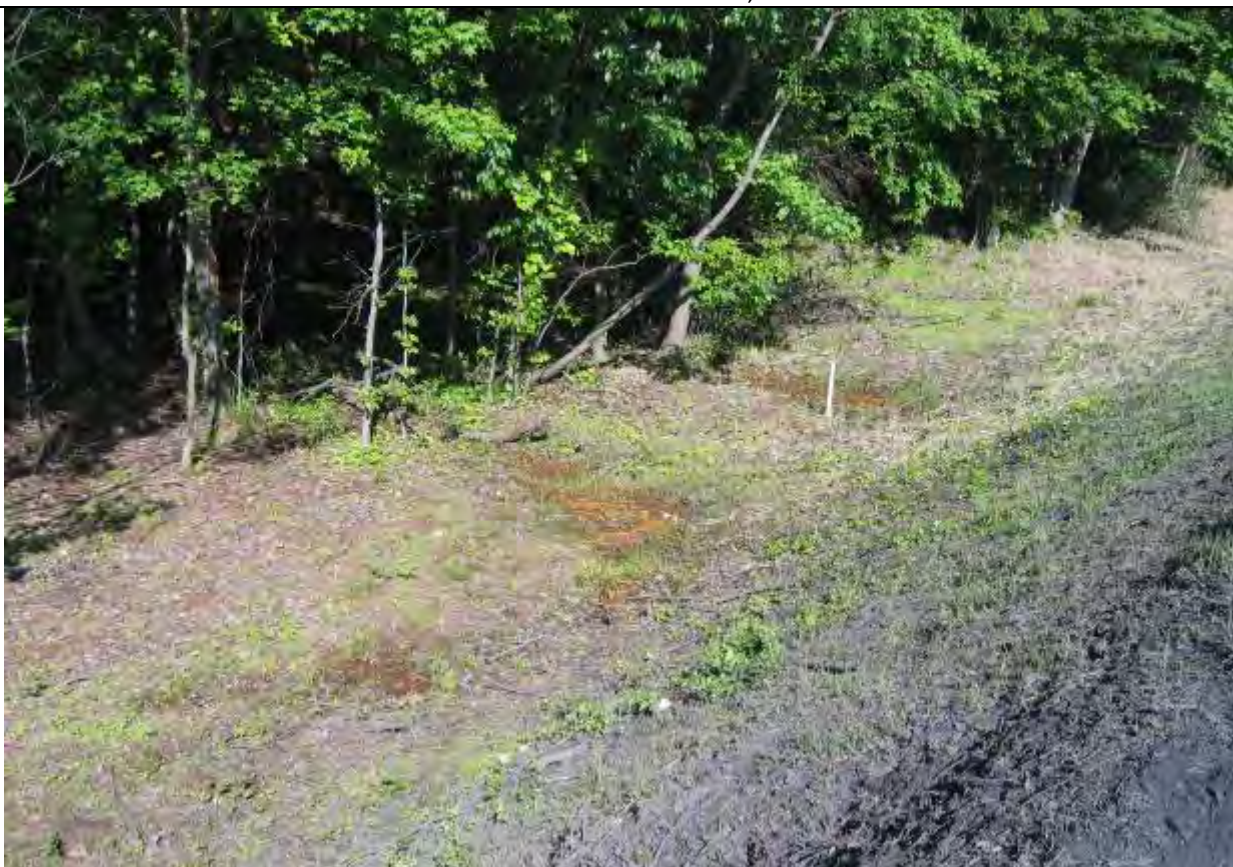
Wet areas at toe of west dike due to seepage and/or poor drainage

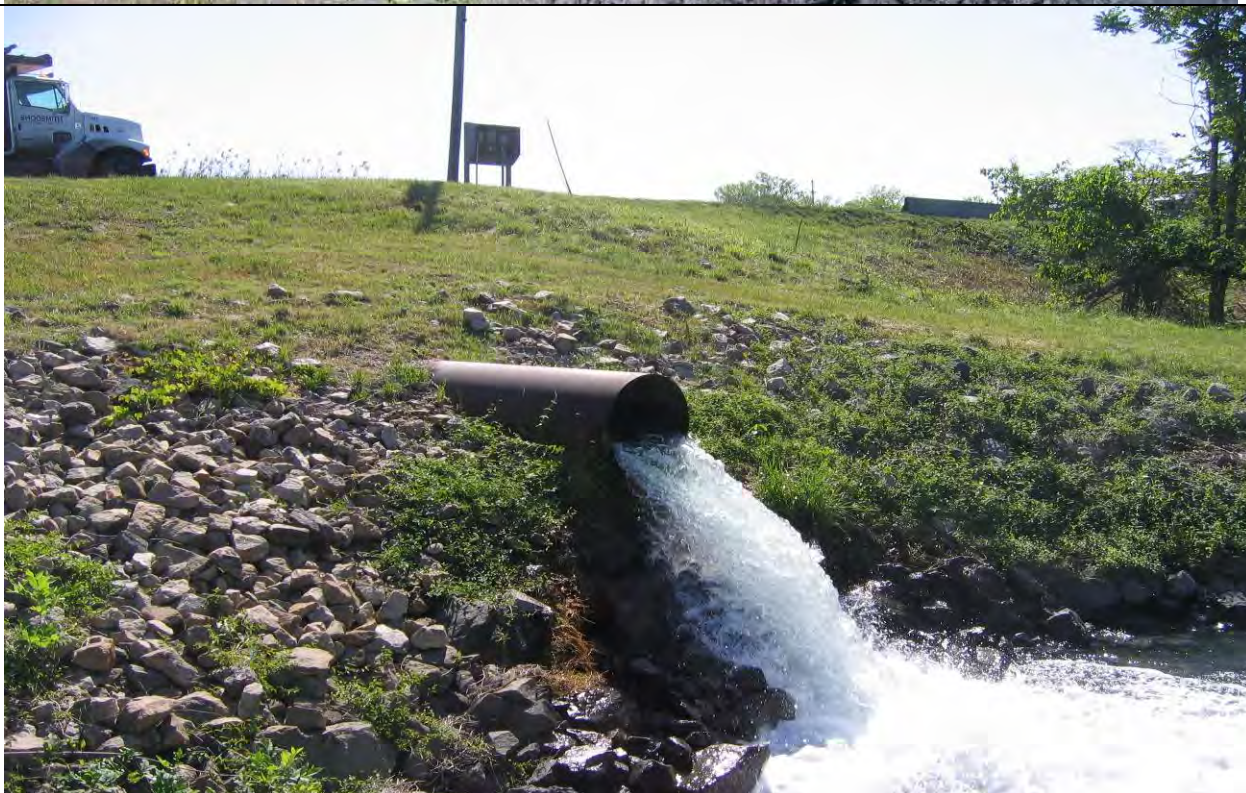
- The outlet (decanting) structure appeared to be in good operating condition. The metal railings and support members exhibited some minor corrosion. The outlet pipe, the source of the former 1980's seepage problem, appeared to be in good condition with no signs of seepage emerging from the embankment slope at the outfall plunge pool area. (Photo 6)

View of outfall into riprap line plunge pool

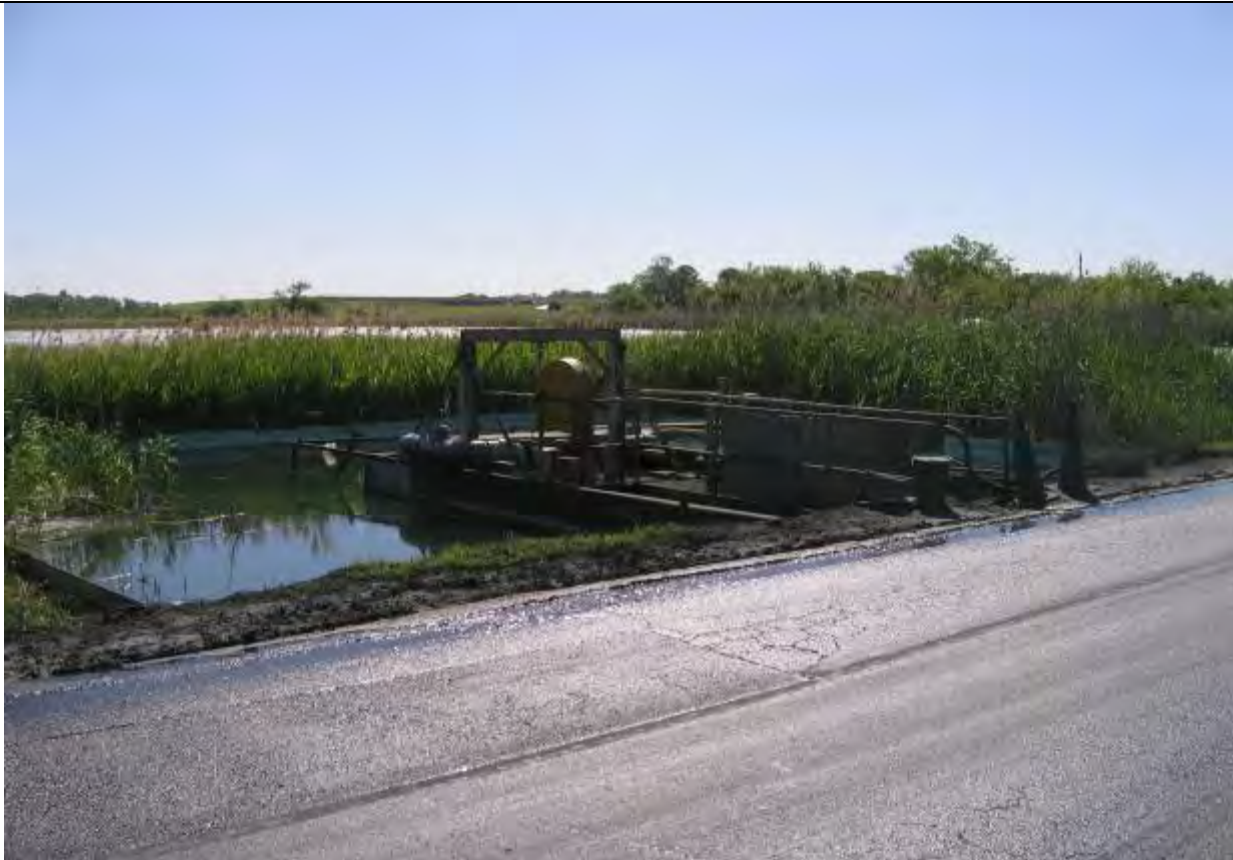
Photo Number:  
7

Description:  
View of  
outlet/decant  
weir structure  
with floatable  
debris baffles in  
background

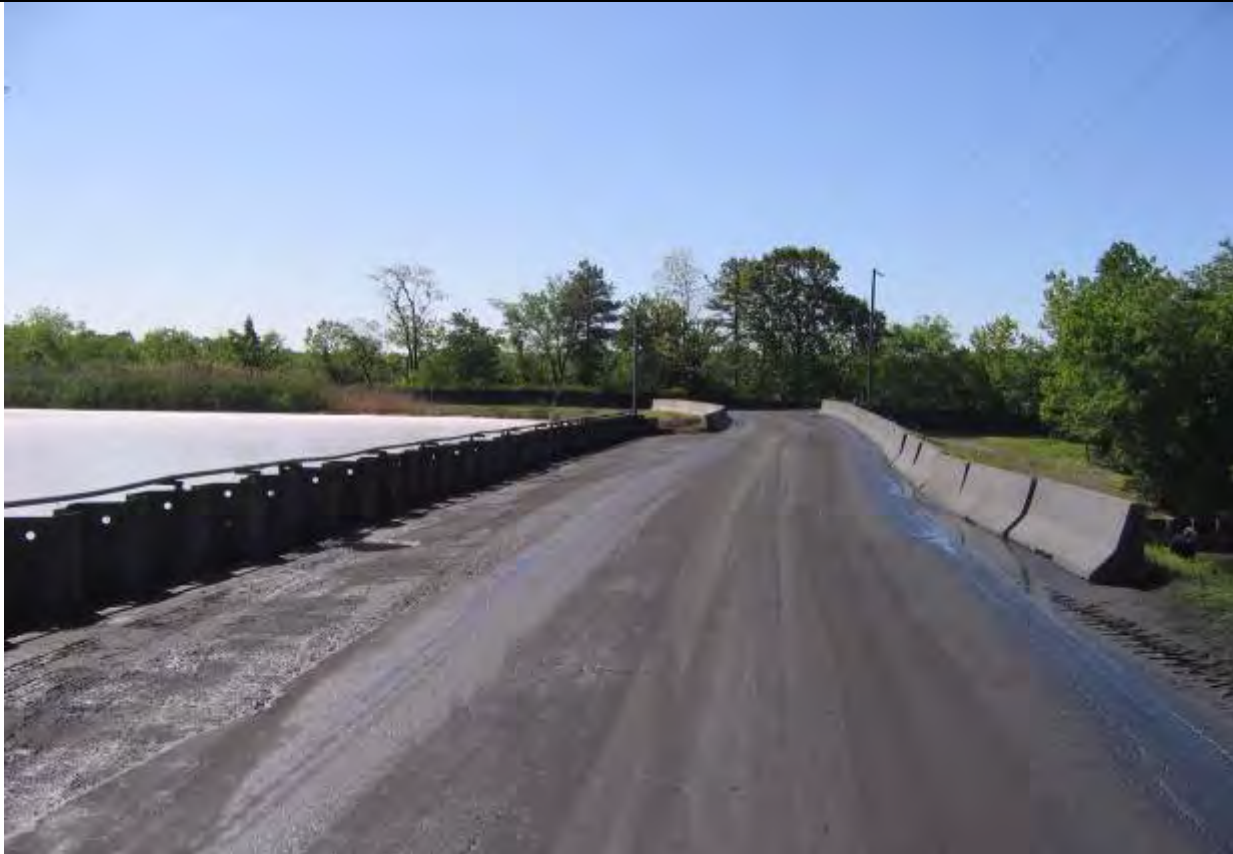
Photo Number:  
8

Description:  
View of sheet  
pile cutoff wall  
at south end of  
west dike

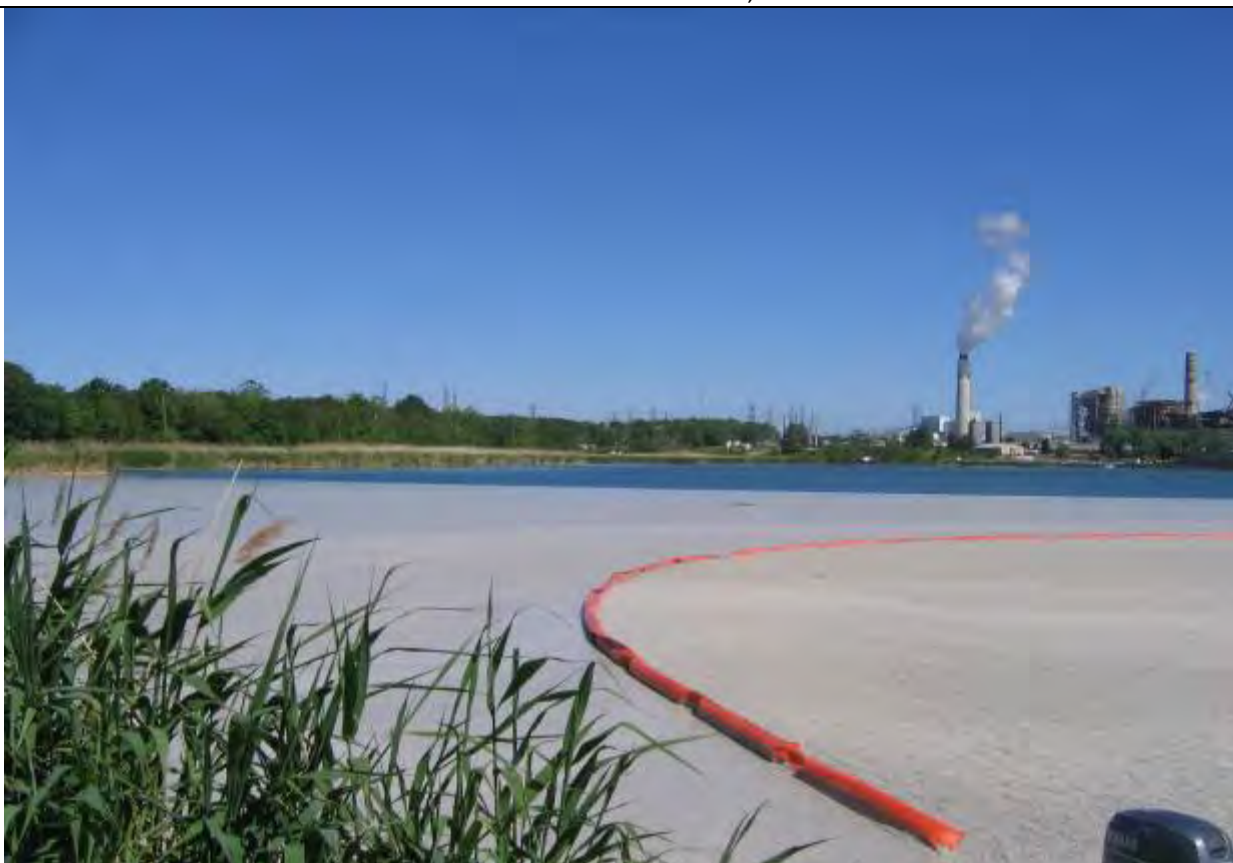
Photo Number:  
9

Description:  
Cenosphere  
harvesting area  
at south end of  
pond

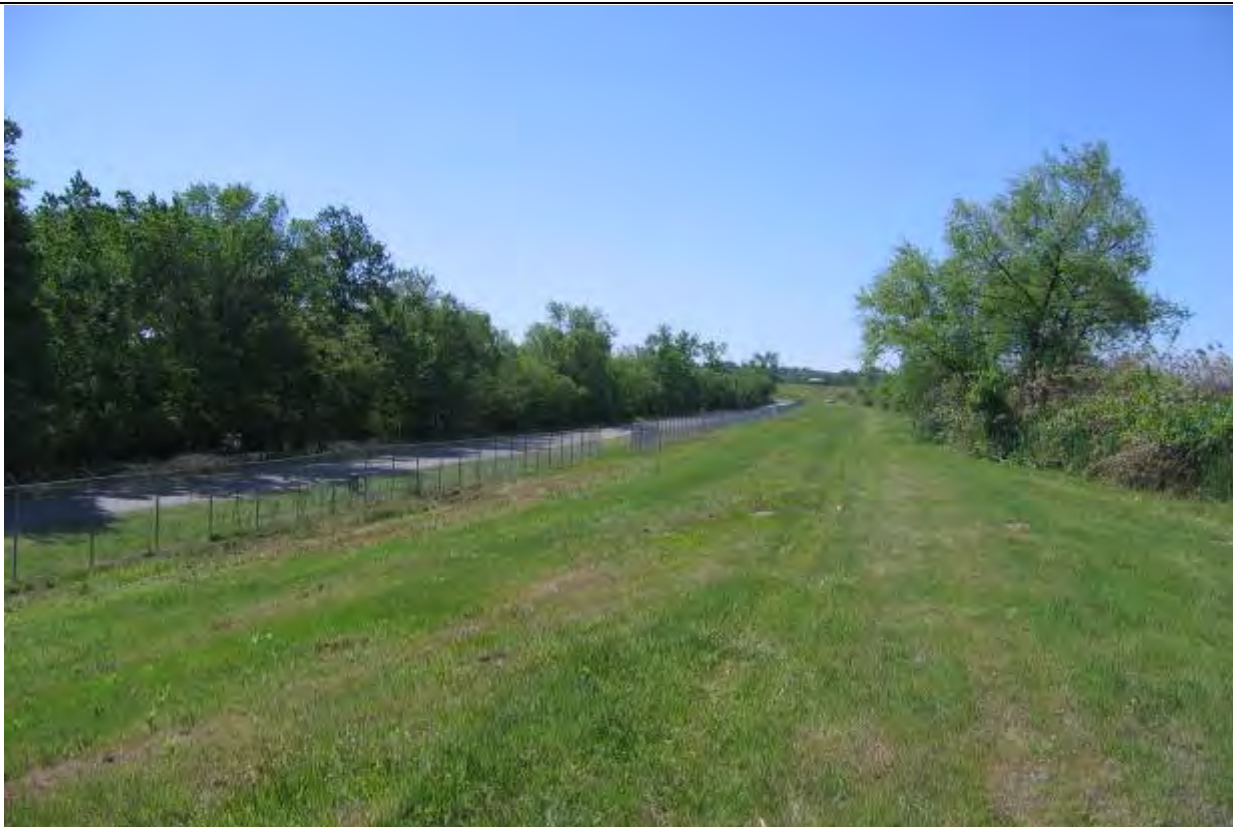
Photo Number:  
10

- The crest and downstream slope of east dike were covered with well-maintained grass. The upstream slope of the east dike was overgrown with thick reedy vegetation. A few small trees were observed as well. (Photo 10)

Description:  
View along east  
dike  
Note: Trees and  
heavy  
vegetation on  
upstream slope  
and  
impoundment  
interior

- Remove/control heavy vegetation along freeboard of upstream slopes
- Paint metal components of outlet structure to control corrosion
- Use care when digging flow channels in accumulated ash to avoid undercutting/excavation into upstream slope of east dike
- Periodically remove accumulated sediment from embankment toe ditches and regrade to improve drainage of stormwater

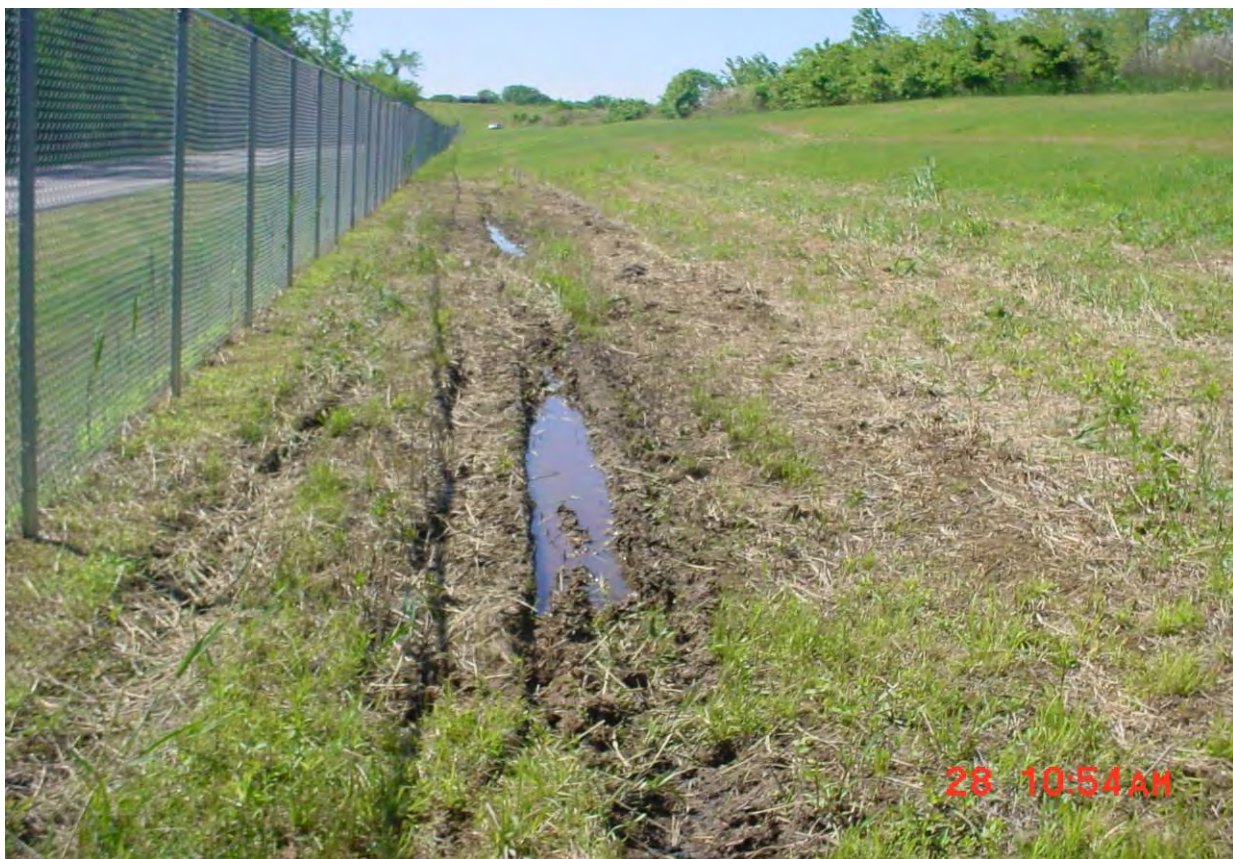
- Several wet areas were observed at the downstream toe of the east dike. The wetness appeared to be due to poor stormwater drainage in isolated low-lying areas, but may also be related to discharge from the toe drains. Mowing tractor has created ruts in wet, soft areas that contribute to pooling of stormwater. (Photo 11)

Description:  
Wet area and  
rutting due to  
tractor at toe of  
east dike

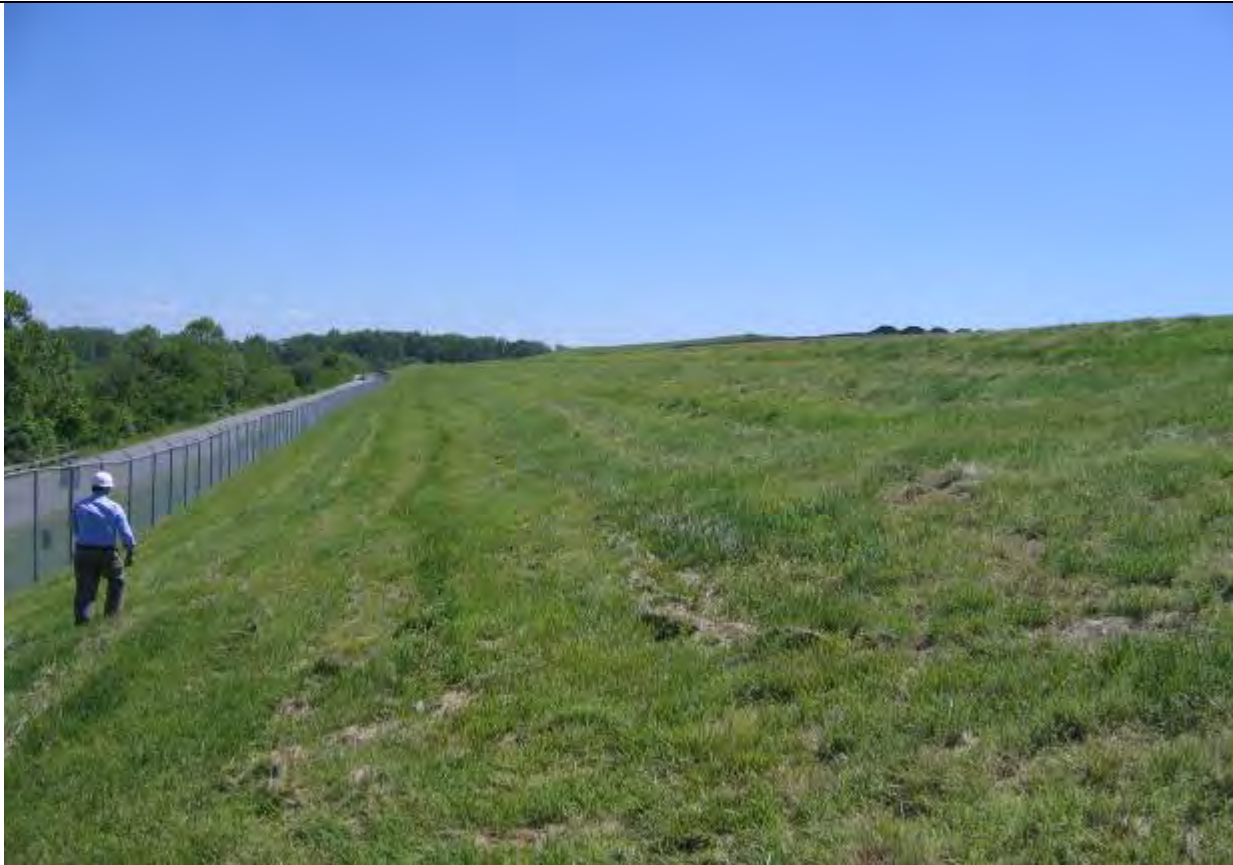
Orientation:  
NEDescription:  
View along  
downstream  
slope of north  
dike

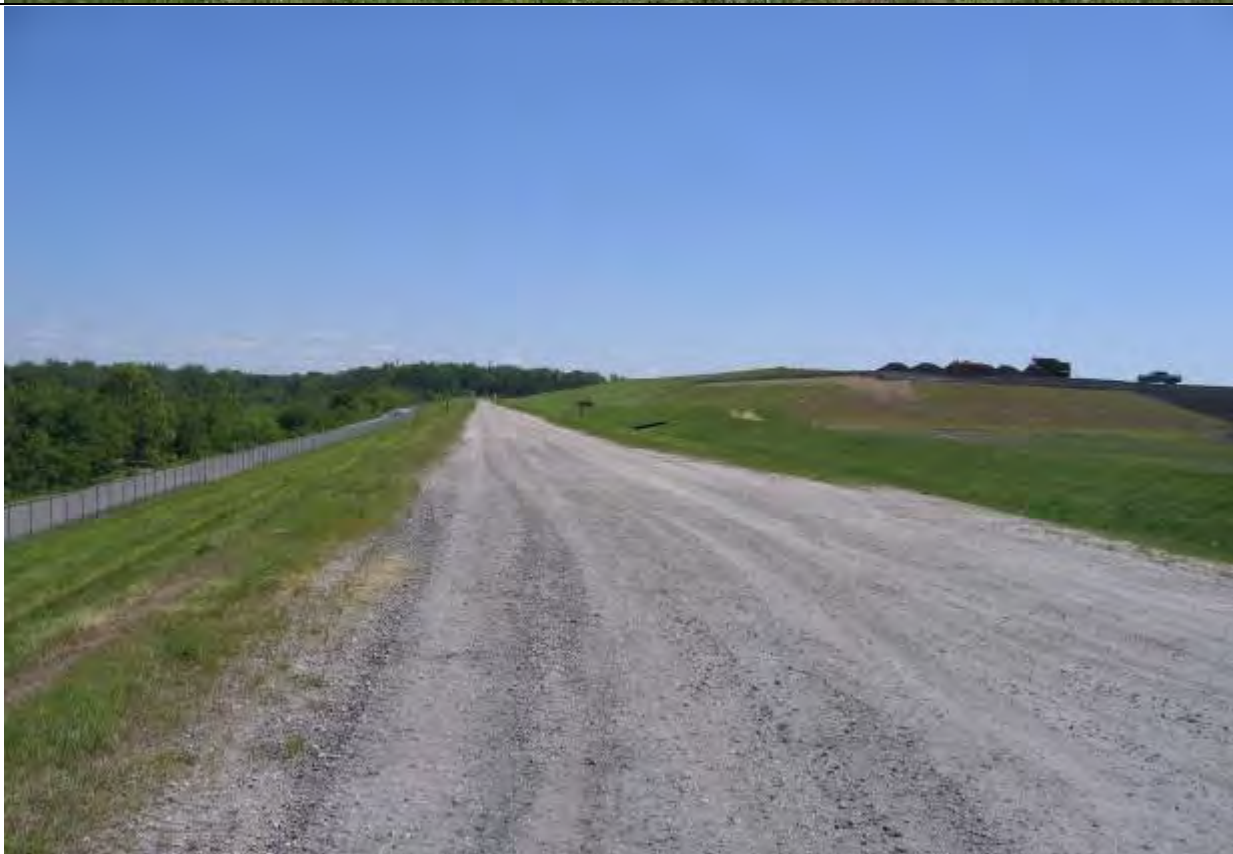
Date:  
4/28/2010Photo Number:  
2Photographer:  
DDW

Date:  
4/28/2010Photo Number:  
1Photographer:  
DDWOrientation:  
NEDescription:  
View along  
crest of north  
dikeNote: Dry  
disposal of ash  
in the right  
background

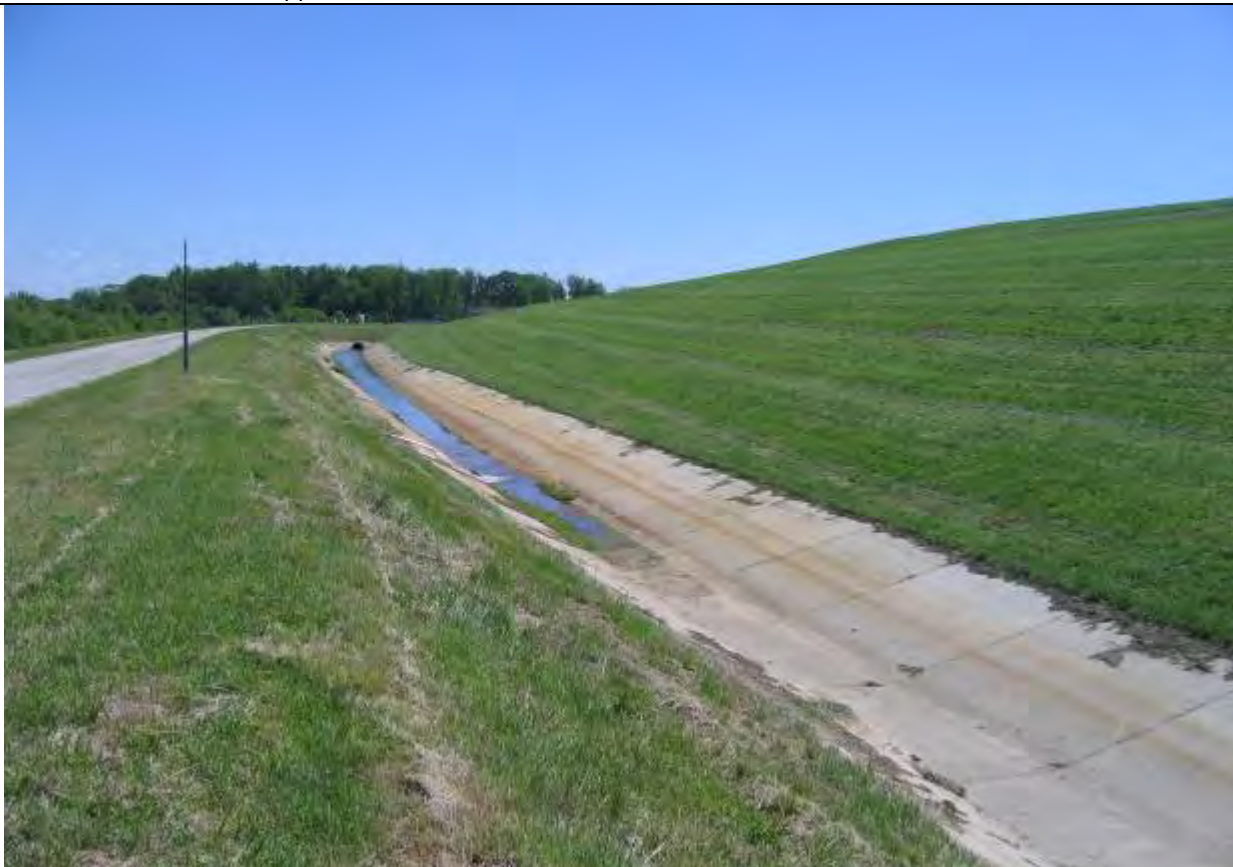
Photo Number:  
3

Description:  
Concrete-lined  
ditches for  
stormwater  
management of  
runoff from dry  
disposal ash  
mound

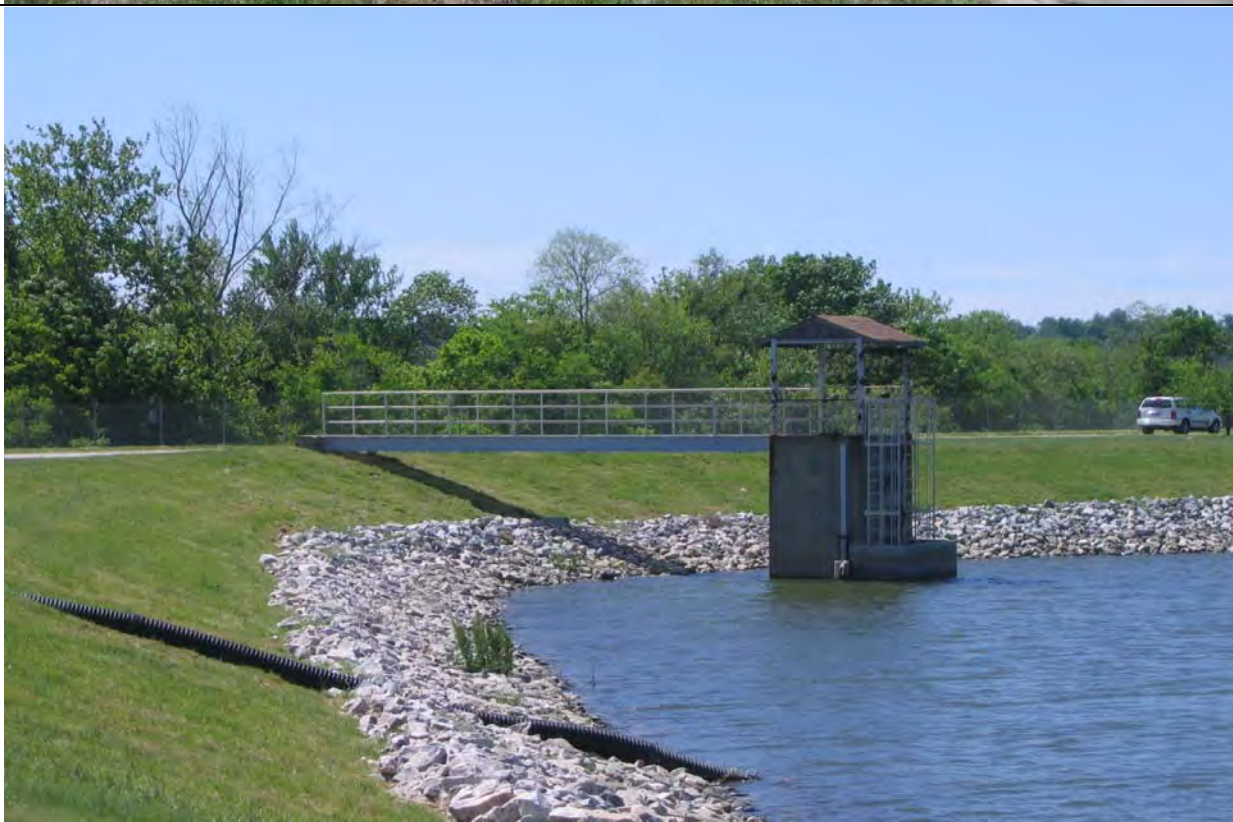
Photo Number:  
4

Description:  
Stormwater/  
sediment pond  
and outlet  
structure

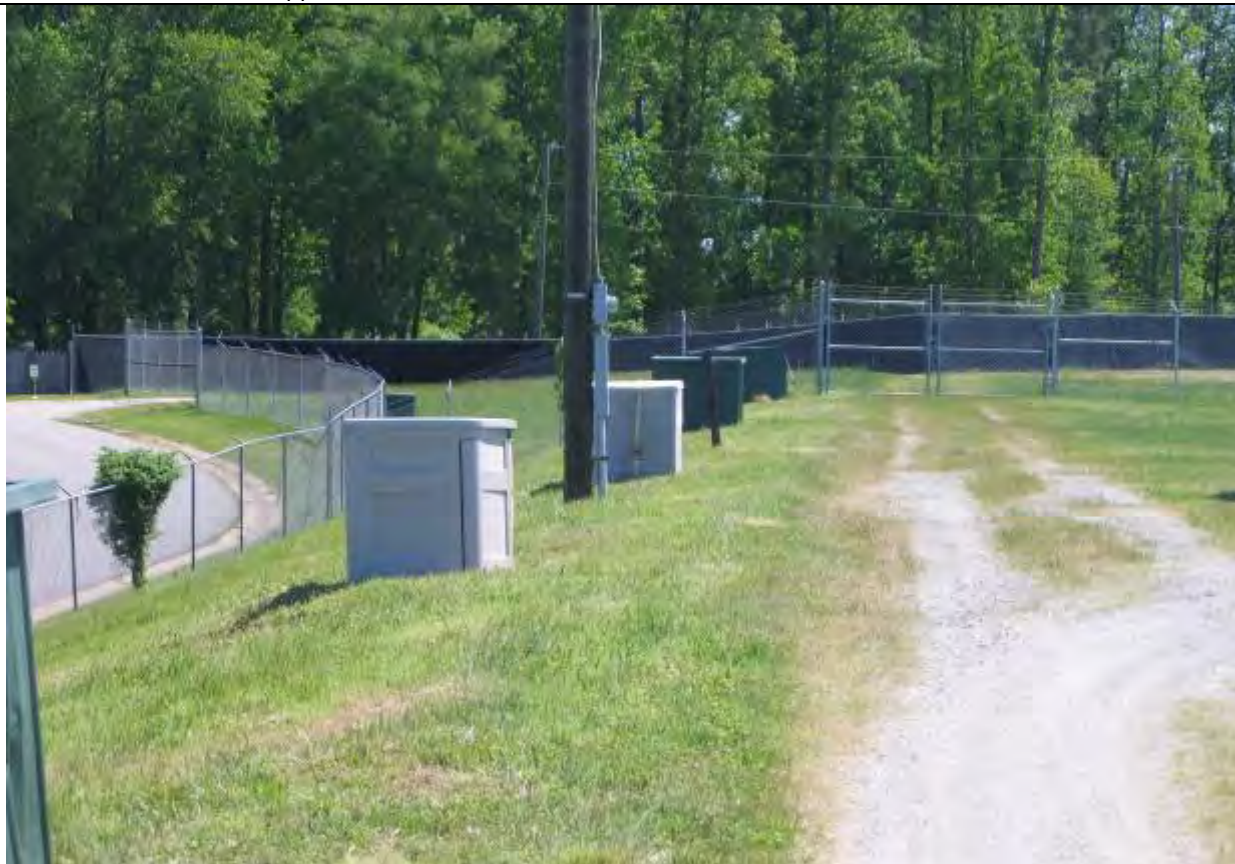
Photo Number:  
5

Description:  
Relief/  
dewatering  
wells at  
northeast  
corner of upper  
ash pond

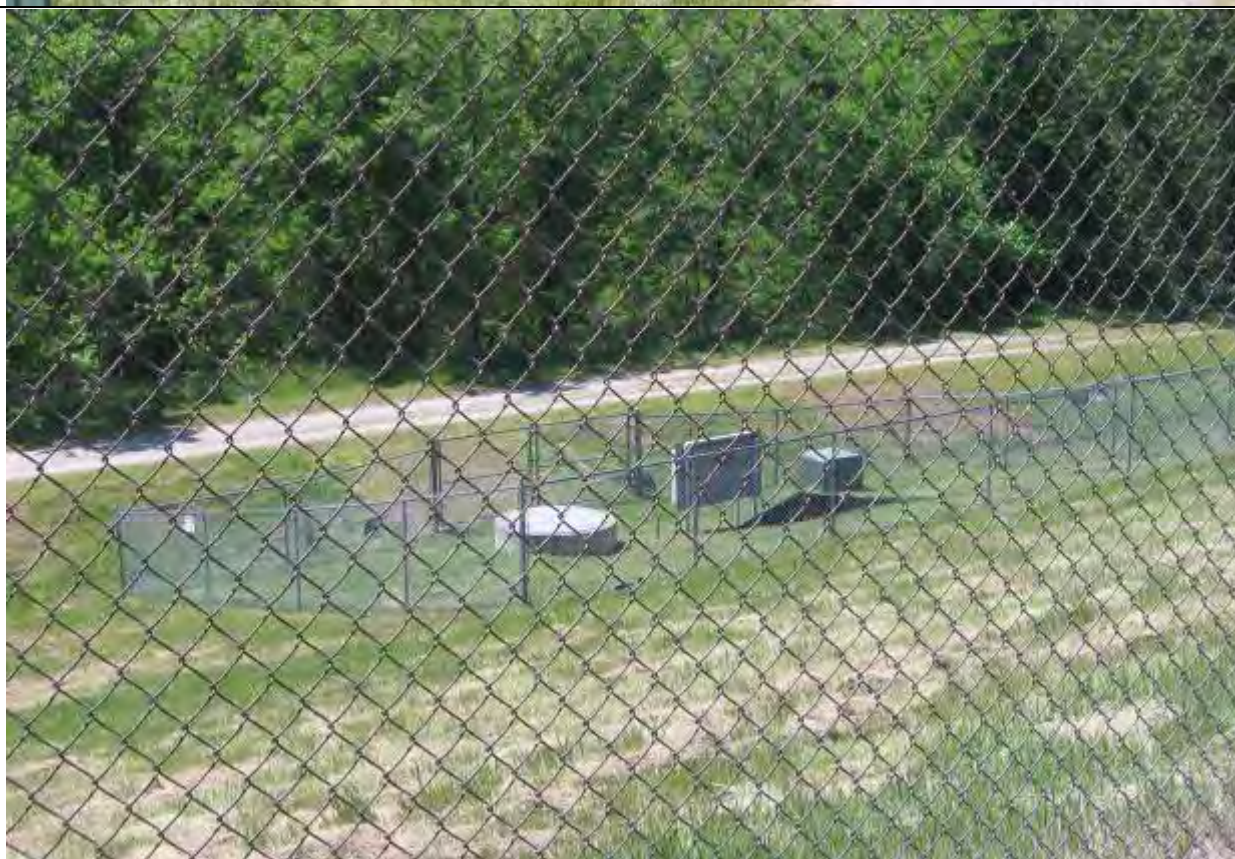
Photo Number:  
6

Description:  
Toe drain  
sump/pump  
station at toe of  
south dike
