Dam Safety Assessment of CCW Impoundments

Chesterfield Power Station

September 29, 2010

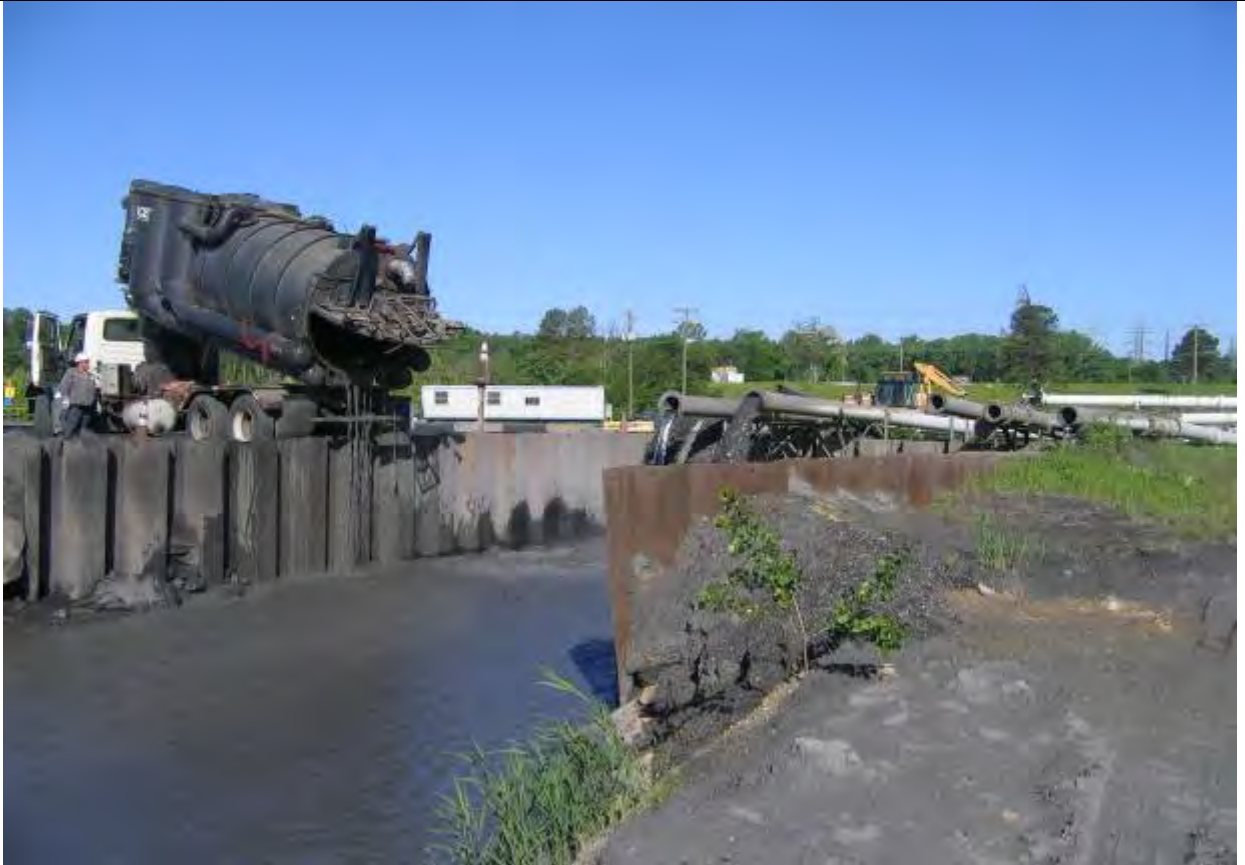
Photo Number:
1

Description:
View of sluiced
CCW discharge
to lower ash
pond

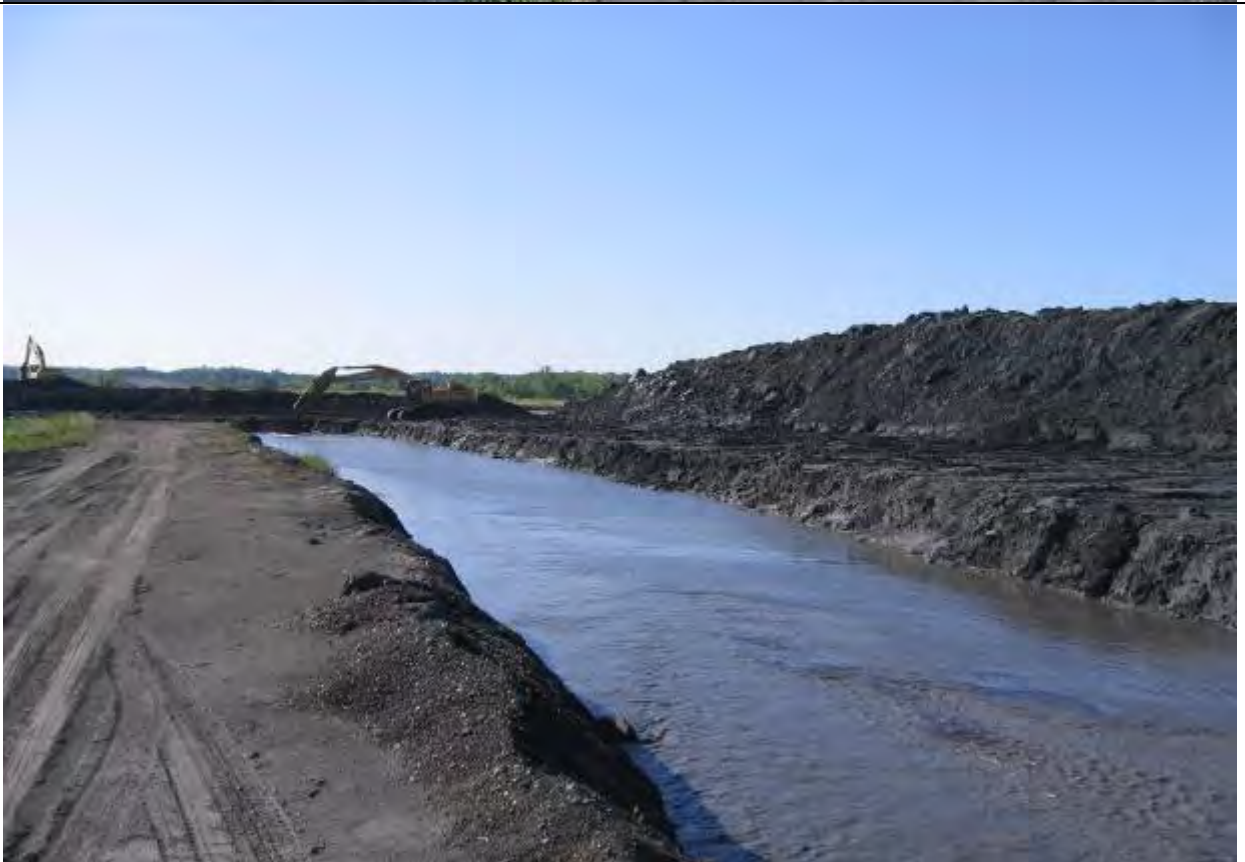
Photo Number:
2

- Heavy vegetation along freeboard portion of upstream slopes
- Poor drainage and /or areas of minor seepage along the toe of slopes of the western and eastern dikes
- Minor corrosion of metal components of outlet structure
- Channel excavation into or very close to upstream embankment at isolated location of eastern dike

Description:
Excavated
channel in
accumulated
ash

Note: Stockpiles
of ash to be
transported to
Upper Ash Pond
closure area

- Paint metal components of outlet structure to control corrosion
- Use care when digging flow channels in accumulated ash to avoid undercutting/excavation into upstream slope of east dike
- Periodically remove accumulated sediment from embankment toe ditches and regrade to improve drainage of stormwater

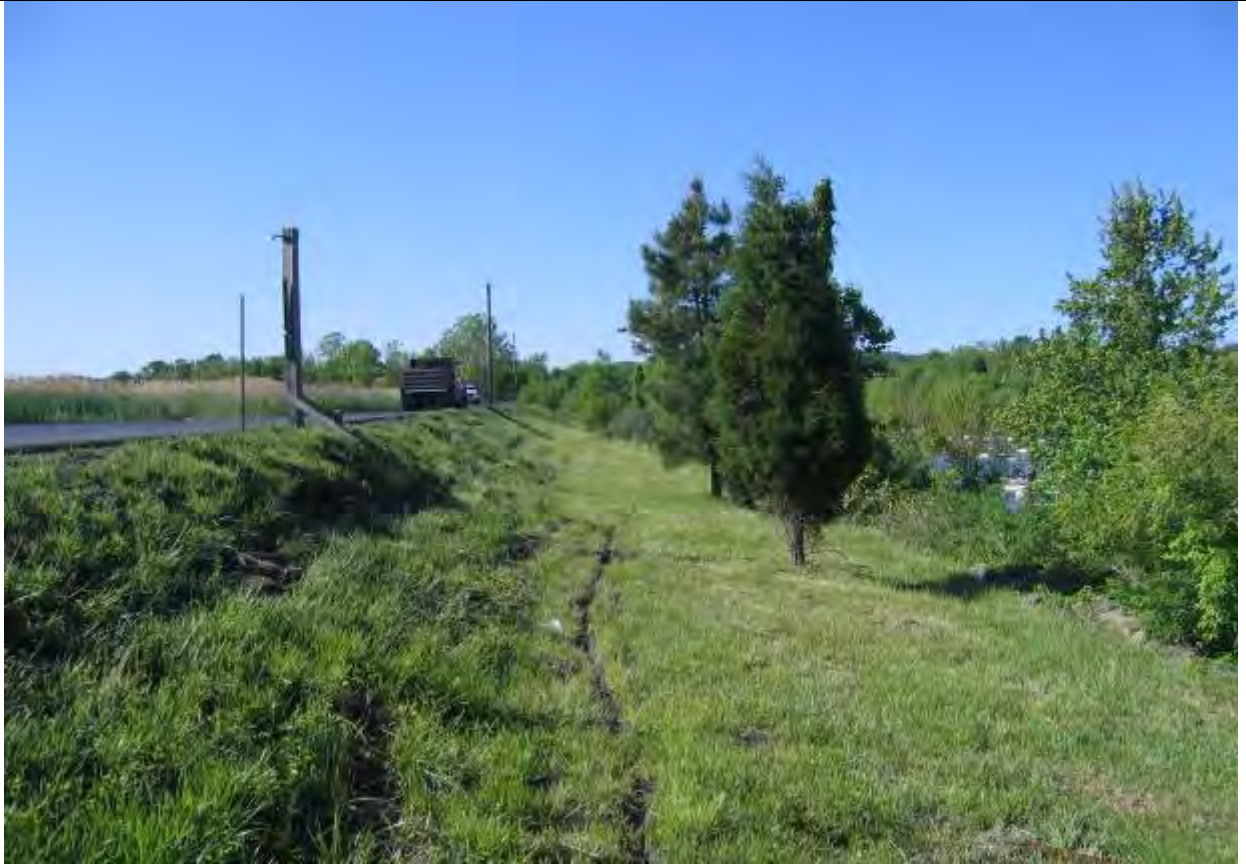
Photo Number:
3

- The crest of the western dike is a paved roadway that carries ash truck traffic to and from the Upper Ash Pond. The crest appeared to be in good condition. (Photo 3)

Description:
View along
down slope toe
of west dike

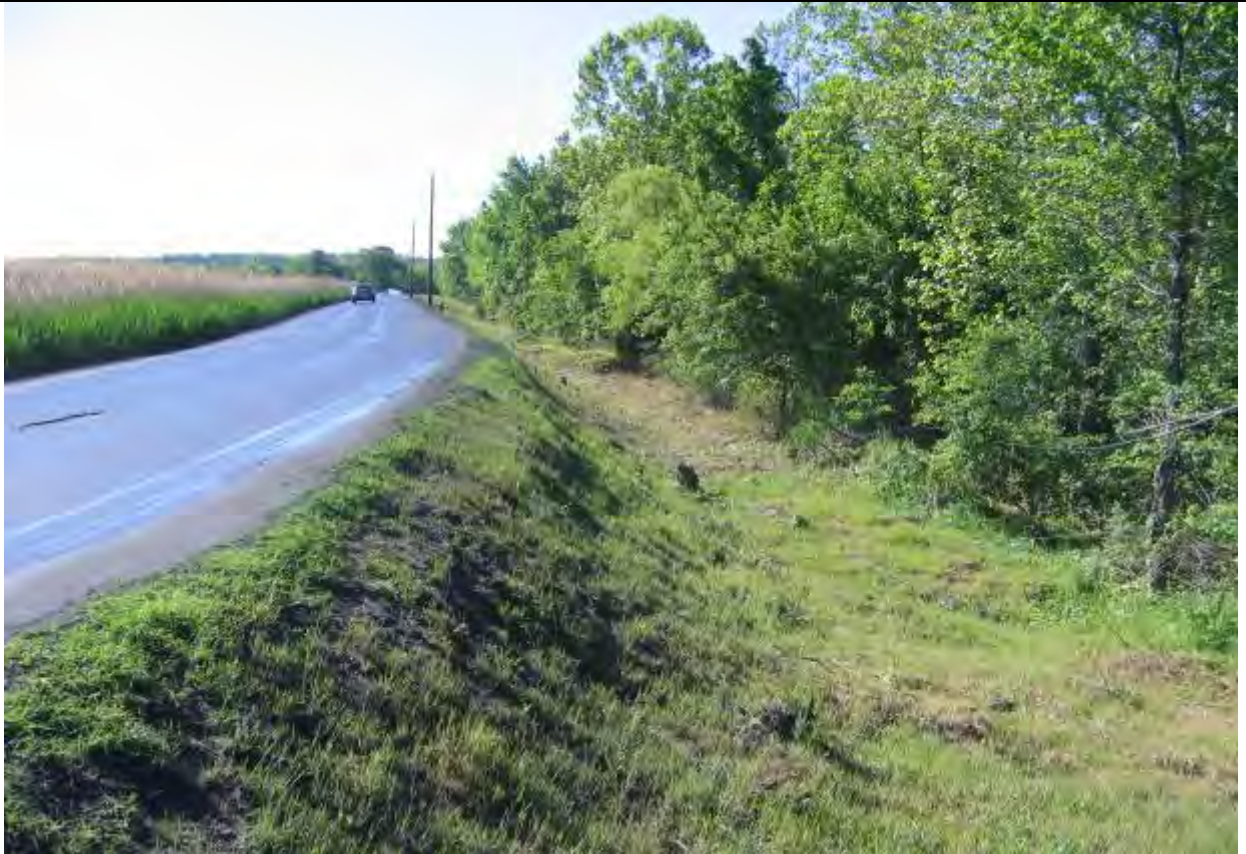
Photo Number:
4

The Lower Ash Pond dam is considered to be in **FAIR** condition, due to calculated slope stability factors of safety of the west dike that are below typically accepted criteria for embankment dams. While acceptable performance is expected under all required loading conditions, recent stability analyses for a deep-seated slope failure of the downstream slopes indicate that two sections of the west dike have calculated factors of safety less than the typically accepted USACE factor of safety criteria of 1.5, under normal pool, steady state seepage loading conditions with truck surcharge load. Slope stability analyses for a shallow slope failure mode indicate calculated factors of safety of 1.0 or less for two sections of the west dike for all loading conditions. The report recommends several options for improving the stability of the west dike. We understand that DVP Fossil & Hydro Engineering is assessing the various options and plans to implement the stabilizing measures in the near future.

Description:
View along
downstream
slope and toe of
west dike

Note: Steepness
of slope

Measures should be implemented to improve the stability of the downstream slope of the western dike and bring the stability factors of safety up to accepted criteria for all loading conditions and failure modes. The stability improvements implemented should include a means to improve drainage and monitor seepage along the toe of western dike.

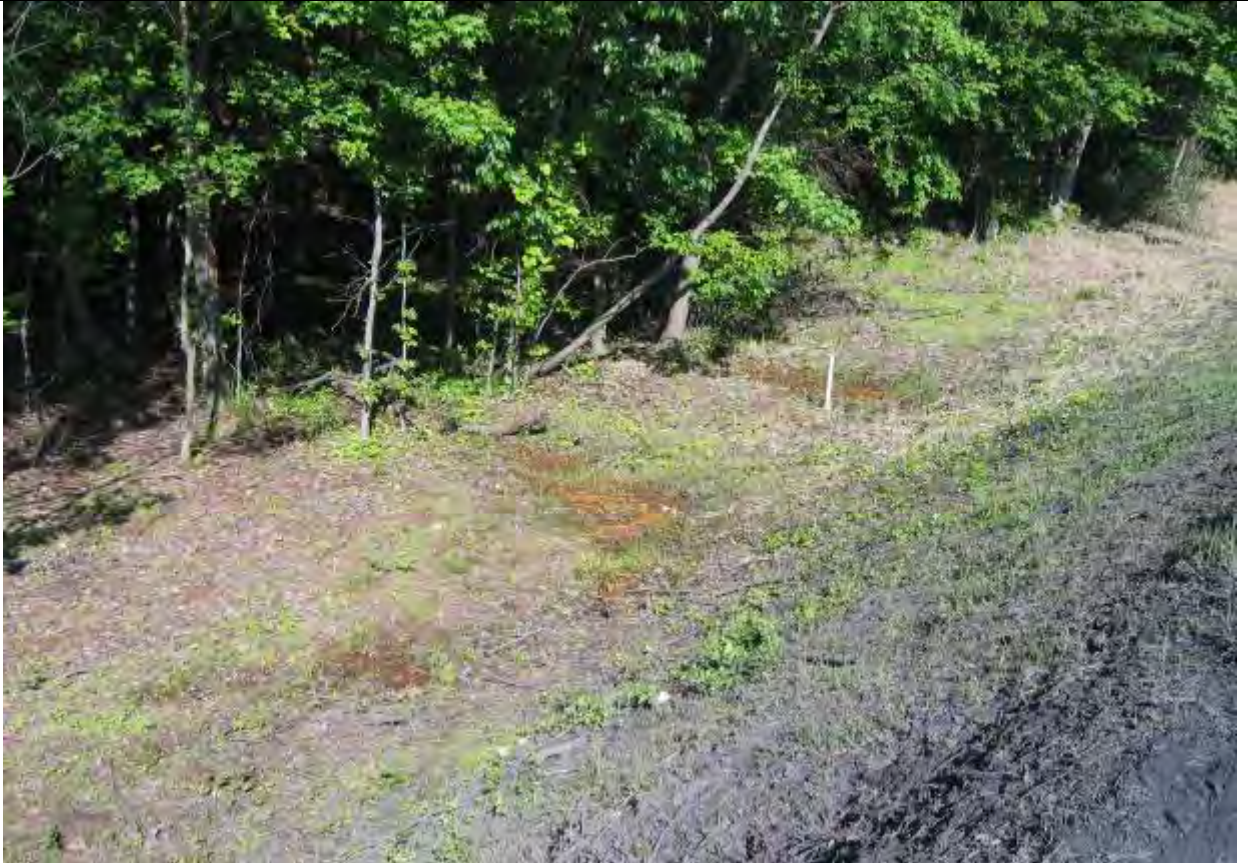
Photo Number:
5

Description:
Wet areas at toe of west dike due to seepage and/or poor drainage

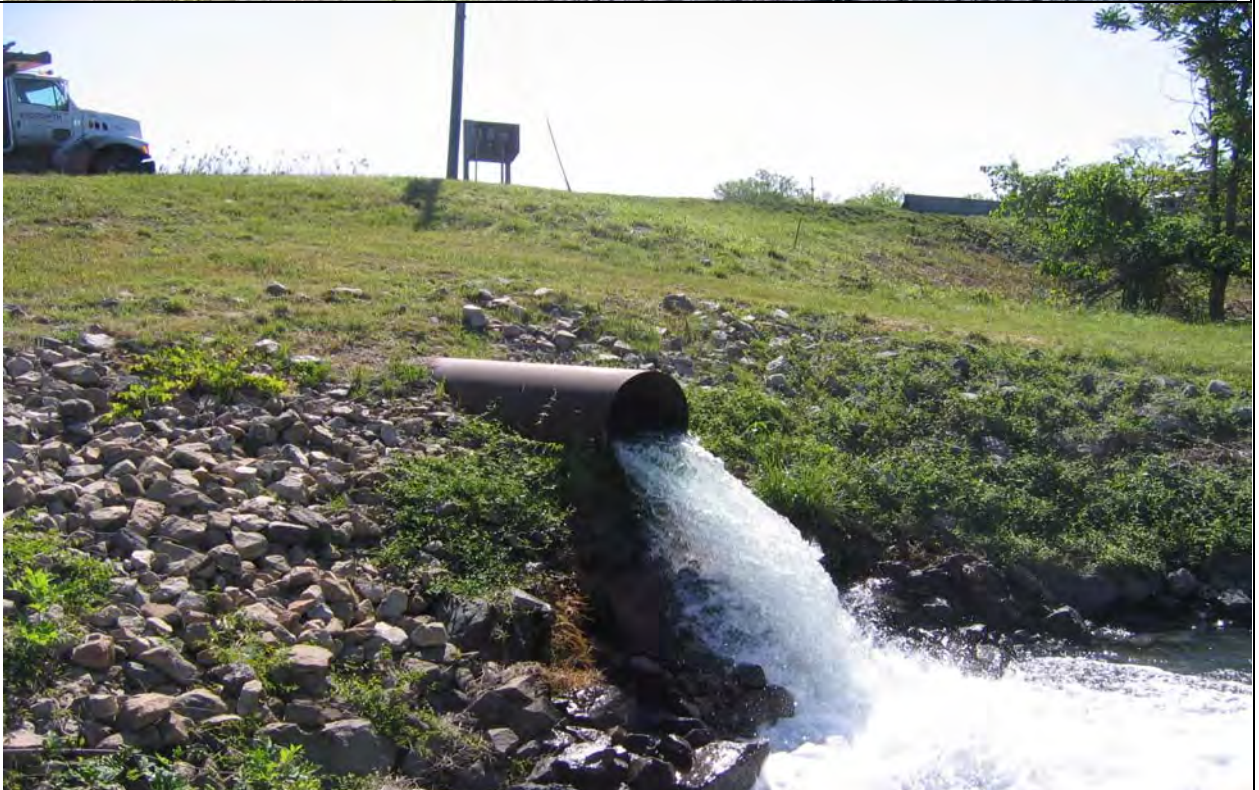
Photo Number:
6

- The outlet (decanting) structure appeared to be in good operating condition (Photo 7). The metal railings and support members exhibited some minor corrosion. The outlet pipe, the source of the former 1980's seepage problem, appeared to be in good condition with no signs of seepage emerging from the embankment slope at the outfall plunge pool area. (Photo 6)

Description:
View of outfall into riprap line plunge pool

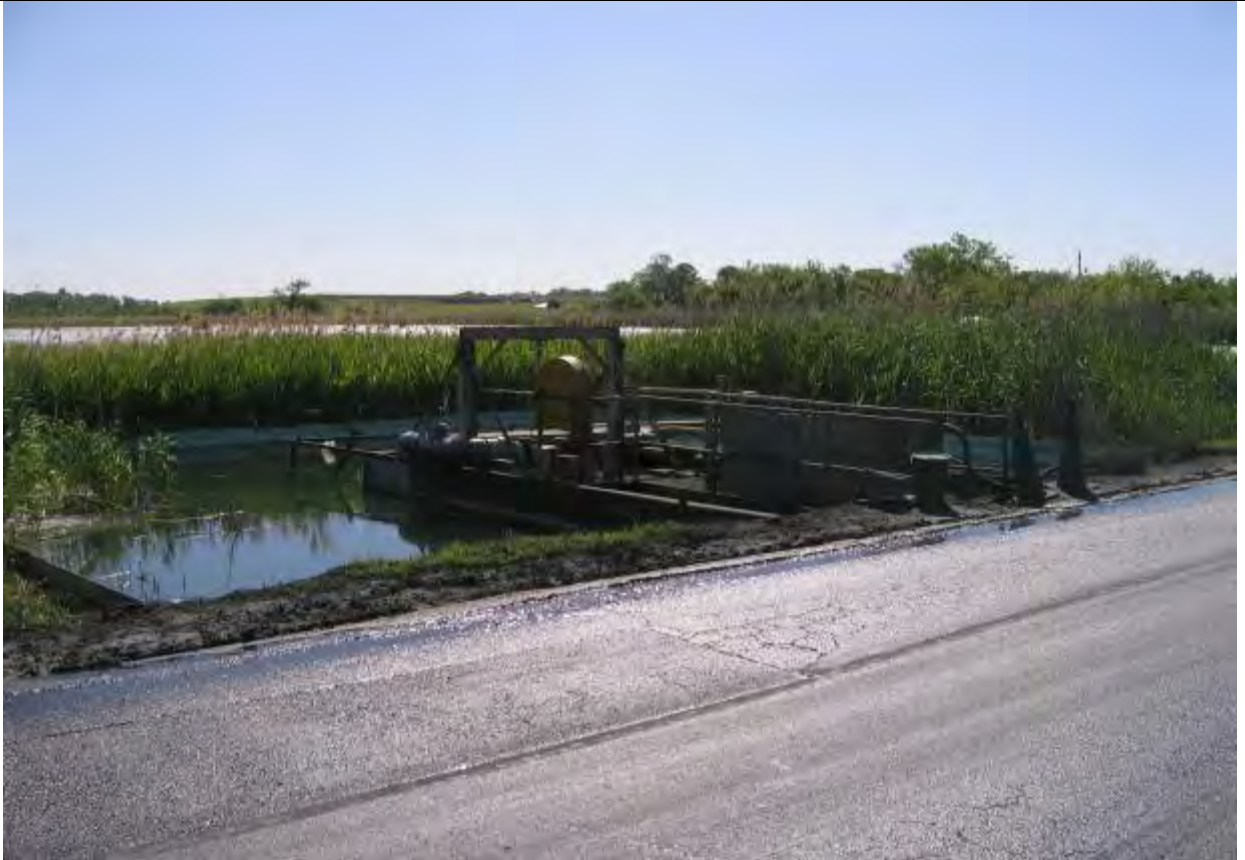
Photo Number:
7

Description:
View of outlet/decant weir structure with floatable debris baffles in background

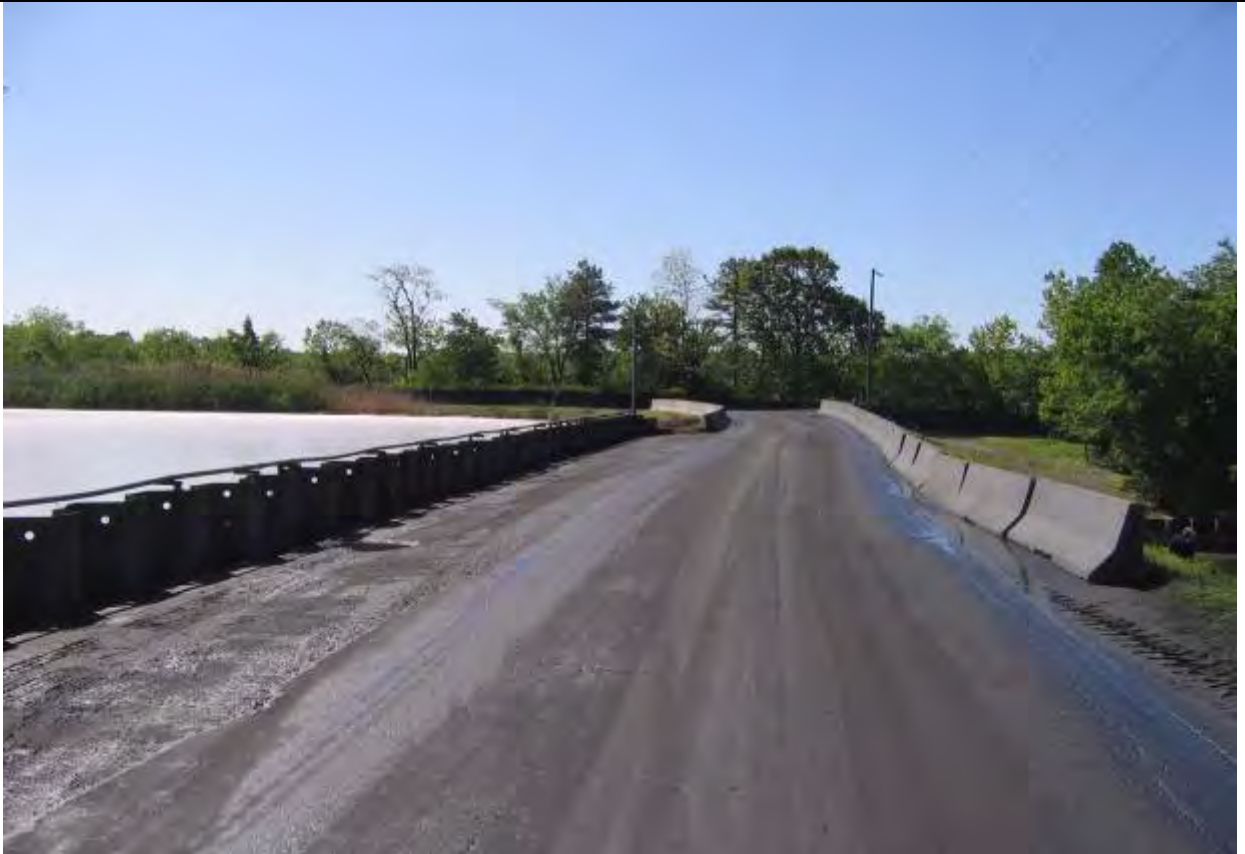
Photo Number:
8

Description:
View of sheet pile cutoff wall at south end of west dike

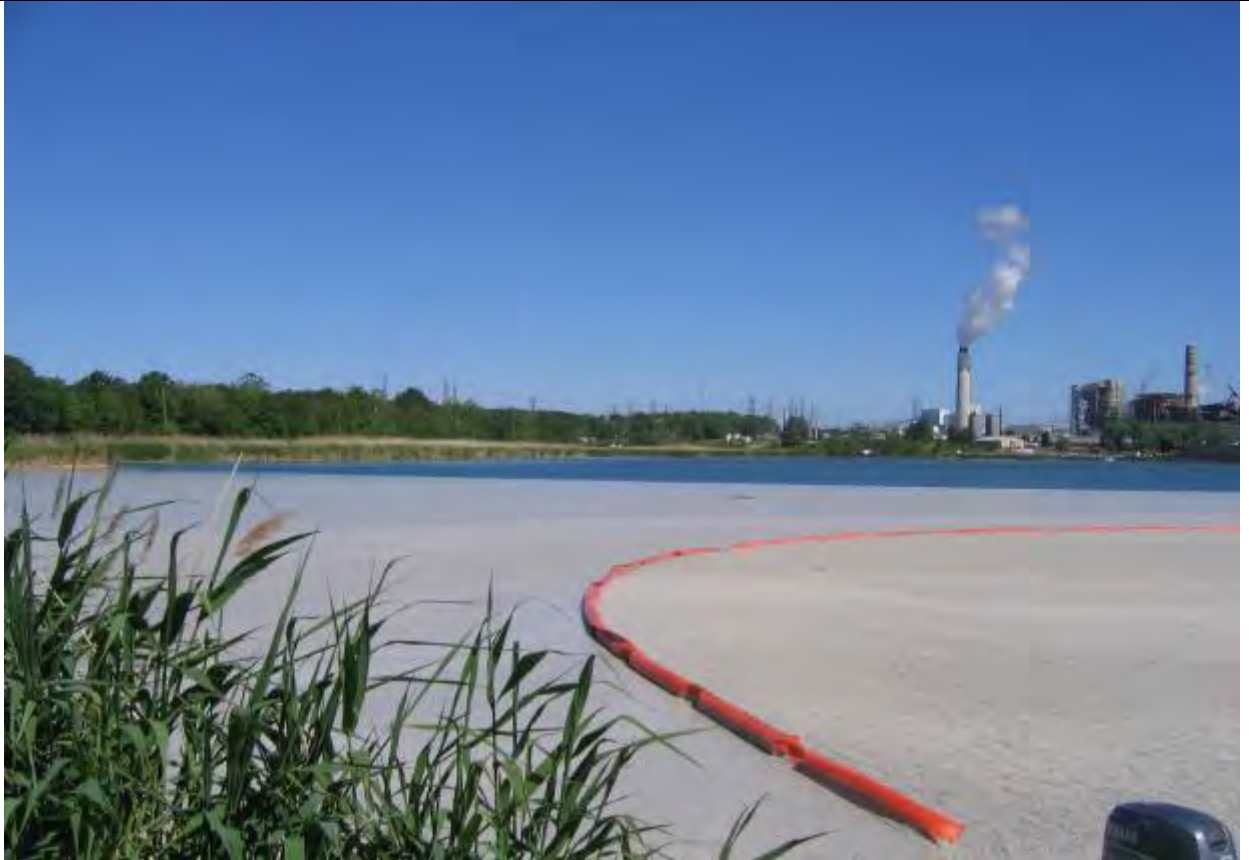
Photo Number:
9

Description:
Cenosphere
harvesting area
at south end of
pond

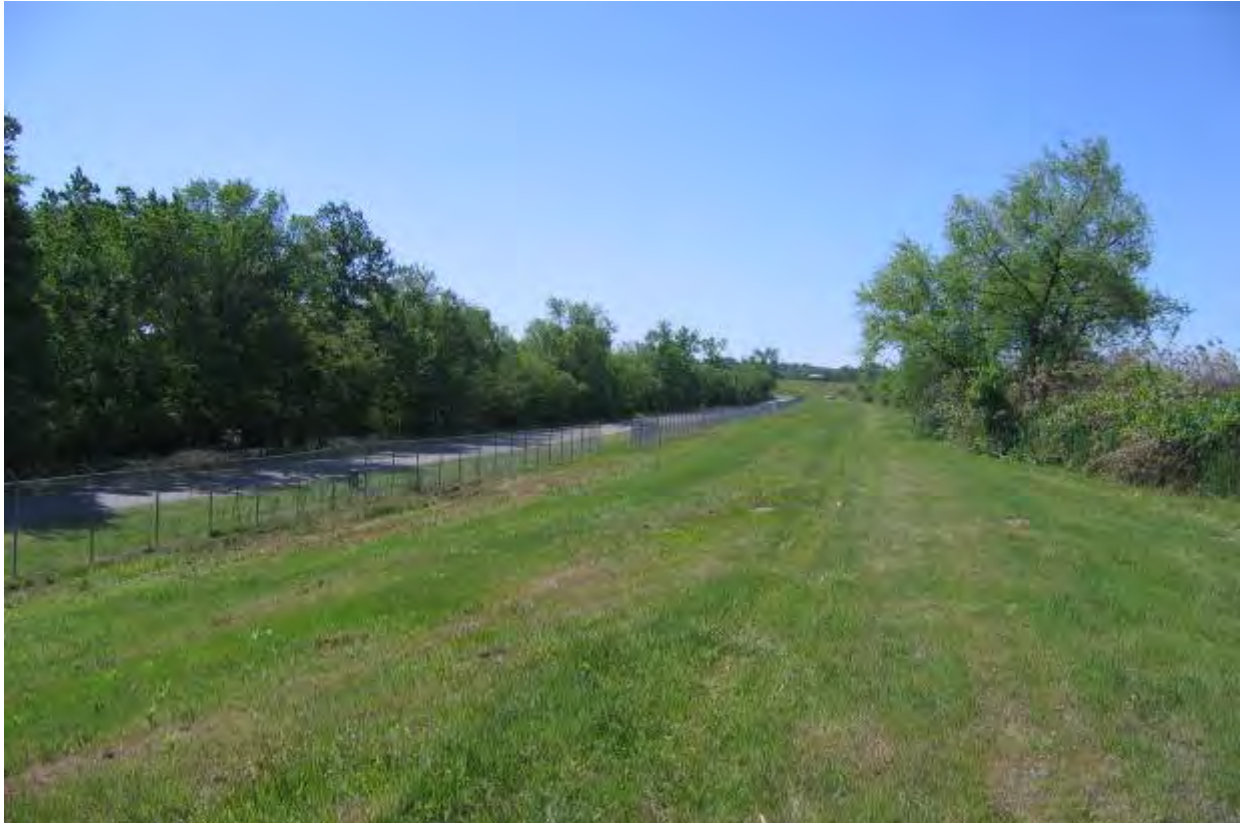
Photo Number:
10

- The crest and downstream slope of east dike were covered with well-maintained grass. The upstream slope of the east dike was overgrown with thick reedy vegetation. A few small trees were observed as well. (Photo 10) Very little of the inboard dike slope is exposed above the ash/water levels. There is mostly ash and little free water along the east dike.

Description:
View along east
dike
Note: Trees and
heavy
vegetation on
upstream slope
and
impoundment
interior

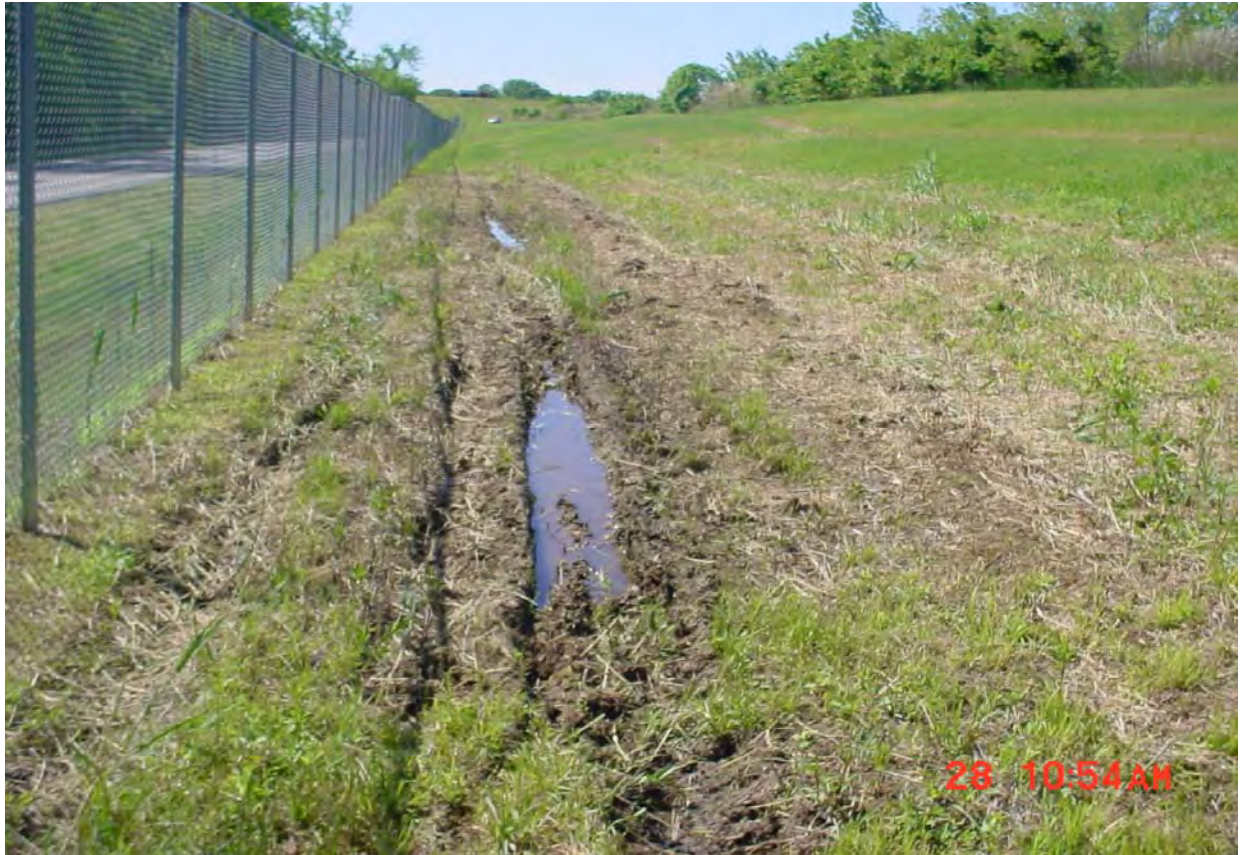
Photo Number:
11

- Several wet areas were observed at the downstream toe of the east dike. The wetness appeared to be due to poor stormwater drainage in isolated low-lying areas, but may also be related to discharge from the toe drains. Mowing tractor has created ruts in wet, soft areas that contribute to pooling of stormwater. (Photo 11)

Description:
Wet area and rutting due to tractor at toe of east dike

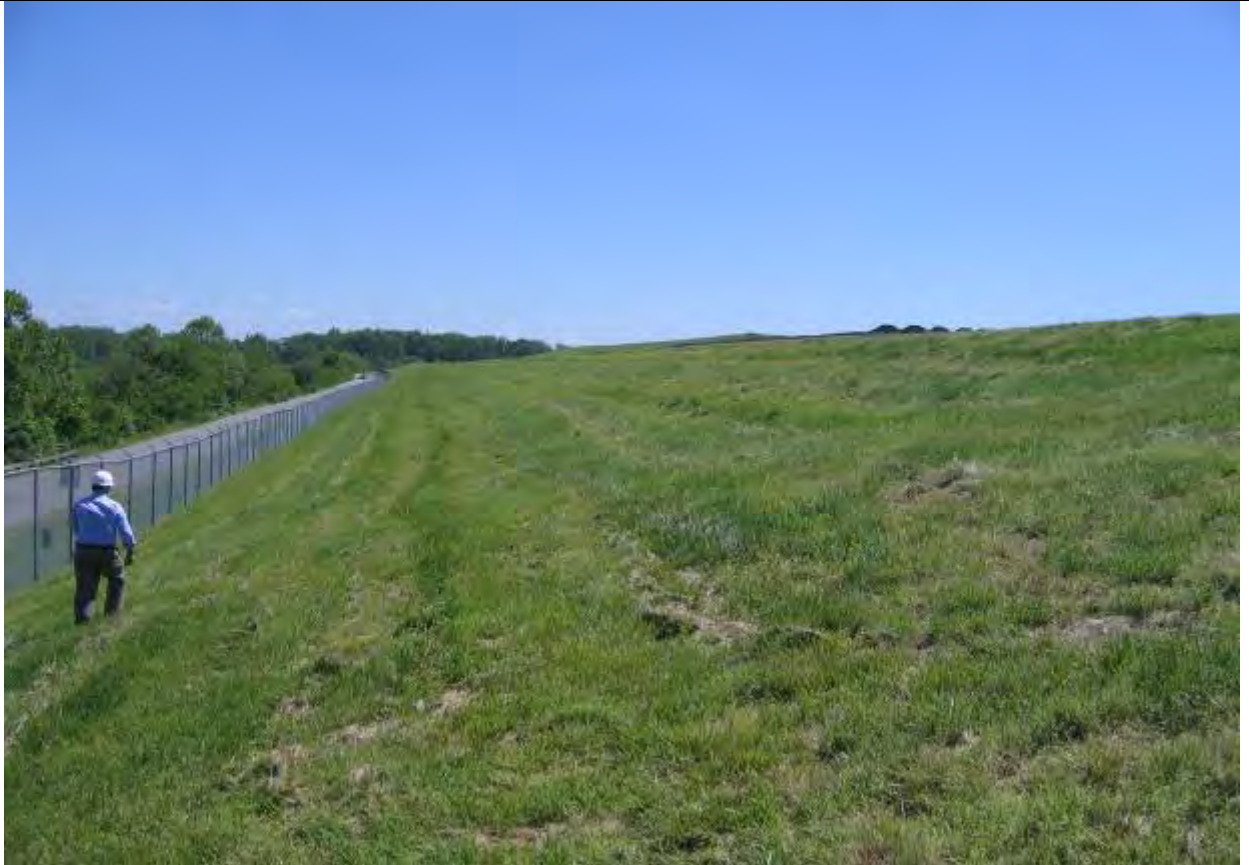
Photo Number:
1

- The outer dikes of the pond are covered with well-maintained grass. (Photo 1)
- The crest of the dikes serve as gravel-surface roads which were observed to be in good condition. (Photo 2) Some minor ponding of stormwater was observed in isolated locations on the crest.

Description:
View along
downstream
slope of north
dike

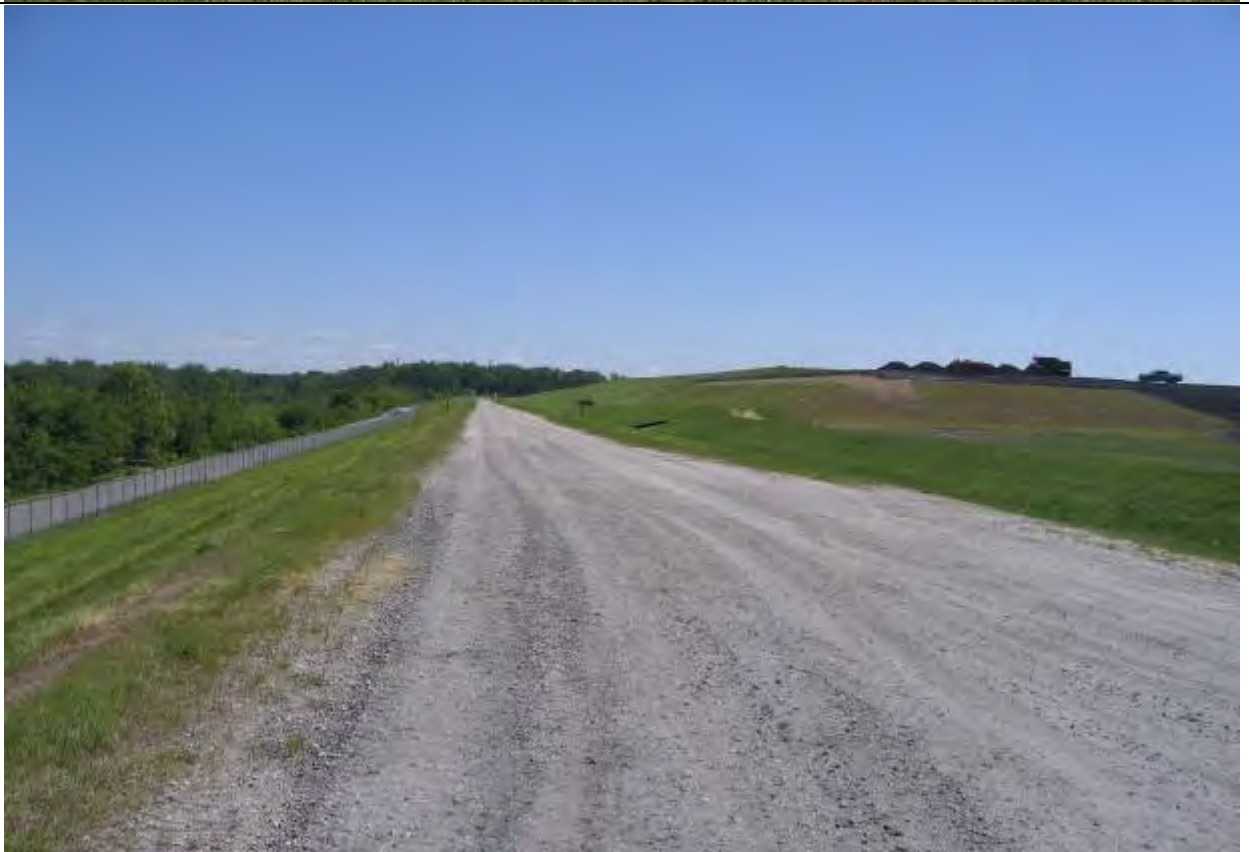
Photo Number:
2

Description:
View along
crest of north
dike

Note: Dry
disposal of ash
in the right
background

- Place additional crushed stone road base in rutted or depressed areas along the crest. Regrade to prevent ponding of stormwater and further deterioration by truck traffic.
- Clean rust from metal components of decanting tower and repaint to maintain the structural members over the long term.
- Periodically remove accumulated sediment from toe ditches along south dike and regrade to improve drainage.

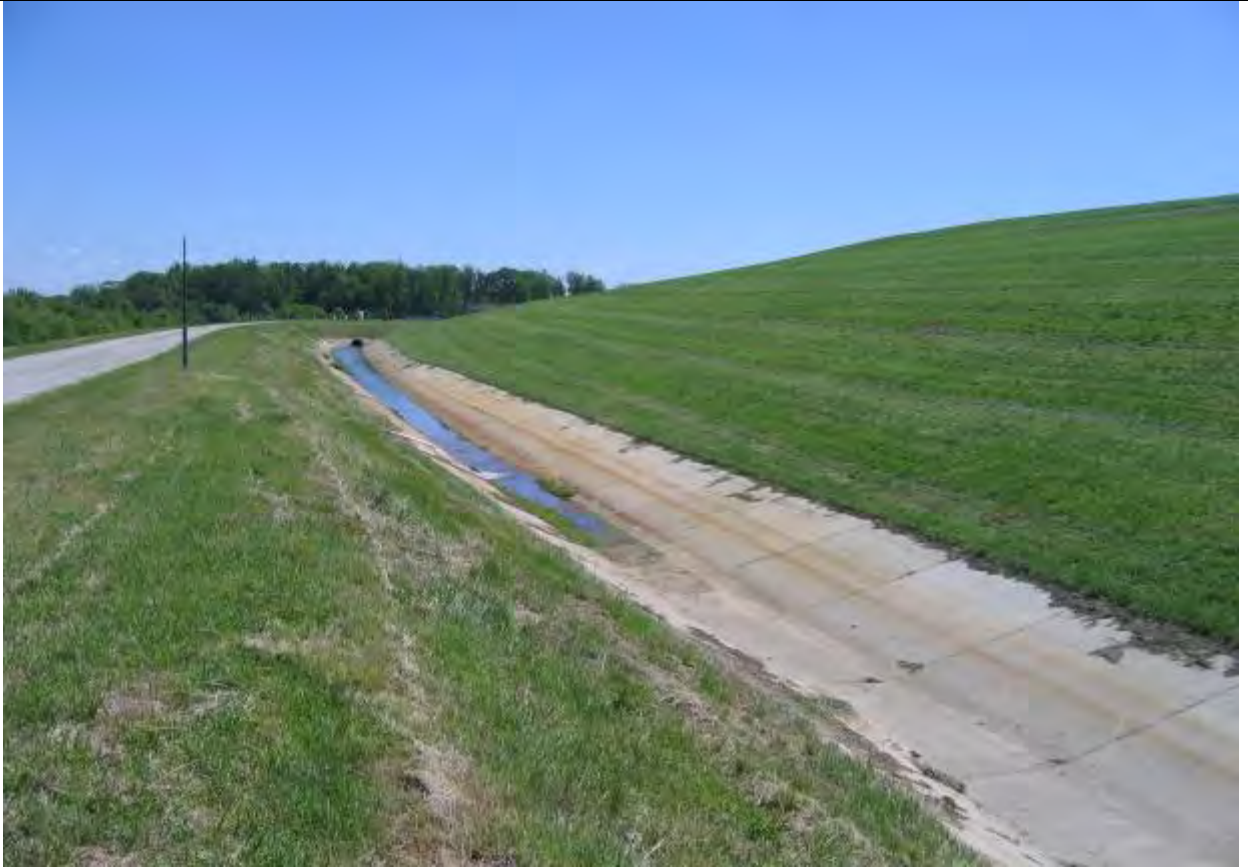
Photo Number:
3

Description:
Concrete-lined
ditches for
stormwater
management of
runoff from dry
closure areas

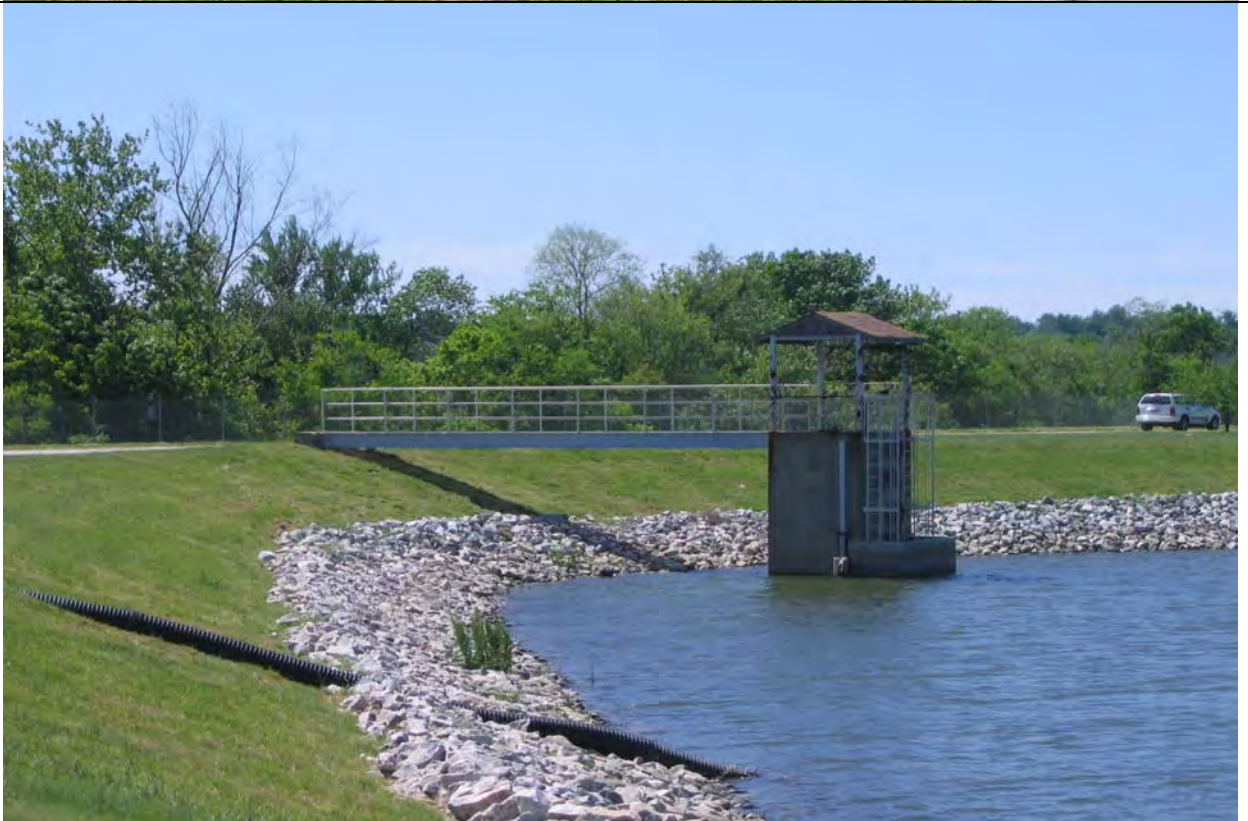
Photo Number:
4

Description:
Stormwater/
sediment pond
and outlet
structure

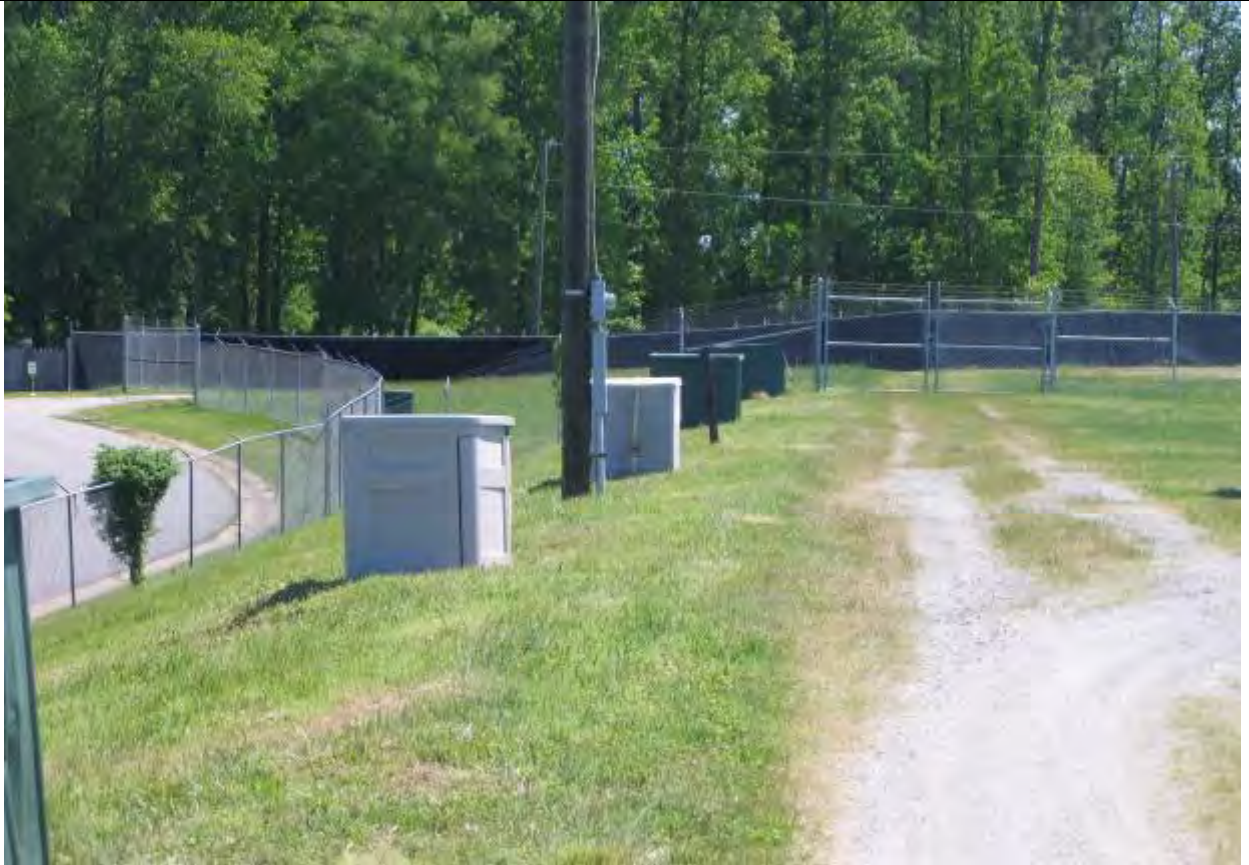
Photo Number:
5

- The relief/dewatering wells were observed at the eastern end of the north dike. These wells were formerly used to lower the phreatic surface through the dike when instability of the downstream toe berm and Henricus Park access road was experienced. The pumped wells are not currently in use but remain serviceable in the unlikely event they are needed. (Photo 5)

Description:
Relief/
dewatering
wells at
northeast
corner of upper
ash pond

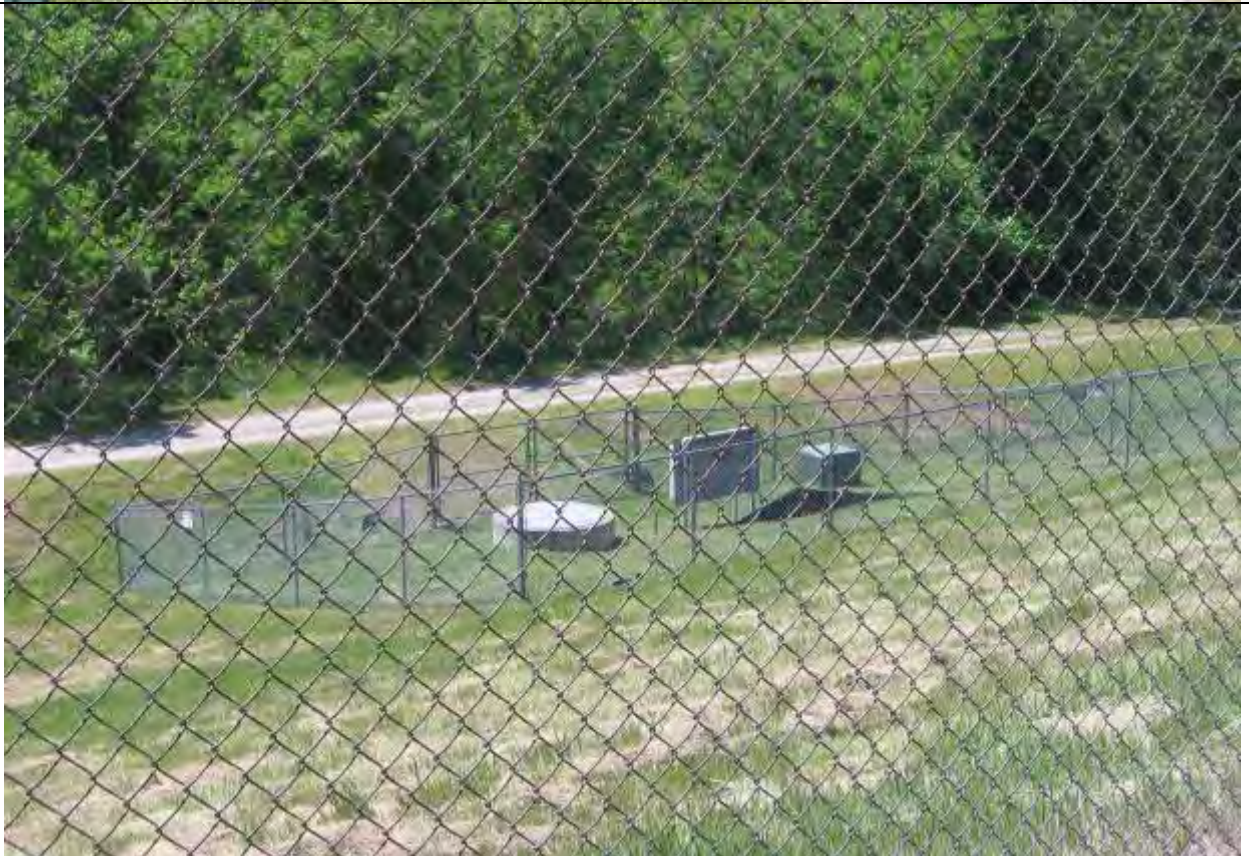
Photo Number:
6

- The toe drain pump stations, which pump to the concrete-lined ditches at the perimeter of the dry CCW disposal area, were observed to be collecting some flow and the pumps were functioning normally. (Photos 6 & 7) Drainage piping for the toe drain pump station is installed below the ground in the embankments.

Description:
Toe drain
sump/pump
station at toe of
south dike

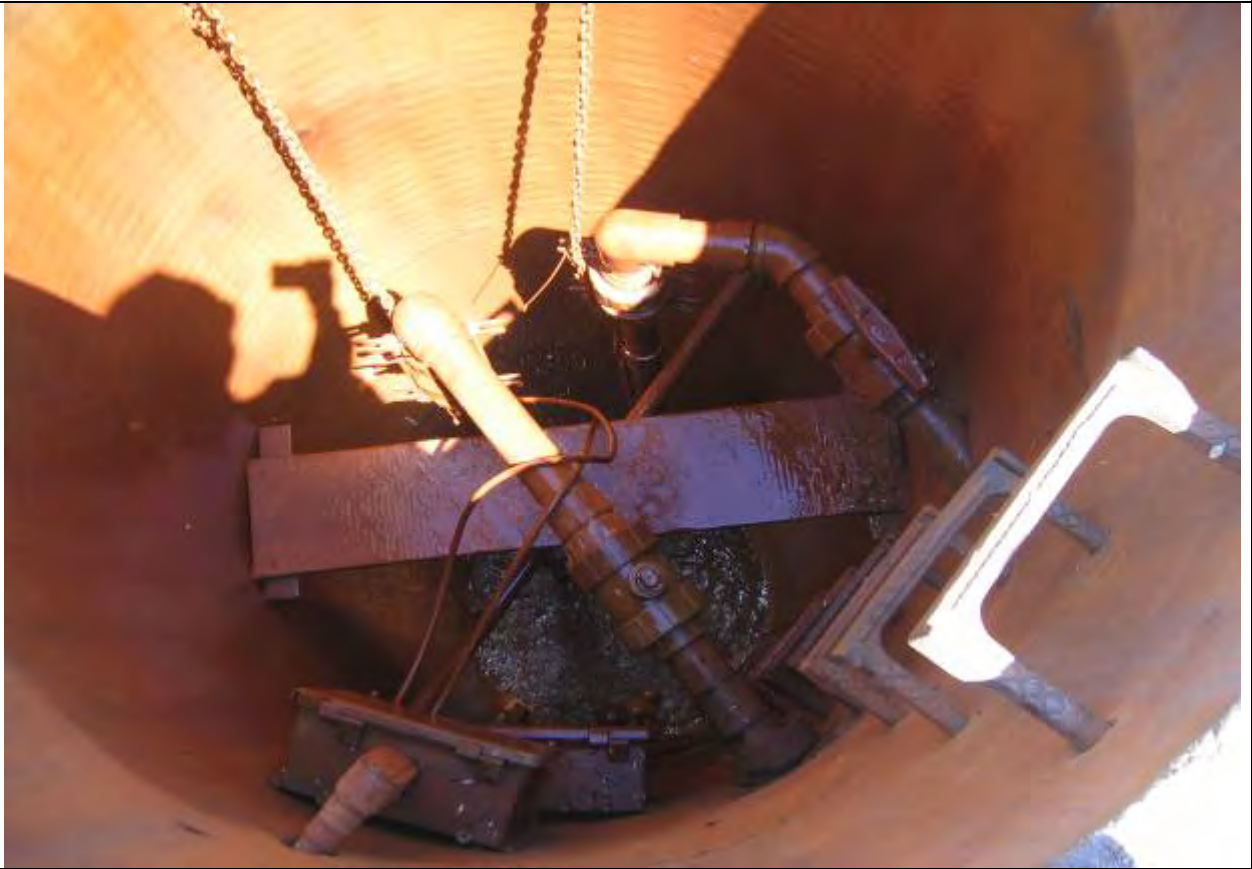
Photo Number:
7

Description:
Interior of toe
drain
sump/pump
station
