Dam Safety Assessment of CCW Impoundments

Possum Point Power Station

September 8, 2010

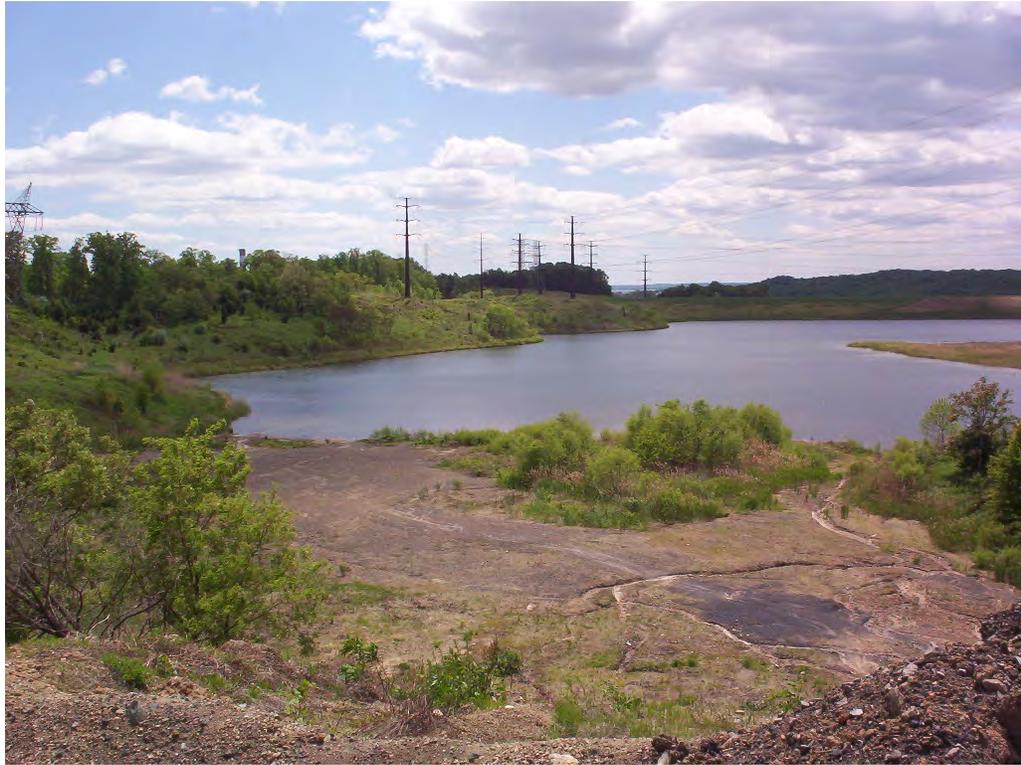
Photo Number:
1

Description:
Reservoir from
north bank.
Note dredged
material in
foreground of
picture

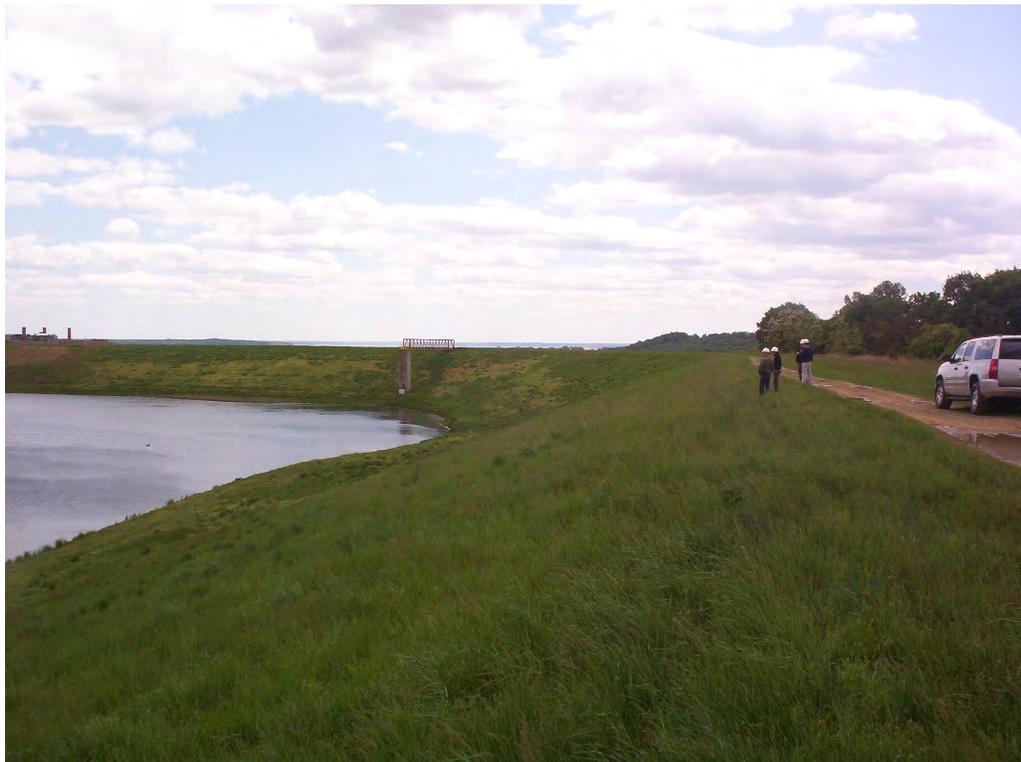
Photo Number:
2

- The upstream slope of the embankment is covered with well-tended grass, which is mowed 2-3 times per year (Appendix B – Photo 2 and 3).
- As noted in the review of the documents, Dominion Virginia Power (DVP) personnel reported that a 24-inch thick clay liner had been installed on the upstream slope of the dam. Apparently, a large amount of rain fell last year and caused minor sloughing of the slope. Ongoing repairs have included regrading and hydroseeding of the slope. At the time of the site visit, the grass had not been reestablished on the slope. This area can be seen on the left side of Photo 3 (Appendix B).

Description:
Crest of dam
looking
upstream face.

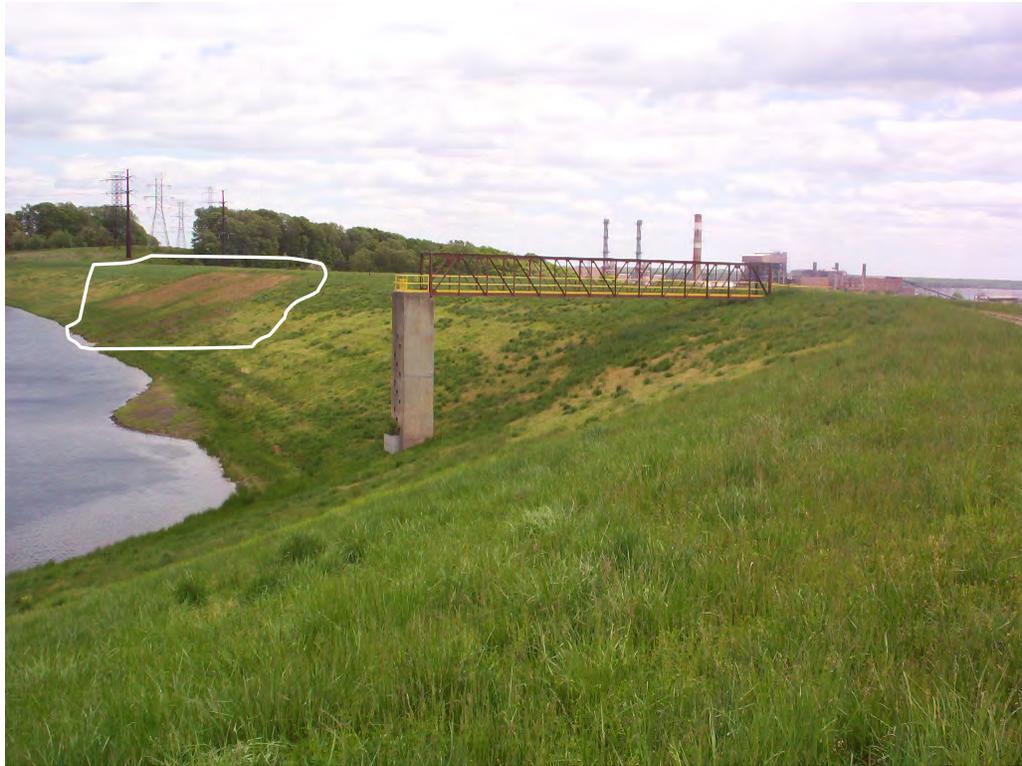
Photo Number:
3

Description:
Upstream slope of dam and decant tower. Note area of bare soil toward middle of the dam which has recently been repaired due to sloughing of soil on top of clay layer.

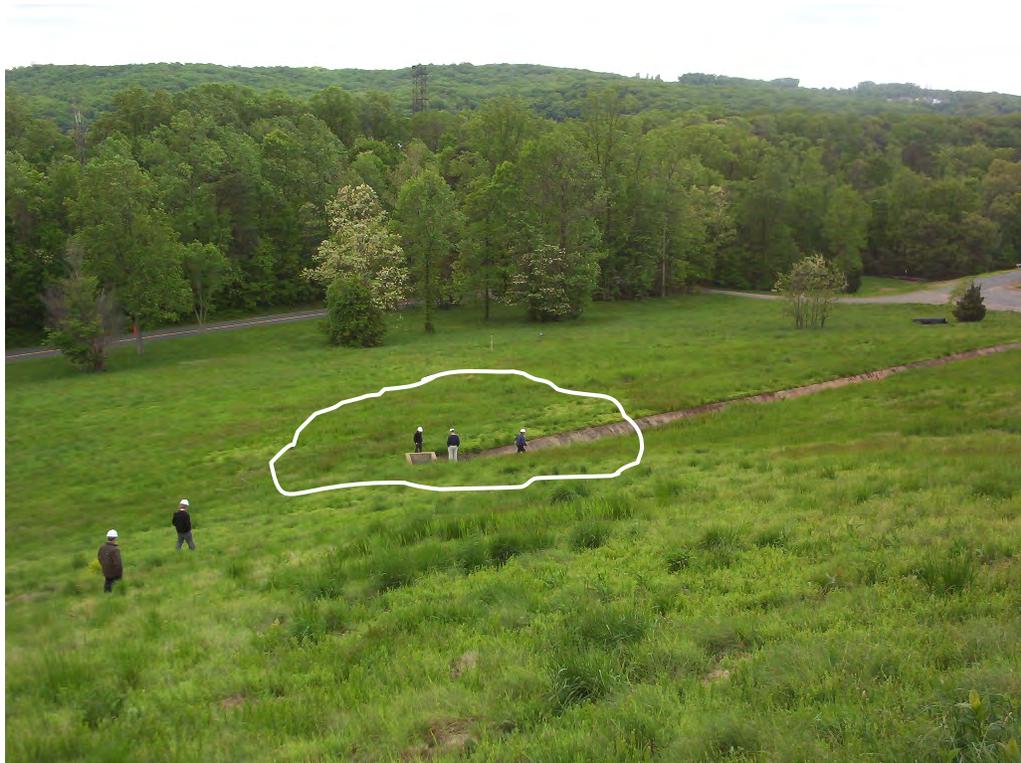
Photo Number:
4

- In the vicinity of the right abutment, there is a saturated area along the downstream slope of the embankment that appears to be below the pond water level. DVP operators stated that this area is wet throughout the year, which results in difficulty in mowing because the tractors get stuck. DVP also noted that this area was wet prior to the construction of the dam and it appears to be a perched groundwater condition at the interface between the embankment and natural ground. The area of saturation is shown by the taller grasses in Appendix B – Photo 4 and Photo 7.

Description:
Downstream slope of dam and drainage outfall structure and concrete channel. Approximate area of wetness highlighted.

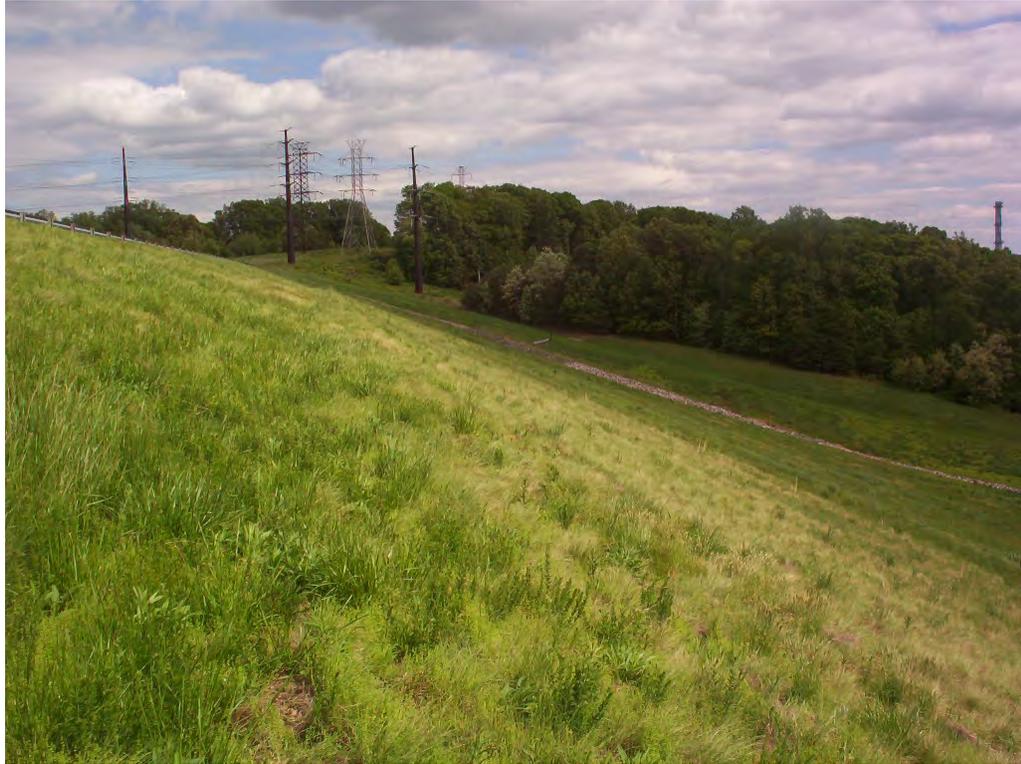
Photo Number:
5

- The downstream slope of the dam is well maintained, although there are some minor erosion gullies visible. (Appendix B – Photo 5). There are also several locations where sloughing occurred after construction. These areas have been repaired by filling with large riprap. A close examination of these areas showed no visible signs of continued movement.

Description:
Downstream
slope of dam.

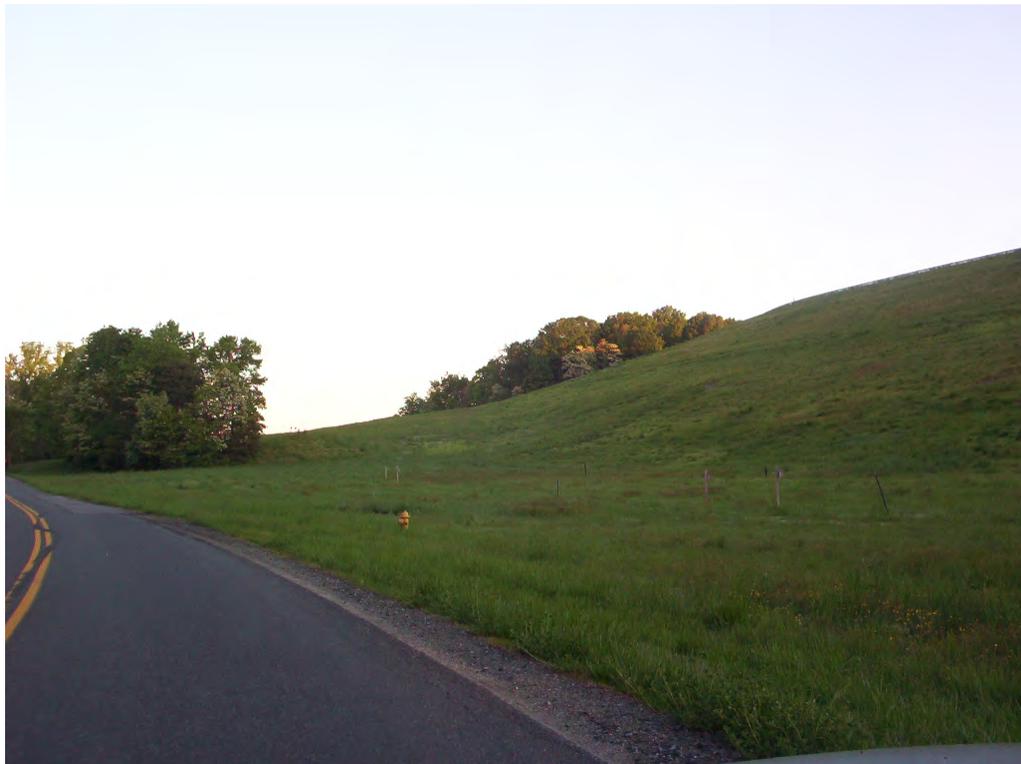
Photo Number:
6

Description:
Downstream
slope of dam.
Toe-drainage
structure near
fire-hydrant in
fore-ground

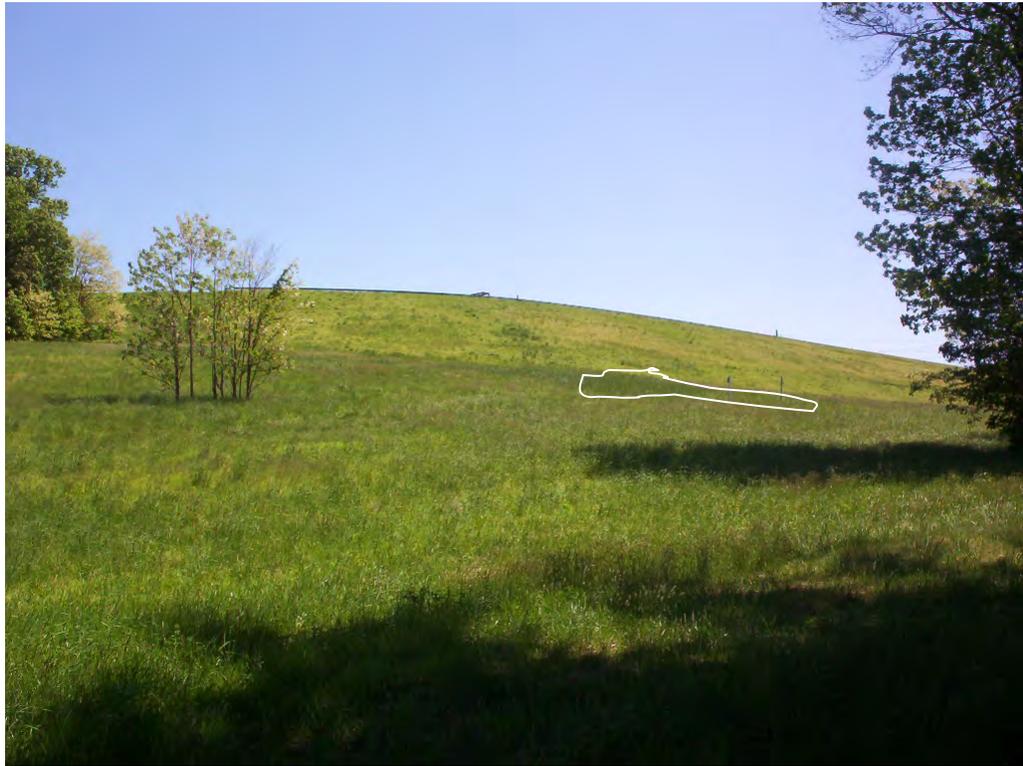
Photo Number:
7

Description:
Downstream
slope of dam.
Approximate
area of surface
wetness
highlighted.
(See also
Photo 4)

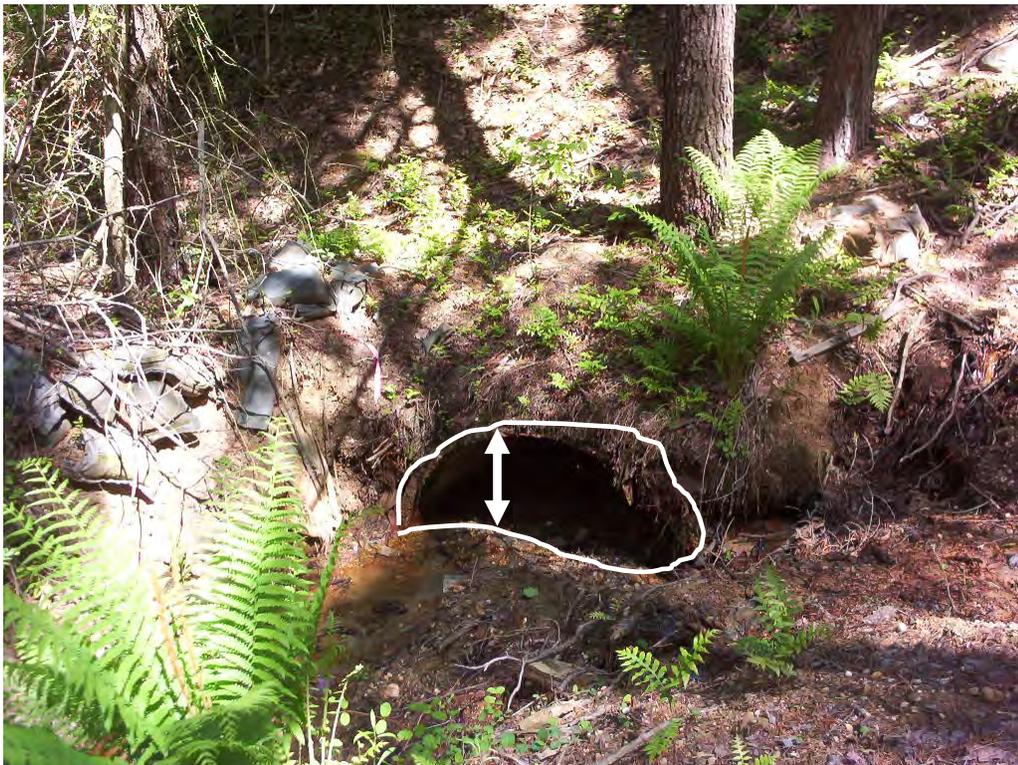
Photo Number:
8

Description:
Toe-drain outlet
pipe. Note,
sediment in
ditch only
provide 2.25'
opening in 6-
foot pipe.

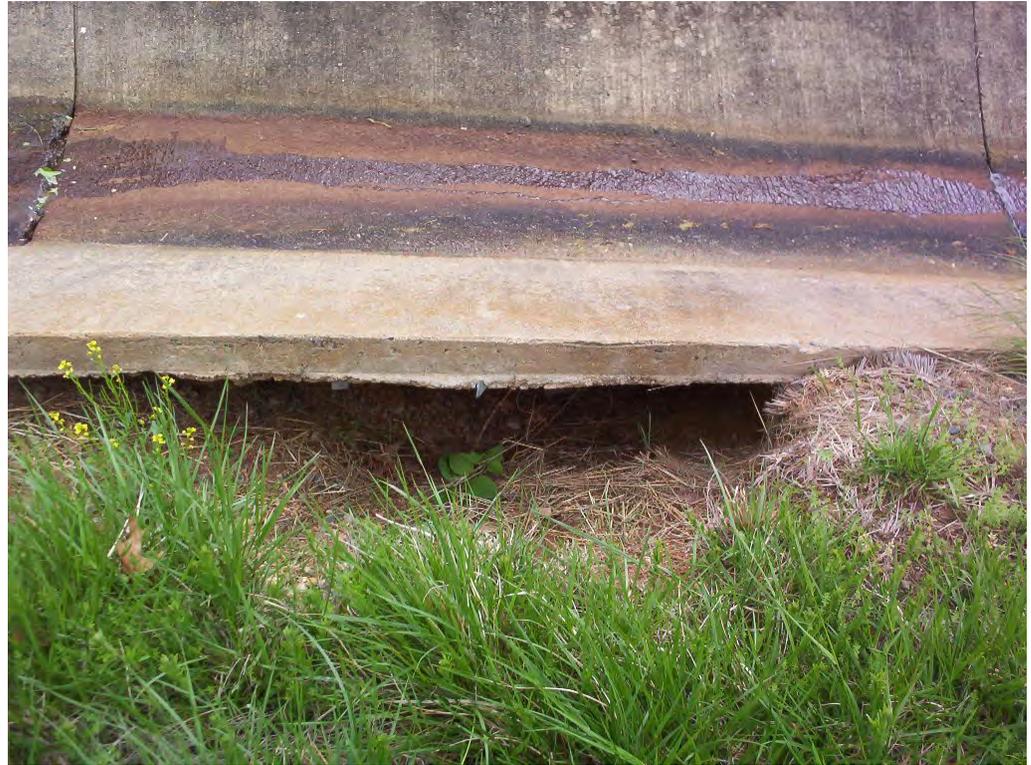
Photo Number:
9

Description:
Erosion at
downstream
concrete lined
channel from
Ash Pond D to
Ash Pond E

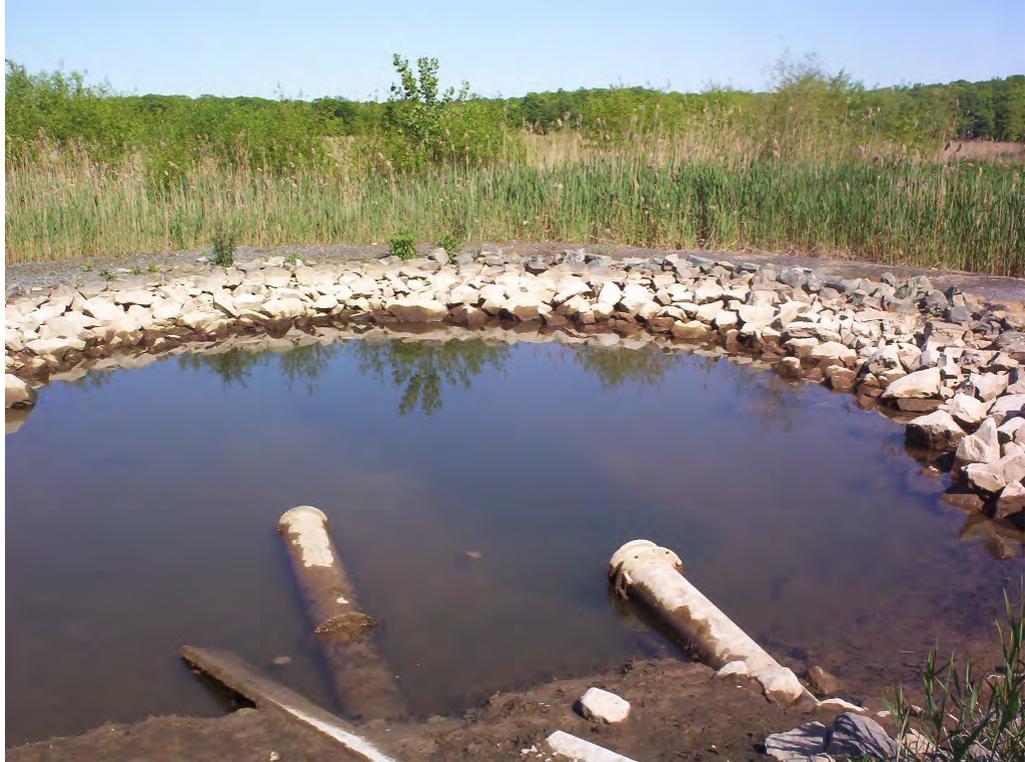
Photo Number:
1

Description:
Photo of stilling basin as pipes enter Ash Pond E

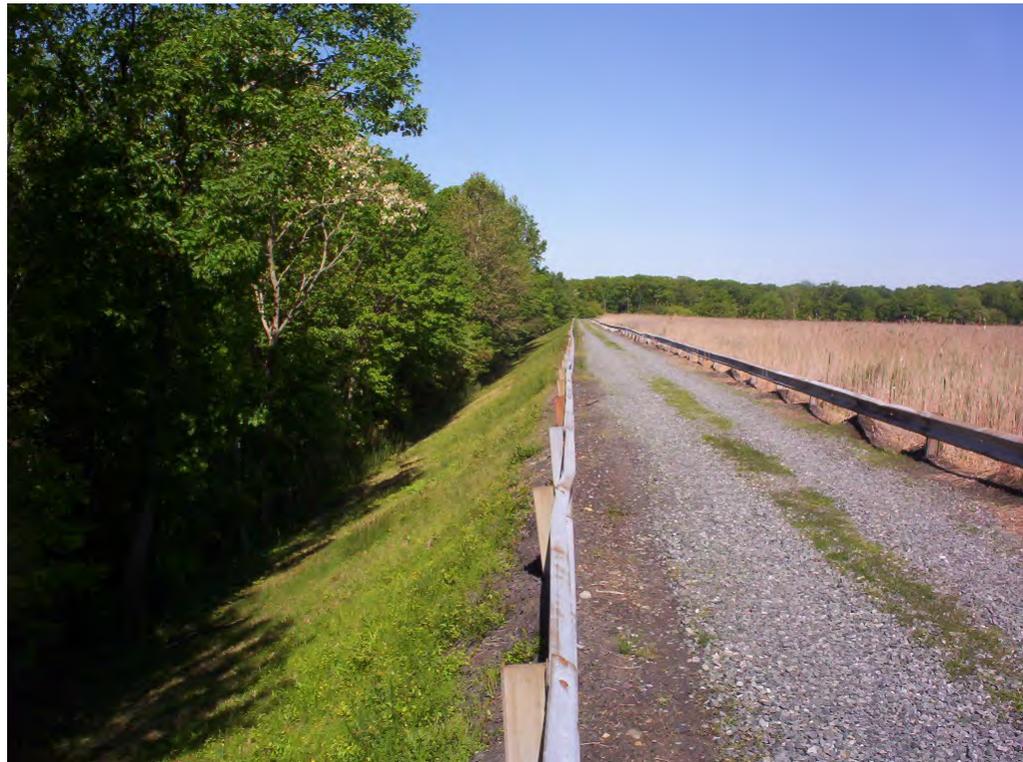
Photo Number:
2

Description:
Crest of dam looking West

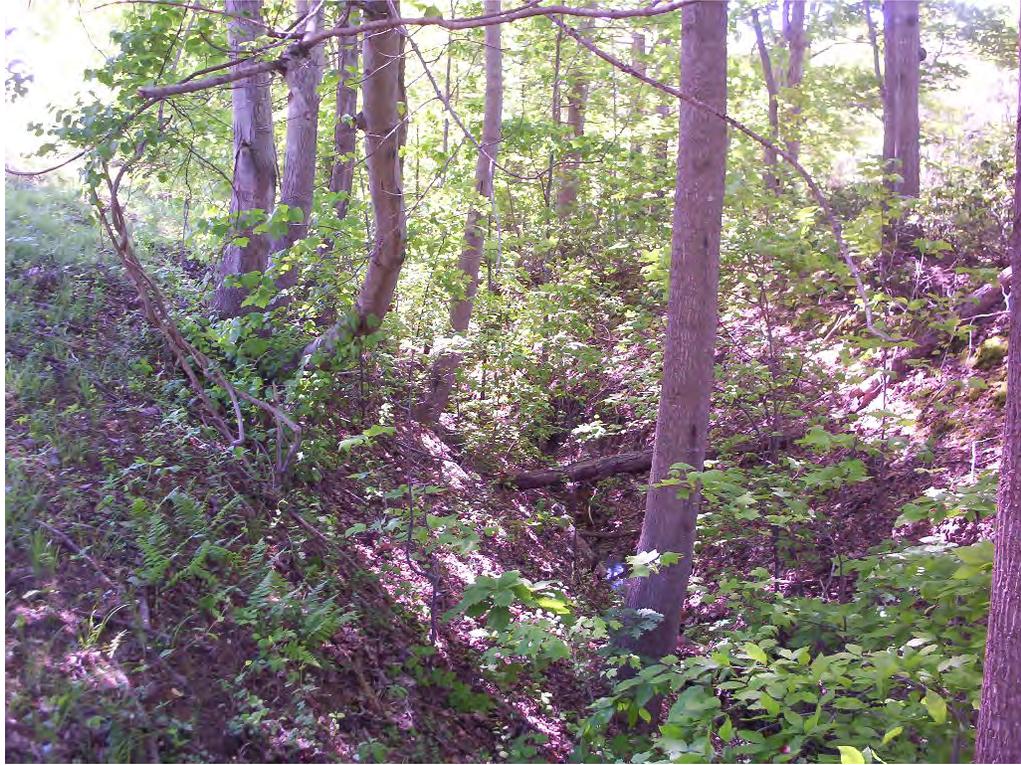
- There are trees of various size (3” dia. – 20” dia.) immediately downstream of the toe of the slope (Appendix C – Photos 3, 6, 7, and 11).
- A crushed-stone access road was constructed over the length of the crest in the area of the dam that still impounds water (not filled in with CCW). Within the past year, a layer of geotextile and riprap were placed on the upstream slope of the embankment to alleviate historical erosion. This work resulted in some crest disturbance and the crest was repaired by placing geotextile, a 3”-6” layer of dense graded aggregate, and a layer of #57 stone to provide a driving surface for maintenance vehicles (Appendix C – Photos 4, 6, 9, and 10).

Deep ditch at toe of slope

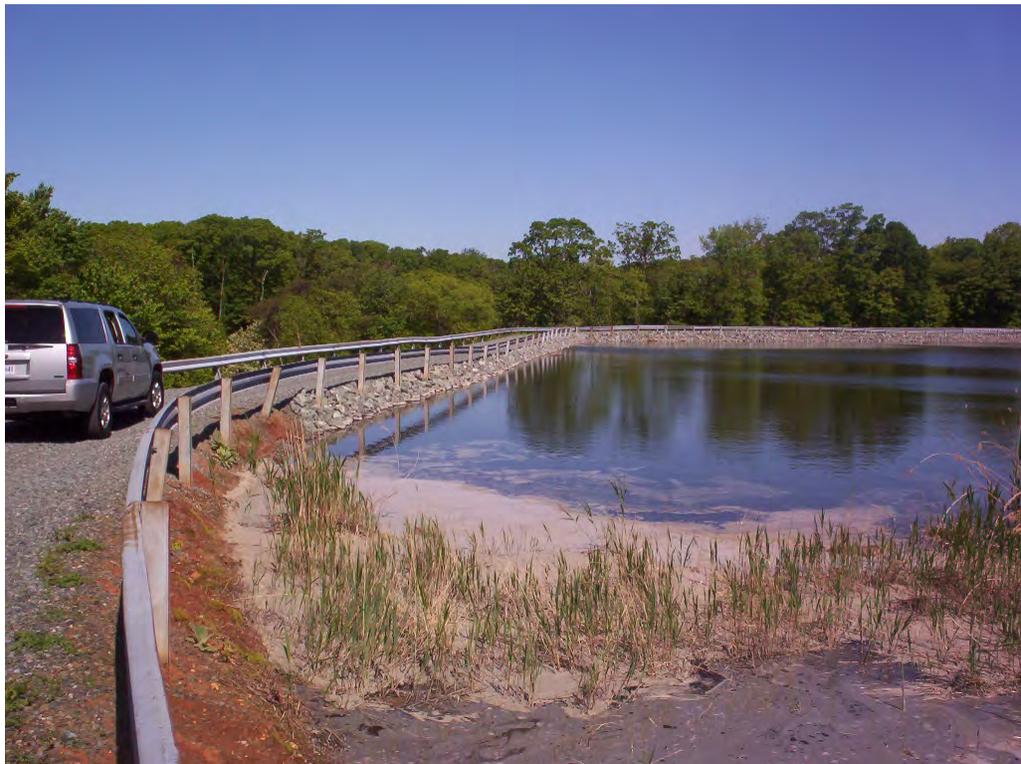
- The road appears to be in good condition; however, there is visible variation in the crest elevation, which could be an indication of differential settlement along the crest of the dam (Appendix C – Photo 4). The actual crest elevation could not be established from the site visit or the records, but it appears to vary by as much as 2 feet. The elevation difference can be seen if Photo 10 and Photo 4 are compared. Survey elevations were not obtained during the site inspection, but at the southwestern corner of the impoundment, the apparent difference between the water surface elevation and the crest of the dam was less than three feet.

View along crest of dam/upstream side. Note cenospheres in foreground and accumulated CCW

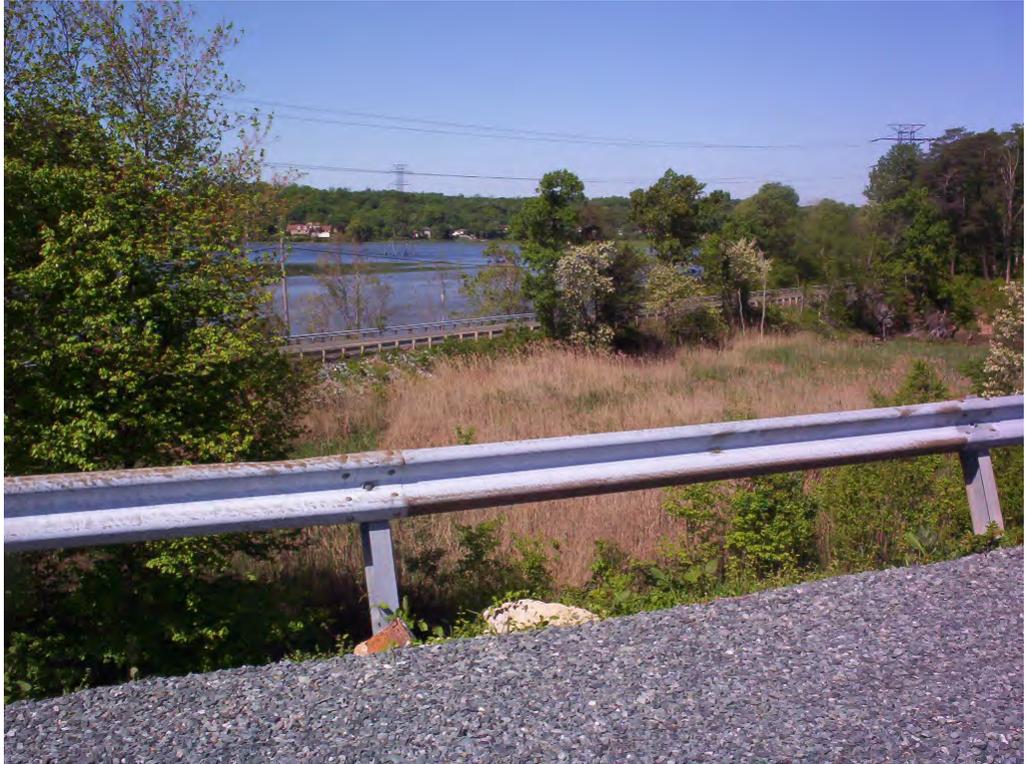
Photo Number:
5

Looking at marsh area downstream of dam and close proximity to Quantico Creek (bay).

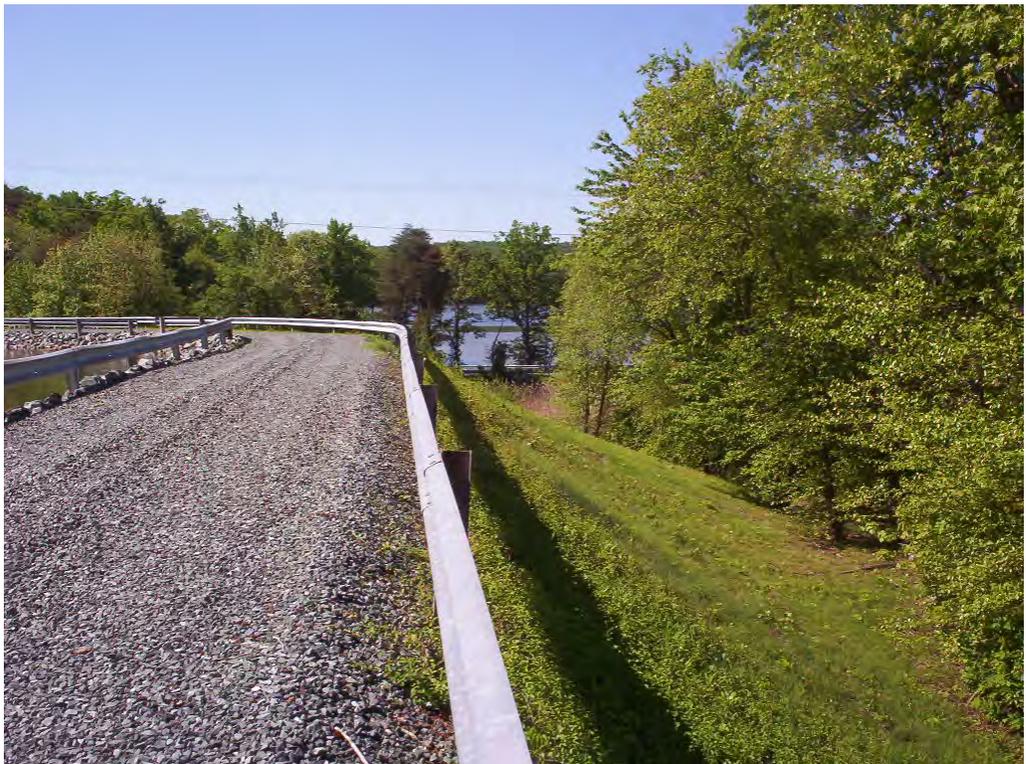
Photo Number:
6

Description:
Crest of dam looking at downstream slope. Notice trees encroaching on toe of dam.

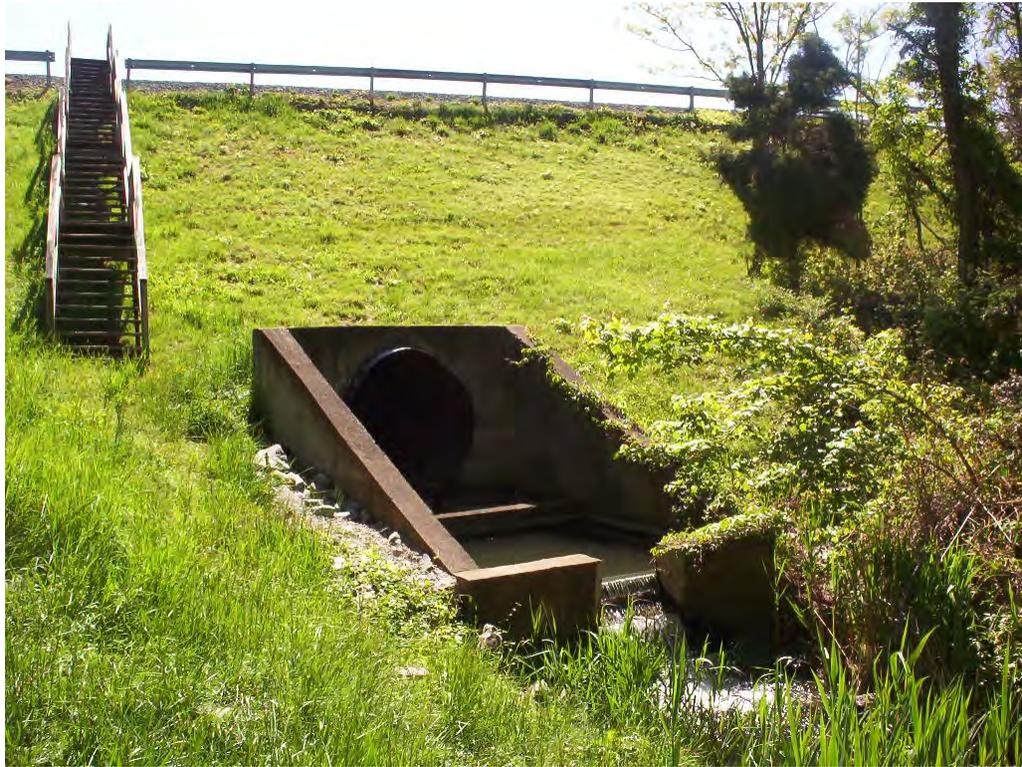
Photo Number:
7

- The outlet structure appeared to be in good condition and functioning normally (Appendix C – Photo 7 and Photo 8). However, the operators adjust the pond elevation by inserting or removing stop logs at the spillway drop inlet and it could not be determined if there is adequate freeboard between the maximum pool elevation and the low point on the crest of the embankment.

Description:
Outfall
Structure.
Steps on left
provide access
from the crest
of the dam.
Monthly VPDES
samples are
collected at this
location.

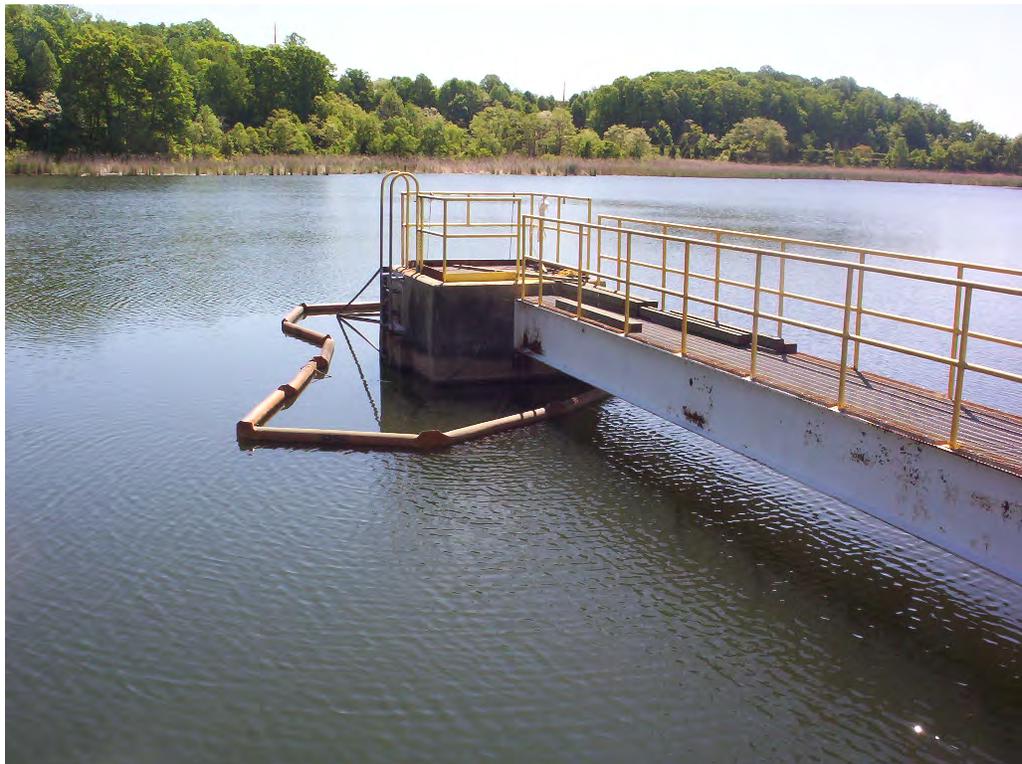
Photo Number:
8

Description:
Decant
structure. Note
boom on
surface to
prevent
floatables from
entering
discharge pipe.

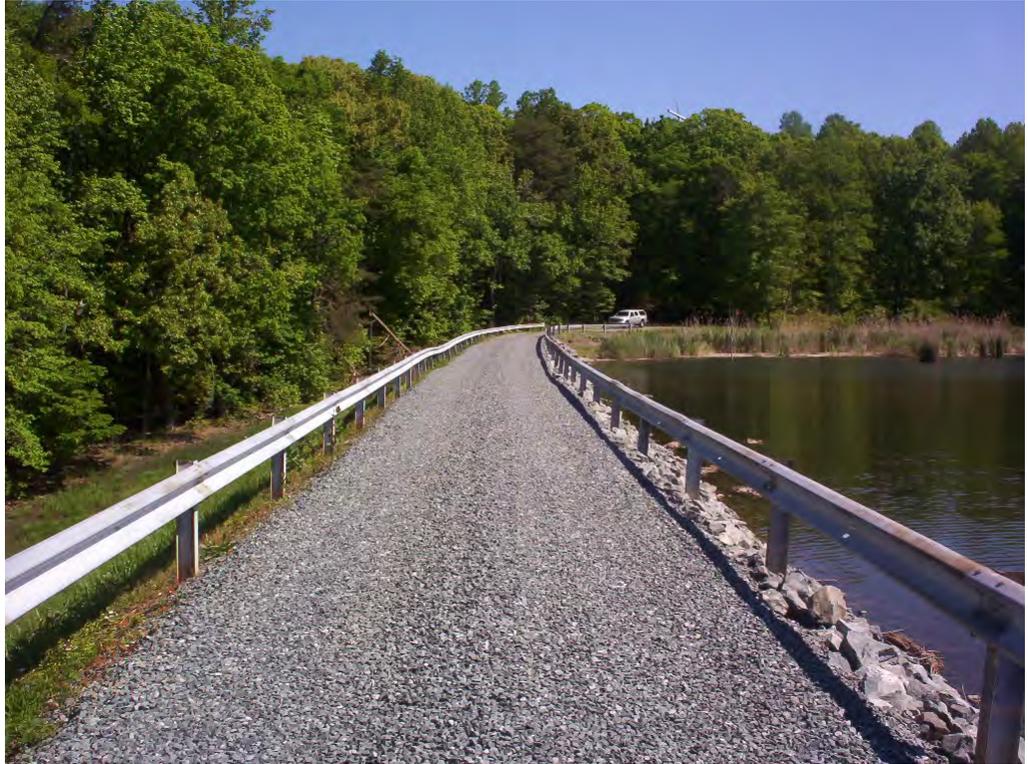
Photo Number:
9

Description:
Crest of dam.
Noted gravel
driving surface
and rip-rap on
upstream face
of dam.

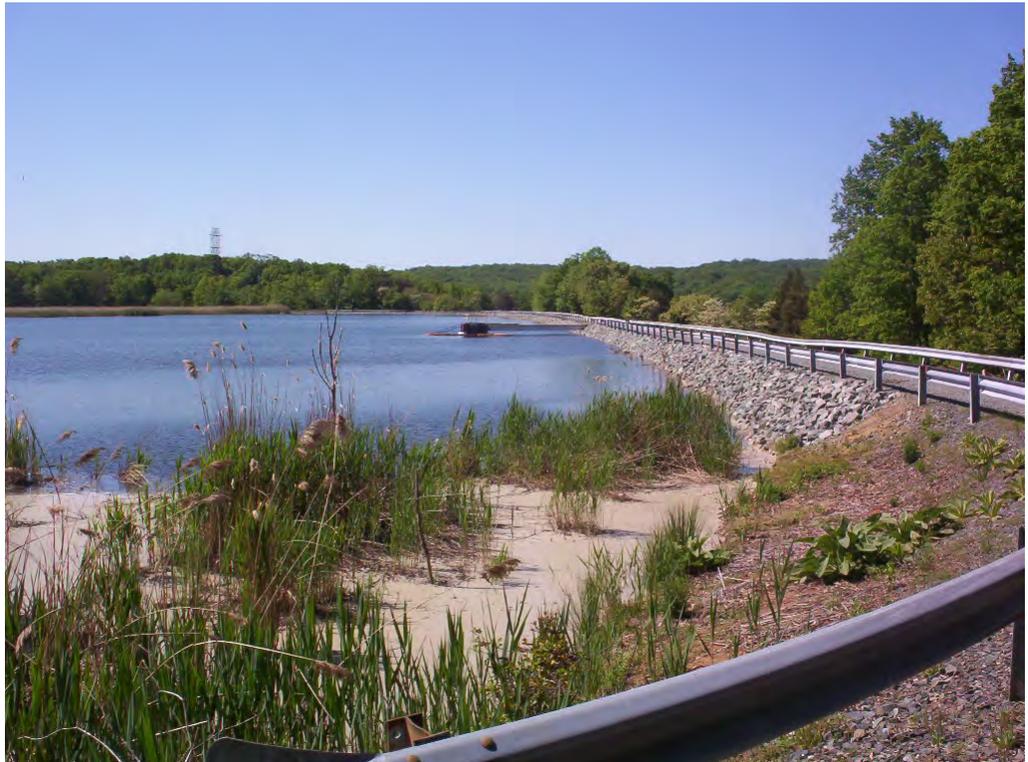
Photo Number:
10

Description:
Upstream face
of dam.

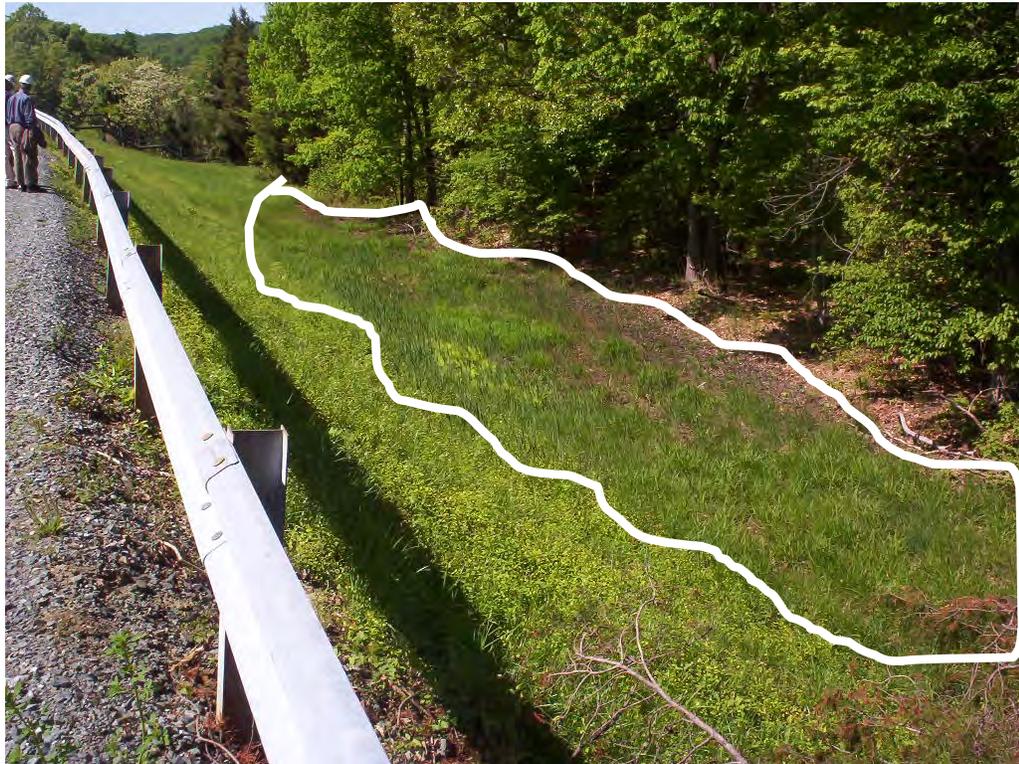
Photo Number:
11

- Between the outlet structure and the northwestern end of the embankment, there appears to be some seepage along the toe that extends partially up the downstream slope of the dam. DVP noted that this area is monitored, as it is often wet and difficult to mow (Appendix C – Photo 11). It is estimated that the saturated soil extends approximately 1/3 of the height of the embankment at this location.

Description:
Downstream
slope of dam.
Approximate
area of wet
slope outlined,
potential
seepage or poor
drainage issues.
