US EPA ARCHIVE DOCUMENT

DRAFT REPORT

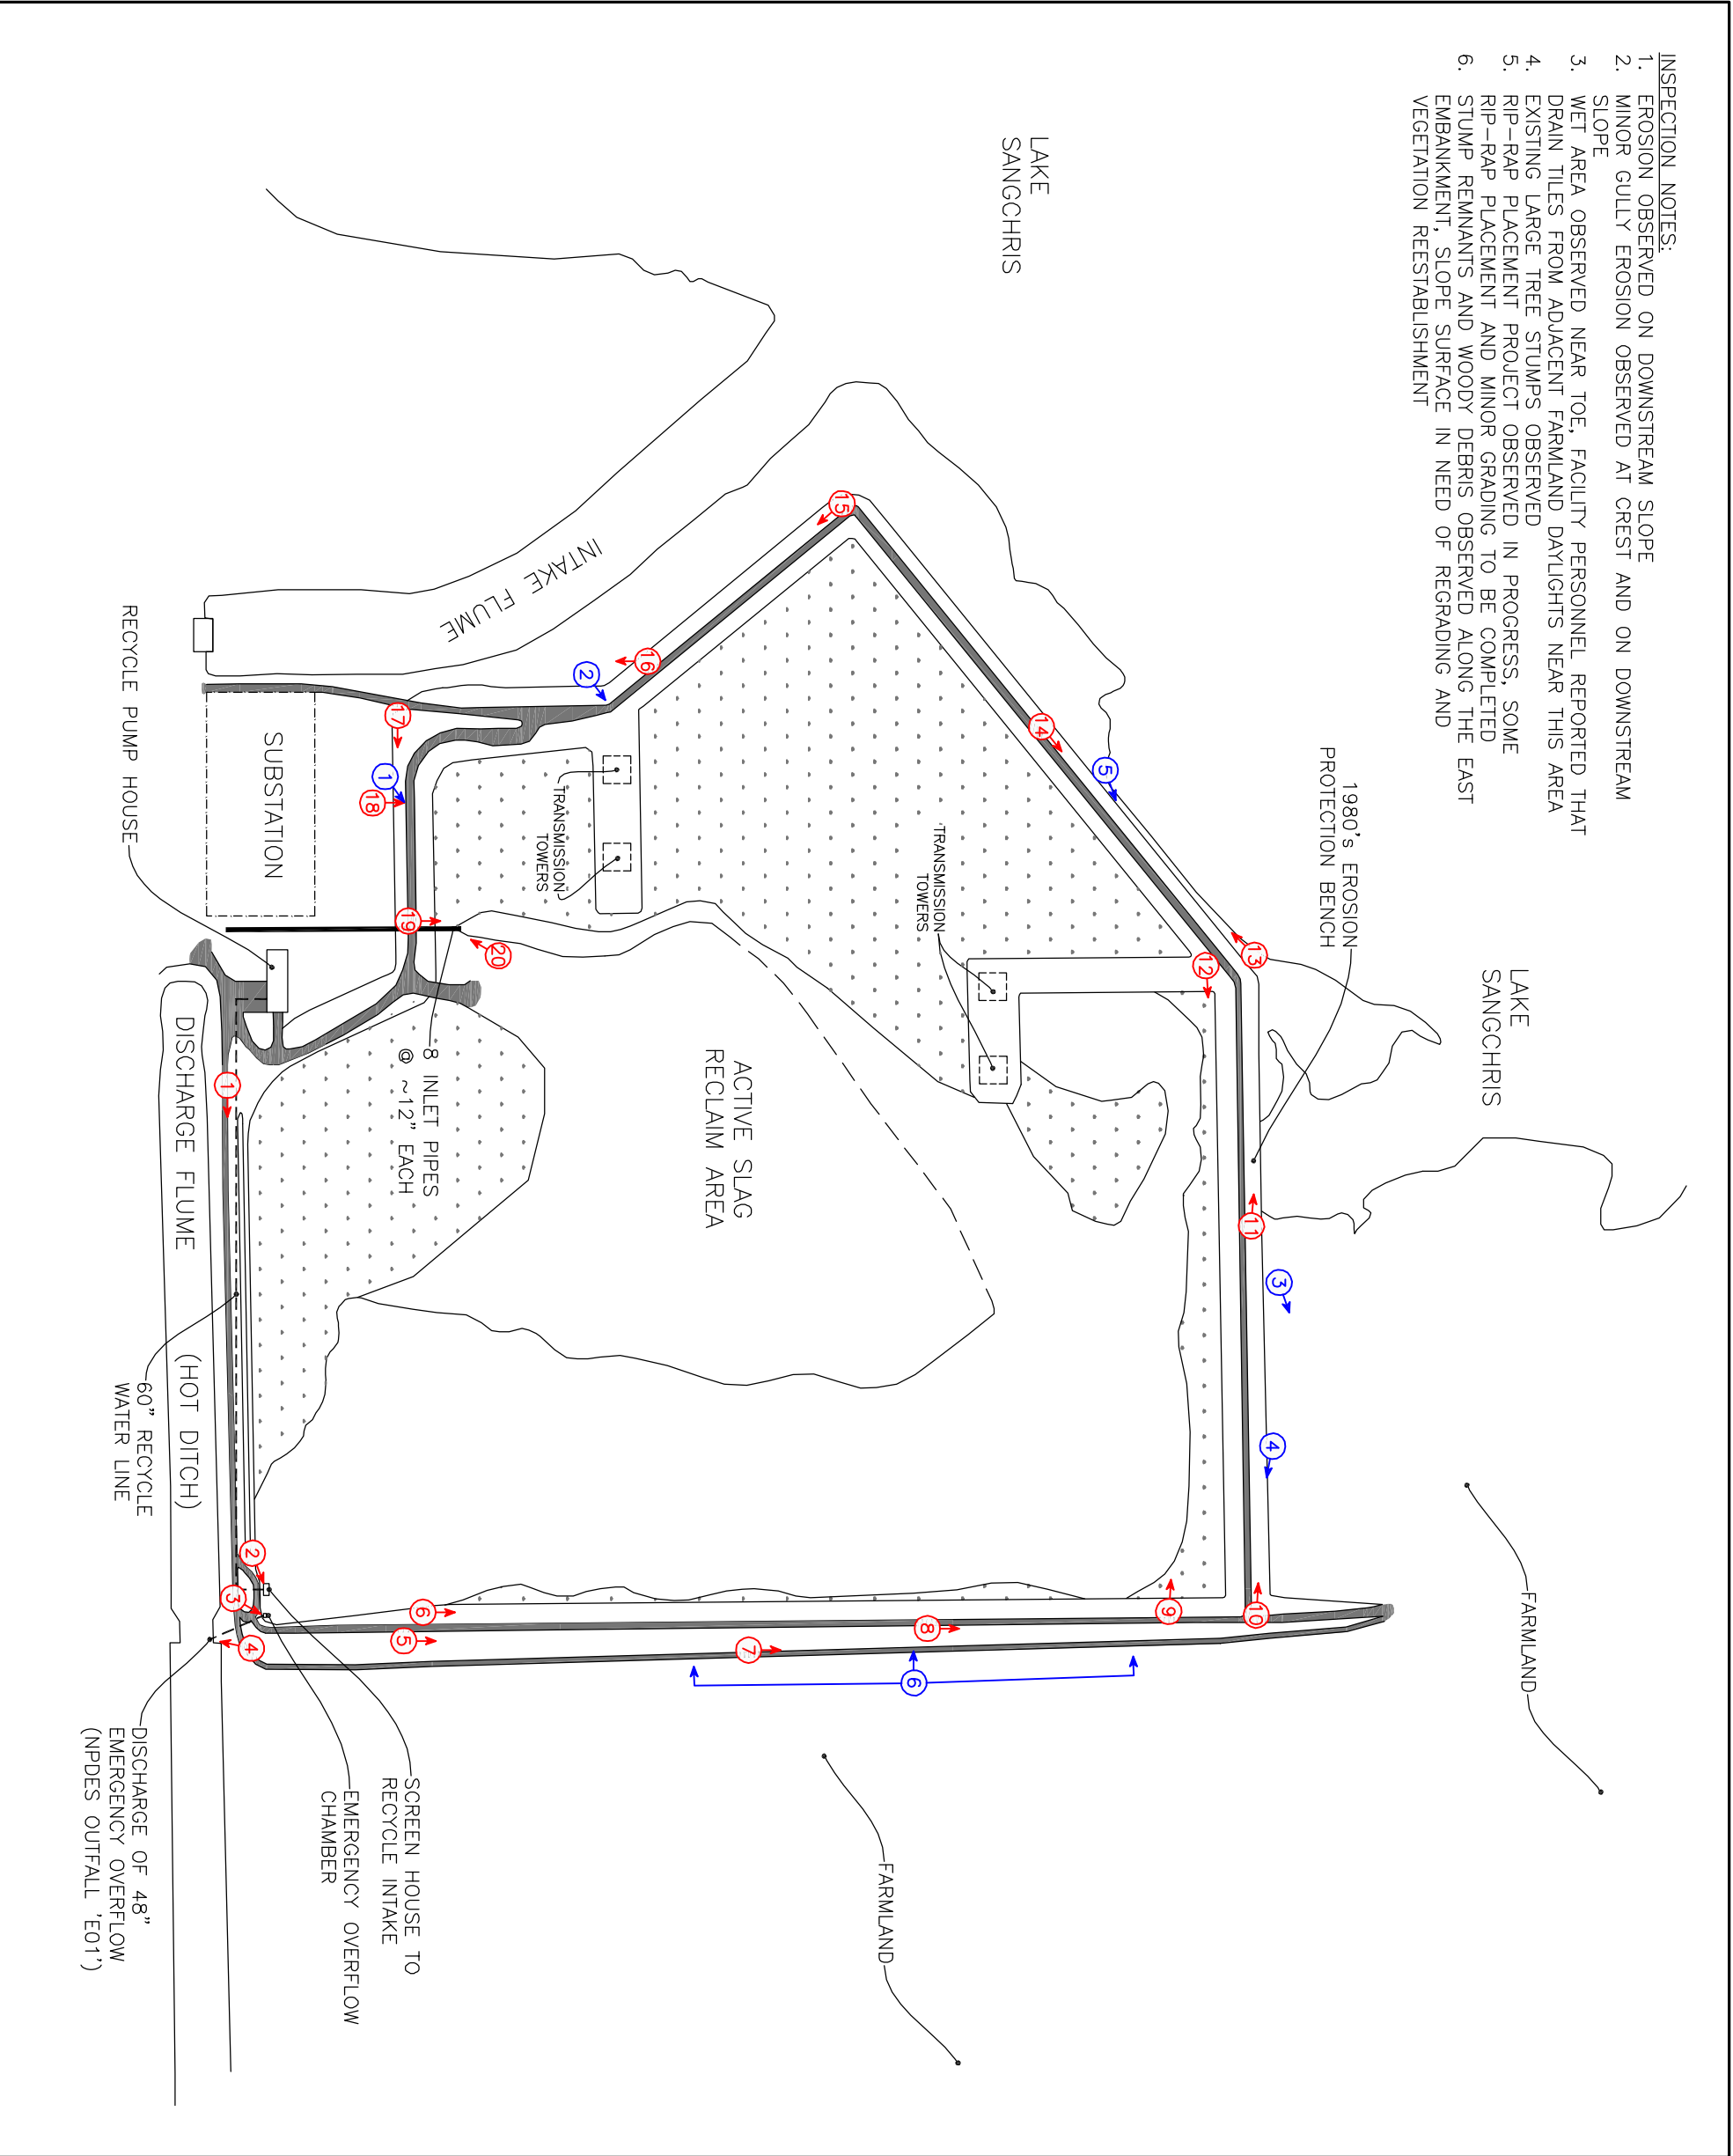
- INSPECTION NOTES:**
1. EROSION OBSERVED ON DOWNSTREAM SLOPE
 2. MINOR GULLY EROSION OBSERVED AT CREST AND ON DOWNSTREAM SLOPE
 3. WET AREA OBSERVED NEAR TOE, FACILITY PERSONNEL REPORTED THAT DRAIN TILES FROM ADJACENT FARMLAND DAYLIGHTS NEAR THIS AREA
 4. EXISTING LARGE TREE STUMPS OBSERVED
 5. RIP-RAP PLACEMENT PROJECT OBSERVED IN PROGRESS, SOME RIP-RAP PLACEMENT AND MINOR GRADING TO BE COMPLETED
 6. STUMP REMNANTS AND WOODY DEBRIS OBSERVED ALONG THE EAST EMBANKMENT, SLOPE SURFACE IN NEED OF REGRADING AND VEGETATION REESTABLISHMENT

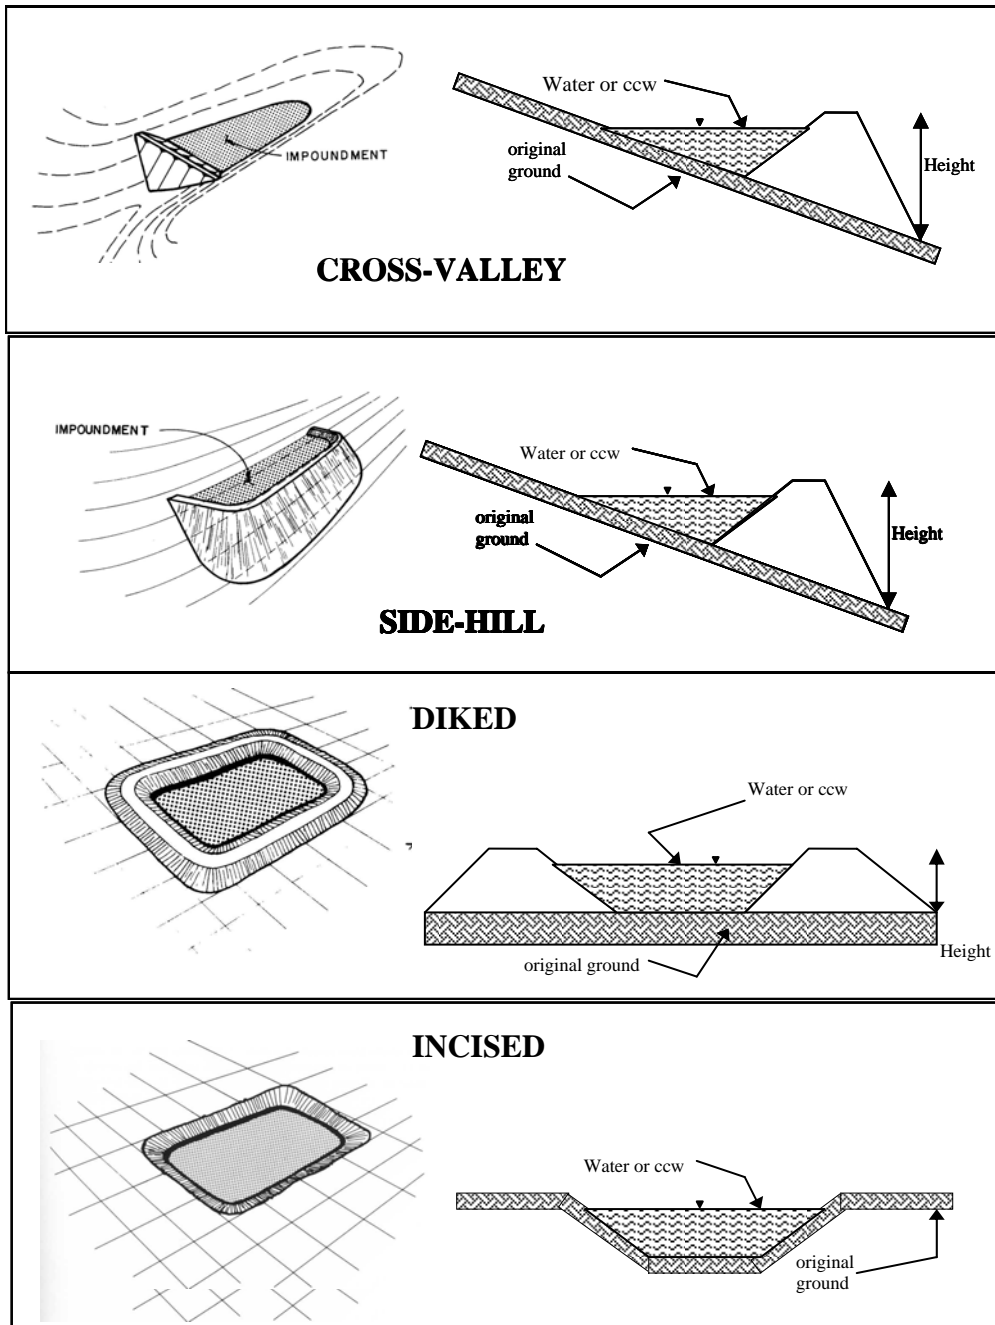
Cross-Valley
 Side-Hill
 Diked (All 7 sides)
 Incised (form completion optional)
 Combination Incised/Diked

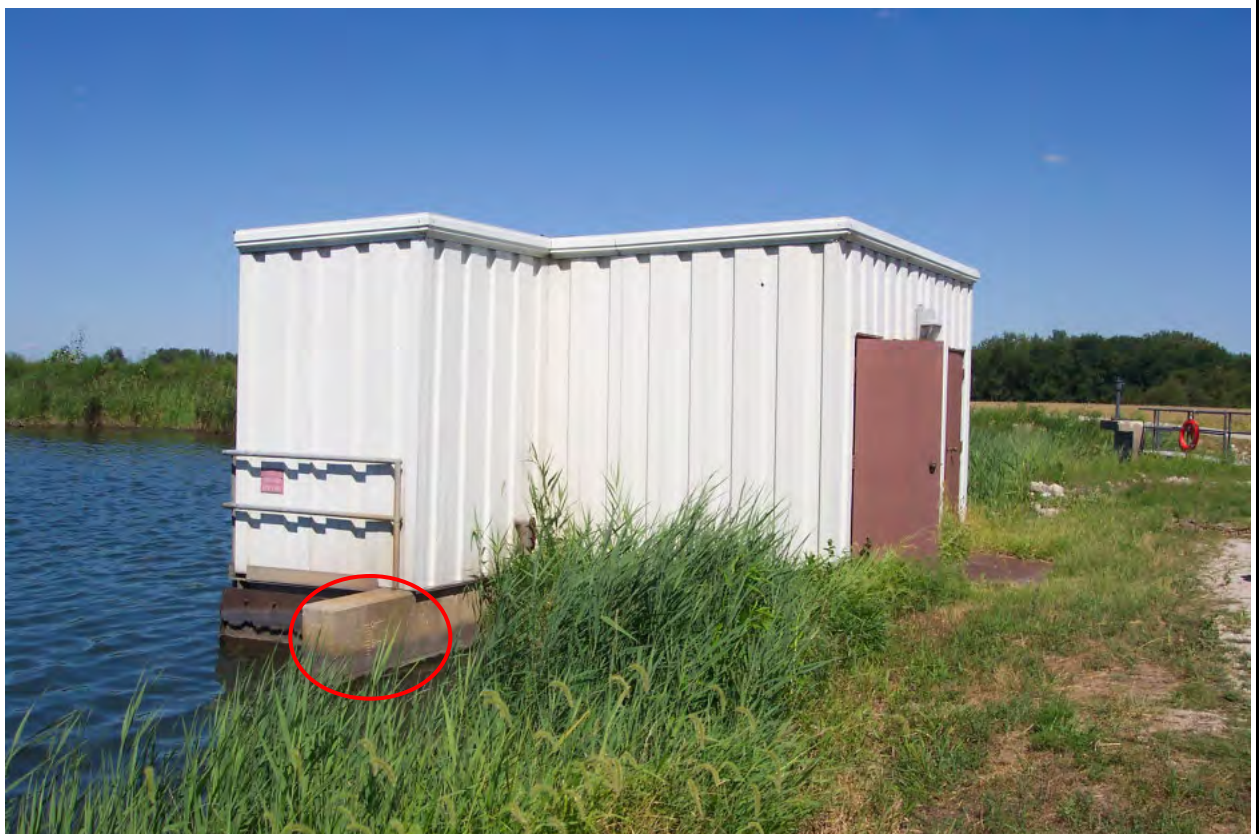
Note gage markings on building foundation. This level observed/recorded multiple times daily.

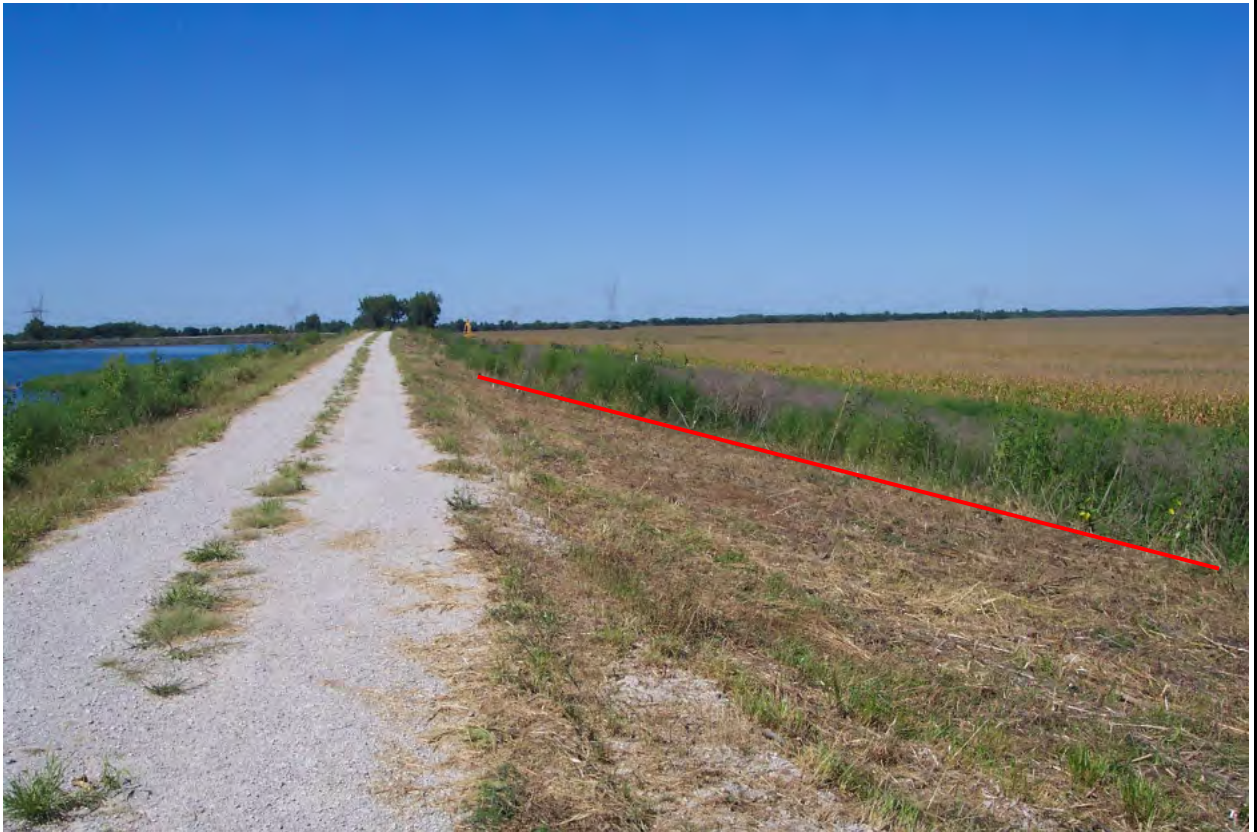
Note condition
of mowed area
versus not
mowed area

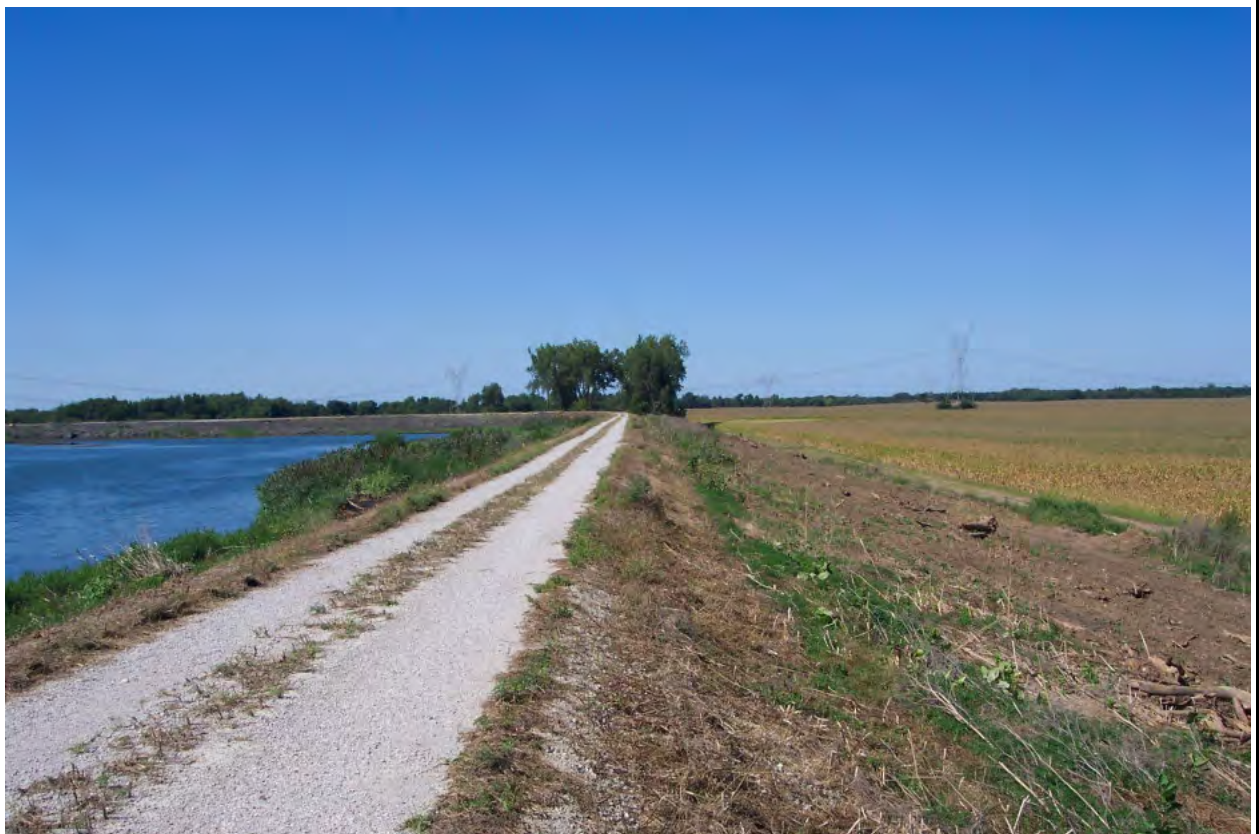
Note condition of downstream embankment slope where grubbing has been recently completed

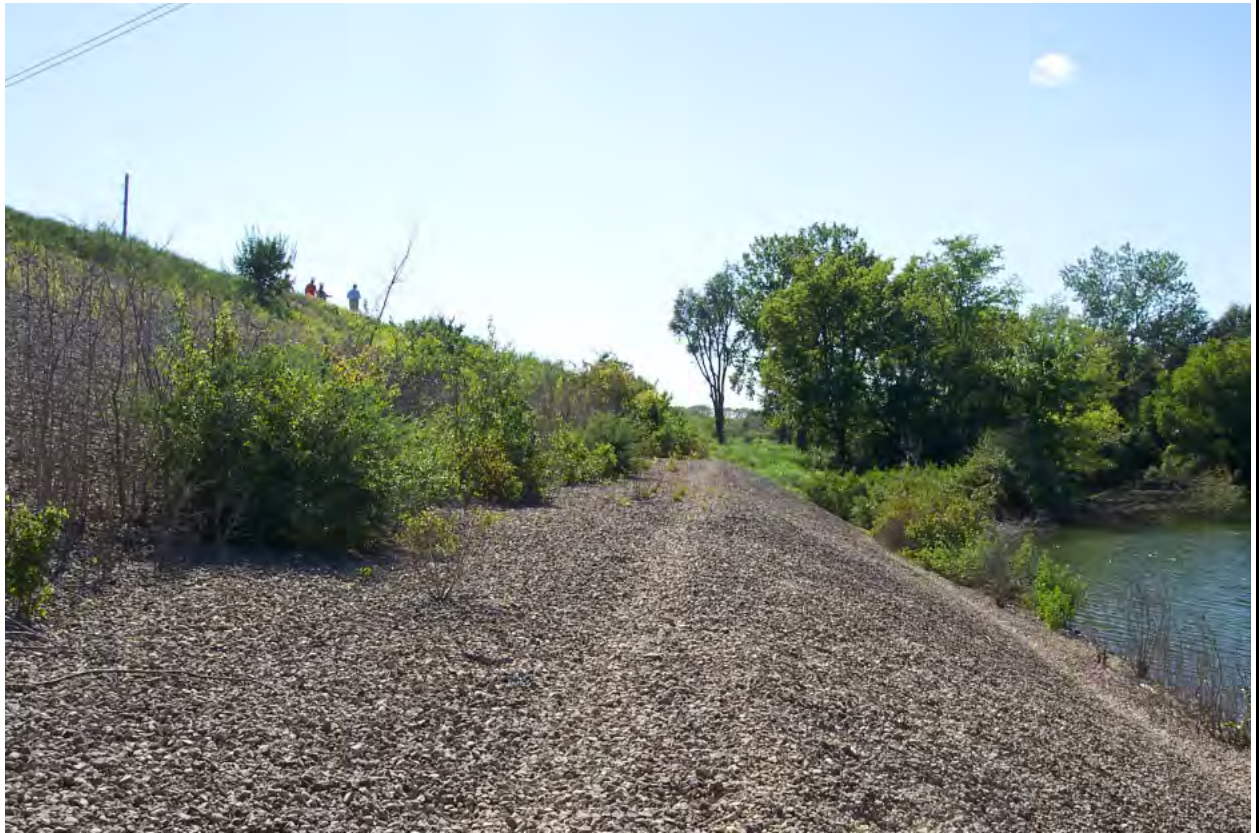
Description:
View along section of north embankment, area repaired to protect against wave erosion in 1980's
