# Assessment of Dam Safety

## Coal Combustion Surface Impoundments (Task 3)

Dayton Power &  
Light Company

JM Stuart Station

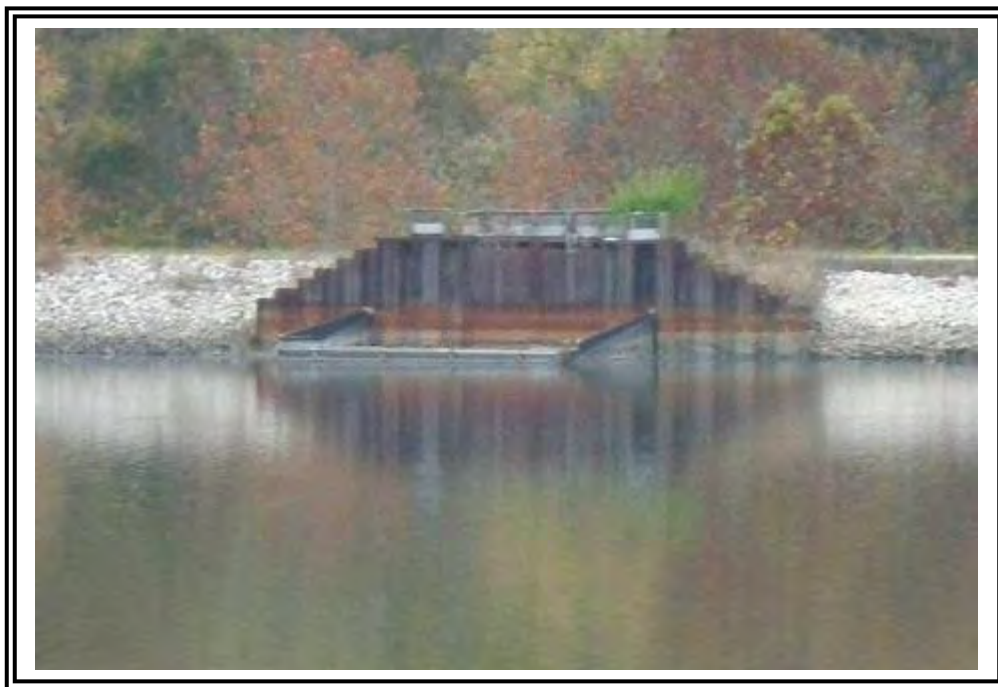
Near the west end of the pond an outlet structure was observed (Photos 8 and 9). It appeared to be a concrete drop inlet intake structure with metal sheeting and a skimmer to keep debris from fouling the structure. The outlet structure appeared to be operating properly. The observed location of the outlet structure differs from the location shown on the 1968 drawing.

Looking north across the pond at the outfall structure.

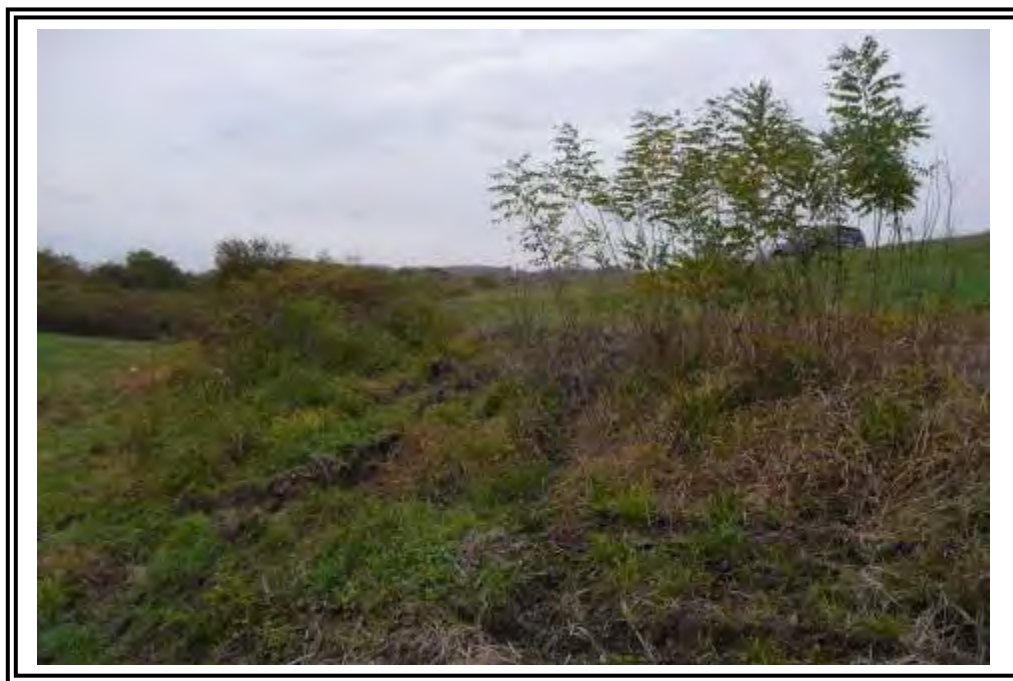
10

In general, the south dike (Photo 6) and the north dike (Photos 20 and 21) appeared to be maintained and mowed. However, seepage initiated slope softening and subsequent mowing induced rutting and slope deformation was observed on the downstream slopes of the dikes in at least four locations. One such area measured approximately 326 feet long approximately 52 feet from the toe with 6 to 12 inches of standing water (Photos 15 and 16). These areas often had heavier vegetation, scrub brush, and small trees established where routine tractor mounted mowing had not occurred for a fairly long period of time as a consequence of the softened slope conditions (Photos 11 and 12). In most cases however, these areas were generally covered with heavier grass and other weedy vegetation (Photos 10, 19 and 22)

Seep softened and deformed area with denser vegetation on the downstream slope at the southwest end of the pond.

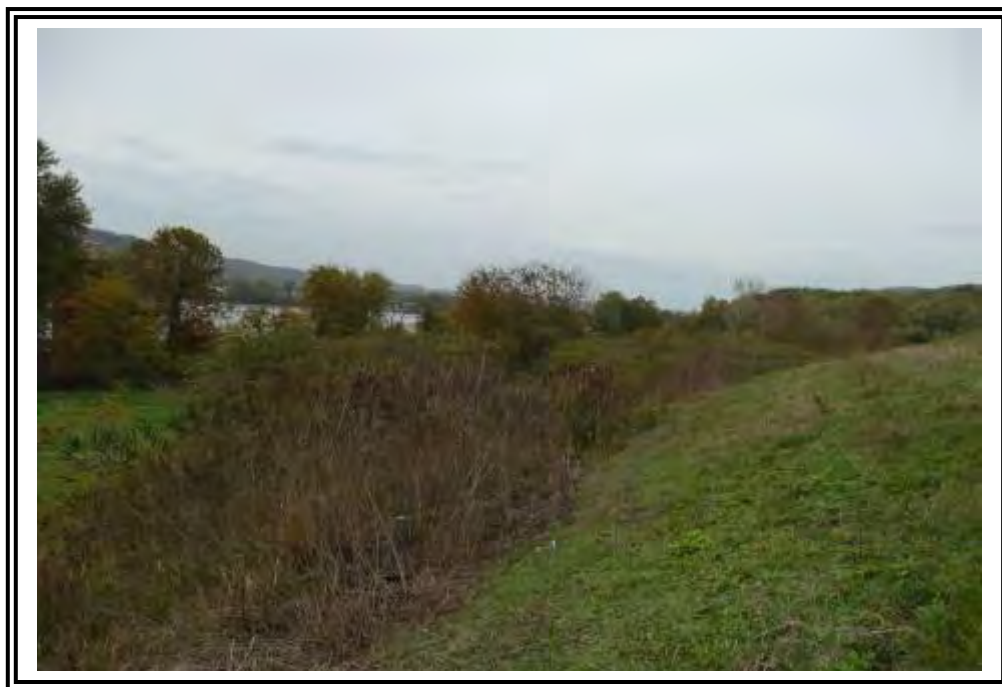
11

Heavier vegetation noted in area of seep on southwest end of pond.

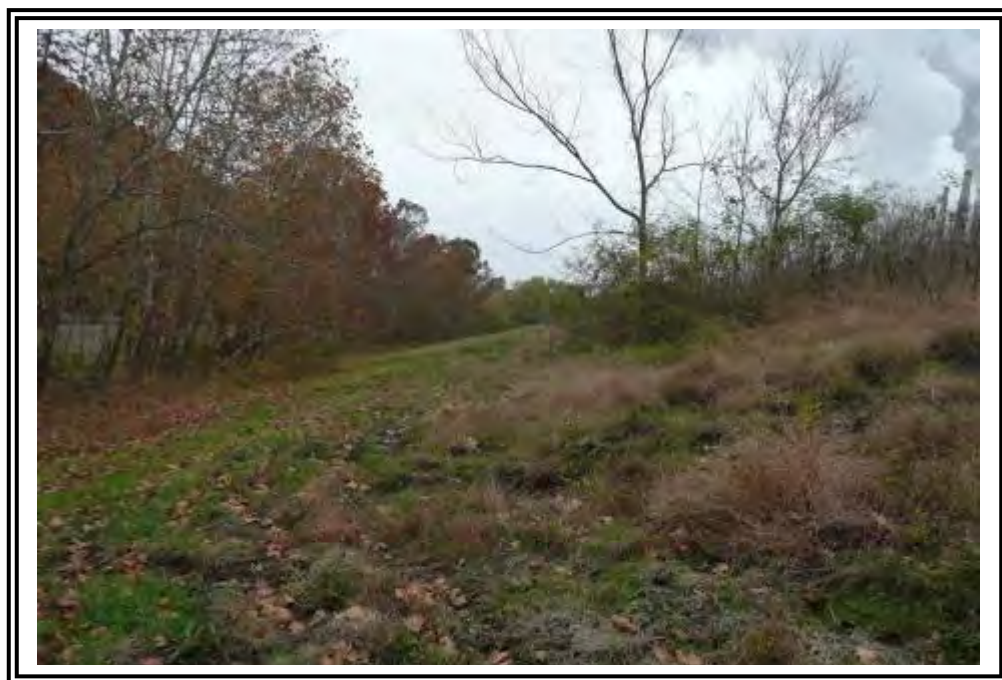
12

Another view of heavier vegetation and slope deformation in seep area at west end of pond.

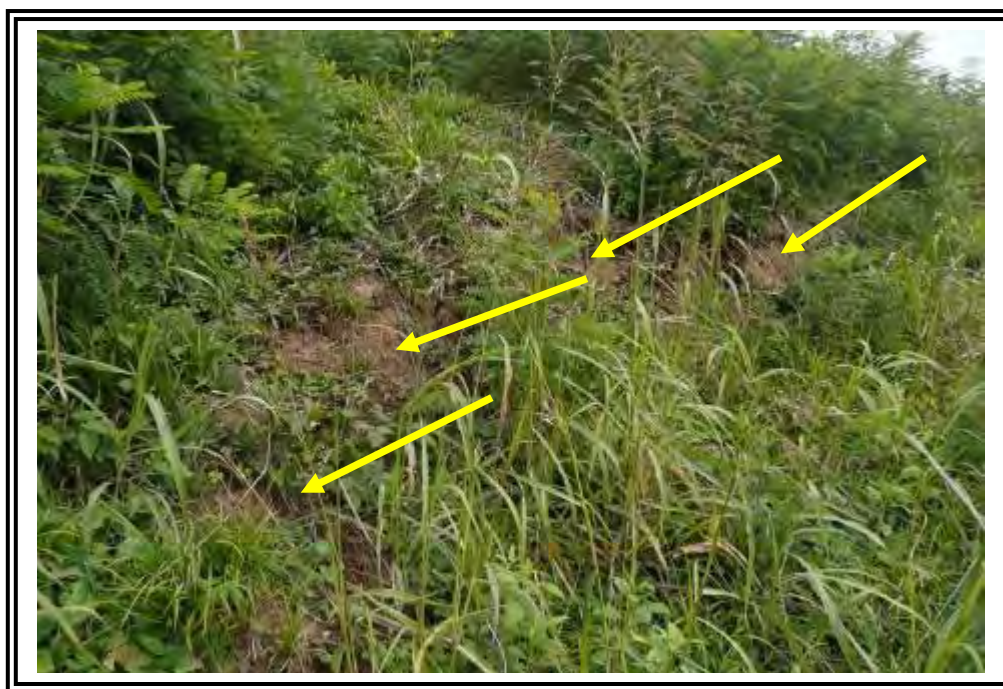
13

In addition to the seeps and resulting softened slope areas, scarp areas were observed on the south side of the pond and western extremity of the pond. A scarp on the south dike (Photo 13) occurred along a heavily vegetated, over-steepened portion of the dike adjacent to a haul road drainage ditch. It measured roughly 52 feet in length along the dike centerline. The scarp encountered on the west end of the pond measured approximately 30 feet in length and appeared to occur in a location of softer soil (Photo 14). Standing water was observed in this scarp and the soft soil in the area of the scarp it is likely the result of seepage at this location.

Partially vegetated scarp in heavily vegetated, steeper slope on south side of the pond.  
Approximately 52 feet long. (See arrows)

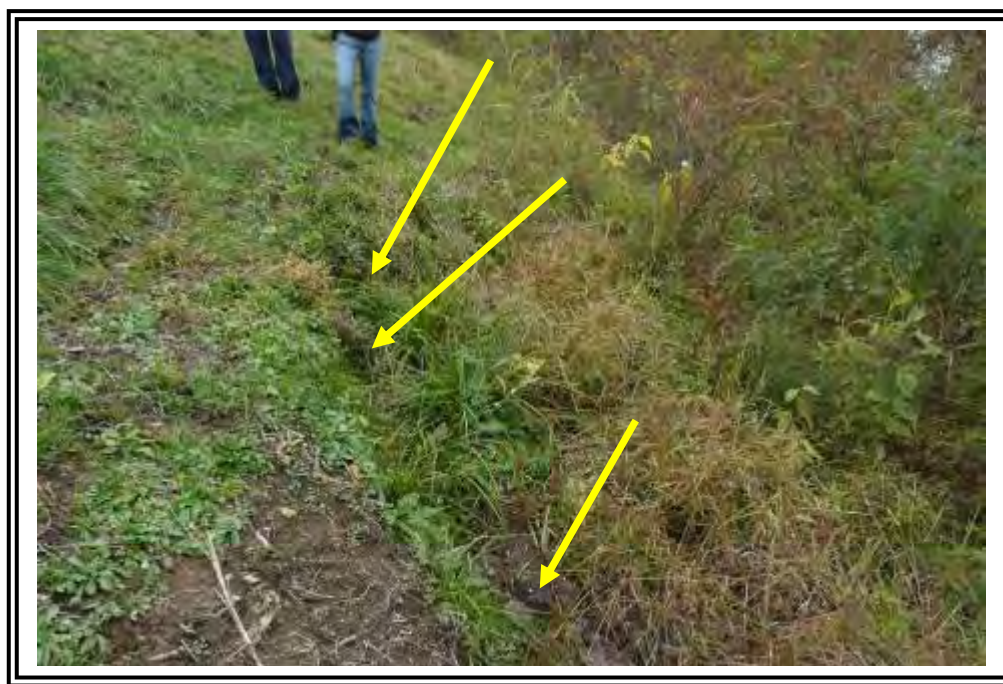
14

Vegetated scarp with standing water on west side of the pond. Approximately 30 feet long. (See arrows)

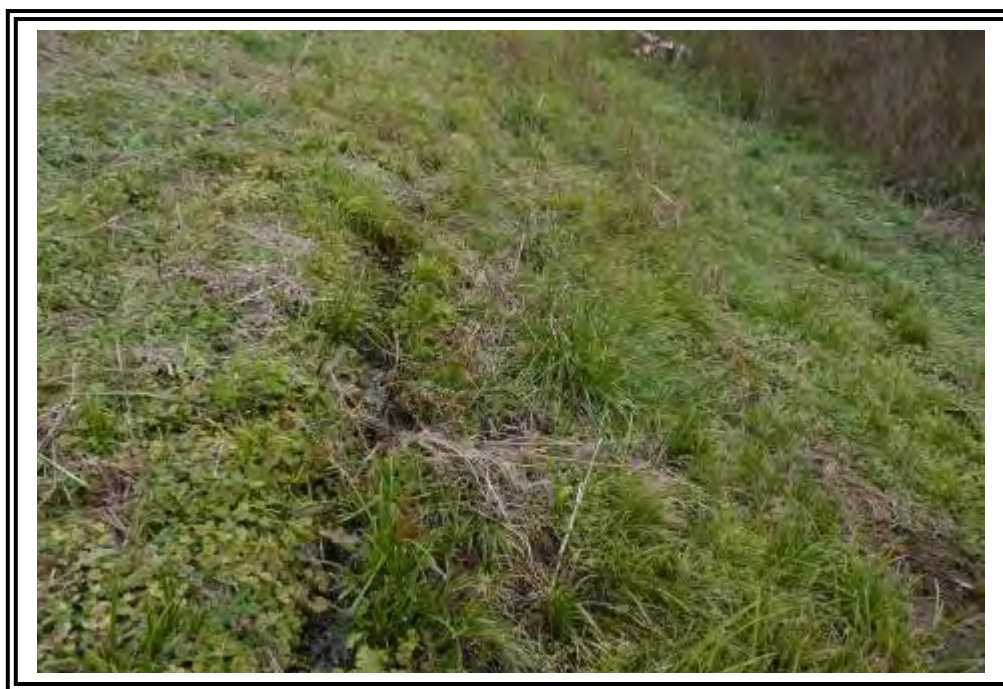
15

Close up of a rut with standing seep water.

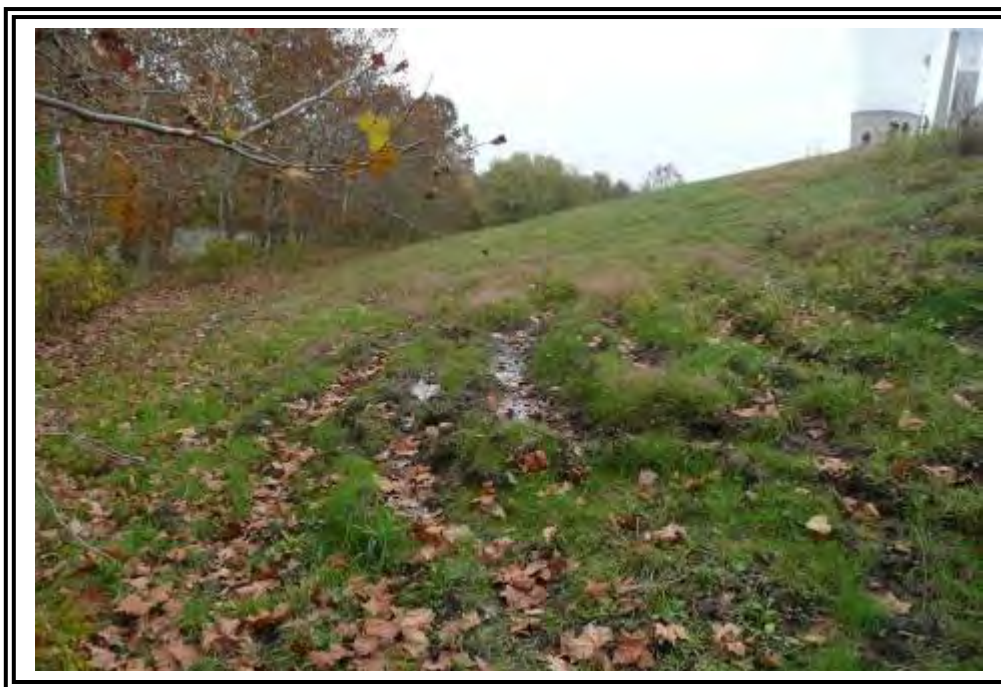
19

Looking east along the downstream slope of the northern dike.  
Notice the taller grass and rutting with standing seep water.

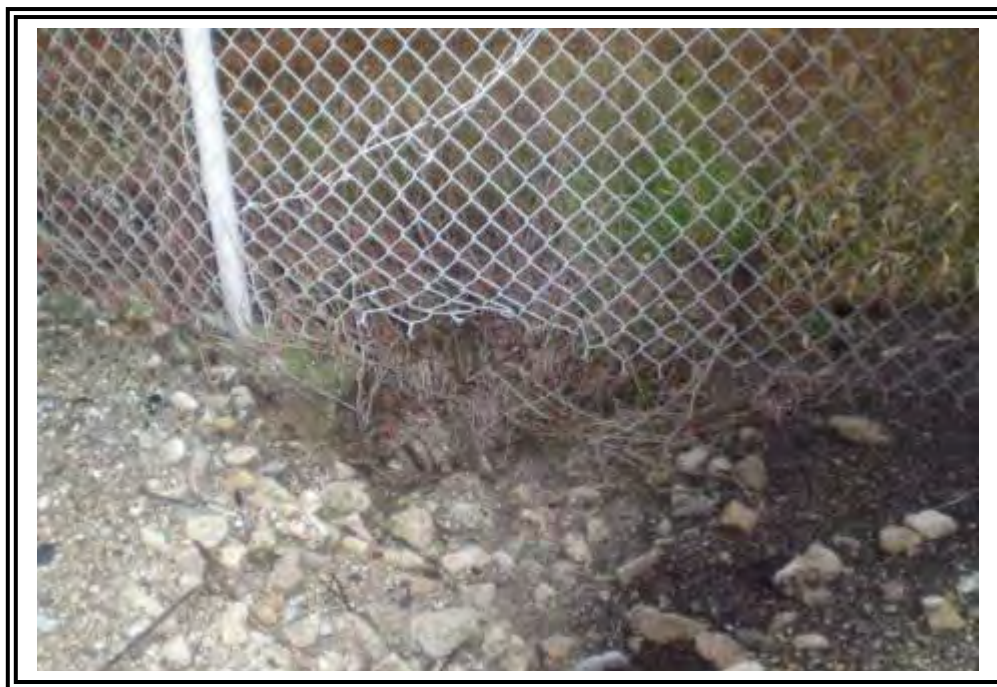
41

Close up of erosion at edge of crest under the fence on the west dike of pond.

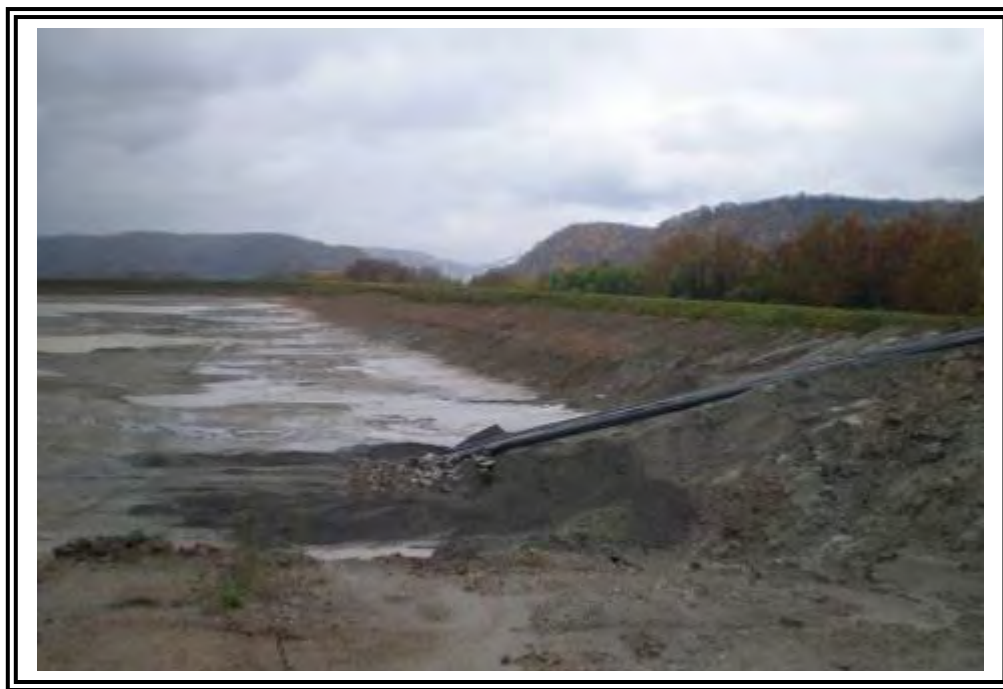
45

Looking east along the upstream slope of the southdike.  
There was very little grass cover due to summer dredging activities.

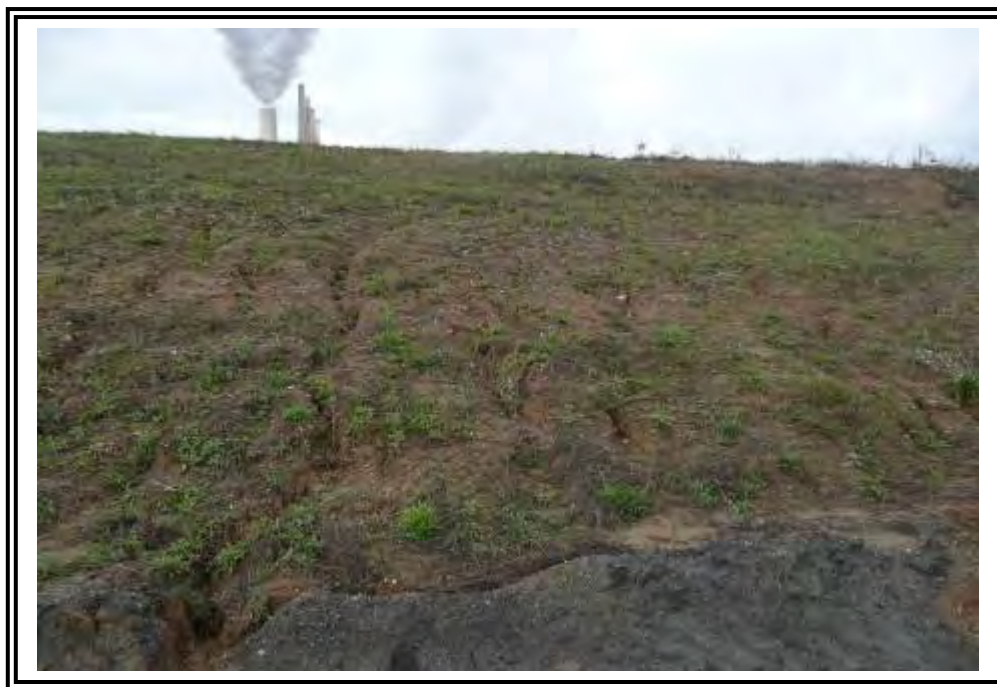
47

A close up of erosion rills and loss of grass cover on the downstream slope of the east dike.

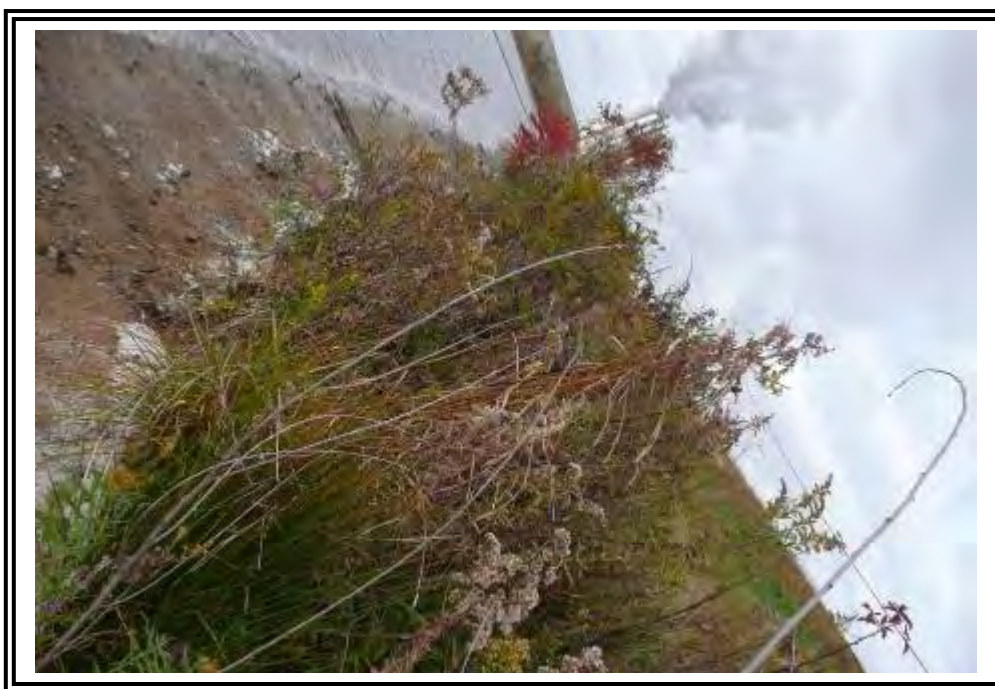
57

The north wall of the pond appears to be at the approximate foundation level for Landfill 11 (formerly Pond 8) as seen in Photo 61. This area is moderately to heavily vegetated with weeds, grasses, brush, and smaller trees (Photos 56, 57, 59, and 62). The pond level was down slightly during the site visit, and some beaching erosion was visible as noted in Photos 58 and 59. Standing water was also encountered intermittently in this area (Photo 60), but this was likely due to the recent rains, sheetflow runoff from the landfill, and the fairly flat topography in the area between Pond 6 and Landfill 11.

Moderate to heavy weedy, brushy vegetation on north dike of Pond 6, looking west.

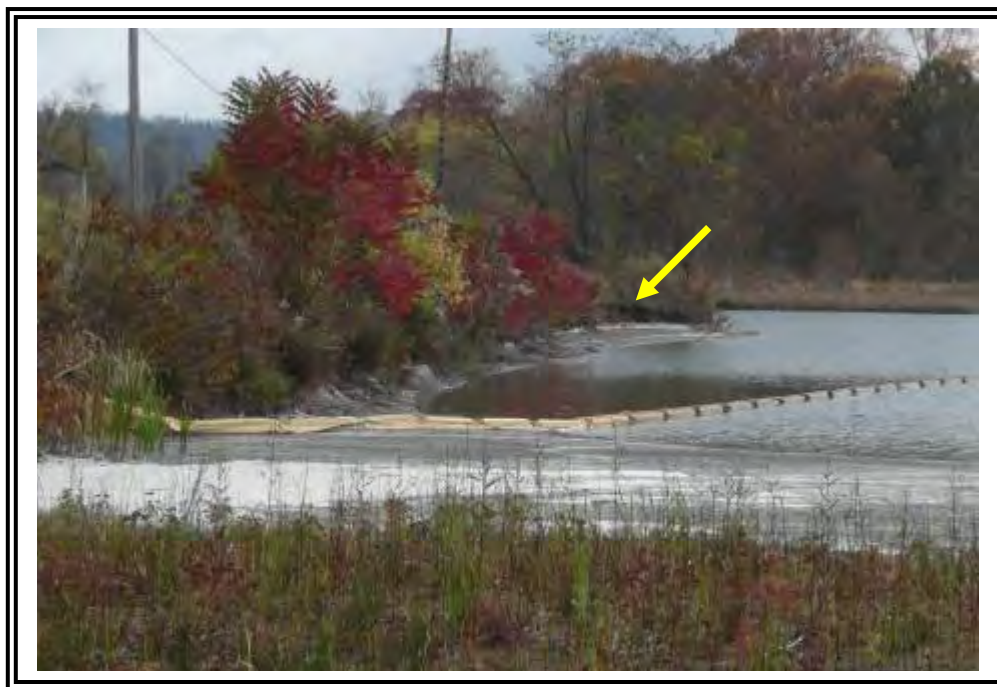
59

Vegetation on north dike of Pond 6 and beaching erosion (arrow), looking east.

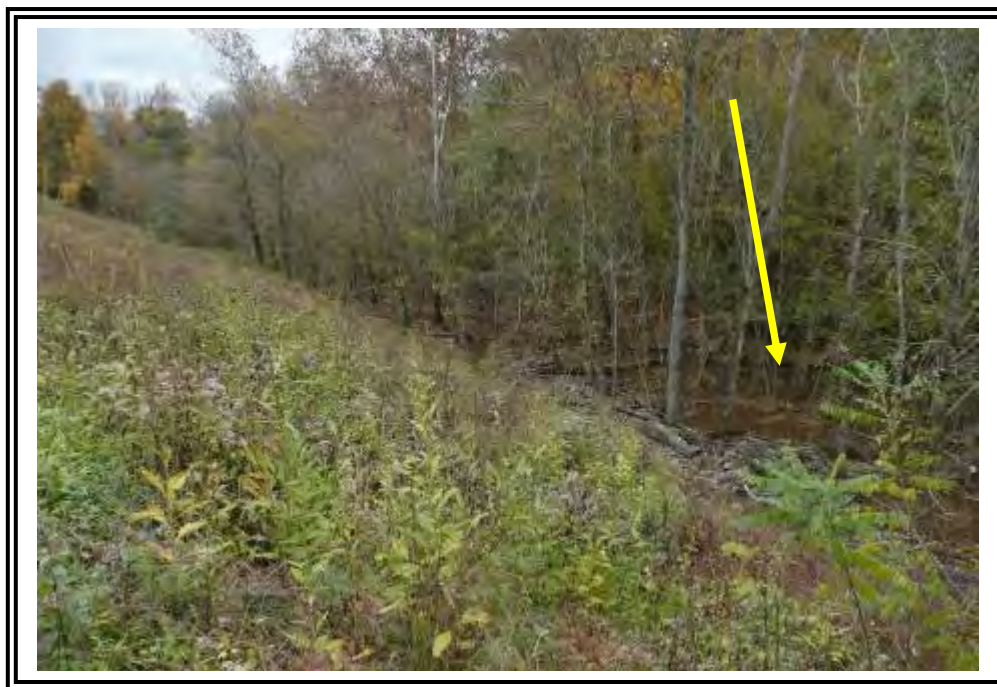
69

Downstream east dike slope of Pond 6, looking north from mid-slope.  
Creek area at toe on right side of photo (arrow).

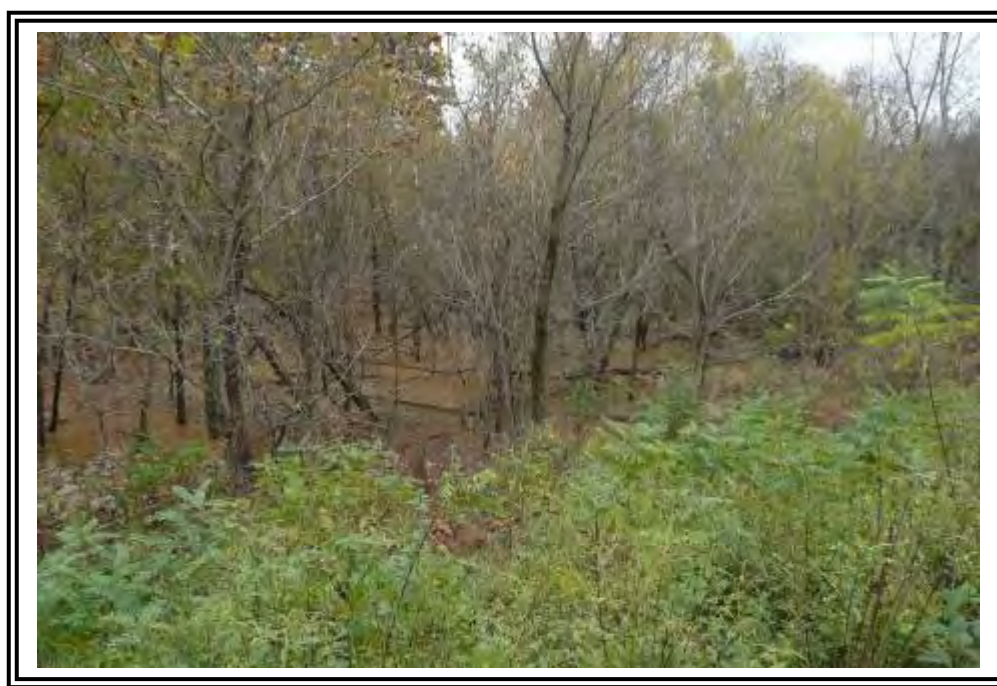
70

Another view of water in creek backing up against downstream toe on east dike of Pond 6.

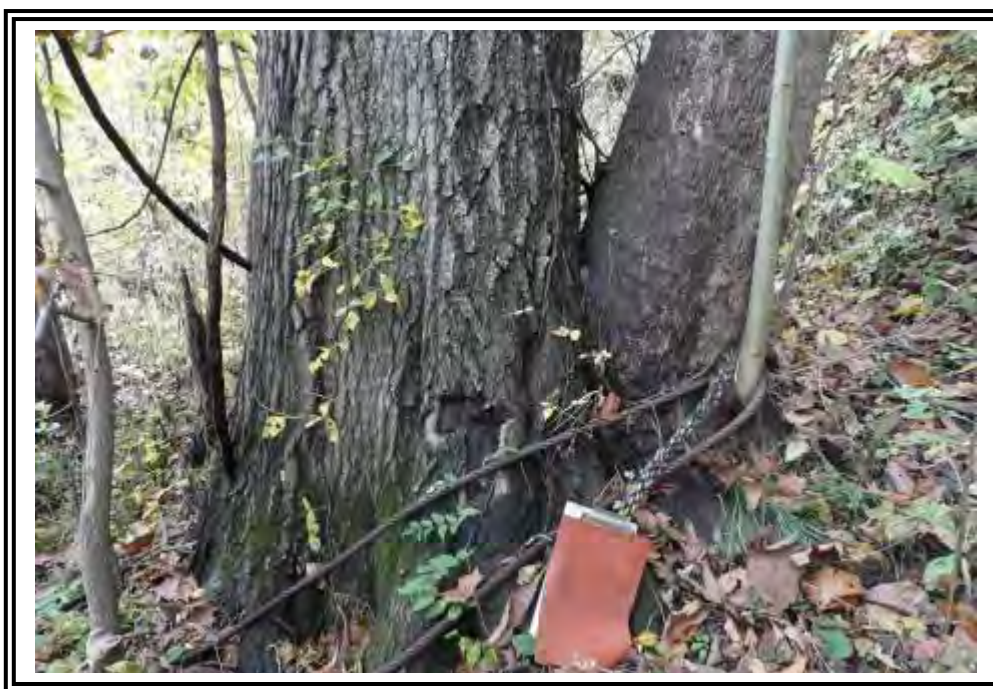
89

A close up of a large tree on the downstream slope of Pond 7 south dike near the Ohio River bank.

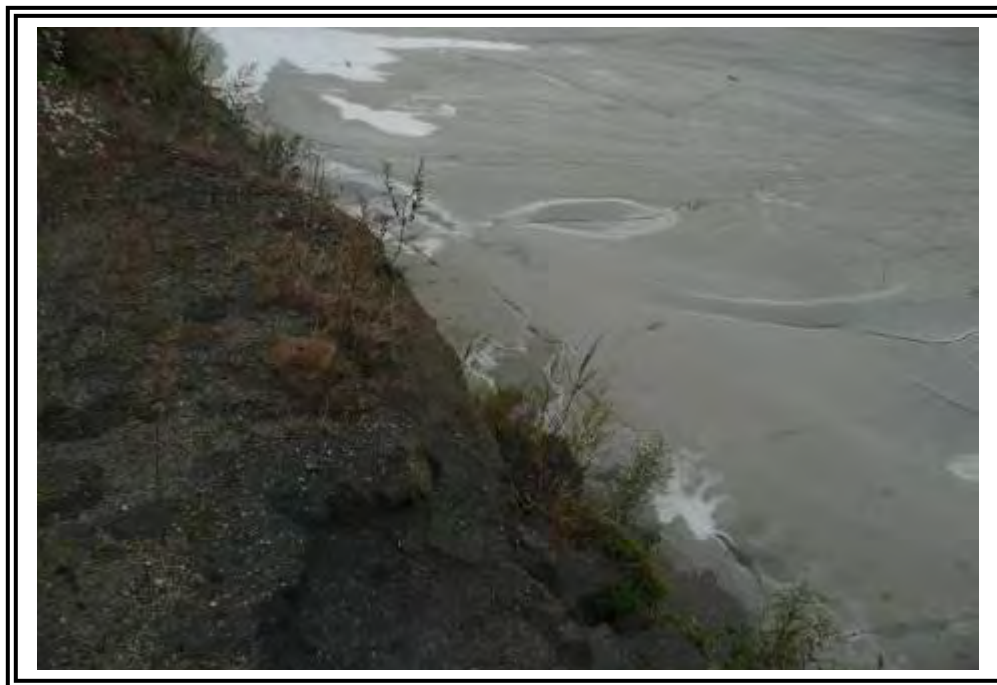
93

Close-up of steep upstream slope and looser material on western dike of Pond 7.

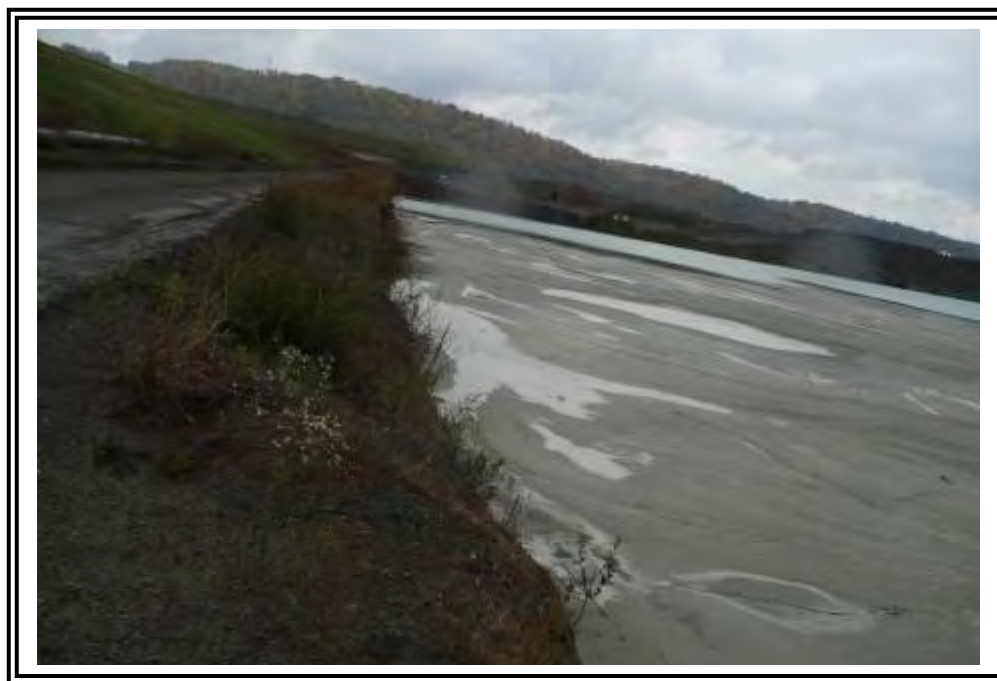
94

The west side of Pond 7 appears to be partially incised, with the crest area functioning as a haul road and foundation for Pond 3A (Photo 94). Grading and routine maintenance activities for the haul road have created a very steep upstream slope subject to sloughing (Photo 93). This combination of steep geometry and loose granular slope surface material has resulted in sparse weedy vegetation and erosion rill formation where runoff is concentrated (Photo 95). Since this pond is presently the active ash basin, an ash delta has formed along the portion of the wall adjacent to where the sluice lines enter at the southwest corner of the pond (Photos 87 and 94).

Looking north along the Pond 7 west dike upstream slope. Note ash delta in pond surface.

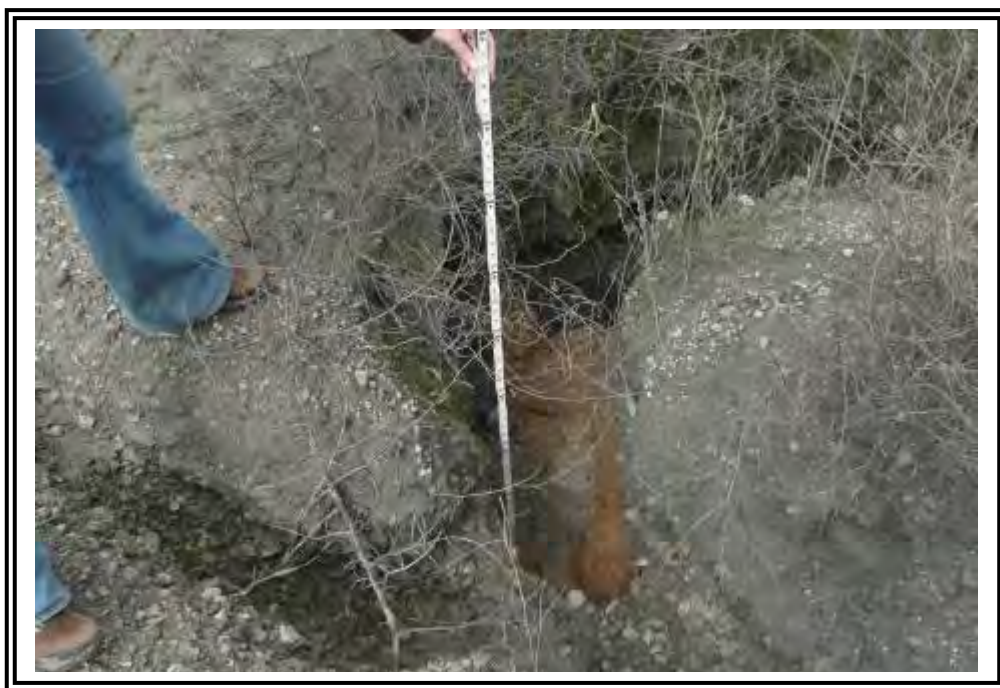
98

Close up of deep erosion rill in the Pond 6 side of the separator dike.

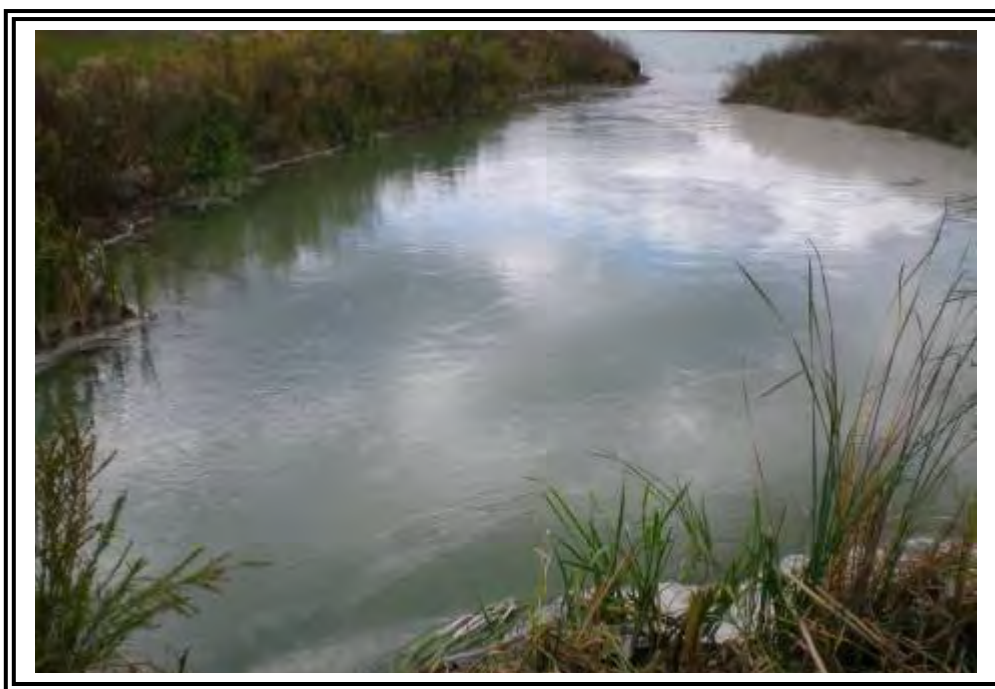
The Pond 7 outlet structure is a drop inlet connected to a culvert conveying water through the north dike into Pond 6. It is located in a small channel excavated through the ash fill separating Ponds 7 and 7A (Photo 101 ). At the time of the site assessment, it was submerged and could not readily be observed. It did not appear to be obstructed and was functioning as required. A trash rack or similar device was not readily visible. (Photo 102)

Channel to outlet structure excavated through ash fill in northwest corner of Pond 7.

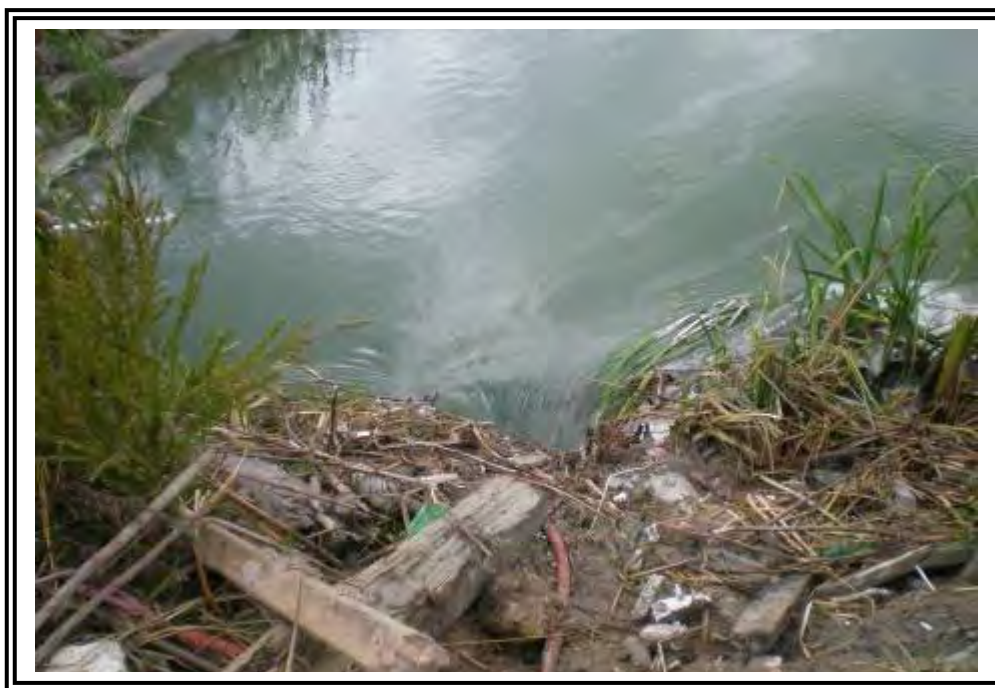
102

Submerged outlet structure for Pond 7 to Pond 6. Note absence of inlet protection.
