**DRAFT REPORT  
ROUND 7 DAM ASSESSMENT  
DTE ENERGY MONROE POWER PLANT  
FLY ASH BASIN AND BOTTOM ASH STORMWATER POND**

**November 8, 2010**

**GZA GeoEnvironmental, Inc.  
19500 Victor Parkway, Suite 300  
Livonia, MI 48152  
GZA File No. 01.0170142.20**

Re: Round 7 Dam Assessment - Draft Report  
EPA Contract No. EP10W001313  
DTE Energy Monroe Power Plant  
Fly Ash Basin and Bottom Ash Stormwater Pond  
Monroe, Michigan

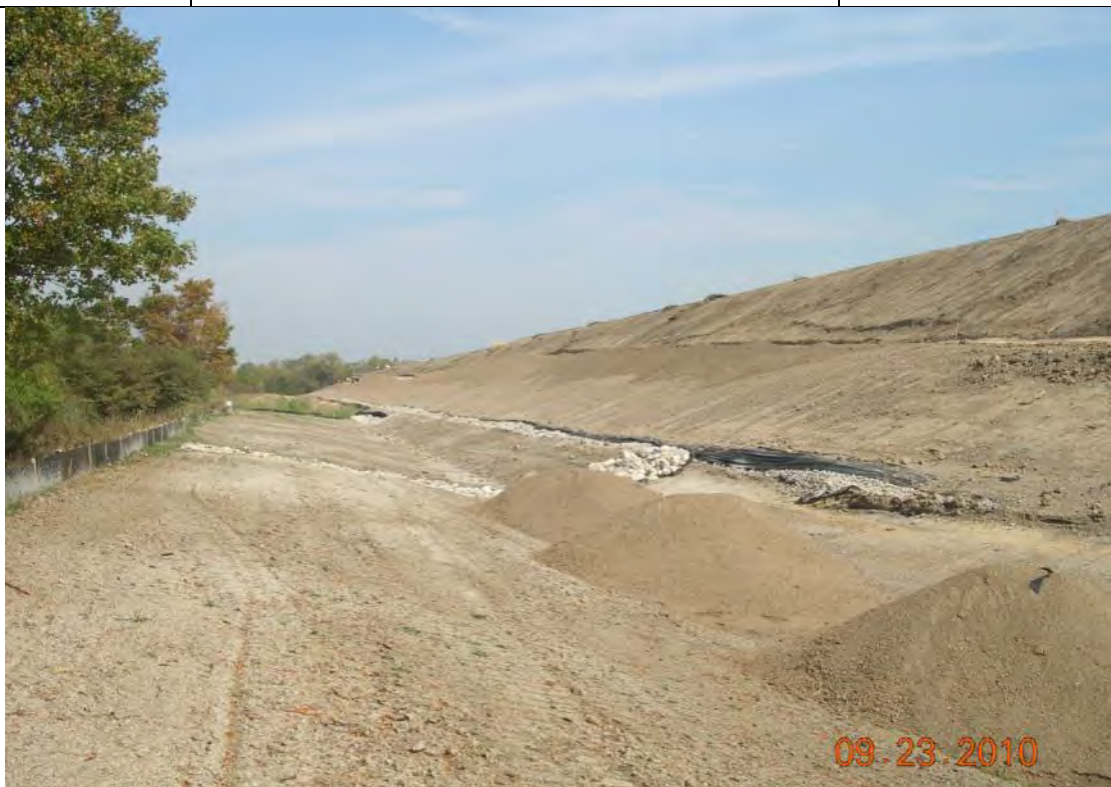
Reconstruction on west  
embankment from  
approximately Station 88 +  
00 to Station 68+00.

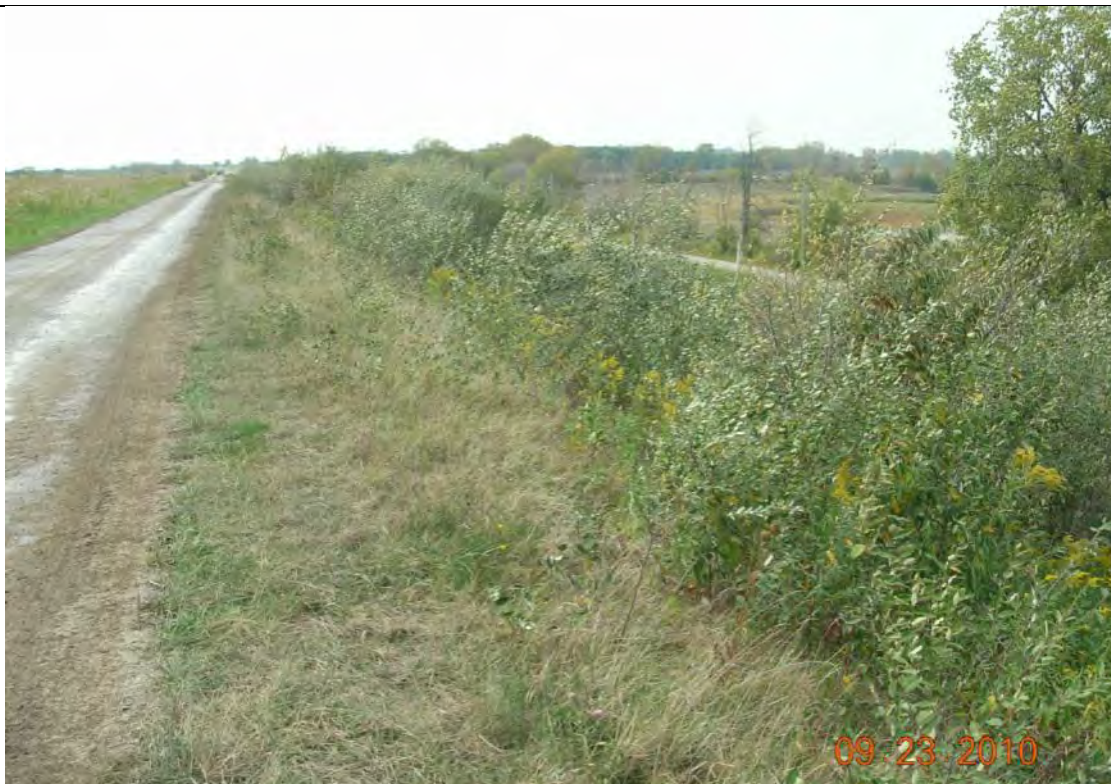
**Photo No.**  
**2**

Vegetation on embankment  
near Station 50+00.

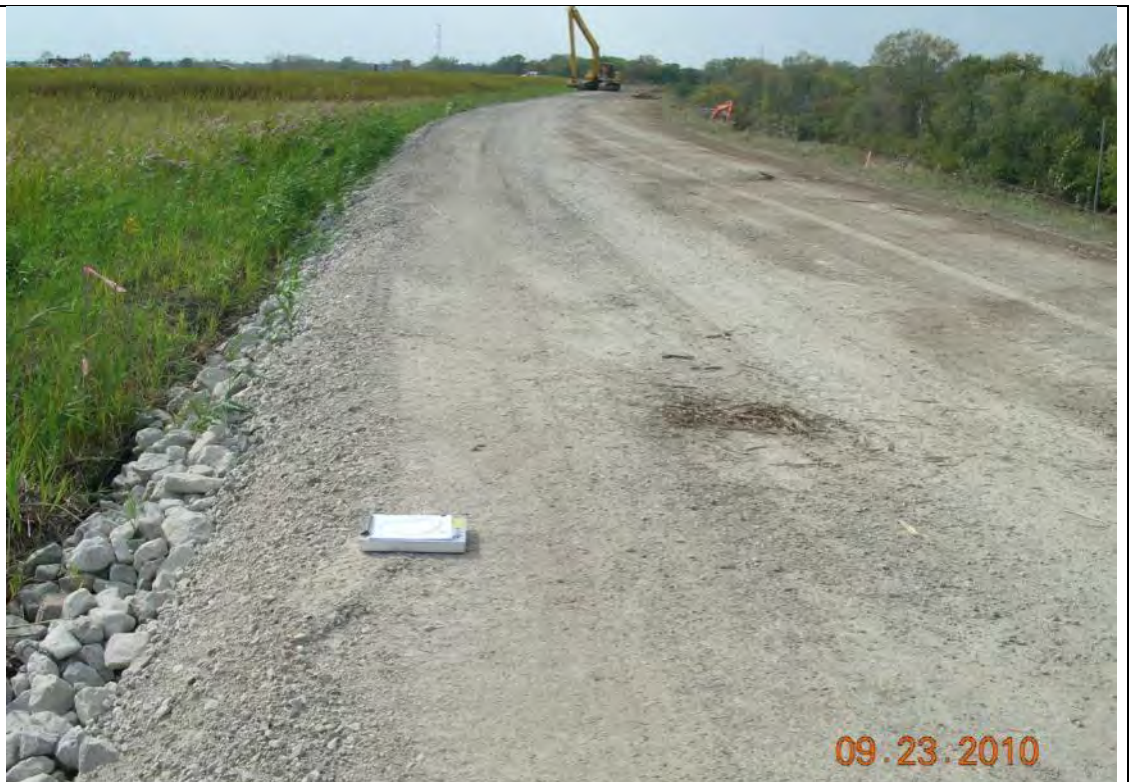
**Photo No.**  
**4**

New road construction along  
the crest near Station 64+00.  
Note the variation in gravel  
color to distinguish between  
the existing and new crest  
road.

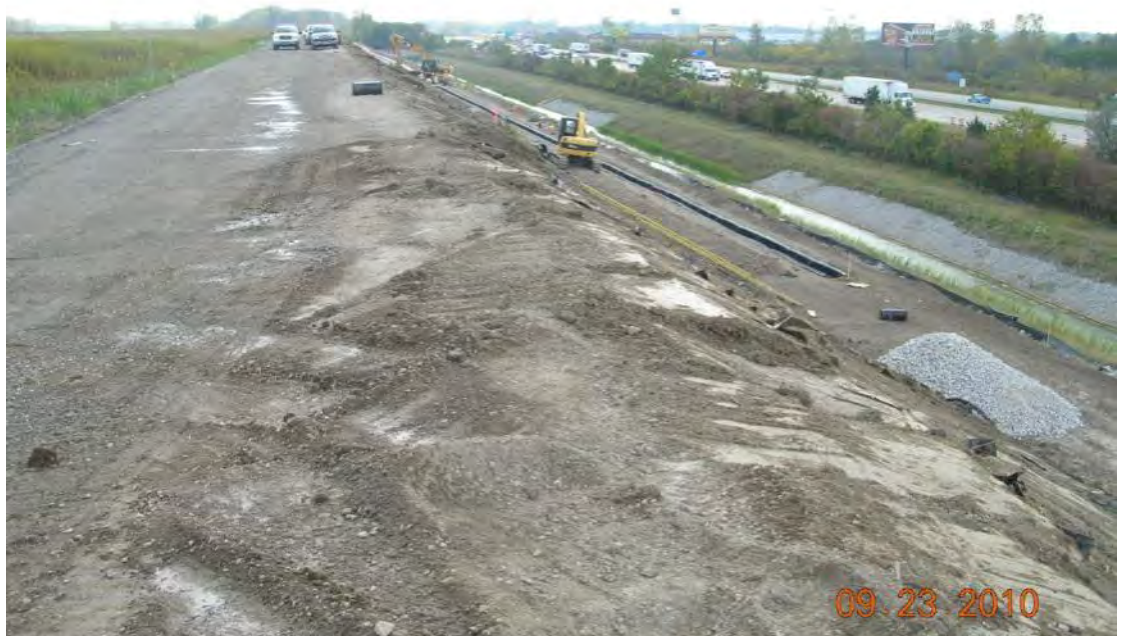
**Photo No.**  
**6**

**Description:**  
Reconstruction of the  
embankment near Station  
69+00. The construction of  
a ditch in mid slope is also  
shown.

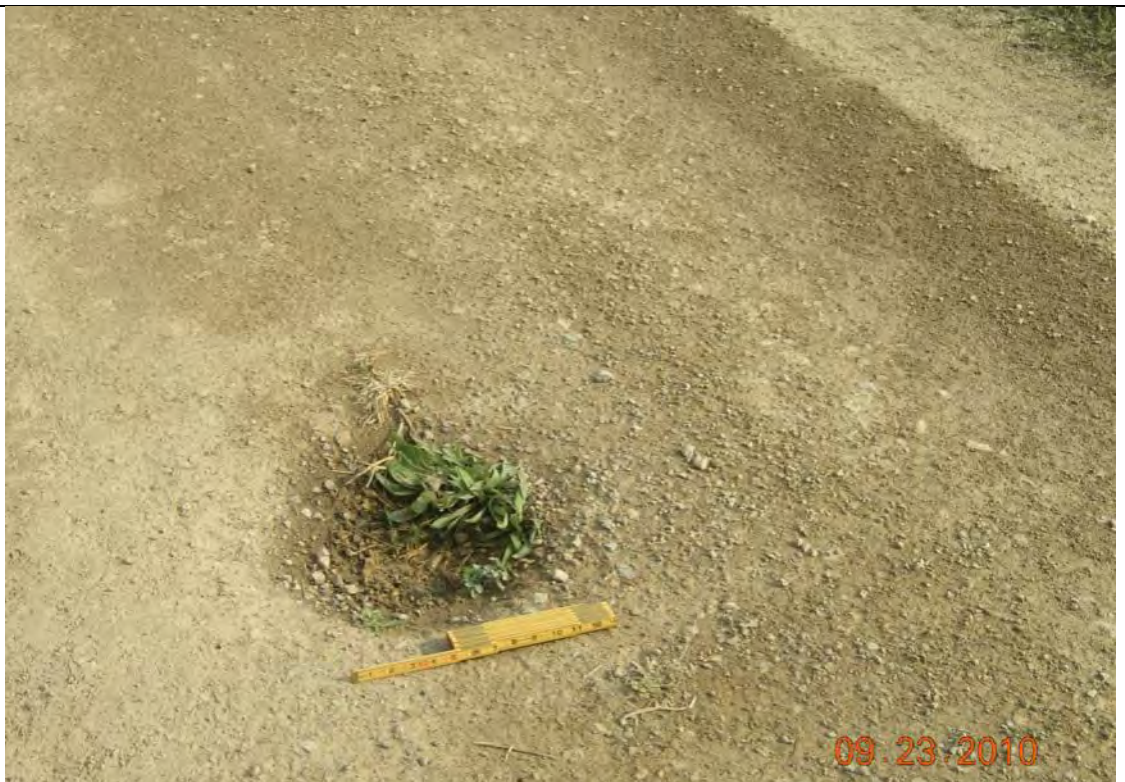
**Photo No.**  
**10**

**Description:**  
Shallow hole in crest road  
due to a surveyor attempting  
to locate surface monument.

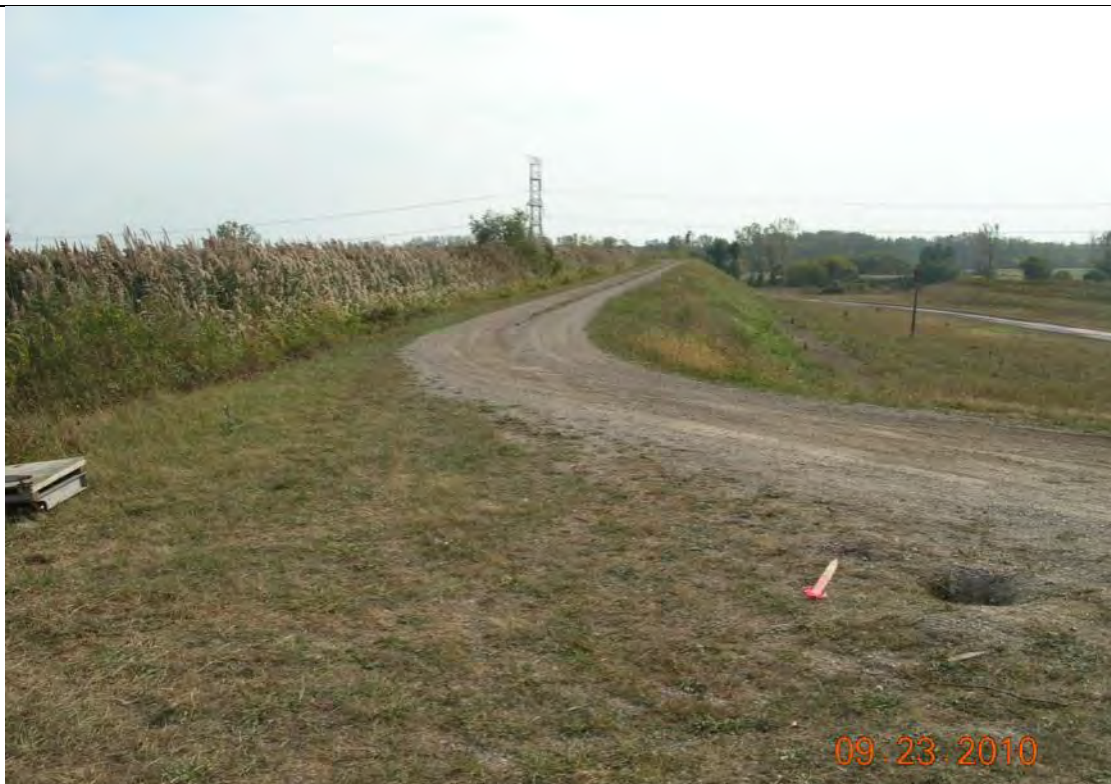
**Photo No.**  
**12**

Crest and embankment near  
Station 104+00. The  
shallow hole on the right of  
the photo was caused by a  
surveyor attempting to locate  
a surface monument.

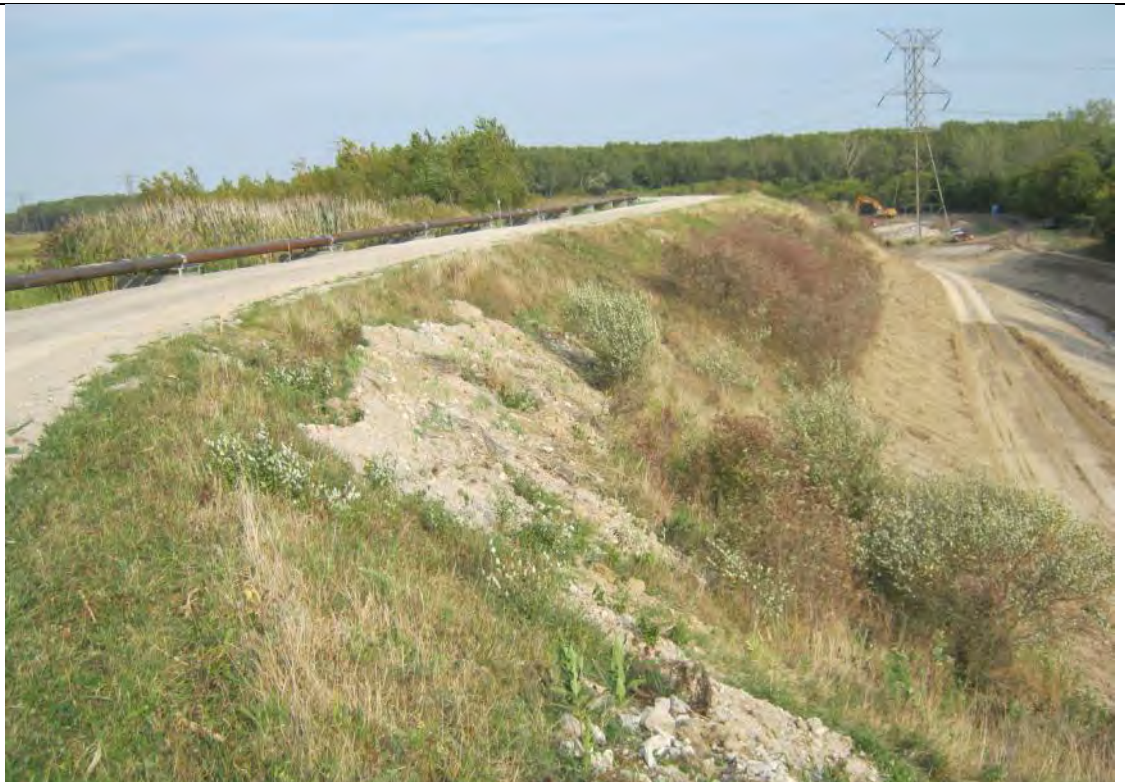
**Photo No.**  
**20**

**Description:**  
Excess road construction  
material placed on the  
embankment near Station  
144+00.

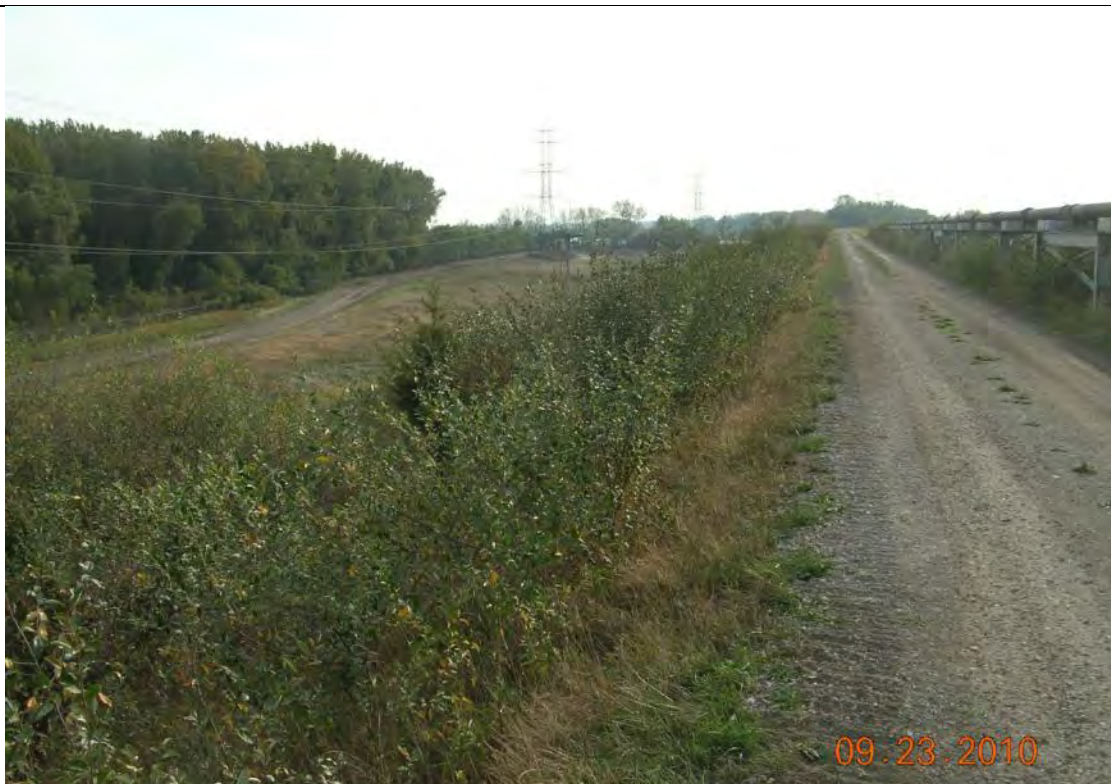
**Photo No.**  
**22**

**Description:**  
Heavy vegetation along  
eastern embankment near  
Station 170+00.

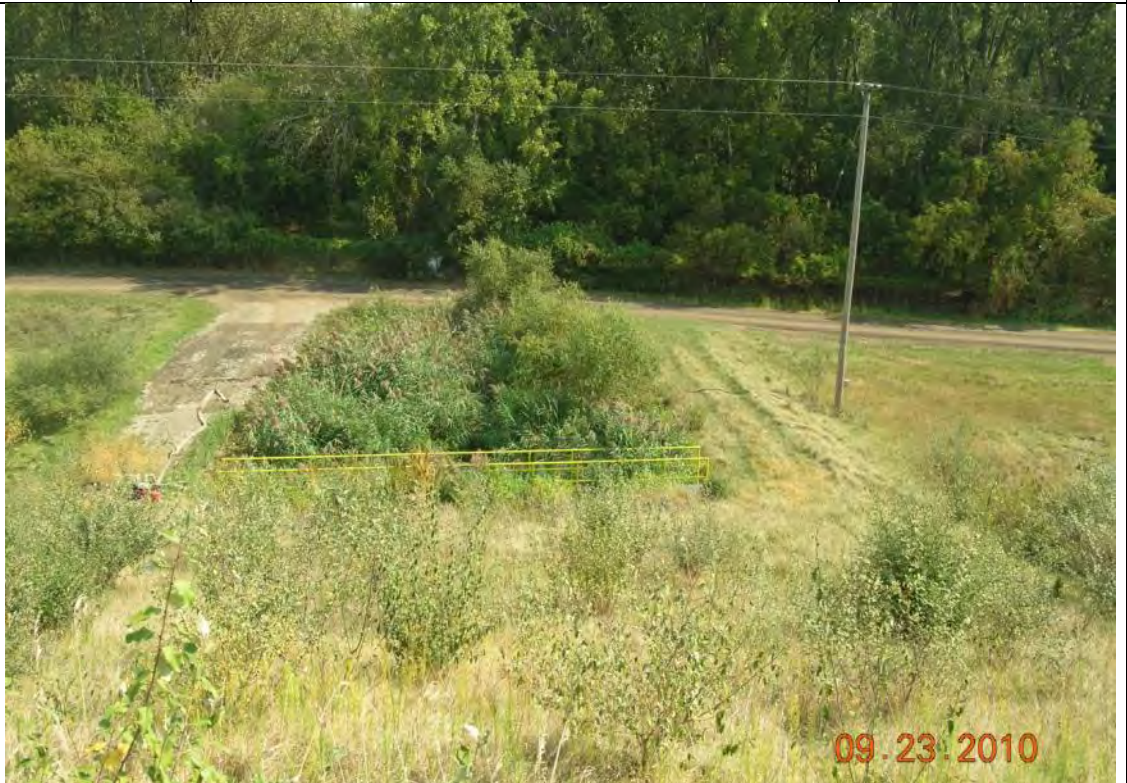
Vegetation growing near  
stilling wells near Station  
177+00.

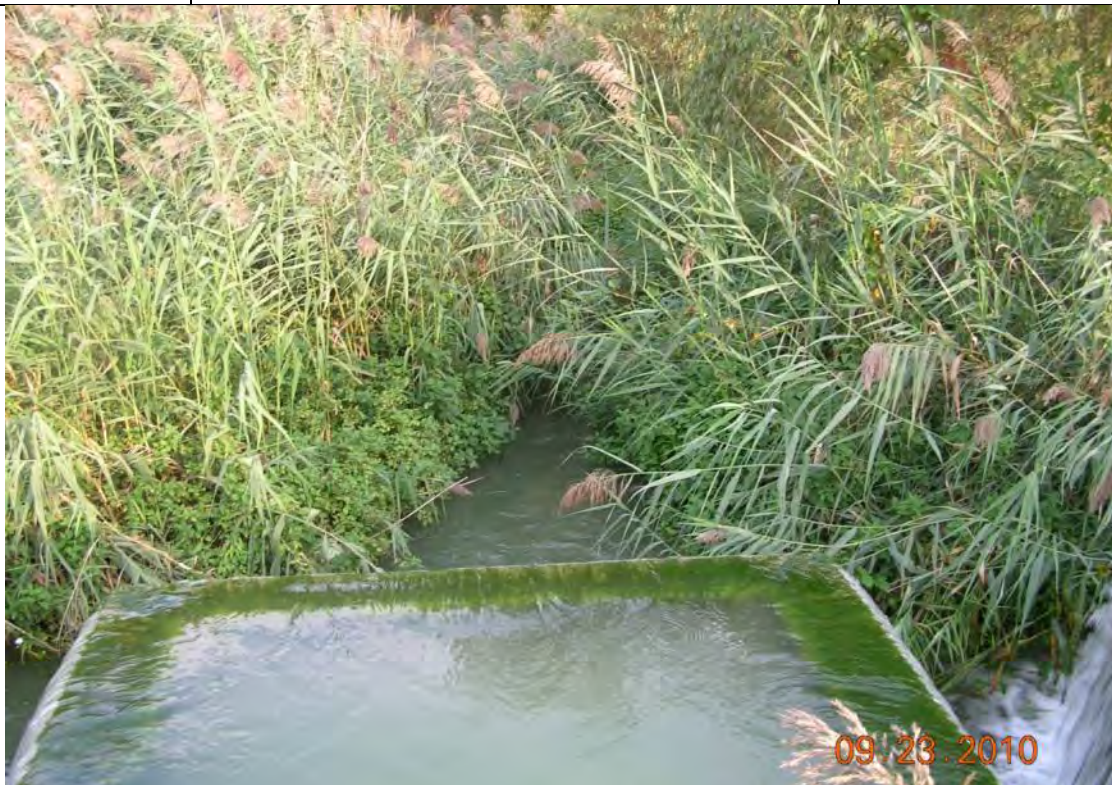
**Description:**  
Vegetation downstream of  
the stilling wells in the  
discharge channel.

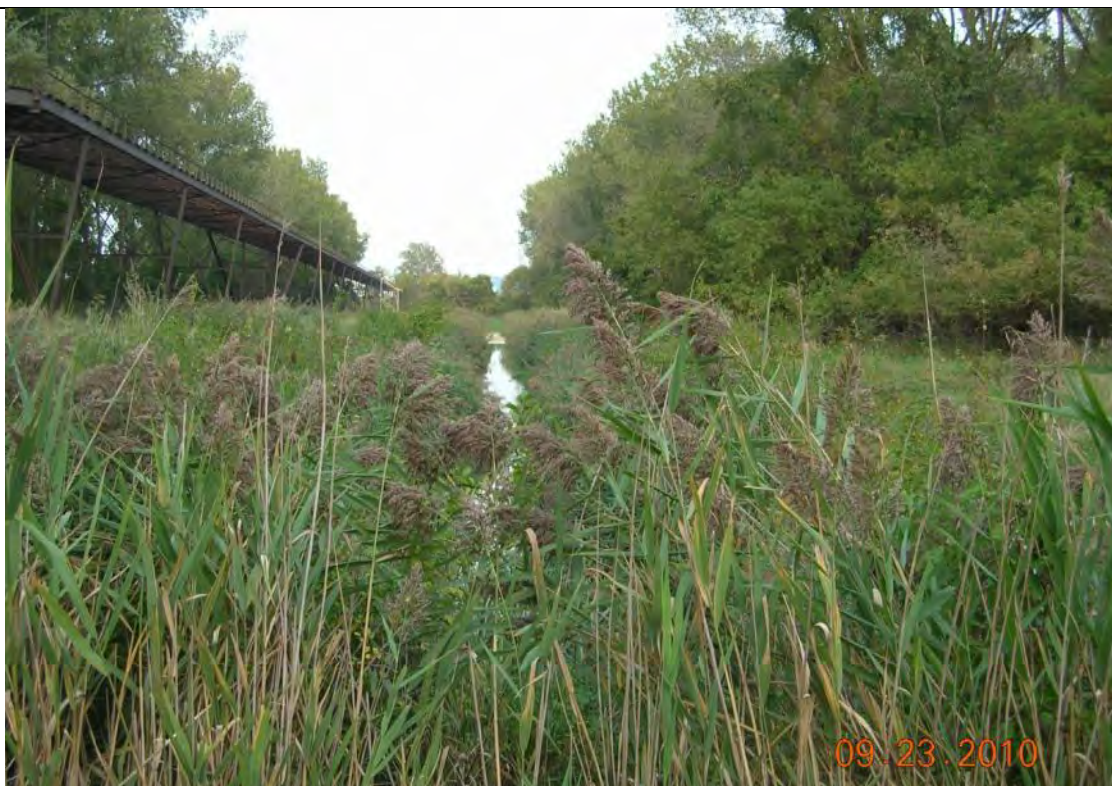
**Photo No.**  
**30**

**Description:**  
Vegetation in the discharge  
channel.

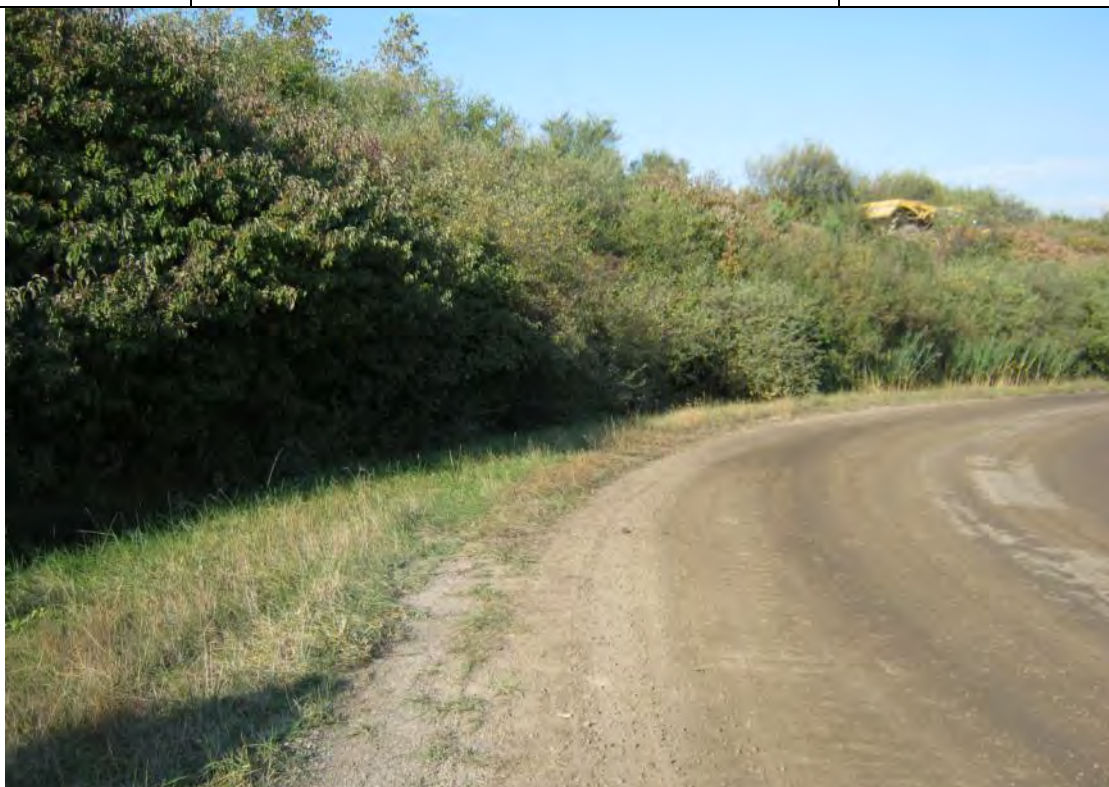
**Description:**  
Vegetation on embankment  
near Station 37+00.

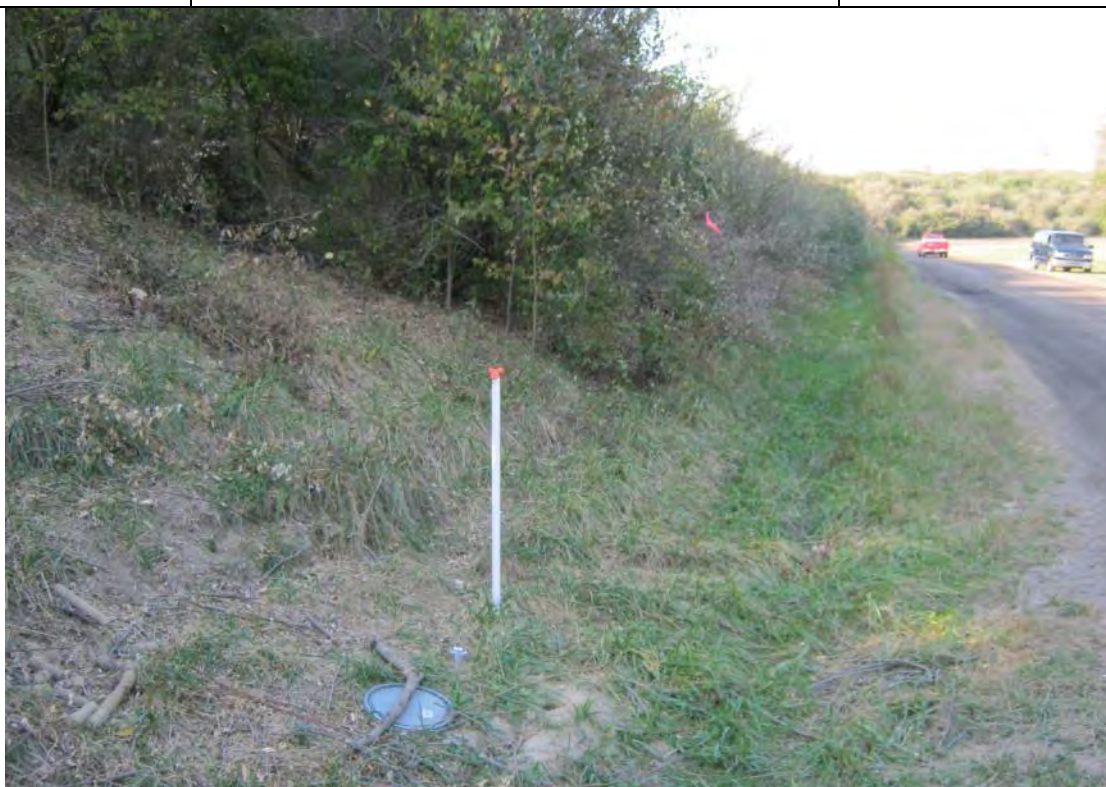
Temporary well installed at  
the toe of the embankment  
near Station 30+00. Also  
shows the heavy vegetation  
along the embankment.

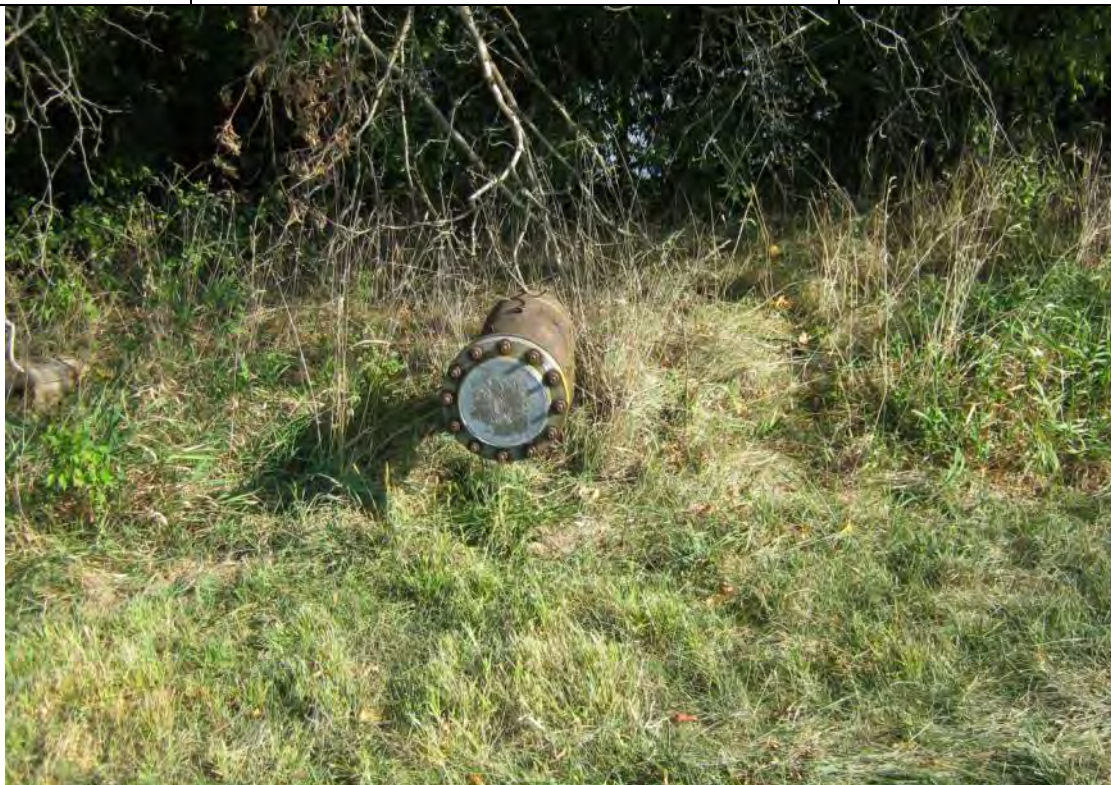
**Description:**  
Unidentified pipe near  
Station 16+00.

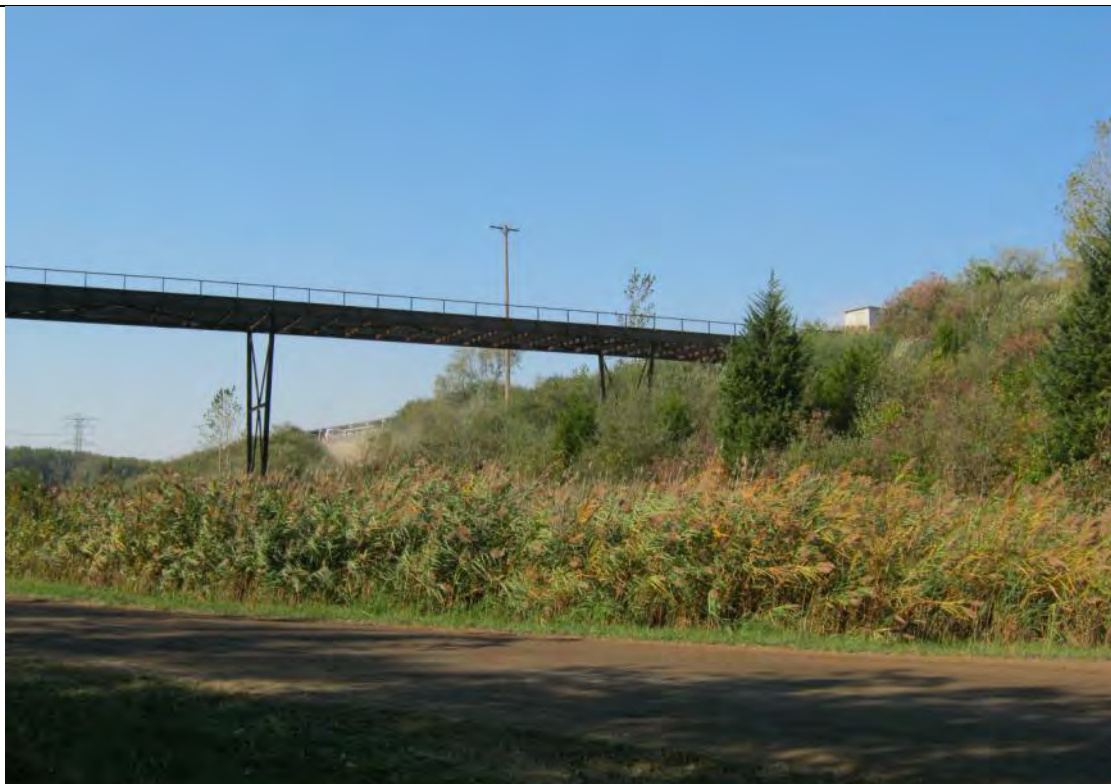
**Photo No.**  
**40**

**Description:**  
Vegetation along the  
embankment near Station  
1+00. The bridge depicted  
supports the fly ash sluice  
transfer pipes.

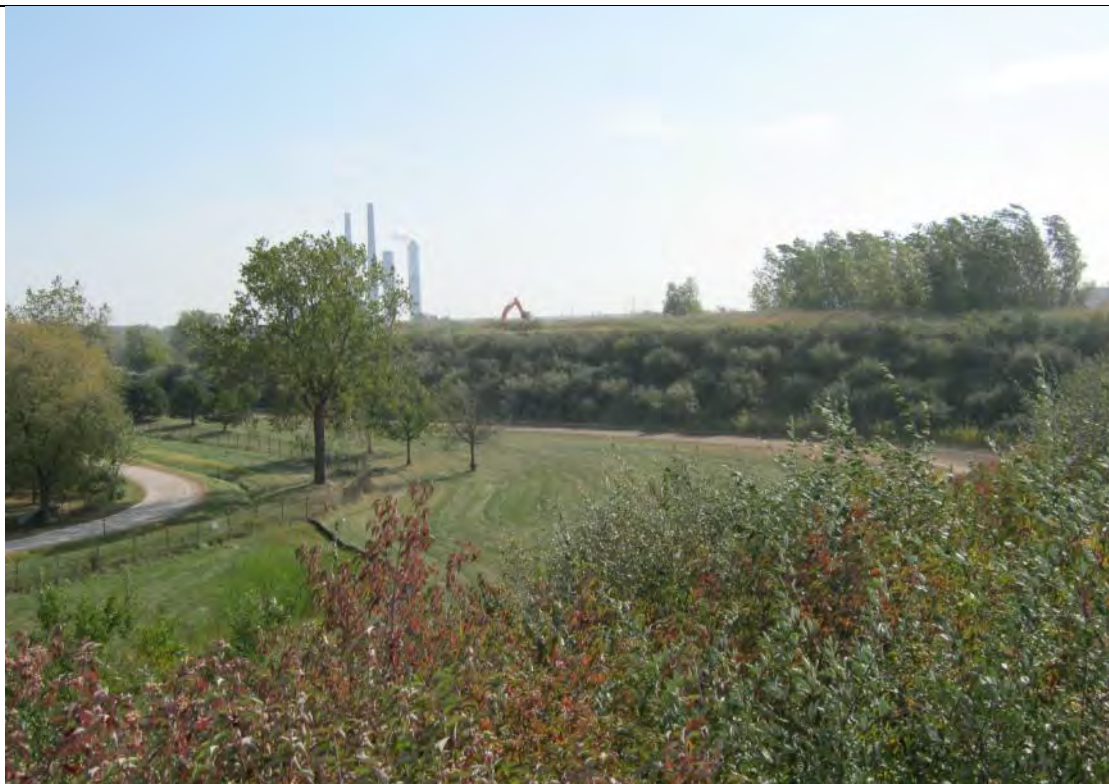
**Photo No.**  
**42**

**Description:**  
View of the vegetation on  
the embankment near Station  
44+00.

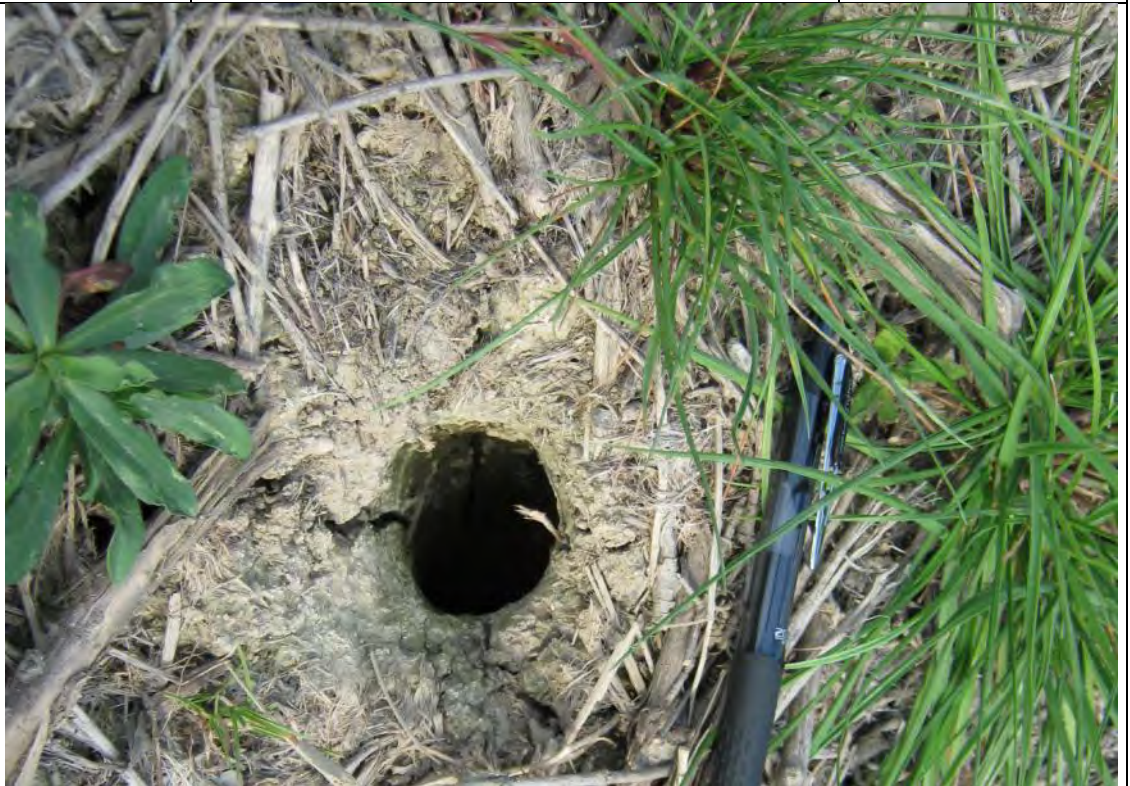
**Description:**  
Small animal burrow at the  
toe of the slope near Station  
132+00.

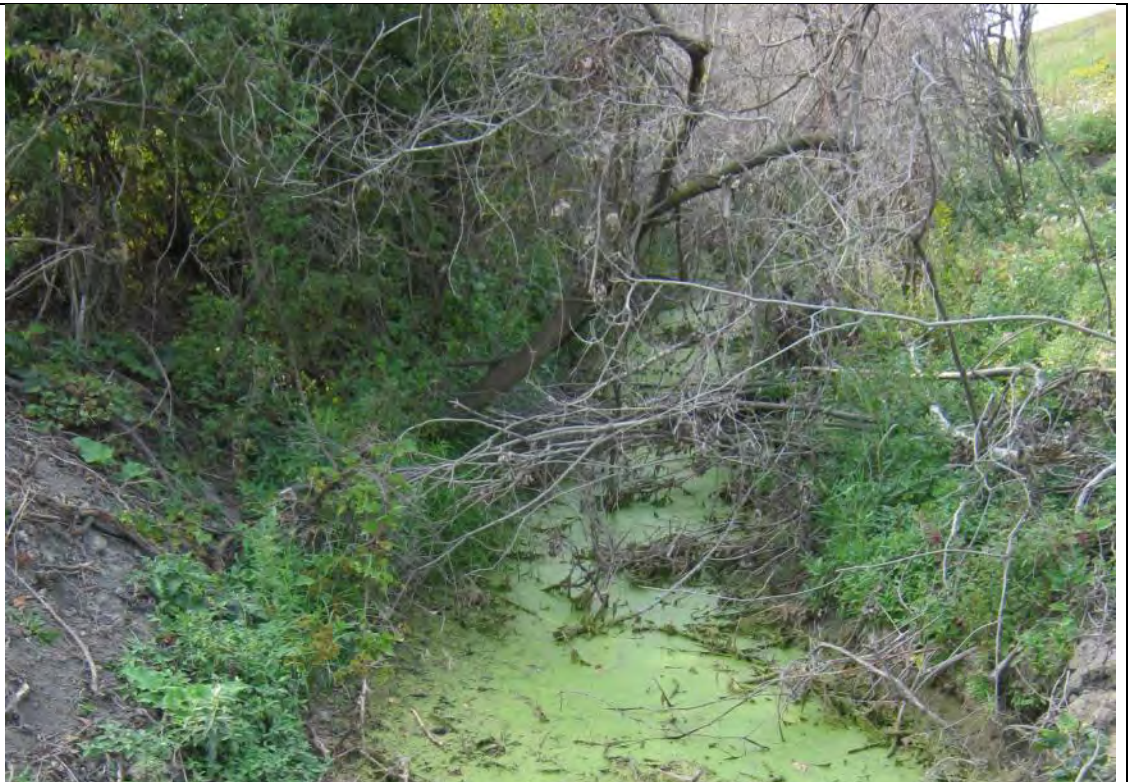
**Photo No.**  
**44**

**Description:**  
Standing water in ditch at toe  
of slope near Station  
139+00.
