**FINAL REPORT
ROUND 7 DAM ASSESSMENT
DTE ENERGY MONROE POWER PLANT
FLY ASH BASIN AND BOTTOM ASH STORMWATER POND**

June 2, 2011

**GZA GeoEnvironmental, Inc.
19500 Victor Parkway, Suite 300
Livonia, MI 48152
GZA File No. 01.0170142.20**

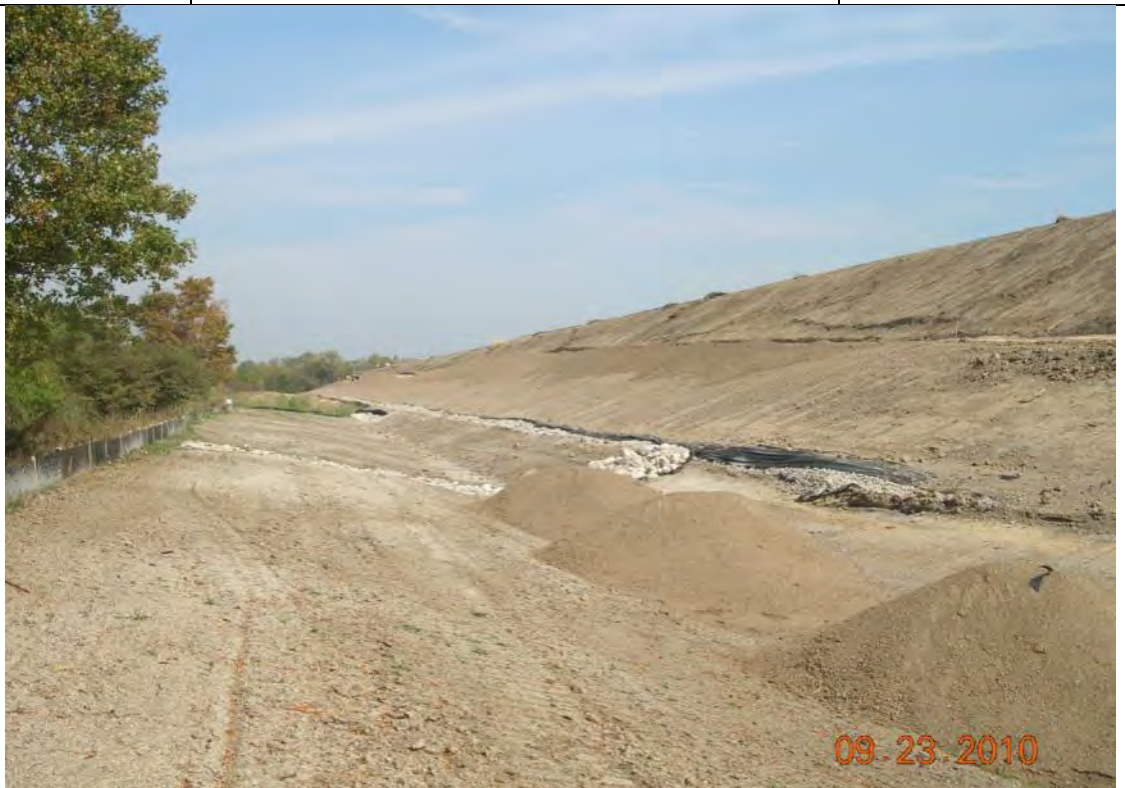
Reconstruction on west embankment from approximately Station 88 + 00 to Station 68+00.

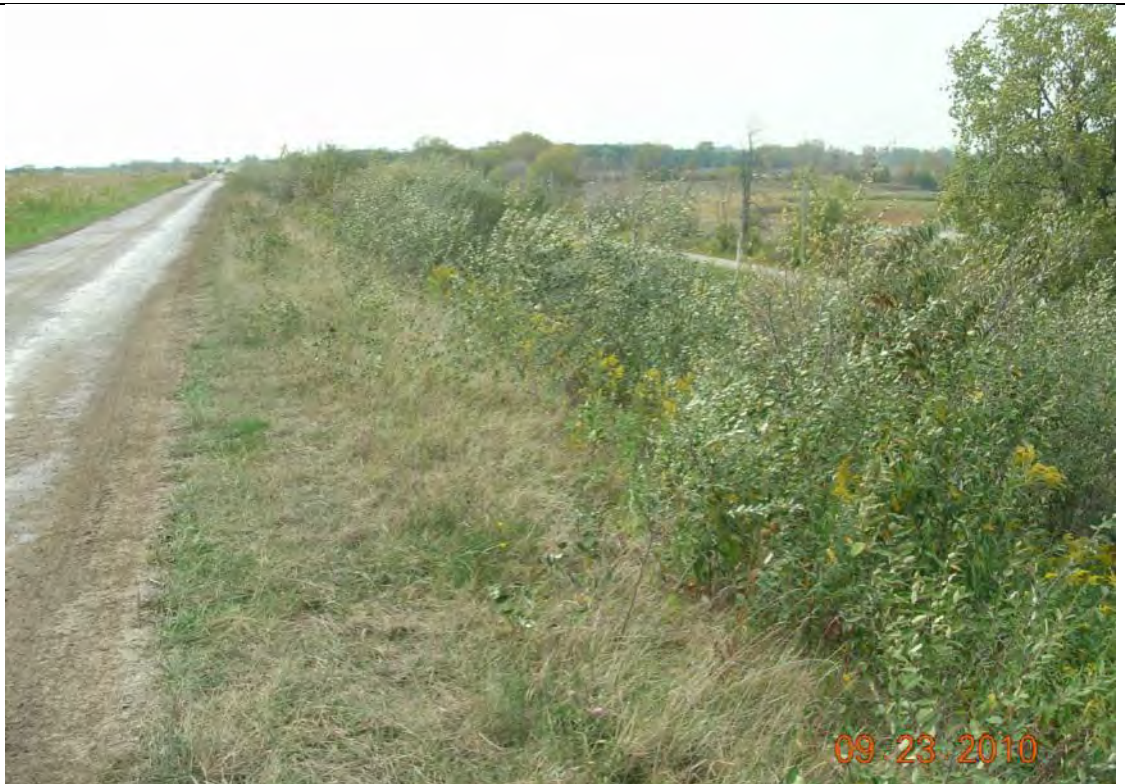
Photo No. 2

Vegetation on embankment near Station 50+00.

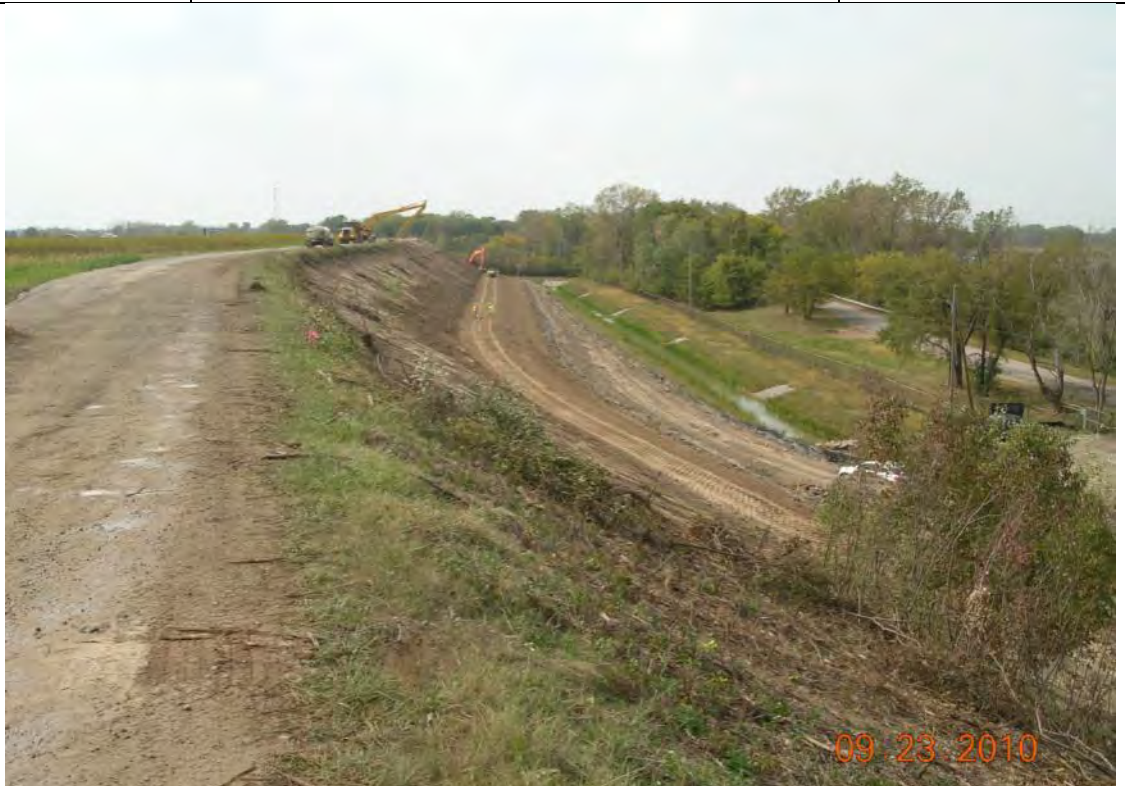
Description: Embankment reconstruction from approximately Station 62+00 to Station 68+00.

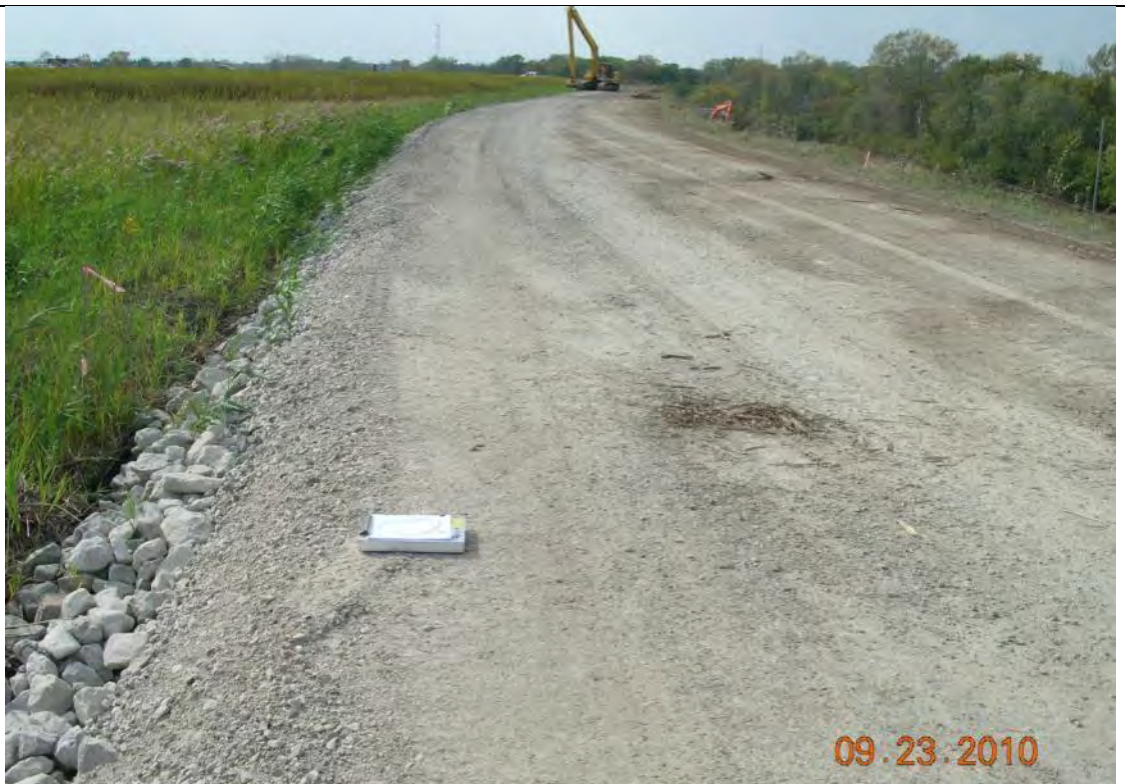
Photo No. 4

Description: New road construction along the crest near Station 64+00. Note the variation in gravel color to distinguish between the existing and new crest road.

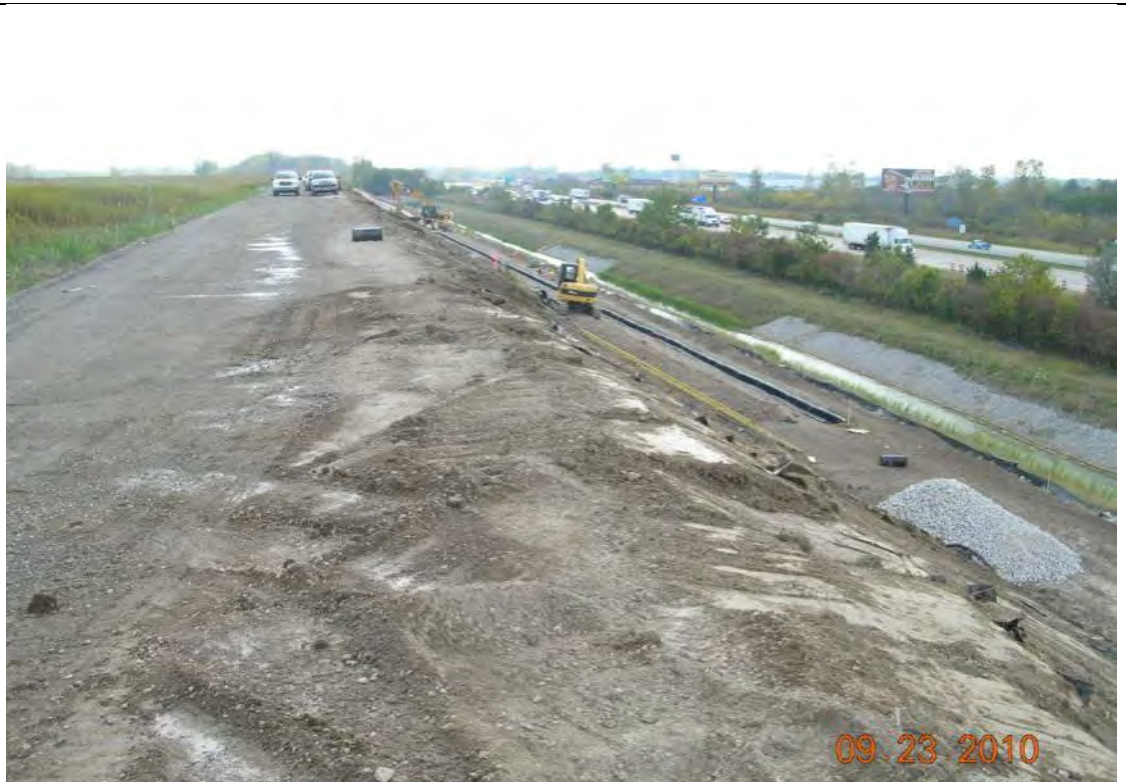
Photo No. 6

Description: Reconstruction of the embankment near Station 69+00. The construction of a ditch in mid slope is also shown.

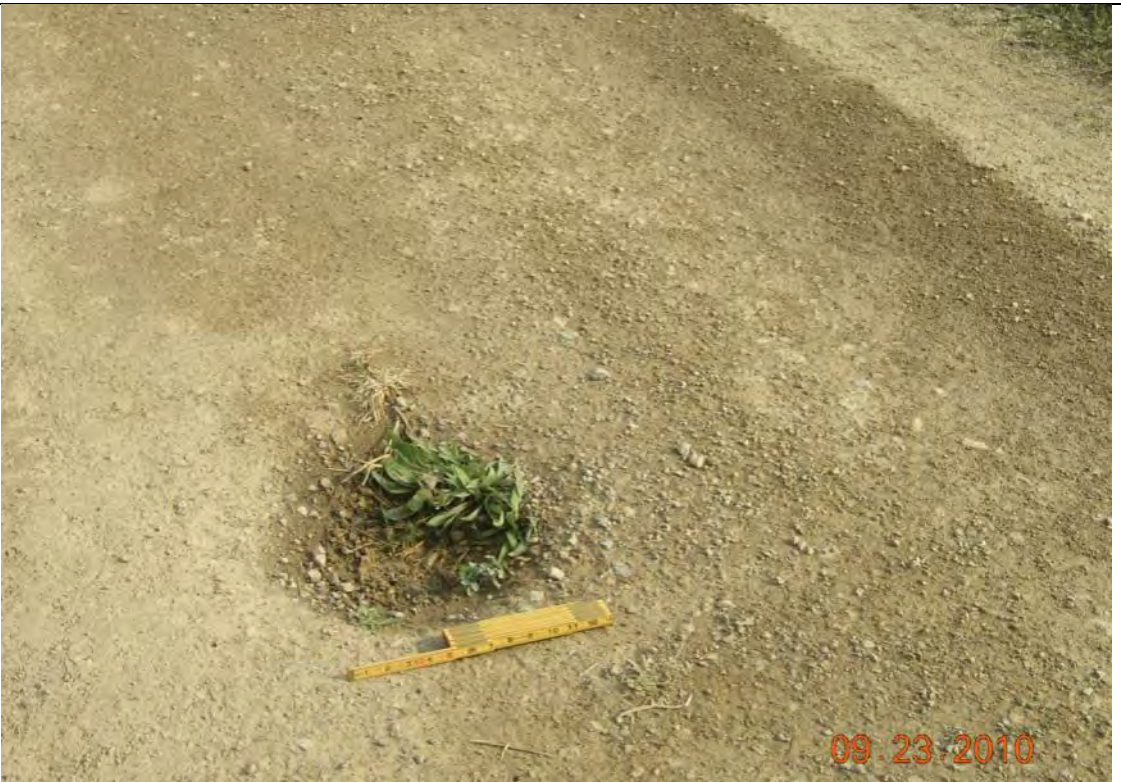
Photo No. 10	Date: 9/23/10
Direction Photo Taken: East

Description:
Shallow hole in crest road due to a surveyor attempting to locate surface monument.

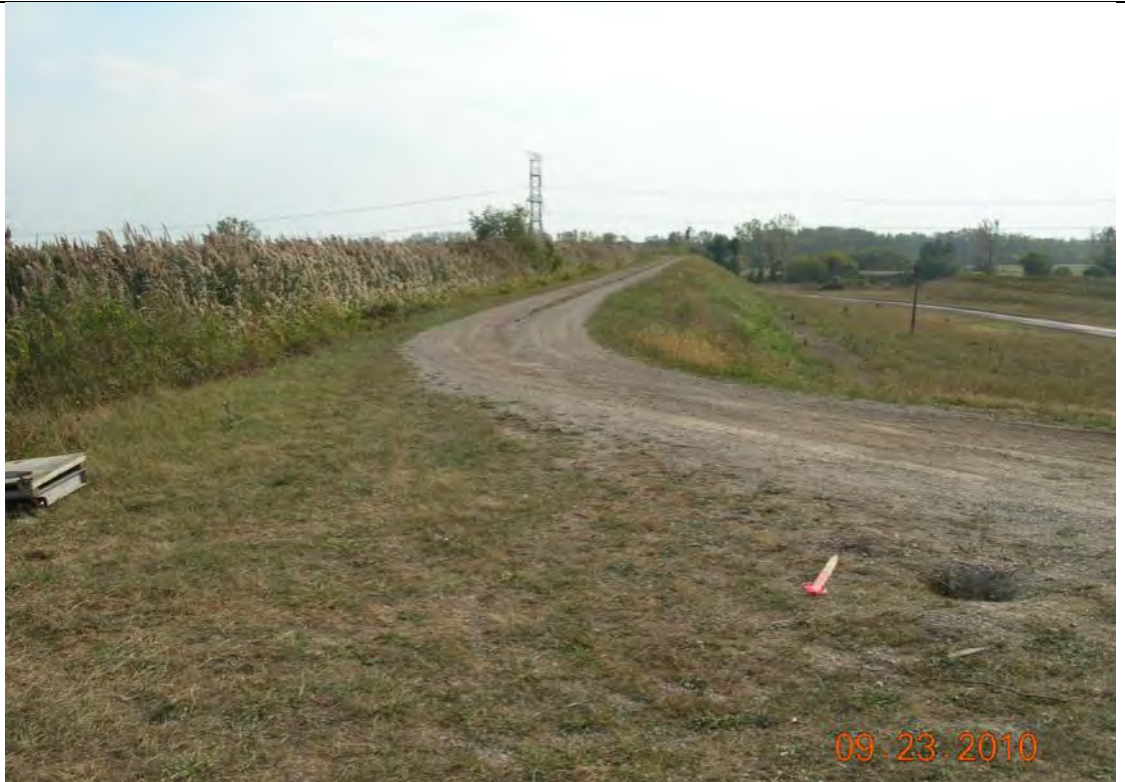
Photo No. 12 Date: 9/23/10

Description: Crest and embankment near Station 104+00. The shallow hole on the right of the photo was caused by a surveyor attempting to locate a surface monument.

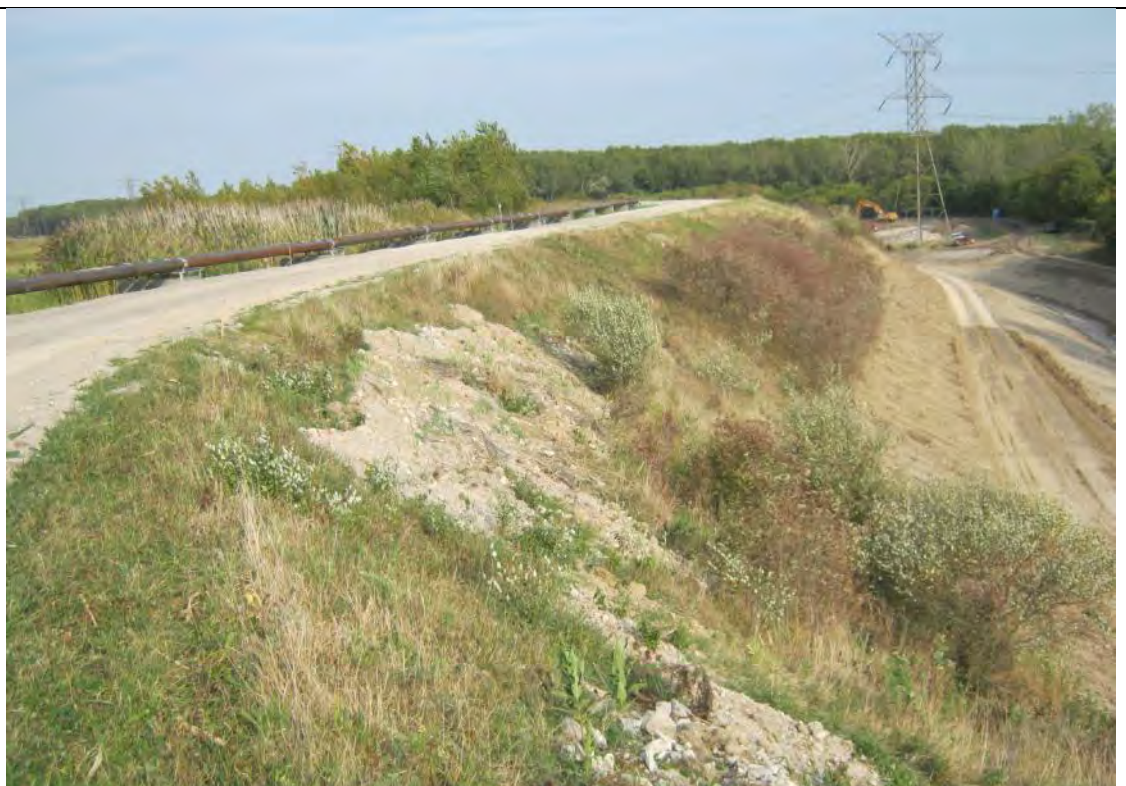
Photo No. 20	Date: 9/23/10
Direction Photo Taken: Northeast

Description:
Excess road construction material placed on the embankment near Station 144+00.

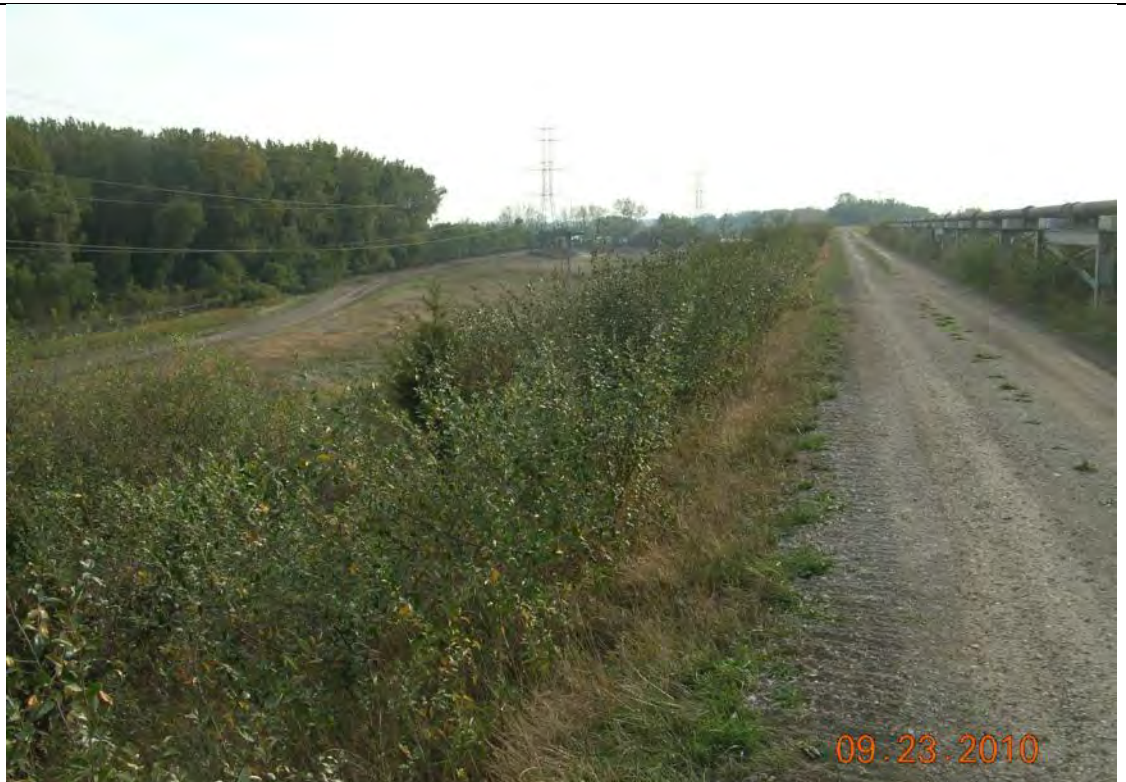
Photo No. 22

Description: Heavy vegetation along eastern embankment near Station 170+00.

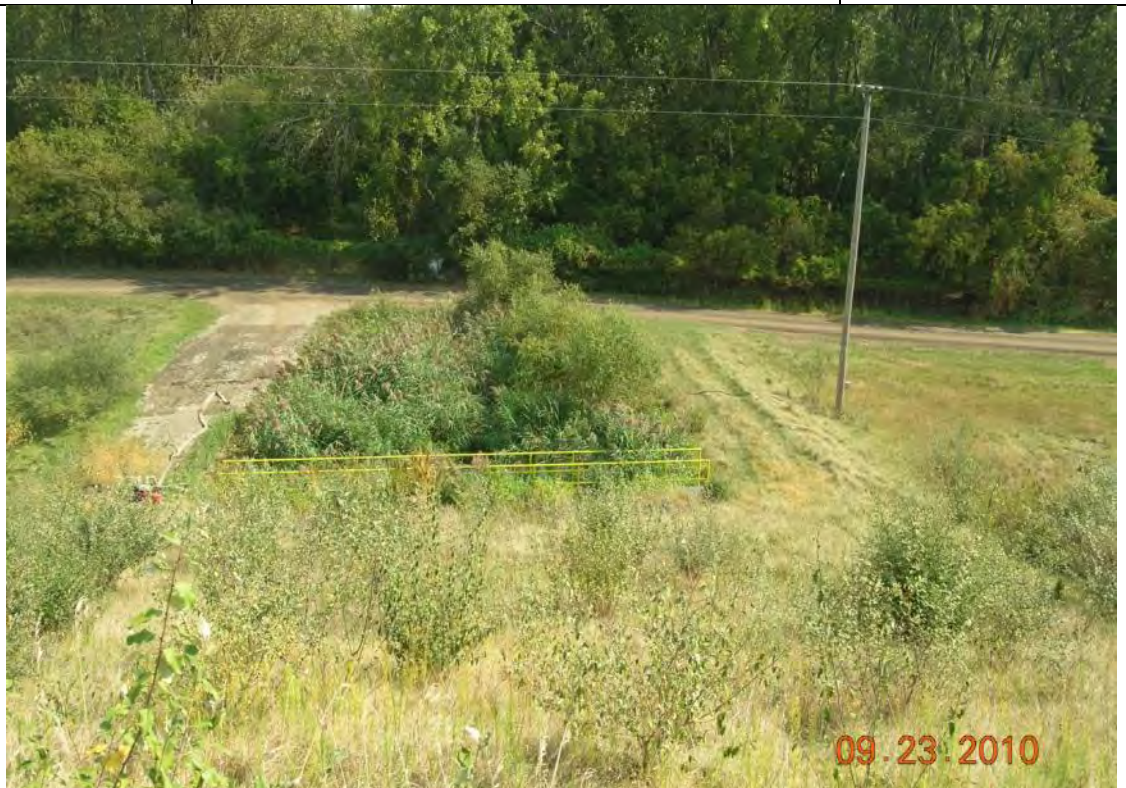
Description:
Vegetation growing near stilling wells near Station 177+00.

1. Clear vegetation from the channel downstream of the stilling wells;
2. Install a staff gauge near the discharge structure in order to take monthly measurements of the Fly Ash Basin water surface elevation;
3. If DTE has the opportunity to stop discharging from the Fly Ash Basin for a limited time period, inspect the discharge pipes from the discharge structure to the stilling wells to verify that they are operating correctly and are in good condition. This may be performed by video photograph.

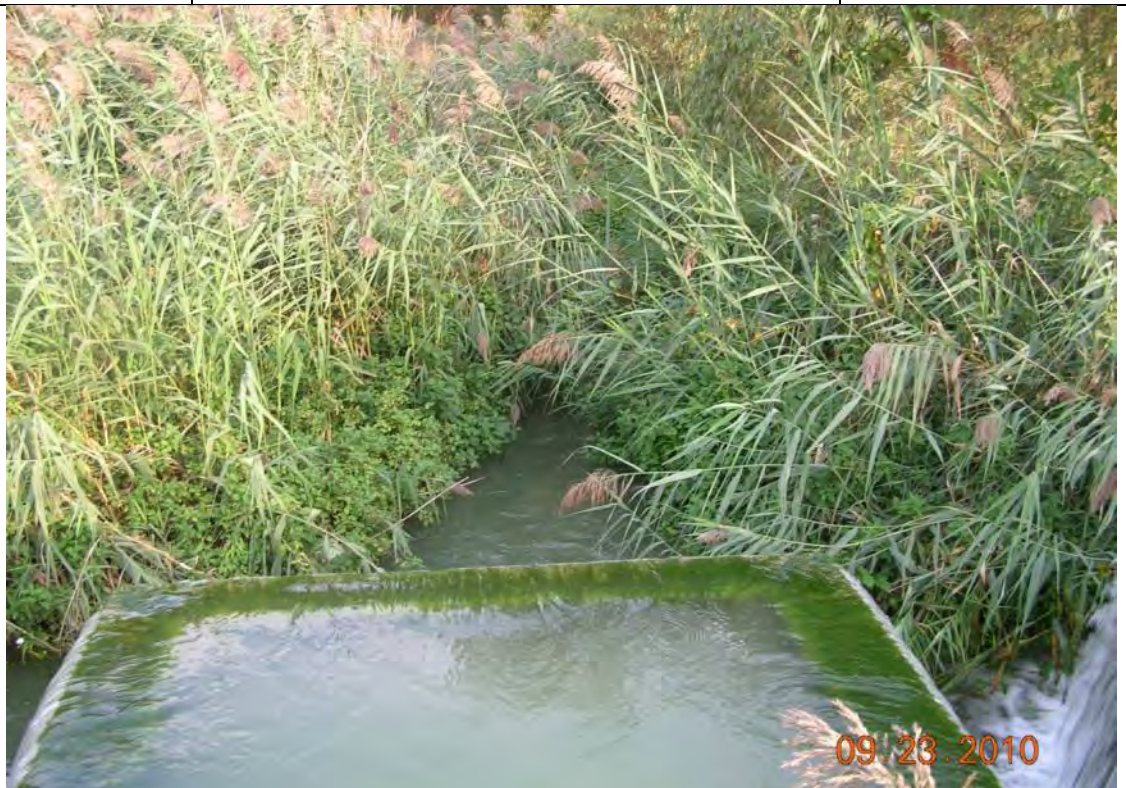
Description:
Vegetation downstream of the stilling wells in the discharge channel.

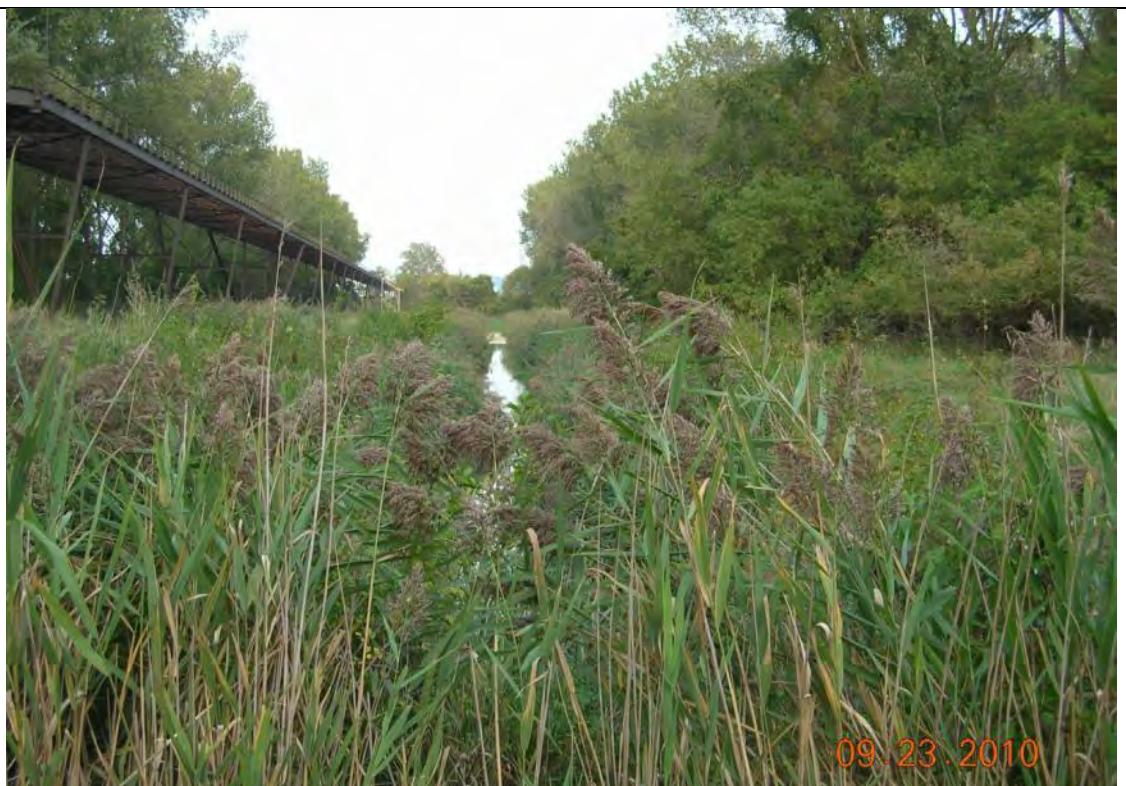
Photo No. 30	Date: 9/23/10
Direction Photo Taken: East

Description:
Vegetation in the discharge channel.

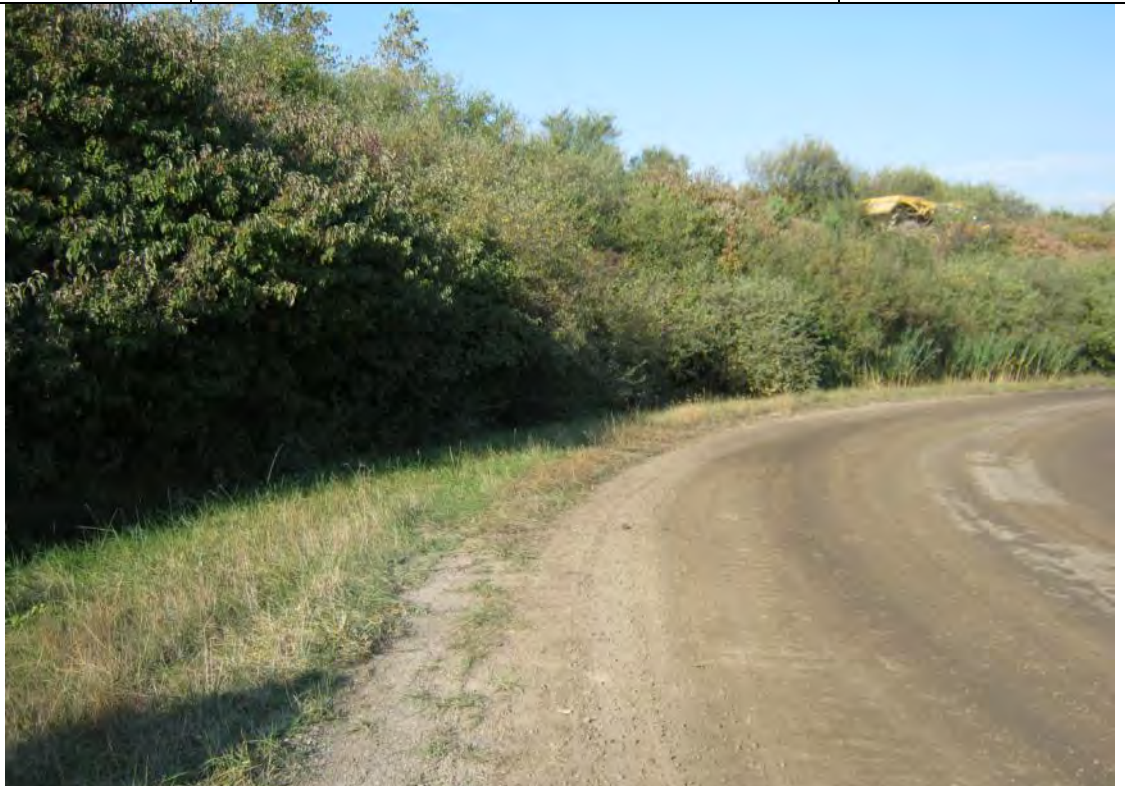
Description:
Vegetation on embankment near Station 37+00.

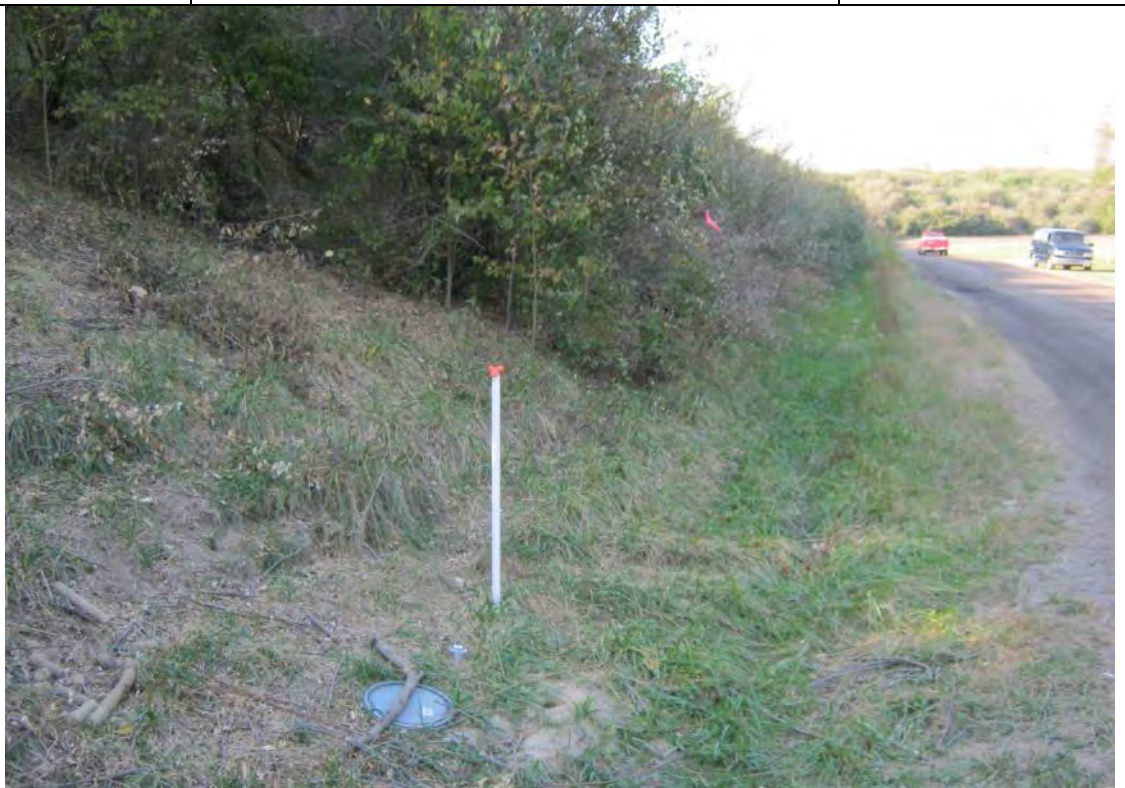
Temporary well installed at the toe of the embankment near Station 30+00. Also shows the heavy vegetation along the embankment.

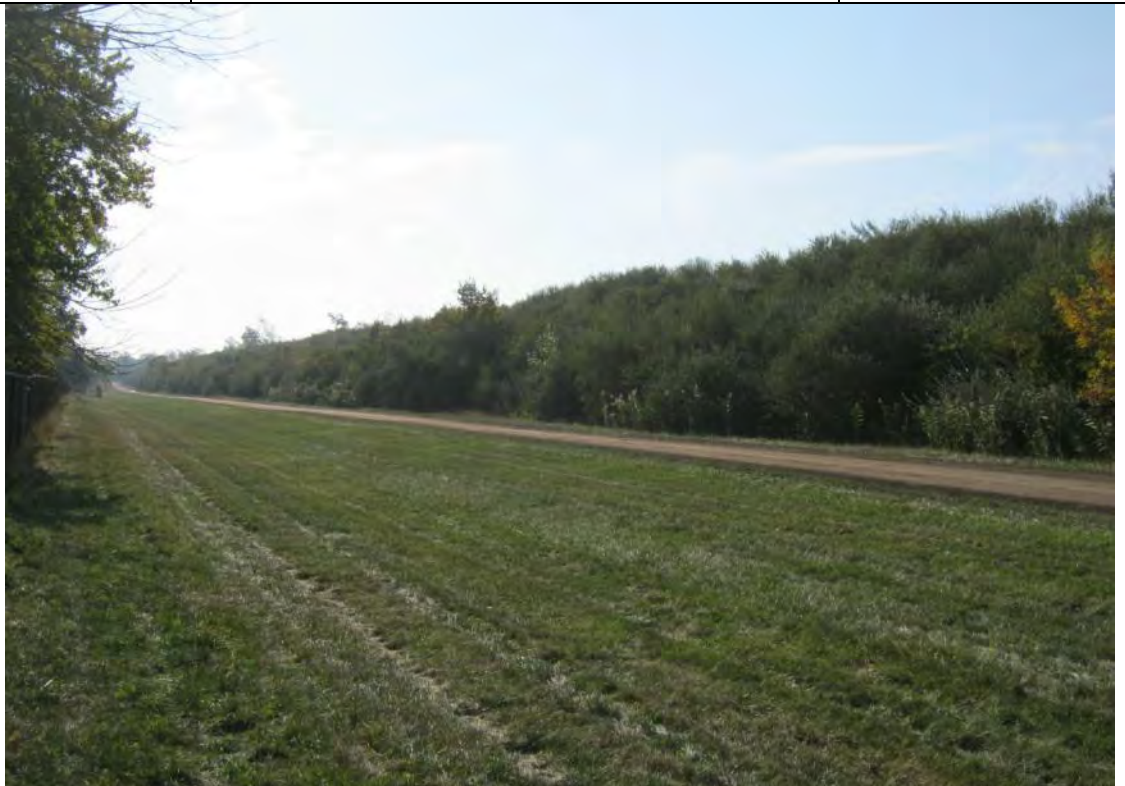
Description: Vegetation along the embankment at approximately Station 24+00.

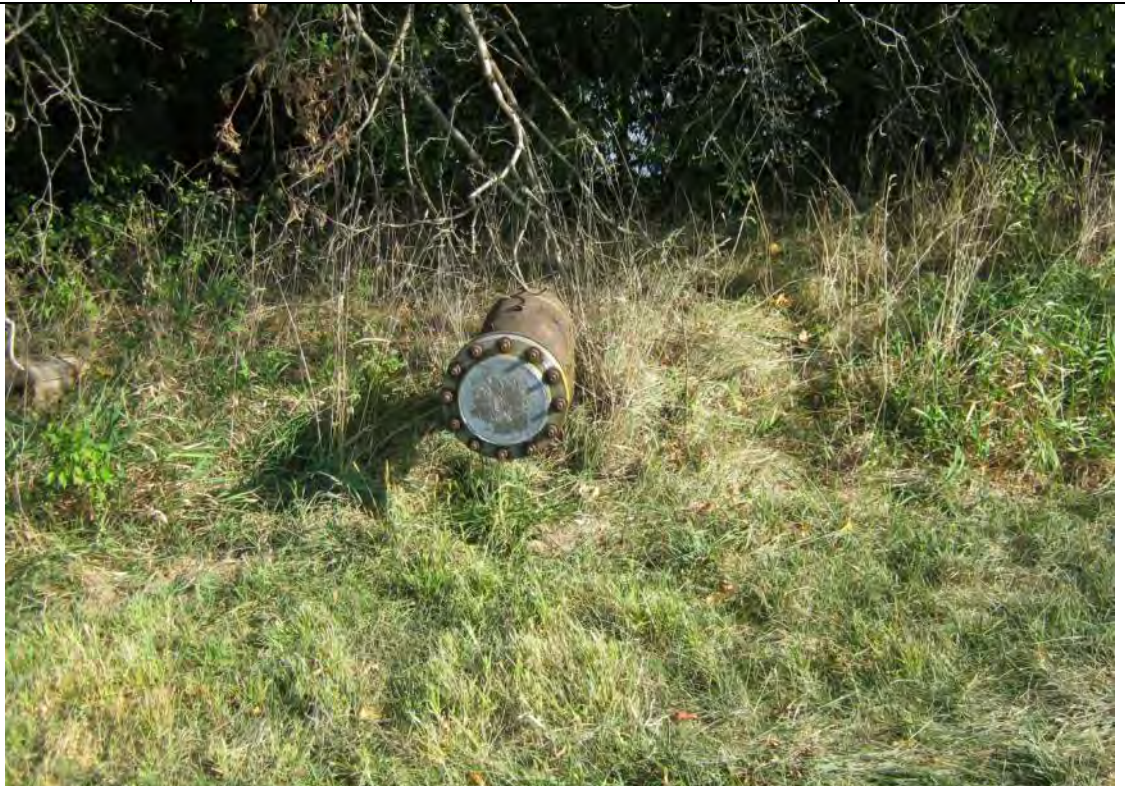
Description: Unidentified pipe near Station 16+00.

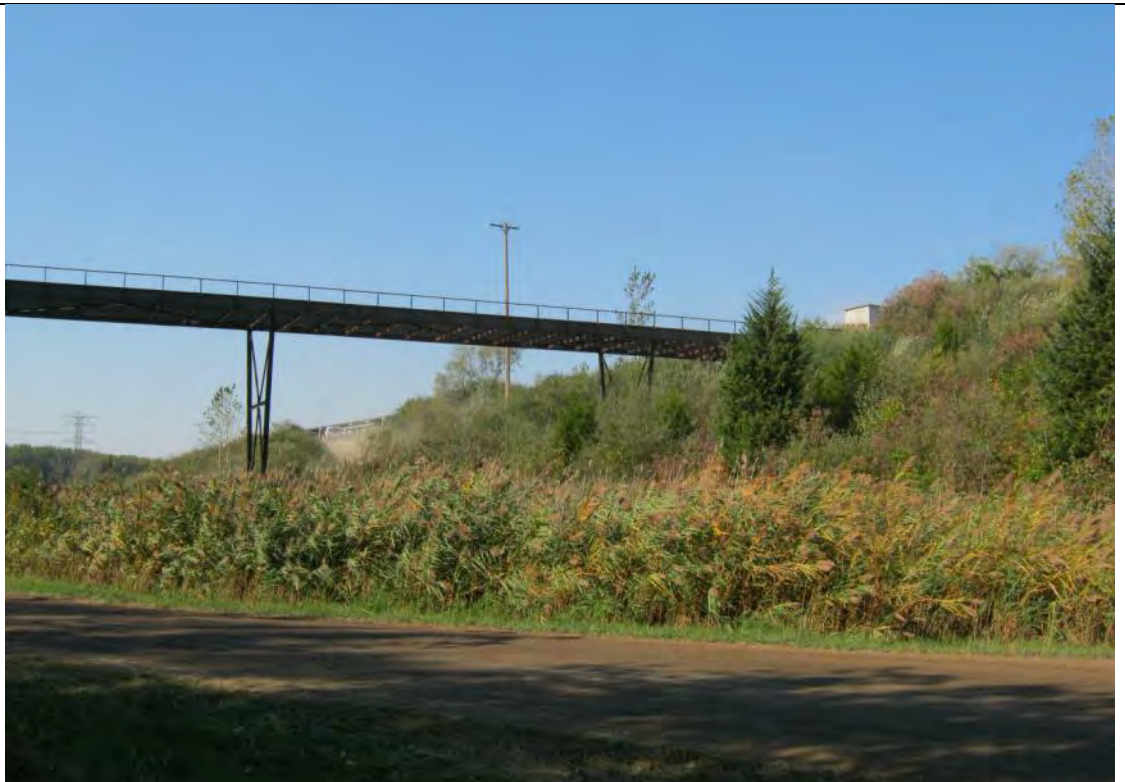
Photo No. 40

Description: Vegetation along the embankment near Station 1+00. The bridge depicted supports the fly ash sluice transfer pipes.

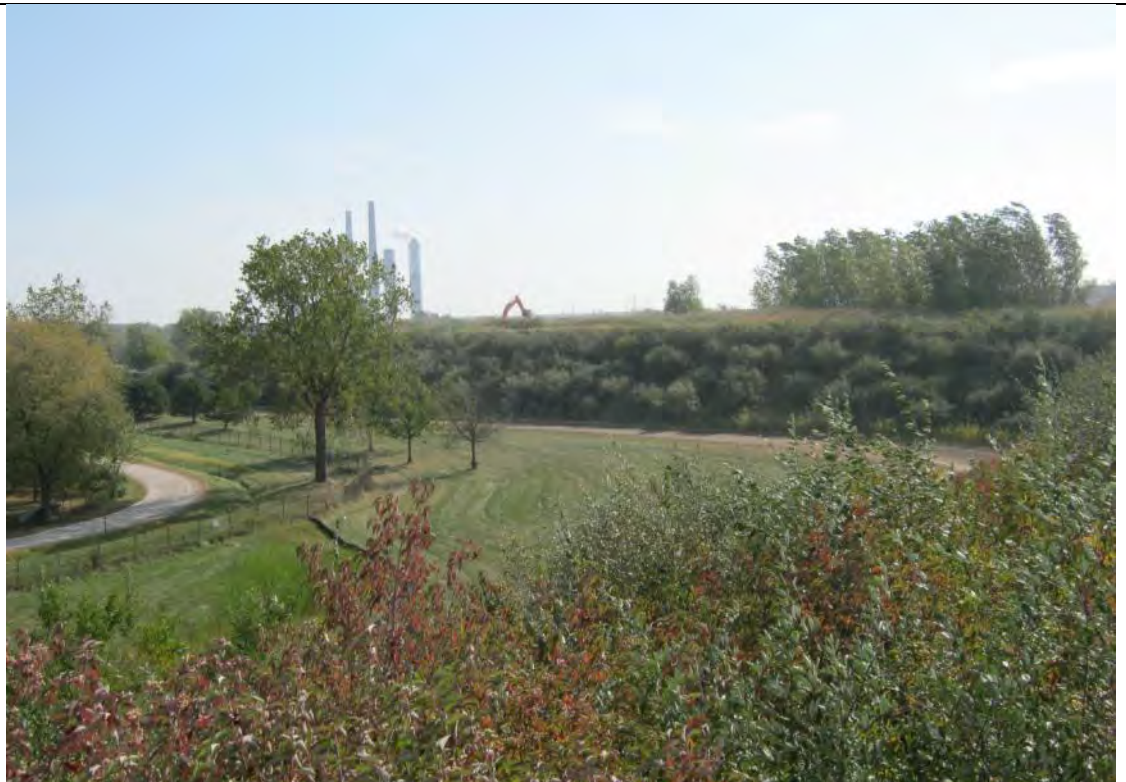
Photo No. 42	Date: 9/24/10
Direction Photo Taken: Northeast

Description:
View of the vegetation on the embankment near Station 44+00.

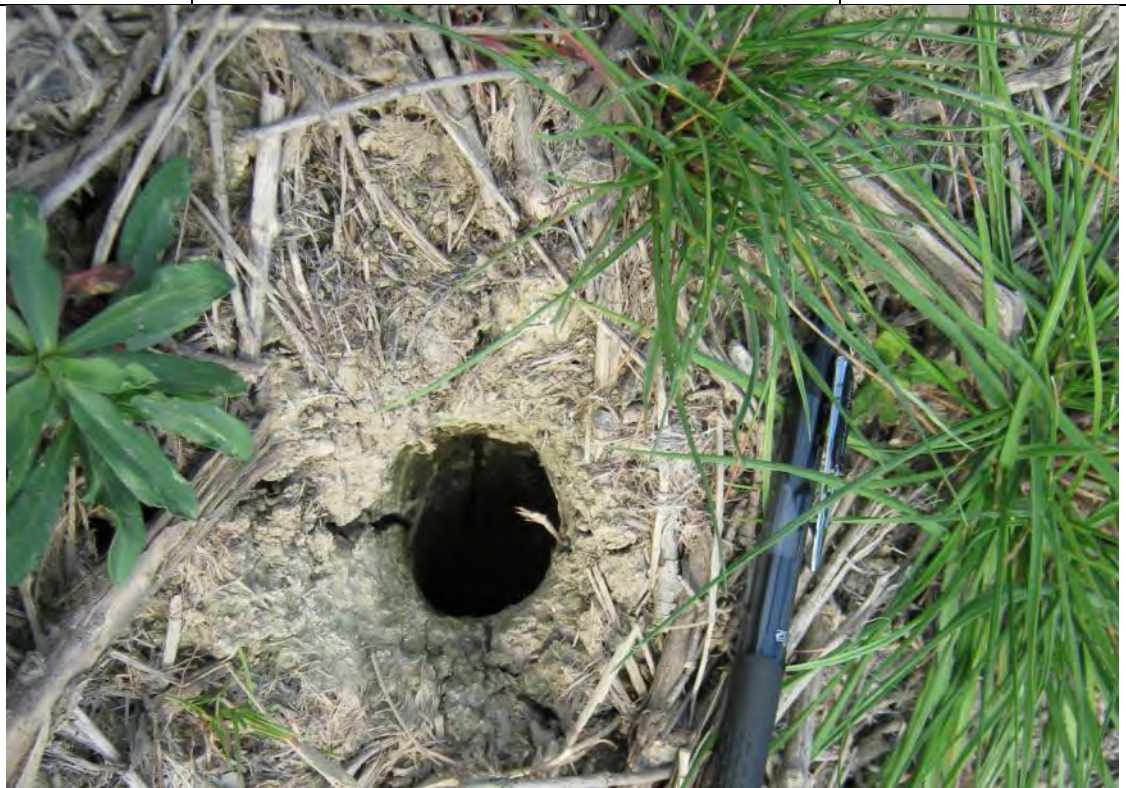
Description:
Small animal burrow at the toe of the slope near Station 132+00.

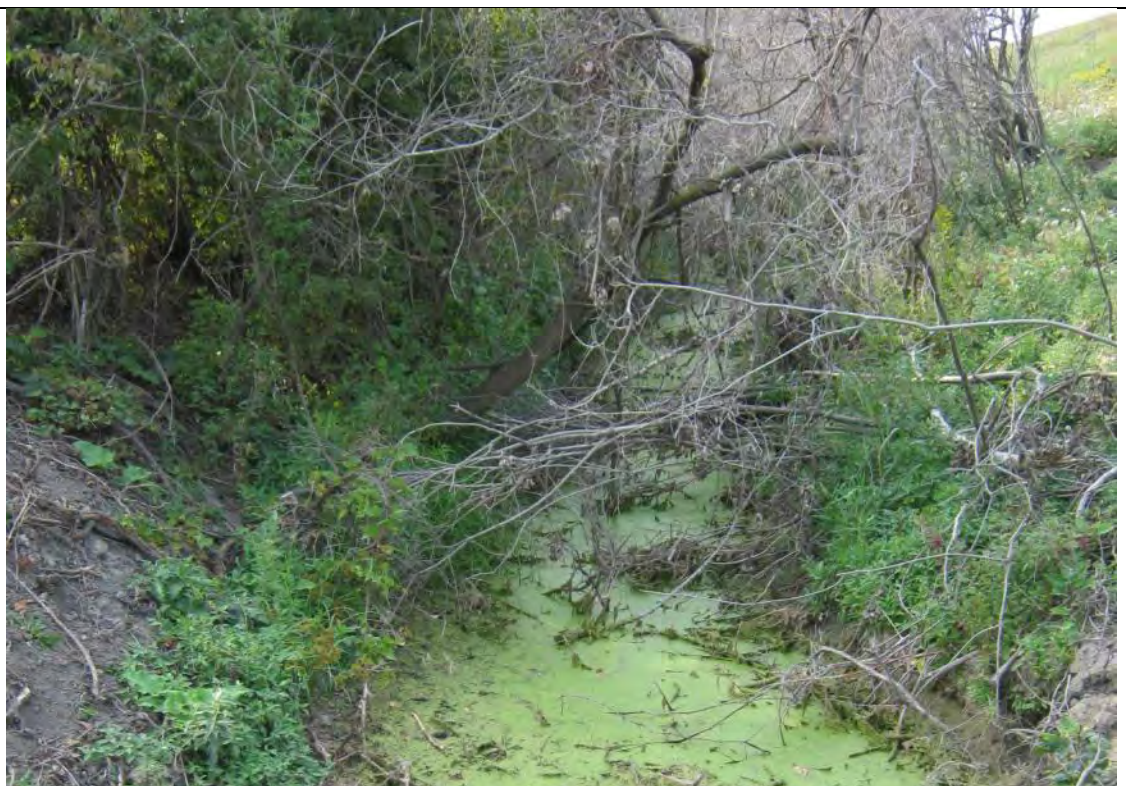
Photo No. 44	Date: 9/23/10
Direction Photo Taken: West

Description:
Standing water in ditch at toe of slope near Station 139+00.
