**Specific Site Assessment for
Coal Combustion Waste
Impoundments at Duke
Energy Indiana (DEI)
Cayuga Generating Station**

Cayuga, Indiana

September 2010
Project 092882

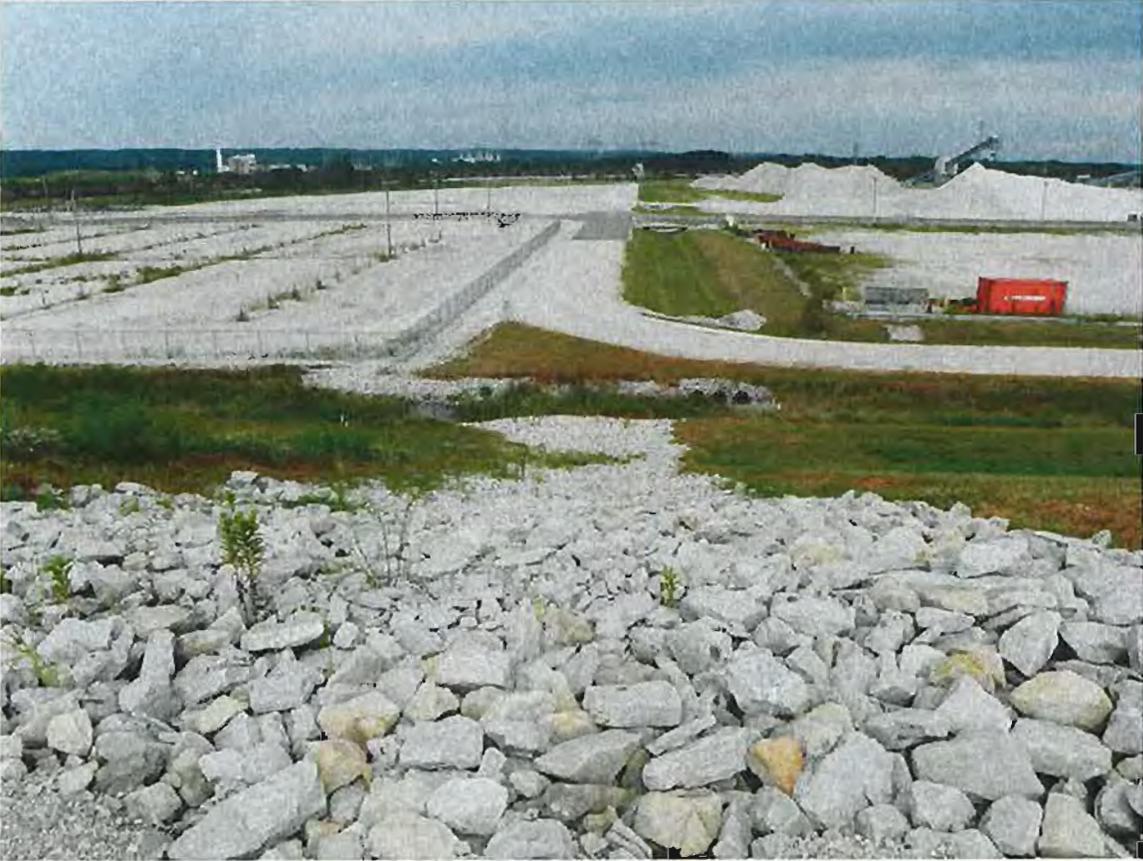
The Lined Ash Disposal Pond – Cell #1 has an open channel emergency spillway. The emergency spillway was designed as a two foot deep by 26 foot wide rectangular channel. The emergency spillway contains about 18 inches of riprap and the riprap voids are filled with road base aggregate. The open space in the channel above the riprap is the shape of a trapezoidal channel 6 inches deep by 20 feet bottom width and 22 feet top width. Spillway rating curves were not provided by DEI. Based on a simplified evaluation for a broad-crested weir condition and assuming the filled void spaces of the riprap do not allow significant flow through the riprap, the spillway capacity is about 21 cubic feet per second (cfs).

Photo 4: Lined Ash Disposal Pond – Cell #1 – Emergency spillway, west dike, looking west

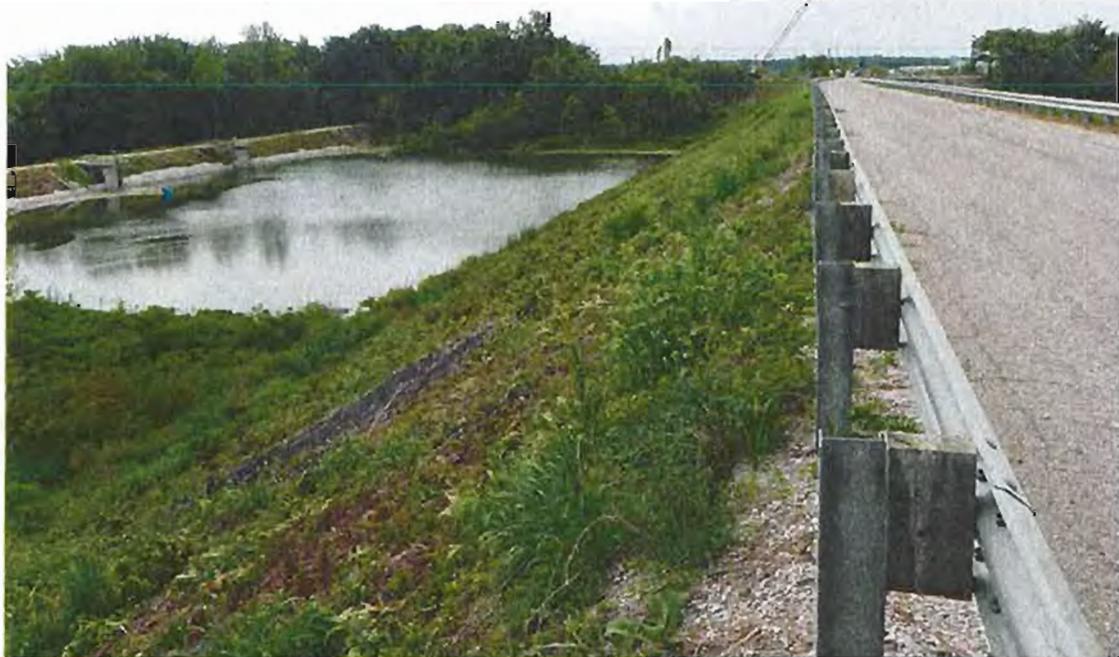
Photo 29: Secondary Ash Settling Pond – West dike upstream slope (divider dike with Primary Ash Settling Pond), note erosion, looking south

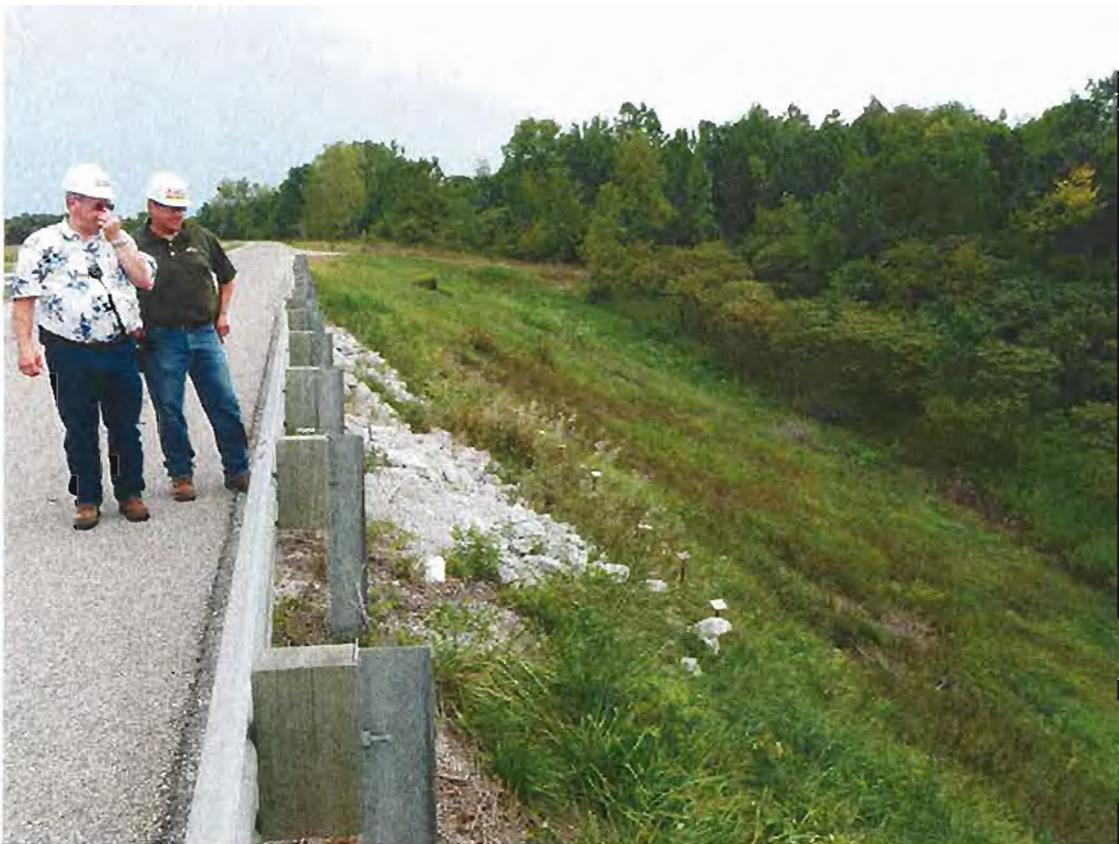
Photo 30: Secondary Ash Settling Basin – West dike upstream slope (divider dike with Primary Ash Settling Basin), note erosion, looking north

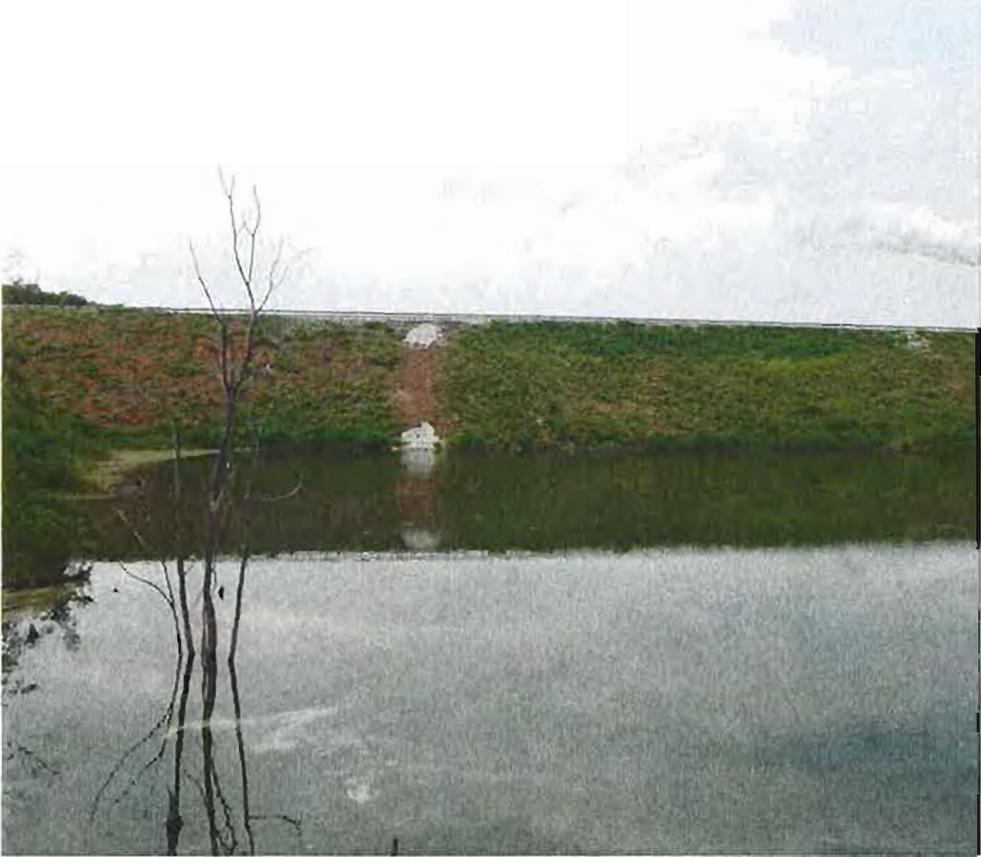
Photo 32: Secondary Ash Settling Basin – West dike upstream slope, note rip rap covering animal holes, looking west

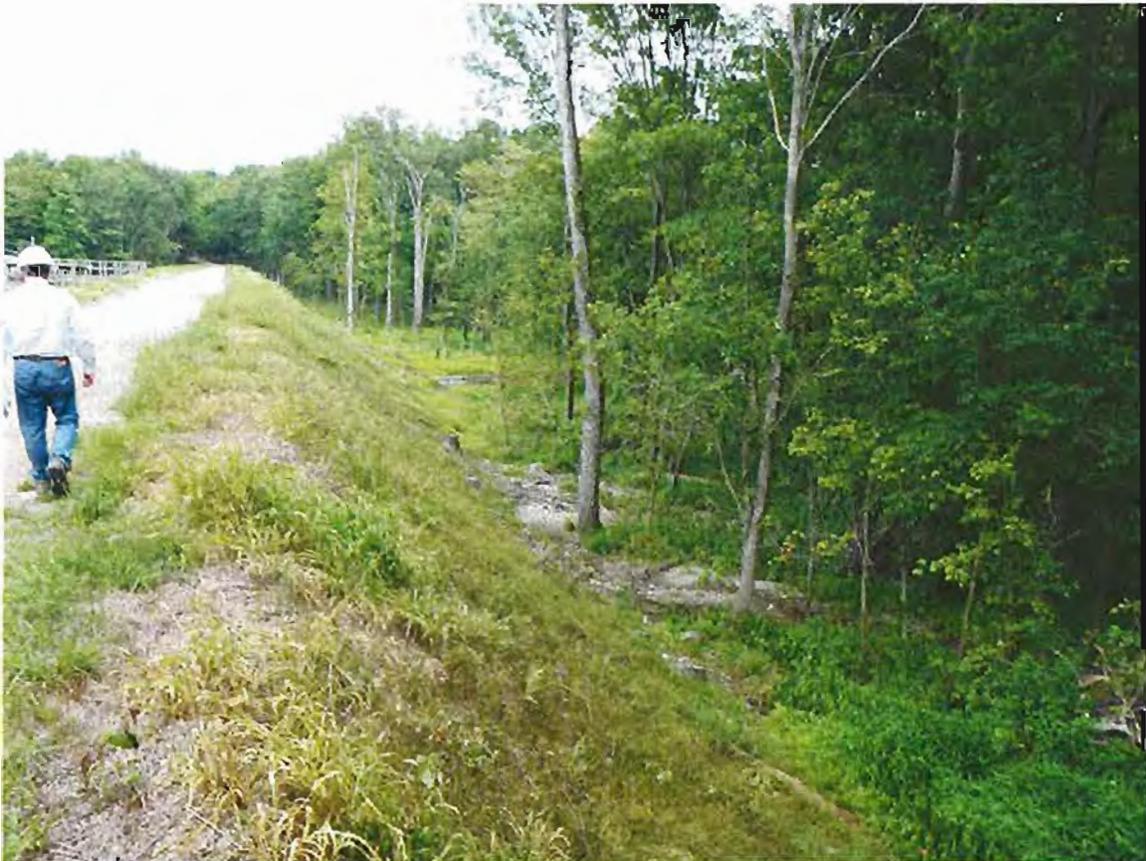
Several trees (up to 2-foot-diameter) were observed at the toe of the downstream slope of the Secondary Ash Settling Basin east dike and the Temporary Cover 2008 area of the Ash Disposal Area #1. A dense growth of large trees and shrubs were also observed on the downstream slope of the Original Ash Pond perimeter north dike, which forms the north dike of the Ash Disposal Area #1 and the supporting dike for the Lined Ash Disposal Pond – Cell #1 and its underlying older ash foundation.

Photo 34: Secondary Ash Settling Basin – East dike downstream slope, note trees within 25' of dam toe, looking north

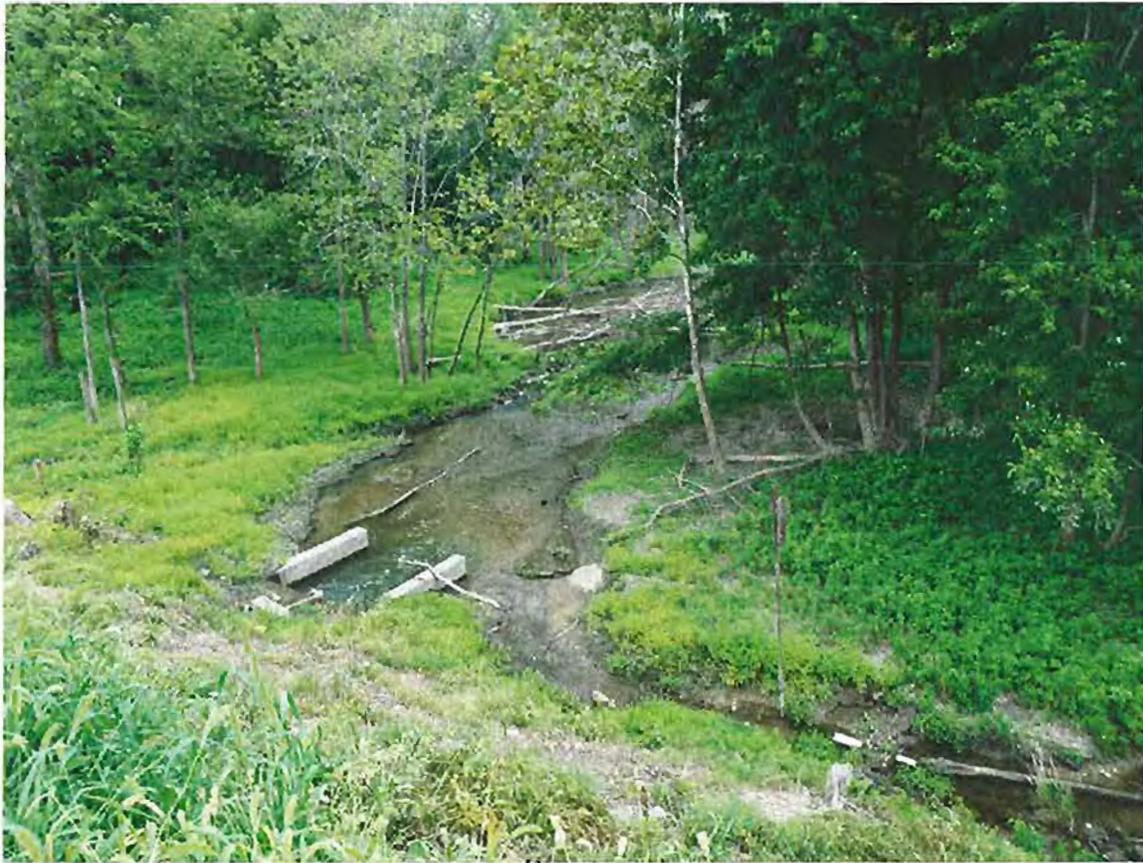
Evidence of potential seepage and erosion was observed on the Primary Ash Settling Basin east dike downstream slope at the location of the outlet pipe, as discussed in the Downstream Slope section above. Duke Energy also reported a wet area at the Primary Ash Settling Basin east dike at the southeastern end of the dam at the downstream toe. Seepage could be occurring through the dam embankment and foundation and through existing natural deposits and flowing downstream into the Secondary Ash Settling basin. Seepage is not measured at this location.

Photo 35: Secondary Ash Settling Basin – East dike downstream toe, outlet and outlet structure to Wabash River, note seepage along downstream toe of dike at right side of photo, looking northeast

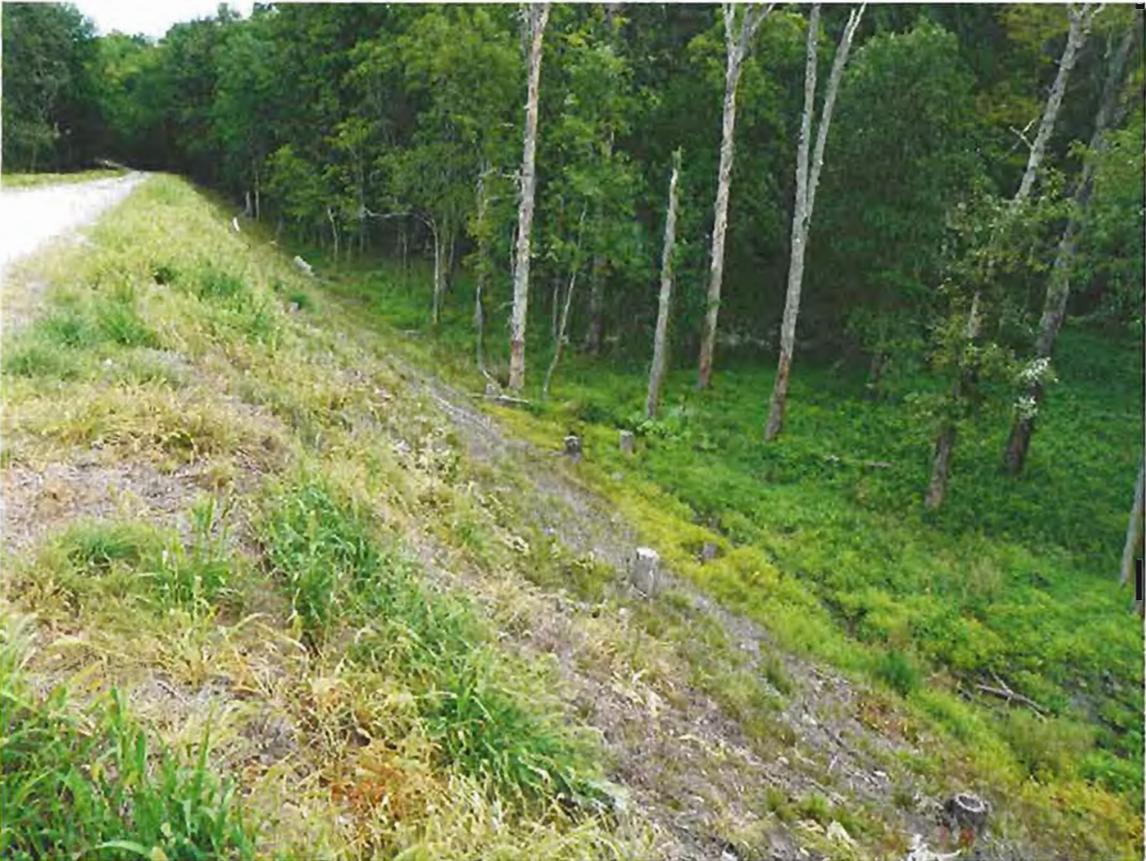
Photo 38: Secondary Ash Settling Basin – East dike downstream slope, note trees within 25' of dam toe, looking north

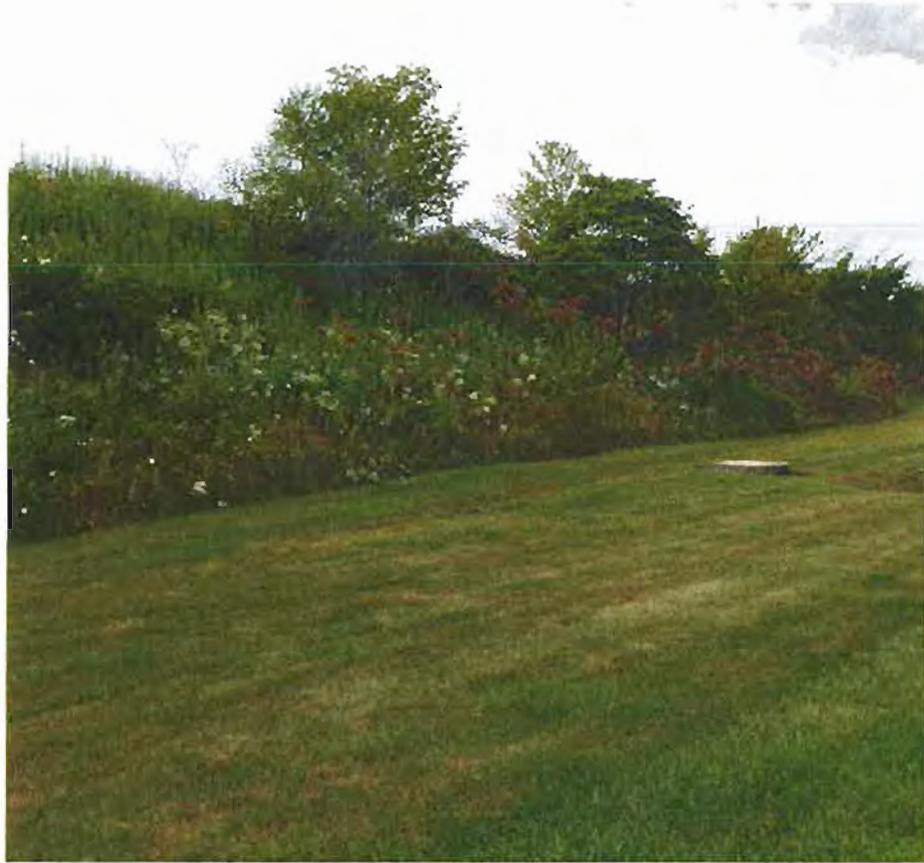
Photo 39: Original Ash Pond – North dike downstream slope, note trees, looking southwest

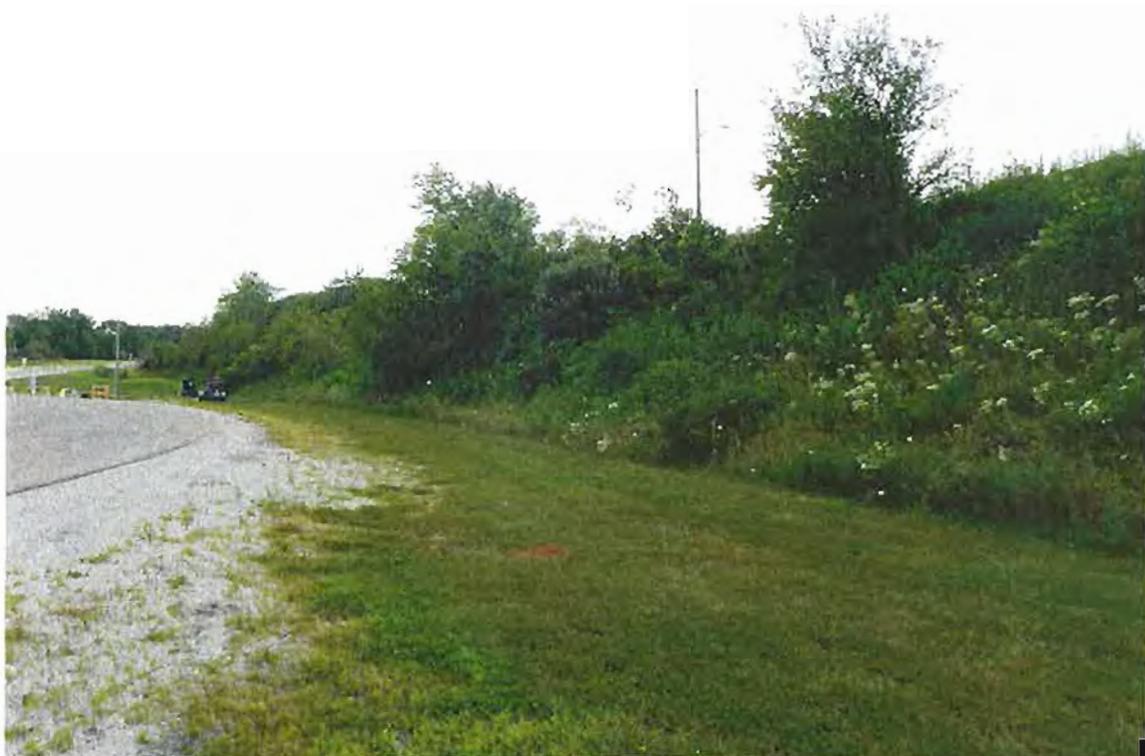
Photo 40: Original Ash Pond – North dike downstream slope, note trees, looking east

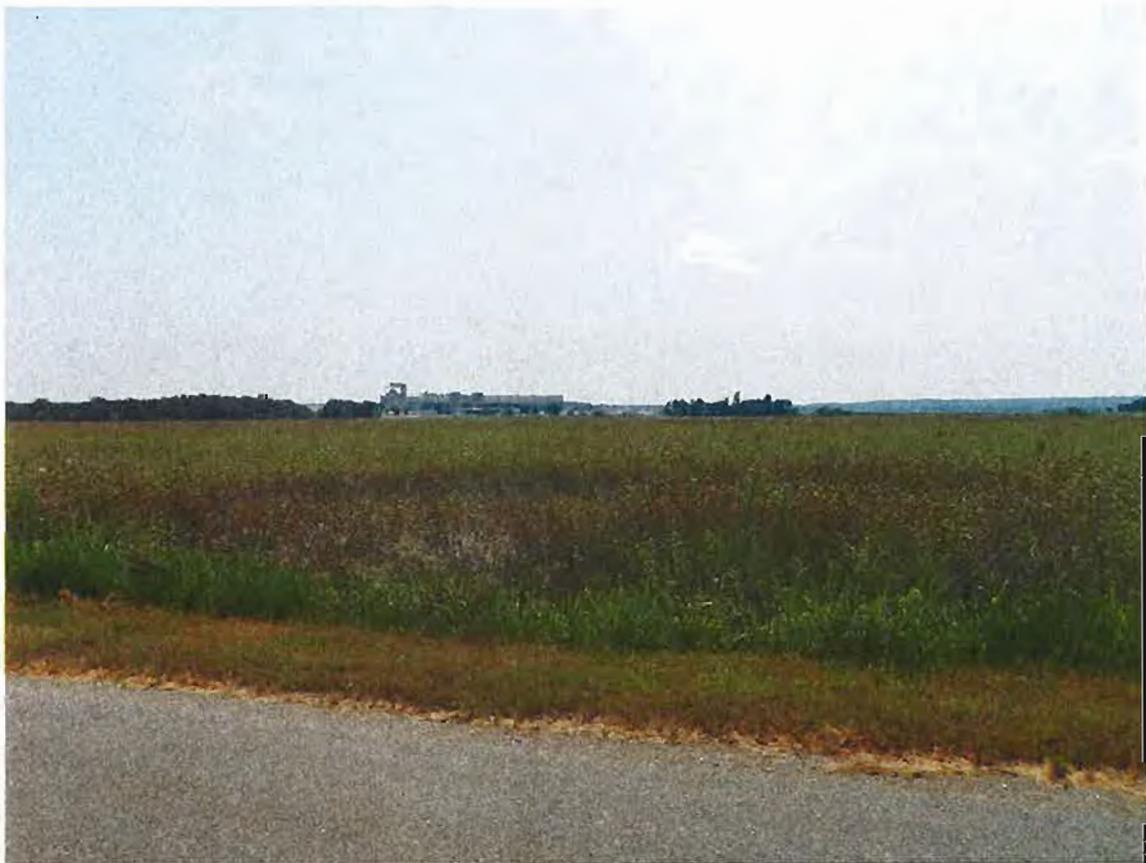
Photo 46: Ash Disposal Area #1 – Temporary Cover 2008 area, looking southwest

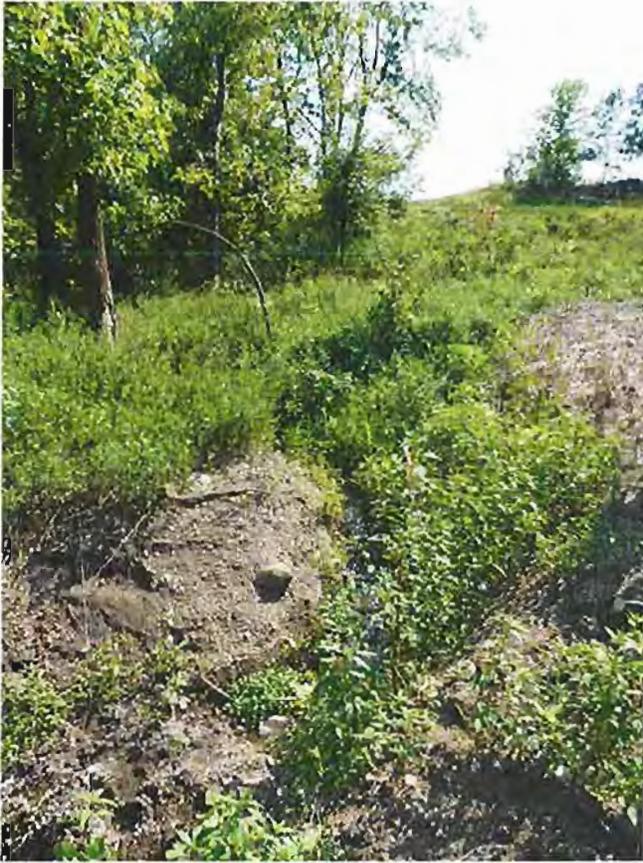
Photo 47: Ash Disposal Area #1 – Downstream of northeast dike downstream toe, note seeps / natural springs, looking southeast

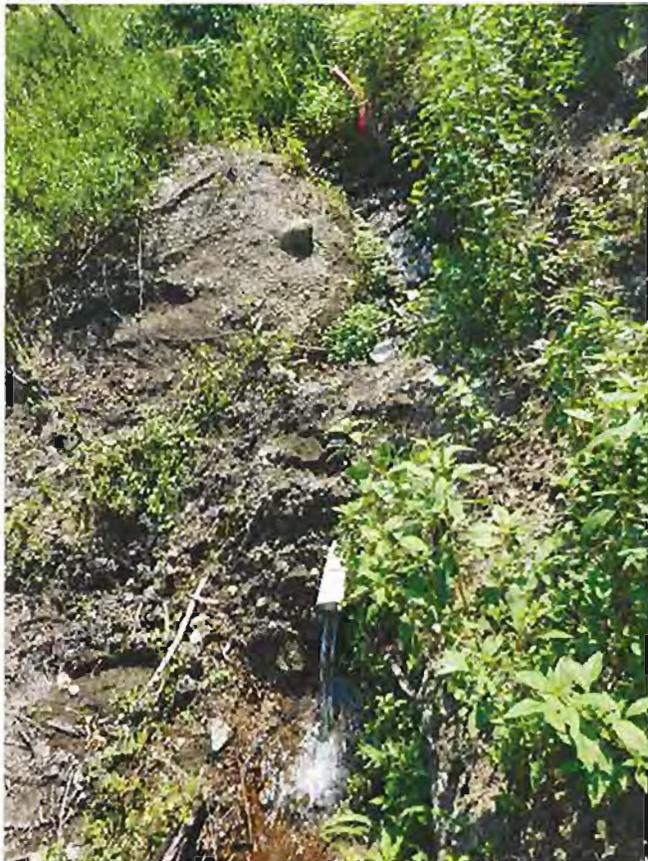
Photo 48: Ash Disposal Area #1 – Downstream of northeast dike downstream toe, note seeps / natural springs, looking southeast
