**Specific Site Assessment for
Coal Combustion Waste
Impoundments at
Duke Energy Indiana (DEI)
Cayuga Generating Station
Cayuga, Indiana**

March 2011
Project 092882

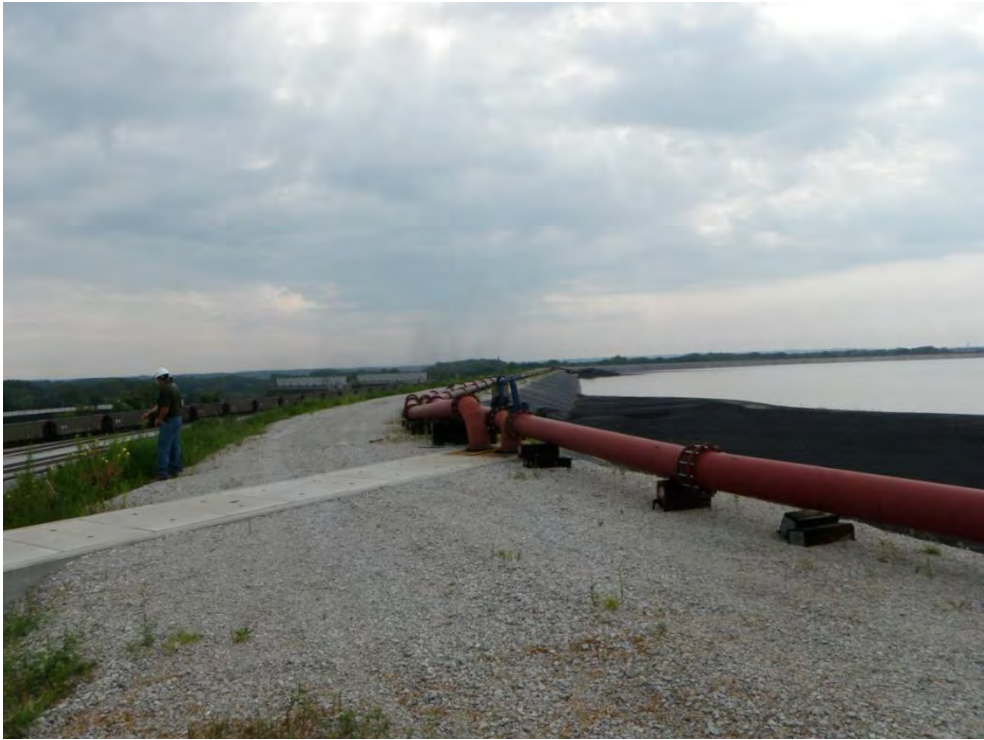
Photo 1: Lined Ash Disposal Pond – Cell #1 - North dike upstream slope and crest, looking east

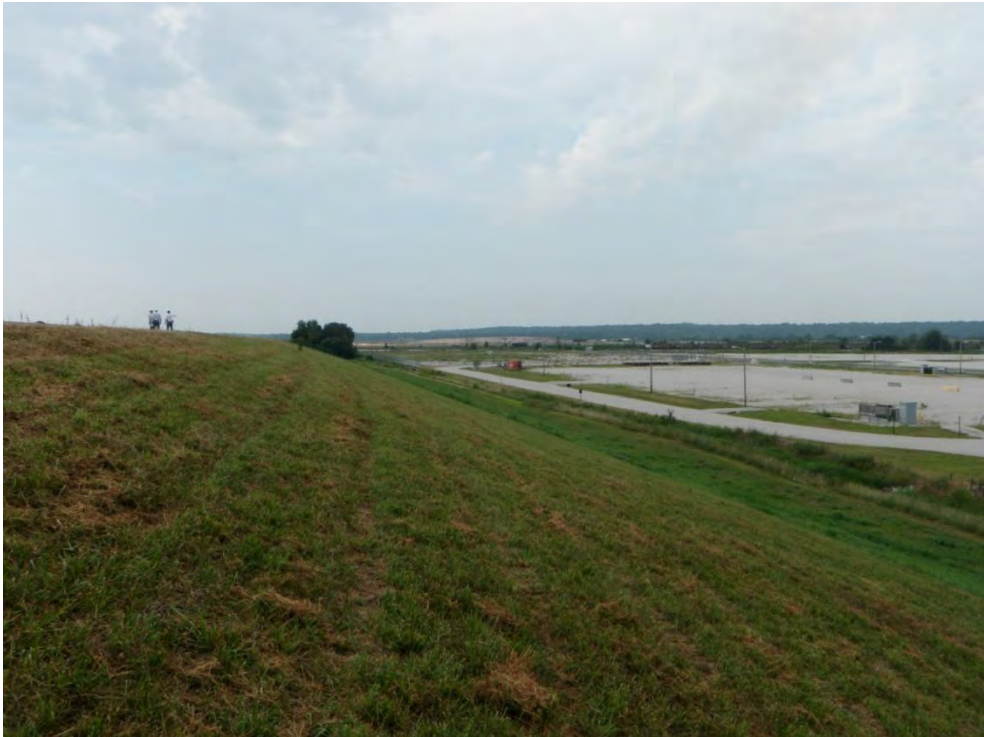
Photo 2: Lined Ash Disposal Pond – Cell #1 – West dike downstream slope, looking southwest

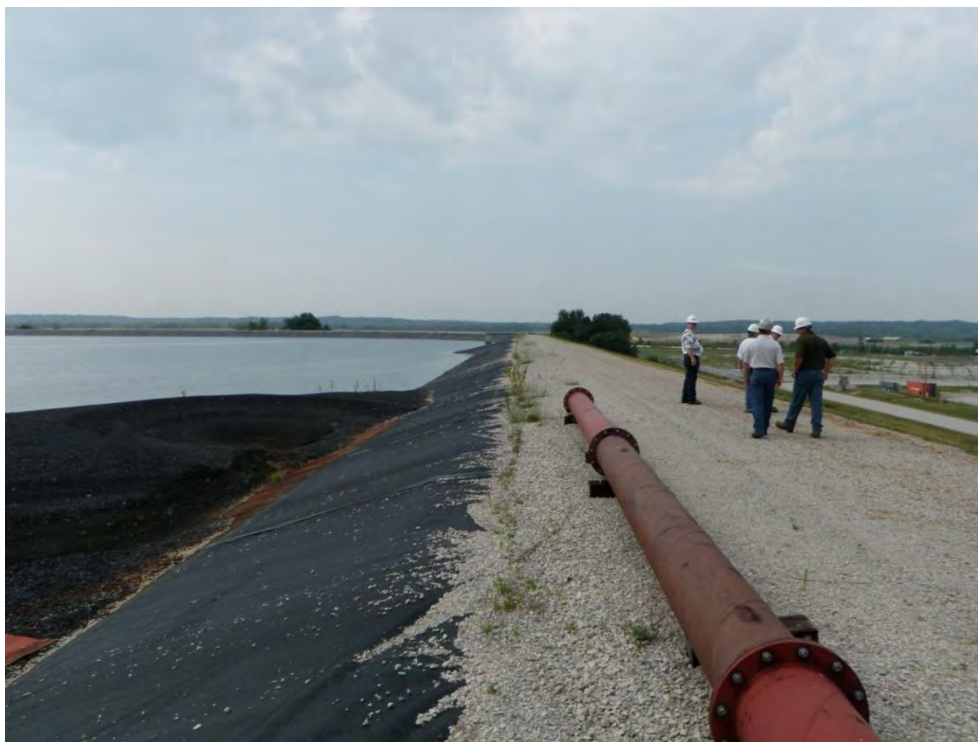
Photo 3: Lined Ash Disposal Pond – Cell #1 – West dike upstream slope, looking south

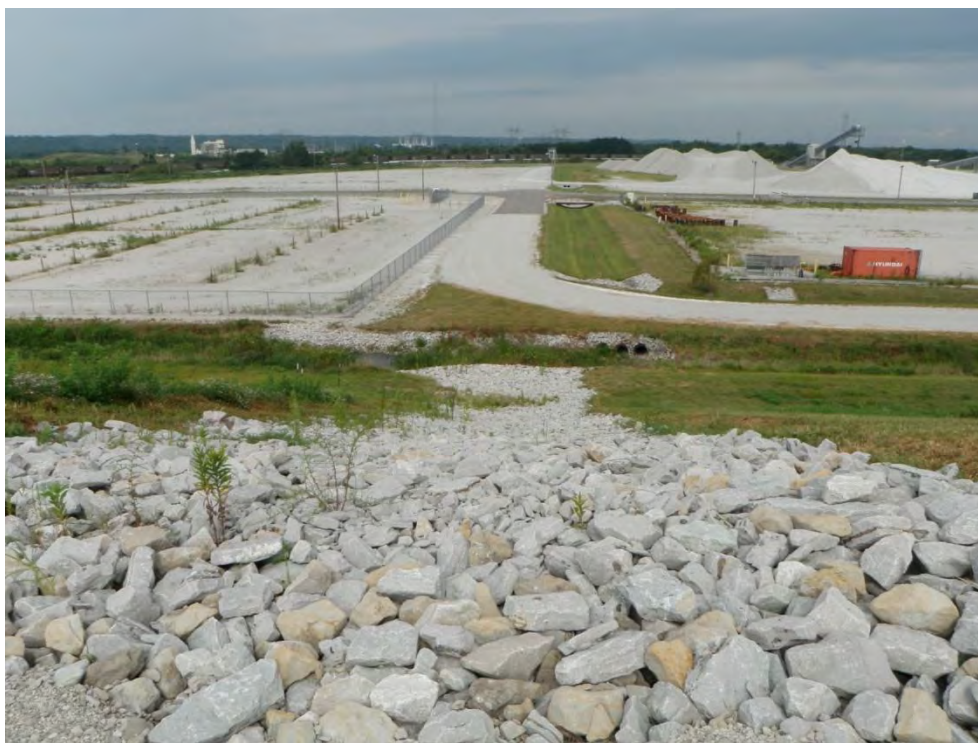
Spillway rating curves were not provided for the Lined Ash Disposal Pond – Cell #1. Based on a simplified evaluation for a broad-crested weir condition and assuming the filled void spaces of the riprap do not allow significant flow through the riprap, the spillway capacity is about 21 cfs.

Photo 4: Lined Ash Disposal Pond – Cell #1 – Emergency spillway, west dike, looking west

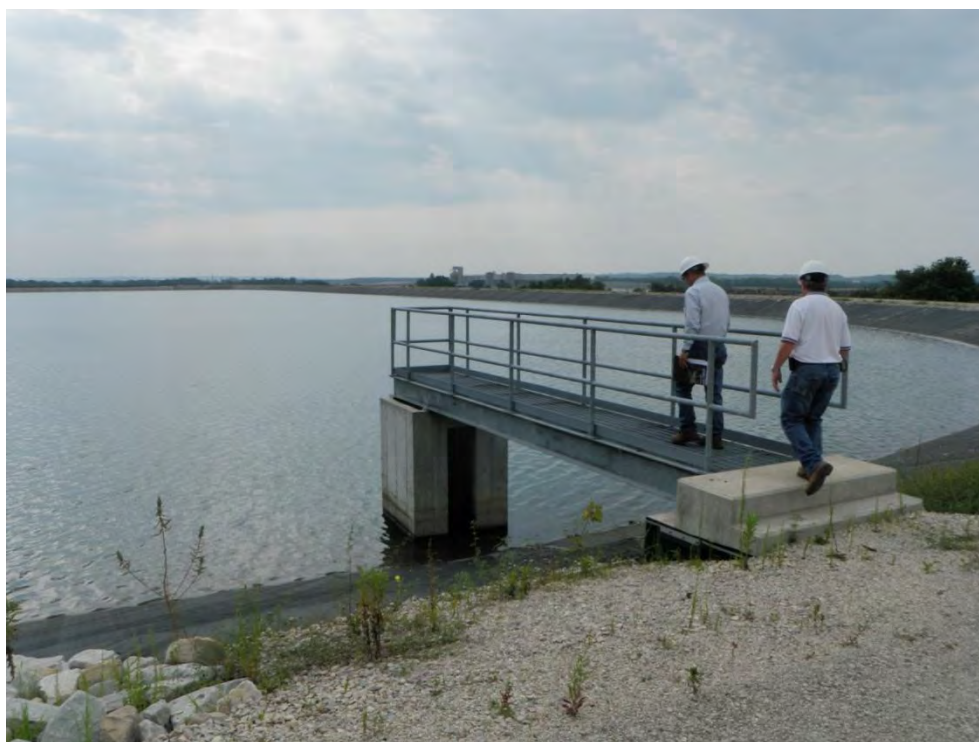
Photo 5: Lined Ash Disposal Pond – Cell #1 – Intake structure, west dike, looking southeast

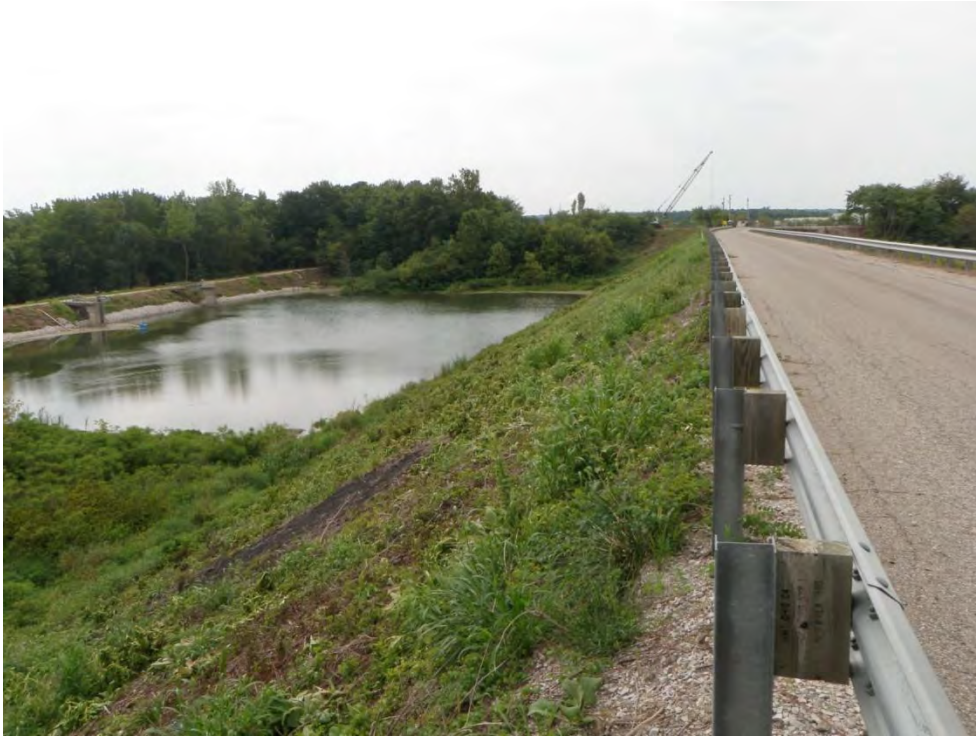
Photo 29: Secondary Ash Settling Pond – West dike upstream slope (divider dike with Primary Ash Settling Pond), note erosion, looking south

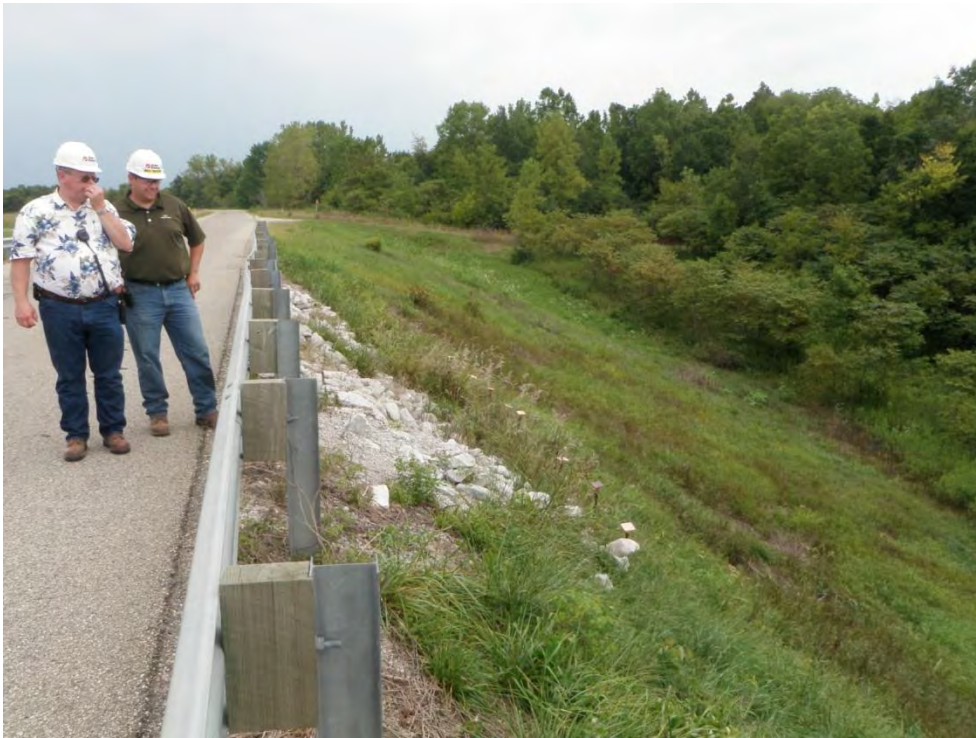
Photo 30: Secondary Ash Settling Basin – West dike upstream slope (divider dike with Primary Ash Settling Basin), note erosion, looking north

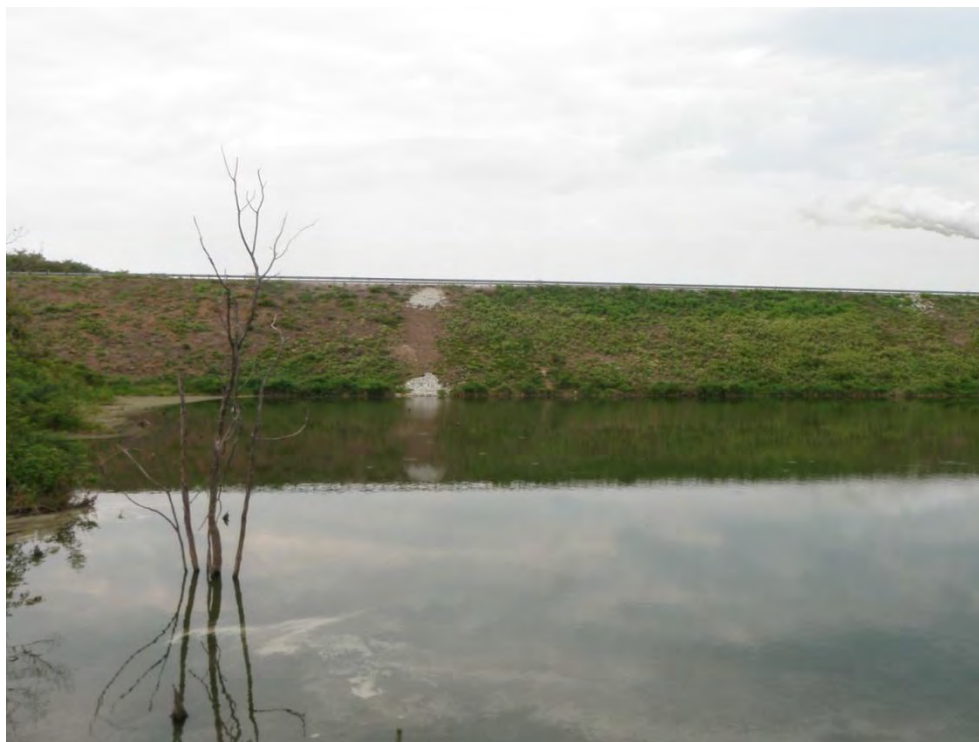
Photo 32: Secondary Ash Settling Basin – West dike upstream slope, note rip rap covering animal holes, looking west

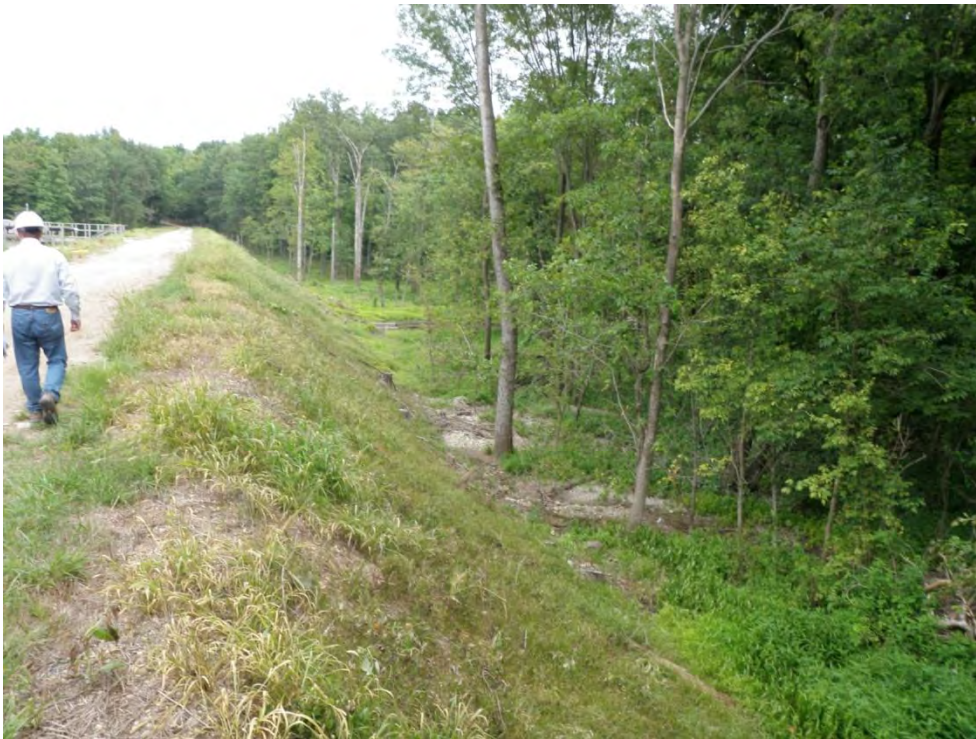
Several trees (up to 2-foot-diameter) were observed at the toe of the downstream slope of the Secondary Ash Settling Basin east dike and the Temporary Cover 2008 area of the Ash Disposal Area #1. A dense growth of large trees and shrubs were also observed on the downstream slope of the Original Ash Pond perimeter north dike, which forms the north dike of the Ash Disposal Area #1 and the supporting dike for the Lined Ash Disposal Pond – Cell #1 and its underlying older ash foundation.

Photo 34: Secondary Ash Settling Basin – East dike downstream slope, note trees within 25' of dam toe, looking north

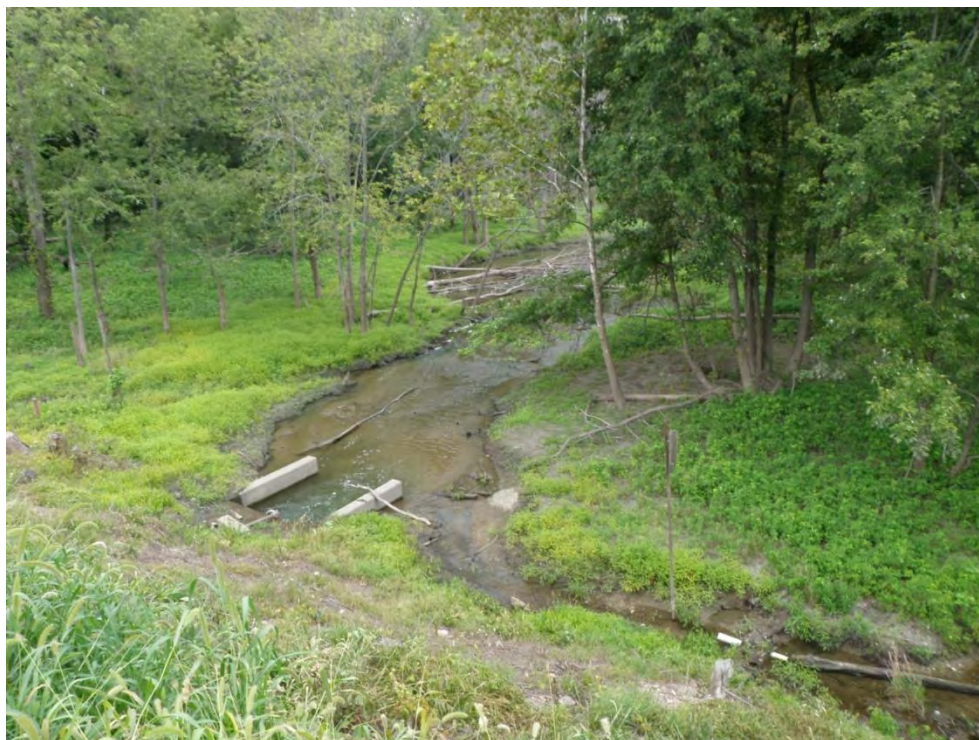
Photo 35: Secondary Ash Settling Basin – East dike downstream toe, outlet and outlet structure to Wabash River, note seepage along downstream toe of dike at right side of photo, looking northeast

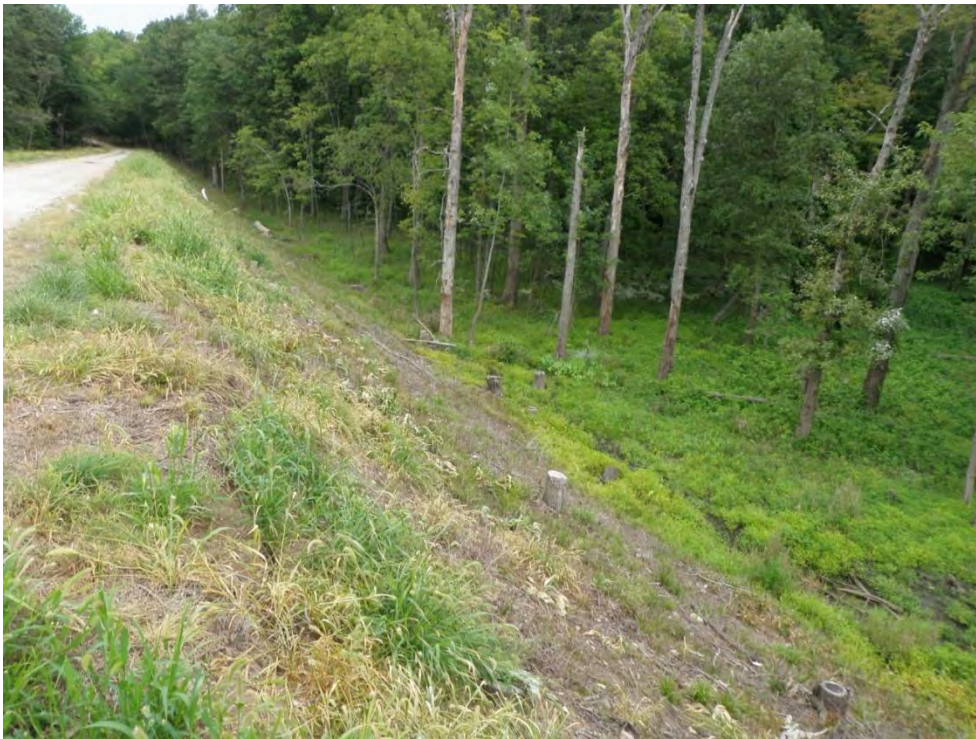
Photo 38: Secondary Ash Settling Basin – East dike downstream slope, note trees within 25' of dam toe, looking north

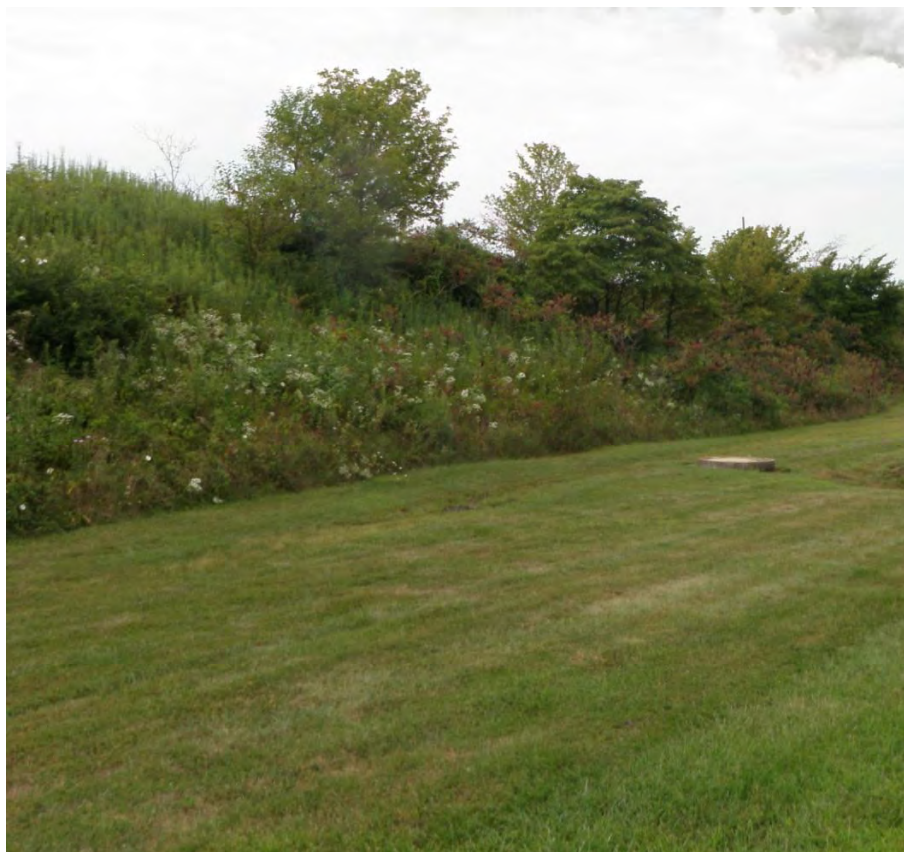
Photo 39: Original Ash Pond – North dike downstream slope, note trees, looking southwest

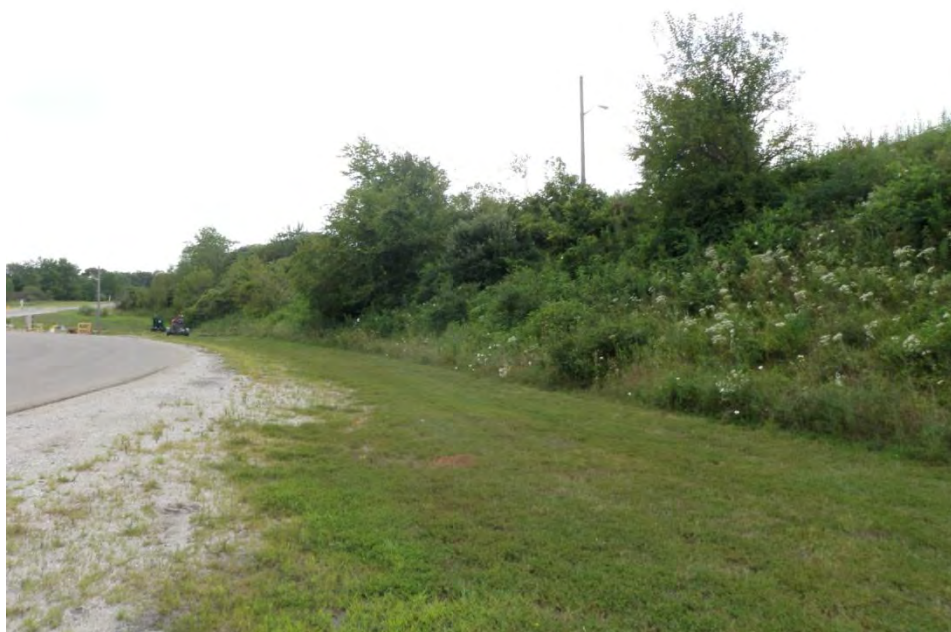
Photo 40: Original Ash Pond – North dike downstream slope, note trees, looking east

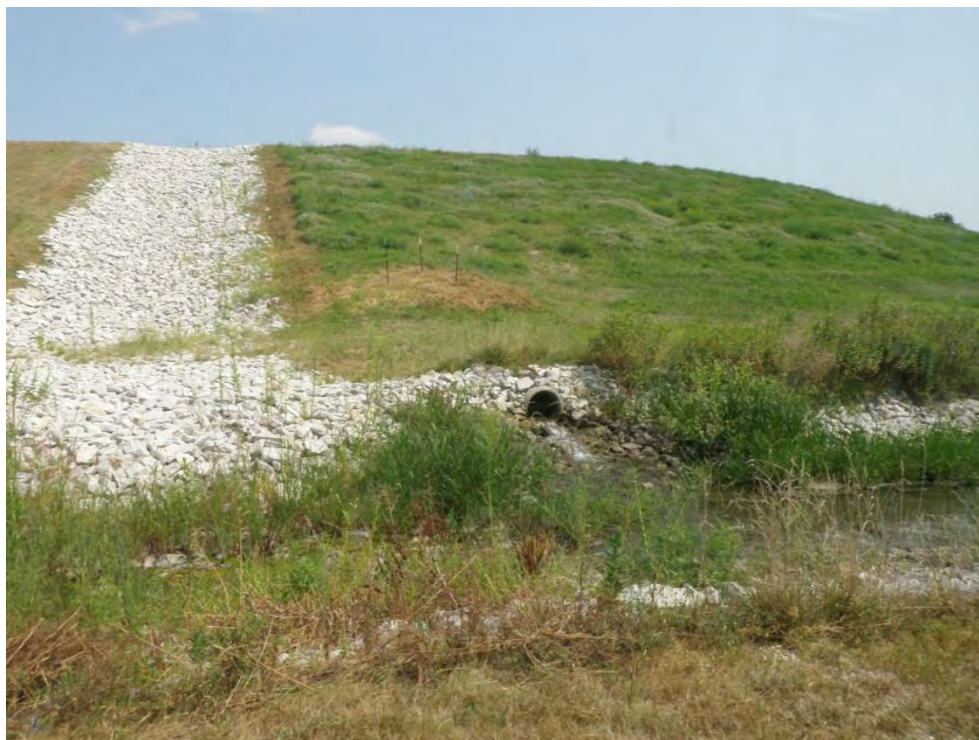
Photo 41: Lined Ash Disposal Pond – Cell #1 – Emergency spillway and outlet pipe, looking east

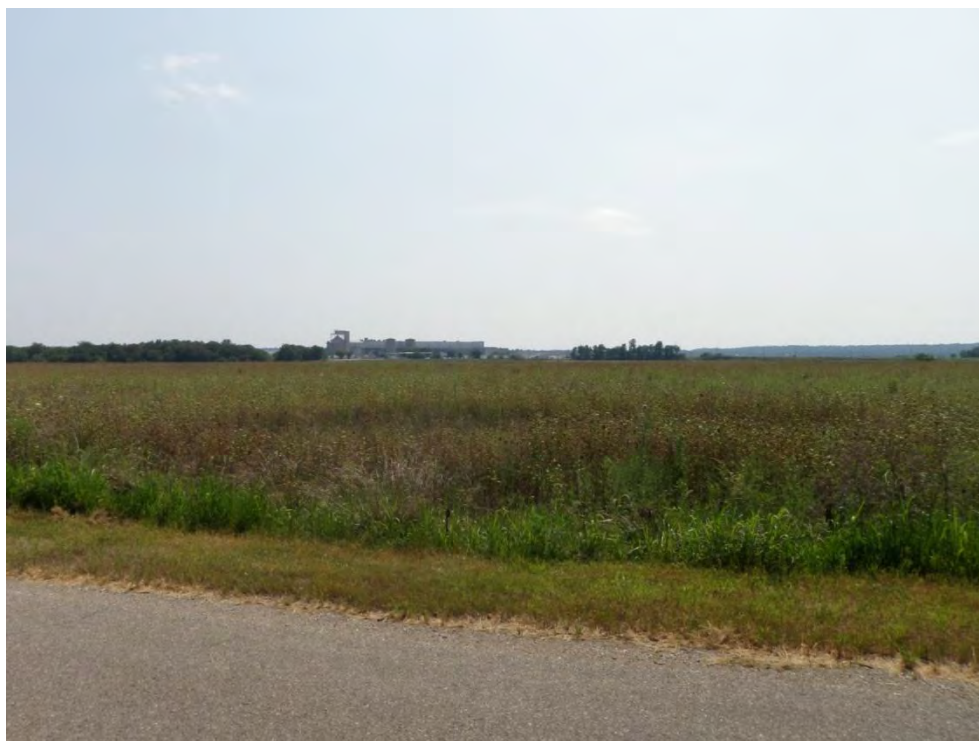
Photo 46: Ash Disposal Area #1 – Temporary Cover 2008 area, looking southwest

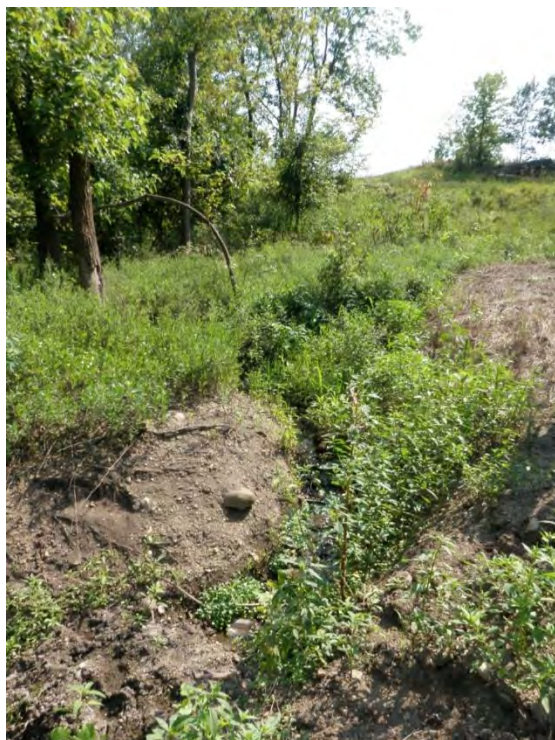
Photo 47: Ash Disposal Area #1 – Downstream of northeast dike downstream toe, note seeps / natural springs, looking southeast

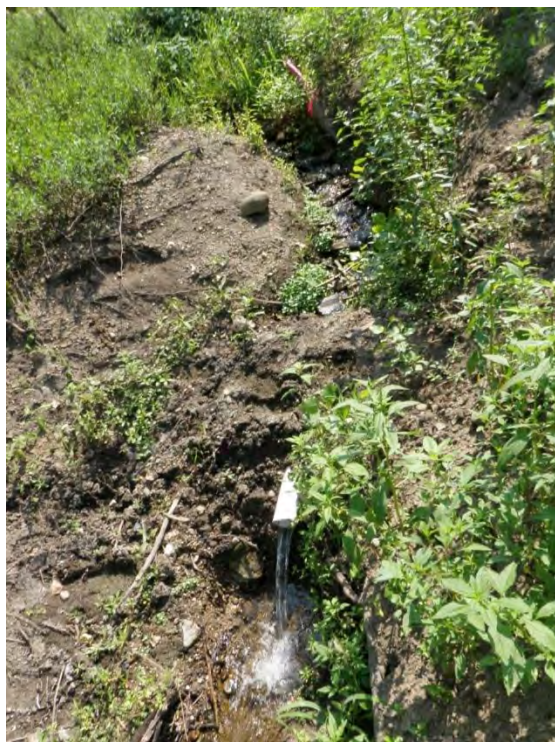
Photo 48: Ash Disposal Area #1 – Downstream of northeast dike downstream toe, note seeps / natural springs, looking southeast
