DUKE ENERGY CORPORATION

Reference: Comments on Draft Dike Inspection Report
Cliffside Steam Station
Mooresboro, North Carolina

Subject: EPA Comments on Duke Energy Corp, Cliffside Power Station,
Mooresboro, NC
Round 9 Draft Assessment Report

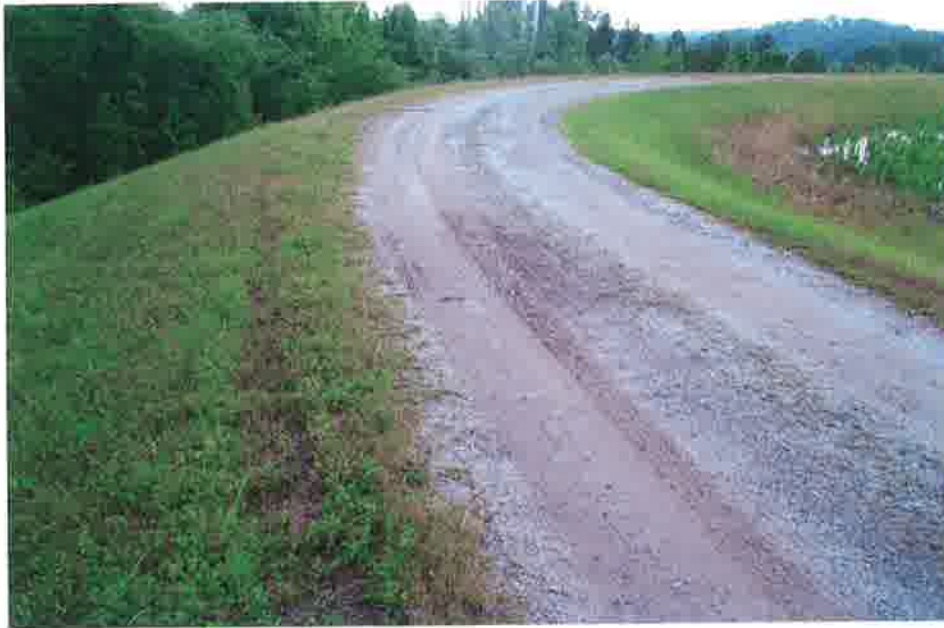
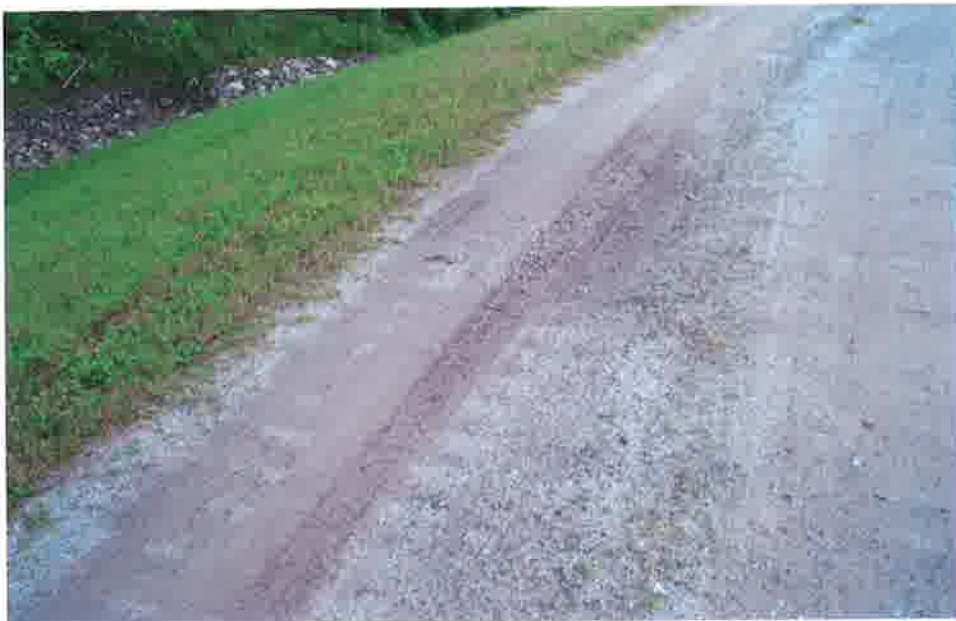
Attachment:
Photographs showing repaired ruts on left abutment crest.

On Page 5-1 section 5.2.1 titled "Crest", it is stated "There was minor rutting along the upstream dike, left abutment crest." Since the inspection in February 2011, the ruts on the crest were repaired in May, 2011 as evidenced in the attached photographs.
