**Coal Combustion Residue Impoundment
Round 9 - Dam Assessment Report**

Cliffside Steam Station

Ash Basin Dikes

Duke Energy Corporation
Mooreboro, North Carolina

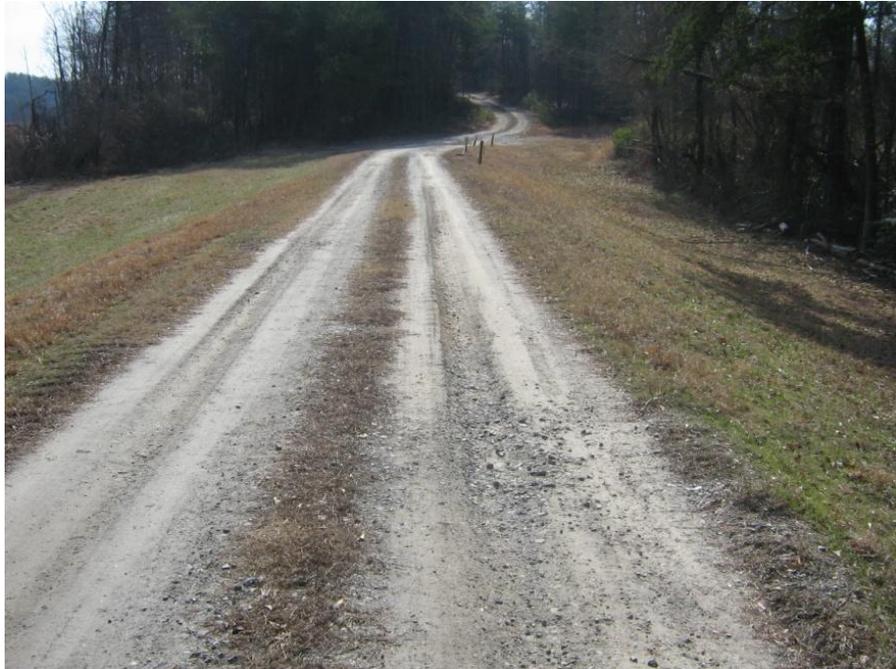
There was minor rutting along the upstream dike, left abutment crest. Subsequent to the date of the field observations, the ruts on the crest were repaired in May, 2011 as evidenced by Duke Energy Corporation photographs. Overall, there were no signs of depressions, tension cracking, or other indications of settlement or shear failure and the crest appeared to be in satisfactory condition.

Minor Rutting Along Crest at Left Abutment

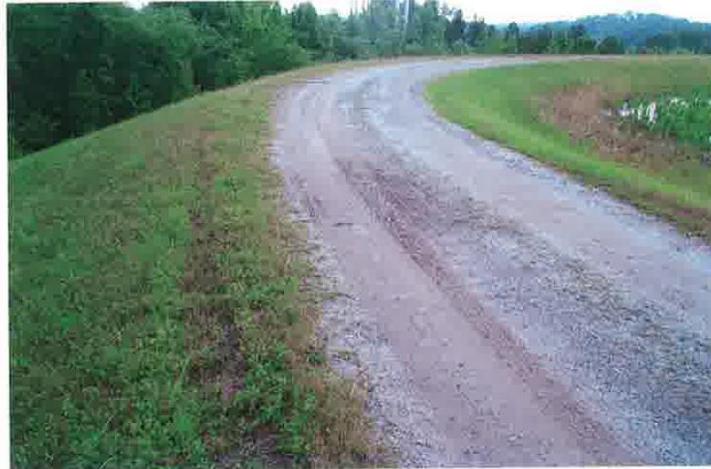
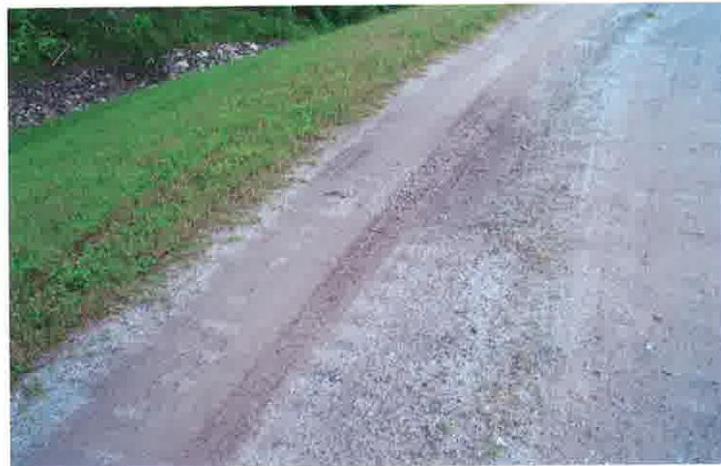
Repaired Rutting Along Crest at Left Abutment

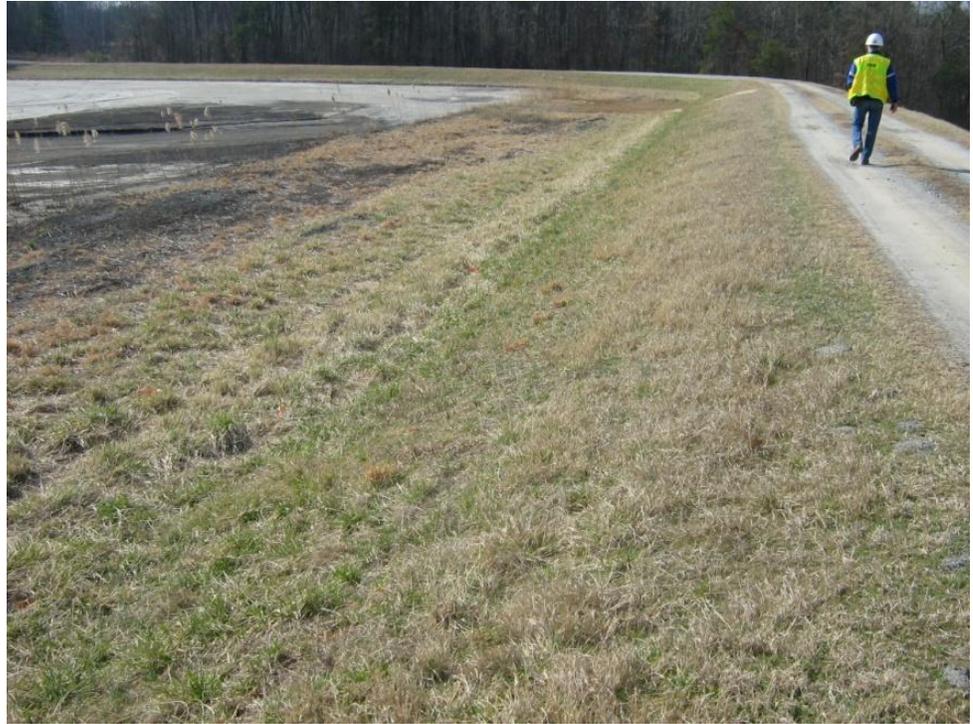
No scarps, sloughs, depressions, bulging or other indications of slope instability or signs of erosion were observed. There was an isolated area that had recently been repaired and was covered with an erosion control fabric.

Upstream slope

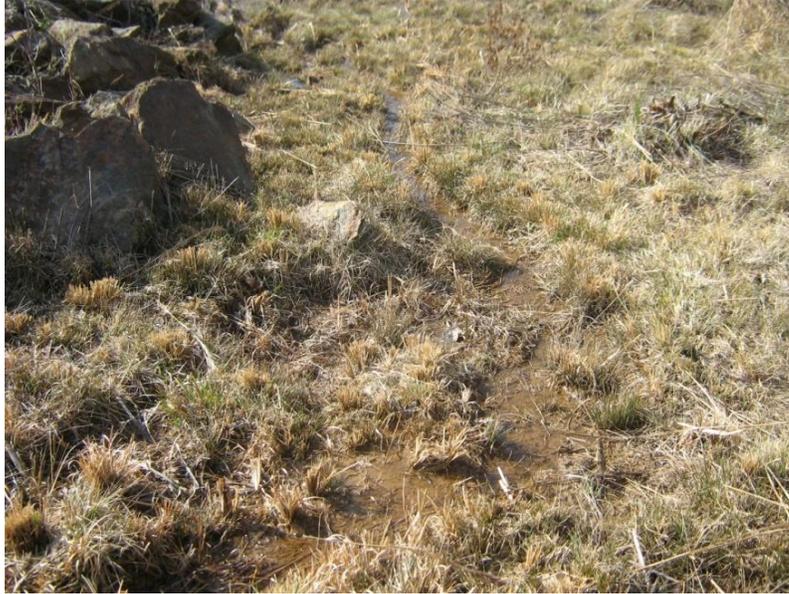
Widespread seepage was observed along the toe. No scarps, sloughs, depressions, bulging or other indications of slope instability or signs of erosion were observed.

Widespread seepage along toe

The surveillance program appears to be adequate. The management unit dikes are instrumented. Multiple piezometers and observation wells have been installed as instrumentation. However, widespread seepage at the toe of the upstream dike and seepage at the toe of the downstream dike need to be monitored and recorded. If discoloration or changes in the flow are observed, then an action plan should be developed

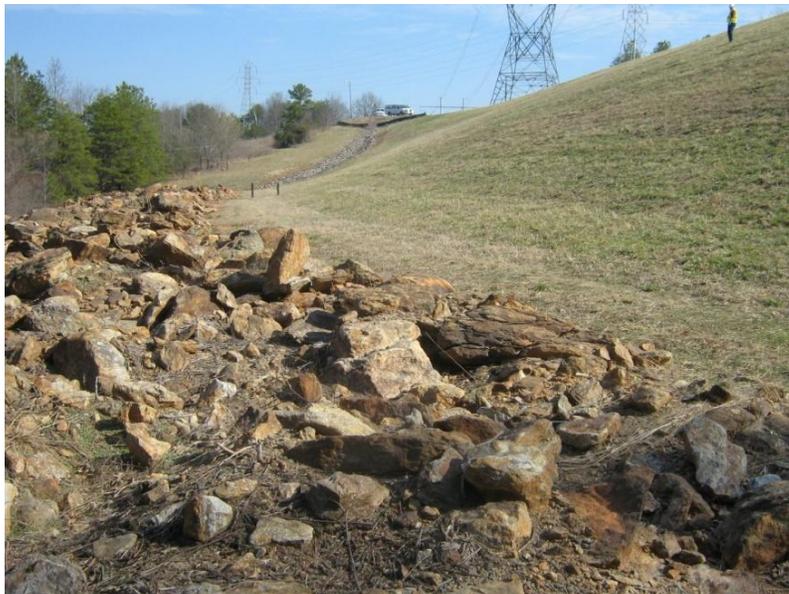
Right Abutment

The abutments and groin areas of the dike appear to be in satisfactory condition.

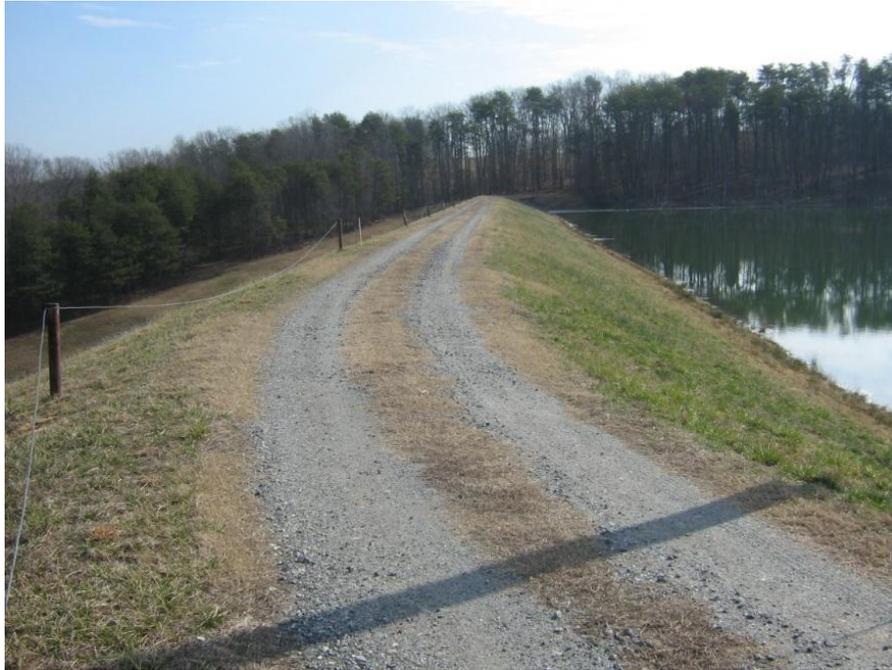
No scarps, sloughs, depressions, bulging or other indications of slope instability or signs of erosion were observed.

Downstream Dike Crest

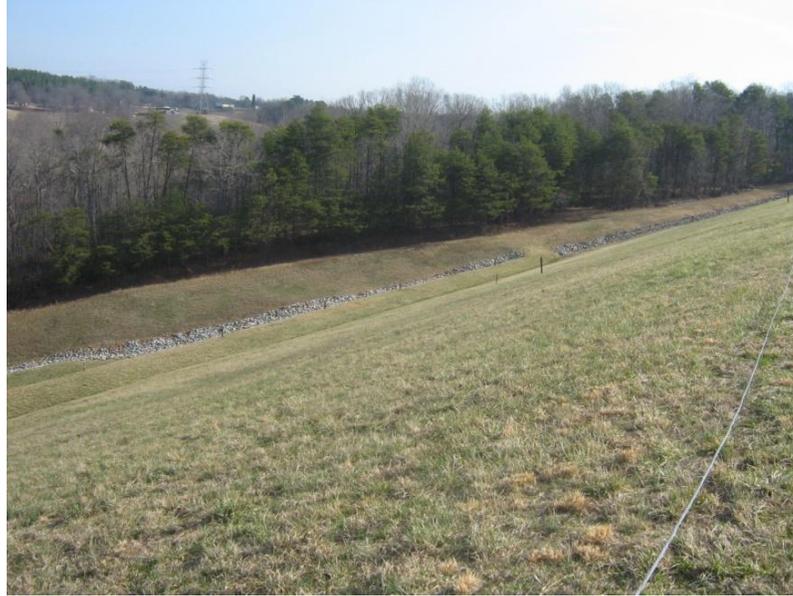
No scarps, sloughs, depressions, bulging or other indications of slope instability or signs of erosion were observed. Seepage was observed at the toe of the slope in the vicinity of the internal blanket drain.

Overall View of Downstream Slope

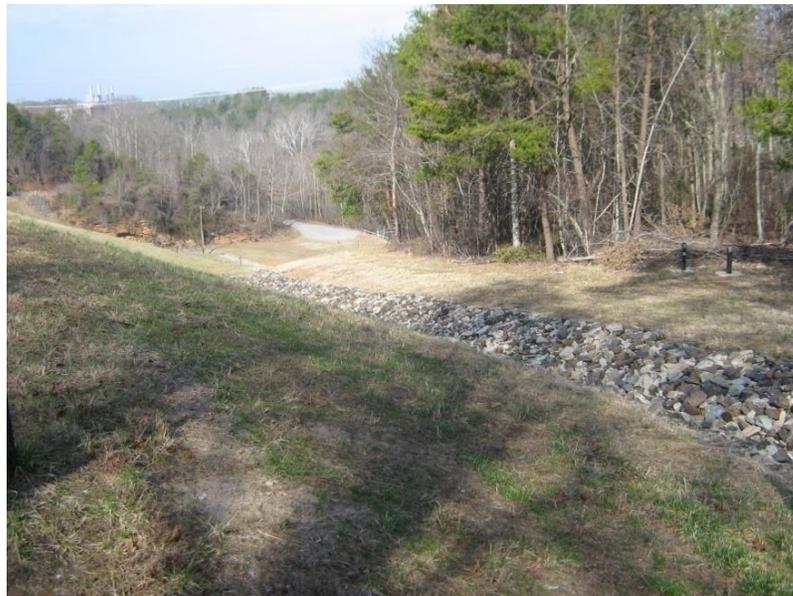
Right Abutment

The abutments and groin areas of the dike appear to be in satisfactory condition.

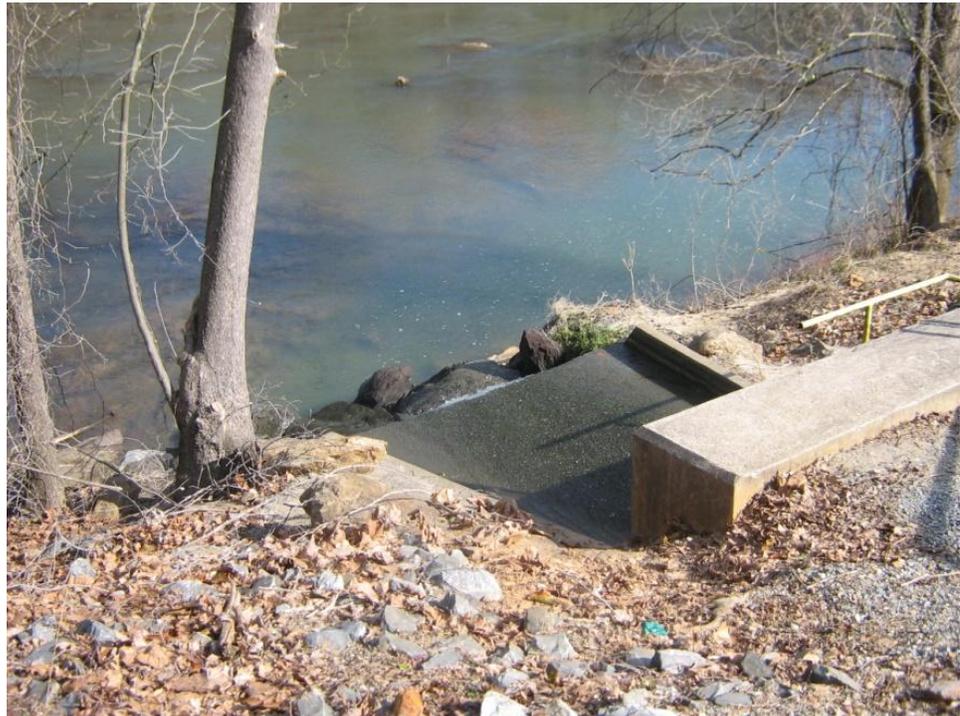
The visual portion of the outlet conduit was functioning properly with no apparent deterioration.

Outfall into Broad River

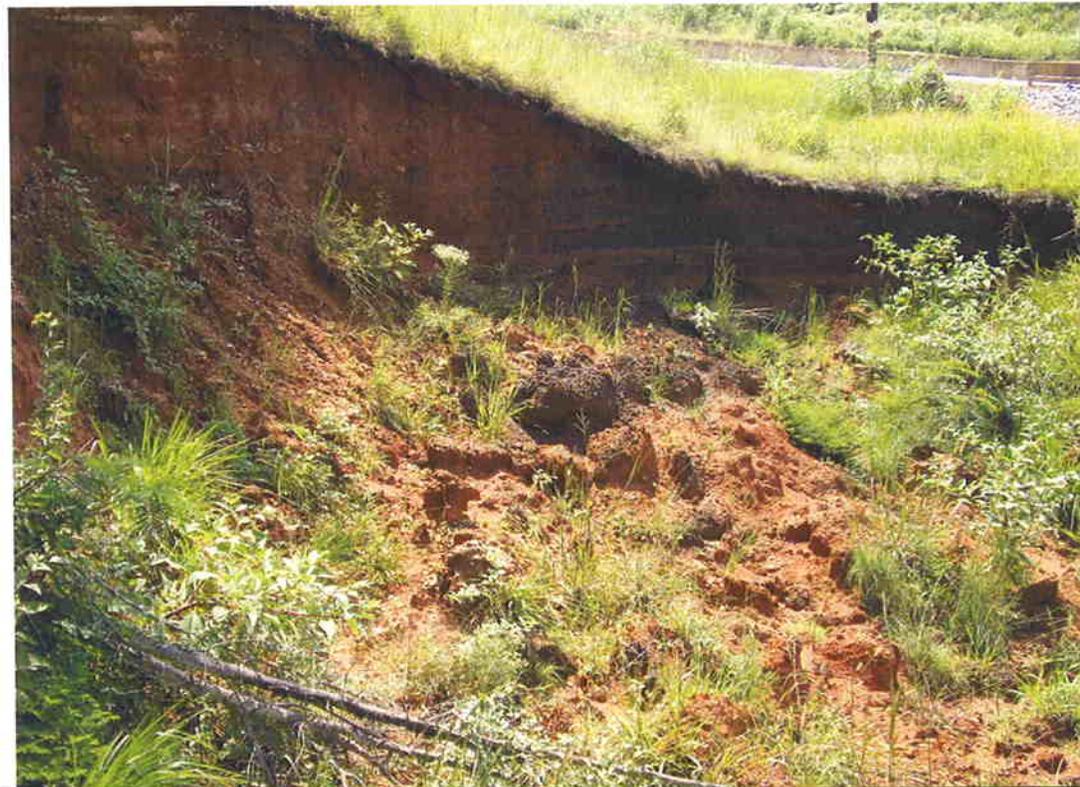
Photograph 4-4A
Failed and eroded area of downstream slope and toe of Units 1-4 old ash basin dike, at about dike centerline station 3+00.

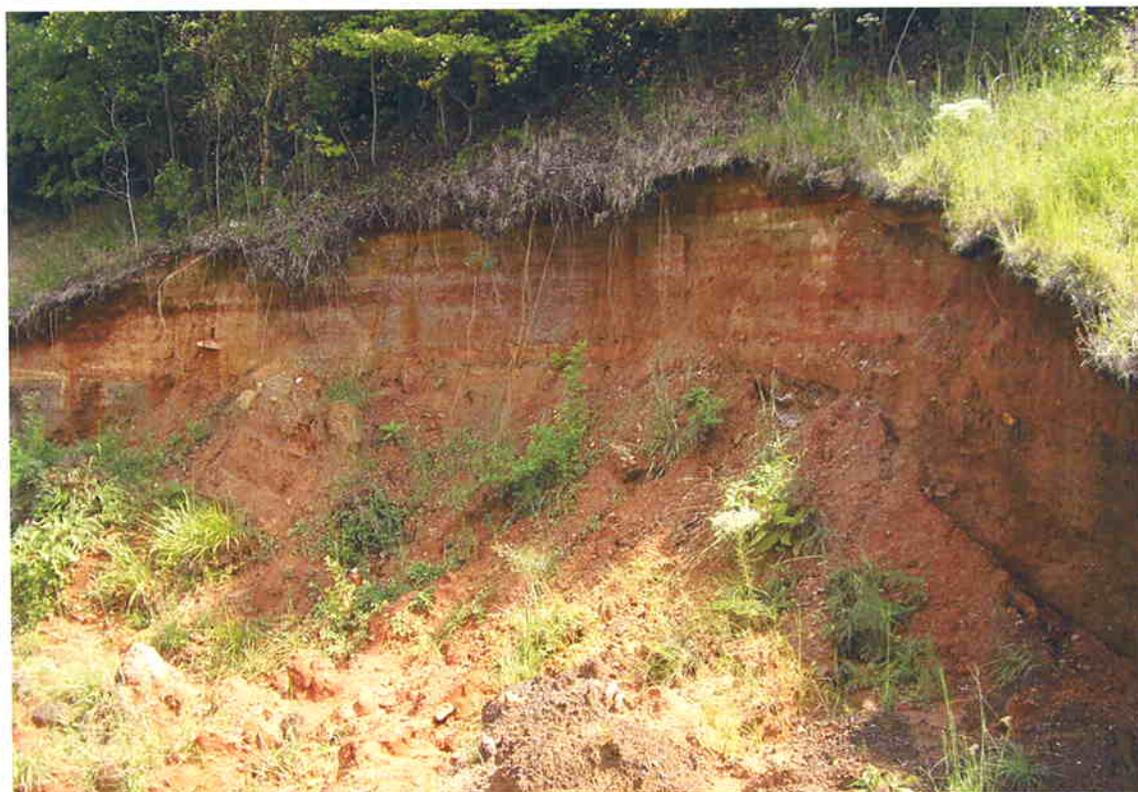
Photograph 4-4B
Failed and eroded area at station 3+00 viewed looking toward the Units 1-4 old ash basin dike centerline.

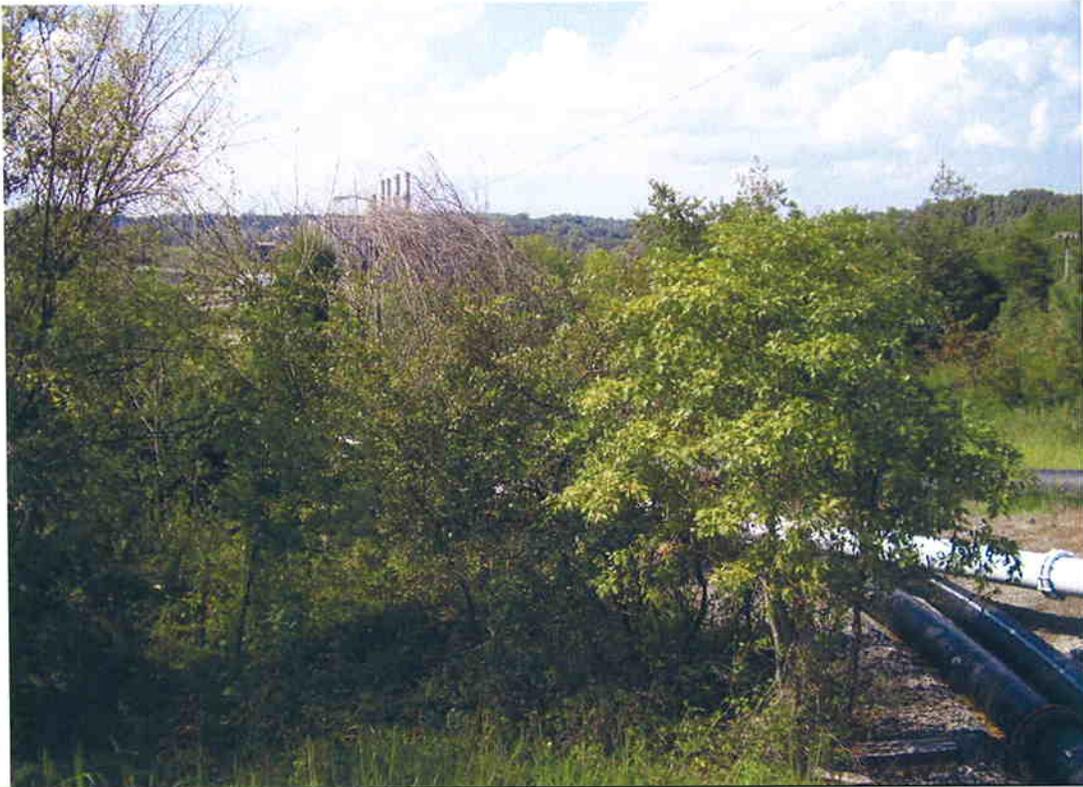
<p>Photograph 4-5</p> <p>Tree growth obscures yard drainage holding pond and dredge spoil pond in Units 1-4 old ash basin area from viewpoint of 2001 inspection photograph.</p>
	Remarks

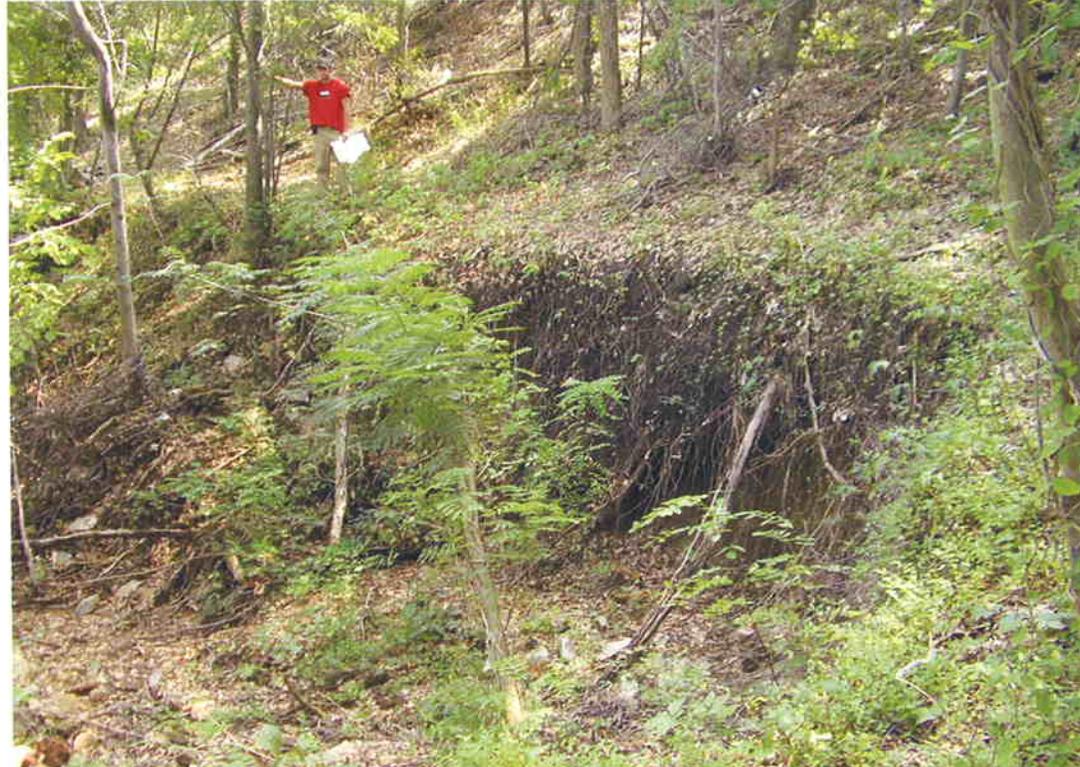
<p>Photograph 4-6C</p> <p>Failed and eroded lower portion of downstream slope of Units 1-4 old ash basin, about 15 ft deep, extending from about station 6+50 to 8+50.</p>

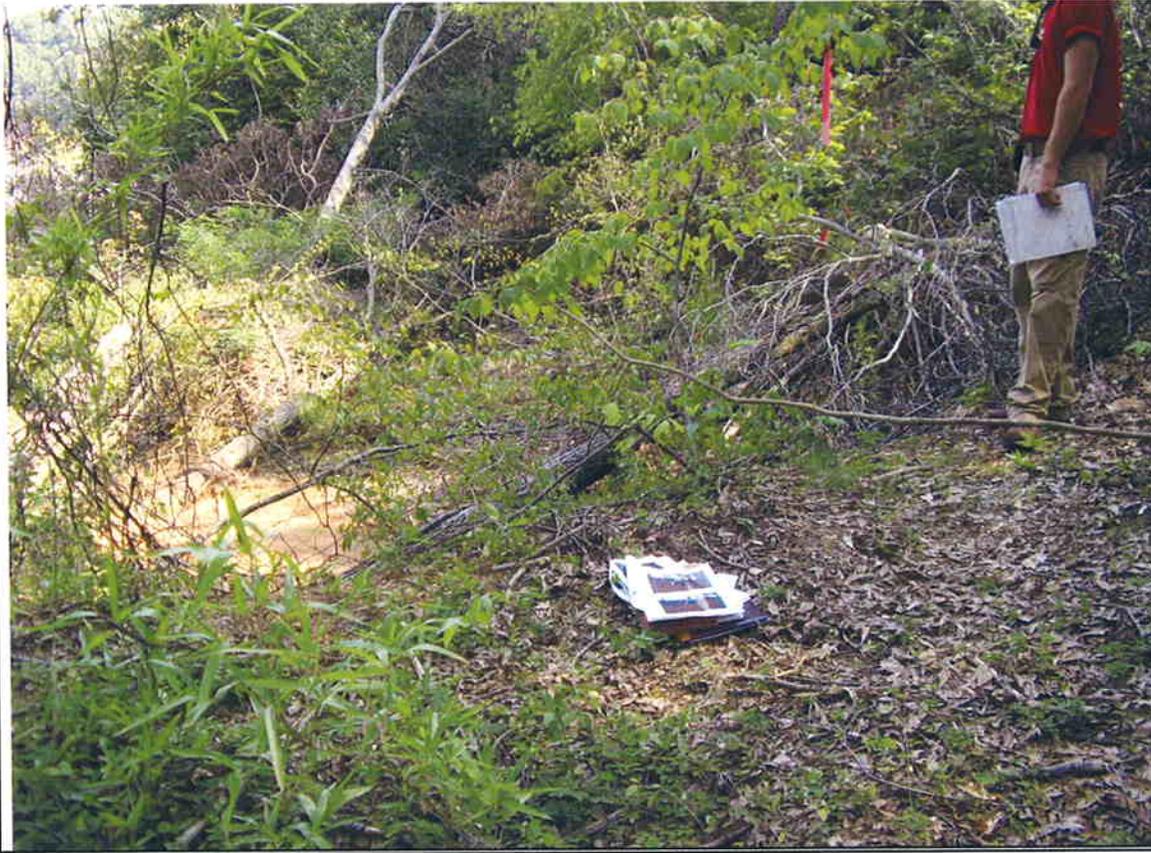
Photograph 4-7B
Approximately 20 ft deep failed and eroded area at downstream slope and toe of Units 1-4 old ash basin dike at about station 11+00.

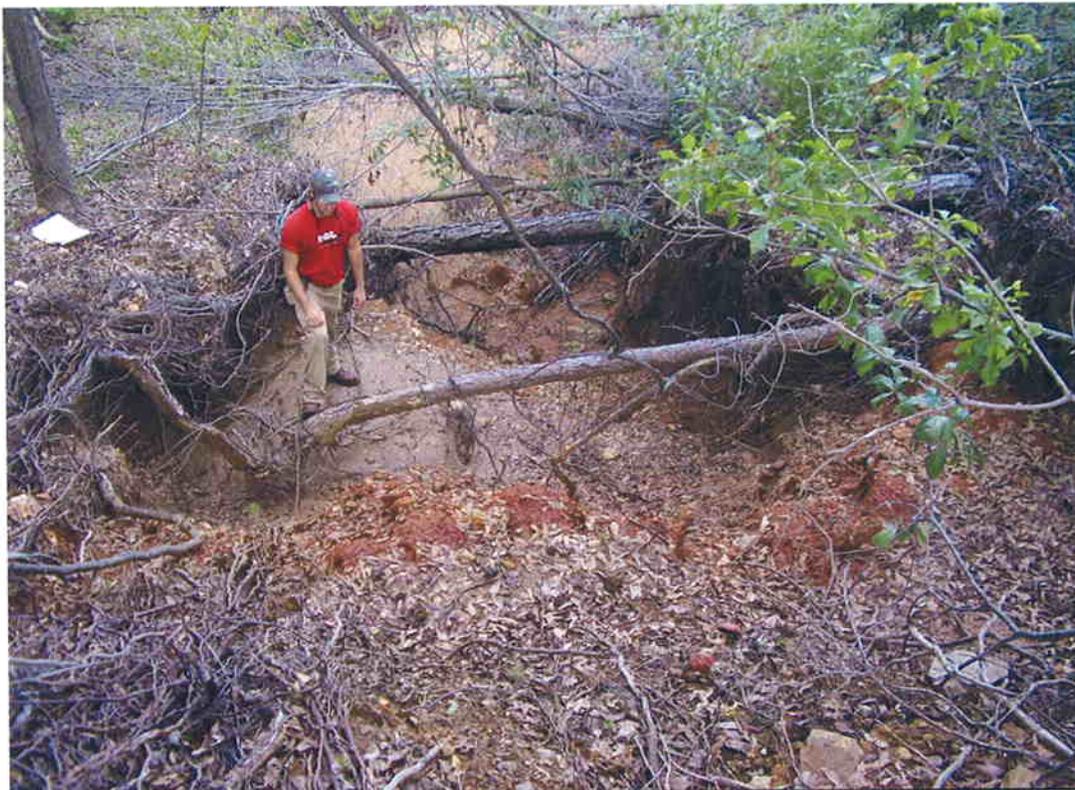
Photograph 4-7C
Failed and eroded area of photograph 4-7B, viewed from above.

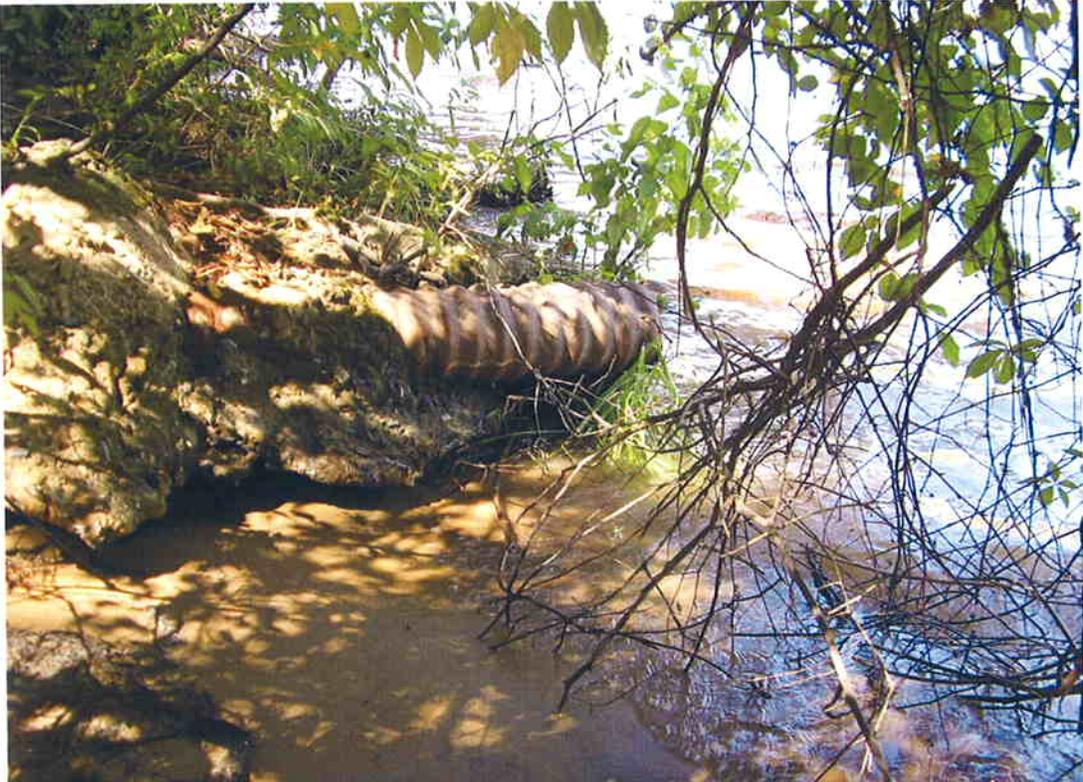
<p>Photograph 4-8</p> <p>Drain pipes at edge of river below toe of outside slope of Units 1-4 old ash basin dike. Ground has eroded more below concrete since last inspection.</p>

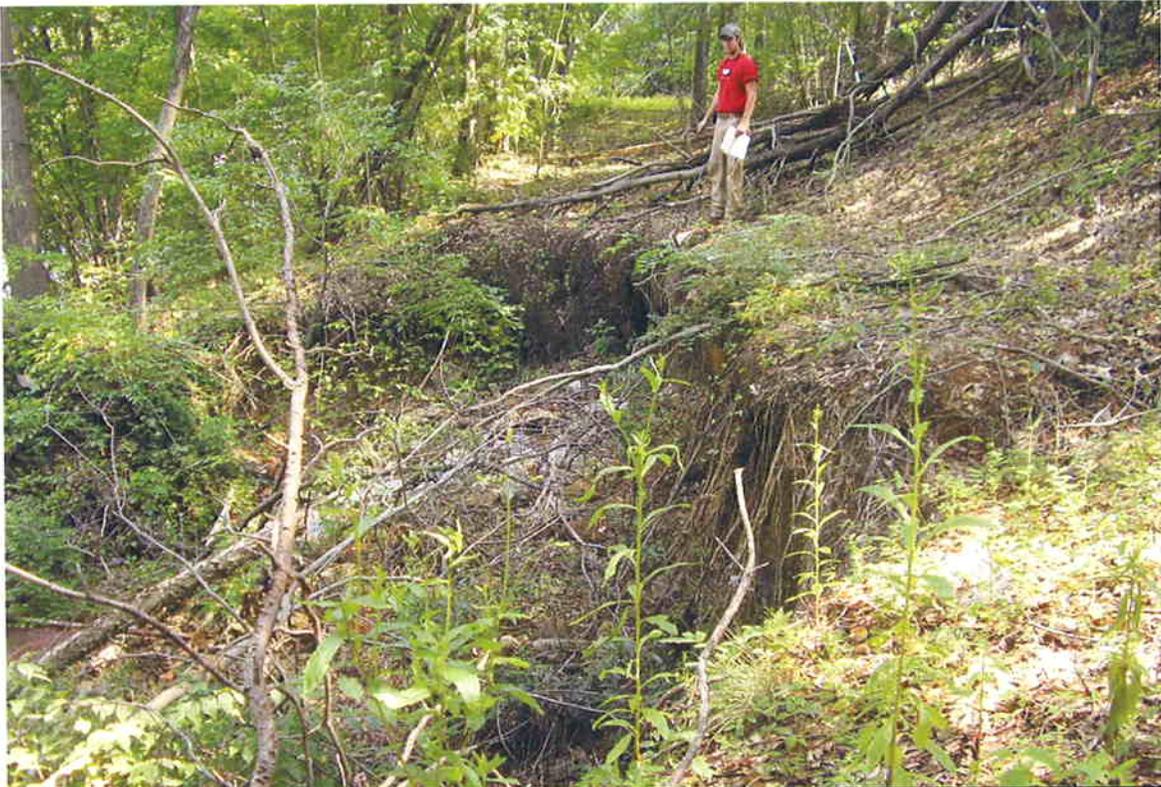
<p>Photograph 4-8A</p> <p>Failed and eroded lower downstream slope of Units 1-4 old ash basin dike at about station 8+00.</p>

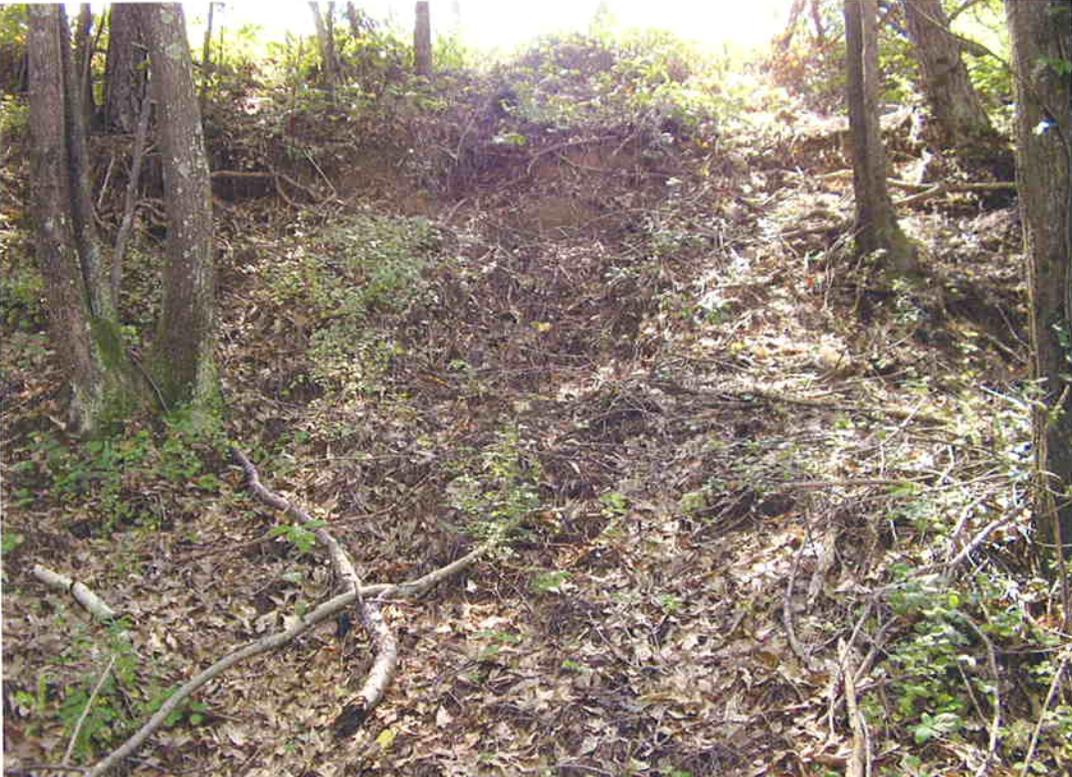
<p>Photograph 4-8B</p> <p>Apparent old slump/eroded area on upper portion of downstream slope of Units 1-4 old ash basin dike, above recent failure area of photograph 4-8A.</p>
	Remarks

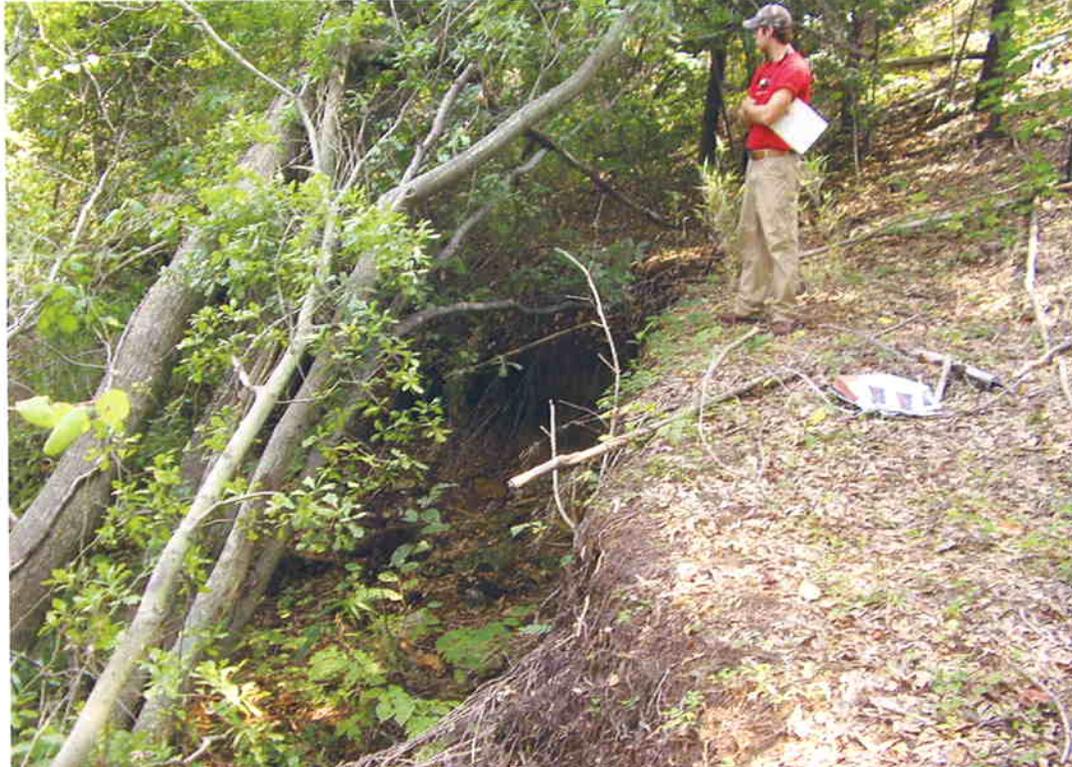
<p>Photograph 4-8C</p> <p>Failed and eroded lower downstream slope of Units 1-4 old ash basin dike, at about station 10+00.</p>

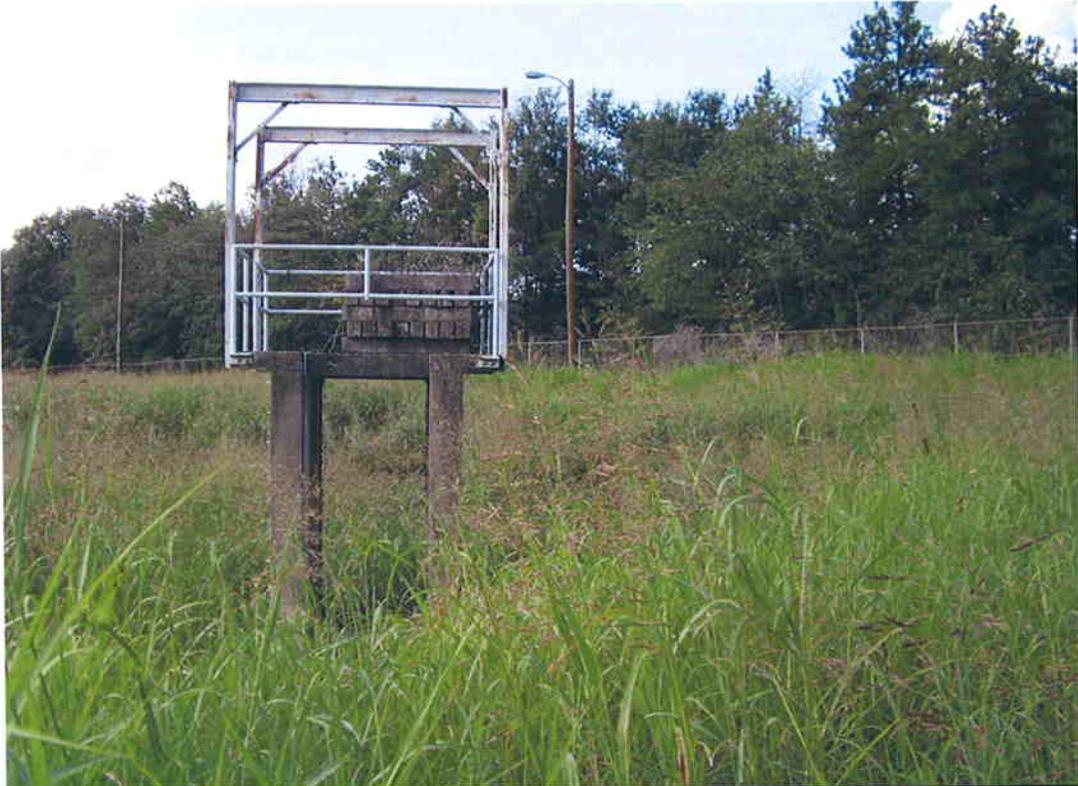
<p>Photograph 4-9</p> <p>View of Units 1-4 old ash basin drainage tower. High grass obscures the ground surface.</p>
	Remarks

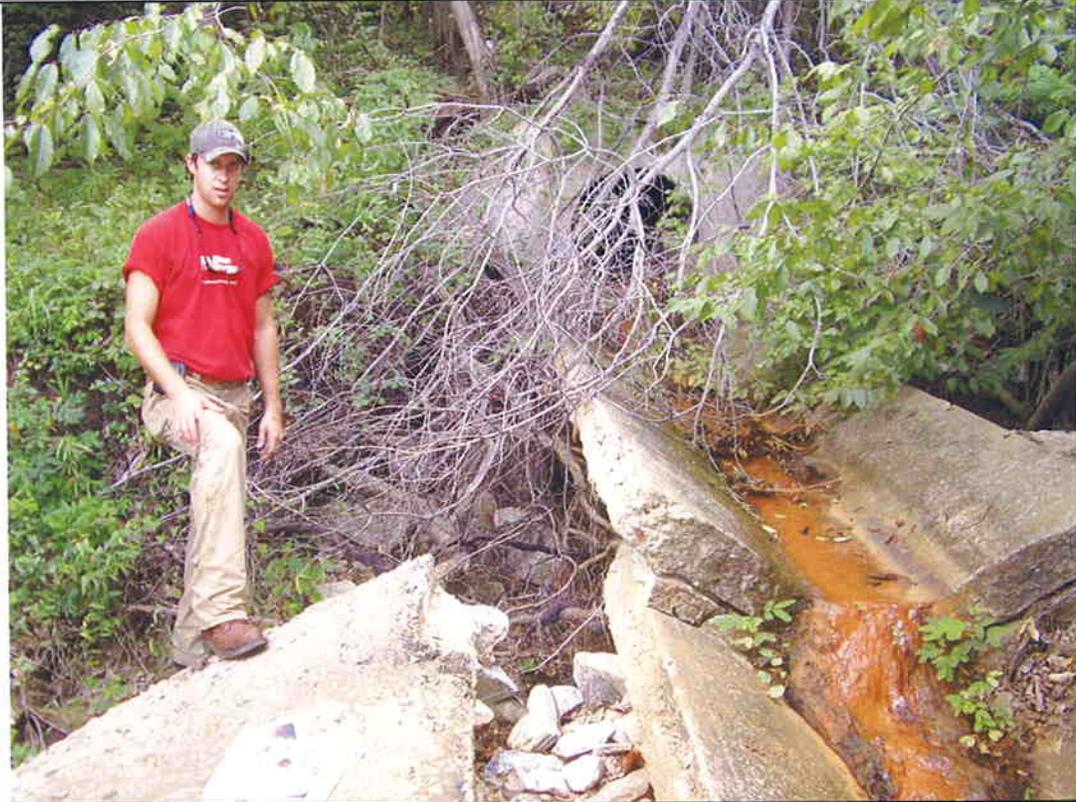
Photograph 4-10A
Severe erosion under and damage to concrete flume of 30 inch CMP outlet for Units 1-4 old ash basin.

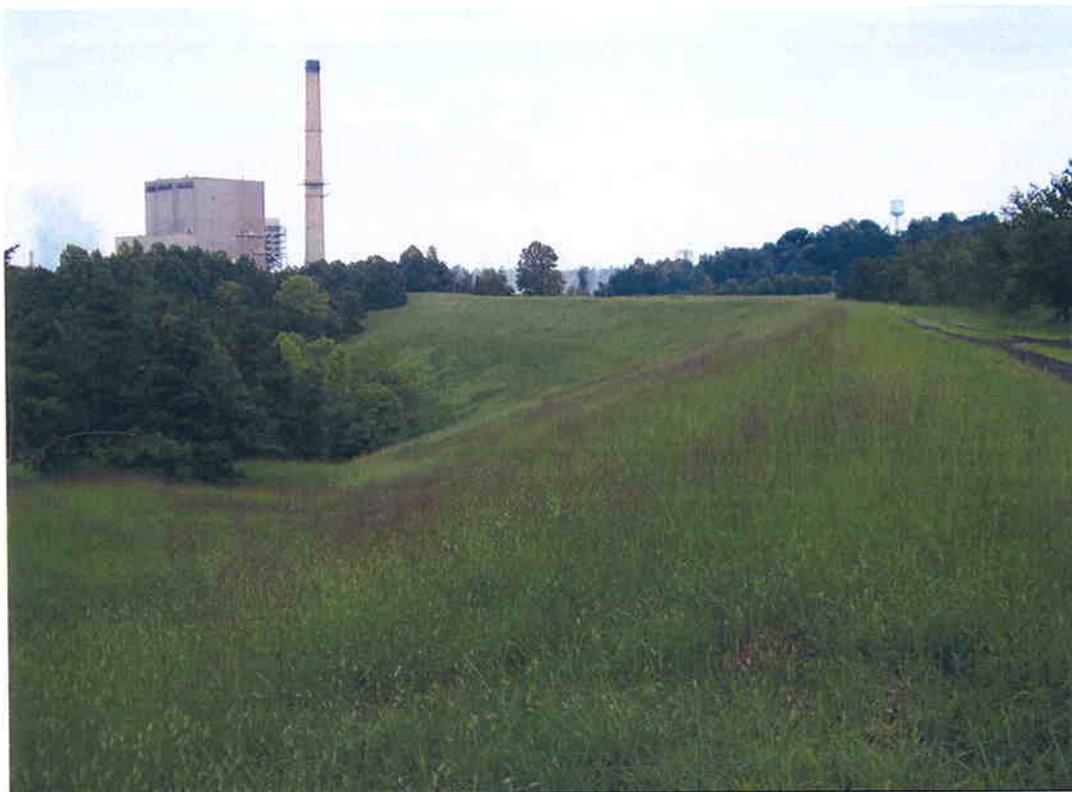
Photograph 4-11
Outside (downstream) slope of unit 5 retired basin main dike. Slope surface obscured by high grass.

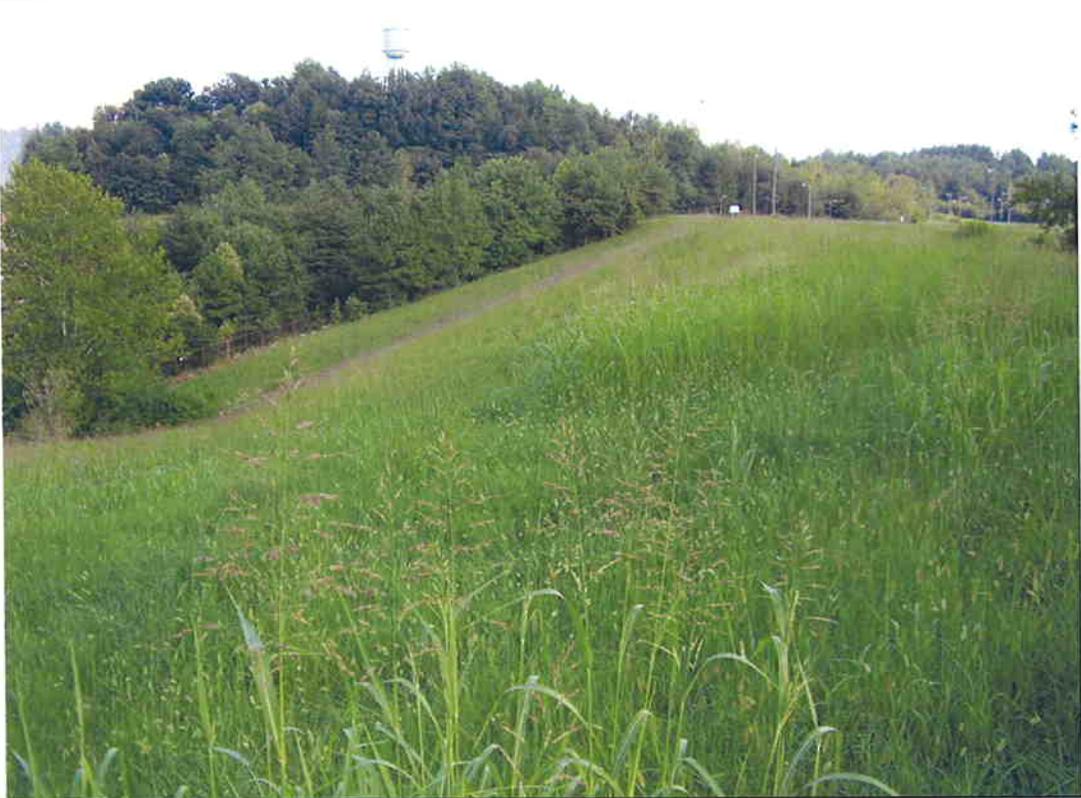
<p>Photograph 4-12B</p> <p>Downstream slope of saddle dike for unit 5 retired basin above cooling tower B. No seepage observed in overgrown low area. High grass obscures slope surface.</p>
	Remarks
	<p>Photograph 4-13</p> <p>See photograph in 1991 Inspection Report.</p>

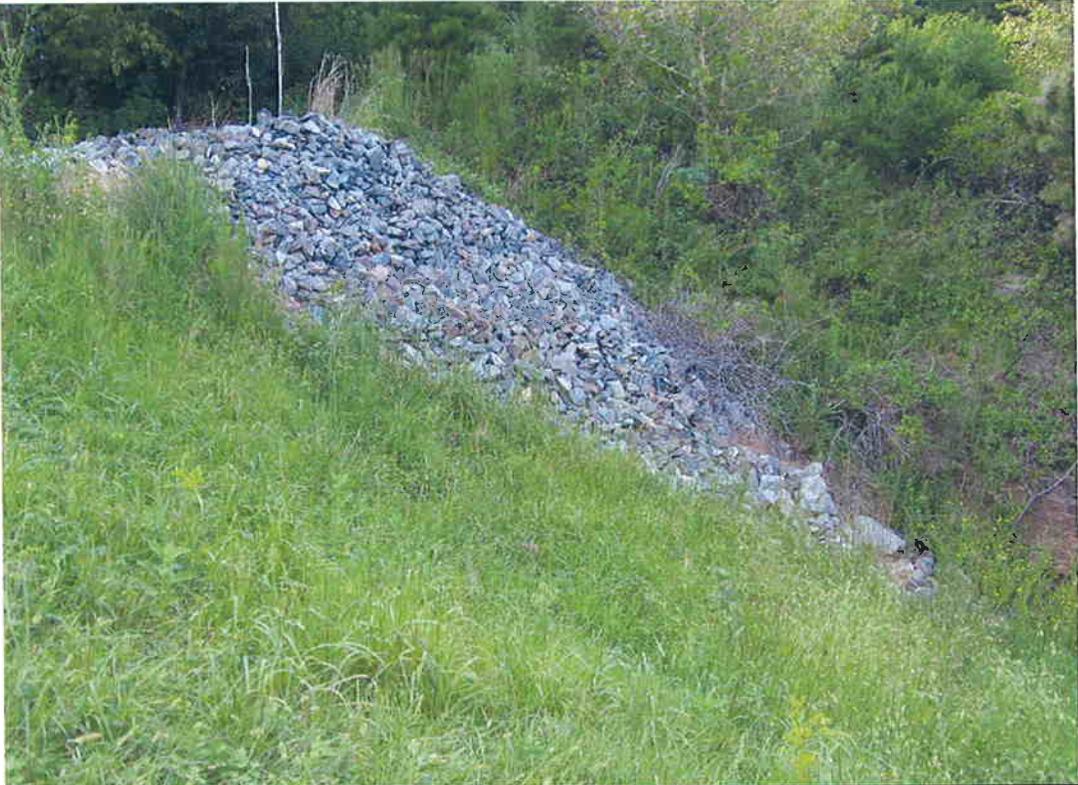
<p>Photograph 4-19</p> <p>Rip-rap blanket over previously repaired slump. Soil erosion continues to occur at toe rip-rap. Note unmowed grass on slope.</p>

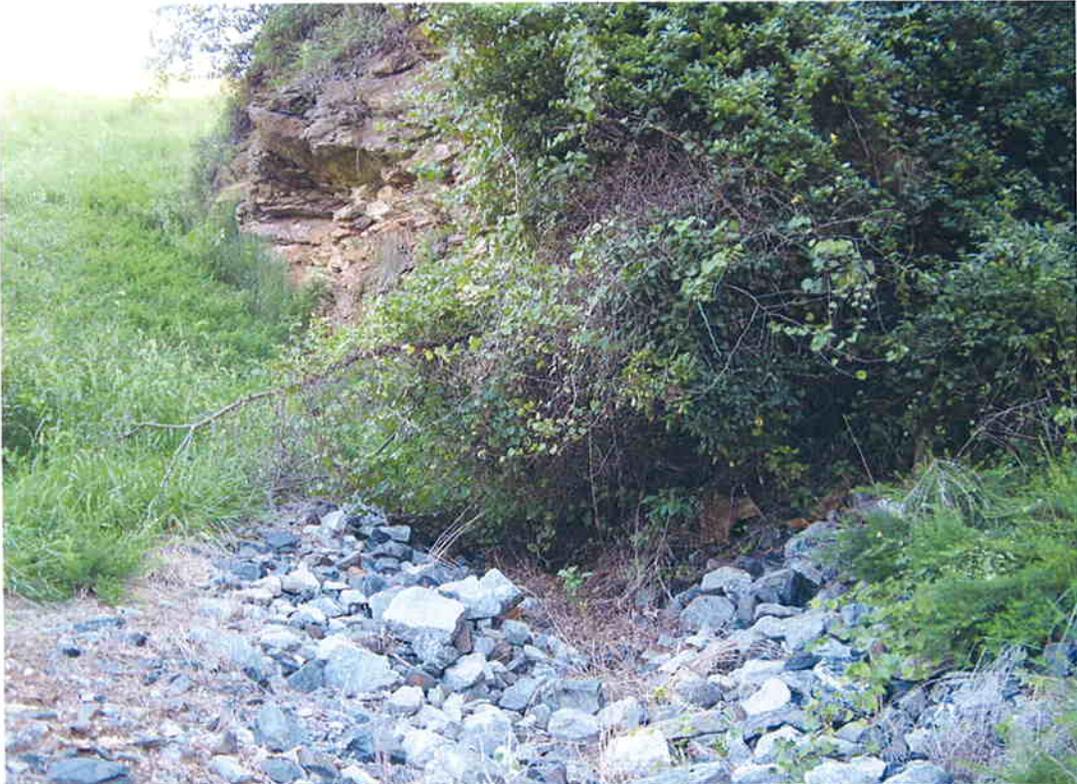
<p>Photograph 4-19A</p> <p>Suck Creek downstream dike, left abutment contact. Weathered rock fallen into rip-rap lined ditch visible in 2001 photograph obscured by vegetation in 2006.</p>
	Remarks
