DRAFT REPORT

Dam Safety Assessment of CCW Impoundments

Edwardsport Plant

September 17, 2010

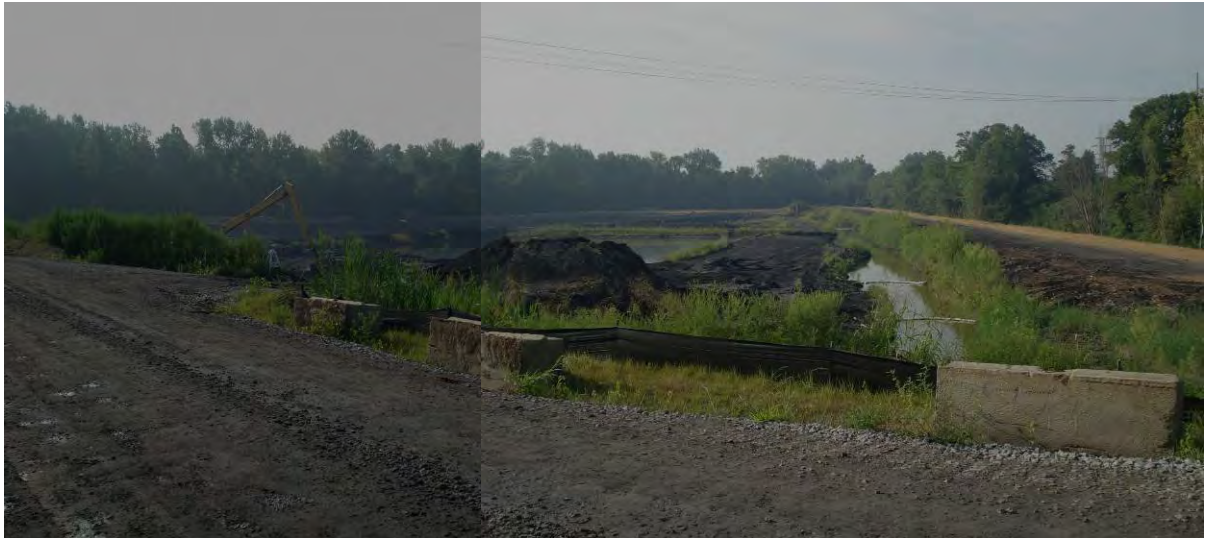
Photo Number:
1

Overview of Primary Ash Pond from northwest corner showing typical condition of crest & inboard slope. Note excavator removing dewatered ash.

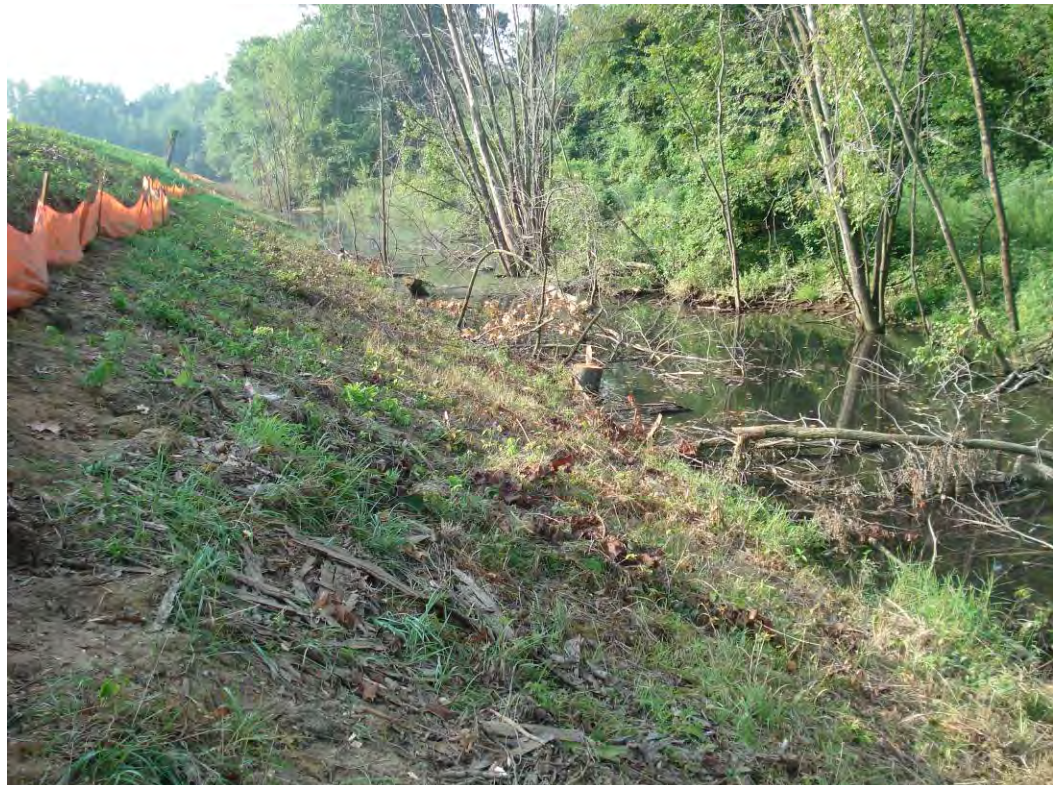
Photo Number:
4

- Ponded water was noted in the drainage swale along nearly the entire toe of the western dike (Appendix B – Photo 4). There was no evidence of piping or flow, and the ponding appeared to be caused by a low area in the swale invert. The northern and eastern toe drainage swales were dry.

Ponded water in drainage swale at Primary Ash Pond dike's western exterior toe.

- Establish turf on the outboard slopes.
- Repair the concrete apron retaining wall.
- Re-grade the western toe swale to drain the ponded water.

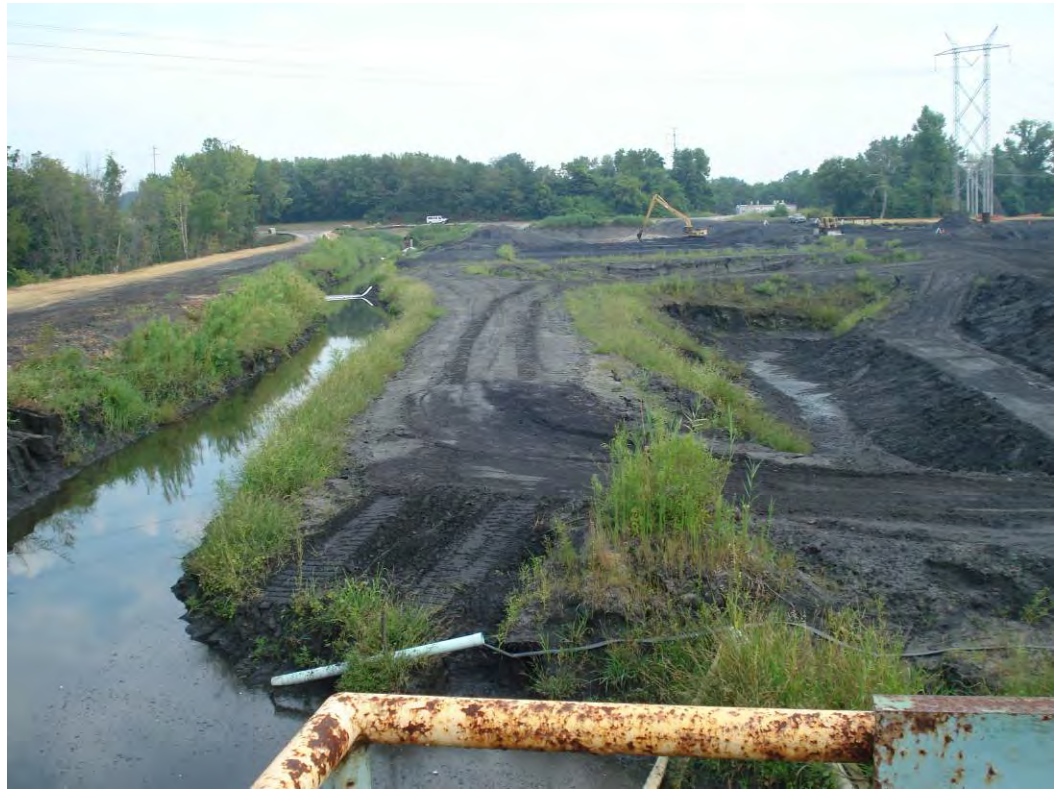
Photo Number:
5

Drainage ditch from CCW and drainage inlets in Primary Ash Pond. Note excavator maintaining flow from decant inlet to ditch.

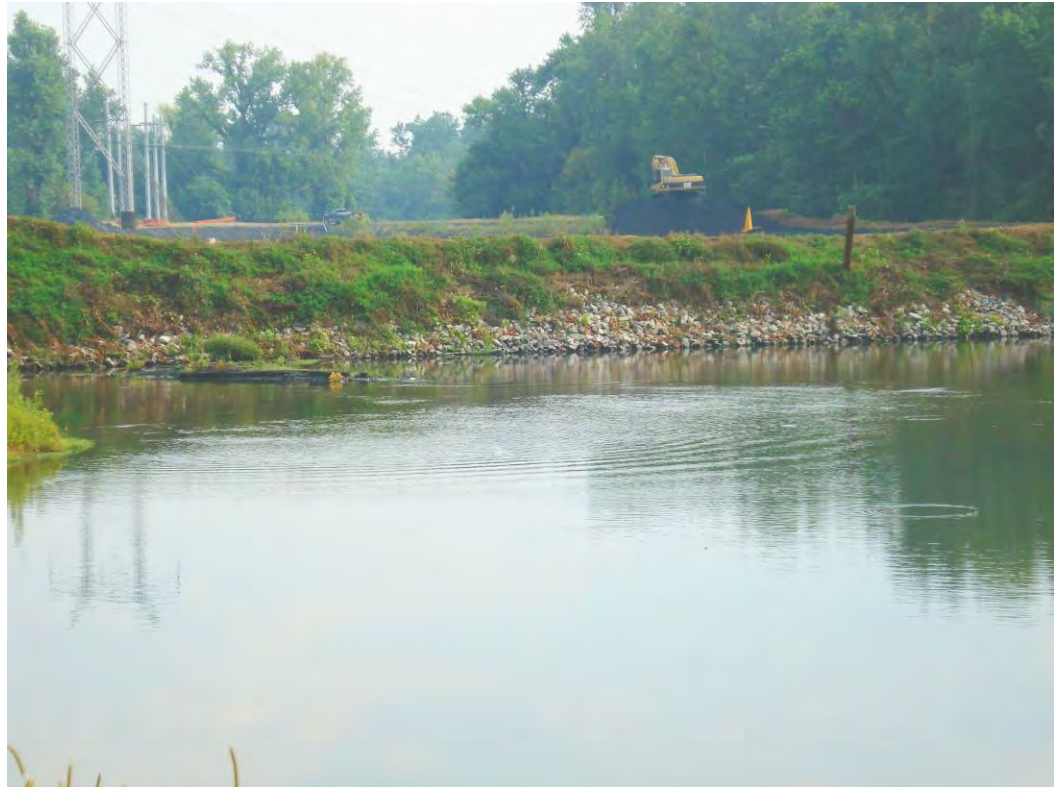
Date:
8/10/10Photo Number:
7Photographer:
SH Snider

- Supernatant from the Primary Ash Pond enters the Secondary Ash Pond below the latter's pool elevation (El. 454) (Appendix B – Photo 7).
- The interior riprap was in good condition and the inboard slope above the riprap was covered with grass about 8 inches long (Appendix B – Photo 7).

Typical condition of dividing dike slope. Mild turbulence in Secondary Ash Pond water surface from Primary Ash Pond outlet conduit. Note excavator stockpiling dewatered Primary Pond ash.

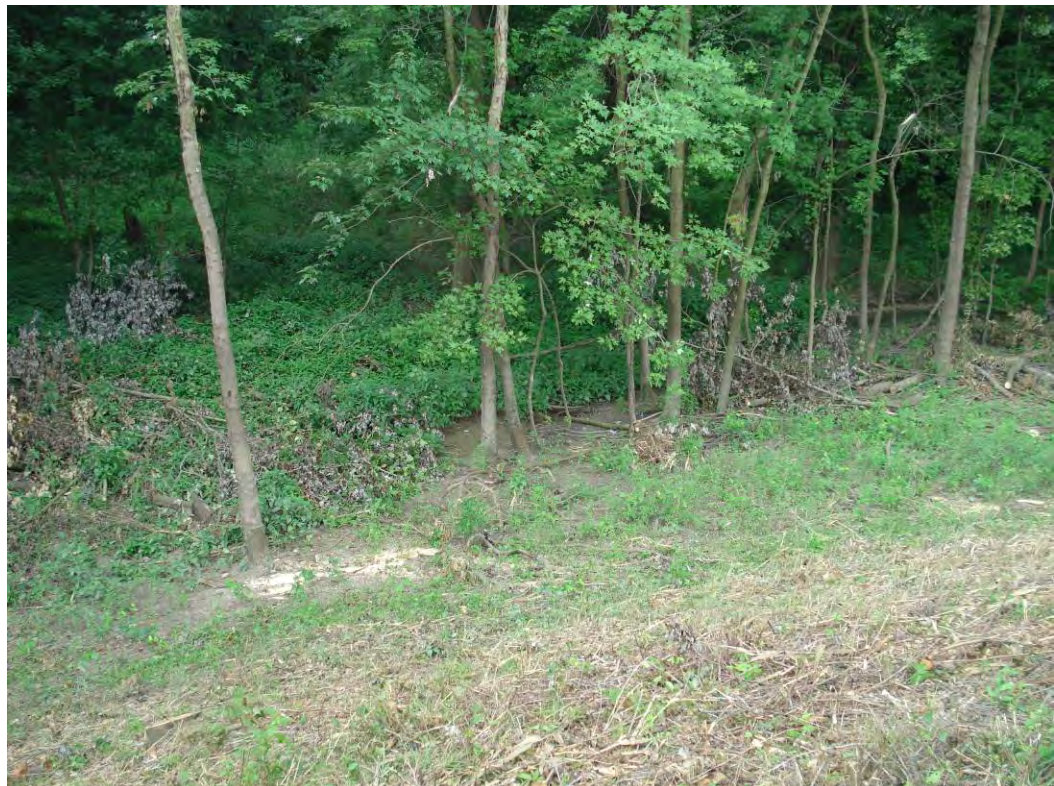
Date:
8/10/10Photo Number:
8Photographer:
SH Snider

Typical condition of southern toe of Secondary Ash Pond.

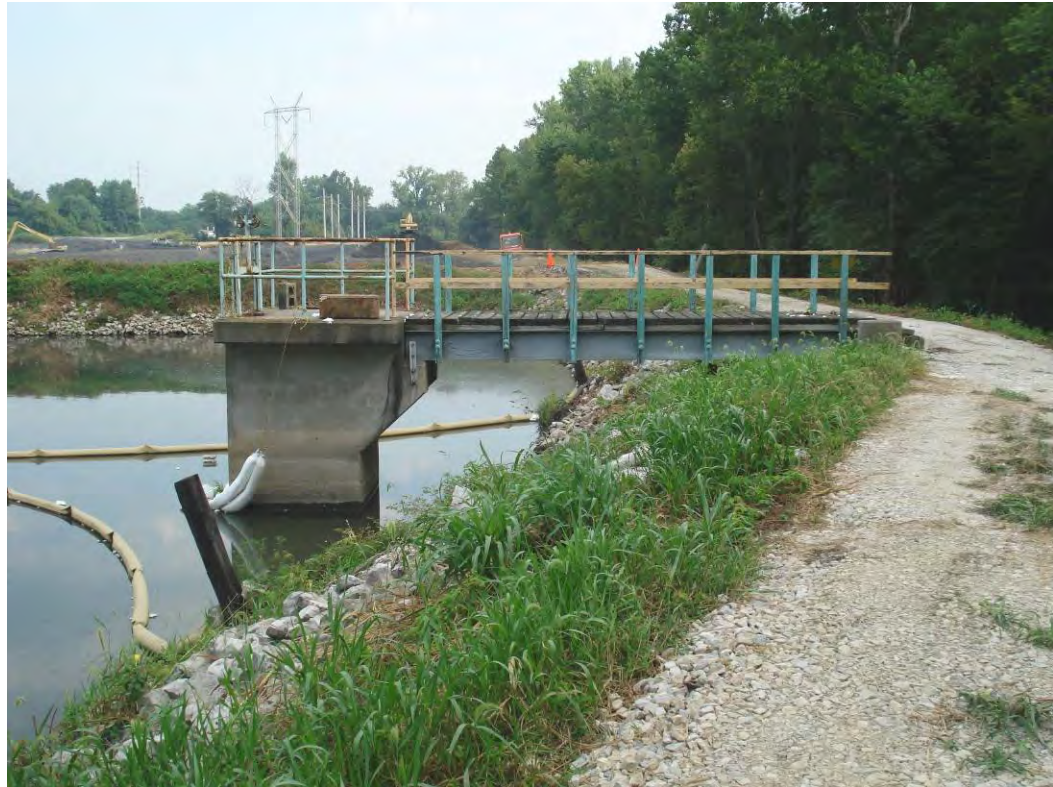
Photo Number:
9

- The Secondary Ash Pond outlet structure was in fair condition. Most of the stoplogs had been removed such that the water level in the Secondary Ash Pond was about 6 inches above the crown of the 18-inch CMP outlet conduit at El. 454, or about 9 feet below the lowest dike crest elevation.

Secondary Ash Pond outlet structure, inboard slope and dike crest. Note lowered pond level about 4 feet below historic norm.

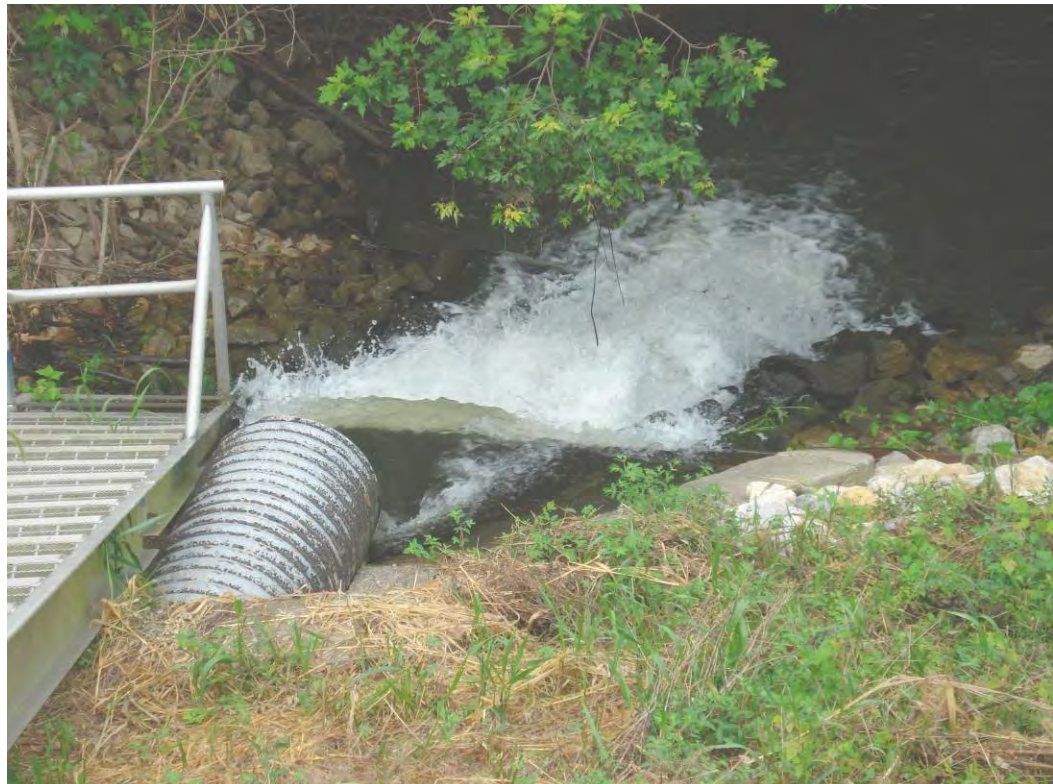
Photo Number:
10

18-inch outlet from Secondary Ash Pond.

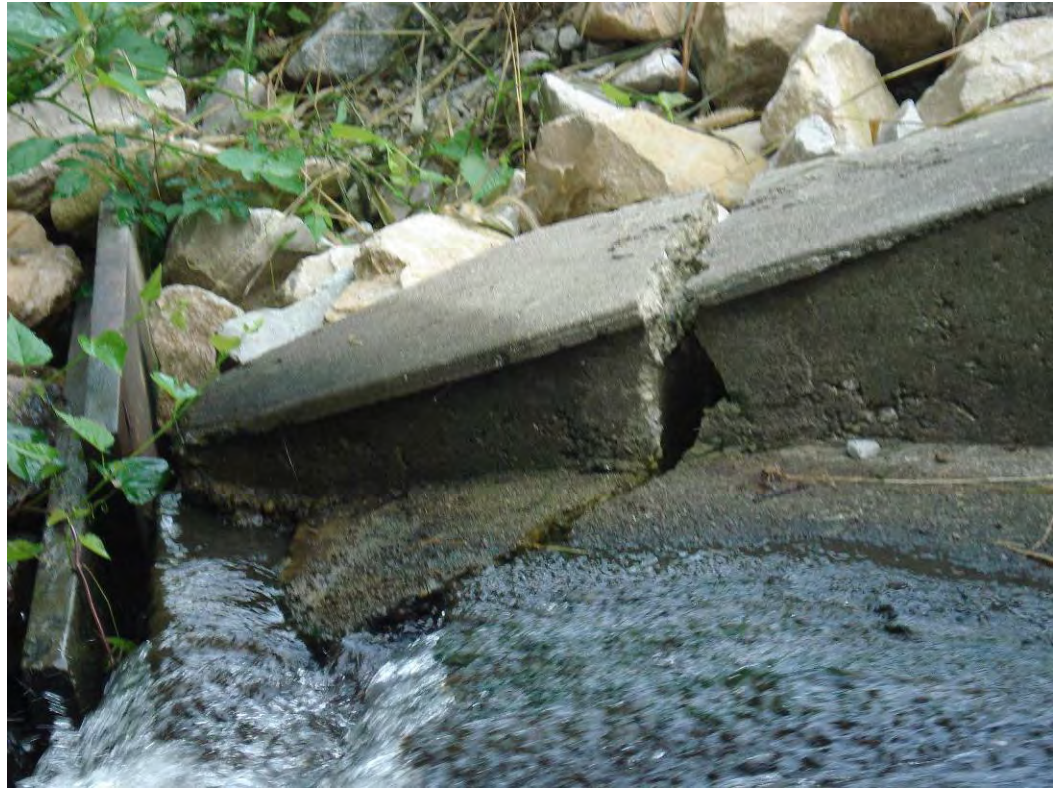
Photo Number:
11

- The outlet conduit discharges onto a concrete apron about 5 feet above the drainage channel invert. The apron terminates in a concrete headwall which was not undermined. The apron's southern concrete training wall was cracked about two feet above its downstream terminus (Appendix B – Photo 11).

Cracked southern retaining wall of Secondary Ash Pond outlet apron.

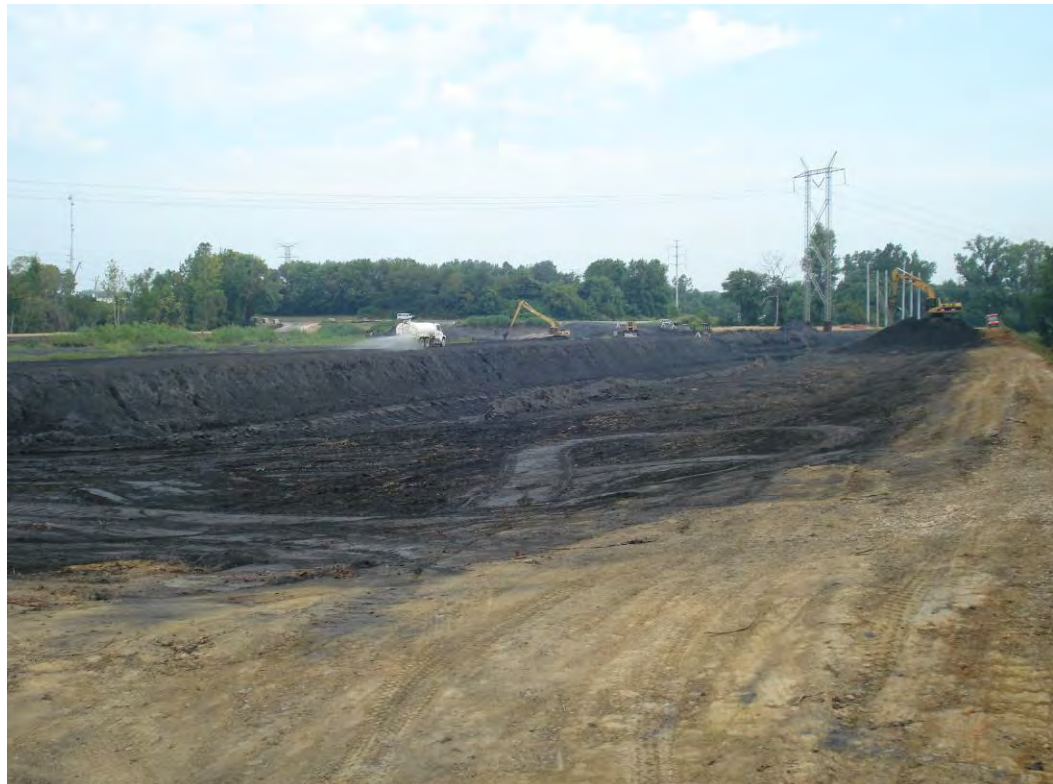
Photo Number:
12

Ash removal from Primary Ash Pond.

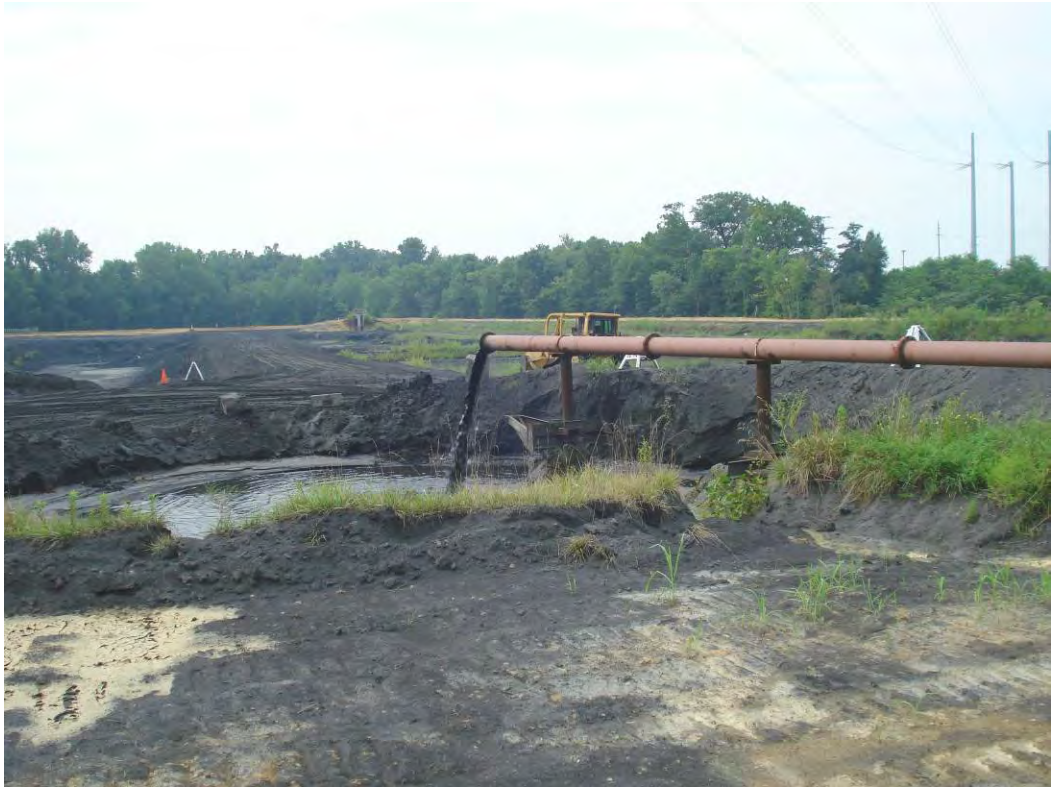
CCW inlet to Primary Ash Pond. Outlet structure at dividing dike in background.
