# Dam Safety Assessment of CCW Impoundments

## Edwardsport Plant

United States Environmental Protection Agency  
Washington, DC

March 31, 2011

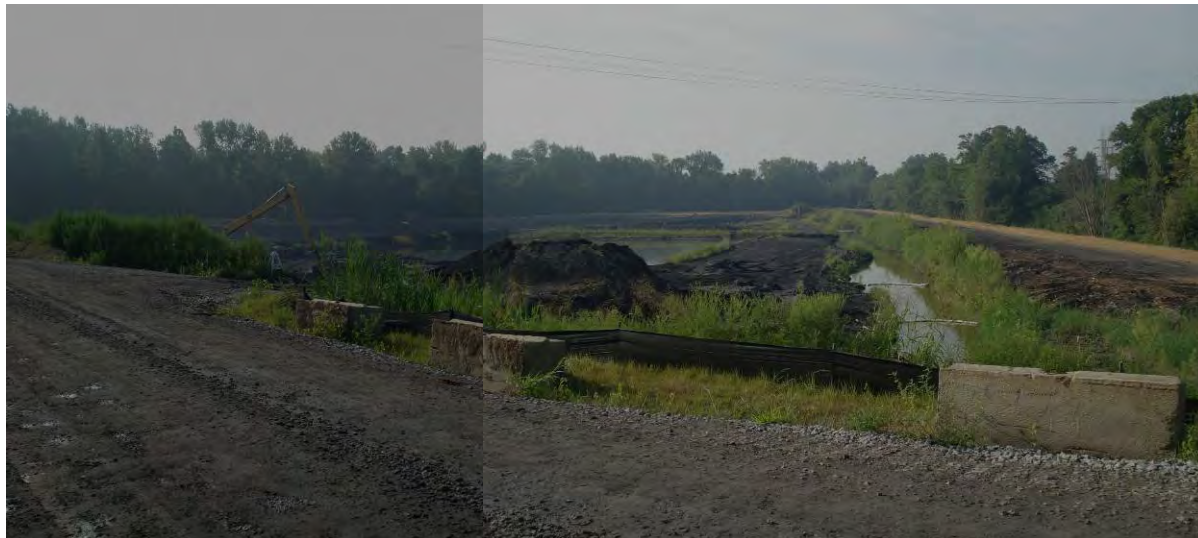
Photo Number:  
1

Overview of Primary Ash Pond from northwest corner showing typical condition of crest & inboard slope. Note excavator removing dewatered ash.

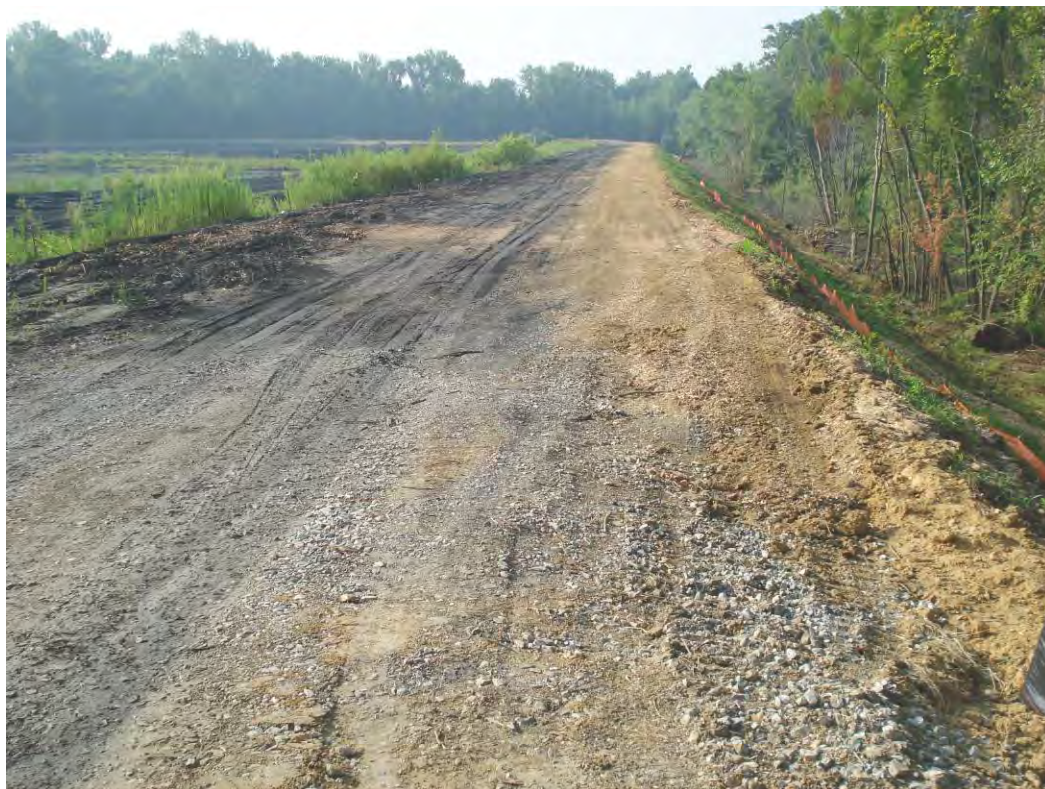
Photo Number:  
2

Typical condition of Primary Ash Pond crest. Note safety fencing on outboard slope.

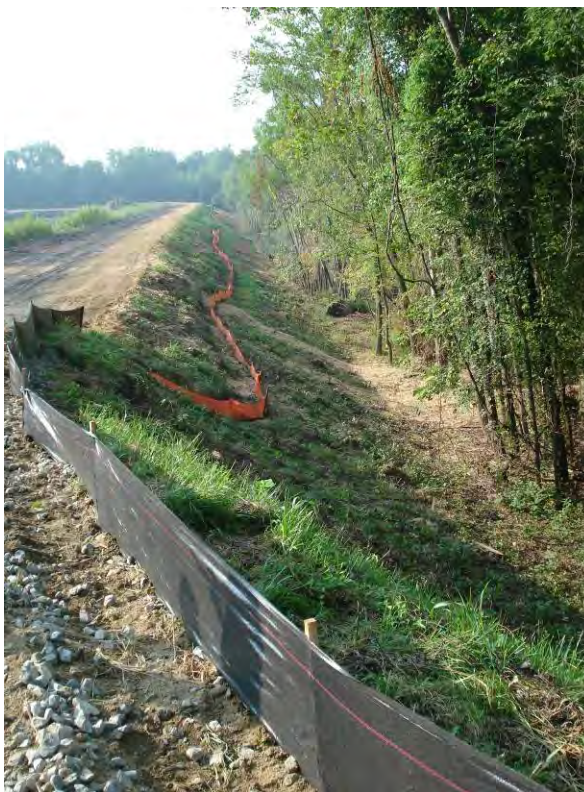
Photo Number:  
3

- Absence of fully-developed turf on the outboard slopes of both dikes.
- Cracked concrete in the apron retaining wall on the Secondary Ash Pond outlet.
- Ponded water in the western drainage swale.

Typical condition of Primary and Secondary Ash Pond exterior dike slopes.

- Establish turf on the outboard slopes.
- Repair the concrete apron retaining wall.
- Re-grade the western toe swale to drain the ponded water.

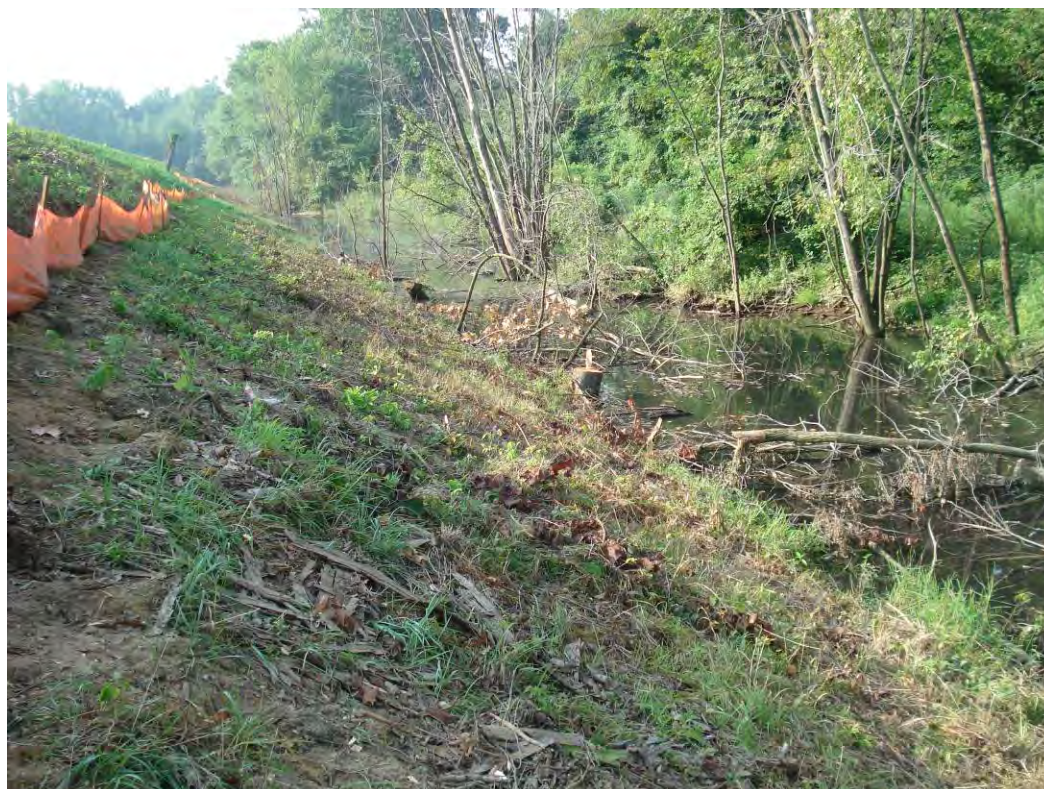
Photo Number:  
4

- Ponded water was noted in the drainage swale along nearly the entire toe of the western dike (Appendix B – Photo 4). There was no evidence of piping or flow, and the ponding appeared to be caused by a low area in the swale invert. The northern and eastern toe drainage swales were dry.

Ponded water in drainage swale at Primary Ash Pond dike's western exterior toe.

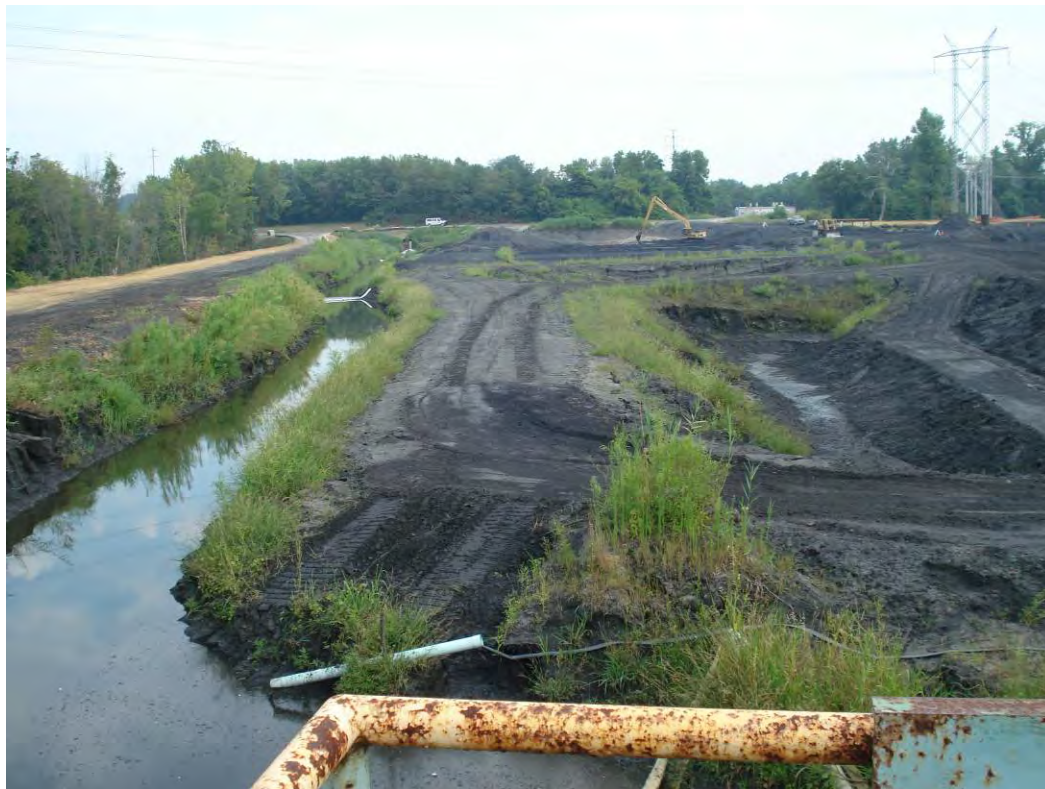
Drainage ditch from CCW and drainage inlets in Primary Ash Pond. Note excavator maintaining flow from decant inlet to ditch.

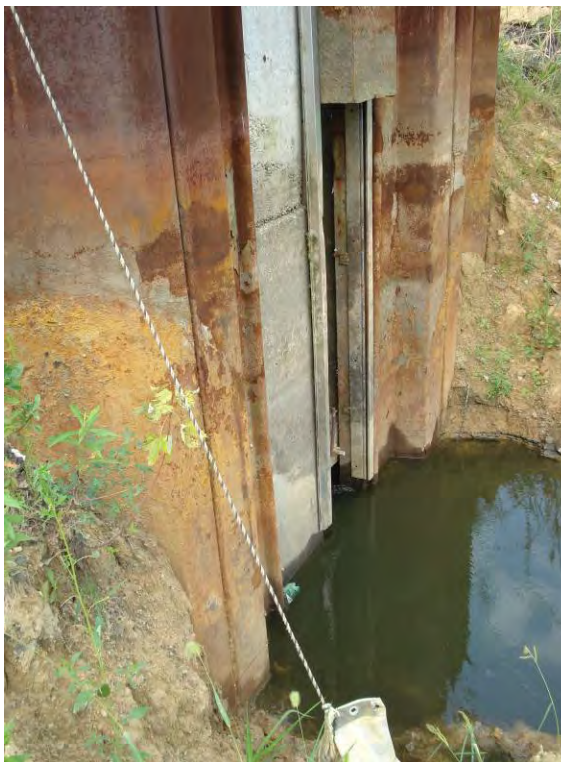
- The reinforced concrete outlet structure was in fair condition. All of its stoplogs had been removed such that the pool elevation was being controlled by the Secondary Ash Pond outlet structure.

Inlet to Primary Ash Pond outlet structure. All stoplogs have been removed to facilitate dewatering and removal of CCW.

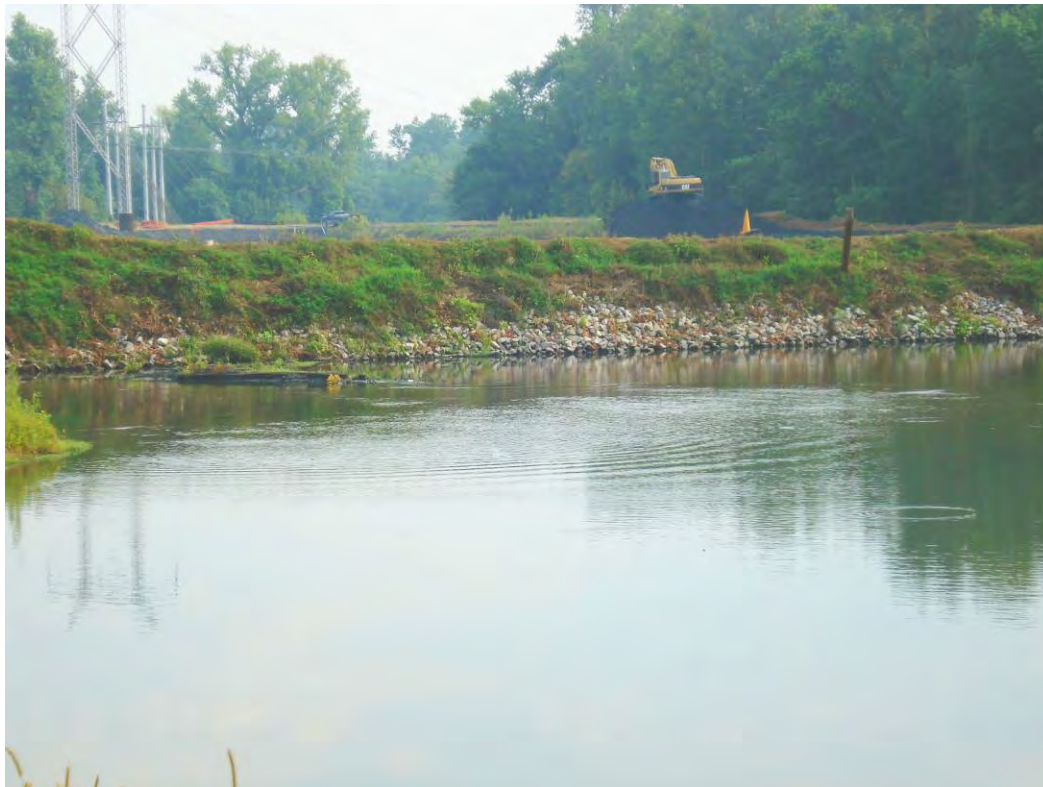
Photo Number:  
7

- Supernatant from the Primary Ash Pond enters the Secondary Ash Pond below the latter's pool elevation (El. 454) (Appendix B – Photo 7).
- The interior riprap was in good condition and the inboard slope above the riprap was covered with grass about 8 inches long (Appendix B – Photo 7).

Typical condition of dividing dike slope. Mild turbulence in Secondary Ash Pond water surface from Primary Ash Pond outlet conduit. Note excavator stockpiling dewatered Primary Pond ash.

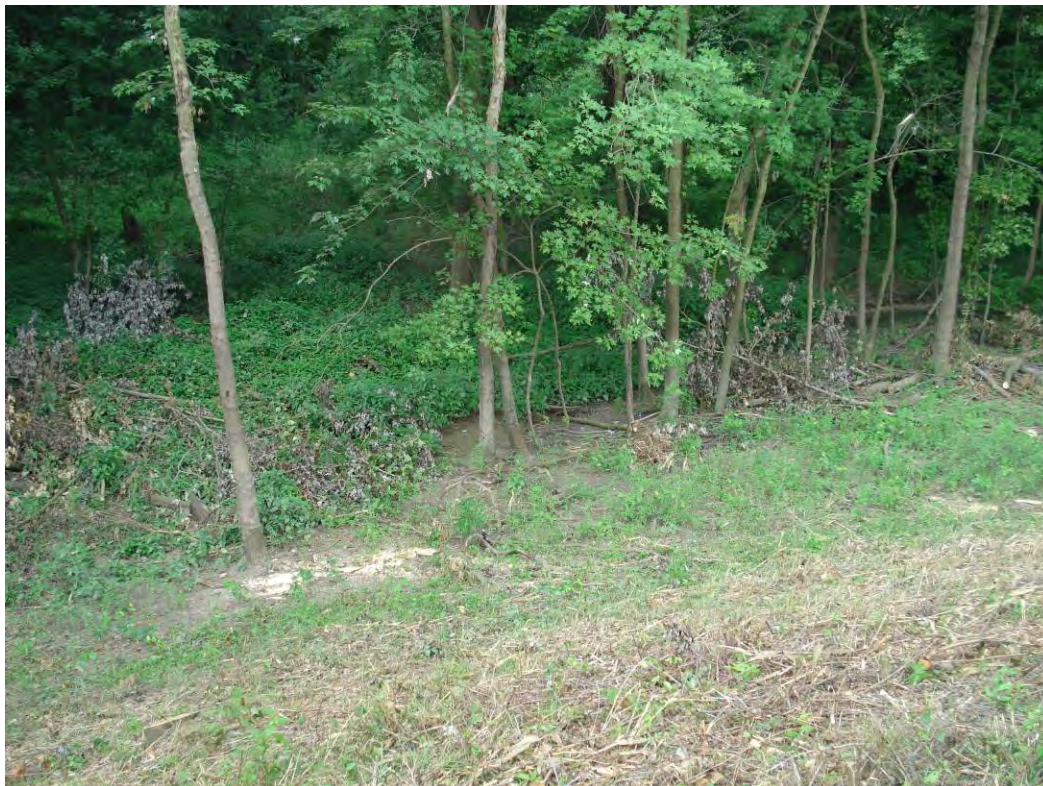
Photo Number:  
8

Typical condition of southern toe of Secondary Ash Pond.

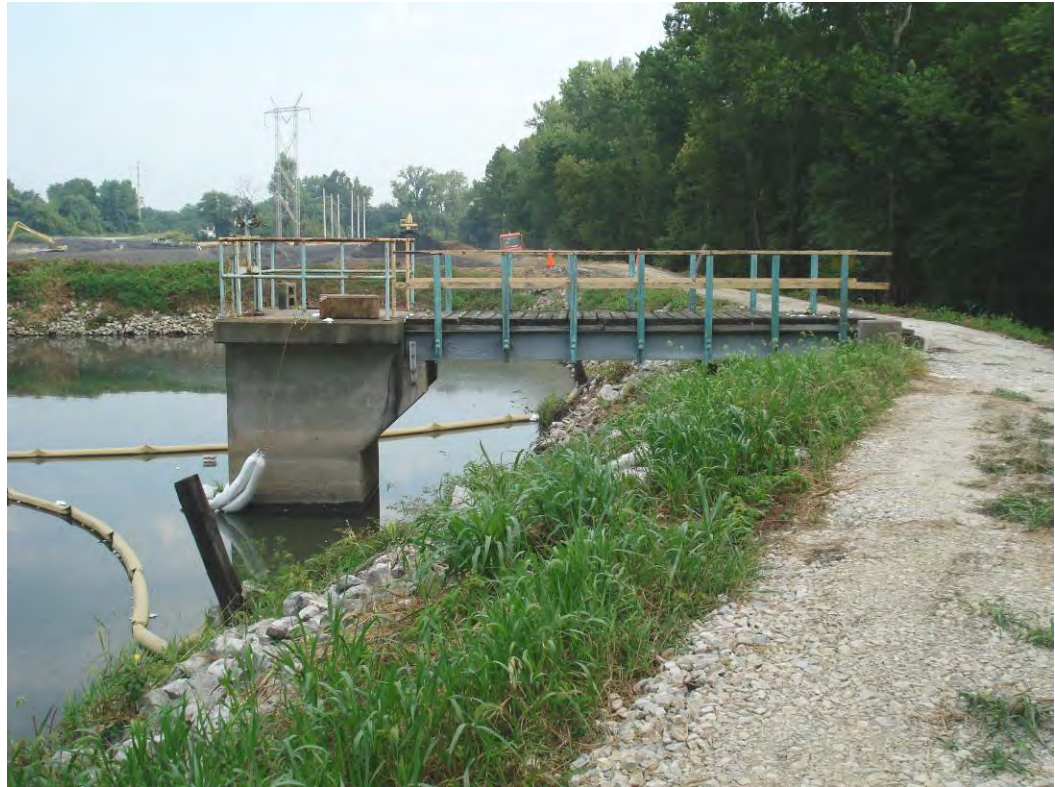
- The Secondary Ash Pond outlet structure was in fair condition. Most of the stoplogs had been removed such that the water level in the Secondary Ash Pond was about 6 inches above the crown of the 18-inch CMP outlet conduit at El. 454, or about 9 feet below the lowest dike crest elevation.

Secondary Ash Pond outlet structure, inboard slope and dike crest. Note lowered pond level about 4 feet below historic norm.

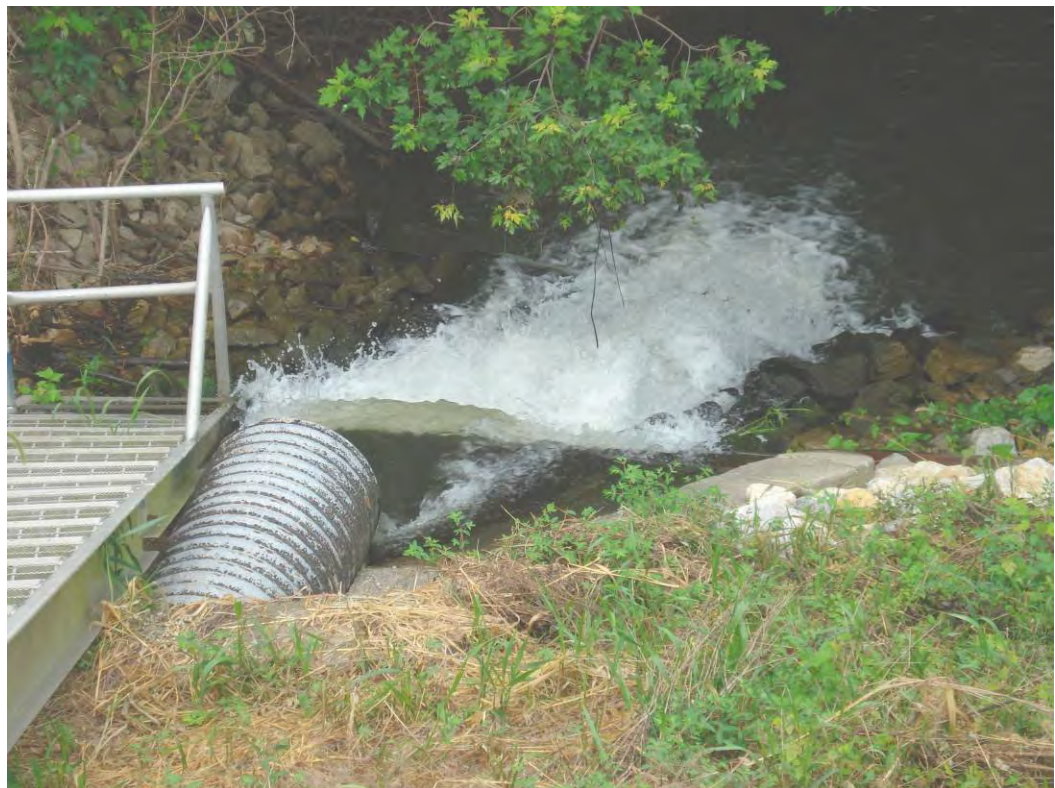
18-inch outlet from Secondary Ash Pond.

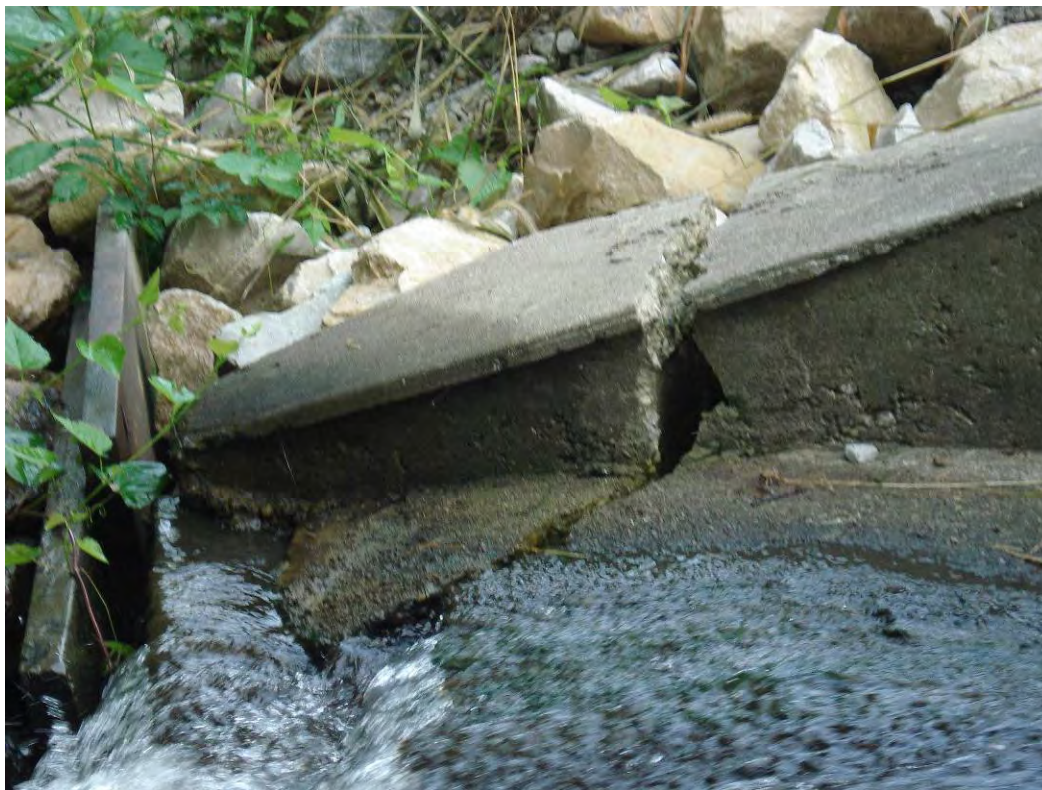
Photo Number:  
11

- The outlet conduit discharges onto a concrete apron about 5 feet above the drainage channel invert. The apron terminates in a concrete headwall which was not undermined. The apron's southern concrete training wall was cracked about two feet above its downstream terminus (Appendix B – Photo 11).

Cracked  
southern  
retaining wall of  
Secondary Ash  
Pond outlet  
apron.

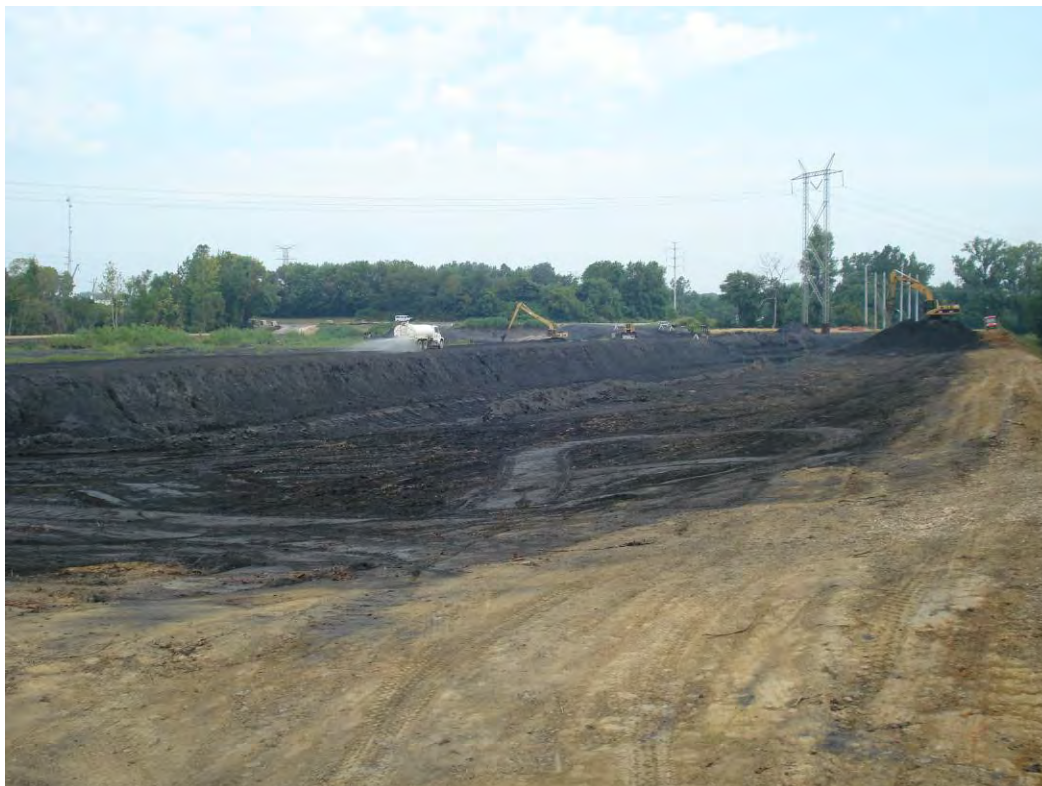
Photo Number:  
12

Ash removal  
from Primary  
Ash Pond.

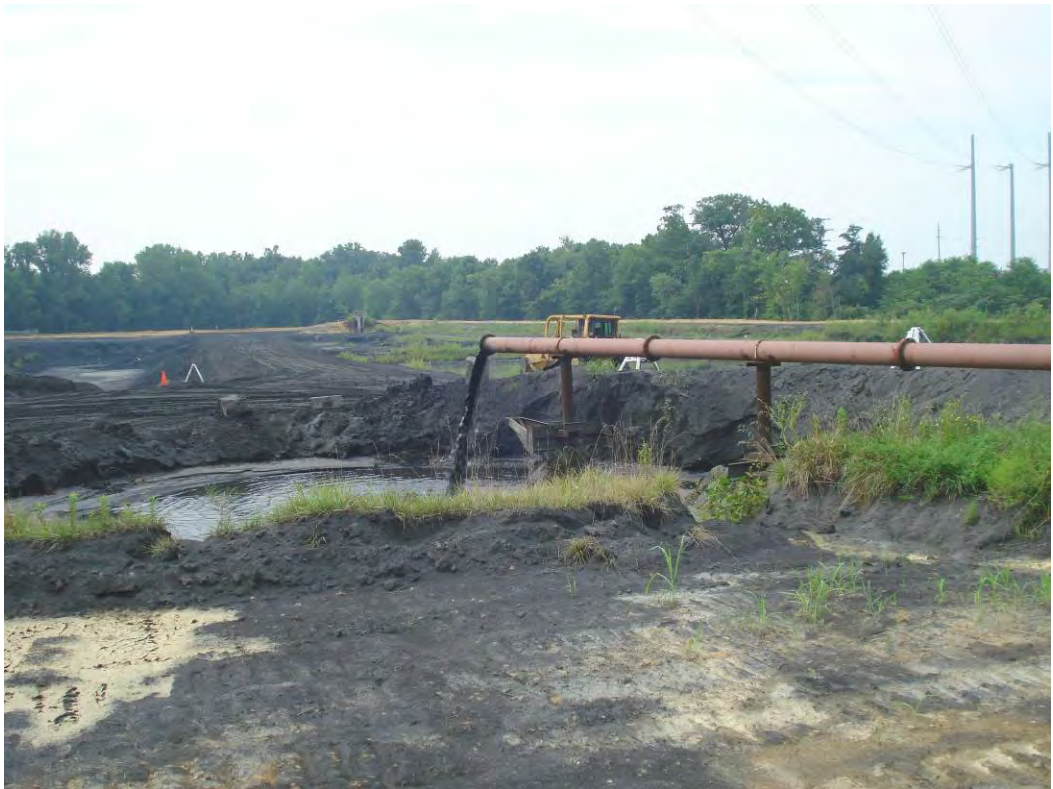
Photo Number:  
13

CCW inlet to  
Primary Ash  
Pond. Outlet  
structure at  
dividing dike in  
background.
