# **Dam Safety Assessment of CCW Impoundments**

## **Gallagher Generating Station**

**United States Environmental Protection Agency**  
**Washington, DC**

April 7, 2011

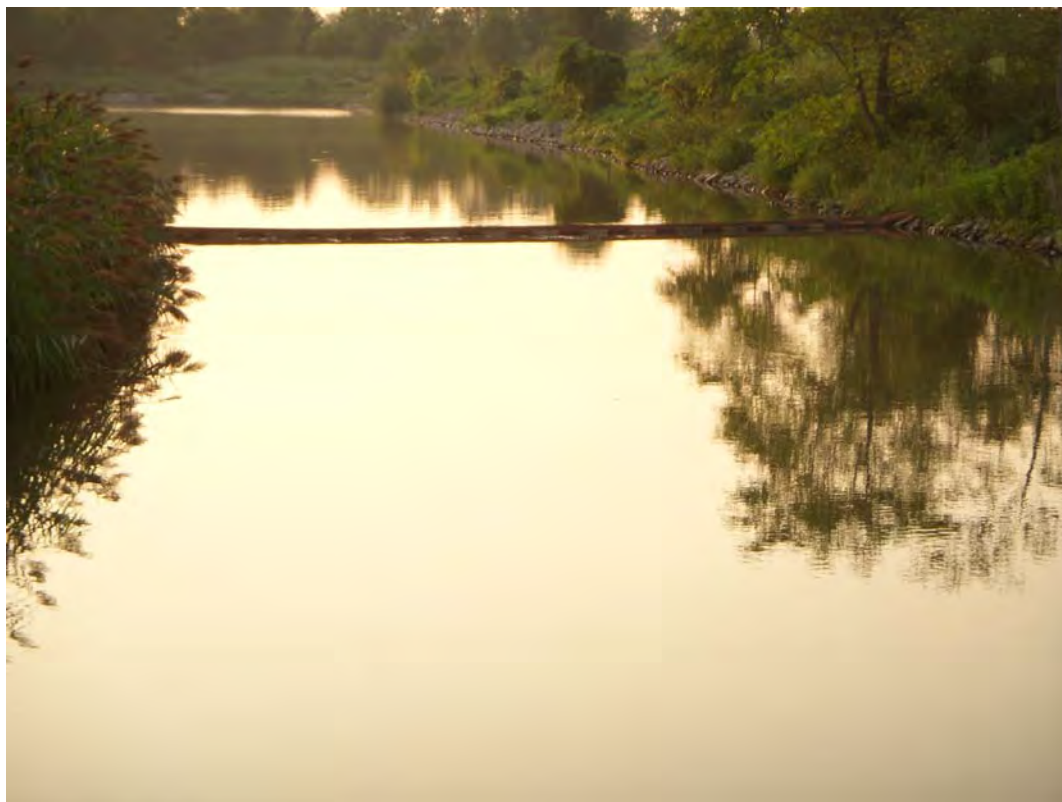
Floating  
skimmer on  
Primary Pond  
outlet channel  
(inlet to Ash  
Pond A)

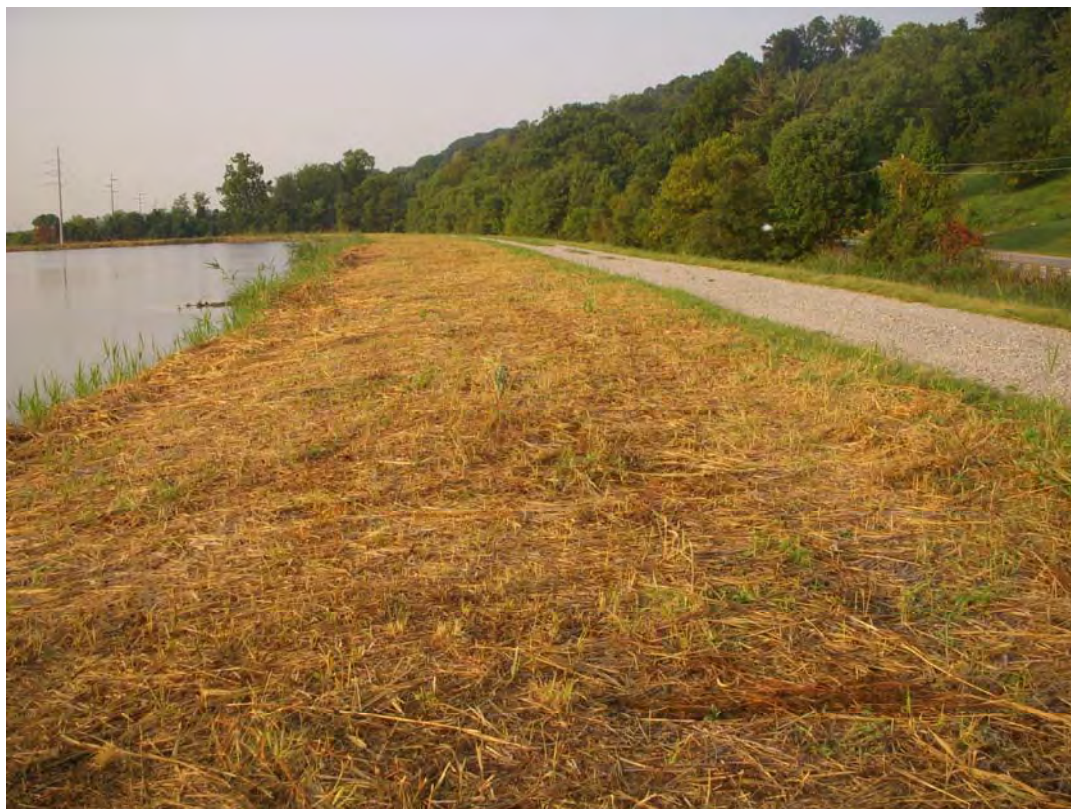
Inboard side of  
western  
embankment of  
Ash Pond A

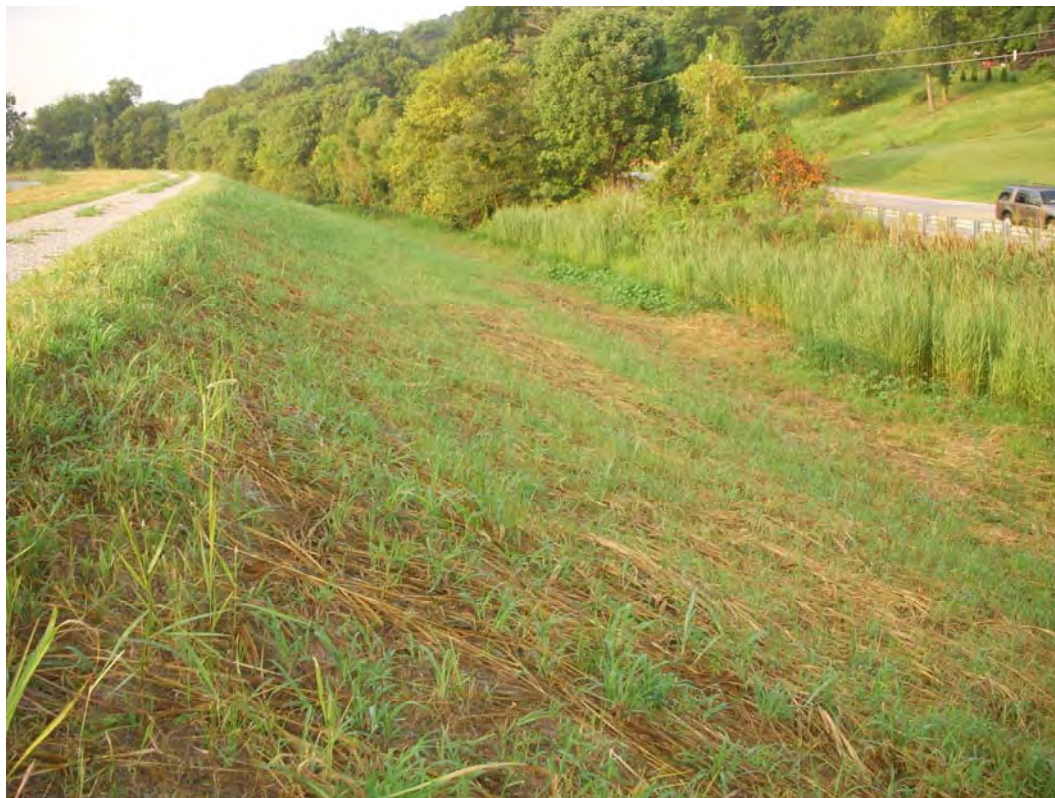
Outboard slope of western embankment of Ash Pond A

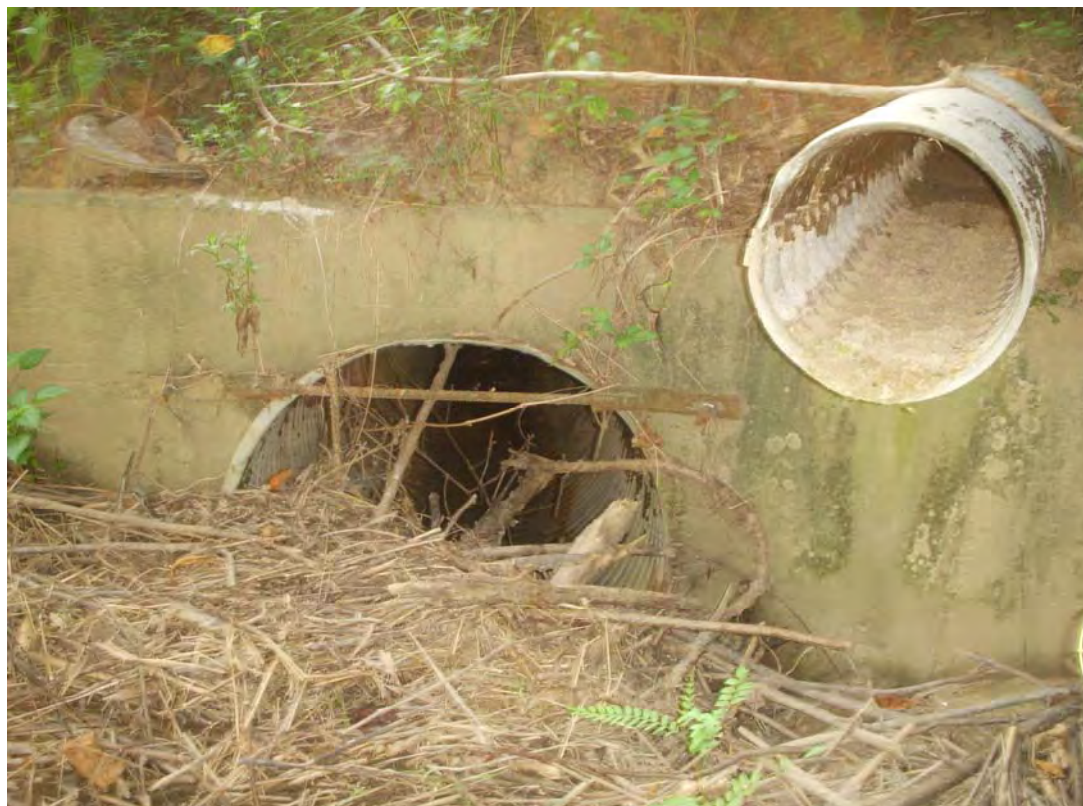
Outlet pipe for the drainage channel at the southwestern corner of Ash Pond A

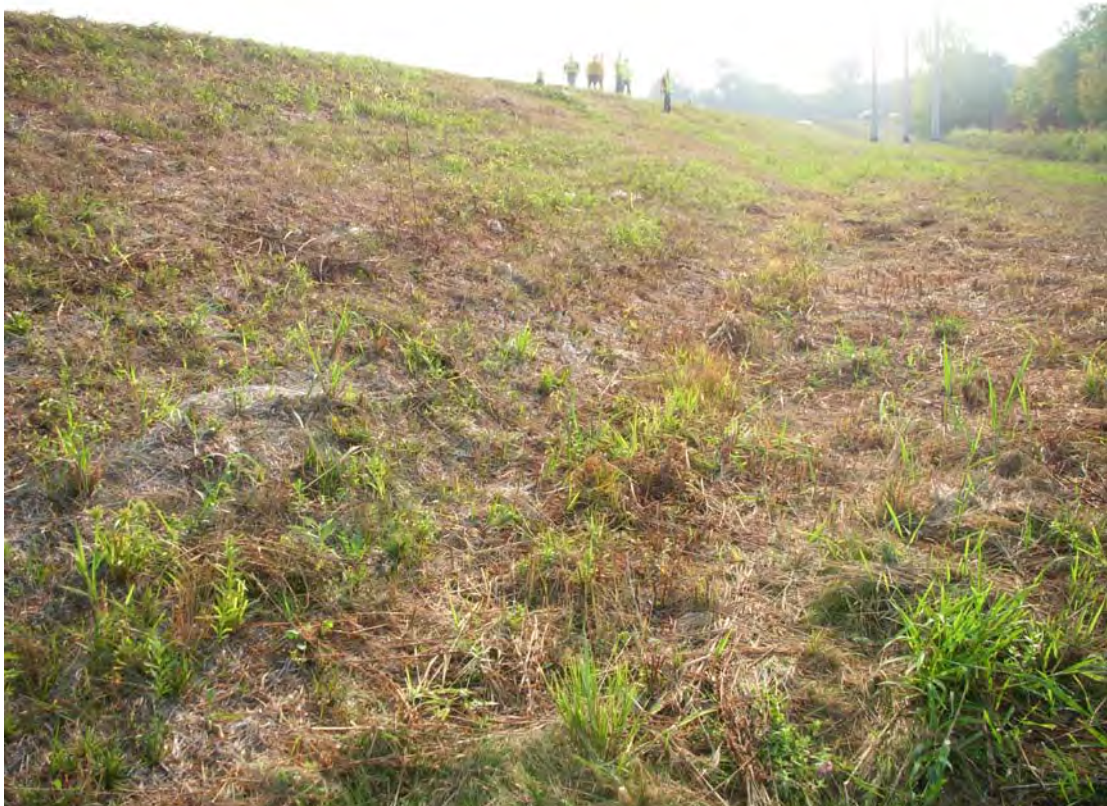
- The outboard slope of the southern embankment ties into an abandoned road embankment (Old River Road). For the purposes of this report, the tie-in point is considered to be the outboard toe of the embankment; however, it should be noted that the abandoned road embankment slopes down to a lower elevation beyond the Ash Pond A embankment (Appendix B – Photos 6 and 7).

Outboard  
slope of  
southern  
embankment of  
Ash Pond A

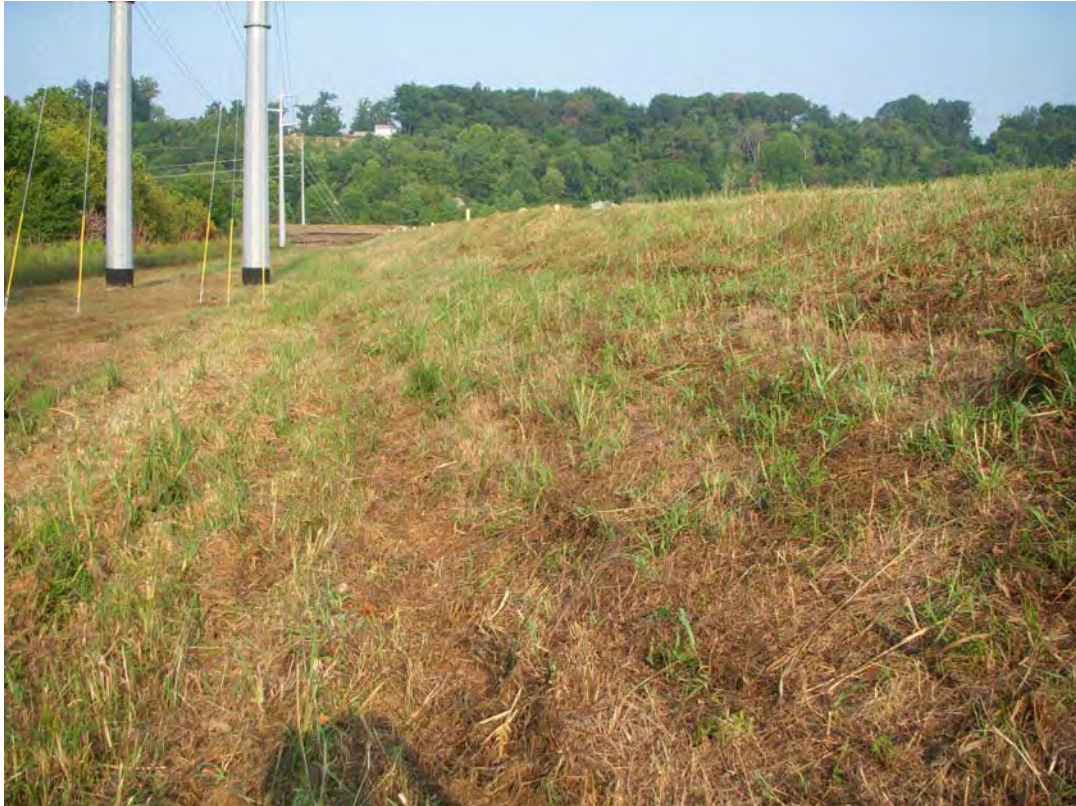
Outboard  
slope of  
southern  
embankment of  
Ash Pond A

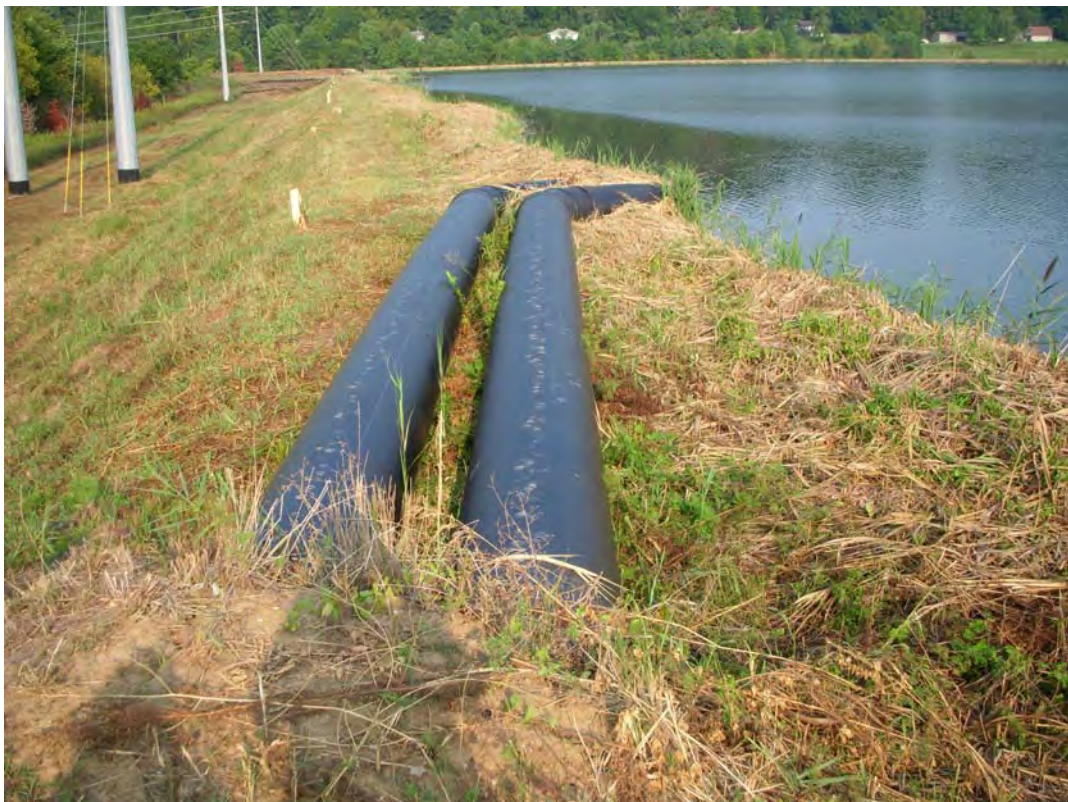
Landfill storm  
water and  
leachate  
effluent pipes  
into Ash Pond A

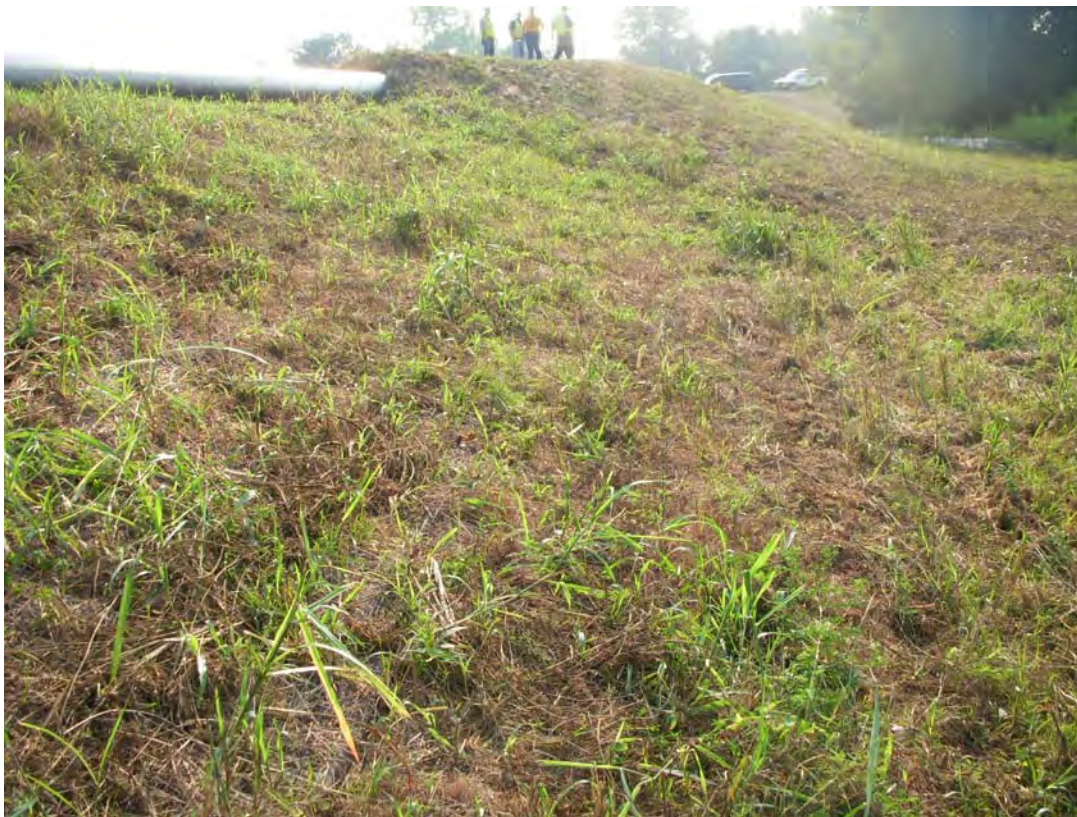
Raised section  
of southern  
embankment of  
Ash Pond A for  
landfill pipe  
cover

- Based on the hydrologic/hydraulic analyses recommended above, a design crest elevation should be established for the embankments and low spots in the crest should be filled/raised to create a uniform crest elevation around Ash Pond A (except in the area of the landfill leachate/drain pipes).

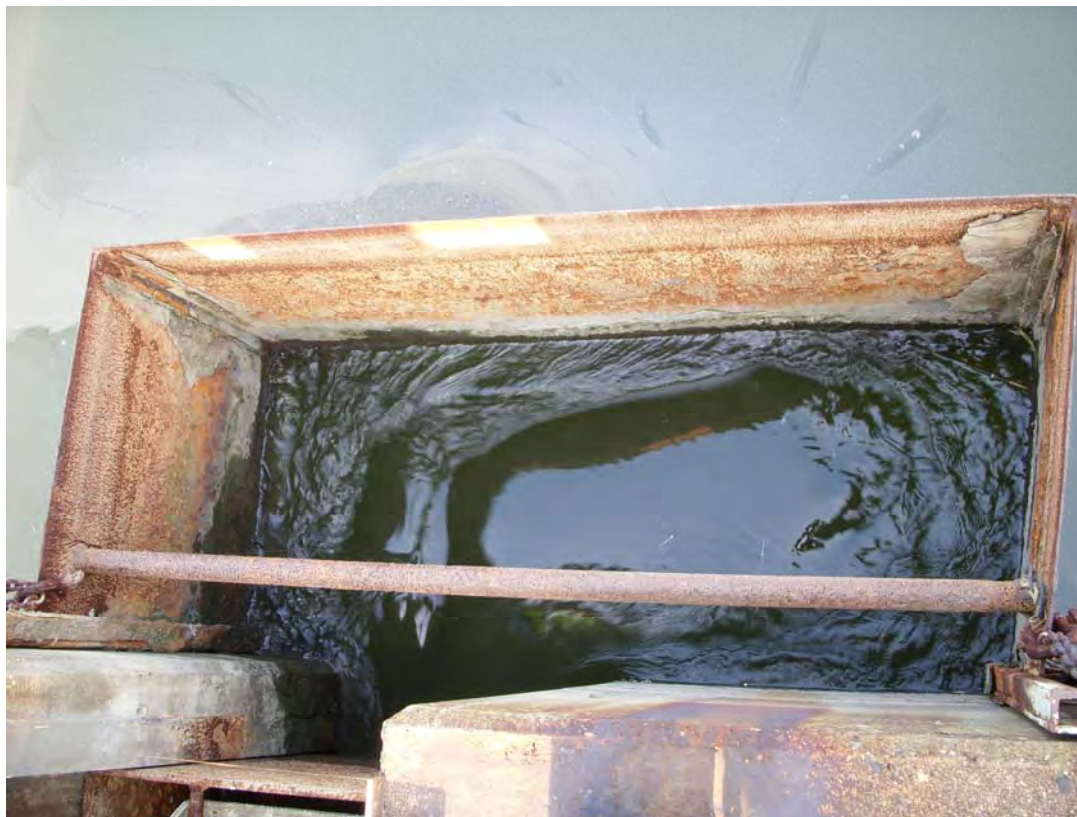
- Weir boxes (rather than trash racks) have been installed to prevent floating debris from entering both the principal and emergency spillways (Appendix B – Photos 10 and 11). The principal spillway appears to be in good condition and functioning as designed, with flow occurring into the Secondary Pond on the date of the inspection. Stop logs are used to adjust the overflow elevation of the principal spillway, as necessary.

Weir box for  
principal  
spillway inlet at  
southeastern  
corner of Ash  
Pond A

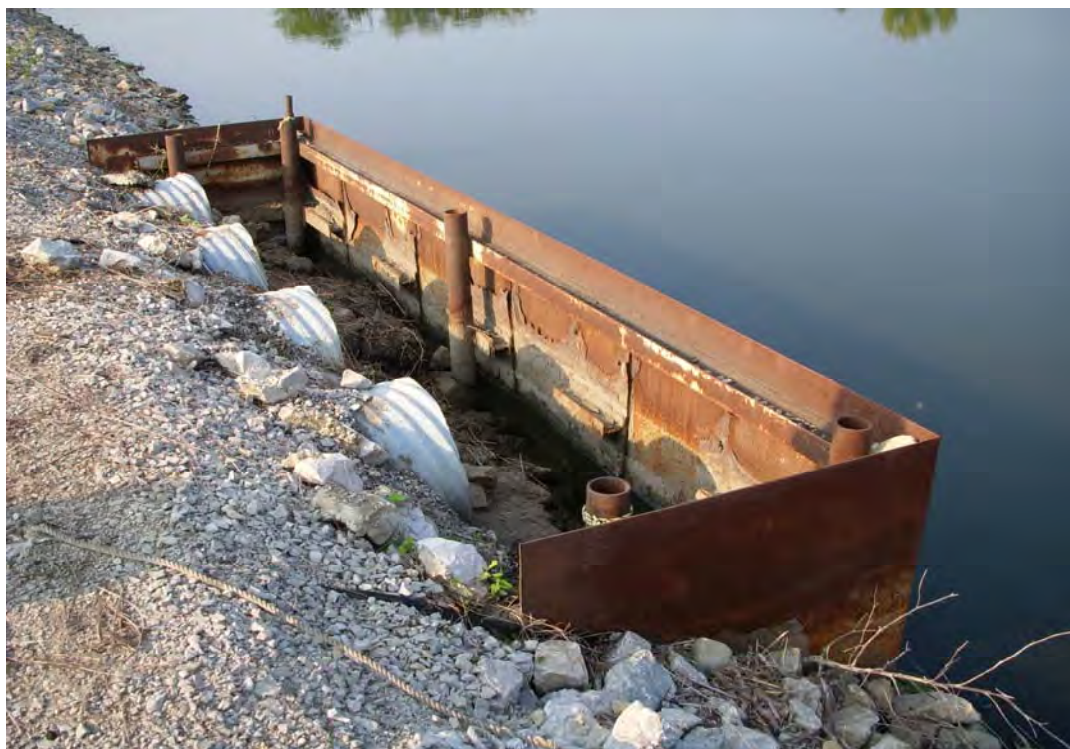
Weir box for emergency spillway outlet pipes from Ash Pond A to the Secondary Pond

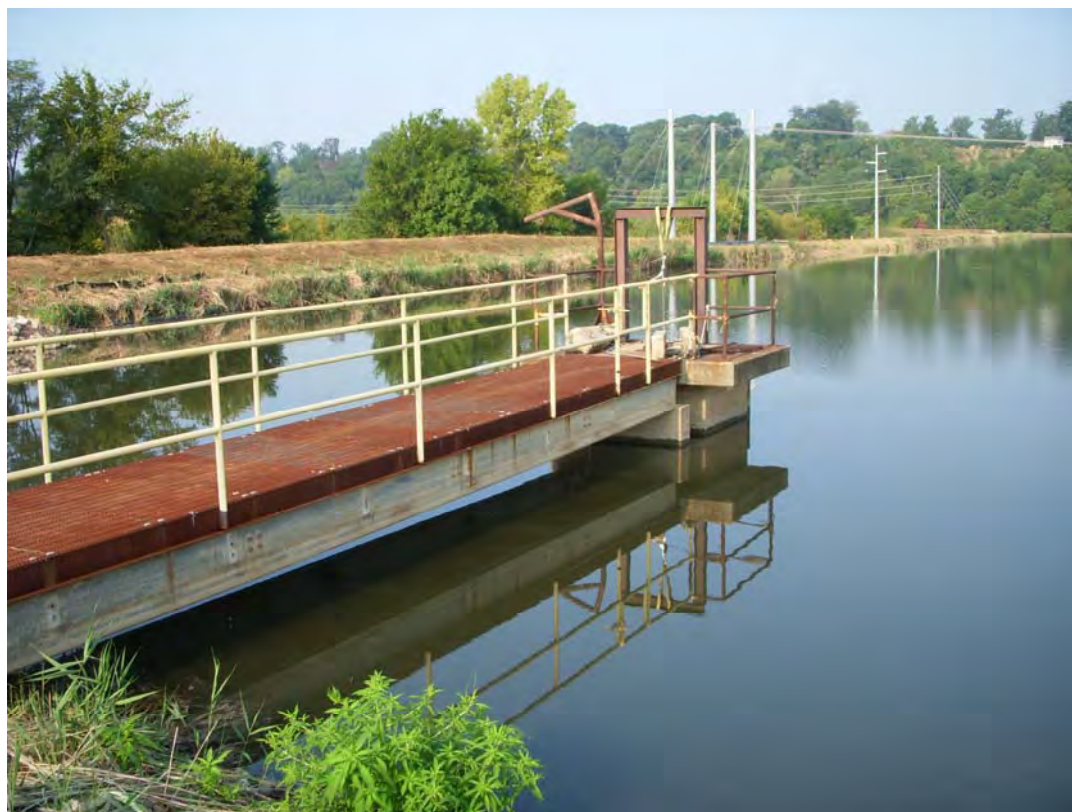
Access bridge and operating platform for Ash Pond A principal spillway

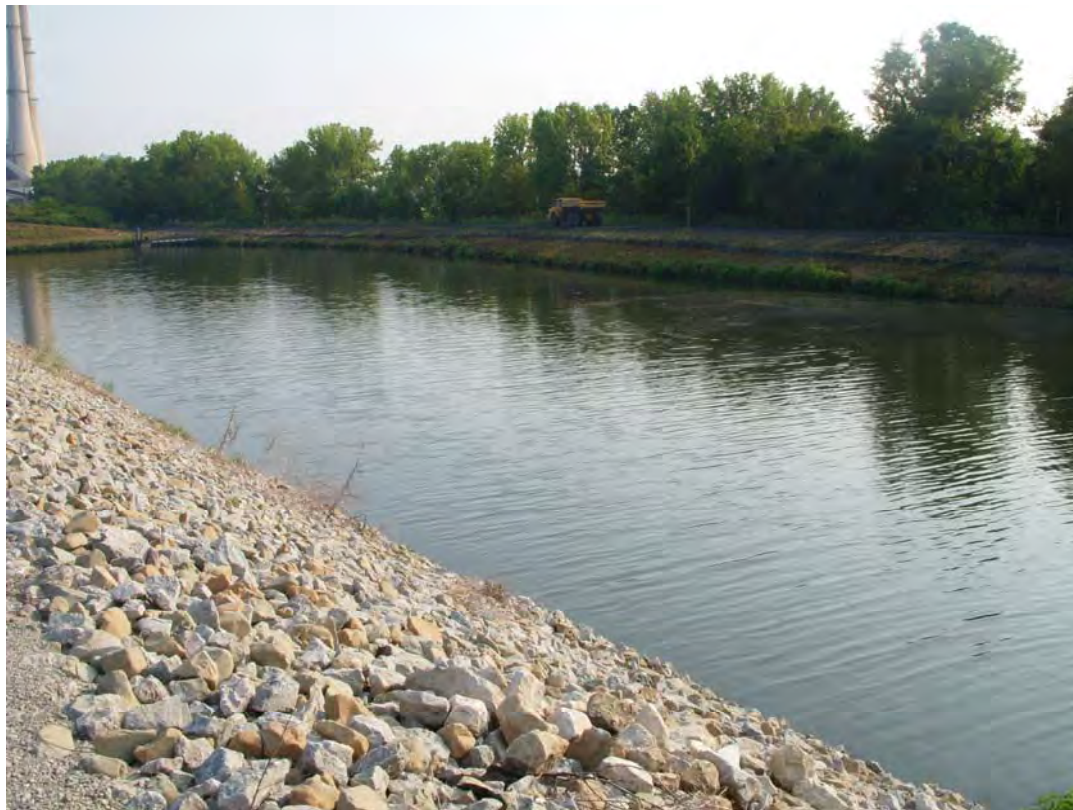
Eastern slope  
of separation  
dike (eastern  
embankment of  
Ash Pond A)

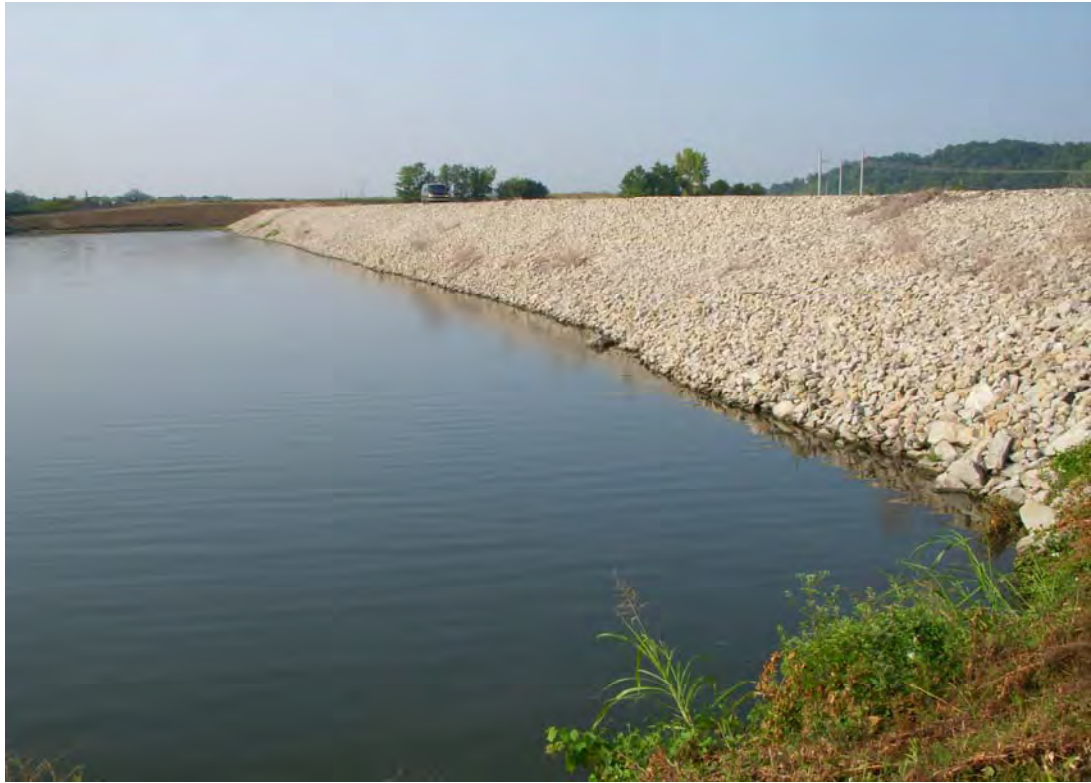
- As noted above, the dike that separates Ash Pond A and the Secondary Pond serves as the western embankment of the Secondary Pond (Appendix C – Photo 1). The Ash Pond A principal spillway outlet pipe is located through the separation dike and, on the date of the inspection, water was discharging into the Secondary Pond. The pool elevation of the Secondary Pond was considerably lower than the Ash Pond A elevation. According to the ATC report, the normal pool elevation of the Secondary Pond is El. 427.

Eastern slope of separation dike (inboard slope of western embankment of Secondary Pond)

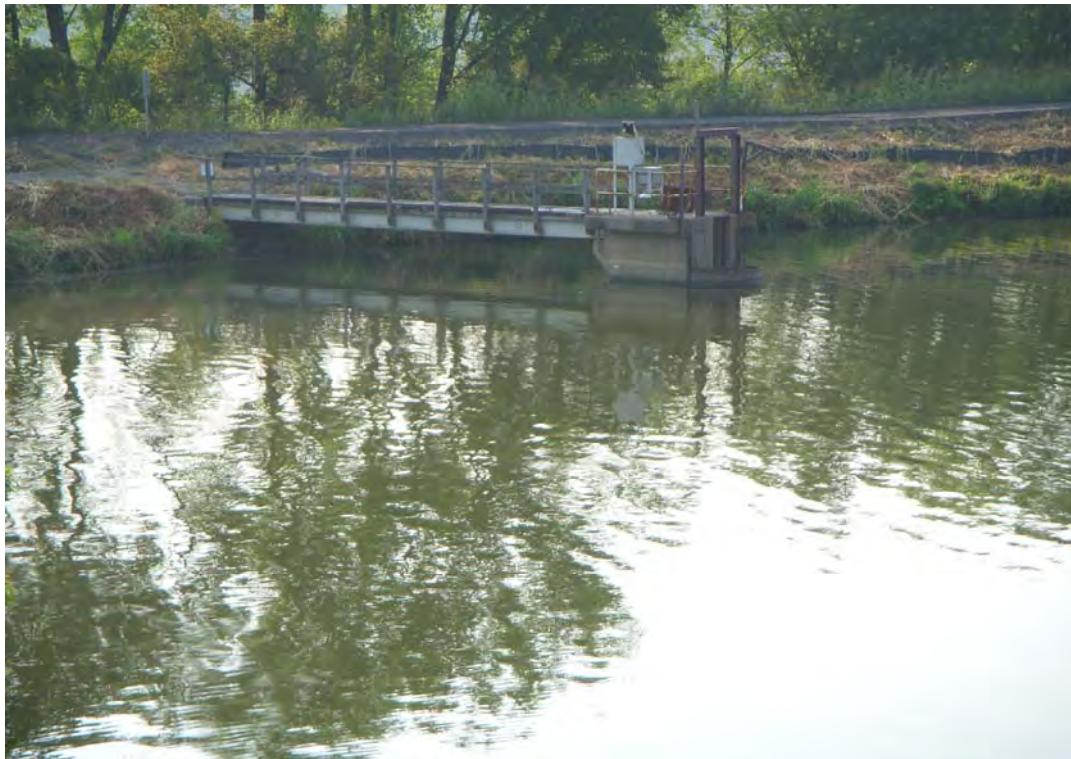
Principal spillway outlet structure for Secondary Pond

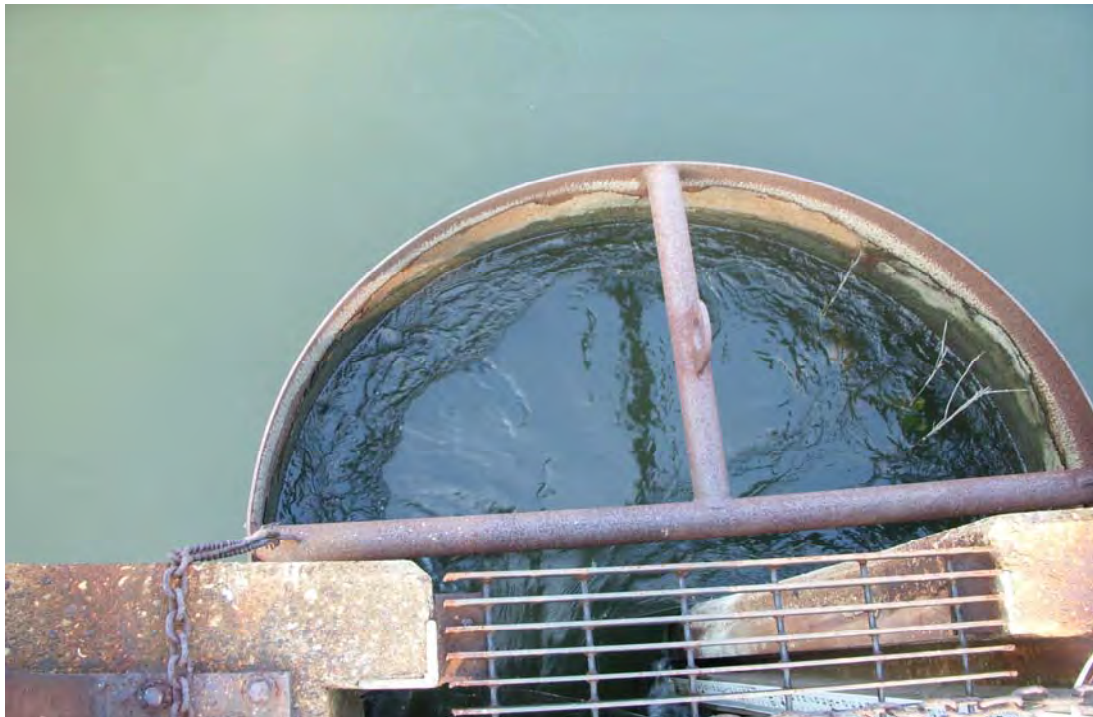
Principal  
spillway inlet  
for the  
Secondary Pond

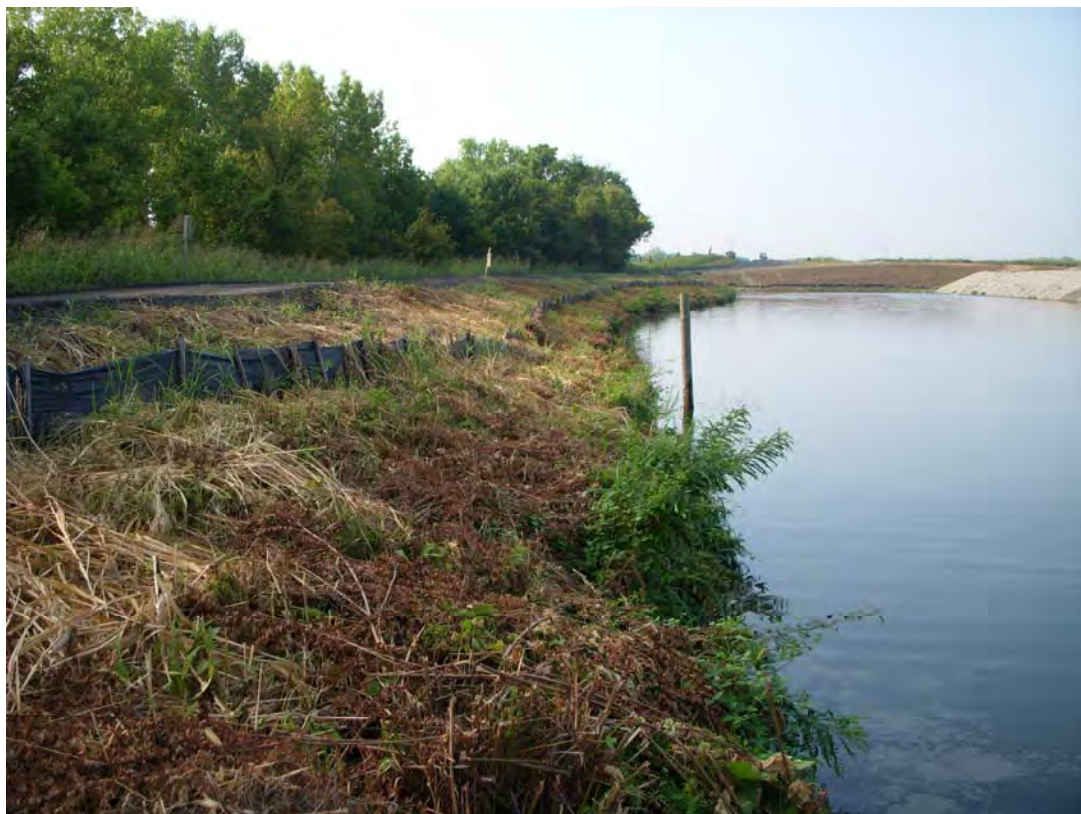
Inboard slope  
of the eastern  
embankment of  
the Secondary  
Pond

- Based on the hydrologic/hydraulic analyses recommended above, an appropriate crest elevation should be established for the eastern embankment of the Secondary Pond. The embankment crest should then be regraded to a uniform elevation to eliminate the significant variation that currently exists in the crest elevation.

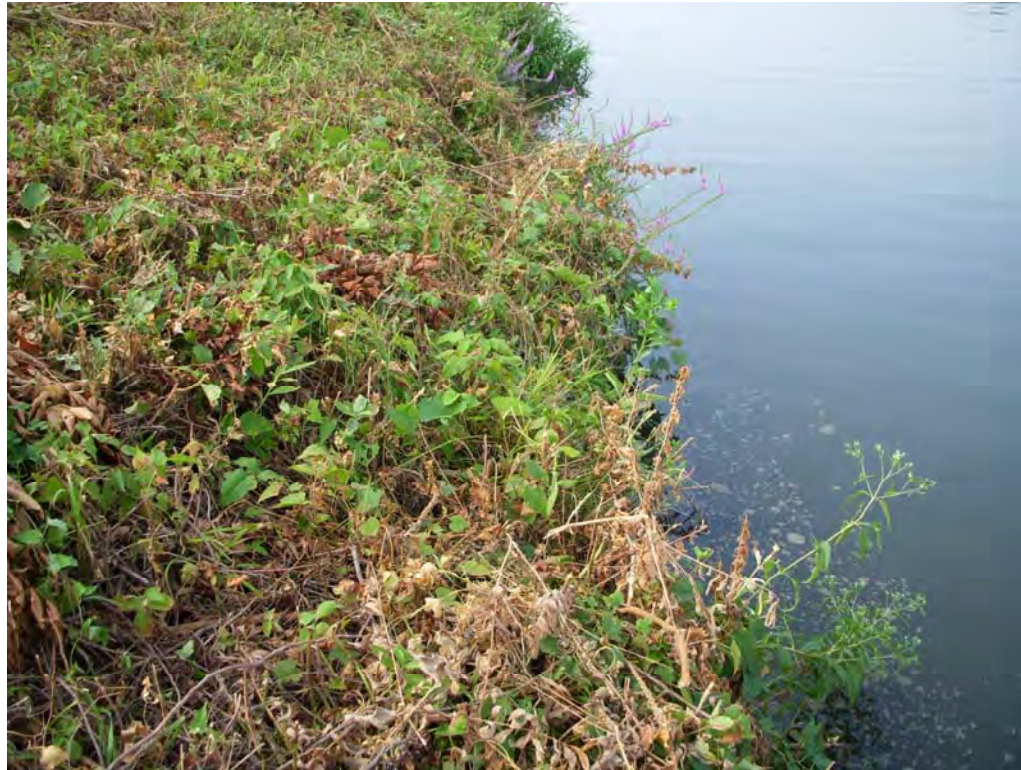
Photo Number:  
5

Description:  
Cut vegetation  
along the  
inboard slope  
of the eastern  
embankment of  
the Secondary  
Pond

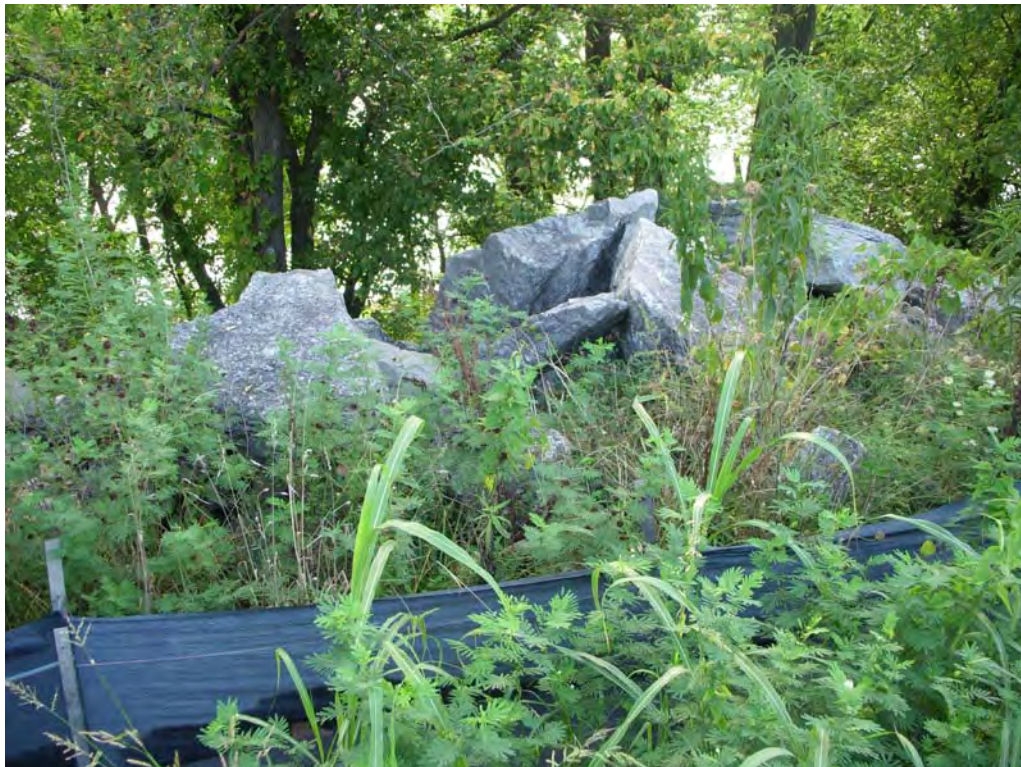
Photo Number:  
6

Large riprap and  
overgrowth of  
trees on  
outboard slope  
of eastern  
embankment  
(Ohio River  
bank) of  
Secondary Pond

- Standard dam safety practice typically recommends the removal of trees from earth embankment sections, due to the potential for uprooting of the trees during storm events and the resulting damage to the embankment. However, since the outboard slope of the eastern embankment also serves as the Ohio River bank, the large trees growing on the slope may reduce the erosion potential from high river flows and, therefore, we recommend that these trees be left in place. However, it would be advisable to perform periodic inspections of this slope, particularly after major storm events, to identify any trees that may have been uprooted and damaged the embankment.

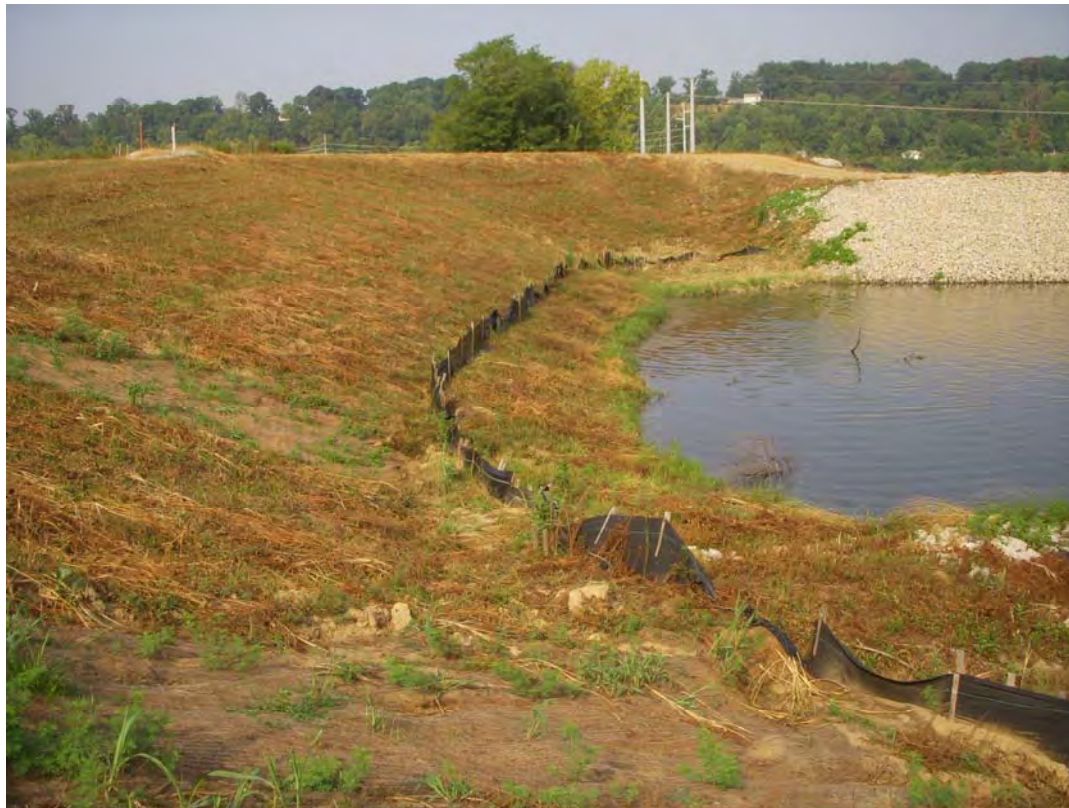
Tie-in of  
separation dike  
and eastern  
embankment  
at south end of  
the Secondary  
Pond

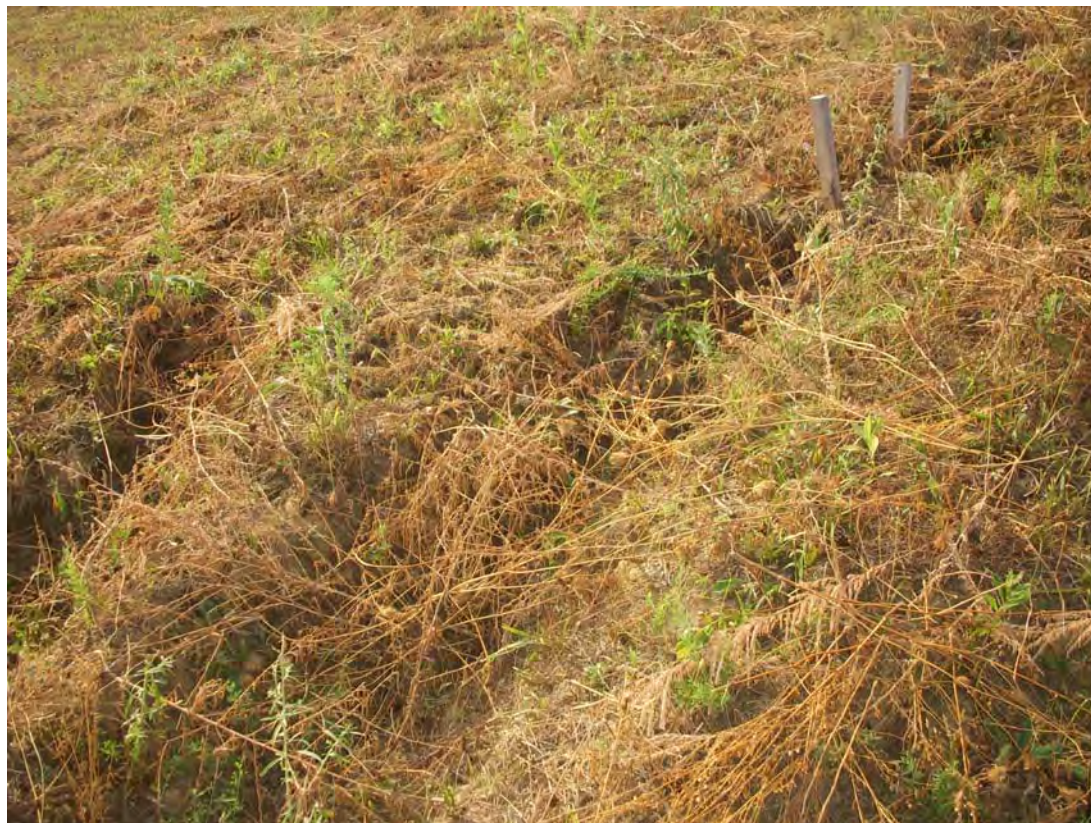
Runoff erosion  
rills along the  
slope at the  
south end of  
the Secondary  
Pond
