## Specific Site Assessment for Coal Combustion Waste Impoundments at Duke Energy Indiana (DEI) Gibson Generating Station

Owensville, Indiana

**GEI Consultants, Inc.**  
4601 DTC Blvd., Suite 900  
Denver, CO 80237

September 2010  
Project 092880

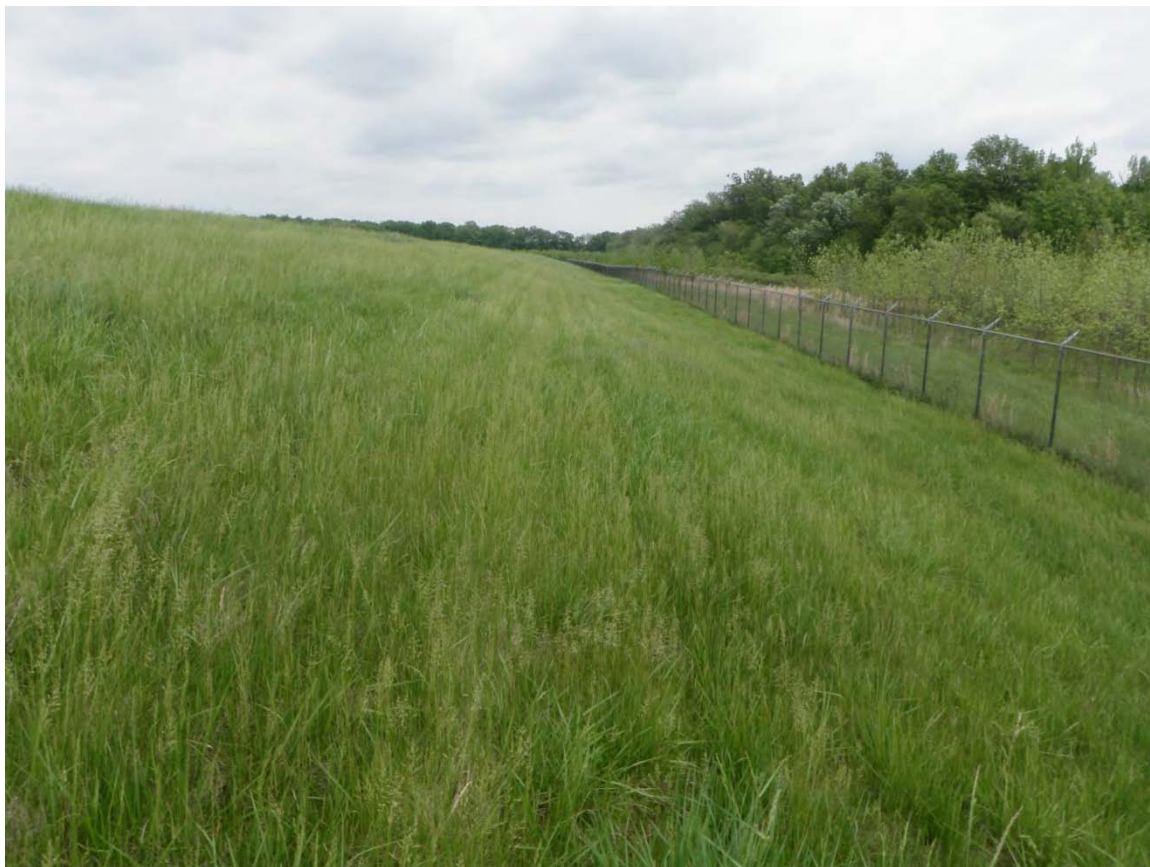
Photo 7: East Settling Basin – South Dike downstream slope, looking west.

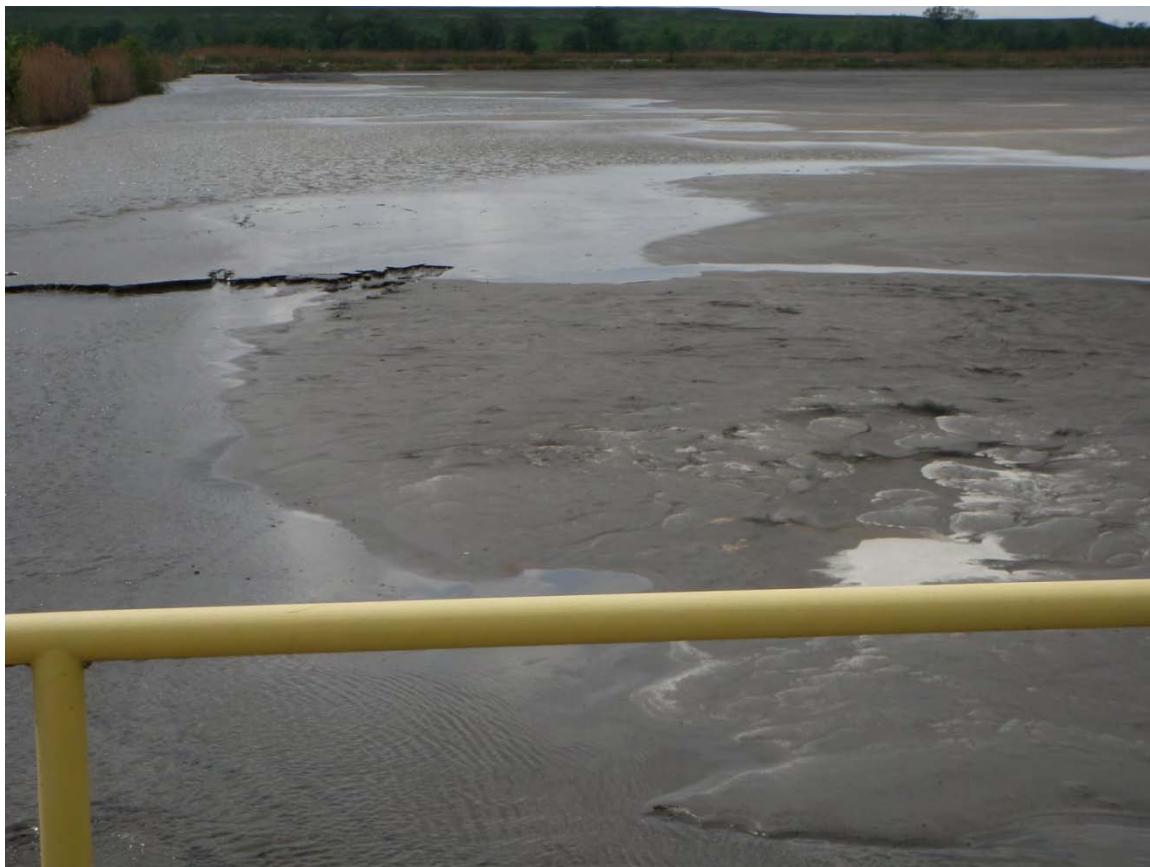
Photo 11: East Ash Pond #1 – EAP #1 reservoir area, approximately 95% full of CCW, looking west.

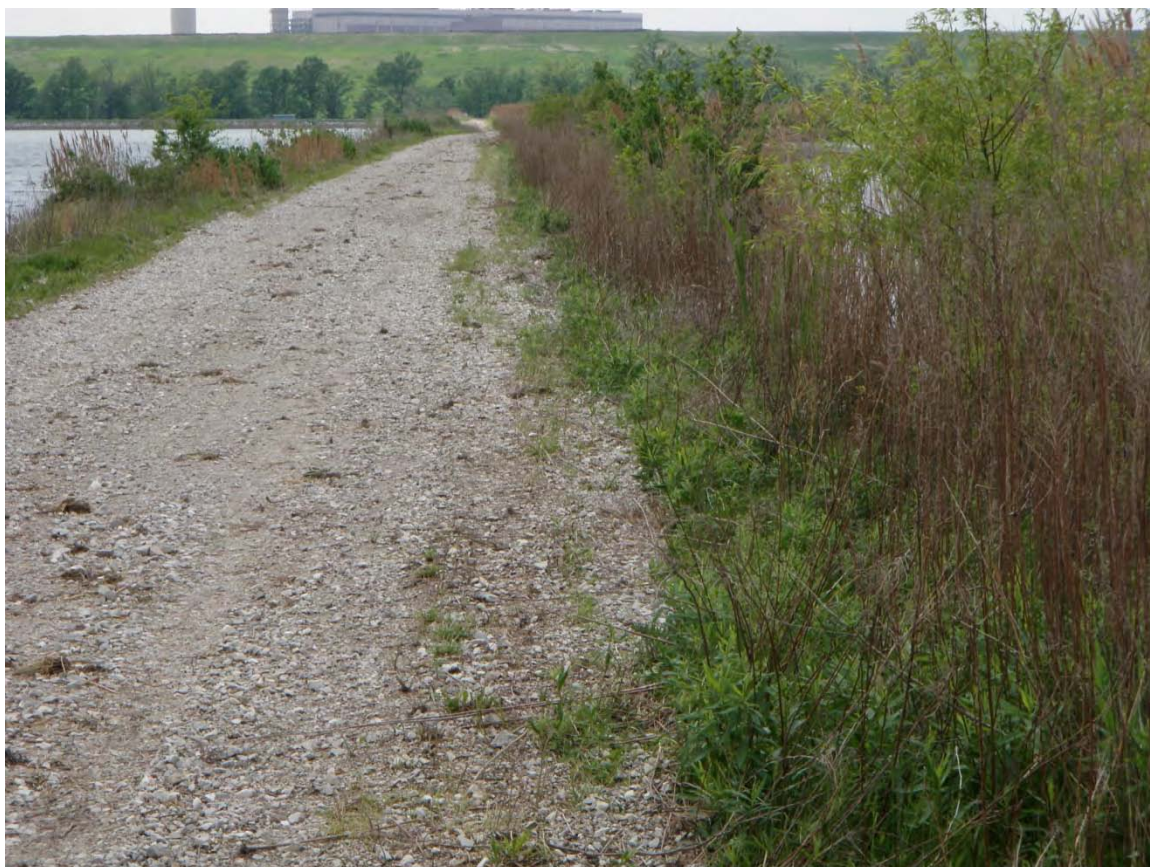
Photo 12: East Ash Pond #1 – Interior dike crest between EAP #1 and Settling Basin, looking west, notice several small trees.

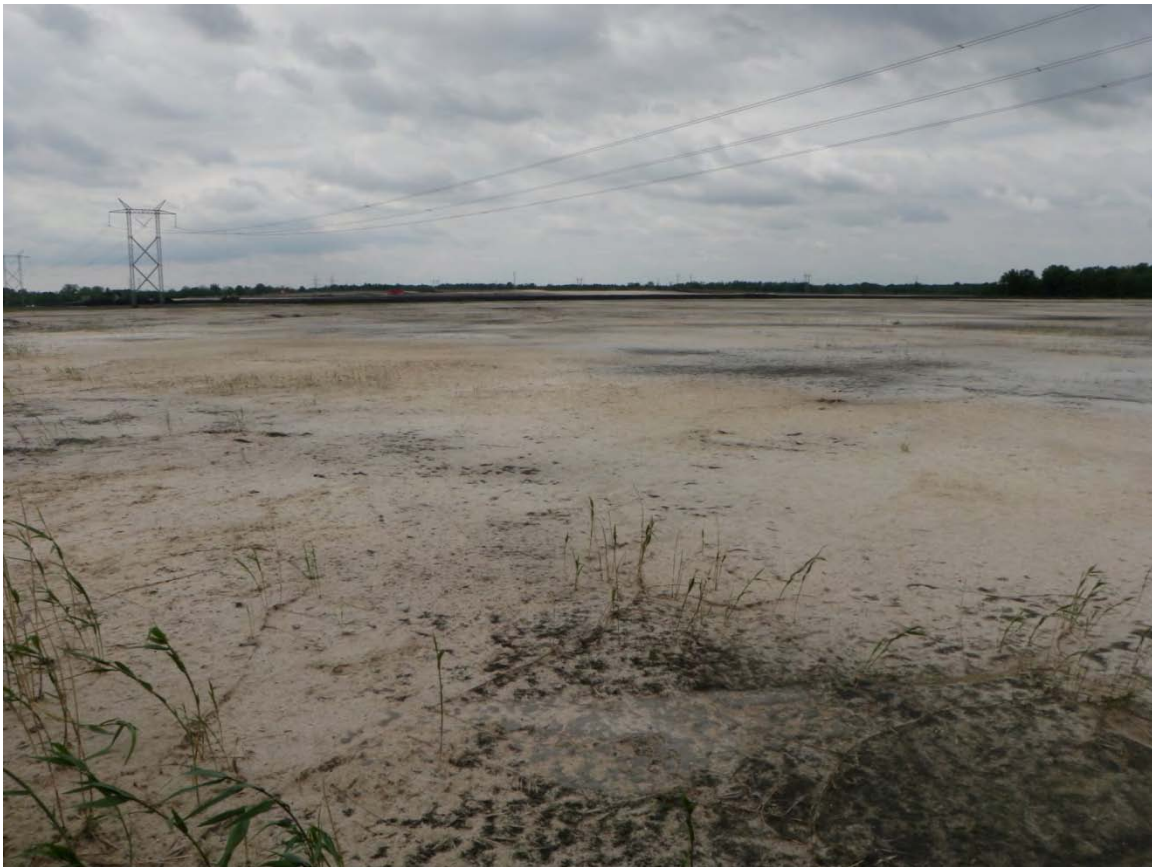
Photo 17: East Ash Pond #3 – EAP #3 reservoir area, about 95% full, in close out phase, looking northwest.

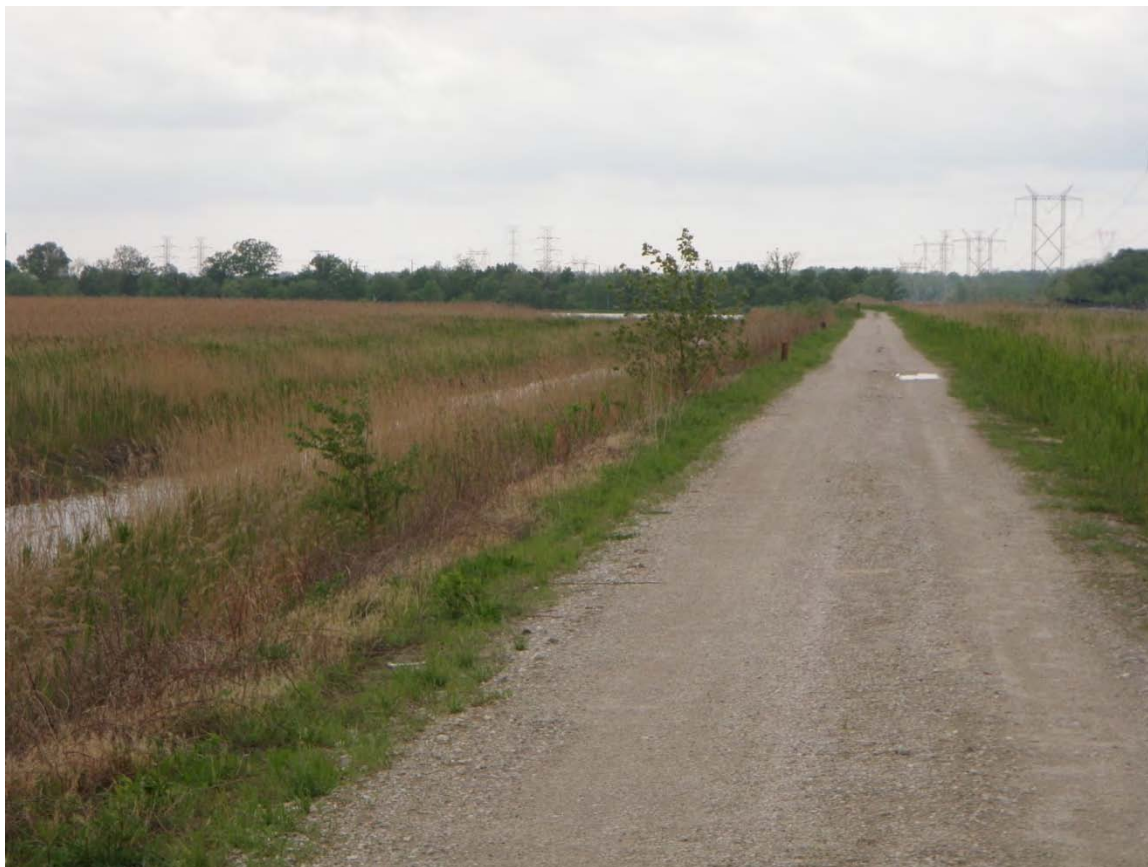
Photo 19: East Ash Pond #3 – Interior dike between EAP #1 and EAP #3, looking west, notice trees along dike.

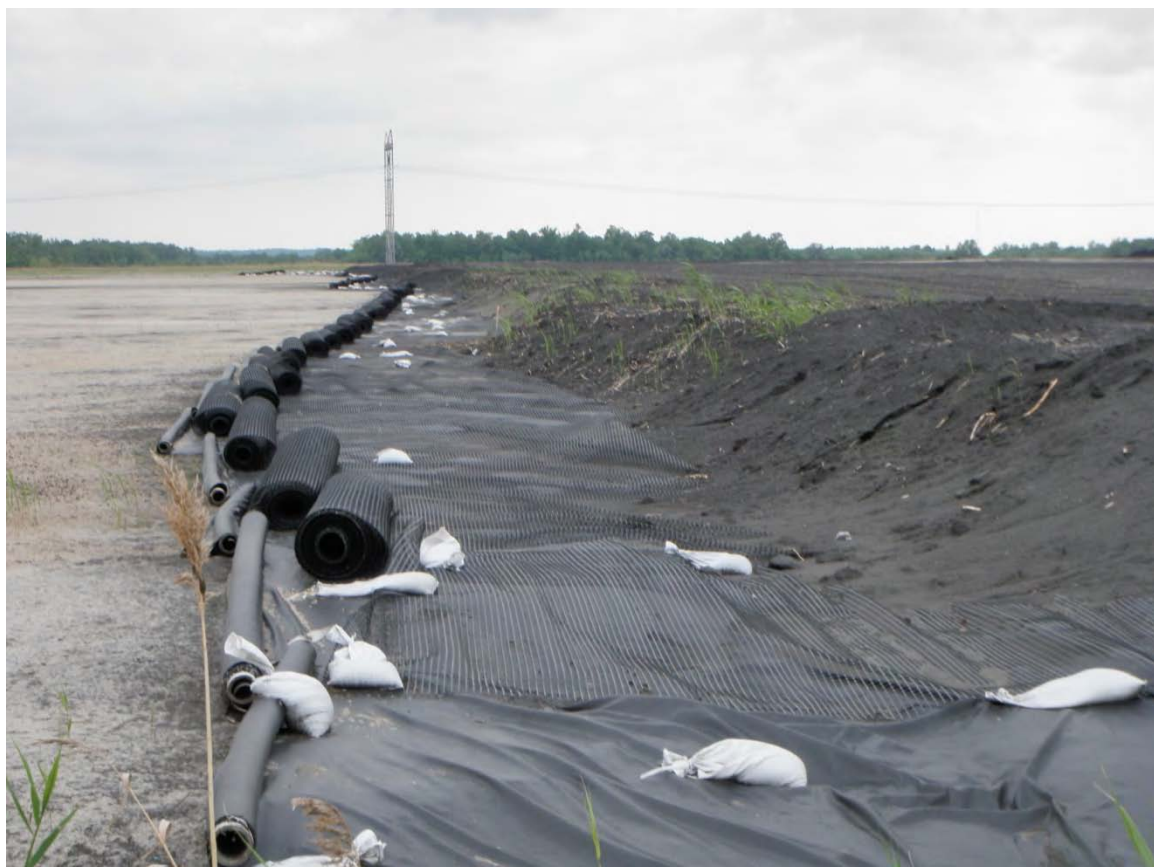
Photo 22: East Ash Pond #3 – EAP #3 capping construction, notice geofabric and geogrid, looking south from north dike.

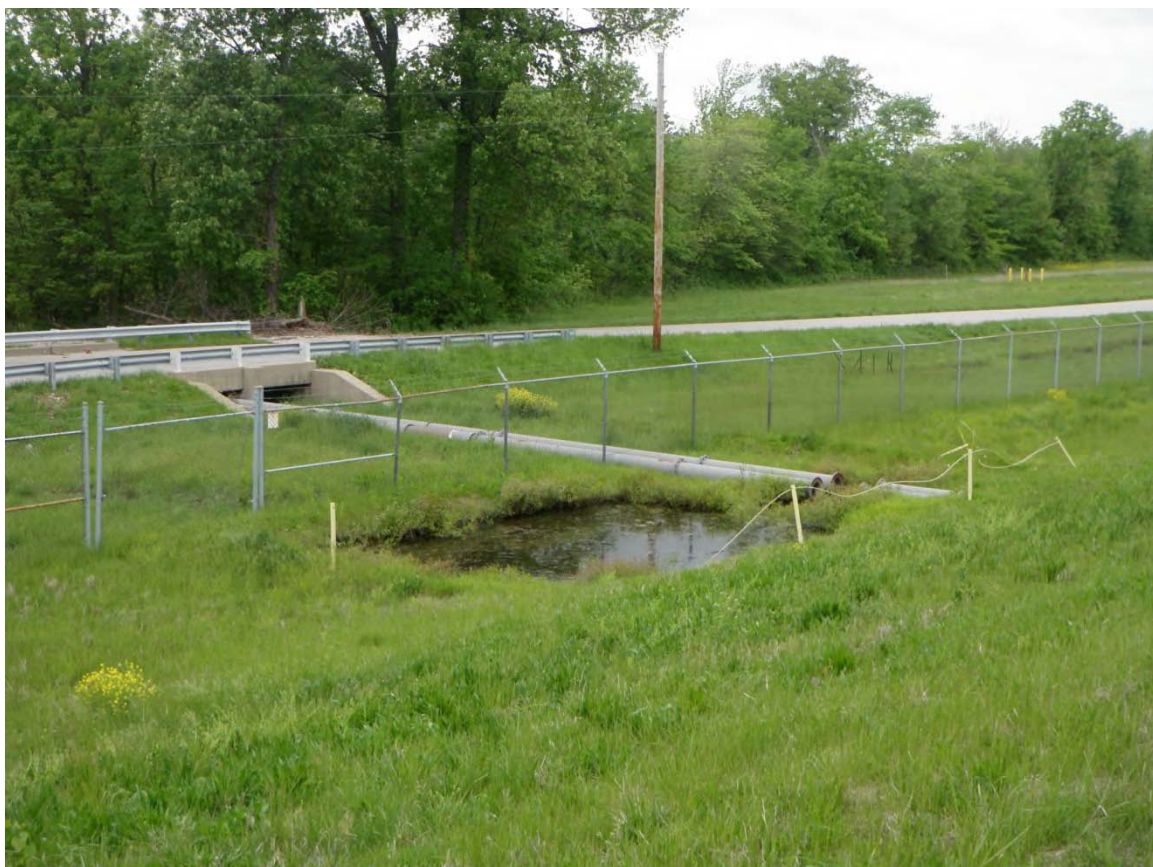
- A small excavated drain or sump pit was observed near the downstream toe of the west dike of East Ash Pond #2 (Photo 30). The excavated pit was previously used to drain the water from the dredge line out-of-service. The excavated pit could potentially initiate a seepage path through the foundation of the west dike if the area is not repaired.

Photo 30: East Ash Pond #2 - EAP #2 downstream slope, abandoned discharge lines and drainage sump, looking northwest.

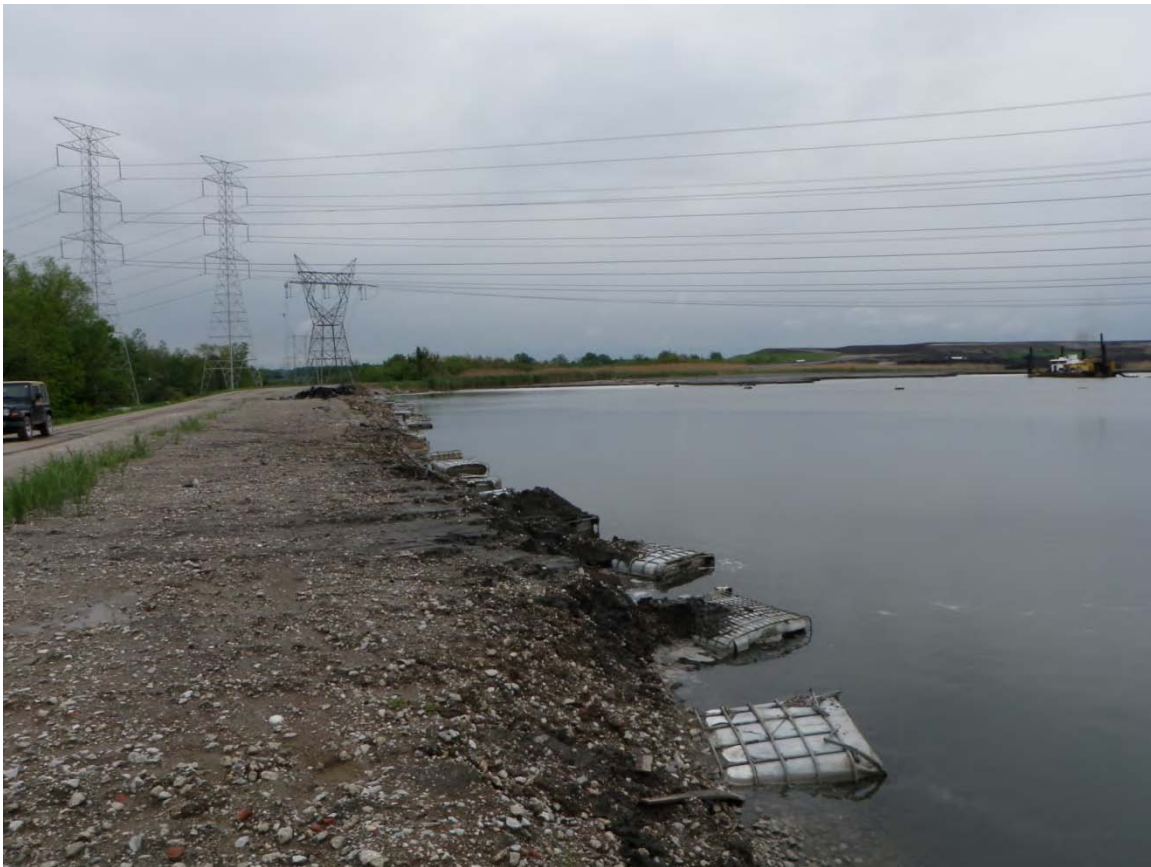
Photo 37: North Ash Pond – North Ash Pond reservoir area, looking east, notice upstream slope extended into reservoir.

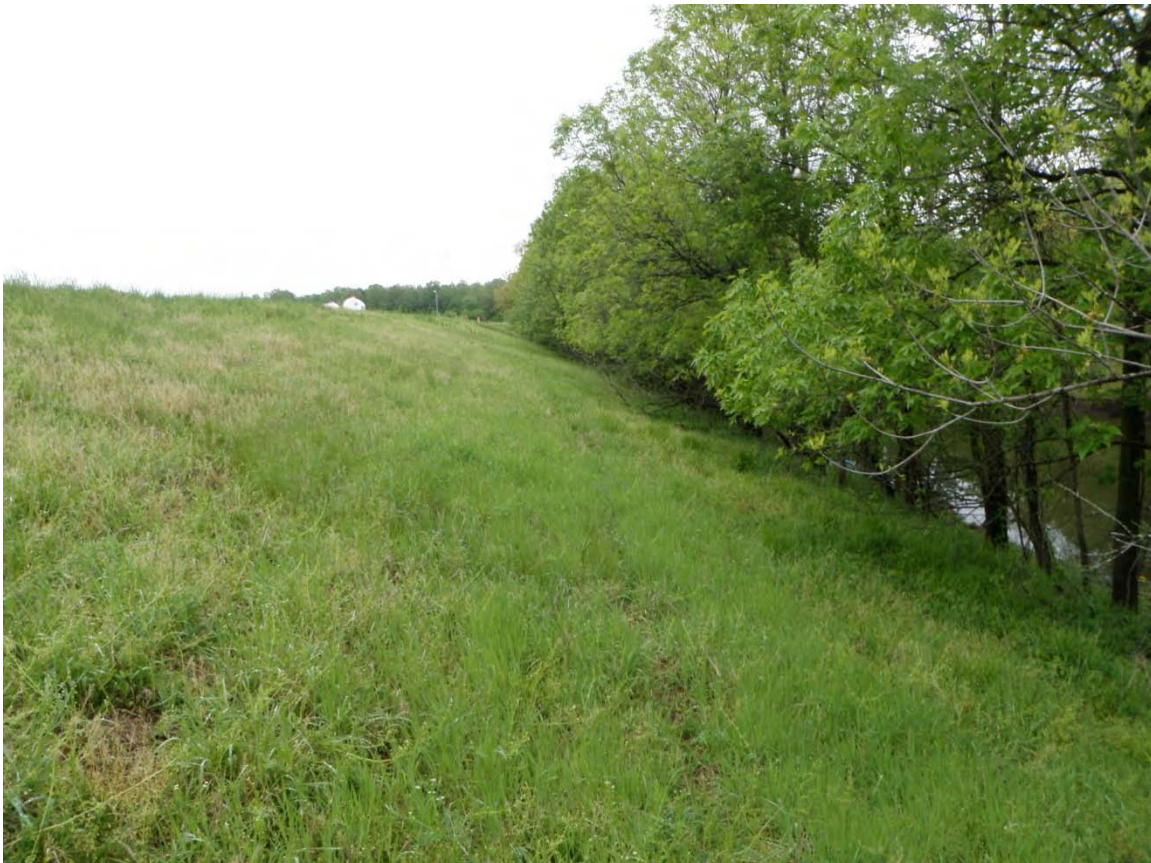
Photo 38: North Ash Pond – North dike downstream slope, looking west, notice large trees in wetland at toe of slope.
