Assessment of Dam Safety Coal Combustion Surface Impoundments (Task 3) Draft Report

Duke Energy Corporation

Miami Fort
Generating Station

North Bend, Ohio

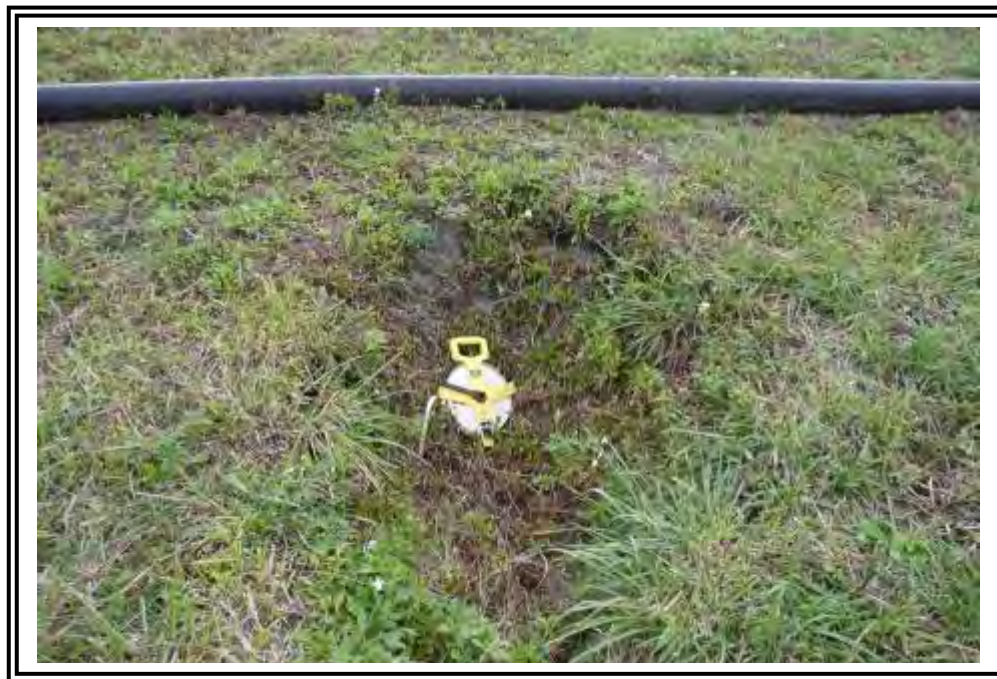
4

Erosion feature, Interior Dike Ash Pond B.

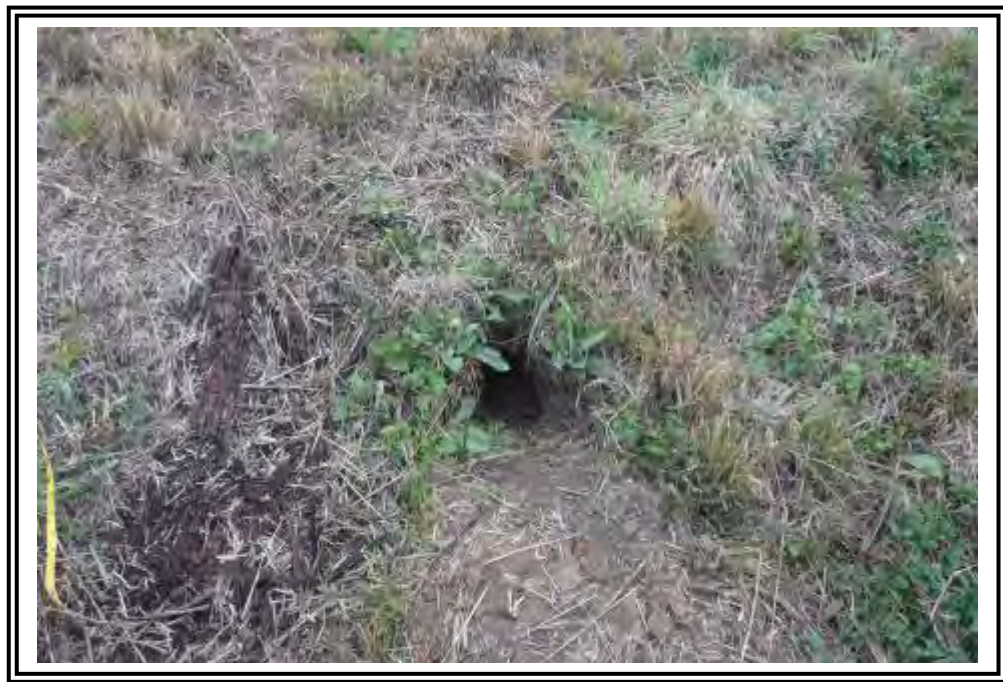
6

Rodent hole (typical).

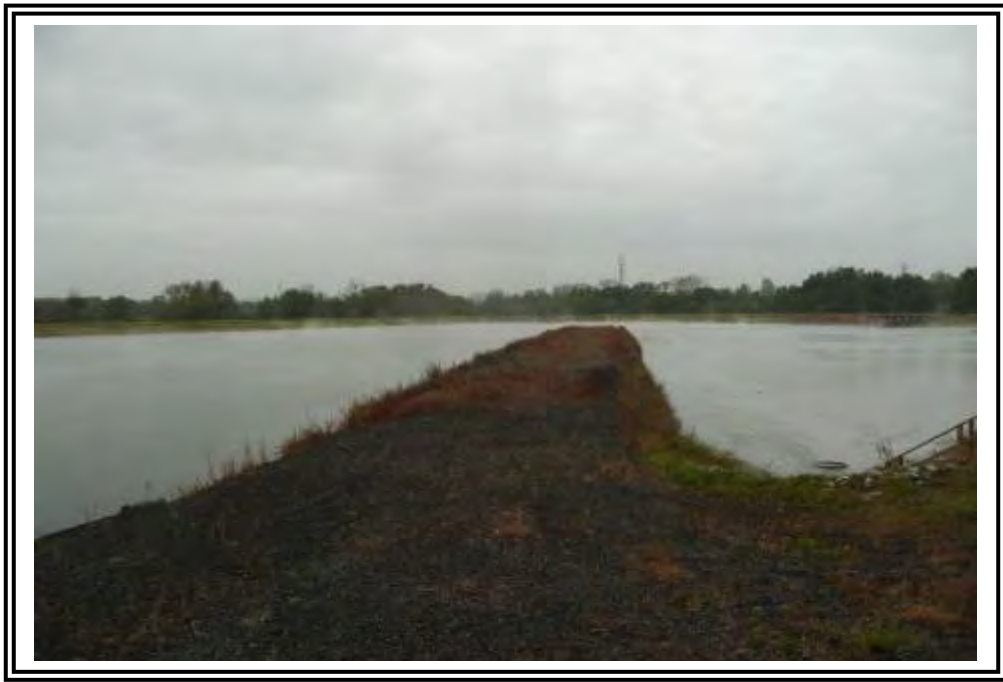
8

Interior groin in Ash Dike B. Feature not shown on plans.

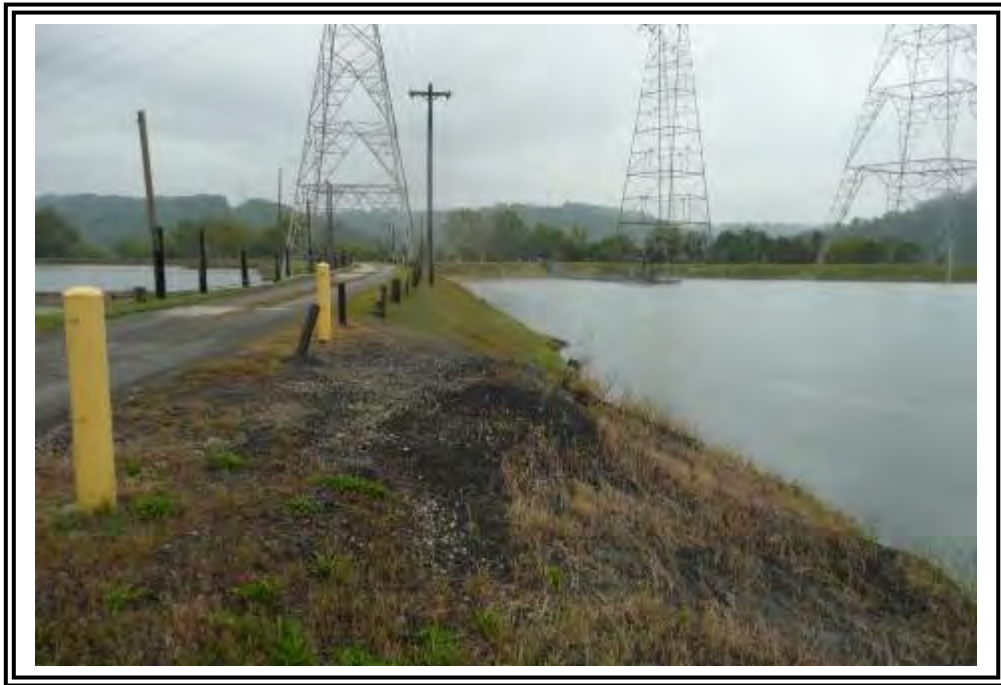
9

Loss of vegetation and erosion on Interior Dike.

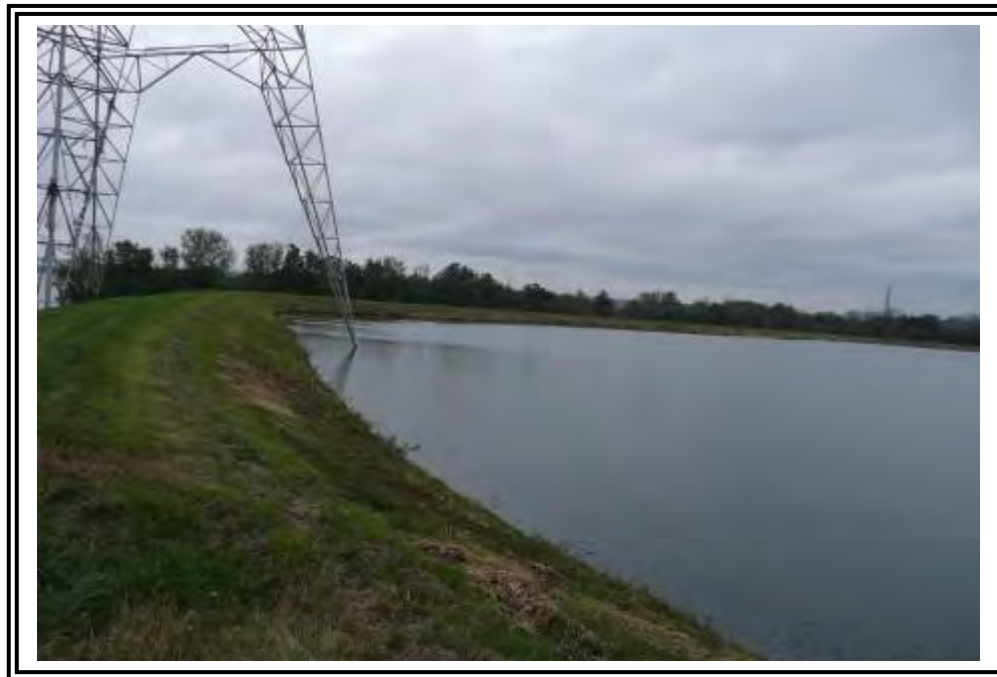
16

A key site feature dominating the southern, central and southern dikes of Ash Pond A and Ash Pond B are three electrical transmission towers. These features can be seen in Photos No. 3, 5, 9, 10 and 18. Their foundation elements penetrate the berms and in some case the bottom of Ash Pond B as seen in Photo No. 16.

Tower foundation at crest of embankment Ash Pond B.

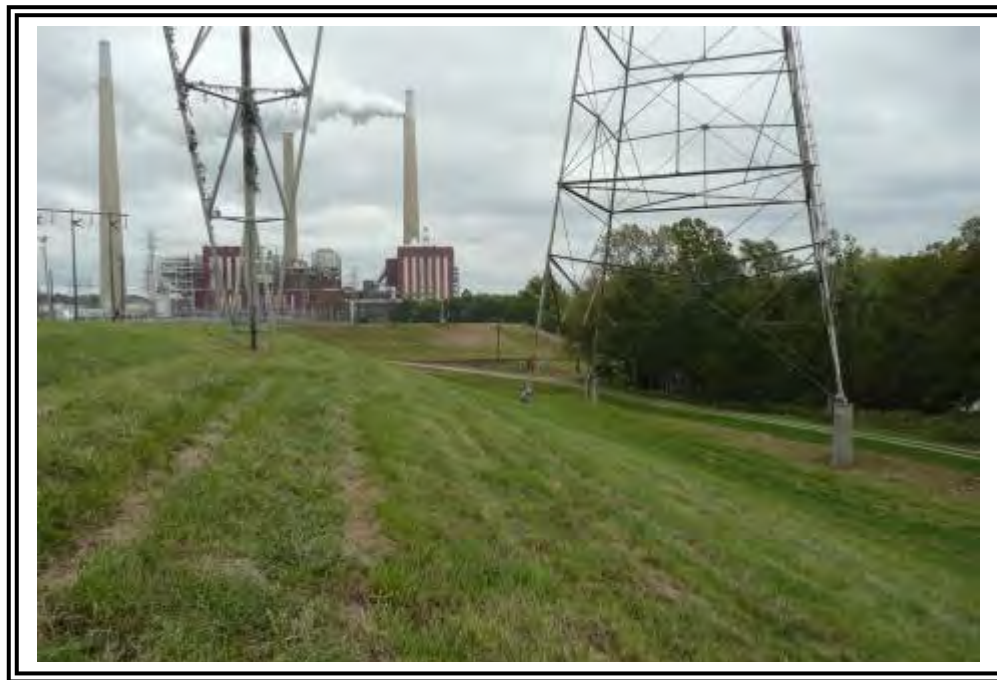
18

The south dike of Ash Pond B intersects the southwestern corner of Ash Pond A as shown in Figure 4. The dike along the south side of the Ash Pond B faces along the Ohio River and is about 36 feet in height. Both upstream and downstream slopes and the crest are vegetated. The crest is about 14 feet wide and generally does not appear to have vehicular traffic across it except for maintenance purposes. An electrical transmission tower straddles the crest of the dike with one foundation element in the pond and the other four legs within the embankment. This structure predated the construction of Ash Pond B. A second tower is located on the downstream face of the dike with one leg in the dike and the other three legs straddling the drainage swale at the toe. The transmission towers and their relationship to Ash Pond A and Ash Pond B can be seen in Photos No. 16, 17 and 18.

Tower foundations, looking east, South Dike Ash Pond B.

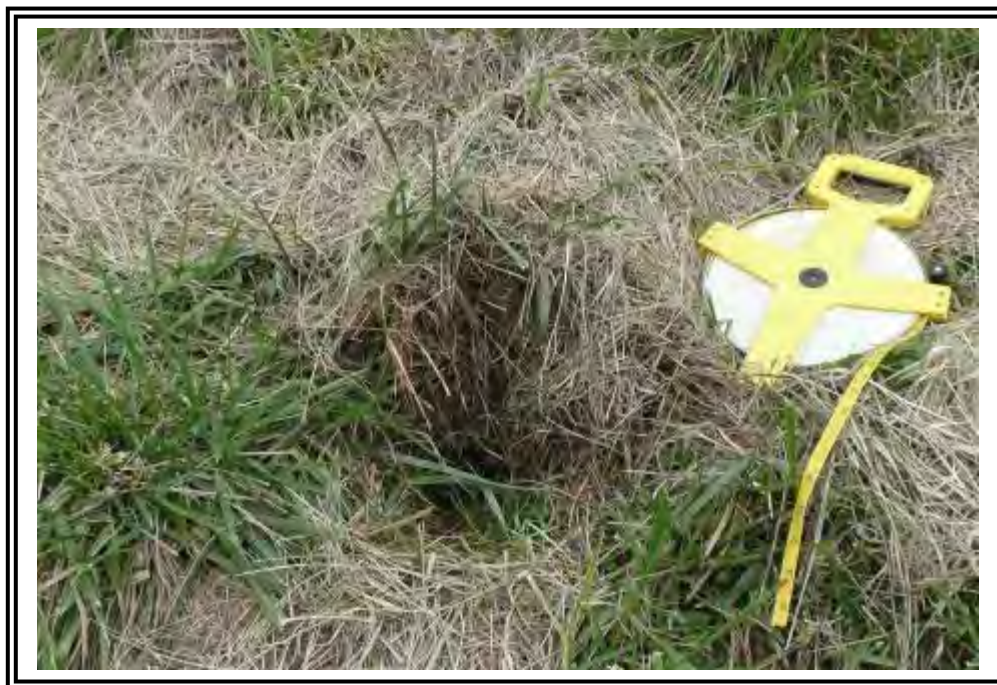
CHA performed visual observations of the western dike of Ash Pond B which can be seen in Photos No. 19, 20, 23, 24 and 25. The dike in this location is approximately 1,300 feet in length and up to about 45 feet high and has a typical crest width of 16 to 18 feet. The entire embankment is covered with grass and mowed at the time of the inspection. No erosion features were noted only a few rodent holes as seen in Photos No. 21 and No. 22.

Rodent hole (typical).

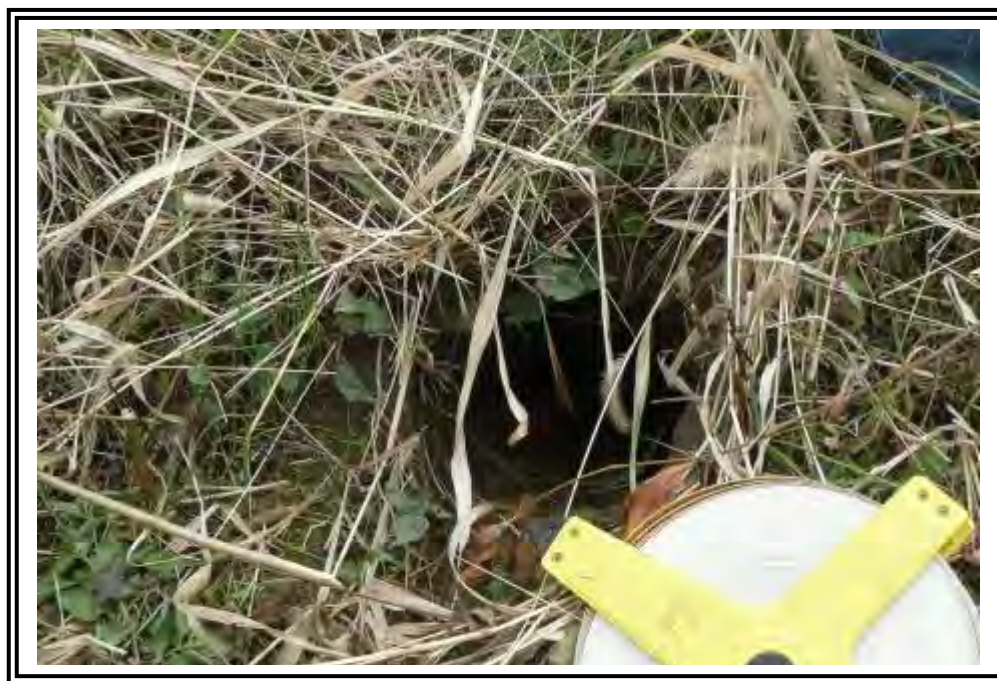
22

Rodent hole (typical).

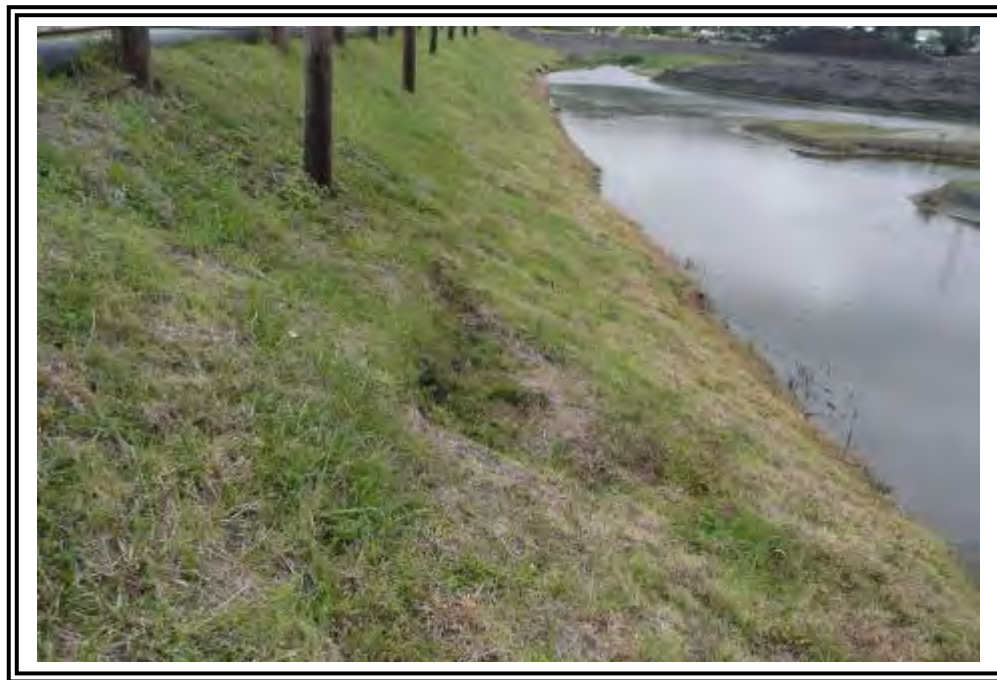
30

Sloughing along Interior Dike, Ash Pond A.

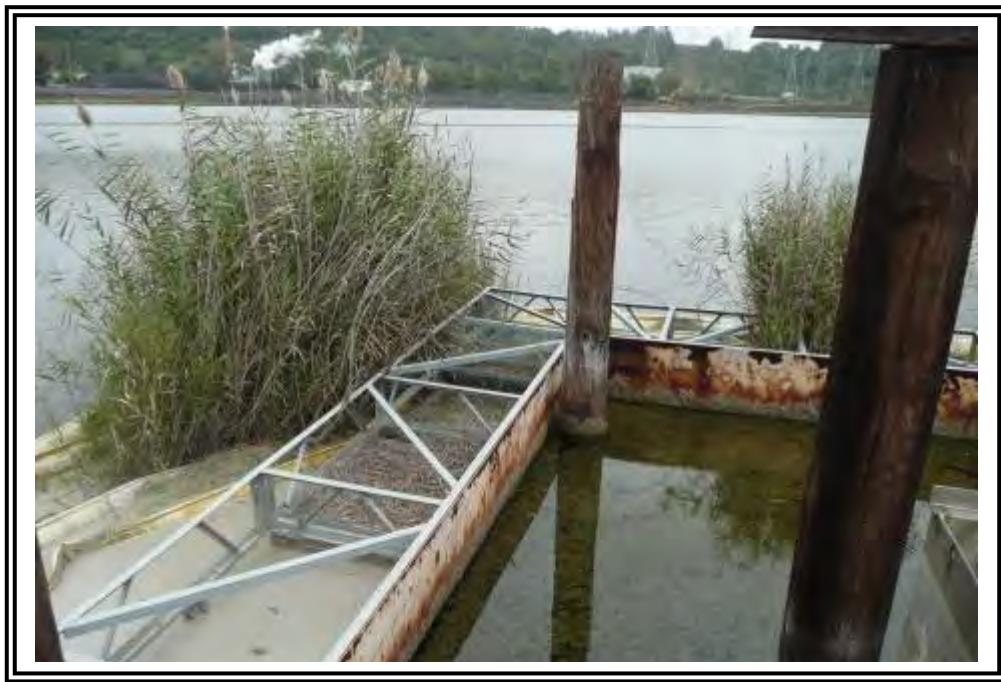
34

Vegetation build-up at Ash Pond A overflow structure.

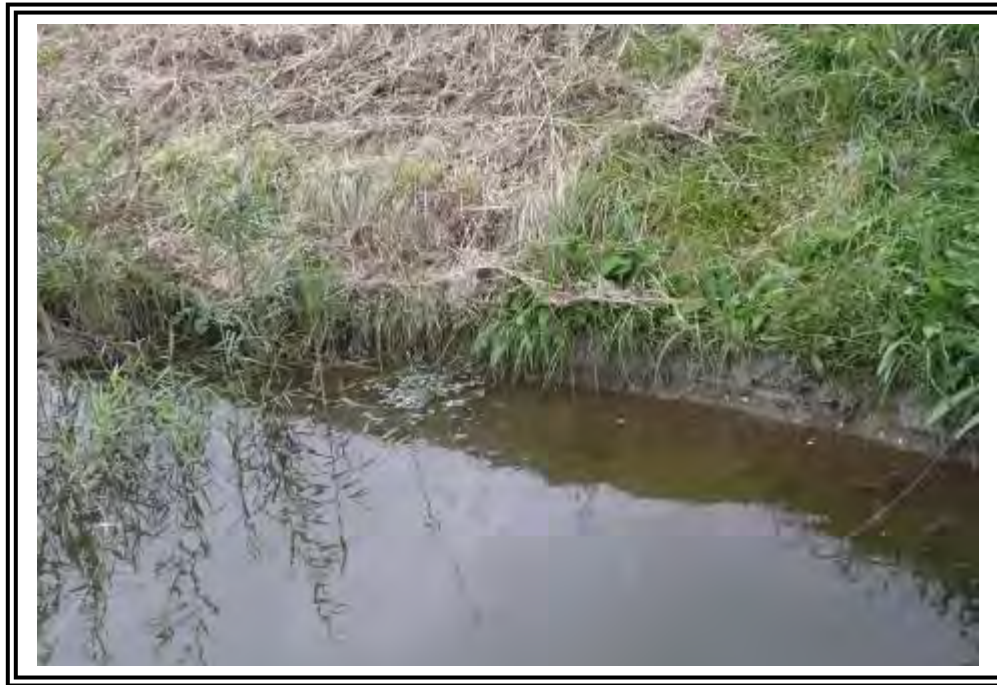
35

Vegetation build-up at Ash Pond A overflow structure.

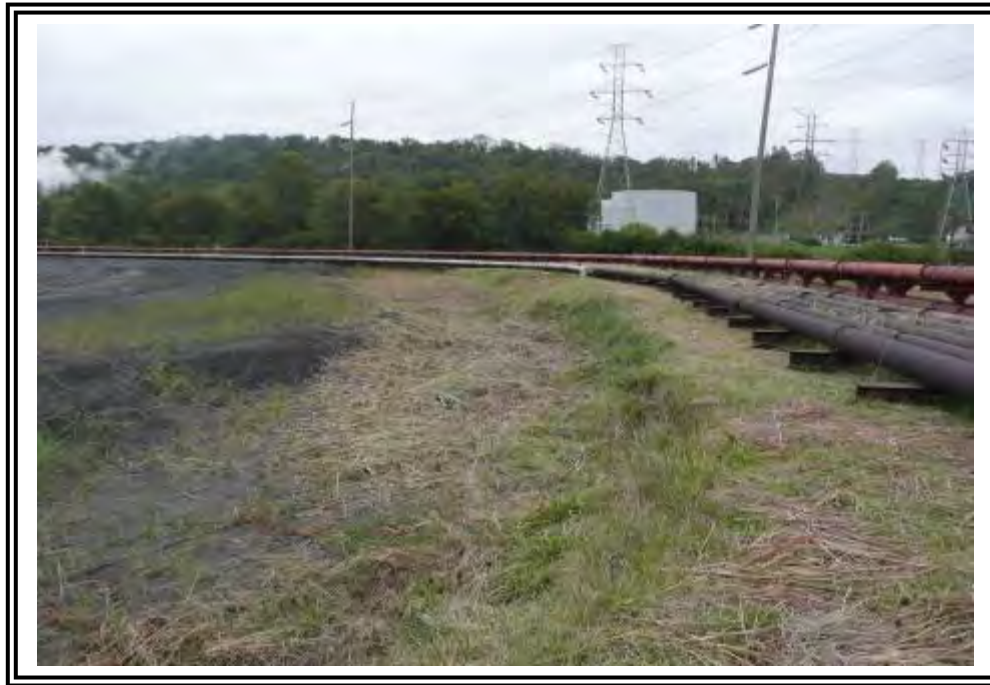
39

The embankment was noted to be in general good condition. Several erosion rills and surface sloughing due to over-steepened slopes were noted along the outside of the berm in particular in the northeast corner (Photo No. 39). Additional erosion was noted on the outside of the fence line.

Ash Pond A northeast corner.

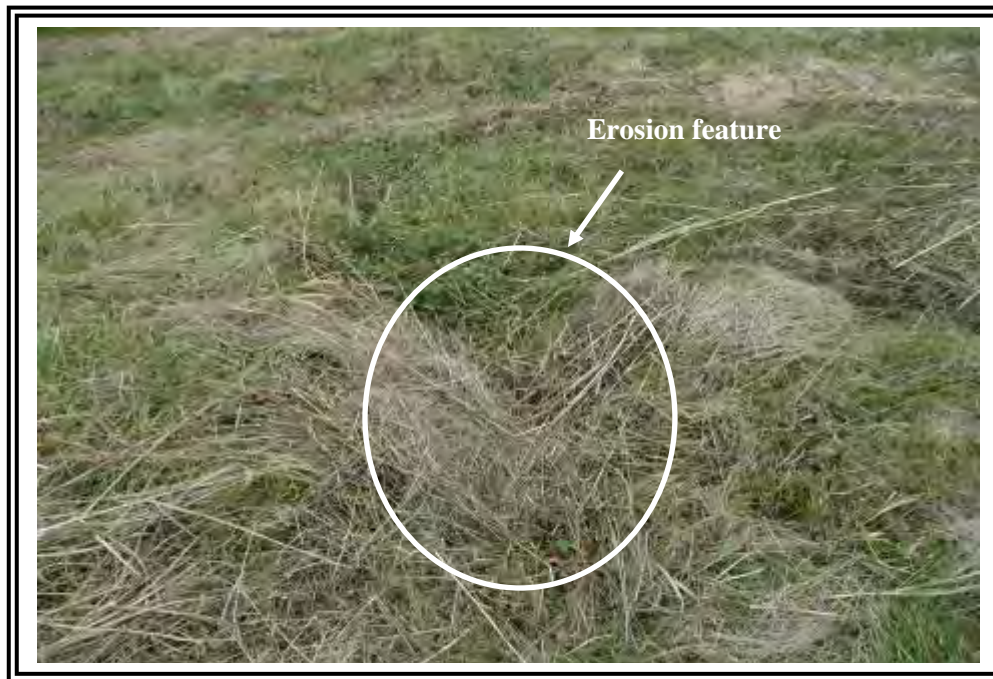
The north dike is predominantly a grass surfaced structure, with a pipe rack running its entire length towards Ash Pond B. The dike and pipe rack can be seen in Photos No. 40, 41 and 44. Occasional vehicular traffic uses the top of the dike outboard of the pipe rack as evidenced by Photo No. 41. Design drawings (Section D-D on Figure 3 indicates that this portion of the berm was not intended to support an access road as a gravel surface was not incorporated into the design. In general the embankment is in good condition. Several erosion features and surficial sloughing along the outside face of the berm were noted and in particular in the northeast corner of the pond. These features can be seen in Photos No. 42 and No. 43. Several rodent holes were also noted in the northwest corner.

Ash Pond A erosion feature, northeast corner.

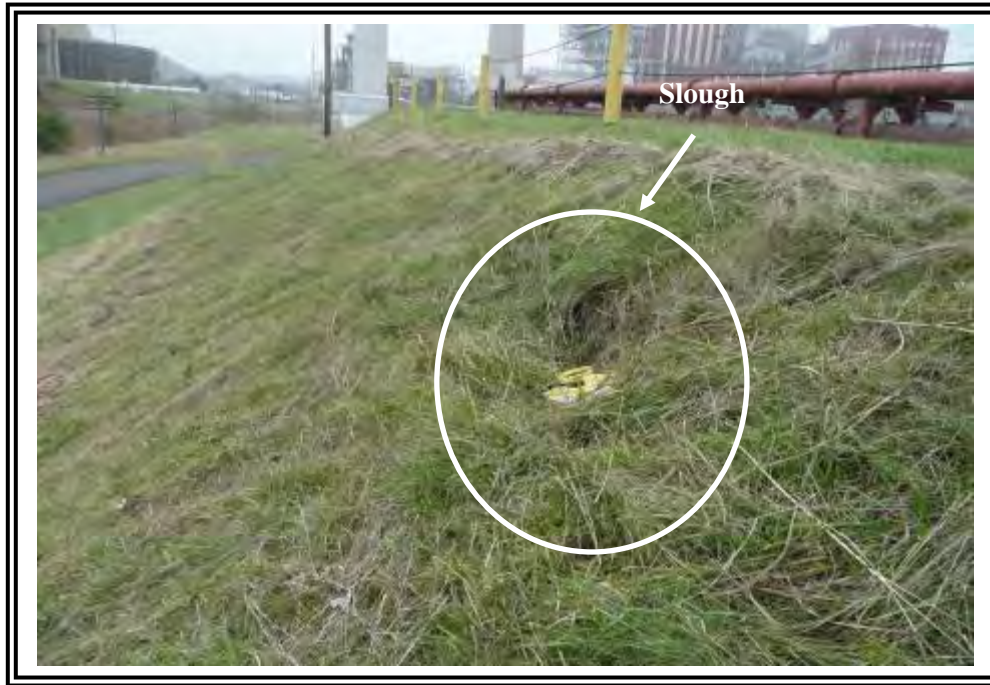
43

Ash Pond A slope slough, north slope.

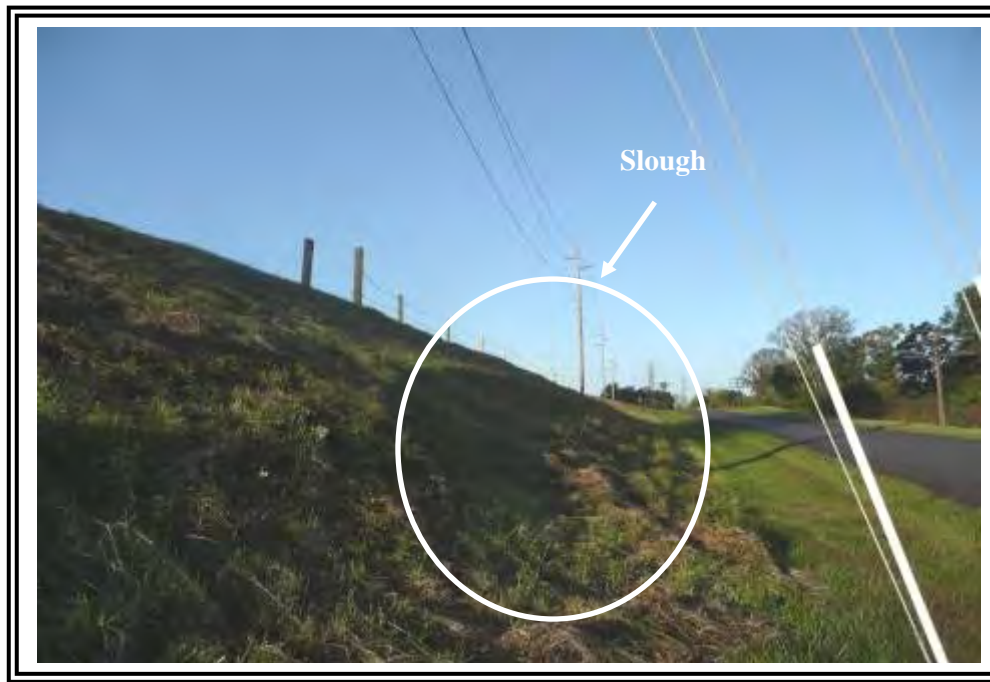
44

Ash Pond A slope slough, north slope.

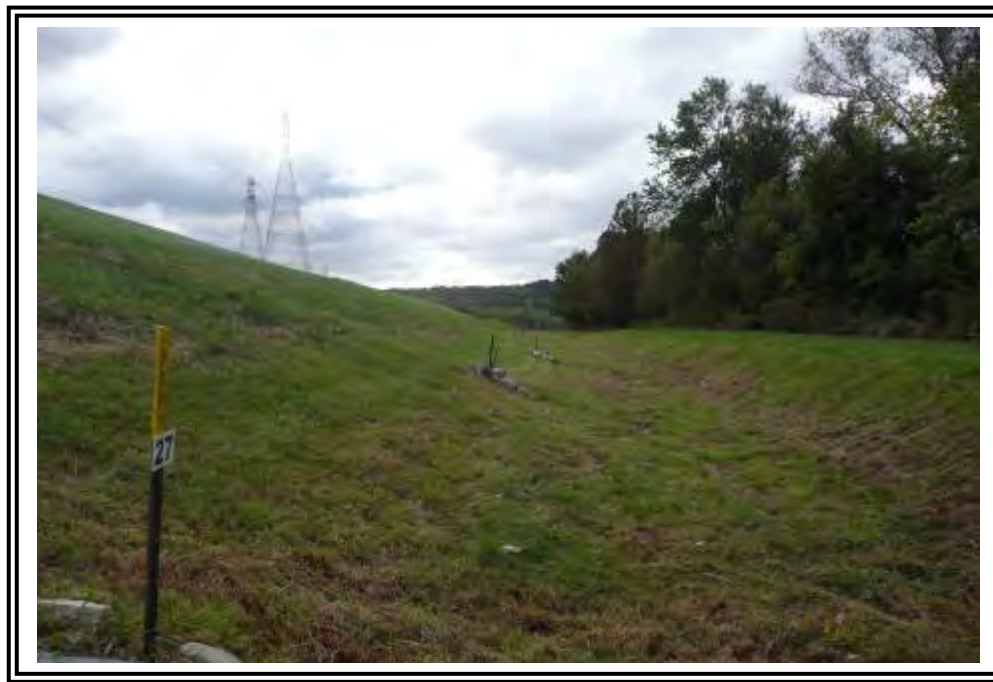
46

The line of outlet pipes extending from the toe drains extending from the toe drains can be seen in Photo No. 46. In addition the same photo demonstrates an area of standing water that is typical of the drainage swale along the west side of the dike. Most of the water appeared at the time to be related to surface runoff and inadequate grading in the swale from recent rainfall events. Most of the toe drains, though active had little flow activity during the site visit. The seepage the toe drain conveys to the drainage swale was clear. It was reported that Duke is reviewing the potential to improve the drainage in this area as well as connect the toe drains for possible collection and recirculation into the ash pond to address environmental concerns.

Ash Pond B toe drains, West Dike.

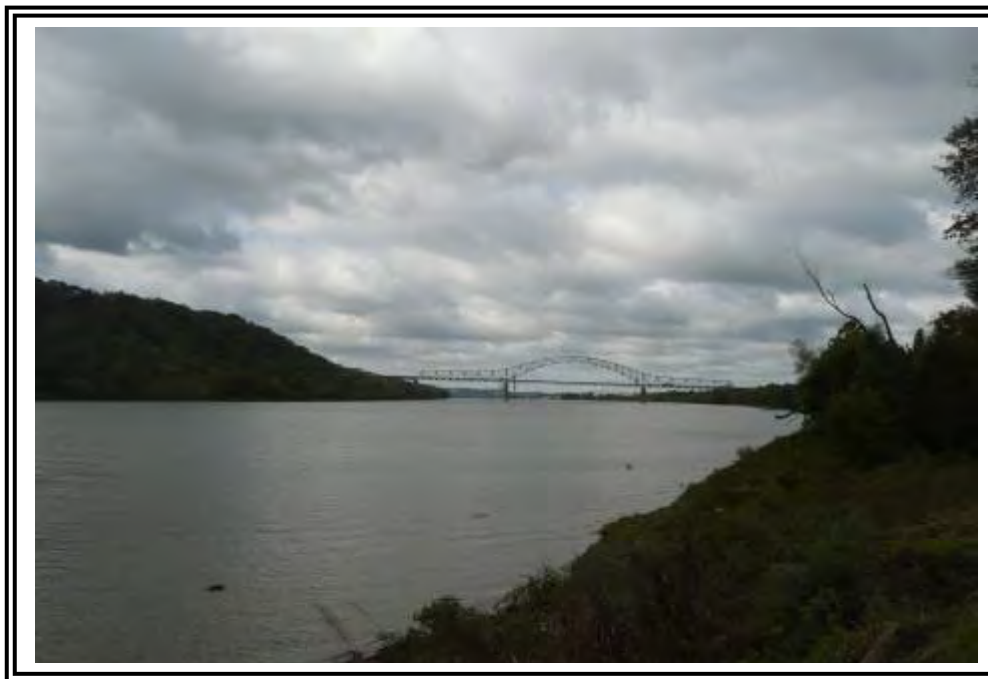
48

No unusual slumps, bulges or erosion features were noted on the south facing slope leading to the Ohio River. The water front area may be seen in Photo No. 48. The dike toes at the high water mark of the River do not have any rip-rip or armor protection against seasonally high water conditions.

Ohio River waterfront adjacent to Ash Pond B.
